ARGONNE NATIONAL LABORATORY
9700 South Cass Avenue
Argonne, Illinois 60439

DECONTAMINATION AND DECOMMISSIONING
OF THE ARGONNE NATIONAL LABORATORY
BUILDING 350 PLUTONIUM FABRICATION FACILITY

FINAL REPORT

February 1985

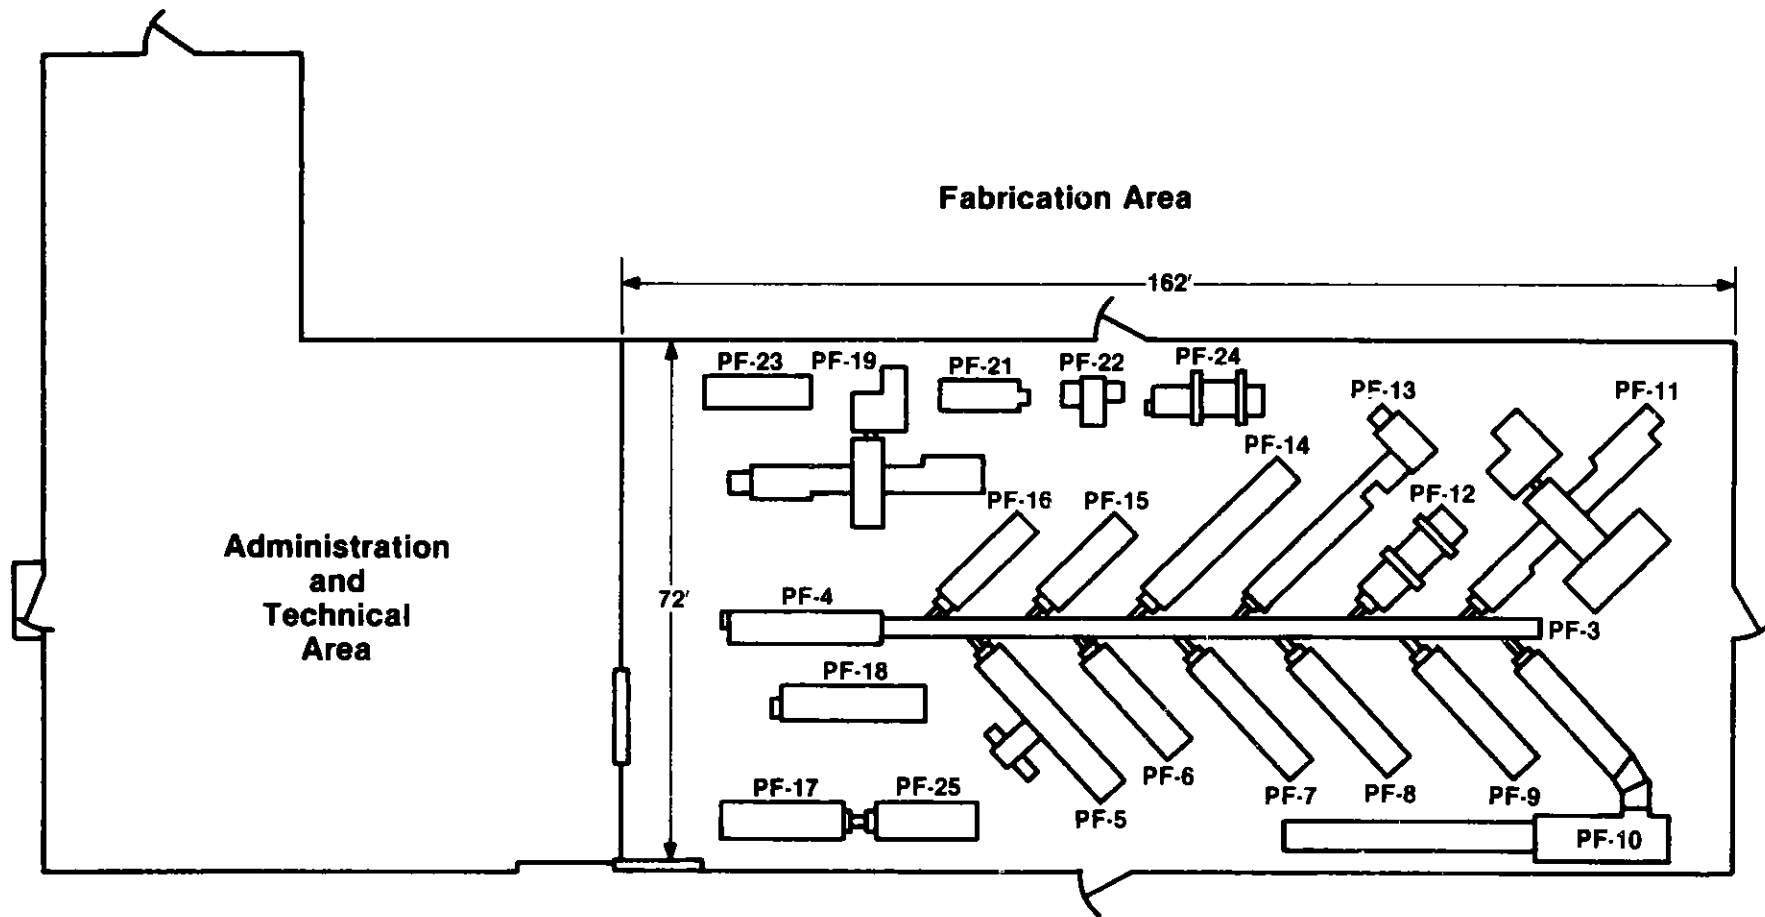
Figure 2-1 Building 350 Original Floor Plan

The PFF was housed in a concrete building 75 meters (245 feet) long by 25 meters (72 feet) wide by 8 meters (25 feet) high and had a service floor extending 4 meters (12 feet) below grade. It was divided into an Administration and Technical Area and a Fabrication Area (Fab Area) with all of the gloveboxes being in the latter location as shown in Figure 2-1.

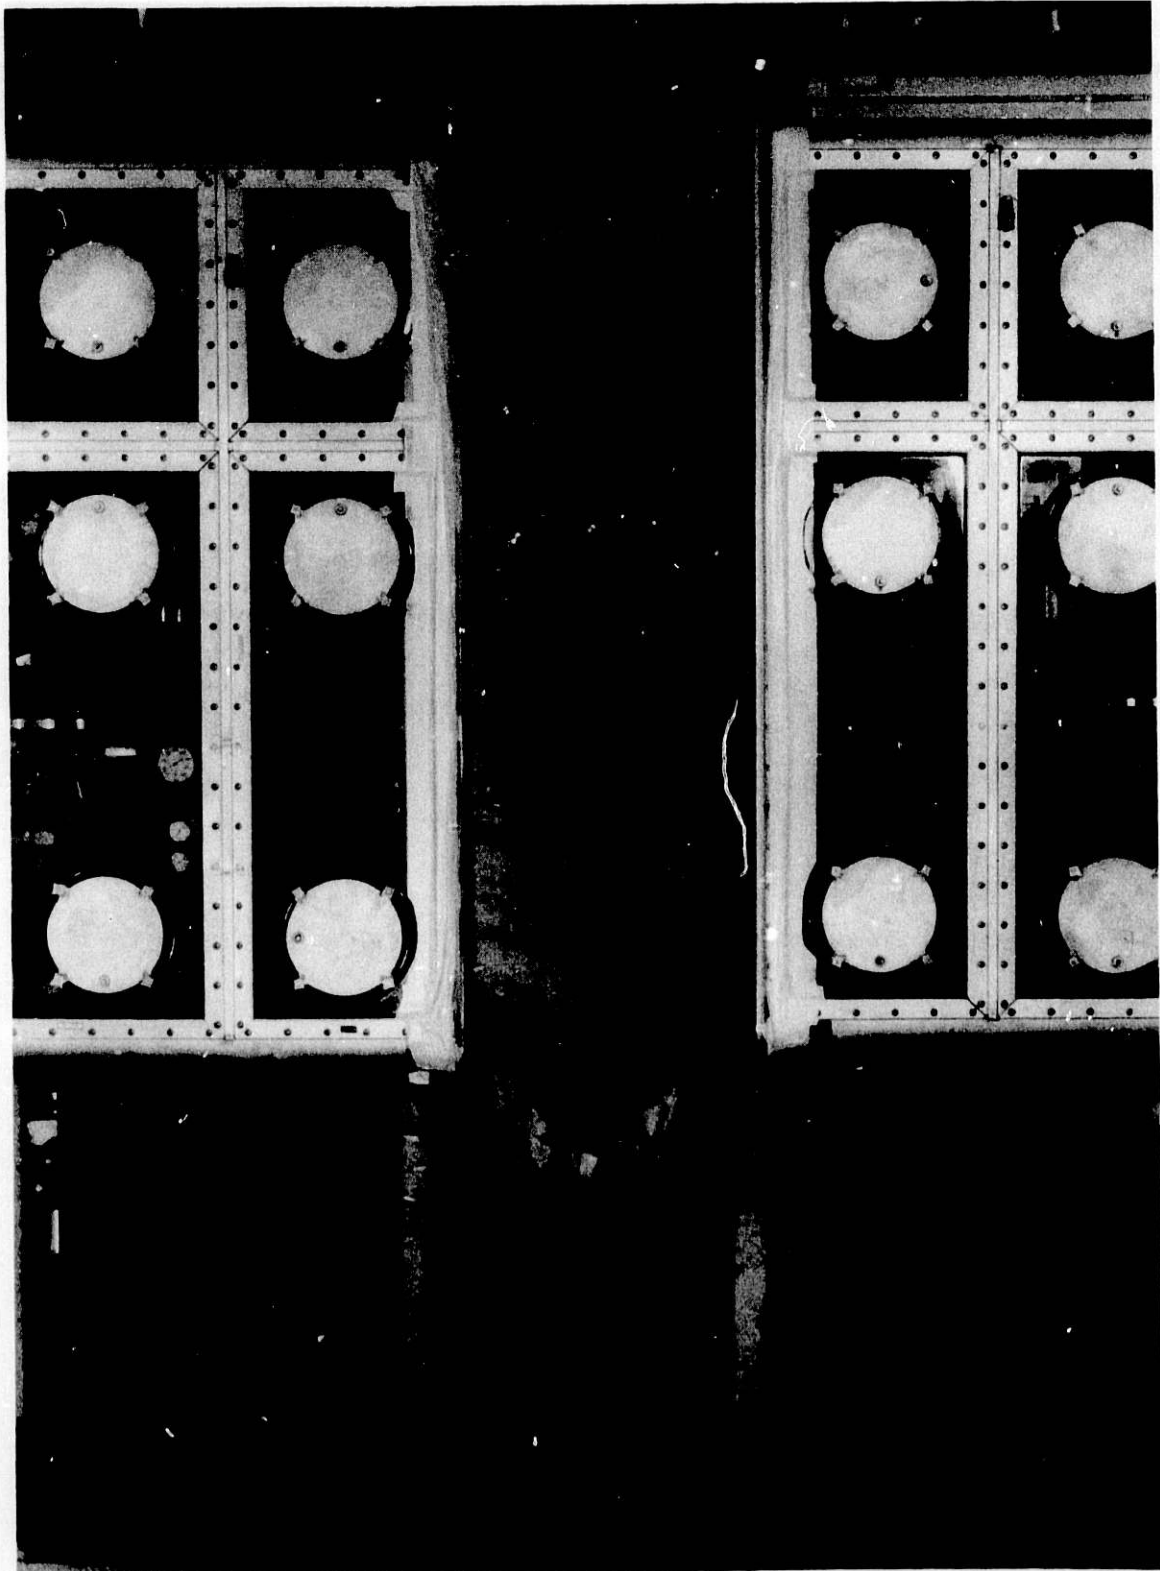
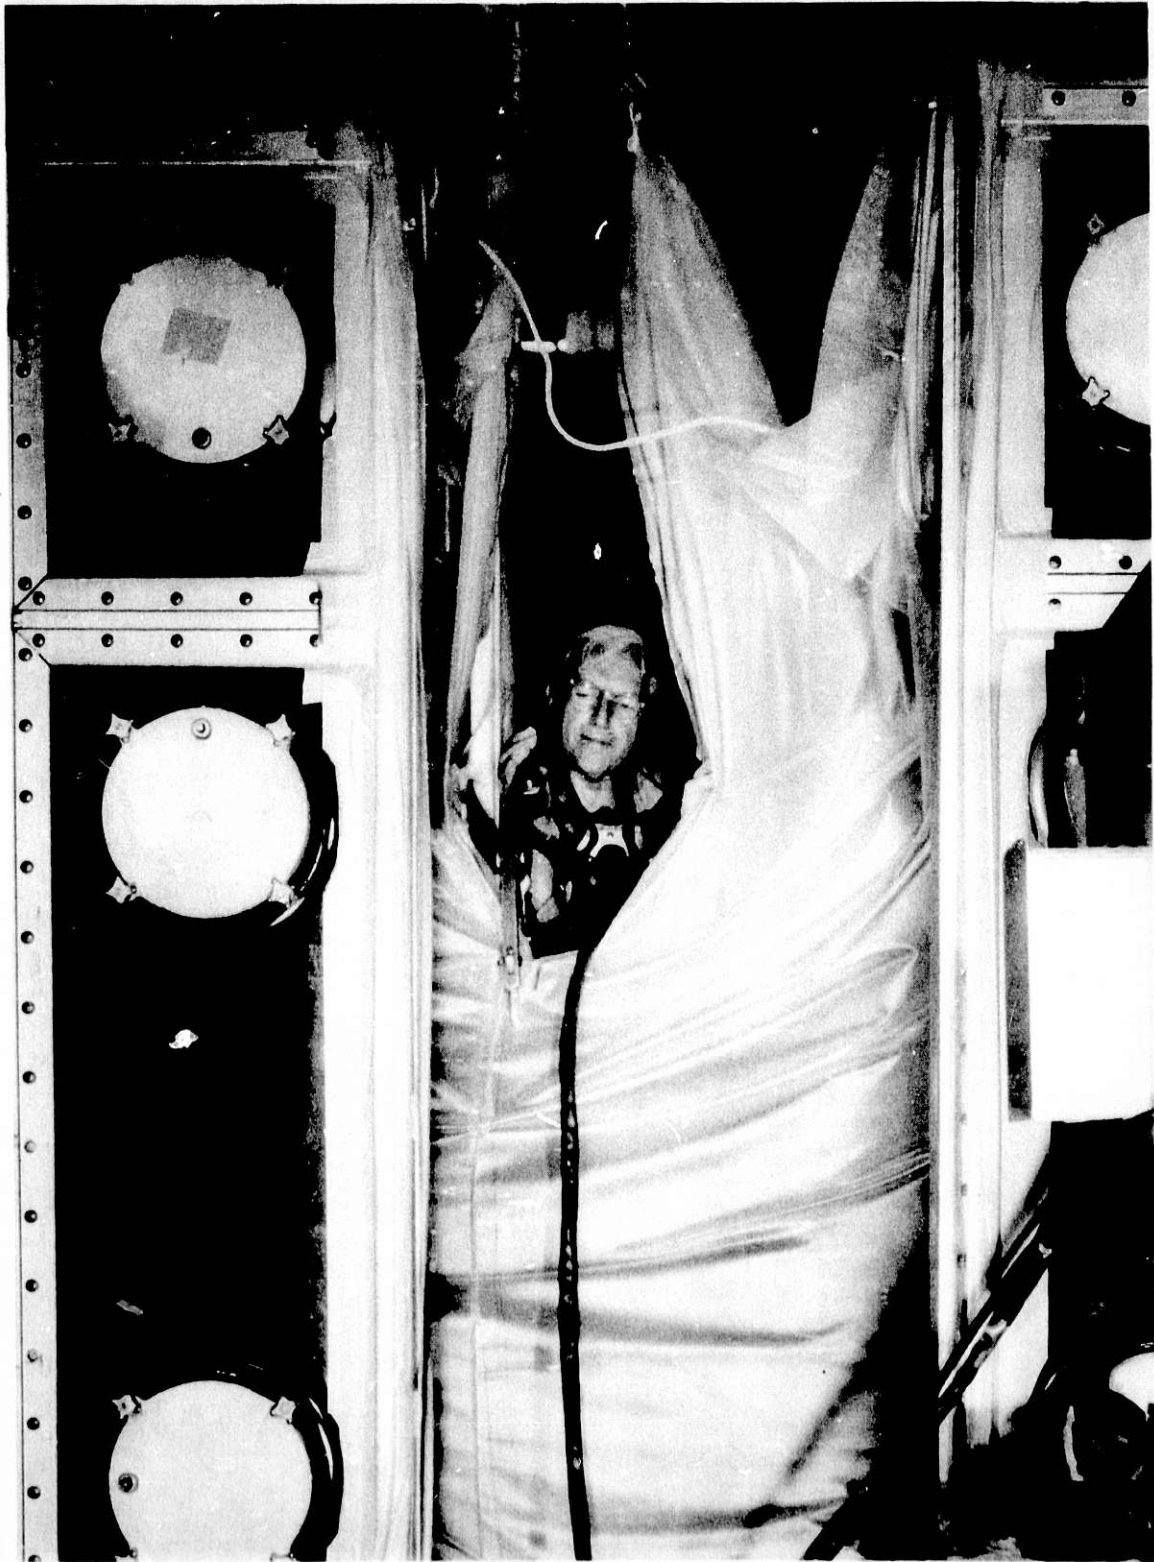
With the completion of those steps, the glovebox was then separated into short lengths, normally 2 meters (6 feet) long, utilizing the bolted-together, flanged, modular design and employing a previously developed plastic pouch and heat-sealing technique (Figures 4-4 thru 4-8). This modular method of glovebox construction, which was not actually developed to simplify or aid decommissioning work, proved to be extremely fortunate as it permitted the hood lines to be disassembled rather than cut with a saw, and it resulted in small units that could be easily handled and transported. Following separation, the individual module, as well as any other components needing size reduction, were placed into a temporary plastic enclosure connected to a double HEPA-filtered exhaust system. Inside this tent, which served to control the spread of contamination, workers equipped with disposable protective clothing and supplied air, disassembled and mechanically cut each item using portable bandsaws, reciprocating saws and/or nibblers so that the resulting pieces would fit into the standard 1.2 X 1.5 X 1.8 meters (4 X 5 X 6 feet) high ANL M-III bin. No flame cutting could be employed due to the combustible nature of the plastic enclosure.

Figure 4-4 Glovebox Prepared for Separation

Figure 4-5 Separated Glovebox Prior to Heat Sealing Pouch

Figure 4-6 Heat Sealing Glovebox Separation Pouch

Figure 4-7 Glovebox Separation Complete

Figure 4-8 End View of Separated Glovebox

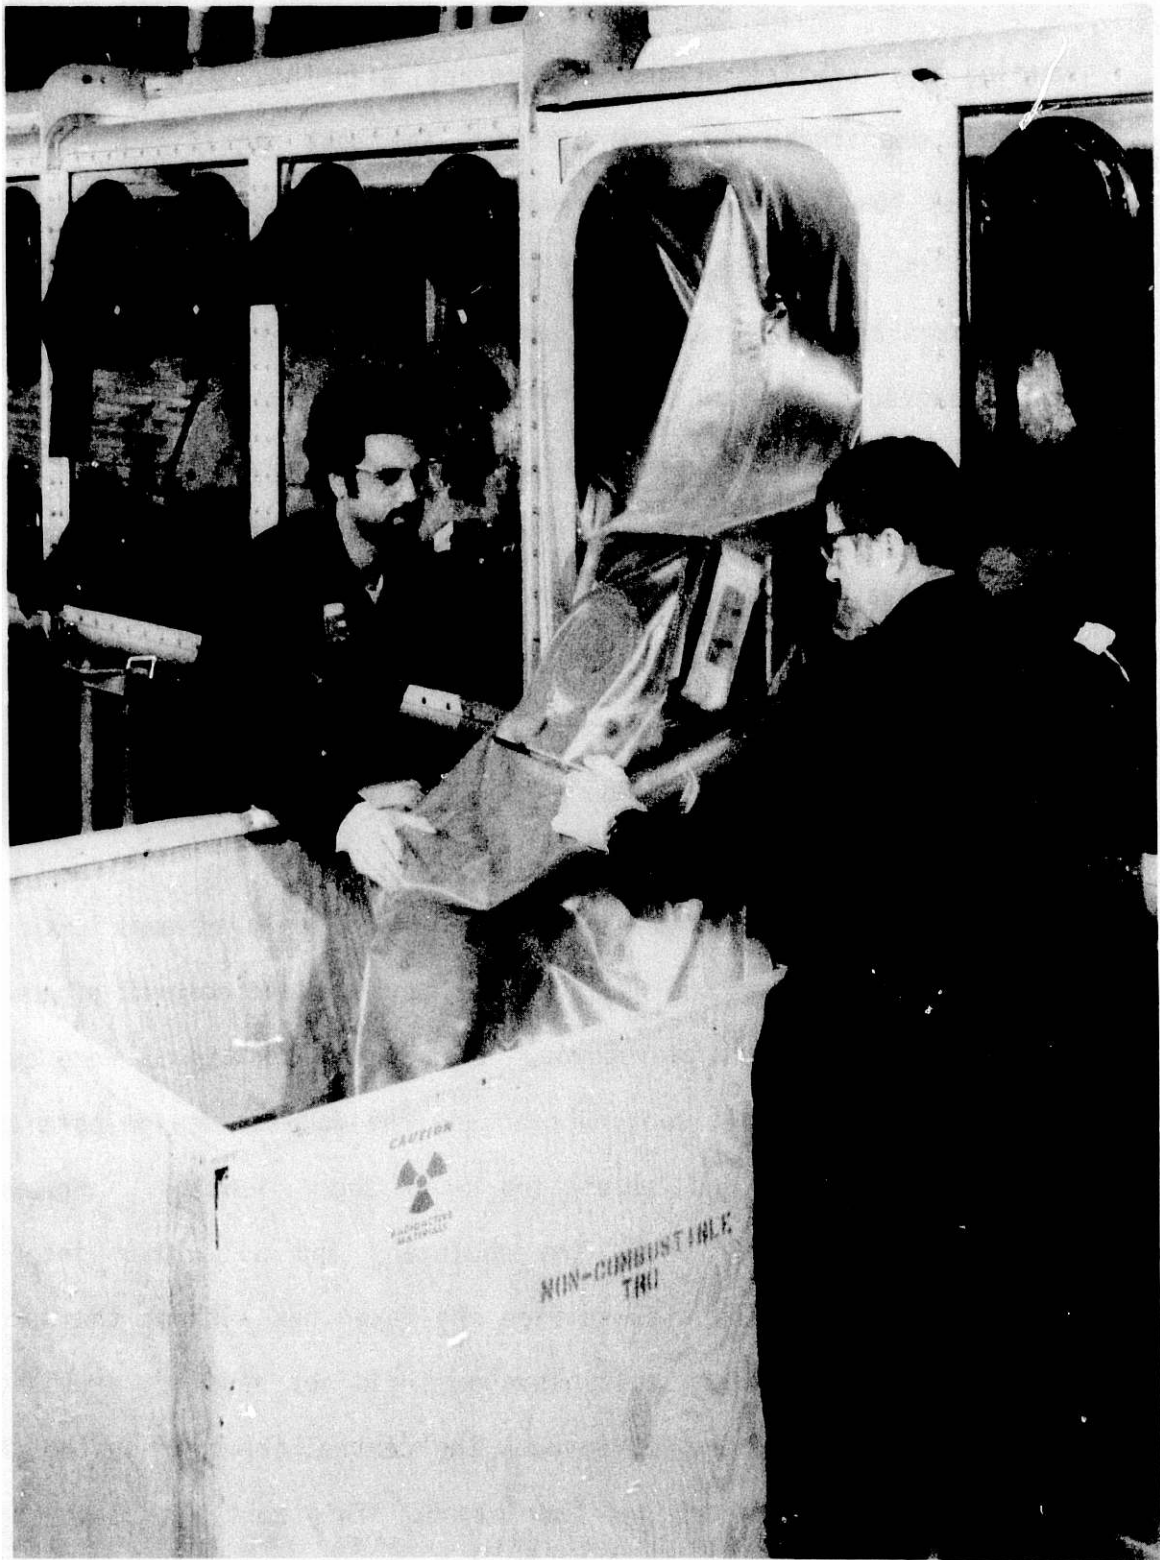
Figure 4-11 Bagging Waste Out of a Glovebox

Through visual observation, it became immediately evident that the first problem to overcome would be the handling and removal of equipment housed within the gloveboxes. Even though most boxes were quite long, the nut-and-bolt construction and the modular design permitted simple disassembly and separation into short lengths. However, before this could be done, the equipment and all other interior apparatus needed to be disassembled and taken out without the spread of contamination. Since most gloveboxes did not have any provisions for material removal except through the central-conveyor system (PF-3), a large bag-out port was fabricated. This port was designed to replace a window and was moved from glovebox to glovebox as the need

arose (Figure 4-11). It had an opening of about 76 cm X 100 cm (30"X 39") and utilized a .5mm (20-mil) thick plastic bag which was held in place on the clamping ring with several layers of tape. The sealed end of the pouch was placed directly into the half-wood liner and large and small items alike were then carefully moved from the glovebox into the bag contained in the liner. When filled, the pouch was dielectrically triple sealed and cut off from the portion still attached to the window (Figure 4-12). The waste then was fully enclosed in plastic which provided the barrier to prevent the escape of any radioactivity. Often a fork truck equipped with an extending boom (Figure 4-13) was used to assist in the removal of heavy components that could not be easily handled through the gloves. A system of eyebolts, eyenuts, washers, clevises, and steel cable passing through the plastic pouch (Figure 4-14) permitted bag out of items weighing as much as 325 kilograms (700 pounds). While the basic bag-out technique is universally used in connection with glovebox work, the development of these modifications and enhancements are unique and proved very successful in solving many of the problems associated with the handling of large and heavy components.

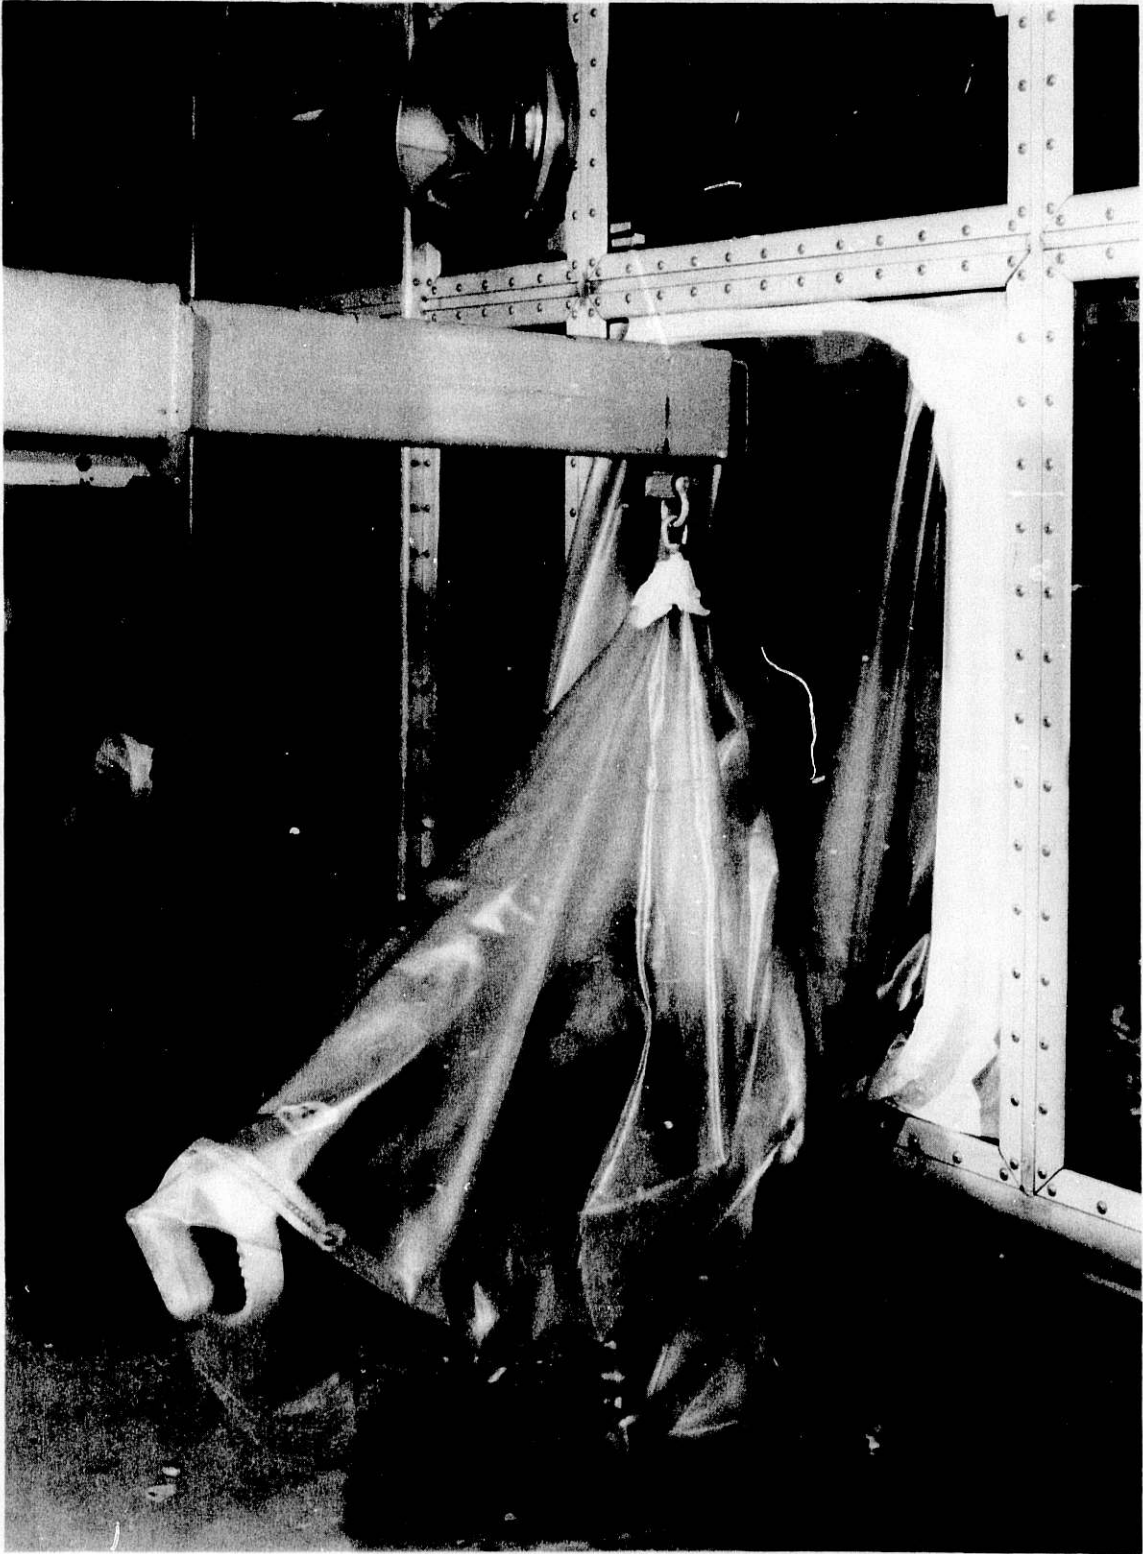
Figure 4-13 Waste Removal Assisted by a Fork Truck Boom

Figure 4-14 Rigging System for Lifting Heavy Items
When Fork Truck Boom Is Assisting

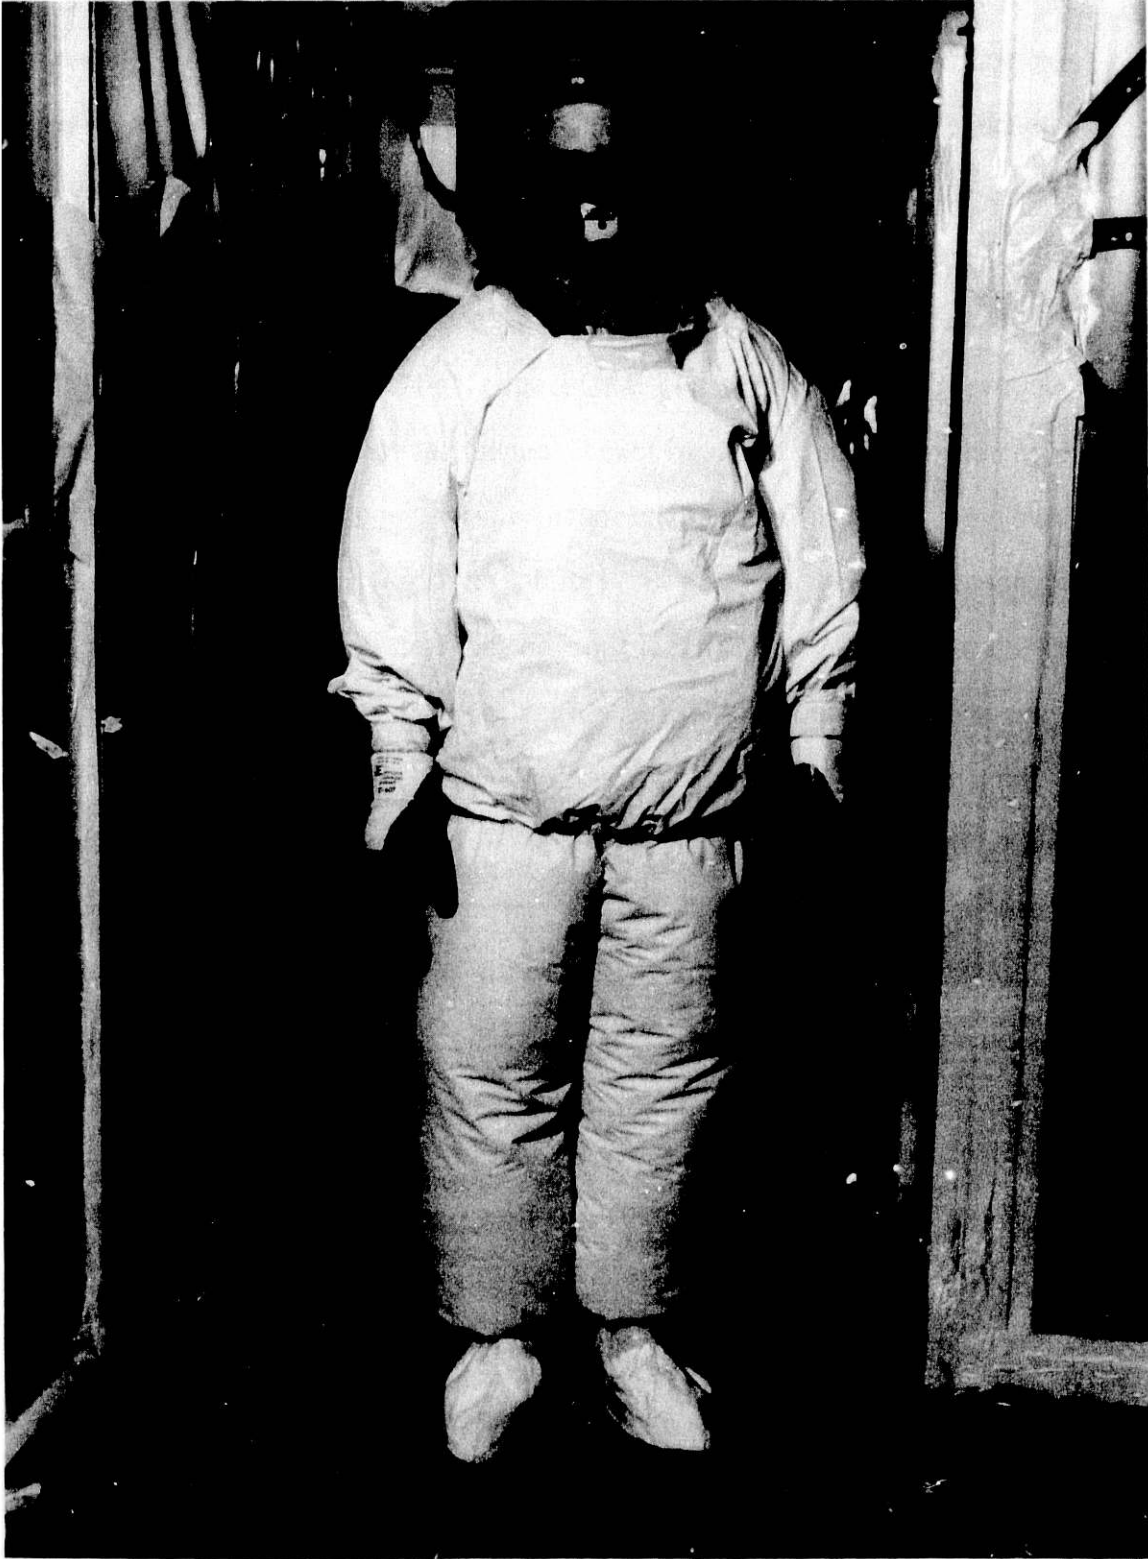
needed. Again the Rocky Flats people were consulted and, using their expertise as well as much of their apparel, which was obtained by purchase order, a system of protection was developed and tested to the satisfaction of the ANL Occupational Health and Safety Division. It consisted generally (Figure 4-26) of several layers of disposable clothing, shoe covers and gloves; a reusable NIOSH-approved, commercially available supplied-air respirator; and communication devices that allowed conversation between all personnel involved in the tent entry both inside and outside the enclosure. Compressed house air was utilized for breathing and it was supplied to workers through a distribution center designed by Rocky Flats from whom it was purchased. This portable unit (Figure 4-27) contained pressure alarms, flow-monitoring devices, auxiliary battery power, and the communications amplifier. It was connected to both house air as well as bottled air which served as a backup in case of a compressor failure. The house air supply was routinely analyzed for purity in accordance with prescribed standards.

The protective clothing system underwent several trials in an environmental chamber using DOP as a test media and, after a few modifications, the data obtained indicated that the protection factors achieved fulfilled safety requirements. Personnel were then repeatedly trained in the proper methods of dressing and undressing before actually entering a contaminated atmosphere. Removal of the used, disposable clothing, which was always left inside the tent for pickup by the next crew to enter, took place at the doorway of the work area and the personnel iso-room under the guidance and assistance of a Health Physics technician.

Figure 4-26 Worker Dressed for Tent Entry

Figure 4-27 Supplied Air Distribution System

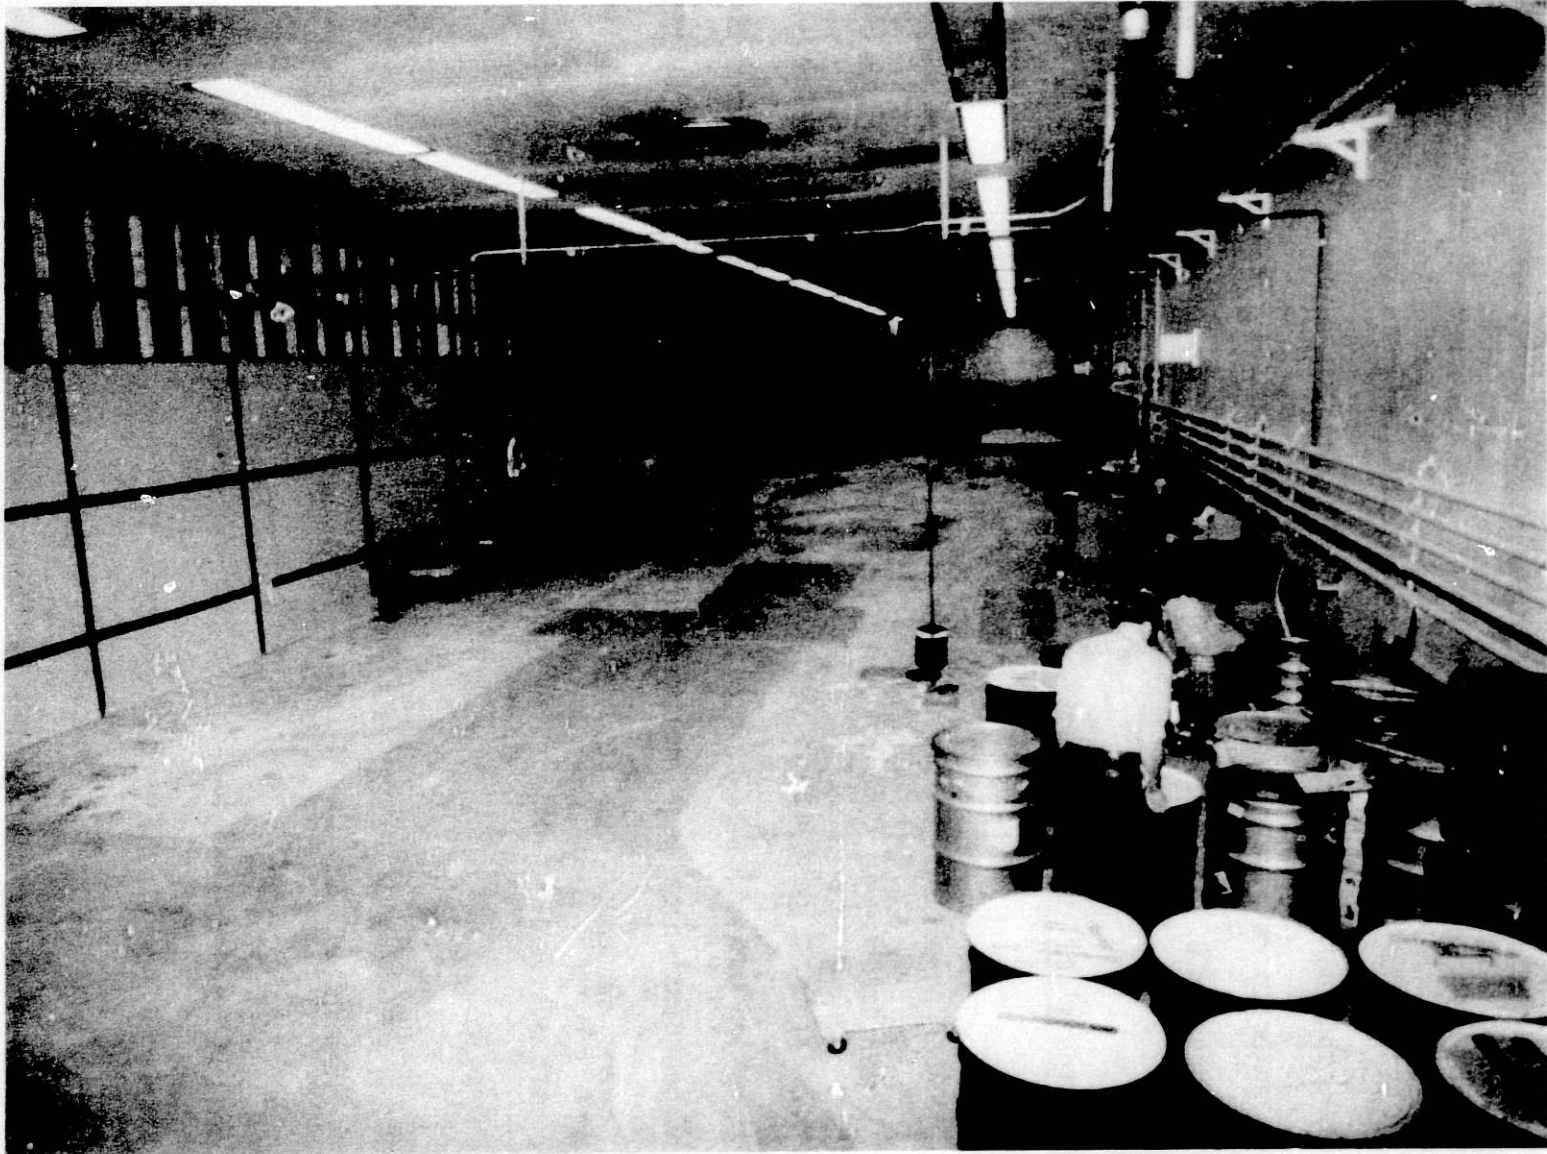
Less manpower, but not cost, would have been needed had a well-engineered, permanent, size-reduction facility been available as initially envisioned. This would have permitted whole glovebox sections to be totally dismantled by "hands-on" techniques rather than the more time-consuming "thru-the gloves" method. However, planning for

Figure 8-1 Fab Area After D&D - Front to Rear

Figure 8-2 Fab Area After D&D - Rear to Front

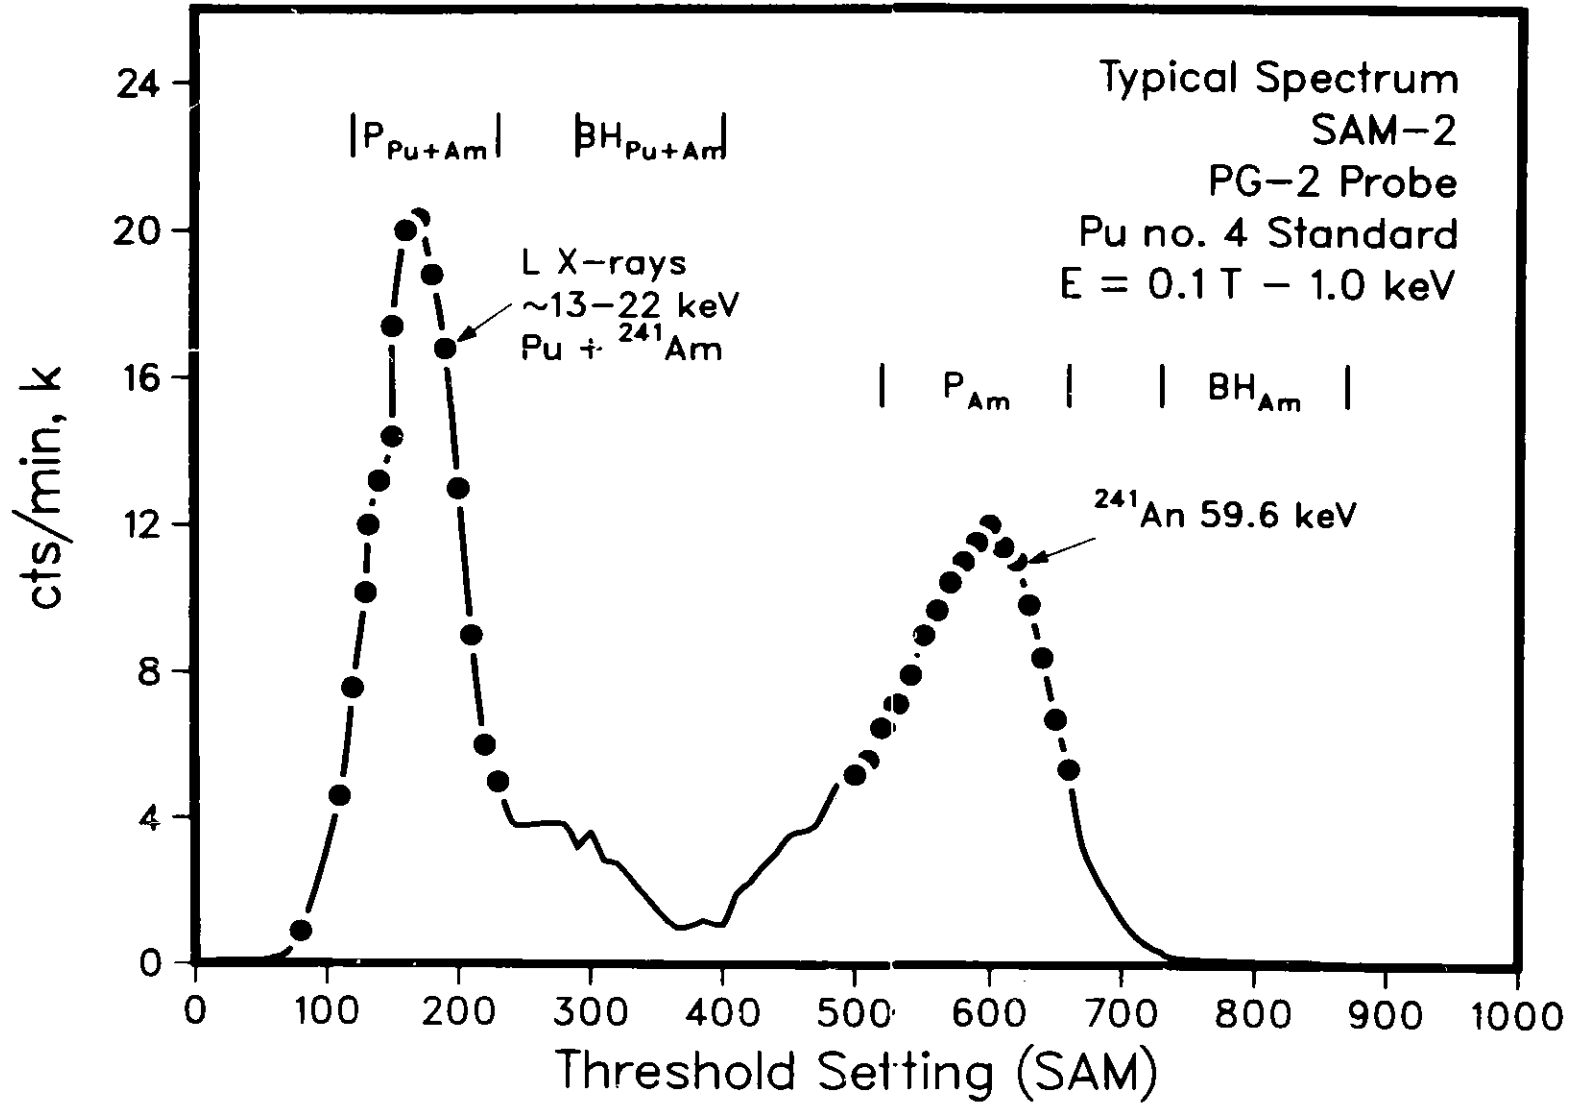
Figure C-8 Typical Spectrum for X-ray Detector

The x-ray detector (2 XM crystal) was used to analyze the 59.5 keV photon emitted by ^{241}Am and the L x-ray complex in the 13-22 keV region, emitted by ^{239}Pu ($\sim 5\%$). A typical spectrum obtained with an x-ray detector is shown in Figure C-8. Since transformations of ^{241}Am and other plutonium radioisotopes result in the emission of x-rays in the same energy region, the analysis of the spectrum is complicated. The ^{239}Pu content cannot be unambiguously determined unless the radionuclide content of the contamination is known. For the four regions of interest indicated in Figure C-8 ($P_{\text{Pu}} + \text{Am}$, $BH_{\text{Pu}} + \text{Am}$, P_{Am} , counts were
