**MATERIALS TECHNOLOGY FOR
COAL-CONVERSION PROCESSES**

**Twelfth Report,
July-December 1977**

ANL-78-6

W. A. Ellingson
Project Leader

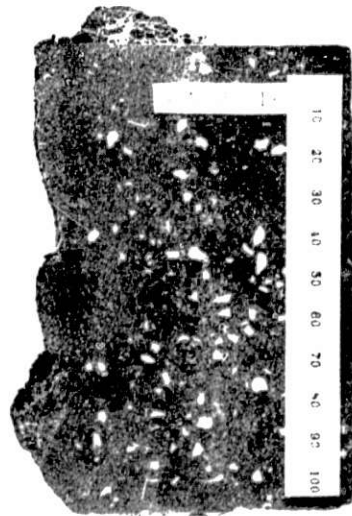
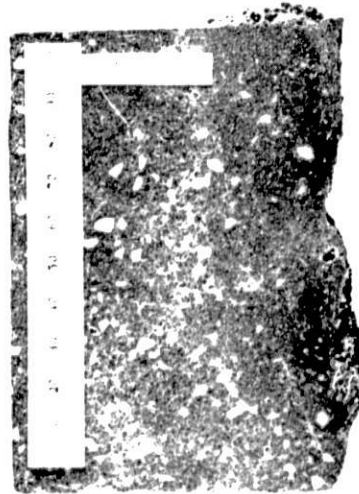
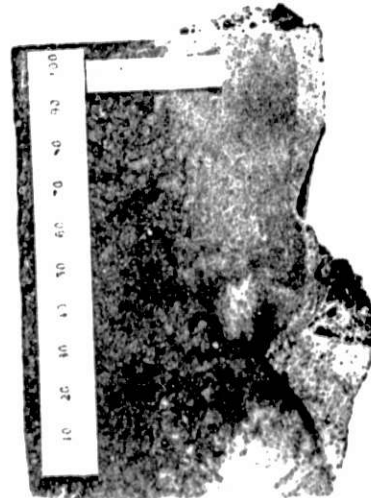
Fig. 1. Cut Sections of Refractories Exposed to Slag Attack In Run 5. (a) Number 19, (b) number 20, (c) number 29, and (d) number 35. Note that the vertical face opposite the ruler was exposed to the slag. Also note that two lines of attack are present which correspond to the two levels of slag during the test. ANL Neg. No. 306-73-94.

Bricks 19, 20, and 29 exhibited similar resistance to corrosion (as measured by the depth of removal), whereas brick 35 showed a marked sensitivity to the temperature excursion. In addition to the bulk removal of the refractory material, a zone that was obviously penetrated by the slag and a zone in which the microstructure had been altered were evident (Fig. 1). Brick 29 had slightly better resistance to penetration and alteration than the other three. Although the effect of length on the depth of removal and obvious penetration was small for bricks 19, 20, and 29, the 1/2-length brick 35 performed distinctly better than the full- or 3/4-length brick of the same composition. Also, the depth of alteration decreased as the length decreased for all bricks tested. To determine whether the alterations in the microstructures were a result of penetration by slag, samples were core drilled and examined with the SEM using x-ray dispersive analysis. The relative intensities of the Mg, Al, Si, Cr, and Fe peaks were compared in the slag, slag-refractory interface, obviously penetrated refractory, and the zone of microstructural alteration ~ 40 mm from the hot face. Evidence for slag penetration was most clear-cut in brick 35, somewhat less so in bricks 19 and 20, and inconclusive in brick 29.

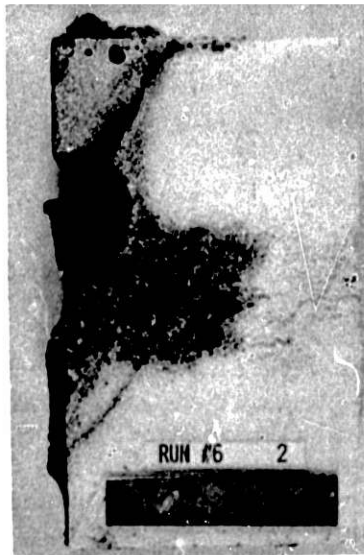
Fig. 5. Cut Sections of the Refractories Exposed to Slag Attack in Run 6. (a) Number 2, (b) number 39, (c) number 38, and (d) number 40. Note that the vertical face on the left-hand side of each brick was exposed to the slag. ANL Neg. No. 306-78-93.

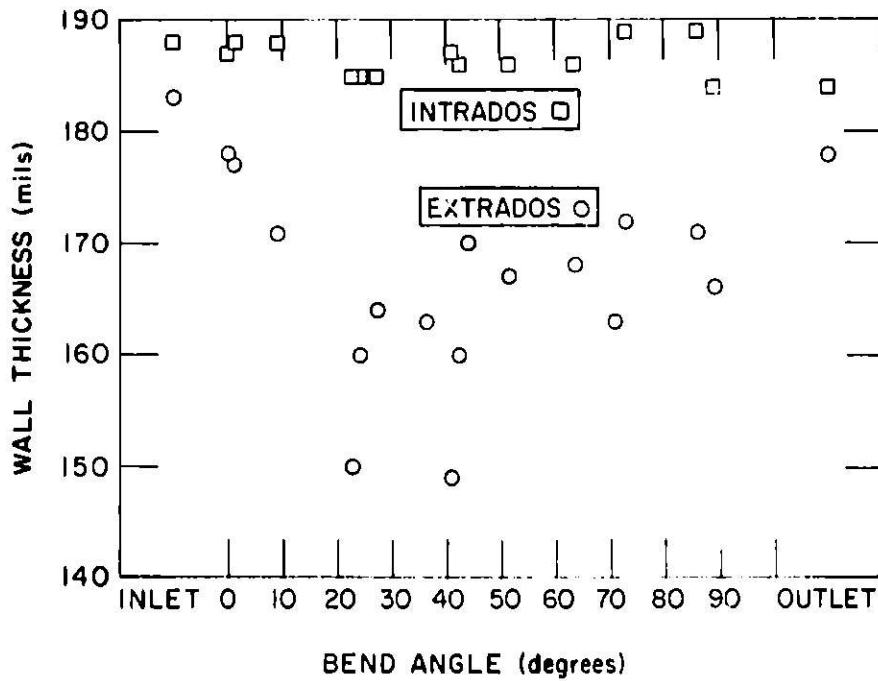
Fig. 8. Synthane Main Coal-feed-line Elbow I Posttest Wall Thickness vs Bend Angle. ANL Neg. No. 306-78-116.

Dimensional data for the pipe sections are given in Tables III and IV, and Figs. 8 and 9 display a portion of these data in graphic form. Lack of perfect initial concentricity (before bending) should be considered when interpreting the results. Data from the relatively unaffected, straight sections at the ends of the elbow provide a basis for interpolation of this error at various positions along the bend. In addition, the 90° bending of the pipe to form the elbow would be expected to cause a change in wall thickness of 0.1-0.15 mm (4-6 mils) at the inner and outer curves of the bend.

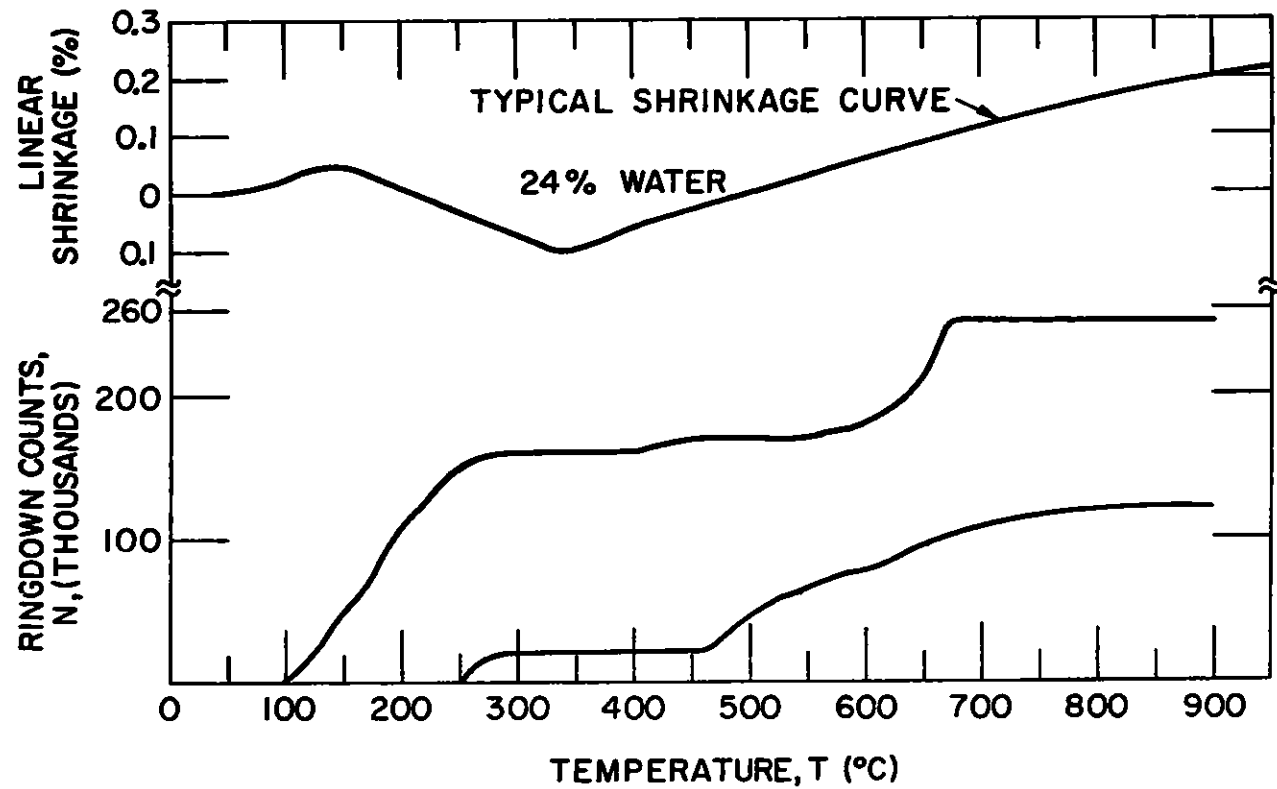
Fig. 15. A Comparison of Acoustic Emission with Refractory Shrinkage.
ANL Neg. No. 306-78-52.

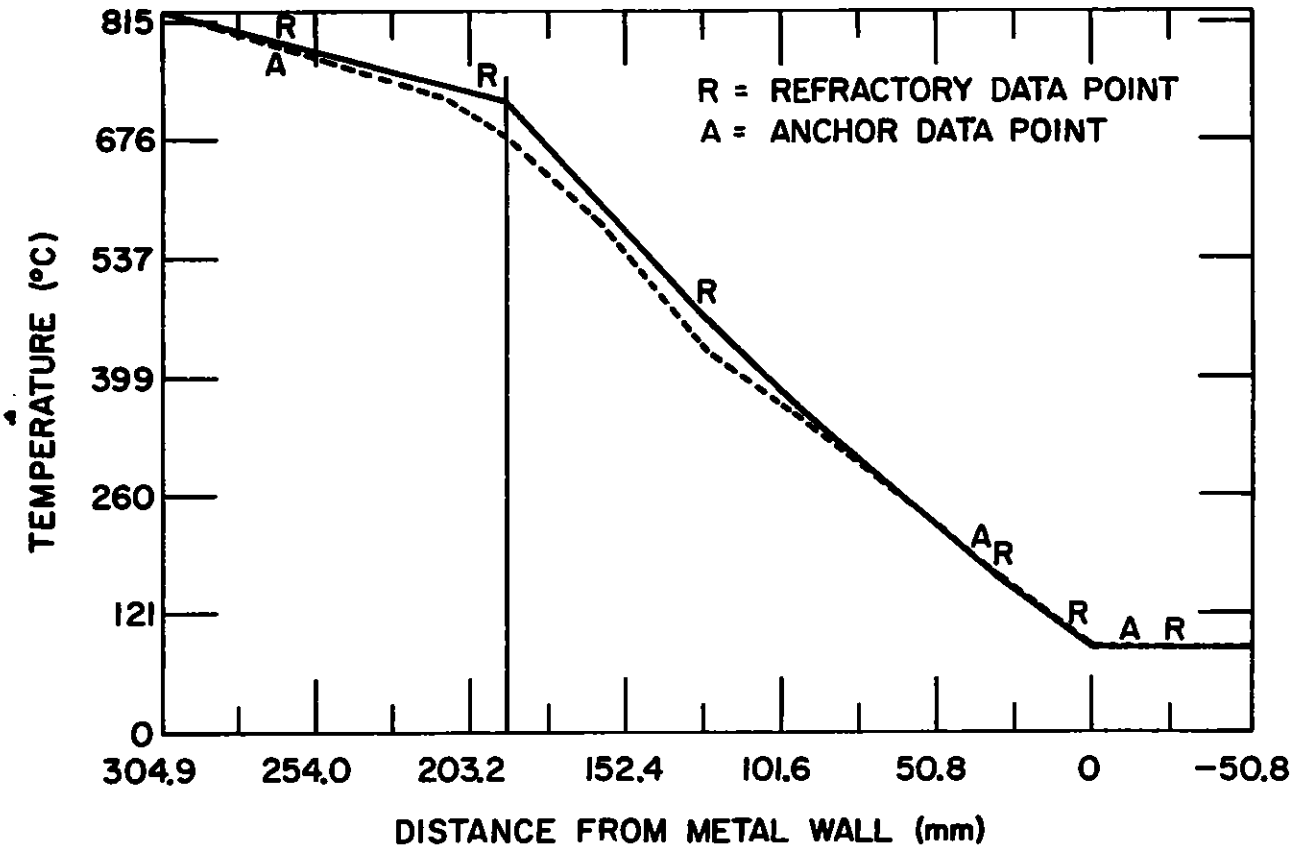
Fig. 16. Thermal Profile of Dual-component Refractory Lining under Steady-state Conditions (from Battelle¹²). ANL Neg. No. 306-78-54 Rev.

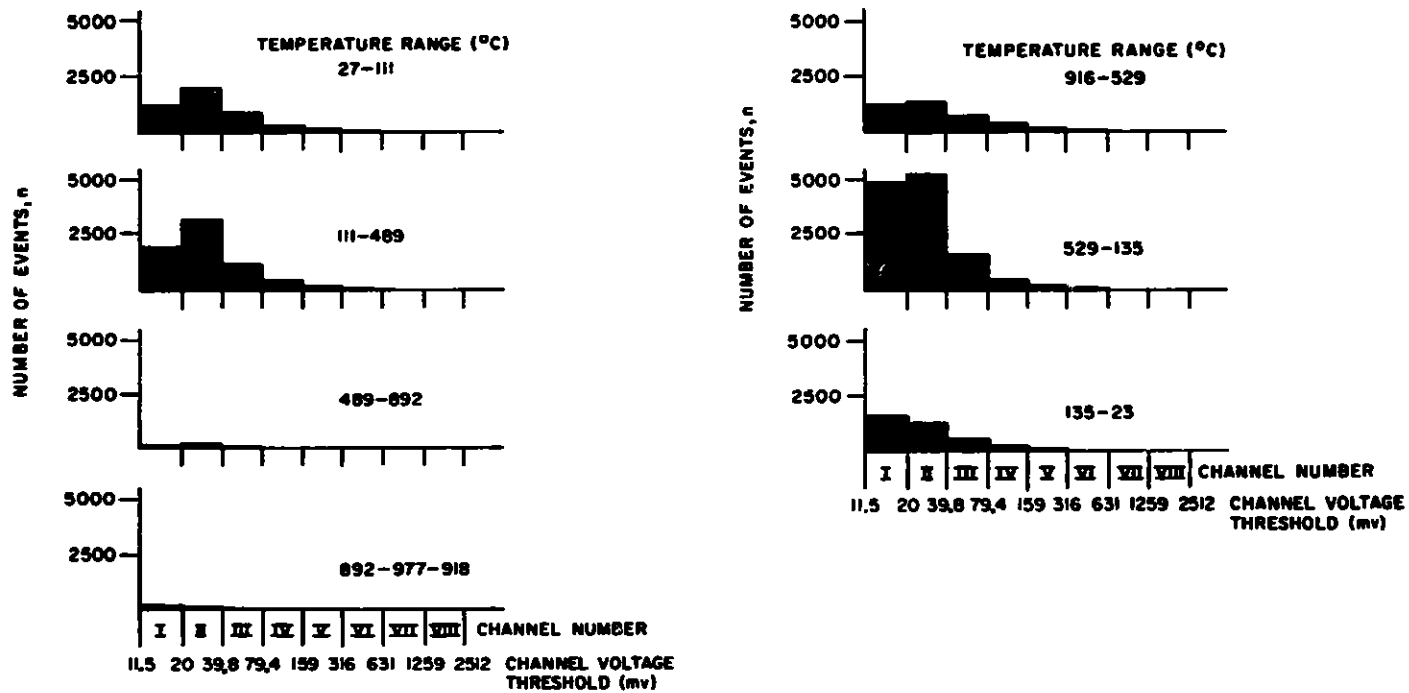
Fig. 17. Amplitude Distribution as a Function of Selected Temperature Ranges for Castolast G (Broadband Transducer). ANL Neg. Nos. 306-78-46 and 306-78-47.

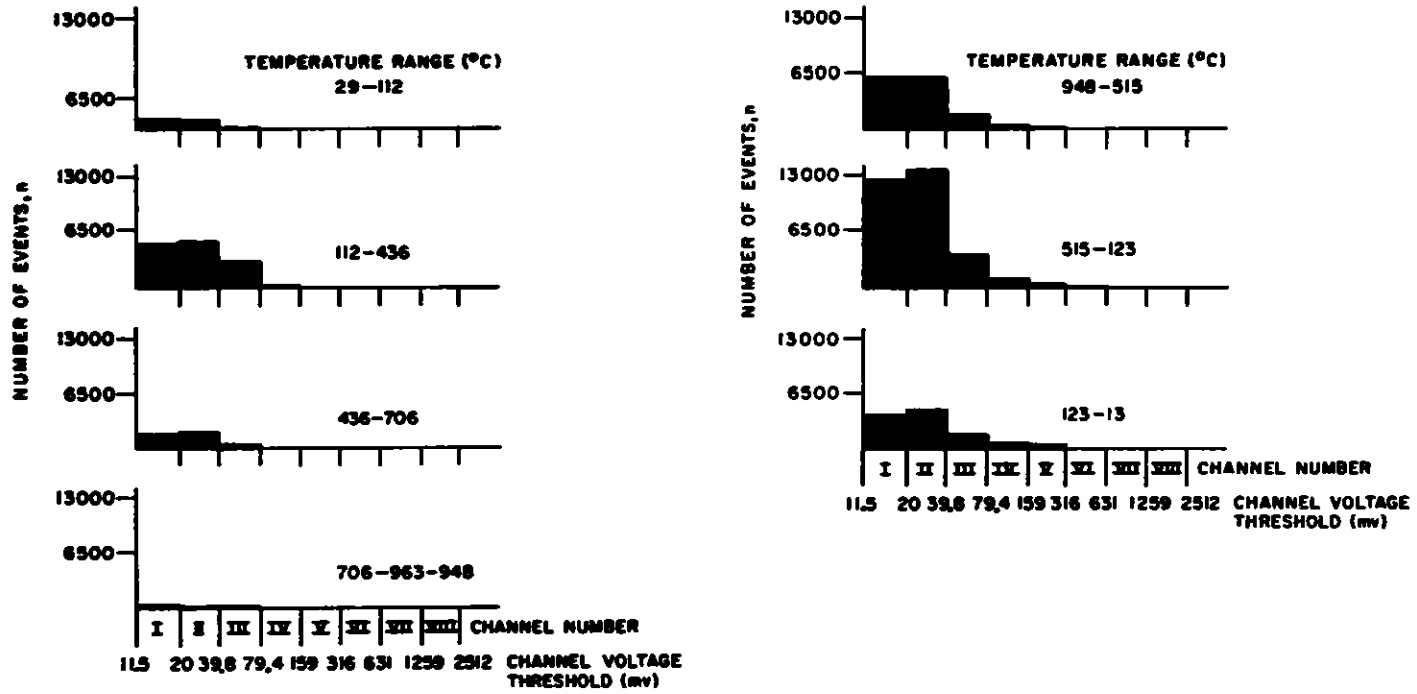
Fig. 18. Amplitude Distribution as a Function of Selected Temperature Ranges for Lightweight-26 (Resonant Transducer -- 175 kHz). ANL Neg. Nos. 306-78-58 and 306-78-59.

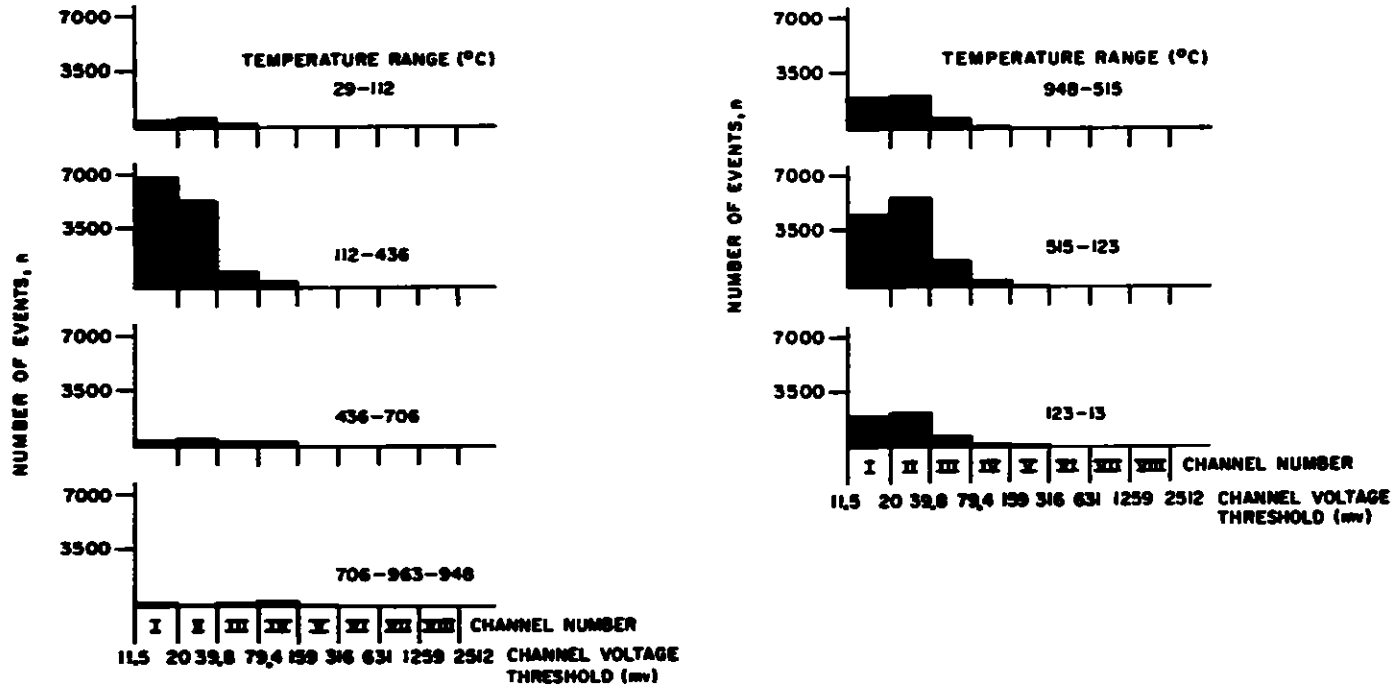
Fig. 19. Amplitude Distribution as a Function of Selected Temperature Ranges for Lightweight-26 (Broadband Transducer). ANL Neg. Nos. 306-78-60 and 306-78-57.

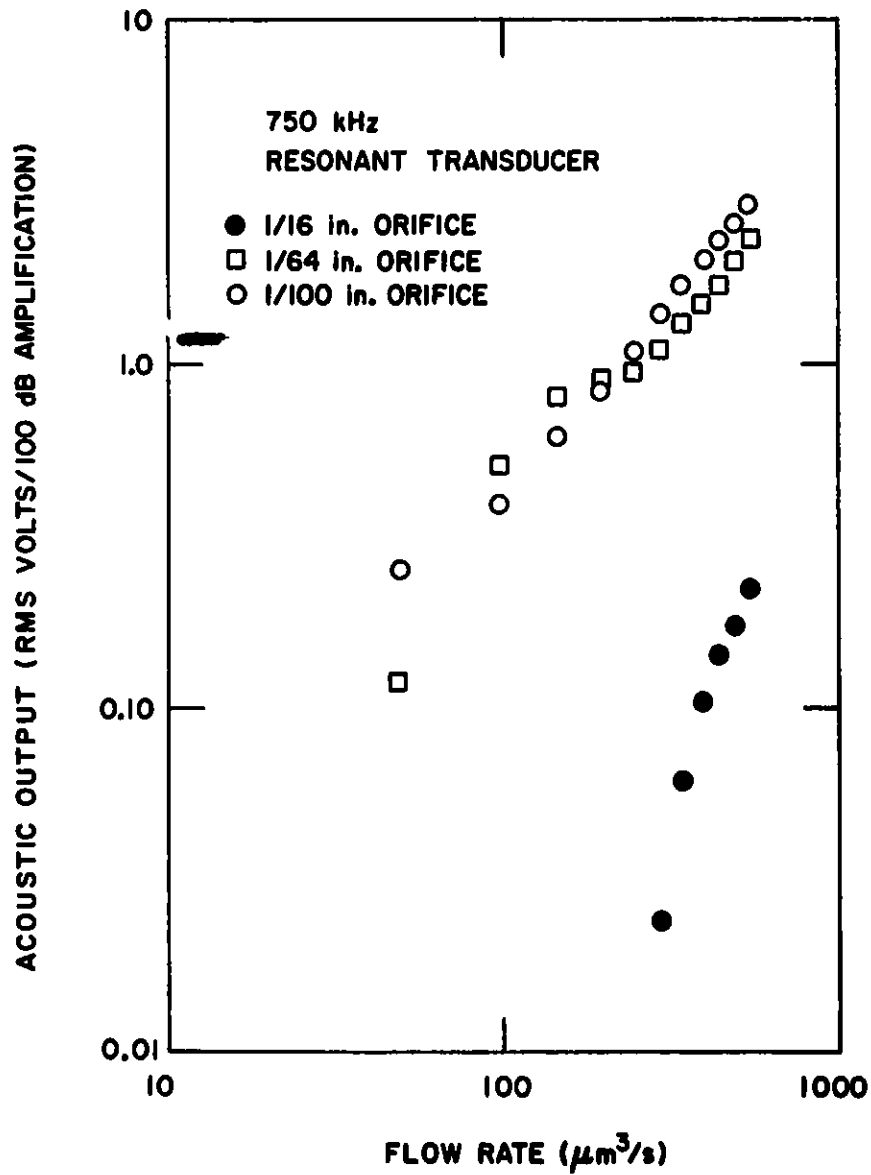
Fig. 27. Acoustic Output of the 750-kHz Transducer as a Function of Flow Rate for Different Transducer Frequencies. ANL Neg. No. 306-77-590.

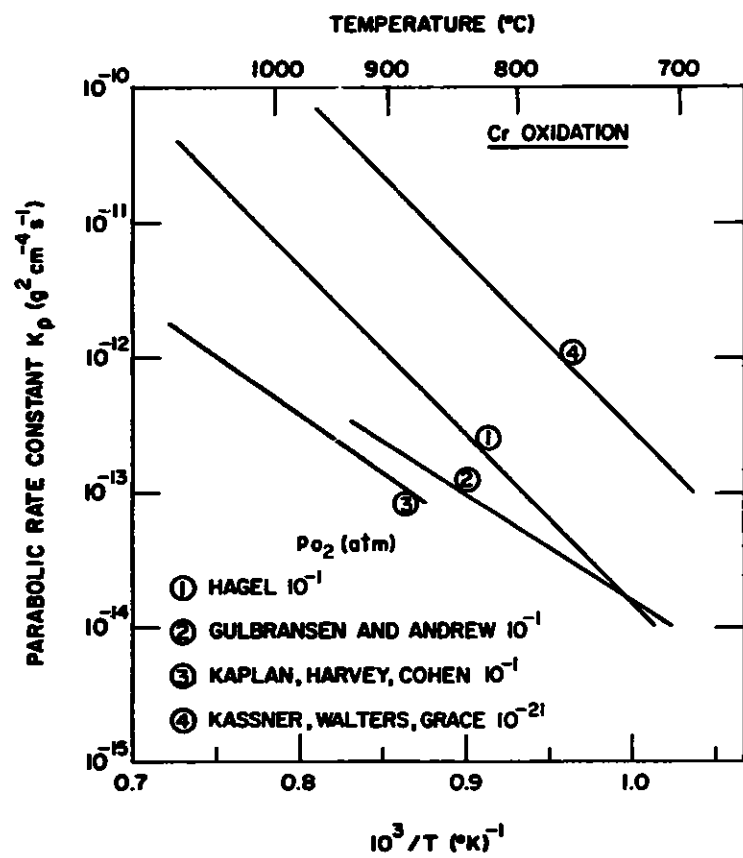
Fig. 30. Temperature Dependence of Parabolic Rate Constants for Oxidation and Sulfidation of "Pure" Chromium. ANL Neg. No. 306-77-195 (Revised).

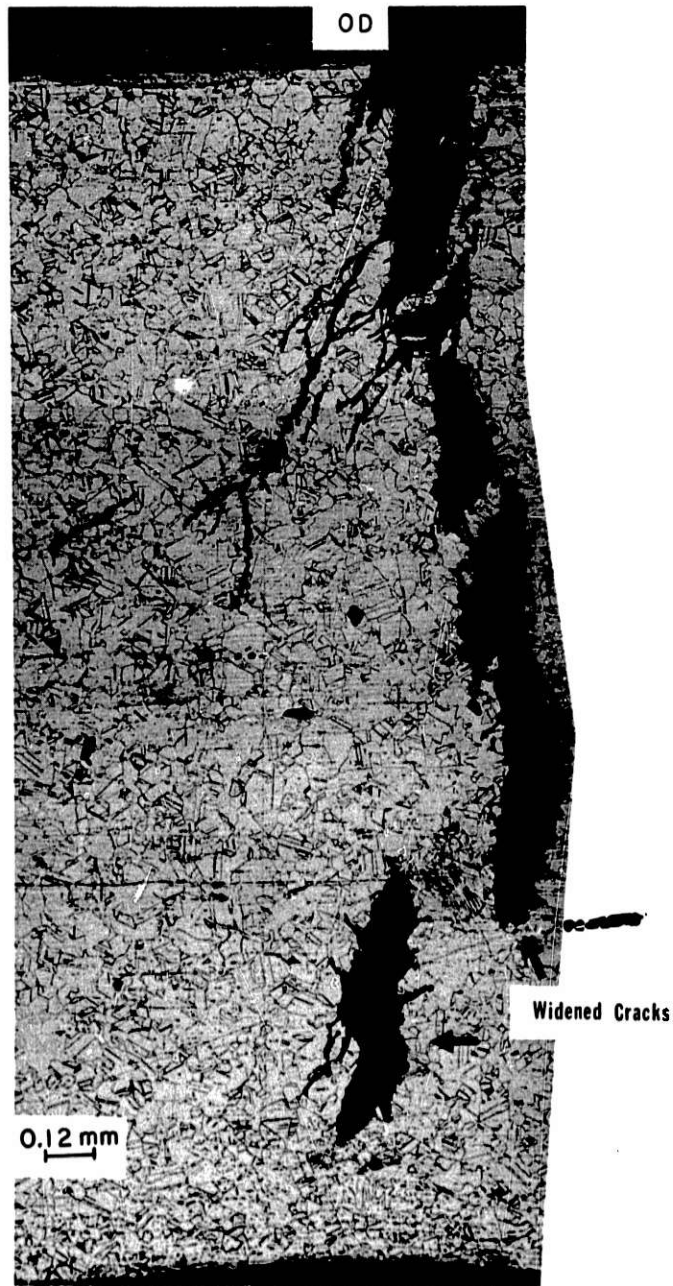
Fig. 48. Cross Section of 6411. Transgranular and branched cracks are visible. ANL Neg. No. 306-78-41.
