MATERIALS TECHNOLOGY FOR COAL-CONVERSION PROCESSES

**Eighteenth Quarterly Report
April—June 1979**

ANL-79-93

W. A. Ellingson
Program Manager

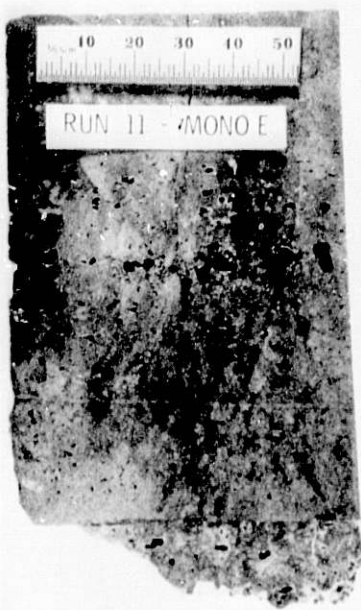
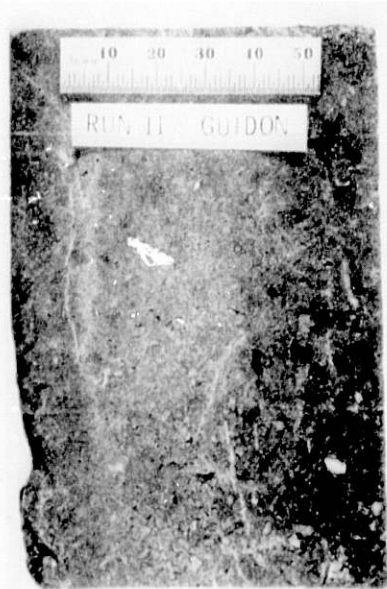
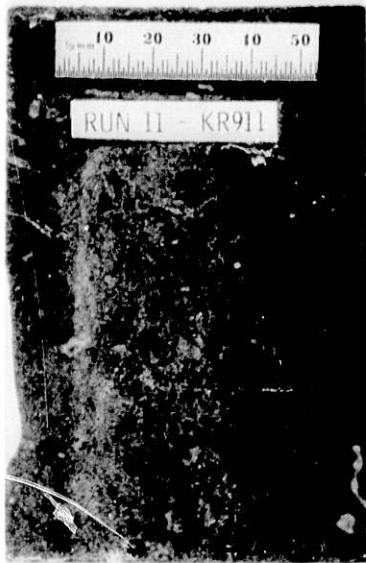
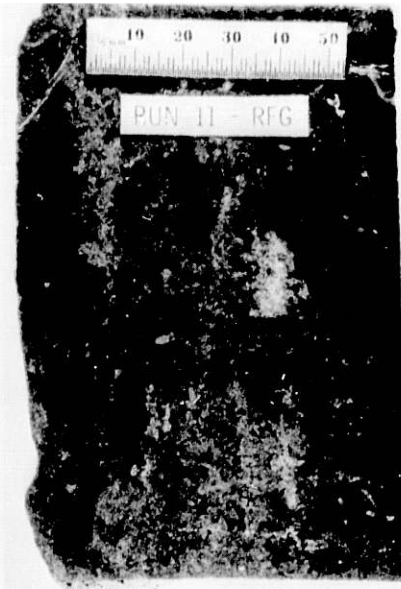
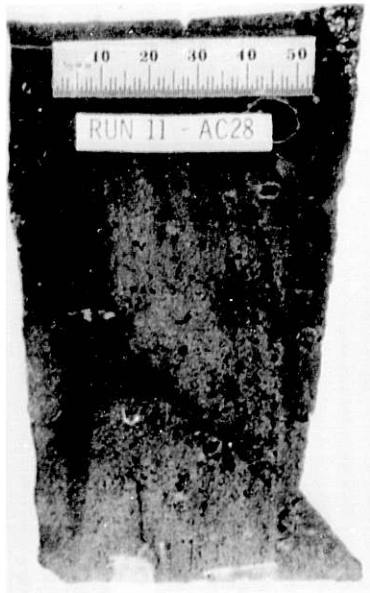
Fig. 3. Cut Sections of the Full-length Refractories Exposed to Slag Attack in Test Run 11. (a) Number 2, (b) number 16, (c) number 22, (d) number 29, (e) number 35, (f) number 41, (g) number 86, (h) number 90, (i) number 280, (j) number 37, and (k) number 852. The left-hand faces of (a)-(i) and (k) and the right-hand face of (j) were exposed to the slag. ANL Neg. Nos. 306-79-873, 874 and 872.

As in tests with acidic slags, the effects of chromia content and density on corrosion resistance were evident. The most corrosion-resistant refractory was the fused-cast chrome-spinel (number 22). Even the half-length chrome-spinel brick, which was tested without water cooling, exhibited little attack. The fused-cast alumina-32% chromia refractory (number 280) also evinced excellent corrosion resistance, but was badly cracked (Fig. 3i) by thermal shock. As the chromia content was decreased, the resistance of alumina-chromia refractories to corrosive attack decreased rapidly. The alumina-10% chromia refractories (number 16, a sintered product, and number 86, a ramming mix) suffered only about the same amount of corrosion as did the fused-cast alumina refractory (number 2), despite much higher porosity ($\sim 17\%$ for numbers 16 and 86 versus 1% for number 2). However, these lower-density products were penetrated to a much greater degree by the slag, resulting in substantial swelling above the slag line (see Figs. 3b and 3g).

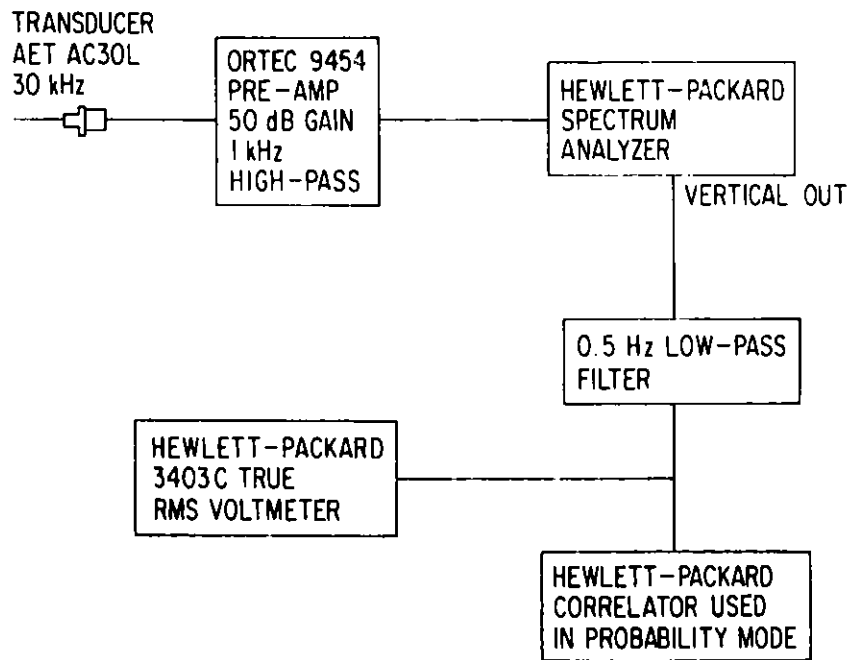
Fig. 6. Schematic Diagram of Passive Acoustic Data Acquisition System. Low-frequency noise is filtered at the preamplifier. The signal fed to the rms voltmeter and correlator is taken from the vertical output when the spectrum analyzer is used in the manual-scan mode. ANL Neg. No. 306-79-902.

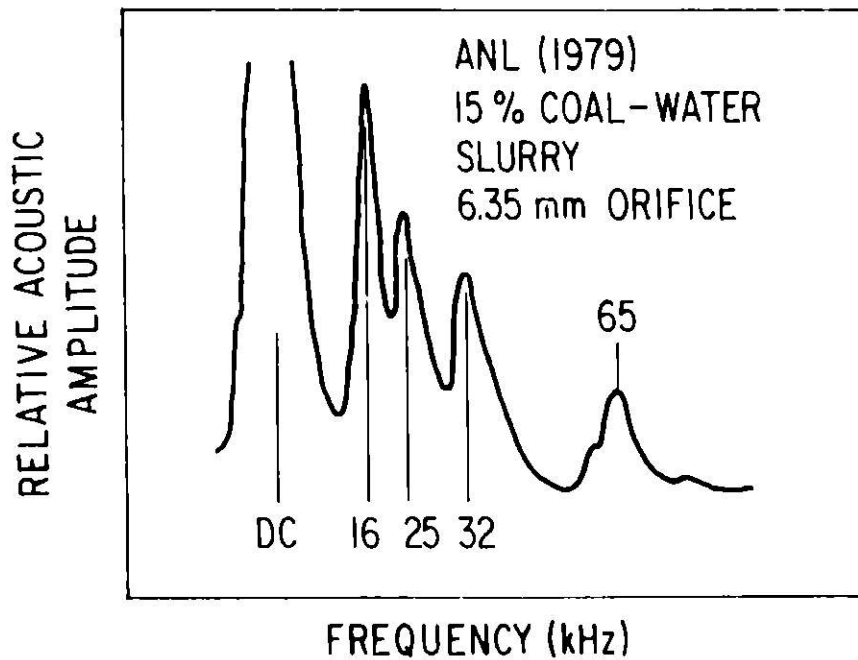
Fig. 7. A Typical Acoustic Spectrum Obtained from a 20% Coal Slurry Flowing through a 6.35-mm Orifice. Peaks of interest from right to left are 65, 32, 25 and 16 kHz. ANL Neg. No. 306-79-893.

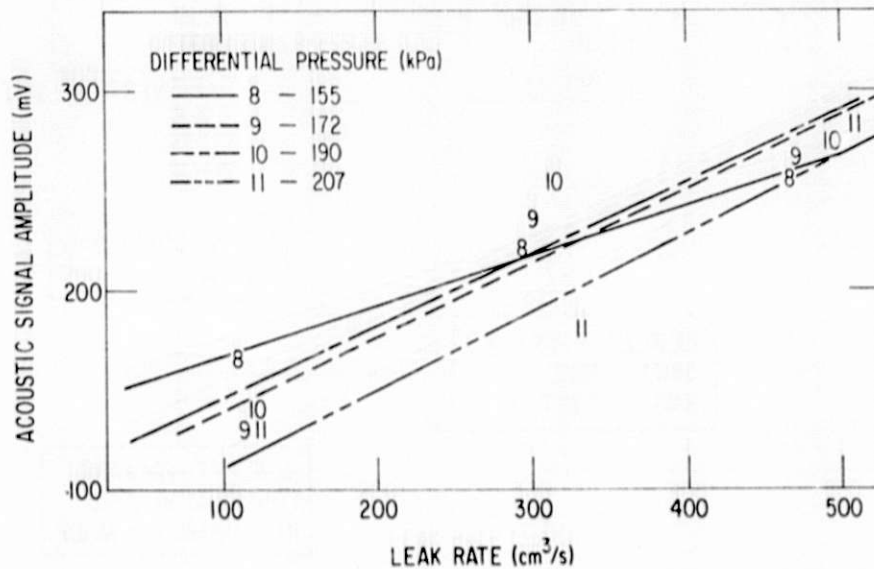
Fig. 8. Acoustic Signal Amplitude vs Leakage Rate for Higher Differential Pressure Ranges. Note that the data show a wide scatter and that for a given signal level the leakage rate can vary by $100 \text{ cm}^3/\text{s}$. However, note that the acoustic signal level increases by a factor of 2 between no flow and $500 \text{ cm}^3/\text{s}$. ANL Neg. No. 306-79-892.

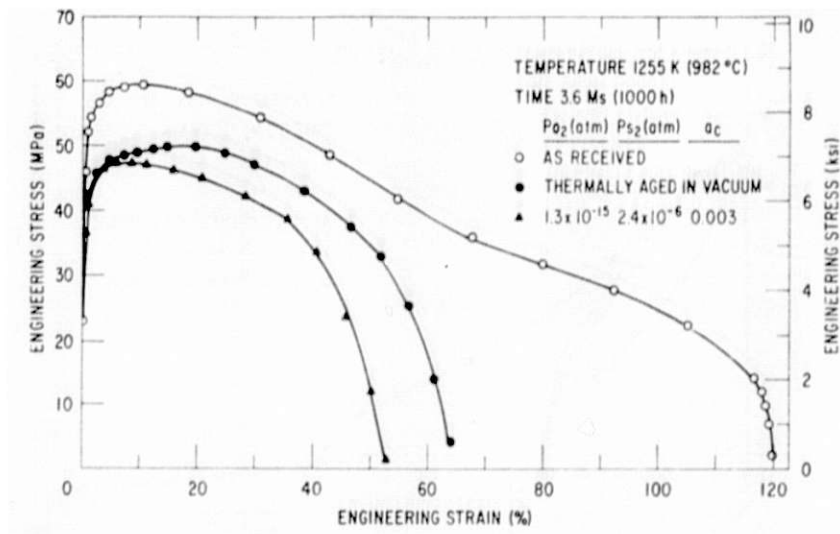
Fig. 12. Engineering Stress-Engineering Strain Behavior for Incoloy 800 in the As-received and Thermally Aged Conditions and After 1000-h Exposures to Complex Gas Mixtures at 982°C. ANL Neg. No. 306-79-86.

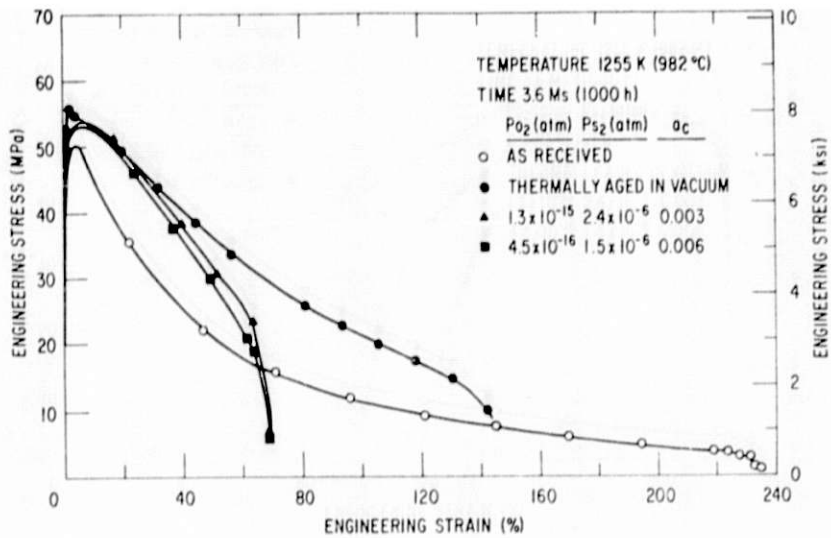
Fig. 14. Engineering Stress-Engineering Strain Behavior for Inconel 671 in the As-received and Thermally Aged Conditions and After 1000-h Exposures to Complex Gas Mixtures at 982°C. ANL Neg. No. 306-79-76.

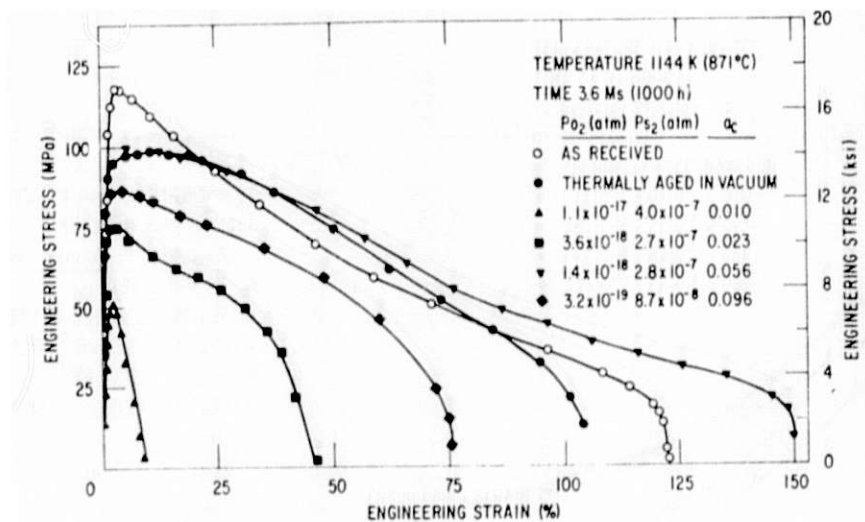
Fig. 16. Engineering Stress-Engineering Strain Behavior for Incoloy 800 in the As-received and Thermally Aged Conditions and After 1000-h Exposures to Complex Gas Mixtures at 871°C. ANL Neg. No. 306-79-93.

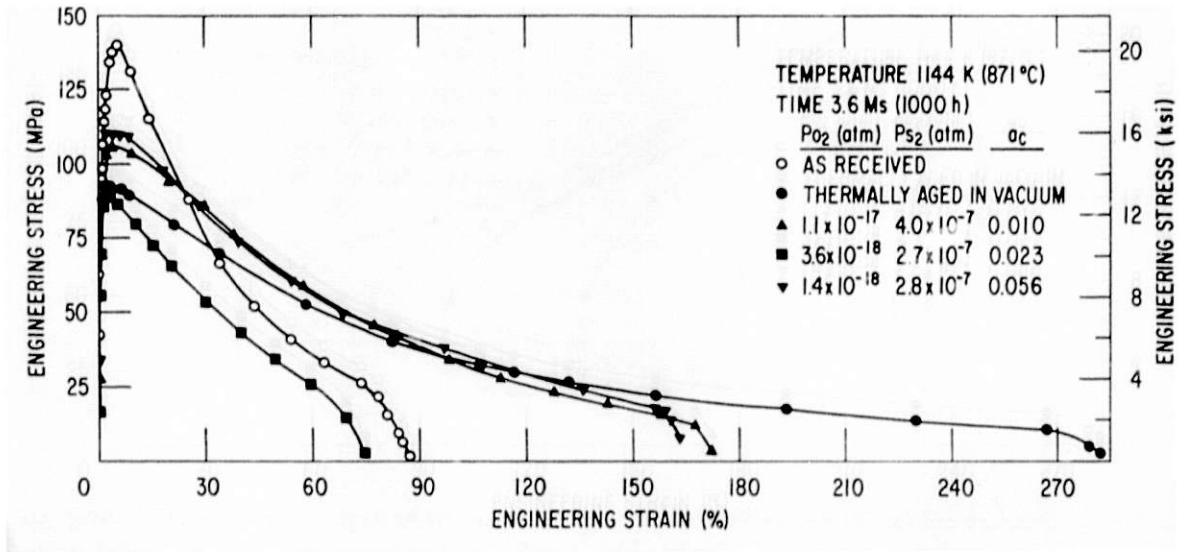
Fig. 18. Engineering Stress-Engineering Strain Behavior for Inconel 671 in the As-received and Thermally Aged Conditions and After 1000-h Exposures to Complex Gas Mixtures at 871°C. ANL Neg. No. 306-79-84.

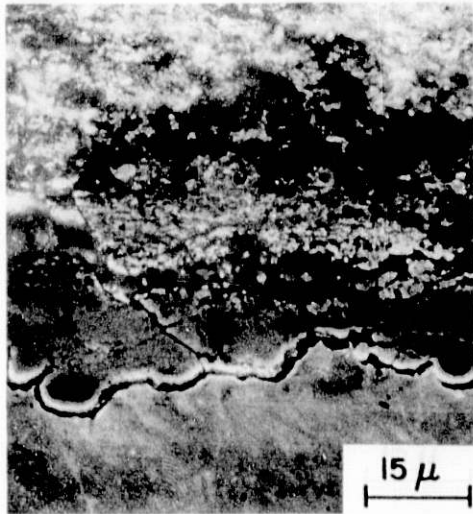
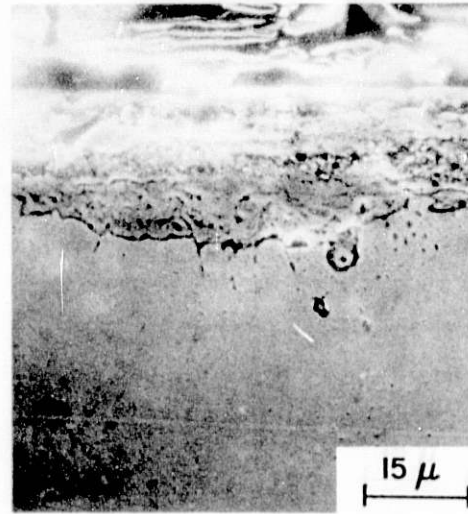
Fig. 27. SEM Micrographs of Fe-9Cr-1Mo Steel After a 100-h Exposure Inside the Fluidized Bed. CT-1, without salt; CT-2, 0.3 Mol % CaCl_2 ; CT-3, 0.5 mol % NaCl ; and CT-4, 1.9 mol % Na_2CO_3 . ANL Neg. No. 306-79-684.
