**MATERIALS TECHNOLOGY FOR  
COAL-CONVERSION PROCESSES**

**Progress Report for  
January—March 1980**

**ARGONNE NATIONAL LABORATORY, ARGONNE, ILLINOIS**

**Prepared for the Office of Fossil Energy**

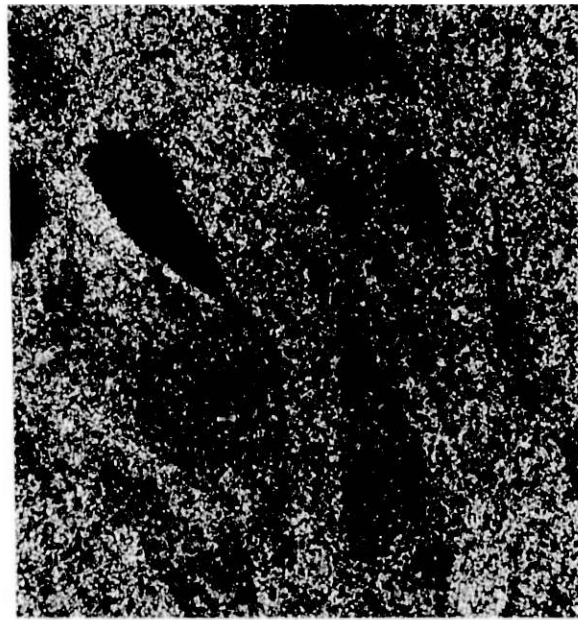
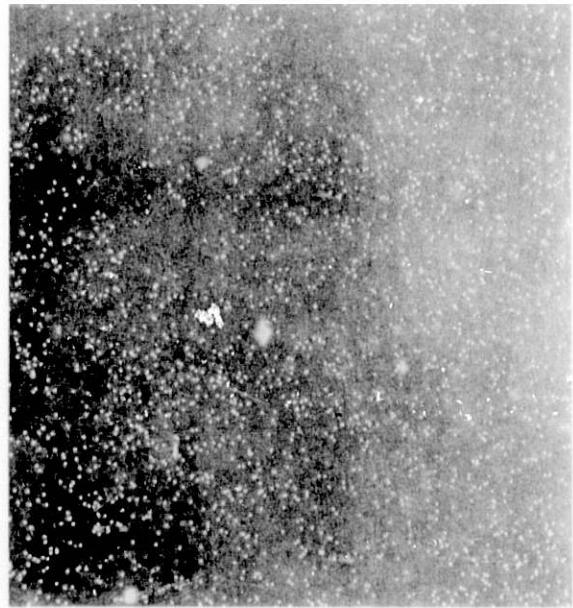
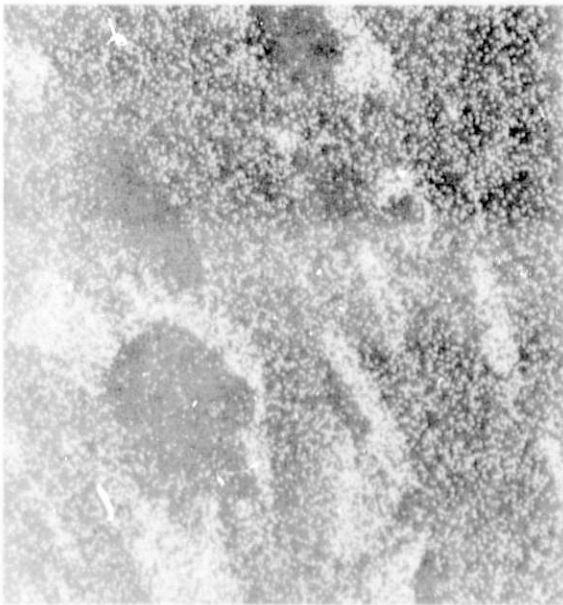
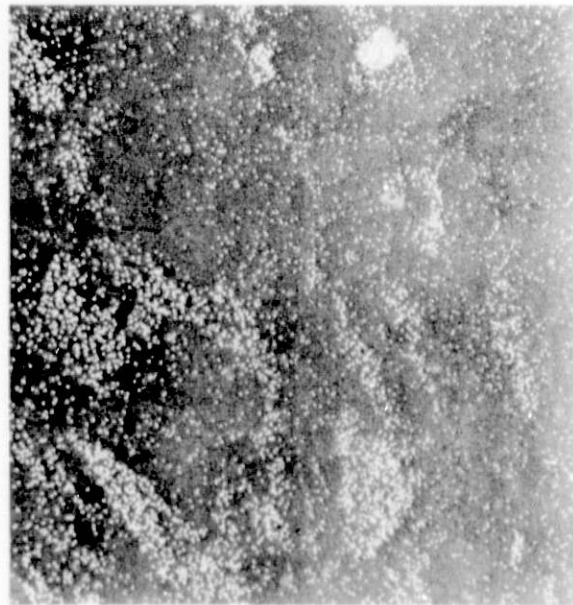
Fig. 3. SEM Photograph and Elemental Scans of the Slag-Refractory Reaction Products (Area Similar to the Lower Left of Fig. 2). (a) SEM, (b) Al, (c) Cr, (d) Fe, (e) Mg, (f) Ca, and (g) Si. Note that some Cr is in solution in the CA<sub>6</sub> phase. ANL Neg. Nos. 306-80-202, 200.

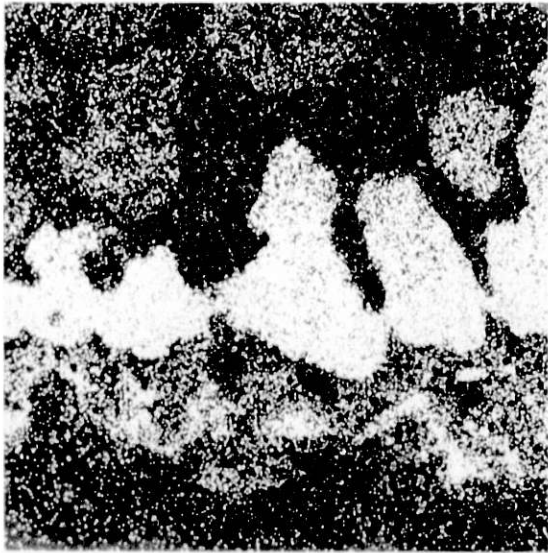
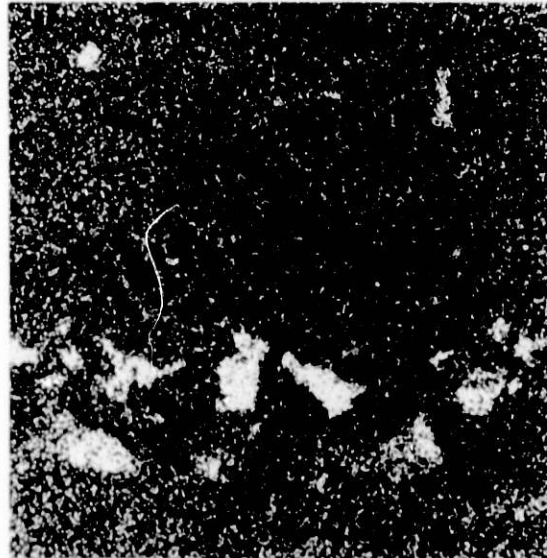
Fig. 7. Slag-Refractory Interface of the Fused-cast Magnesia-Spinel Refractory Exposed to a Basic Coal Slag in Test Run 11. (a) SEM photograph, (b) Mg scan, (c) Al Scan, (d) Fe scan, (e) Ca scan, and (f) Si scan. ANL Neg. Nos. 306-80-203, 201.

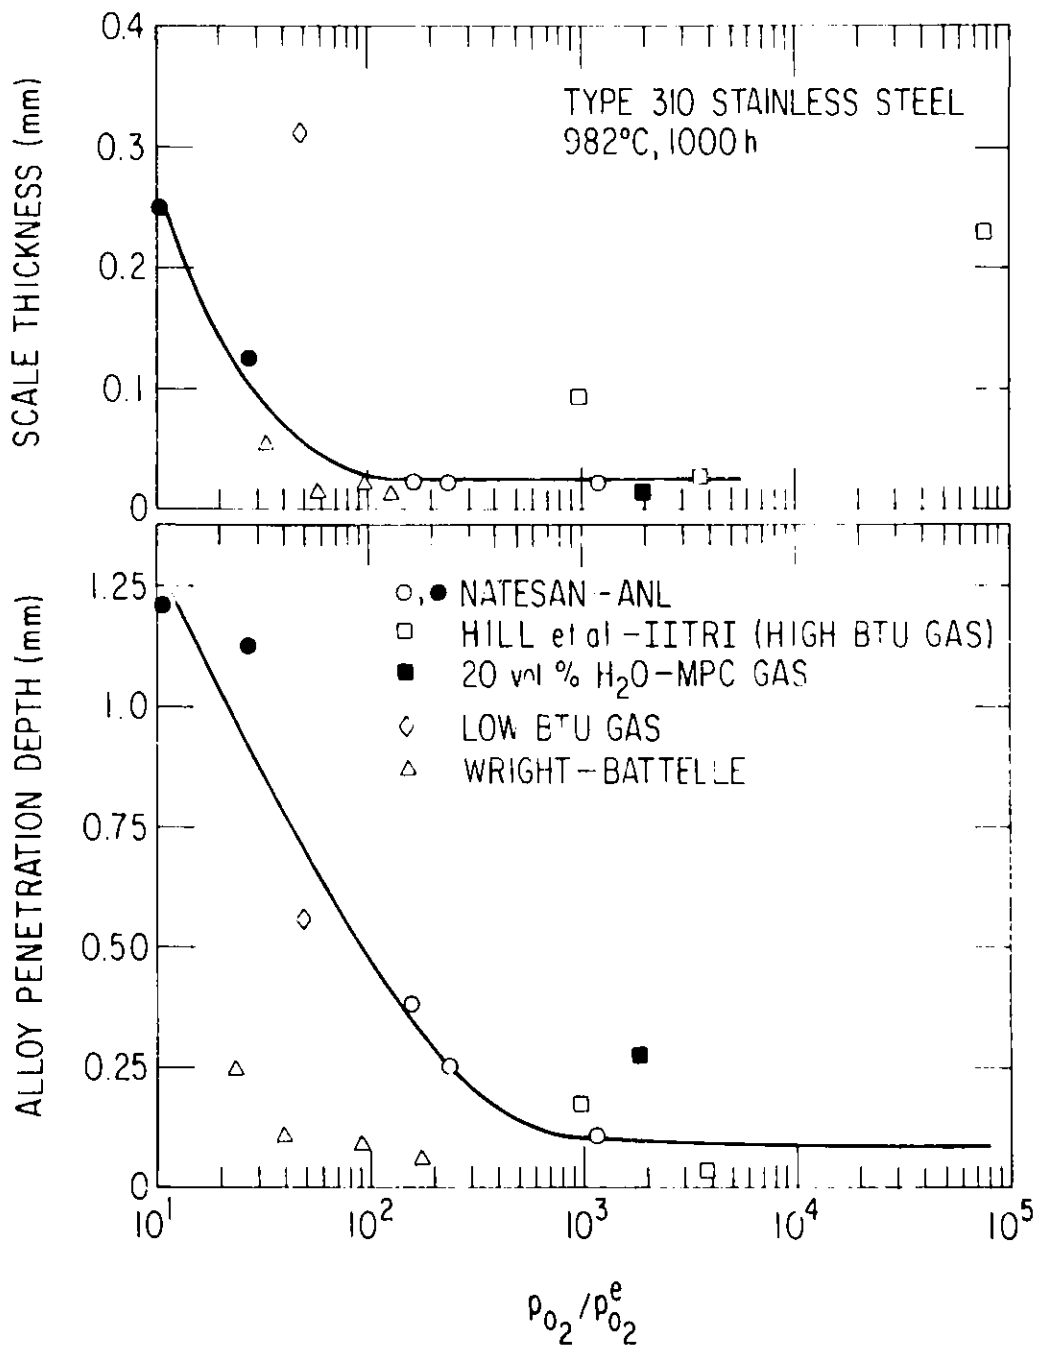
Fig. 12. A Comparison of Data on Scale Thickness and Alloy Penetration Depths for Type 310 Stainless Steel Exposed for 1000 h to Multicomponent Gas Environments at 982°C. ANL Neg. No. 306-79-1963.

The effect of variation in oxygen and sulfur partial pressures on the corrosion behavior of alloys can be evaluated by a comparison of 1000-h data on scale thickness and intergranular penetration obtained by different researchers. Natesan<sup>4-6,10-11</sup> obtained data on Incoloy 800 and Type 310 stainless steel with varying  $p_{O_2}$  and  $p_{S_2}$  at 982° and ambient pressure. Wright<sup>7</sup> obtained similar data at total pressures of 34 and 102 atm. Hill et al.<sup>8</sup> obtained data on these alloys for the MPC gas mixture, MPC gas modified with 20 vol. % H<sub>2</sub>O, and low-Btu gas that included nitrogen. The data on scale thickness and alloy penetration depth from all these investigations are plotted as a function of excess oxygen parameter ( $p_{O_2}/p_{O_2}^e$ ) in Figs. 12 and 13 for Type 310 stainless steel and Incoloy 800, respectively. In general, the results show that below an oxygen pressure threshold represented by  $p_{O_2}/p_{O_2}^e \sim 10^3$ , the total corrosion (scale thickness + penetration depth) of the alloys is significant. However, the data of Wright, Hill et al. (low-Btu gas), and Natesan (30 vol. % CH<sub>4</sub> in inlet gas) show significantly lower values of scale thickness and penetration depth for Incoloy 800 and probably for Type 310 stainless steel. In these experiments, the oxygen pressure is low enough that a protective oxide layer does not develop on the alloy; on the other hand, the carbon activity in the gas is high enough to form stable Cr-rich carbides in the alloy. As a result, the corrosion behavior of the material depends on the relative rates of formation of carbides vs sulfides in the scale. Wright has observed a hard layer of carbide on the specimens tested in these environments. Once the carbide scale layer is formed, the extent of corrosion will be determined by either the transport of sulfur through the carbide layer or by the sulfidation of carbide particles in the scale layer. Significant carburization depths have been reported by Hill et al. for specimens exposed to low-Btu gas environments. Very little fundamental information is presently available on the relative role of carbon and sulfur in the mixed-gas environment on the corrosion behavior of materials (in the absence of protective oxide scales). Since high carbon activities are expected at elevated system
