**DESIGN, CONSTRUCTION, AND INITIAL OPERATION OF
THE ANL RESEARCH SALT-GRADIENT SOLAR POND**

**Y. S. Cha, W. T. Sha,
and J. R. Hull**

ARGONNE NATIONAL LABORATORY, ARGONNE, ILLINOIS

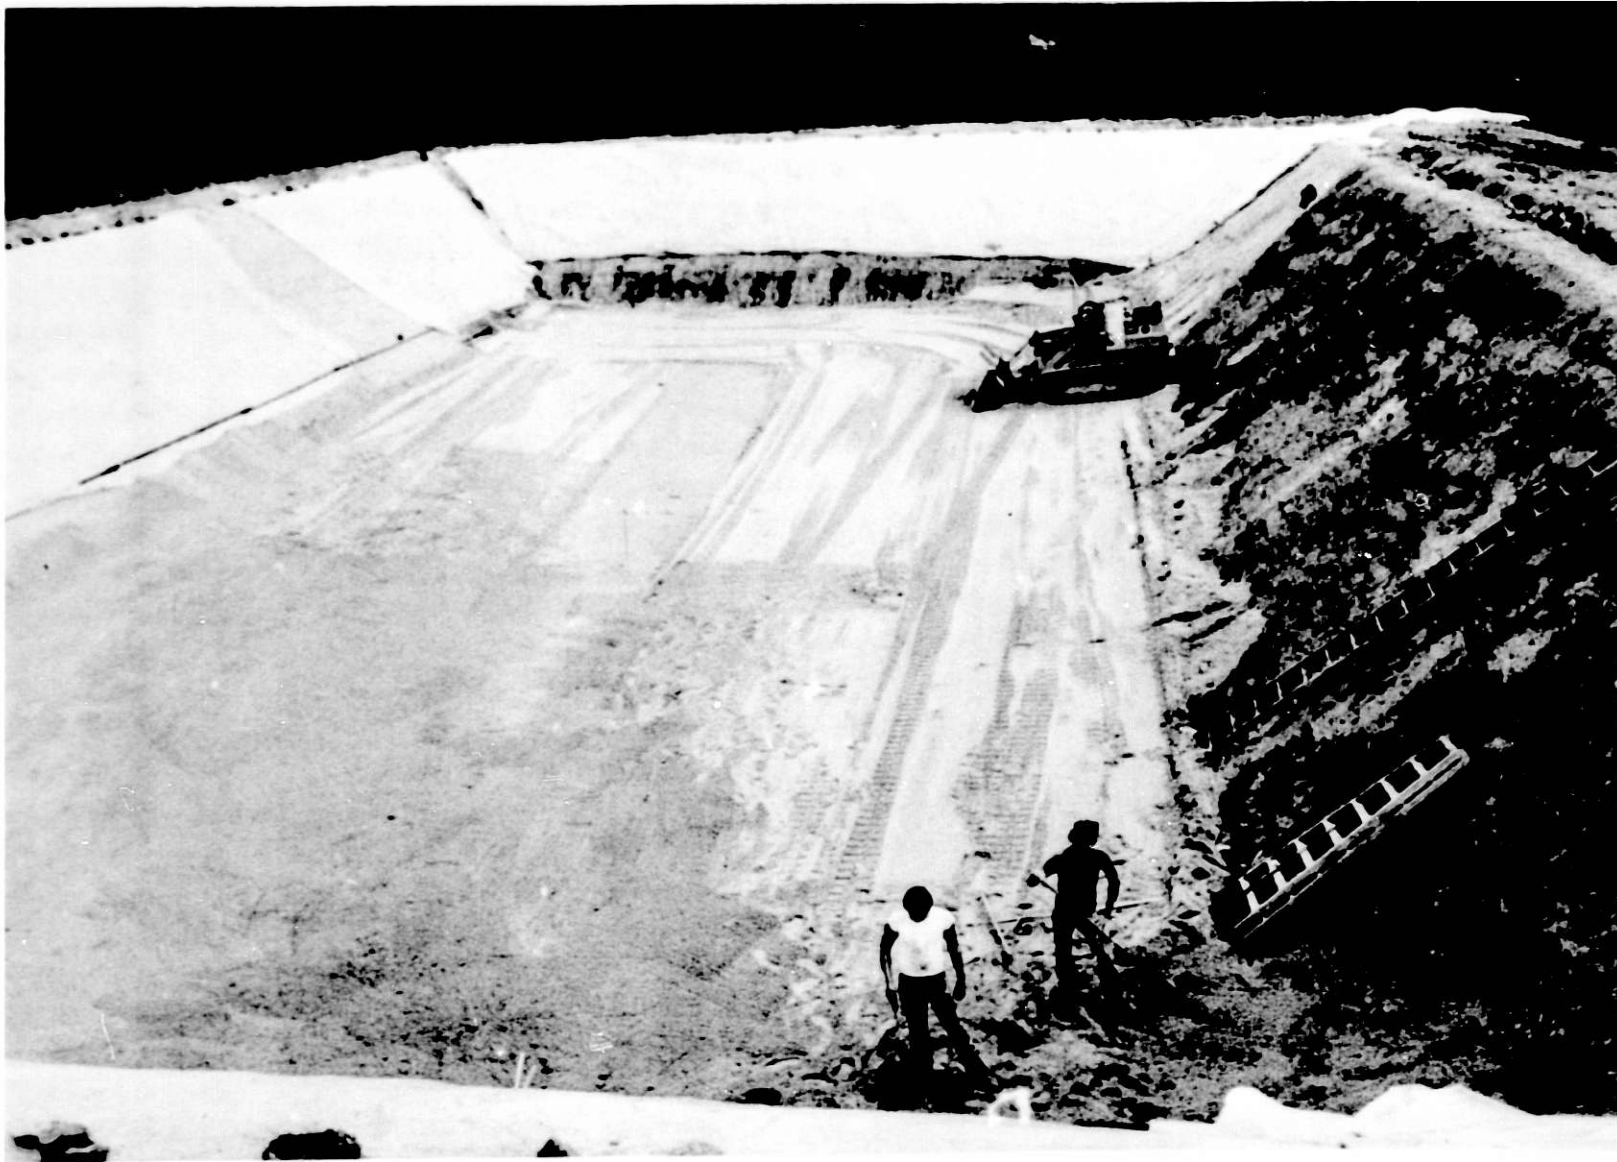
Fig. 11. Plastic Sheets on the Slopes of the Pond to Prevent Rain Erosion during Construction

During construction of the pond, there was a five-week period for installing the underground thermocouples (Figs. 9 and 10) and conductivity probes right after the excavation and before the application of sand on the bottom of the pond. During this same period, the drain tile system was also installed. The underground instrumentation and drain tile work were completed on August 15. During the month of August, there was unusually high rainfall in this area which caused significant erosion of soil on the slopes. Erosion channels as deep as 0.3 m (1 ft) were observed in certain places. It was decided that the slopes had to be refinished. This would cost an additional \$2850. The back-hoe came back to prepare the slopes again and this time the slopes were covered with inexpensive plastic sheets as soon as they were finished to prevent further erosion (Fig. 11). During the entire excavation period, a sump pump (Fig. 12) was used to get rid of most of the water accumulated in the pond. When all the slopes were finished, the plastic sheets were

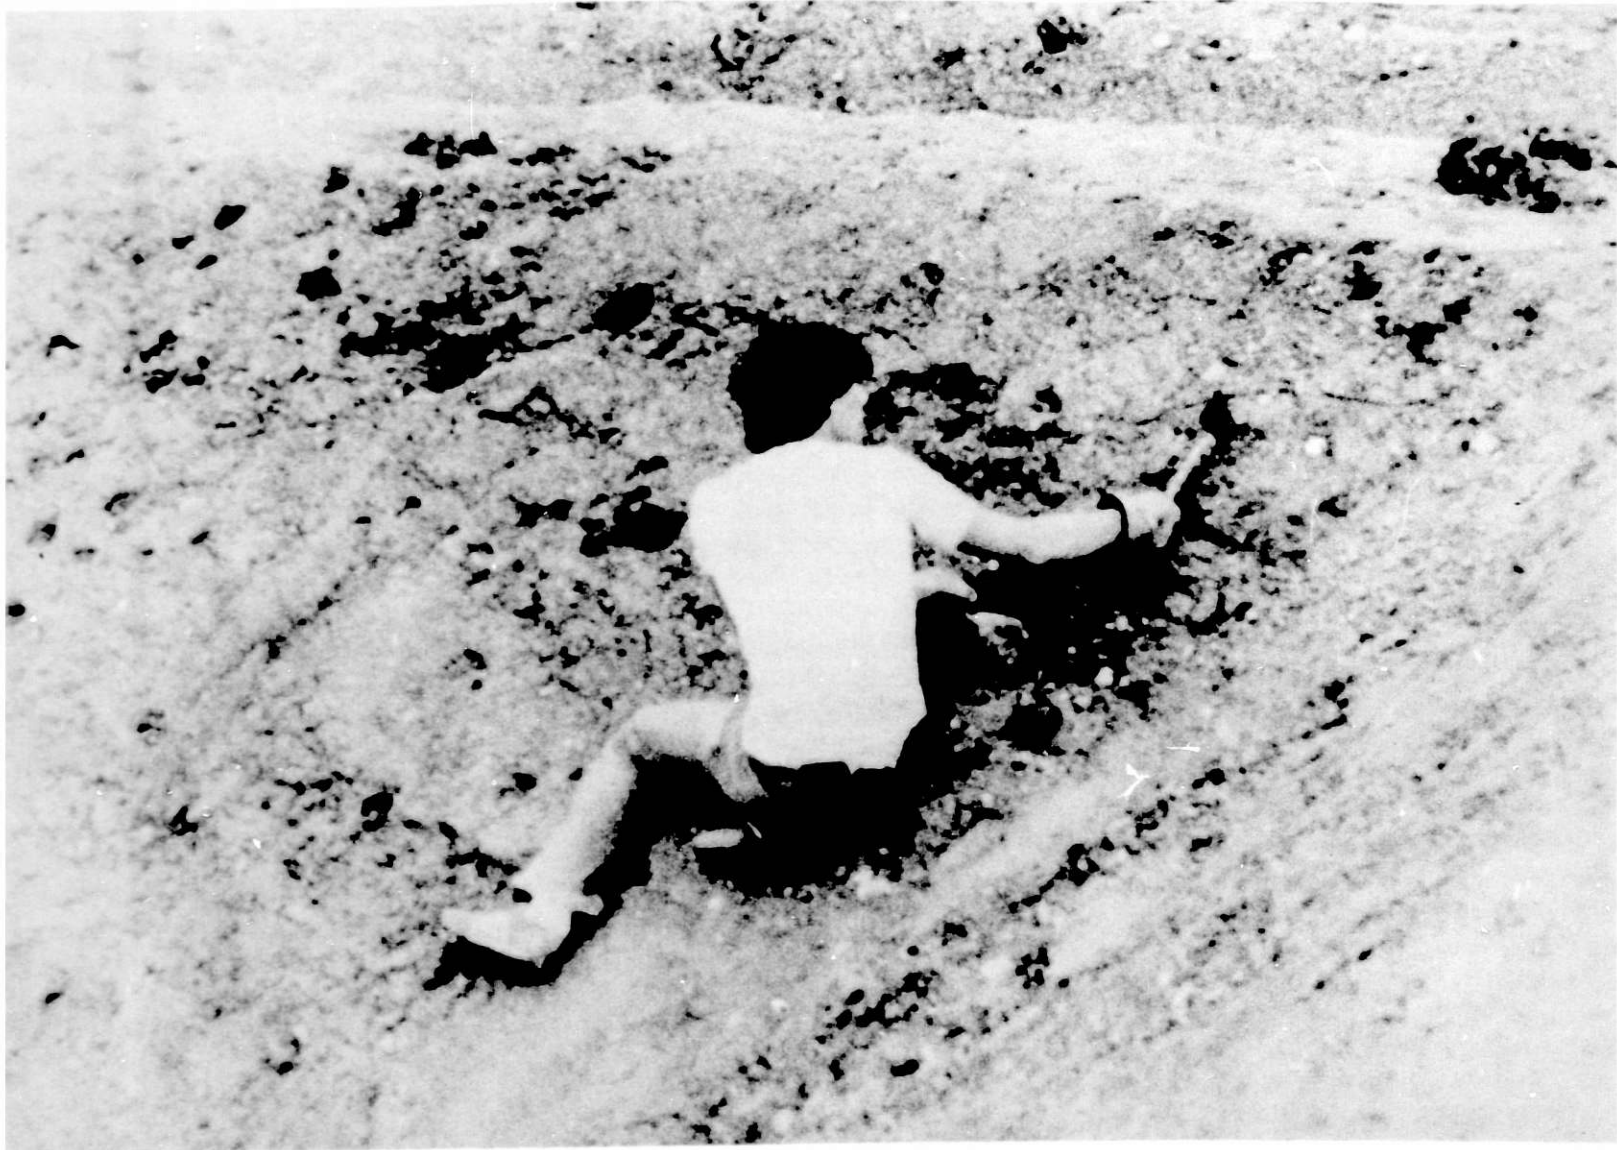
Fig. 13. Removing Rocks and Roots from the Slopes of the Pond

removed gradually. In the meantime, intensive labor began to remove roots and rocks projecting above the surfaces (Fig. 13). Mud from the bottom of the pond was used to fill large holes and dents on the slopes. This was part of the effort to make the surfaces of the pond slopes as smooth as possible in order to minimize the probability of damaging the liner. Large rocks were also removed from the bottom of the pond before sand application. A total of 200 tons (10 truck loads) of mason sand was applied which provided a layer of sand with a thickness of 15 cm (6 in) on the bottom of the pond (Fig. 14).

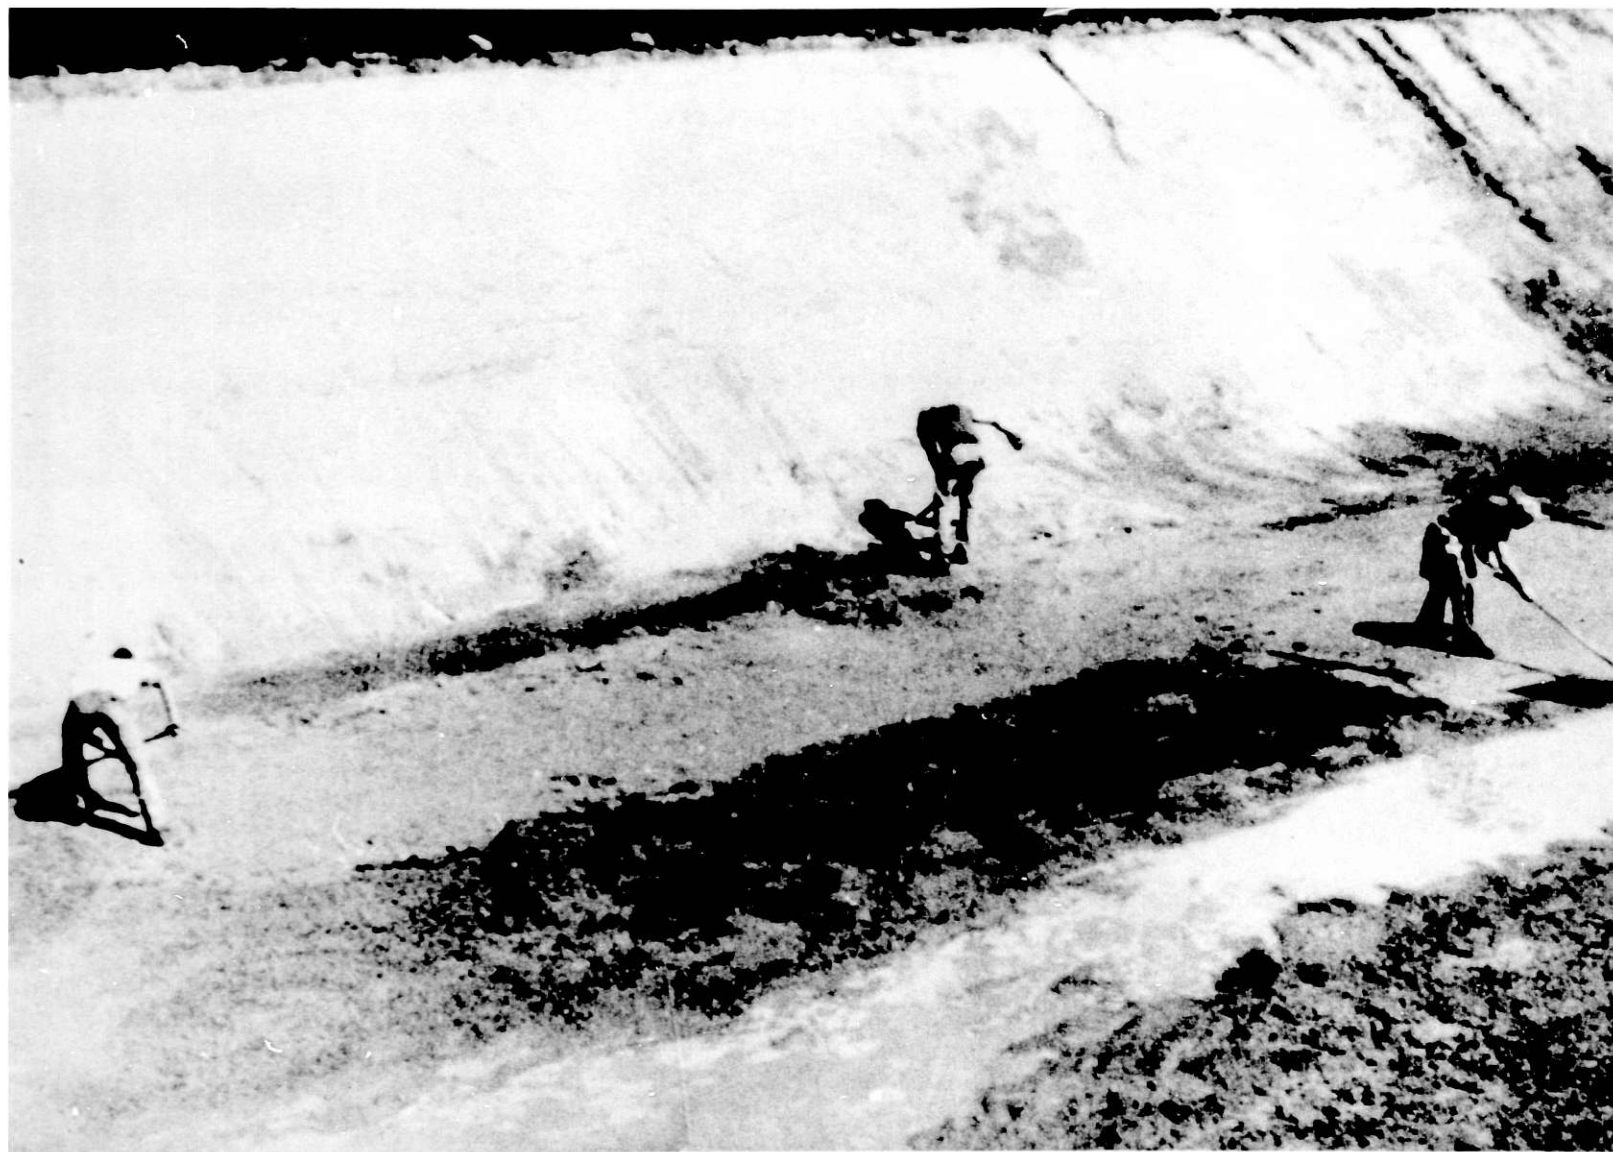
Fig. 14. Sand Application at the Bottom of the Pond

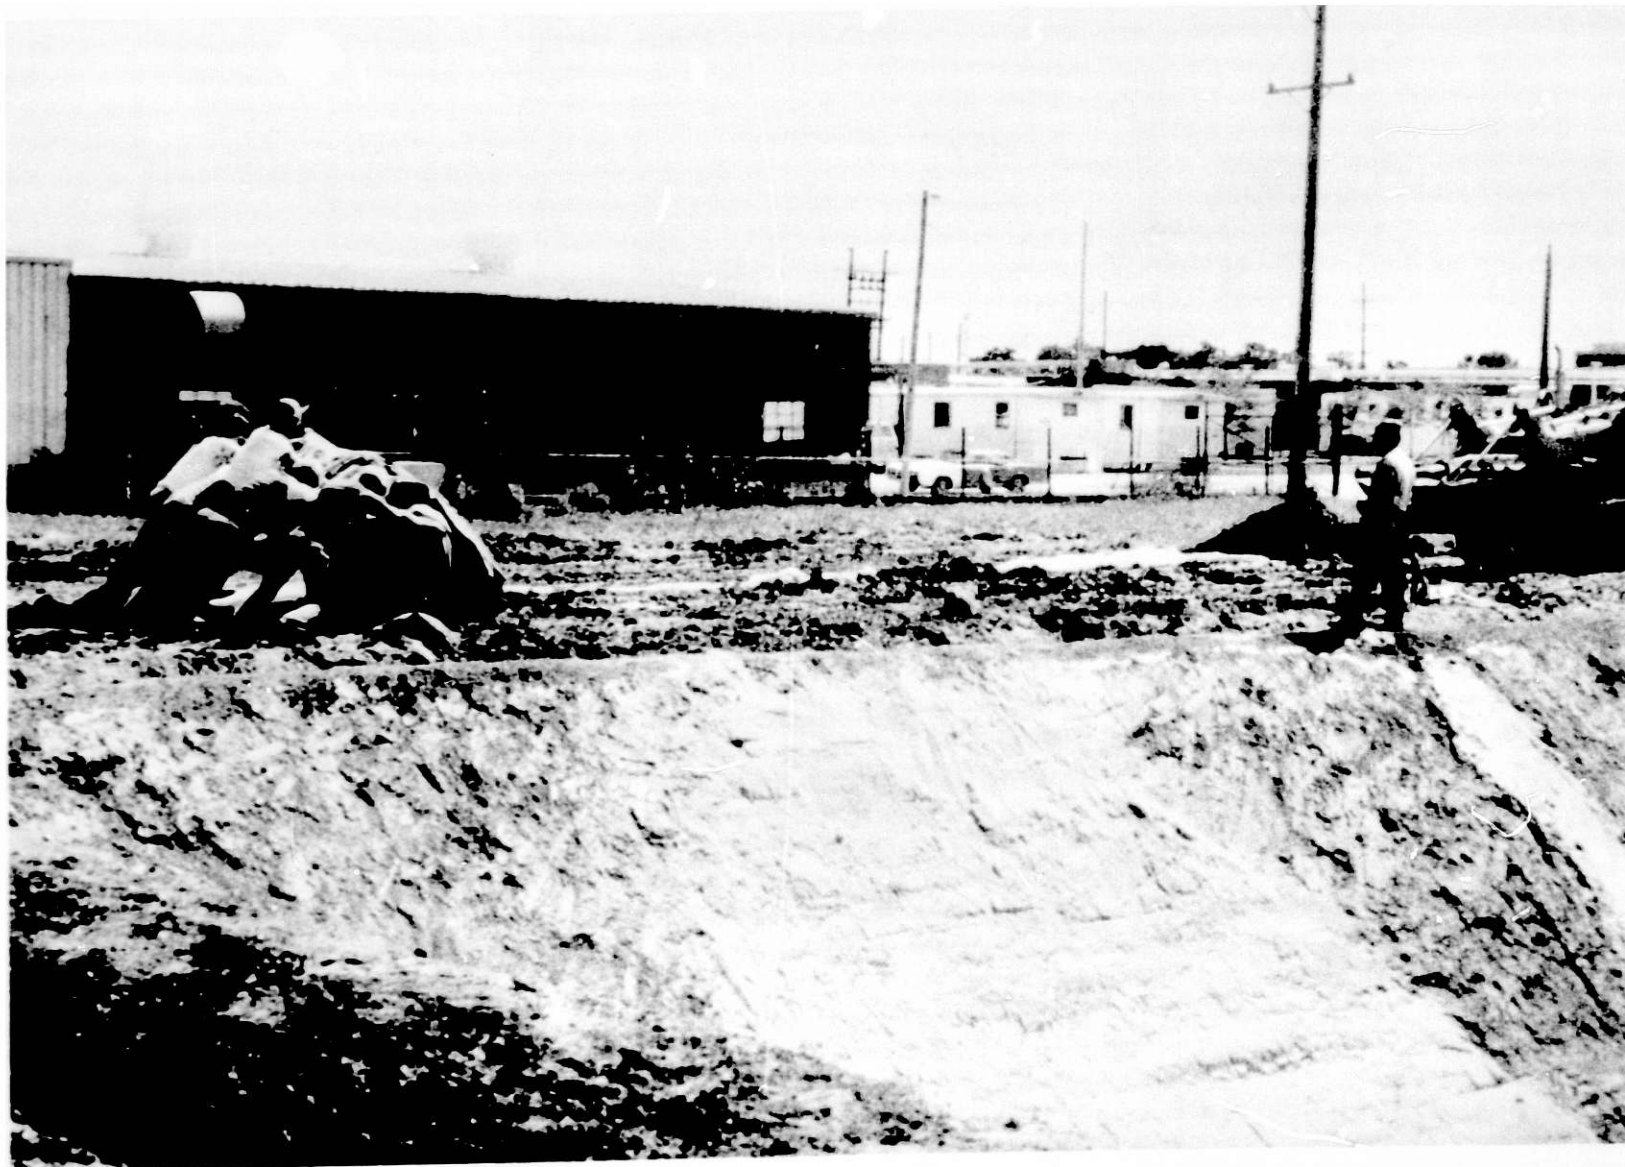
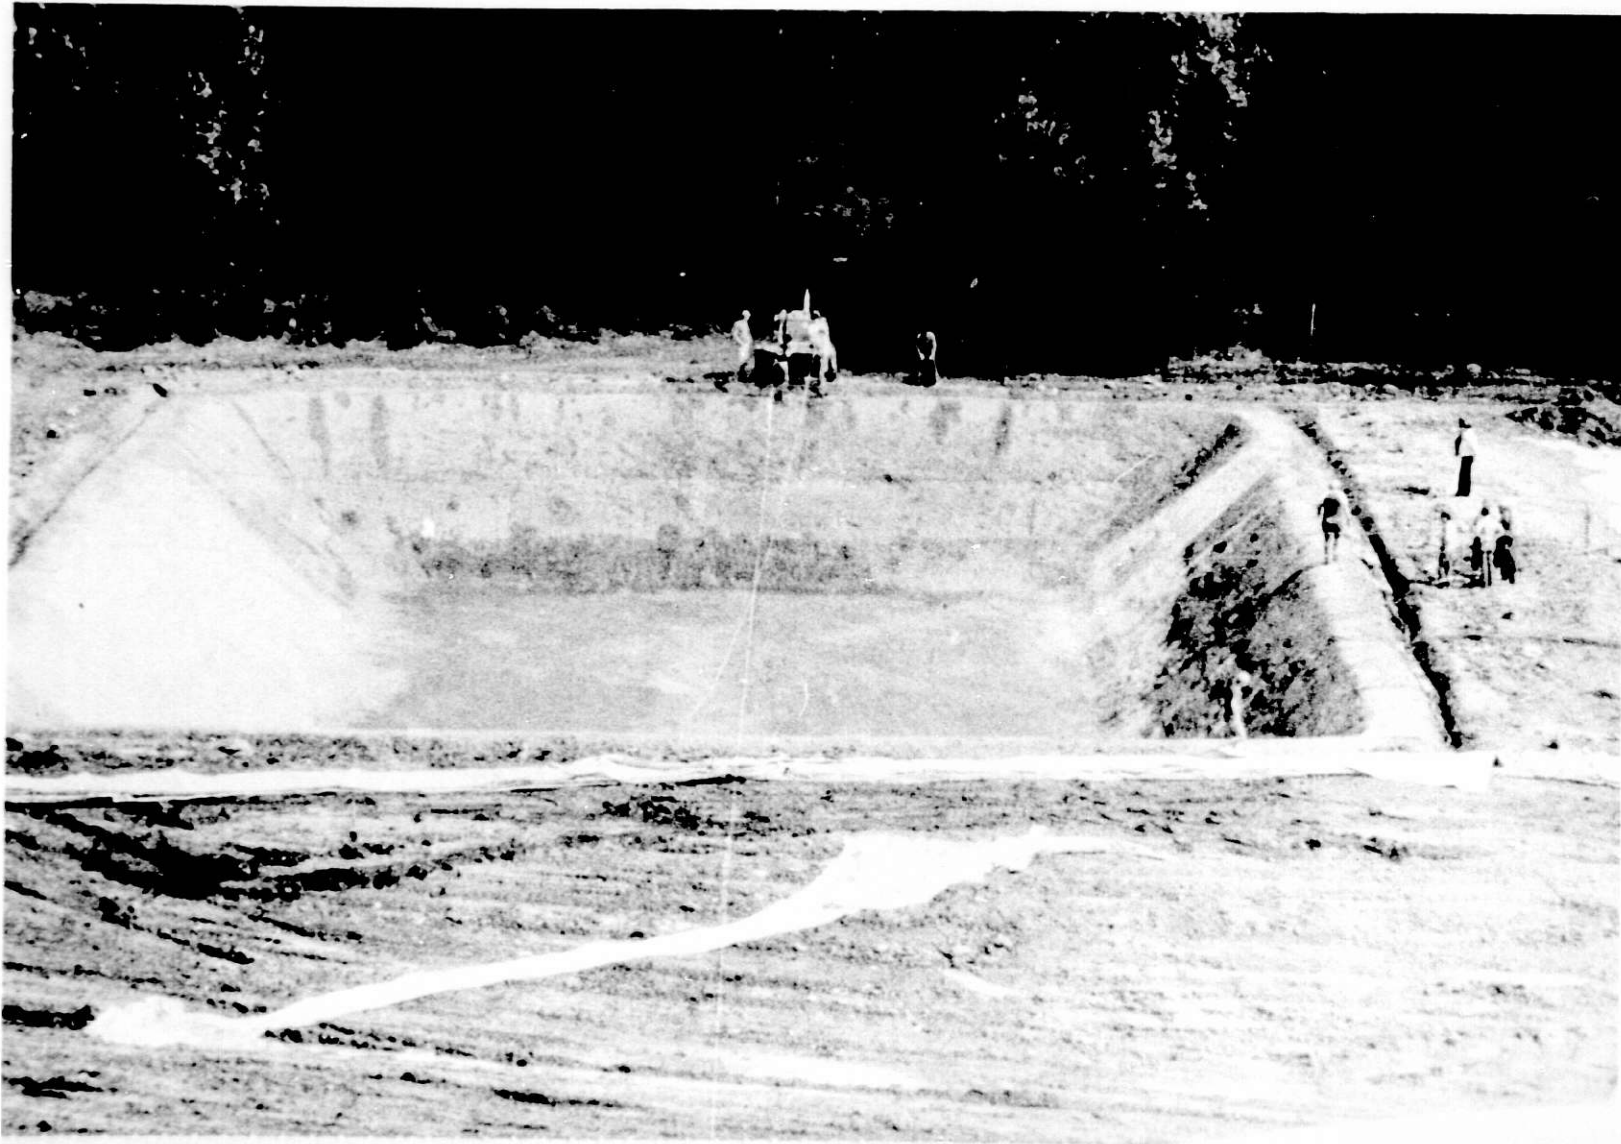
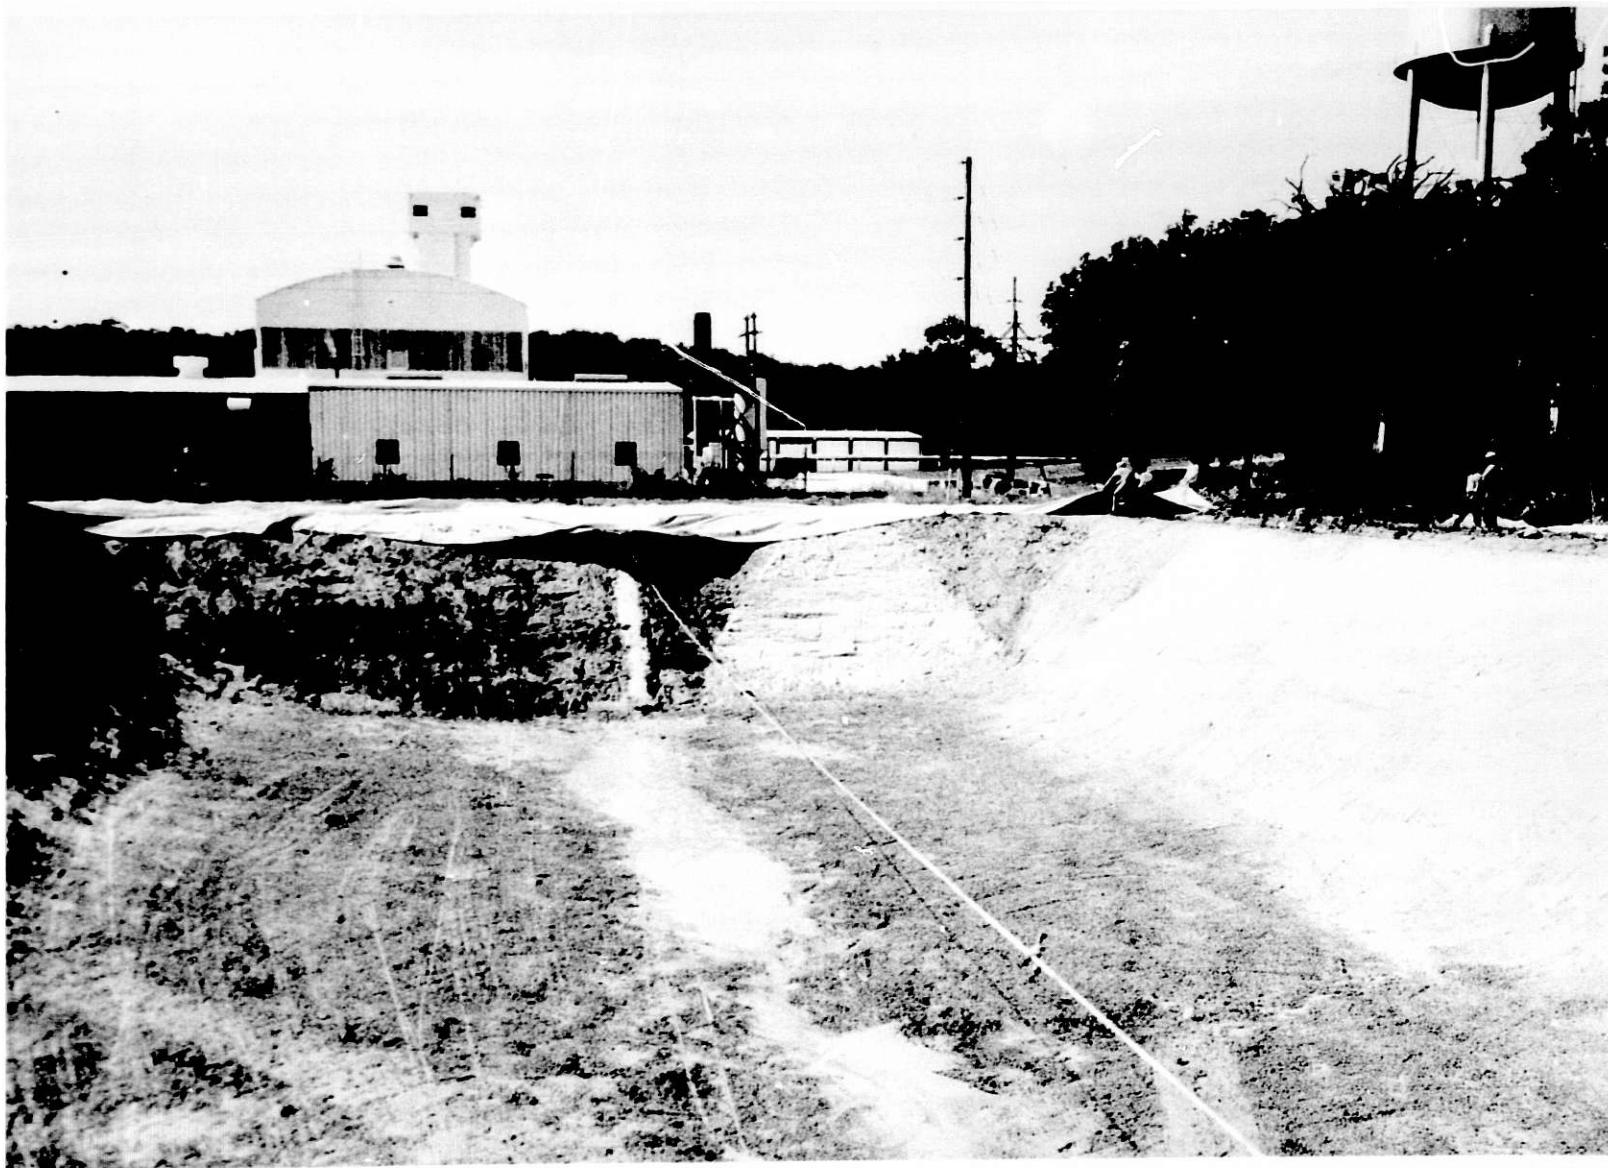
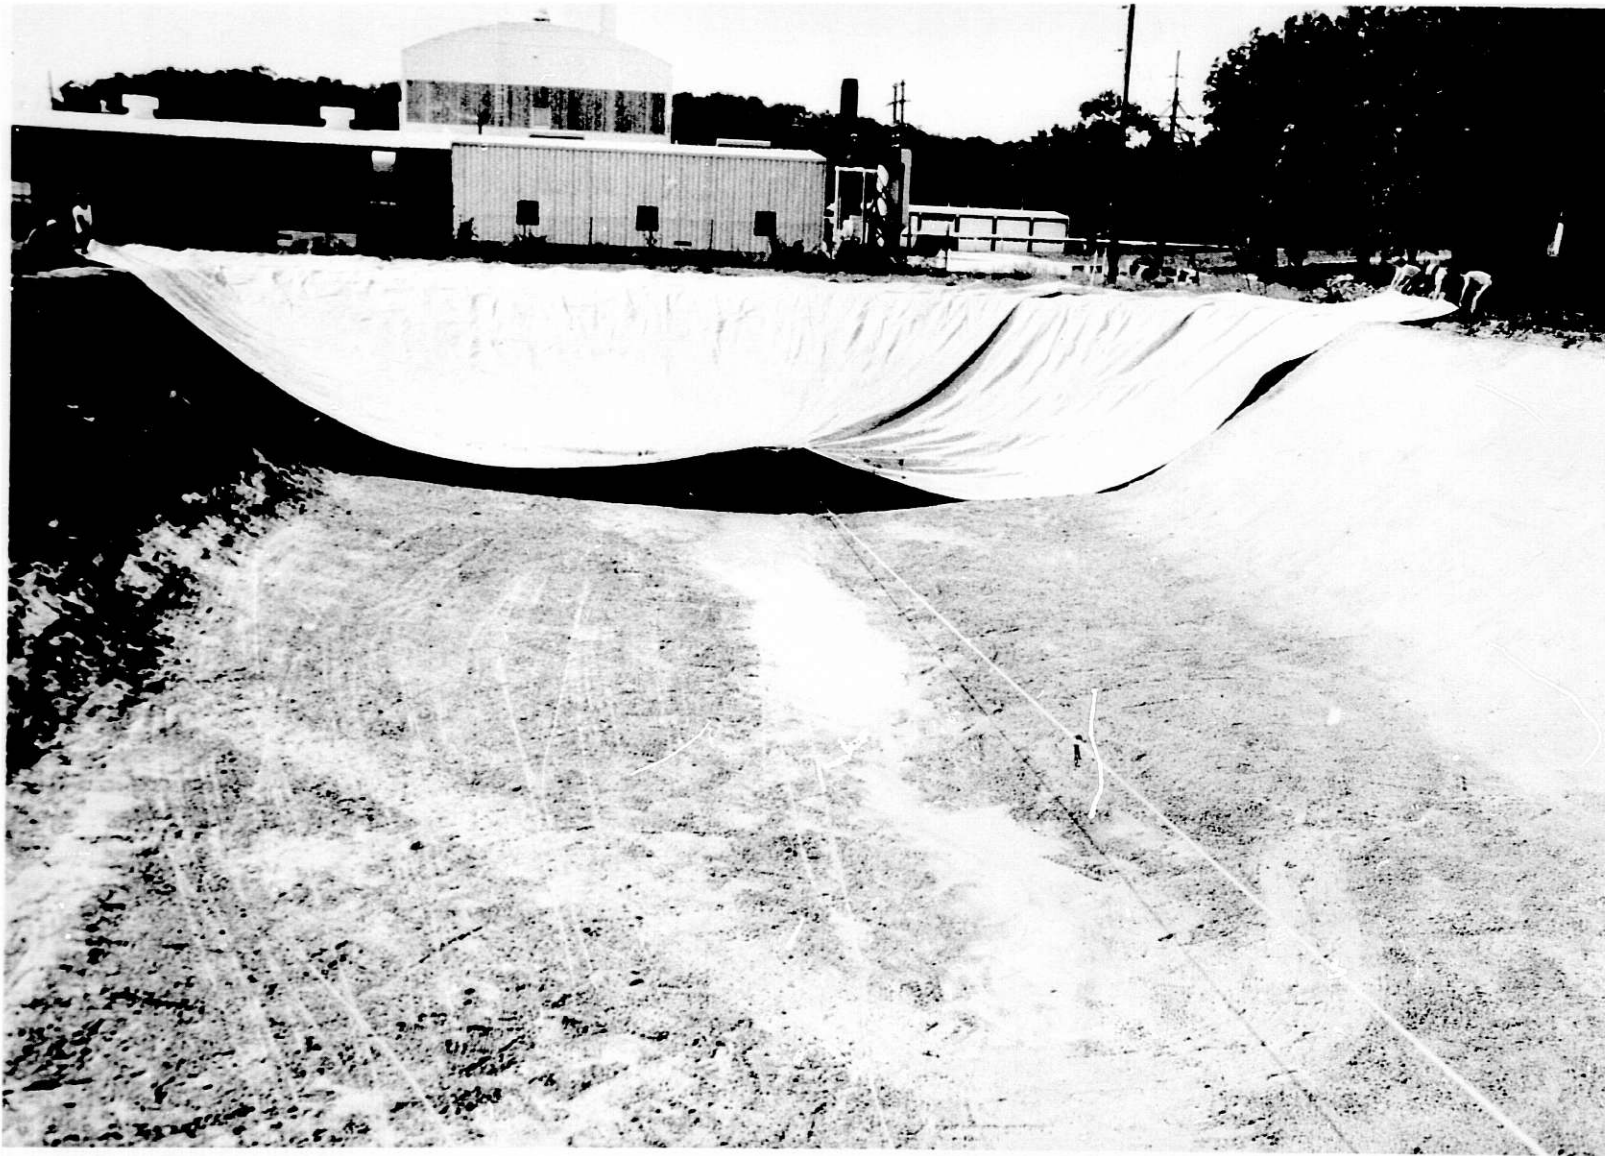
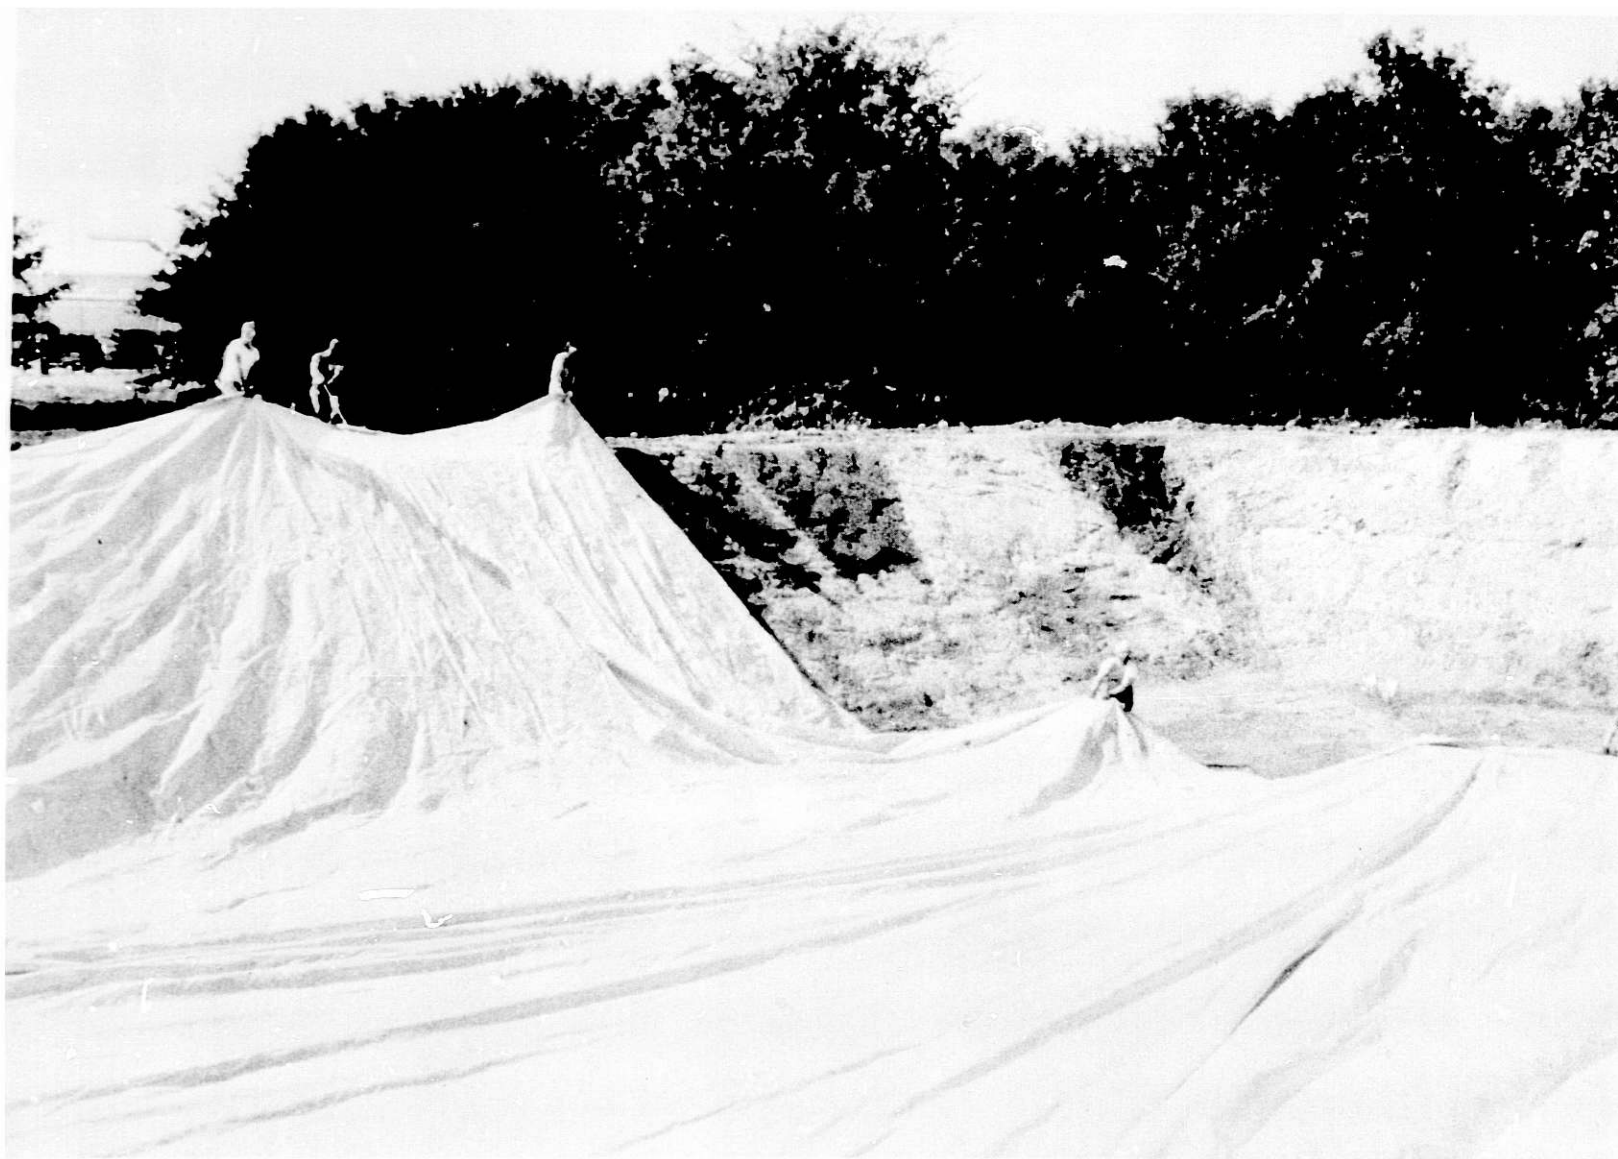
Fig. 15. Unfolding the Liner on the West Bank of the Pond

Fig. 16. Liner Ready to Be Unfolded Across the Pond

Fig. 17. Front-end Loader Beginning to Pull the Liner Across the Pond

Fig. 18. Another View of Liner Unfolding

Fig. 19. Two-thirds of the Pond Covered with the Liner

Fig. 21. Liner Completely in Place

The XR-5 Shelter-Rite liner was transported to Argonne from a local distributor (M. Putterman Company of Chicago). It came as one piece folded into a 1.8 m (6 ft) cubicle and was stored near the pond site. The surface condition of the pond was inspected carefully by Argonne staff and by the Contractor, and final approval was given for the installation of the liner. The liner was first moved to the northwest corner of the pond by a fork-lift truck and then unrolled along the west bank with the help of a front-end loader (Figs. 15 and 16). The front-end loader was then moved to the east bank to help unfold the liner across the pond. A specially designed clamp was used to hold the liner at midplane. The clamp was connected to the front-end loader via a rope. As the front-end loader moved eastward, the liner began unfolding (Figs. 17 and 18). In the meantime, several persons were trying to swing the front-end of the liner up and down in order to get more air underneath the liner to reduce friction. When 2/3 of the pond was covered by the liner, the clamp broke loose as a result of too much friction between the ground and the liner. The contractor decided to make a cut in the north-south direction at the center of the liner so that the clamp could be applied there. This would enable the front-end loader to pull only the second half of the liner and reduce the friction significantly (Fig. 19). The cut was about 2.4 m (8 ft) long and was repaired later by thermal seams (Fig. 20). Double seams were used. The first seam was 0.3 m by 3 m and on top of this seam was the second seam (0.6 m by 4 m) which totally enclosed the first seam. After the liner was securely in place (Fig. 21), it was thoroughly examined to determine if any defect or damage existed. Only one small defect was found and repaired by thermal seam. The entire process of liner installation took about one day. The final grading of the berm was completed shortly after that.

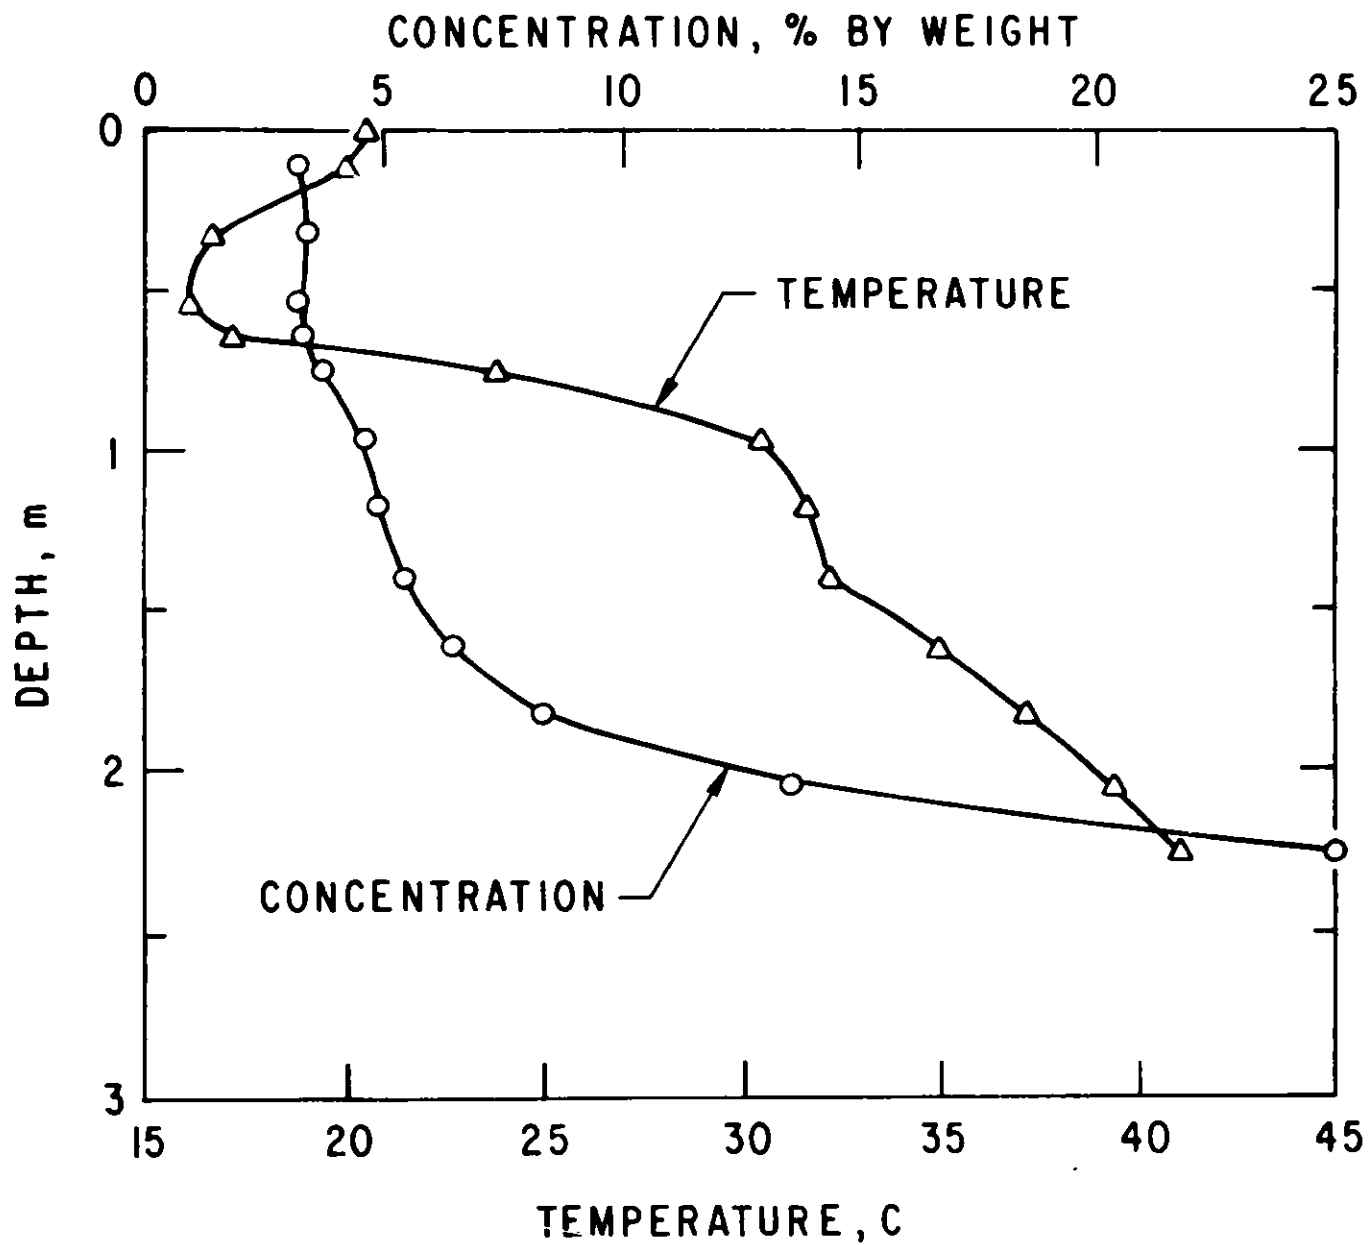
Fig. 28. Vertical Temperature and Concentration Profiles of the ANL-RSGSP on April 27, 1981

Construction of the ANL-RSGSP was completed in November of 1980. By this time, the pond contained approximately 500,000 gallons of water and 700 tons of salt. Since winter was almost here, it was decided not to establish the salt gradient by artificial means until the next spring (a natural salt-gradient should develop). Throughout the winter of 80-81 the pond maximum temperature was monitored. In March of 1981, the pond began to heat up. A small modification of the naturally-occurring salt-gradient was established by injecting fresh water at a level of approximately 0.3 m (1 ft) below the surface. A total of 40,000 gallons of water was injected through the diffuser. A more detailed account of the salt-gradient modification will be reported separately. In this report, the results of initial operation of the pond can be summarized in Figs. 27 to 29. Figure 27 shows the maximum pond temperature variation with time. Figure 28 shows the vertical temperature and concentration profiles of the pond in the spring. The salt concentration distribution in Fig. 28 is the result of natural diffusion. Figure 29 shows the temperature and concentration distributions obtained in July after some modification
