**EVALUATION OF CERAMIC REFRACTORIES  
FOR SLAGGING GASIFIERS:  
SUMMARY OF PROGRESS TO DATE**

**ARGONNE NATIONAL LABORATORY, ARGONNE, ILLINOIS**

September 1978

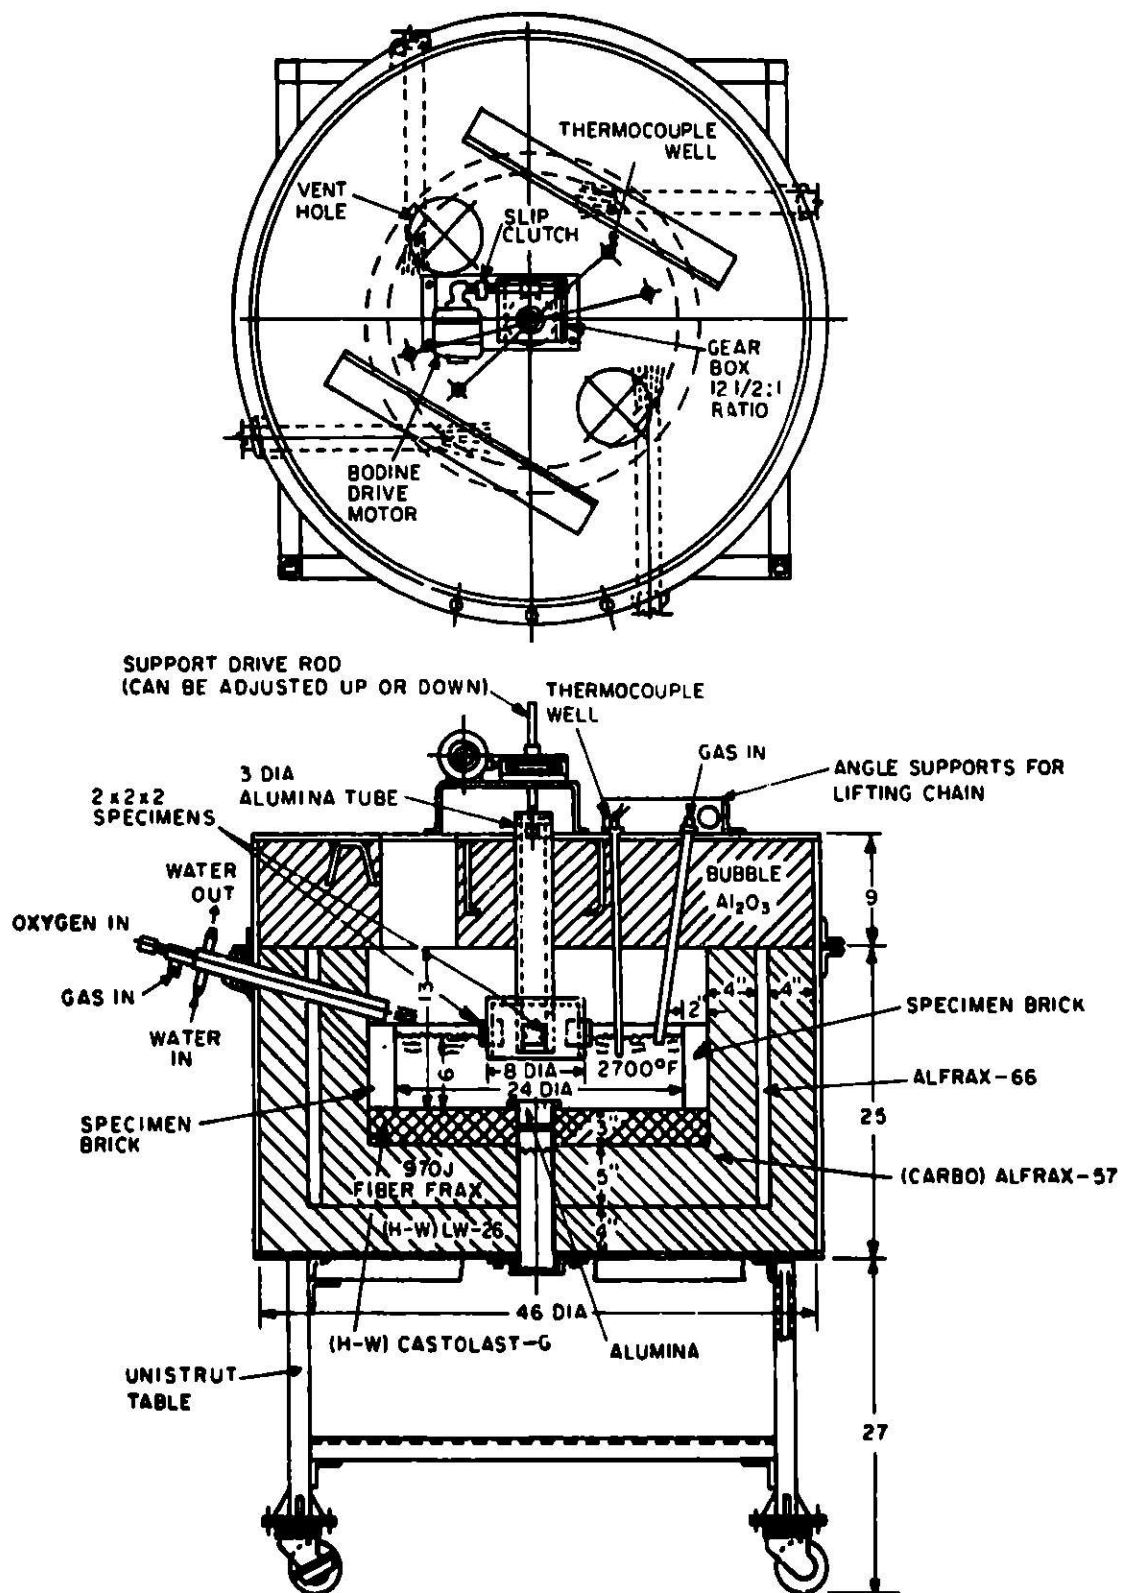
Fig. 1. Schematic of the Slag-corrosion Furnace as Originally Designed. The rotating sample holder in the center of the furnace was dismantled after repeated failures. ANL Neg. No. 306-78-767.

Figure 1 shows a schematic of the slag-corrosion furnace as originally designed. The rotating sample holder in the center of the furnace was dismantled after repeated failures, and the refractories to be tested were embedded in the wall of the furnace. The refractory samples tested without water cooling (test runs 1-3) were 65-75 mm long and  $\sim 110$  mm (4-1/2 in.) wide.

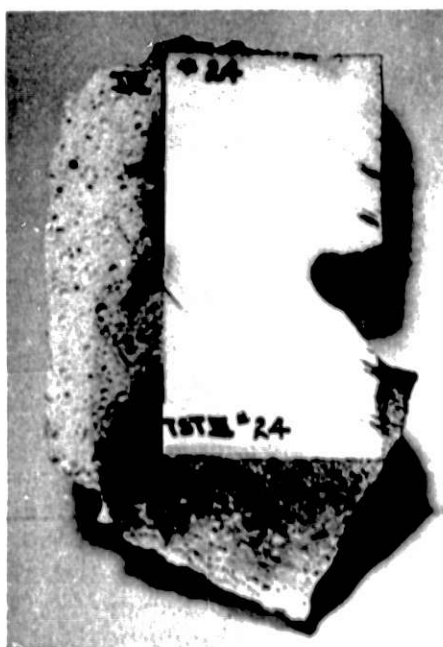
Fig. 2. Cut Sections of the Fused-cast Refractories Exposed to Slag Attack in Test Run 3. (a) Alumina-zirconia-silica (number 65), (b) alumina (number 24), and (c)  $\text{Cr}_2\text{O}_3\text{-MgO-Fe}_2\text{O}_3$  spinel (number 22; note negligible attack). Neg. No. MSD-63801.

The refractories tested in run 3 are identified and their relative corrosion resistance summarized in Table VI. The sintered magnesia-chrome spinel and alumina-chrome specimens exhibited relatively small volume losses and depths of removal despite significant slag penetration. The alumina-silica and alumina-zirconia-silica bricks performed poorly, as did a silicon oxynitride brick. Figure 2 shows the three fused-cast refractories after exposure to the slag in test run 3. The alumina-zirconia-silica brick (number 65) was completely dissolved at the slag line; the alumina refractory showed significant removal, whereas the fused-cast  $\text{Cr}_2\text{O}_3\text{-MgO-Fe}_2\text{O}_3$  spinel brick exhibited negligible interaction with the slag.

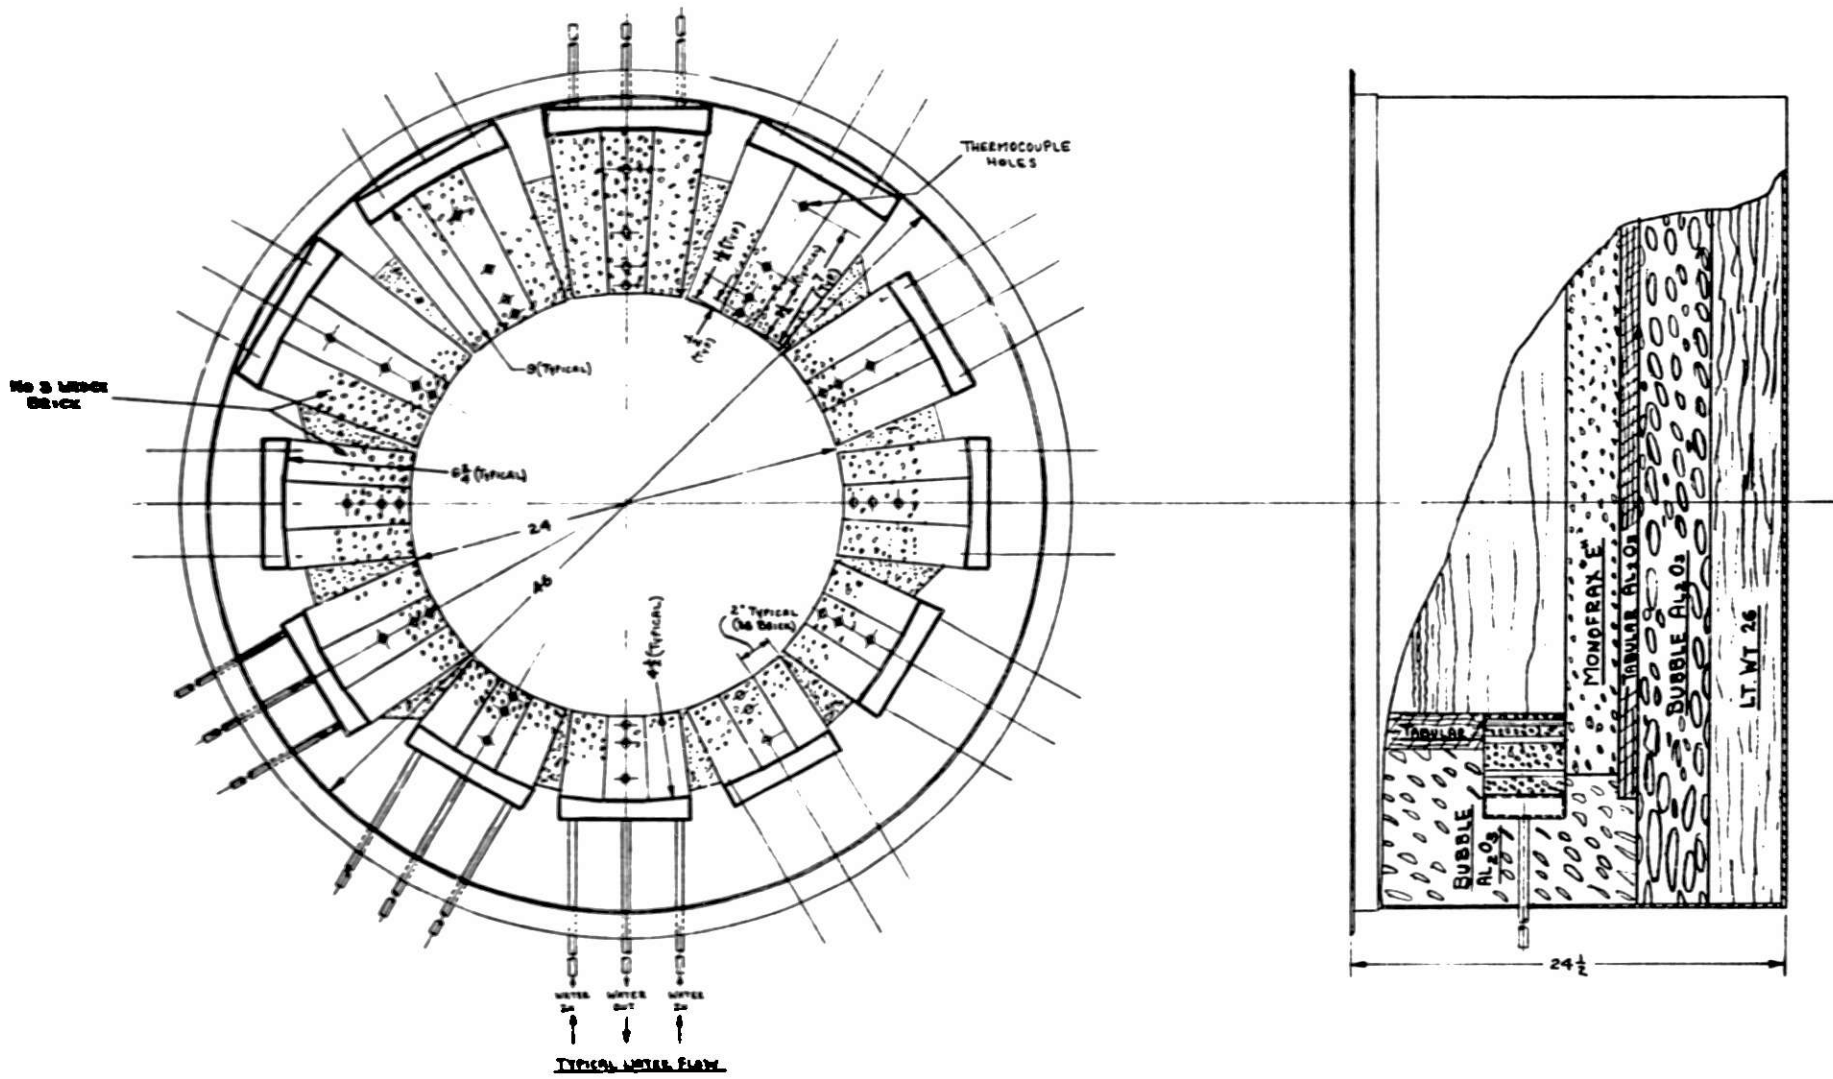
Fig. 3. Top and Side Views of the New Bottom Section of the Slag-corrosion Furnace. Dimensions are in inches. ANL Neg. No. 306-77-47.

The slag-corrosion furnace was modified to produce prototypic thermal gradients within the refractory bricks through the use of water-cooled chills (Fig. 3). Water temperature and flow were monitored so that heat flux could be calculated. Standard 9-in. x 4-1/2-in. x (3,2)-in. wedge bricks were used (if wedges were not available, straights were cut to fit) with the narrow ends of the bricks exposed to the slag. The wedges were cut to three different lengths so that three different temperature gradients could be studied. Bricks of four different compositions were tested simultaneously. Each chill cooled three bricks of the same length and composition. The center brick was thereby shielded from the effects of neighboring bricks of different lengths and/or composition.

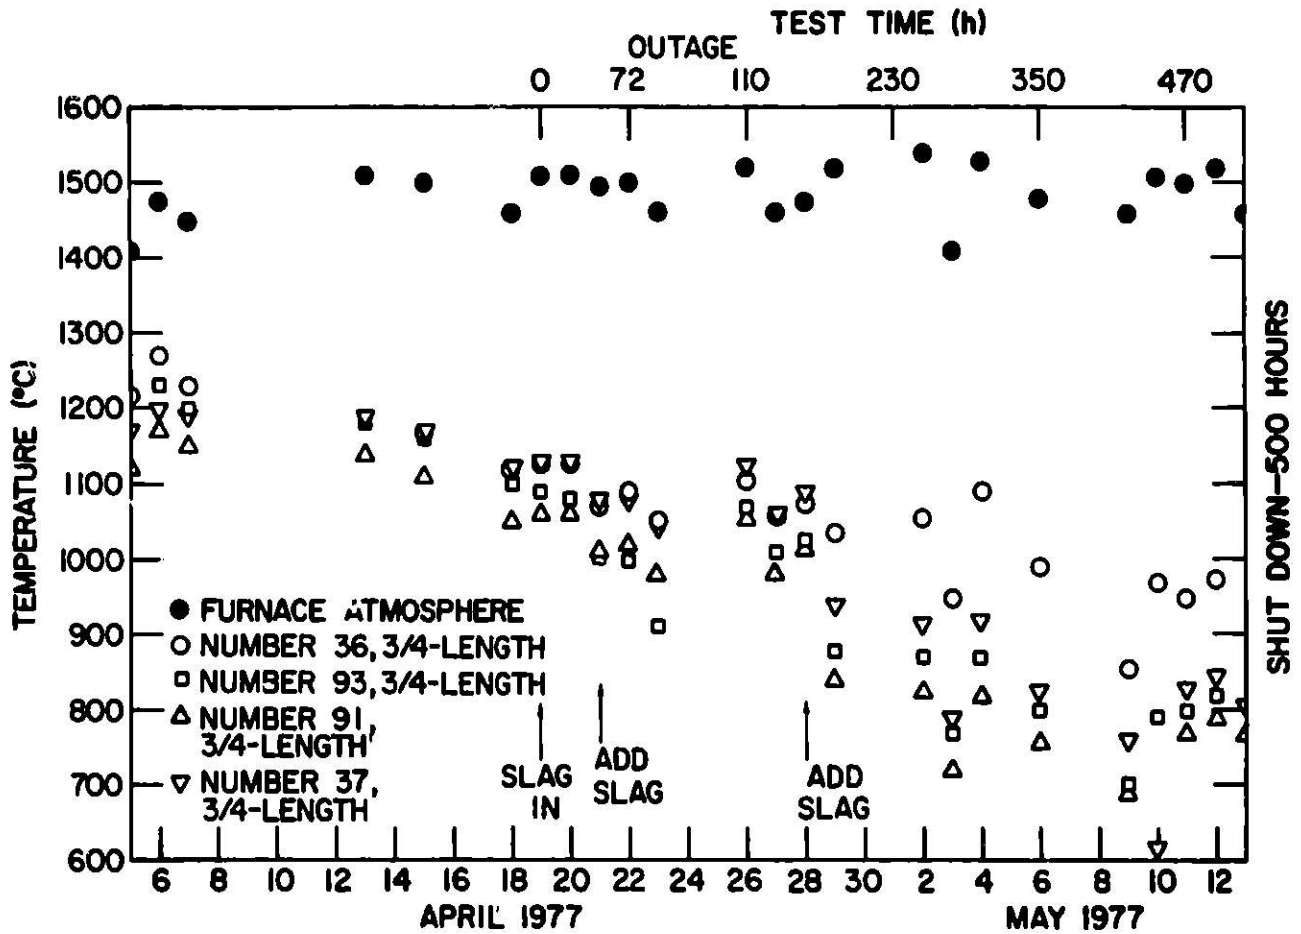
Fig. 4. Furnace Plenum Temperature and Midheight Brick Temperatures 12.7 mm (0.5 in.) from the Hot Face of 3/4-length Bricks of Each Composition During Test Run 4. ANL Neg. No. 306-77-382.

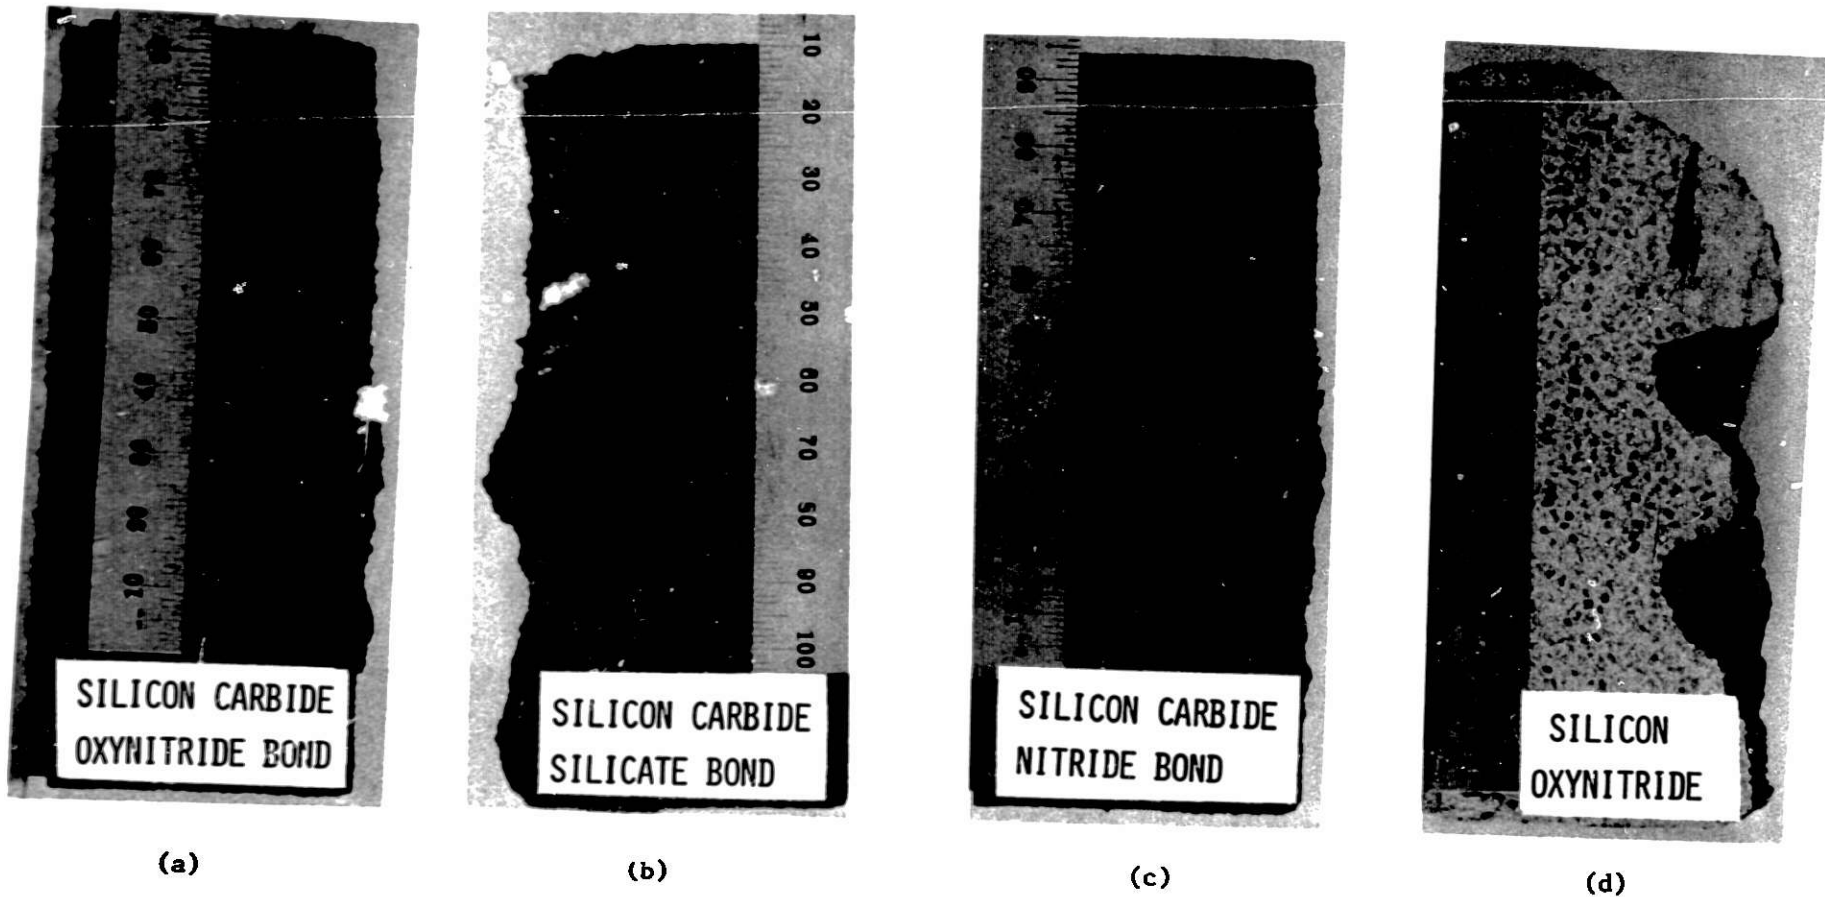
Fig. 6. Cut Sections of the 3/4-length Refractories Exposed to Slag Attack in Test Run 4. The vertical faces opposite the ruler were exposed to the slag. (a) Oxynitride-bonded silicon carbide (number 37), (b) silicate-bonded silicon carbide (number 93), (c) nitride-bonded silicon carbide (number 91), and (d) silicon oxynitride (number 36). Note the three levels of slag attack. ANL Neg. No. 306-77-387.

The bricks were removed from the furnace after 500 h. They were sectioned lengthwise in the vertical plane so that slag attack (material removal and slag penetration) could be viewed in cross section. The vertical sections cut from the 3/4-length bricks of each type are shown (right side up) in Fig. 6. The vertical face of each brick opposite the ruler was exposed to slag. Three lines of attack are visible that correspond to the three levels of slag during the test. Although these three lines are apparent on all bricks, in the photographs they are most evident on the silicon oxynitride, the material that was attacked the most.

All of the silicon carbide bricks exhibited little attack, contrary to the results obtained in test run 2 in which water cooling was not employed. The capability of the silicon carbide to resist attack may be attributed to the high thermal flux within the bricks, which reduced the hot-face temperature to ~1450°C. Typical values of heat flux for the silicon carbide bricks with chills were 40-50 kW/m<sup>2</sup> for full-length bricks; 50-70 kW/m<sup>2</sup> for 3/4-length bricks; and 60-90 kW/m<sup>2</sup> for 1/2-length bricks. The heat flux values were obtained by multiplying the measured thermal gradient by the published value of thermal conductivity, and should be considered only approximate because of the nonuniform heat-flow conditions mentioned previously.

Only slight differences in resistance to slag attack among the three types of silicon carbide bricks were detected. The oxynitride-bonded silicon carbide brick (number 37) was somewhat less resistant; the silicon oxynitride brick (number 36) was much less resistant, with the maximum depth of removal an order of magnitude higher than in any of the carbide bricks. The effect of the length of the brick on the depth of removal is shown in Fig. 7, and, as can be seen, even the 1/2-size silicon oxynitride brick exhibited substantial attack.

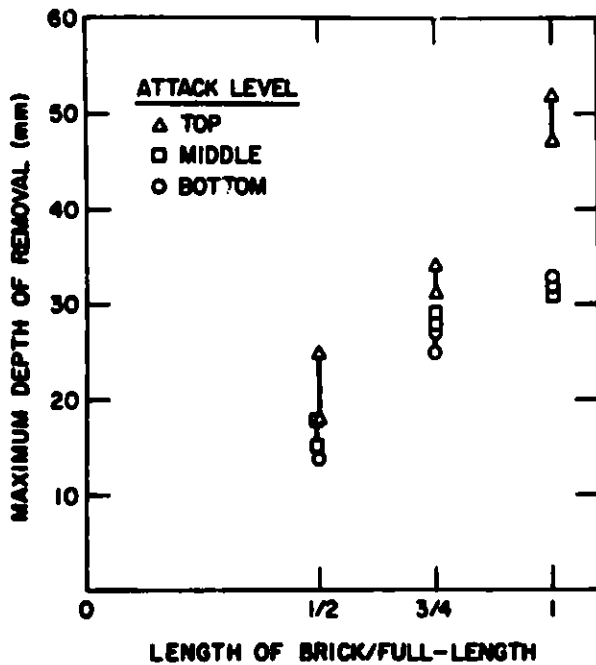
Fig. 7. Maximum Depth of Removal as a Function of Brick Length for Silicon Oxynitride Refractory Bricks Exposed in Test Run 4. ANL Neg. No. 306-77-372.

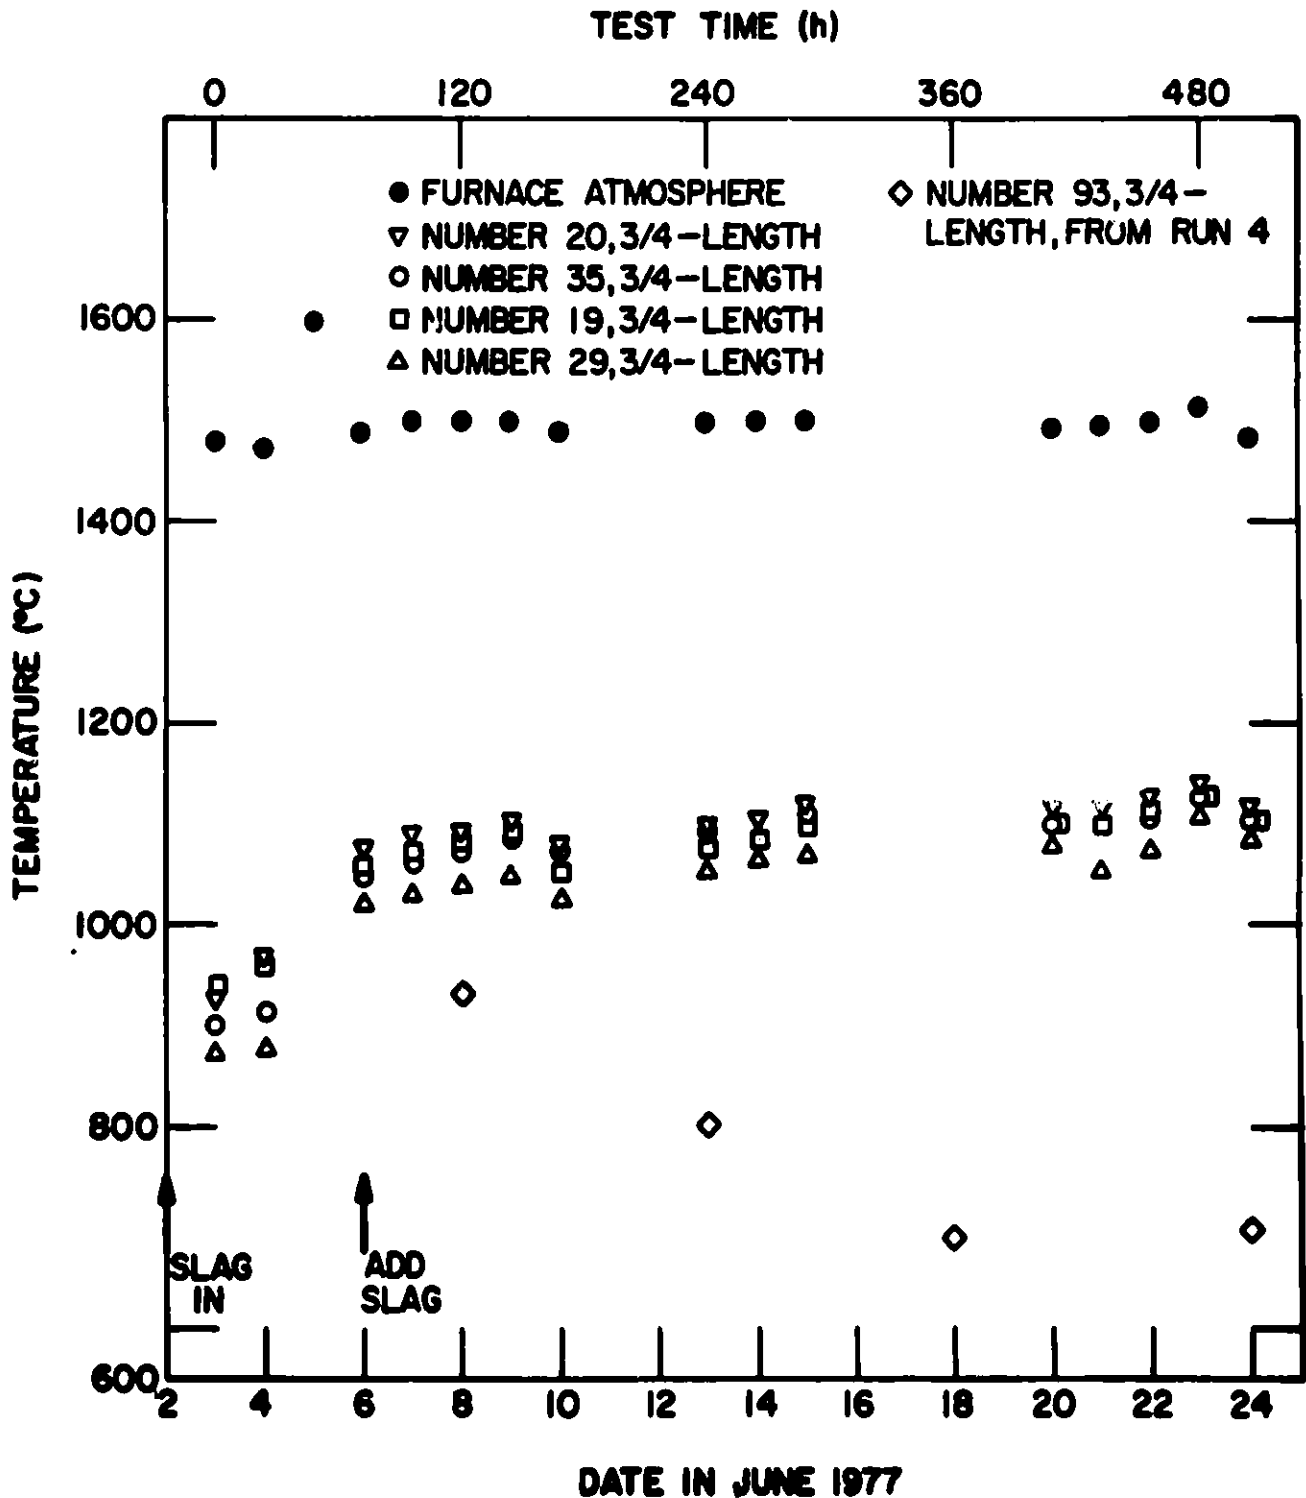
Fig. 8. Furnace Plenum Temperature and Midheight Brick Temperatures 38.1 mm (1.5 in.) from the Hot Face of Magnesia-Chrome 3/4-length Refractory Bricks During Test Run 5. ANL Neg. No. 306-77-381.

The fifth run included four direct-bonded magnesia-chrome spinel bricks. The furnace temperatures, and midheight temperatures in the 3/4-length bricks at a location 38.1 mm from the hot face, are shown in Fig. 8. Shown for comparison are the temperatures within a 3/4-length silicon carbide brick (number 93) from run 4, also at a location 38.1 mm from the hot face. Typical thermal profiles within the bricks are shown in Fig. 9. Since the thermal conductivity of silicon carbide refractories is almost an order of magnitude higher than that of the magnesia-chrome refractories, some differences in the thermal profiles were observed (compare Fig. 9 with Fig. 5). Typical heat fluxes in the magnesia-chrome bricks were  $8 \text{ kW/m}^2$  for full-length bricks,  $11 \text{ kW/m}^2$  for 3/4-length bricks, and  $13 \text{ kW/m}^2$  for 1/2-length bricks. These values are 1/5 to 1/7 of the heat-flux values in the silicon carbide bricks.

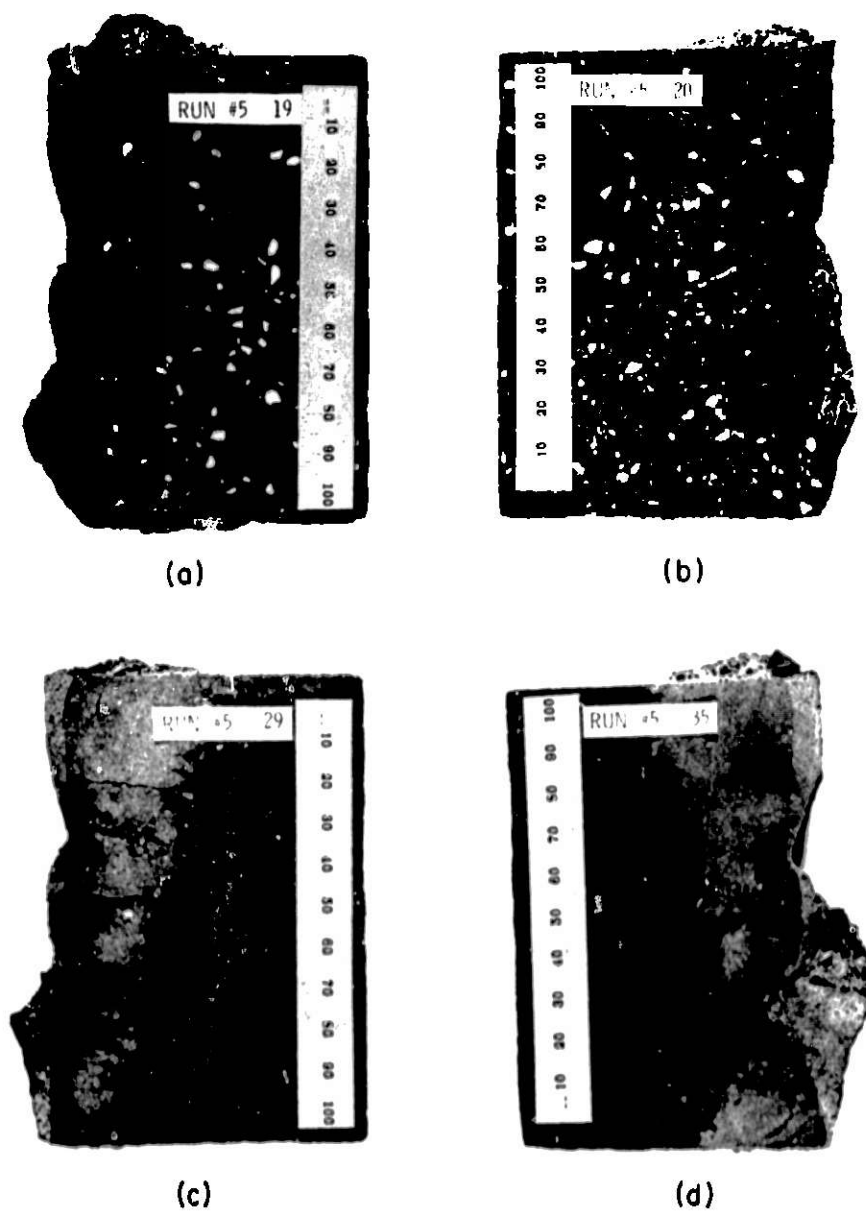
Fig. 10. Cut Sections of the Full-length Refractories Exposed to Slag Attack in Test Run 5. (a) Number 19, (b) number 20, (c) number 29, and (d) number 35. The vertical face opposite the ruler was exposed to the slag. There are two lines of attack, corresponding to the two levels of slag during the test. ANL Neg. No. 306-78-94.

The relative corrosion resistance of the magnesia-chrome refractories tested in run 5 is summarized in Table X. Posttest photographs of partial sections of the full-length bricks are shown in Fig. 10. For each brick, the vertical side opposite the ruler was exposed to the slag and two lines of slag attack are evident, corresponding to the two additions of slag made during the test. The B/A ratio of the slag (a simulated Montana Rosebud) was constant at  $\sim 0.6$  throughout the entire test, but an excursion of the plenum temperature to  $\sim 1600^\circ\text{C}$  occurred just before the second slag addition. Thus, the bottom line of slag attack corresponds to an  $\sim 70$ -h exposure at a plenum temperature of  $1500$  to  $1600^\circ\text{C}$ , whereas the top line of attack was the result of an  $\sim 430$ -h exposure at a plenum temperature of  $1500^\circ\text{C}$ .

Bricks number 19, 20, and 29 exhibited similar resistance to corrosion, as measured by the depth of removal, whereas brick number 35 showed a marked sensitivity to the temperature excursion (Table X). In addition to the bulk removal of the refractory material, a zone that was obviously penetrated by the slag and a zone in which the microstructure had been altered were evident (Fig. 10). Brick number 29 showed slightly greater resistance to penetration and alteration than the other three. Whereas the effect of length on the depth of removal and obvious penetration was small for numbers 19, 20, and 29, the 1/2-length brick number 35 performed distinctly better than the full- or 3/4-length brick of the same composition. Also, the depth of alteration decreased as the length decreased for all bricks tested. In order to determine if the alterations in the microstructure were a result of penetration by slag, samples were core drilled and examined with the SEM using x-ray dispersive analysis. The relative intensities of the Mg, Al, Si, Cr, and Fe peaks were compared in the slag, slag-refractory interface, obviously penetrated refractory, and in the zone of microstructural alteration ~40 mm from the hot face. Evidence for slag penetration was most clear-cut in brick number 35, somewhat less so in bricks number 19 and 20, and inconclusive in brick number 29.

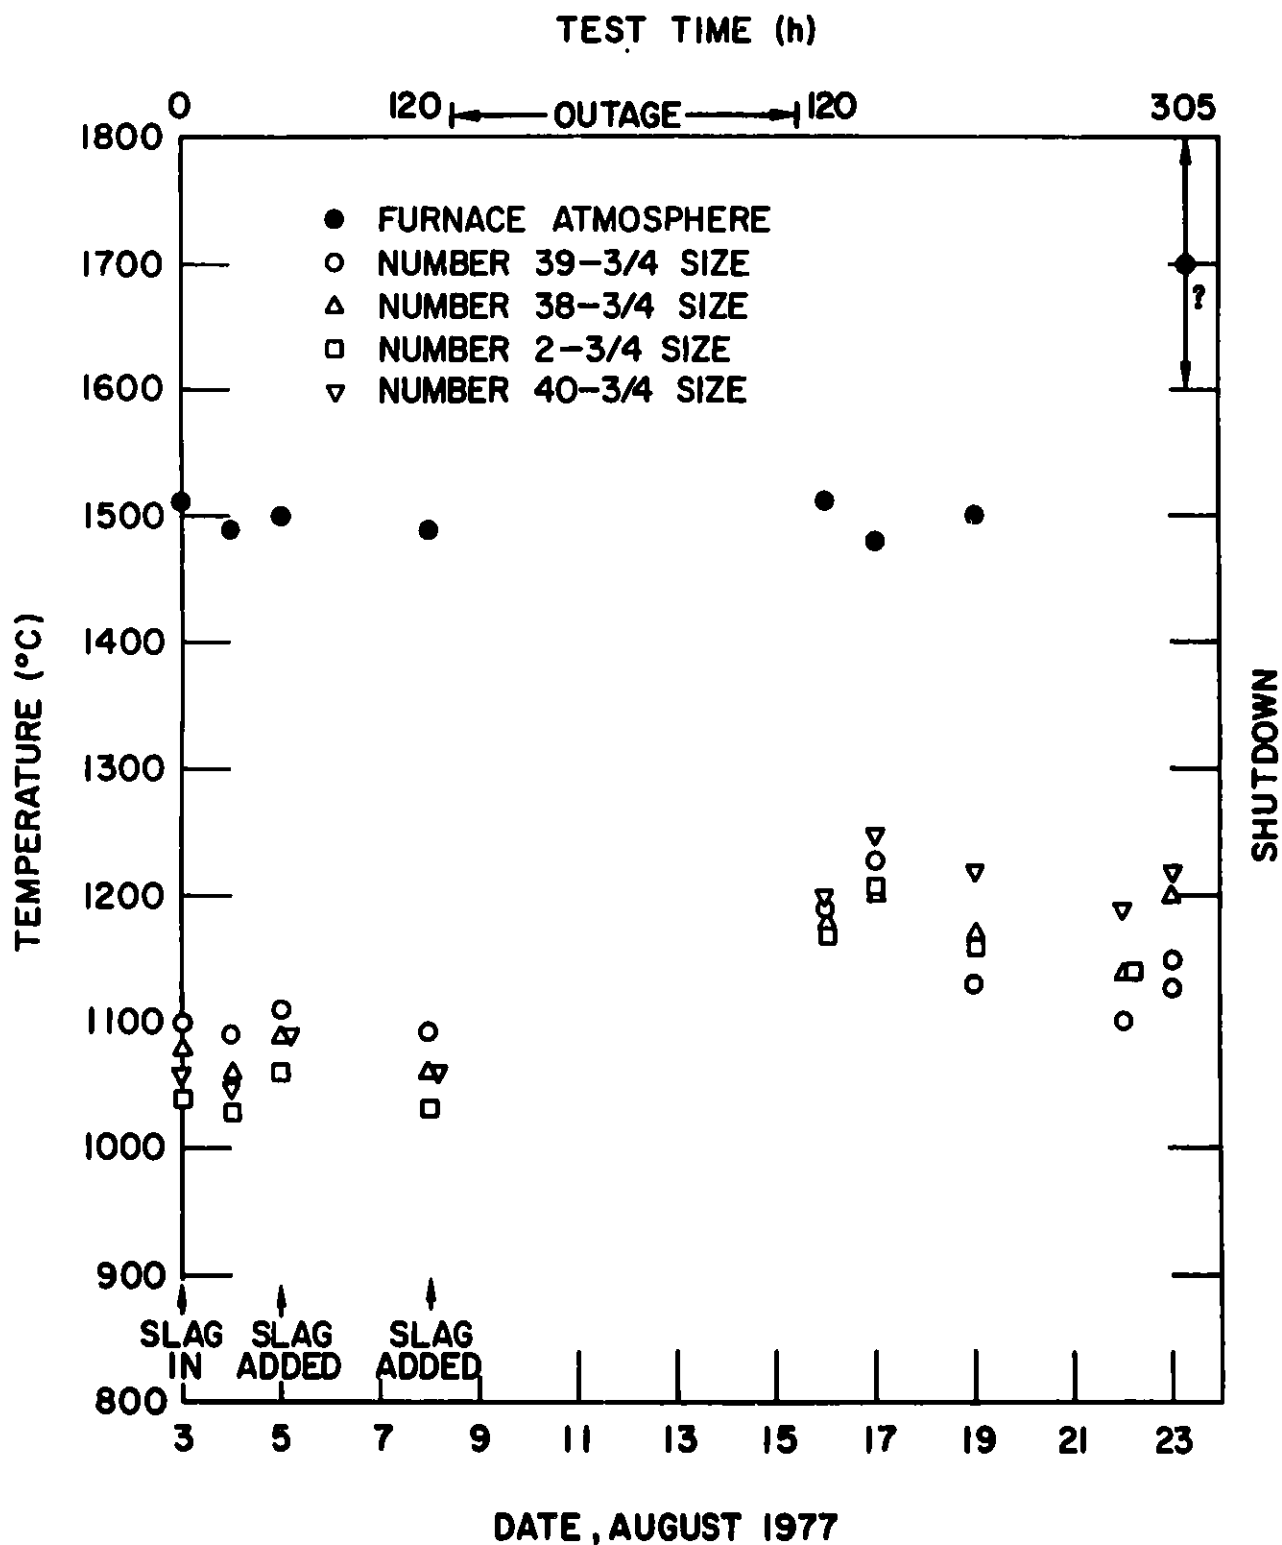
Fig. 11. Furnace Plenum Temperature and Midheight Brick Temperatures 38.1 mm from the Hot Face of 3/4-length Bricks of Each Composition During Test Run 6. ANL Neg. No. 306-78-48.

The furnace plenum temperature and the midheight temperatures 38.1 mm (1.5 in.) from the hot face of the 3/4-length bricks are shown in Fig. 11. At 305 h into the run, a temperature excursion, which occurred as a result of a thermocouple failure, caused the bubble-alumina insulating wall to slump; the test had to be terminated because of the resulting hot spot on the shell. It is estimated that the plenum temperature reached ~1700 to 1800°C overnight during the excursion. Temperature profiles in the bricks on August 18, 1977 are shown in Fig. 12. The relative resistance to corrosion of the refractories in run 6 is presented in Table XII, and cut sections of the 3/4-length bricks are shown in Fig. 13. Only one line of attack is evident upon examination despite the fact that slag was added twice during the test. The absence of two lines of attack indicates that the corrosion which occurred during the temperature excursion was sufficient to eradicate the first line of attack. A comparison of the attack on brick number 39 in this test with the attack on numbers 19 and 20 in test 5 (bricks of similar composition and structure) indicates that the conditions in run 6 were very severe indeed. In light of this severity, the corrosion resistance of the fused-cast alumina-chrome brick (number 38) may be quite good at 1450-1500°C, and therefore it will be retested in the future. As evident from the posttest photographs, bricks number 2 and 39 contained substantial porosity which provided an easy avenue for penetration and corrosion. Also evident are numerous thermal-shock cracks that occurred in the three fused-cast refractories (numbers 2, 38, and 39). No such cracks were found in the sintered brick (number 40).

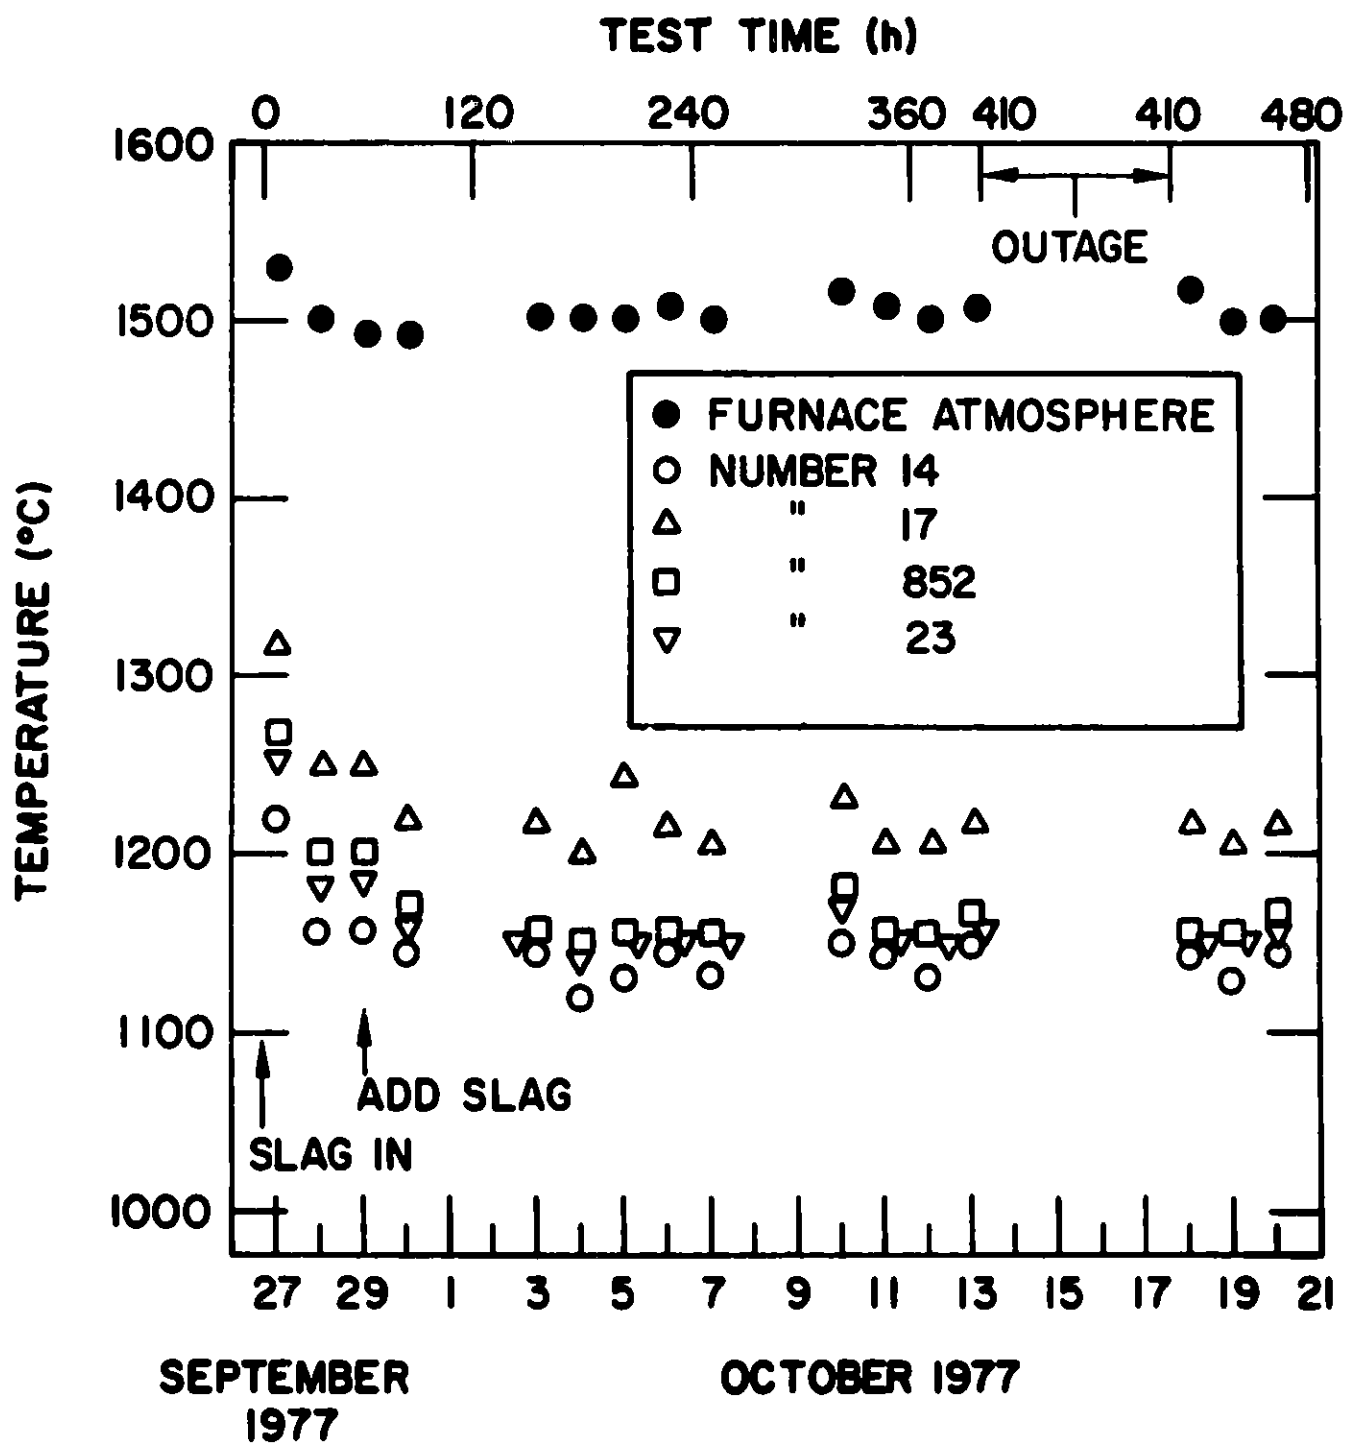
Fig. 14. Furnace Plenum Temperature and Midheight Brick Temperatures 12.7 mm (0.5 in.) from the Hot Face of 3/4-length Bricks of Each Composition During Test Run 7. ANL Neg. No. 306-78-416.

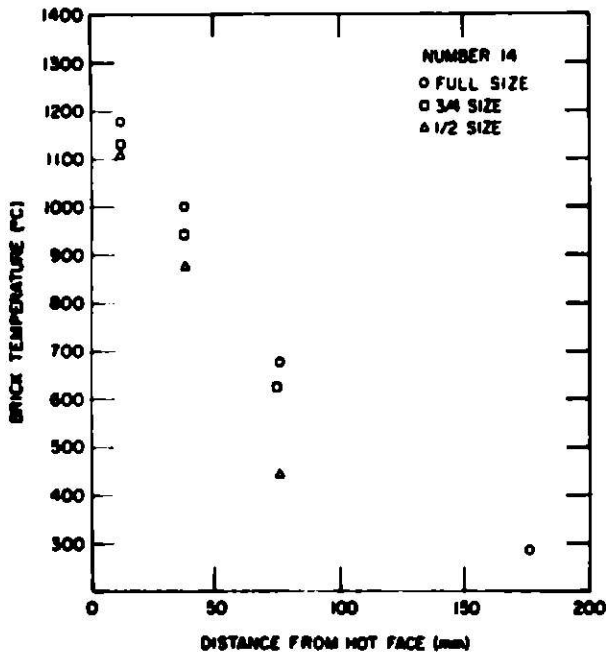
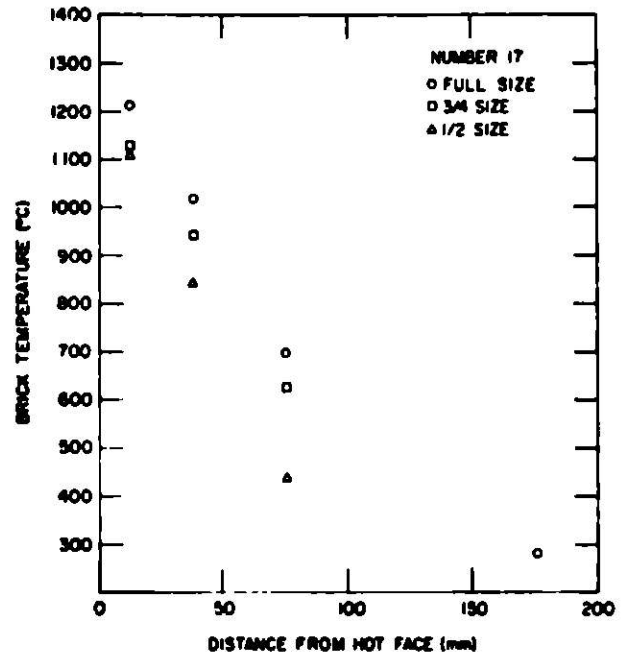
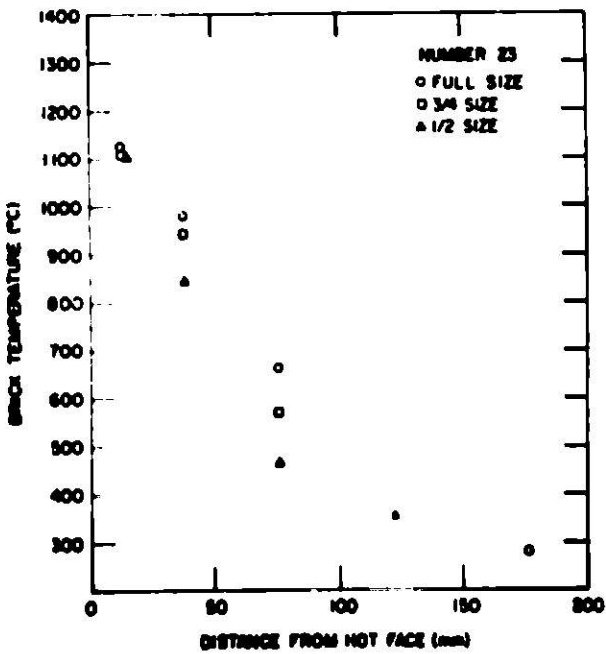
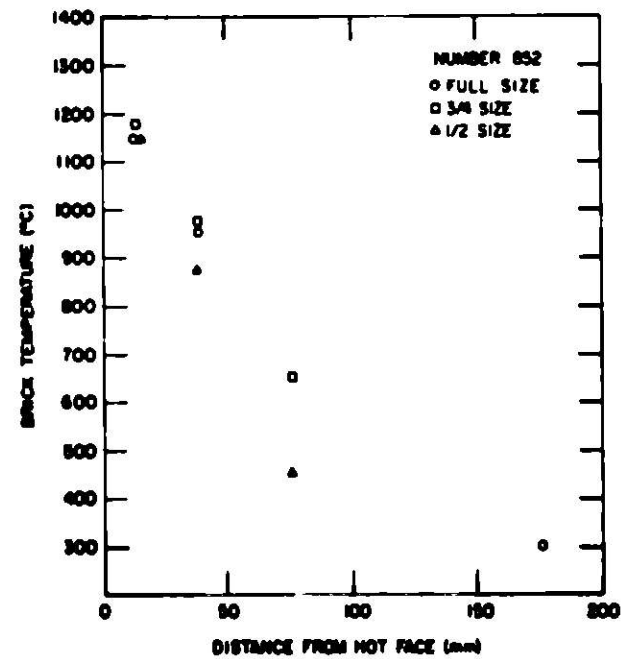
Fig. 15. Midheight Temperatures in Bricks During Test Run 7 at Four Locations in Full-length Bricks and at Three Locations in 3/4- and 1/2-length Bricks. (a) Alumina-silica (number 14), (b) alumina-silica (number 17), (c) alumina-chrome (number 23), and (d) alumina-chrome (number 852). ANL Neg. No. 306-78-768.

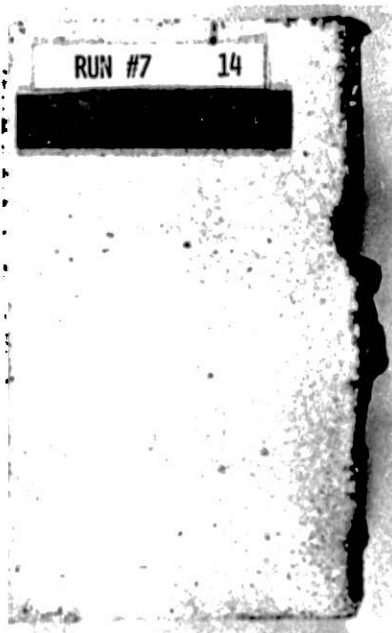
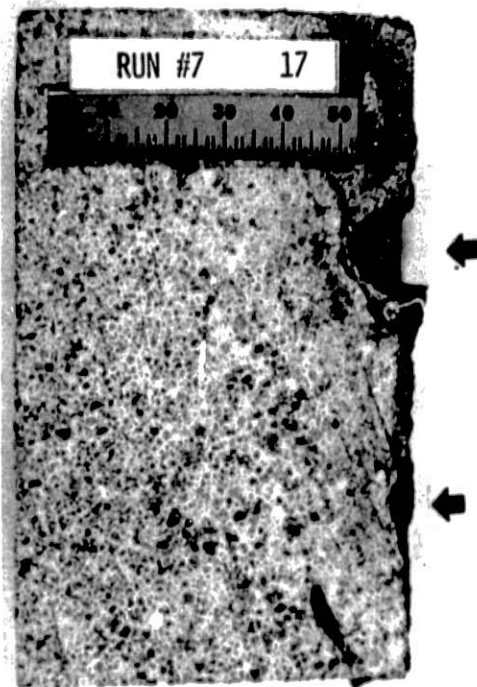
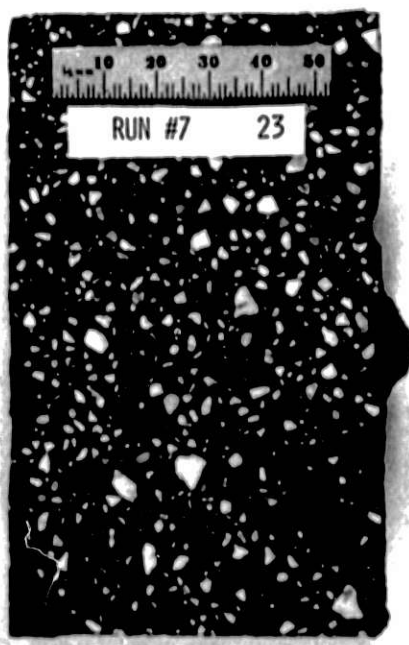
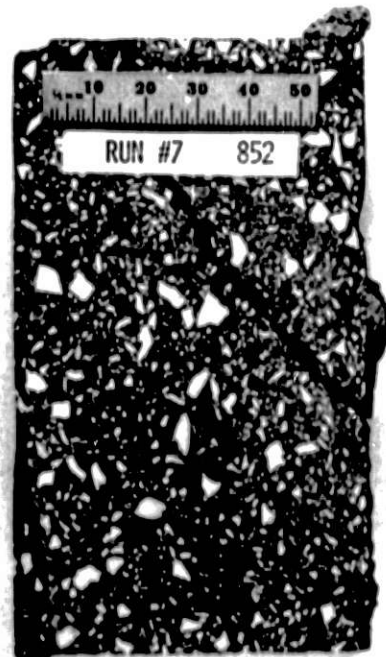
Fig. 16. Cut Sections of the 3/4-length Refractories Exposed to Slag Attack in Test Run 7. (a) Alumina-silica (number 14), (b) alumina-silica (number 17), (c) alumina-chrome (number 23), and (d) alumina-chrome (number 852). The vertical face on the right-hand side of each brick was exposed to the slag. Two lines of slag attack are visible on brick number 17 [see arrows in (b)]. ANL Neg. No. 306-78-714.

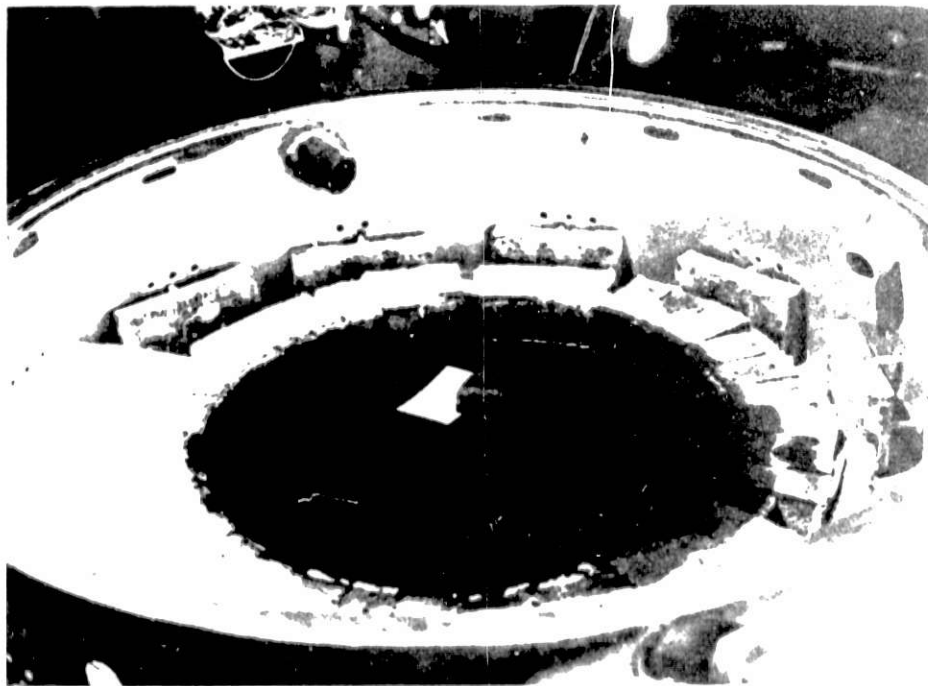
Fig. 17. Posttest Photograph Showing the Placement of the Standard Specimen of Refractory Number 2 in Test Run 12. The furnace has been partially disassembled, the insulating upper wall removed, and the cooling chamber for the 1/2-size bricks detached. A 76 mm x 127 mm (3 in. x 5 in.) file card has been placed next to the specimen to illustrate the depth of corrosion. (Sd. 12, 1950-72-700.)
