**EVALUATION OF CERAMIC REFRACTORIES  
FOR SLAGGING GASIFIERS:  
SUMMARY OF PROGRESS TO DATE**

**ARGONNE NATIONAL LABORATORY, ARGONNE, ILLINOIS**

September 1978

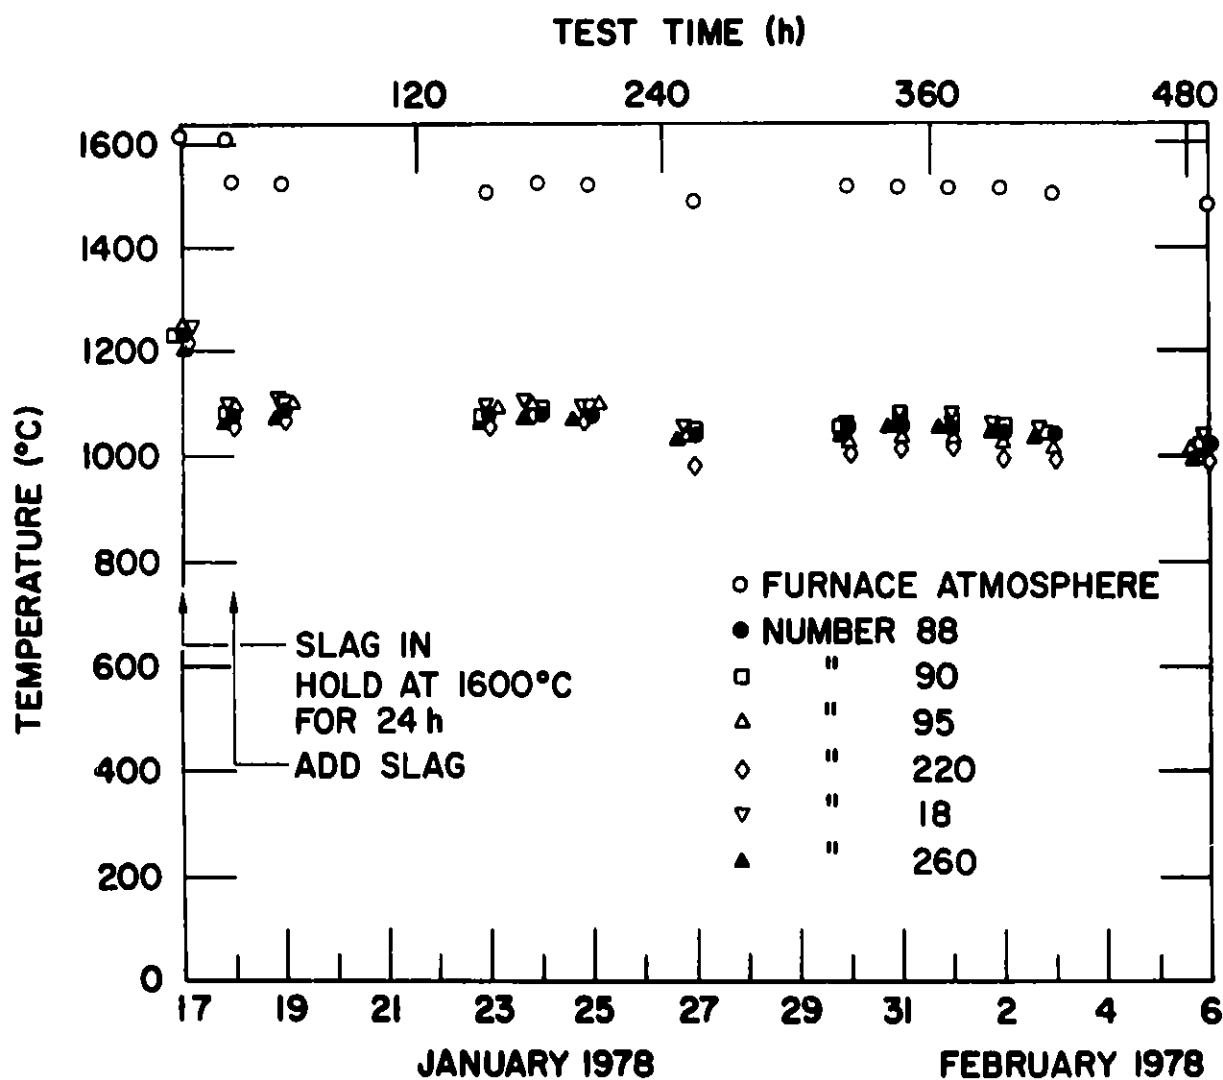
Fig. 18. Furnace Plenum Temperature and Midheight Brick Temperature 38.1 mm (1.5 in.) from the Hot Face of Full-size Bricks of Each Composition During Test Run 8. ANL Neg. No. 306-78-417.

The temperature history of run 8 is presented in Fig. 18. A simulated Montana Rosebud slag (B/A = 0.7) was introduced to a depth of  $\sim 15$  mm, and the plenum temperature was raised to  $\sim 1600^\circ\text{C}$  for  $\sim 24$  h with a partial pressure of oxygen of  $\sim 10^{-2}$  Pa. The temperature of the brick-slag interface was  $\sim 1550^\circ\text{C}$ . The plenum temperature was then reduced to  $\sim 1500^\circ\text{C}$  and additional slag was added to raise the level to 60 mm. The furnace temperature was held at  $1500^\circ\text{C}$  (brick-slag interface at  $1400$ – $1430^\circ\text{C}$ ) for 475 h with a partial pressure of oxygen of  $\sim 10^{-3}$  Pa. The temperature profiles within each refractory at mid-height are shown in Fig. 19 (furnace plenum at  $1610^\circ\text{C}$ ) and Fig. 20 (furnace plenum at  $1520^\circ\text{C}$ ). Examination of the refractories and the standard reveals two lines of slag attack (Figs. 21–23). Since the vertical temperature gradient in the slag pool was steep ( $5$ – $10^\circ\text{C}/\text{mm}$ ), the effect of the 475-h hold at  $1500^\circ\text{C}$  on the bottom slag line was negligible. Thus, the bottom line of attack corresponds to 24 h at  $1600^\circ\text{C}$ , whereas the top line of attack is the result of 475 h at  $1500^\circ\text{C}$ . Table XV summarizes the relative resistance of the refractories tested in run 8. The alumina-chrome compositions exhibited superior corrosion resistance, even during the short exposure at  $1600^\circ\text{C}$ . Brick number 260, a sintered alumina-chrome composition, showed almost no attack, although a number of deep thermal-shock cracks developed during the test. Note in Fig. 22 that a crack parallel to the hot face (about 20–30 mm from it) completely separated the hotter and cooler (not shown) portions of the brick. Refractory number 18, an alumina-chrome ramming mix, also exhibited negligible corrosion but substantial cracking, which may have resulted from either thermal shock or physical growth. The other alumina-chrome ramming mix, number 88, was also very resistant to corrosion and did not crack, although it did suffer considerable penetration. The alumina-silica compositions (numbers 90 and 95) also remained free of cracks, although they suffered considerable penetration and corrosion.

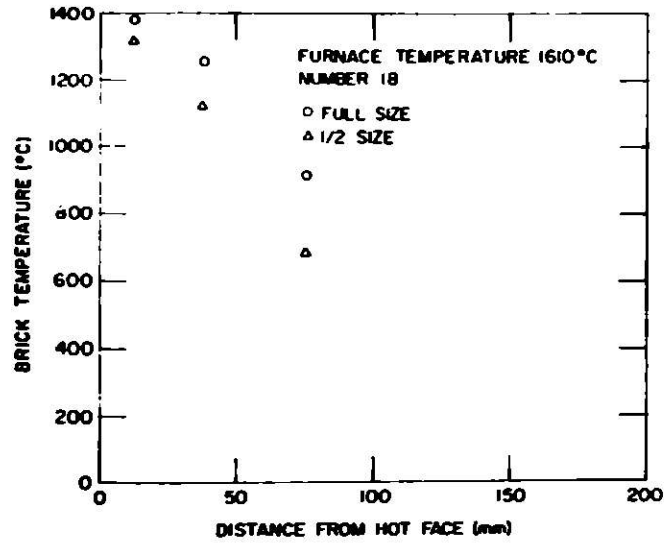
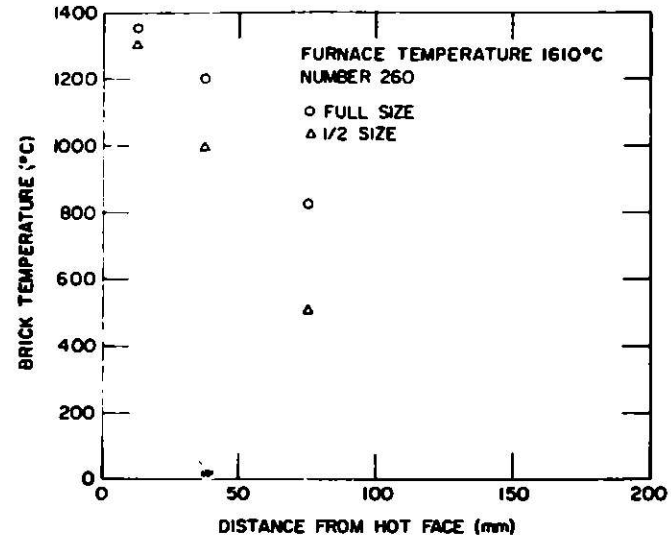
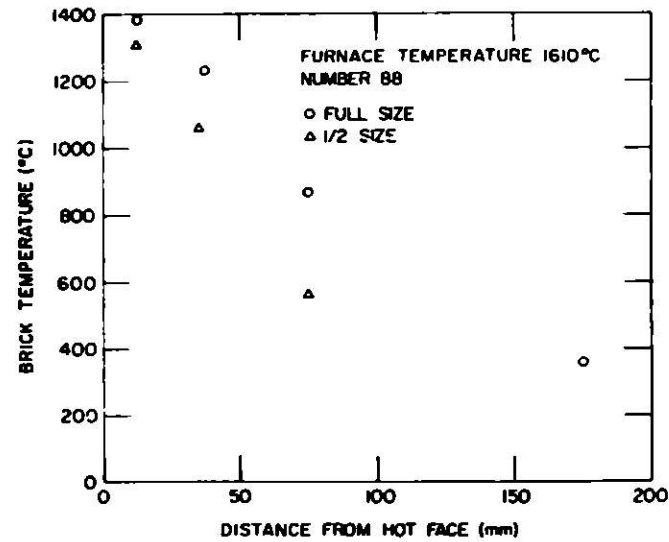
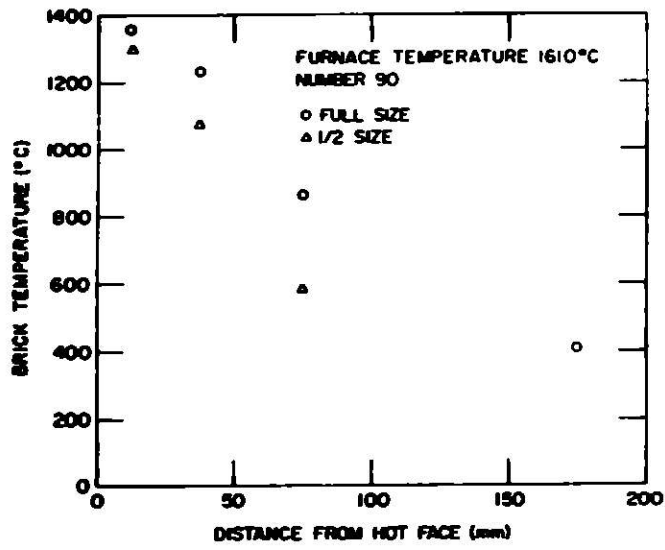
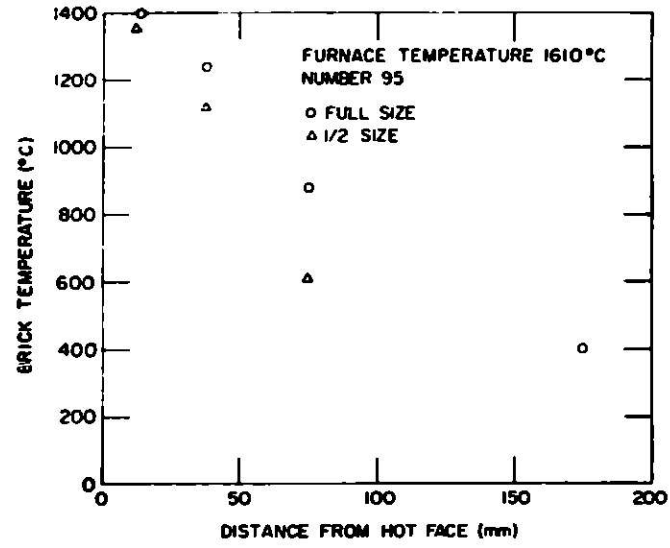
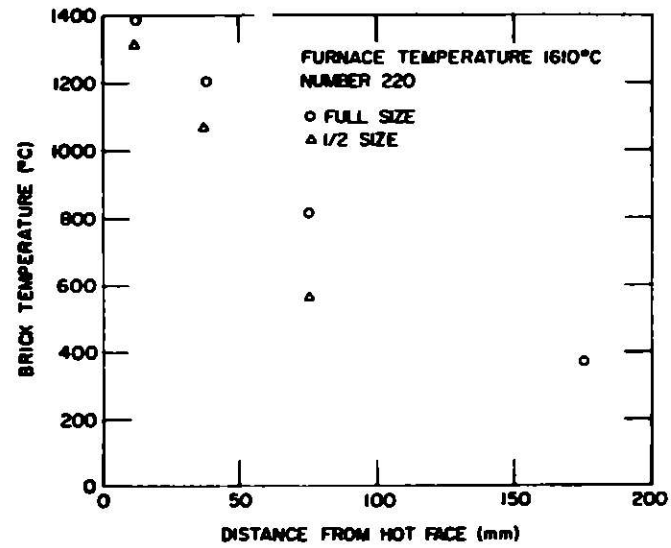
Fig. 19. Midheight Brick Temperature Versus Distance from Hot Face in Test Run 8 with Furnace Plenum Temperature = 1610°C. (a) Number 90, (b) number 95, (c) number 220, (d) number 18, (e) number 260, and (f) number 88. ANL Neg. Nos. 306-78-770 and 306-78-771.

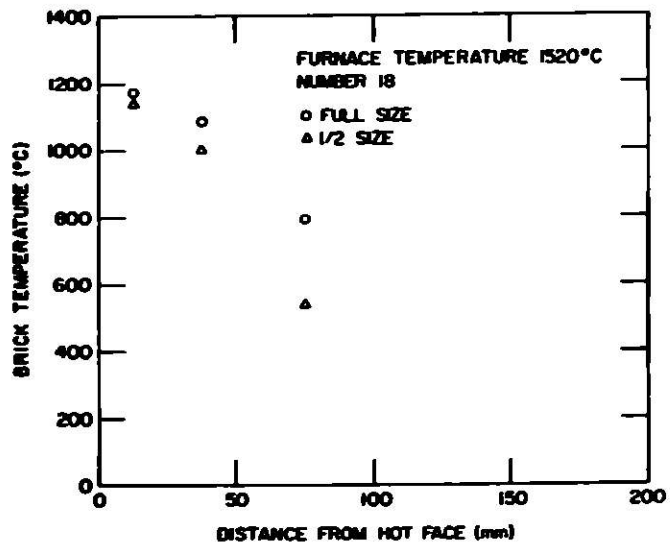
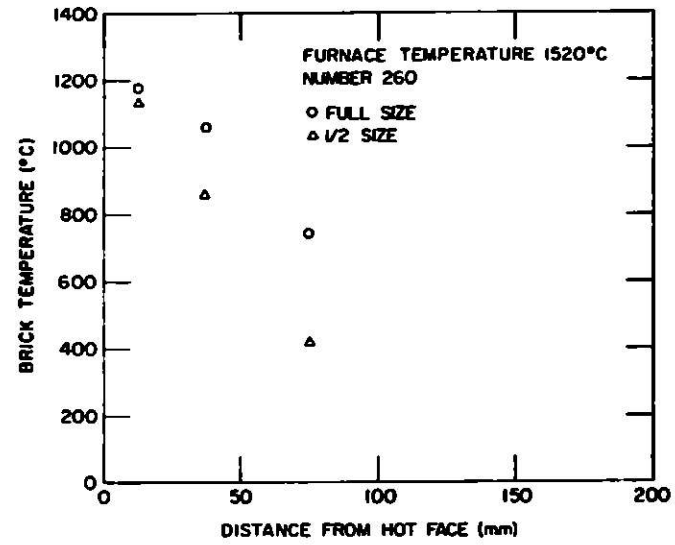
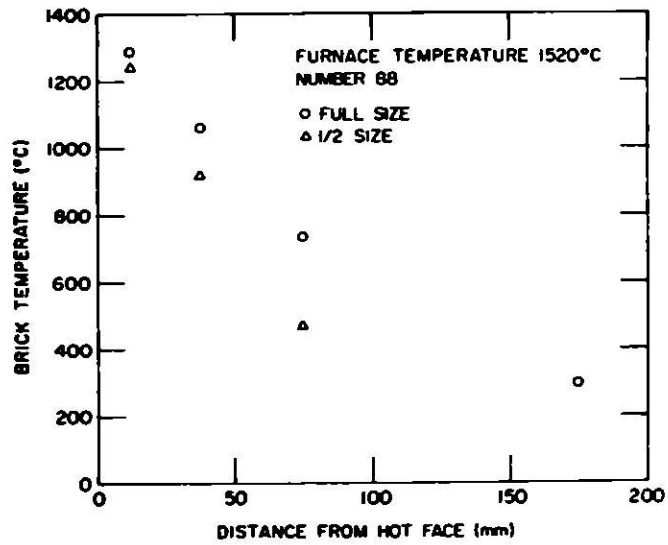
Fig. 20. Midheight Brick Temperature Versus Distance from Hot Face in Test Run 8 with Furnace Plenum Temperature = 1520°C. (a) Number 90, (b) number 95, (c) number 220, (d) number 18, (e) number 260, and (f) number 88. ANL Neg. Nos. 306-78-772 and 306-78-773.

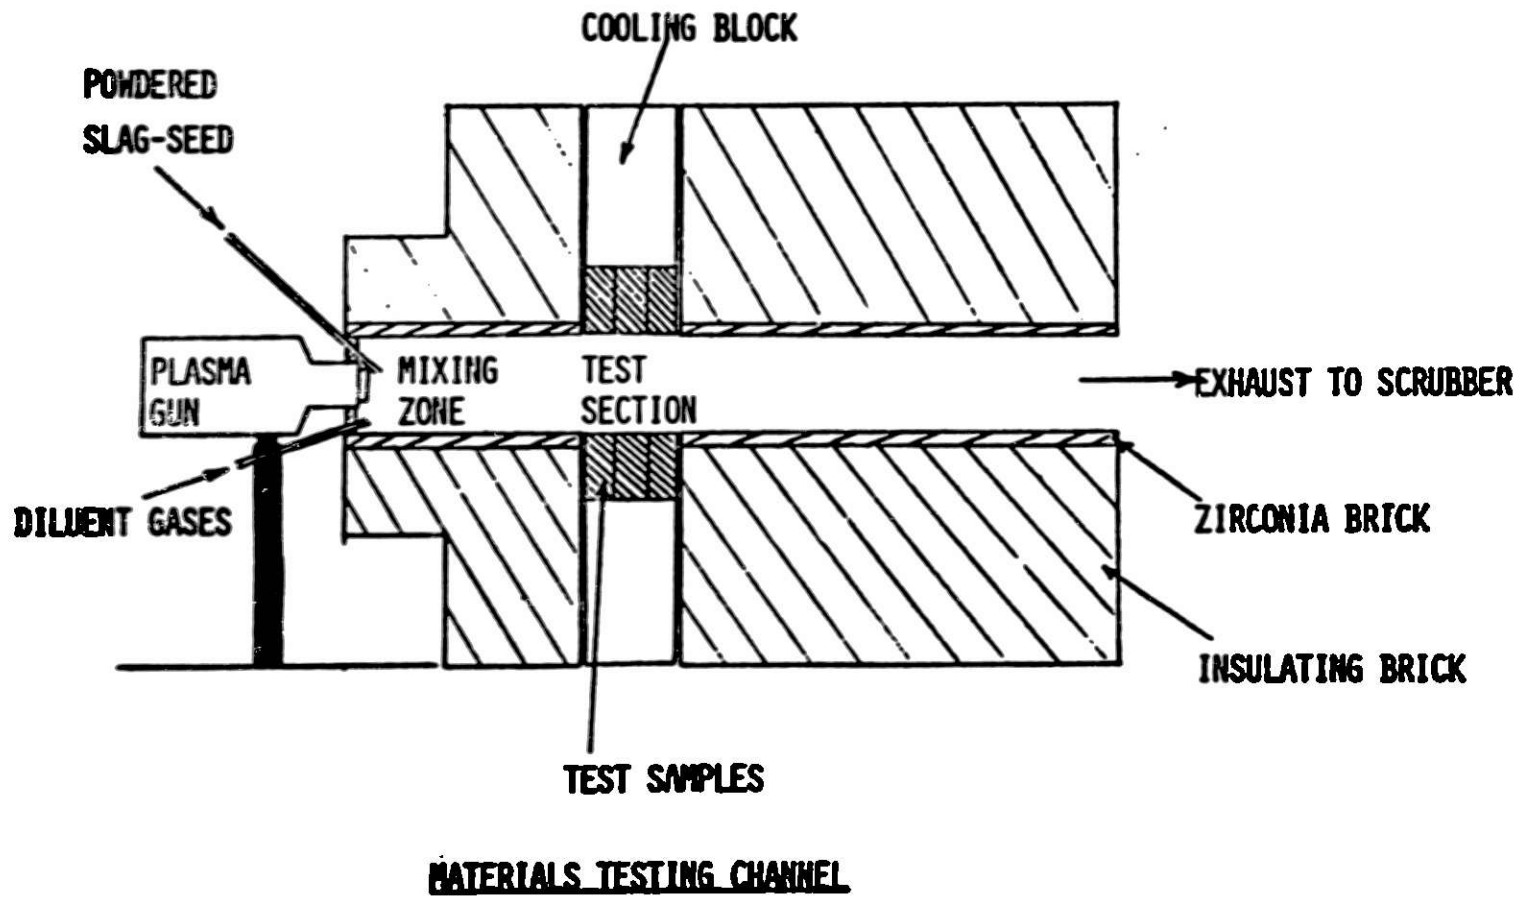
Fig. 24. Schematic of the Plasma Torch Materials Testing Facility. Neg. No. MSD-65260.

Further tests are planned in the slag corrosion furnace to evaluate the performance of the leading candidate materials to basic slags. Additional testing will be conducted using the plasma torch facility at ANL (Fig. 24). In this facility, samples can be exposed at temperatures up to  $1700^\circ\text{C}$  to the simultaneous effects of a dynamic flowing/frozen slag layer, erosion from slag particles that have been injected into the plasma, and to gaseous corrosion.
