THE ROLE OF RAINFED FARM PONDS  
IN SUSTAINING AGRICULTURE AND  
SOIL CONSERVATION IN THE DRY  
HIGH VALLEY REGION OF  
COCHABAMBA, BOLIVIA:  
DESIGN CONSIDERATIONS  
AND POST IMPOUNDMENT  
ANALYSIS

THESIS

MASTER OF SCIENCE

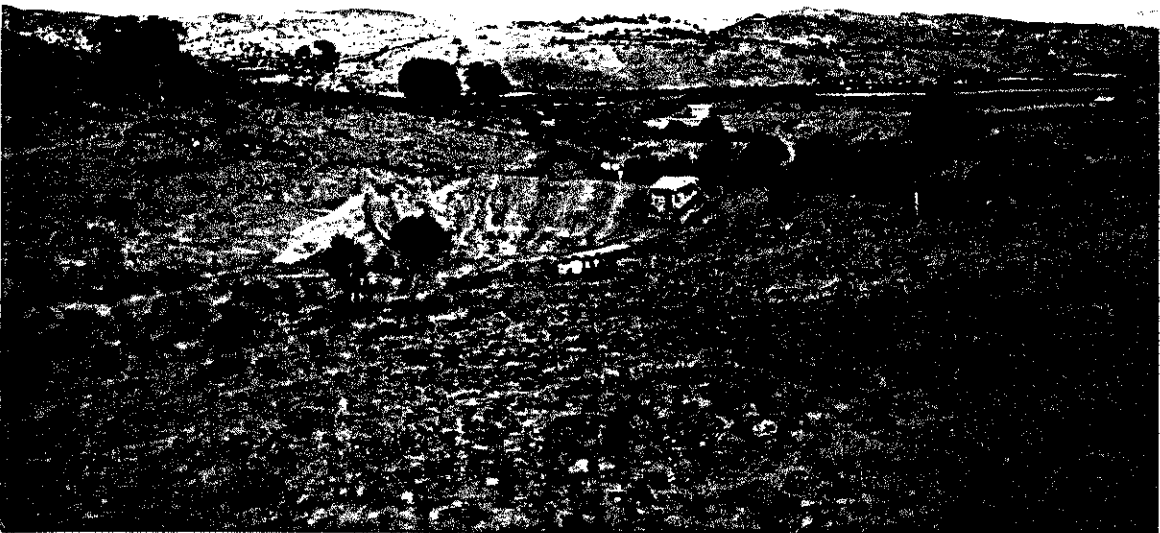
**Photo 6. (Above)      Ideal Silt Trap, Constructed as Part of Inflow Channel.**  
**Photo 7. (Below)      Actual Pond Excavation.**

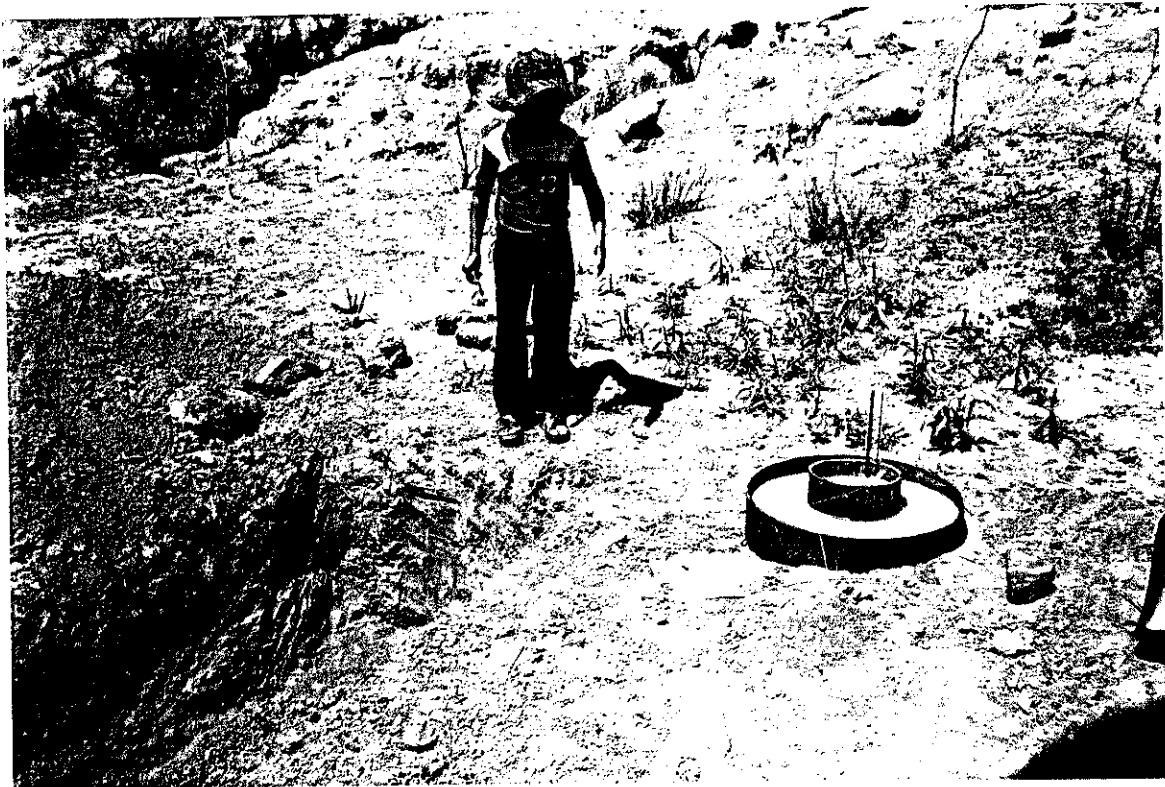
**Photo 8. (Above) Determining the Adequacy of the Soil Using the "Ring Method."**

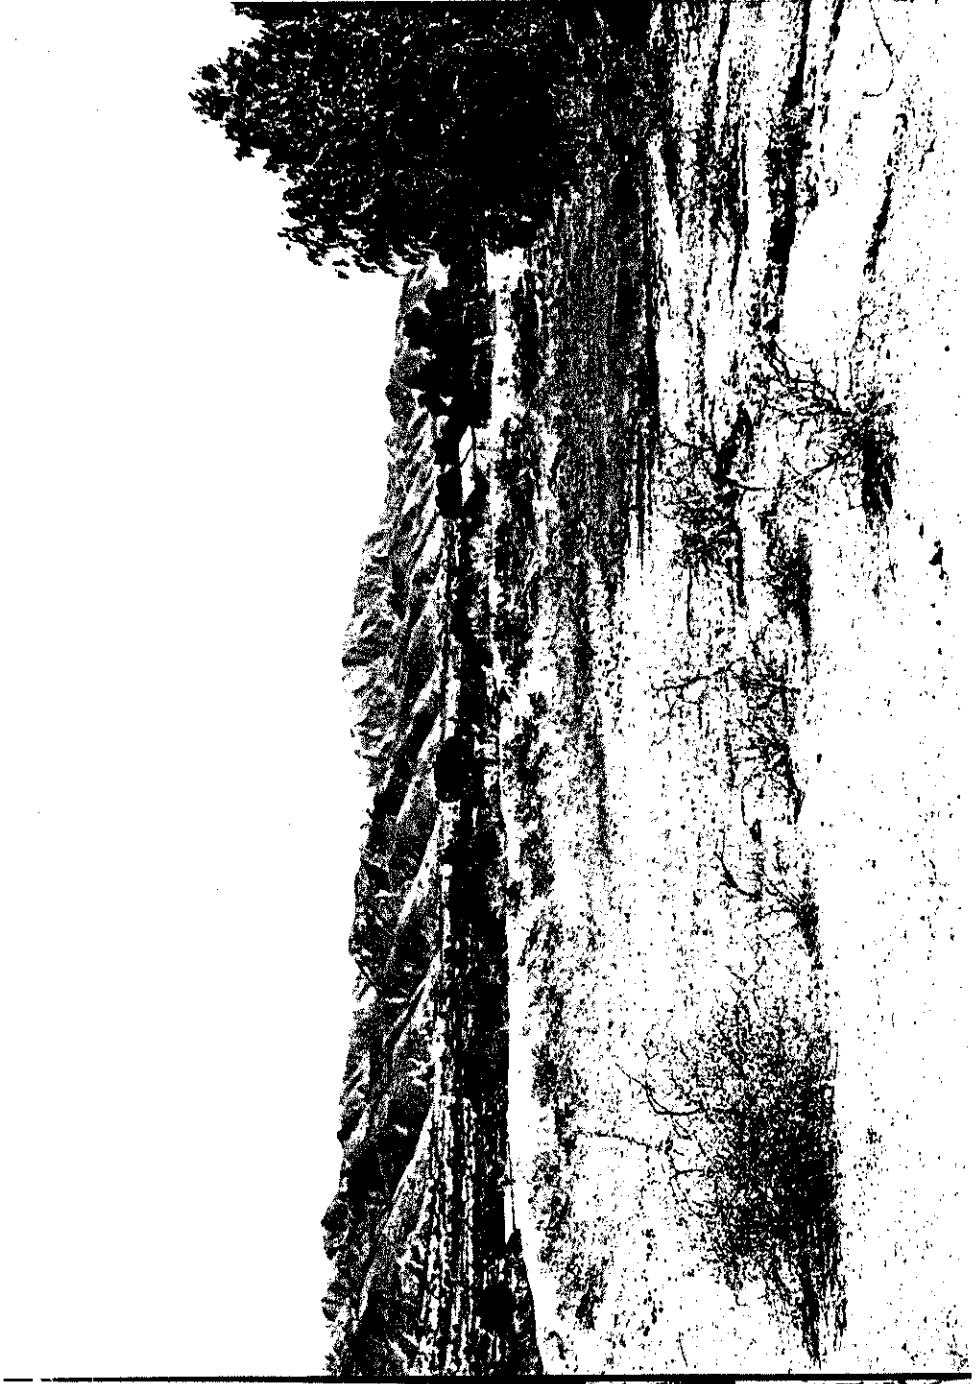
4

Person In Charge, And Number of Families per Pond	Existing Pond Capacity	Current Condition	Pond Use	Water Sources
Epifanio Perez, 3 families	250 M <sup>3</sup>	Functioning Well	Supplemental Irrigation and Livestock	Runoff, Gully, and Irrigation System

Alleviation of Land-use Problems	Problems Identified Comments	Irrigation Increases (Potential)		Crop Production and Additional Comments
Supplemental	Permanent			
Improvement of Soil erosion and cover conditions in fields below.	Size, would be dry if not for multiple water sources.	0.3 Has.	NA	Limited supplemental irrigation, 10% max. increase in production, livestock use adequate.

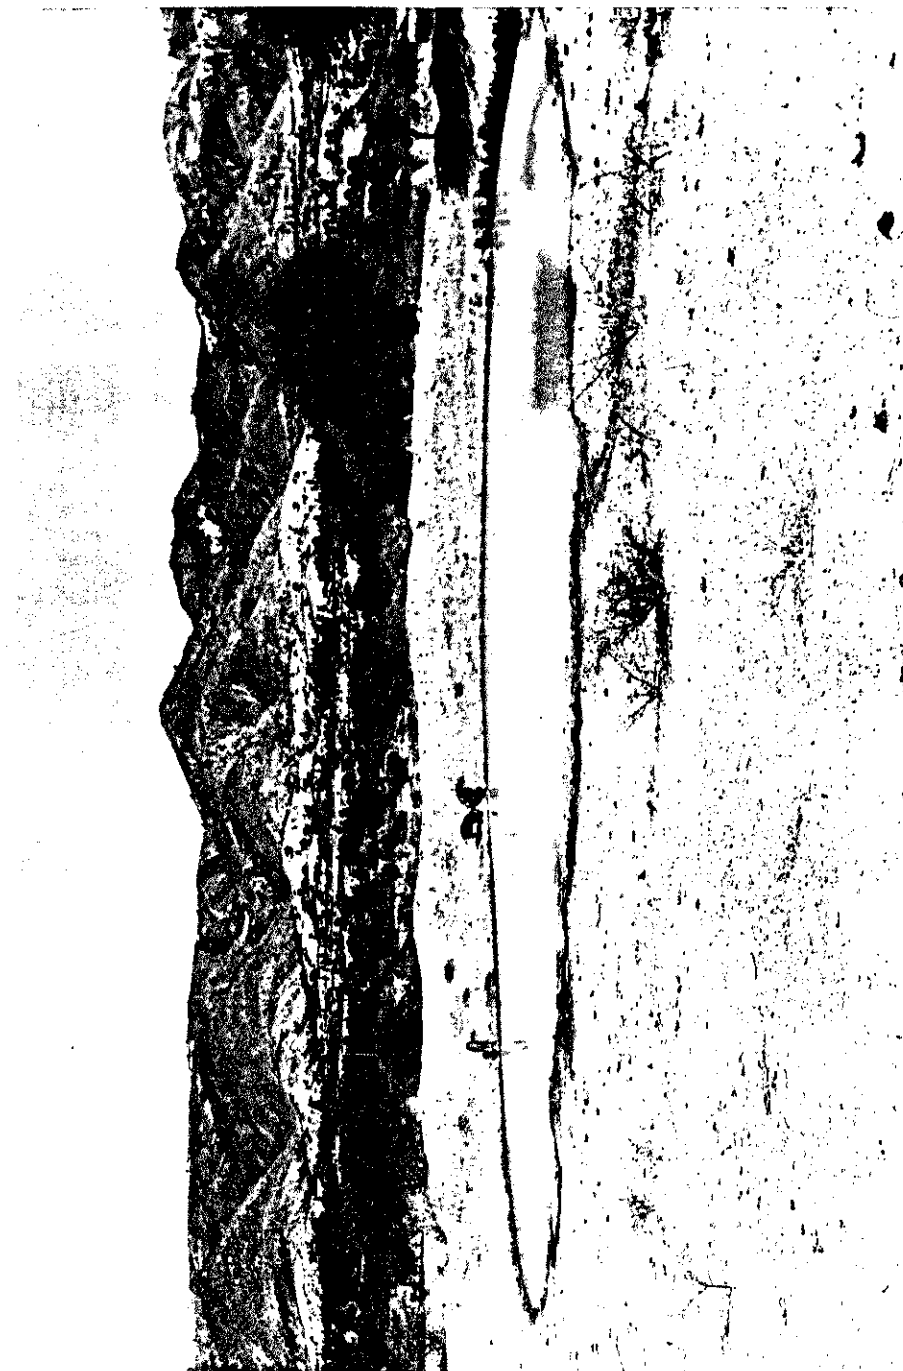
5

Person In Charge, and Number of Families per Pond	Existing Pond Capacity	Current Condition	Pond Use	Water Sources
Erazmo Leon, 4 families	1000 M <sup>3</sup>	Functioning Adequately	Supplemental Irrigation, Small-Scale Irrigation, and Livestock	Runoff and Gully Flow Combination

Alleviation of Land-use Problems	Problems Identified Comments	Irrigation Increases (Potential)		Crop Production and Additional Comments
		Supplemental	Permanent	
Improvement of soil and cover conditions near sites within pond influence, water does not run down road as did in past.	Size somewhat limiting, no complementary structures, but water yr. round. Irrigation could be increased.	2.0 Has.	0.4 Has.	Can produce on average 2 additional crops per yr. of either dry beans or onions. An estimated 25% increase in agricultural production. Need all complementary structures to increase ag.

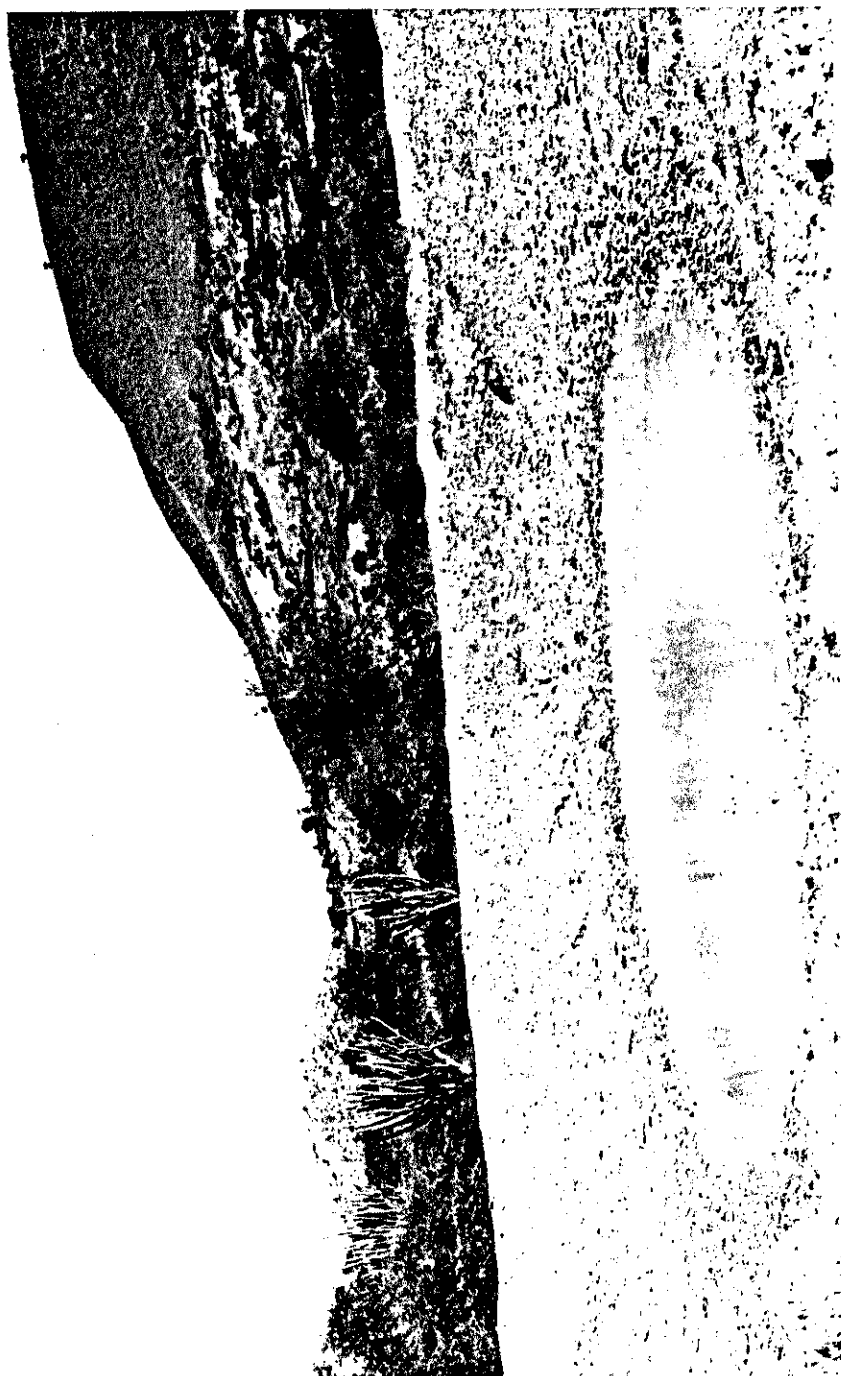
9

Person In Charge, and Number of Families per Pond	Existing Pond Capacity	Current Condition	Pond Use	Water Sources
Cirilo Macias, 4 families	500 M <sup>3</sup>	Functioning Adequately	Supplemental Irrigation and Livestock	Runoff and Gully Flow Combination

Alleviation of Land-use Problems	Problems Identified Comments	Irrigation Increases (Potential)		Crop Production and Additional Comments
		Supplemental	Permanent	
Improvement of cover conditions near pond site and checking of gully erosion.	Size, lack of complementary structures and maintenance limit agriculture	1.0 Has.	0.2 Has.	Limited supplementary irrigation and livestock, Estimated 30% increase in water available at harvest or seed time.

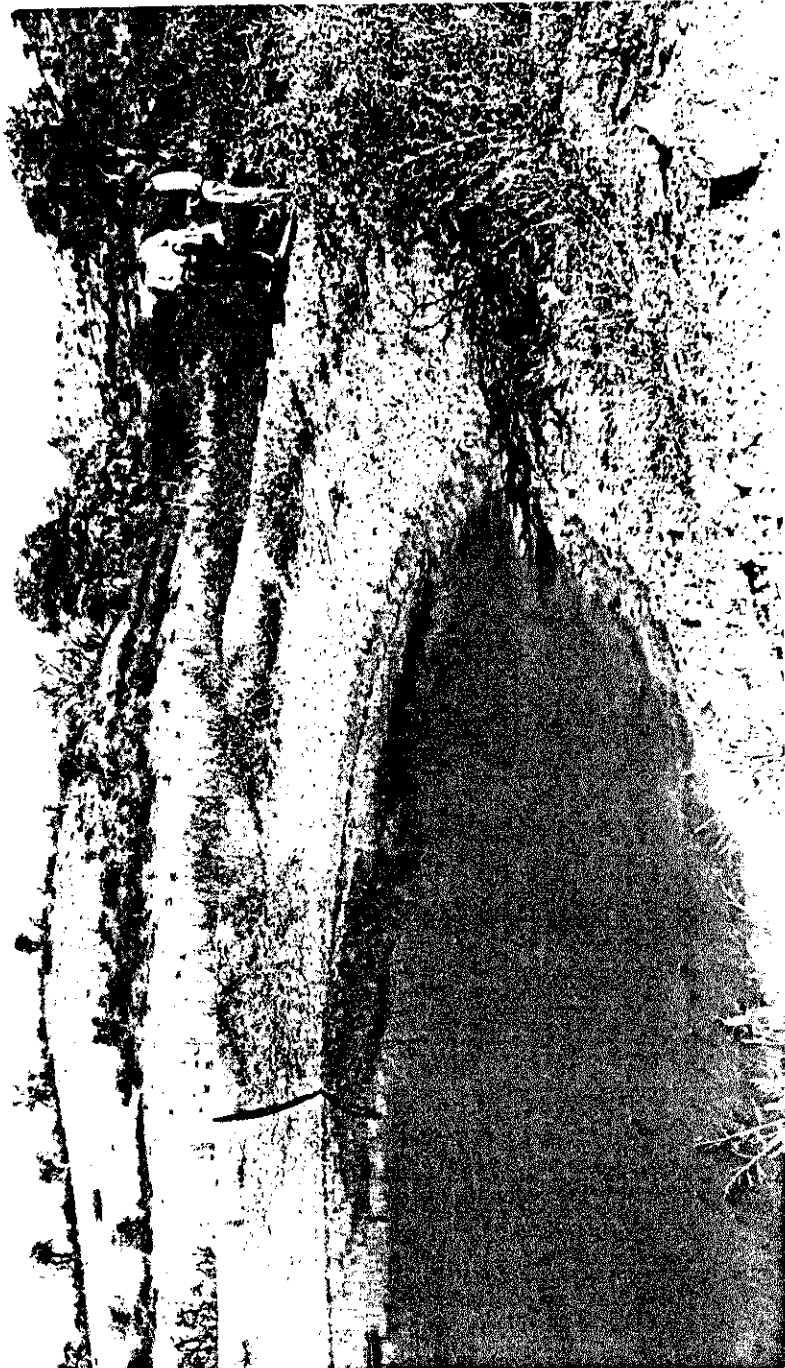
## 11

Person In Charge, and Number of Families per Pond	Existing Pond Capacity	Current Condition	Pond Use	Water Sources
Zenon Crespo, 4 families	2000 M <sup>3</sup>	Functioning Well	Supplemental, Small-Scale and Permanent Irrigation, and Livestock	Runoff and Gully Flow Combination

Alleviation of Land-use Problems	Problems Identified Comments	Irrigation Increases (Potential) Supplemental      Permanent		Crop Production and Additional Comments
Improvement of soil and cover conditions near sites within pond influence.	No significant problems, some farmers wish to increase volume further.	4.0 Has.	0.8 Has.	On average 2 additional crops can be produced per year. Estimated 50% increase in overall agricultural production.

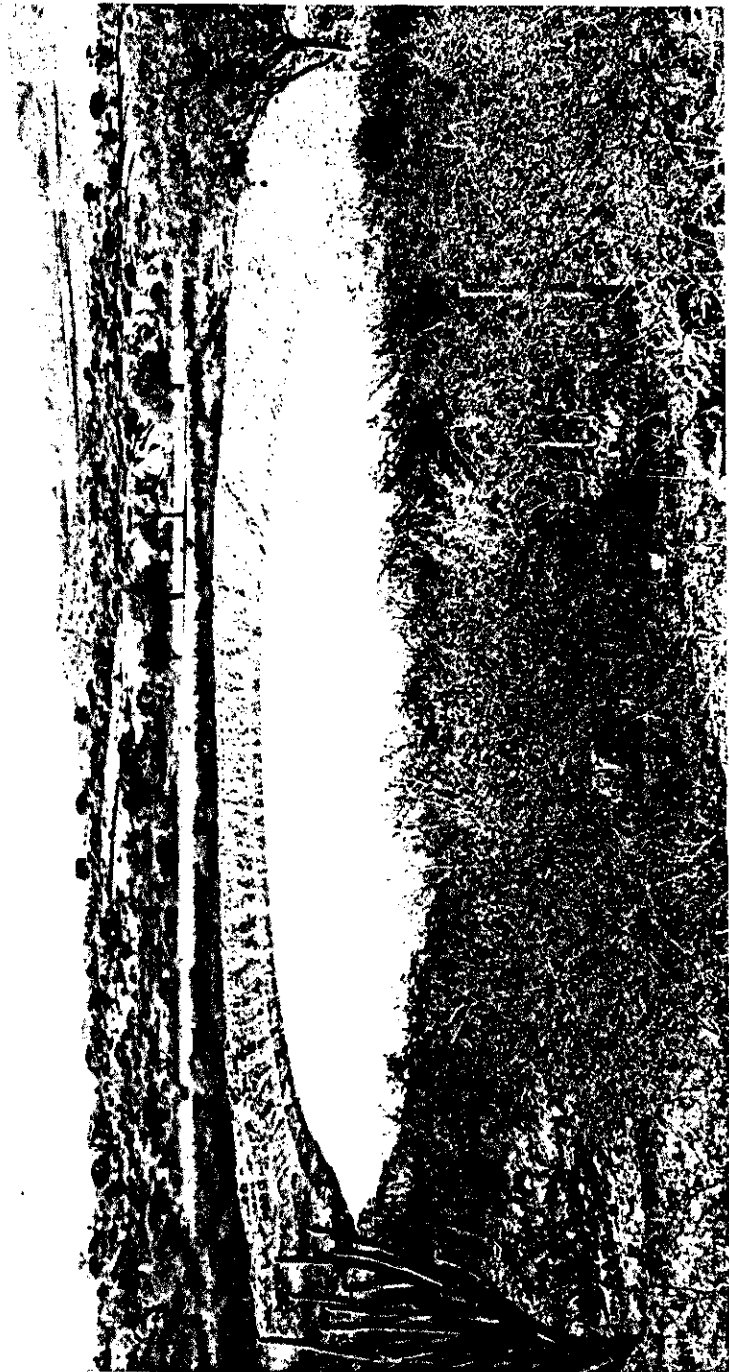
## 12

Person In Charge, and Number of Families per Pond	Existing Pond Capacity	Current Condition	Pond Use	Water Sources
Roberto Maldonado, 3 families	600 M <sup>3</sup>	Functioning Adequately	Supplemental Irrigation and Livestock	Runoff and Gully Flow Combination

Alleviation of Land-use Problems	Problems Identified Comments	Irrigation Increases (Potential)		Crop Production and Additional Comments
		Supplemental	Permanent	
Improvement of soil, and vast improvement of cover conditions within pond influence.	Size, lack of complementary structures and routine maintenance limit agriculture	1.2 Has.	0.24 Has.	Limited supplementary irrigation and livestock, 20% max. estimated increase in agricultural production.

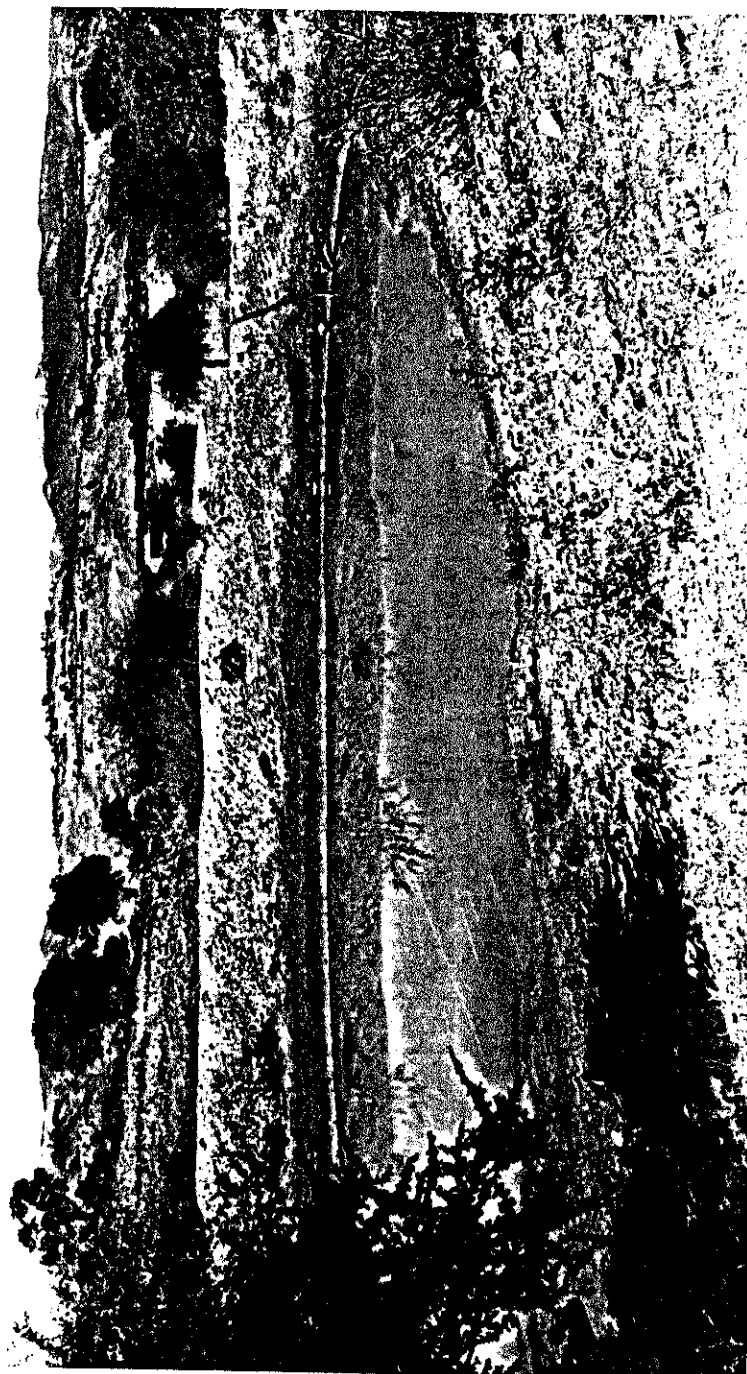
22

Person In Charge, and Number of Families per Pond	Existing Pond Capacity	Current Condition	Pond Use	Water Sources
Leonidas Iriarte, 6 families	1000 M <sup>3</sup>	Functioning Adequately	Supplemental Irrigation and Livestock	Runoff and Gully Flow Combination

Water Availability	Complementary Structures, Extent	Extent of Fencing	Maintenance	Sedimentation Estimate
Dries Up Each Year, By Aug.	All in Place	In Crop Area Only	Do Yearly	30 M <sup>3</sup> / YR. (if not maintained)

Alleviation of Land-use Problems	Problems Identified Comments	Irrigation Increases (Potential)		Crop Production and Additional Comments
		Supplemental	Permanent	
Little or no improvement in soil erosion or cover conditions but erosion in actual pond occurring as design criteria was not met.	Size is limiting factor for full agricultural potential. Pond banks eroding, no measures taken to retard process.	2.0 Has.	0.4 Has.	Limited supplementary irrigation and livestock, 25% max. estimated increase in agricultural production, 2 additional crops, depends on the yr. Size of pond and more reliable water sources could increase ag. output

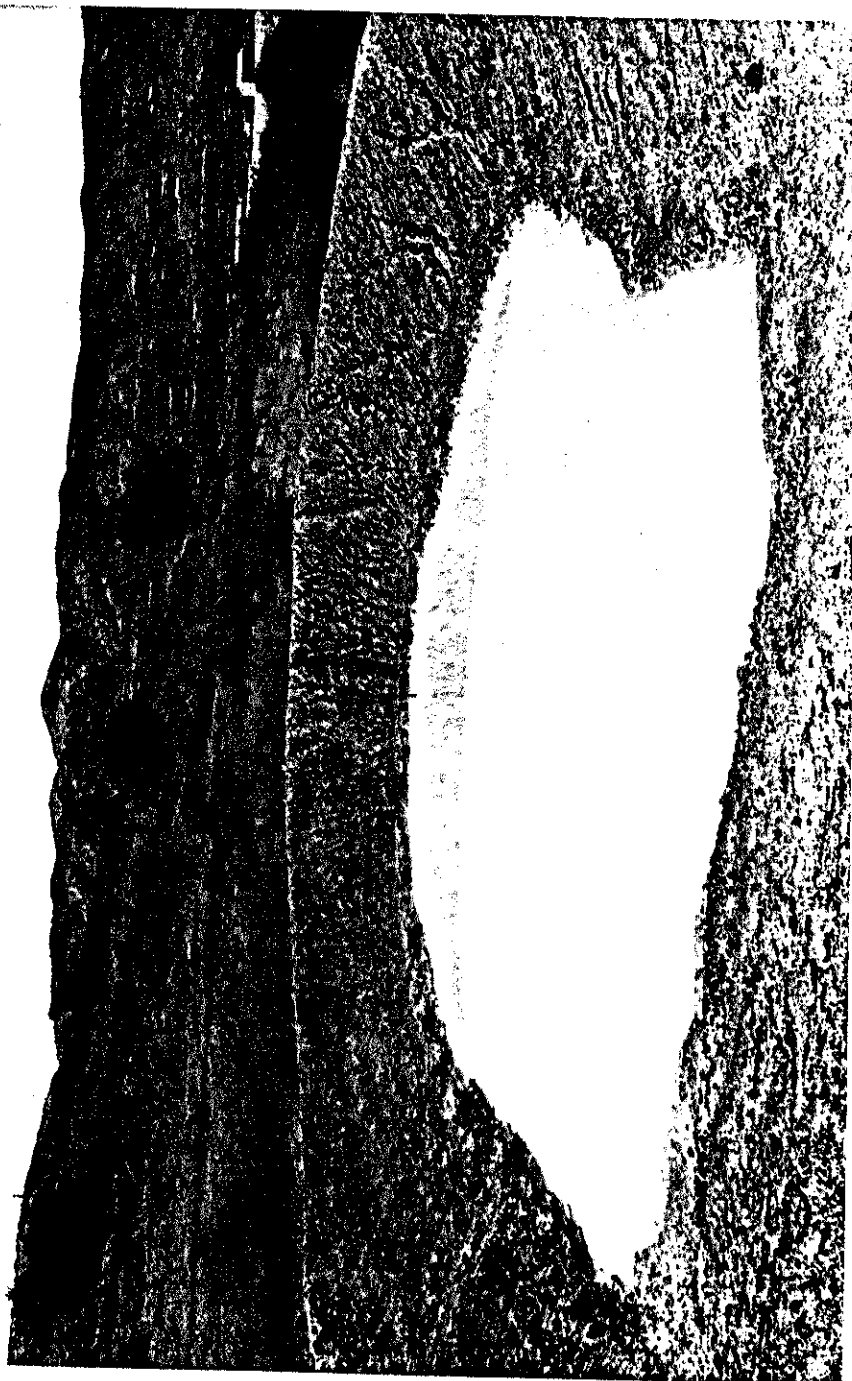
23

Person In Charge, and Number of Families per Pond	Existing Pond Capacity	Current Condition	Pond Use	Water Sources
Emilio Montano, 3 families	300 M <sup>3</sup>	Functioning Adequately	Supplemental Irrigation and Livestock	Runoff Only

Water Availability	Complementary Structures, Extent	Extent of Fencing	Maintenance	Sedimentation Estimate
Dries Up Each Year, By April	All in Place	In Crop Area Only	Limited, as need arises only	30 M <sup>3</sup> / YR. 10 yrs., if not maintained

Alleviation of Land-use Problems	Problems Identified Comments	Irrigation Increases (Potential)		Crop Production and Additional Comments
		Supplemental	Permanent	
Improvement of soil but not cover conditions near sites within pond influence, improvement of cover conditions crop area only.	Size is limiting factor. Design criteria lacking as drainage area far from pond. Pond siltation, maintenance lacking.	0.4 Has	NA	Limited supplementary irrigation and livestock, 10% max. estimated increase in agricultural production. Pond volume insufficient for full agricultural potential.
