TECHNICAL NOTE 2991

ACCELERATIONS AND PASSENGER HARNESS LOADS MEASURED
IN FULL-SCALE LIGHT-AIRPLANE CRASHES

By A. Martin Eiband, Scott H. Simpkinson
and Dugald O. Black

August 1953

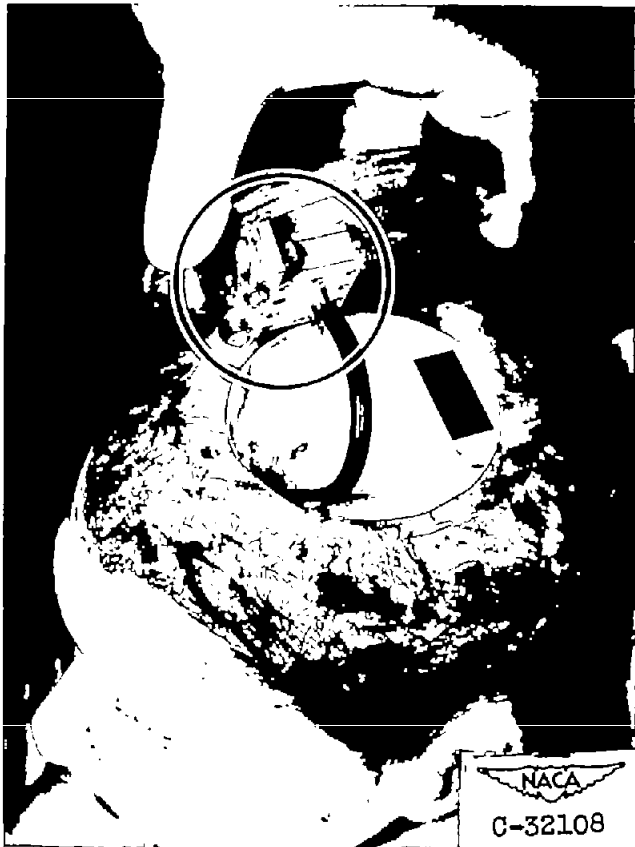
(f) Accelerometer installed in head of rear dummy.

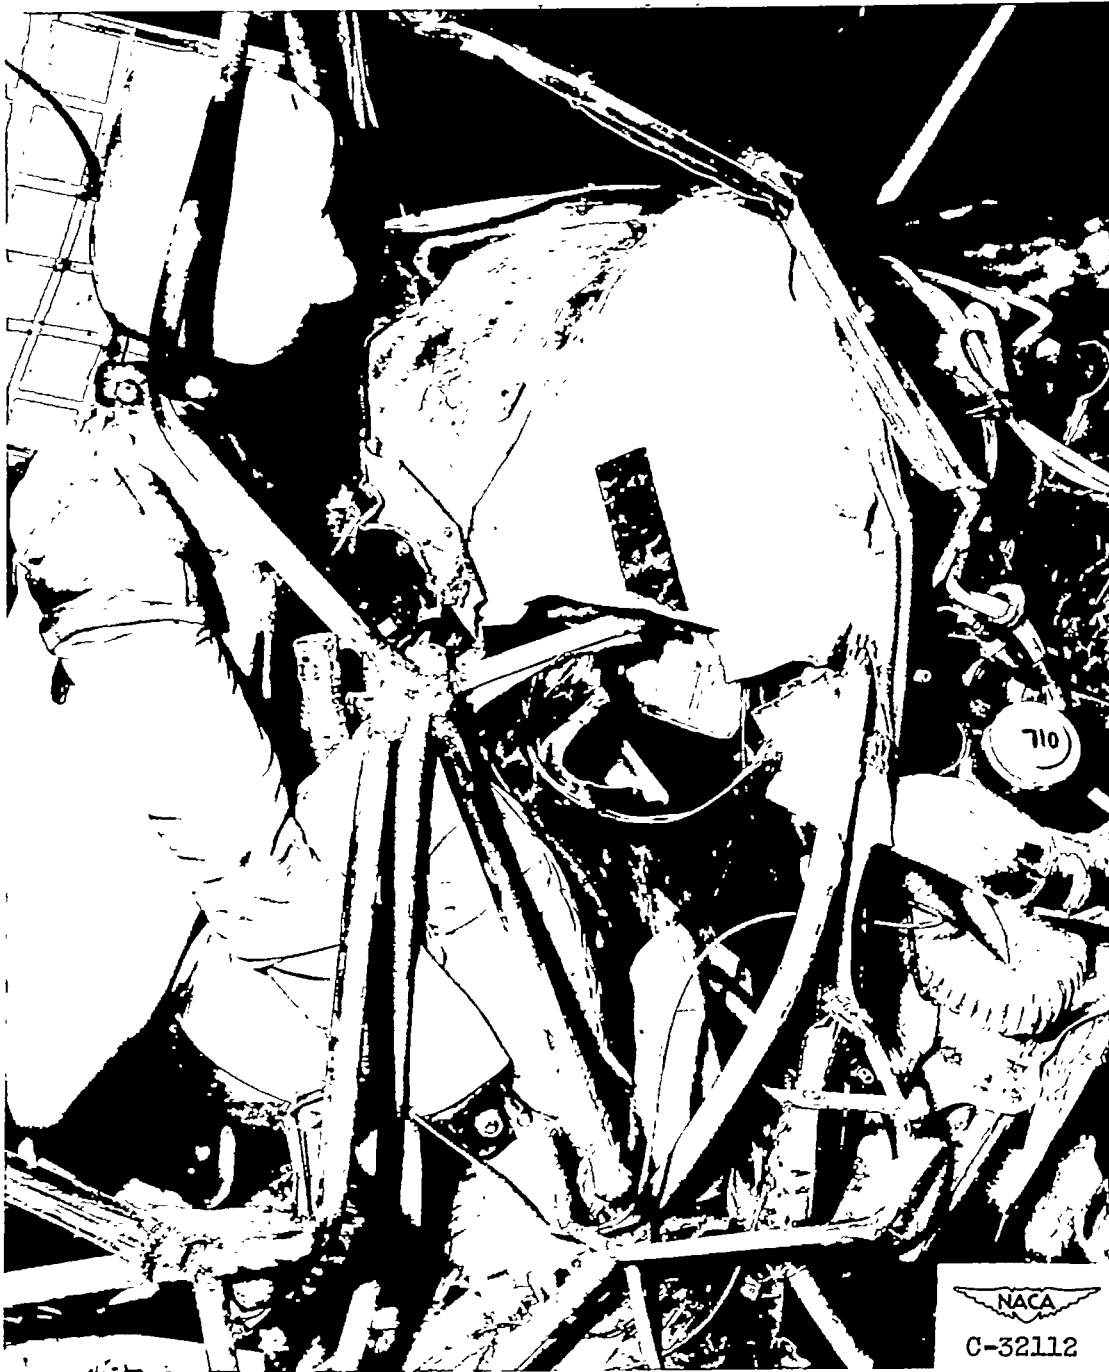
Figure 16. - Position of parachute dummy in front seat of airplane after crash.

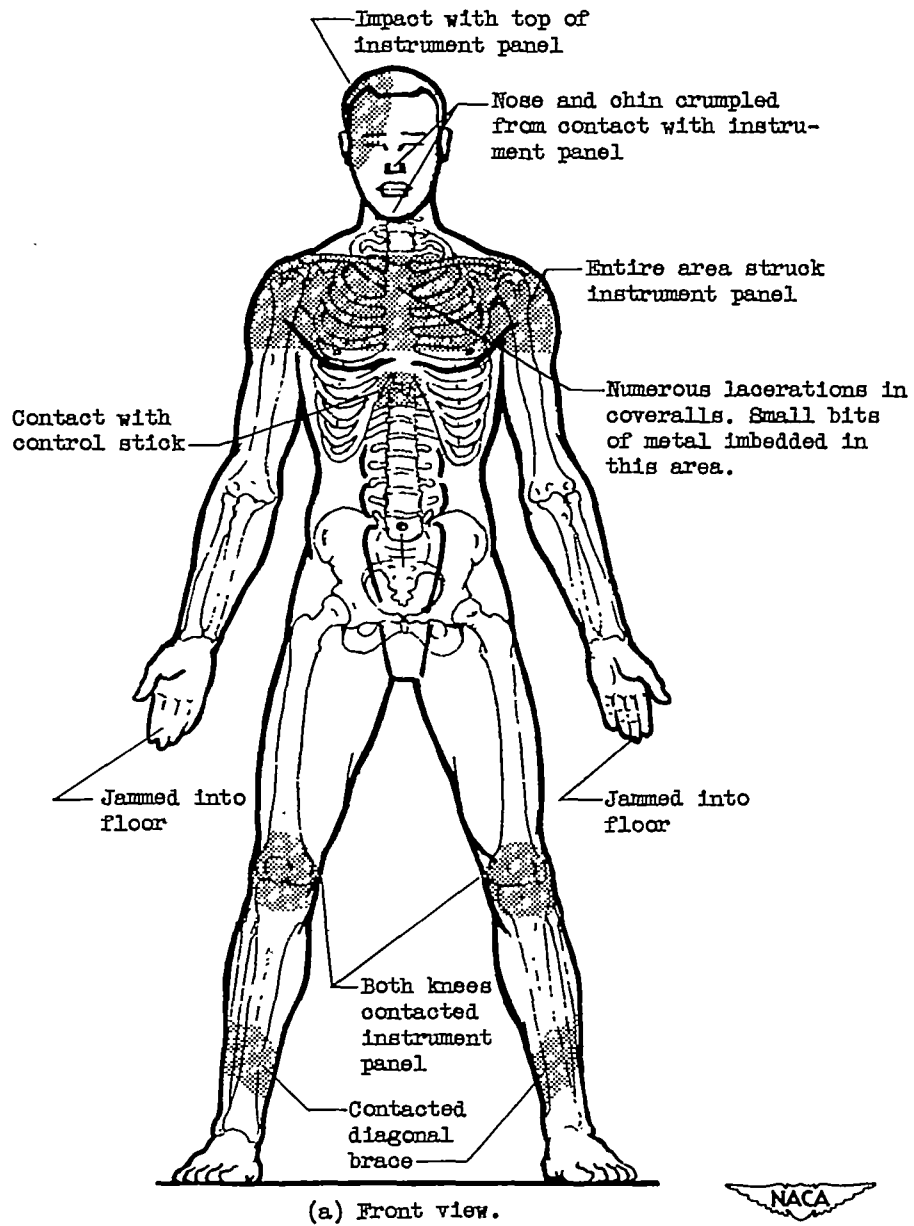
Figure 17. - Location, area, and cause of blows sustained by front-seat dummy in 60-mph crash.

A recent statistical analysis (ref. 6) shows that of 800 accidents that were considered survivable, injuries of the head were more frequent than injuries of any of the five remaining gross body areas. Head injuries were sustained in 88 percent, or 704, of the 800 accidents analyzed. With regard to the occurrence of fatal injuries in accidents involving aircraft of all types, German accident statistics (ref. 7) reveal that 50 percent of all injuries were injuries of the head, and that 70 to 80 percent of the fatal injuries were caused by injuries of the head. When the areas over which the front dummy contacted structure in the 60-mph crash (fig. 17) are considered, the statistics on human injury incurred by this sort of contact in actual accidents are quite understandable.

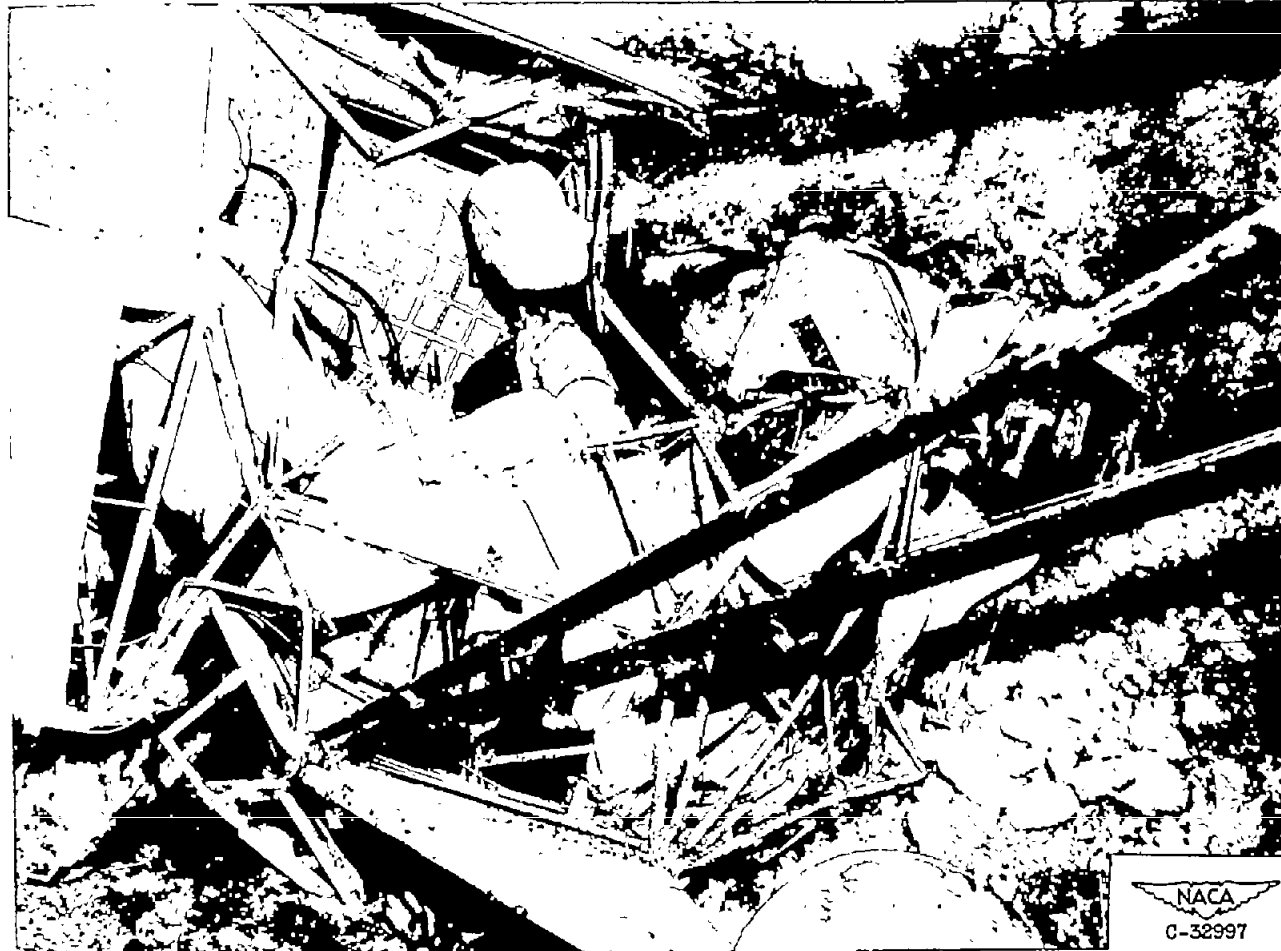
(a) Impact speed, 42 mph.
Figure 19. - Crash damage to airplane structure.

Figure 19. - Continued. Crash damage to airplane structure.

Figure 19. - Concluded. Crash damage to airplane structure.

Collapse of cabin structure. - Potential injury of the occupants due to inward-collapsing cabin structure is indicated by comparison of the extent of the collapse of the cabin structure in figure 19. The figures show photographs of the cabin area following the 42-, 47-, and 60-mph crashes. As indicated by comparison of these photographs, an increase of speed at impact with the barrier caused a corresponding reduction of the volume enclosed by the cabin structure. Figure 19(a) shows that, during the 42-mph crash, deformation of the cabin was minor. Appreciable reduction in cabin volume was noticeable with an increase of impact speed to 47 mph. During this crash, the cabin volume was reduced by the rearward displacement of the instrument panel, as may be detected by comparing the position of the upper, forward, right-side diagonal brace in figure 19(b) with its undistorted position after the 42-mph crash, figure 19(a). With an impact speed of 60 mph, considerable reduction in cabin volume resulted. This reduction resulted from (1) rearward movement of the instrument panel nearly to the front dummy's chest and (2) collapse of the longerons under the rear seat (fig. 19(c)). Distortion of the cabin structural tubing during cabin deformation may increase the probability of injury to the occupants. An example of this distortion is shown by the upper cabin members projecting into the proximity of the heads of both dummies in figure 19(c). It is evident from inspection of figure 19 that, if occupants of an airplane during a crash are to be protected from the additional hazard of striking the deformed cabin structural members collapsing around them, the cabin structure itself must be strong enough to resist the decelerative forces occurring at impact.
