NACA RM No. L8A09

GENERAL HANDLING-QUALITIES RESULTS OBTAINED DURING  
ACCEPTANCE FLIGHT TESTS OF THE BELL XS-1 AIRPLANE

FLIGHT TESTS OF THE BELL XS-1 AIRPLANE

SUMMARY

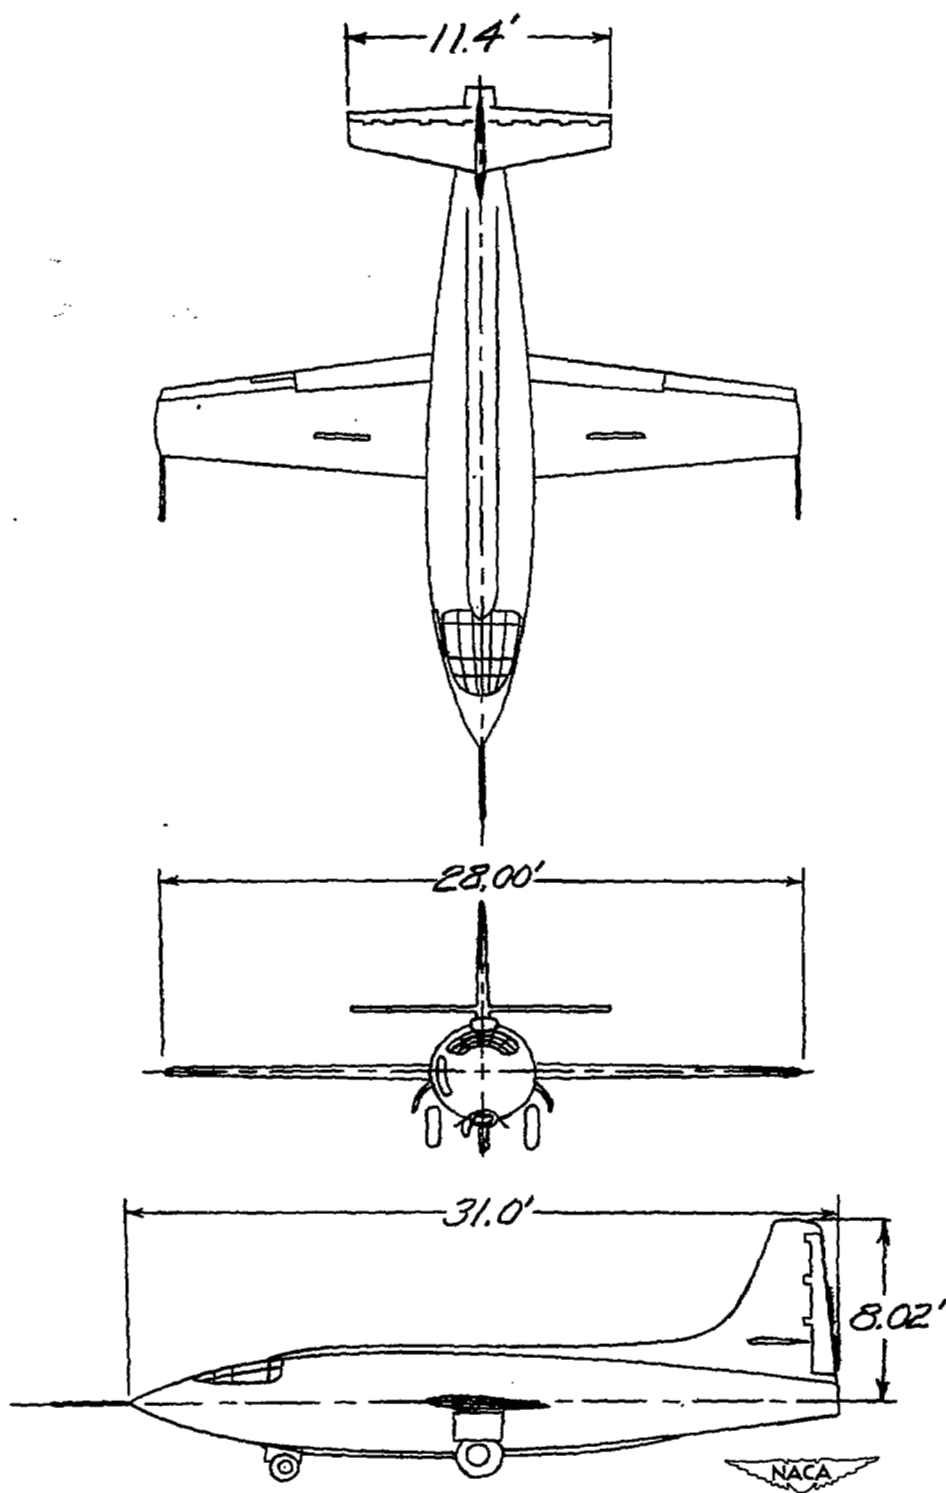
Figure 1.- Three-view drawing. X-1 airplane.

The Bell XS-1 airplane is a single-place, midwing monoplane powered by a four-cylinder, liquid-fuel rocket engine, built specifically for flight research in the transonic speed range. The physical characteristics of the airplane as tested are listed in table I. A three-view drawing of the airplane is presented in figure 1 and photographs of the airplane are presented as figure 2. The variation of control-surface position with wheel and pedal movement is presented in figure 3. Figure 4 presents no-load measurements of the control-system friction made by measuring the control position and control force as the control was slowly deflected. The large amounts of friction in the rudder and aileron control systems should be especially noted.

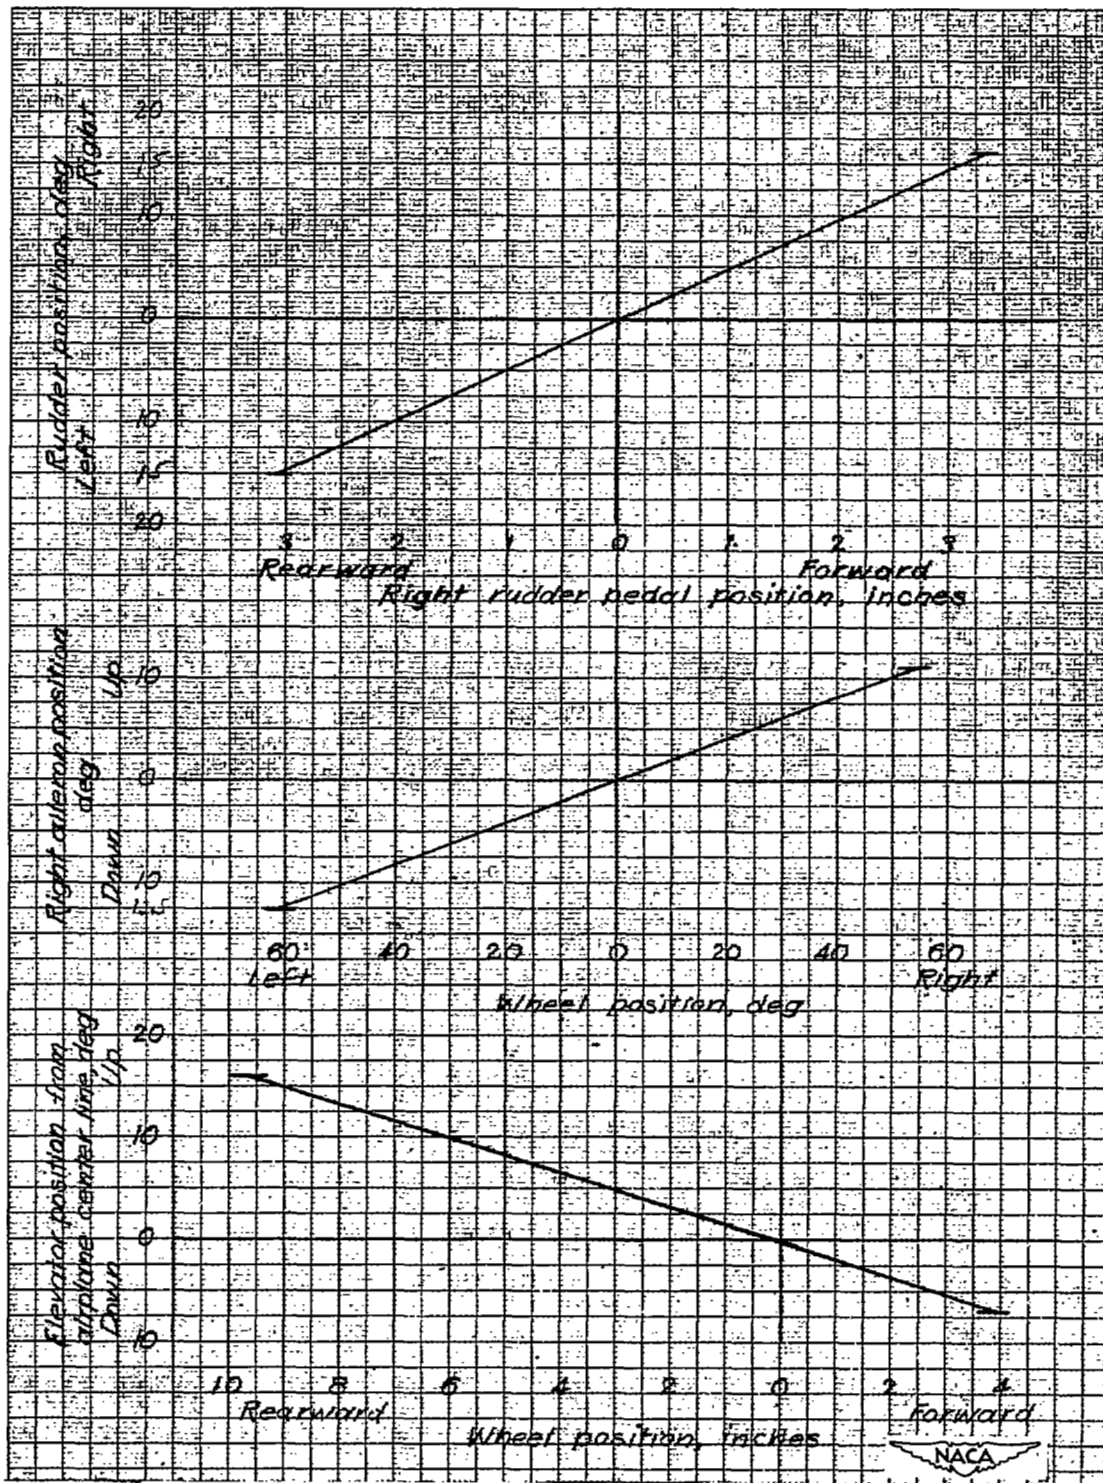
Figure 3.- Variation of control-surface deflection with pilot's control position. XS-1 airplane.

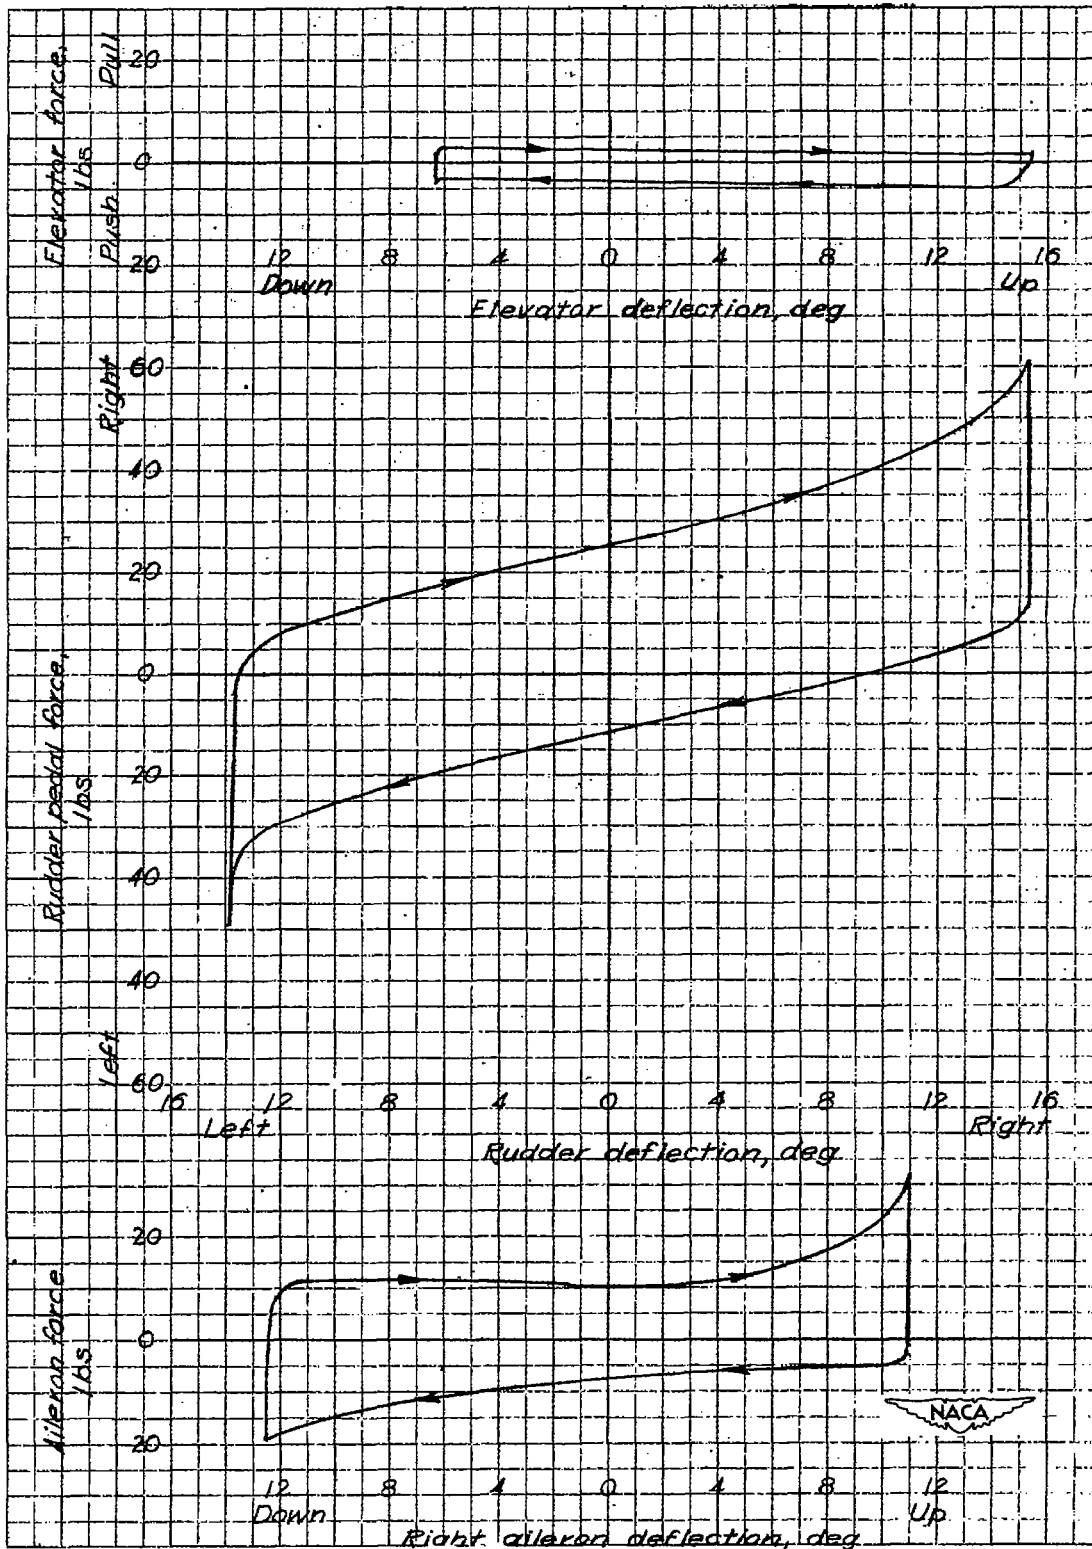
Figure 4.- Control forces required to deflect control surfaces under no load on the ground. XS-1 airplane.

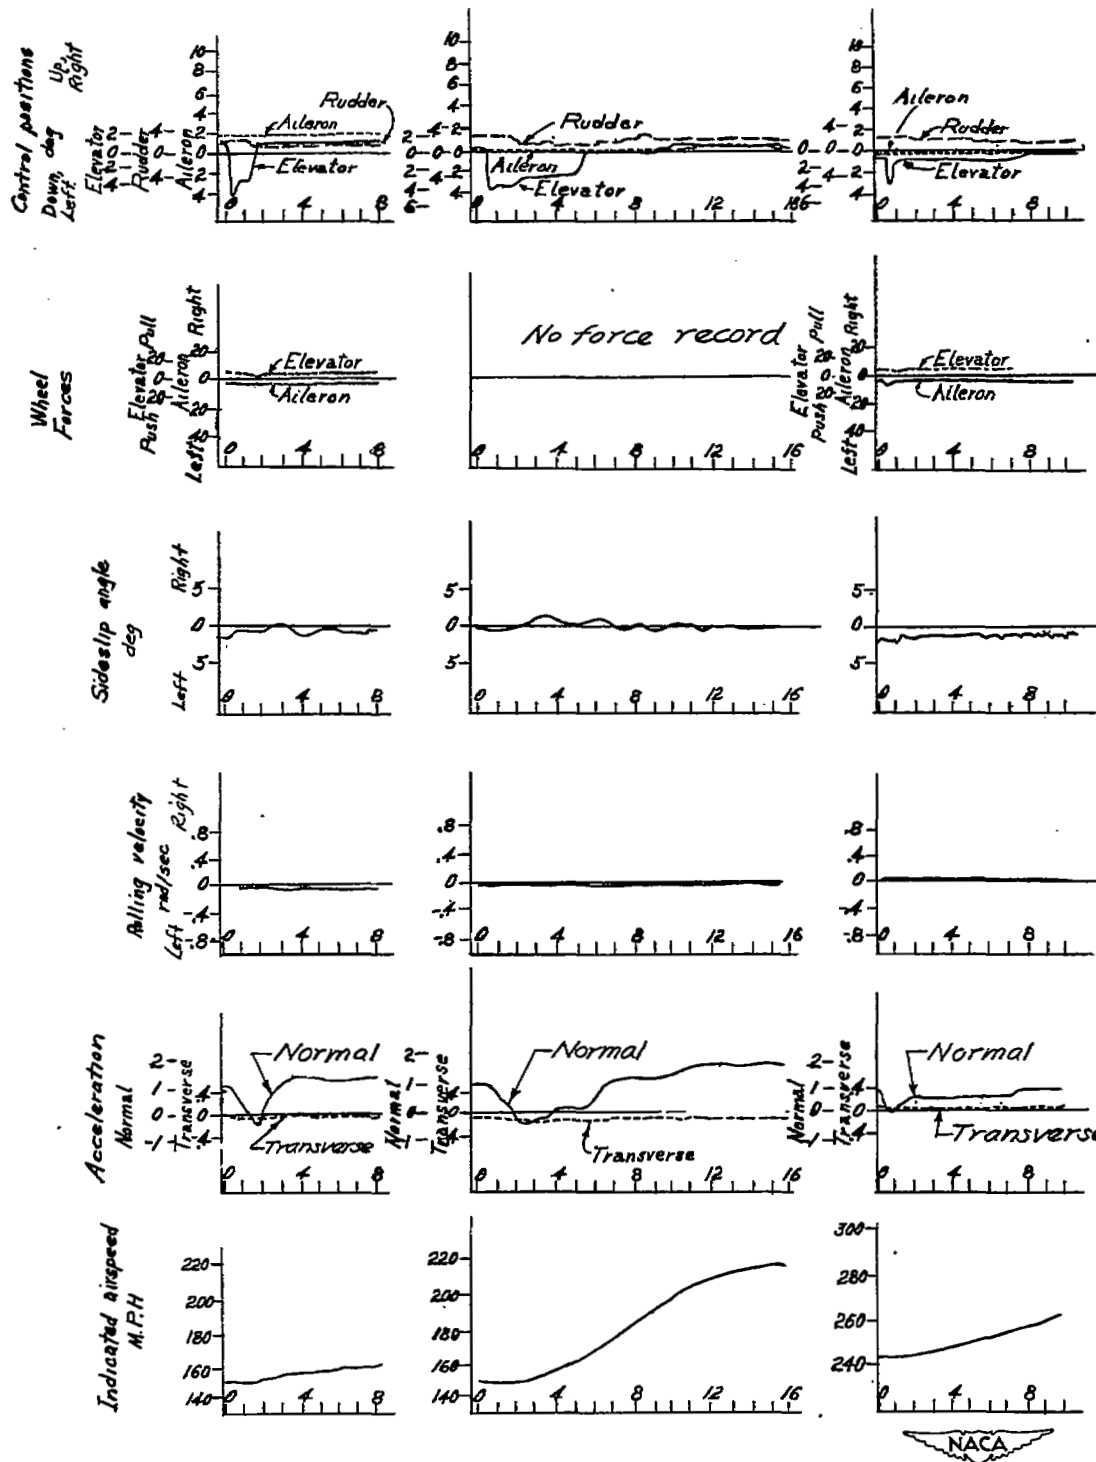
Figure 5.- Time histories of abrupt deflection and release of elevator control. XS-1 airplane.  $\frac{W}{S} = 32.5 \text{ lb/sq ft.}$

elevator control. Results of these tests are presented in figure 5. This figure shows that the short-period longitudinal oscillation is completely damped.

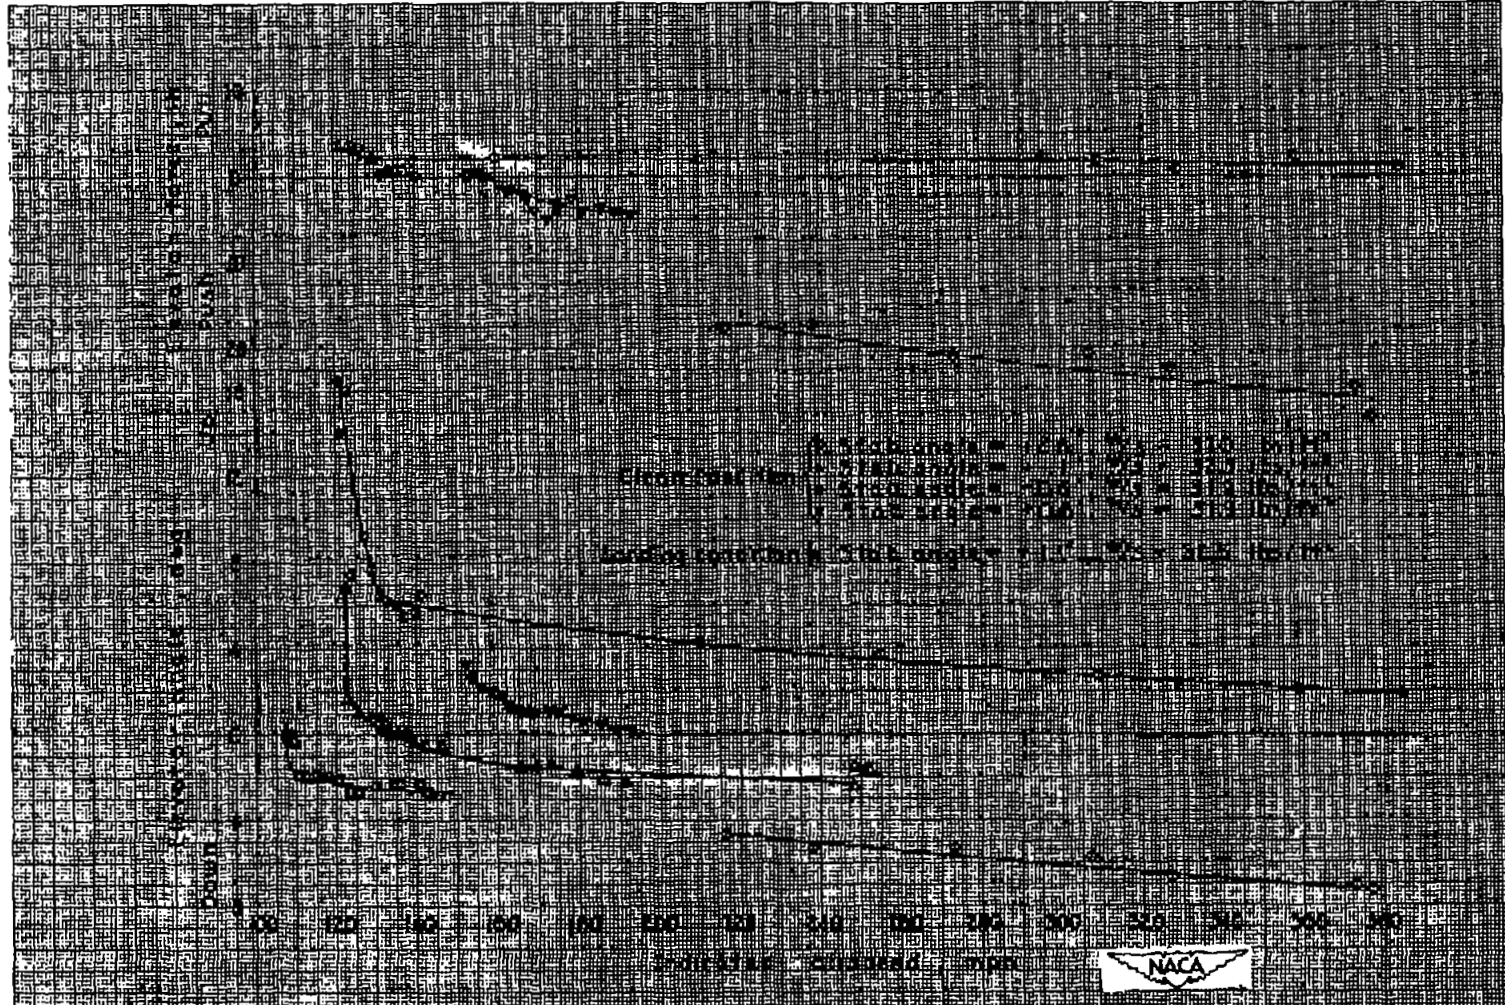
Figure 6.- Variation of elevator stick force and position required for trim with indicated airspeed as measured in steady gliding flight at various wing loadings and stabilizer positions. Center-of-gravity location at approximately 25 percent M.A.C. XS-1 airplane with 10-percent-thick wing.

The static longitudinal stability was obtained from measurements of the elevator positions and forces required to trim at various speeds. Figures 6 to 9 present the results of these measurements. In figure 6 the elevator position and force required for trim as a function of indicated airspeed is plotted for steady gliding flight at various wing loadings and stabilizer positions for the airplane with the 10-percent-thick wing. Examination of the data shows that both the stick-fixed and stick-free static longitudinal stability are positive but low. The relatively high friction in the elevator control ( $\pm 3$  lb) combined with the small size of the elevator and low stick-free stability has the effect of masking the measured control forces. The elevator-position variation with indicated airspeed of figure 6 is replotted in figure 7 as the variation of elevator position for trim with normal-force coefficient. The elevator positions have been corrected to zero stabilizer angle by using a value of  $r$ , the elevator effectiveness, of 0.42 obtained from flight data. A marked increase in the stick-fixed static stability is noticed as maximum lift is approached. These results are in general agreement with wind-tunnel results.

The results of tests with the 8-percent-thick wing (fig. 9) in steady gliding flight, although limited, bear out the positive but low static longitudinal stability evidenced by the results for the airplane incorporating the 10-percent-thick wing. No appreciable differences in the static longitudinal stability of the Bell XS-1 airplane with either the 10-percent-thick or the 8-percent-thick wing are evidenced from these results (figs. 6 and 9).

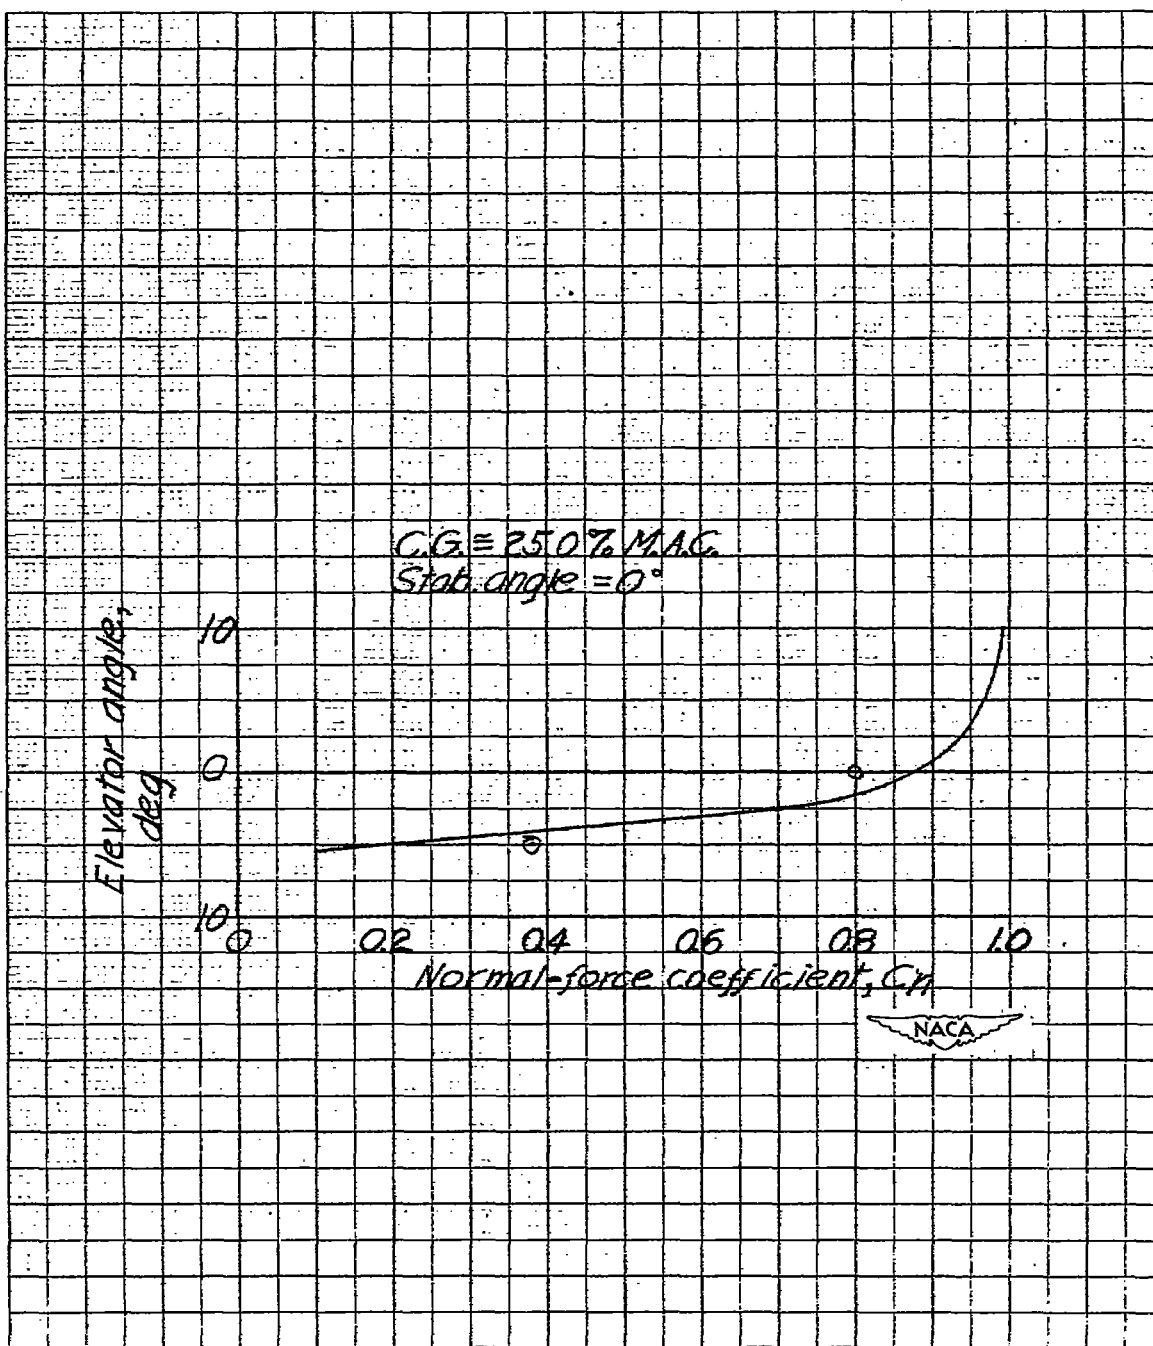
Figure 7.- Variation of elevator position, corrected to zero stabilizer position, required for trim with normal-force coefficient for steady gliding flight with flaps and gear up. Center-of-gravity location at approximately 25 percent M.A.C.; XS-1 airplane with 10-percent-thick wing.

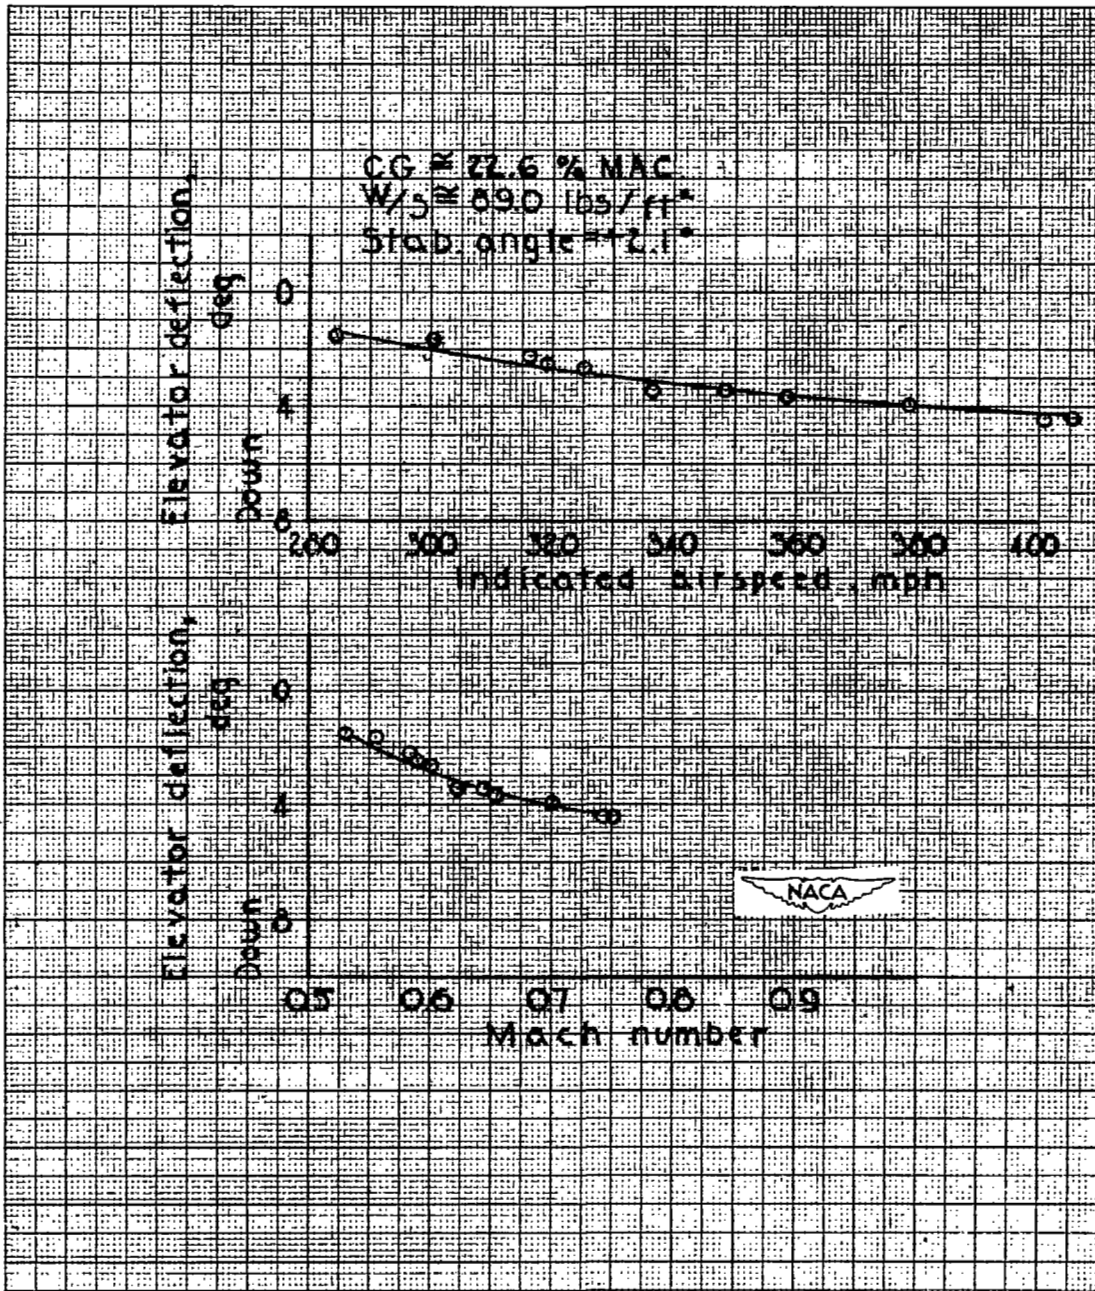
Figure 8.- Variation of elevator position with indicated airspeed and Mach number for trim in steady powered flight. XS-1 airplane with 10-percent-thick wing. Center of gravity approximately 22.6 percent M.A.C.;  $\frac{W}{S} = 89$  lb/sq ft. Stabilizer position 2.1°.

The variation of elevator position with indicated airspeed and Mach number for steady power-on flight is presented in figure 8. The center-of-gravity location for these results was at about 22.6 percent mean aerodynamic chord as compared with the center-of-gravity location of about 25 percent mean aerodynamic chord for the results of figures 6 and 7. The speed range covered was from an indicated airspeed of 284 miles per hour to 406 miles per hour and for a Mach number range from 0.53 to 0.75. The results as seen from this figure indicate that power has little effect on the longitudinal stability of the Bell XS-1 up to the highest speeds tested. Also, no undesirable longitudinal-trim changes are indicated.

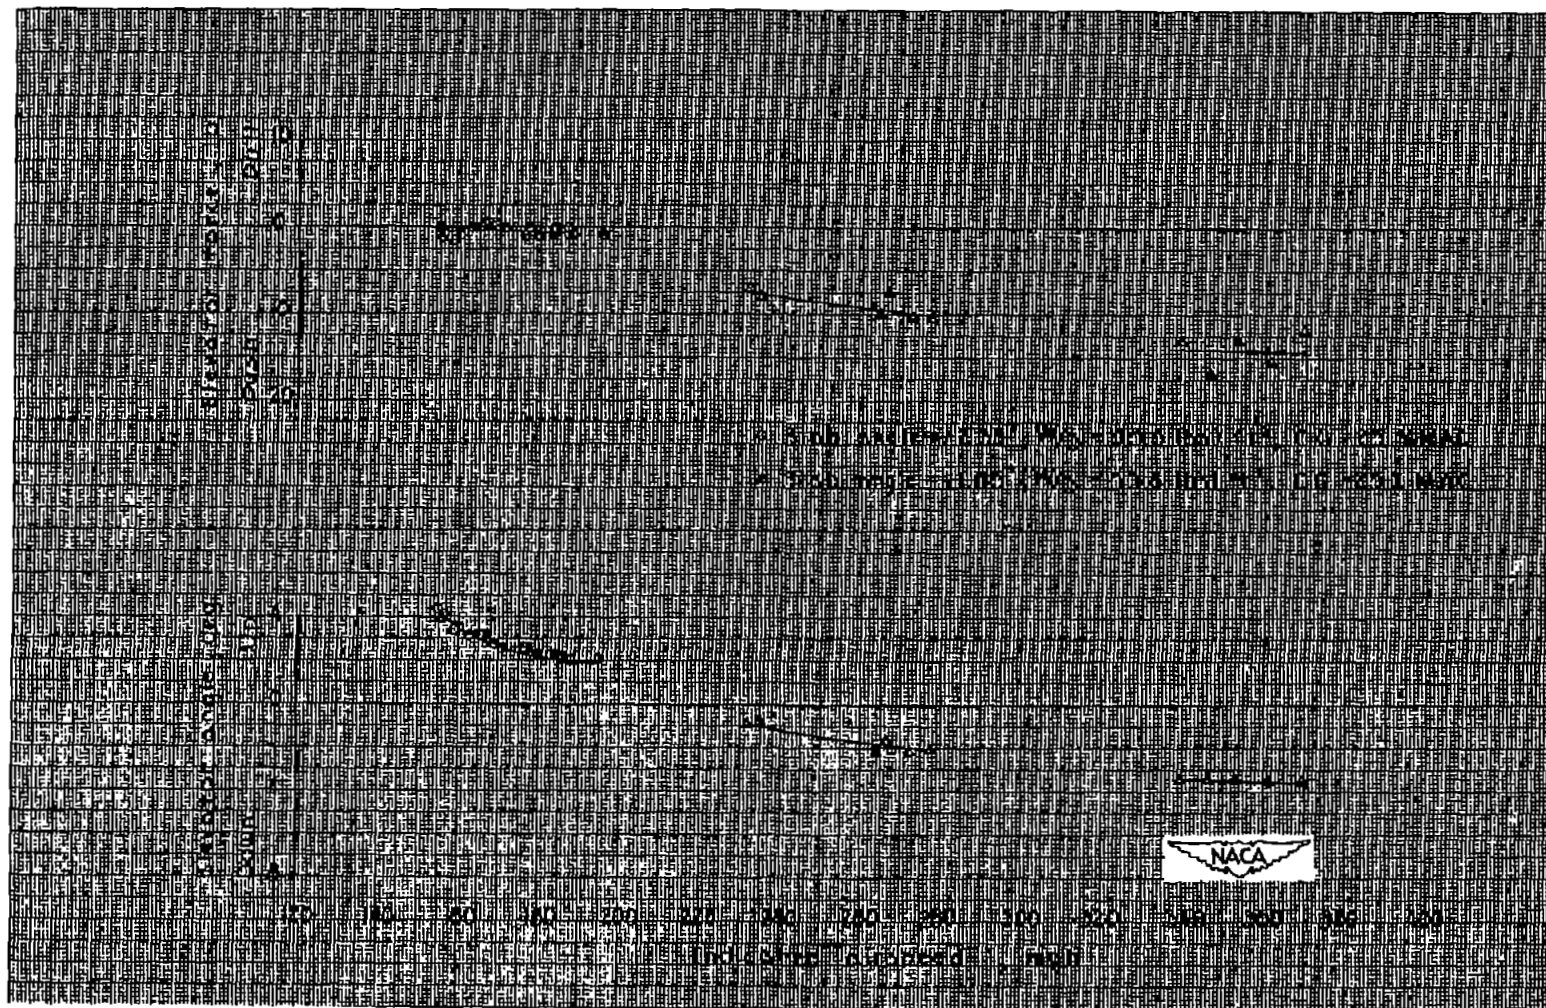
Figure 9.- Variation of elevator stick force and position with indicated airspeed for trim in steady gliding flight with several stabilizer settings. XS-1 airplane with 8-percent-thick wing. Center of gravity 25 percent M.A.C.;  $\frac{W}{S} = 53.8$  lb/sq ft.

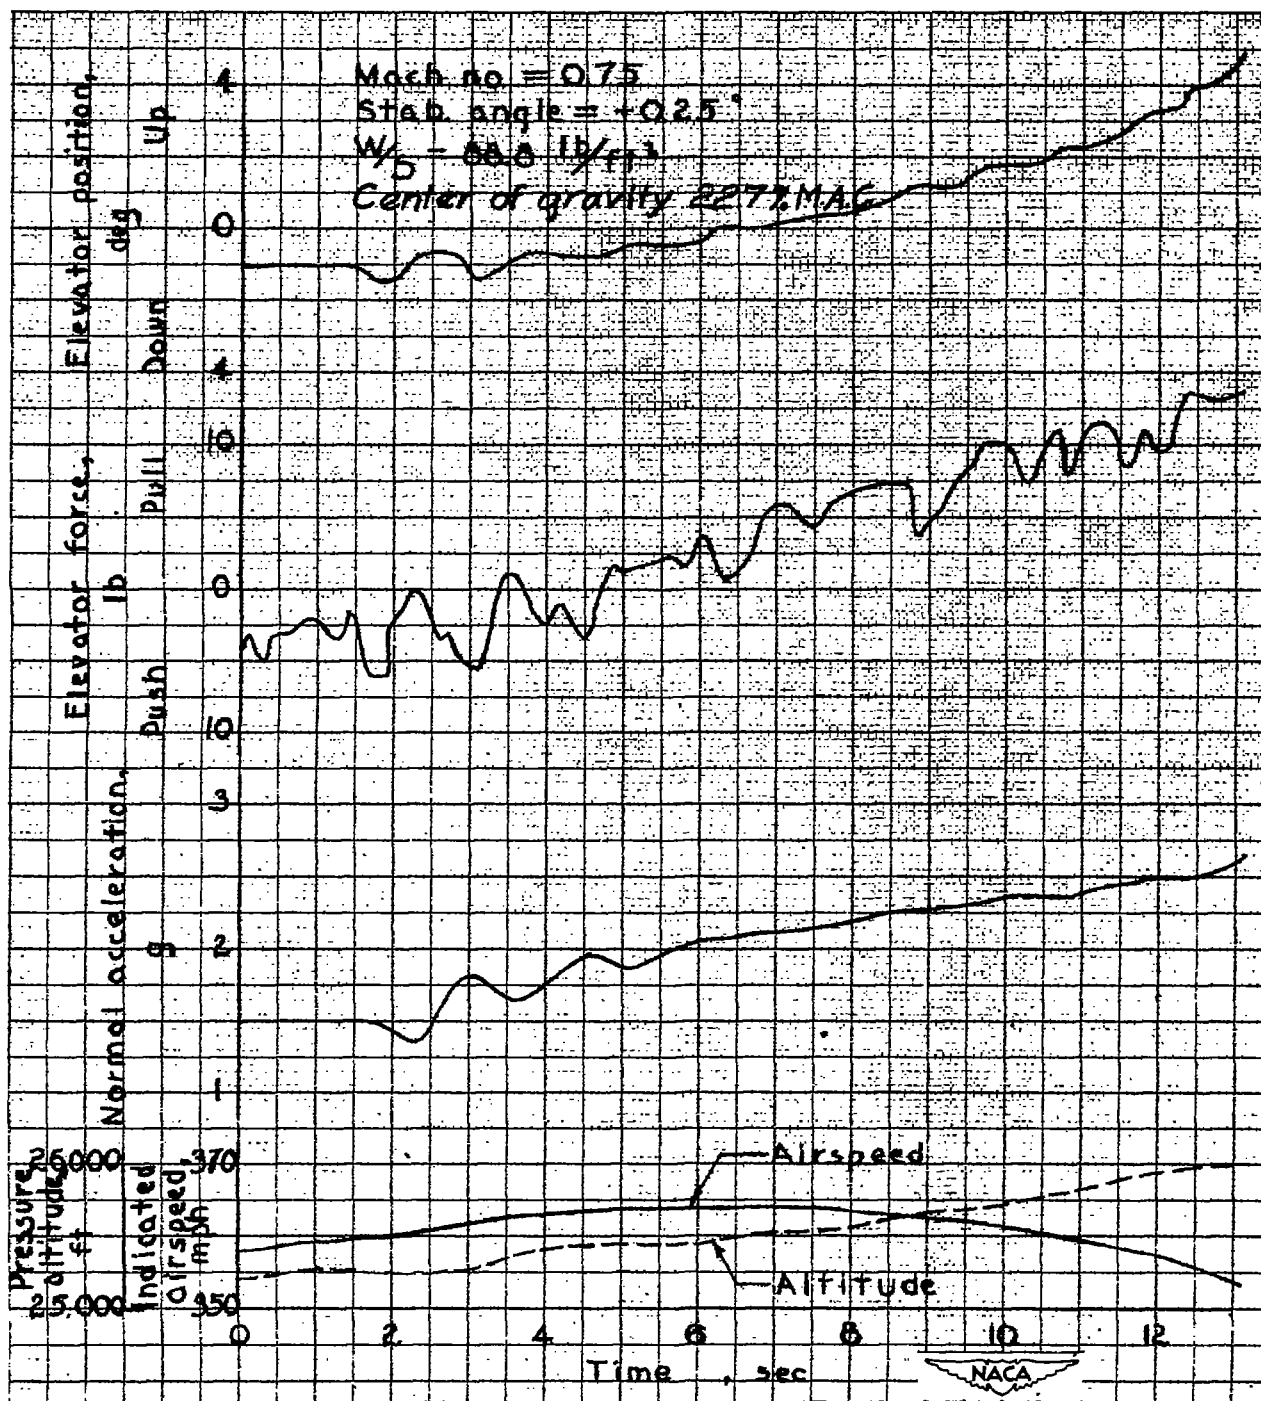
Figure 10.- Time history of a power-on turn with slowly increasing normal acceleration at a Mach number of about 0.75. XS-1 airplane with 10-percent-thick wing.

altitude so that complete data for a given Mach number would be obtained in one run. Time histories of two turns are presented in figures 10 and 11. In one turn (fig. 10) the record switch was turned on after the turn was started, but the turn was fairly steady considering the friction in the control system. In the other turn (fig. 11) the elevator was moved in an unsteady manner and the rate of increase of acceleration with time was too high at the beginning of the turn. Since several of the turns were made in this manner, the slopes of the curves of elevator deflection against normal-force coefficient and the elevator force per g should be compared only in a general way for large changes in acceleration or lift coefficient for turns at different Mach numbers. Figures 12 through 16 present the stick-fixed and stick-free accelerated-flight longitudinal-stability results obtained from the turns. The Mach number range covered is from 0.48 to 0.75. The elevator-position variation with normal acceleration and normal-force coefficient and the force per g gradients indicate a decrease in stability for turns (figs. 13 to 16) made at Mach numbers from 0.65 to 0.72. At the highest Mach number tested ( $M = 0.75$ ) an increase in longitudinal stability is indicated (figs. 14 and 16).

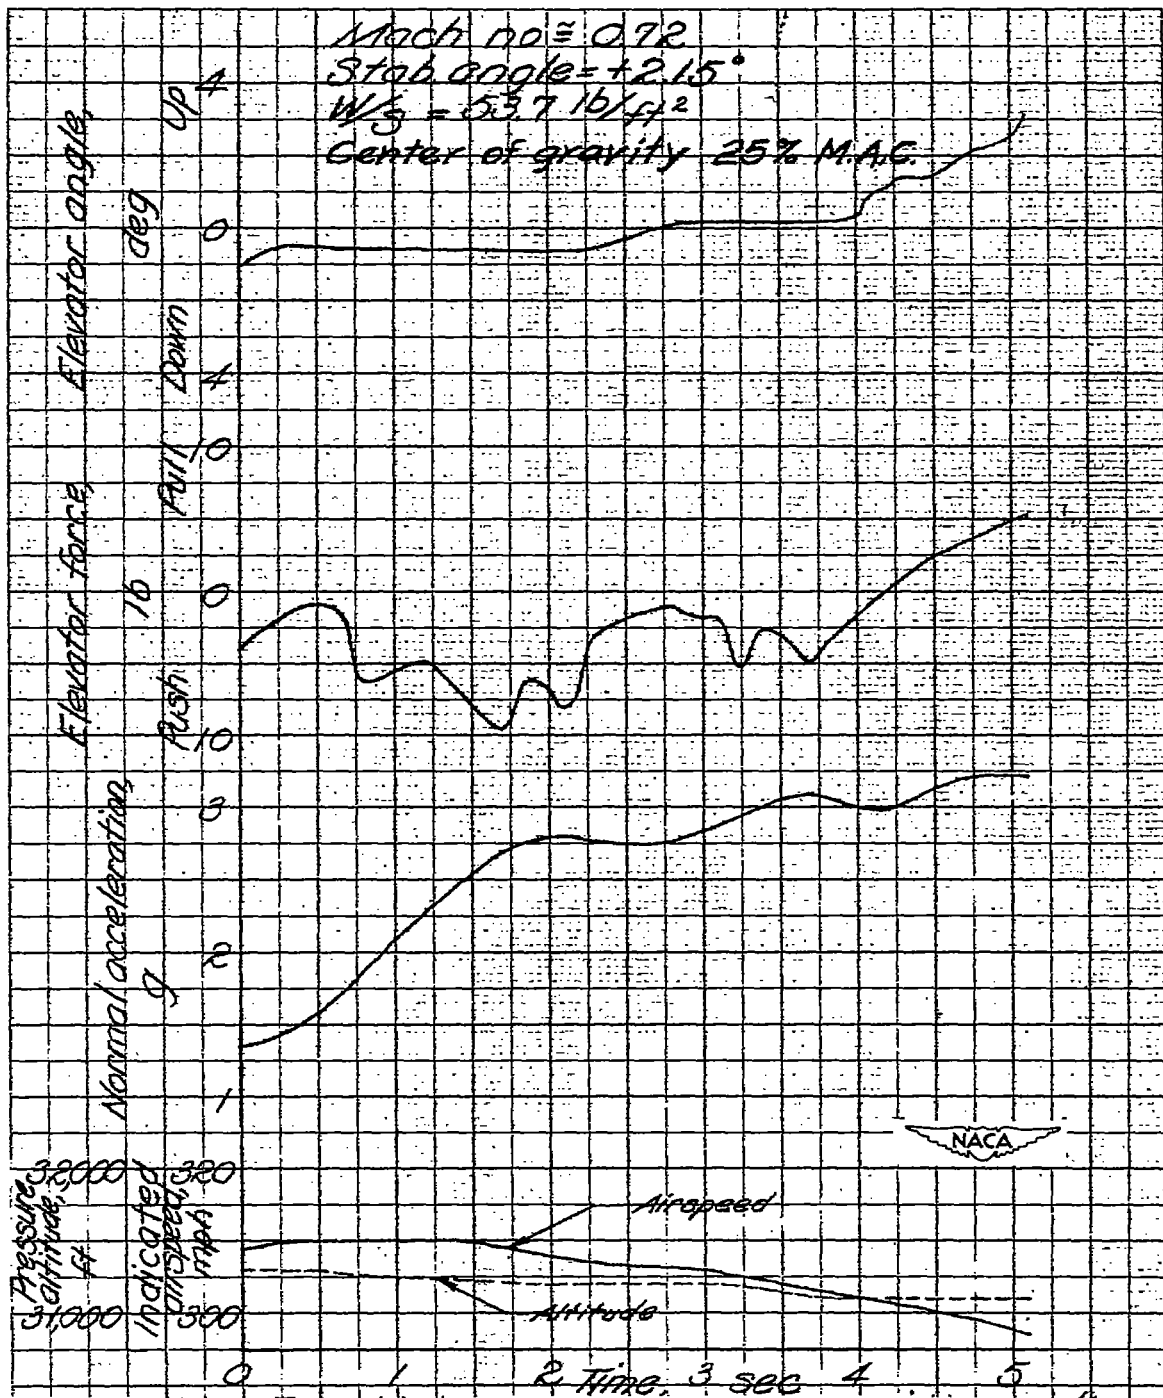
Figure 11.- Time history of a power-off turn with rapidly increasing normal acceleration at a Mach number of about 0.72. XS-1 airplane with 8-percent-thick wing.

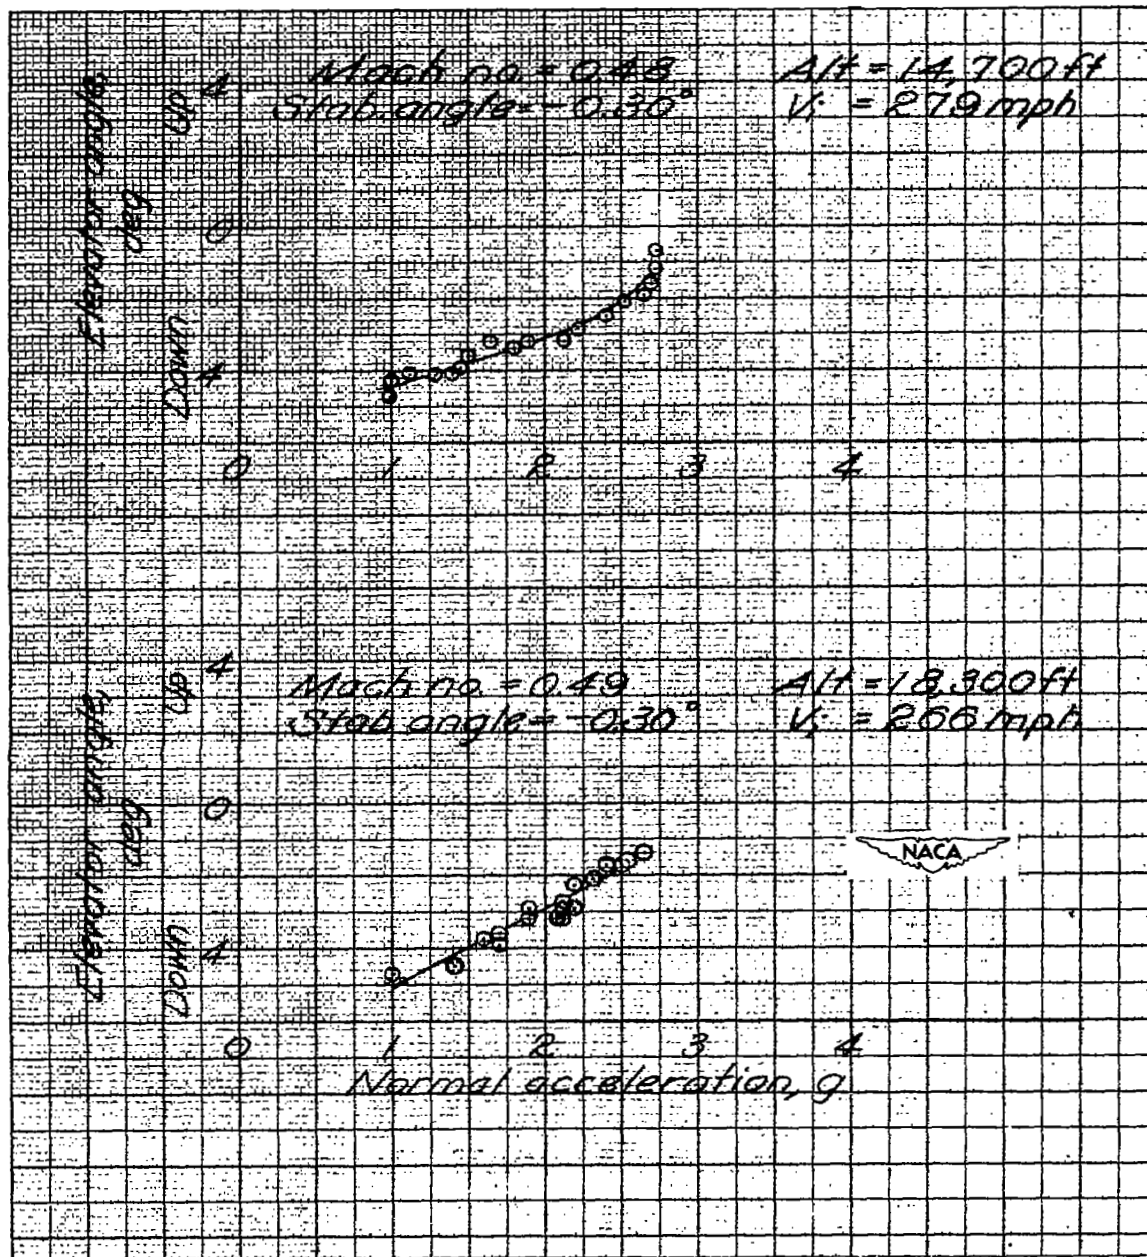
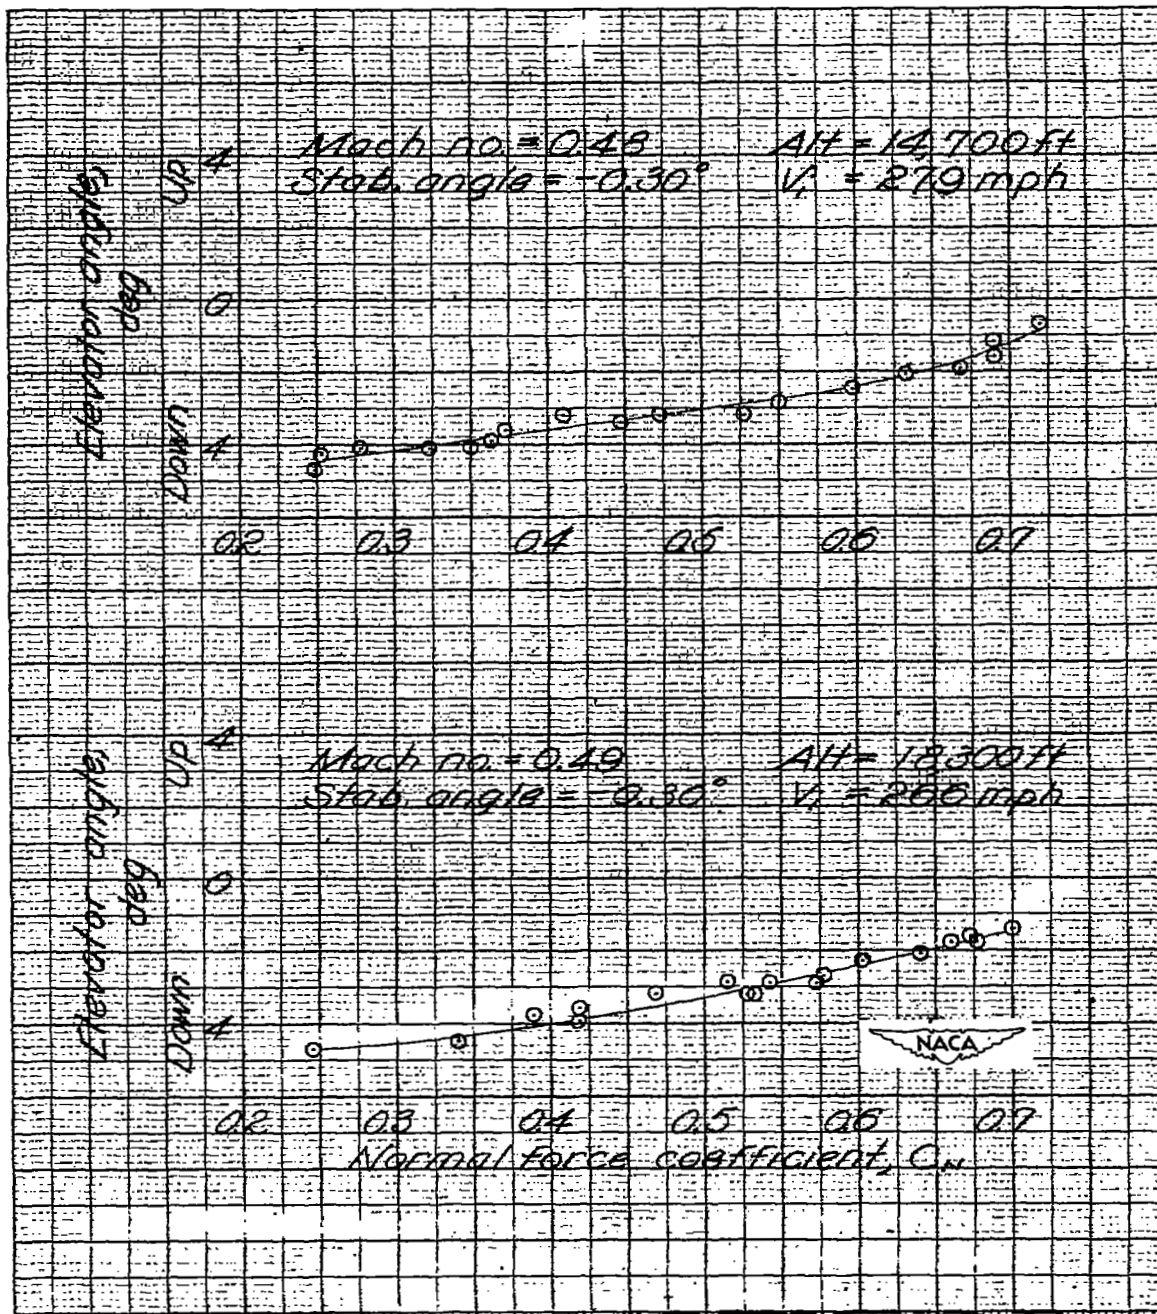
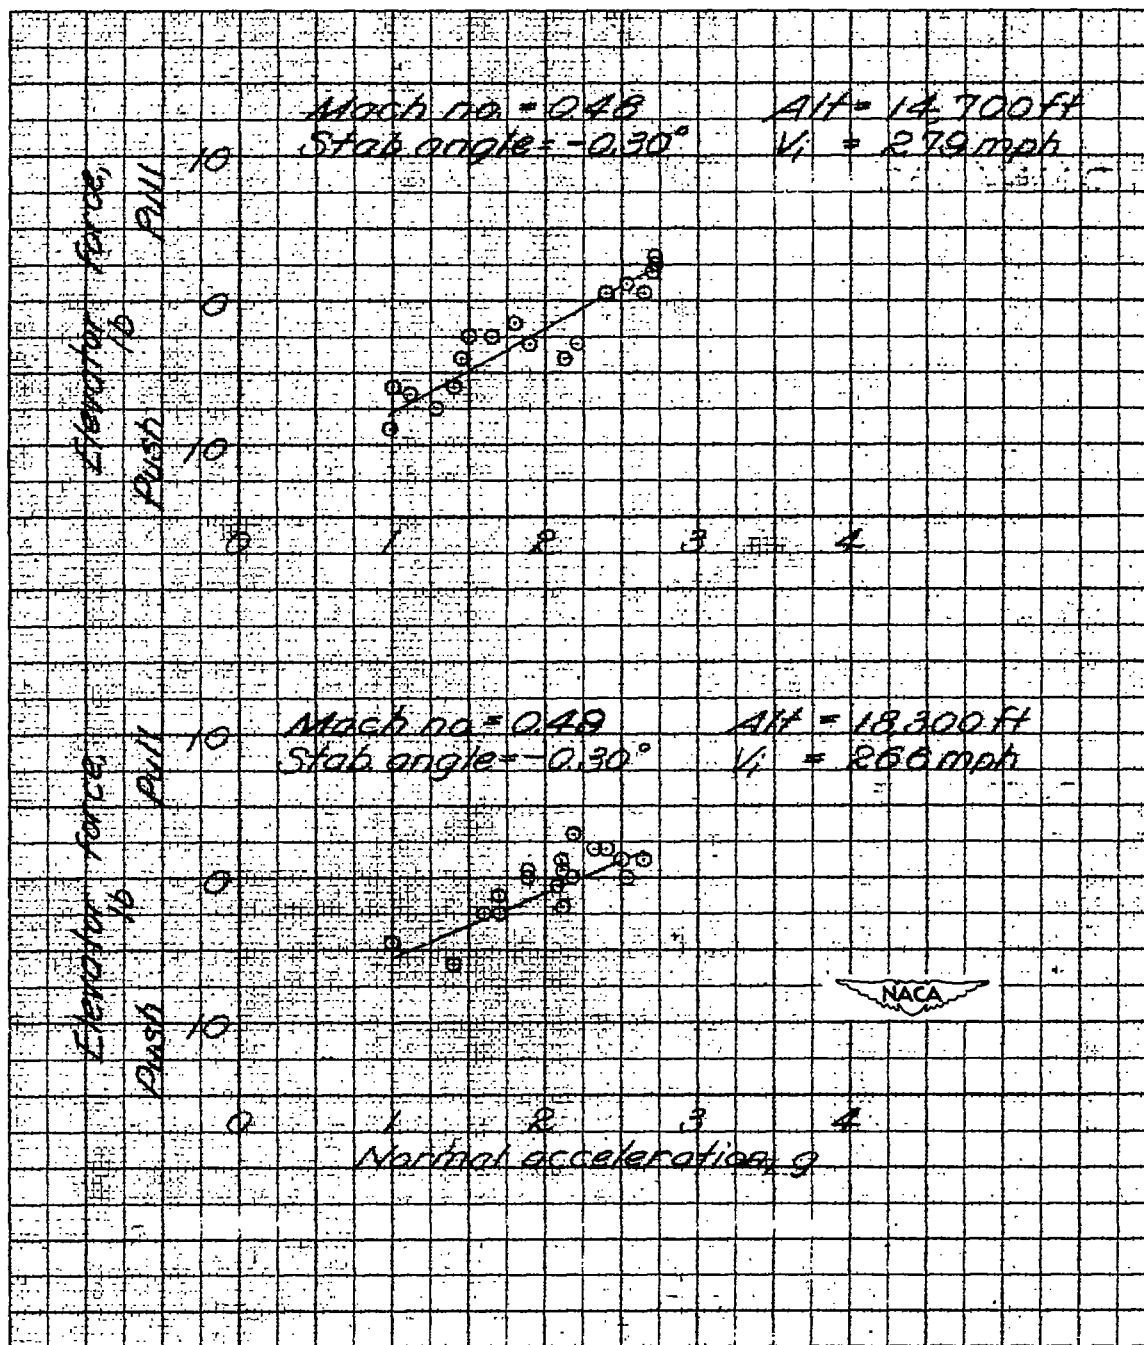
(a) Variation of elevator position with normal acceleration.

Figure 12.- Results obtained in turns at Mach numbers of 0.48 and 0.49, XS-1 airplane with 10-percent-thick wing. Gliding flight; center of gravity, 25.3 percent M.A.C.;  $\frac{W}{S} = 51.9$  lb/sq ft.

(b) Variation of elevator position with normal-force coefficient.

(c) Variation of elevator wheel force with normal acceleration.
