NACA RM No. L8A09

GENERAL HANDLING-QUALITIES RESULTS OBTAINED DURING  
ACCEPTANCE FLIGHT TESTS OF THE BELL XS-1 AIRPLANE

FLIGHT TESTS OF THE BELL XS-1 AIRPLANE

SUMMARY

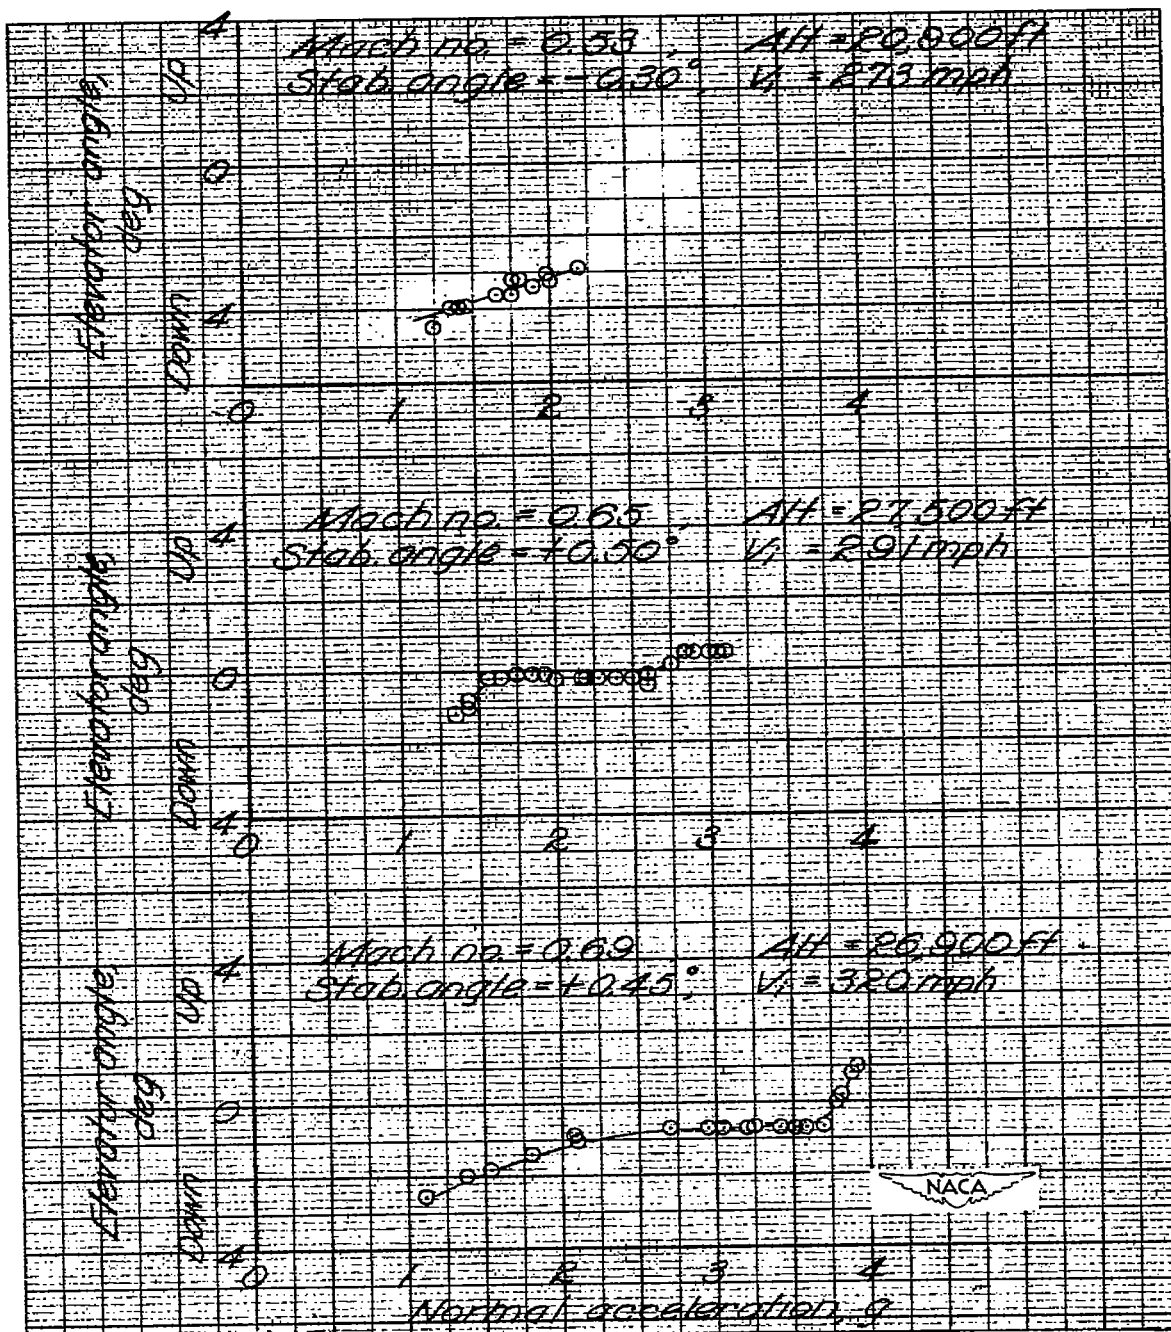
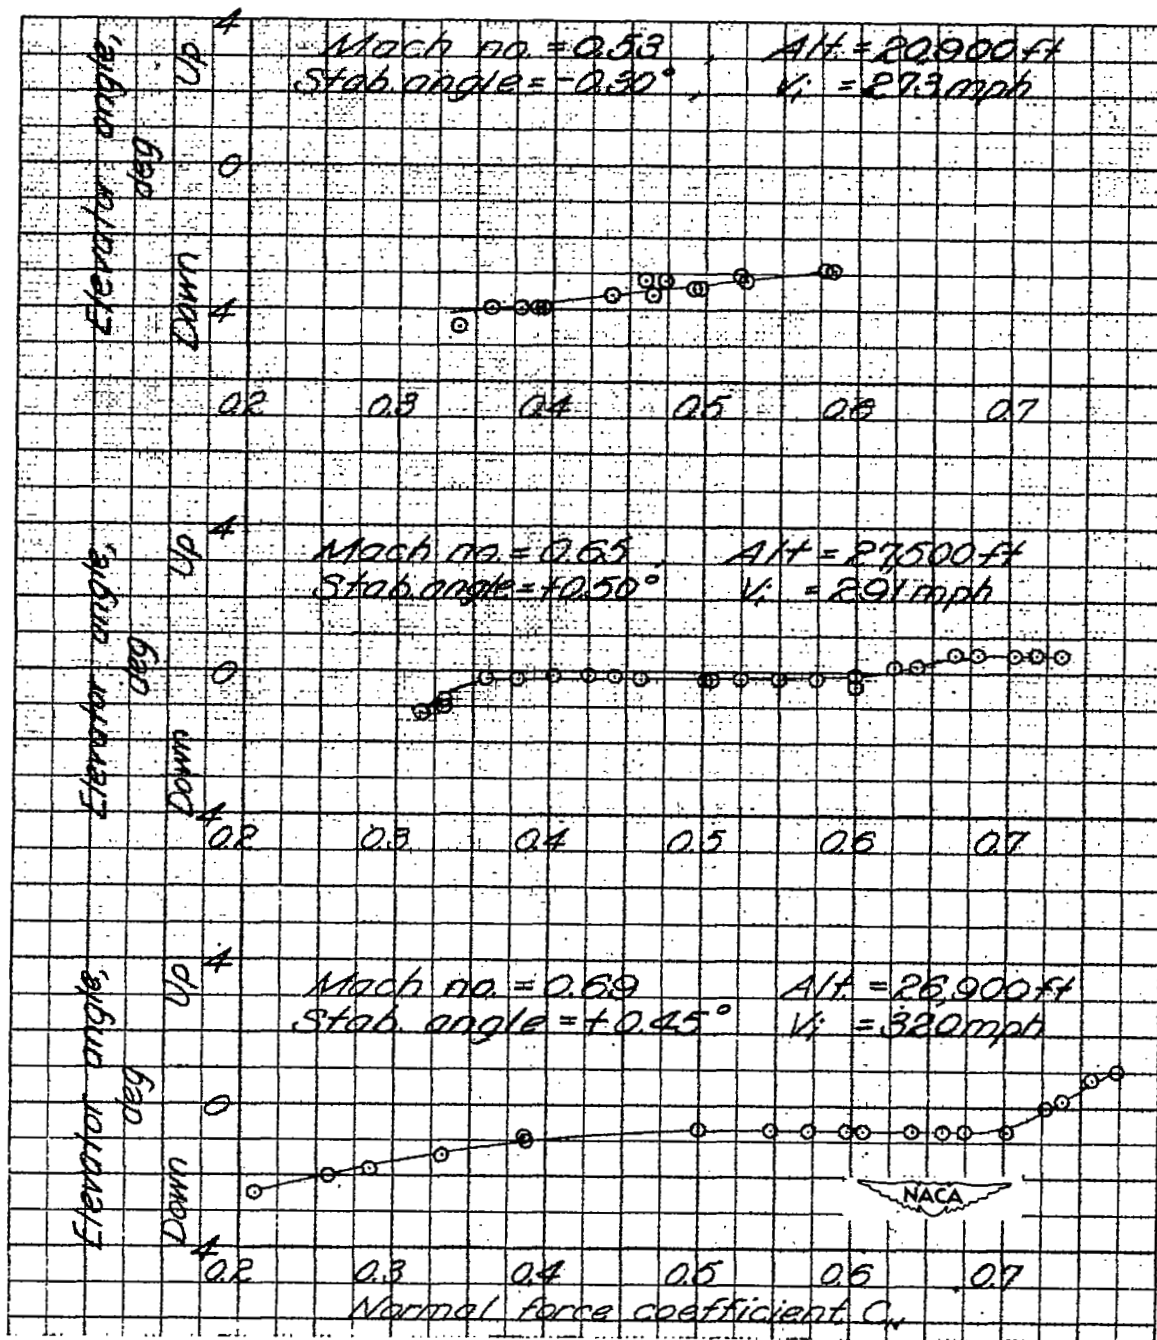
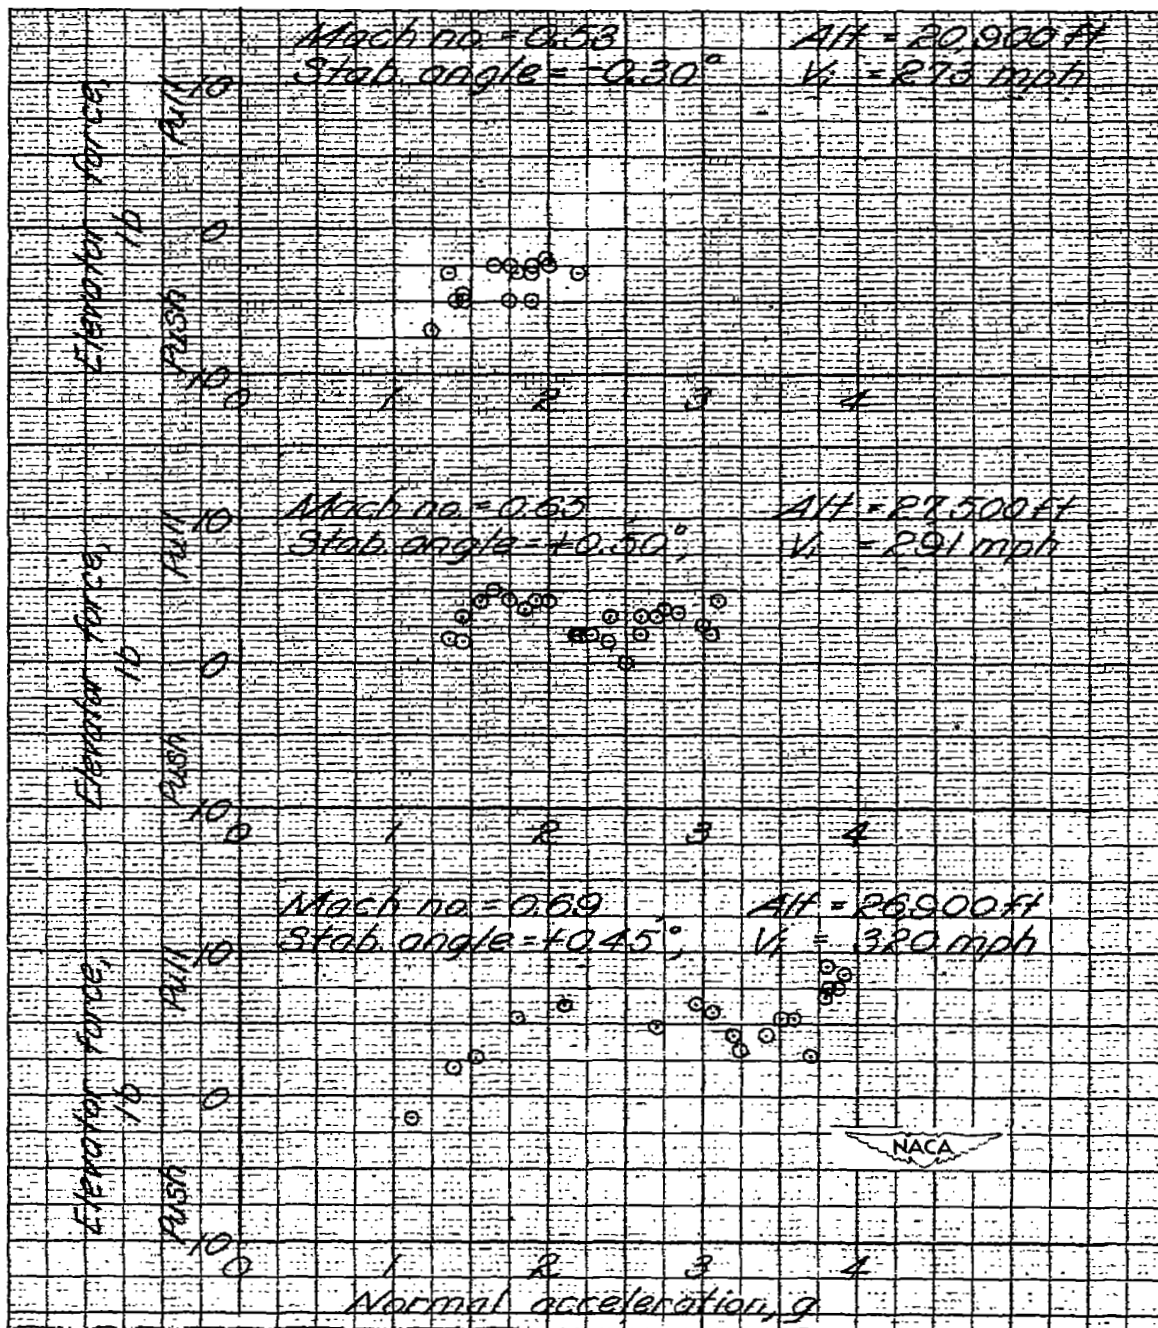
(a) Variation of elevator position with normal acceleration.

Figure 13.- Results obtained in turns at Mach numbers of 0.53, 0.65, and 0.69. XS-1 airplane with 10-percent-thick wing. Gliding flight; center of gravity, 25.3 percent M.A.C.;  $\frac{W}{S} = 51.9$  lb/sq ft.

(b) Variation of elevator position with normal-force coefficient.

(c) Variation of elevator wheel force with normal acceleration.

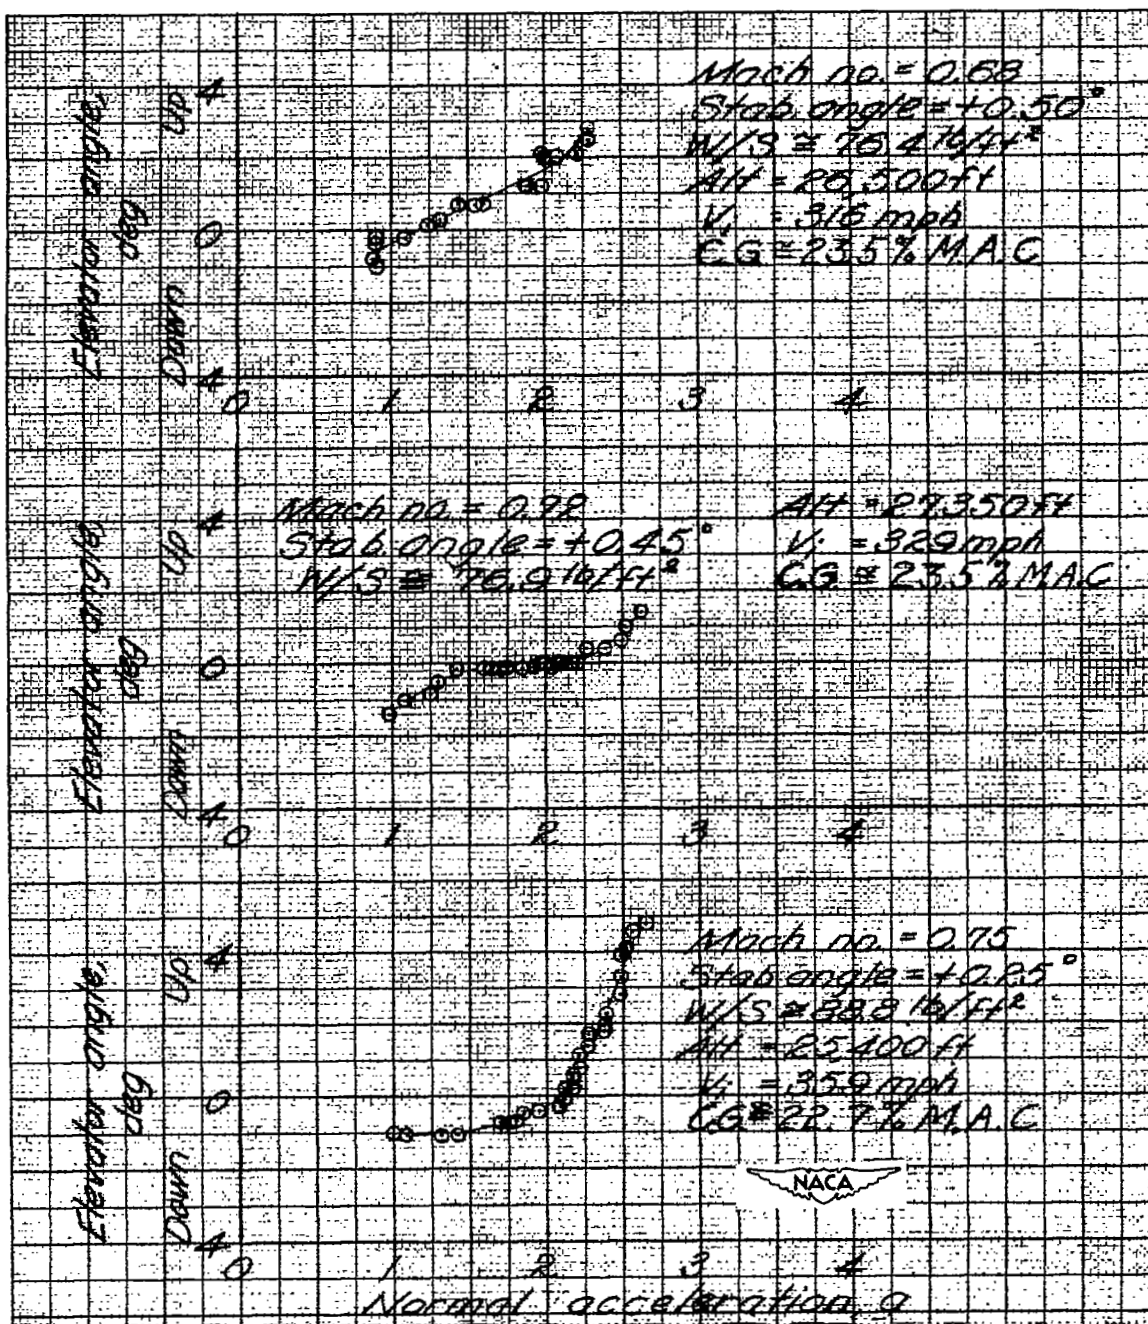
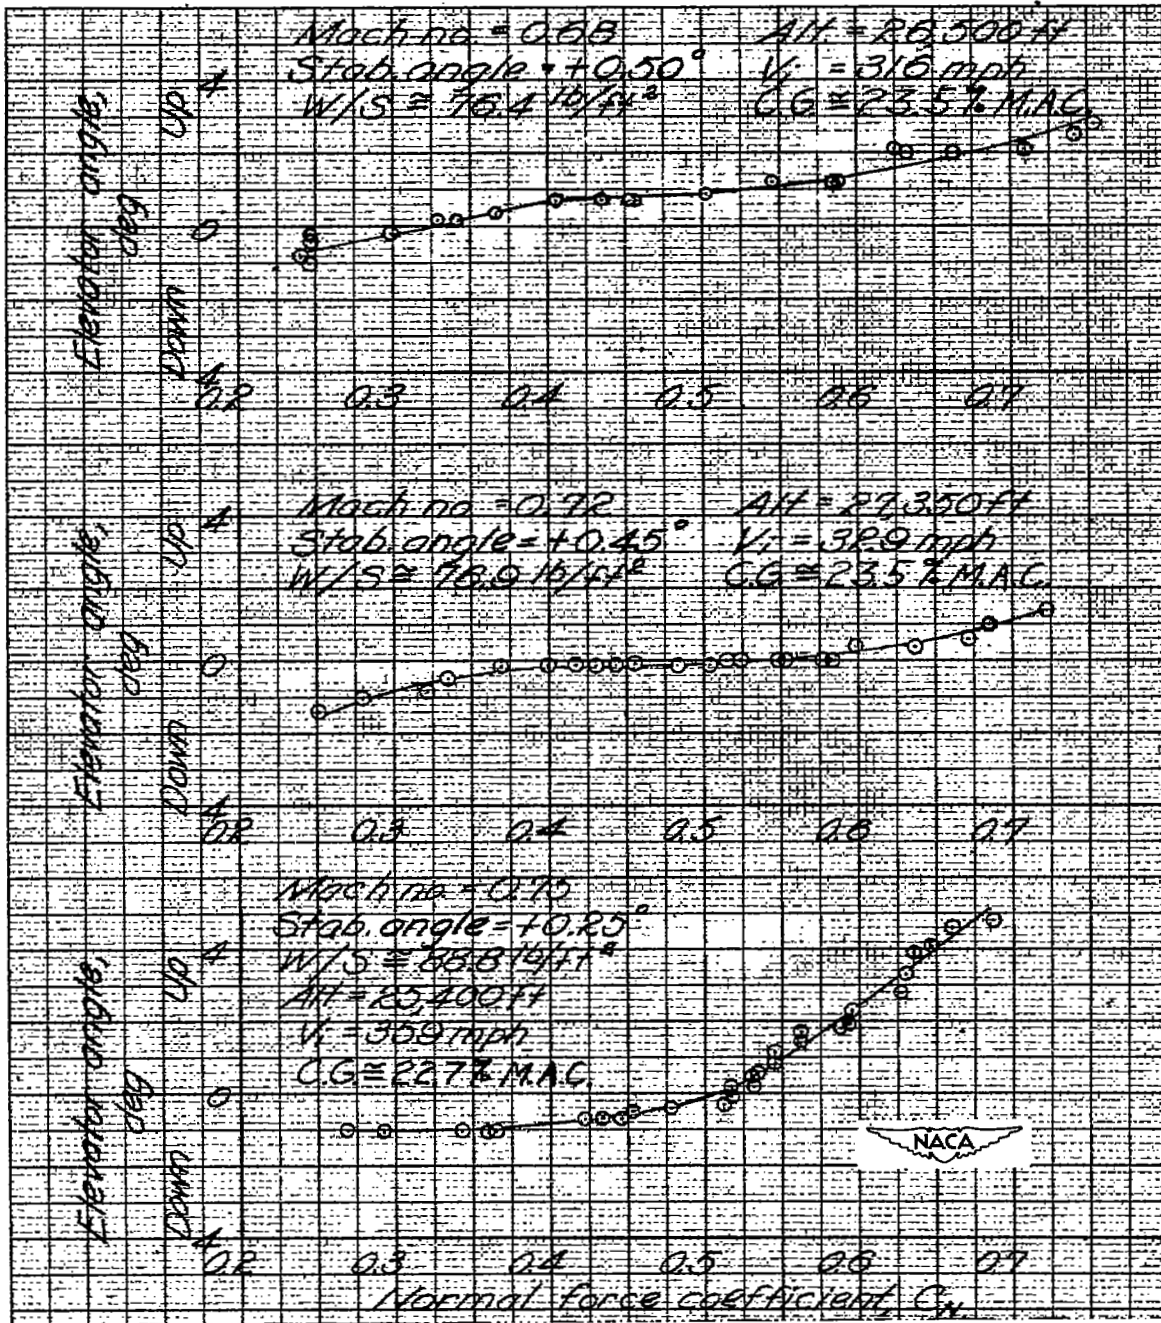
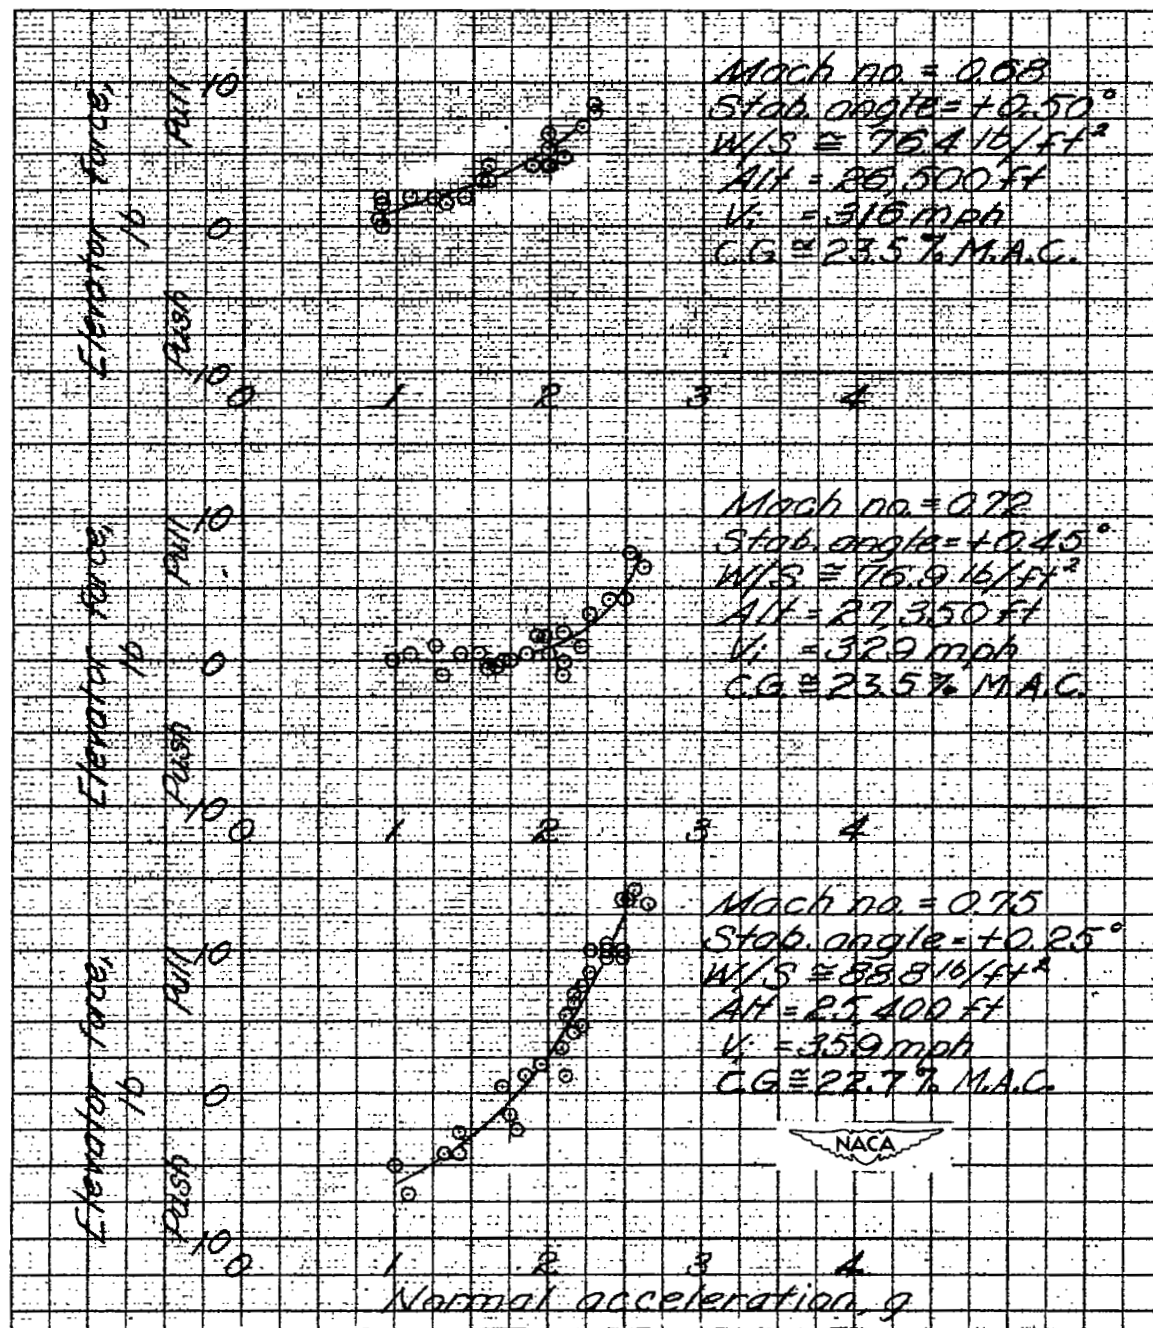
(a) Variation of elevator position with normal acceleration.

Figure 14.- Results obtained in turns at Mach numbers of 0.68, 0.72, and 0.75 with power on. XS-1 airplane with 10-percent-thick wing.

(b) Variation of elevator position with normal-force coefficient.

(c) Variation of elevator wheel force with normal acceleration.

altitude so that complete data for a given Mach number would be obtained in one run. Time histories of two turns are presented in figures 10 and 11. In one turn (fig. 10) the record switch was turned on after the turn was started, but the turn was fairly steady considering the friction in the control system. In the other turn (fig. 11) the elevator was moved in an unsteady manner and the rate of increase of acceleration with time was too high at the beginning of the turn. Since several of the turns were made in this manner, the slopes of the curves of elevator deflection against normal-force coefficient and the elevator force per g should be compared only in a general way for large changes in acceleration or lift coefficient for turns at different Mach numbers. Figures 12 through 16 present the stick-fixed and stick-free accelerated-flight longitudinal-stability results obtained from the turns. The Mach number range covered is from 0.48 to 0.75. The elevator-position variation with normal acceleration and normal-force coefficient and the force per g gradients indicate a decrease in stability for turns (figs. 13 to 16) made at Mach numbers from 0.65 to 0.72. At the highest Mach number tested ( $M = 0.75$ ) an increase in longitudinal stability is indicated (figs. 14 and 16).

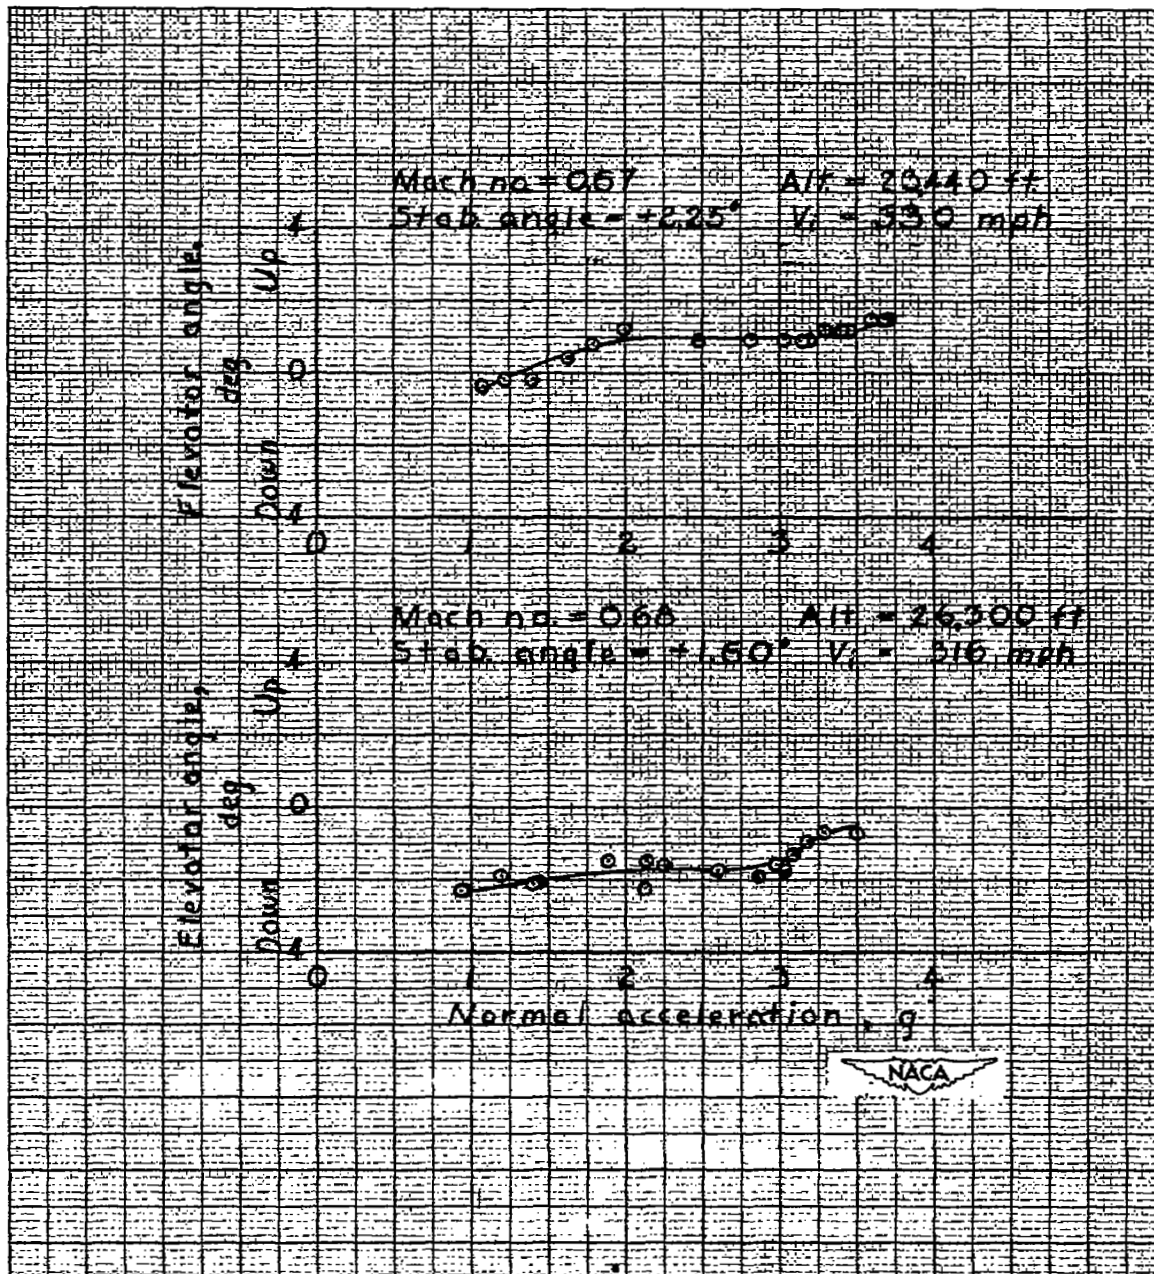
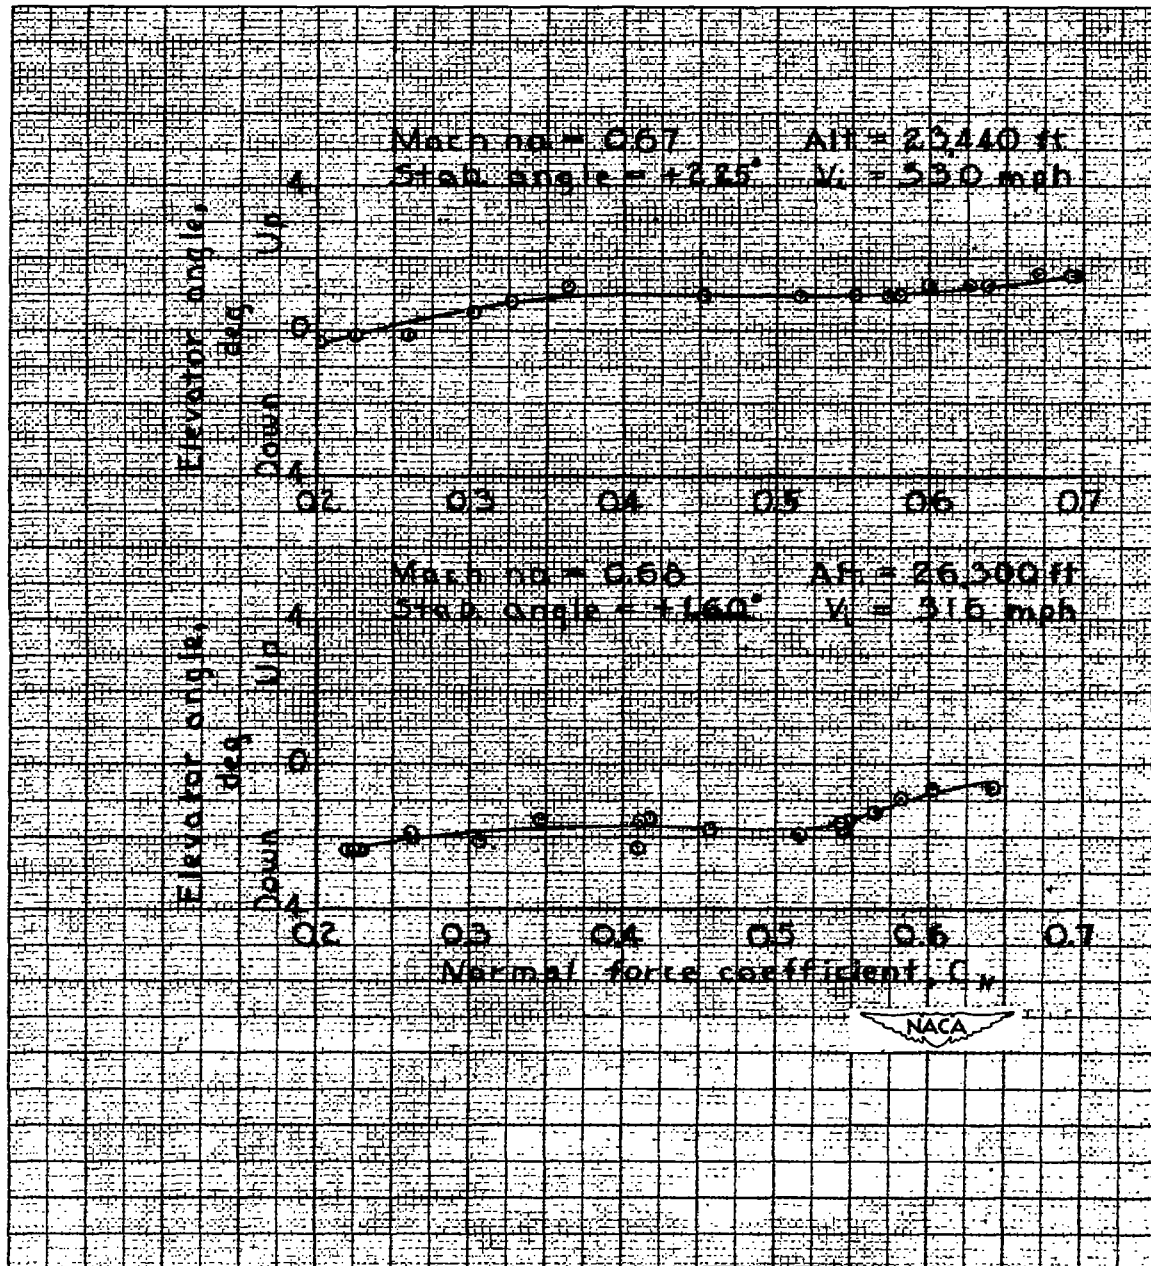
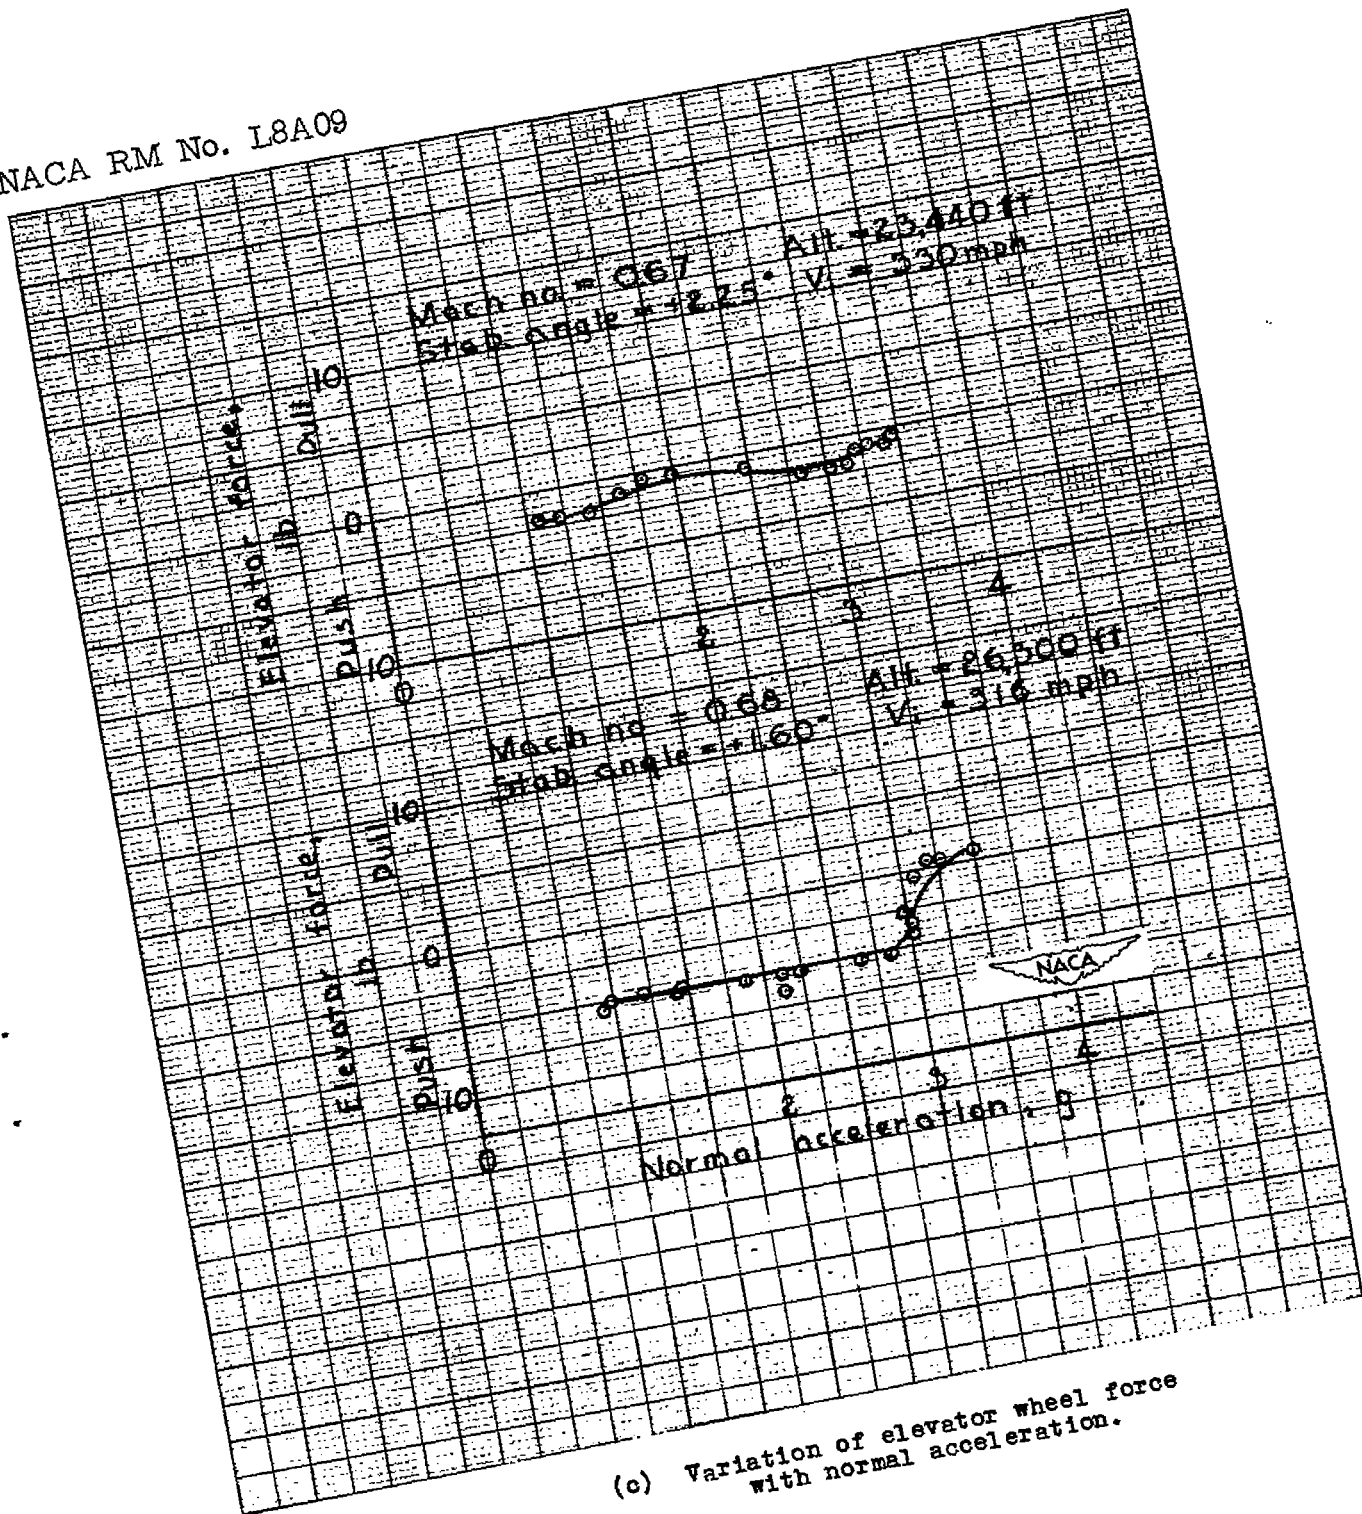
(a) Variation of elevator position with normal acceleration.

Figure 15.- Results obtained in turns at Mach numbers of 0.67, 0.68, XS-1 airplane with 8-percent-thick wing. Gliding flight; center of gravity, 25 percent M.A.C.;  $\frac{W}{S} = 53.8$  lb/sq ft.

(b) Variation of elevator deflection with normal-force coefficient.

(c) Variation of elevator wheel force with normal acceleration.

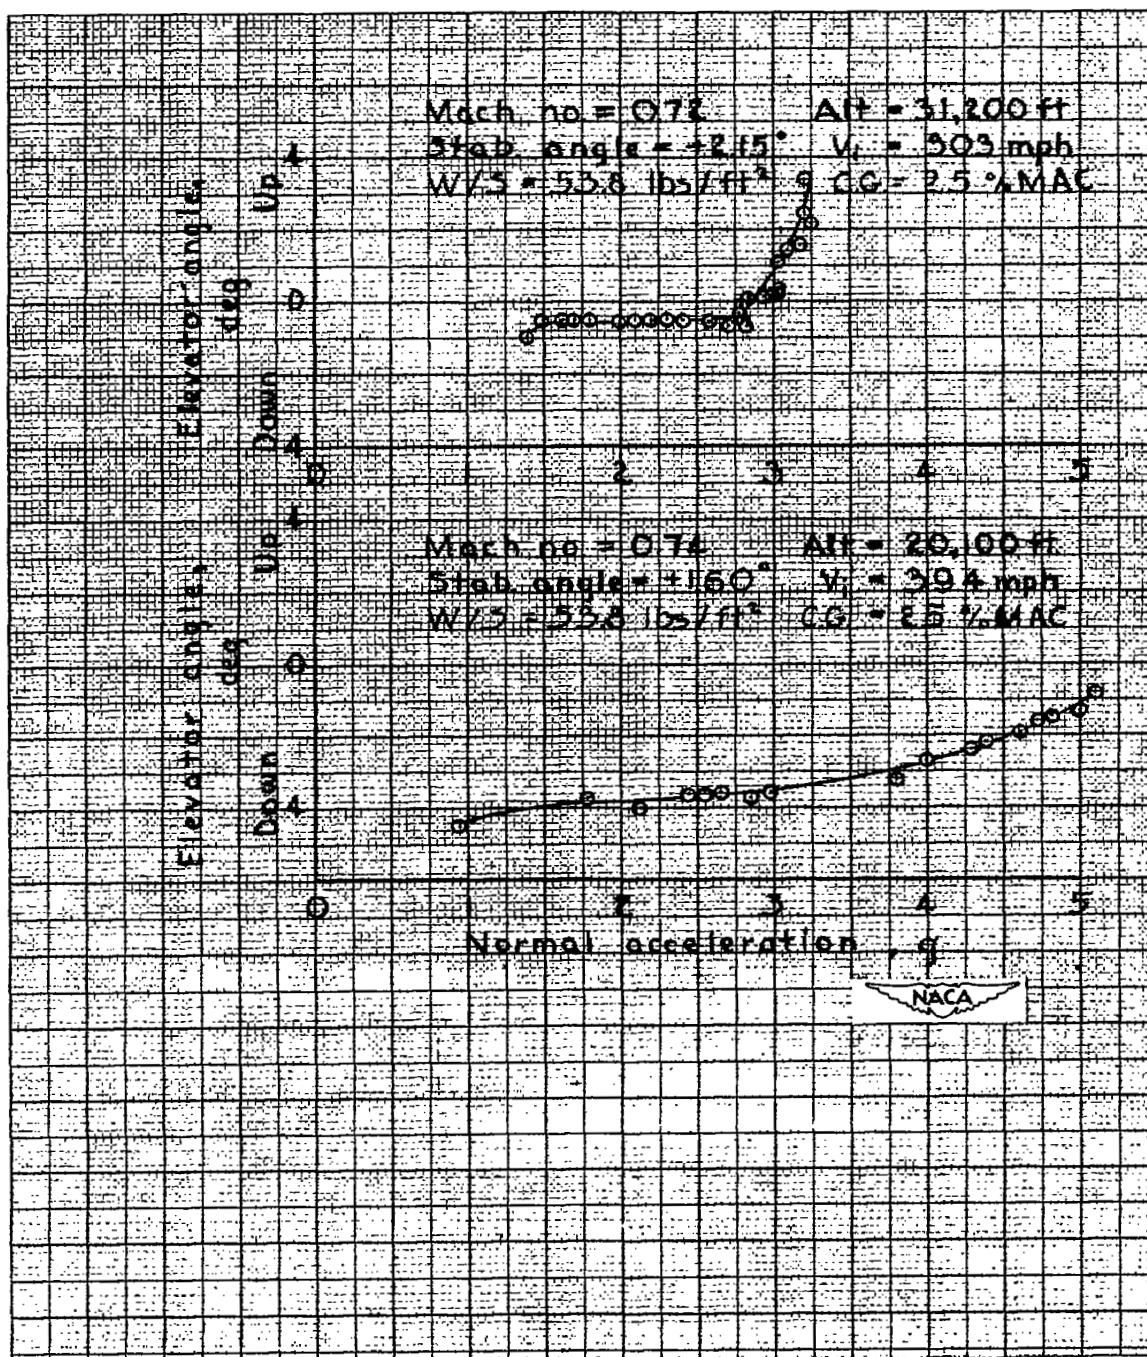
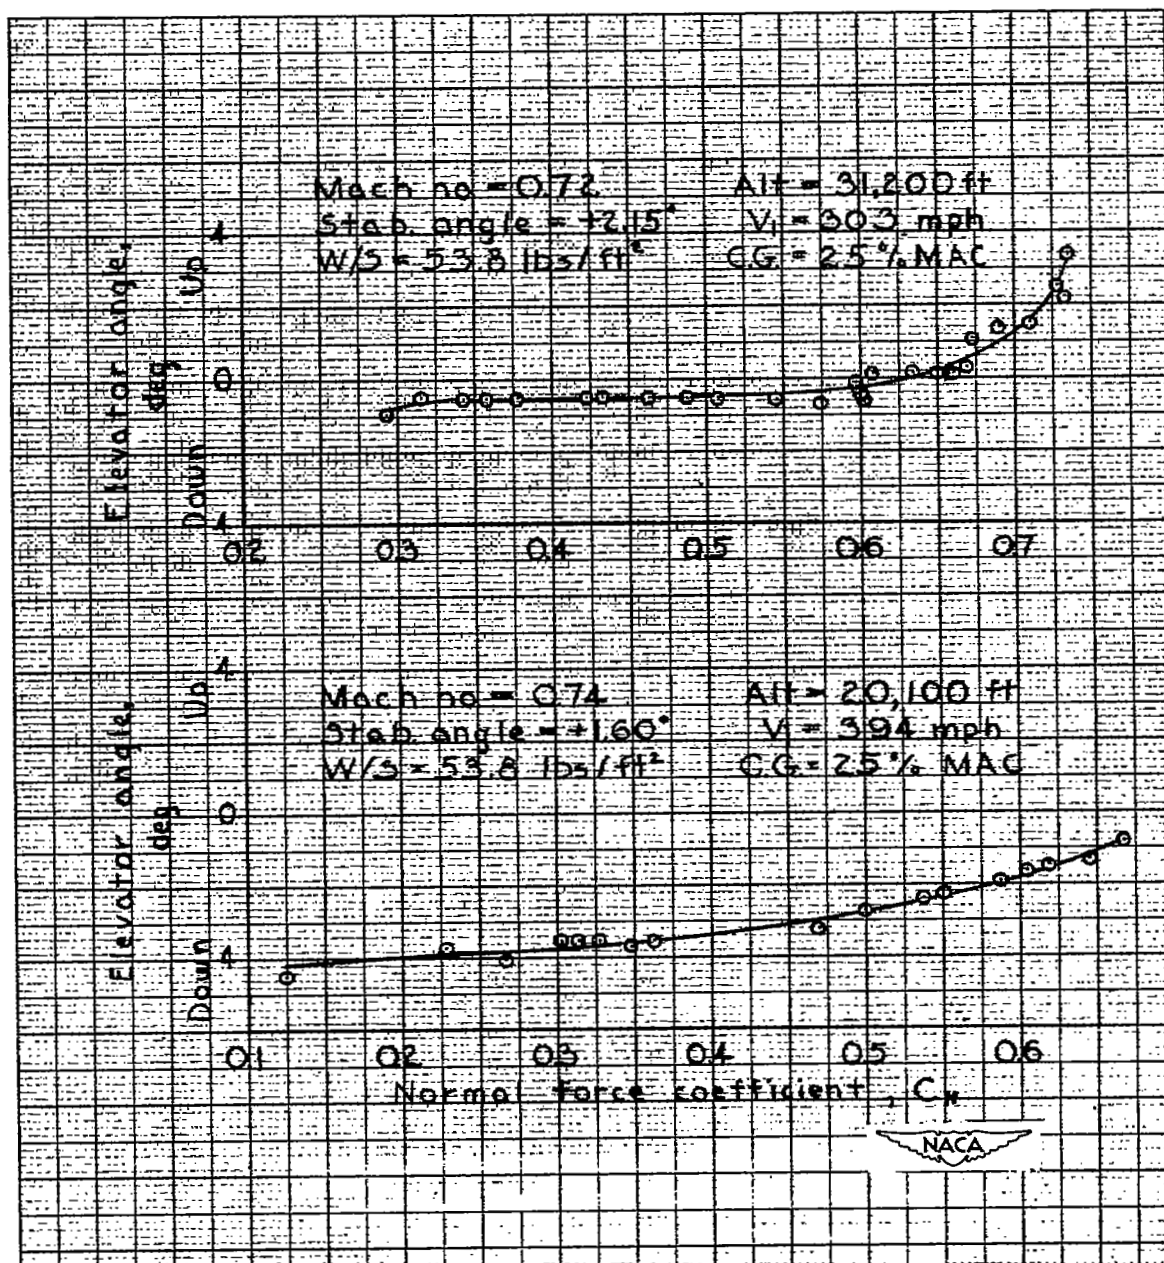
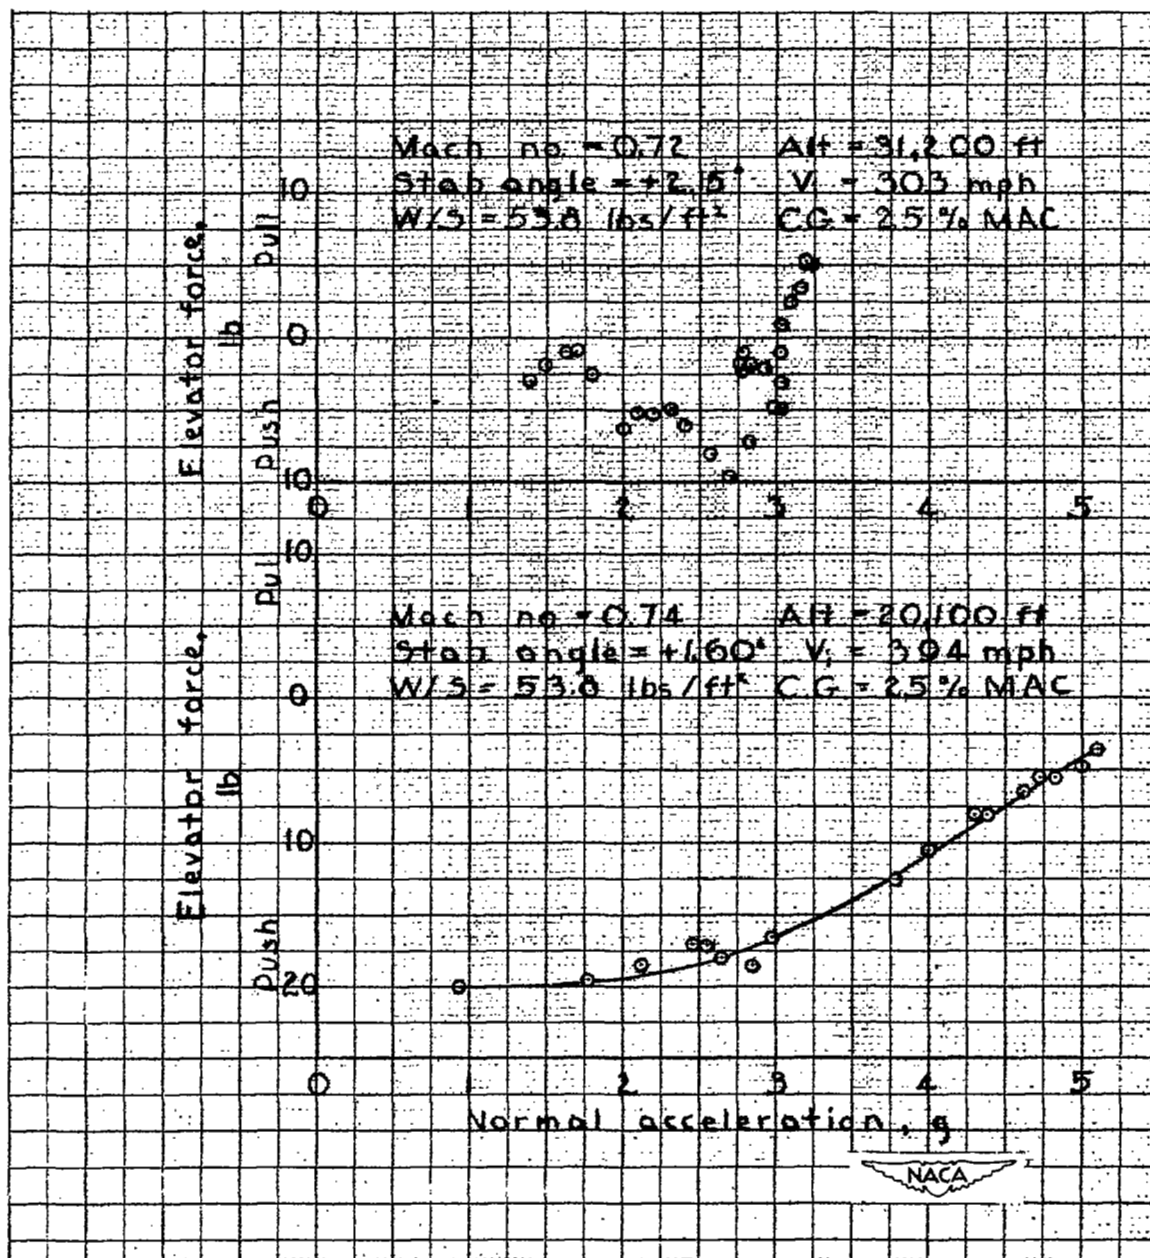
(a) Variation of elevator position with normal acceleration.

Figure 16.- Results obtained in turns made at Mach numbers of 0.72 and 0.74. XS-1 airplane with 8-percent-thick wing. Gliding flight; center of gravity, 25 percent M.A.C.;  $\frac{W}{S} = 53.8$  lb/sq ft.

(b) Variation of elevator angle with normal-force coefficient.

(c) Variation of elevator wheel force with normal acceleration.

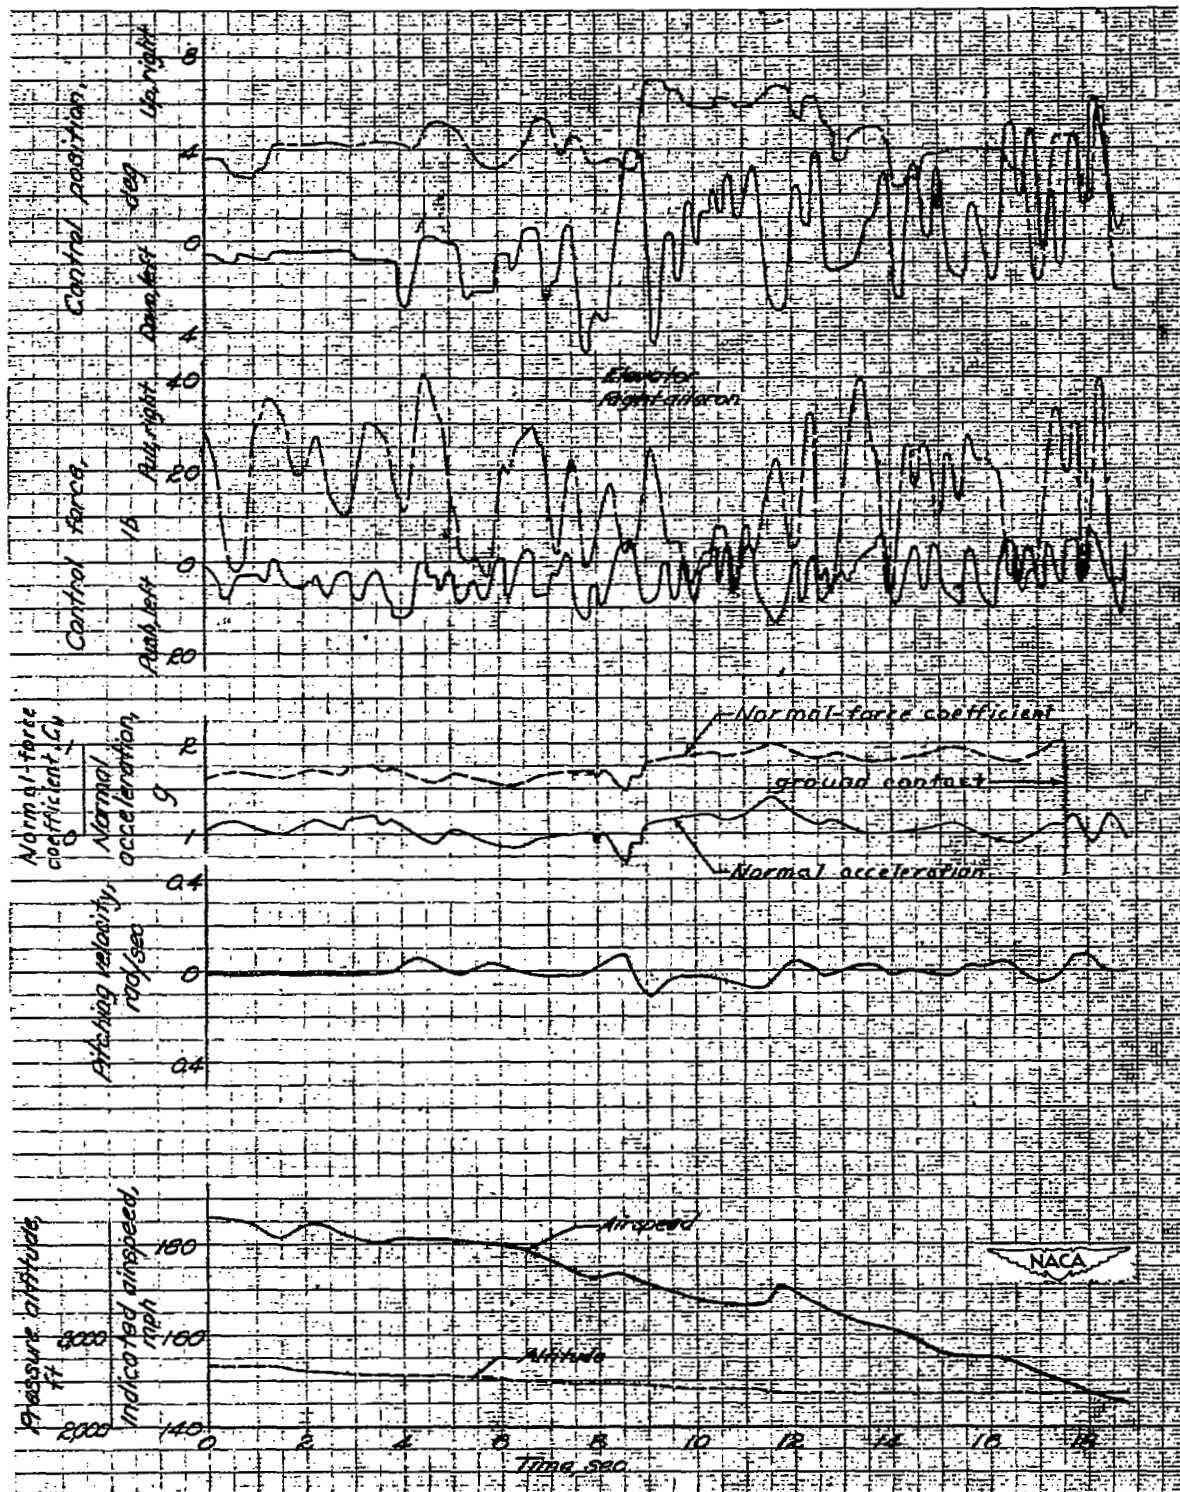
Figure 17.- Time history of a landing, XS-1 airplane with 8-percent-thick wing. Center of gravity, 25 percent M.A.C.  $\frac{W}{S} = 53.8$  lb/sq ft. Stabilizer angle,  $1.75^\circ$ .

The elevator control in landing was sufficiently powerful to effect landings near minimum speed with the stabilizer set near neutral in the center-of-gravity range tested. Time histories of landings are given in figures 17, 18, and 19. It should be noted that in figure 19 where the highest lift coefficient was reached, nearly full-up elevator was used.

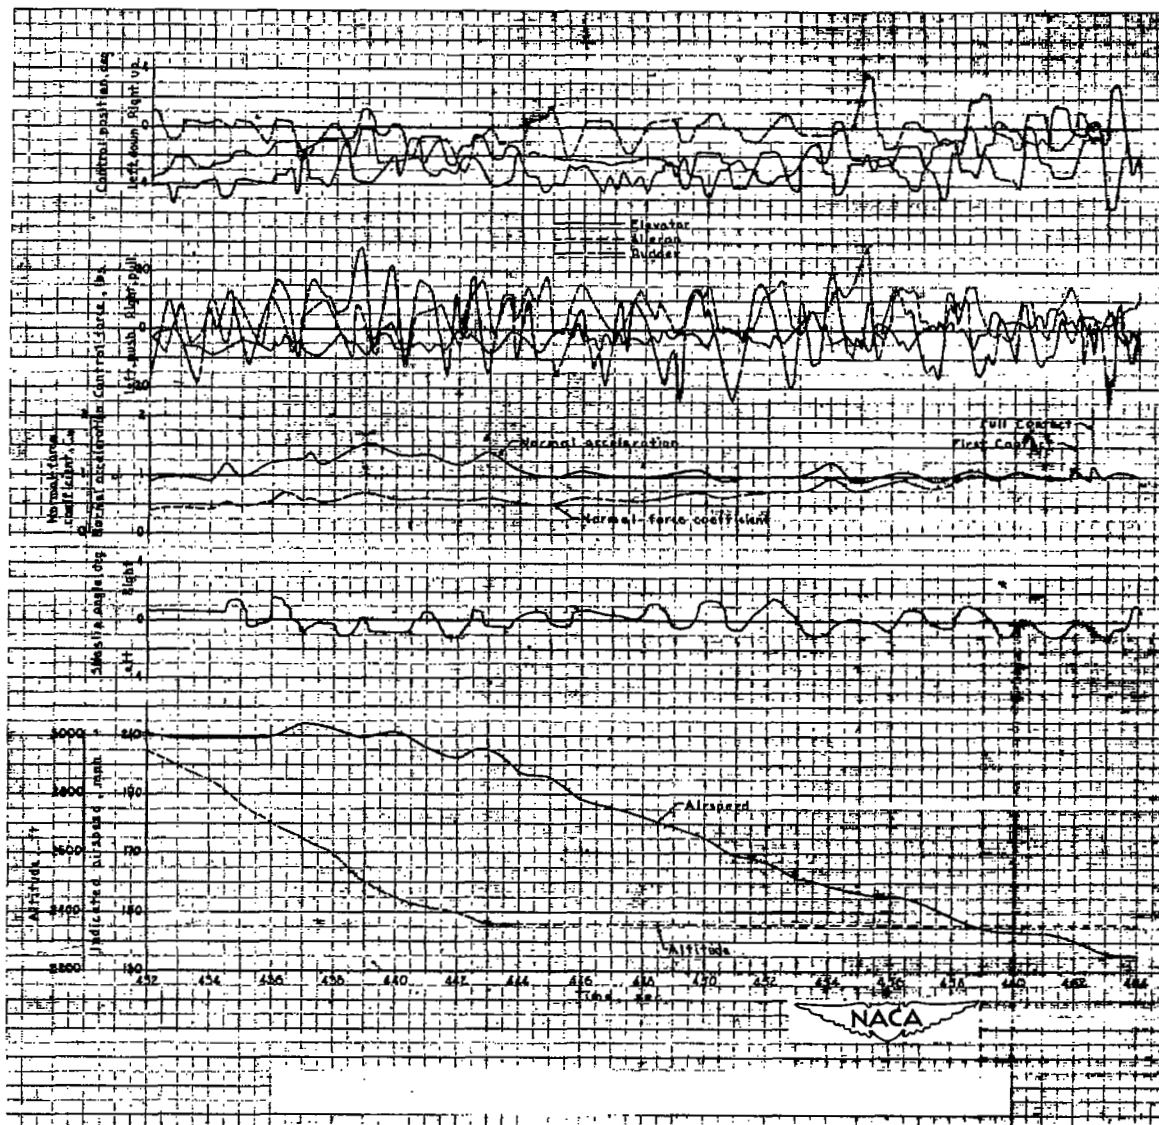
Figure 18.- Time history of a landing, XS-1 airplane with 10-percent-thick wing. Center of gravity, 25.3 percent M.A.C.

$\frac{W}{S} = 51.9$  lb/sq ft. Stabilizer setting,  $0.6^\circ$ .
