NACA RM No. L8A09

GENERAL HANDLING-QUALITIES RESULTS OBTAINED DURING  
ACCEPTANCE FLIGHT TESTS OF THE BELL XS-1 AIRPLANE

FLIGHT TESTS OF THE BELL XS-1 AIRPLANE

SUMMARY

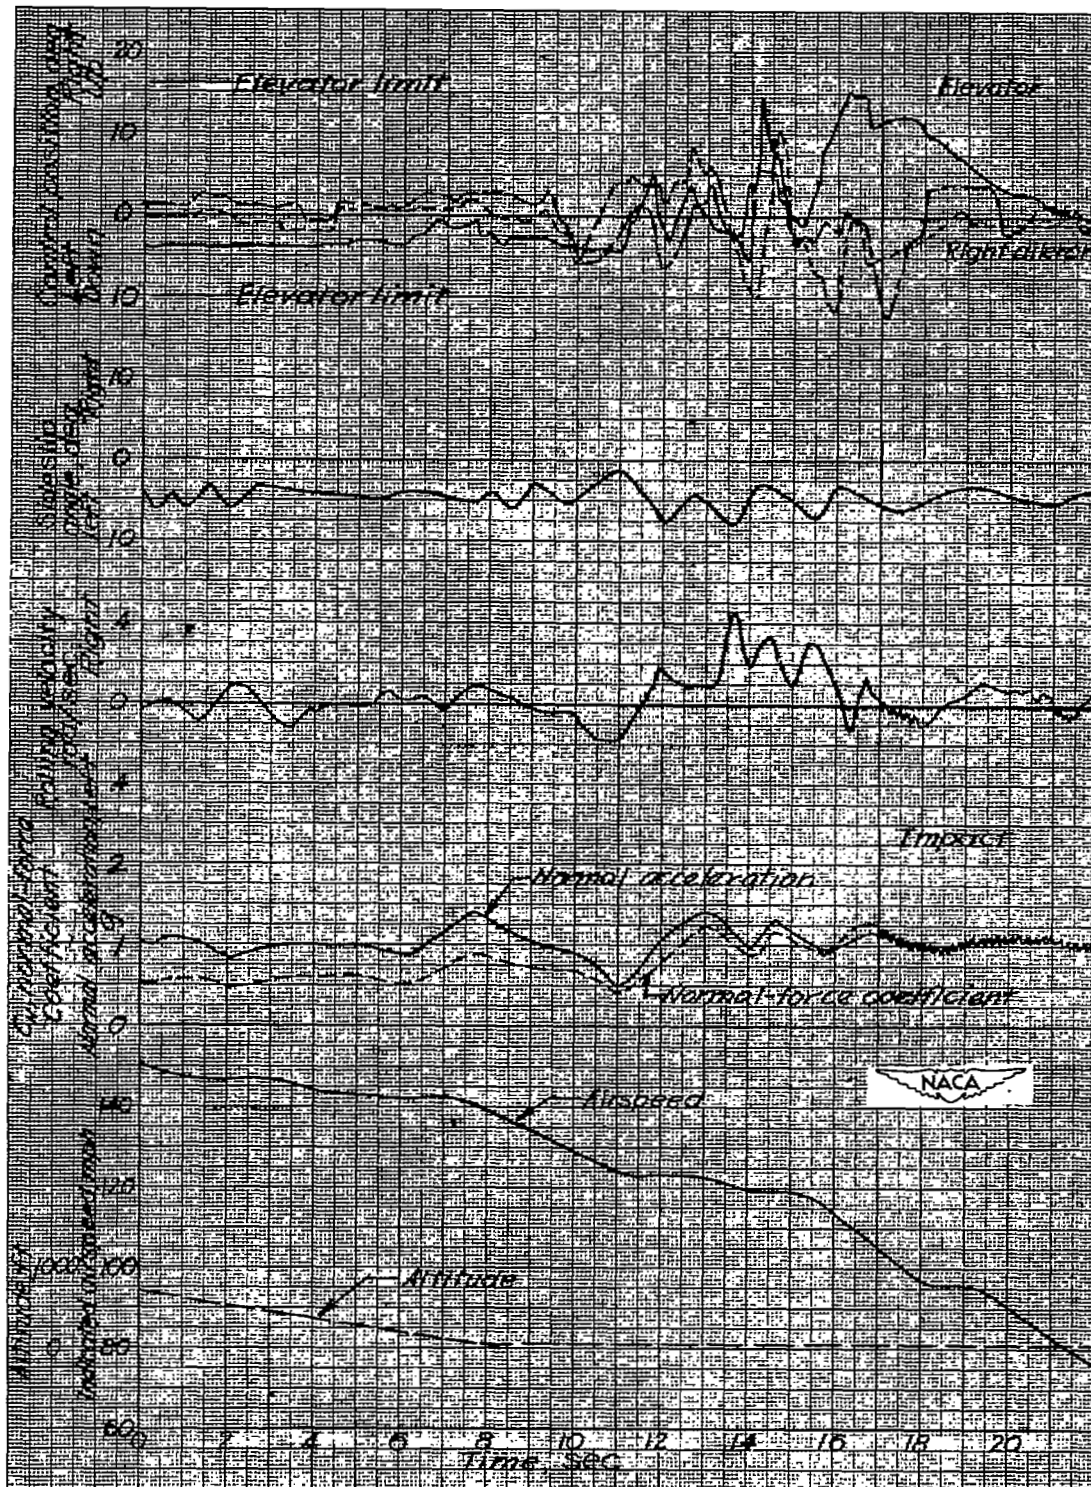
Figure 19.- Time history of a landing, XS-1 airplane with 10-percent-thick wing. Center of gravity, 25 percent M.A.C.  $\frac{W}{S} = 32.5$  lb/sq ft. Stabilizer setting,  $1.1^\circ$ .

The elevator control in landing was sufficiently powerful to effect landings near minimum speed with the stabilizer set near neutral in the center-of-gravity range tested. Time histories of landings are given in figures 17, 18, and 19. It should be noted that in figure 19 where the highest lift coefficient was reached, nearly full-up elevator was used.

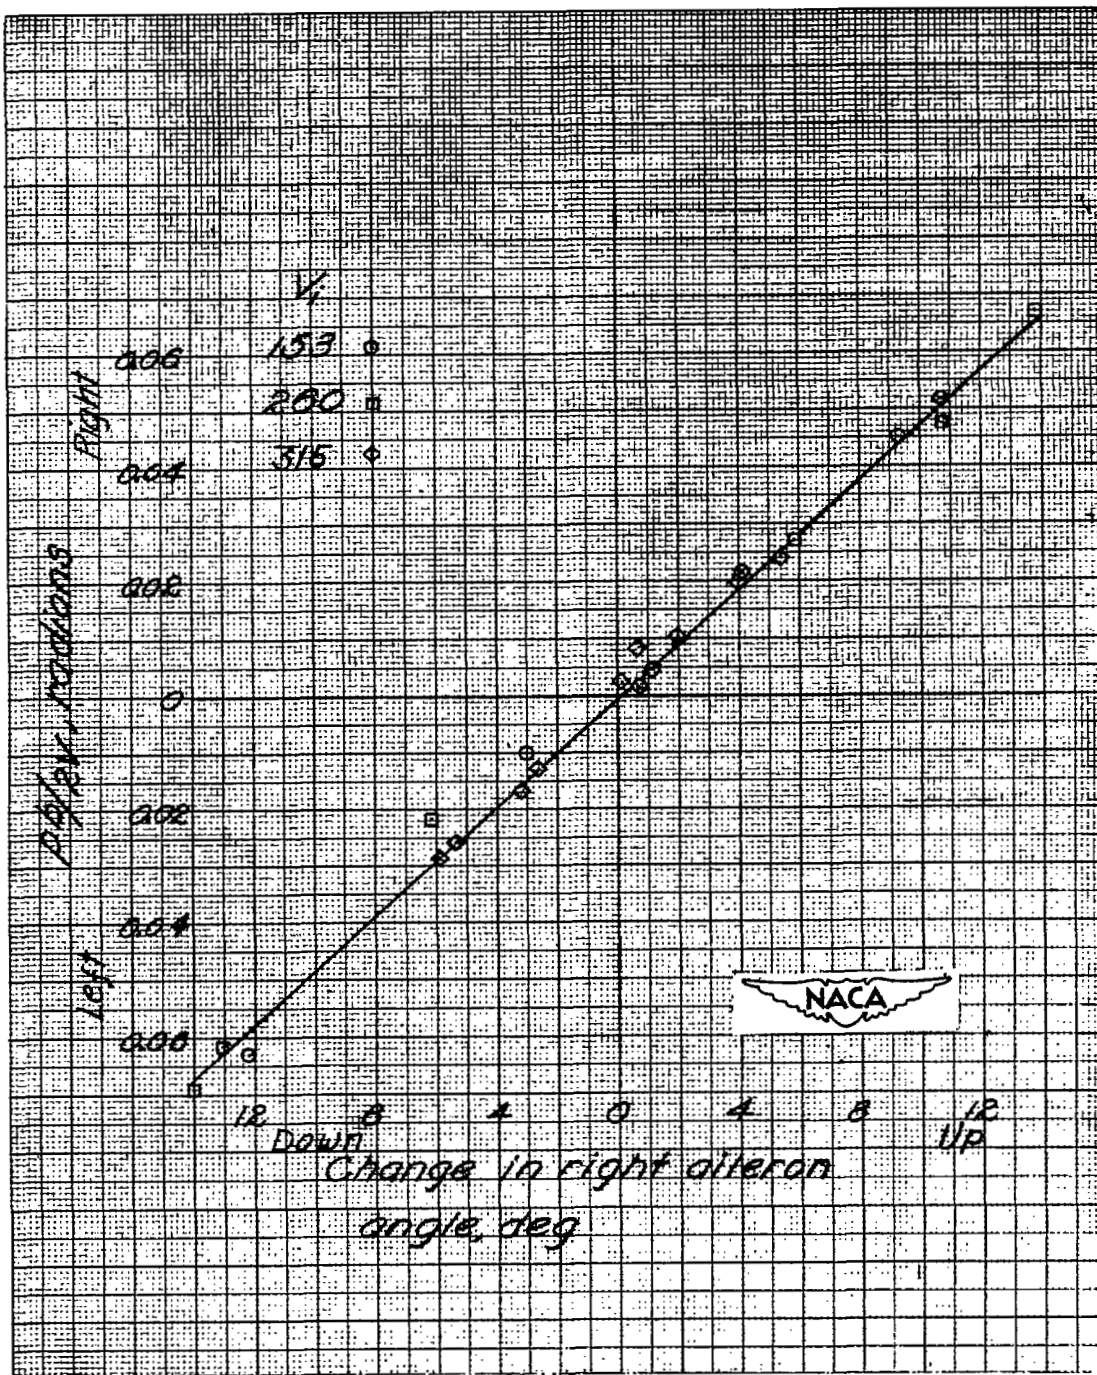
Figure 20.- Variation of helix angle  $\frac{pb}{2V}$  with change in right aileron deflection as measured in clean condition, rudder-fixed aileron rolls. XS-1 10-percent-thick-wing airplane.

The only measure of aileron effectiveness obtained during the Bell conducted acceptance flights was obtained from a few rudder-fixed aileron rolls at indicated airspeeds of 153 miles per hour, 260 miles per hour, and 315 miles per hour. The results are plotted in figure 20 as the variation of helix angle  $pb/2V$  with right aileron deflection. Examination of this figure shows that although the maximum value of  $pb/2V$  with full aileron deflection as obtained in the rolls at an indicated airspeed of 260 miles per hour is below the minimum acceptable of 0.07 radian, the rate of change of  $pb/2V$  with aileron deflection compares fairly well with that of present-day fighters. The aileron control is considered satisfactory, however, because even though the maximum  $pb/2V$  obtainable with the Bell XS-1 is low, the rolling velocities are fairly high because of the short wing span. No satisfactory measurements of the aileron control forces were obtained because the high aileron friction (see fig. 4) masked the aileron forces. An indication of the effect of the aileron friction in the handling characteristics of the Bell XS-1 airplane is given in figure 21, which is a sample time history from a steady-flight record. The pilot is continually applying aileron force; the ailerons, however, are not moving.

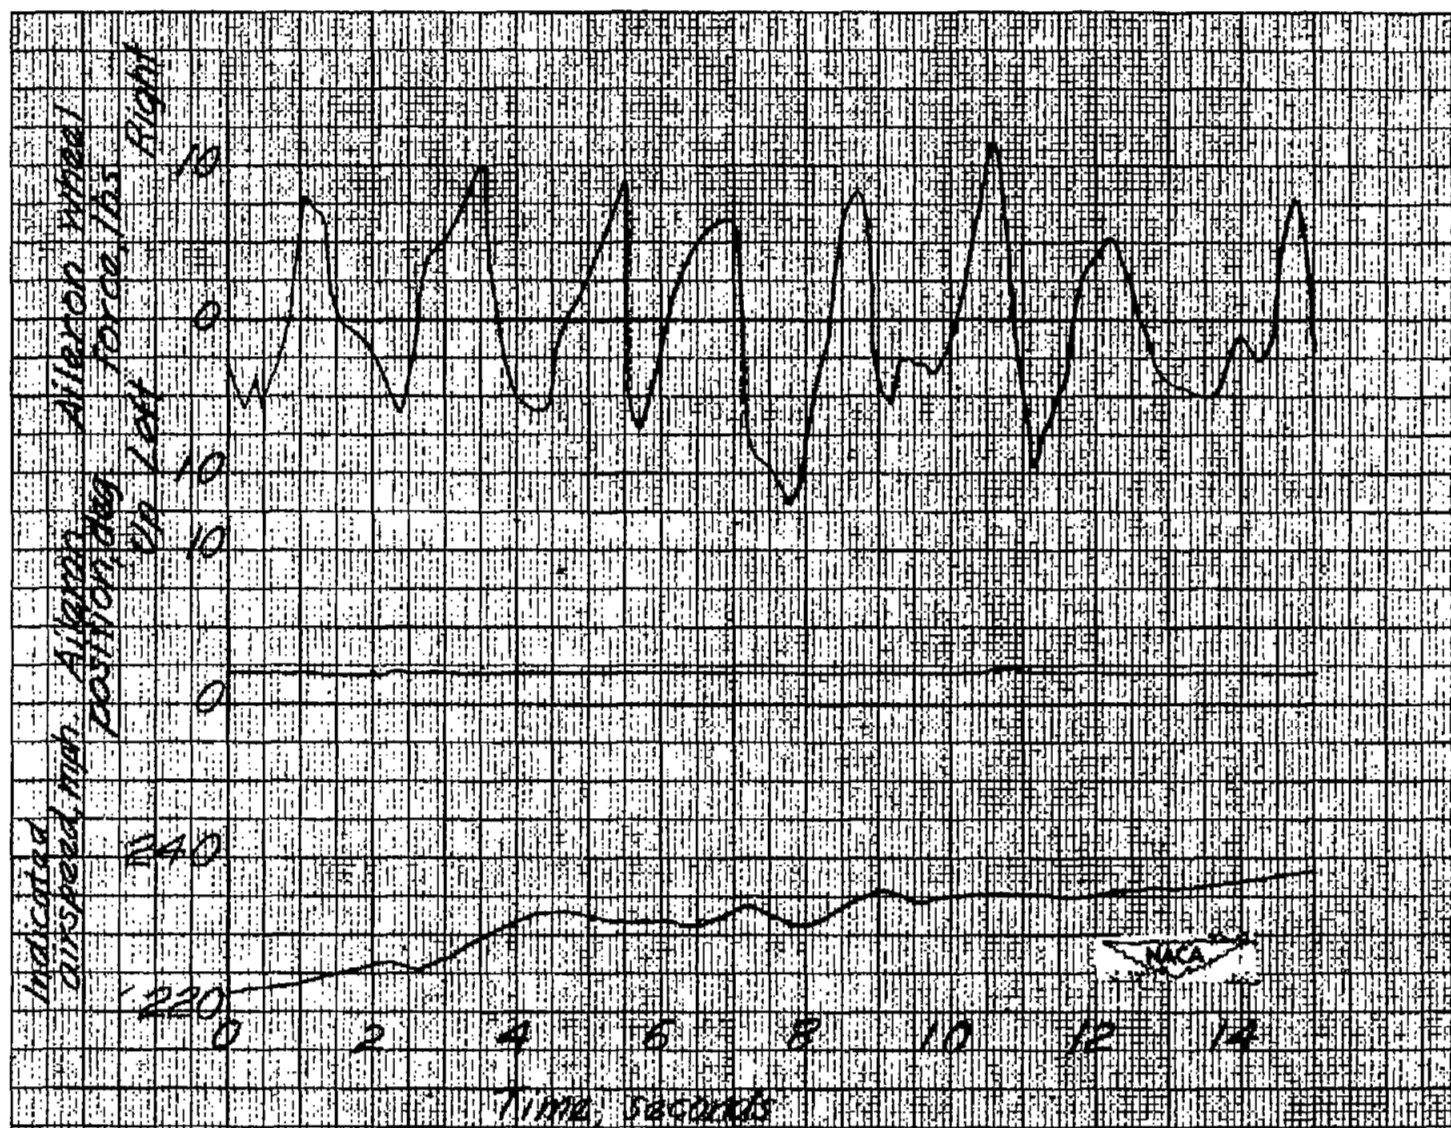
Figure 21.- Typical time history showing aileron force and position during steady flight.  
XS-1 airplane with 10-percent-thick wing.

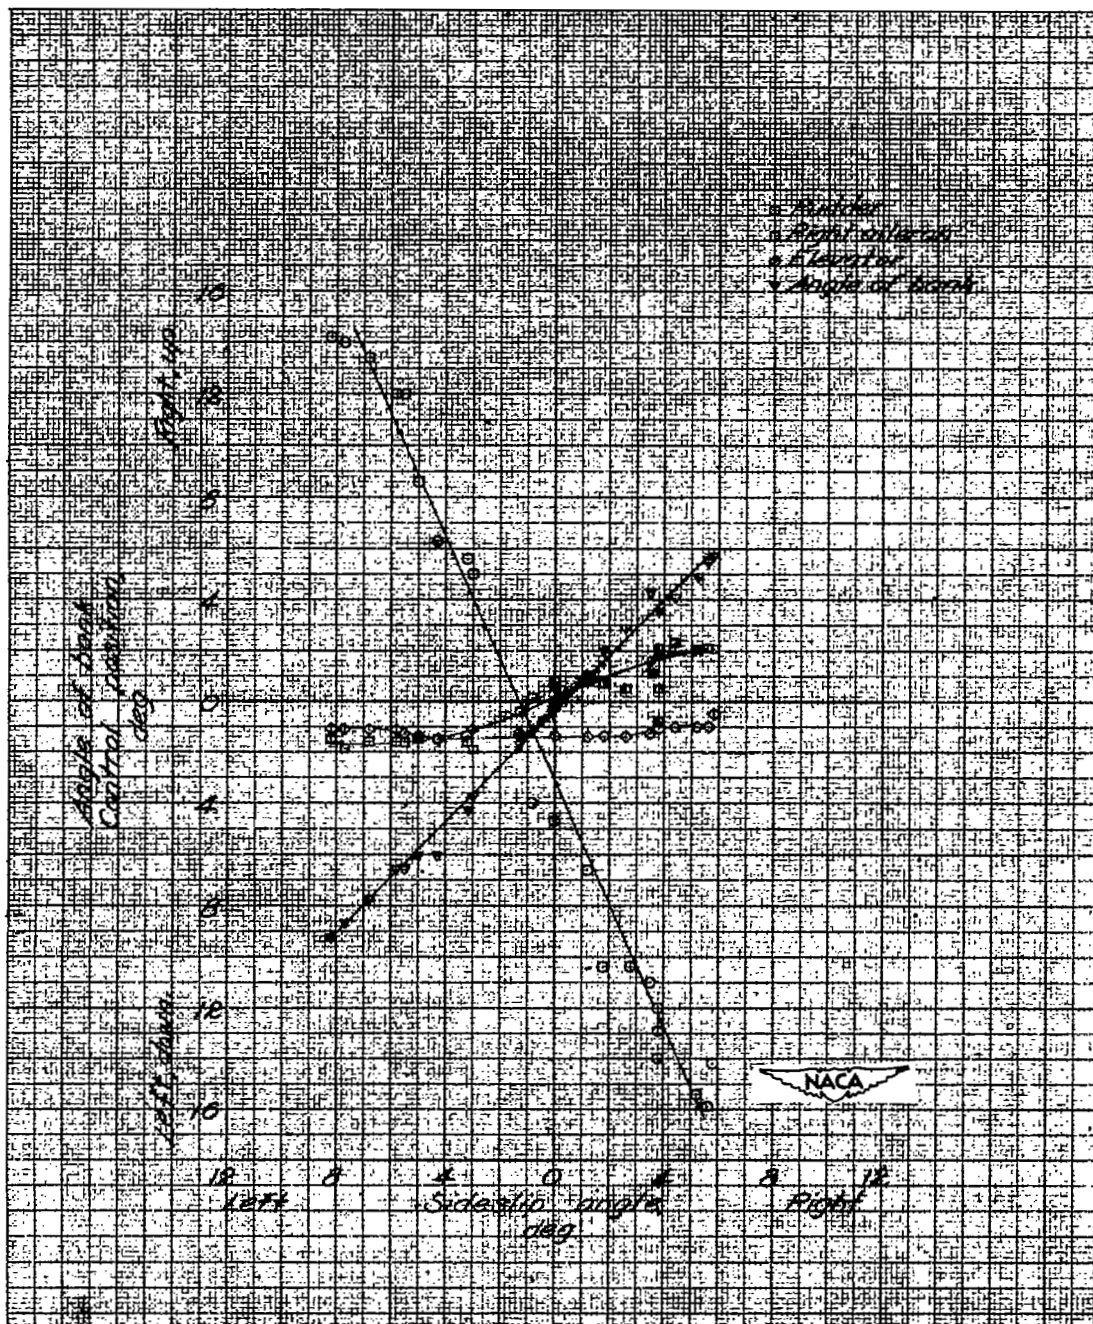
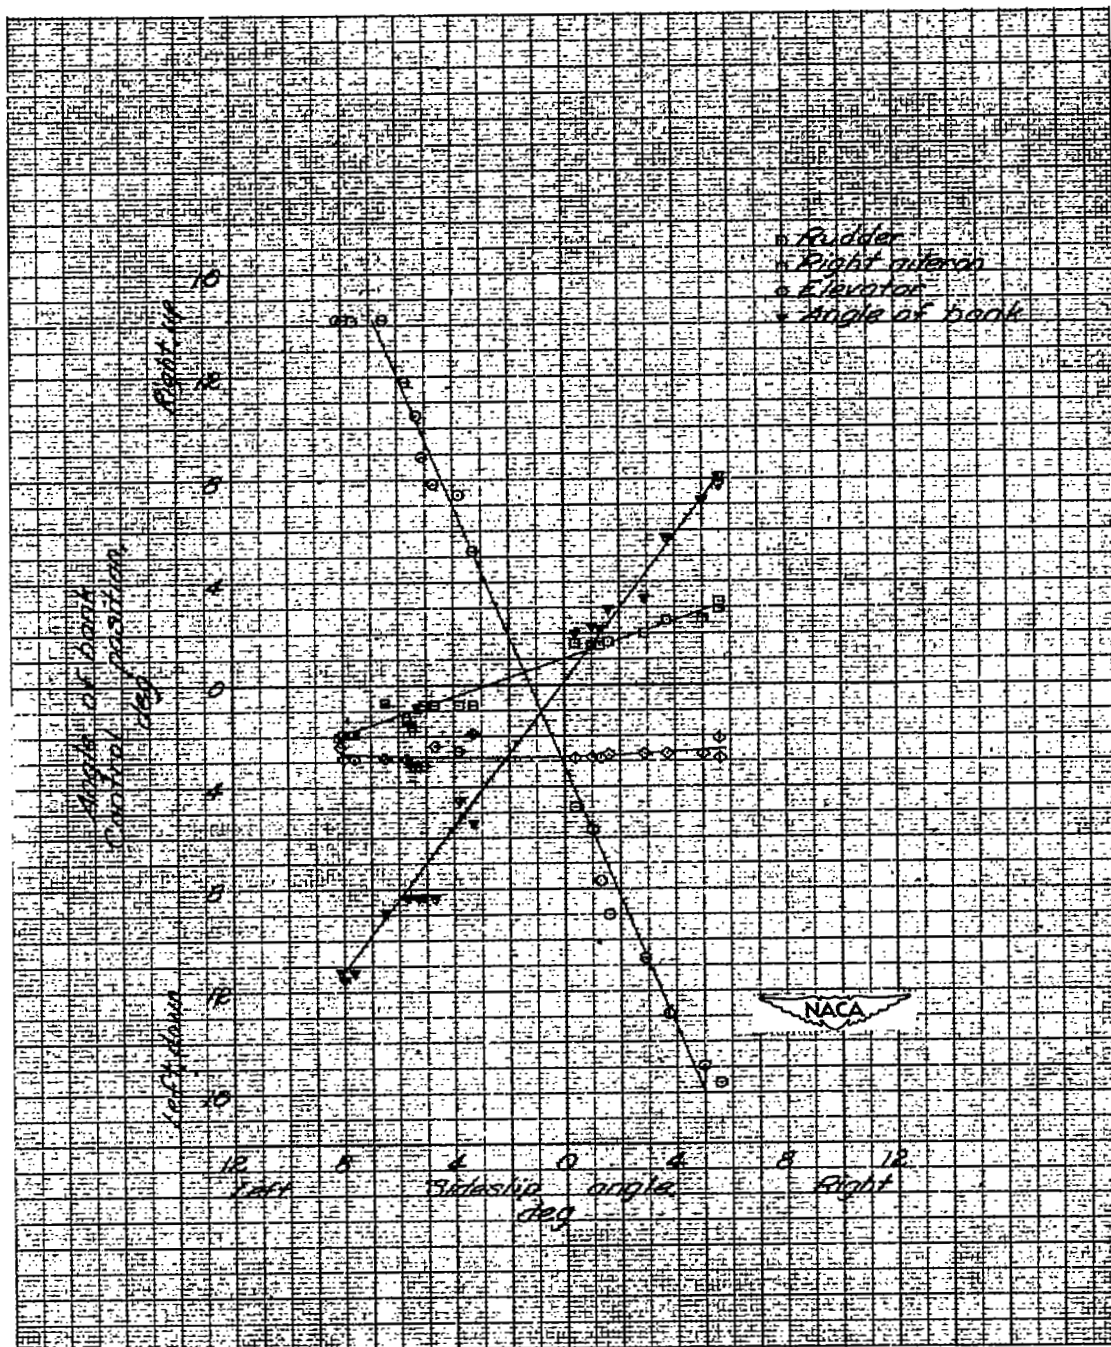
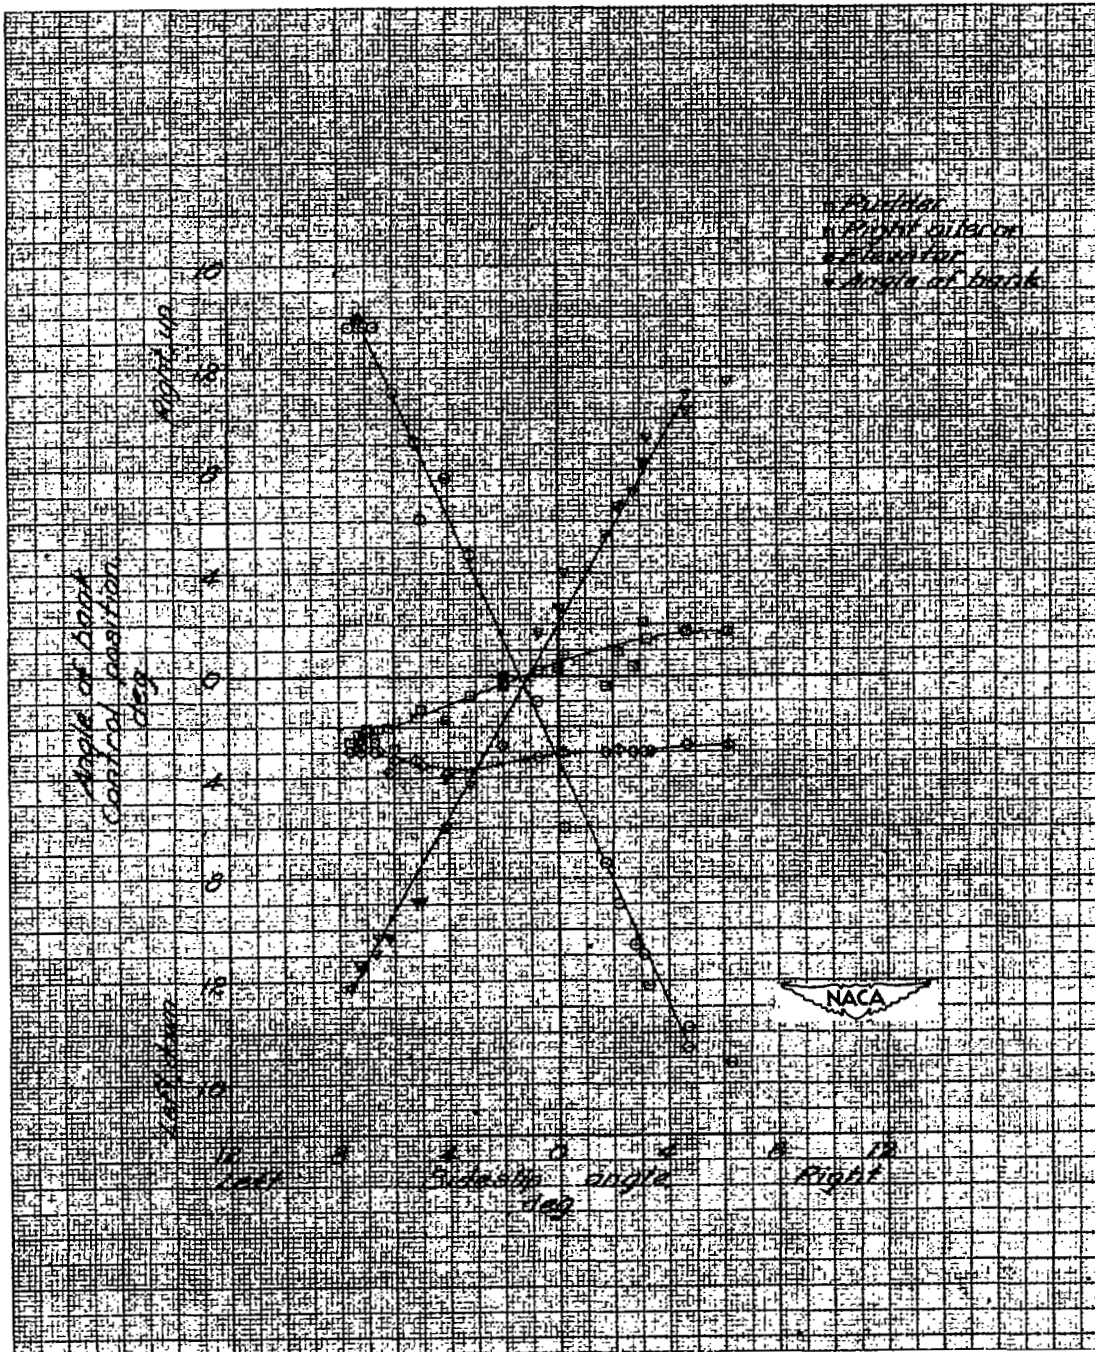
(a)  $V_1 = 130$  mph.

Figure 22.— Steady sideslip characteristics, XS-1 airplane with 10-percent-thick wing. Gliding flight; flaps and gear down.

(b)  $V_1 = 150$  mph.

(c)  $V_1 = 172$  mph.

The static directional stability of the Bell XS-1 was measured in continuous sideslips made by slowly deflecting the rudder and by using aileron and elevator control to maintain straight flight at constant speed. The results of these tests are presented in figures 22 to 24 where rudder, aileron, and elevator position and angle of bank are shown as functions of sideslip angle. No control-force measurements were made during these tests. The directional stability as indicated by the variation of rudder position with sideslip angle is very high. Values of  $C_{n\dot{\psi}}$  calculated from these data show very close agreement with the wind-tunnel measured value of  $C_{n\dot{\psi}} = 0.0034$ . This value of  $C_{n\dot{\psi}}$  indicates directional stability about three times as great as that measured on fighters which were considered to have good directional stability. The lateral stability (dihedral effect) is positive for all conditions tested as indicated by the variation of aileron position with sideslip angle. The pitching moment due to sideslip was small under all conditions tested as shown by the variation of elevator angle with sideslip angle. The cross-wind force was positive; that is, right bank accompanied right sideslip.

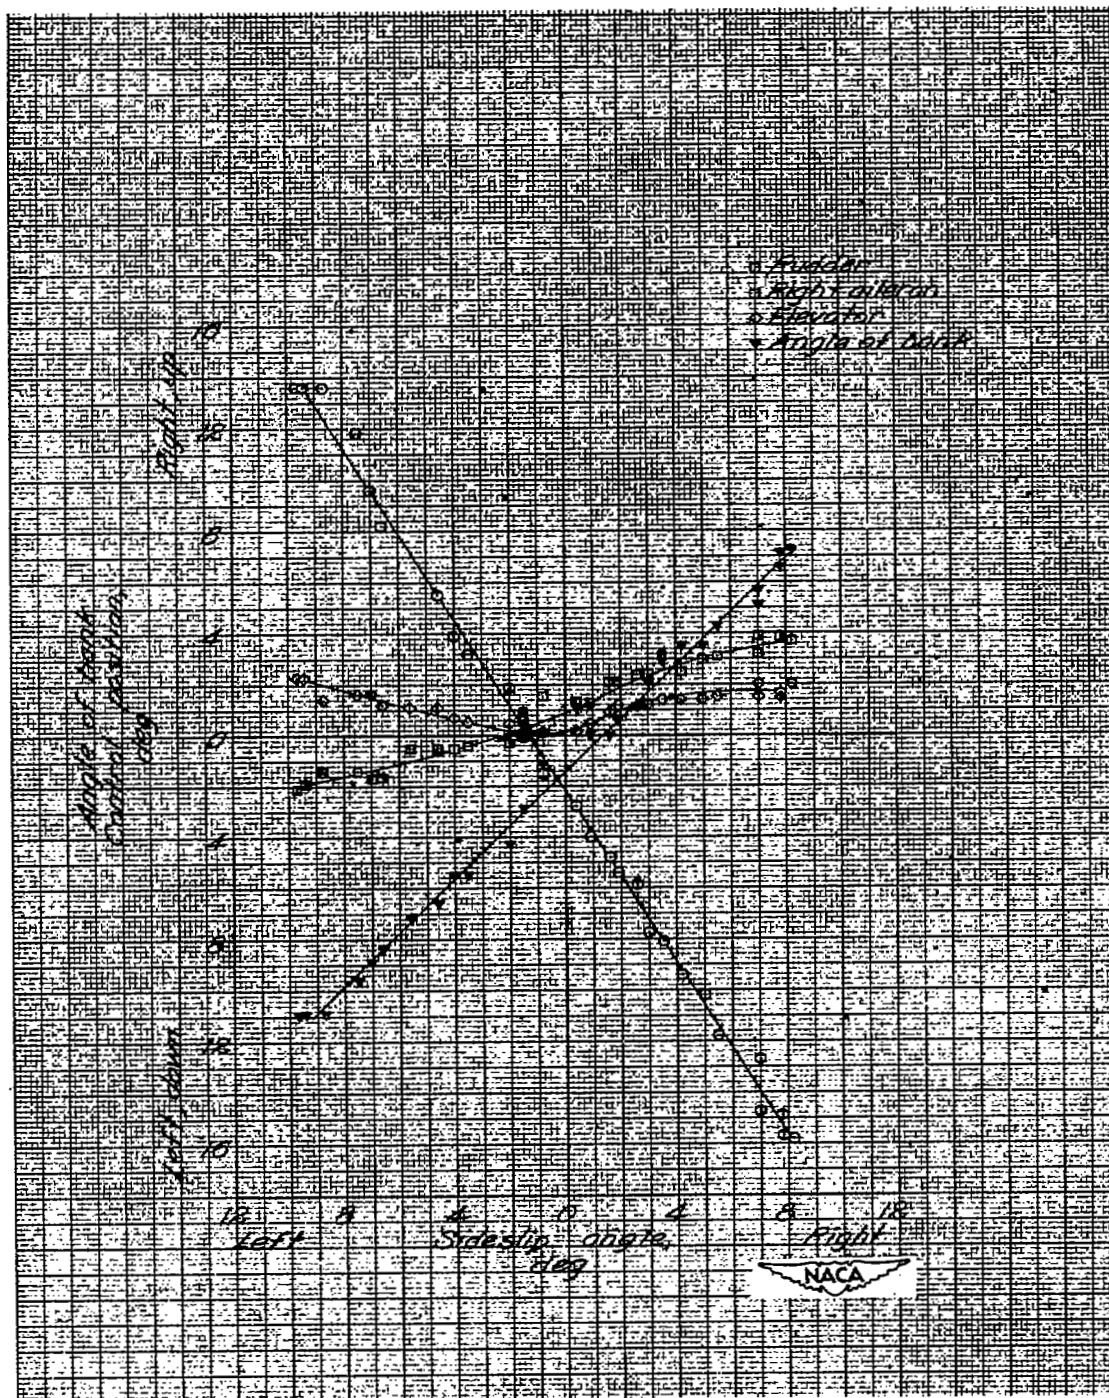
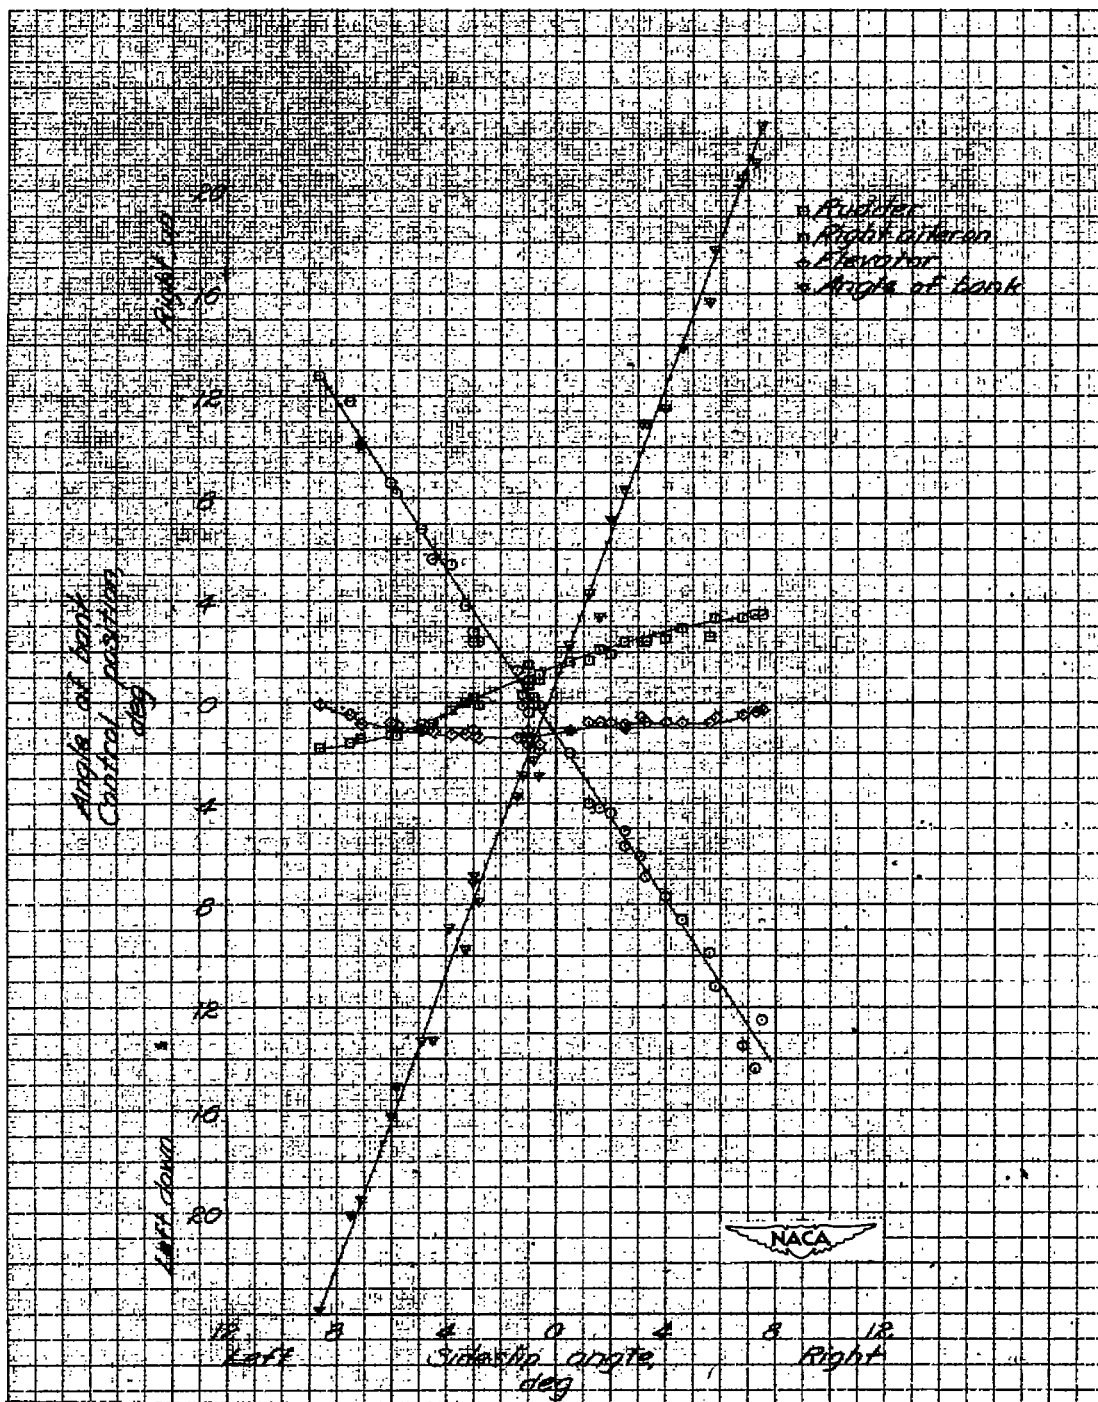
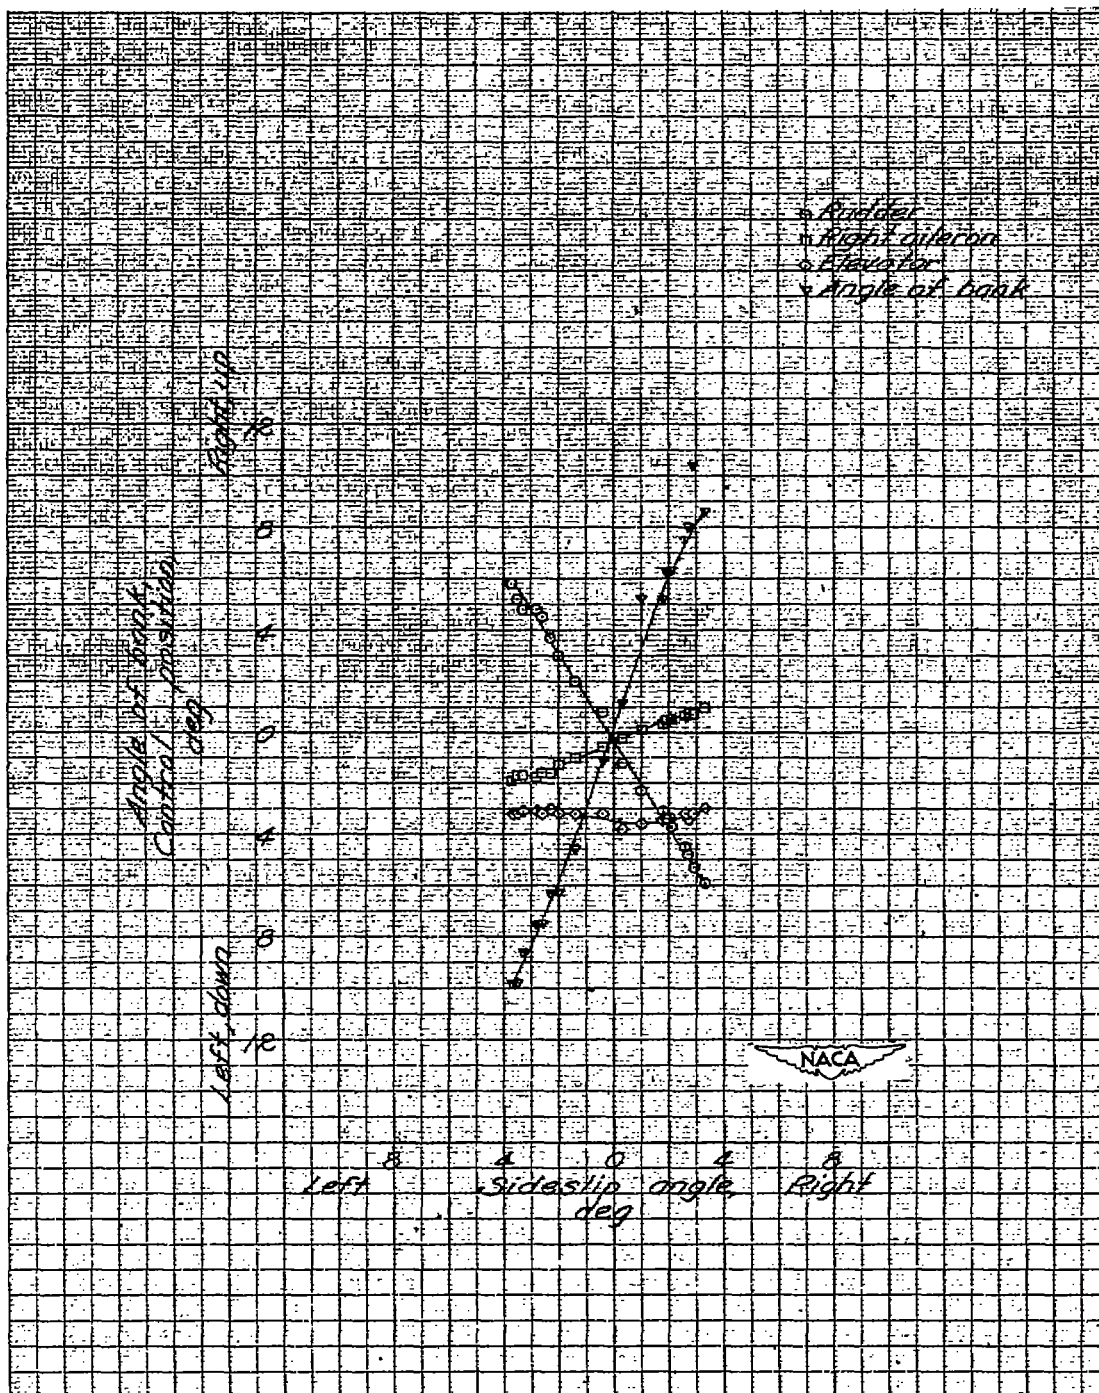
(a) Gliding flight,  $V_1 = 150$  mph.

Figure 23.—Steady sideslip characteristics, XS-1 airplane with 10-percent-thick wing. Flaps and gear up.

(b) Gliding flight,  $V_1 = 247$  mph.

(c) Power on;  $V_1 = 400$  mph;  $M = 0.72$ .

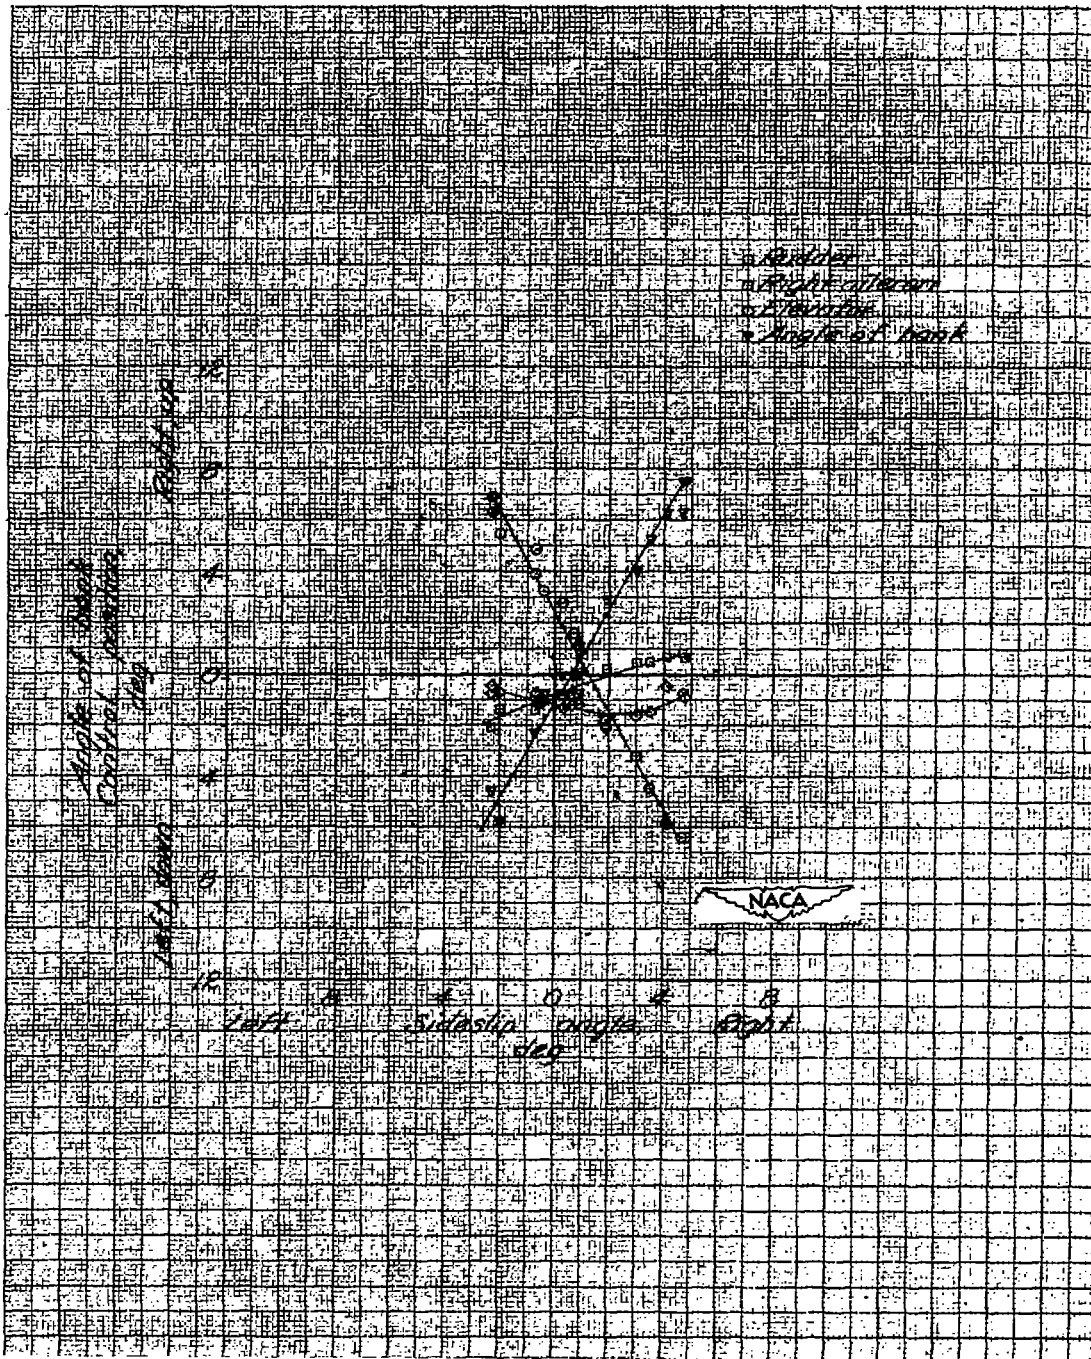
Figure 24.- Steady sideslip characteristics, XS-1 airplane with 8-percent-thick wing. Power on; flaps and gear up;  $V_1 = 295$  mph;  $M = 0.77$ .

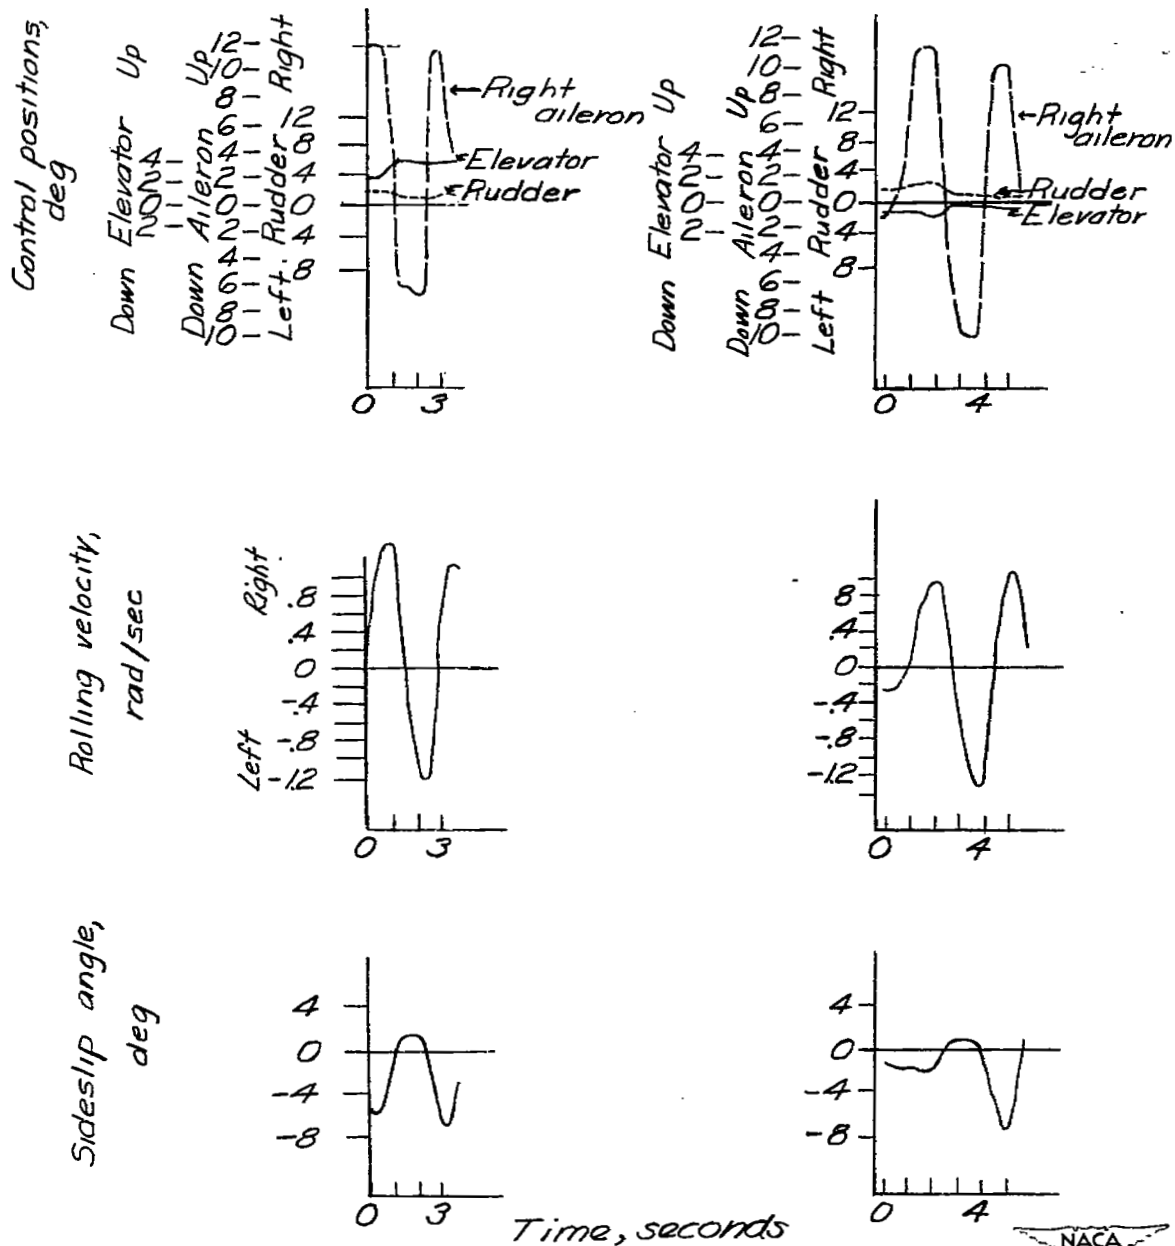
Figure 25.- Time histories of abrupt aileron rolls at 150 mph with rudder held fixed. XS-1 airplane.

The sideslip due to the use of ailerons was small even at low speeds due to the high directional stability and relatively low values of helix angle  $\psi_b/2V$ . Time histories of aileron rolls made with rudder fixed are shown in figure 25. The rudder control was sufficiently powerful to overcome the sideslip due to the use of ailerons as indicated in figure 26, which presents time histories of abrupt aileron rolls in which the pilot overcontrolled and used more rudder than necessary to overcome the sideslip due to ailerons.

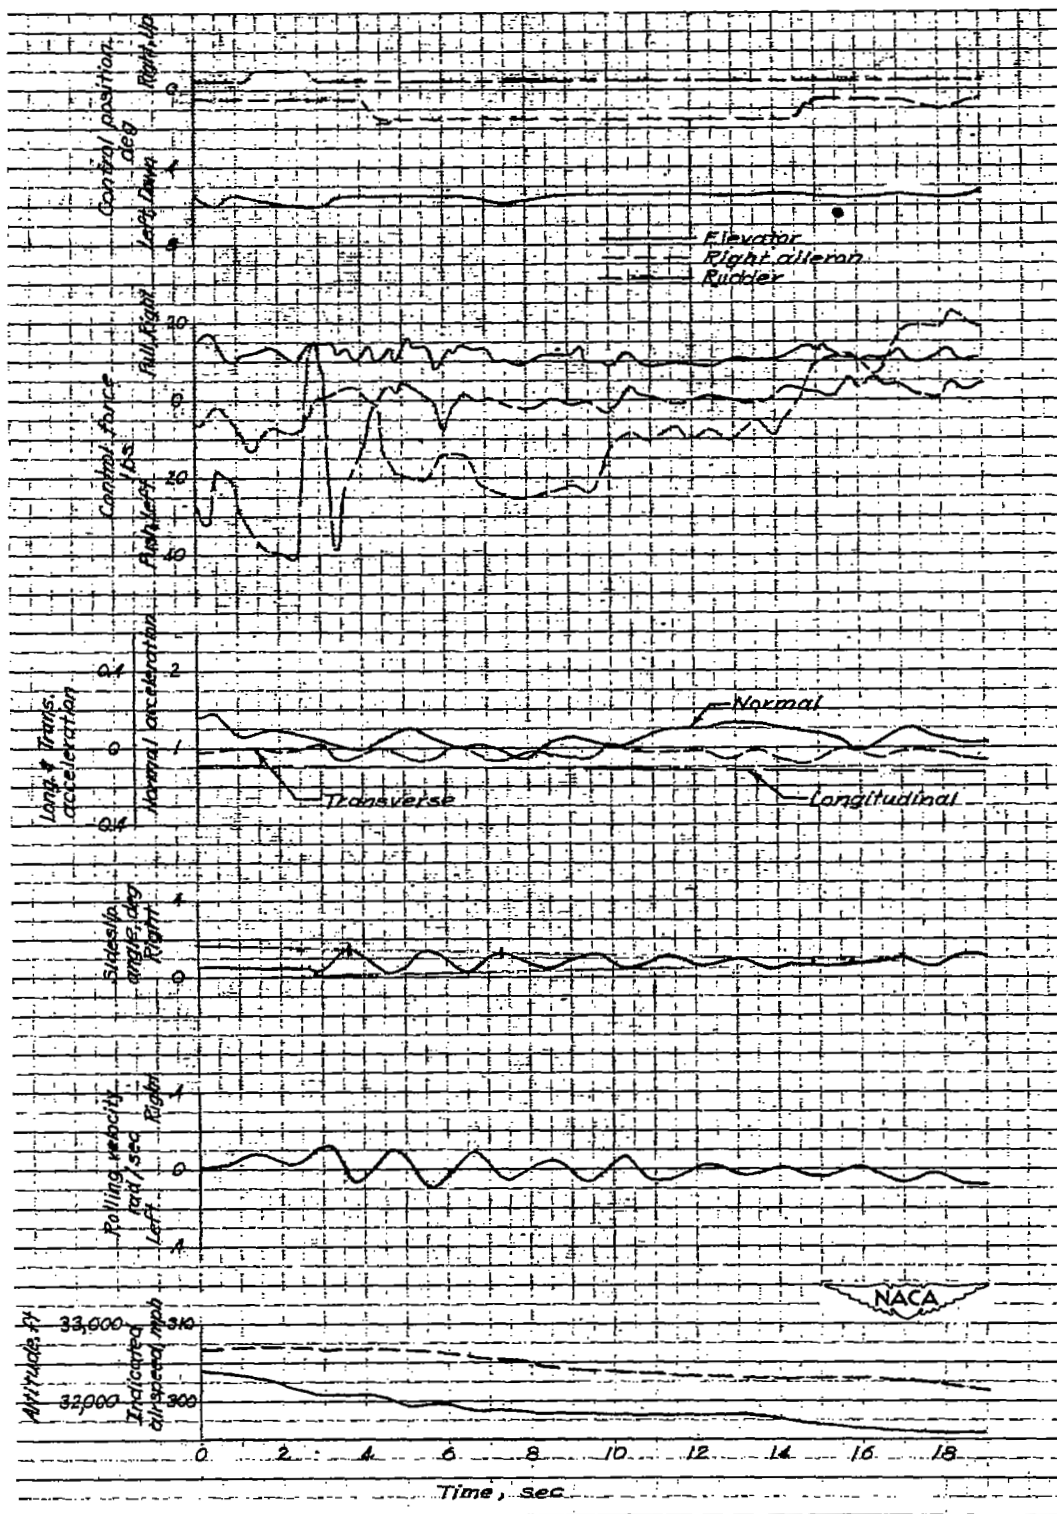
Figure 27.- Time history of a stick-fixed inadvertent lateral oscillation. Gliding flight; relative density factor,  $\mu$  of about 100. XS-1 airplane with 10-percent-thick wing.

During the course of the acceptance flight tests, inadvertent lateral oscillations were encountered at fairly high Mach numbers which were induced by small control movements. These oscillations were poorly damped. A time history of an oscillation encountered in straight flight is presented in figure 27. An oscillation which occurred during a turn entry is shown in figure 28. A lateral oscillation following abrupt release of the rudder from a yawed condition is shown in figure 29. It should be noted that the oscillation continues at small amplitude although the initial damping of the disturbance is satisfactory.

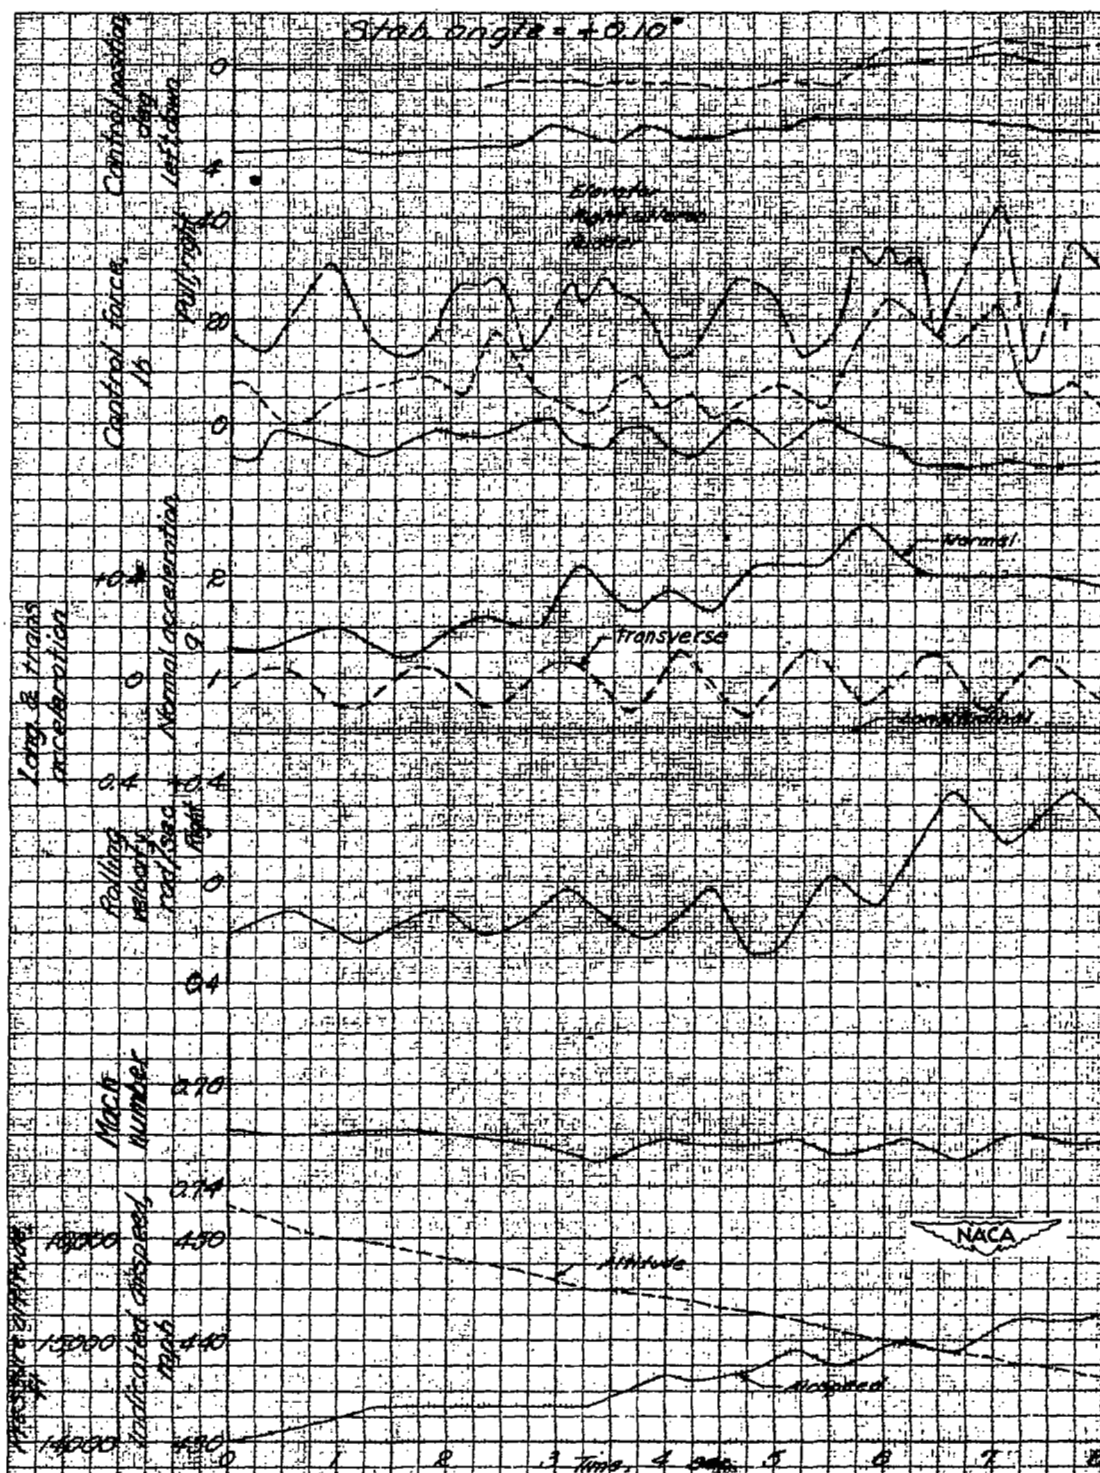
Figure 28.- Time history of an inadvertent lateral oscillation in a power-off turn, rough air. Relative density factor  $\mu$  of about 45. XS-1 airplane with 10-percent-thick wing.

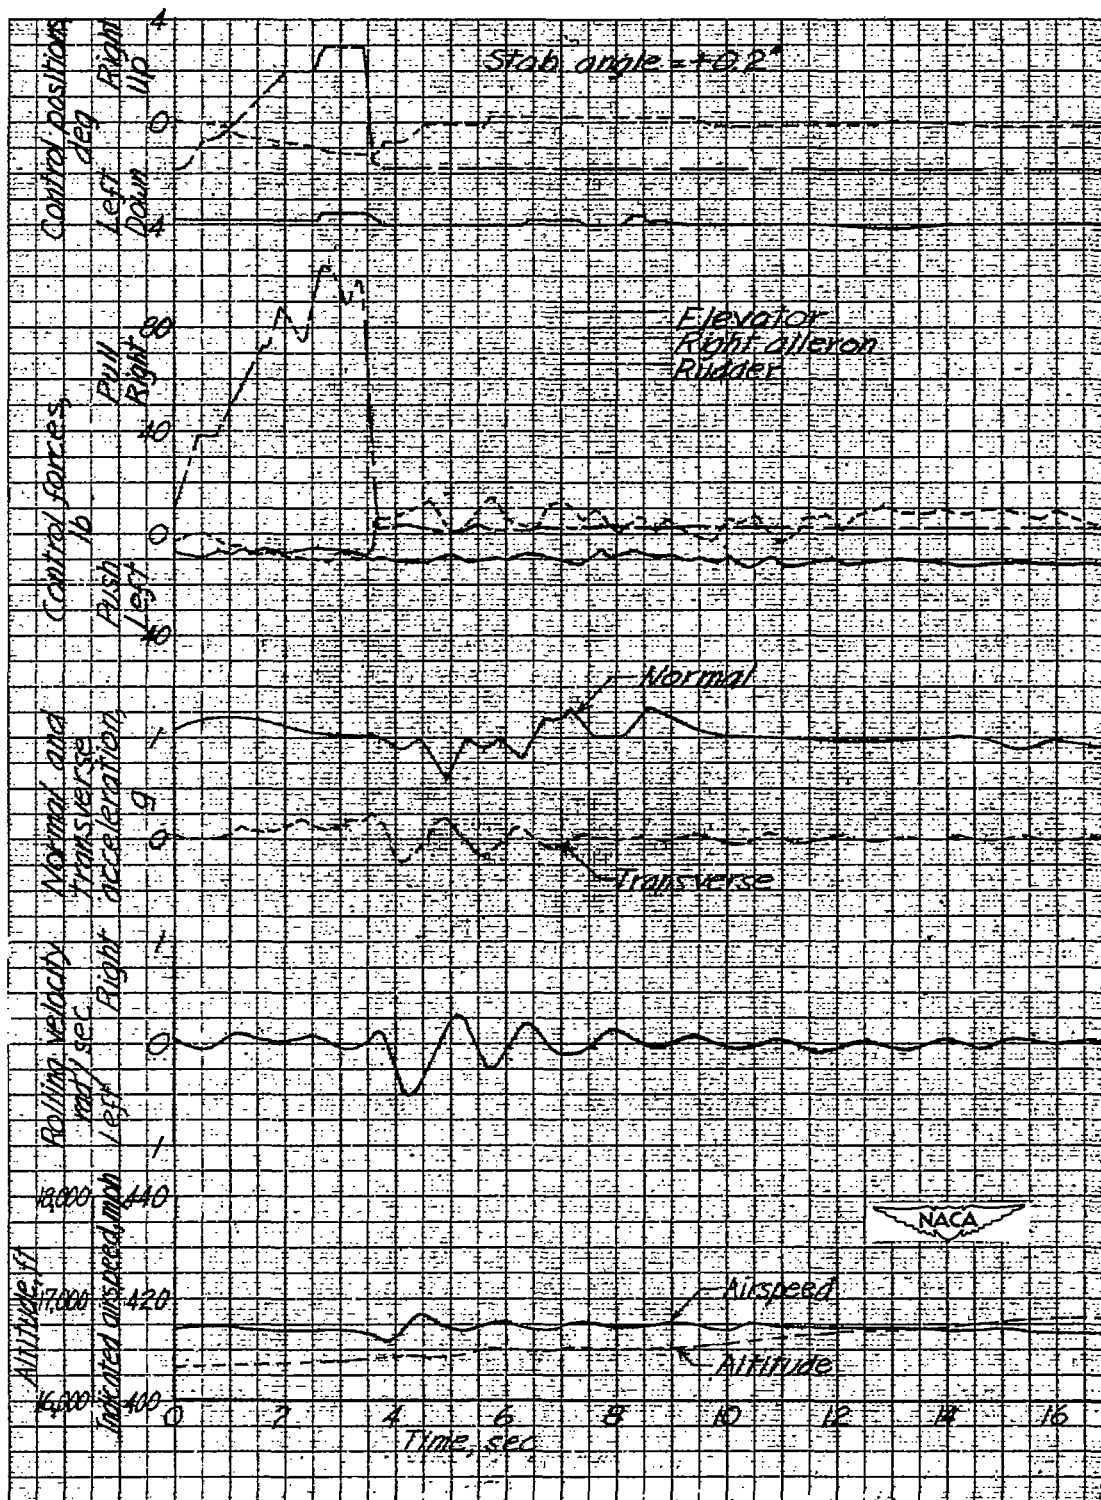
Figure 29.- Time history of abrupt rudder release with power on.  
 $M = 0.73$ ,  $\frac{W}{S} = 72.1$  lb/sq ft. XS-1 airplane with 10-percent-thick wing.
