NACA RM No. L8A09

GENERAL HANDLING-QUALITIES RESULTS OBTAINED DURING  
ACCEPTANCE FLIGHT TESTS OF THE BELL XS-1 AIRPLANE

FLIGHT TESTS OF THE BELL XS-1 AIRPLANE

SUMMARY

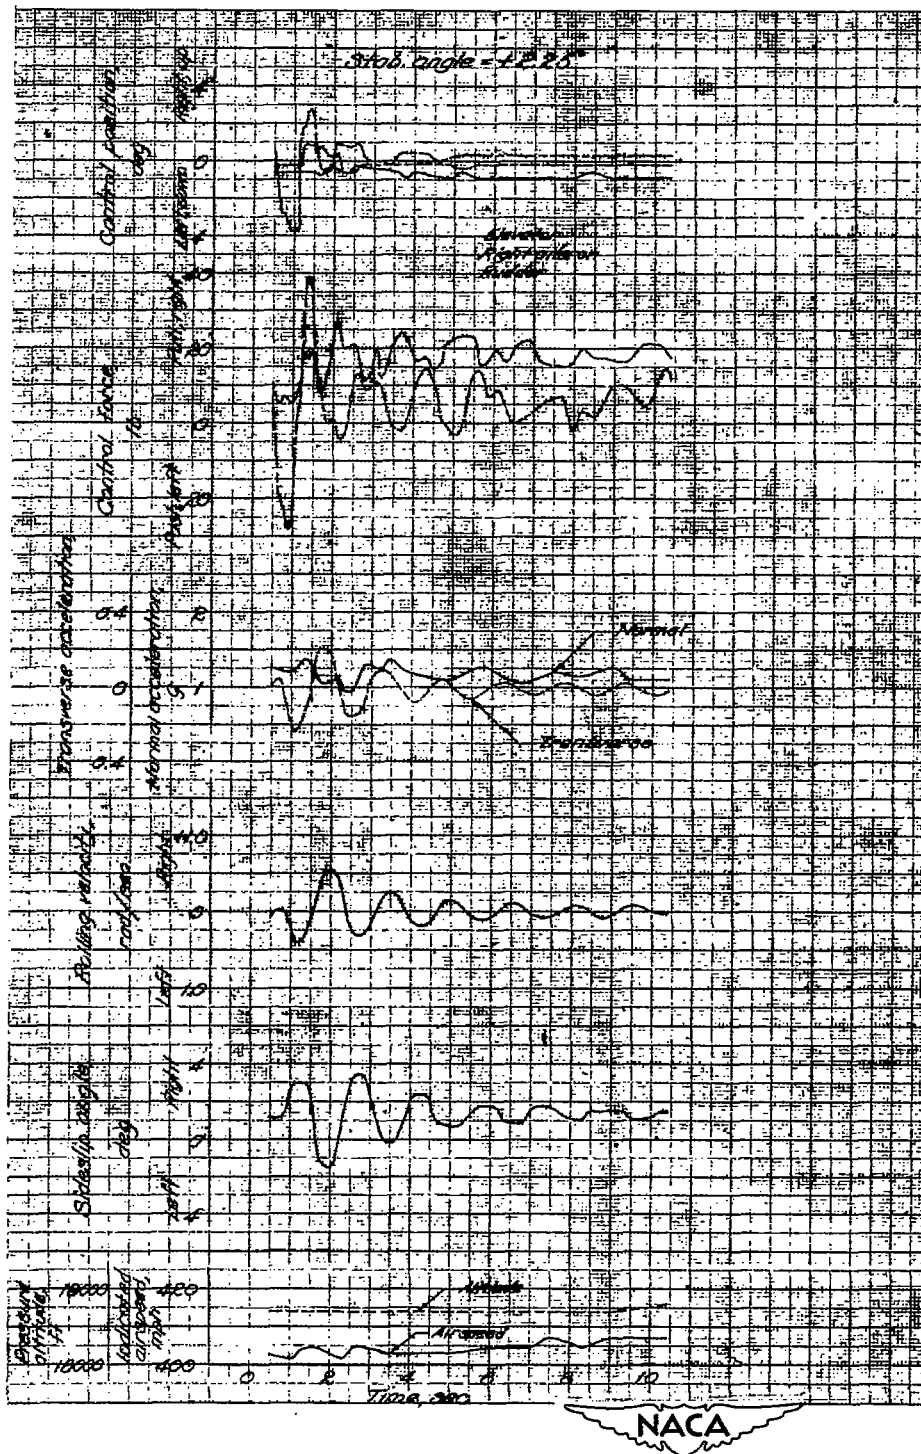
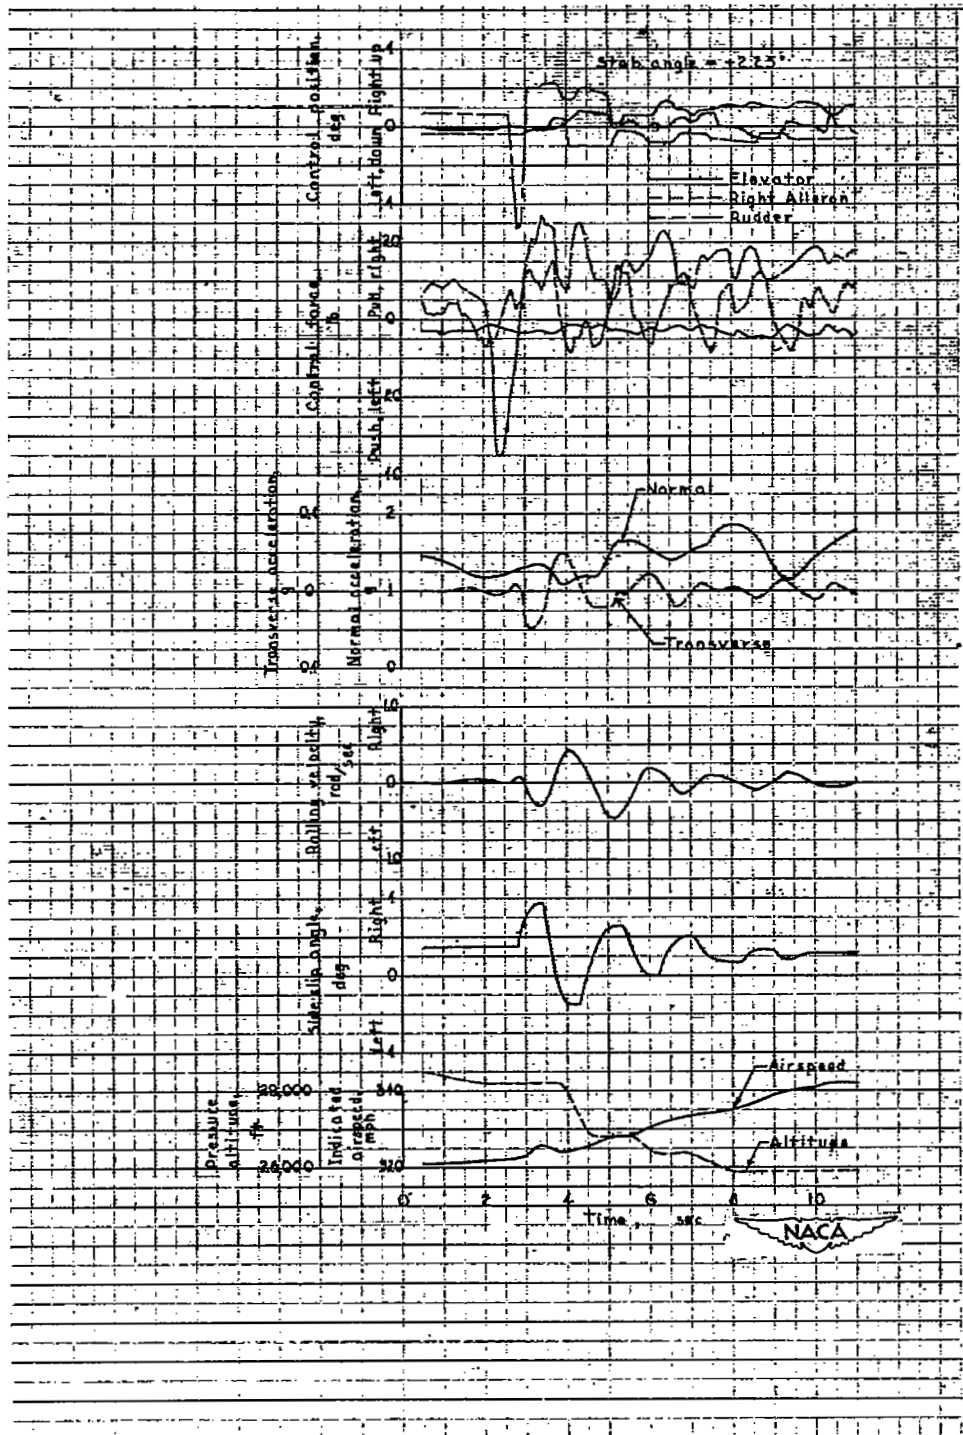
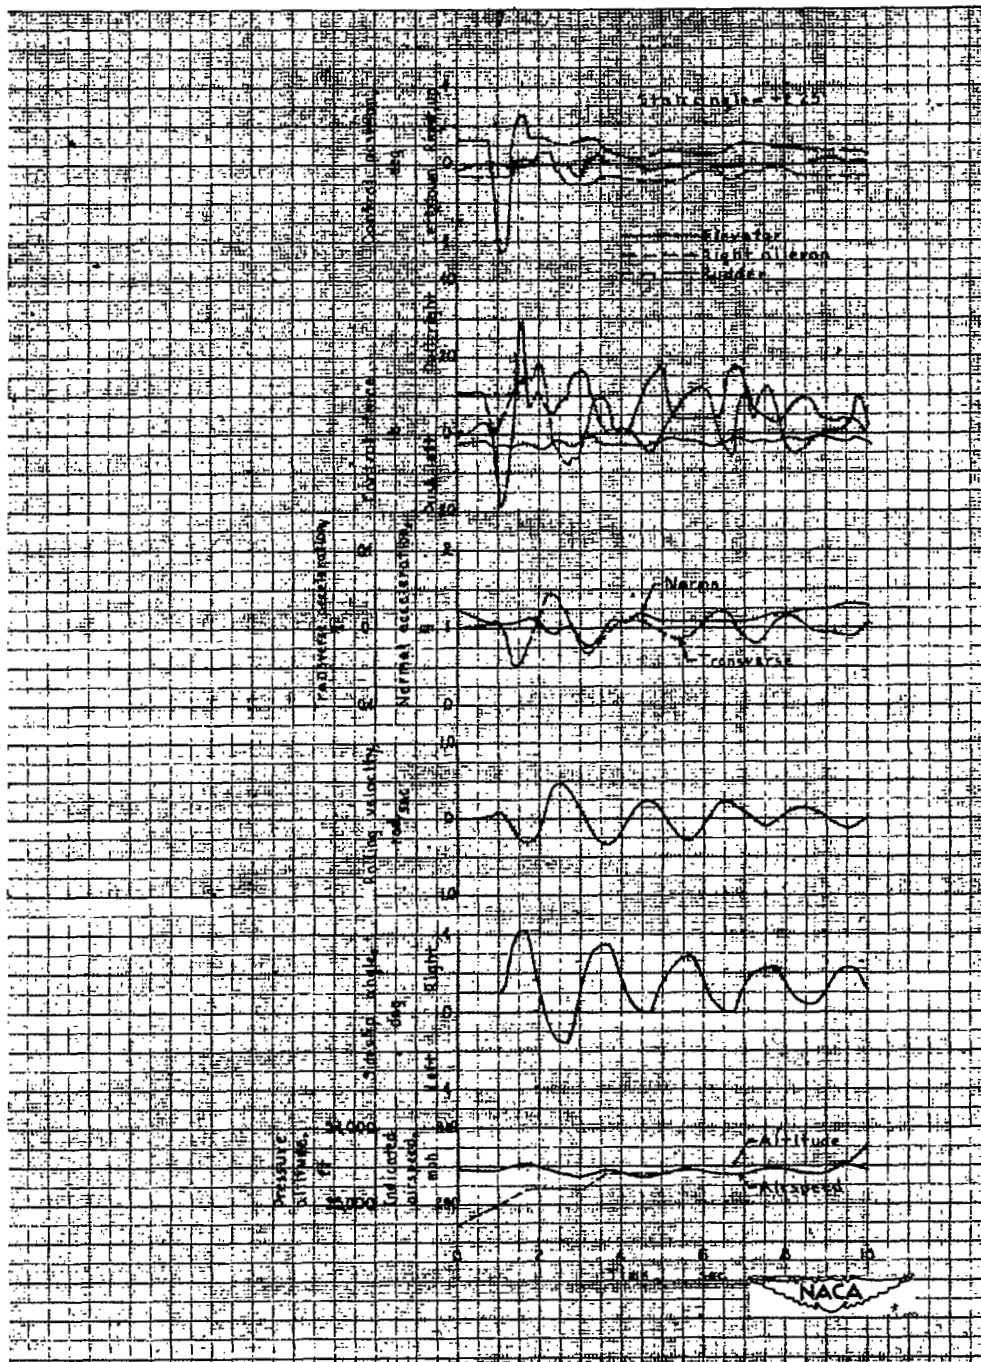
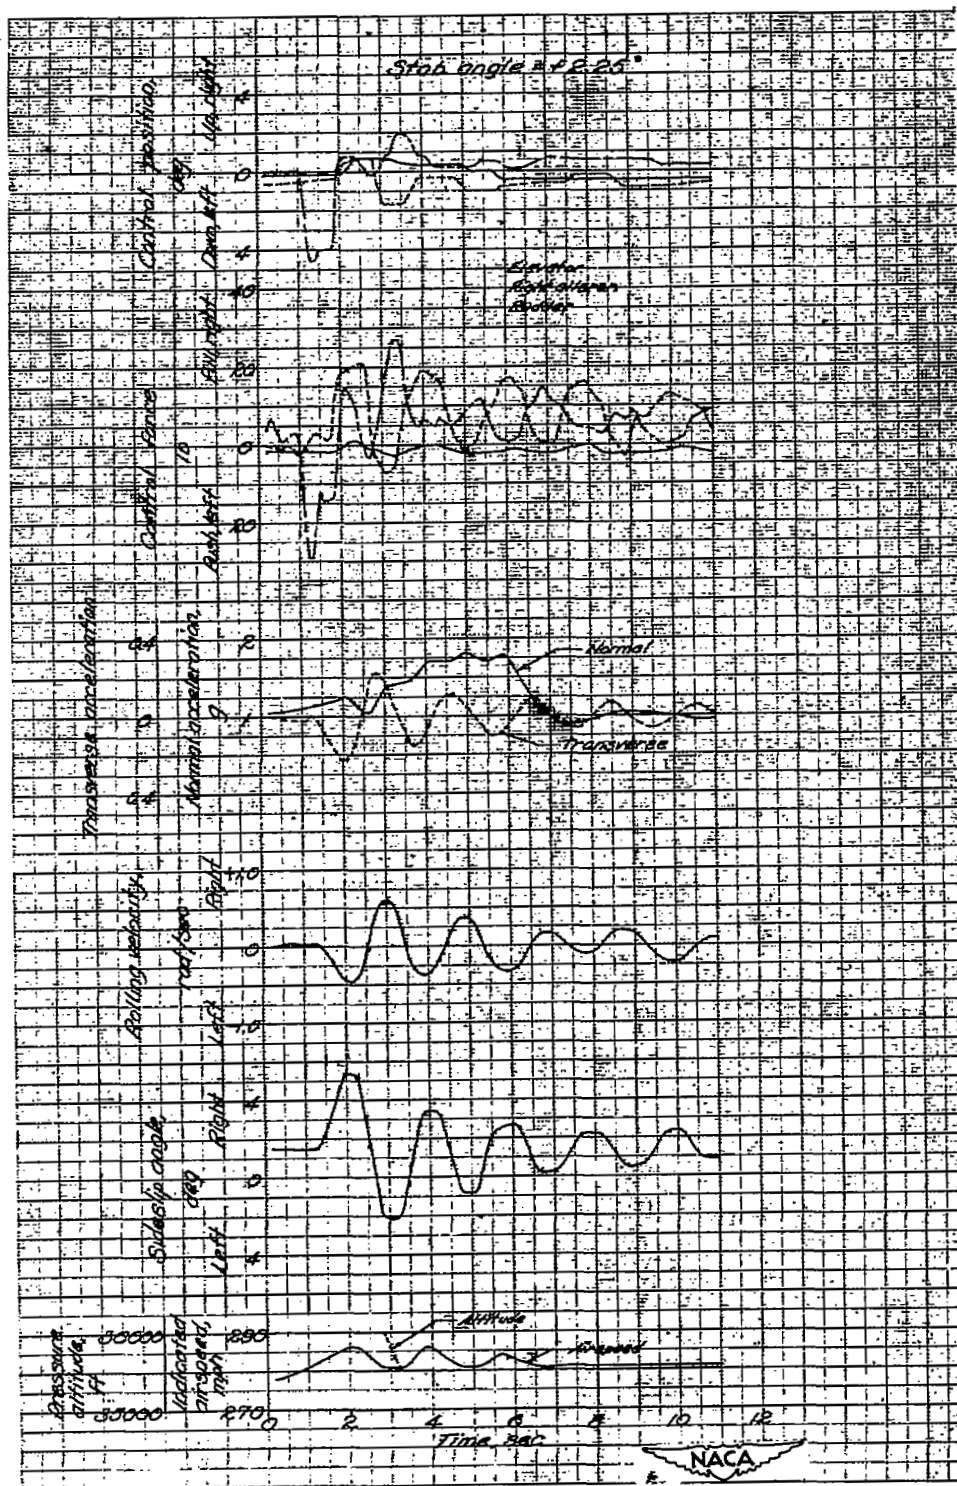
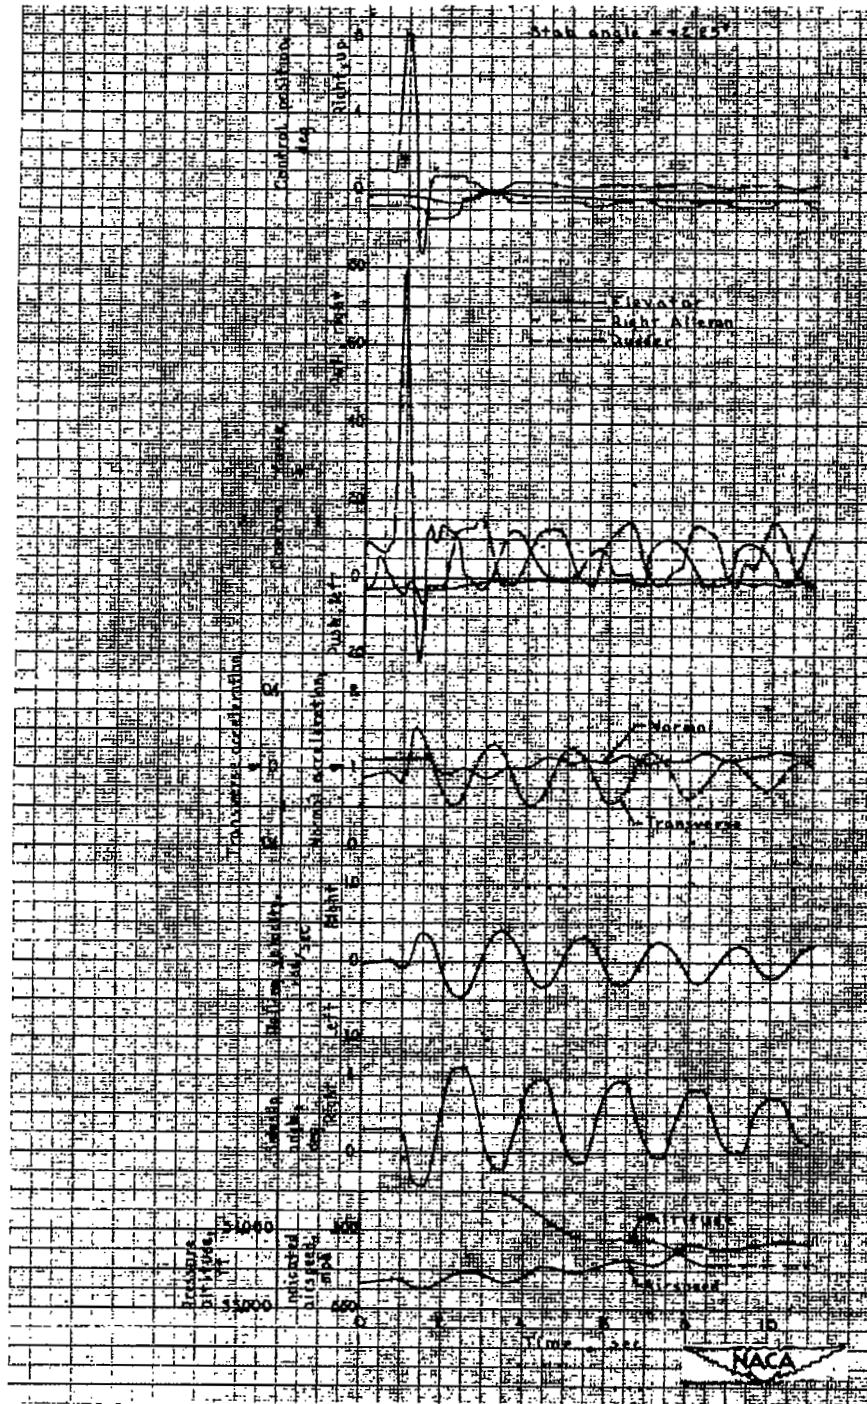
(a) Full Fuel.

Figure 30.—Time histories of abrupt rudder kicks with essentially constant relative density factors and an average Mach number of about 0.740. Various amounts of fuel aboard. XS-1 8-percent-thick-wing airplane.

(b) 40 percent fuel.

(c) 25 percent fuel.

(d) No fuel.

pilot-induced oscillations were made with various amounts of fuel aboard. The altitude for the maneuvers was varied so that the airplane density factor and Mach number were essentially constant. The pilot attempted to deflect the rudder abruptly and then to return the rudder to neutral and hold it there. The results of these tests are presented as time histories of the rudder kicks in figure 30. As can be seen in this figure, the pilot did not hold the rudder or ailerons steady after initially deflecting the rudder. It is difficult to draw any definite conclusions concerning the effects of fuel on the damping of the lateral oscillations because of these control motions. There is no evidence, however, that the presence of fuel aboard had any effect on the damping of the lateral oscillations.

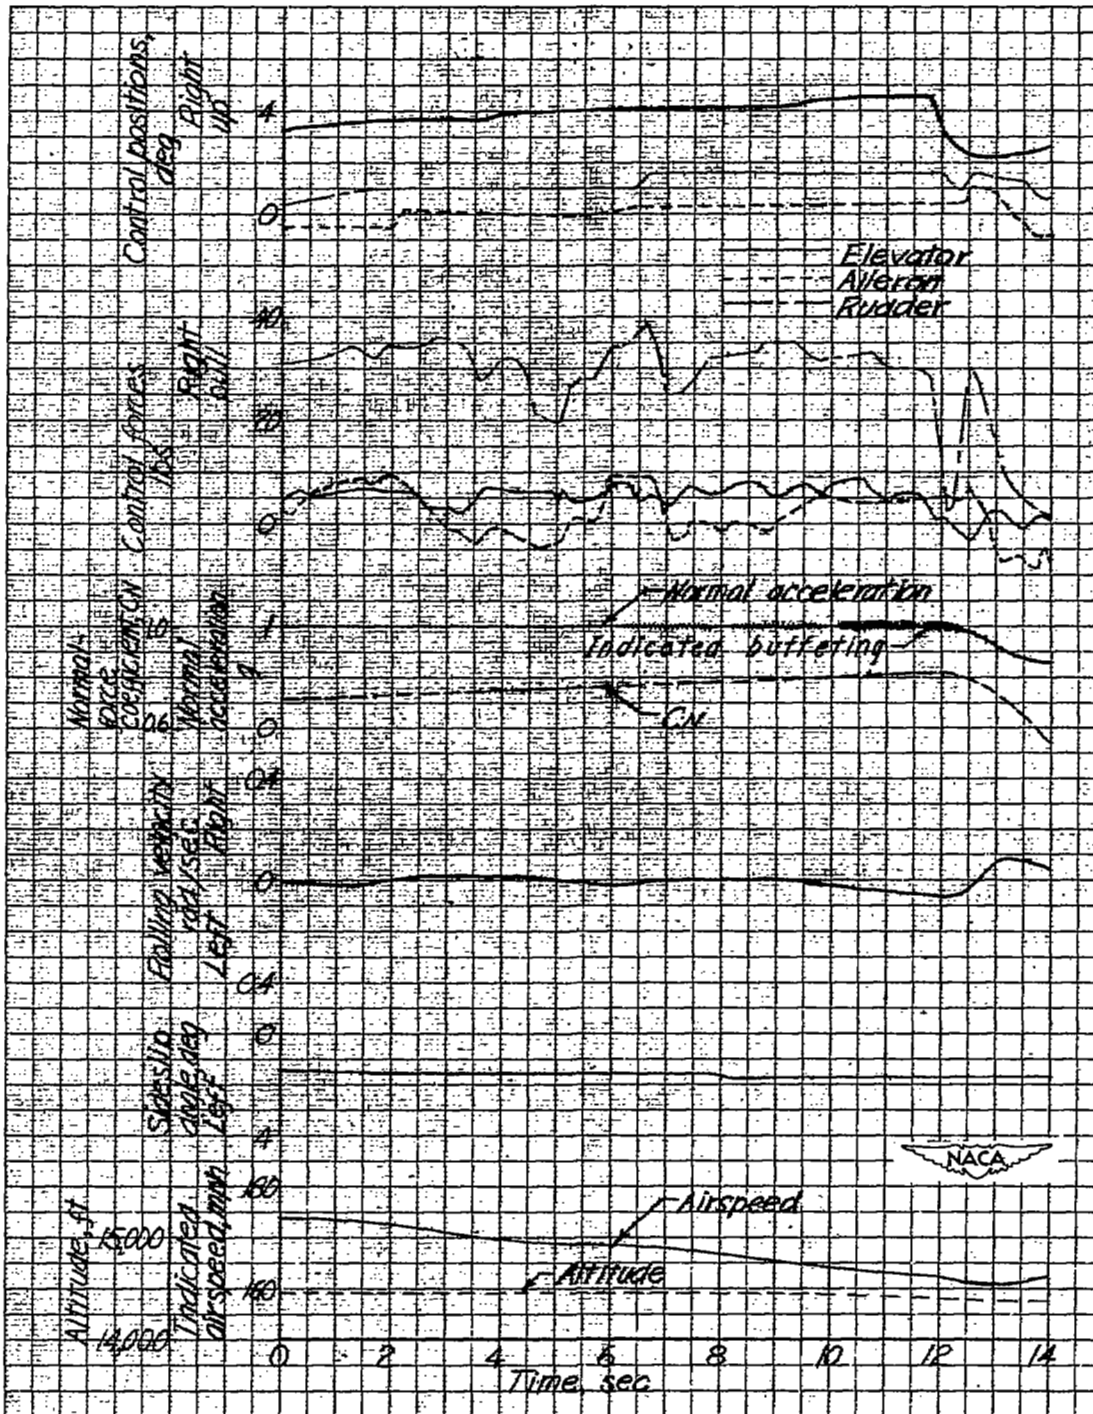
Figure 31.- Time history of a steady stall. XS-1 airplane with 10-percent-thick wing. Gliding flight; flaps and gear up. Center of gravity, 25 percent M.A.C.  $\frac{W}{S} = 56.3$  lb/sq ft. Stabilizer position,  $0.25^\circ$ .

The stalling characteristics of the Bell XS-1 were investigated in unaccelerated flight and in accelerated flight. Time histories of stalls made with flaps and gear up are presented in figures 31 and 32 for the Bell XS-1 with the 10-percent-thick wing. In the stall presented in figure 31, the pilot discontinued the stall approach at the first roll-off. The pilot reported that the roll-off was preceded by buffeting. In the stall presented in figure 32, the pilot continued the stall approach after the initial roll. An oscillation in roll developed which the pilot controlled up to the stall which was evidenced by the airplane pitching downward. It should be noted that full-up elevator was used at the stall. For this time history, it was assumed that the airplane was at 1g up to the time of minimum speed, in calculating values of normal-force coefficient. A time history of a stall made with the Bell XS-1 with the 8-percent-thick wing, flaps and gear up, is presented in figure 33. The stalling characteristics with the 8-percent-thick wing are similar to the characteristics measured with the 10-percent-thick wing. Time histories of stalls made with flaps and gear down are presented in figures 34 and 35 for the 10-percent-thick and 8-percent-thick wings, respectively. The stalling characteristics with flaps and gear down are similar to the characteristics with flaps and gear up. The pilot reported stall warning in the form of buffeting in all cases, and the rolling motions during the stall were never violent. The stalling characteristics in 1g flight, as measured during the flight tests, are in general agreement with the stalling characteristics predicted from the wind-tunnel tests.

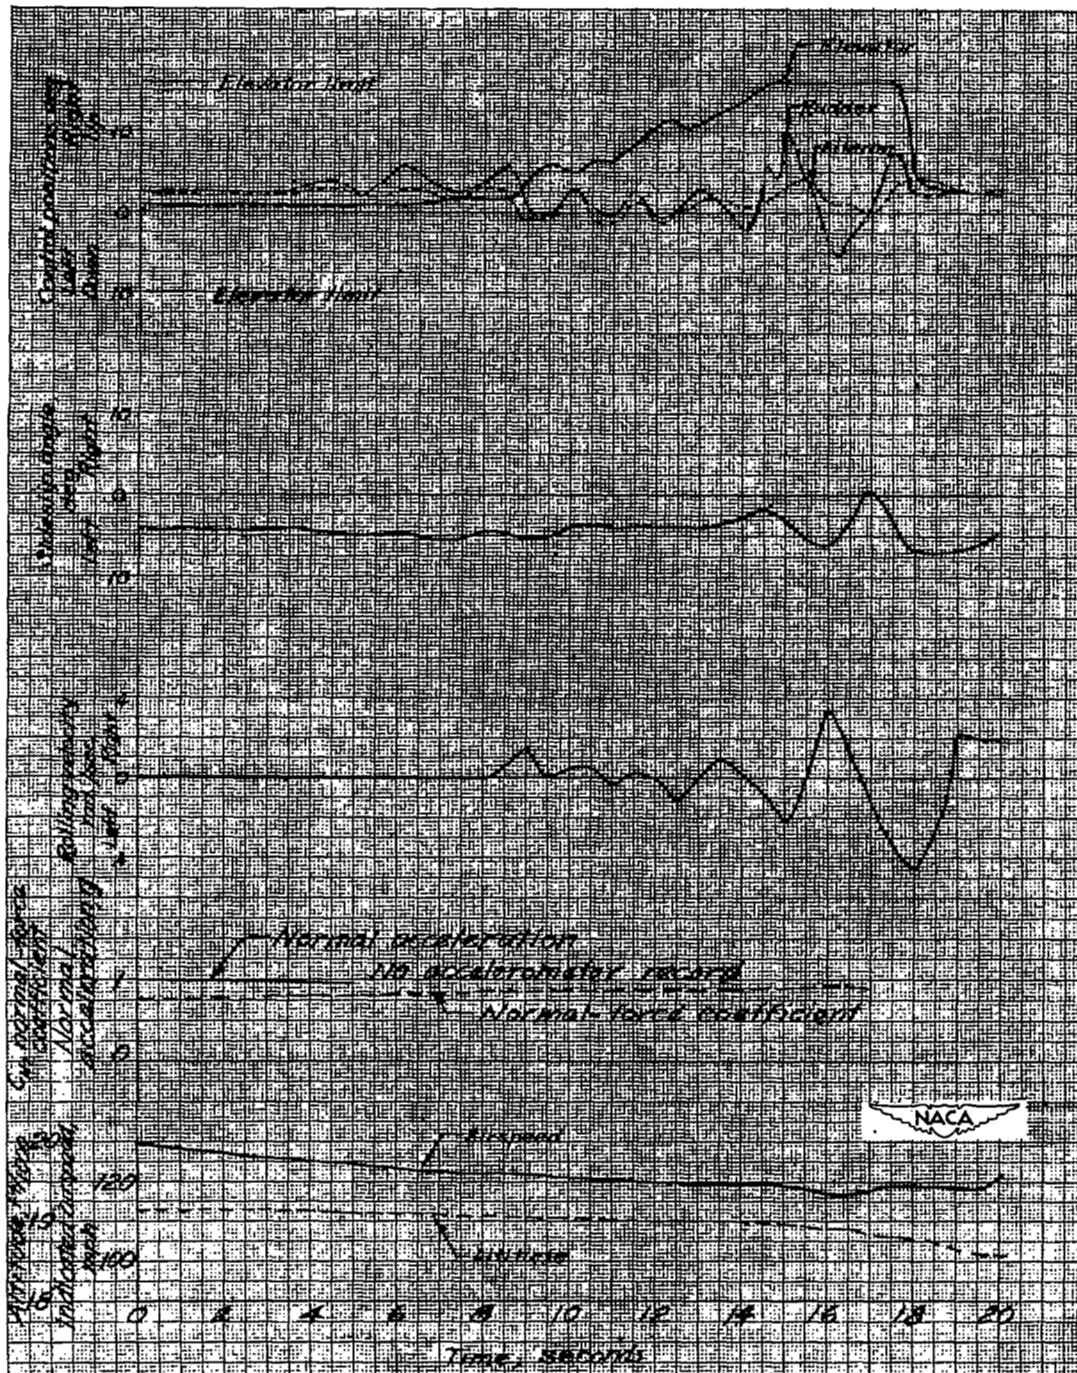
Figure 32.- Time history of a steady stall. XS-1 airplane with 10-percent-thick wing. Gliding flight; flaps and gear up;  $\frac{W}{S} = 32.5$  lb/sq ft. Stabilizer settings,  $1.0^\circ$ .

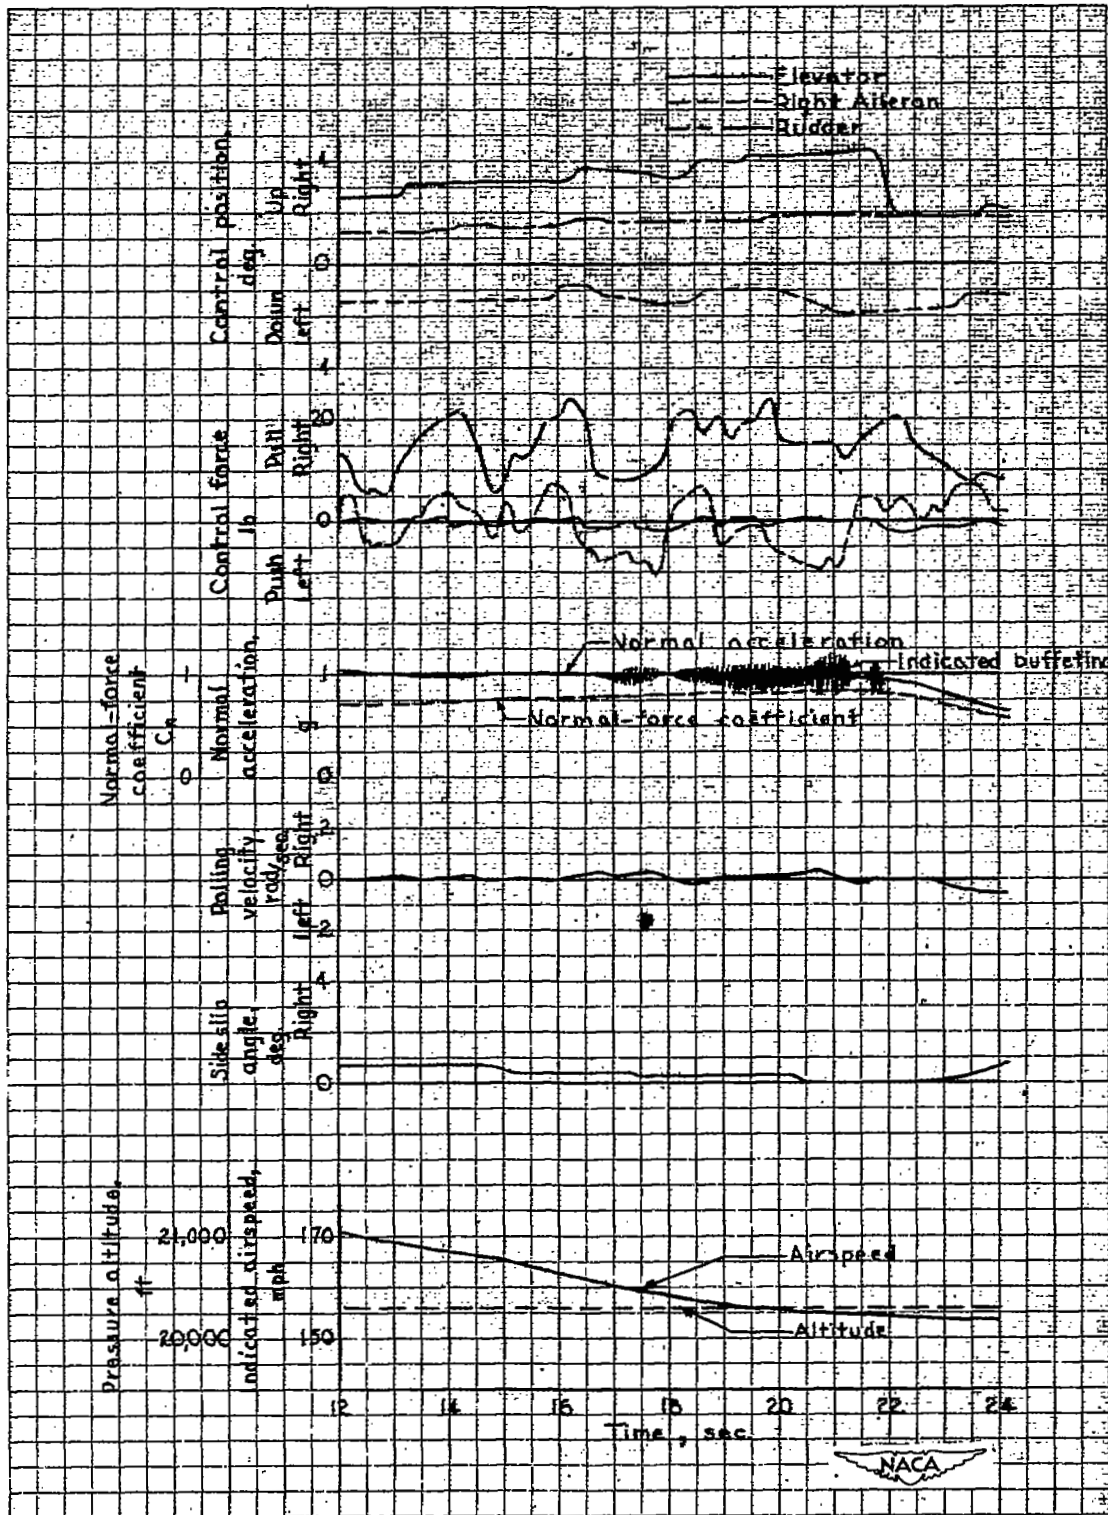
Figure 33.- Time history of a steady stall, XS-1 airplane with 8-percent-thick wing. Gliding flight; flaps and gear up.

$\frac{W}{S} = 53.8$  lb/sq ft. Stabilizer setting,  $2.35^\circ$ .

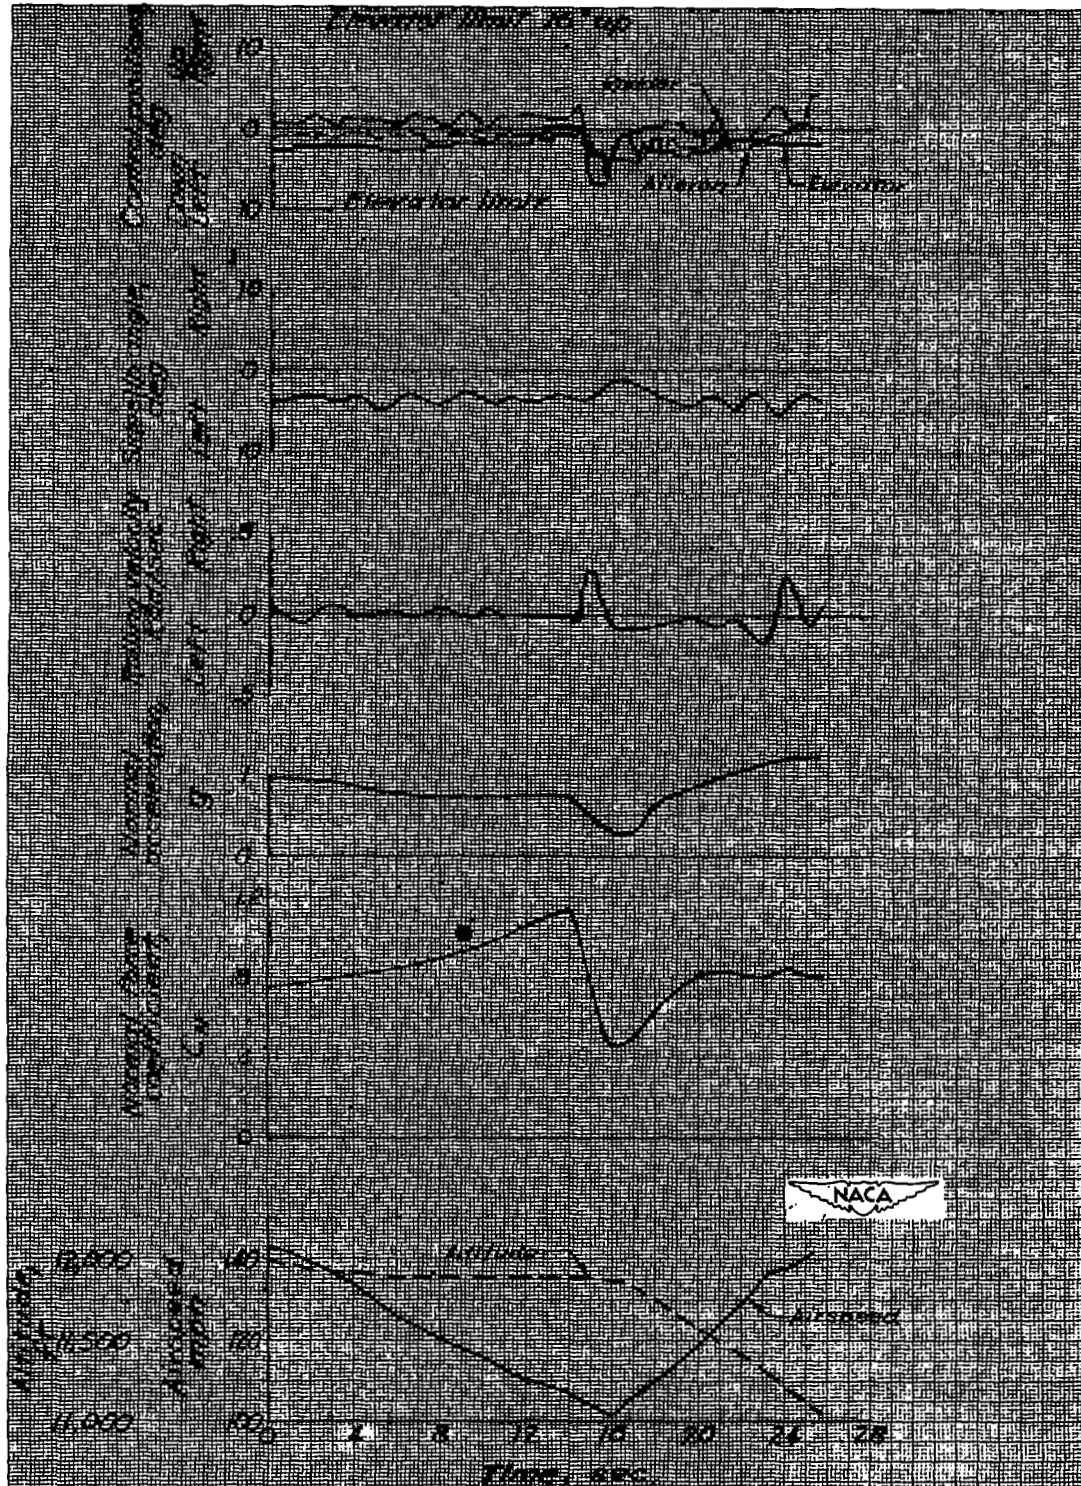
Figure 34.- Time history of a steady stall, XS-1 airplane with 10-percent-thick wing. Gliding flight, flaps and gear down. Center of gravity, 25 percent M.A.C.,  $\frac{W}{S} = 32.5$  lb/sq ft. Stabilizer setting,  $1.0^\circ$ .

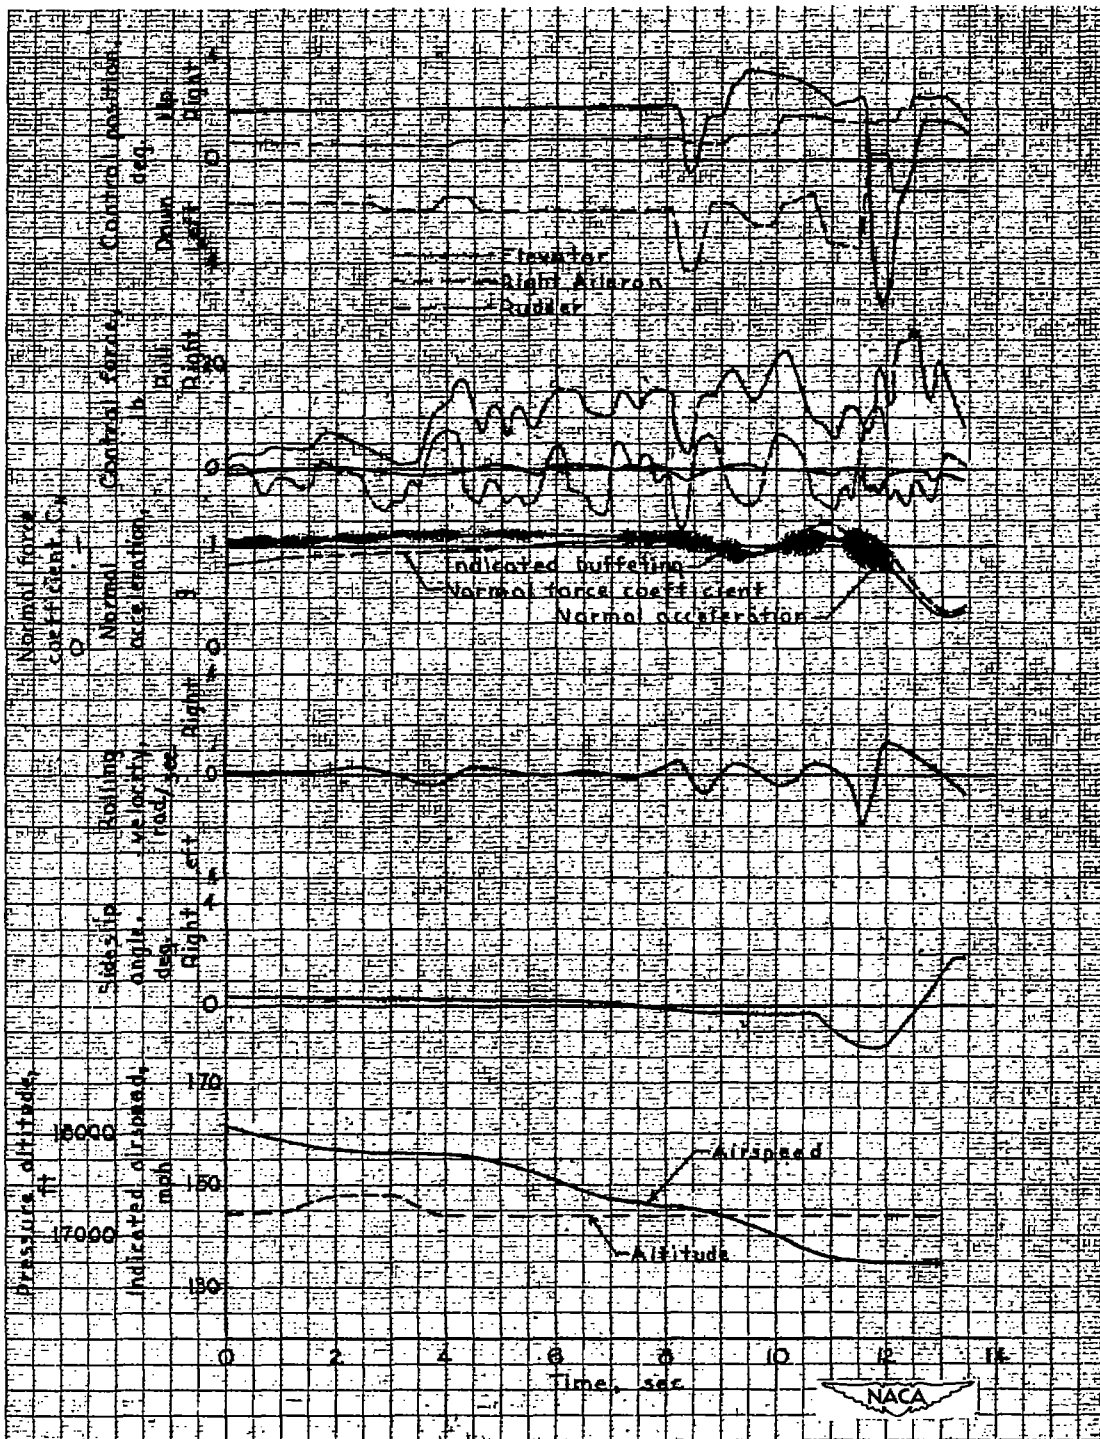
Figure 35.- Time history of a steady stall, XS-1 airplane with 8-percent-thick wing. Gliding flight, flaps and gear down. Center of gravity, 25.0 percent M.A.C.  $\frac{W}{S} = 53.8$  lb/sq ft. Stabilizer position,  $2.35^\circ$ .

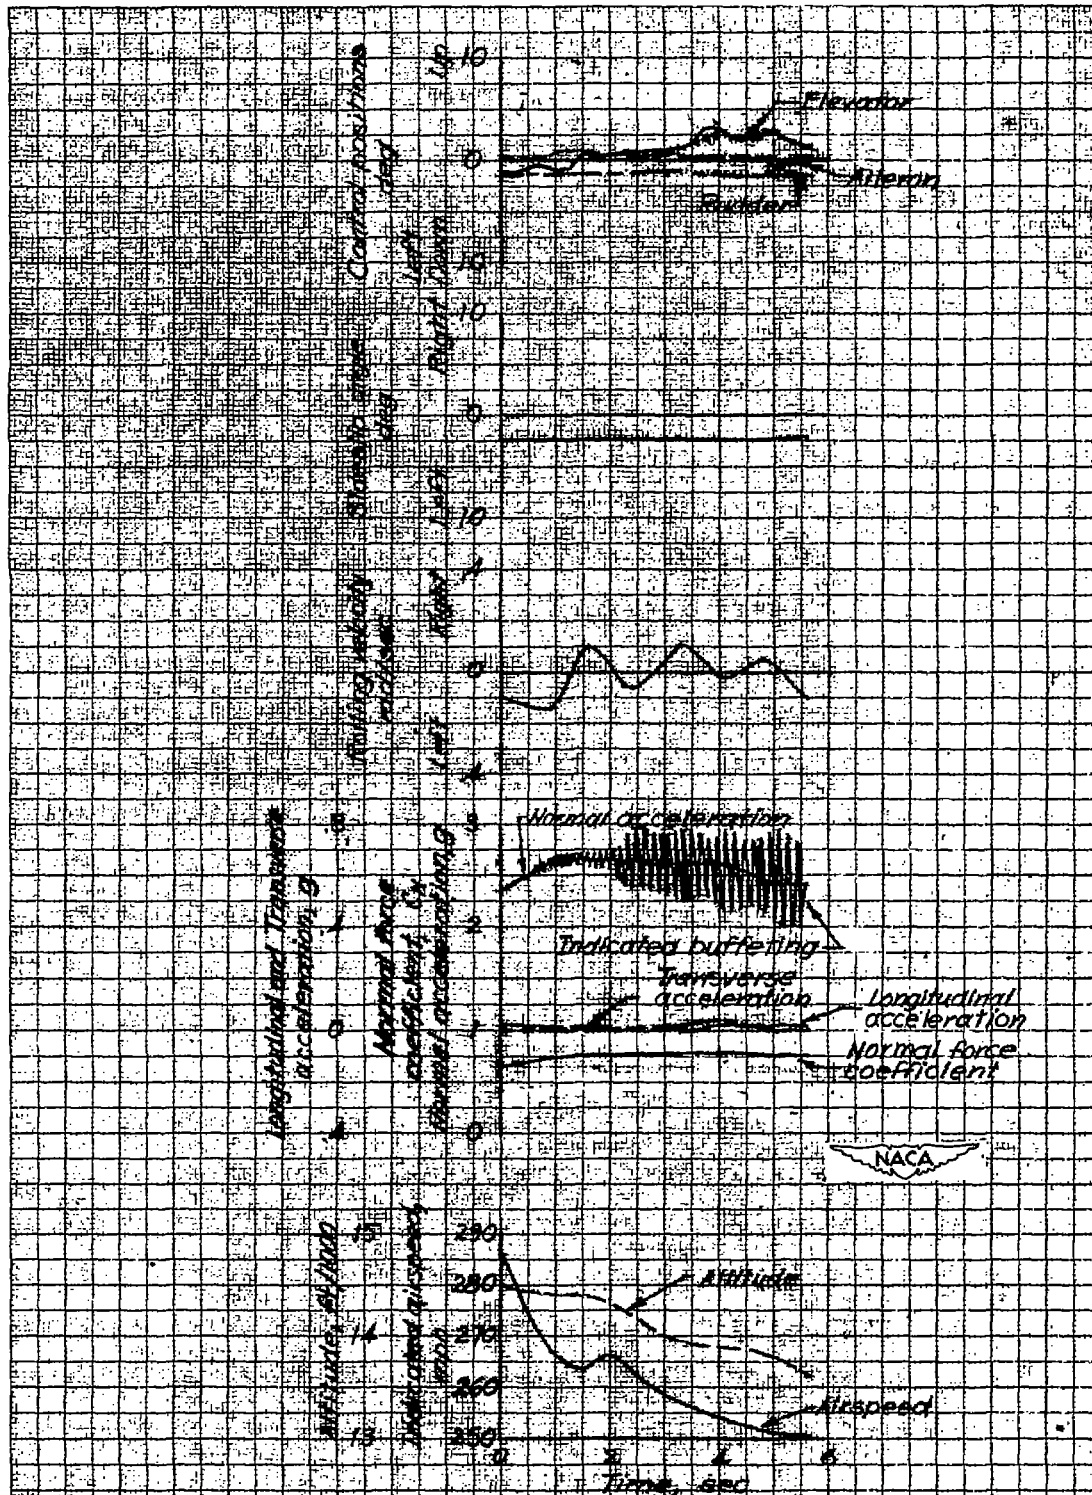
Figure 36.- Time history of a stalled turn. XS-1 airplane with 10-percent-thick wing. Center of gravity, 25 percent M.A.C.  $\frac{W}{S} = 51.9$  lb/sq ft.

The stalling characteristics in accelerated flight were considered satisfactory. There was stall warning in the form of buffeting, and there were no violent motions of the airplane as the stall was approached. A time history of a stalled turn is presented in figure 36. Time histories of abrupt pull-ups to the stall are presented in figures 37 and 38. It should be noted in figure 37 that a rolling

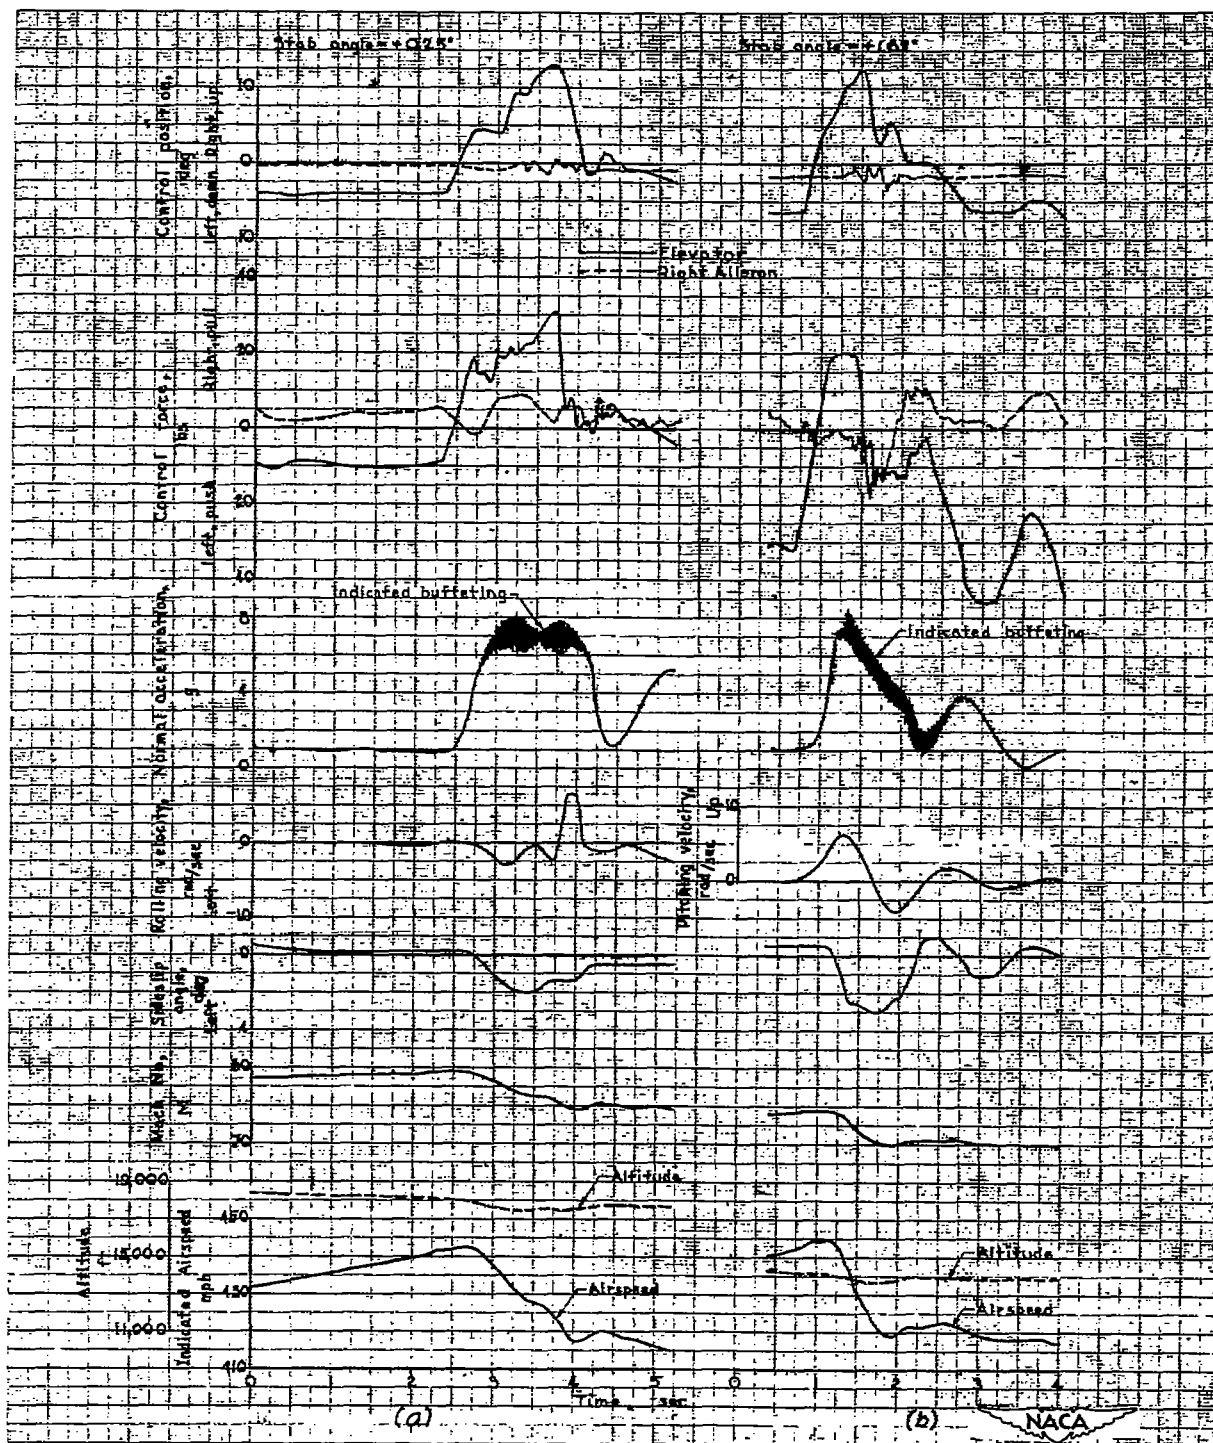
(a) XS-1 airplane with 10-percent-thick wing. Center of gravity, 25.3 percent M.A.C.

Figure 37.- Time histories of power-off abrupt pull-ups.

oscillation accompanies the stall, but the airplane did not roll completely over when the ailerons were not used. In figure 38, aileron control was applied at the stall and a snap roll resulted.

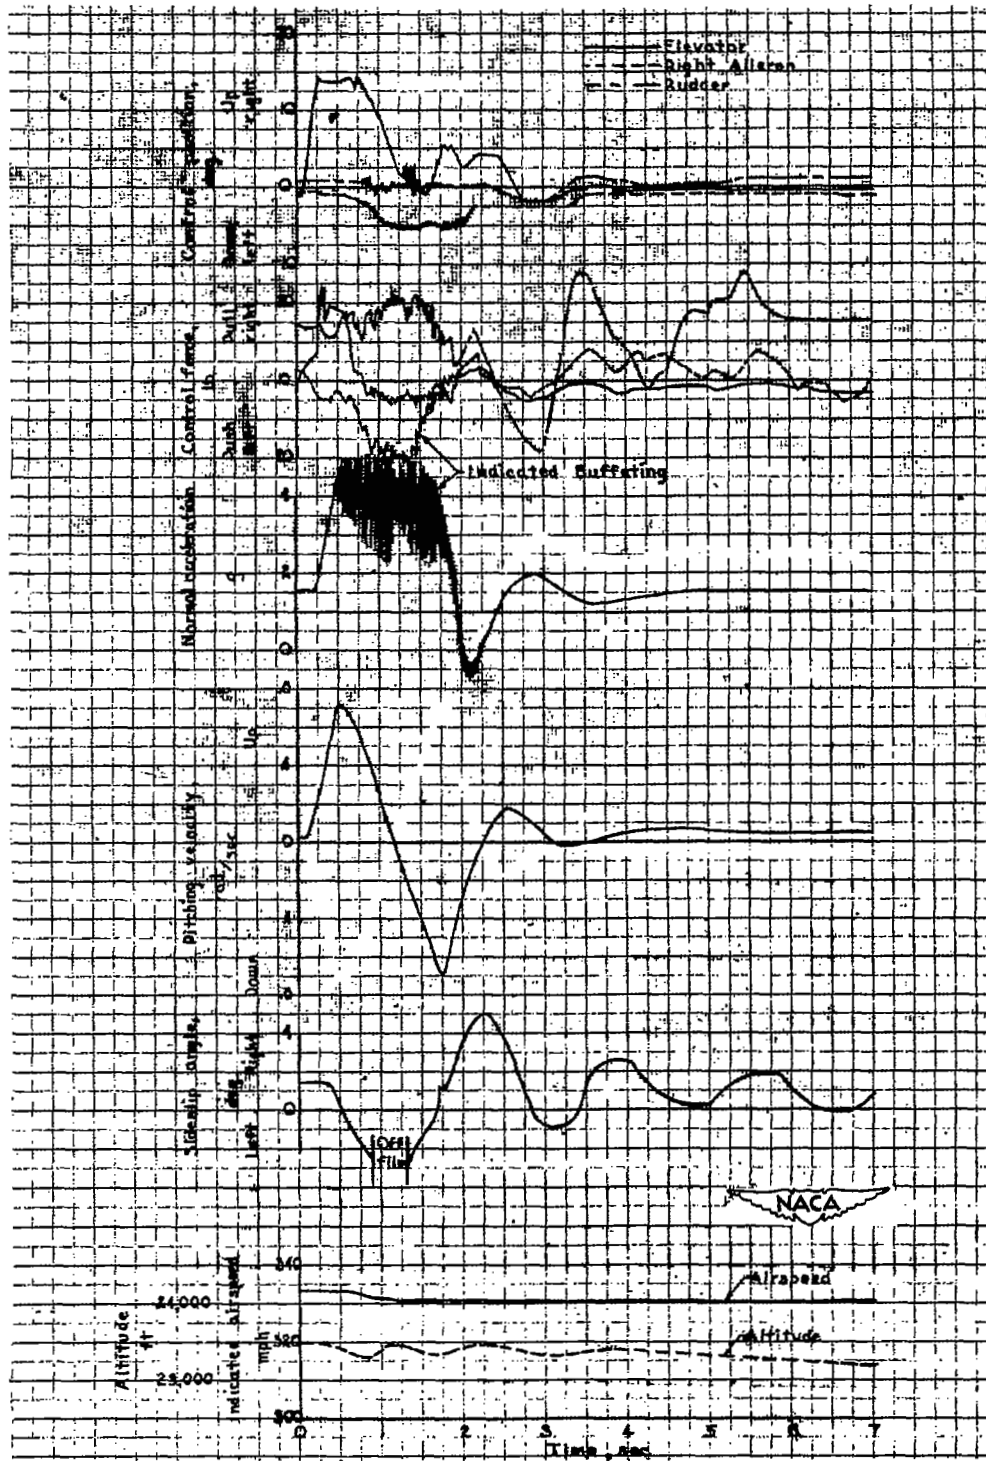
Figure 38.- Time history of an abrupt pull-up followed by a snap roll. XS-1 airplane with 8-percent-thick wing. Center of gravity, 25.0 percent M.A.C.  $\frac{W}{S} = 53.8$  lb/sq ft. Stabilizer position,  $2^\circ$ .
