# RESEARCH MEMORANDUM

COMPARISON OF NATIONAL BUREAU OF STANDARDS CERAMIC

COATINGS L-7C AND A-417 ON TURBINE BLADES

IN A TURBOJET ENGINE

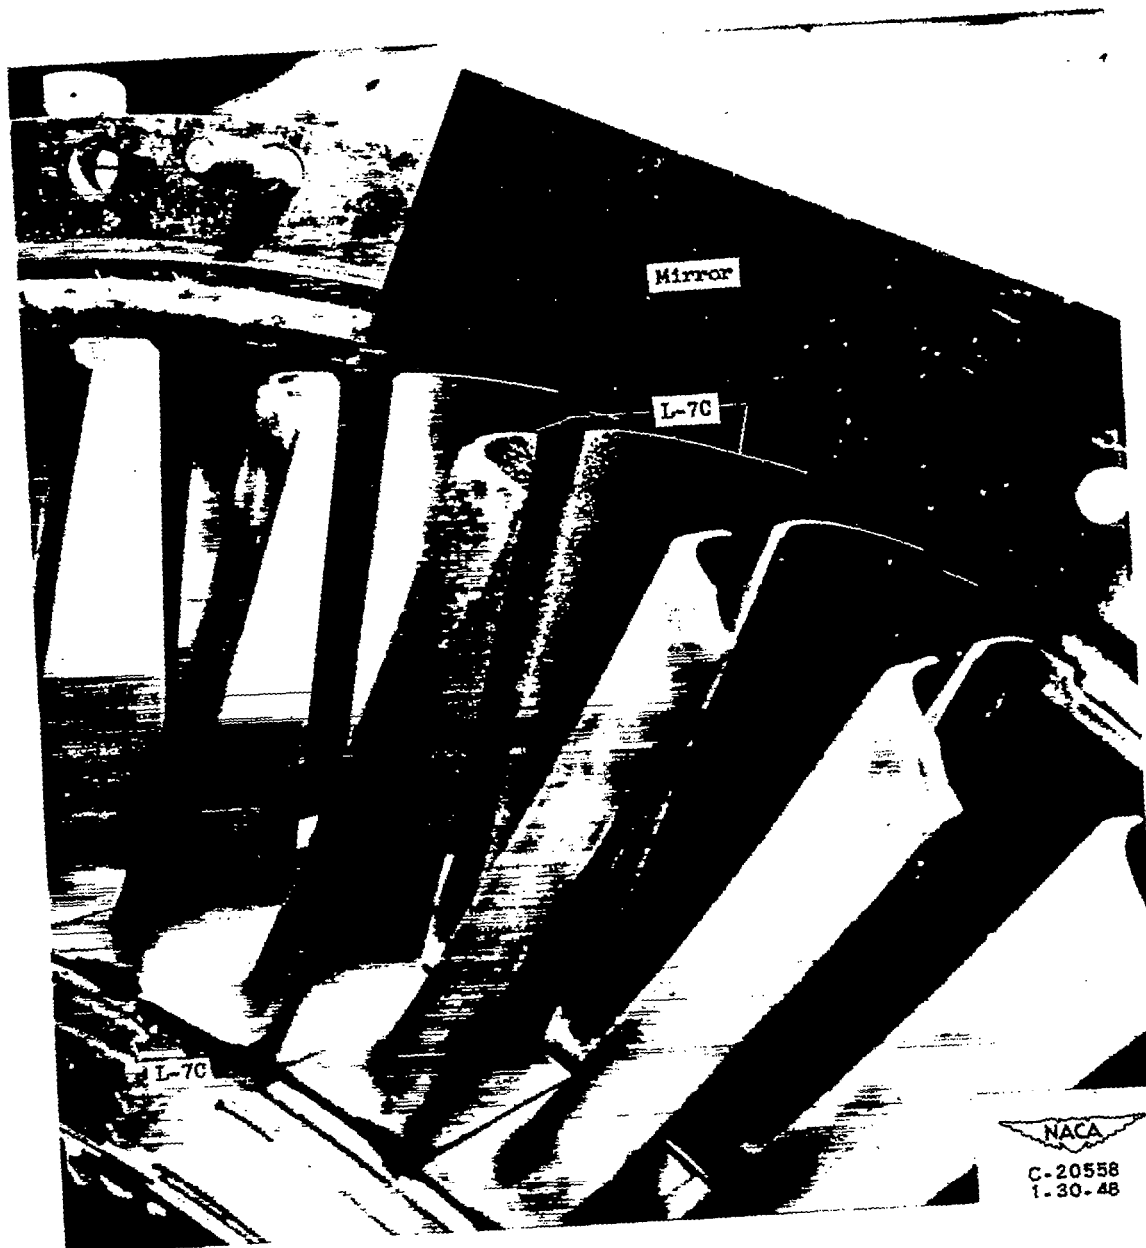
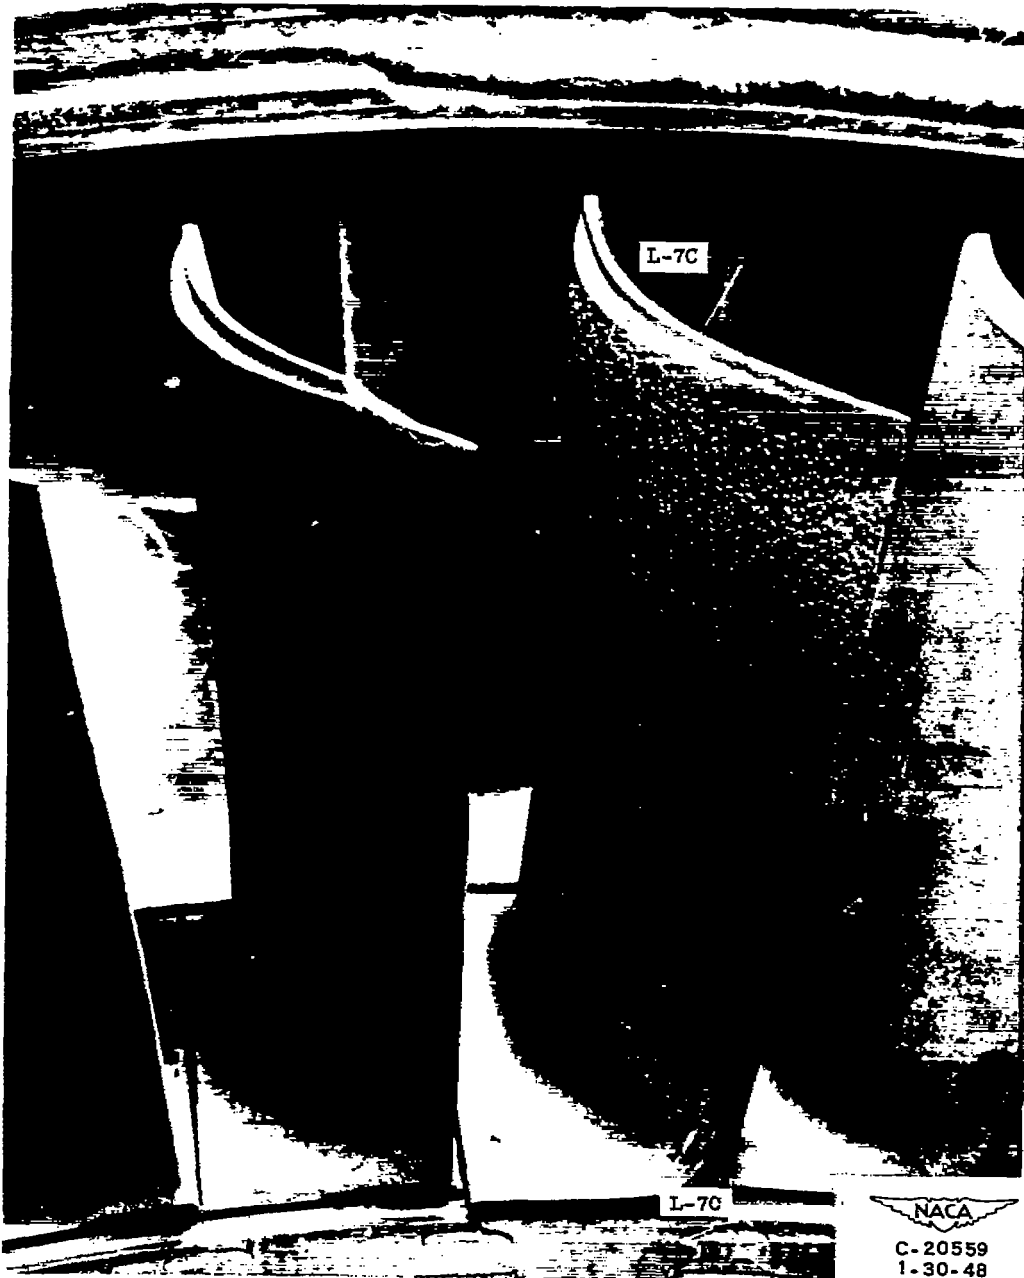
(a) Leading edge and mirror reflection of concave side.

Figure 3. - Turbine blade 1 after five engine operating cycles (1 hr, 40 min). Ceramic coating L-7C.

(b) Trailing edge and convex side.

A ceramic-coated blade before installation in the engine is shown in figure 2. The coated blades had no previous running time and the appearance of all four blades was similar. Figure 1 shows the locations of the ceramic-coated blades in the turbine wheel. Blade 1 is shown in figure 3 after five operating cycles. During this first run, coating L-7C became rough and small ceramic beads and radial-flow lines appeared (probably as a result of the starting temperatures, which may have exceeded the 1650° F fusion temperature of the material). Turbine blade 3 had this same appearance. Blade 2 after the first five cycles is shown in figure 4. This A-417 coating, which has a fusion temperature of 1850° F, showed no evidence of flow. The appearance of blade 4 was similar.

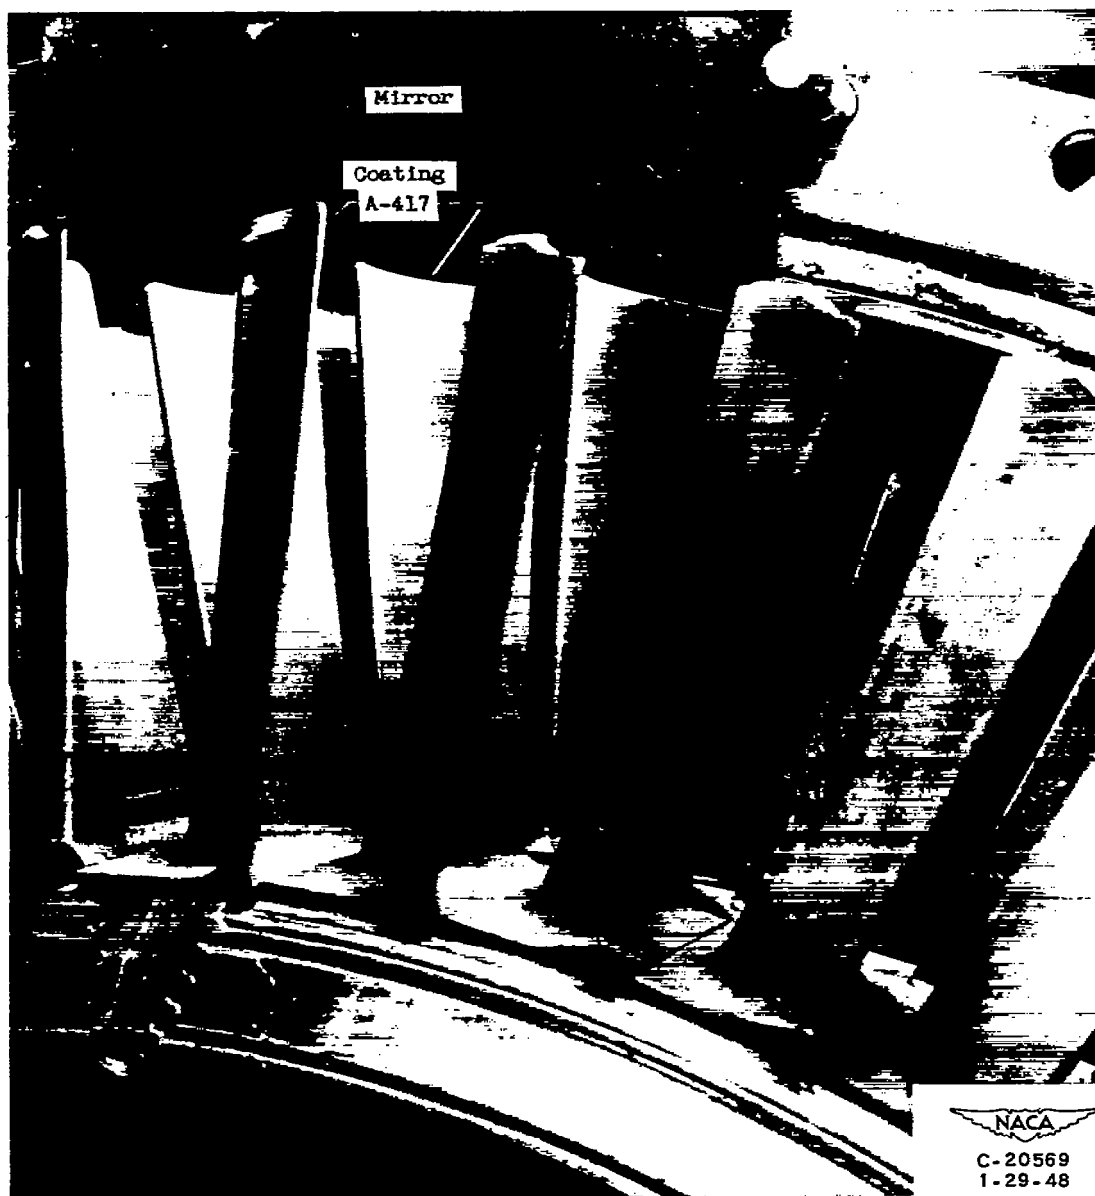
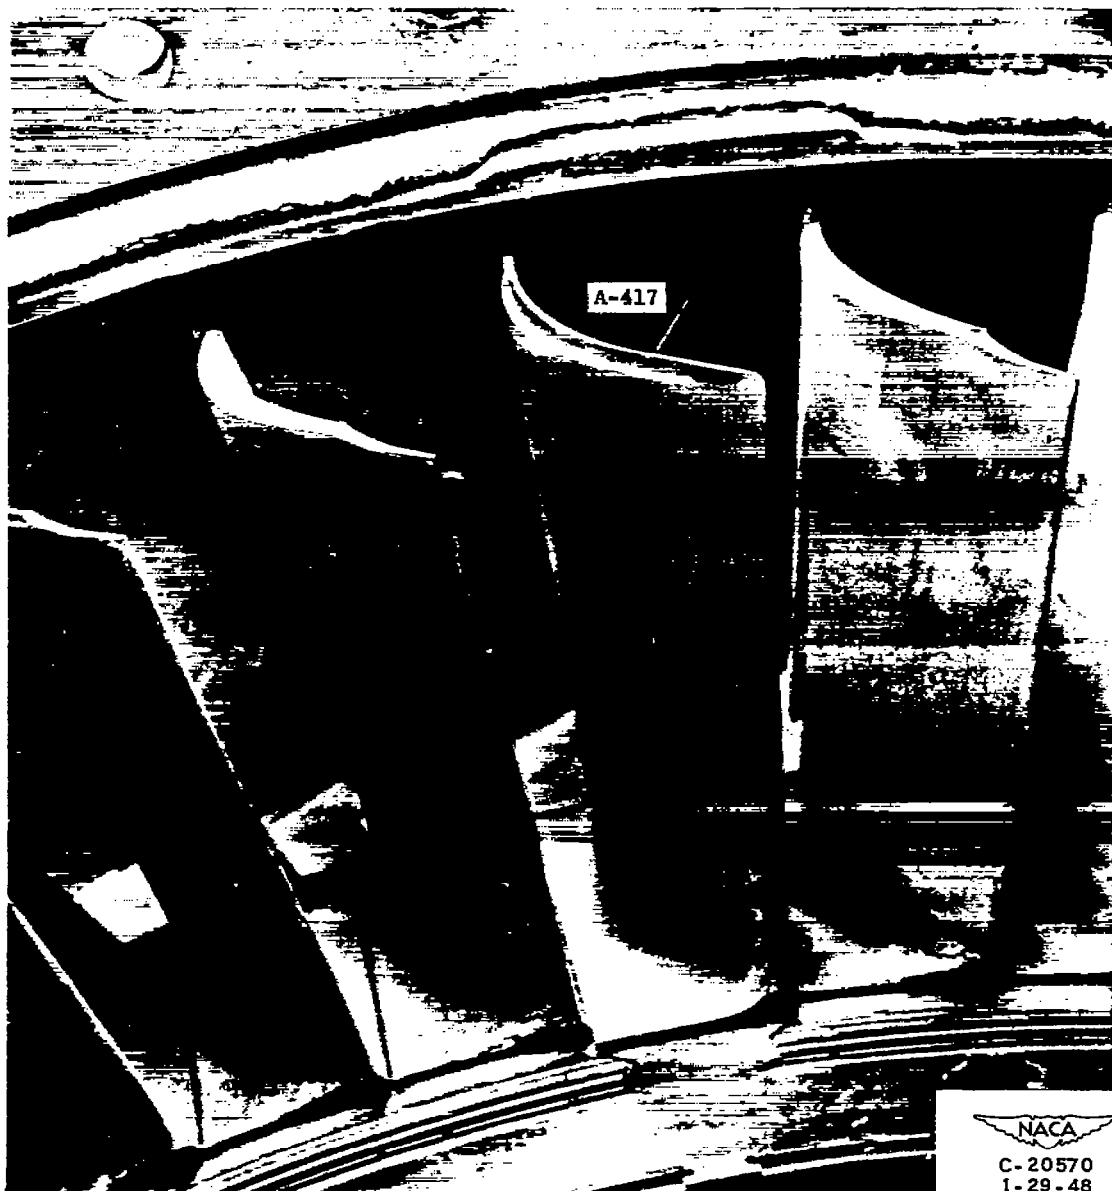
(a) Leading edge and mirror reflection of concave side.

Figure 4. - Turbine blade 2 after five engine operating cycles (1 hr, 40 min). Ceramic coating A-417

(b) Trailing edge and convex side.

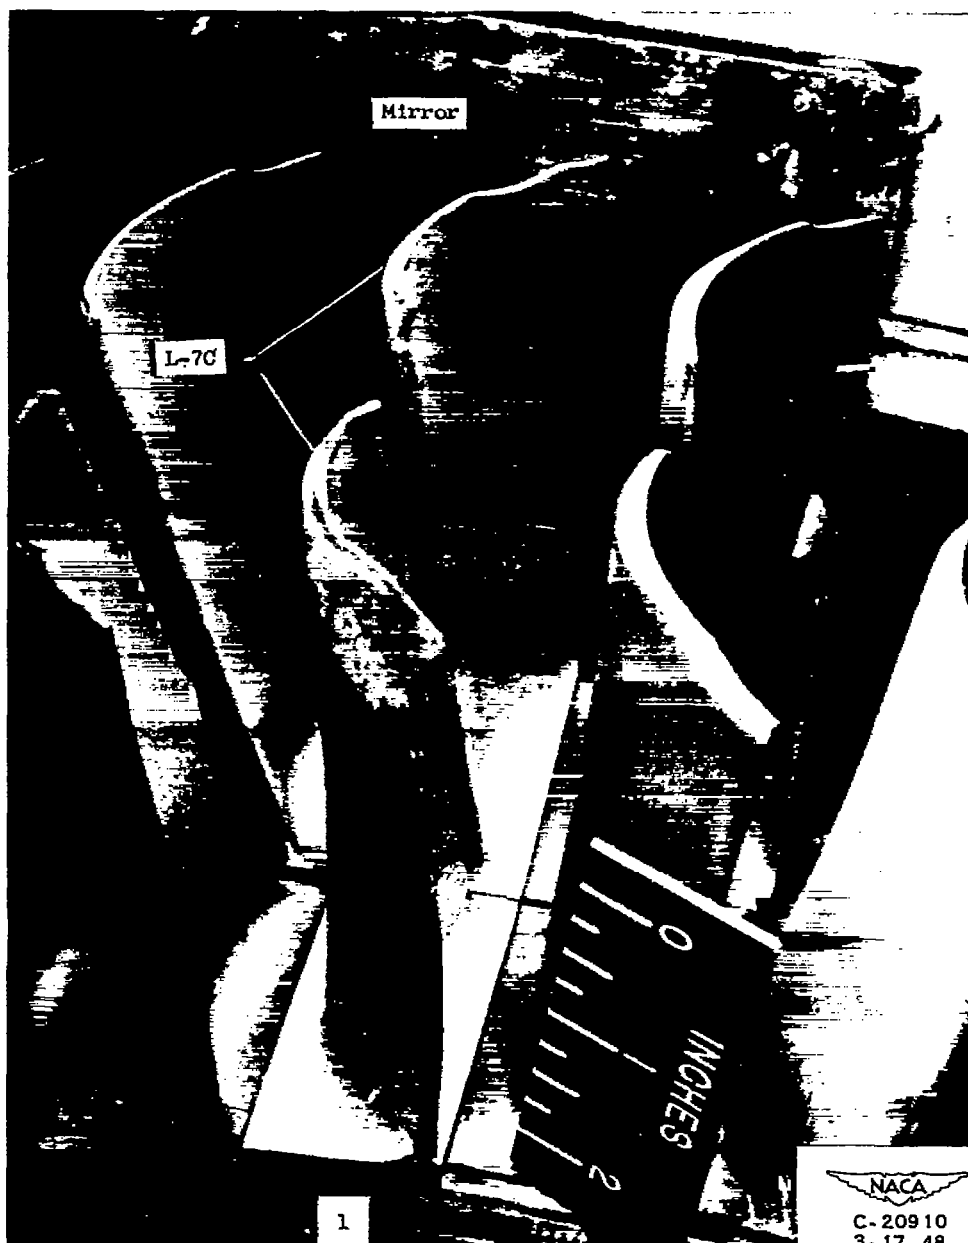
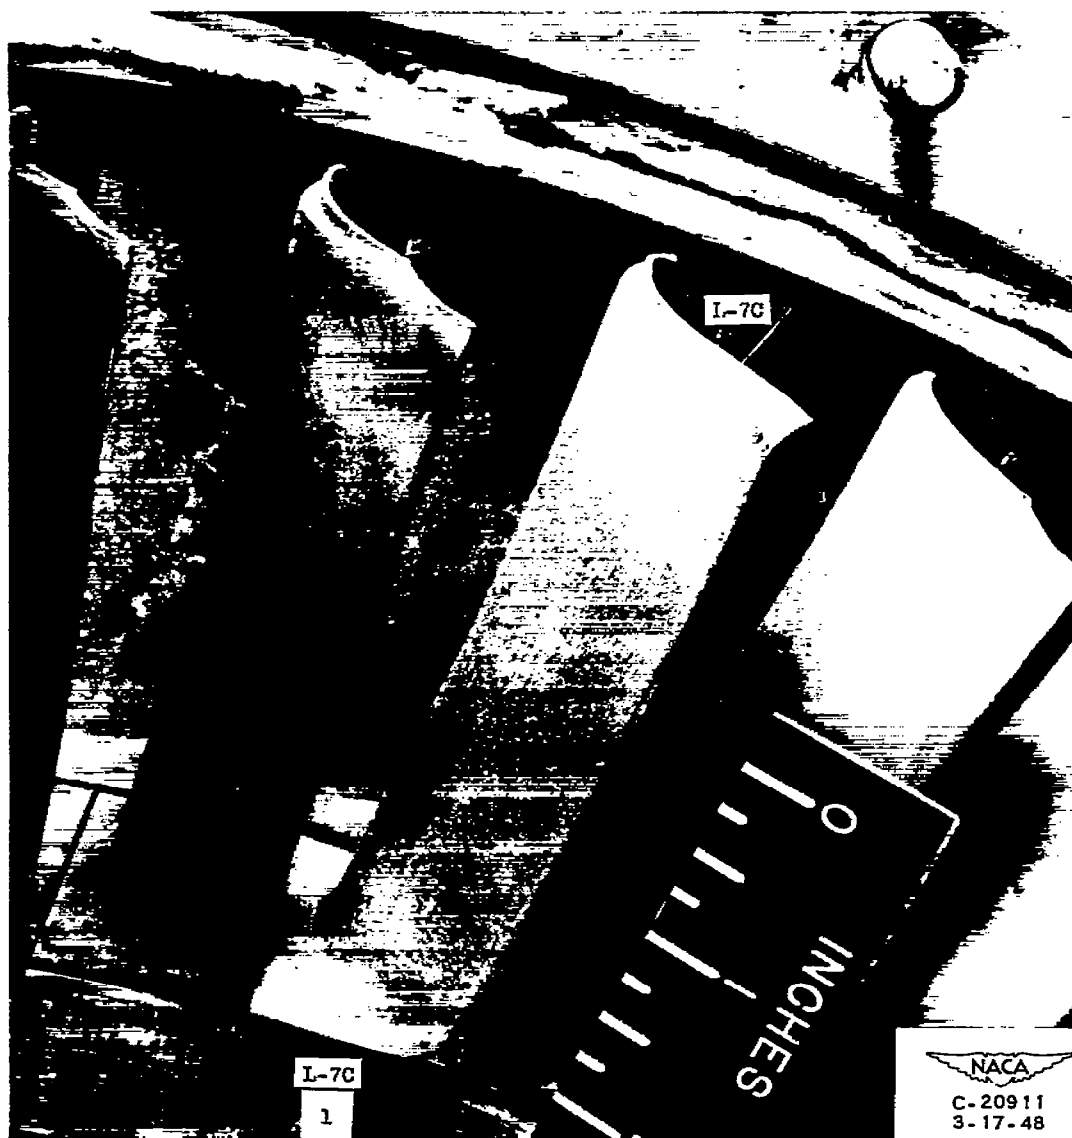
(a) Leading edge and mirror reflection of concave side.

Figure 5. - Turbine blade 1 after 100 engine operating cycles (33 hr, 20 min). Ceramic coating L-7C.

(b) Trailing edge and convex side.

Blades 1 and 2 at the end of 100 cycles are shown in figures 5 and 6, respectively. Many of the ceramic beads (coating L-7C), which were formed during the first five cycles, have disappeared but coating A-417 shows no evidence of flow. Both coatings flaked off somewhat at the tip of the blades, but this flaking is probably the result of dents in the blades caused by foreign particles hitting the blades and by accidental contact with the tail cone while it was being removed in order to inspect the turbine wheel.

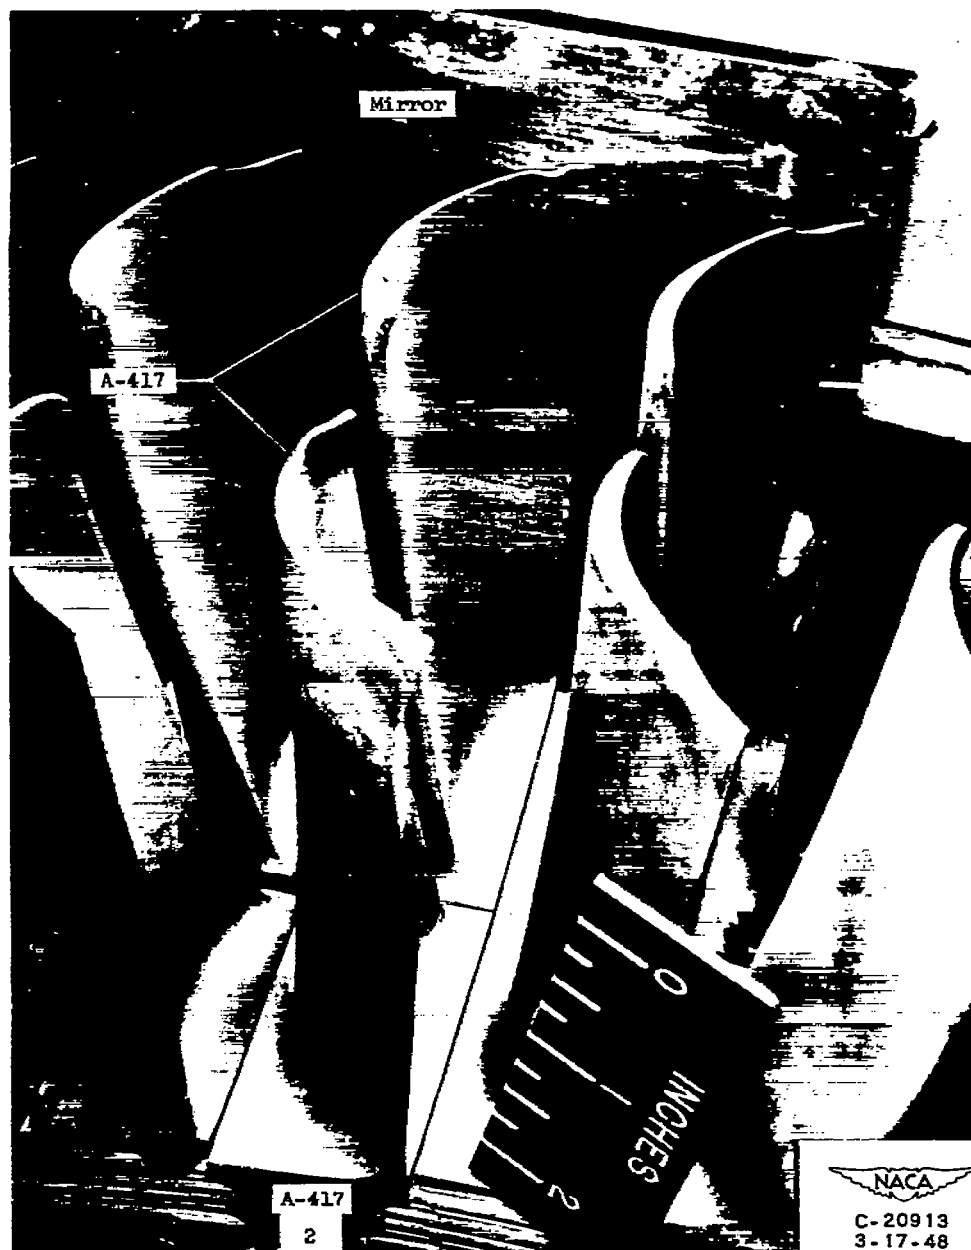
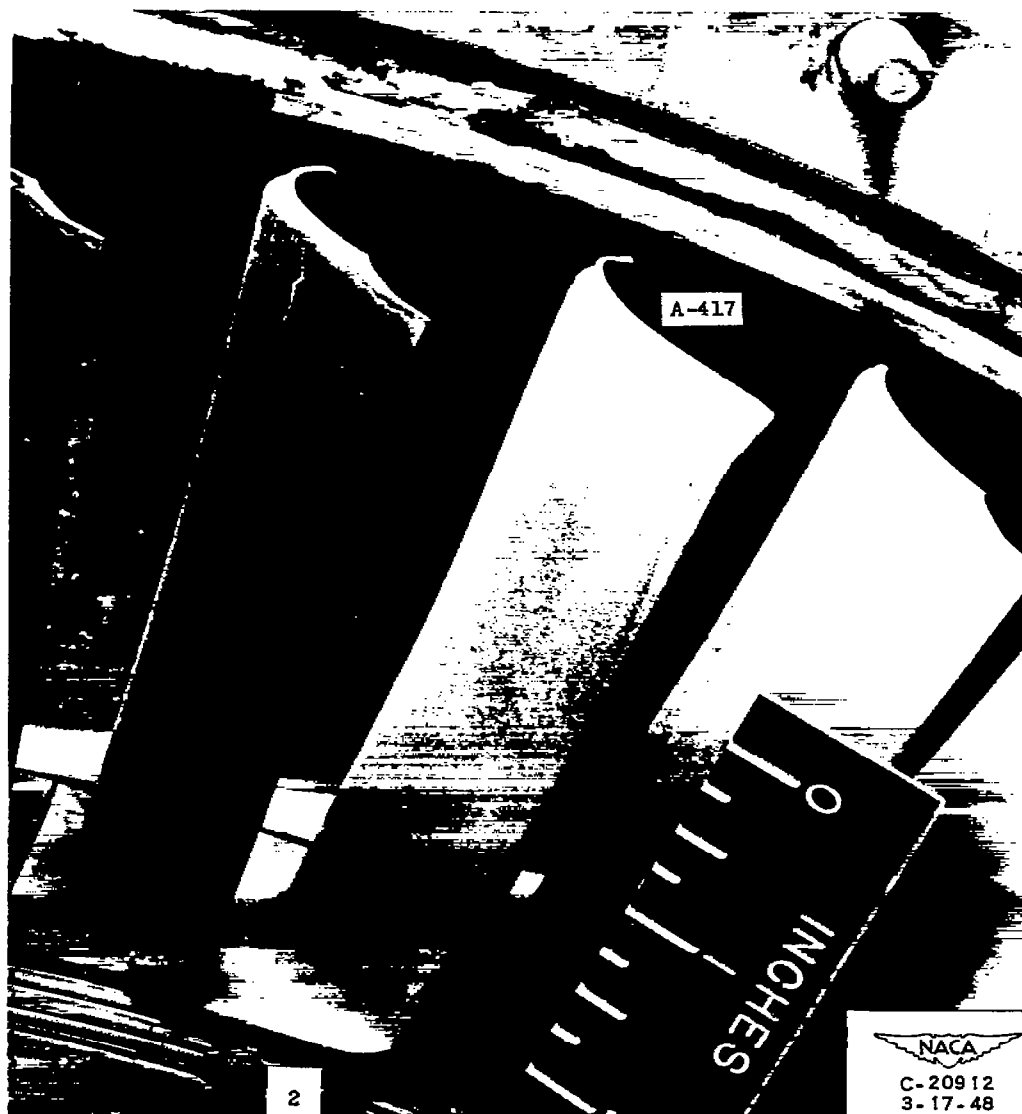
(a) Leading edge and mirror reflection of concave side.

Figure 6. - Turbine blade 2 after 100 engine operating cycles (33 hr, 20 min). Ceramic coating A-417.

(b) Trailing edge and convex side.
