October 1944 as  
Memorandum Report L4J19

RÉSUMÉ OF NACA STABILITY AND CONTROL TESTS  
OF THE BELL P-63 SERIES AIRPLANE

By Harold I. Johnson

Langley Memorial Aeronautical Laboratory  
Langley Field, Va.

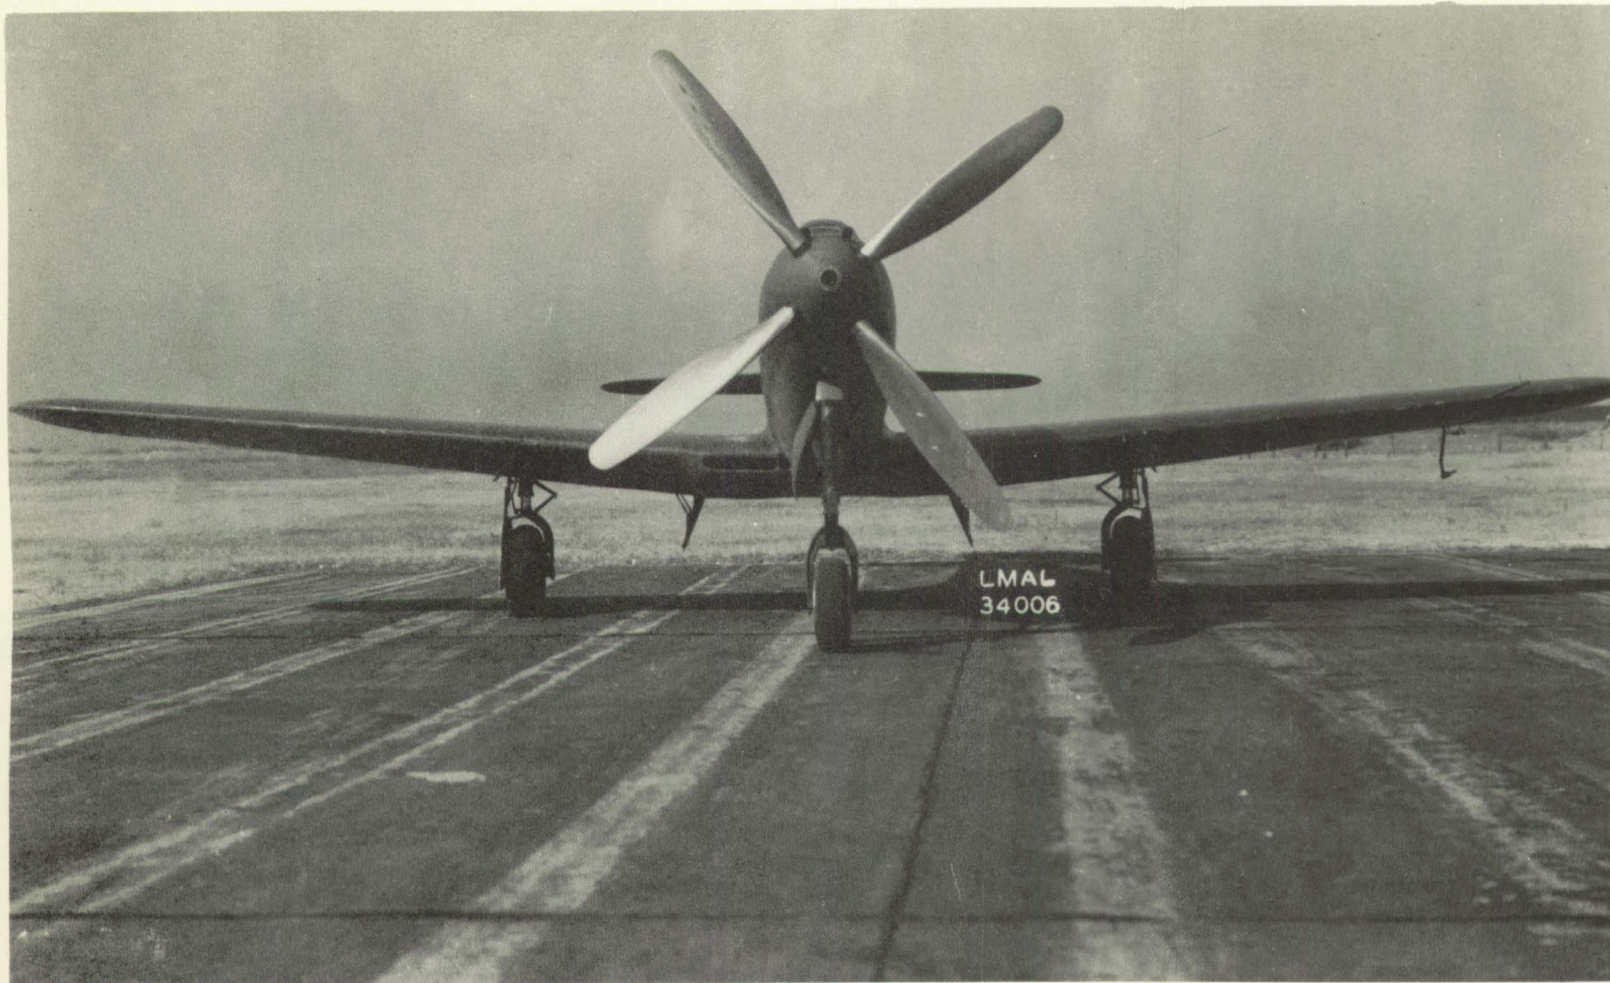
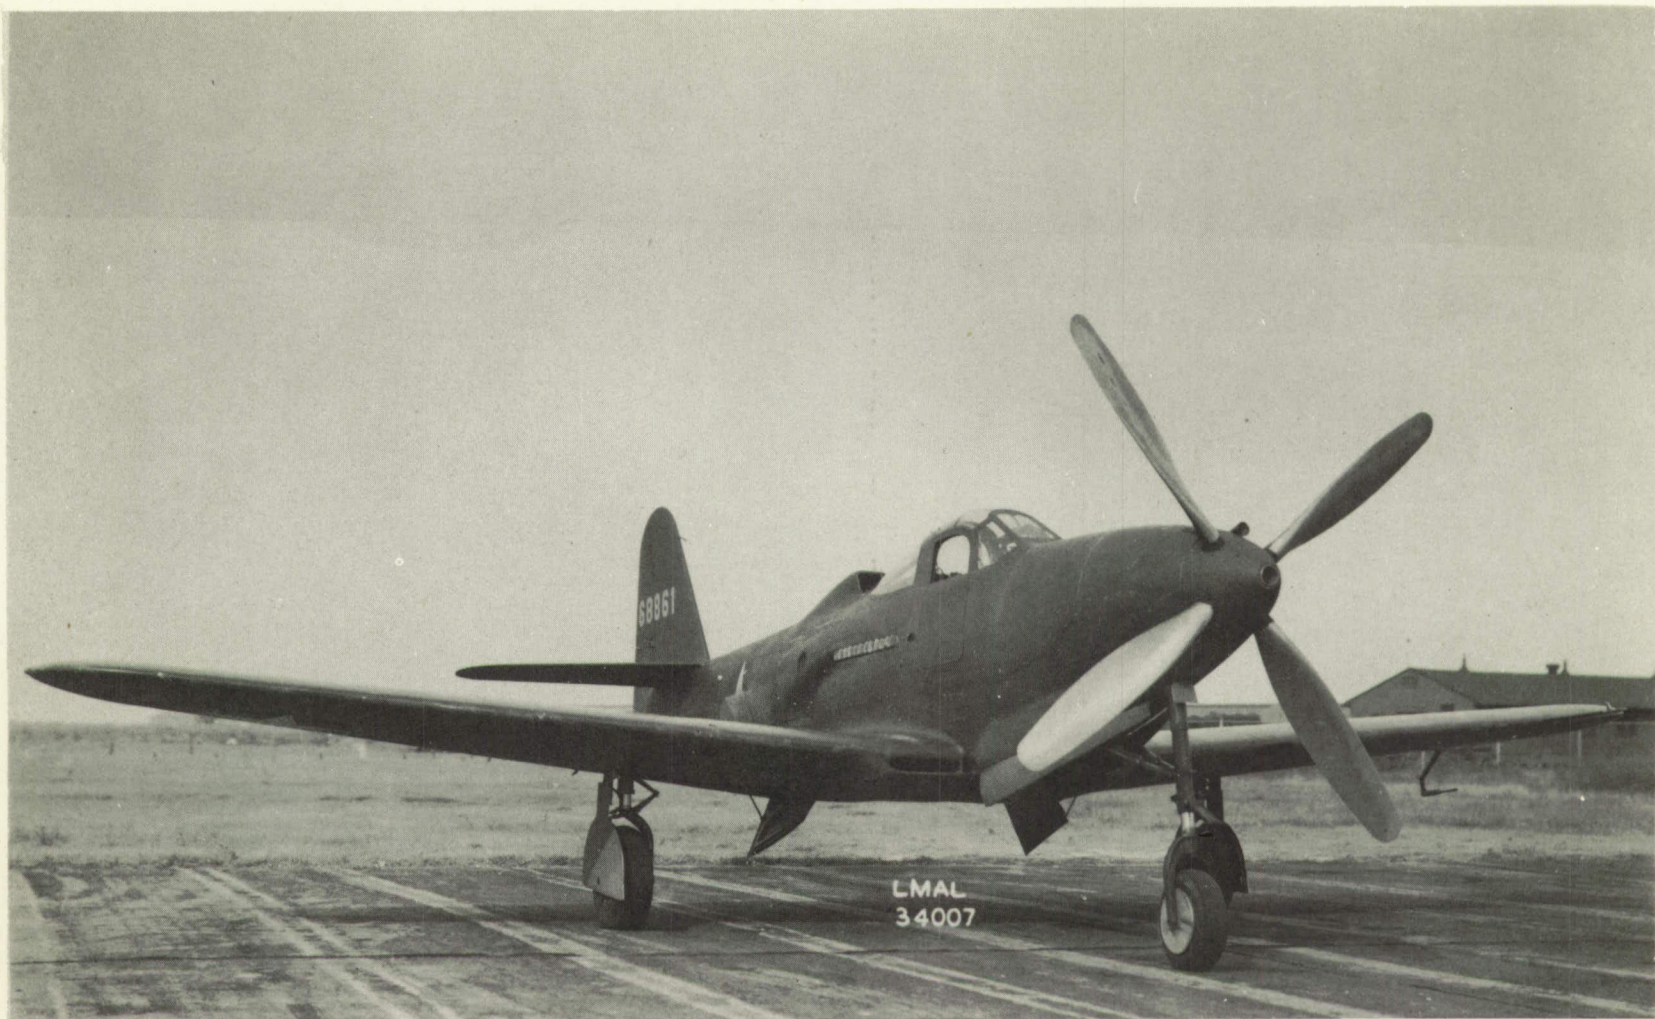
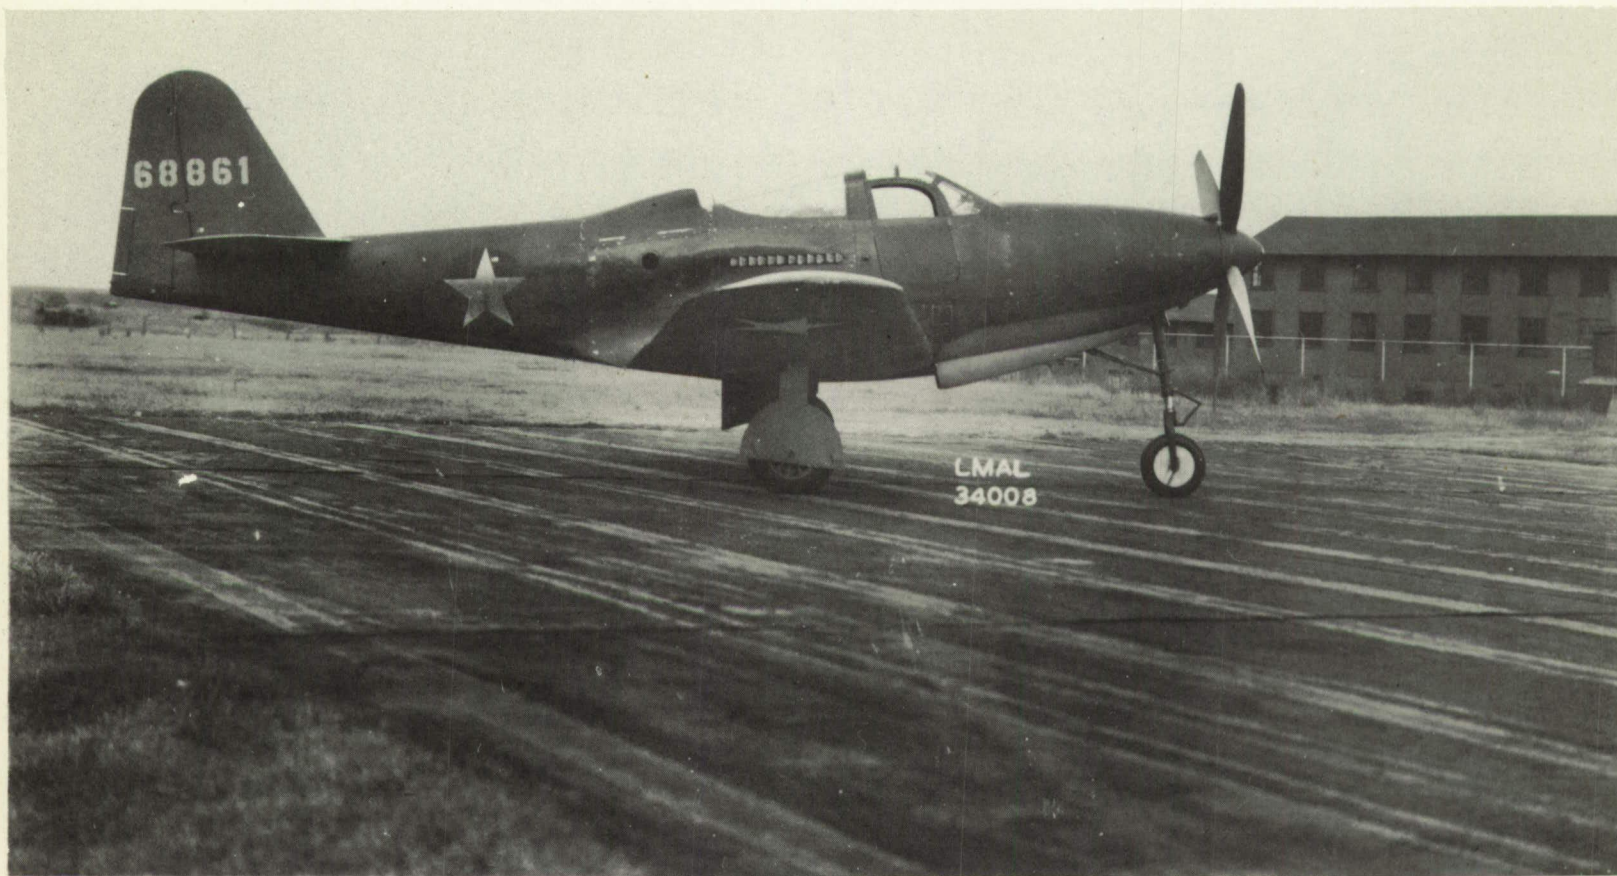
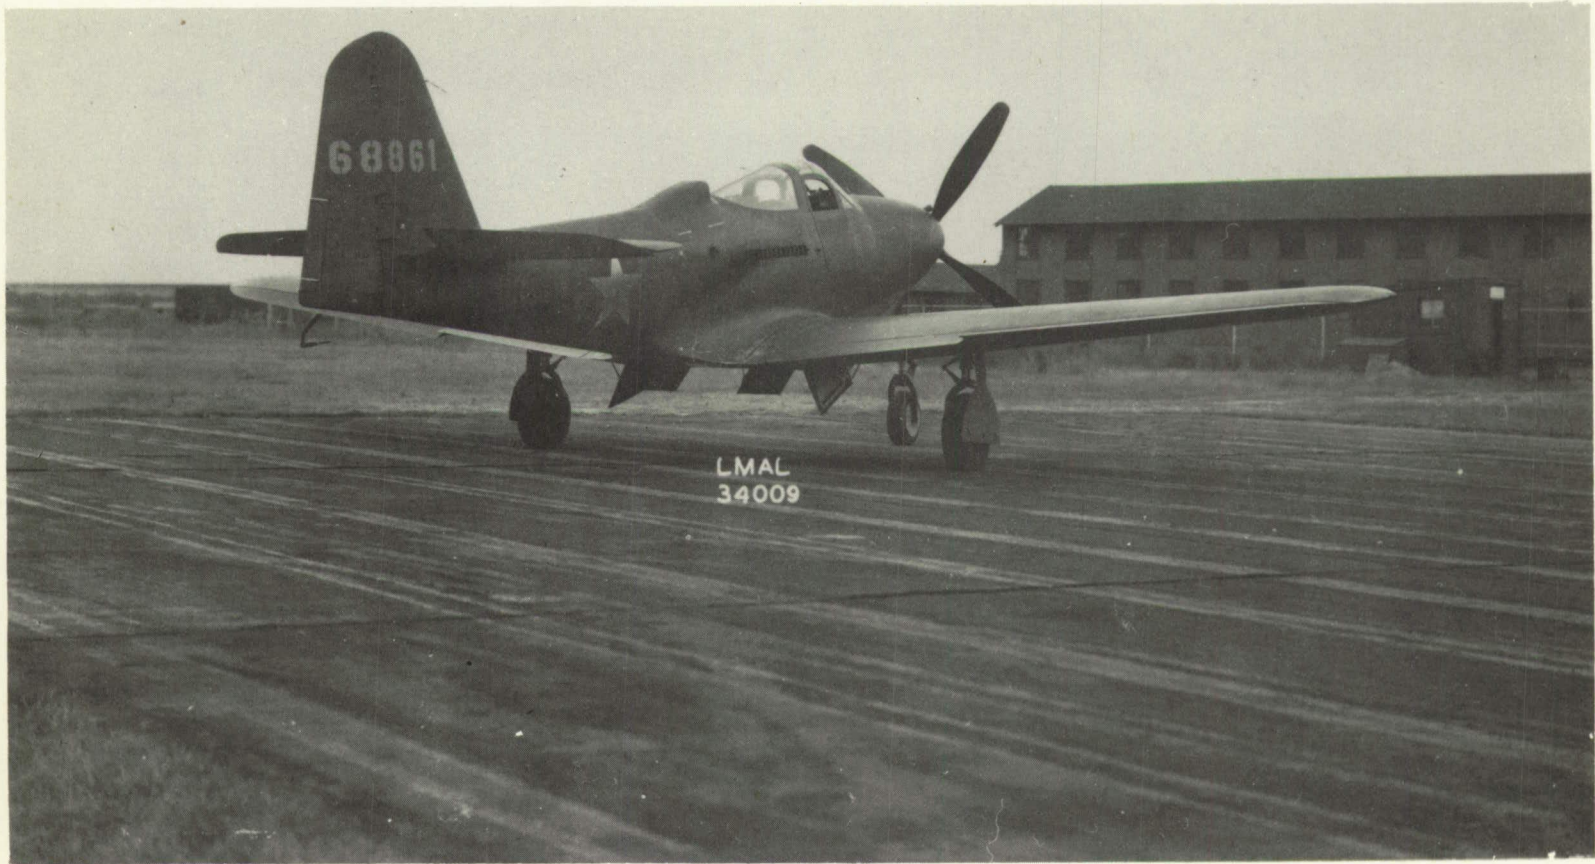
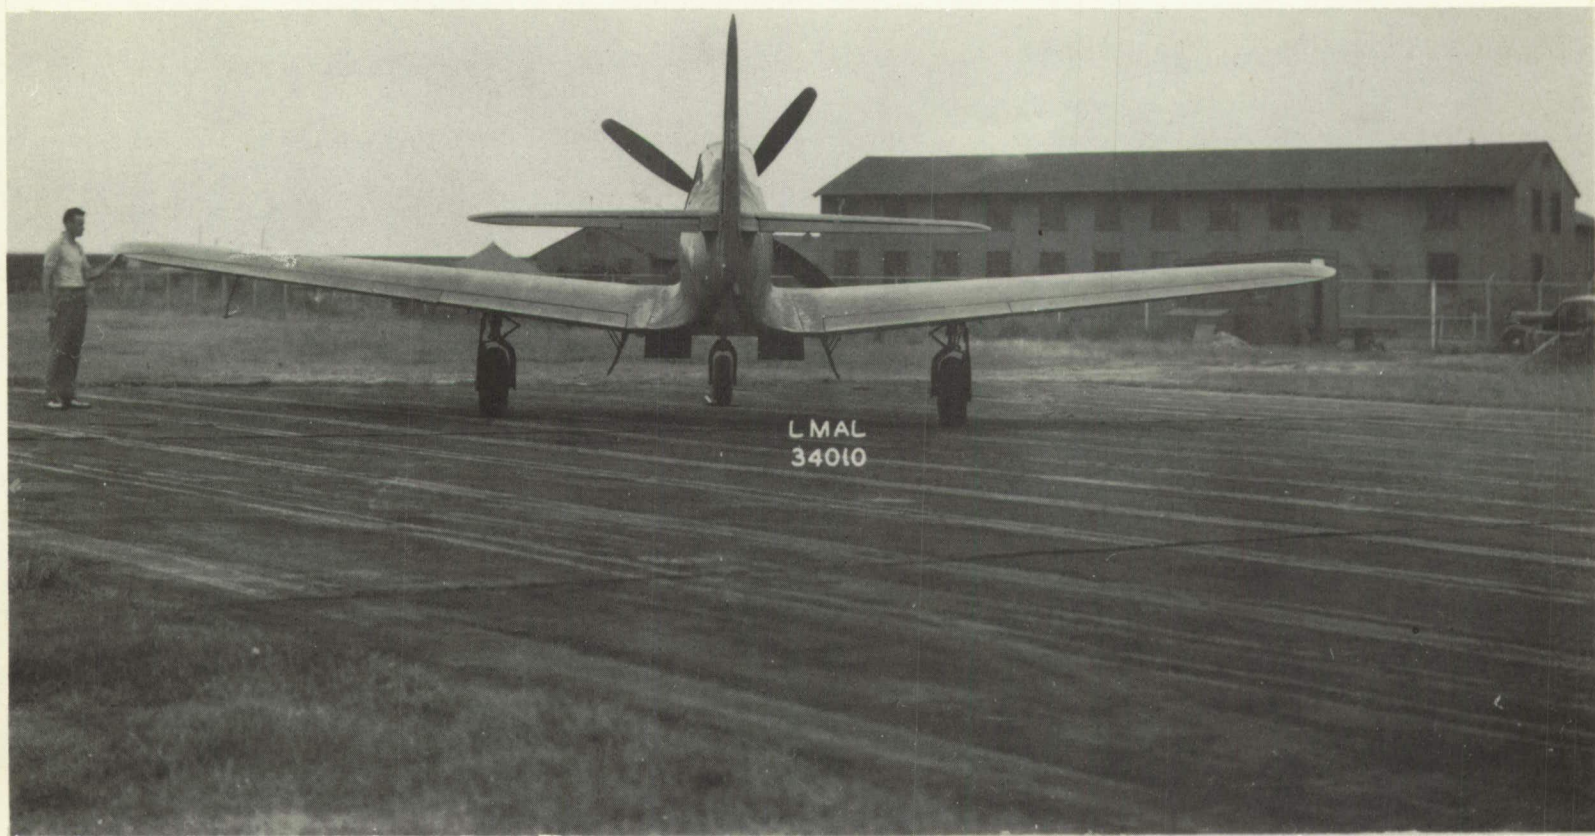
(a) Front view.

Figure 1.- Photographs of original Bell P-63A-1 airplane (AAF No. 42-68861).

(b) Three-quarter front view.

(c) Side view.

(d) Three-quarter rear view.

(e) Rear view.

Figure 1 contains five reproduced pictures of an early model P-63A-1 airplane. Figure 2 is a three-view drawing of the same airplane. Initial flight tests and nearly all wind-tunnel model tests were conducted with this version of the P-63 series airplane. Aileron dimensional characteristics are graphically portrayed in figure 3. The various horizontal-tail plan forms covered in flight tests of longitudinal stability are shown in figure 4. Figure 5 shows cross-sectional outlines of the different elevators tested in flight. Figure 6 describes the two different vertical tail surfaces used in the flight work done to improve the directional stability and control characteristics of the airplane. Finally, figure 7 shows photographs of the modified P-63A-1 airplane as it is presently being tested. The airplane represented by figure 7 differs from that shown by figure 1 in that it is equipped with larger horizontal and vertical tail surfaces and has a dorsal fin.

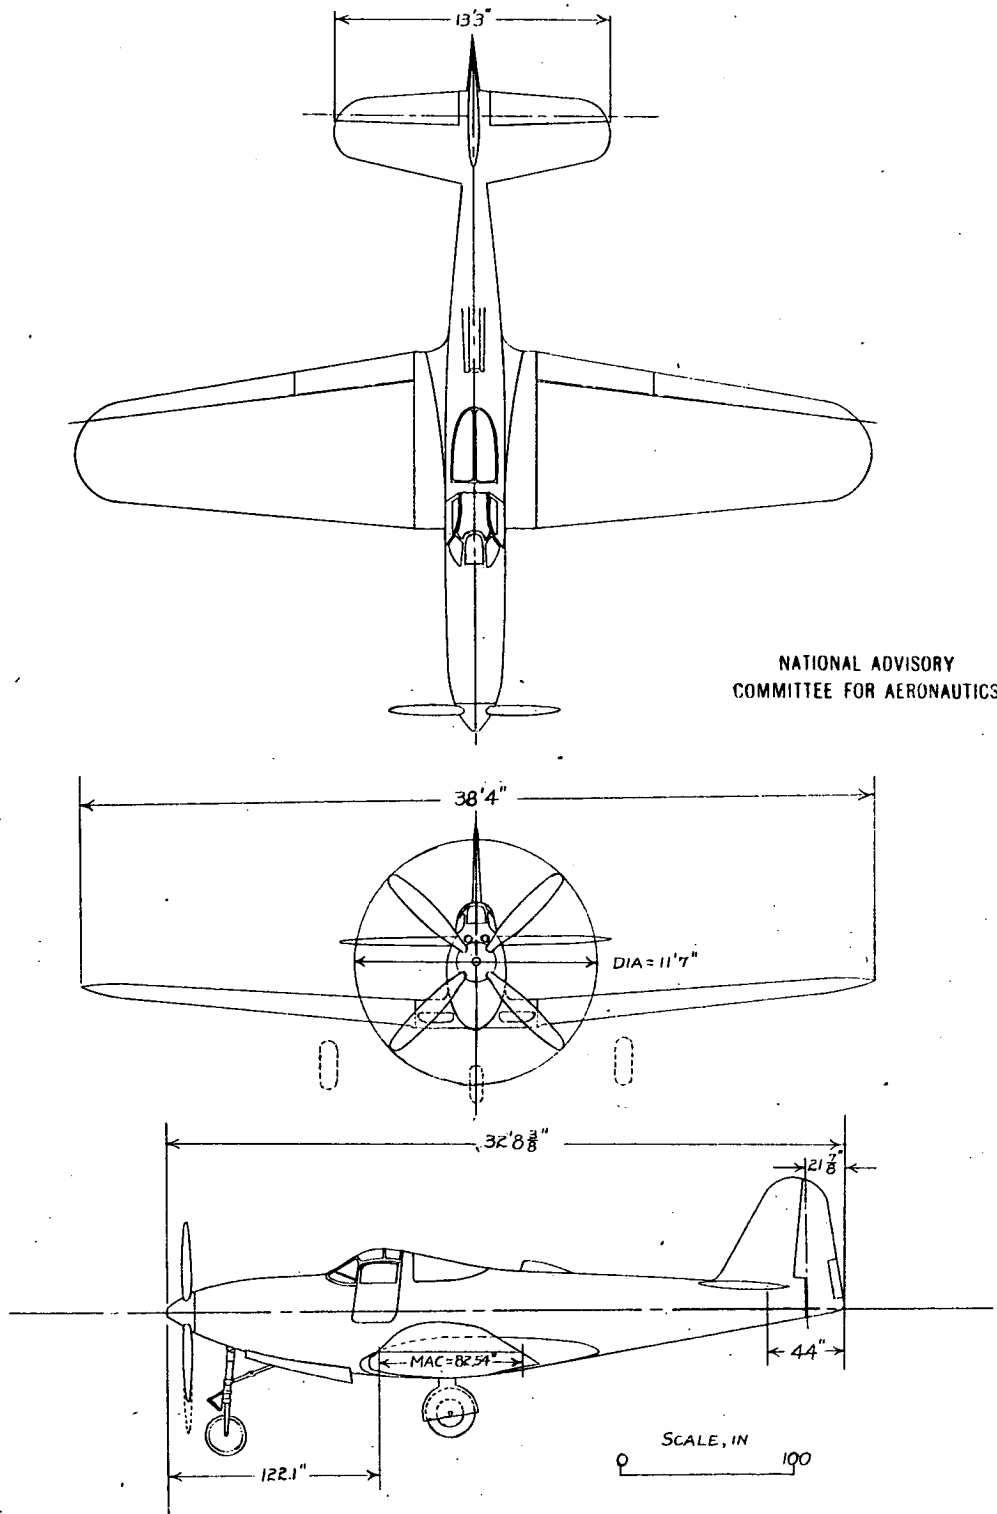
Figure 2.- Three-view drawing of original Bell P-63A-1 airplane.

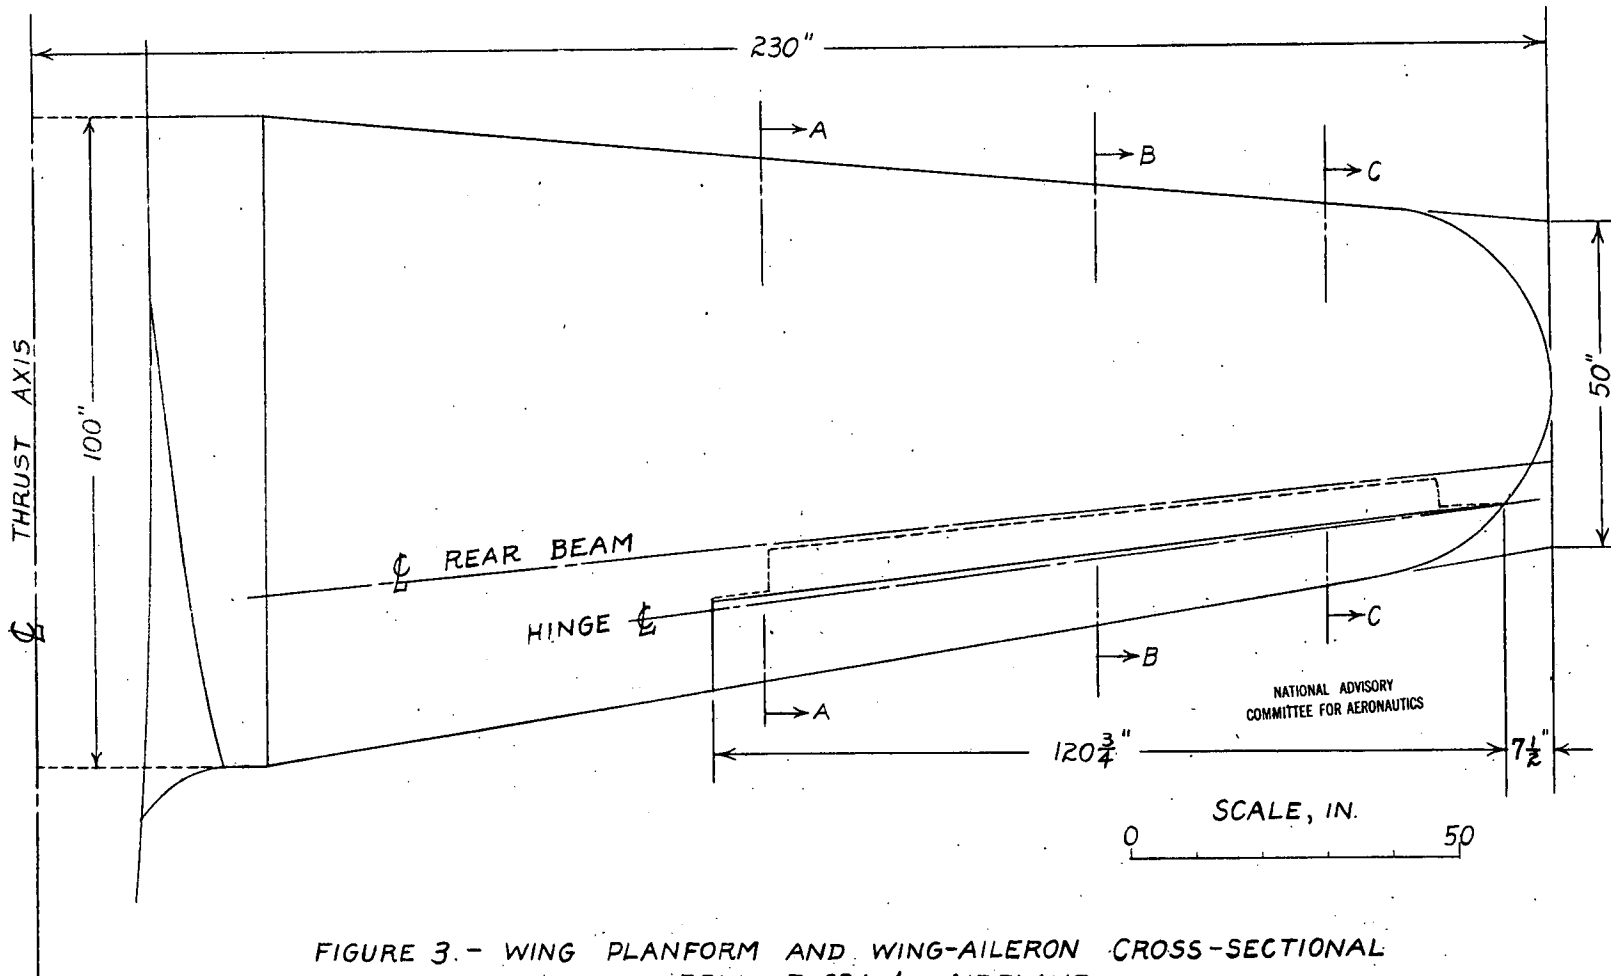
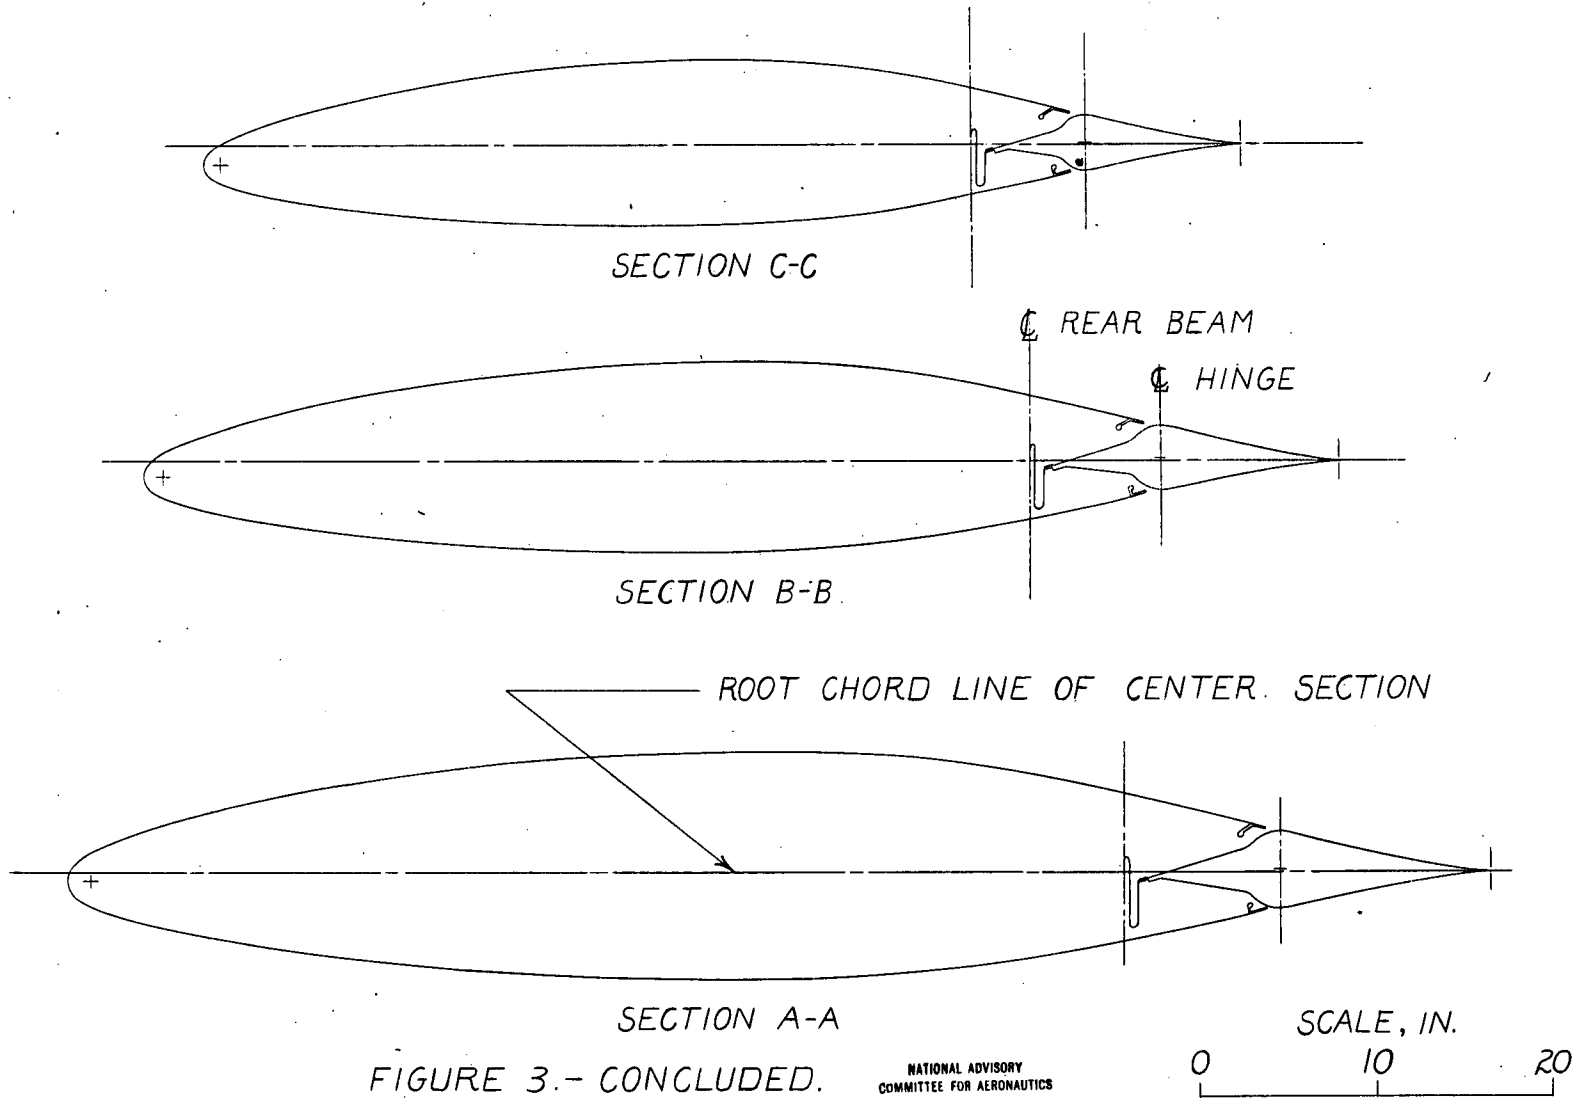
FIGURE 3. - WING PLANFORM AND WING-AILERON CROSS-SECTIONAL OUTLINES OF BELL P-63A-1 AIRPLANE.

(A) WING PLANFORM.

(B) WING-AILERON CROSS-SECTIONAL OUTLINES.

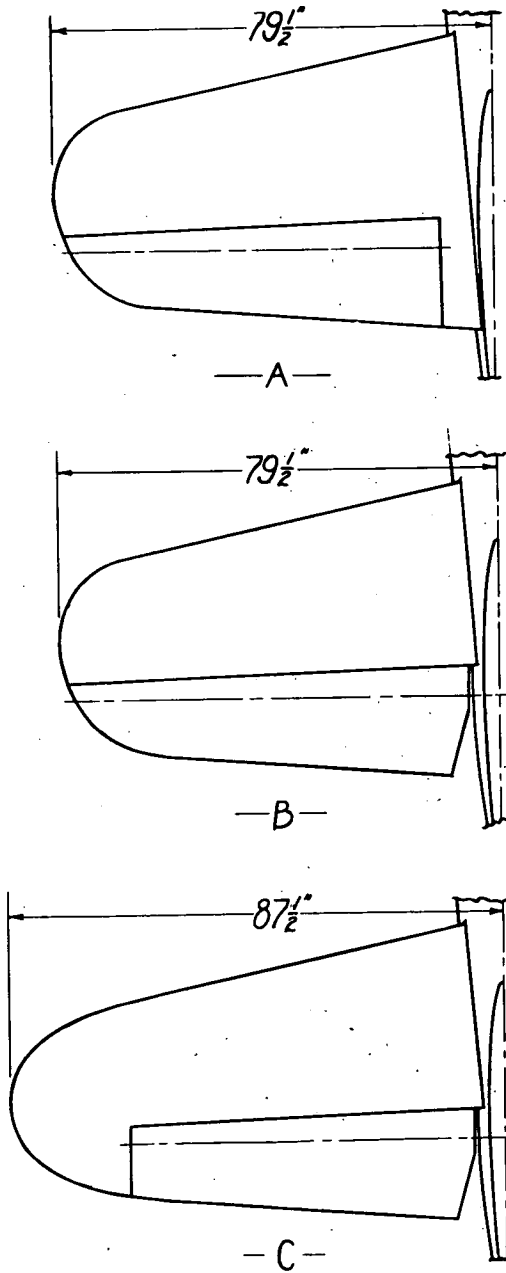
Figure 4. - Planforms of horizontal tails tested on the P-63A-1-BE airplane

The original P-63A-1 horizontal tail surfaces had the plan form shown in figure 4(a). The elevator was fabric covered and its ribs were  $8\frac{1}{2}$  inches apart on the average. The elevator section shape is shown in figure 5(a). It may be noted that the elevator surfaces in the trailing-edge region were flat and formed an acute angle of about  $13^\circ$ . The original stabilizer incidence was  $2.7^\circ$  nose up with respect to the airplane thrust axis.

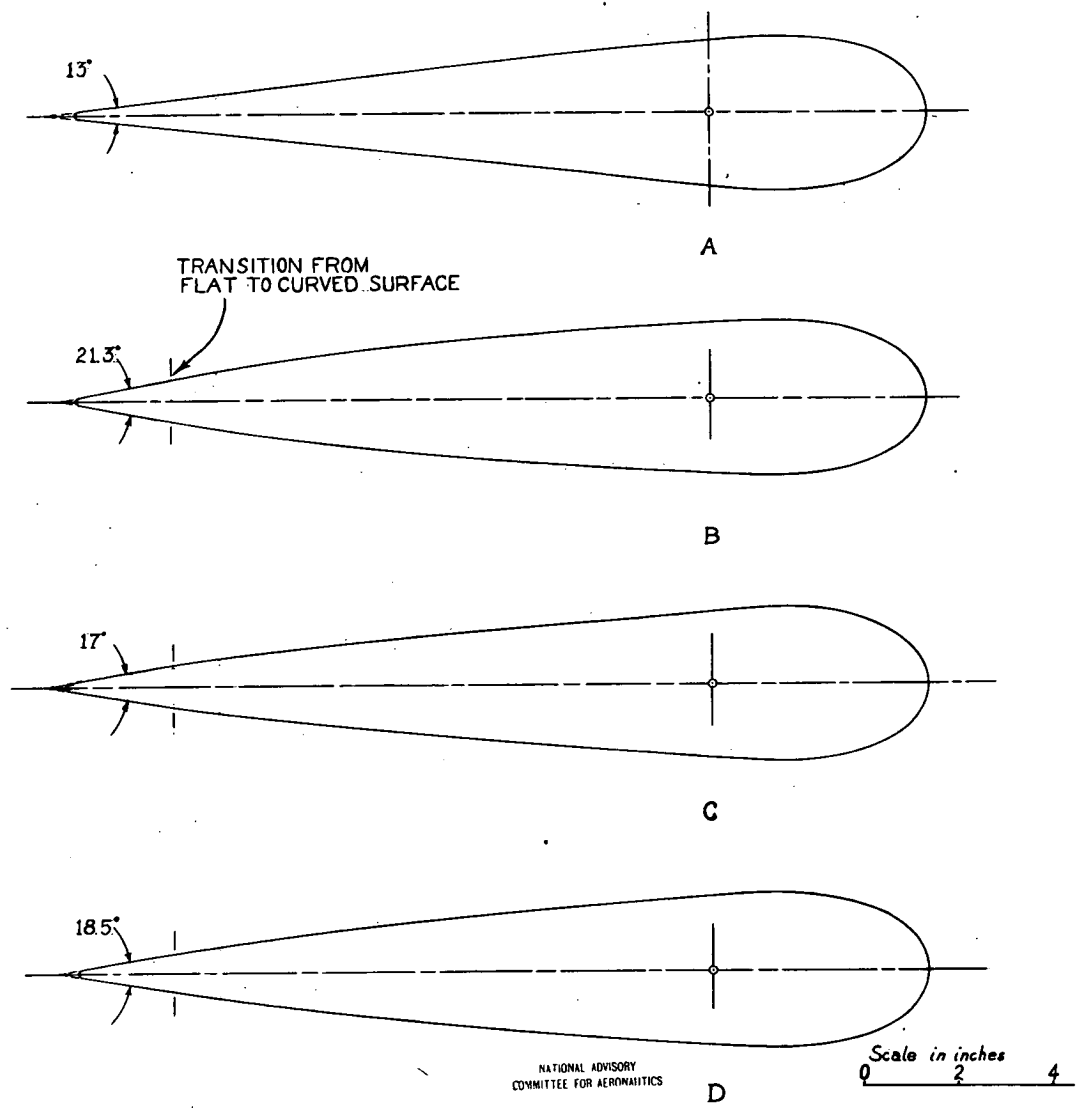
FIGURE 5-CROSS-SECTIONAL OUTLINES OF THE VARIOUS ELEVATORS TESTED ON THE P-63A-1 AIRPLANE. SECTIONS ARE FOR SPANWISE STATIONS 15 INCHES FROM AIRPLANE CENTERLINE.

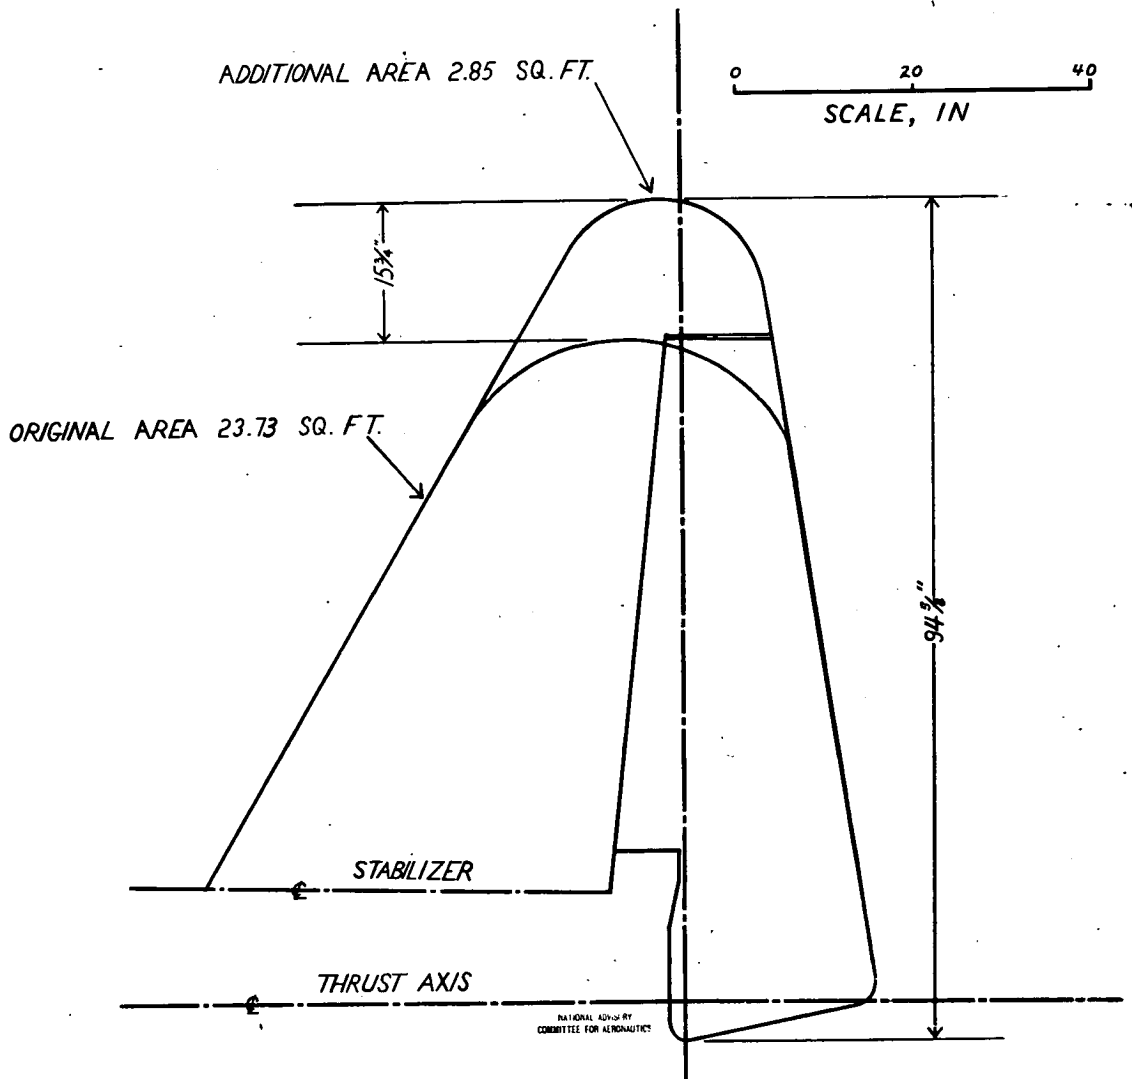
FIGURE 6. - ORIGINAL AND ENLARGED VERTICAL TAIL SURFACES TESTED ON P-63A-1 AIRPLANE

## Vertical tail (plan forms shown in fig. 6):

Original	Enlarged
Height along hinge center line, in. . . . .	78.87	94.62
Total area, sq ft . . . . .	23.73	26.58
Fin area, sq ft . . . . .	13.47	15.96
Total rudder area, sq ft . . . . .	10.26	10.62
Rudder area aft of hinge center line, sq ft . . . . .	8.30	8.65
Rudder area forward of hinge center line, sq ft . . . . .	1.96	1.97
Rudder trim tab area, sq ft . . . . .	0.84	0.84
Distance rudder hinge center line to L.E. of M.A.C., in. . . . .	248.40	248.40
Fin offset from thrust axis, deg. . . . .	0	0
Rudder travel, deg. . . . .	±30	±30

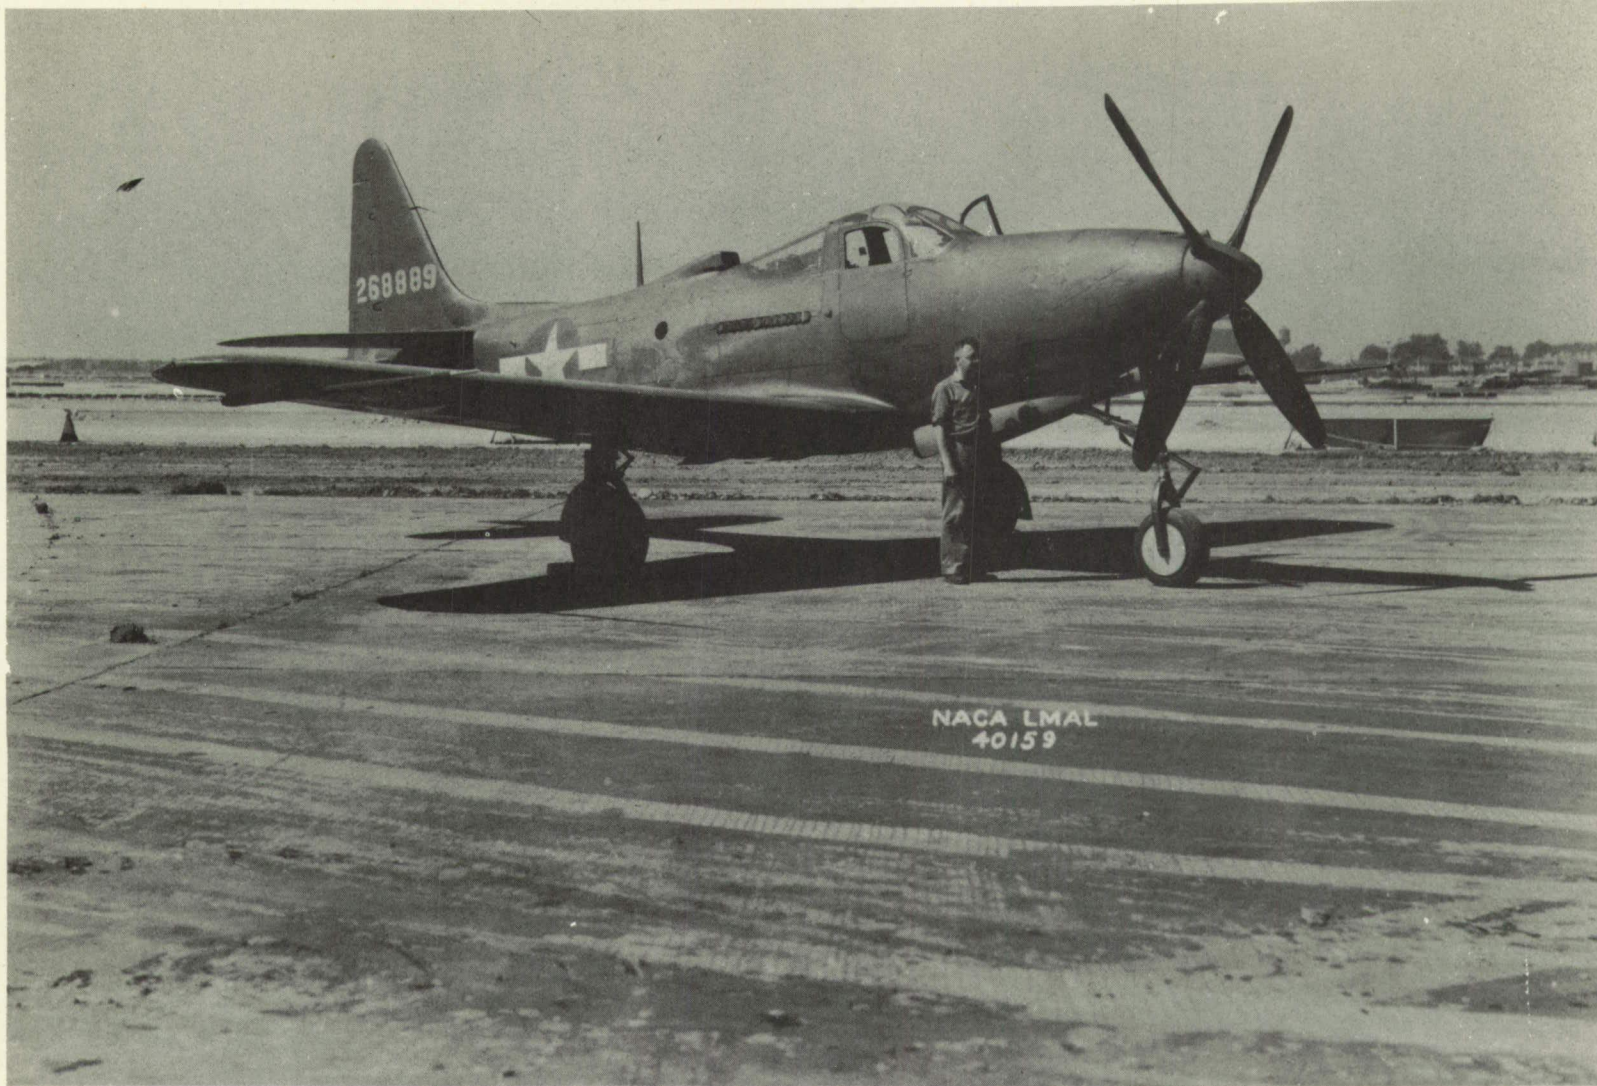
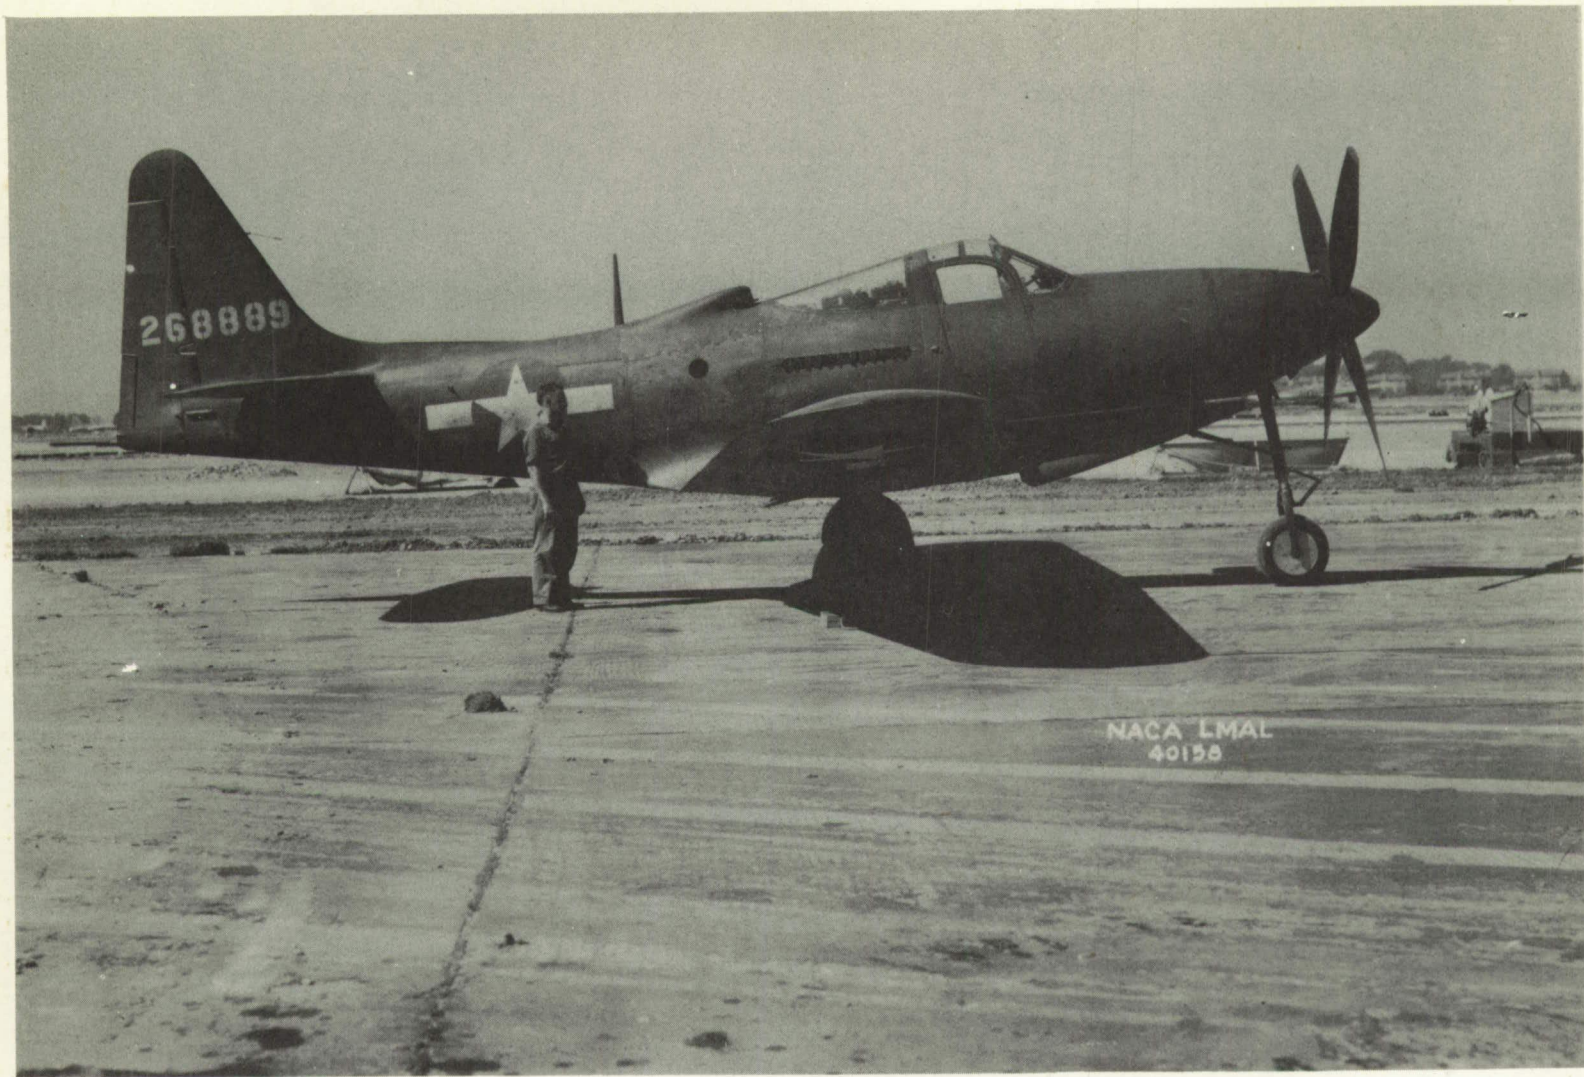
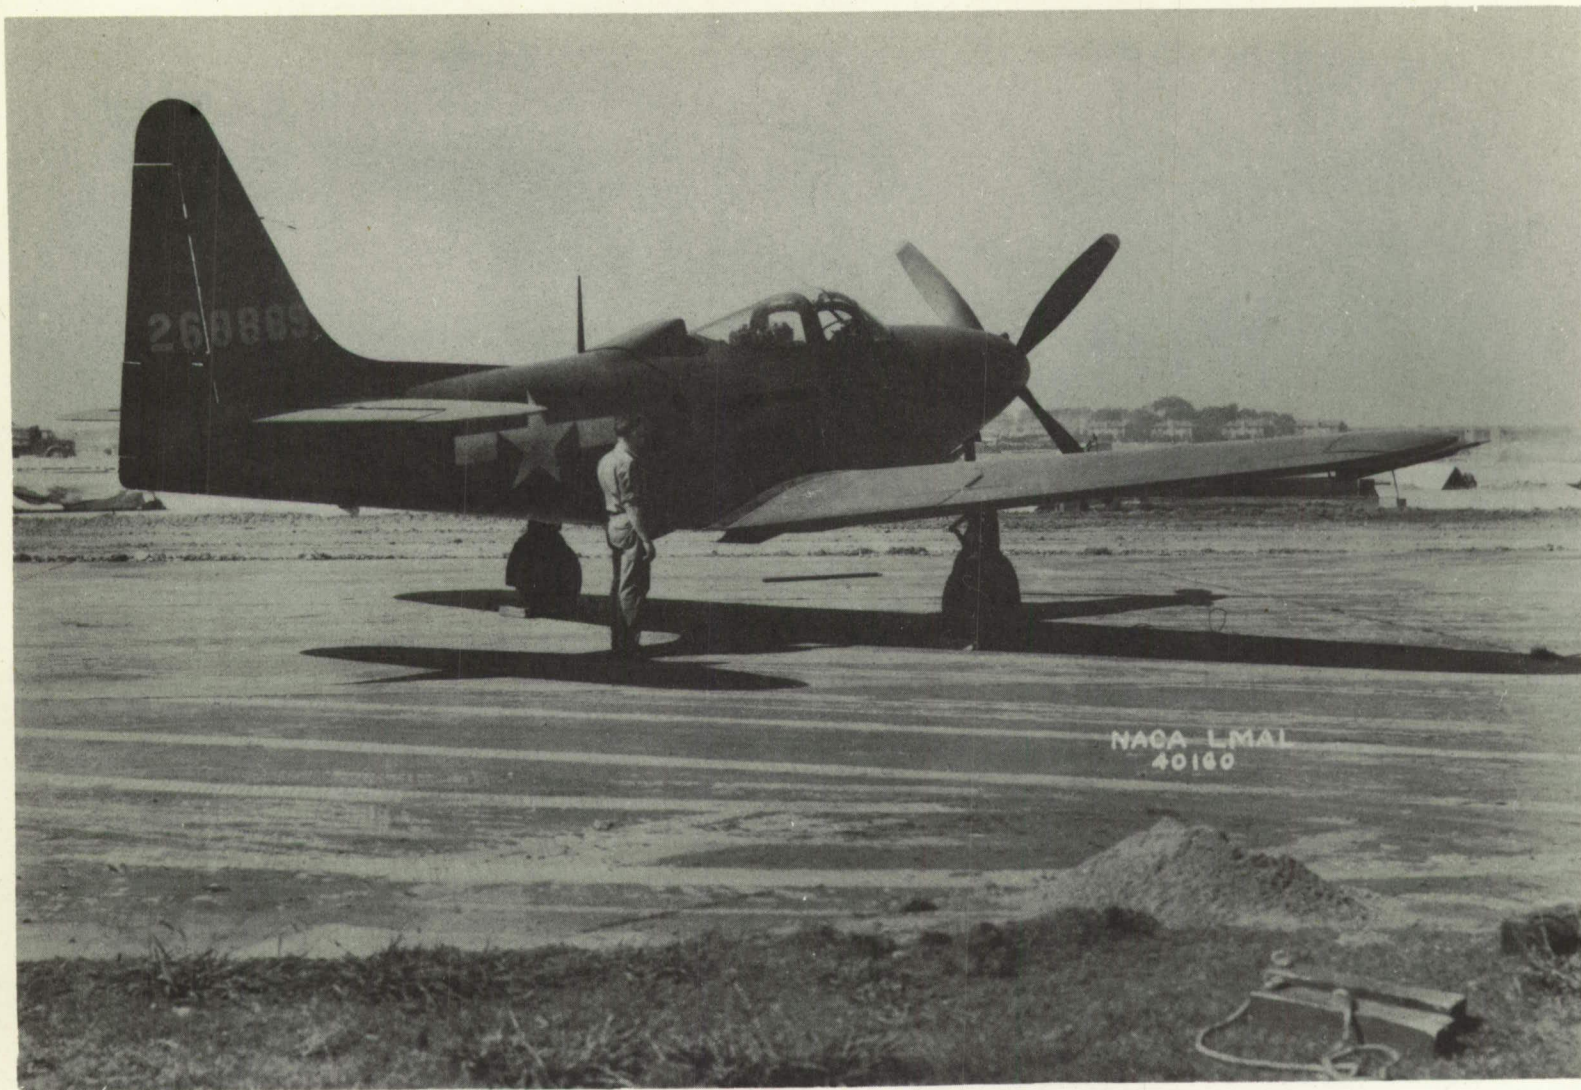
(a) Three-quarter front view.

Figure 7.- Three-view photographs of modified P-63A-1-BE airplane presently being tested at the NACA.

(b) Side view.

(c) Three-quarter rear view.

During the course of the longitudinal-stability flight test programs, it was found that the directional stability of the P-63A-1 airplane was inadequate. In turn entries, small inadvertent motions of the rudder caused large amounts of skidding. Also, in certain steady flight conditions, an undamped directional oscillation existed even when the pilot attempted to hold all the controls absolutely fixed. A time history of such an oscillation is shown in figure 31. Due to the apparent weak directional stability of the airplane, measurements of its directional characteristics in typical maneuvers were made and then the same tests were repeated after an enlarged vertical tail had been installed to make the directional stability more satisfactory. Outlines of both the original and enlarged vertical tails tested are shown in figure 6. Dimensional characteristics of both vertical tails are given in the appendix. Figure 7 contains reproduced views of the airplane with

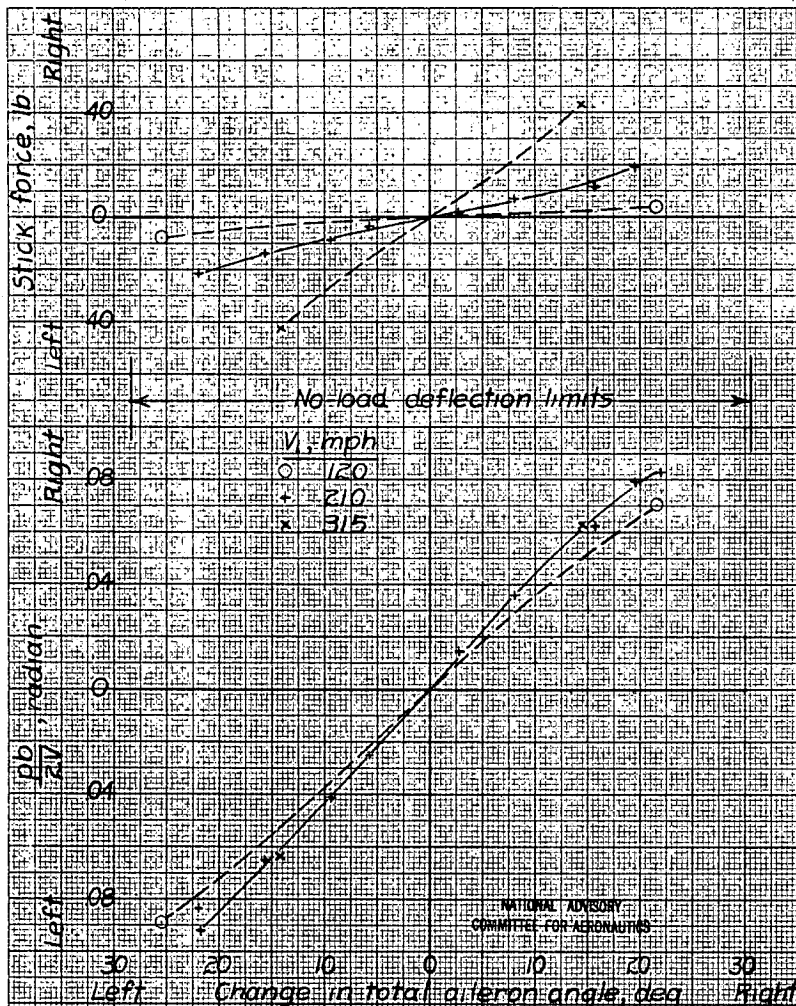
Figure 8.- Aileron stick forces and wing-tip helix angles plotted against estimated true change in total aileron angle. Bell P-63A-1 airplane, power for level flight, clean condition.

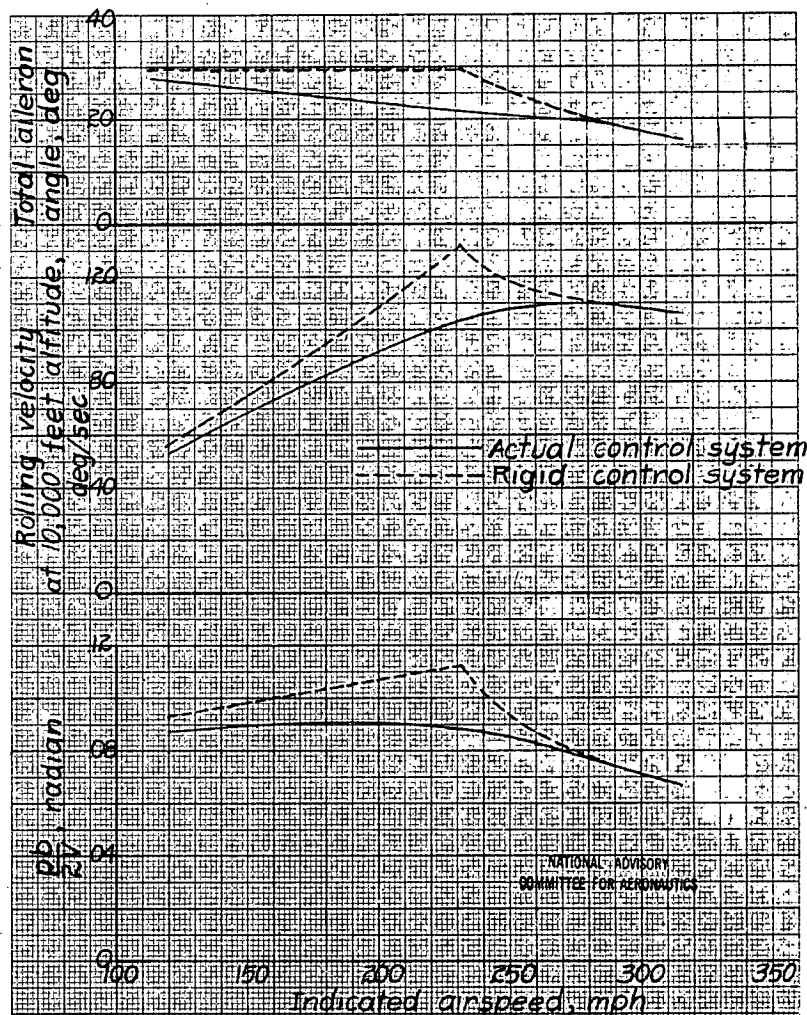
Figure 9.- Estimated average rolling performance of Bell P-63A-1 airplane with 50 pound stick force.
