October 1944 as  
Memorandum Report L4J19

RÉSUMÉ OF NACA STABILITY AND CONTROL TESTS  
OF THE BELL P-63 SERIES AIRPLANE

By Harold I. Johnson

Langley Memorial Aeronautical Laboratory  
Langley Field, Va.

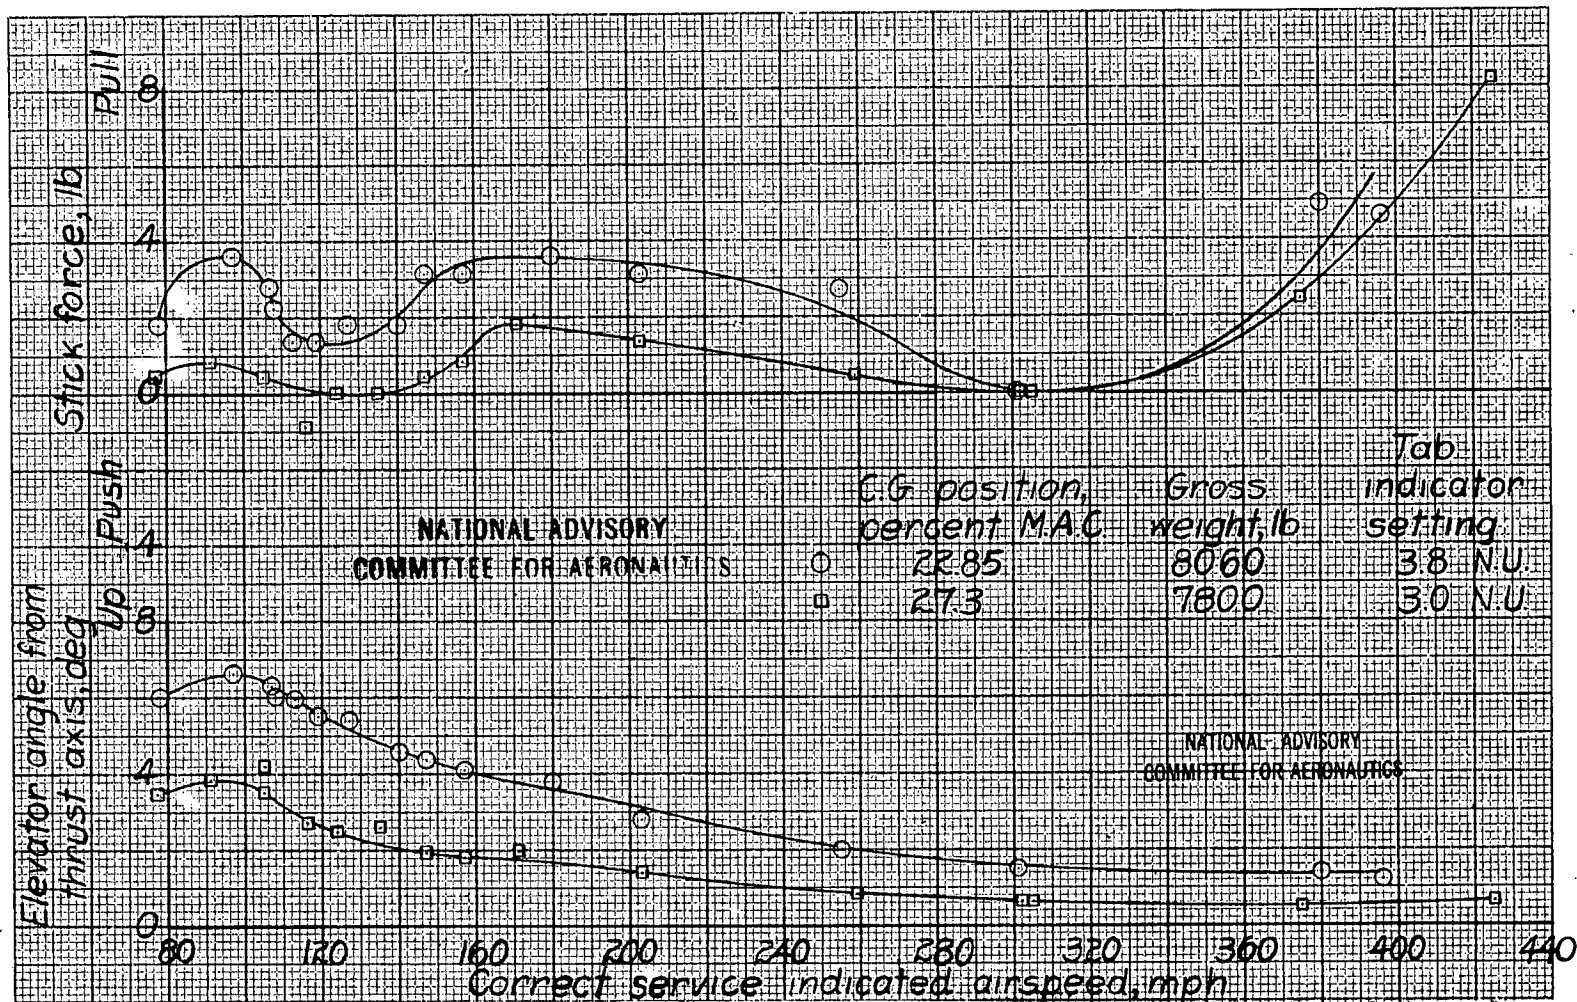
Figure 10.- Variation of stick force and elevator angle required to trim the Bell P-63A-1 airplane in straight flight plotted as a function of indicated airspeed for two center-of-gravity positions. Normal rated power at 10,000 feet (2600 RPM, 43 in. Hg), all cooling shutters locked in closed position, flaps and gear retracted.

Static longitudinal stability.- The static longitudinal stability of the original P-63A-1 airplane is shown in figures 10 and 11 for power on and power off, respectively. When the airplane was trimmed for zero elevator stick force at 300 miles per hour indicated airspeed, the variation of stick force with speed always went in the wrong direction at higher speeds. This characteristic was extremely undesirable. It was caused by aeroelastic distortion of the horizontal stabilizer and elevator due to the combination of a too high positive stabilizer incidence and a very flexible elevator covering. Further analysis of the elevator-angle variations with speed indicated that the center of gravity for which neutral stability would occur with stick fixed was at 32 percent of the mean aerodynamic chord with either power on or off at 10,000 feet altitude for speeds at which the airplane would be flown for protracted periods of time. The significance of this measurement is that it establishes an extreme rearward center-of-gravity limit beyond which the airplane should not be flown even if acceptable stick-force characteristics are present. As can be seen from figures 10 and 11, the stick-force characteristics of the original P-63A-1 airplane in straight flight were unsatisfactory at all center-of-gravity positions at high speed.

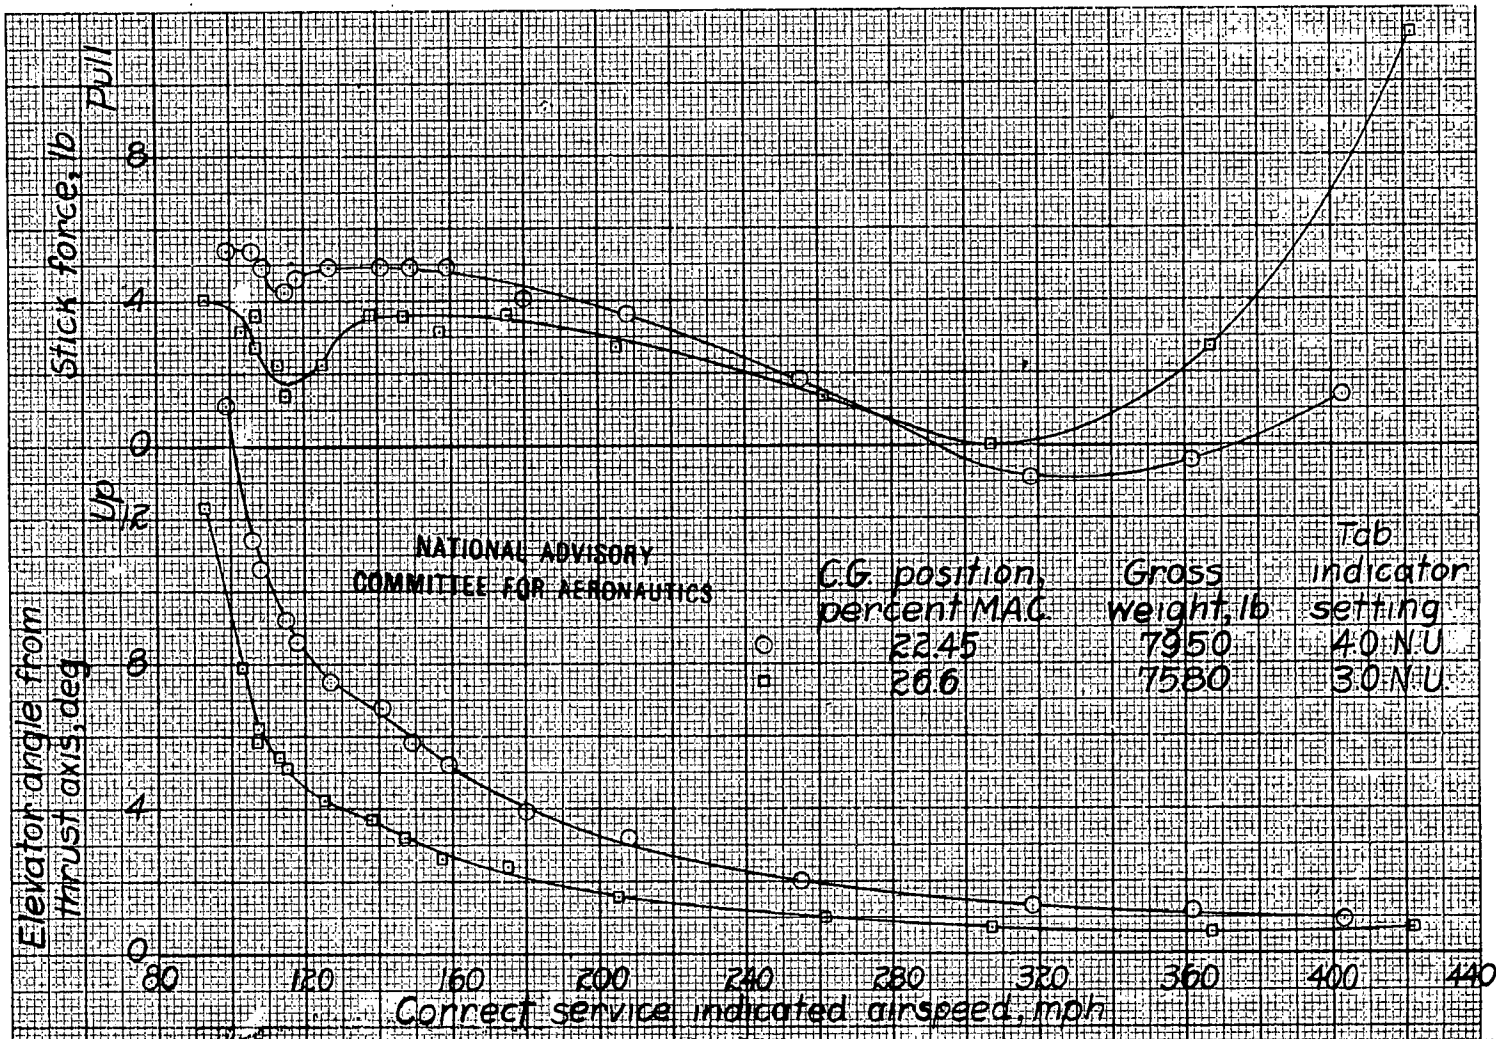
Figure 11.- Variation of stick force and elevator angle required to trim the Bell P-63A-1 airplane in straight flight plotted as a function of indicated airspeed for two center-of-gravity positions. Engine idling; all cooling shutters locked in closed position, flaps and gear retracted.

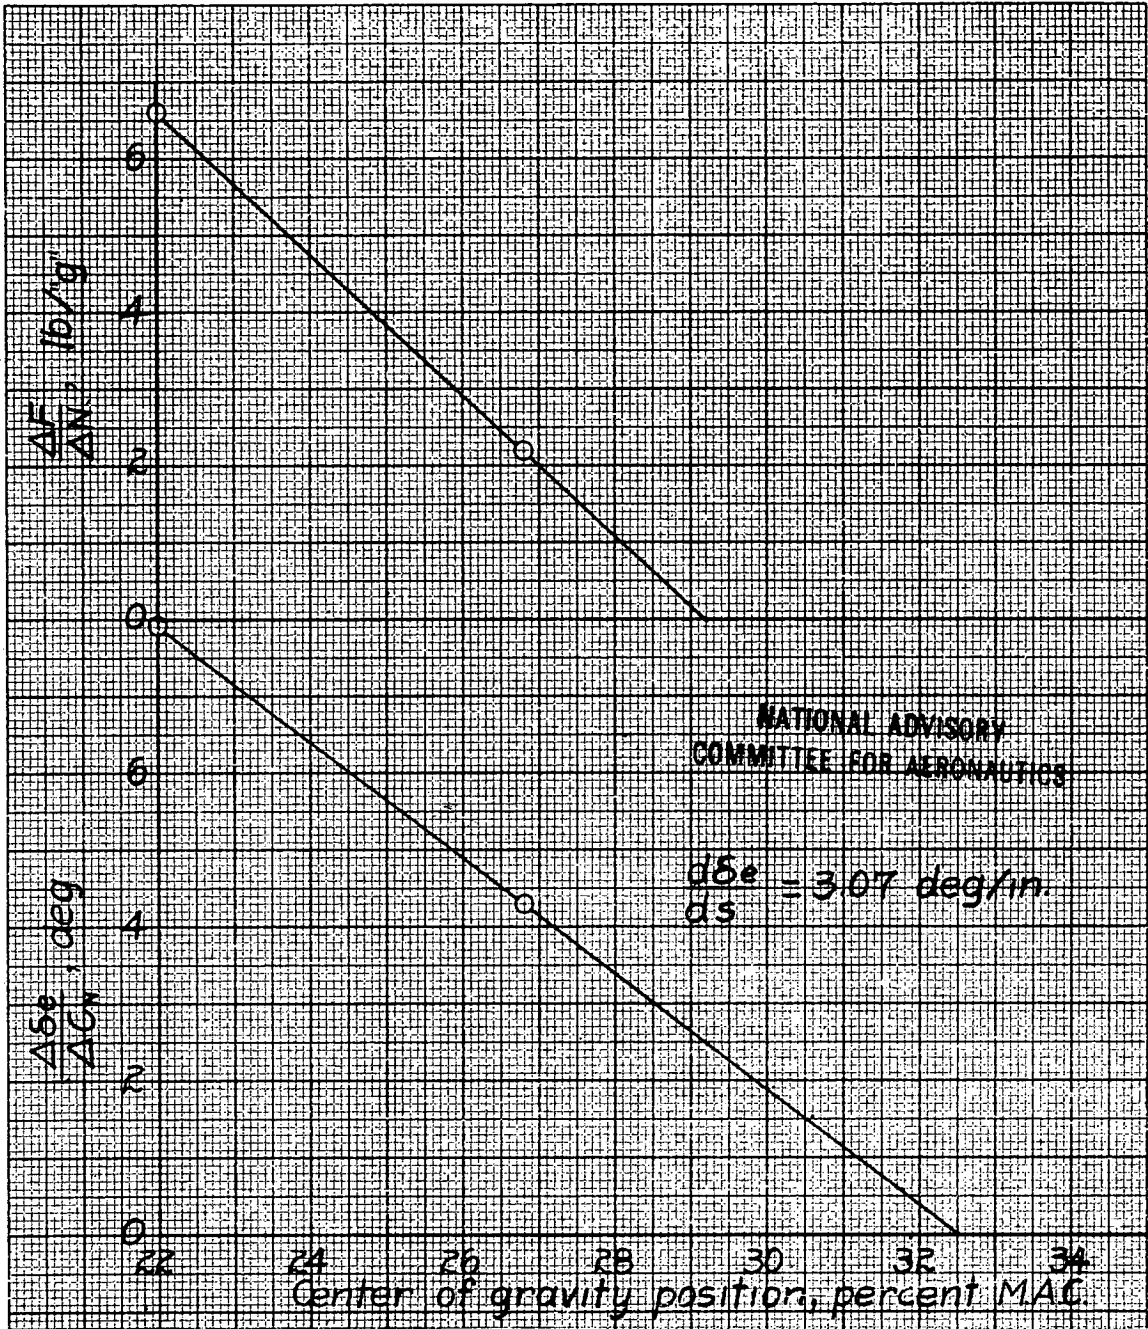
Figure 12.- Summary of the longitudinal stability and control characteristics of an original P-63A-1 airplane (AAF No. 42-68861) in steady turning flight with normal rated power at 10,000 feet altitude (2600 RPM, 43 in. Hg). Clean condition, all cooling shutters locked in closed position.

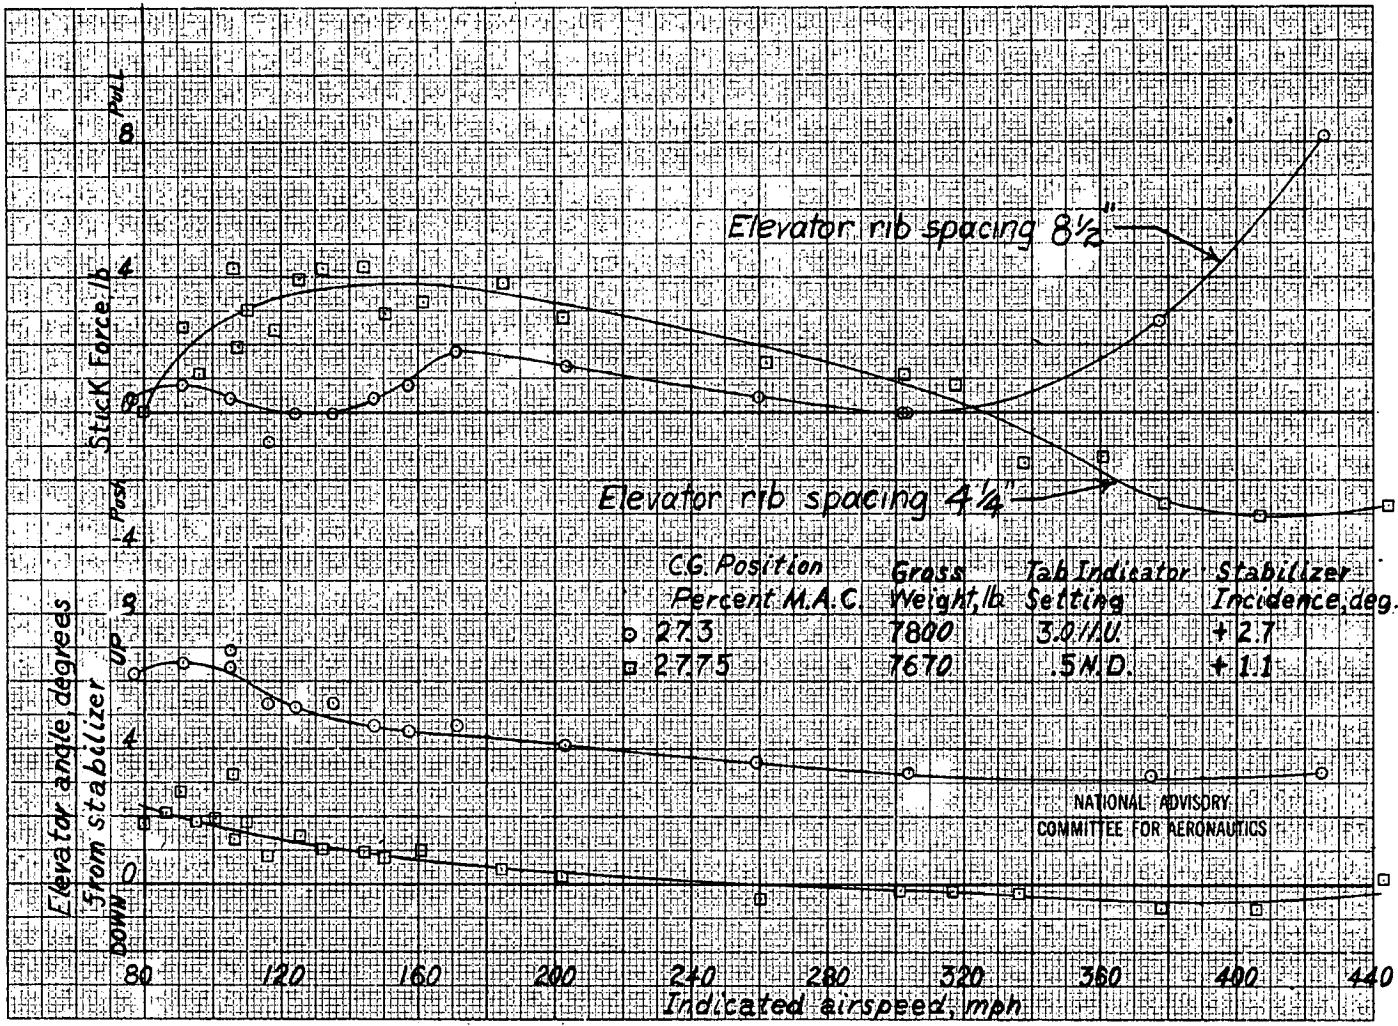
Figure 15.- Data showing the effect of stabilizer incidence setting and stiffness of elevator fabric covering on the static longitudinal stability characteristics of a P-63A-1 airplane (AAF No. 42-68889). Clean condition, normal rated power (2600 RPM, 43 in. Hg), altitude range 5-10,000 feet.

Figure 15 shows a comparison between static longitudinal stability characteristics of the original and modified stabilizer-incidence, elevator-stiffness combinations. It may be noted that with the stabilizer incidence at  $1.1^\circ$  the elevator is practically lined up with the stabilizer at high speeds so that there is practically no tendency for fabric bowing to warp the elevator mean camber line and hence cause undesirable stick-force variations. This is borne out by the stick-force measurements shown in figure 15 since no force reversal occurred with the lowered incidence, stiffer-elevator combination.

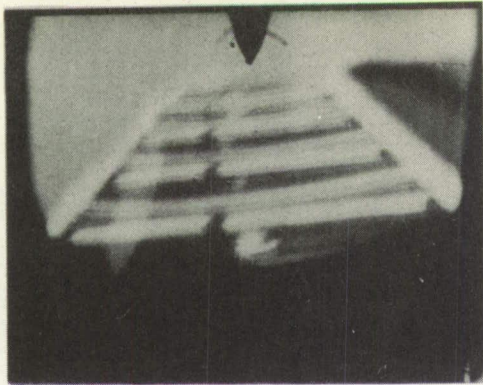
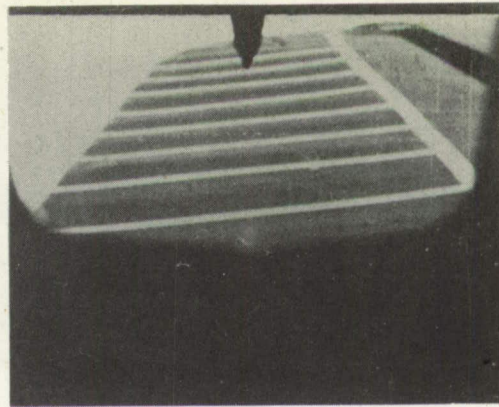
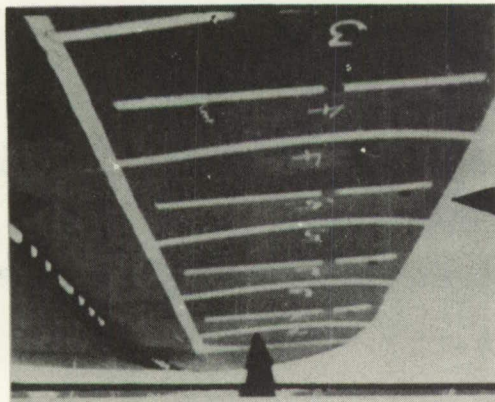
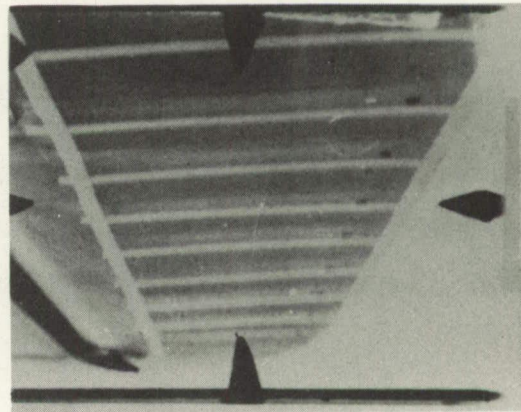
Figure 16.- Examples of photographs taken to investigate the effects of elevator fabric distortion.

(a) Original P-63A-1 elevator in straight flight at  $V_i = 350$  MPH. Elevator rib spacing  $8 \frac{1}{4}$  inches.

(b) Stiffened P-63A-1 elevator in straight flight at  $V_i = 350$  MPH. Elevator rib spacing  $4 \frac{1}{4}$  inches.

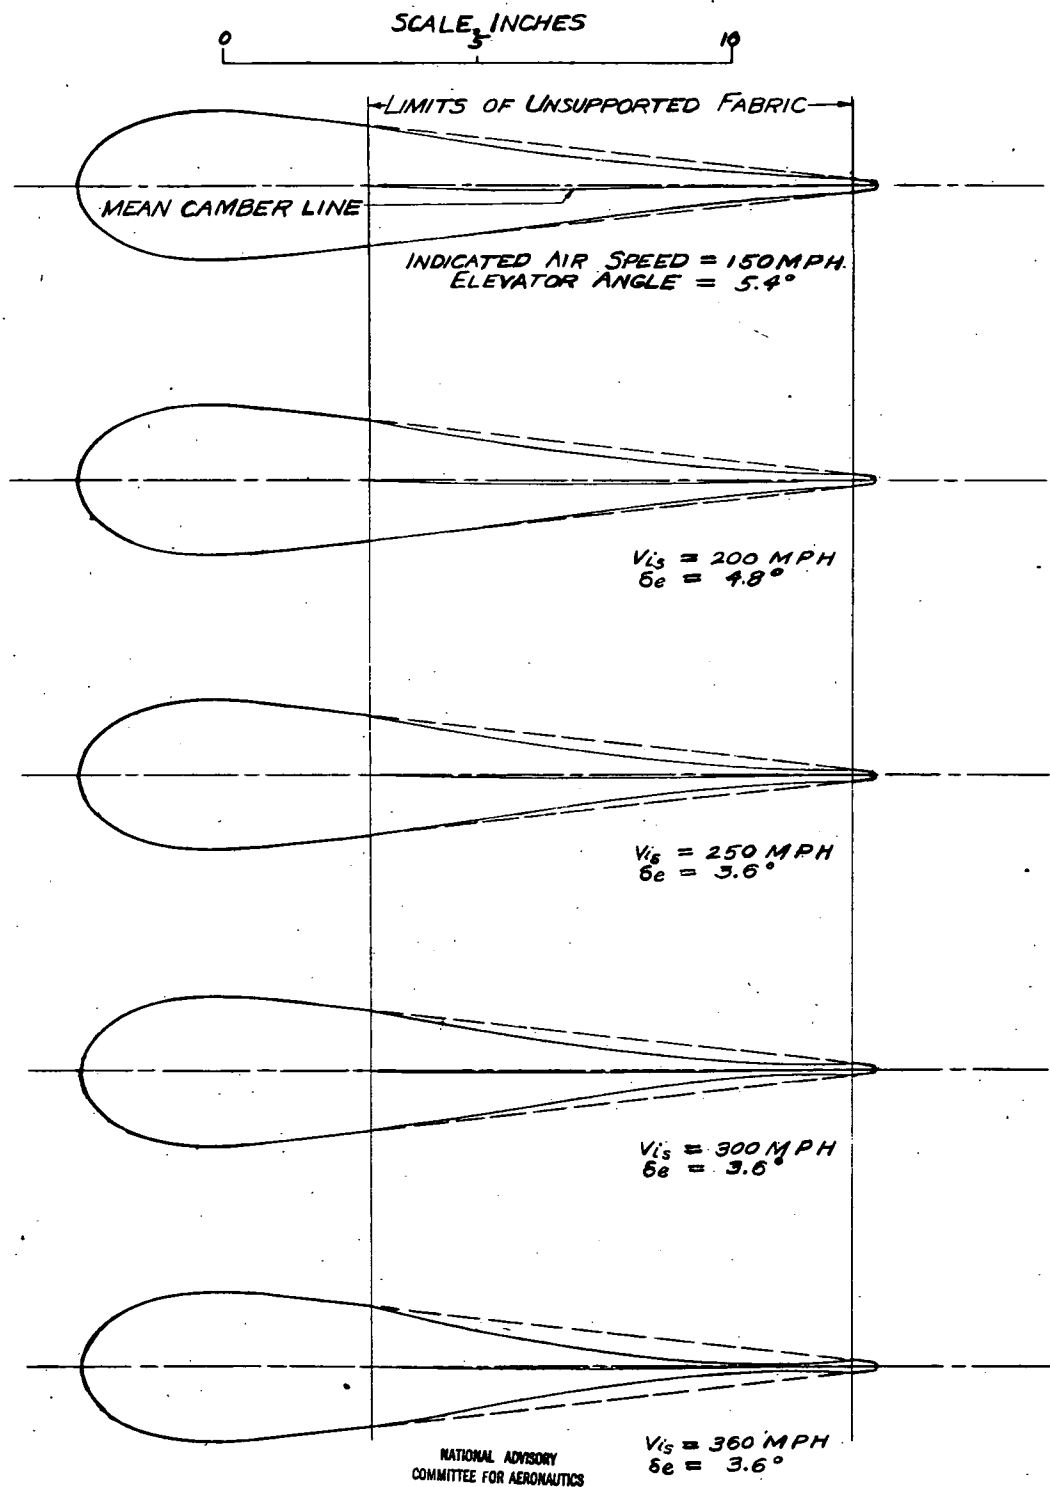
FIGURE 17.- ELEVATOR SECTIONS AT CENTER OF PANEL NUMBER 4 (FIGURE 13) SHOWING THE VARIATION OF FABRIC DEFLECTION WITH INDICATED AIRSPEED AT AN ACCELERATION OF  $1g$ . ELEVATOR ANGLES ARE GIVEN WITH RESPECT TO STABILIZER. (+ = UP); STABILIZER INCIDENCE  $2.7^\circ$  ELEVATOR RIB SPACING  $8\frac{1}{2}$  INCHES.

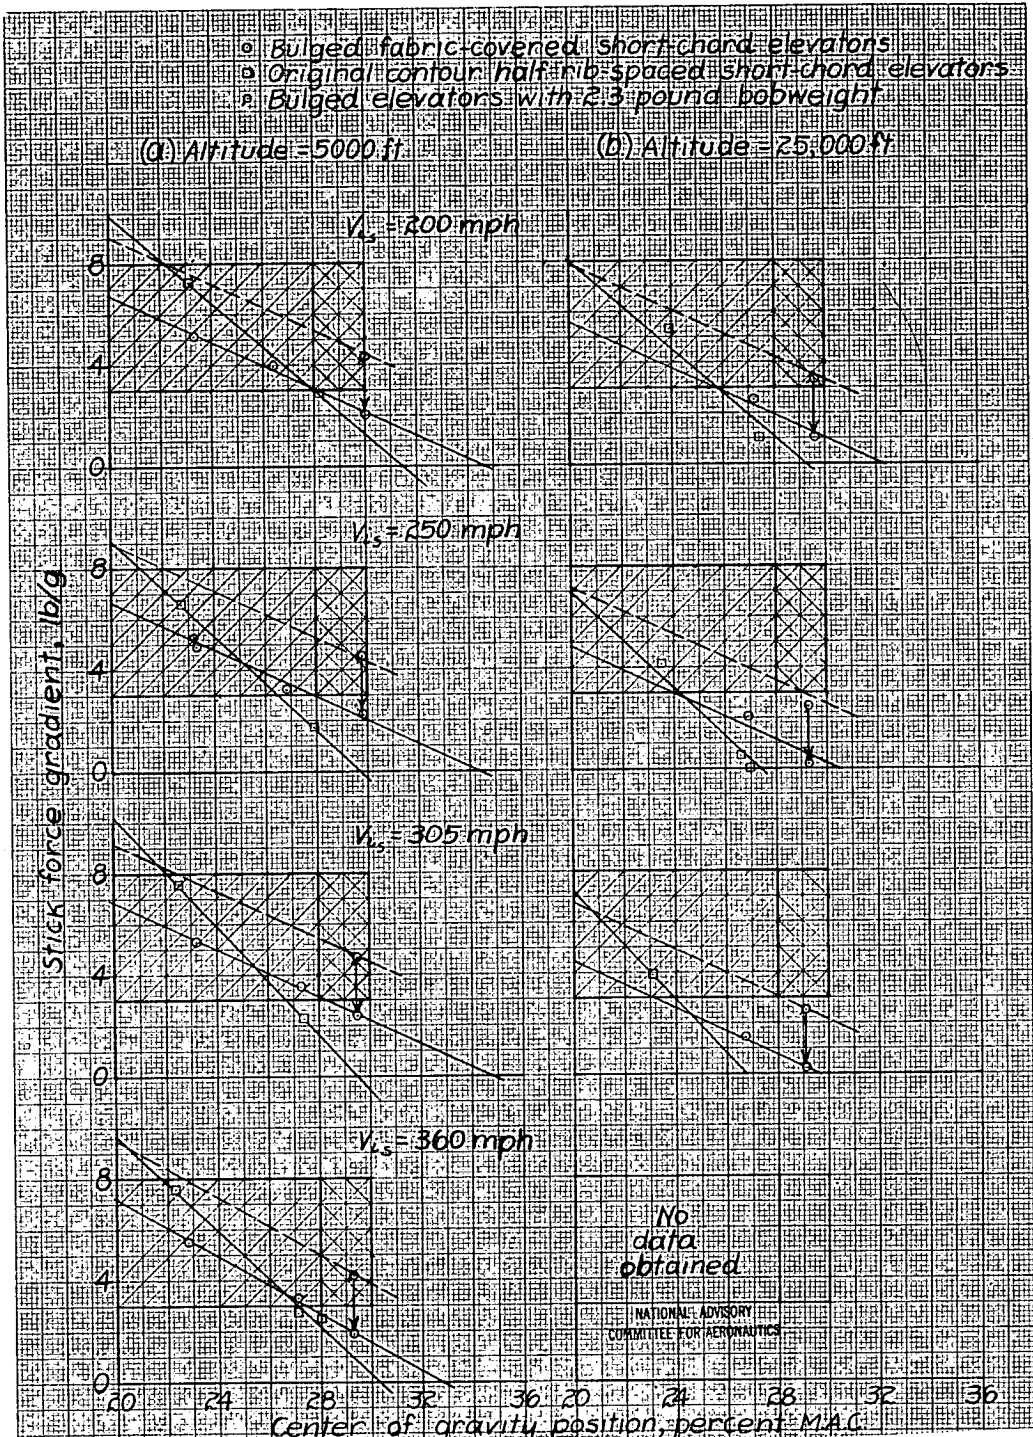
Figure 20.- Summary of the stick-free maneuvering characteristics of the P-63A-1 airplane with bulged fabric-covered short-chord elevators having 9 inches trailing edge strips, elevator-stabilizer gap =  $\frac{1}{8}$  inch and with original contour half rib-spaced fabric-covered short-chord elevators for (a) 5000 feet altitude and, (b) 25,000 feet altitude. Clean condition, power on, stabilizer incidence  $+1.1^\circ$ .

Testing technique consisted in making steady turns at various steady accelerations with different constant indicated airspeeds at 5,000 and 25,000 feet altitudes. The data were plotted as stick force and elevator angle required to trim against normal acceleration in multiples of the acceleration of gravity. An example of such a plot is shown in figure 19. From plots of this form the stick-force gradient was found by dividing the average stick-force increment between 1g and 5g by 4. Then, to determine the stick-free maneuver point (center-of-gravity position at which stick-force gradient would be zero) the stick-force gradients at different center-of-gravity positions were plotted as a function of center-of-gravity position, as is shown in figure 20, and straight lines were drawn through the test points. The pertinent points brought out by the data for original-contour half rib-spaced short-chord elevators, shown in figure 20, were the following:

Summaries of the stick-force characteristics of the airplane with the bulged elevators installed are shown in figures 20 and 21. It may be noted that the variations of stick-force gradient with center-of-gravity position were almost small enough to meet the objective but that the stick-force gradients were too low at rearward center-of-gravity positions. This was corrected by installing a 2.3-pound bobweight in the elevator control system in the case of the fabric-covered bulged elevators and a  $3\frac{1}{4}$  pound bobweight in the case of the metal-covered bulged elevators. A bobweight is simply weight unbalance in the elevator control system which adds stick force in proportion to the normal acceleration on the airplane. In level, or 1g, flight the stick-force increment due to the bobweight is trimmed out with the elevator trim tab. The actual variations of stick force with acceleration were very satisfactory with the bulged elevators as can be seen from the typical plot shown in figure 22. Besides supplying the desired stick-force characteristics in steady accelerated flight, the bulged elevators gave excellent static stability characteristics, an example of which is shown in figure 23. Also, the elevator-free short-period oscillation characteristics were satisfactory. In spite of all these good points, however, some bad control-feel characteristics were inherent in the use of these highly balanced elevators.

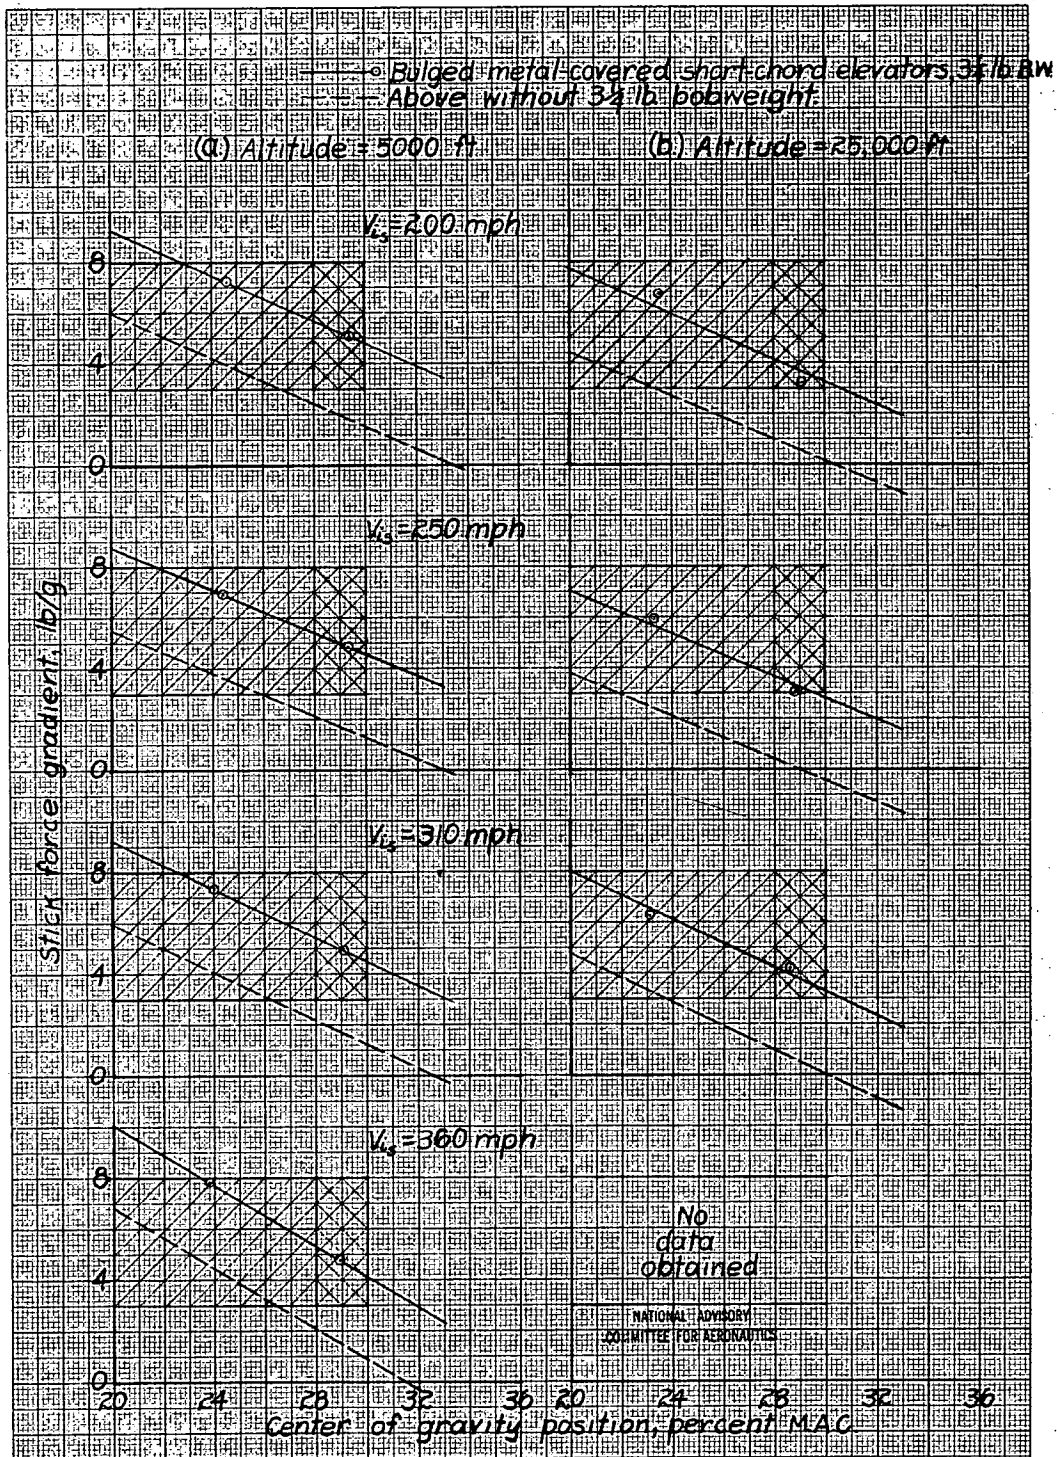
Figure 21.- Summary of the stick-free maneuvering characteristics of the P-63A-1 airplane with bulged metal-covered short-chord elevators having an average trailing edge angle of  $17.0^\circ$  and with the elevator-stabilizer gap reduced to about  $\frac{1}{8}$  inch for (a) 5000 feet altitude, and (b) 25,000 feet altitude. Clean condition, power on, stabilizer incidence  $+1.1^\circ$ .

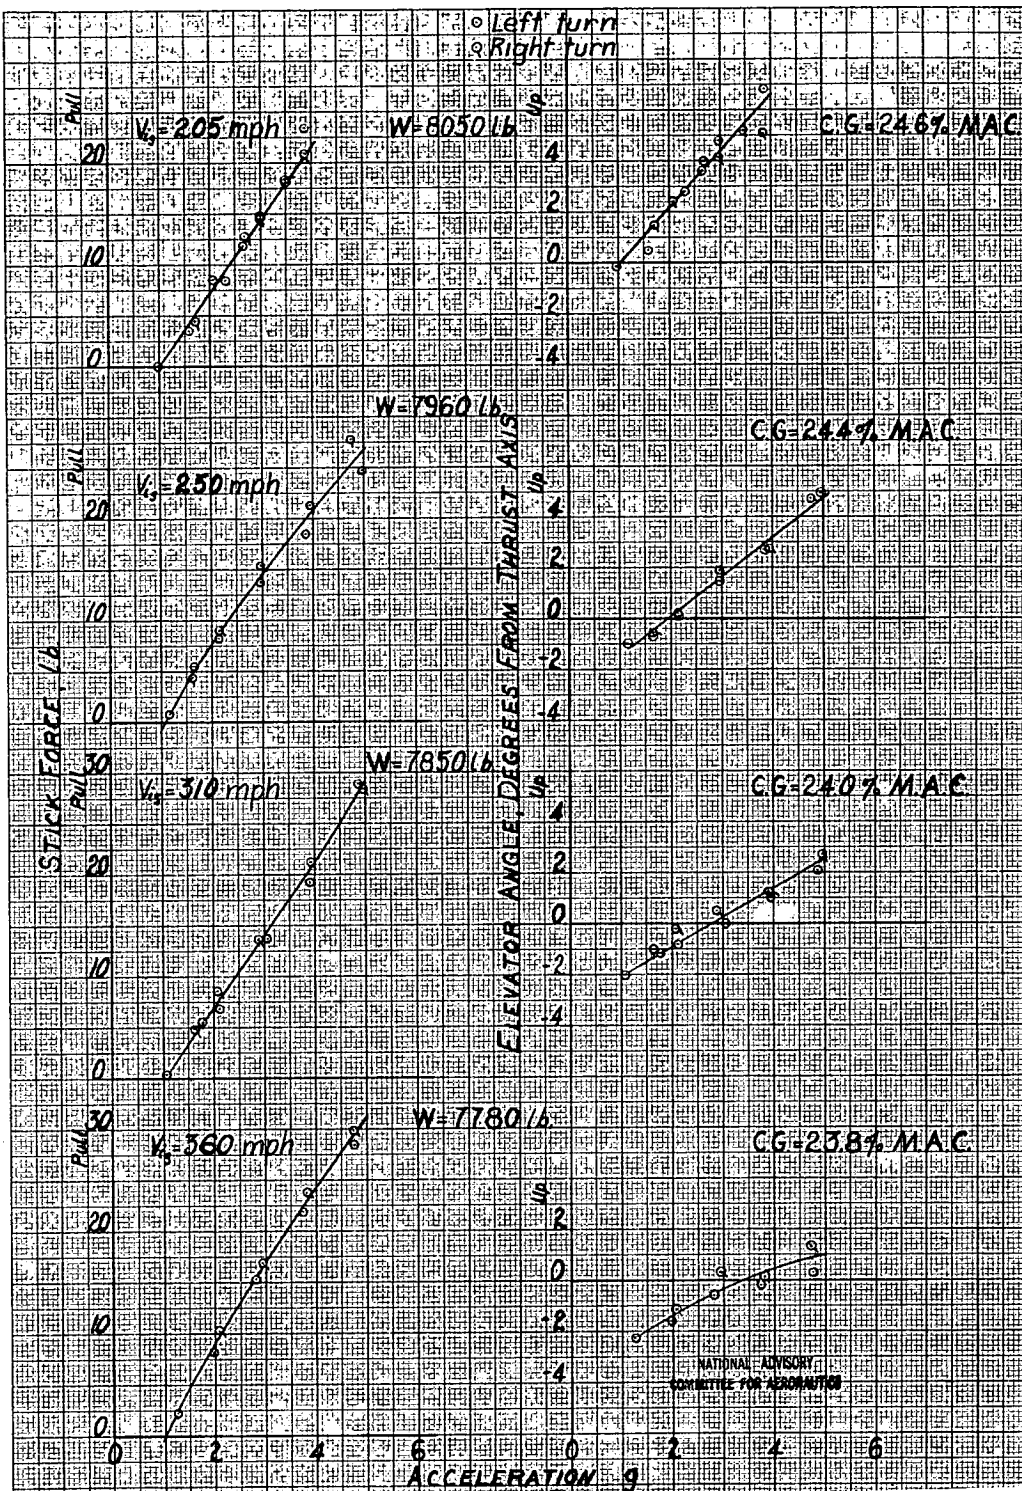
Figure 22.- Variation of stick force and elevator angle required to trim in turning flight with normal acceleration for various service indicated airspeeds. Bell P-63A-1 airplane, bulged metal-covered short-chord elevators with  $3\frac{1}{4}$  pound bobweight,  $\frac{1}{8}$  inch elevator-stabilizer gap, stabilizer incidence  $\pm 1.1^\circ$ . Clean condition, normal rated power (2600 RPM, 43 in. Hg), coolant shutters closed, altitude approximately 5000 feet.

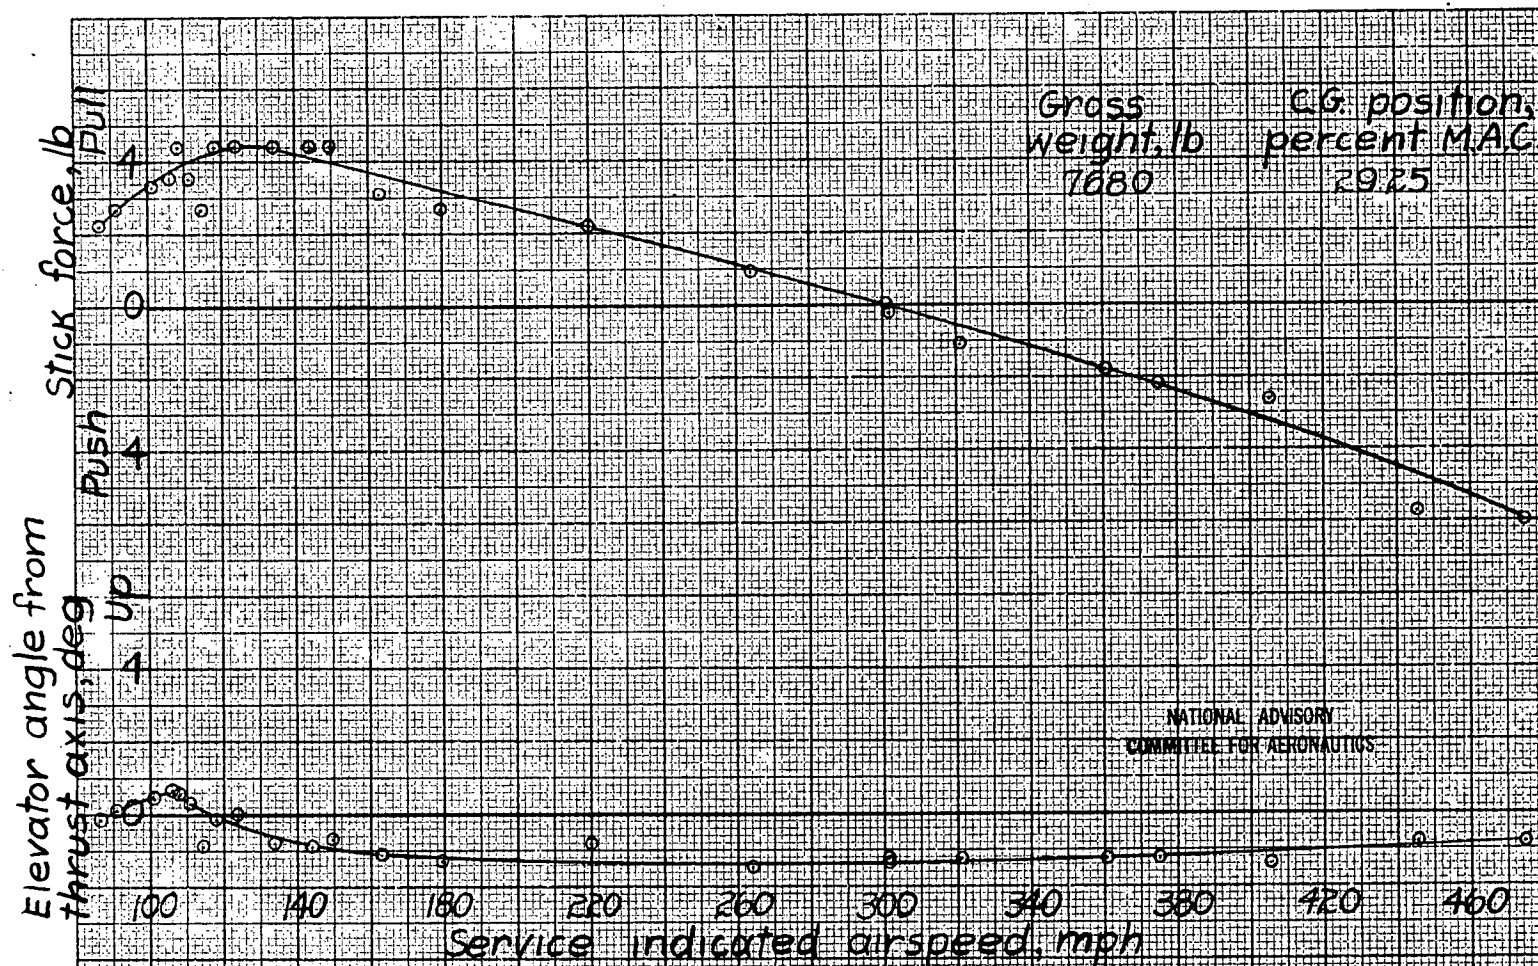
Figure 23.- Variation with service indicated airspeed of stick force and elevator angle required to trim in straight flight. Bell P-63A-1 airplane, bulged metal-covered short-chord elevators with  $3\frac{1}{4}$  pound bobweight,  $\frac{1}{8}$  inch elevator-stabilizer gap, stabilizer incidence  $+1.1^\circ$ . Clean condition, normal rated power (2600 RPM, 43 in. Hg), coolant shutters closed, altitude approximately 5000 feet.

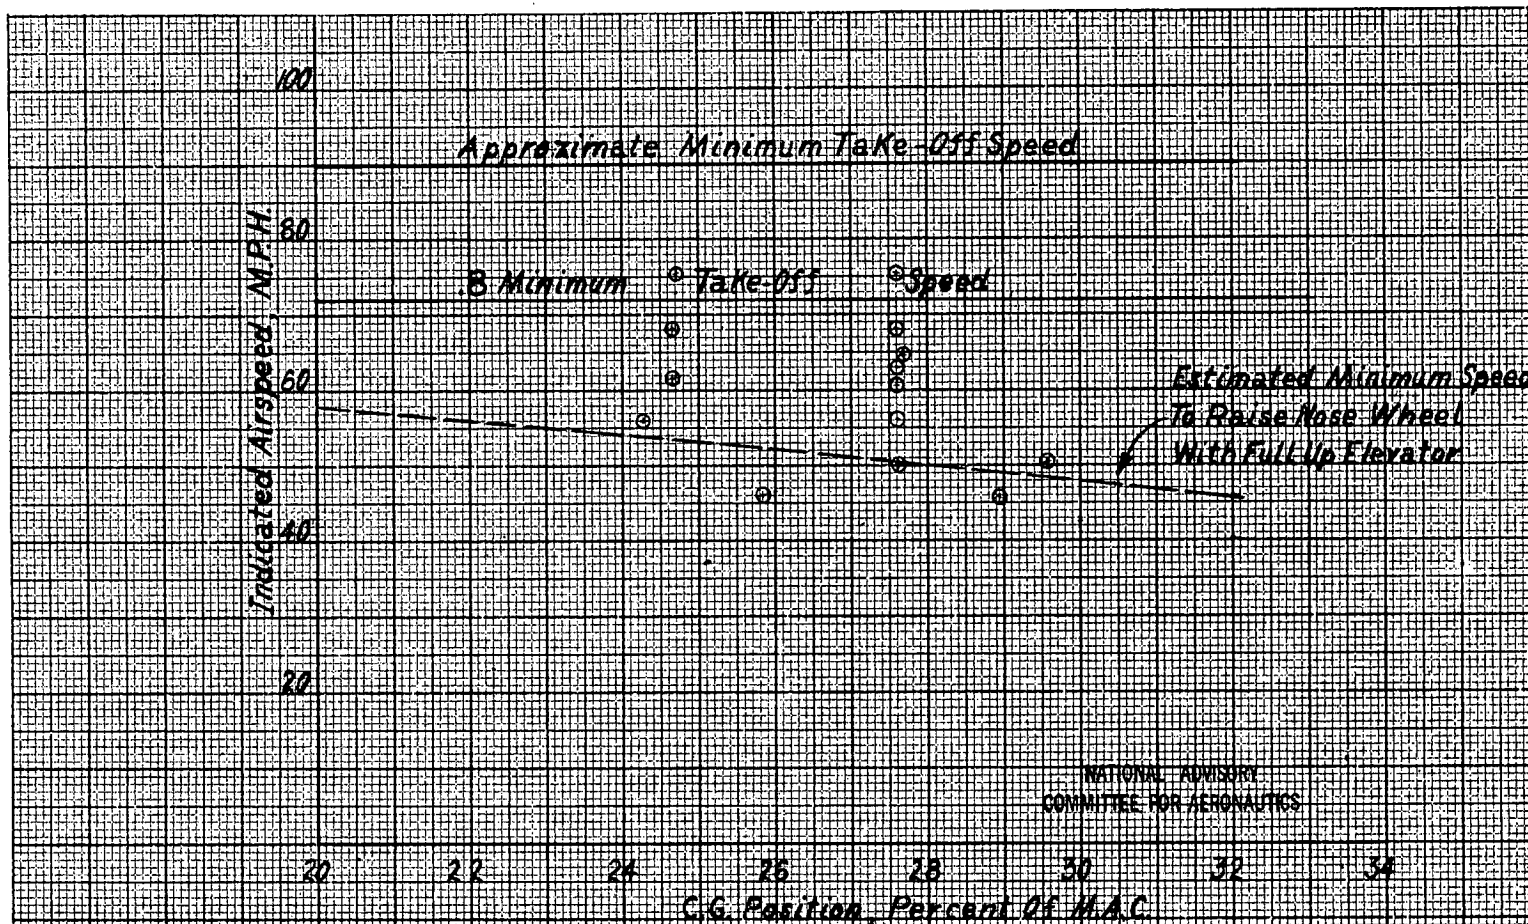
Figure 24.- Data showing speeds at which nose wheel was raised from concrete runway during take-off using various amounts of up-elevator deflection. Faired curve is estimated variation of minimum speed with full-up elevator deflection. Bell P-63A-1 airplane, horizontal tail planform shown in Figure 4B, various different elevators installed.

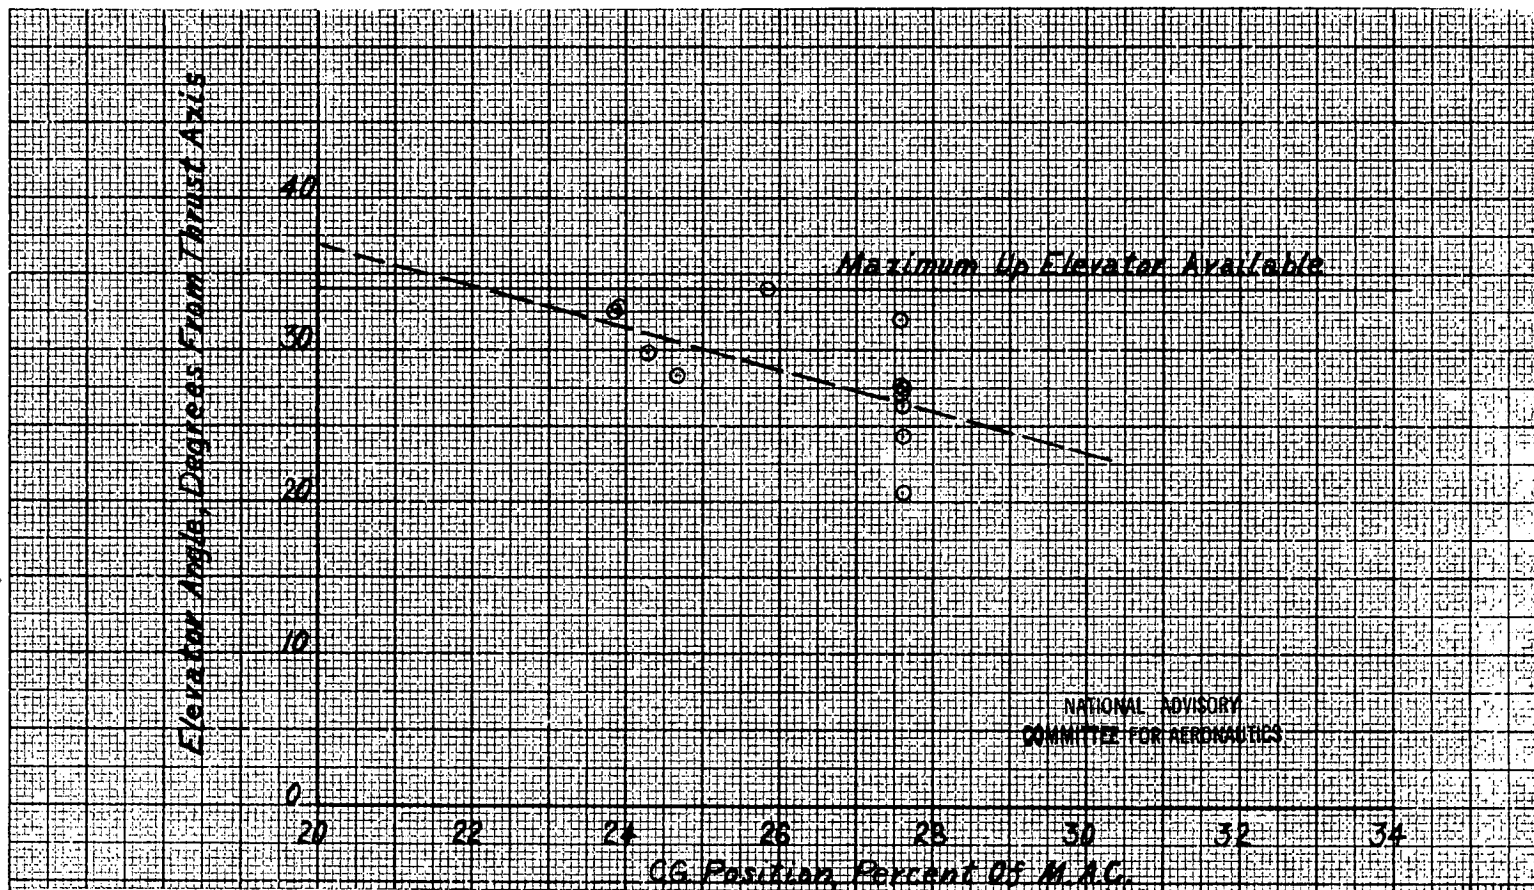
Figure 25.- Data showing the amount of elevator control necessary to make minimum speed landings with power off and landing flaps full down. Bell P-63A-1 airplane, horizontal tail planform shown in Figure 4B, various different elevators installed.

Figure 25 indicates the available elevator power is slightly deficient to make minimum-speed landings with center-of-gravity positions forward of 22 percent of the mean aerodynamic chord. Since this deficiency is only marginal and since the power-off landing test condition is the severest possible, it may be concluded that the P-63A-1 airplane has sufficient elevator power to make minimum-speed landings in any condition it is likely to be used in service.

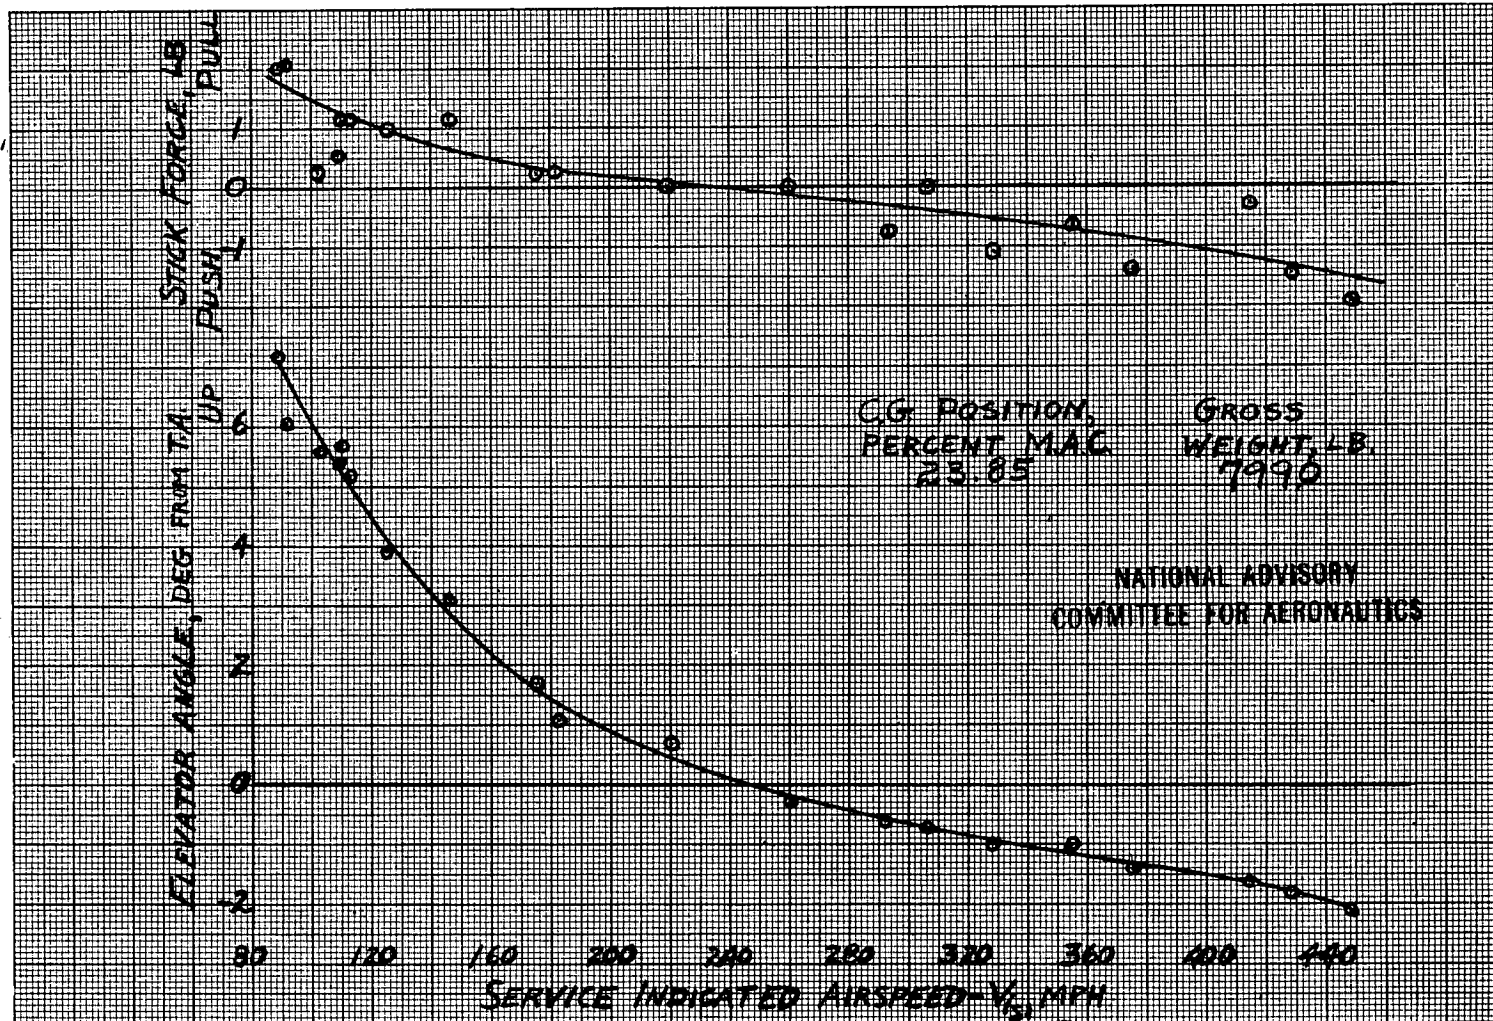
Figure 26.- Variation with indicated airspeed of stick force and elevator angle required to trim a Bell P-63A-1 airplane in straight flight. Horizontal tail shown in Figure 4C, bulged fabric-covered elevator shown in Figure 5D, elevator-stabilizer gap unsealed. Clean condition, normal rated power (2600 RPM, 43 in. Hg), altitude 5000 feet.
