October 1944 as  
Memorandum Report L4J19

RÉSUMÉ OF NACA STABILITY AND CONTROL TESTS  
OF THE BELL P-63 SERIES AIRPLANE

By Harold I. Johnson

Langley Memorial Aeronautical Laboratory  
Langley Field, Va.

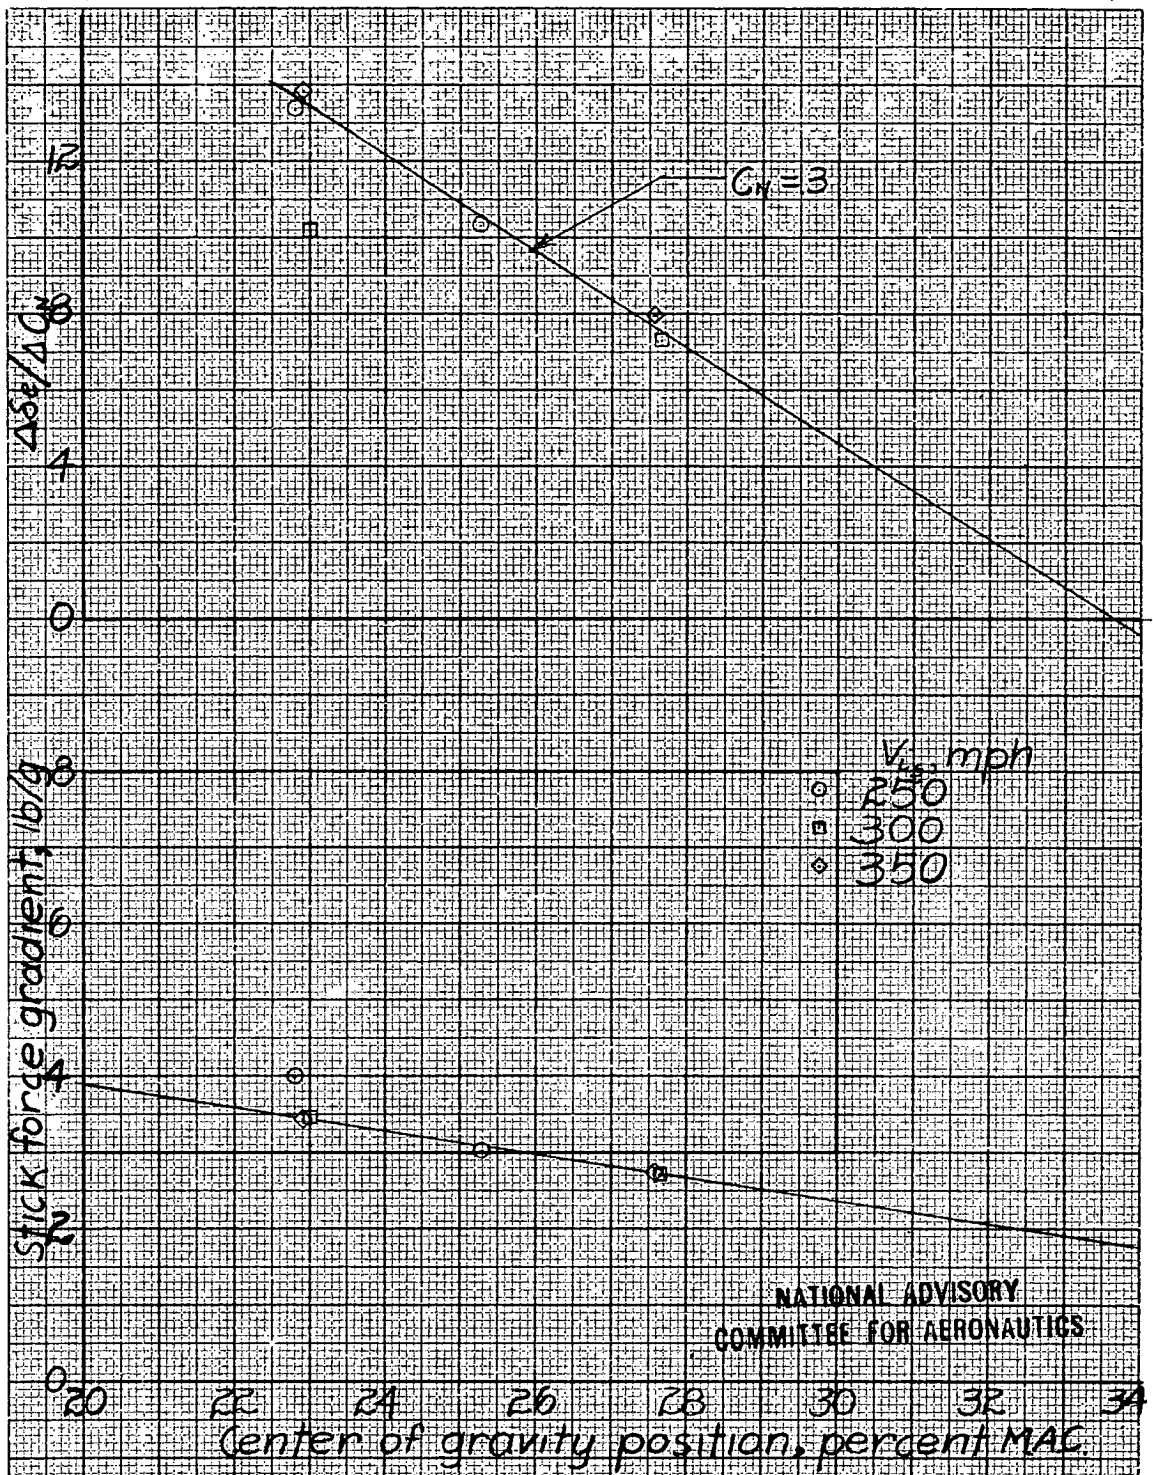
Figure 27.- Summary of the longitudinal stability characteristics of the Bell P-63A-1 airplane in steady, turning flight. Enlarged horizontal tail shown in figure 4C, bulged fabric-covered elevators shown in figure 5D, elevator stabilizer gap unsealed. Clean condition, normal rated power (2600 RPM, 43 in. Hg), altitude 5000 feet.

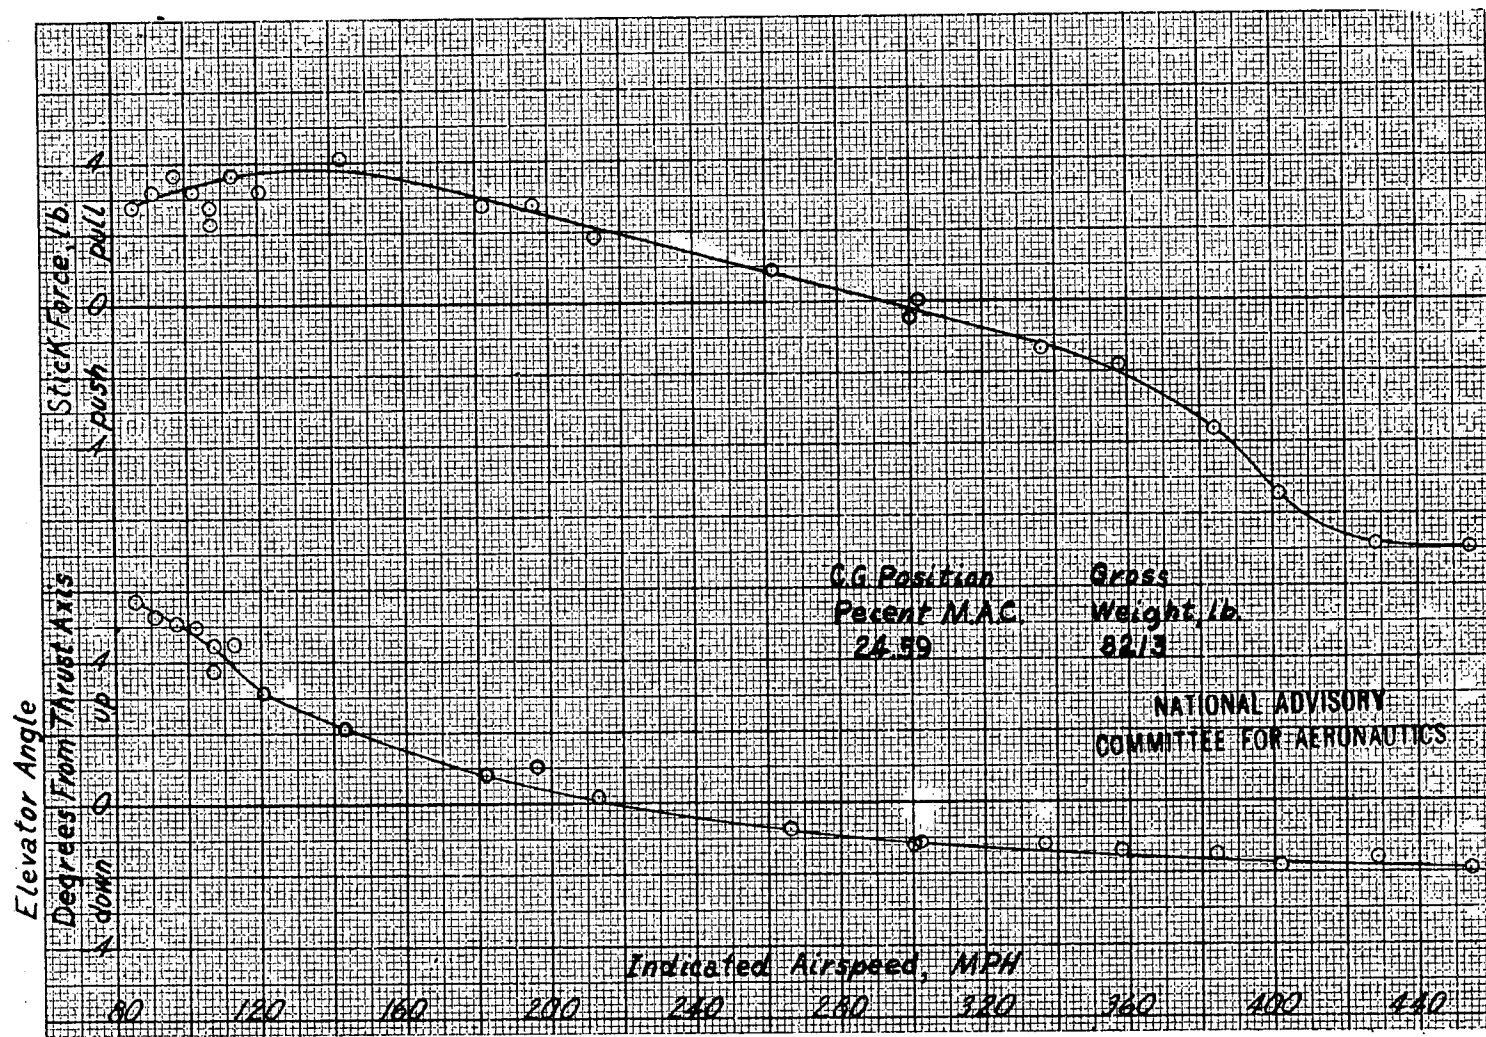
Figure 28.- Variation with indicated airspeed of stick force and elevator angle required to trim a Bell P-63A-1 airplane in straight flight. Horizontal tail shown in Figure 4C, bulged fabric-covered elevators shown in Figure 5D, elevator-stabilizer gap sealed. Clean condition, normal rated power (2600 RPM, 43 in. Hg), altitude 5000 feet.

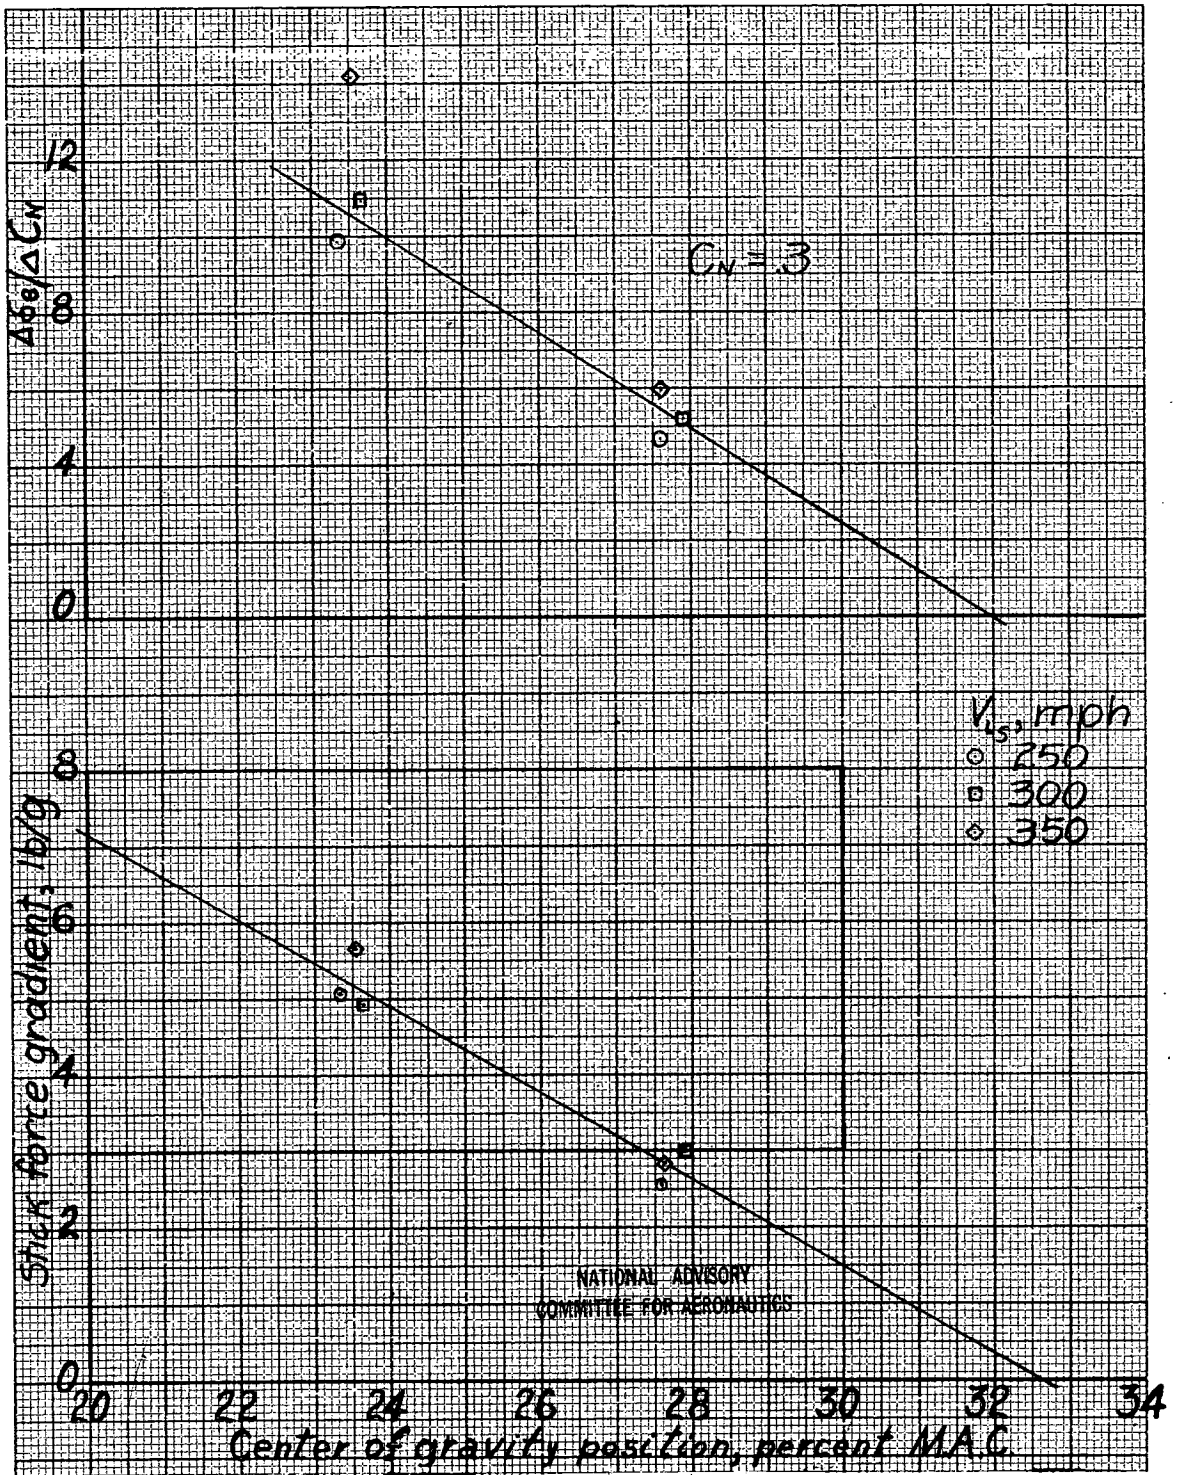
Figure 29.- Summary of the longitudinal stability characteristics of the Bell P-63A-1 airplane in steady turning flight. Enlarged horizontal tail shown in Figure 4C, bulged fabric-covered elevators shown in Figure 5D, elevator-stabilizer gap sealed. Clean condition, normal rated power (2600 RPM, 43 in Hg), altitude 5000 feet.

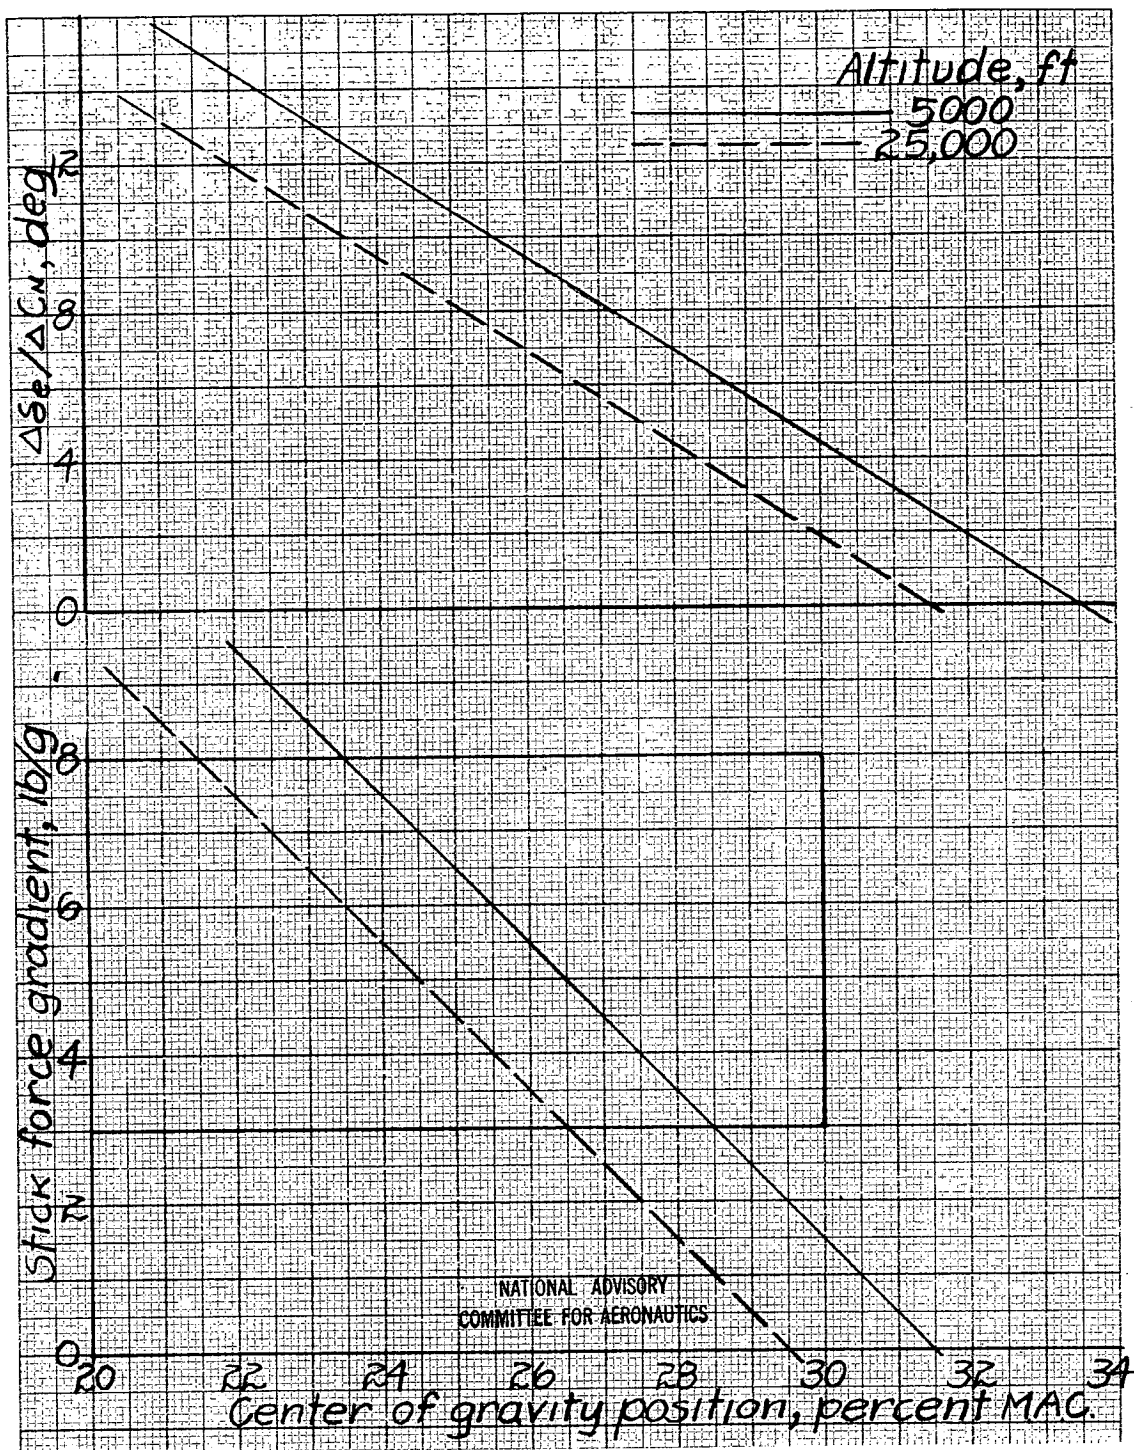
Figure 30.- Predicted longitudinal stability characteristics for steady turning flight.. Bell P-63A-1 airplane with enlarged horizontal tail and original contour production elevators at  $V_1 = 250-300$  MPH. Clean condition, normal rated power, two different altitudes, no bob weight. No flight tests have yet been made at the NACA with this airplane configurations.

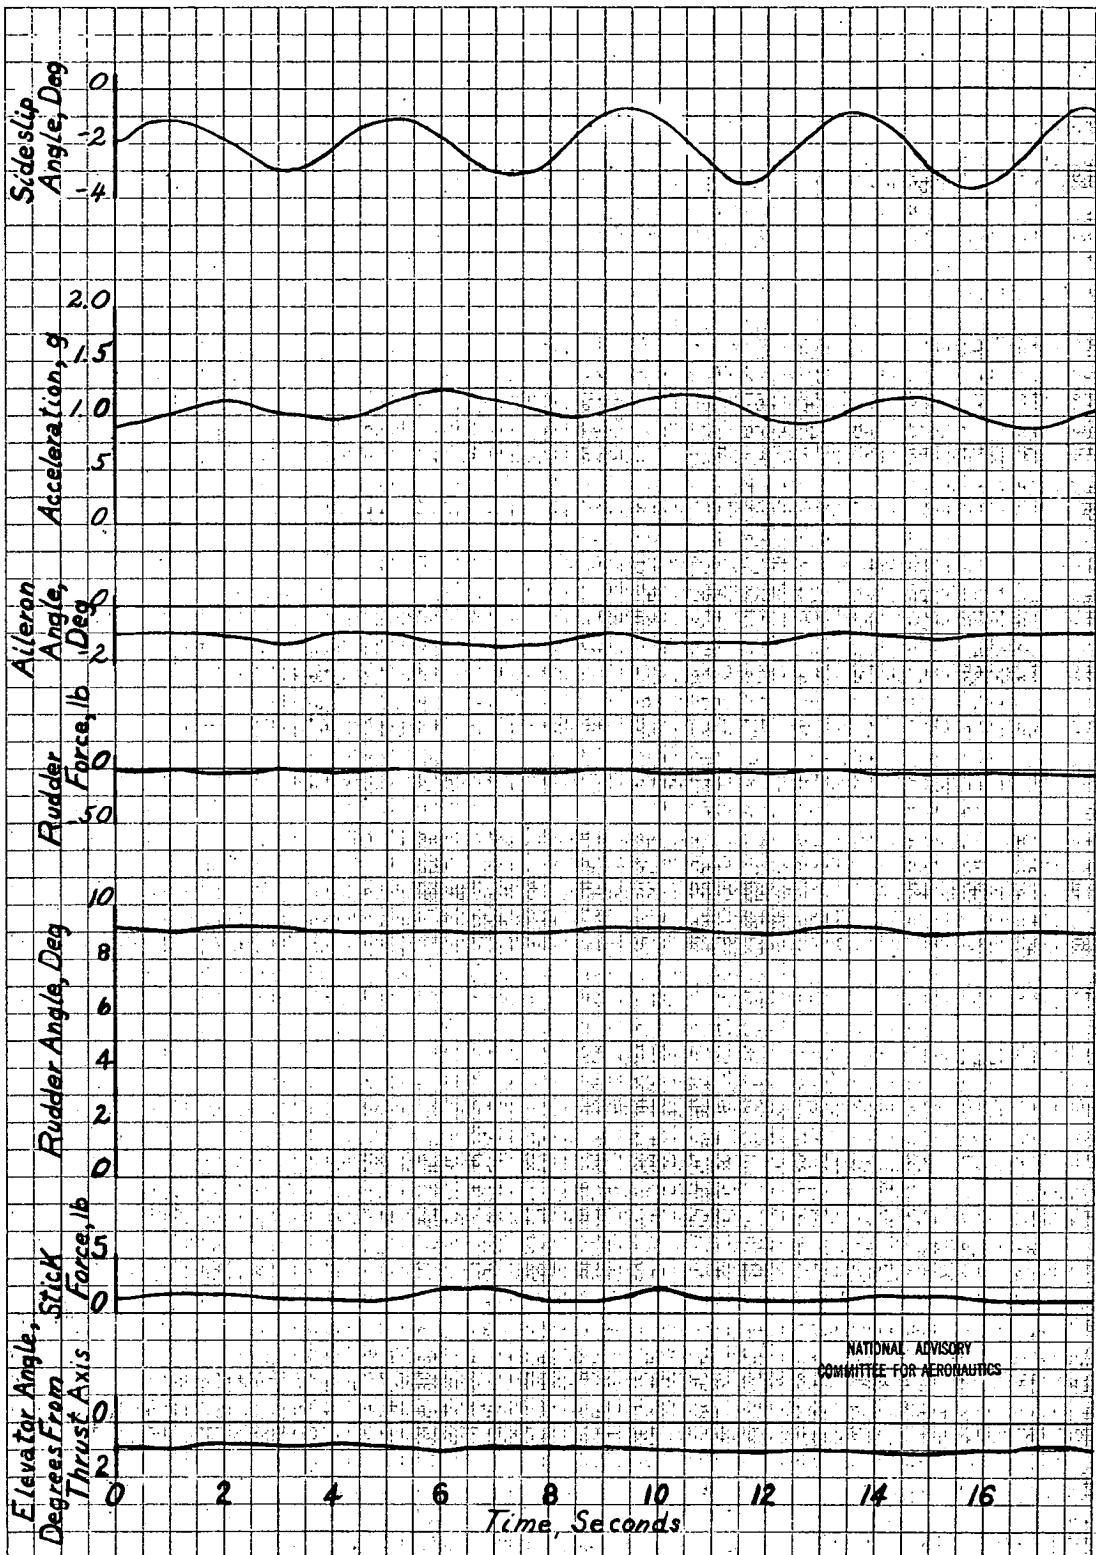
Figure 31.- Time history showing an undamped directional oscillation which occurred with a P-63A-1 airplane with the original vertical tail installed even though the pilot attempted to hold all controls fixed. Climbing condition at 22,000 feet altitude. The occurrence of such an oscillation indicates weak directional stability.

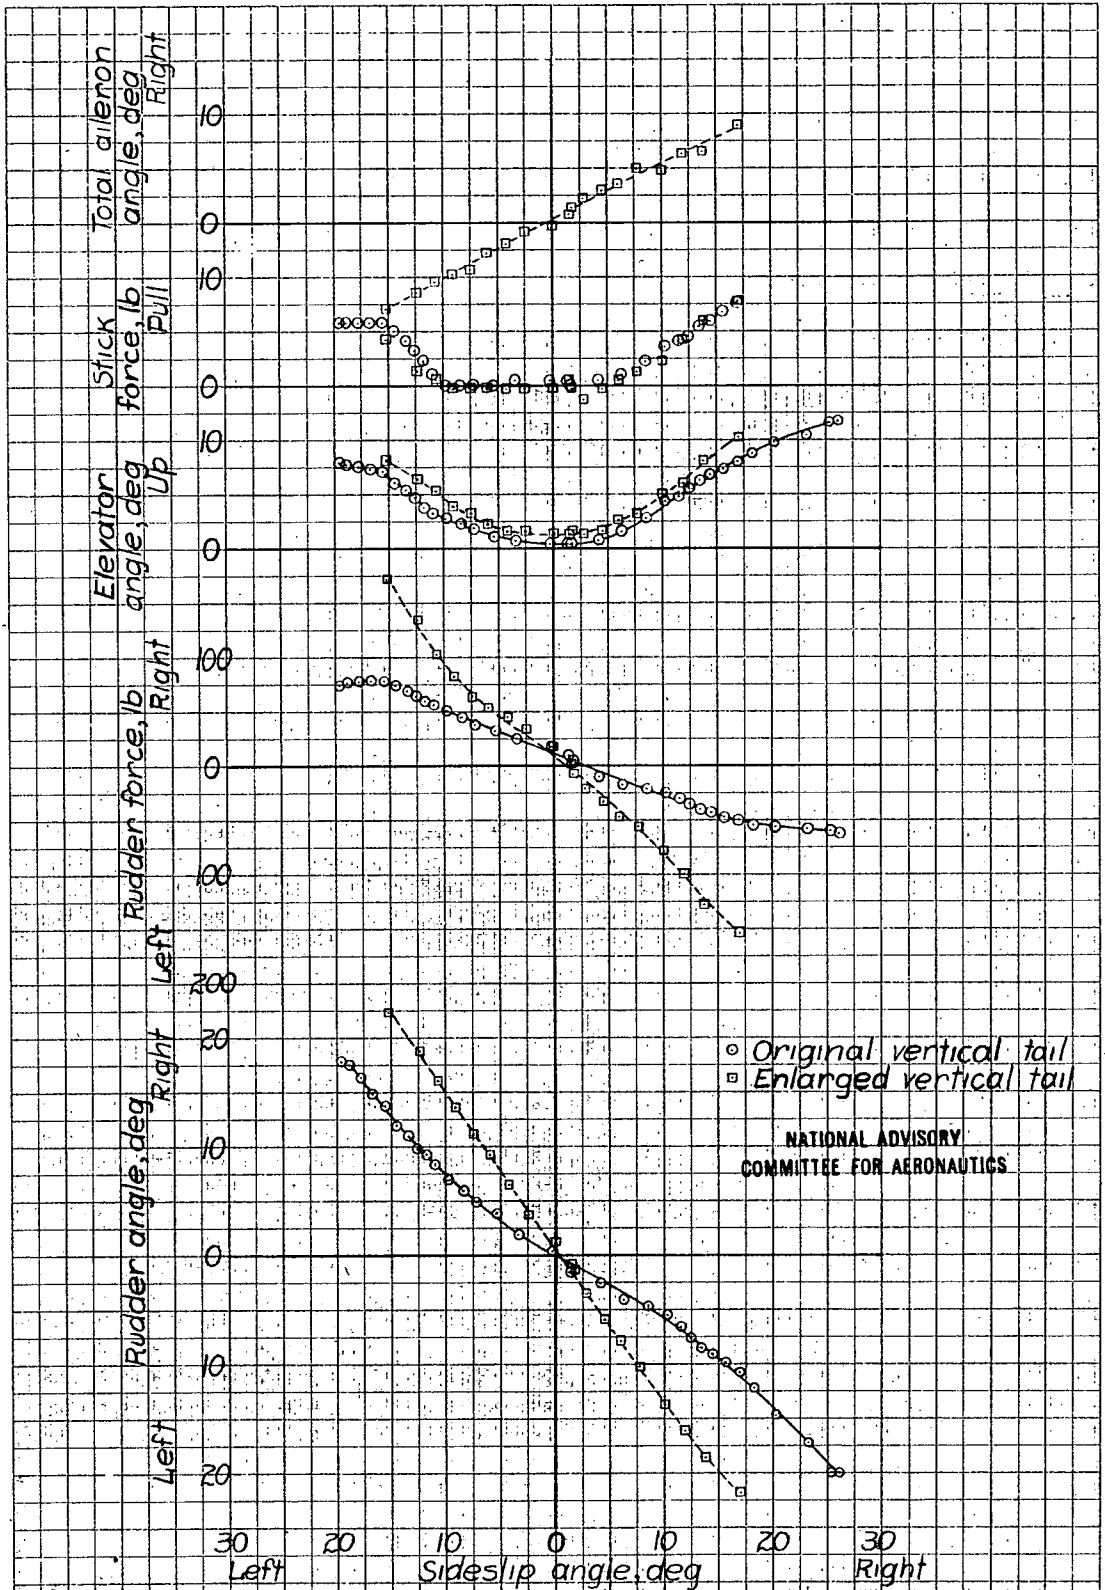
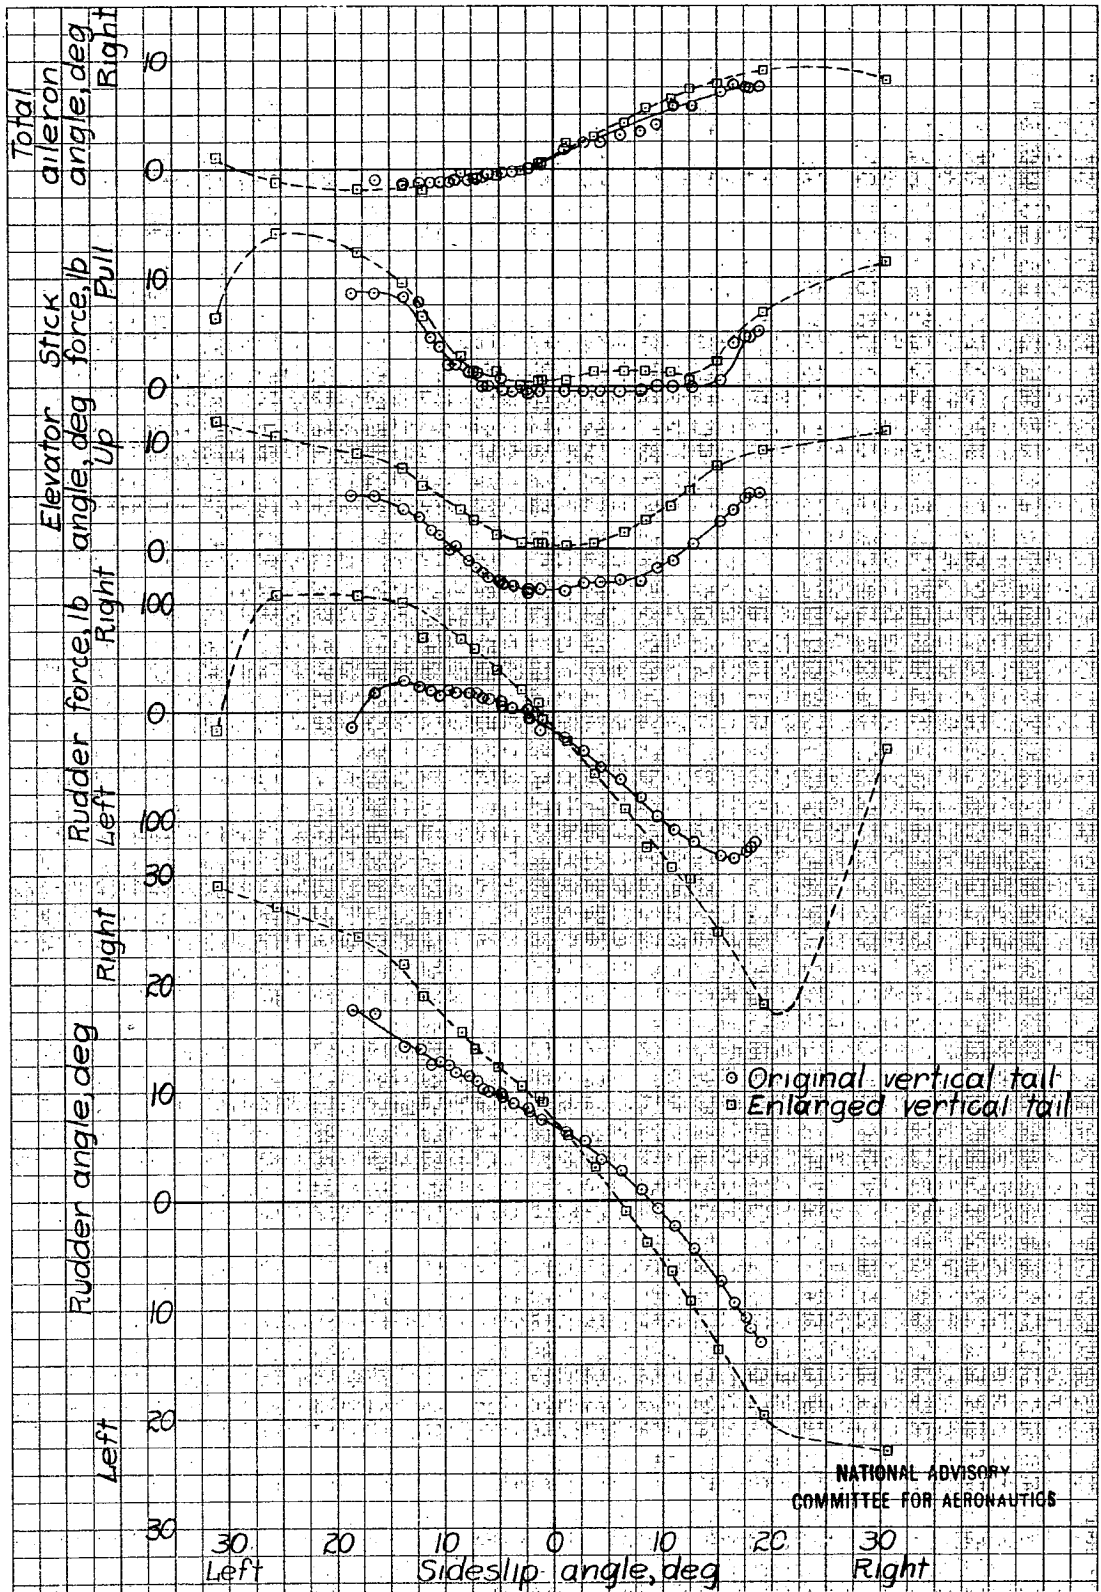
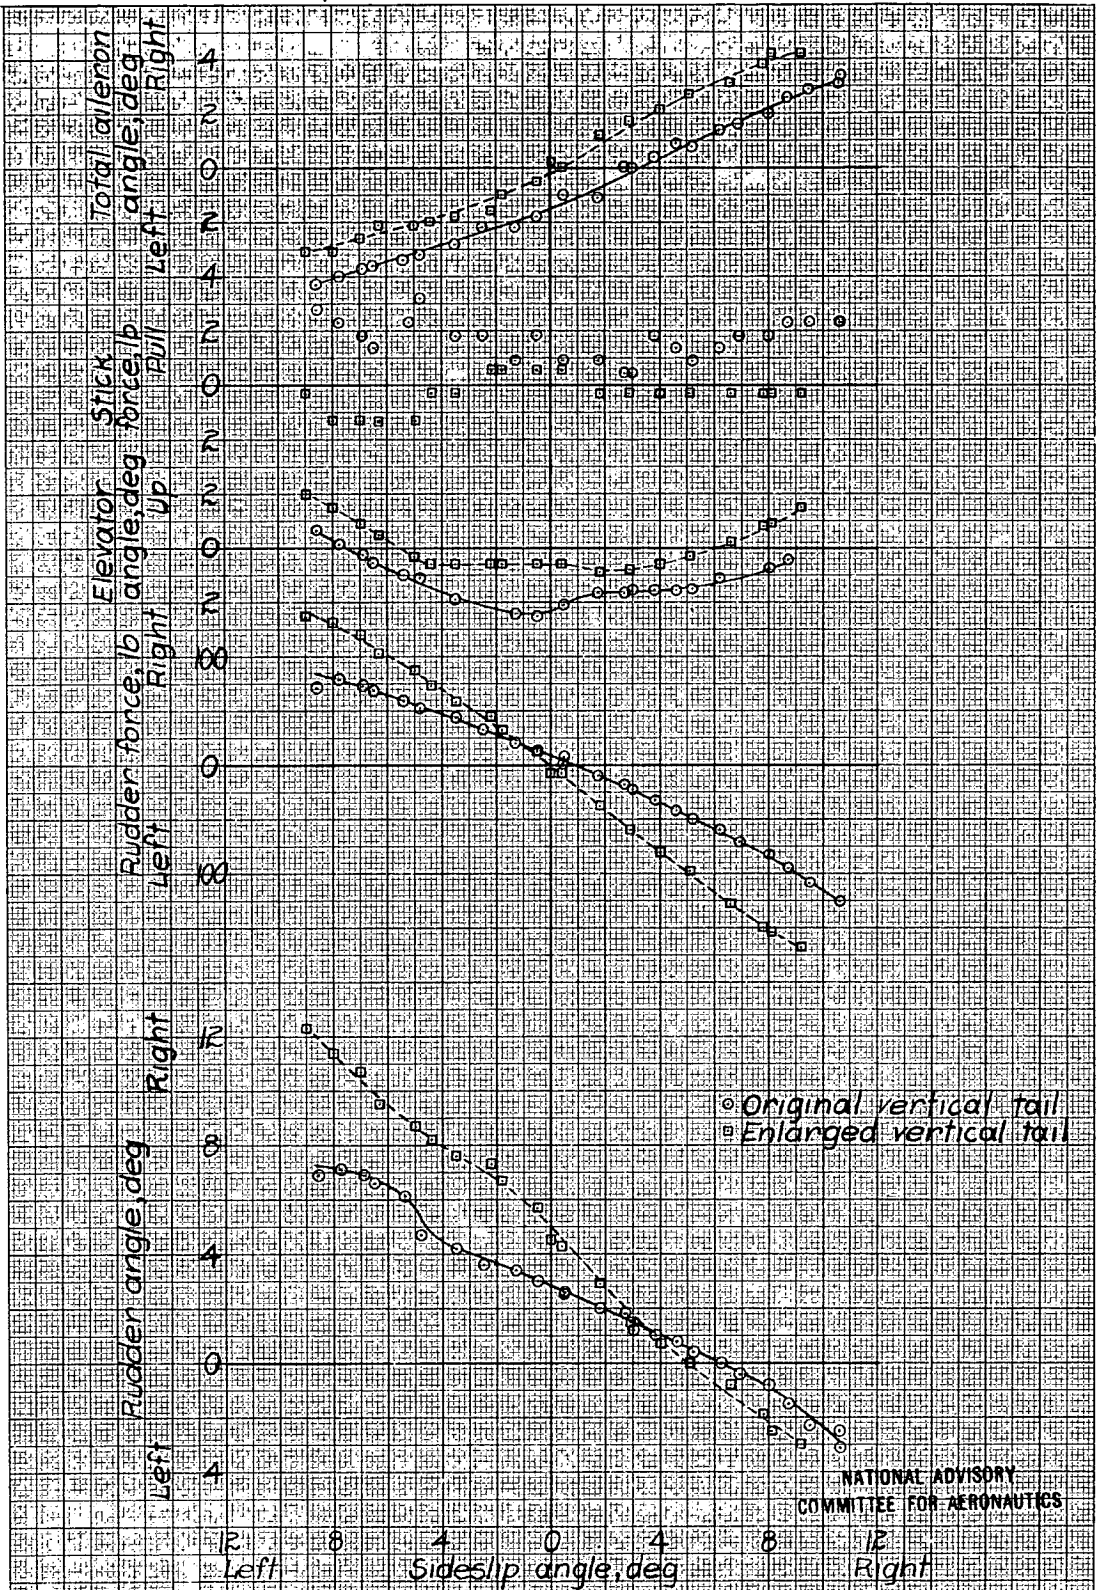
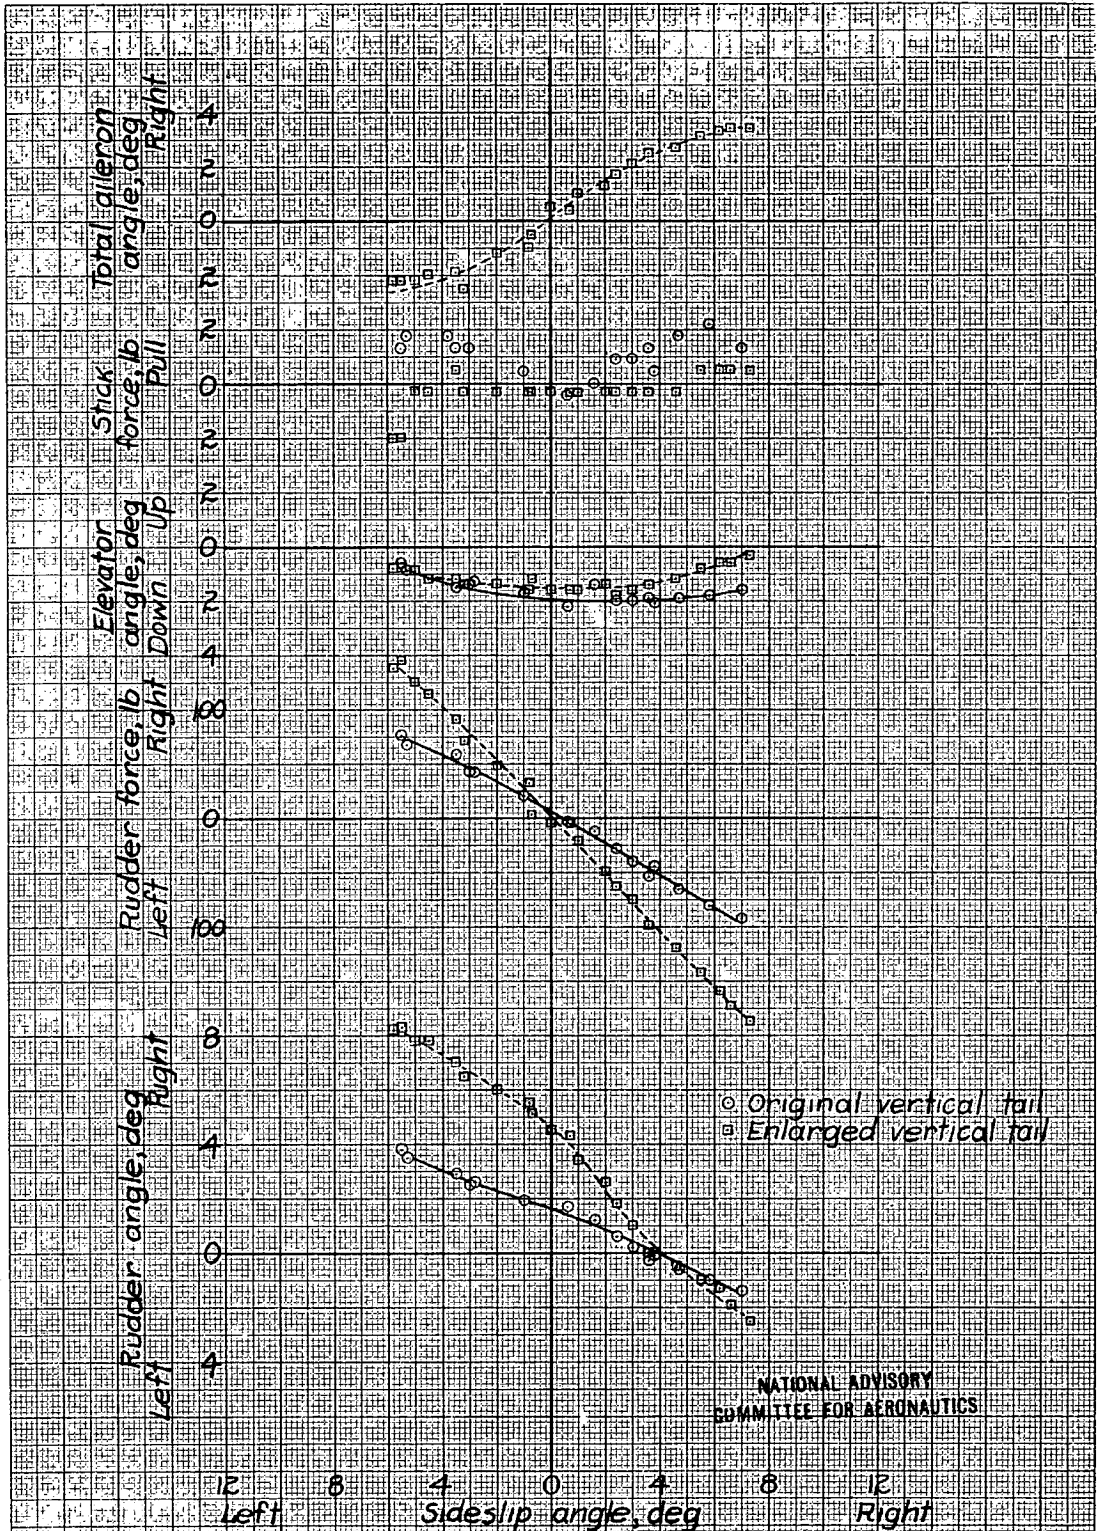
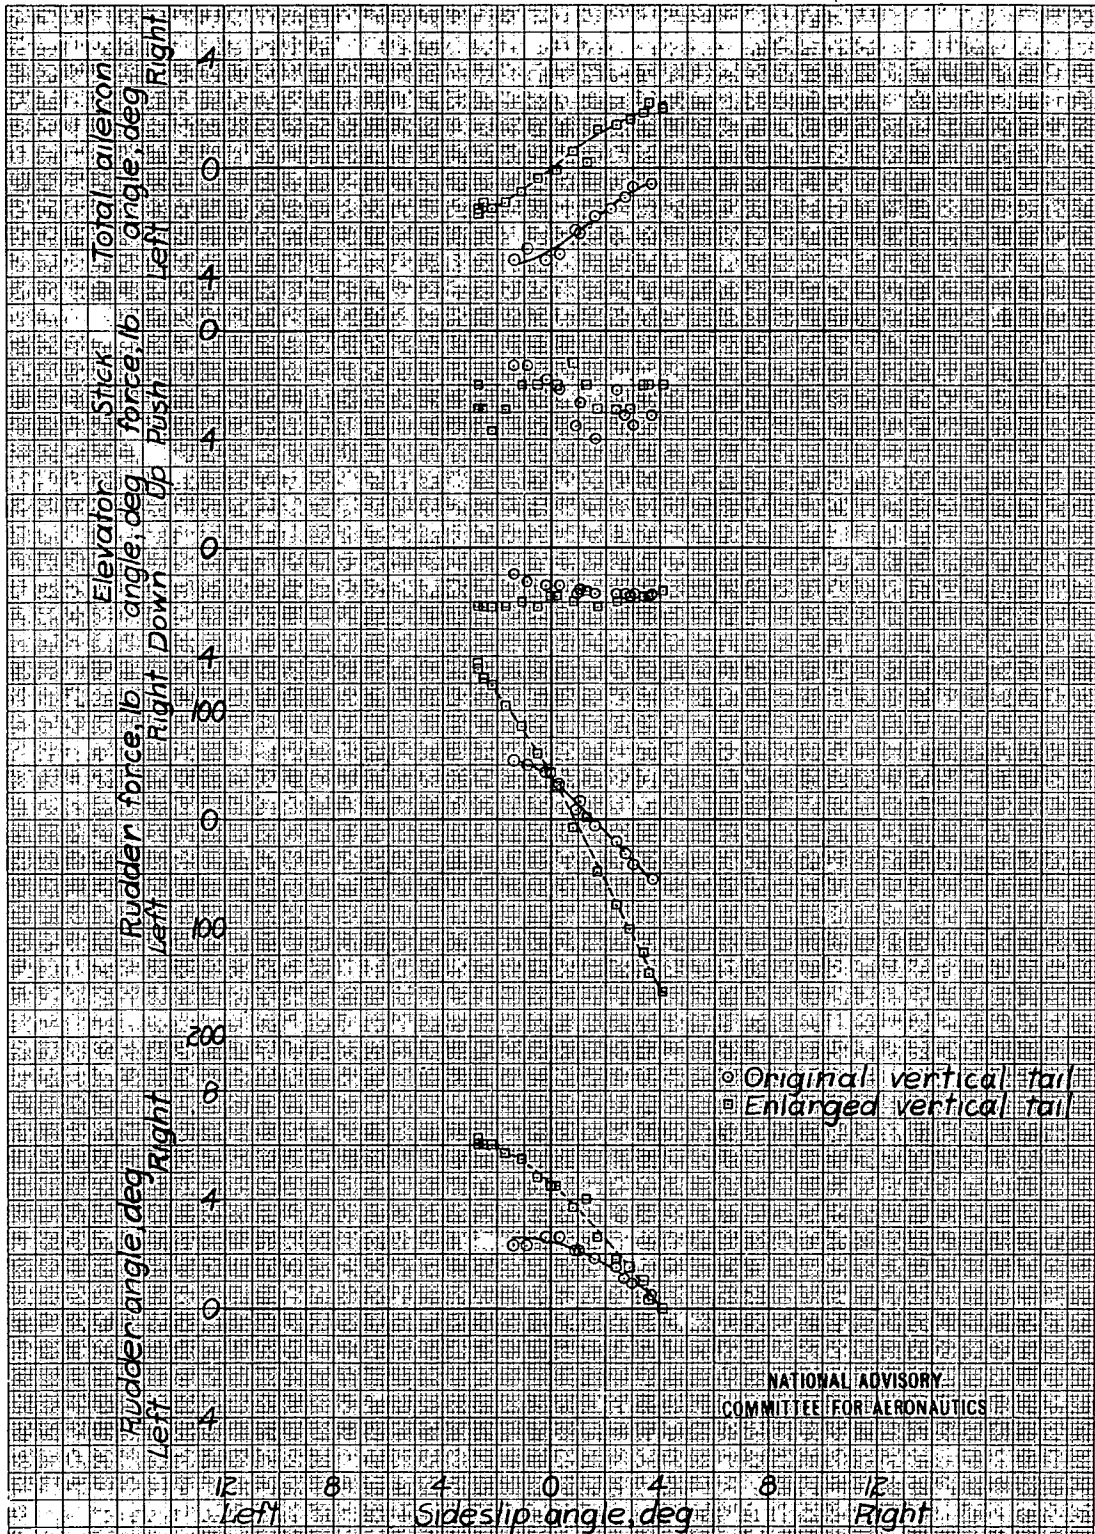
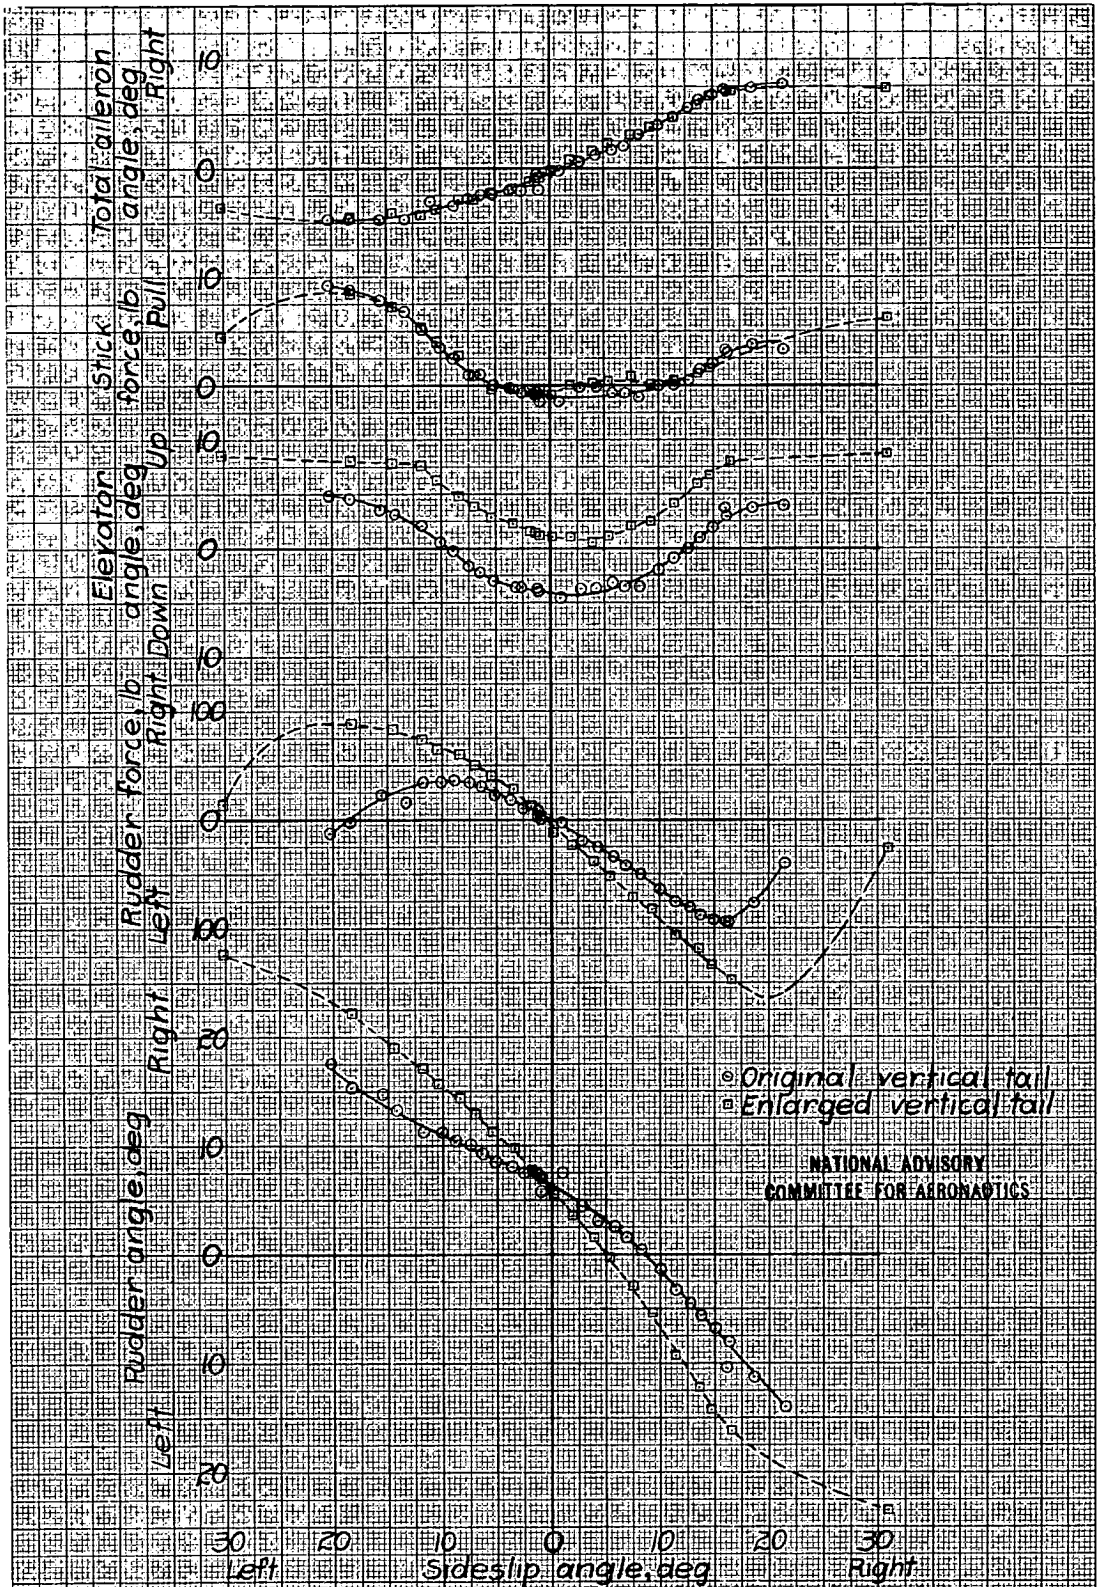
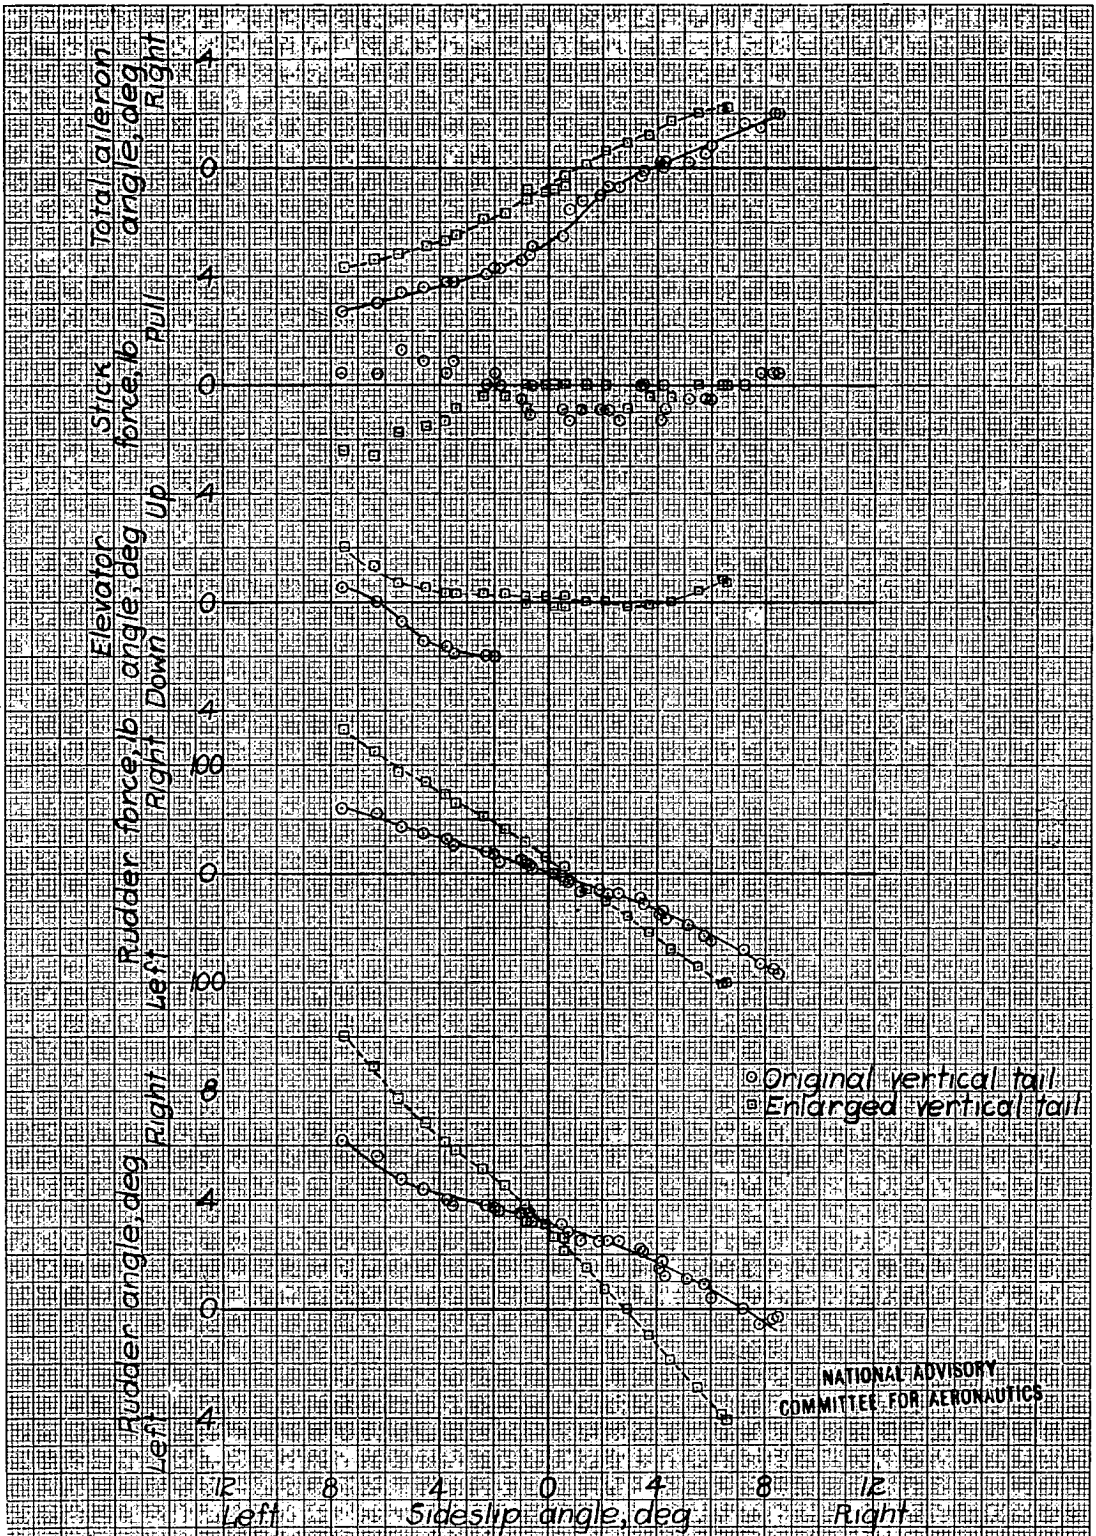
Figure 32.- Sideslip characteristics of P-63A-1 airplane with power off at  $V_{i_s} = 150$  mph at 5000 feet altitude.

Figure 33.- Sideslip characteristics of P-63A-1 airplane with rated power (2600 RPM, 43 in. Hg.) at  $V_{1s} = 150$  mph at 5000 feet altitude.

Figure 34.- Sideslip characteristics of P-63A-1 airplane with rated power (2600 RPM, 43 in Hg.) at  $V_{1g} = 250$  mph at 5000 feet altitude.

Figure 35.- Sideslip characteristics of P-63A-1 airplane with rated power (2600 RPM, 43 in. Hg.) at  $V_{1g} = 300$  mph at 5000 feet altitude.

Figure 36.- Sideslip characteristics of P-63A-1 airplane with rated power (2600 RPM, 43 in. Hg.) at  $V_{is} = 400$  mph at 5000 feet altitude.

Figure 37.- Sideslip characteristics of P-63A-1 airplane with power on (2600 RPM, 38 in. Hg.) at  $V_{18}$  = 150 mph at 22,000 feet altitude.

Figure 38.- Sideslip characteristics of P-63A-1 airplane with power on (2600 RPM, 39 in. Hg.) at  $V_{i_0} = 250$  mph at 25,000 feet altitude.

The results of all the sideslip tests made with each vertical tail installed on the airplane are shown in figures 32 to 38, inclusive. The following table is a key showing the airplane conditions corresponding to each set of sideslip data:

Figure no.	Service indicated airspeed (mph)	Power conditions	Altitude (ft)
32	150	Engine idling	5,000
33	150	Normal rated (2600 rpm, 43 in. Hg.)	5,000
34	250	-----do.-----	5,000
35	300	-----do.-----	5,000
36	400	-----do.-----	5,000
37	150	Power on (2600 rpm, 38 in. Hg.)	22,000
38	250	Power on (2600 rpm, 39 in. Hg.)	25,000

An examination of these data shows that, in general, about twice as much rudder force and rudder deflection is required to produce a given change in sideslip angle with the enlarged vertical tail as with the original. Furthermore, the rudder-force reversal, which occurs in low-speed high-power conditions (figs. 33 and 37), occurs at much higher sideslip angles with the enlarged vertical-tail installation. In this connection, the dorsal fin shown in figure 7 was built for the express purpose of eliminating the rudder-force reversal altogether. Preliminary tests with this dorsal fin installed indicate that it does accomplish complete elimination of the rudder-force reversal.

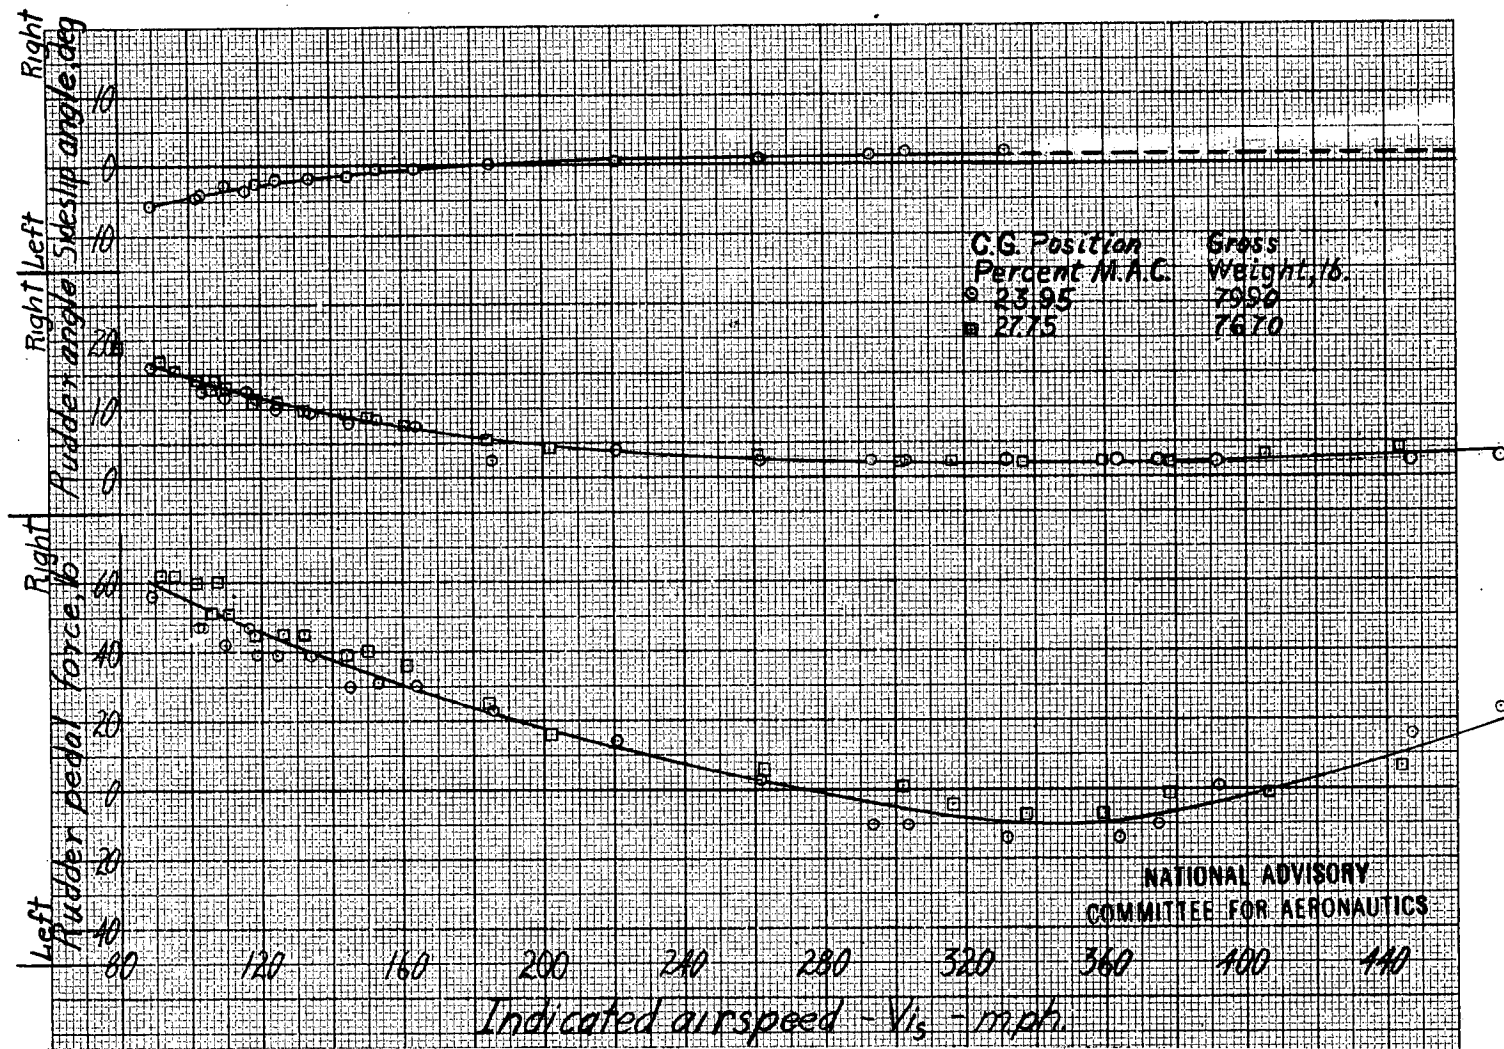
Figure 39.- Directional trim characteristics of P-63A-1 airplane with original vertical tail showing the variations in rudder force and angle with indicated airspeed to maintain straight, wings-level flight. Clean condition, normal rated power (2600 RPM, 43 in. Hg), altitude 5000 feet.
