October 1944 as  
Memorandum Report L4J19

RÉSUMÉ OF NACA STABILITY AND CONTROL TESTS  
OF THE BELL P-63 SERIES AIRPLANE

By Harold I. Johnson

Langley Memorial Aeronautical Laboratory  
Langley Field, Va.

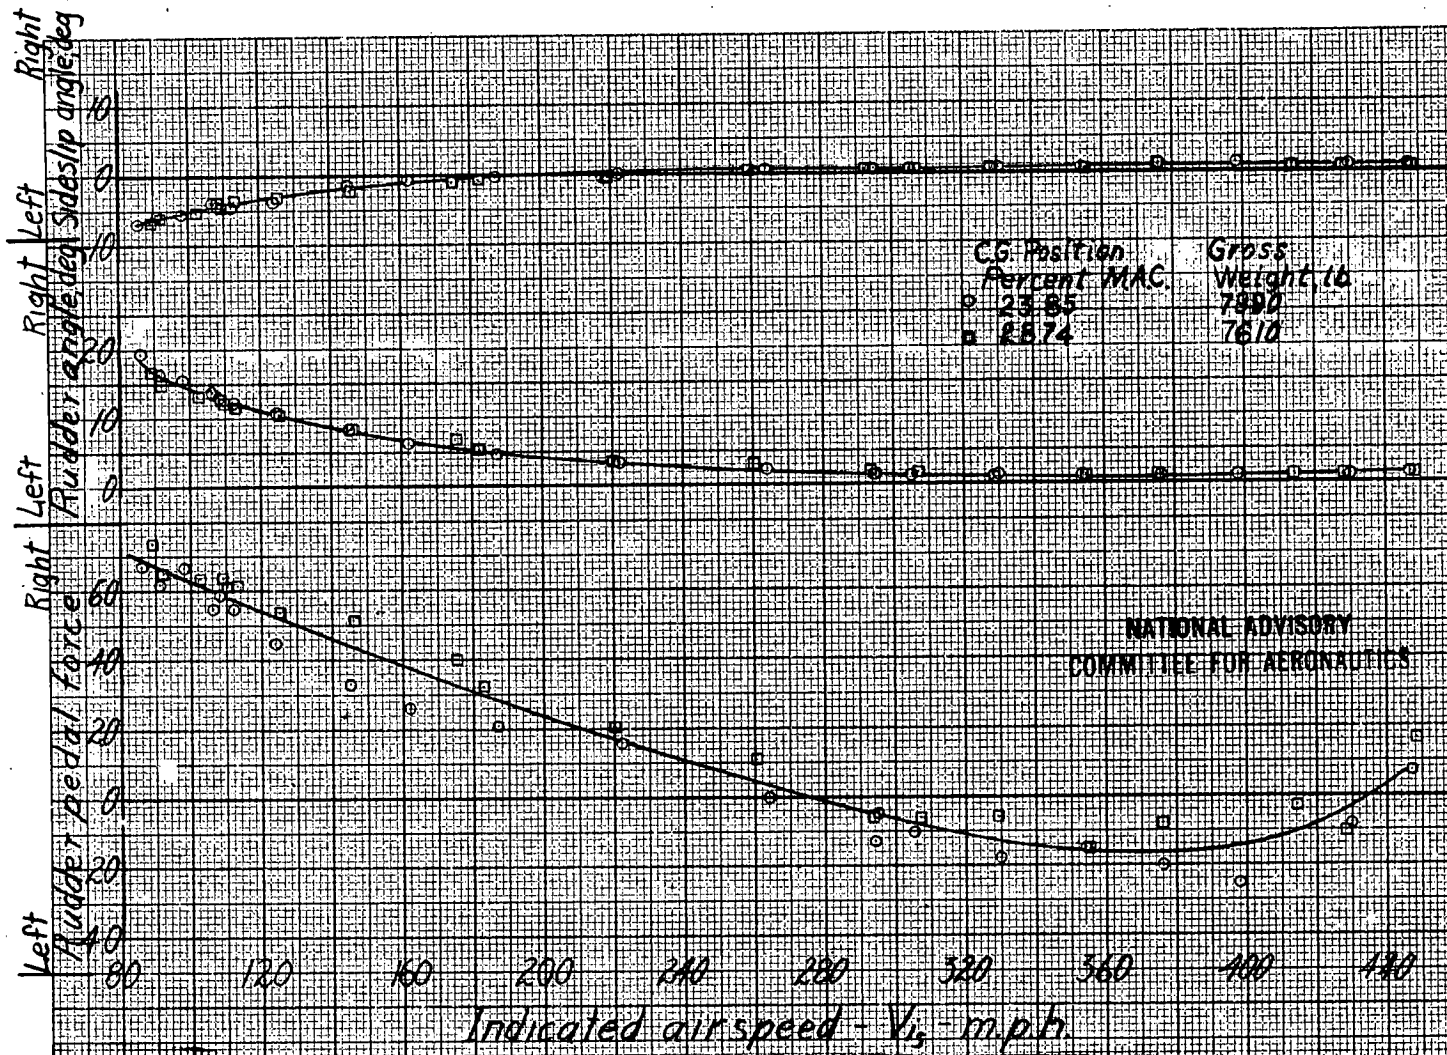
Figure 40.- Directional trim characteristics of P-63A-1 airplane with enlarged vertical tail surfaces showing the variation in rudder force and angle with indicated airspeed to maintain straight, wings-level flight. Clean condition, normal rated power (2600 RPM, 43 in. Hg.), altitude 5000 feet.

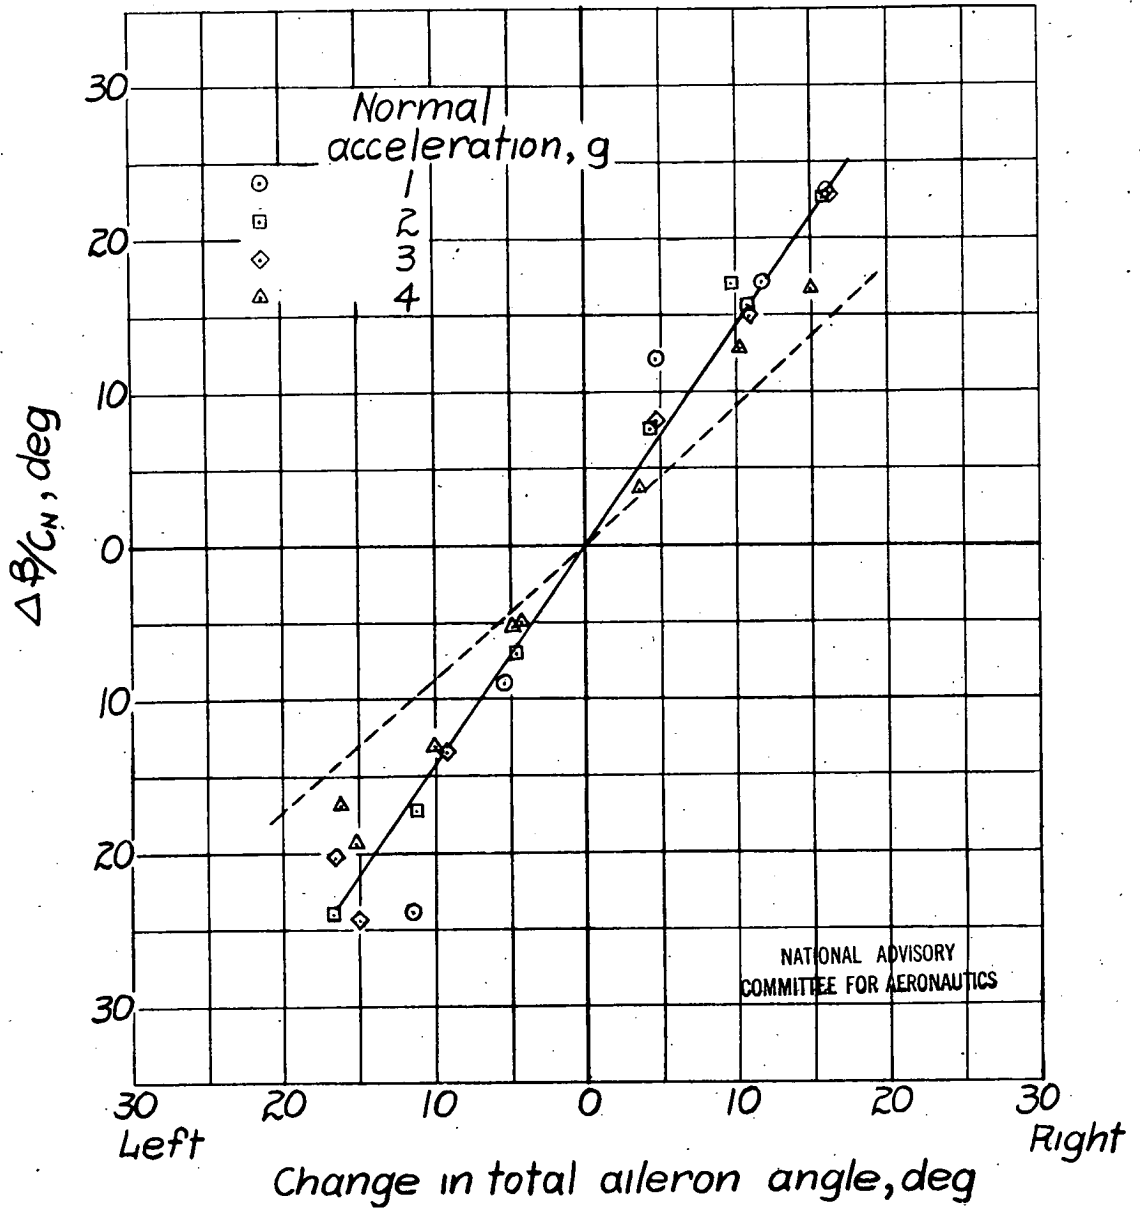
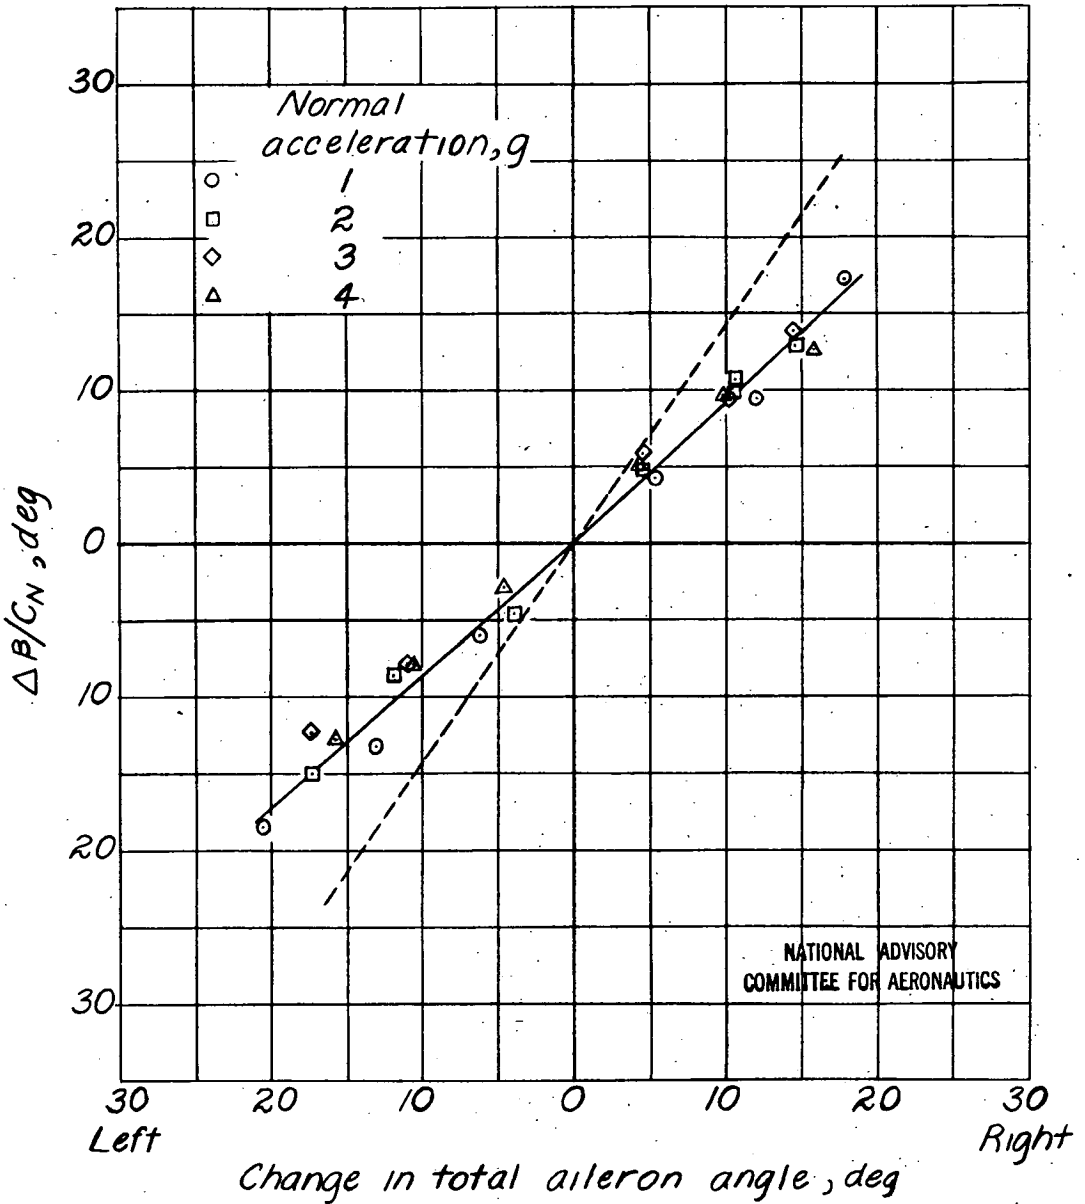
Figure 41.- Results of rudder-fixed rolls out of pull-outs at various normal accelerations at an indicated speed of 250 MPH at 5000 feet altitude using constant propeller blade angle and thrust coefficient. Bell P-63A-1 airplane (AAF No. 42-68889). (a) Original vertical tail. Dash line is faired curve for enlarged vertical tail shown in figure 41b.

(b) Enlarged vertical tail. Dash line is faired curve for original vertical tail shown in figure 41a.

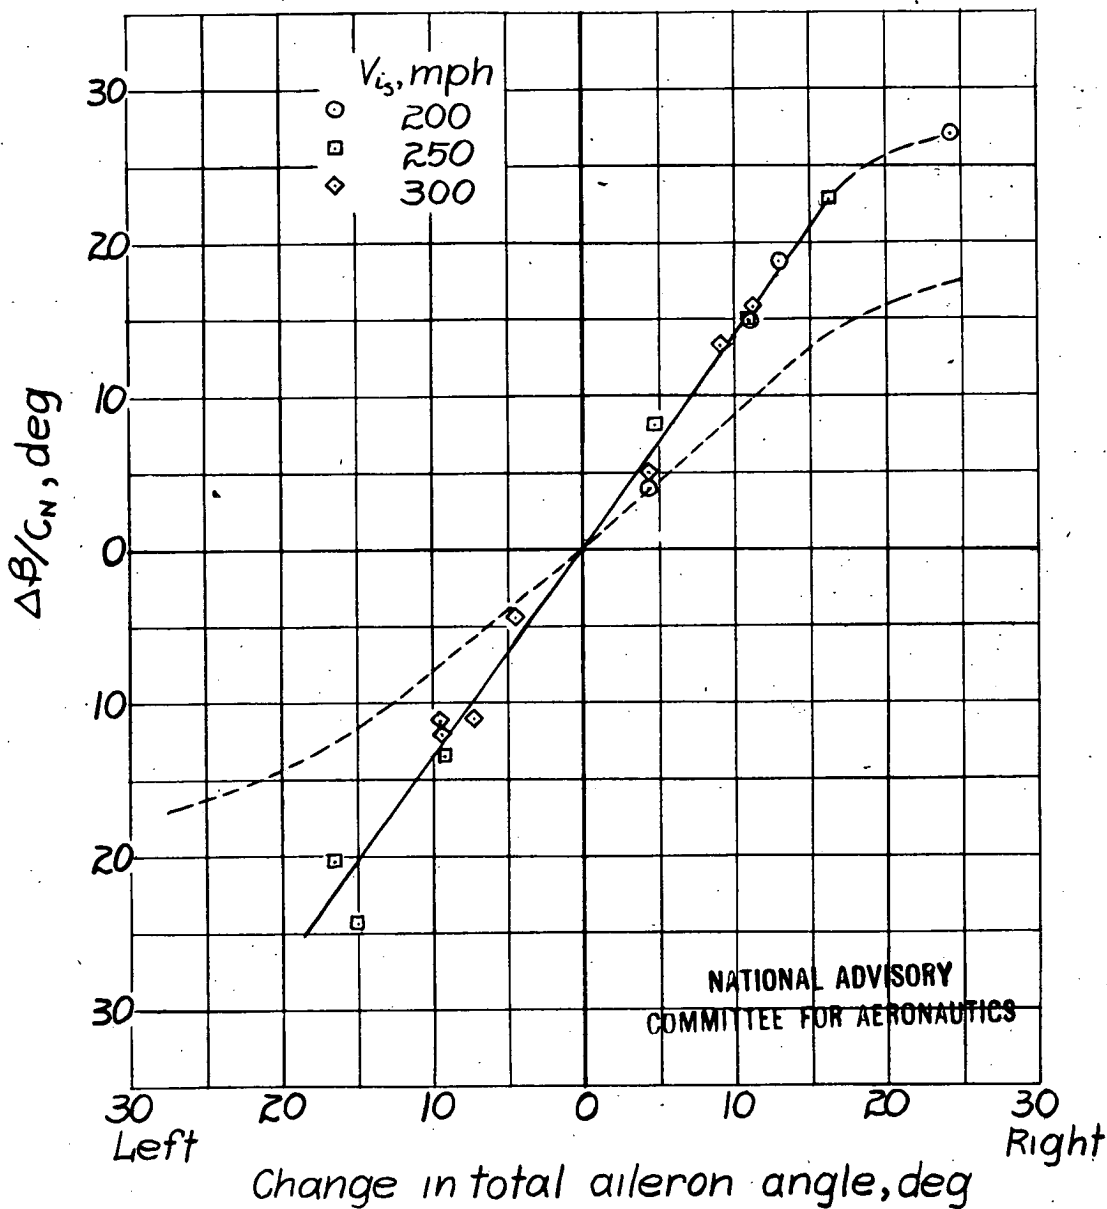
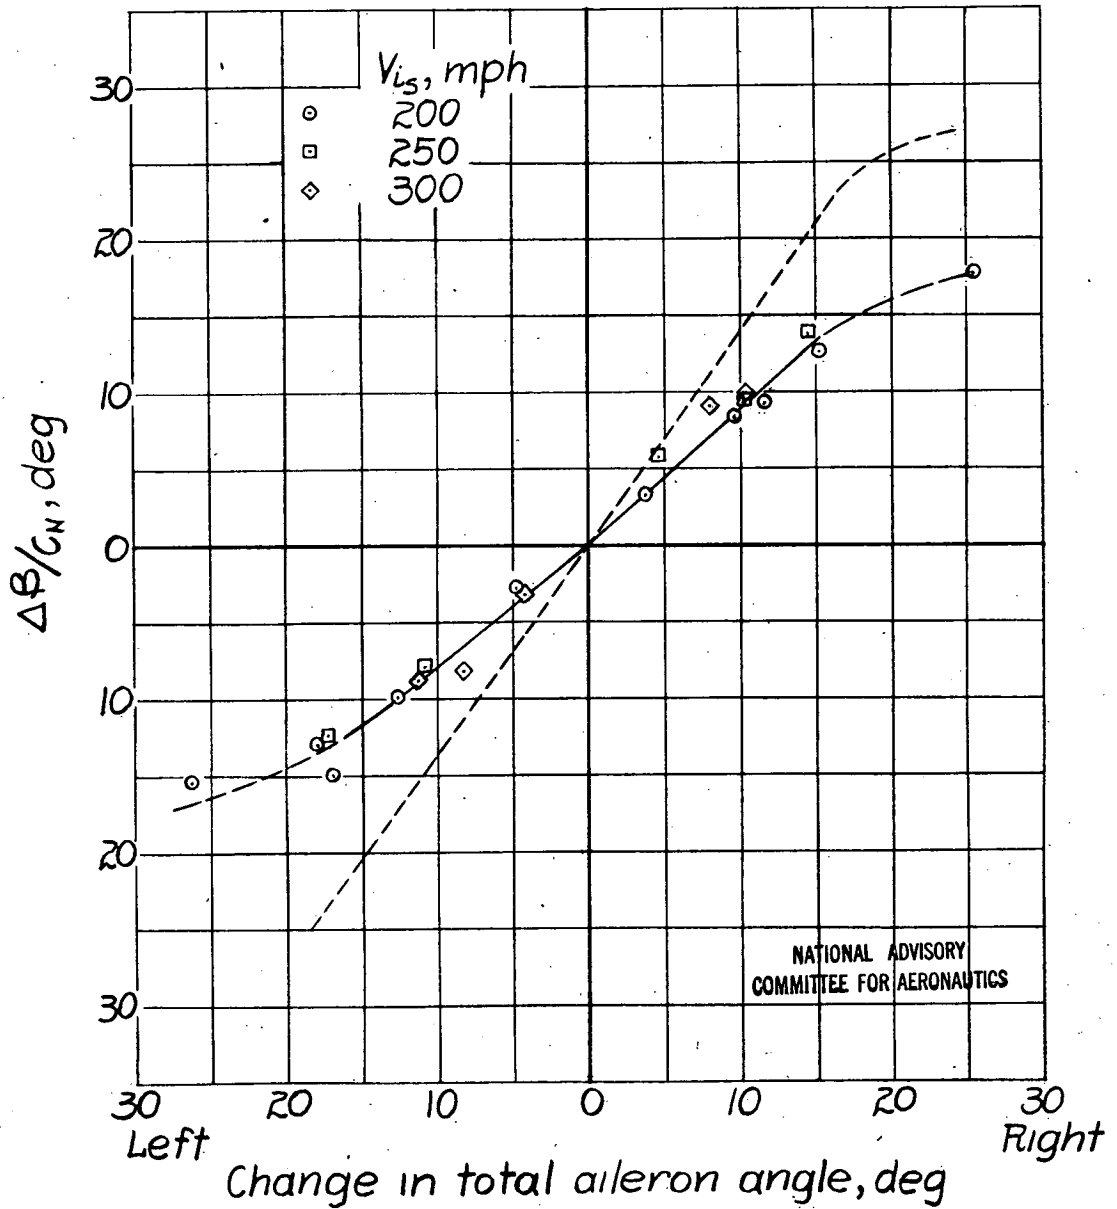
Figure 42.- Results of rudder-fixed rolls out of 3 g pull-outs at 5000 feet altitude at various speeds using constant propeller blade angle and thrust coefficient. Bell P-63A-1 airplane (AAF No. 42-68889). (a) Original vertical tail. Dash line is faired curve for enlarged vertical tail shown in figure 42b.

(b) Enlarged vertical tail. Dash line is faired curve for original vertical tail shown in figure 42a.

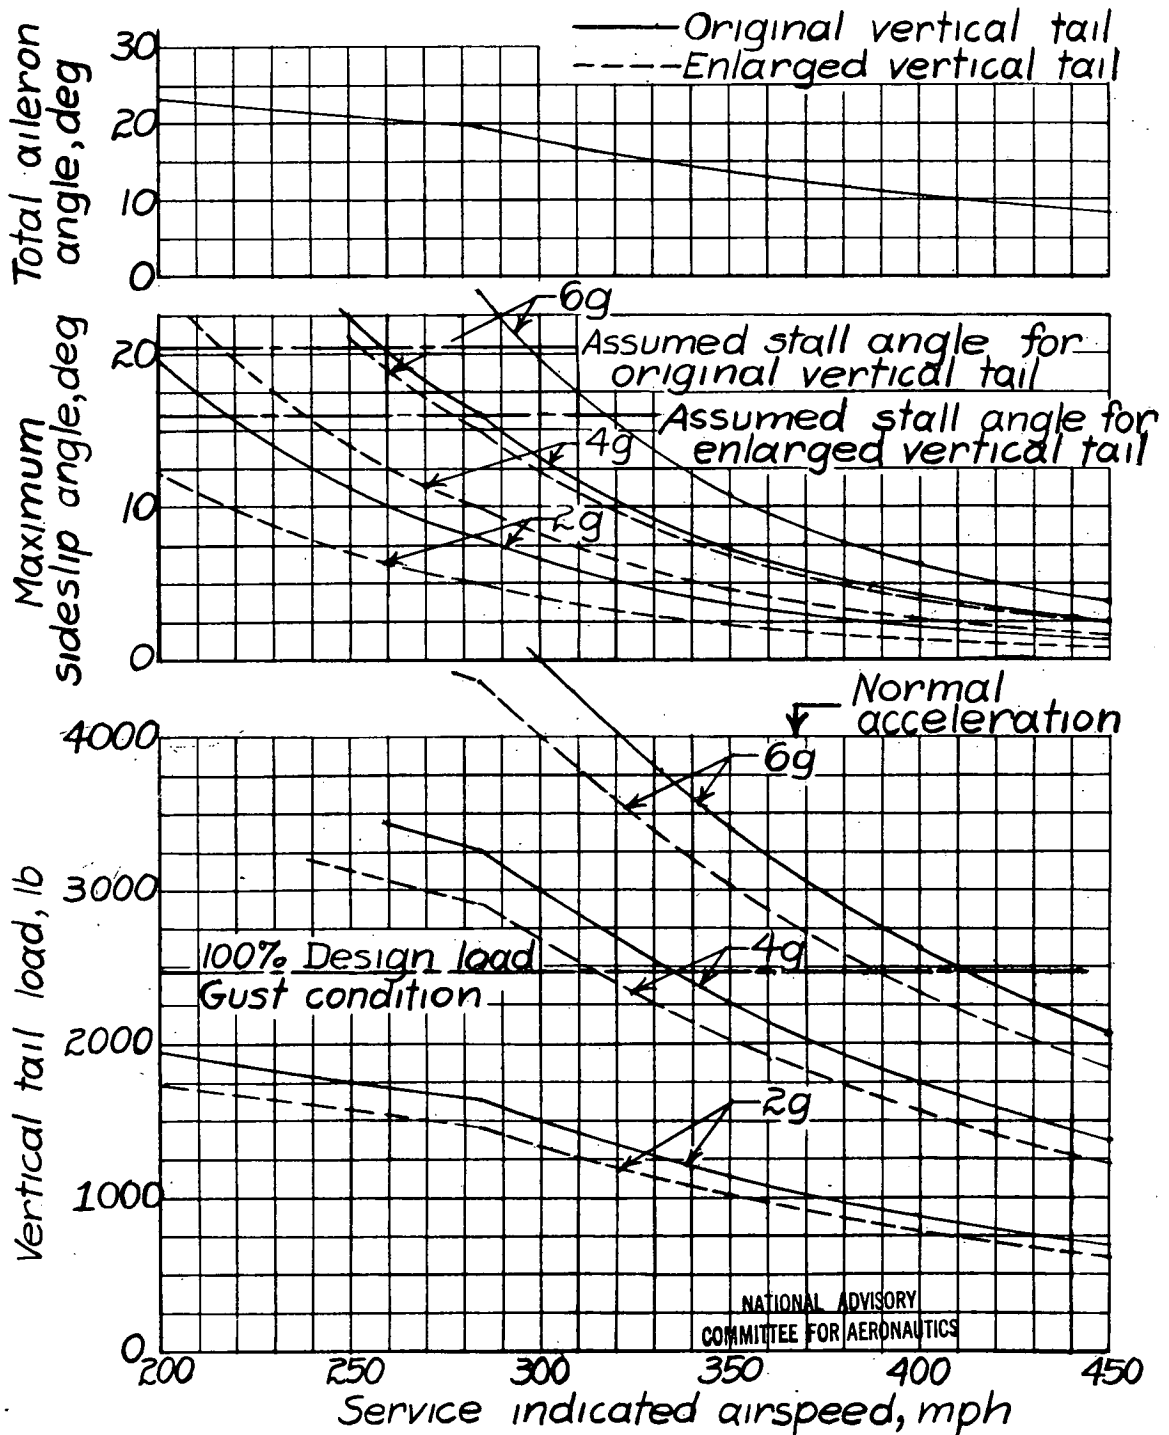
Figure 43.- Estimated maximum vertical tail loads to be expected in rudder-fixed rolls during accelerated flight employing 50 pounds aileron stick force.

It will be seen that the vertical-tail loads likely to be produced due to aileron action would exceed the design strength of the vertical tail for the gust condition if fast rolls were made above about  $3g$  normal acceleration. This indicates an immediate need for increasing the vertical-tail strength and also, very likely, for increasing the torsional strength of the fuselage. Under given aileron-deflection conditions the vertical-tail load appears to be somewhat lower for the enlarged vertical tail. This is due to the large directional-stability increase which restricts the maximum sideslip angles caused by rolling to much smaller values. When the sideslip angles are restricted the unstable fuselage and propeller yawing moments are reduced and, hence, the vertical-tail loads are also reduced.
