April 1946 as
Memorandum Report E6C07

TESTS OF CAST ALUMINUM-ALLOY MIXED-FLOW IMPELLERS

By John E. Douglas and Irving R. Schwartz

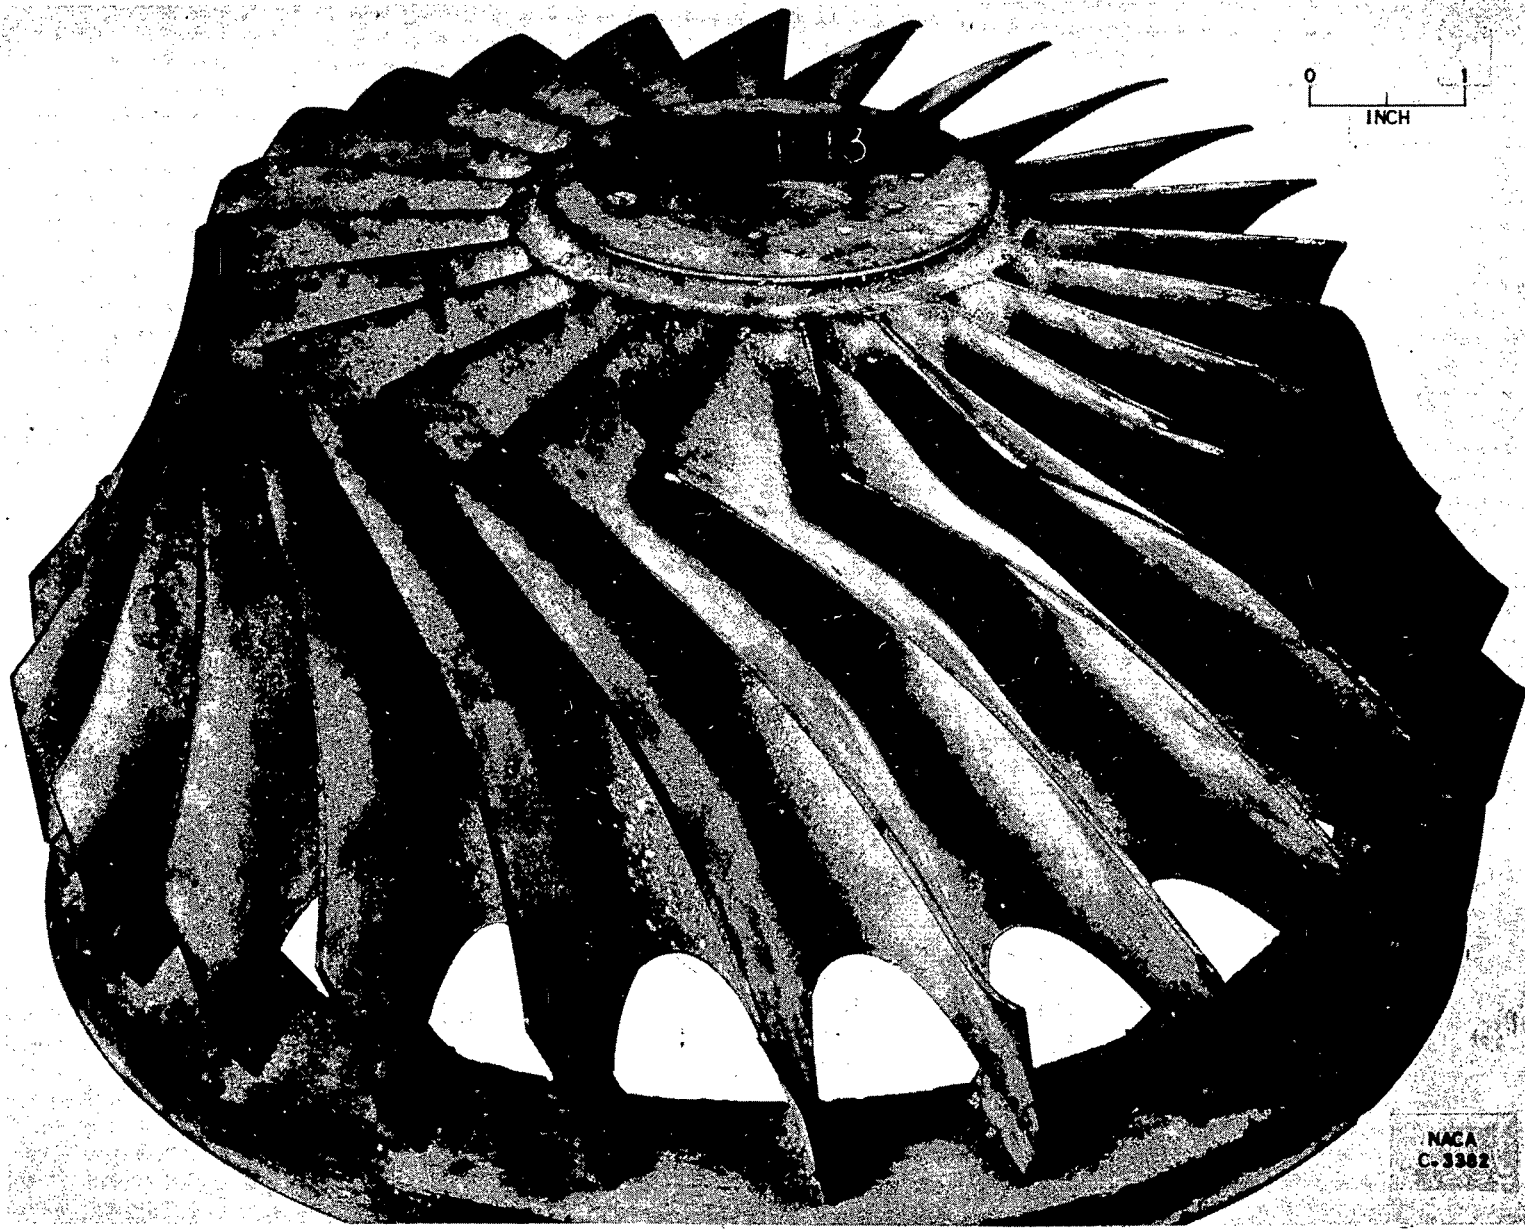
Figure 1. - Cast mixed-flow impeller received from the U.S. Naval Engineering Experiment station, Annapolis, Md.

Impellers. - Twelve mixed-flow impellers were cast by the lost wax process using a machined experimental centrifugal impeller as a master pattern. This impeller is of the mixed-flow type with 23 backward-swept blades. It was designed to discharge the air with an axial velocity component. Unlike the conventional centrifugal impeller, the blades do not have abruptly curved sections at the inlet. Because of the shape of the impeller passage, the angular acceleration of the air is continuous along a radius; the angular velocity of the air, however, is always less than that of the impeller. A typical cast impeller furnished by the U. S. Naval Engineering Experiment Station, Annapolis, Md., is shown in figure 1. The feeder flange, which was removed from the finished impeller, supports the blade tips and helps prevent warping during the heat-treating process.

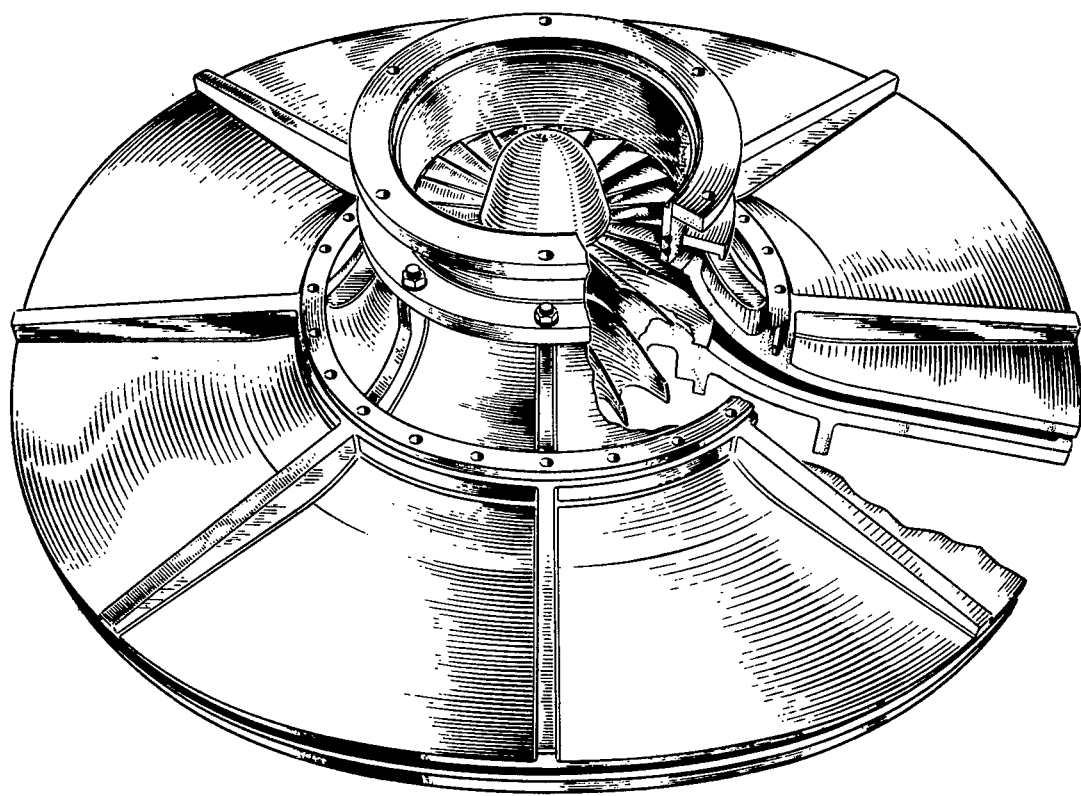
Figure 2. - Sketch of cast mixed-flow impeller with vaneless diffuser.

Diffusers. - A 34-inch vaneless diffuser, that was used with the cast mixed-flow impeller was designed to have an area expansion of a 6° equivalent cone along a logarithmic spiral flow path through the diffuser at design load. This diffuser design was also used with the machined impeller. The throat ratio of the vaneless diffusers (ratio of passage width at the diffuser entrance to passage width at the impeller tip) was increased from 0.534 for the diffuser used with the machined impeller to 0.748 for the diffuser used with the cast impeller. This change was made in order to obtain the best

performance from the cast impeller with a vaneless diffuser on the basis of test results from the NACA Langley Field laboratory of a similar mixed-flow impeller with diffusers of various throat ratios. Figure 2 is a drawing of the cast impeller with the vaneless diffuser.

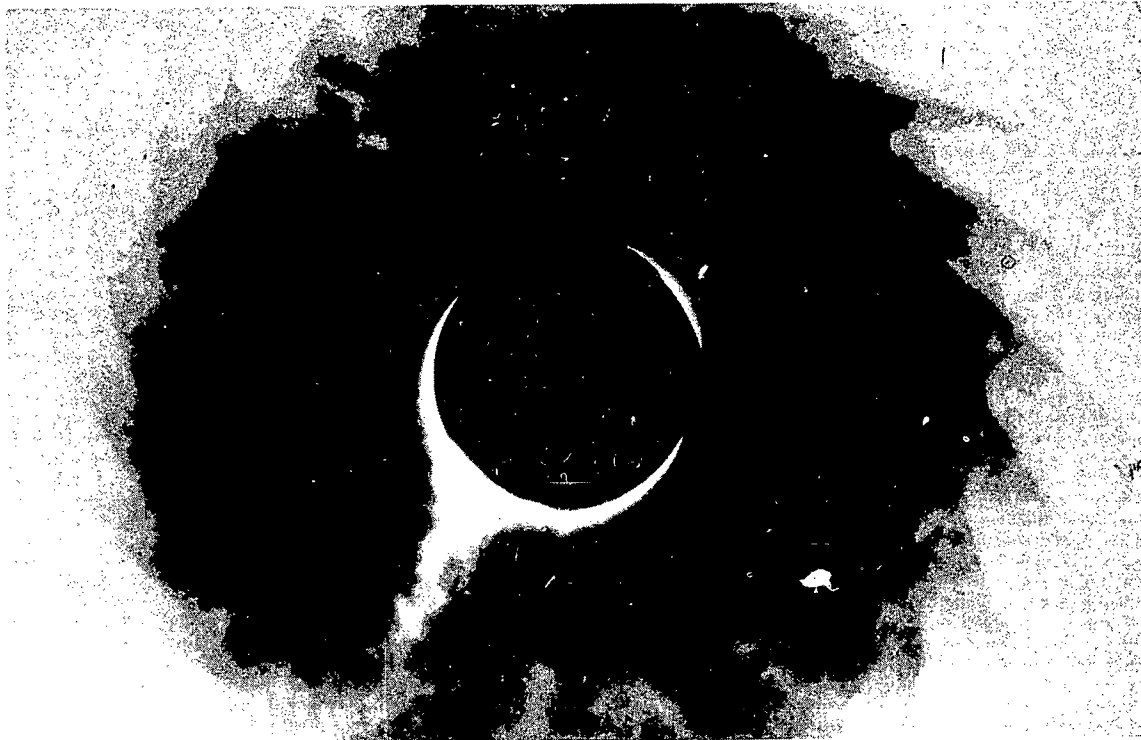
(a) Impeller 2-9, unsatisfactory impeller of alloy 2 with porosity and shrinkage cracks.

Figure 3. - X-rays of hub of cast mixed-flow impellers.

X-ray examination. - The X-ray examinations disclosed that only one of the six impellers of alloy 2 and five of the six impellers of alloy 1 could be considered satisfactory with regard to the internal quality of the castings. The X-ray photographs in figure 3 illustrate a satisfactory and an unsatisfactory hub of an impeller of each alloy. The best impeller of alloy 2 (2-23) had a slight amount of micro-shrinkage although the predominant defects of this series of castings were large shrinkage cracks and blowholes. Impeller 1-15, which had shrinkage cracks in the hub, was the only impeller of this alloy that had serious defects as shown by X-ray examination. Some of the impellers of alloy 1 had a slight amount of gas porosity, concentrated mostly in the impeller blades.

Spin tests. - Impellers 2-9, 2-22, and 2-24 had serious internal defects, as shown by X-ray examination (table I) and, consequently, broke at rather low tip speeds of 930 to 950 feet per second. Impellers 2-A and 2-6 had fewer internal defects than the forementioned impellers and broke at tip speeds near 1080 feet per second. The best

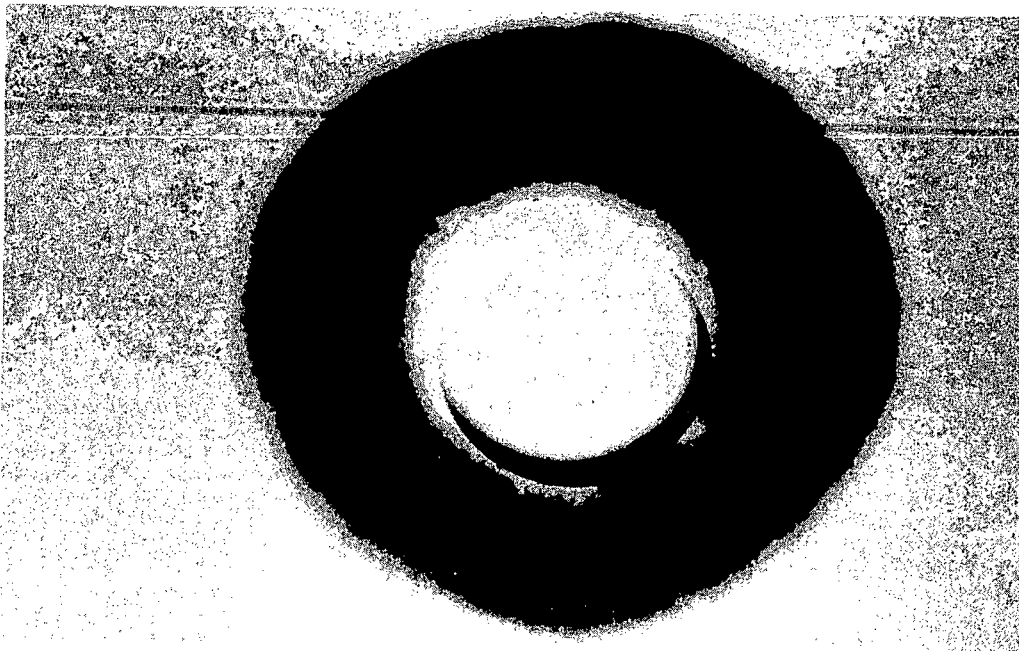
(c) Impeller 1-15, unsatisfactory impeller of alloy 1 with shrinkage cracks.

Impeller 1-15, which had shrinkage cracks in the hub as shown in figure 3(c), began to fail at a tip speed of 1475 feet per second. This impeller was not spun to destruction because radial cracks from the impeller hub were noted when the rig was shut down to measure the impeller elongation. Impeller 1-25, which had some porosity near the rear face of the impeller, and impeller 1-13, which had a fine microscopic porosity throughout, burst at tip speeds of 1641 and 1663 feet per second, respectively. Impellers 1-11 and 1-14, which were the soundest impellers of alloy 1 spin-tested, burst at tip speeds in excess of 1700 feet per second. Surface particles of impellers 1-11 and 1-14 broke loose from the impellers at tip speeds of approximately 1700 feet per second, just before bursting. The bursting speeds of the impellers are listed in table II. A comparison of tables I and II shows that the bursting speed of an impeller of any one alloy is dependent to a large extent on the nature and extent of the internal defects, which may be obtained from X-ray examination.

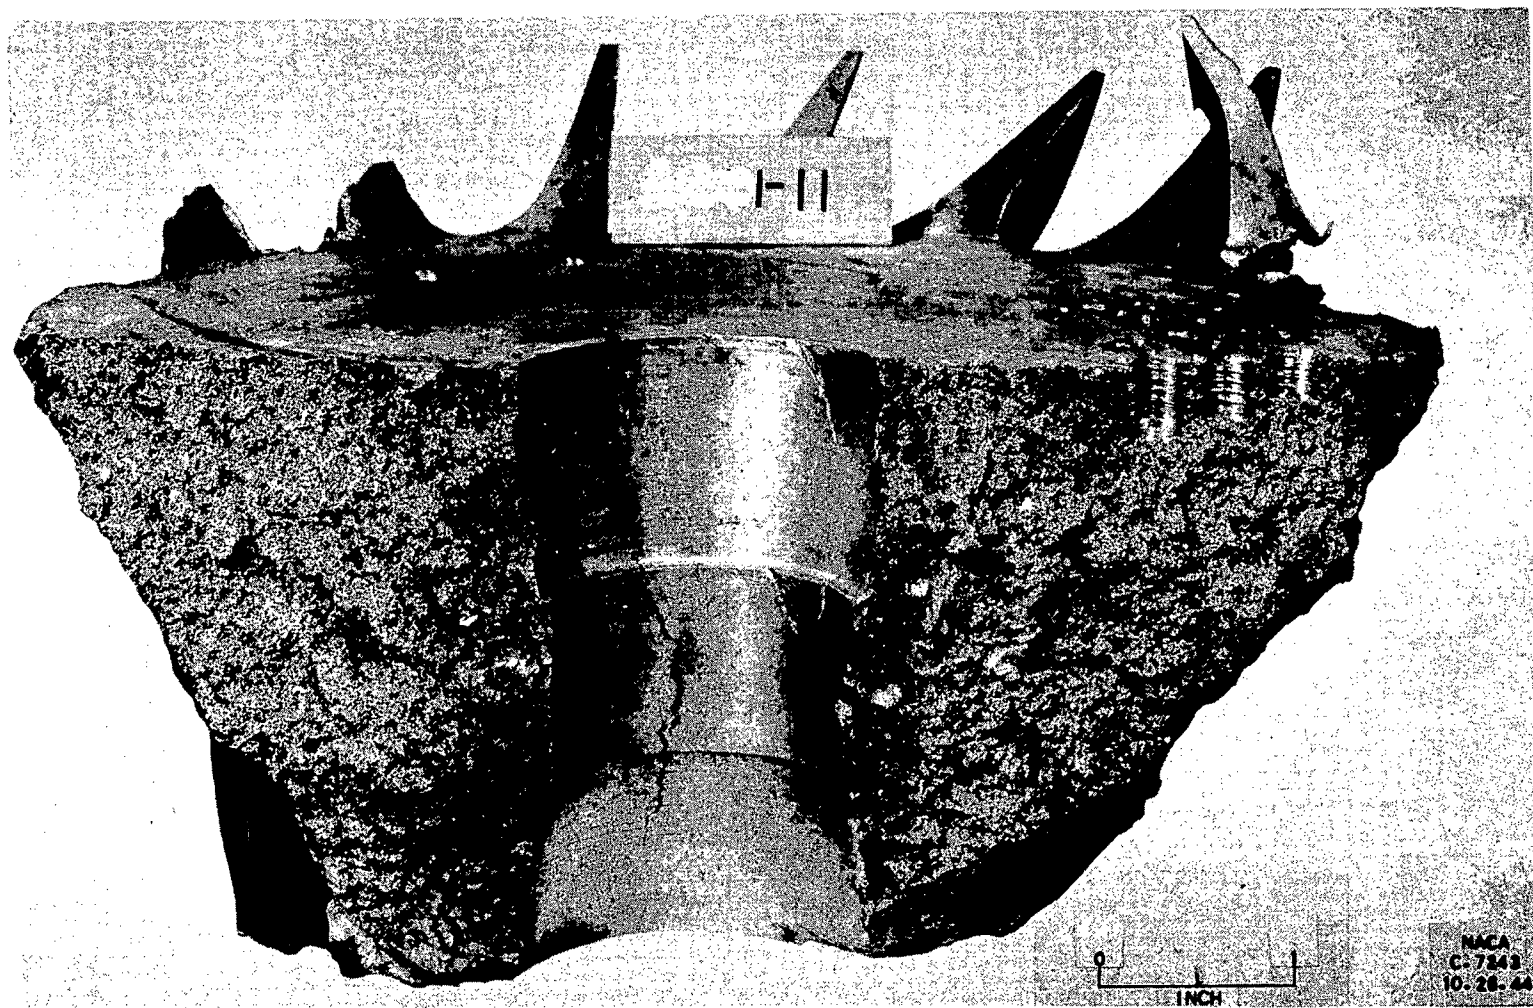
Figure 4. - Typical fragment of cast mixed-flow impeller 1-11 after being spun to destruction.

All of the impellers except 1-15, which was not spun to destruction, failed through the hub. Usually the impellers burst into three parts, by splitting into halves with one of the halves further dividing into two parts. Figure 4 shows a typical fragment of cast impeller 1-11 after being spun to destruction. The roughness of the fracture indicates the porosity.

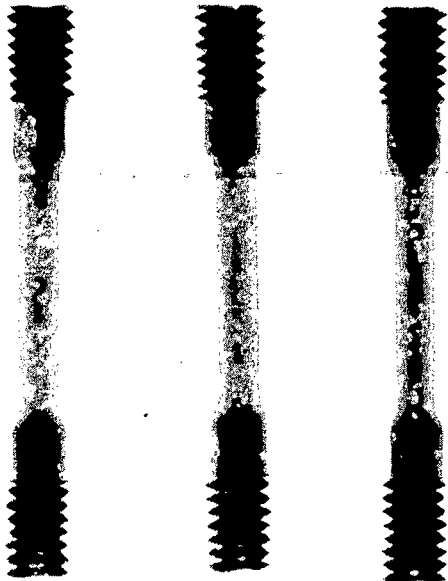
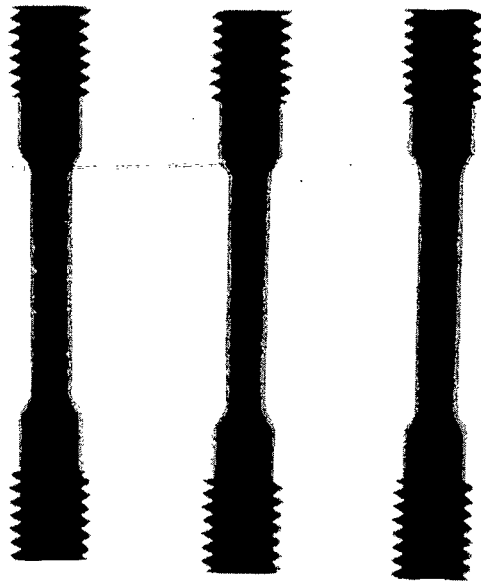
A B C
(a) Specimens from
impeller 2-22

A B C
(b) Specimens from
impeller 2-23

Figure 5. - X-ray photographs of tensile-test specimens cut from fragments of cast mixed-flow impellers.

Tensile-strength tests and X-ray examination of bar specimens. - A comparison of X-ray photographs of tensile-test specimens cut from fragments of impellers 2-22 and 2-23 (figs. 5(a) and 5(b)) with the results of the tensile tests shown in table III demonstrates that the tensile strength varies indirectly with the amount of porosity indicated by X-ray examination. The strength of the tensile-test specimens from impellers of alloy 2 varied from a maximum of approximately 110 percent to about 30 percent of the tensile strength recommended in Navy specifications. The tensile-test results of alloy 2 were erratic because of variations in the extent of porosity and other faults among the test specimens as shown in the X-ray of figures 5(a) and 5(b). The average tensile strength of all tested specimens of this alloy was 20,900 pounds per square inch.

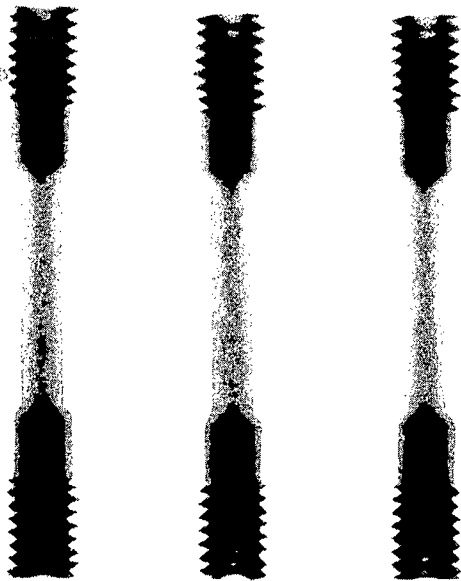
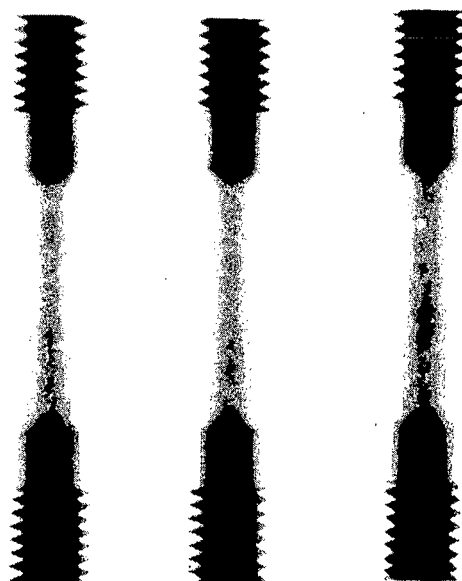
A B C
(c) Specimens from
impeller 1-11

A B C
(d) Specimens from
impeller 1-25

X-ray photographs of tensile-test specimens cut from fragments of impellers 1-11 and 1-25 are shown in figures 5(c) and 5(d). These representative X-rays show that a fine porosity exists in the specimens of alloy 1, which results in tensile strengths varying from a maximum of approximately 70 percent to 26 percent of the tensile strengths recommended in Navy specifications, except for one specimen that broke under the initial load of the testing machine. The tensile strengths of these specimens of alloy 1 are given in table III. The average tensile strength of all specimens of alloy 1 was 23,260 pounds per square inch. The results of the tensile tests of specimens taken from the impellers of both alloys indicated that the material was brittle.

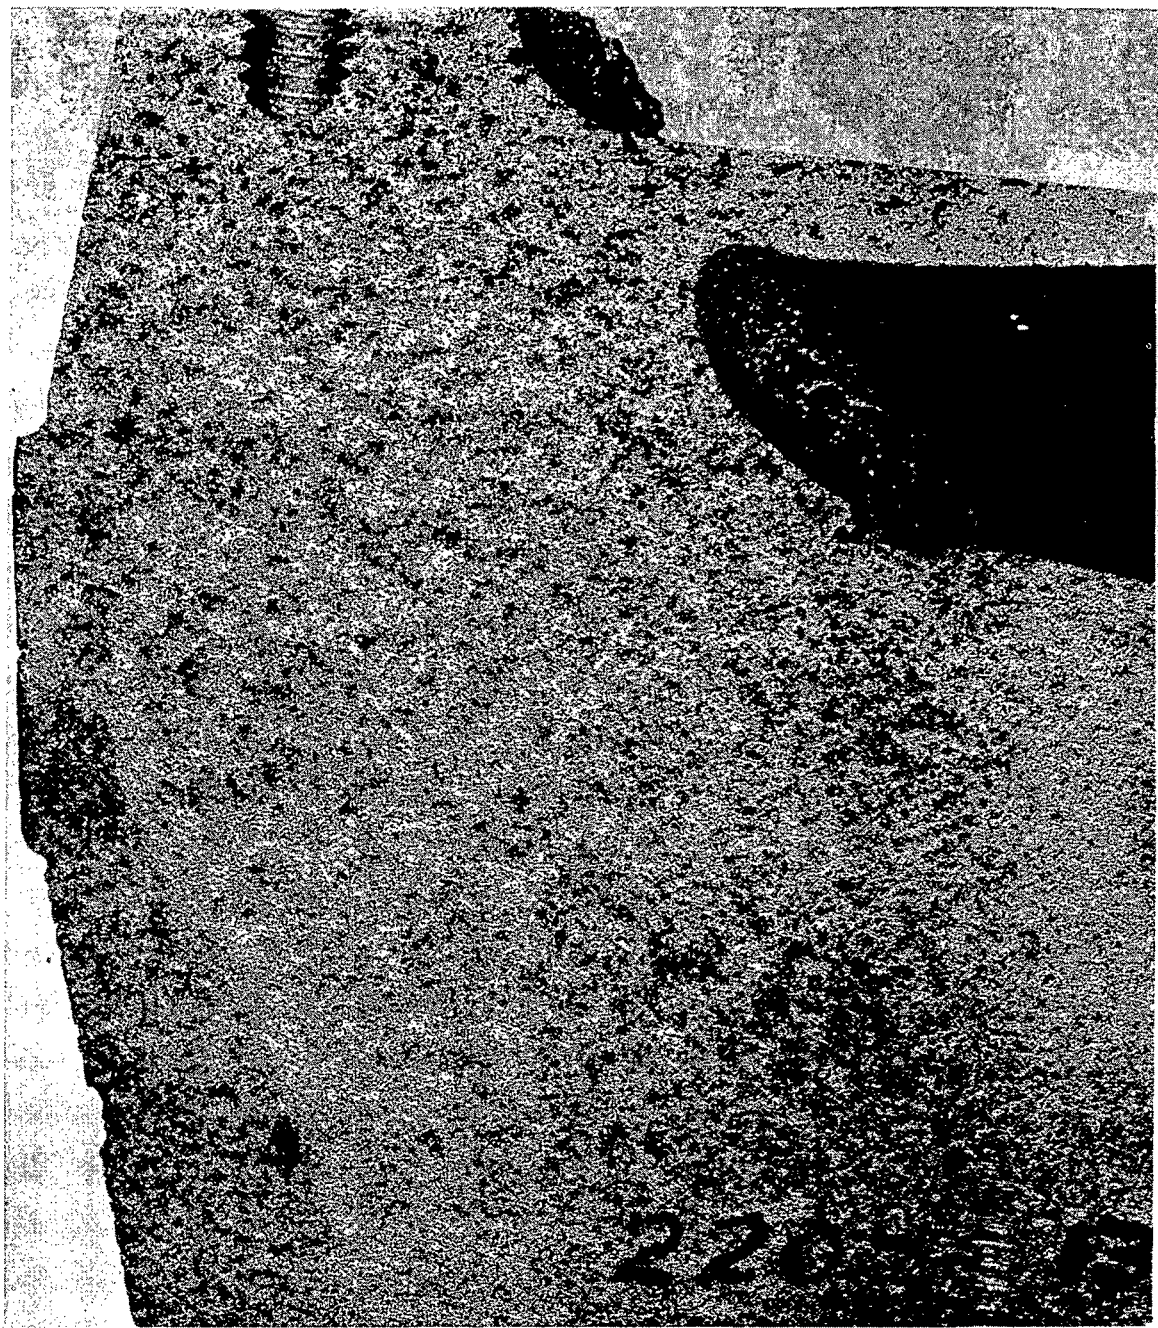
(a) Impeller 1-13.

Figure 6. - Specimens cut from the cast mixed-flow impellers macroetched to show grain structure. X2.25.

Metallurgical examination. - Specimens similar to those used for the internal Brinell hardness determinations were macroetched to examine the grain structure of the cast impellers. The macroetched specimens from typical impellers (1-13 and 2-9) are shown in figure 6. The specimen from impeller 1-13 shows a granular grain structure, porosity, and evidence of segregation, all of which would reduce the physical strength of the impeller. (The tensile strength was less than 70 percent of Navy specifications.) The specimen from impeller 2-9 shows porosity, blowholes, and shrinkage cracks and the grain structure was somewhat dendritic.

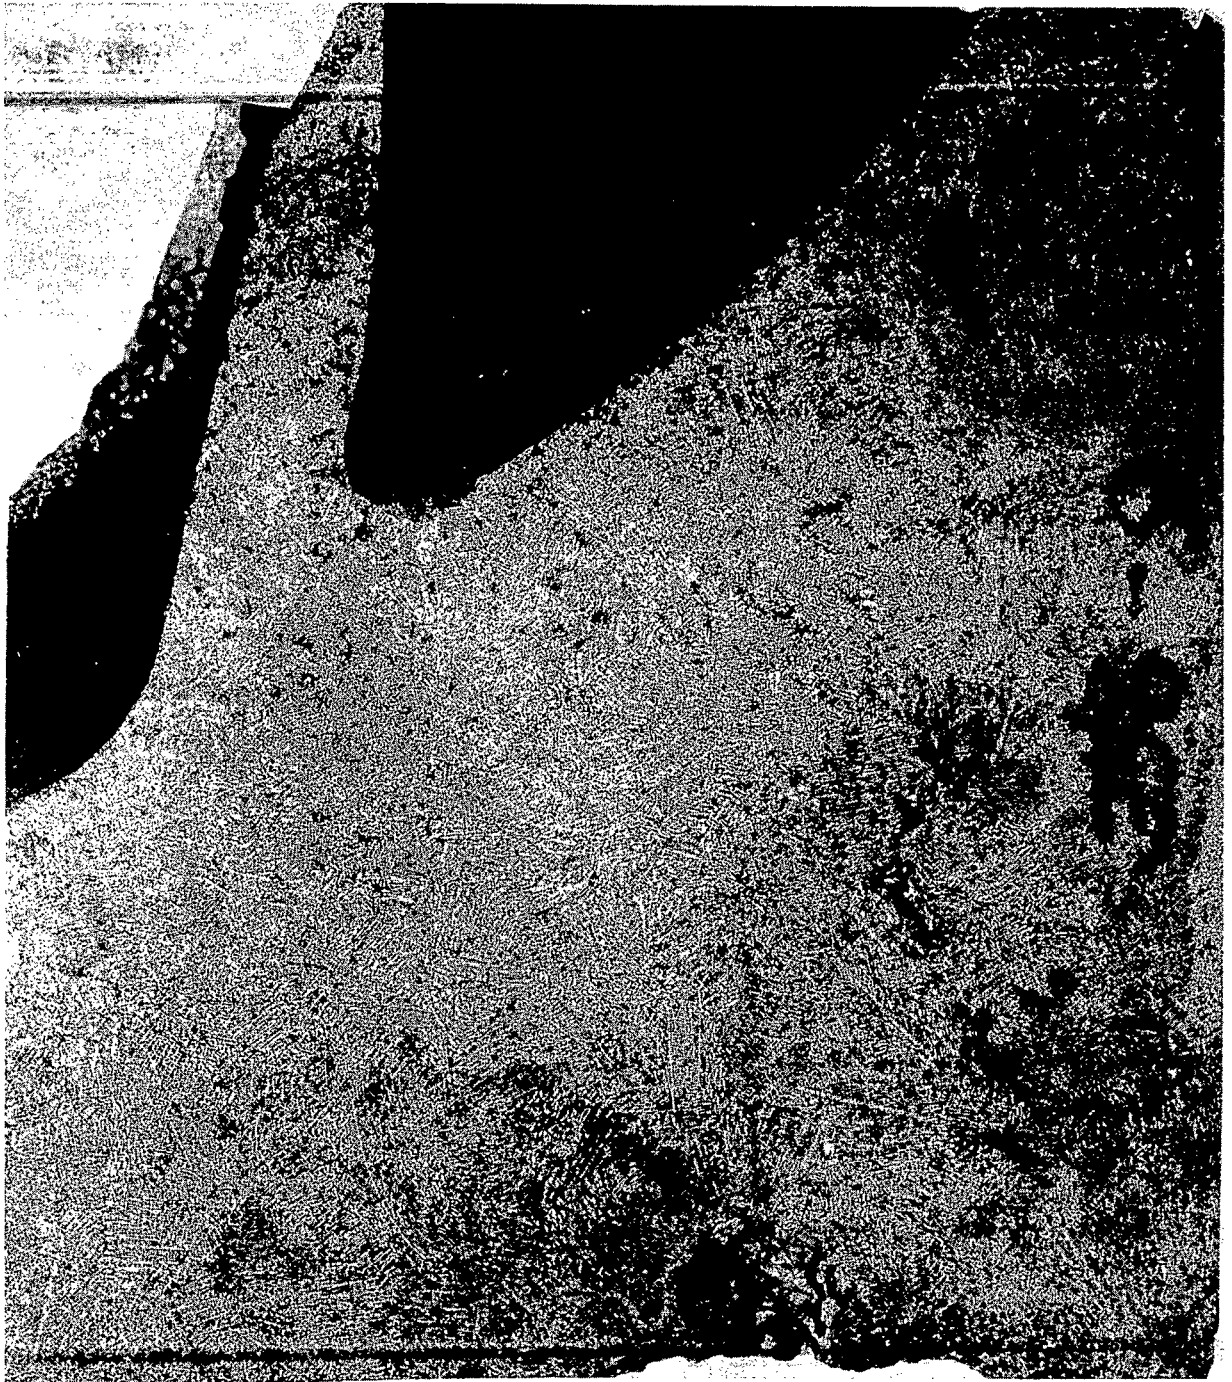
INCH
(b) Impeller 2-9.

Figure 6. - Concluded.

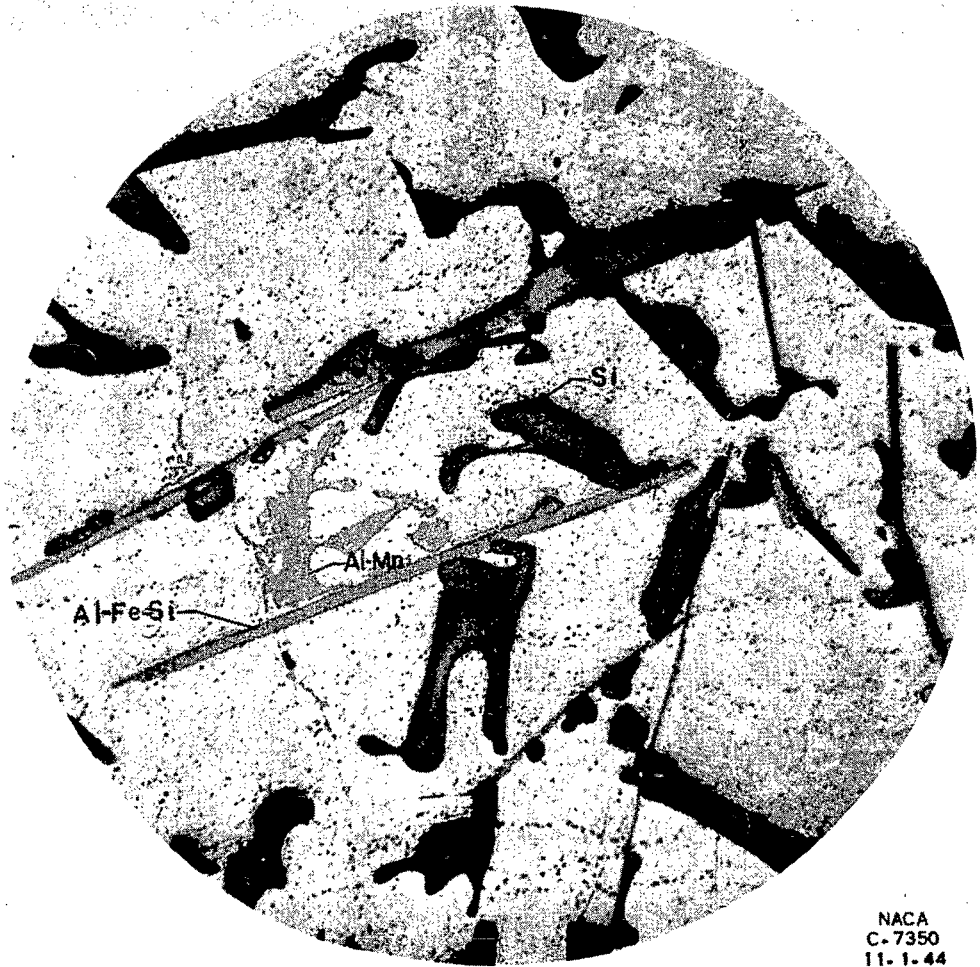
(a) From top of impeller 2-23. Etched in hydrofluoric acid.

Figure 7. - Etched specimens cut from various impellers showing porosity. X500.

The structure of the alloys was further examined from photomicrographs of specimens cut from various portions of the cast impellers. A typical photomicrograph of a specimen of alloy 2 is shown in figure 7(a). The photomicrograph of the specimen showed that aluminum combined with impurities to form Al-Mn and complex compounds of Al-Fe-Si. The free silicon that came out of solution on cooling appears to be fairly uniformly distributed. The photomicrograph in figure 7(b) is of a specimen taken from the top of impeller 1-11 and shows complex compounds of Al-Fe-Mn-Co-Si and Mg_2Si and Al_2O_3 . The fine porosity characteristic of this alloy is shown for impeller 1-11 at a magnification of 500 diameters in figure 7(b) and for impeller 1-15 at a magnification of 100 diameters in figure 8. The solid black areas indicate porosity. In general, the photomicrographs show that the impellers are of the normal structure with the maximum permissible amount of impurities.

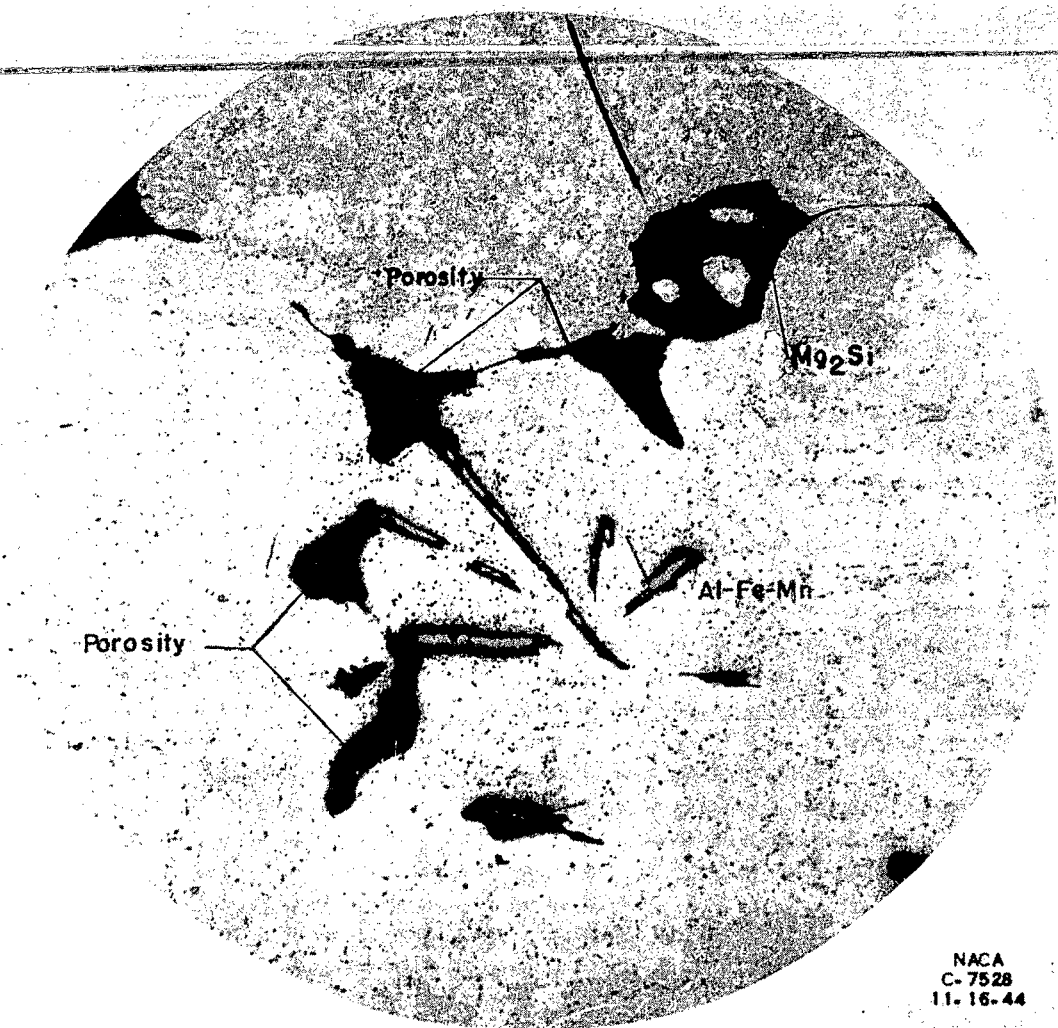
(b) From top of impeller 1-11. Etched in mixed acid.
Figure 7. - Concluded.

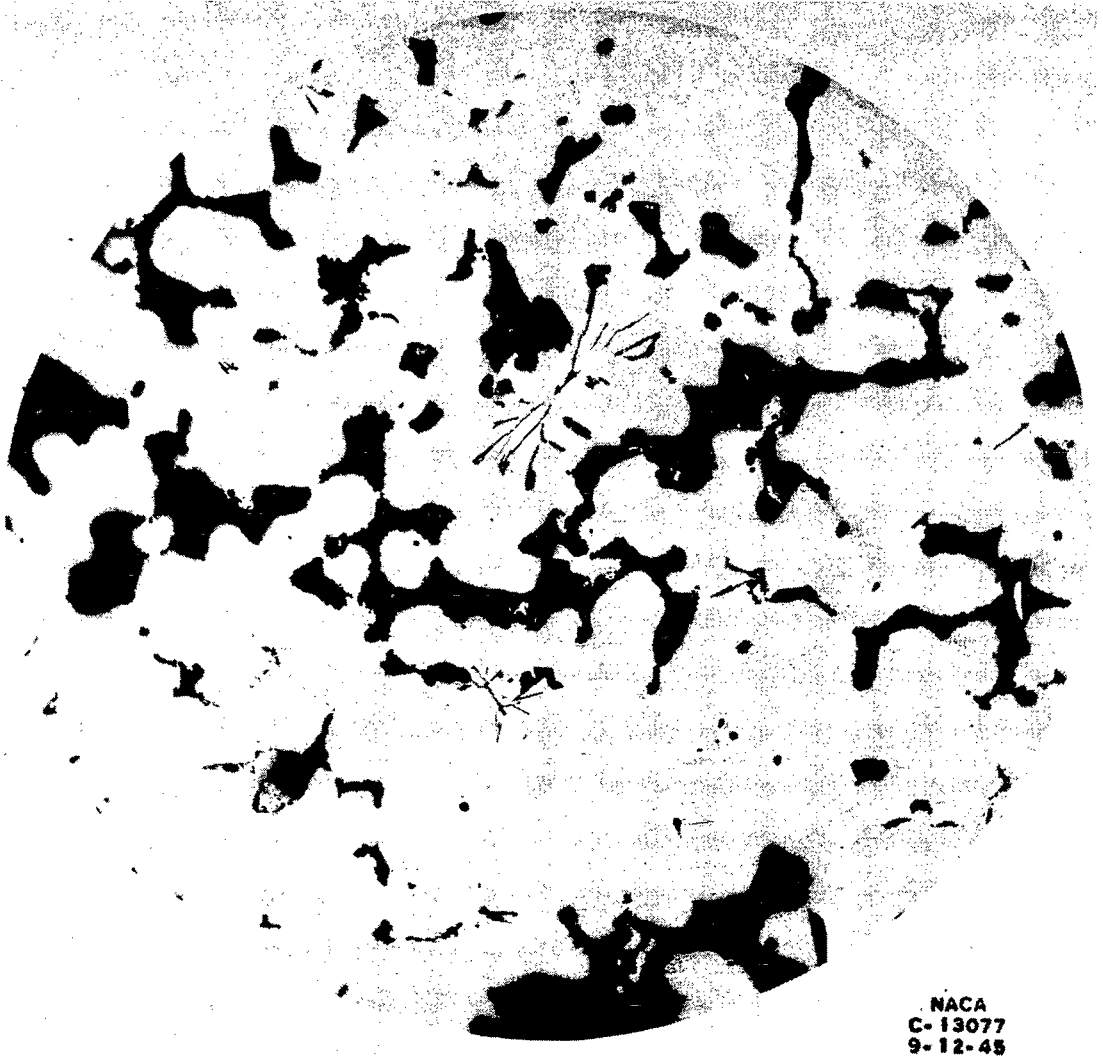
Figure 8. - Etched specimen from bottom of impeller 1-15 showing characteristic porosity of the alloy. Etched in mixed acid. X100.

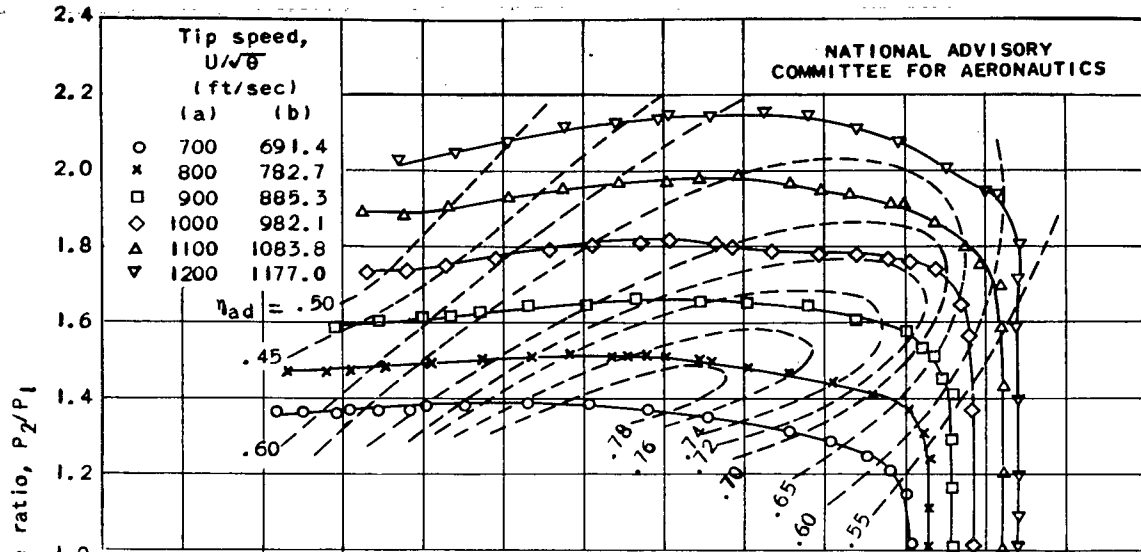
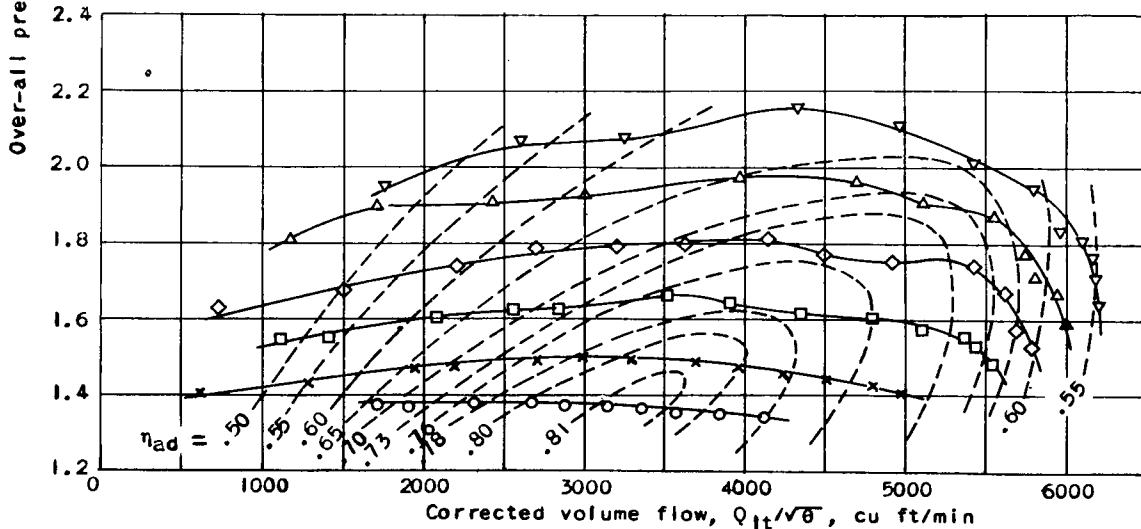
(a) Cast mixed-flow impeller.

(b) Machined impeller.

Figure 9. - Over-all pressure ratio and corrected volume flow with over-all adiabatic efficiency of impellers with NACA vaneless diffuser.

Because of difficulties in obtaining reliable data at the impeller tip caused by the highly turbulent impeller-discharge air, the cast impeller (1-12) that was not spin-tested to destruction was tested in combination with a 34-inch vaneless diffuser and the performance was determined from measurements in the test-rig outlet duct. The performance of the cast impeller is compared with that of the machined impeller in figures 9 and 10. Neither the impellers nor the diffusers were geometrically the same and the method of testing was somewhat different for the two combinations. The essential difference in the testing methods was that the Reynolds number and corrected tip speeds $U/\sqrt{\theta}$ of the two units were slightly different. Test results show that the effect of Reynolds number is small at low Mach numbers; hence, the combined effect of the geometric and impeller surface differences can be adequately determined by performance comparison. Differences in test setup and facilities permitted operation of the cast impeller with the vaneless diffuser at a lower pressure ratio P_2/P_1 than the machined impeller. This difference in minimum pressure ratios at maximum flows prevents a comparison of range at tip speeds of 700 and 800 feet per second but at all the higher tip speeds the machined impeller handled a larger corrected volume of air $Q_{1t}/\sqrt{\theta}$ than the cast impeller (fig. 9). The difference in the maximum flows handled is probably due to the smaller passage area of the cast impeller, which causes critical air velocities (hence choking effects) through the passages of the

cast impeller at lower flows than through the machined impeller passages at comparable tip speeds. The machined impeller was also able to operate at lower flows than the cast impeller at all comparable tip speeds except 700 feet per second. For the test on the machined impeller with the diffuser at this speed, however, operation was apparently halted before final surge had been reached. The greater surface roughness and possible warping of the cast impeller probably led to early separation and consequent surge at higher flows than in the machined-impeller combination.

Although the diffuser used with the cast impeller was designed to improve the performance of this combination, results of these tests (figs. 9 and 10) showed a decrease in over-all performance compared with that of the machined-impeller combination. Most of this decrease in performance can be attributed to the differences in the impellers and is probably due to the effects of the rough casting surface and distortion of the impeller passages during casting and heat-treating.

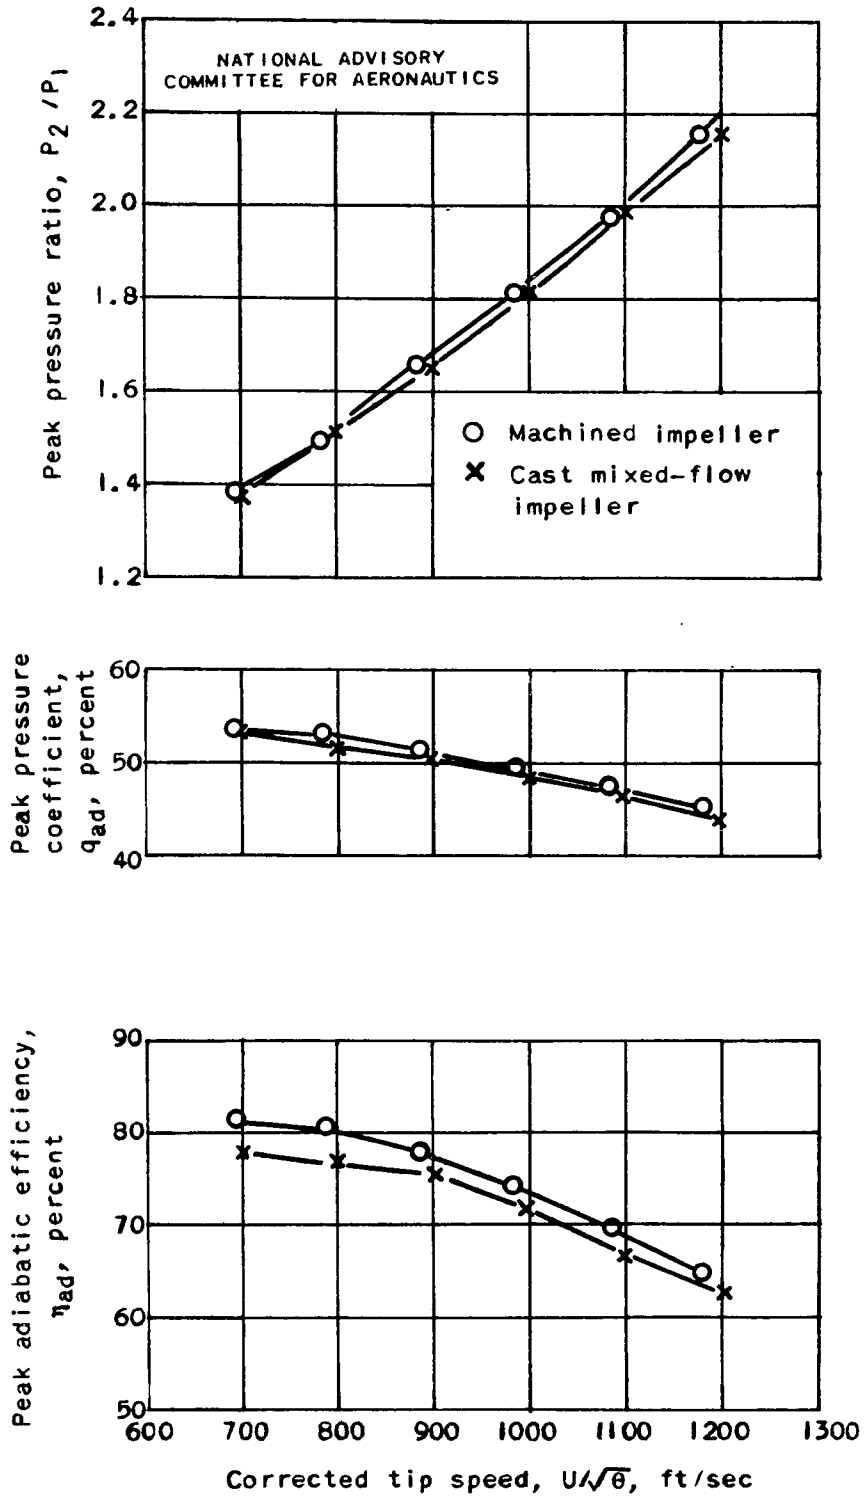
Figure 10. - Over-all peak performance of impellers with NACA vaneless diffuser.

The over-all peak adiabatic efficiency η_{ad} , pressure coefficient q_{ad} , and pressure ratio P_2/P_1 of the two impeller-diffuser combinations are shown in figure 10. The peak adiabatic efficiency of the cast impeller with the diffuser was approximately 78 and 62 percent at corrected tip speeds of 700 and 1200 feet per second, respectively; these efficiencies were approximately 3 points lower than the corresponding peak efficiency of the machined impeller with the diffuser at low speeds and 2 points lower at high speeds. The peak pressure coefficient was approximately 63 percent for both impeller-diffuser combinations at a corrected tip speed of 700 feet per second. The peak pressure coefficient of the cast-impeller combination was slightly lower than that of the machined-impeller combination at all tip speeds above 700 feet per second; at 1200 feet per second, it was 53 percent. The peak pressure ratio of the cast impeller with the vaneless diffuser was slightly lower than that of the machined impeller with the vaneless diffuser at all corrected tip speeds. A maximum pressure ratio of 2.16 was obtained with the cast-impeller combination at a corrected tip speed of 1200 feet per second.
