**Forensic Analyses of Explosion Debris from the  
January 2, 1992 Pd/D<sub>2</sub>O Electrochemistry  
Incident at SRI International**

**A Public Domain Report to  
California Division of Occupational Safety and Health**

**August 15, 1992**

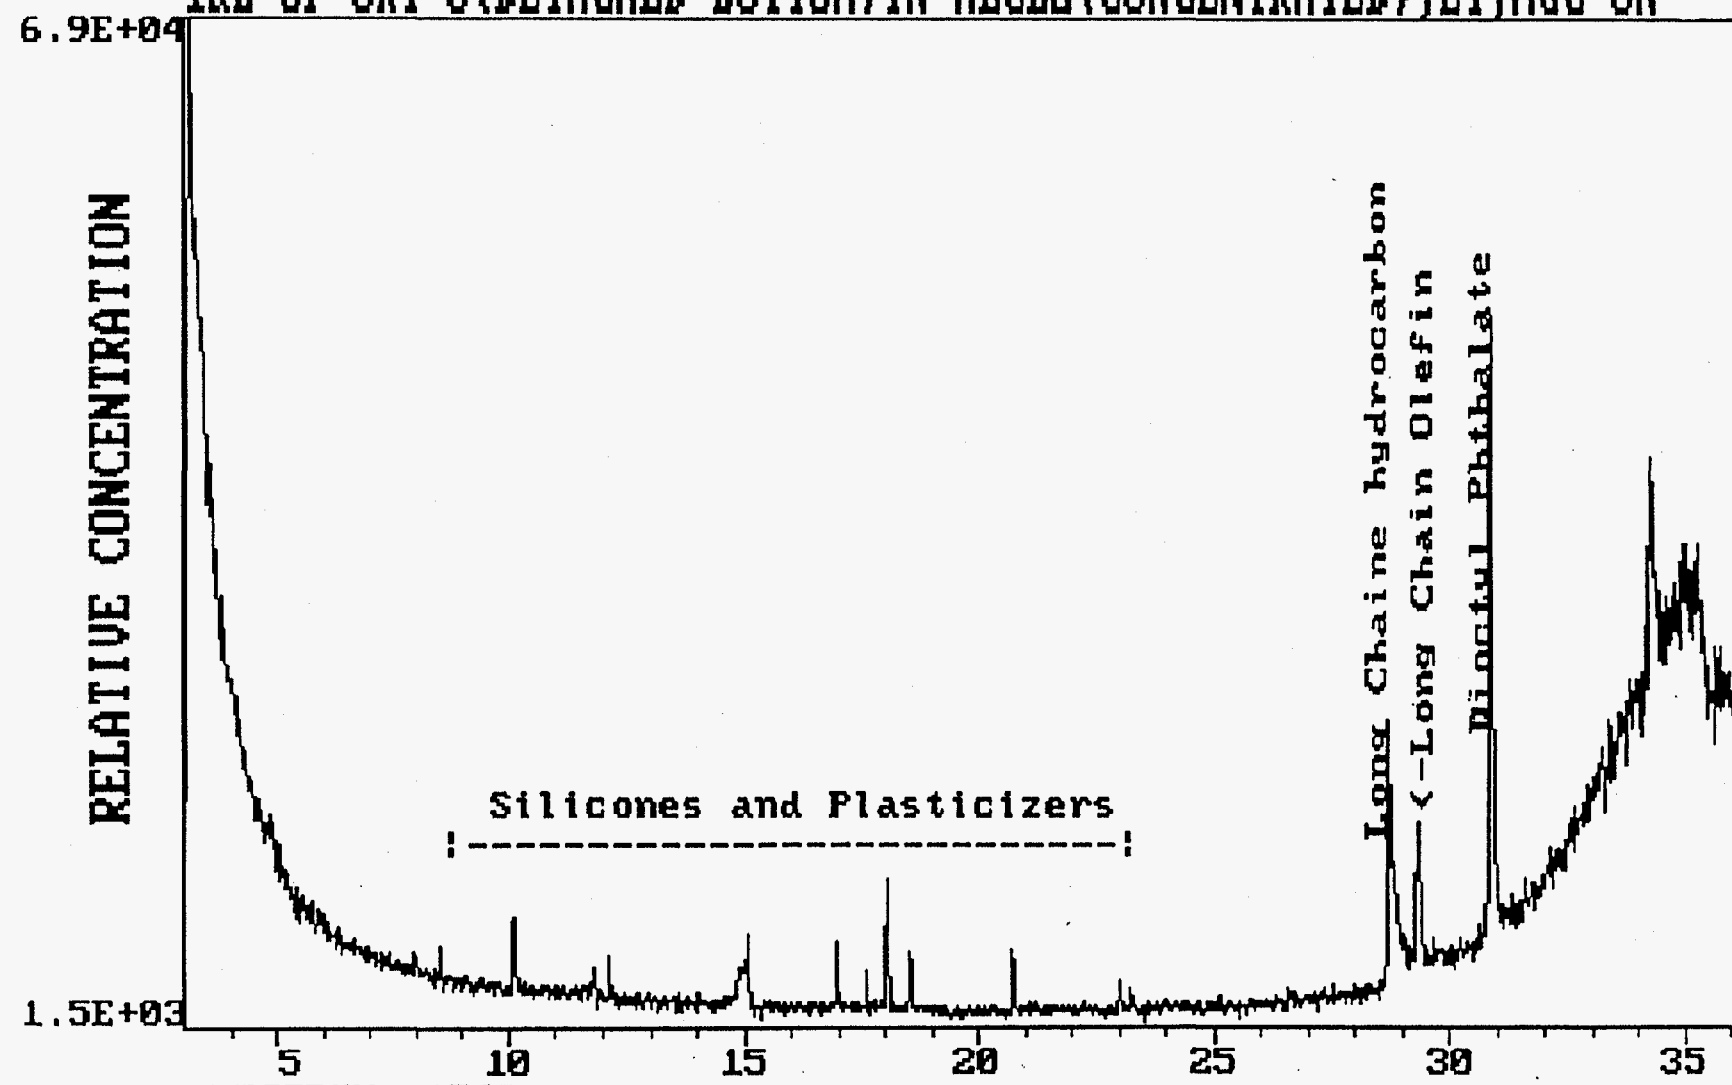
B00886.DAT

1μL OF SRI-3 (DETACHED BOTTOM) IN MECL2 (CONCENTRATED), EI, AGC-ON

The detached stainless steel base was found to be coated with similar silicones and plasticizers. Dioctylphthalate was again the major compound on the surface of this debris specimen. No other major components were seen.

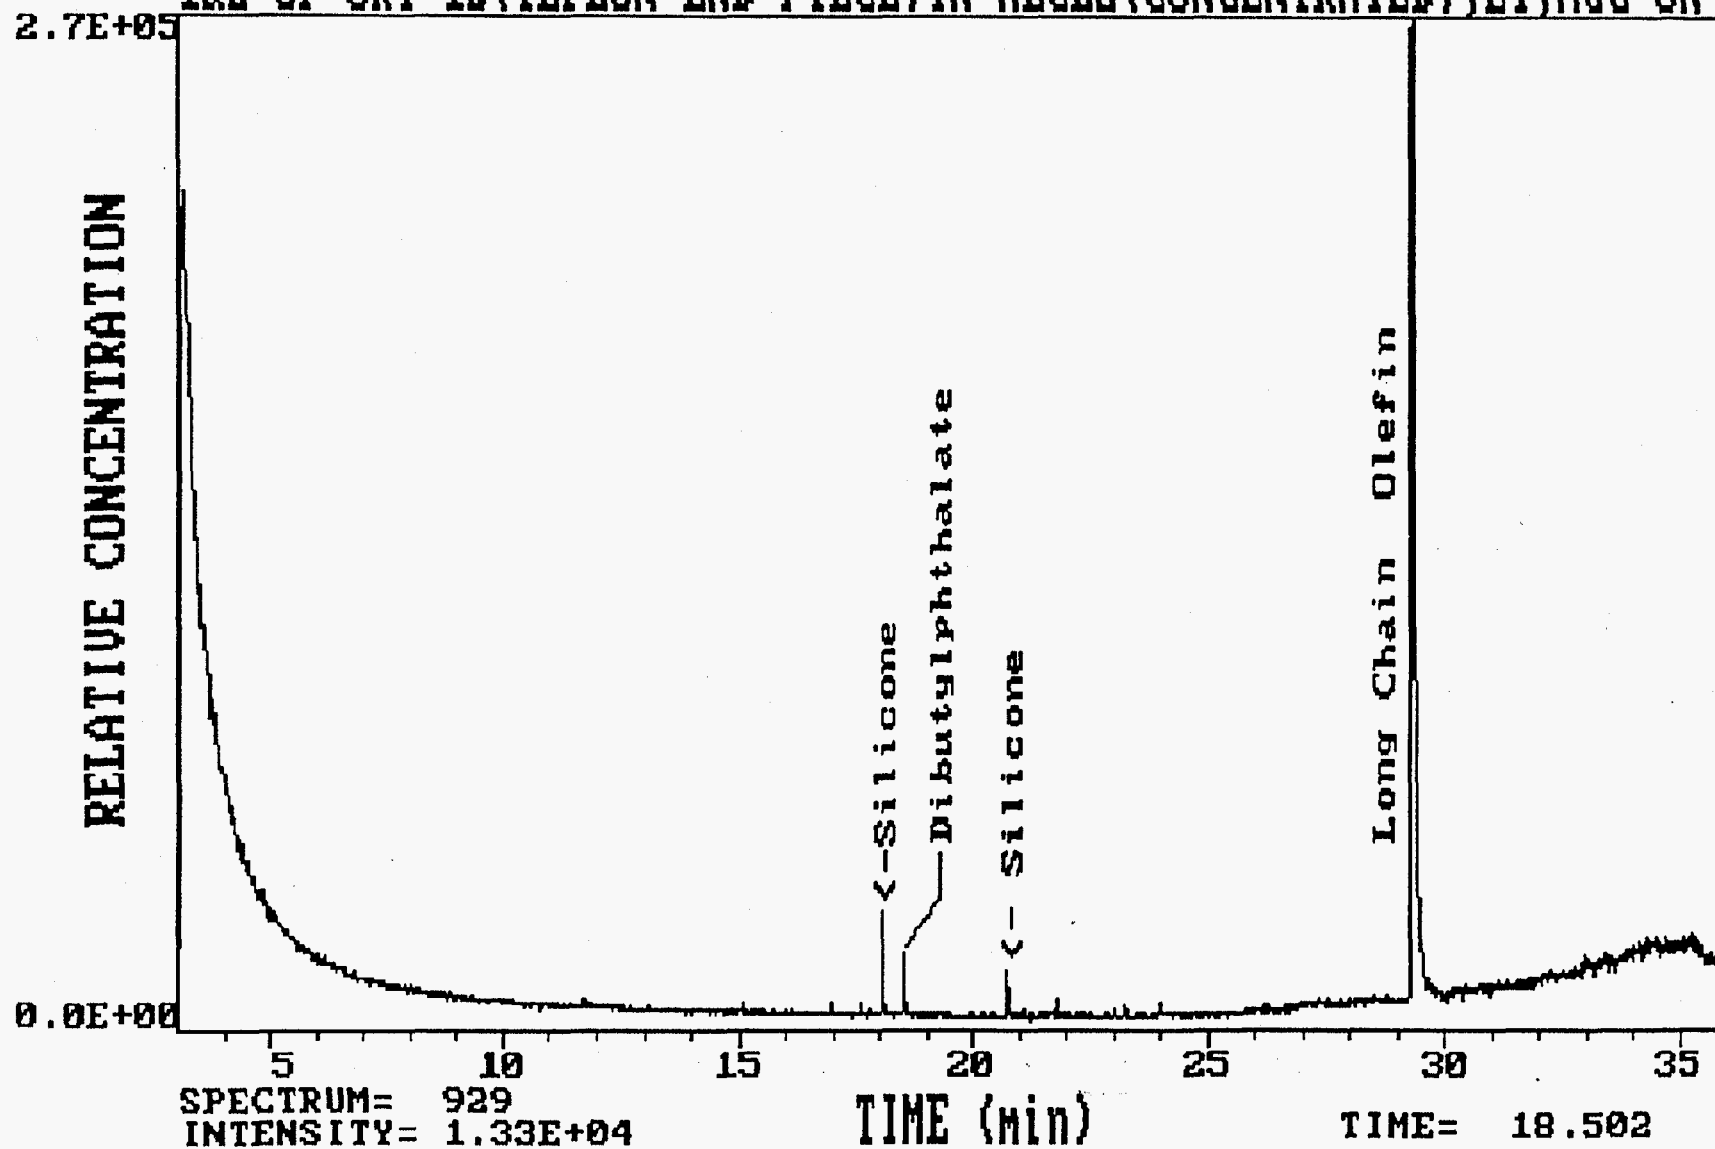
B00880.DAT

1uL OF SRI-1B (TEFLON END PIECE) IN MECL2 (CONCENTRATED), EI, AGC-ON
