ARMY GAS-COOLED REACTOR SYSTEMS PROGRAM

Quarterly Progress Report

1 July through 30 September 1963

AEROJET-GENERAL NUCLEONICS

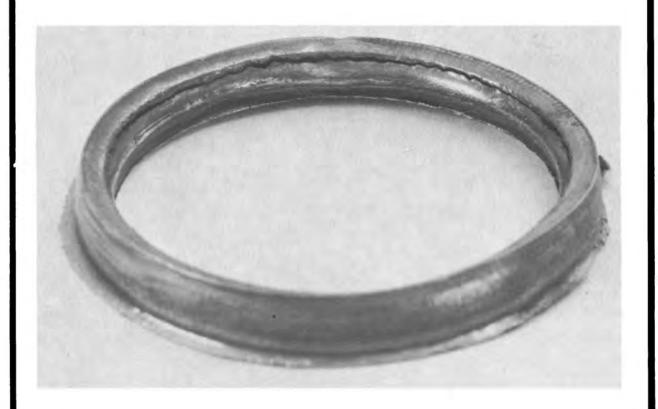
FIGURE 2-1. SEAL WELD FROM PIN 18

Sections of the seal welds from shear pins 16, 17 and 18 were removed for metallographic examination. The seal weld from pin 18, the source of the pressure vessel leak, was found to be cracked as a result of improper welding technique; penetration on the plenum side of the joint was quite shallow and the weld fusion zone was less than 0.01 in. deep. The weld is shown in Figure 2-1 following removal from the reactor. Macro and micro photographs of the failed weld are shown in Figures 2-2 and 2-3.

Note the crack extending along the entire visible surface

The outside of the plenum wall was machined to accommodate the seal cup (see page 20 of Ref. a for complete description of the revised shear pin design) and passages were drilled to vent the space betwen the shear pins and the seal cups to the lower plenum. The seal cups were welded in place and inspected; no deficiencies were observed. A typical completed weld is shown in Figure 2-4.

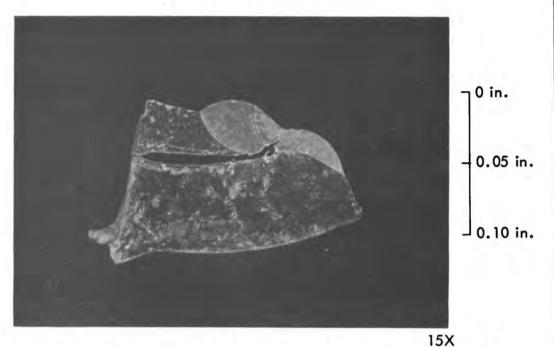
FIGURE 2-2. PHOTOMACROGRAPH OF FAILED SEAL WELD - PIN 18

Note incomplete fusion of joint on the thicker lip (plenum side)

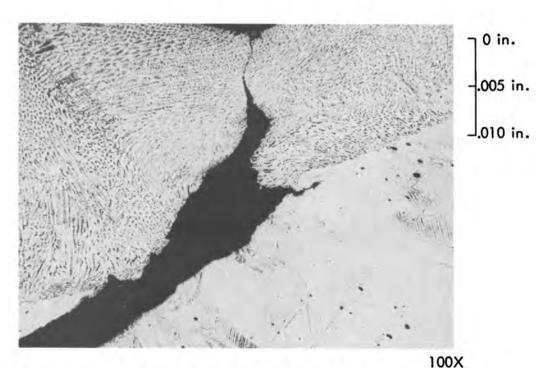
FIGURE 2-3. PHOTOMICROGRAPH OF FAILED SEAL WELD - PIN 18

Note evidence of mechanical working of the fusion zone

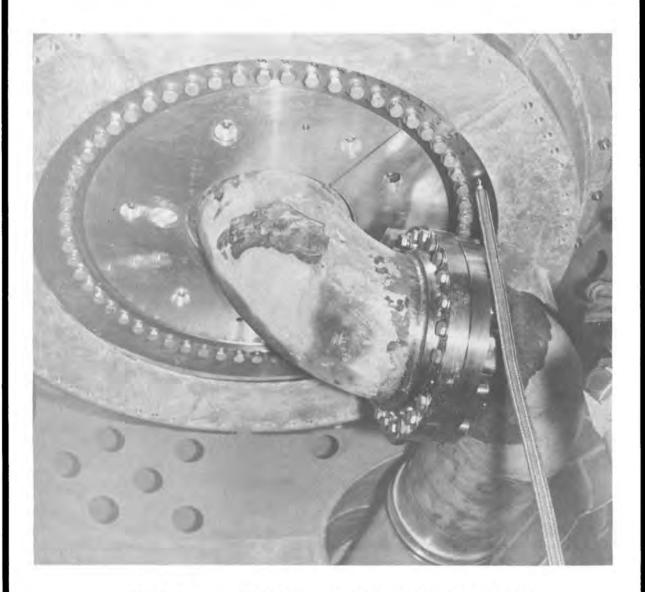
FIGURE 2-5. MODIFIED REACTOR OUTLET GAS DUCT

1) A flanged connection was provided in the reactor outlet gas duct between the two 90° elbows (Figure 2-5). This closure was designed to satisfy the requirements of the ASME Pressure Vessel Code and a prototype was subjected to standard proof and leak tests as well as thermal cycling tests. Minor modifications were required in the lower end seal cone to accommodate the flanged closure.

Note also the modified (bolted) lower moderator seal above

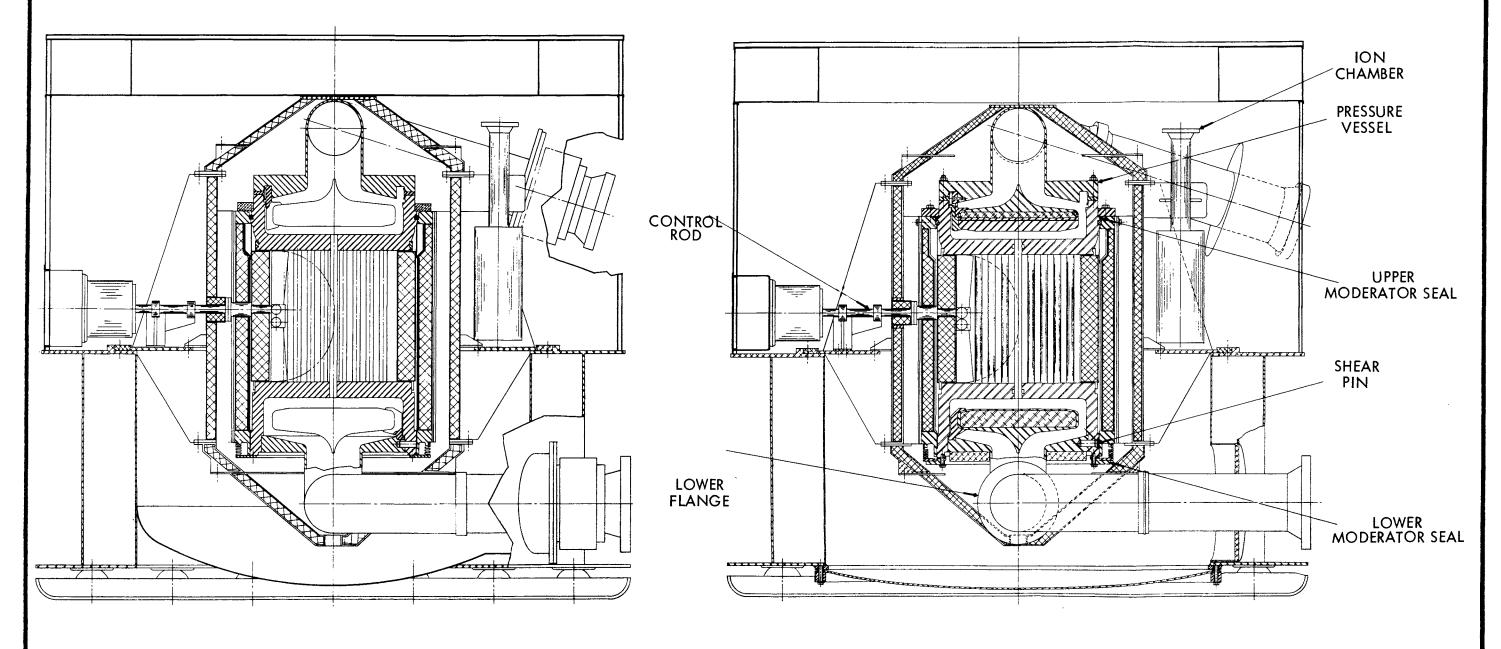
- 2) An aluminum plug was installed in the recessed portion of the lower plenum cap to exclude trapped air at this location and, consequently, reduce thermal stress gradients in the cap (Figure 2-6 and 2-7). A report (Ref. 4) summarizing the effect of this modification and the anticipated stresses in the plenum cap was published.
- 3) The welded closures at the upper and lower moderator seals were replaced with bolted closures to facilitate reassembly and subsequent disassembly. The lower closure was sealed with a "K" seal and a rubber "O" ring, and the upper closure was sealed with aluminum foil formed into the gasket groove. Both of these closures were extensively evaluated in mock-ups prior to installation on the reactor.
- 4) A removable dished head was provided at the bottom of the shield water tank (Figure 2-7).

FIGURE 2-6. ML-1 REACTOR SKID BEFORE MODIFICATION

FIGURE 2-7. ML-1 REACTOR SKID AFTER MODIFICATION

- 1) The repaired pressure vessel was placed in the radial shield.
- 2) The upper and lower moderator seals were assembled and pressure tested.
- 3) The lower gas duct flange connection was fitted, aligned and installed.
- 4) The aluminum filler plug was installed in the recess in the lower plenum cap.
- 5) The modified lower end shielding cone was installed.
- 6) The shielding tank lower head was installed.
- 7) The control rods were installed.
- 8) Thermocouples were installed and routed to a junction box on the exterior surface of the shielding tank to monitor temperatures in the lower cap plug, shielding water and upper moderator seal holddown ring.
- 9) The pressure vessel was hydrostatically and pneumatically tested without evidence of leakage.
