Spent Fuel Test—Climax: An Evaluation of the Technical Feasibility of Geologic Storage of Spent Nuclear Fuel in Granite

Final Report

W. C. Patrick

LAWRENCE LIVERMORE NATIONAL LABORATORY
University of California • Livermore, California • 94550

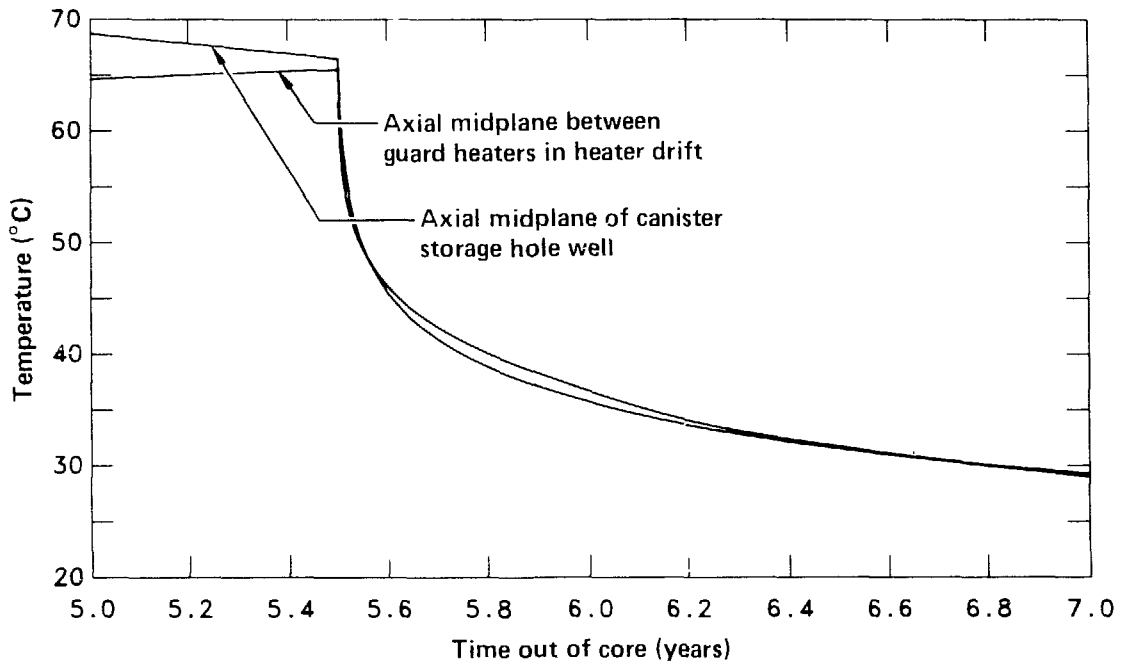
Figure 3-9. Temperature histories near thermal sources resulting from fuel retrieval (after Ballou et al., 1982).

The calculations showed that temperatures dropped rapidly at positions near the thermal sources, bringing temperatures down to about 35°C after only 6 months of cooling (Fig. 3-9). Furthermore, we

found that an additional year of cooling would only lower the temperature another 5 to 7°C. Expressed another way, about 70% of all the temperature change that will ever occur in returning to ambient temperature, occurs during the first 6 months.

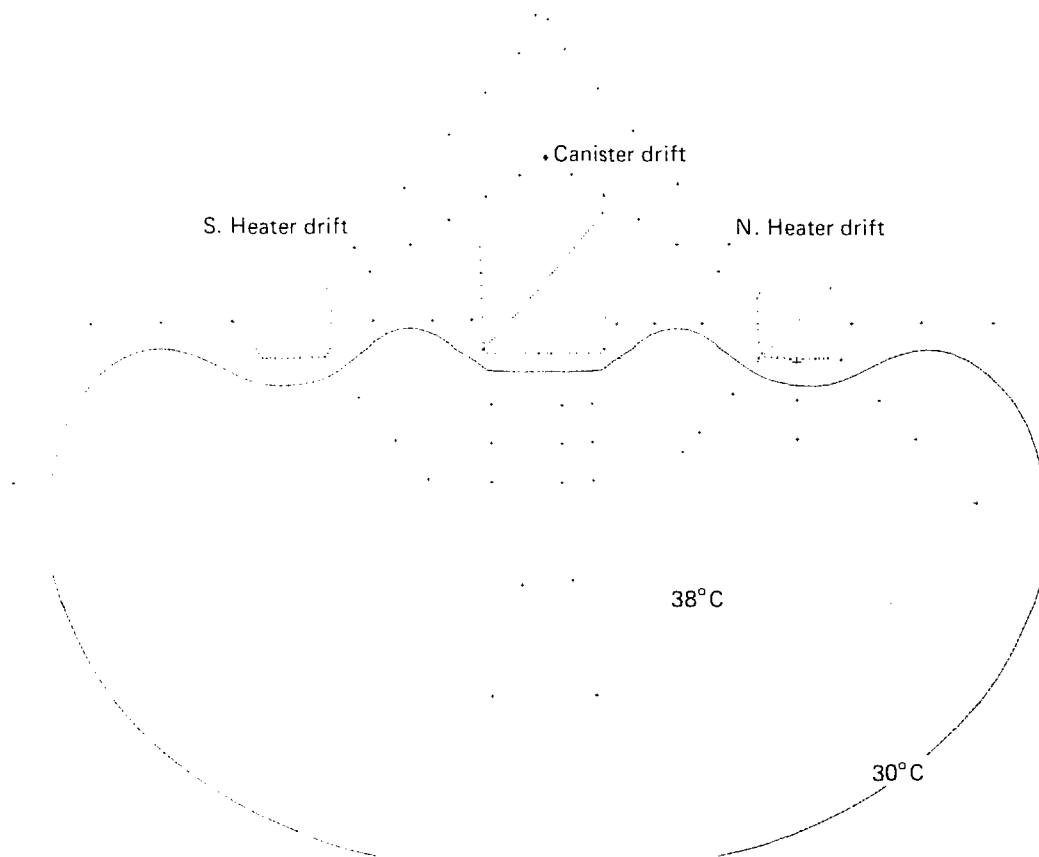
Figure 3-12. Contours of calculated temperatures at a fuel age of 6.0 years out of core, 0.5 years after spent-fuel retrieval (+ denotes thermocouple location) (after Ballou et al., 1982).

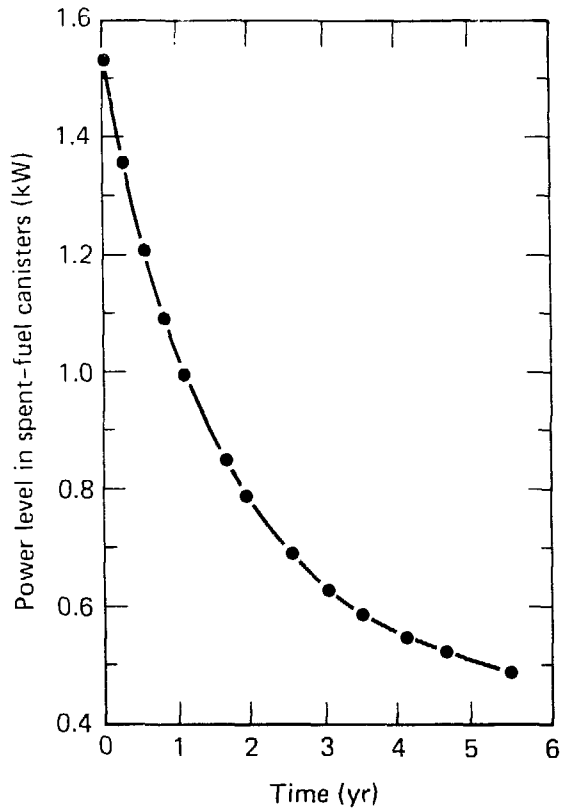
Figure 3-14. Spent-fuel decay curve used in ADINAT calculations (after Butkovich, 1981a).

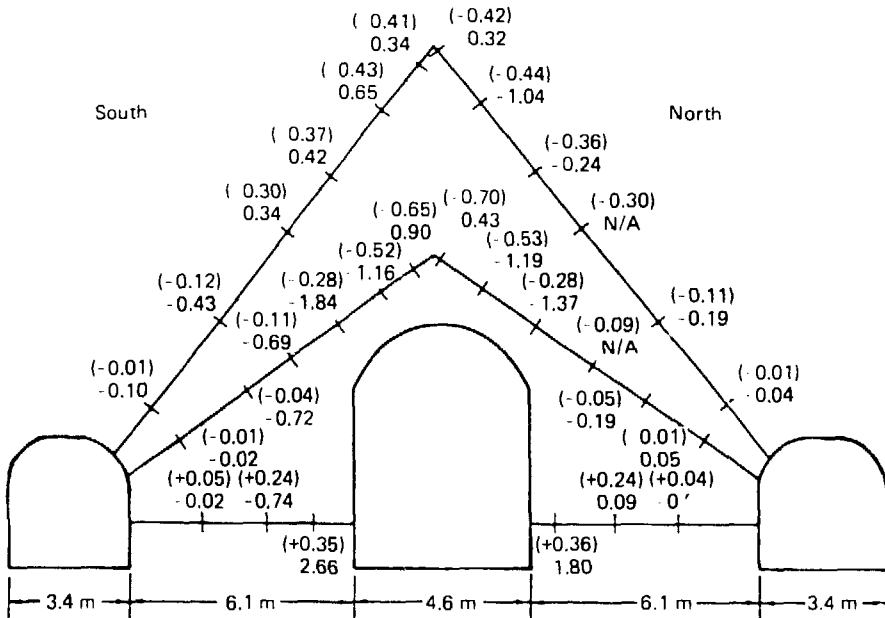
Figure 3-15. Comparison of observed and (ADINA-calculated) displacements (mm) during Mine-by.² Minus sign indicates shortening; plus sign indicates lengthening (after Heuze, Butkovich, and Peterson, 1981).

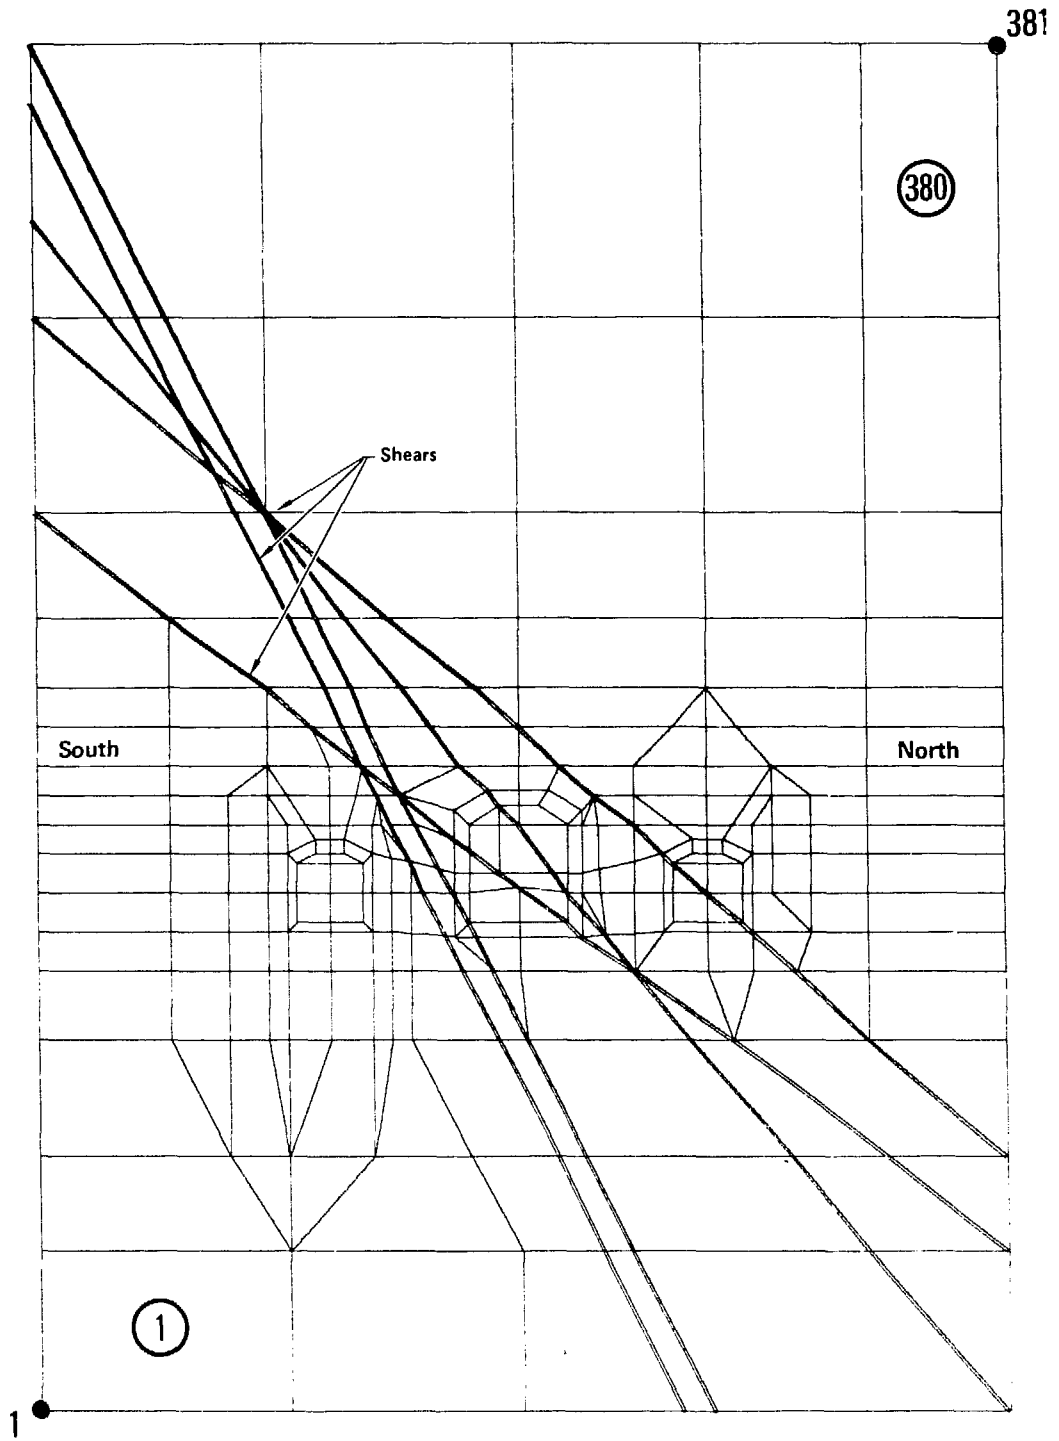
Figure 3-16. Jointed mesh of the SFT—C caverns at station 2 + 83 (381 nodes, 380 elements, after Heuze, Butkovich, and Peterson, 1981).

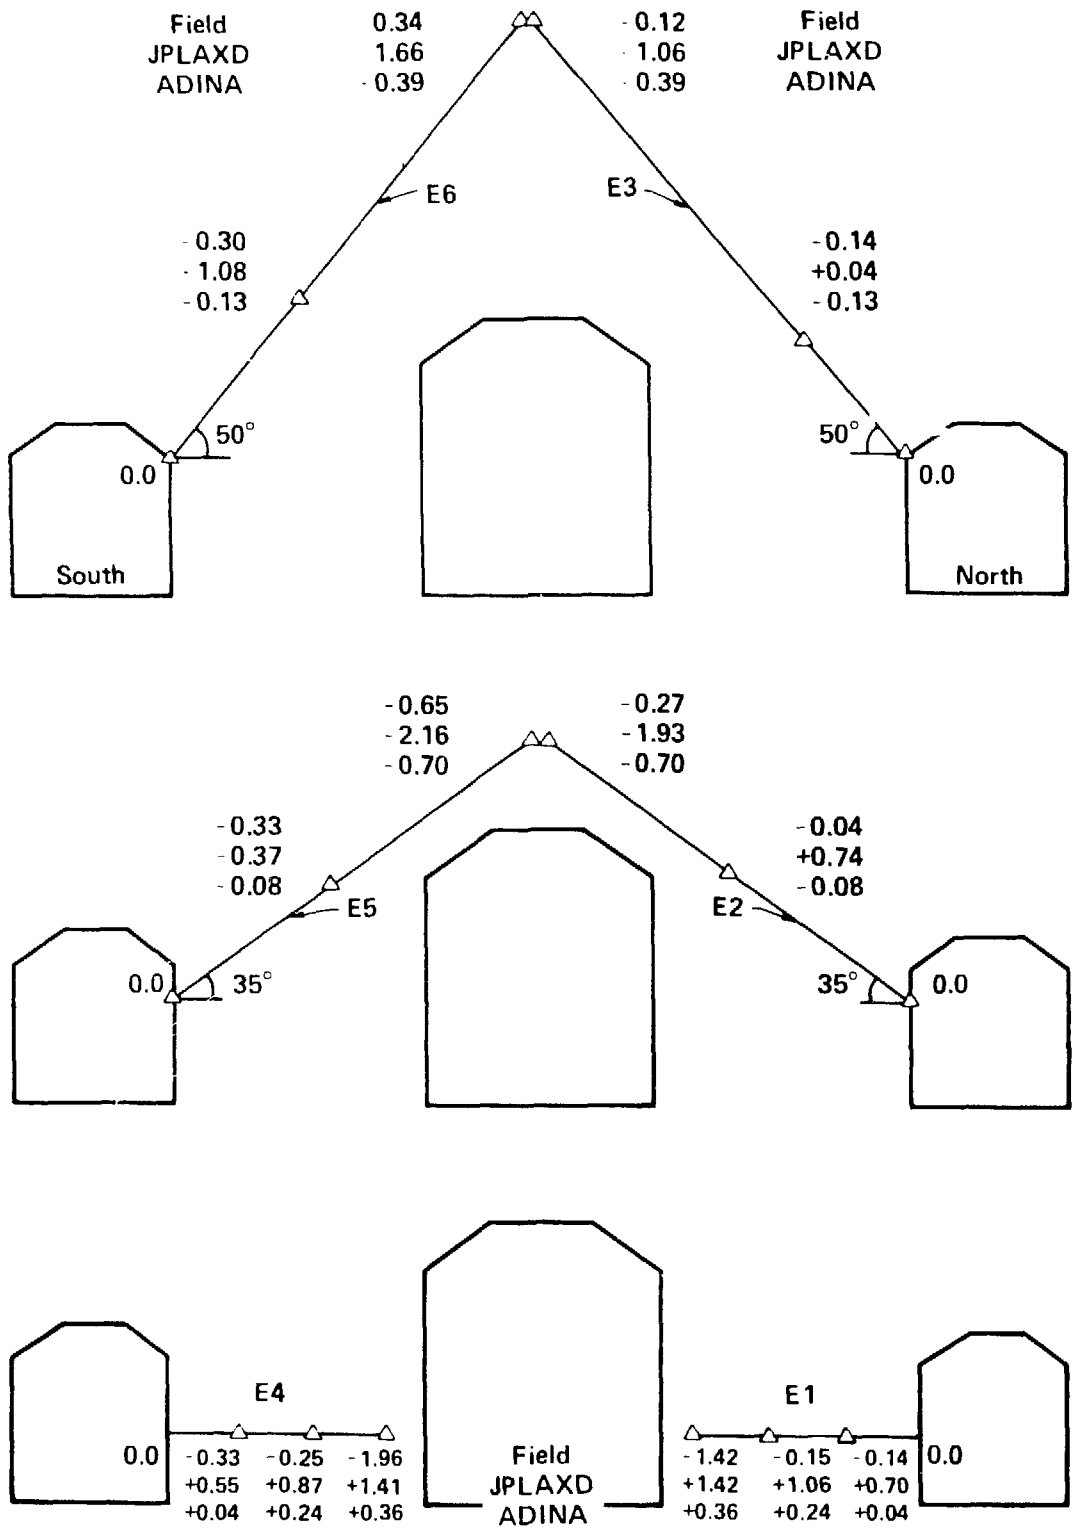
Figure 3-18. Comparison of field observations with JPLAXD and ADINA calculations, for the relative movements of MPE anchors during the mine-by (mm). Station 2+83, non-dilatant joints (after Heuze, Butkovich, and Peterson, 1981).

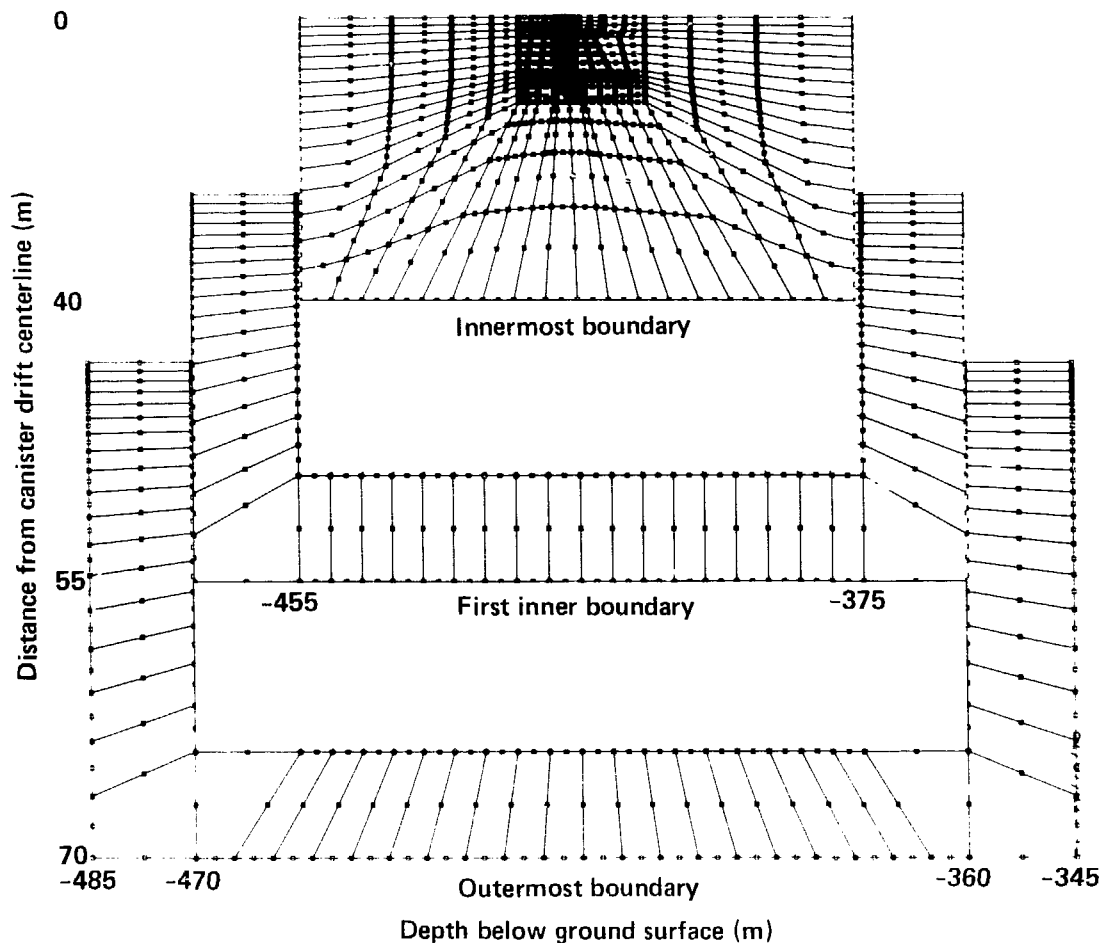
Figure 3-21. Mesh construction allows layers to be peeled off like onion skins (boundary coordinates in meters) (after Butkovich, 1982).

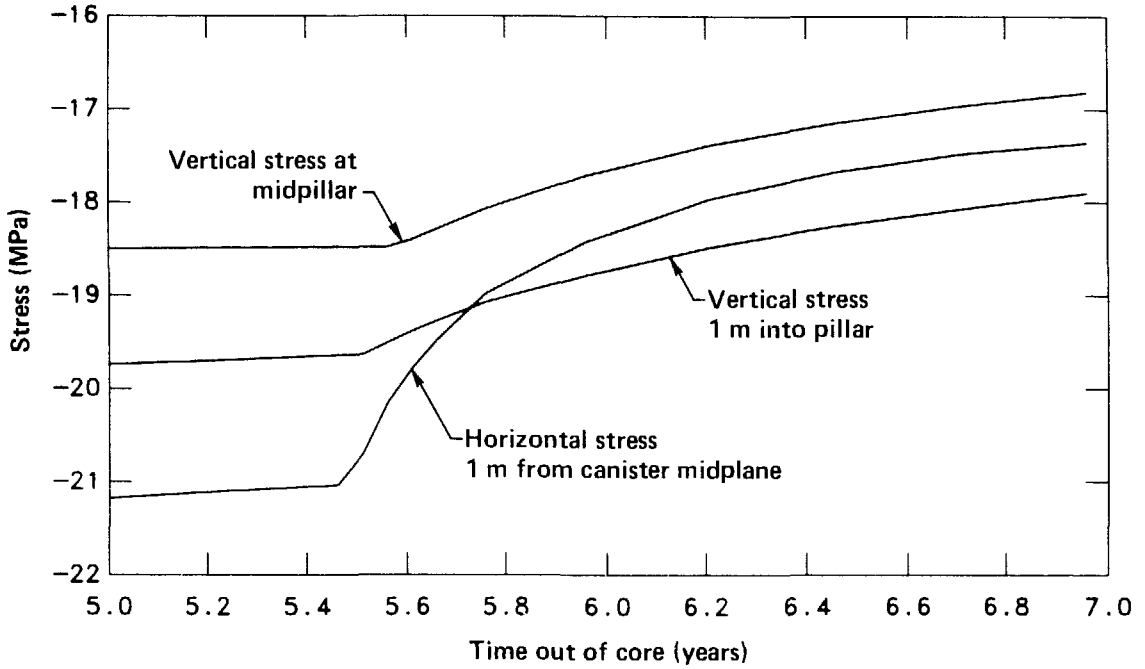
Figure 3-22. Stress changes resulting from fuel retrieval at selected locations (after Ballou et al., 1982).

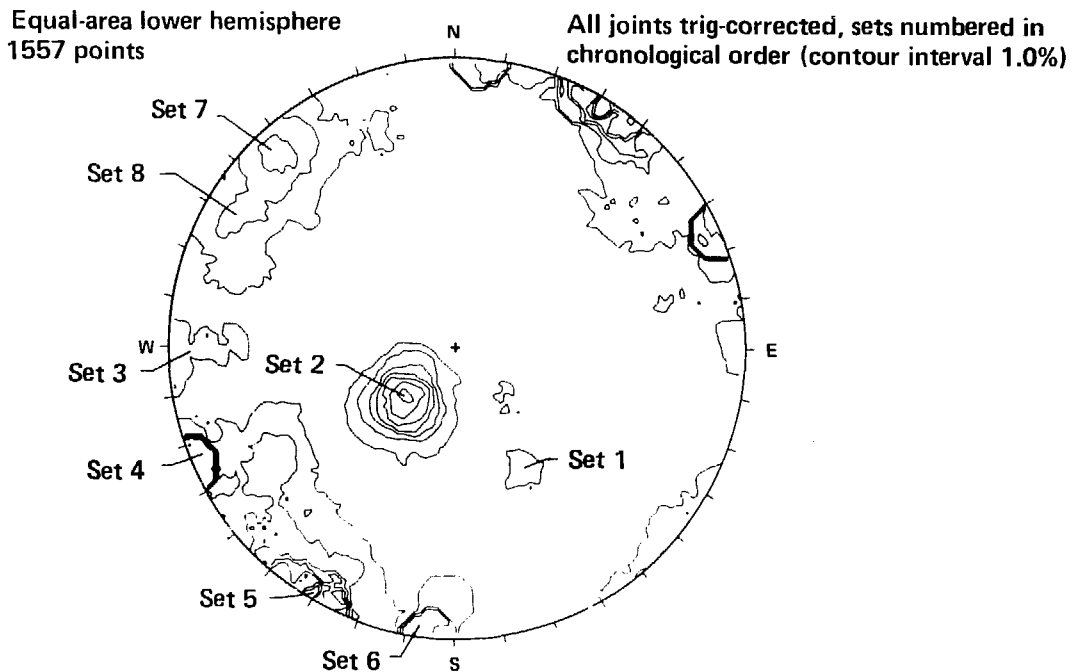
Figure 4-4. Joint sets identified during mapping of the SFT—C (after Wilder and Yow, 1984).

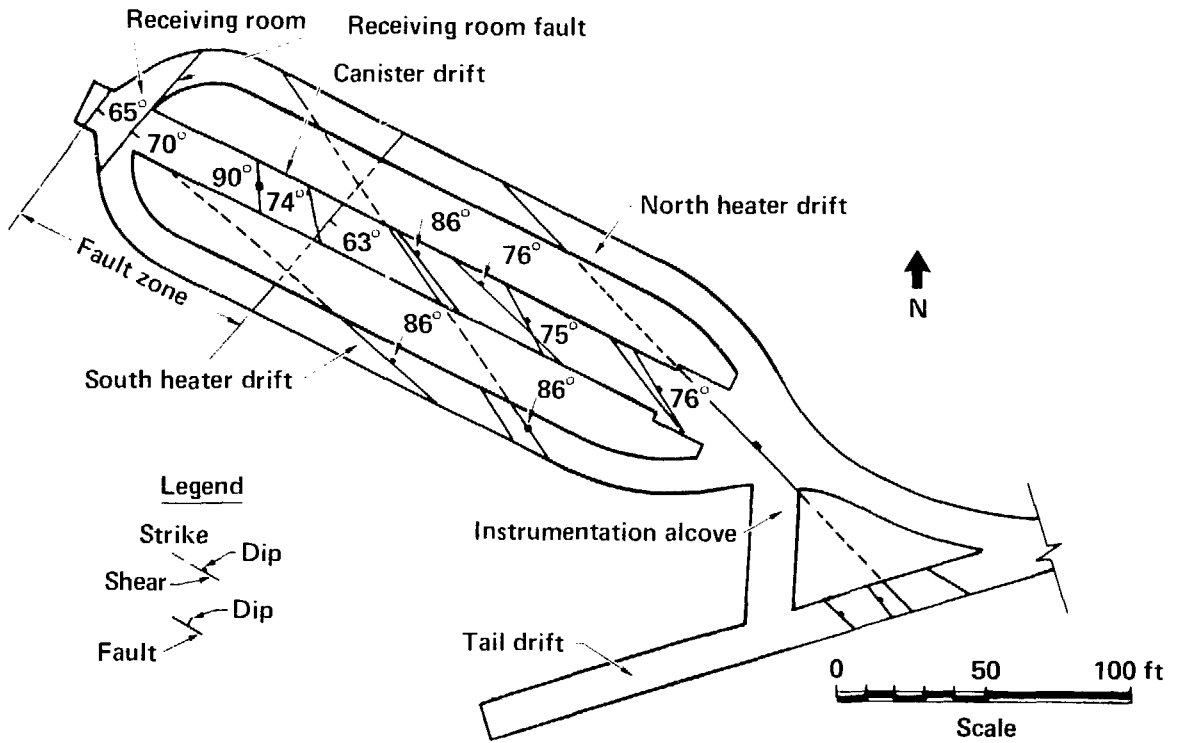
Figure 4-5. Shears and faults in the SFT—C drifts (after Wilder and Yow, 1984).

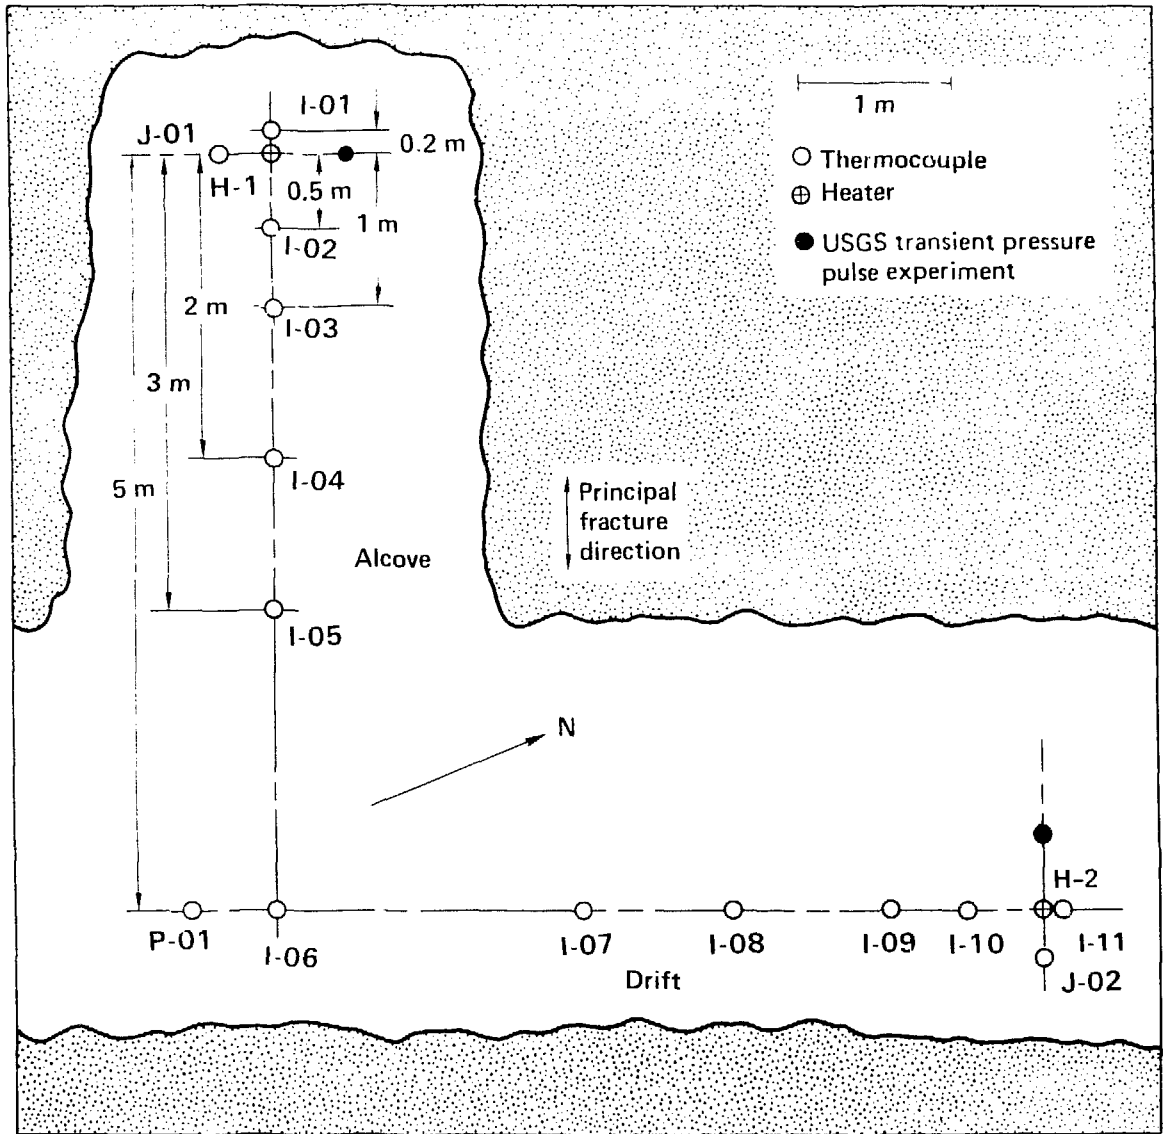
Figure 4-38. Heater test layout (after Montan and Bradkin, 1984).

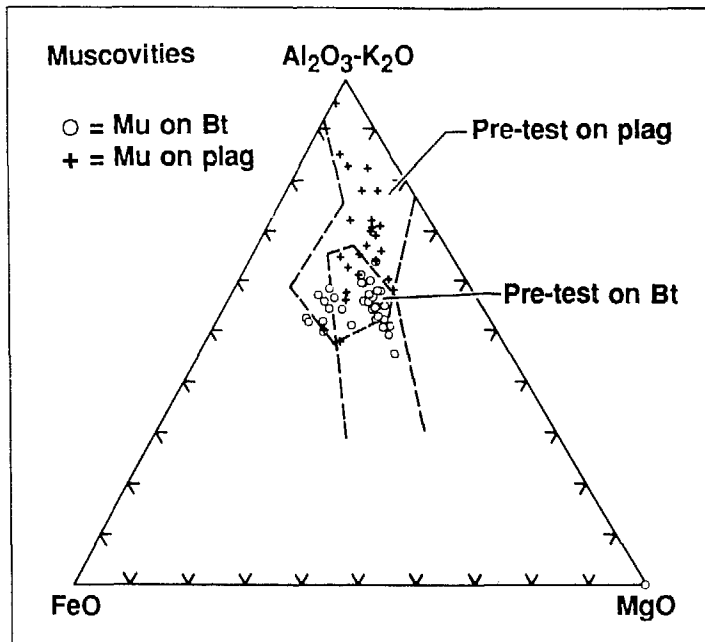
Figure 4-46b. Compositions of post-test muscovites projected from quartz and water. The open circle (o) represents muscovite found on biotite, and the plus (+) is muscovite found on plagioclase. The symbols give post-test data; the range of pre-test data is shown by the two outlined fields (after Ryerson and Beiriger, 1985).

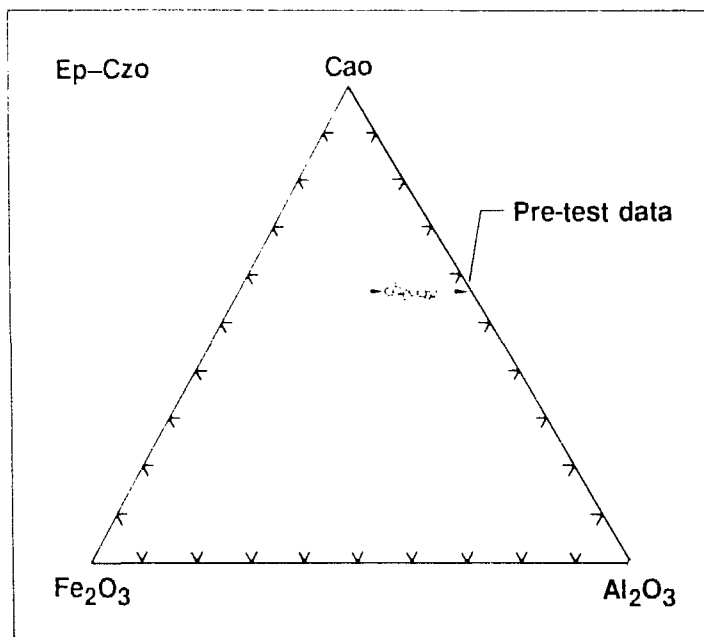
Figure 4-46c. Compositions of post-test epidotes and clinozoisites projected from quartz and water. The symbols give post-test data; the range of pre-test data is shown by the arrows (after Ryerson and Beiriger, 1985).

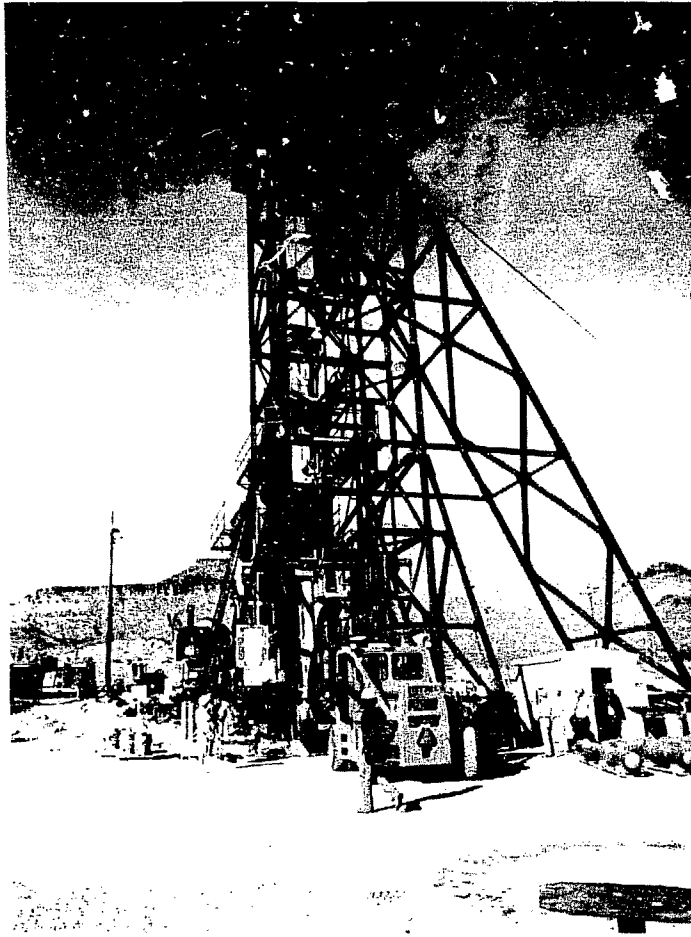
Figure 5-2. Piledriver head frame.

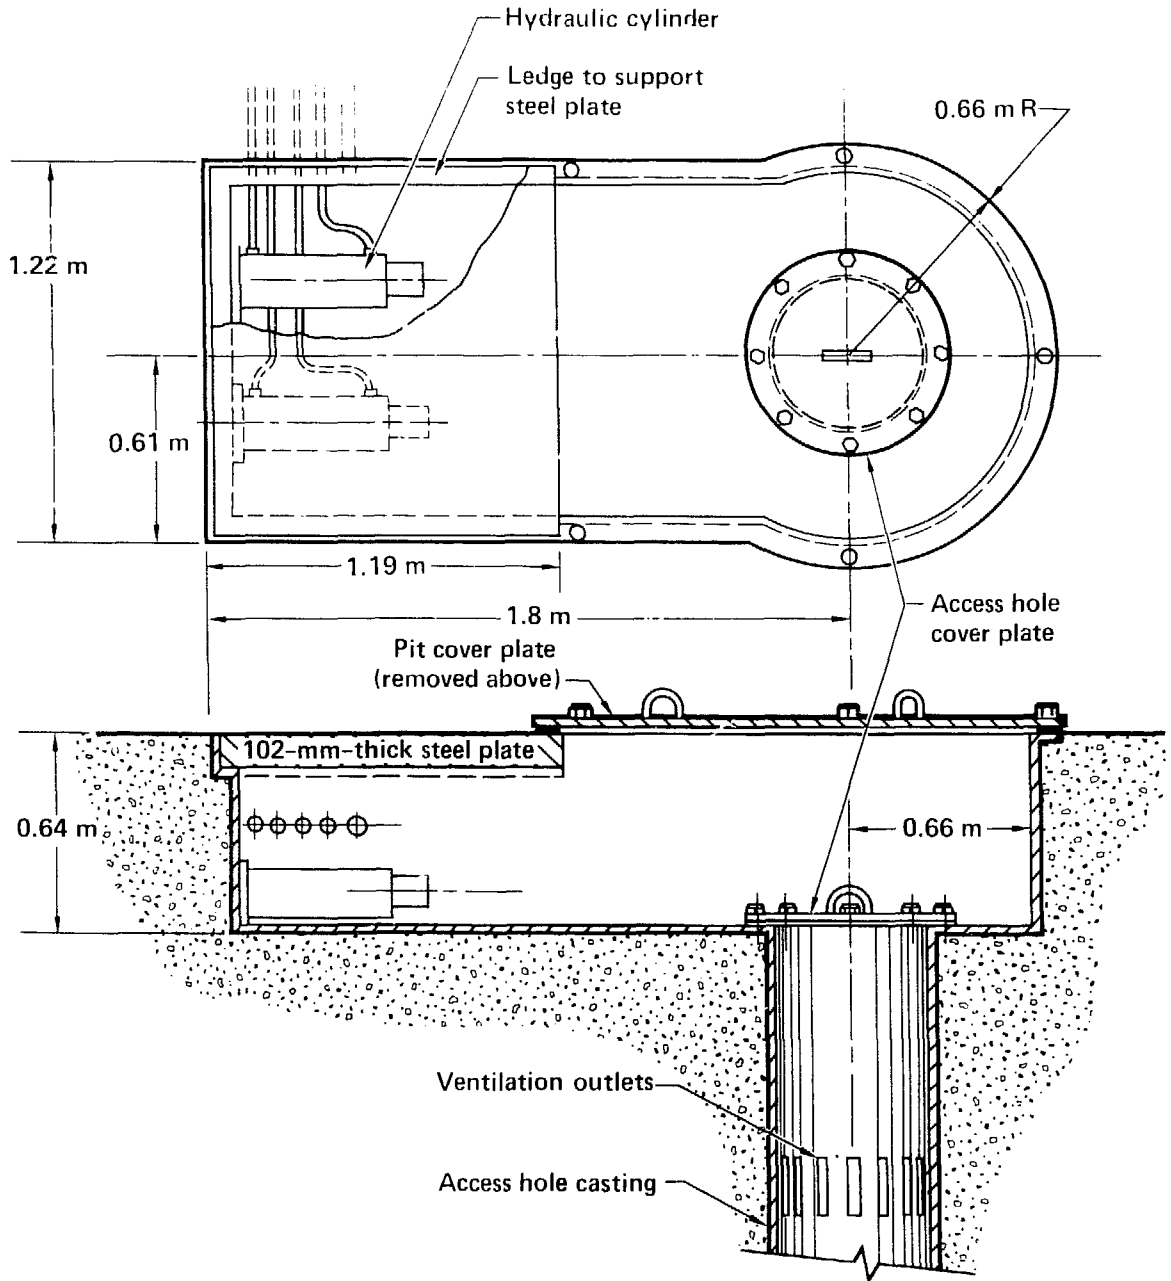
Figure 5-7. Canister access hole pit.

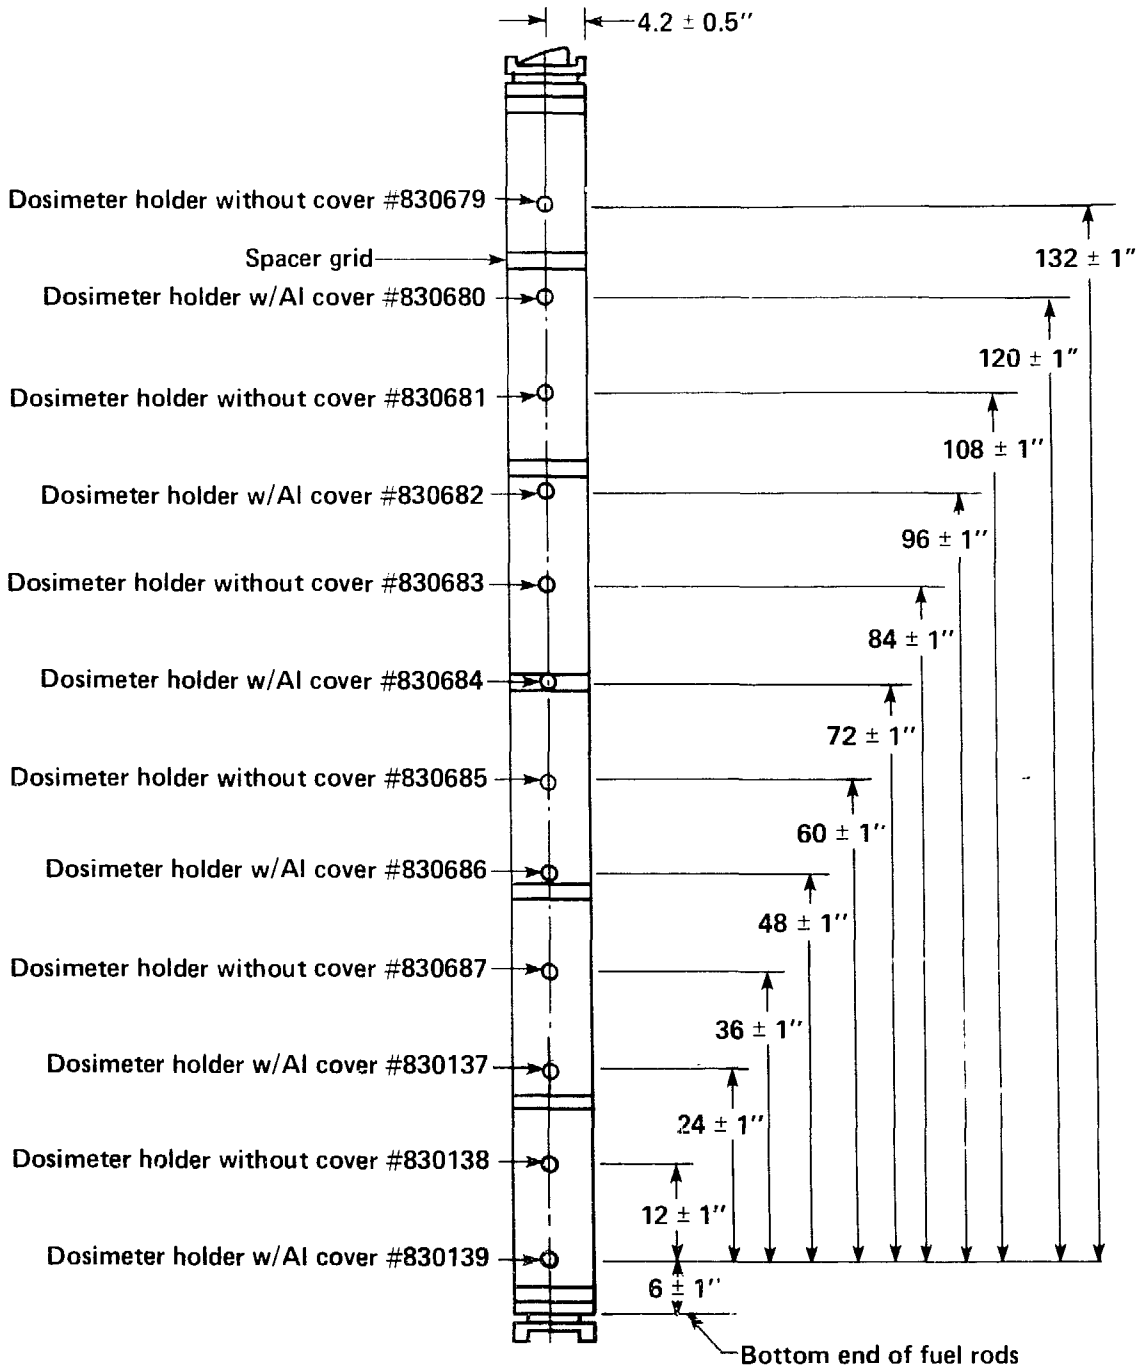
Figure 6-5. Locations of dosimeter holders (after Van Konynenburg, 1984).

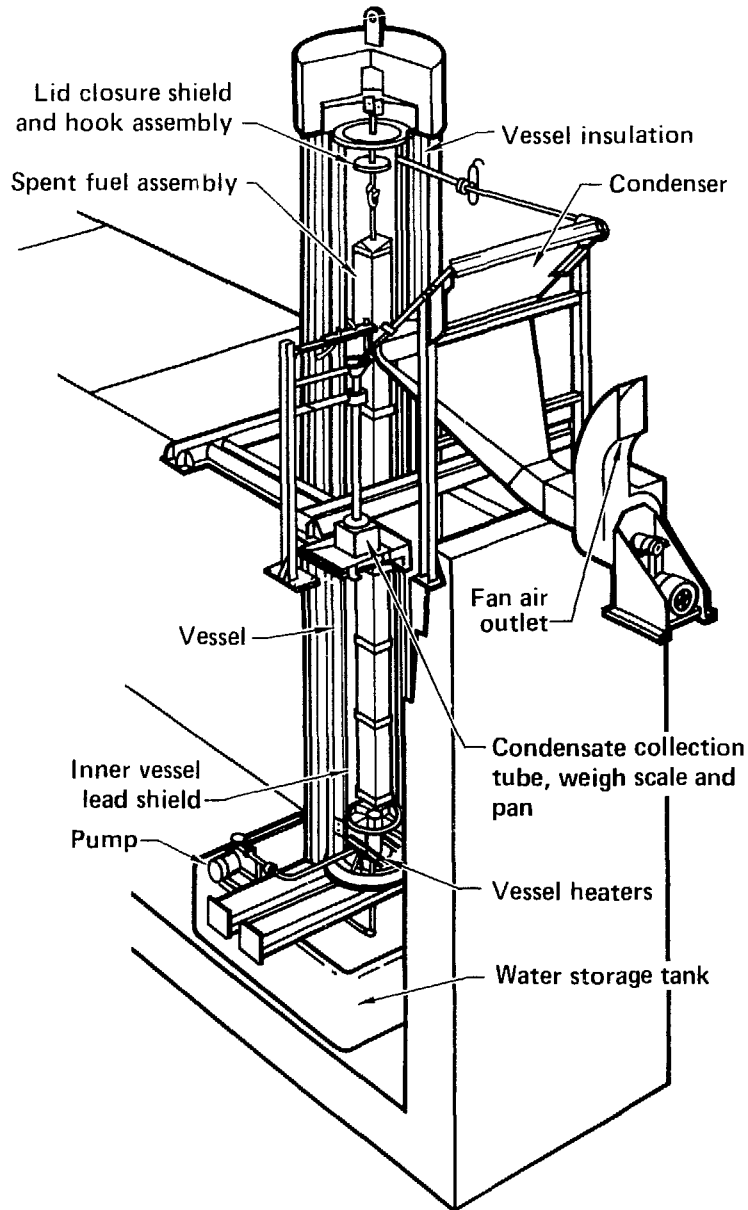
Figure 6-6. Spent-fuel calorimeter (after Schmittroth, Neely, and Krogness, 1982).

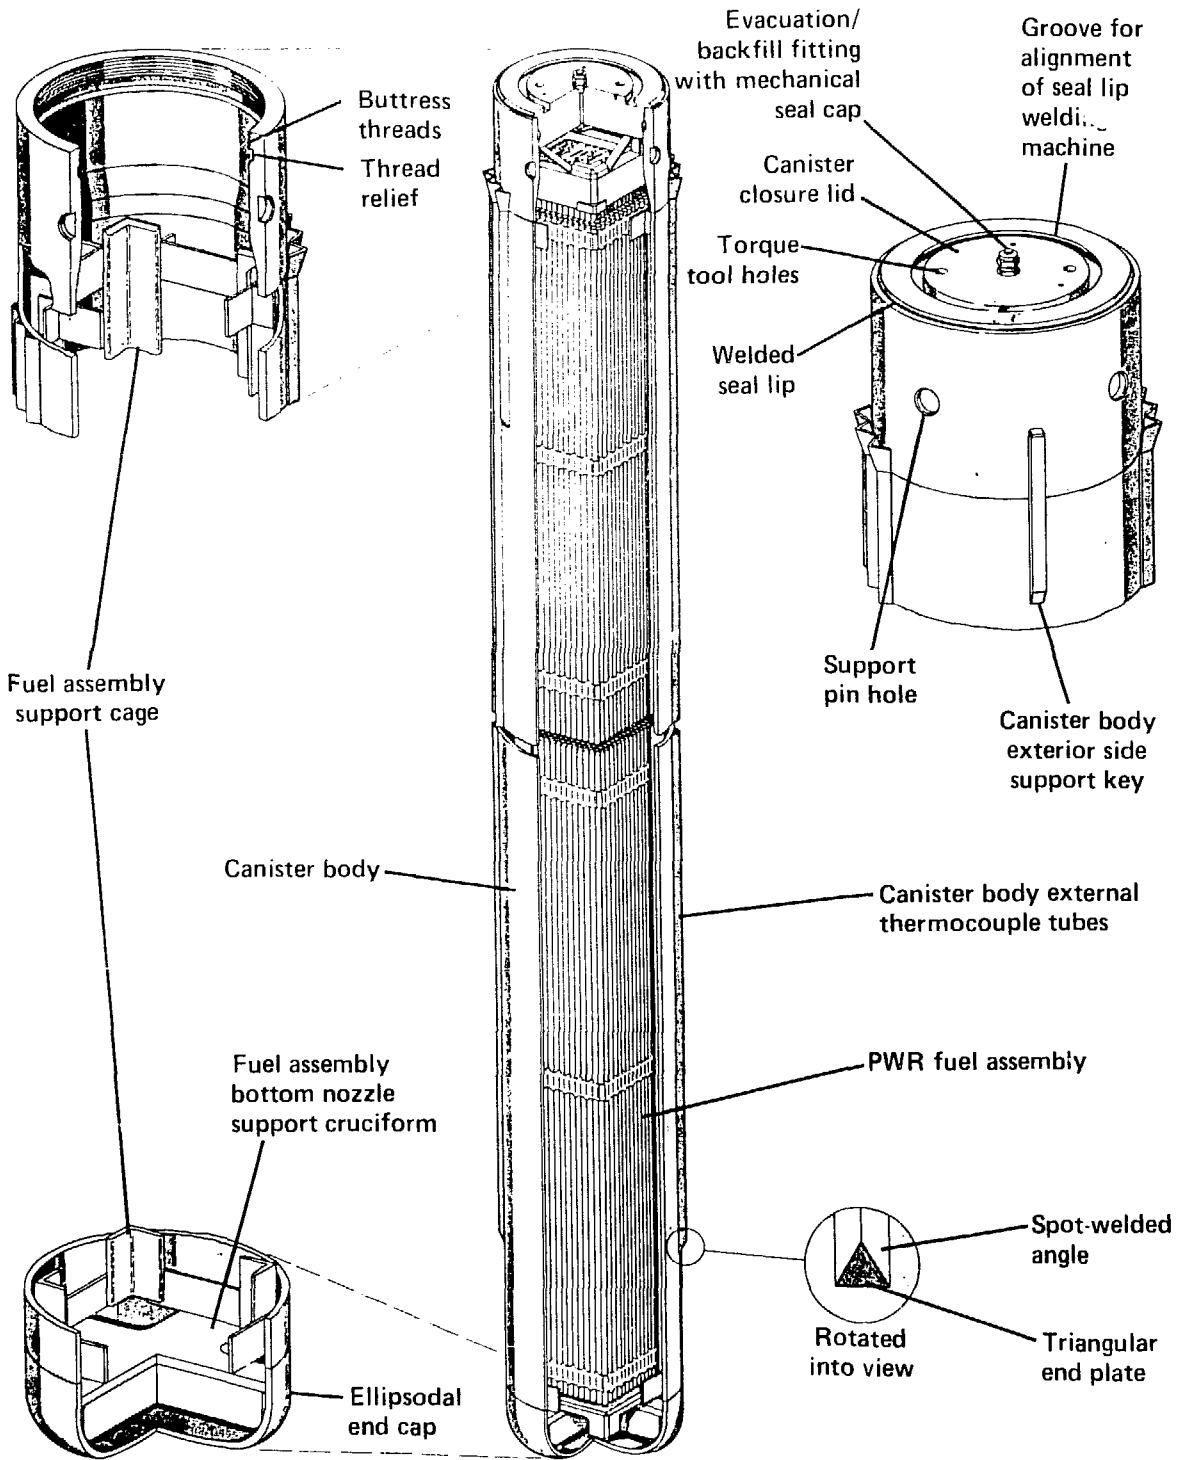
Figure 7-2. Spent-fuel canister assembly (after NVO-210, 1980).

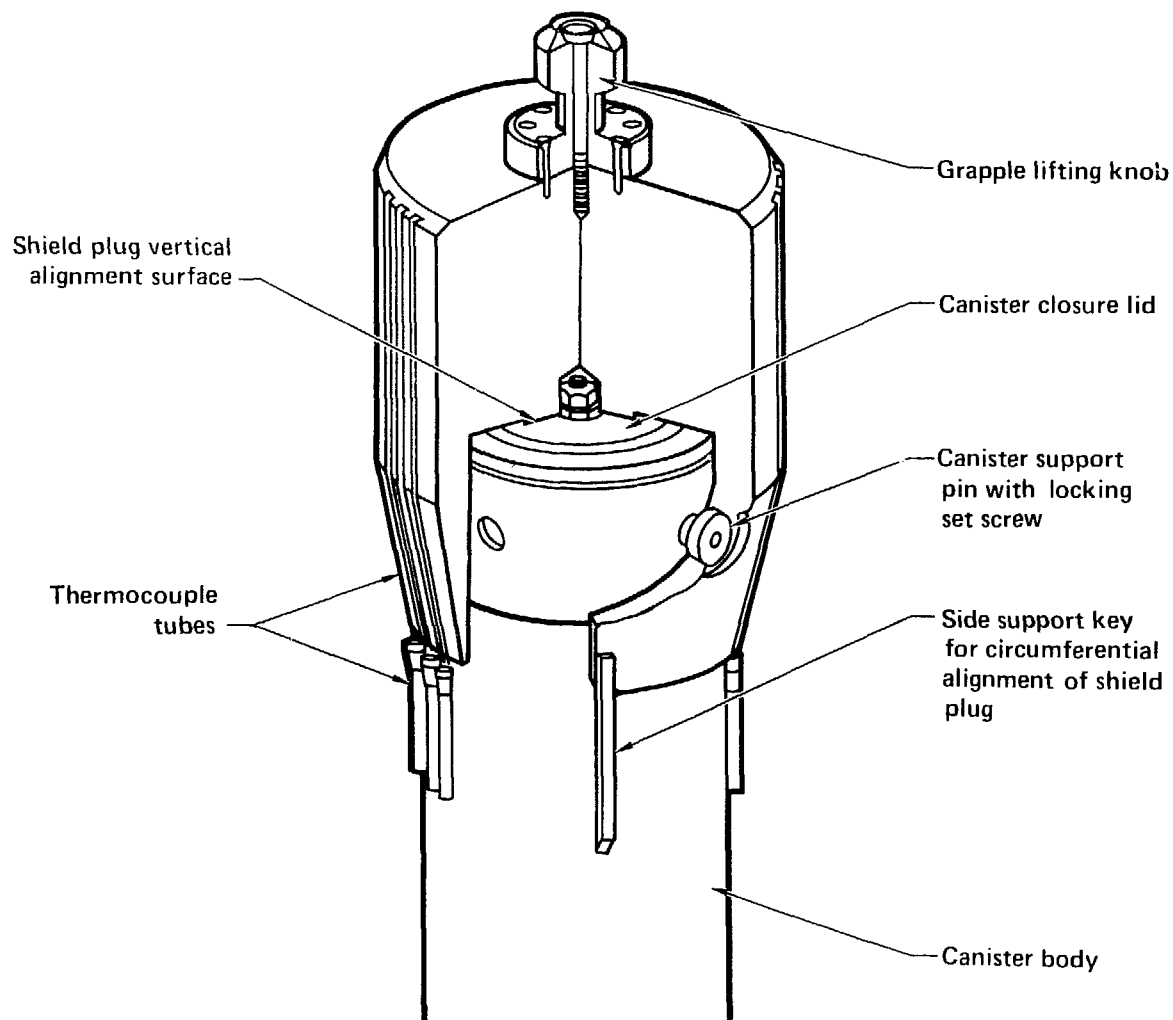
Figure 7-3. Canister/shield-plug mating arrangement (after NVO-210, 1980).

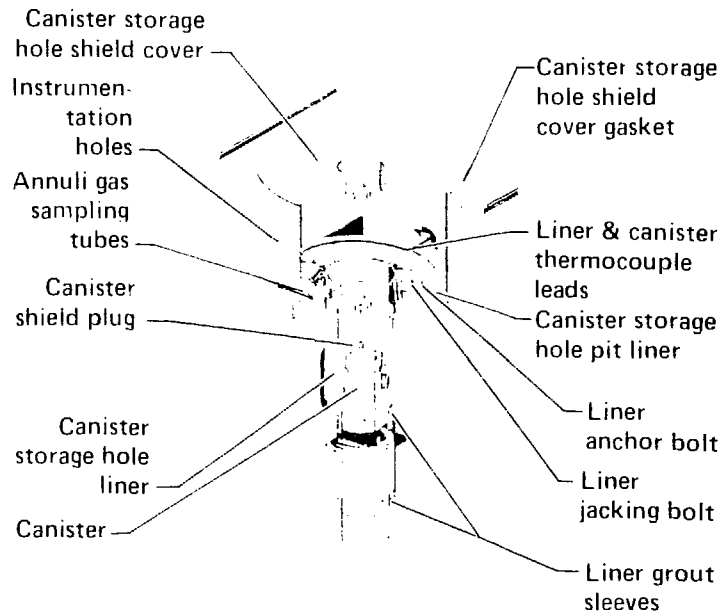
Figure 7-4. Canister storage configuration (after NVO-210, 1980).

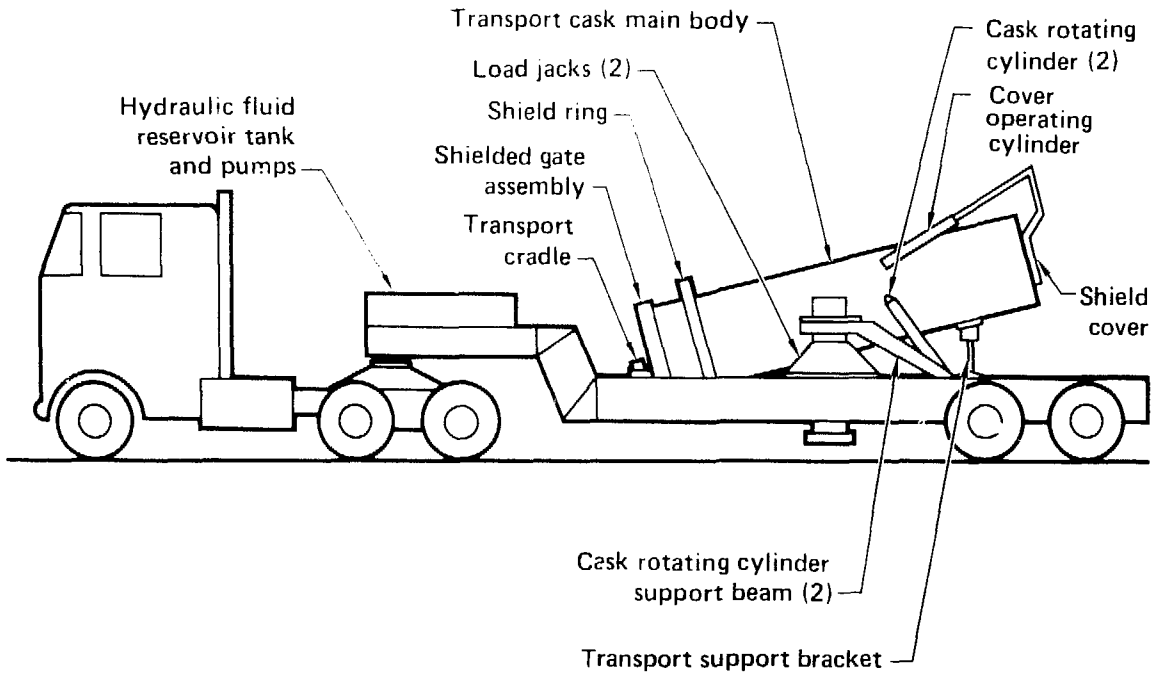
Figure 7-5. Surface Transport Vehicle schematic (after NVO-210, 1980).

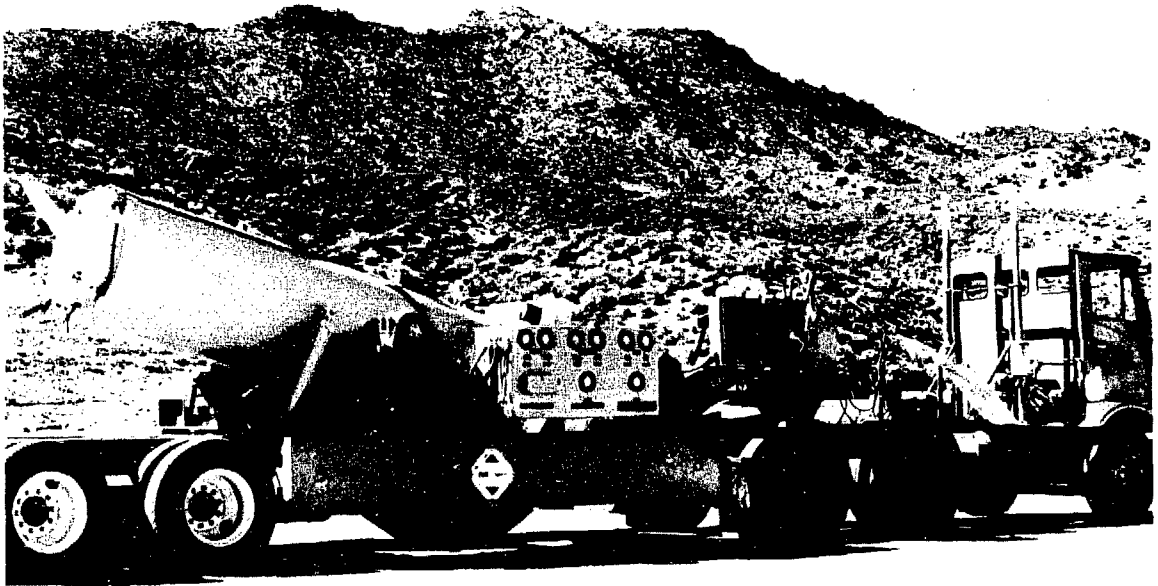
Figure 7-6. Surface Transport Vehicle.

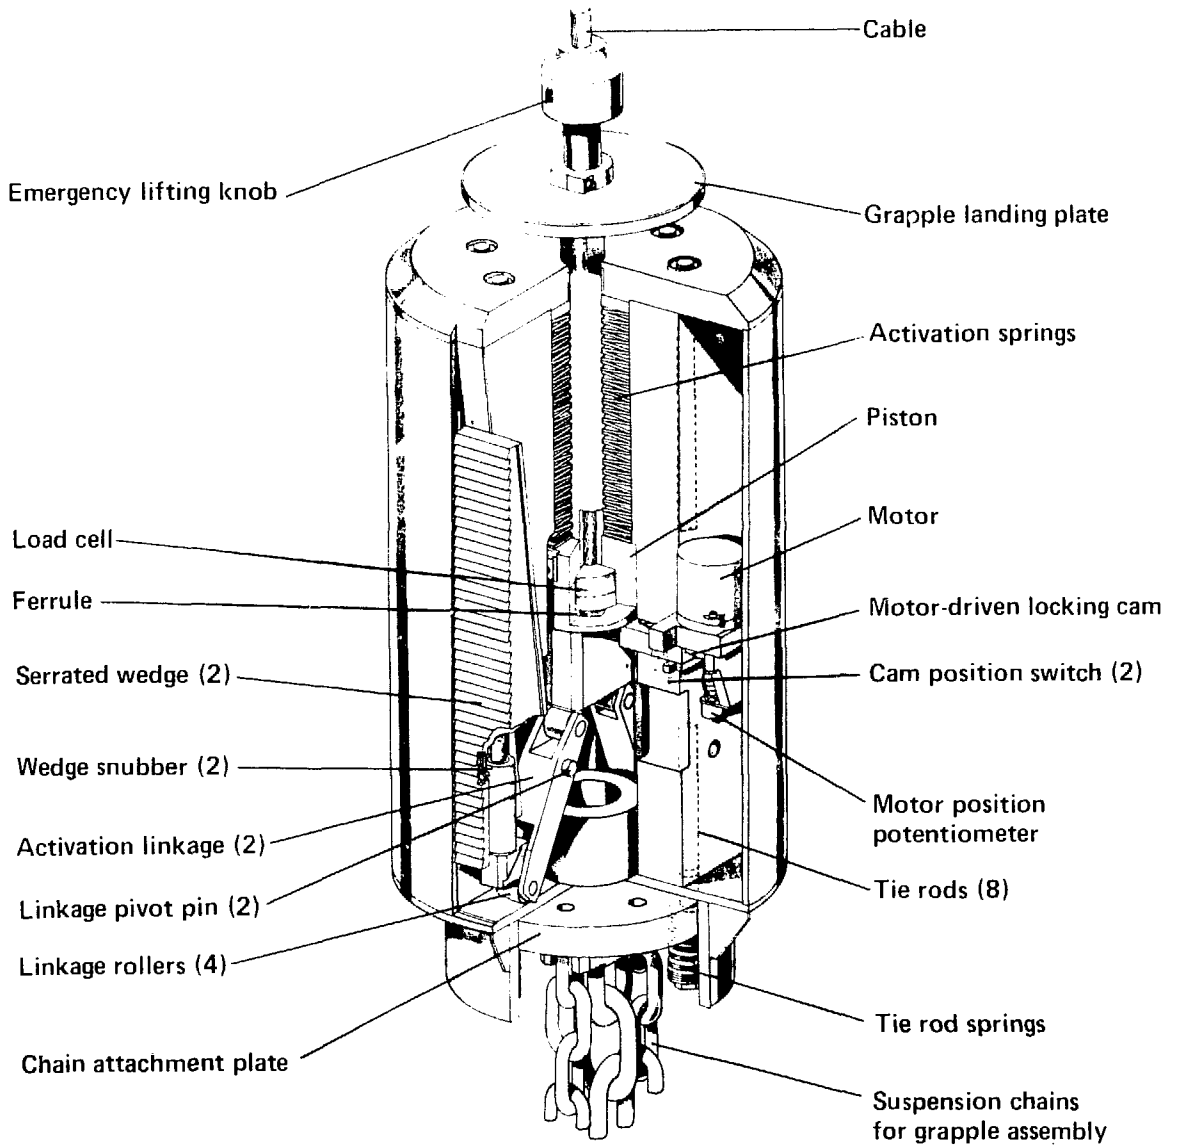
Figure 7-8. Emergency brake assembly (after NVO-210, 1980).
