Spent Fuel Test—Climax: An Evaluation of the Technical Feasibility of Geologic Storage of Spent Nuclear Fuel in Granite

Final Report

W. C. Patrick

LAWRENCE LIVERMORE NATIONAL LABORATORY
University of California • Livermore, California • 94550

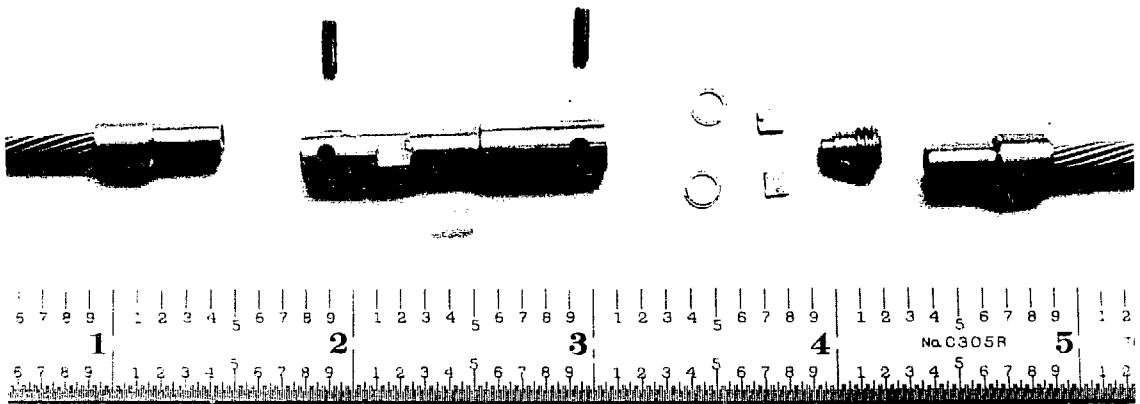
Figure 9-3a. Exploded view of dosimeter subassembly (after Patrick, Rector, and Scarafiotti, 1984).

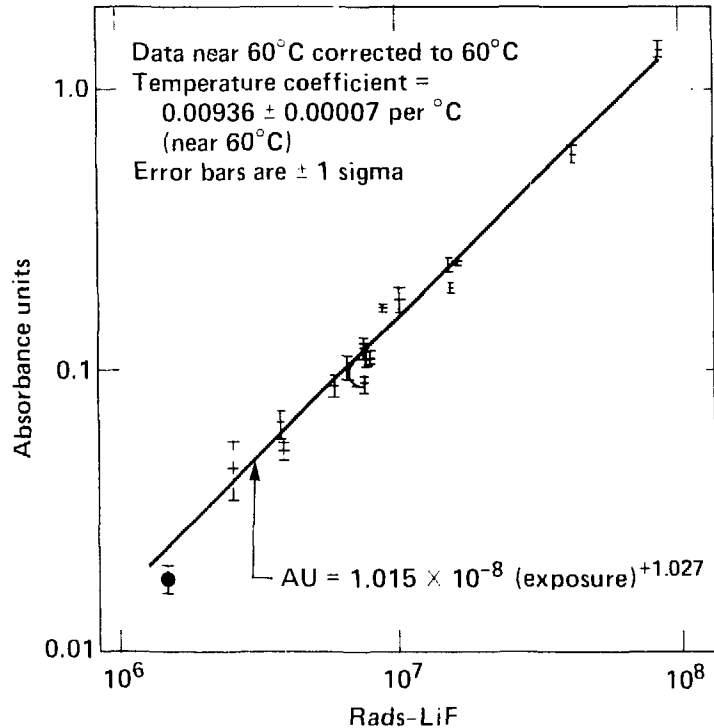
Figure 9-4. Calibration data for the 374-nm peak, polished LiF, 2-mm thickness (after Quam and DeVore, 1984b).

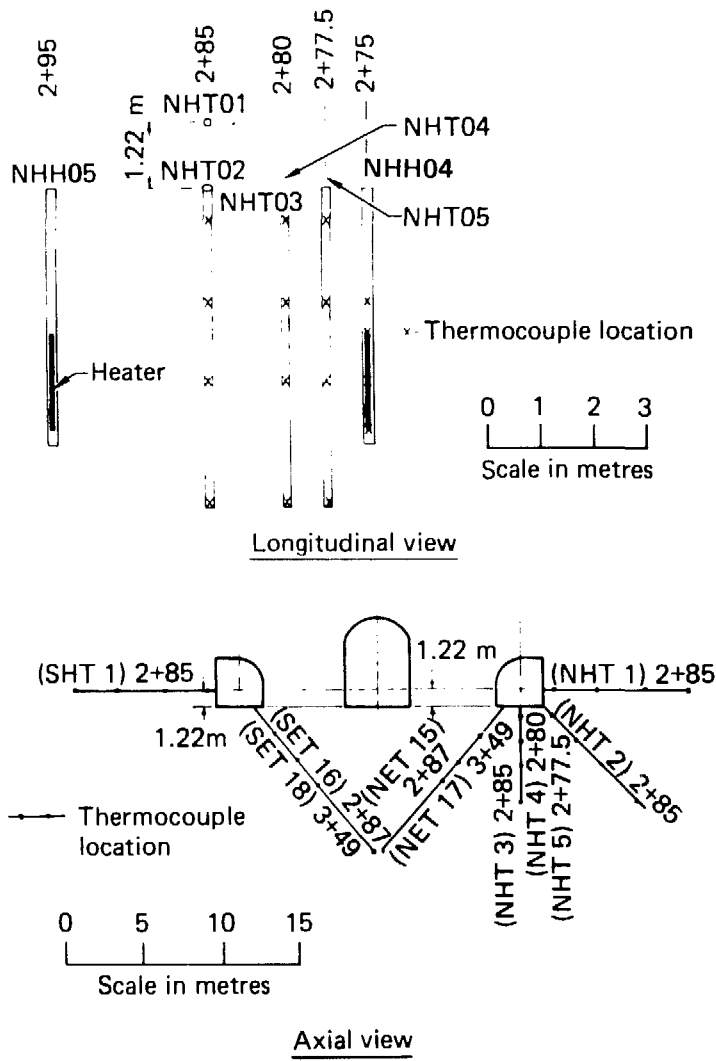
Figure 9-7. Additional intermediate-field thermocouple locations associated with auxiliary heaters (after Patrick, Rector, and Scarafiotti, 1984).

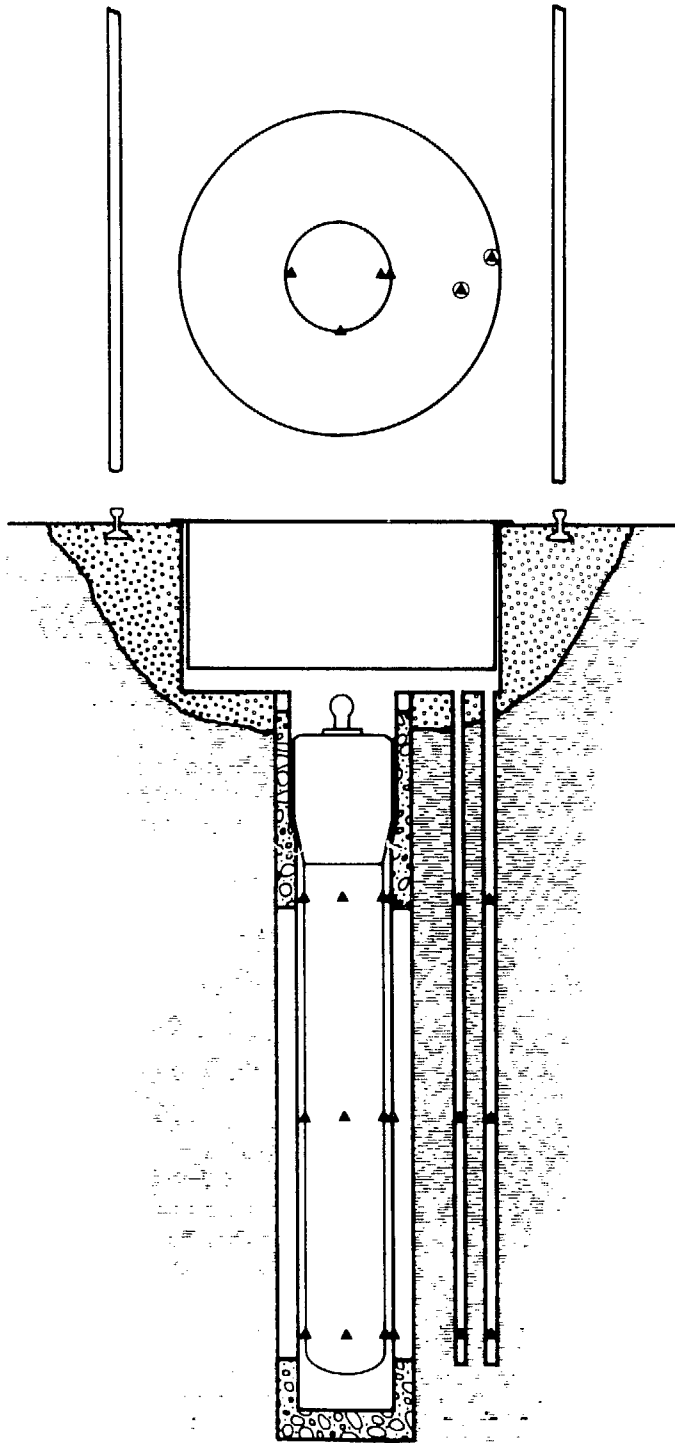
Figure 9-8. Near-field thermocouples. Locations are designated with triangles (after Patrick, Rector, and Scarafiotti, 1984).

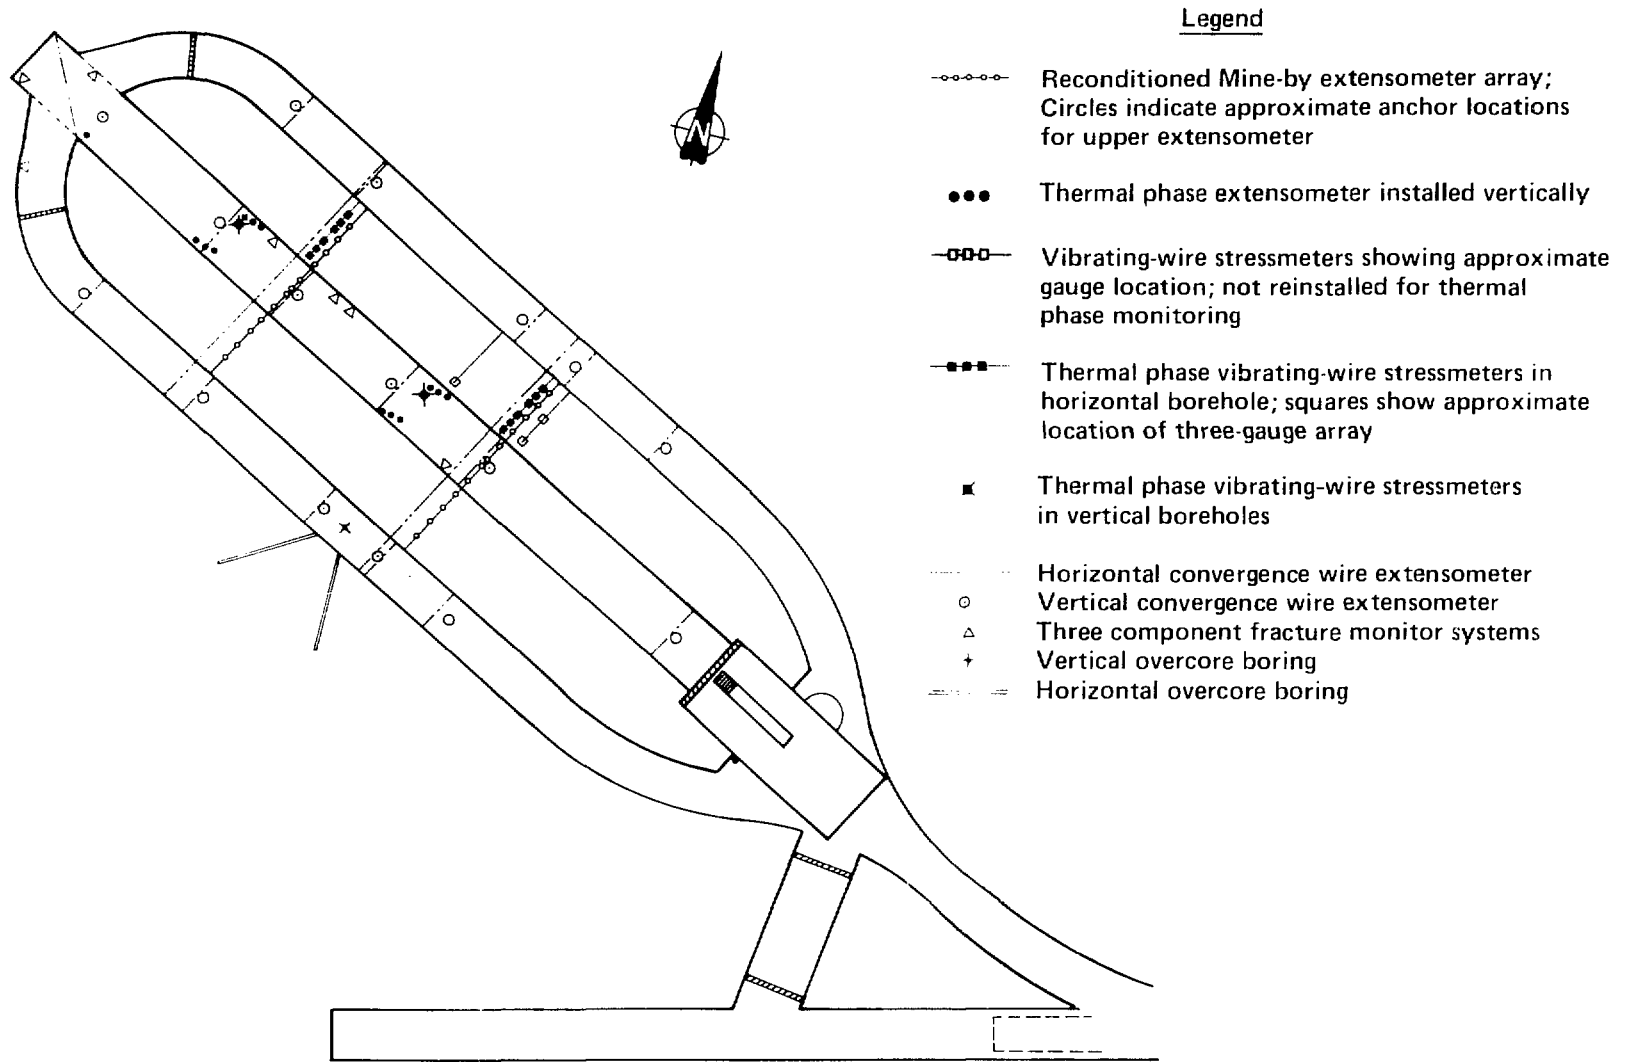
Figure 9-9. Location of thermal phase instrumentation (after Patrick, Rector, and Scarafiotti, 1984).

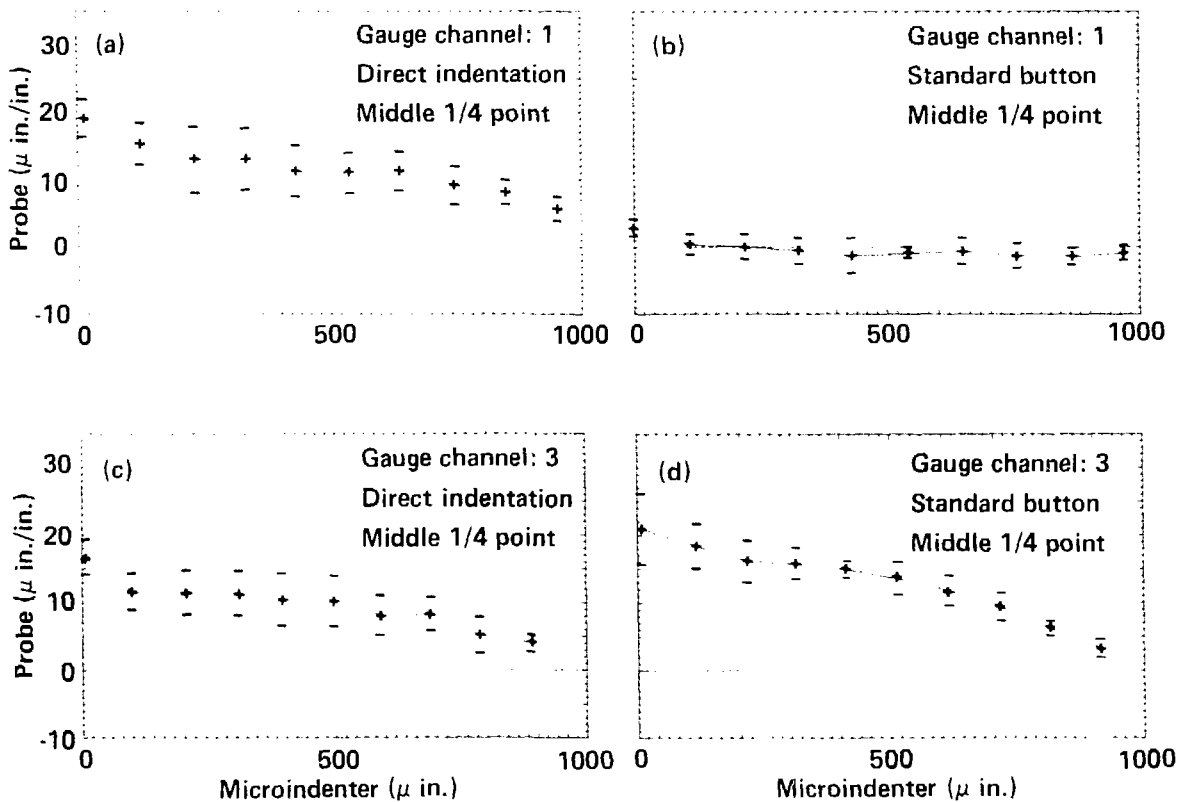
Figure 9-14. Mean hysteresis loop with \pm standard deviation values for standard button on cantilever: (a) and (b) = No. 1 (C-1) BMG channel 1; (c) and (d) = No. 3 (C-3) BMG channel 3. Data are ± 500 MS about the middle one quarter point of the BMG dynamic range (after Ganow, 1985).

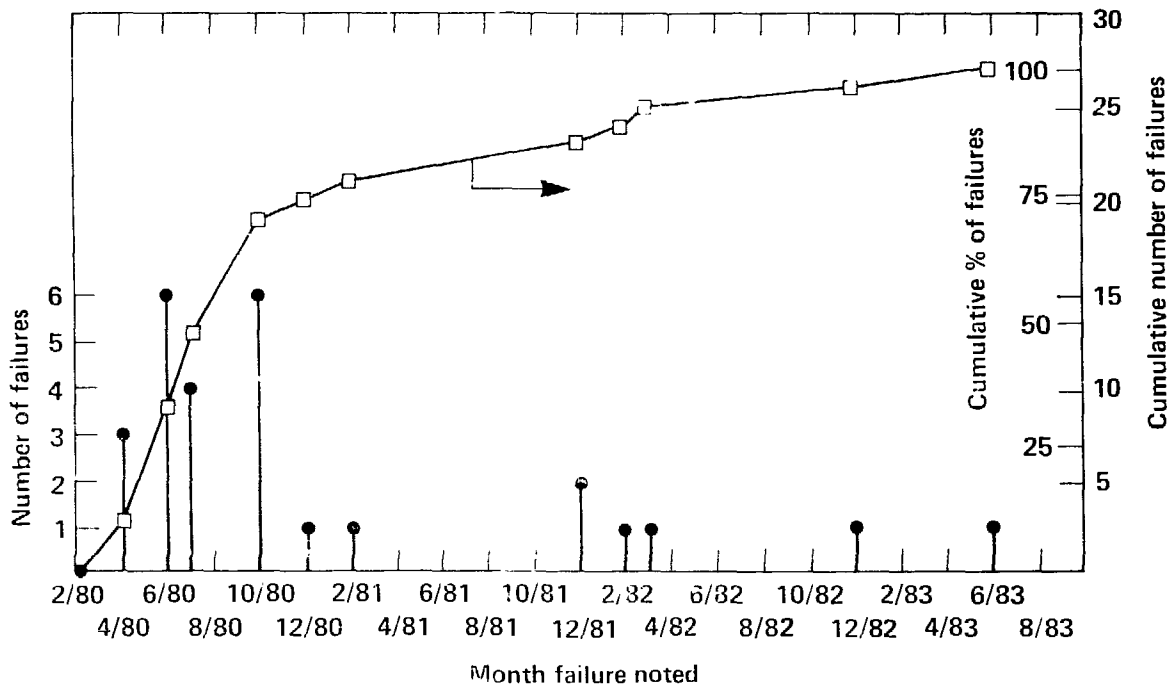
Figure 9-18. History of pressure loss for GxE-series rod extensometers that had pressure maintenance systems (after Patrick, Rector, and Scarafiotti, 1984).

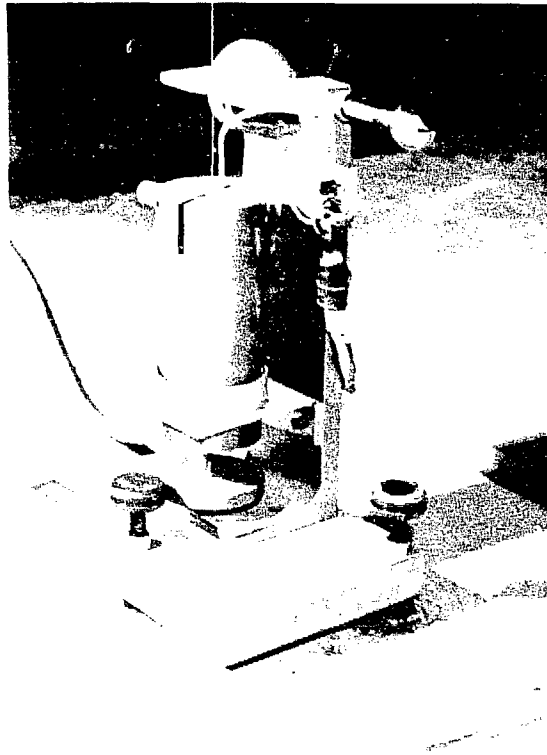
Figure 9-19. Typical canister drift vertical convergence wire extensometer installation (after Patrick, Rector, and Scarafiotti, 1984).

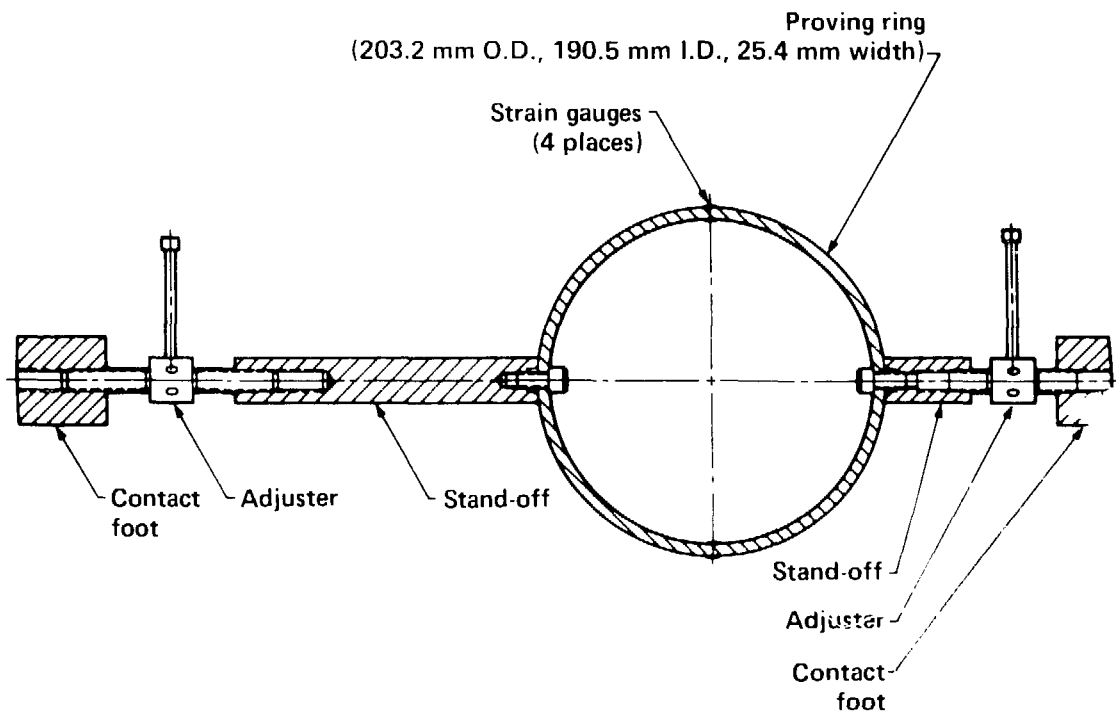
Figure 9-21. Schematic of canister deformation gauge showing strain-gauged proving-ring concept (after Patrick, Rector, and Scarafiotti, 1984).

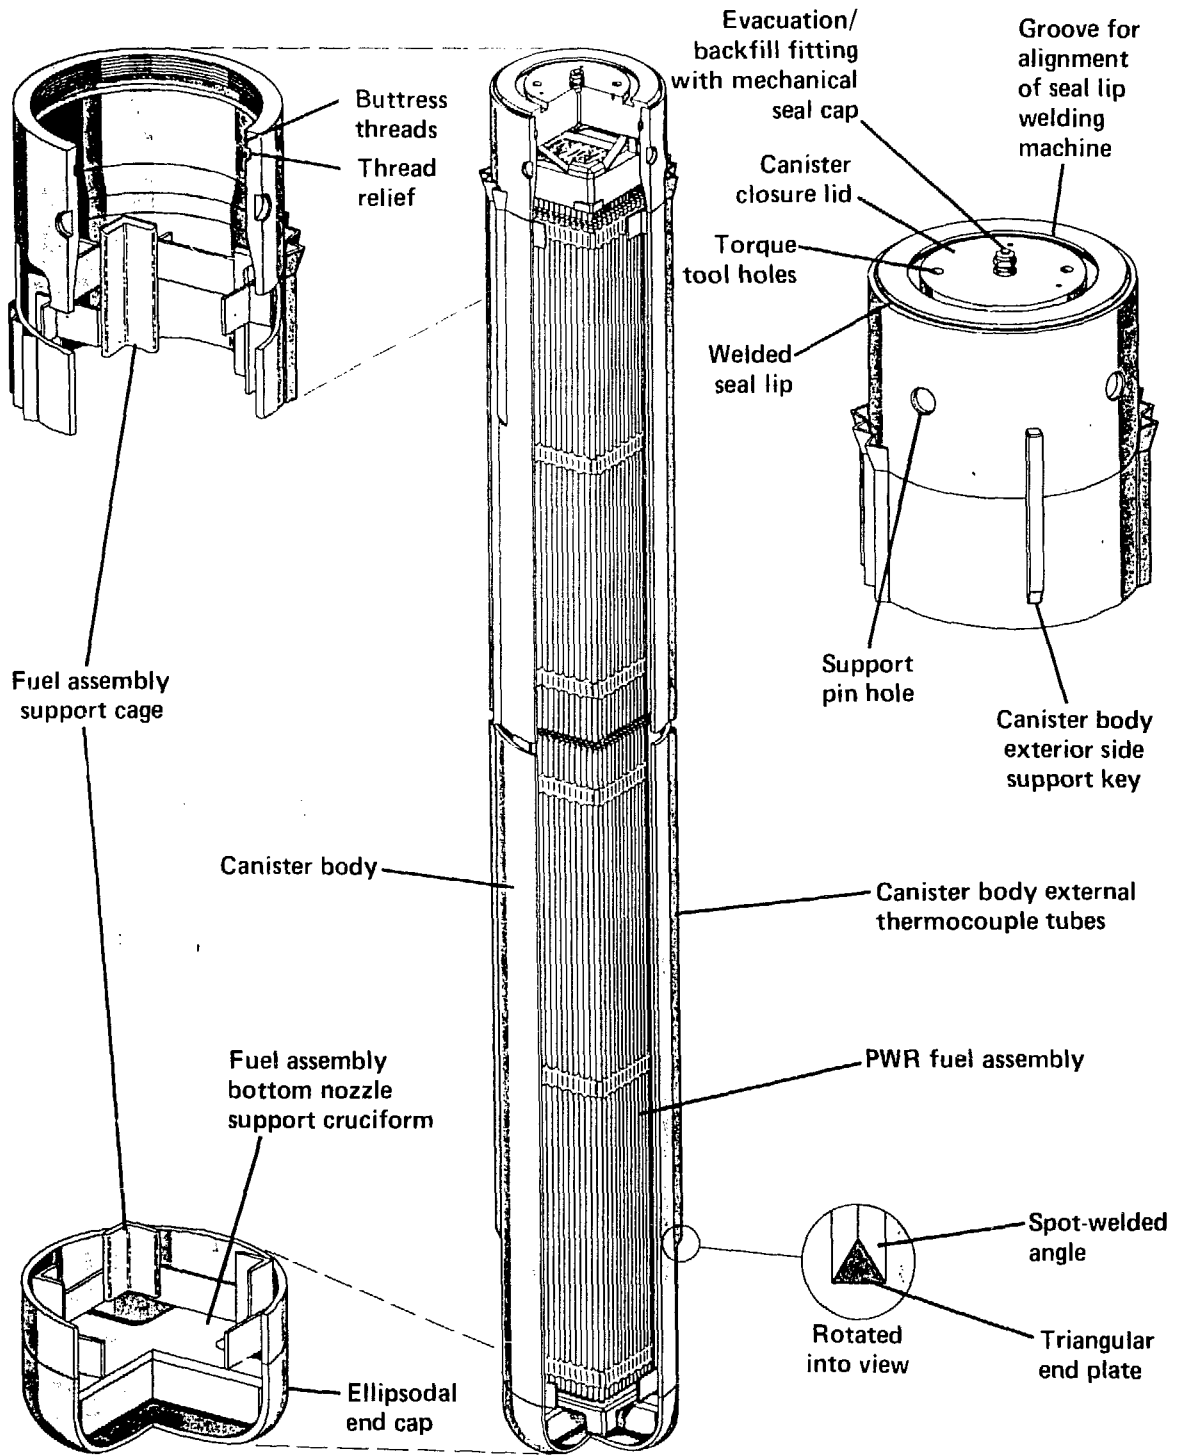
Figure 12-1. Spent-fuel canister assembly (after NVO-210, 1980).

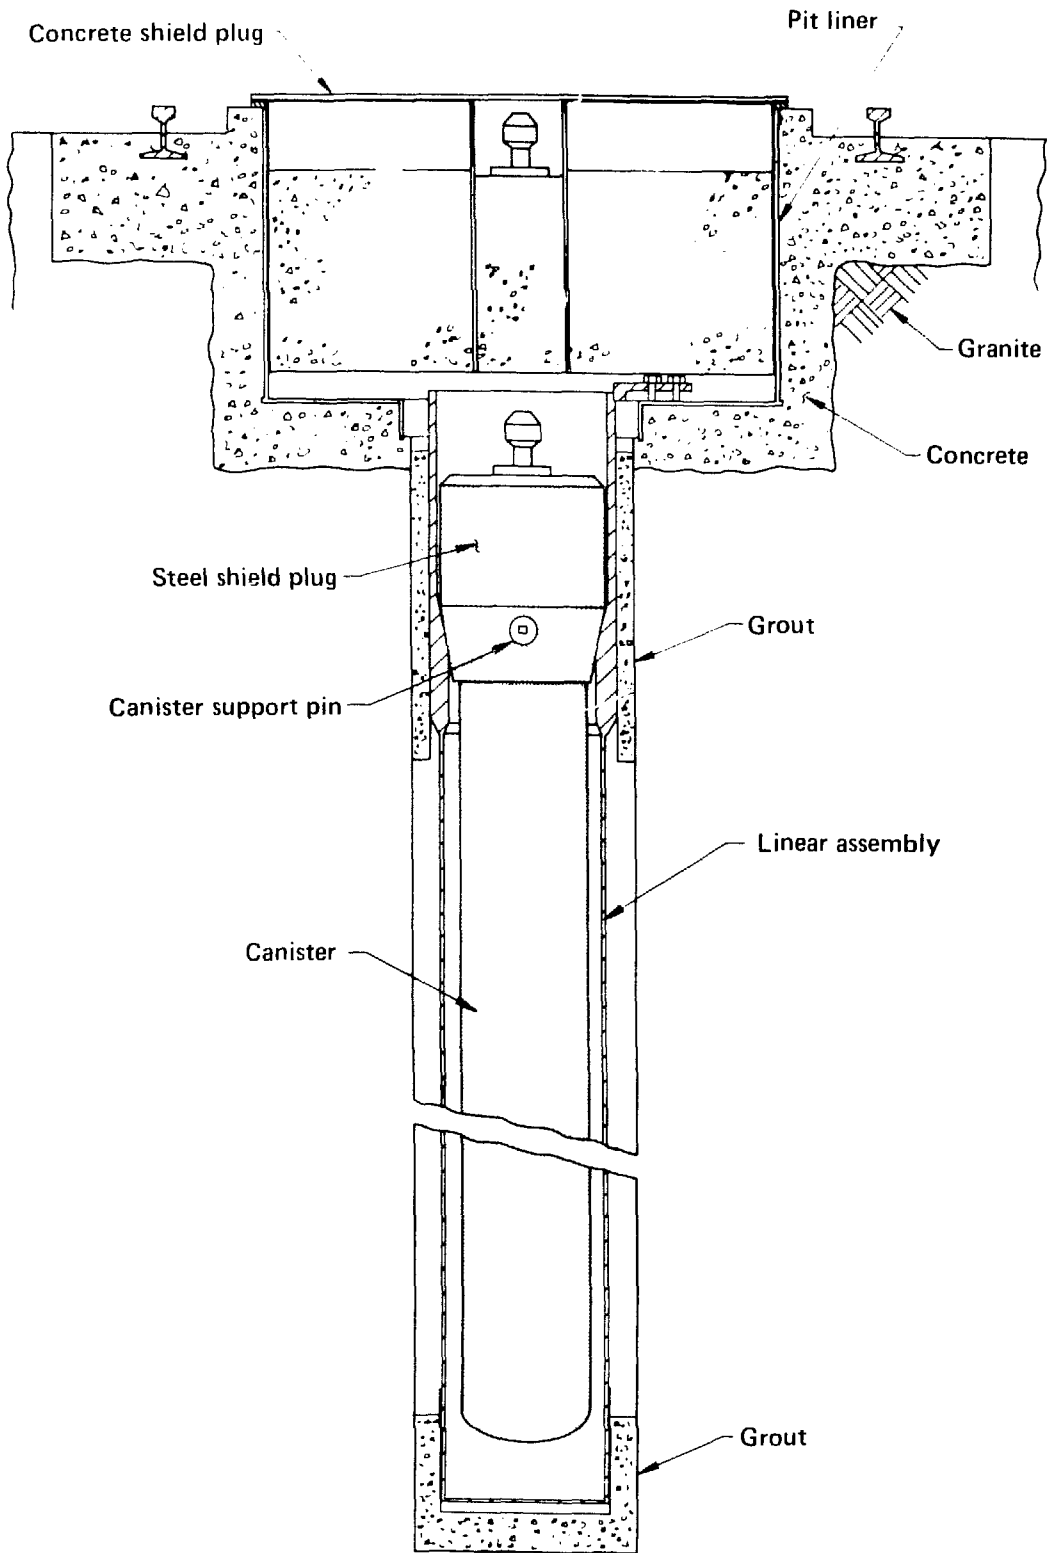
Figure 12-3. Canister storage configuration (Westinghouse Advanced Energy Systems, Pittsburgh, PA—Dwg. No. 615339-1B).

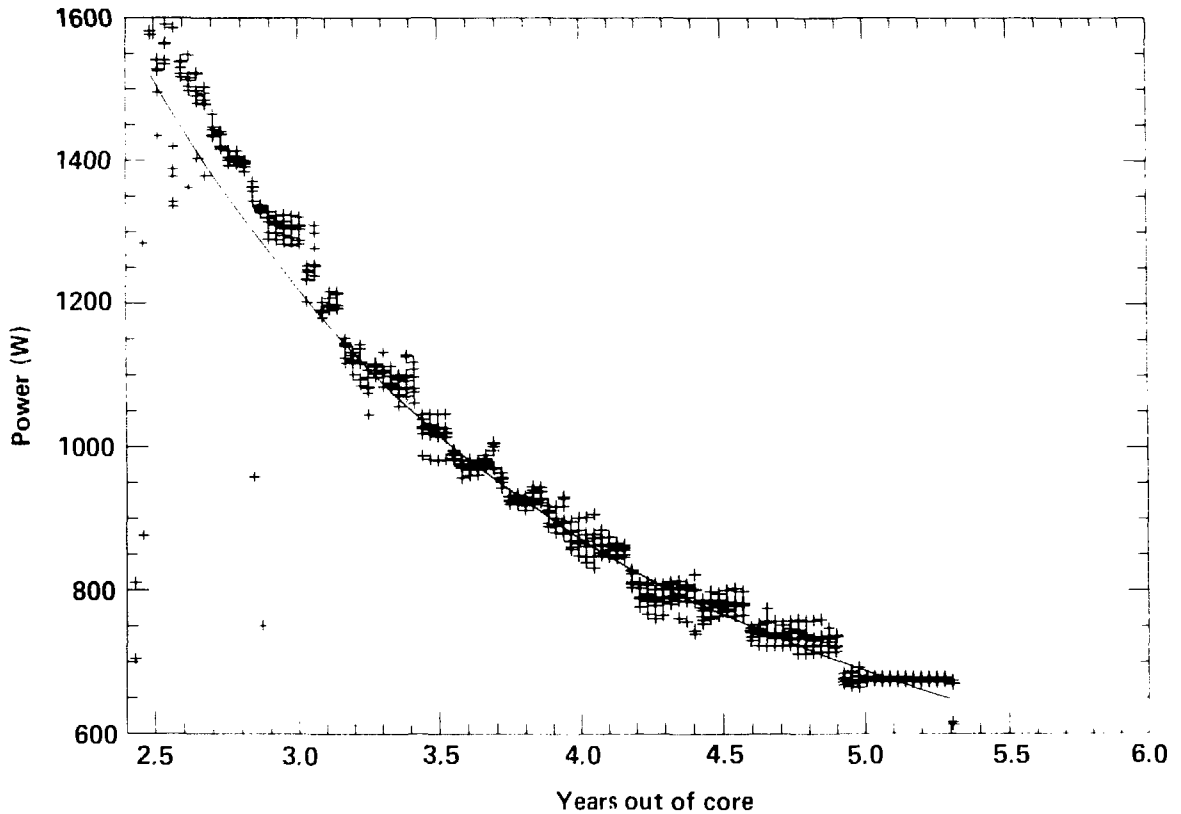
Figure 12-4. Electrical simulator power history showing effect of loop controller addition at 5.0 YOC.

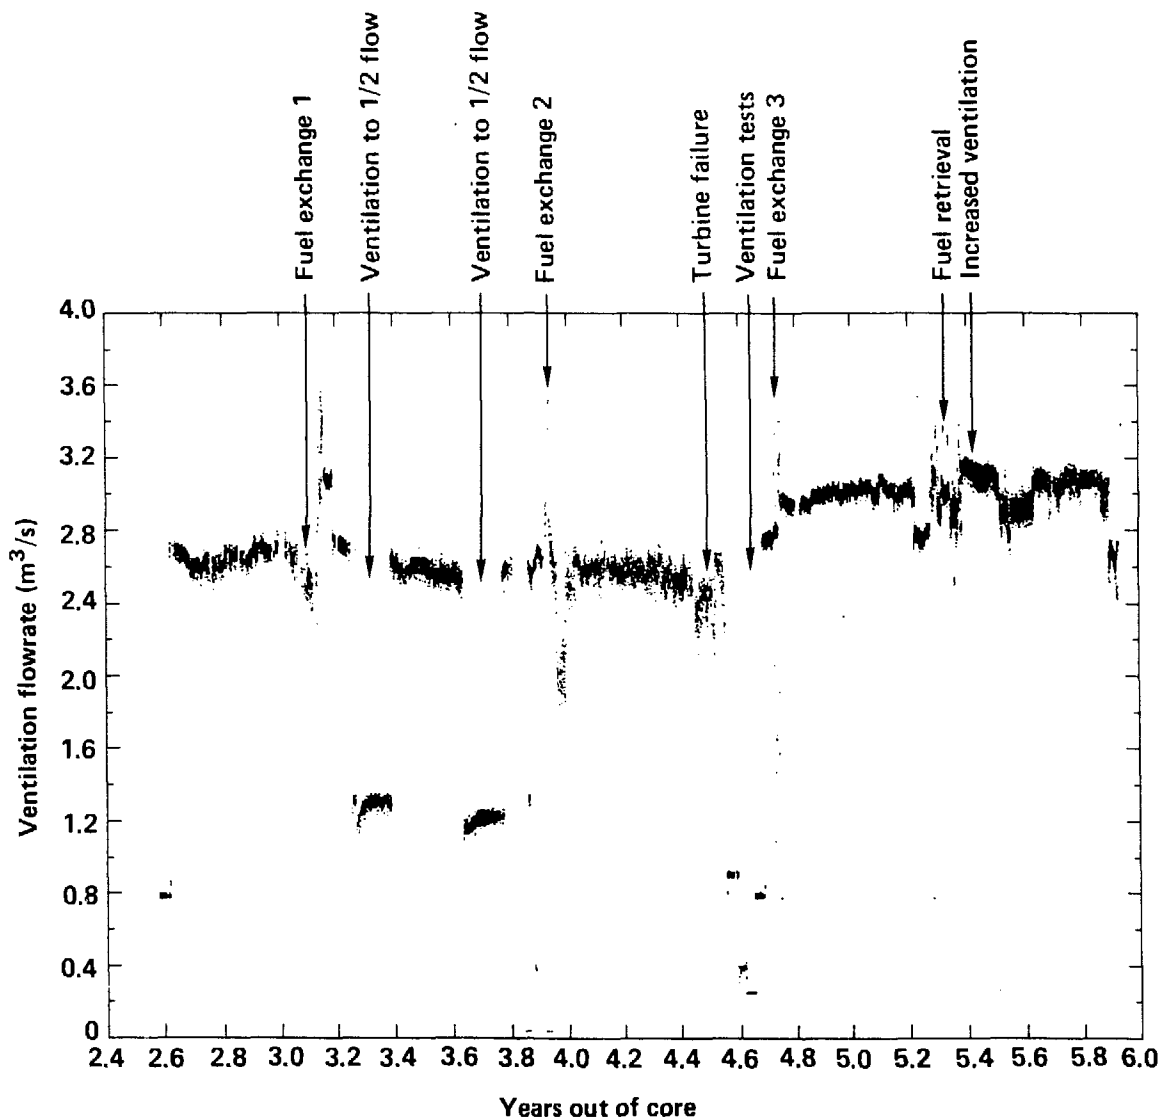
Figure 14-1. Ventilation flowrates through the canister access shaft.

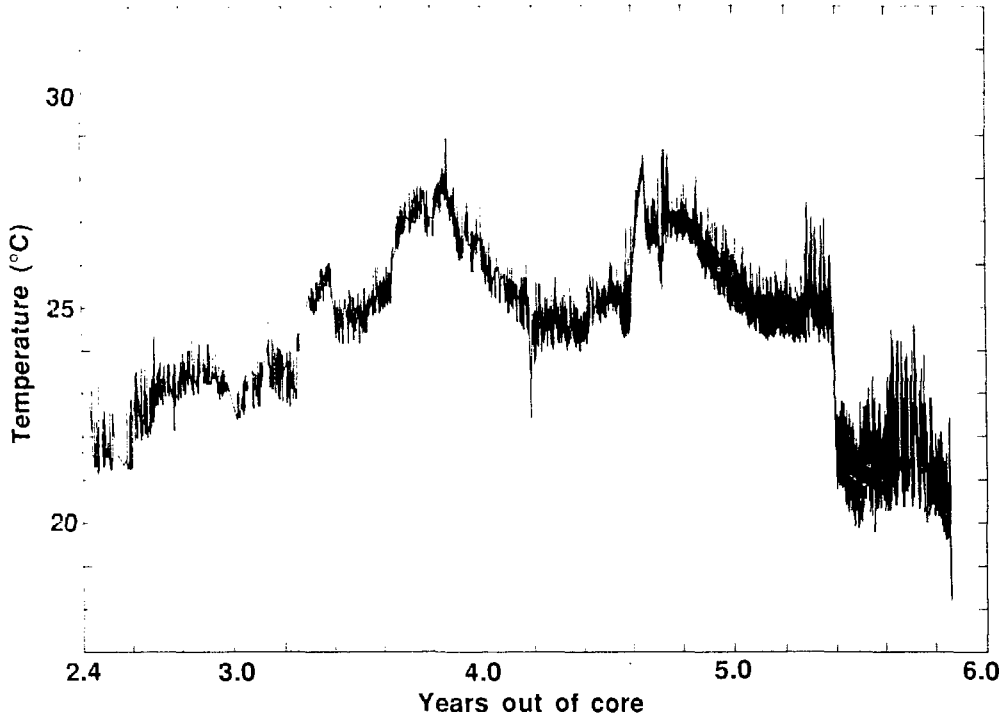
Figure 14-2a. Inlet air temperature.

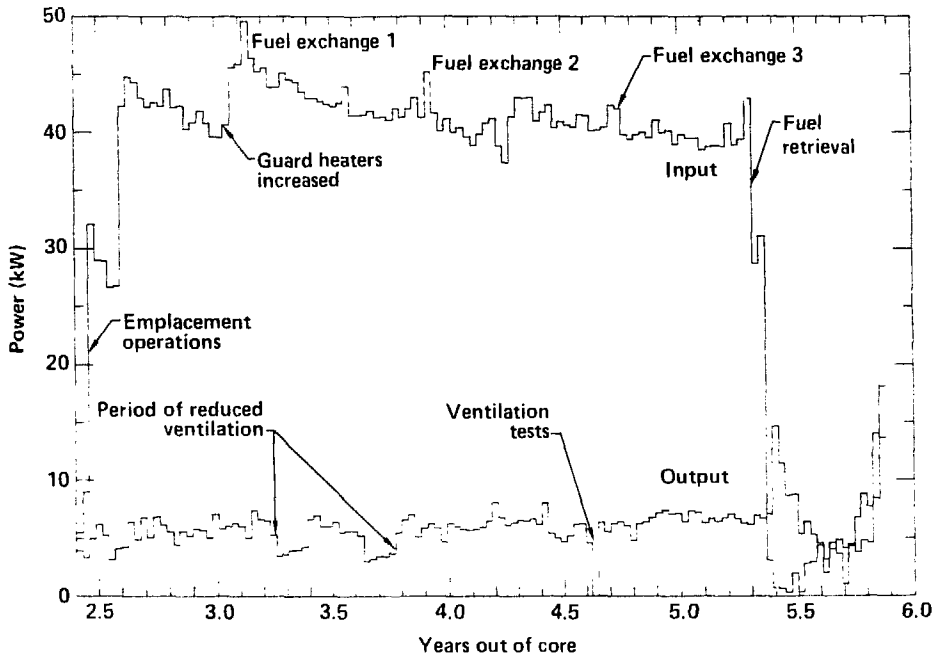
Figure 14-6. Power input and removal history annotated for significant events.

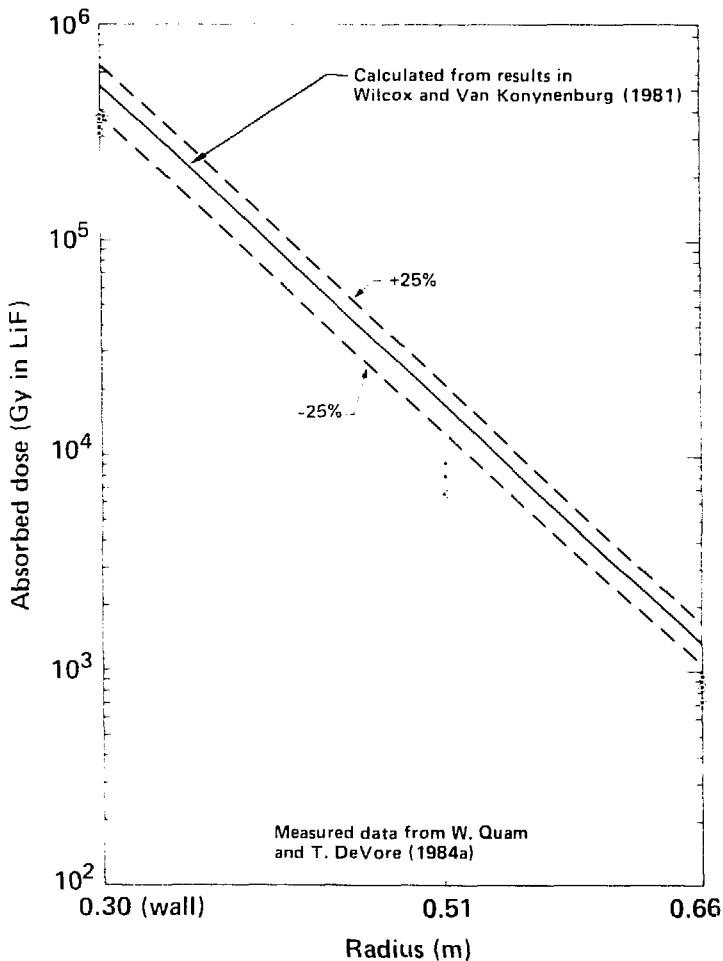
Figure 15-2. Comparison of calculated and optical-absorption-measured doses for hole CEH03 for the period from January 12, 1981 to October 23, 1981 (after Van Konynenburg, 1984).

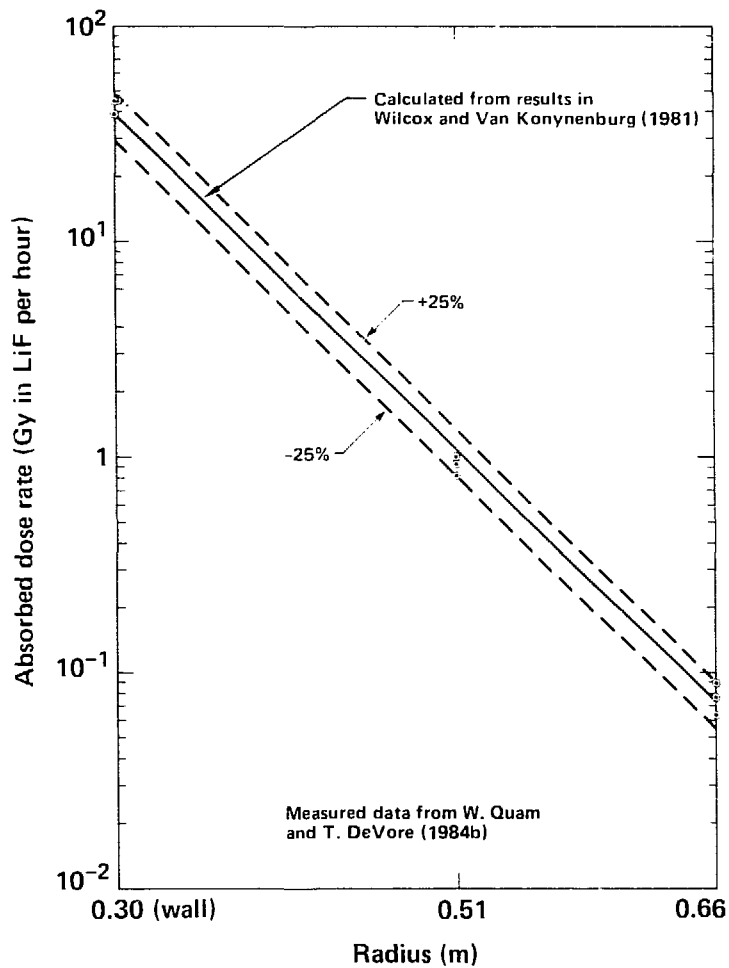
Figure 15-5. Comparison of calculated and thermoluminescence-measured dose rates for hole CEH03 on March 8, 1983 (after Van Konynenburg, 1984).

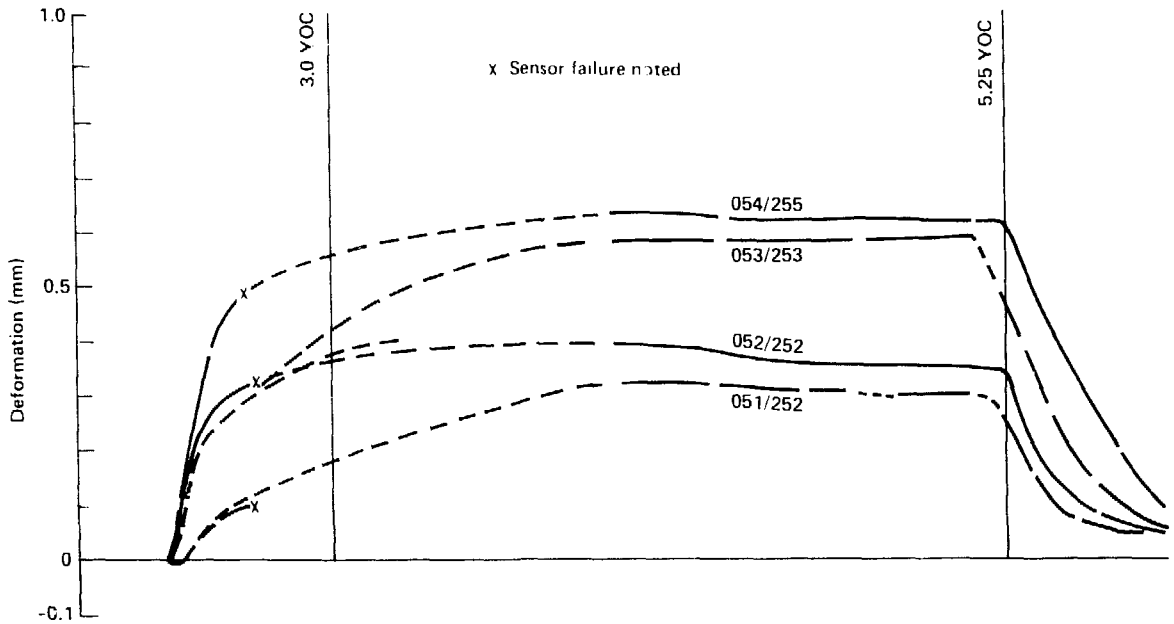
Figure 16-10. Time series of relative displacements recorded by the four-anchor extensometer GBE05. Note that segments of data have been merged because of instrument failures at early times (after Wilder and Yow, 1986).

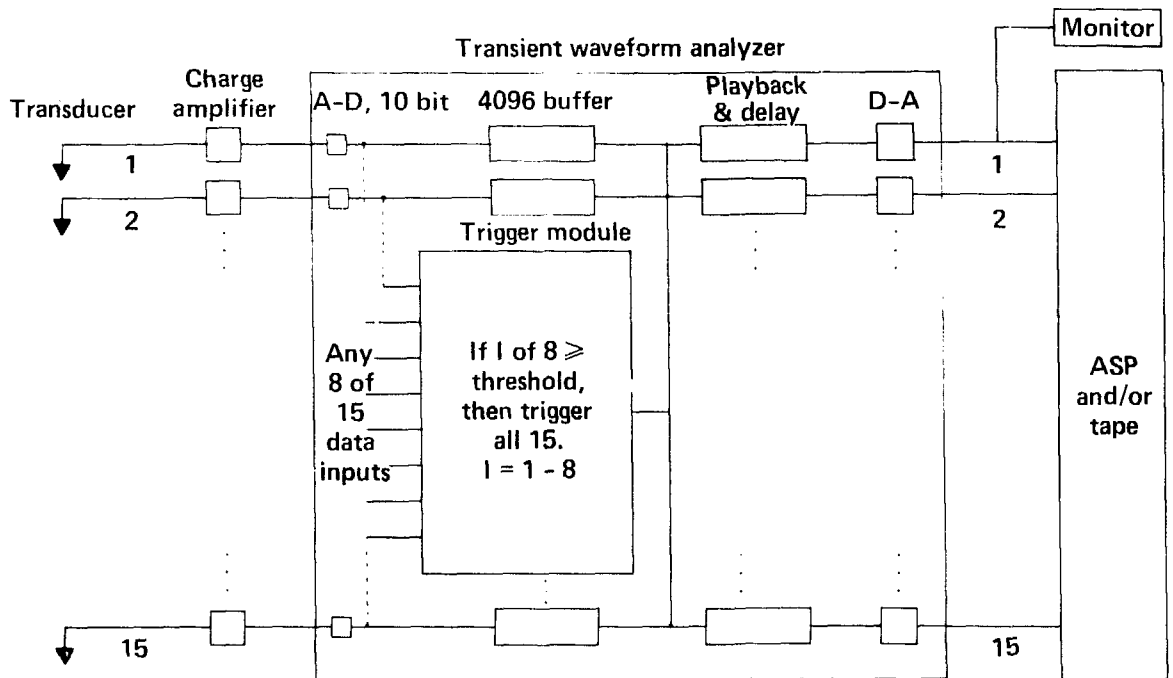
Figure 17-2. Total system showing the AE sensor (transducer), preamplifiers (mounted as close as possible to the sensor), transient waveform analyzer (Physical Data 515-A), and data handling device [either a tape recorder or the automated seismic processor (ASP)] (after Patrick et al., 1982).

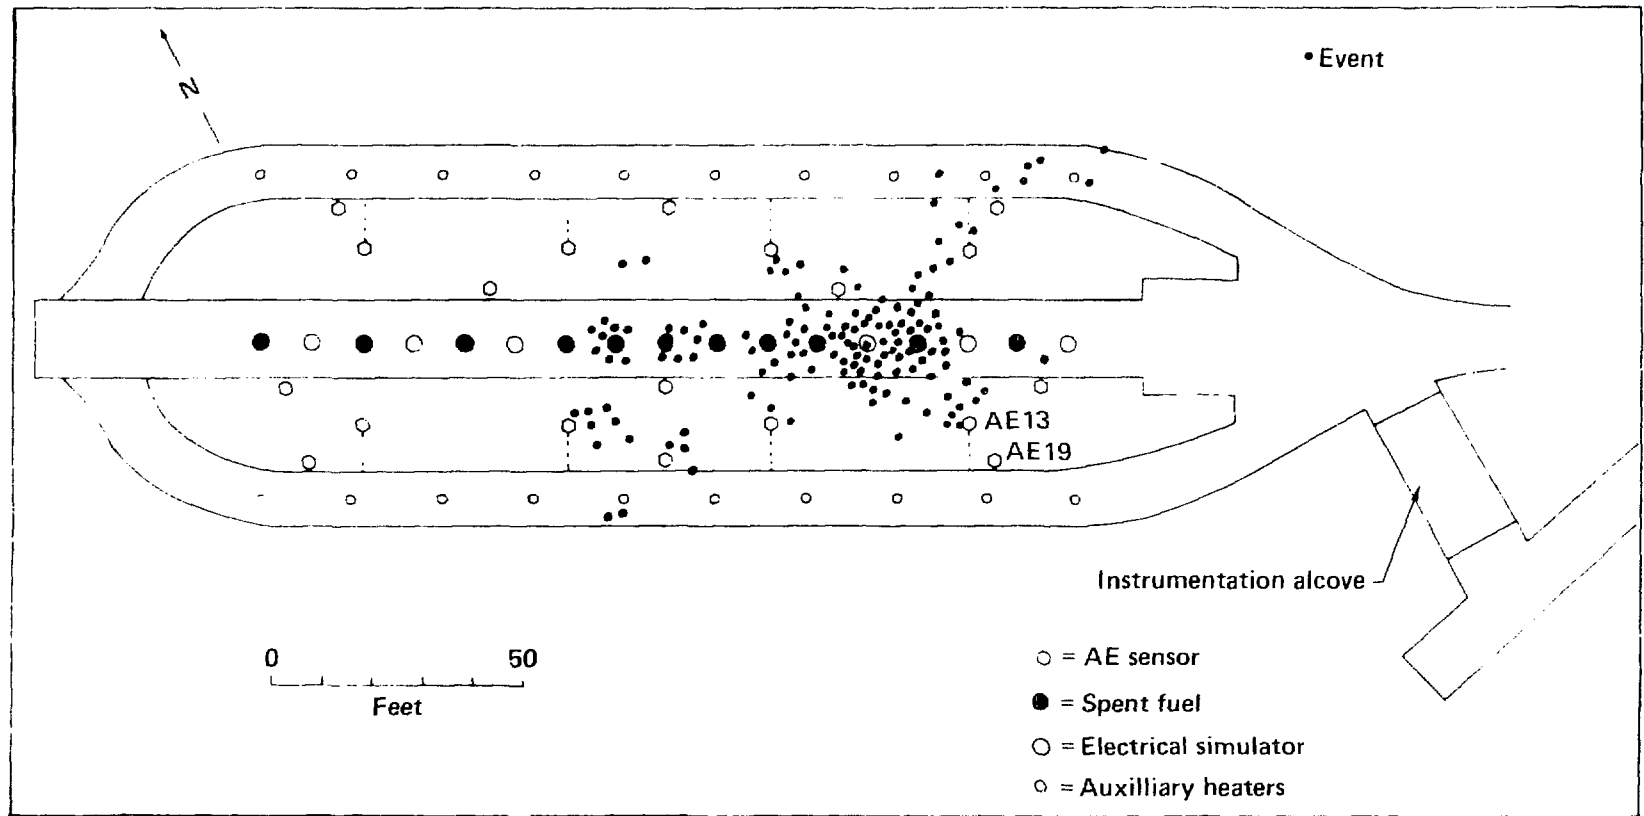
Figure 17-5. Plan view of acoustic instrumentation locations and zones of principal seismic activity (after Patrick et al., 1984).

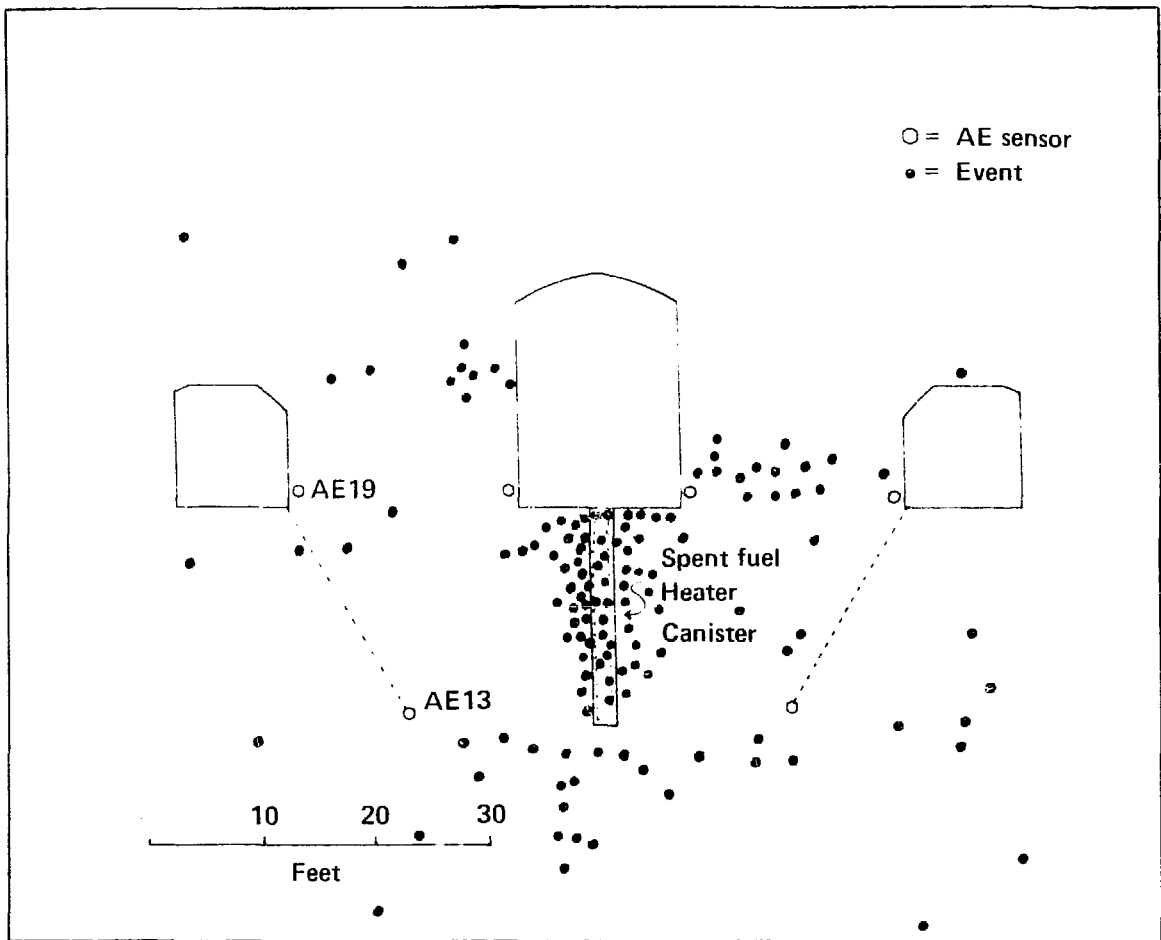
Figure 17-6. Cross-sectional view of acoustic emission instrumentation locations and zones of principal seismic activity (after Patrick et al., 1984).

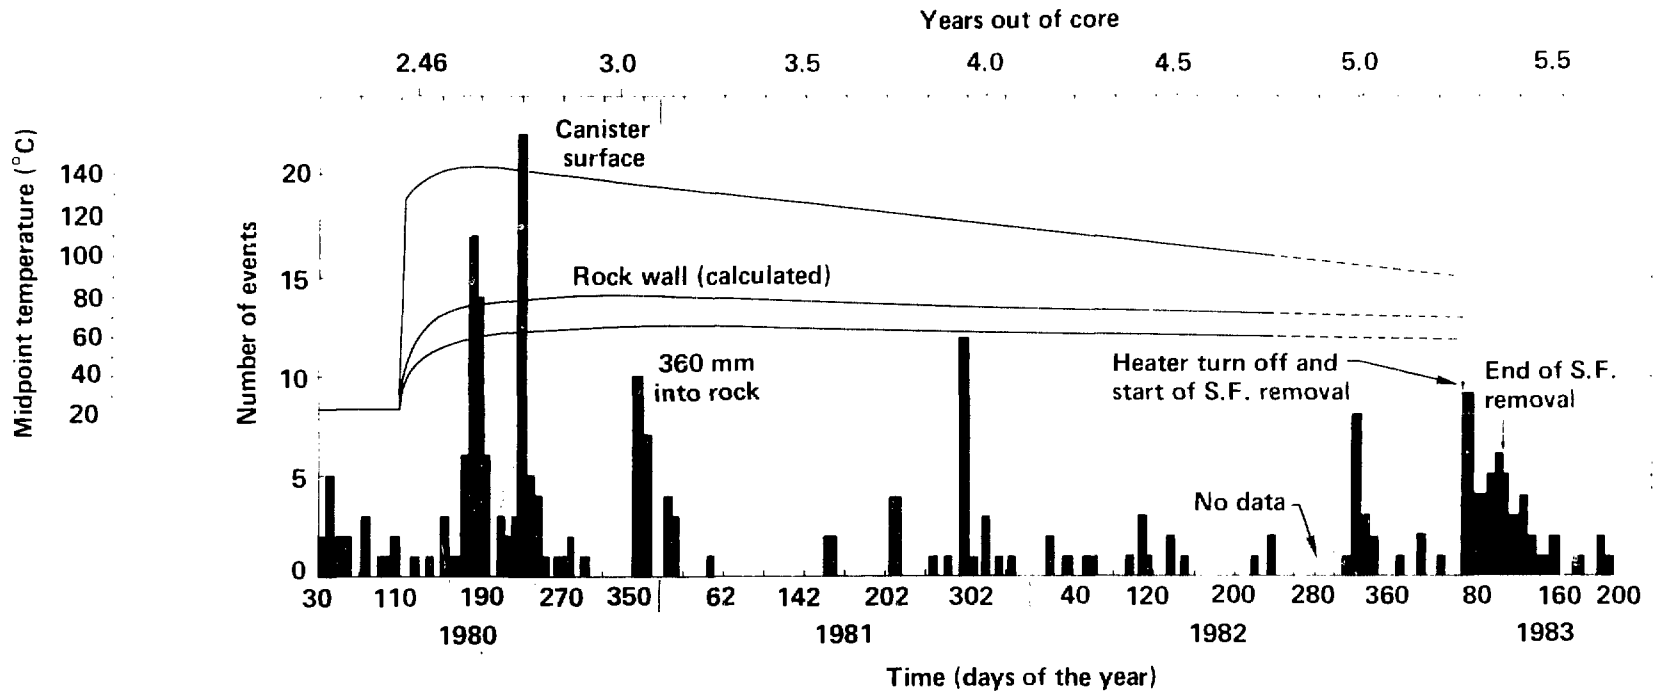
Figure 17-7. AE activity and temperatures from January 1980 through June 1983 (after Patrick et al., 1984).

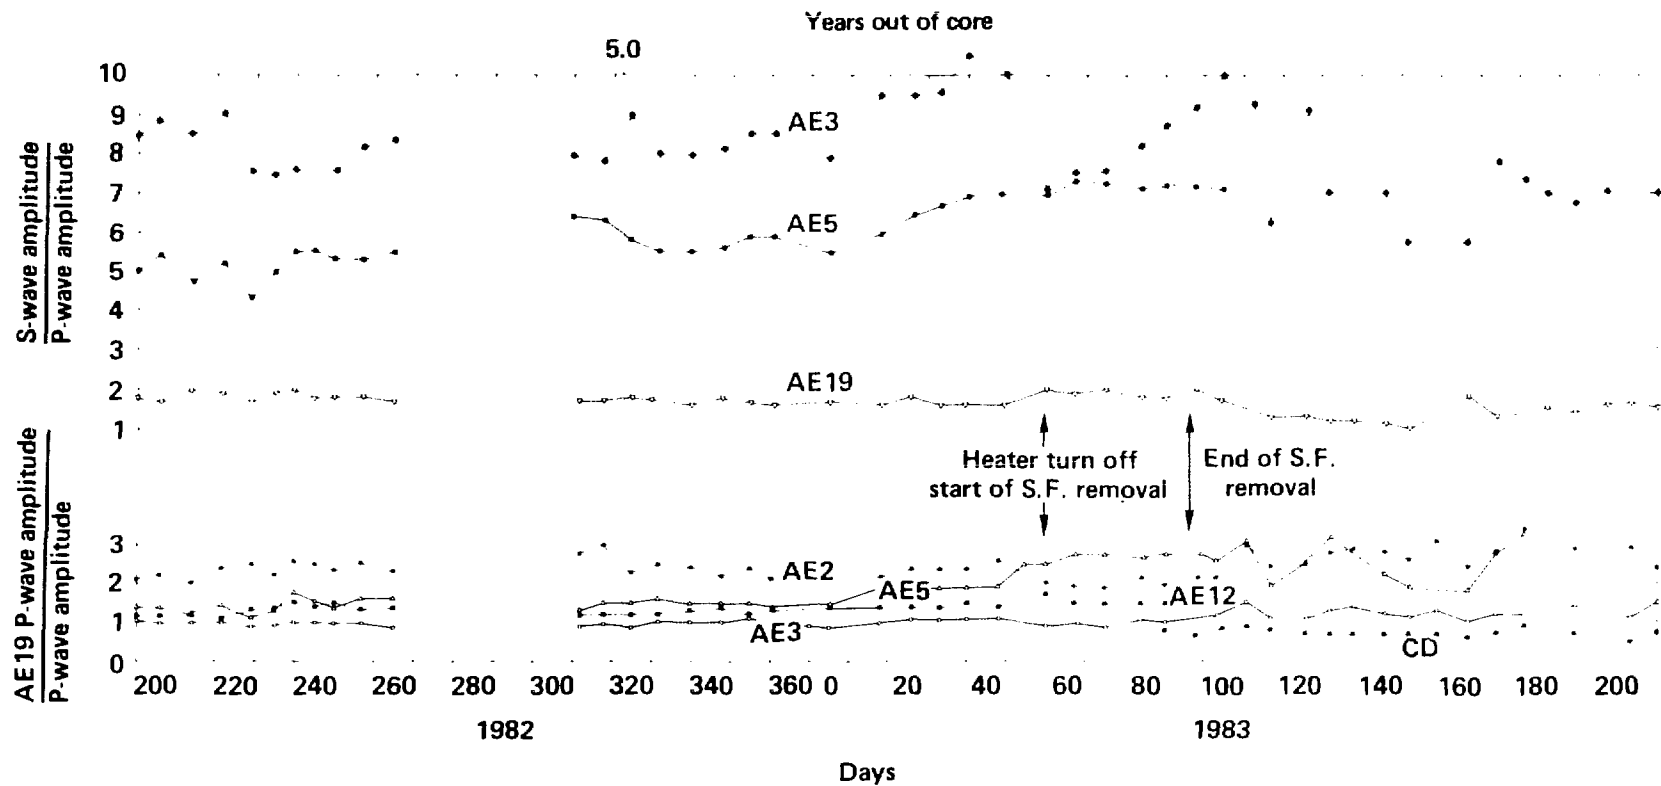
Figure 17-18c. P-wave and S-wave amplitude changes from day 190, 1982, through day 215, 1983 (after Patrick et al., 1984).
