Spent Fuel Test—Climax: An Evaluation of the Technical Feasibility of Geologic Storage of Spent Nuclear Fuel in Granite

Final Report

W. C. Patrick

LAWRENCE LIVERMORE NATIONAL LABORATORY
University of California • Livermore, California • 94550

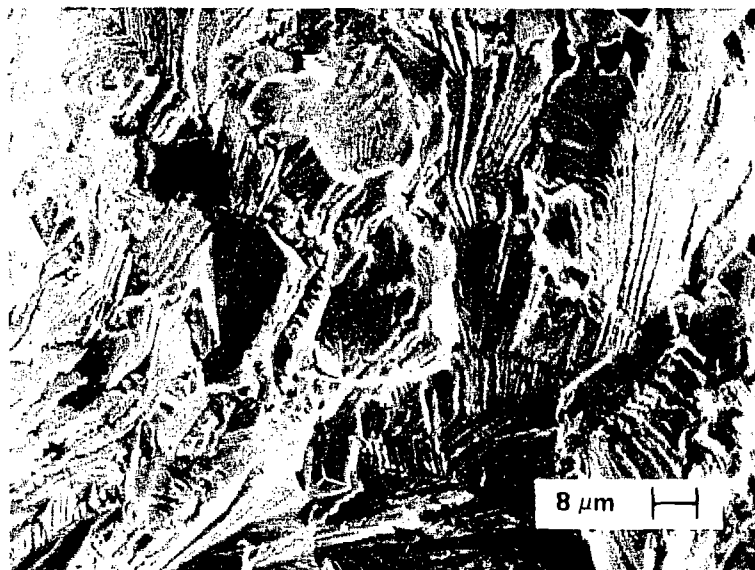
Figure 18-5. Micrograph of stress corrosion cracking in a Superinvar extensometer rod which failed in service (±1000×) (after Patrick et al., 1984).

Superinvar connecting rods corrosion-cracked when in contact with Climax ground water at temperatures near 55 °C. Thermocouple sheathing corroded in two cases where the thermocouples were erroneously sheathed in stainless steel rather than Inconel 600, as specified.

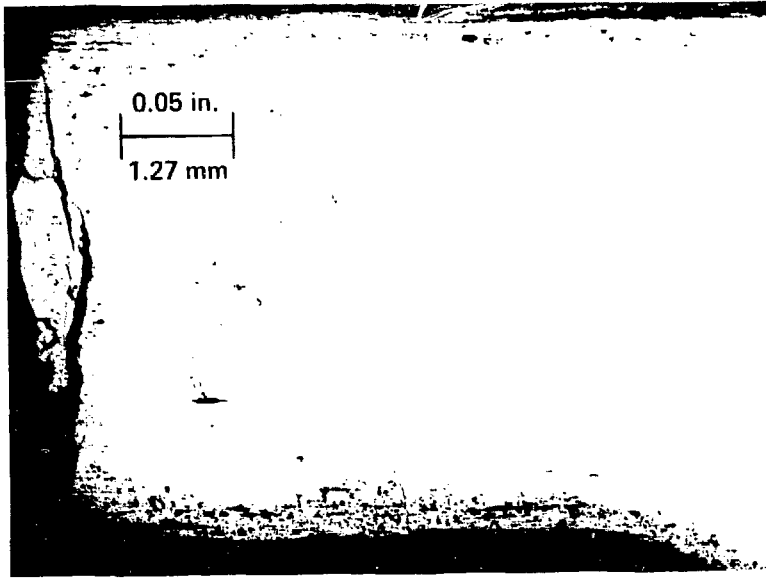
Figure 18-6. Fracture development in a Superinvar rod which failed during testing (21 \times) (after Patrick et al., 1984).

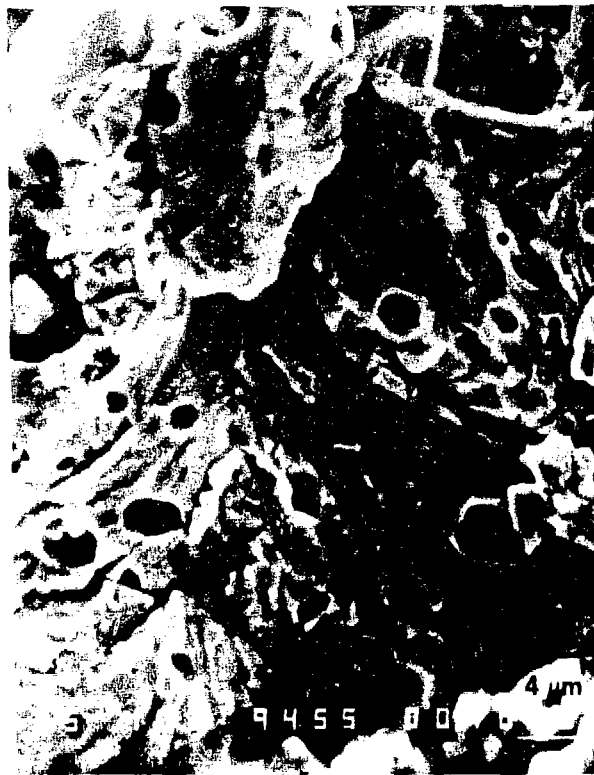
Figure 18-7. Micrograph of fracture surface of Superinvar rod which failed during testing (1000 \times) (after Patrick et al., 1984).

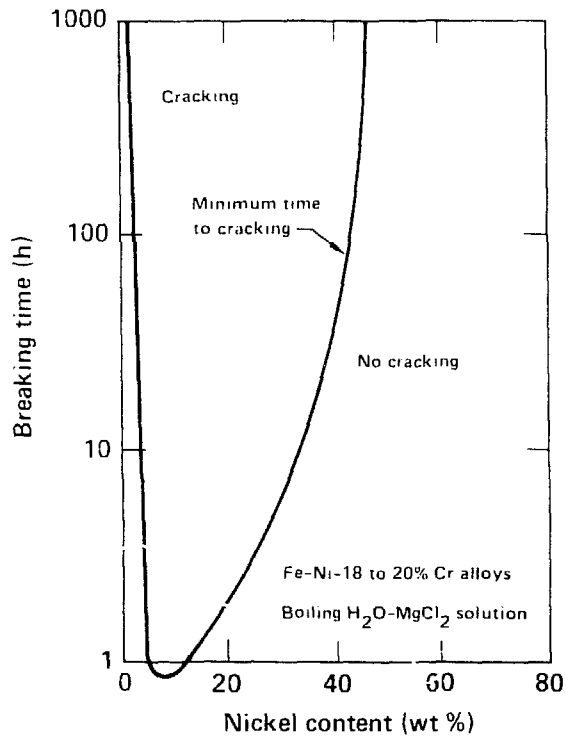
Figure 18-8. Relationship between breaking time and nickel content (after Copson, 1959).
