AIAA 98-0048

IN-FIELD USE OF LASER DOPPLER VIBROMETER ON A WIND TURBINE BLADE*†‡

Mark Rumsey
John Hurtado
Bruce Hansche
Todd Simmermacher
Tom Carne
Sandia National Laboratories
PO Box 5800
Albuquerque, NM 87185

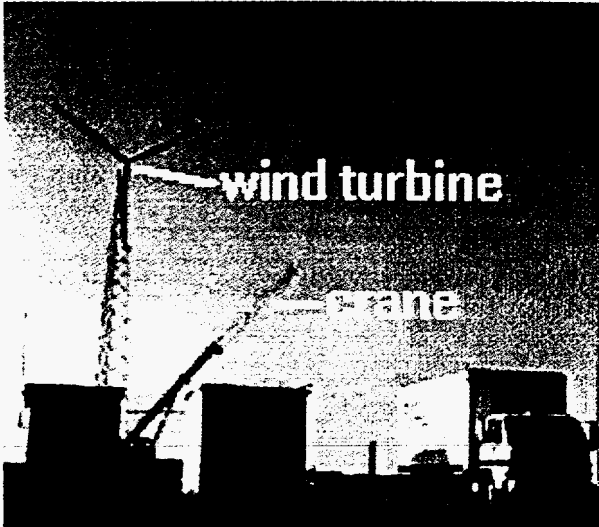
Figure 2A. Bushland test site showing the AOC 15/50 wind turbine and a crane in the background, and the building that housed the LDV (square building in the bottom center of the picture). The crane with a man-bucket was used to gain access to the wind turbine rotor. The computers and remainder of the instrumentation were located in the van on the right.

We collected a total of 13 data sets at the Bushland facility. A diagram of the field test setup is shown in Figure 1. Figures 2A through 2C are a progressive series of snapshots which show our setup and the wind turbine. The snapshot series begins with a far field picture of the setup and ends with a close-up picture of the tip of the vertically orientated wind turbine blade.

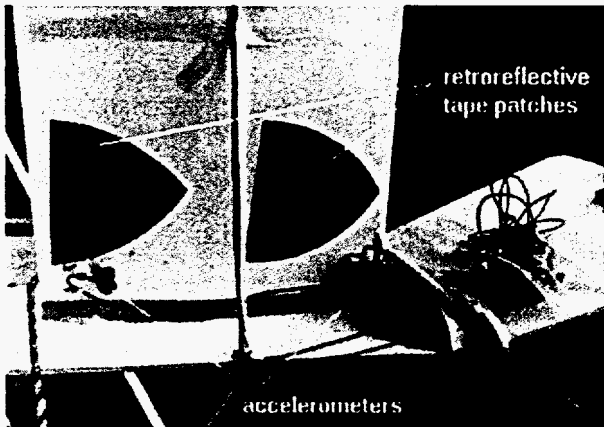
Figure 2C. Close-up view of the tip-brake section of the vertical blade. Note the two retroreflective patches and an accelerometer mounted just below each patch. Nodal location #10 is on the left and nodal location #9 is on the right. The blade chord length at the tip is 406 mm (16 inches).

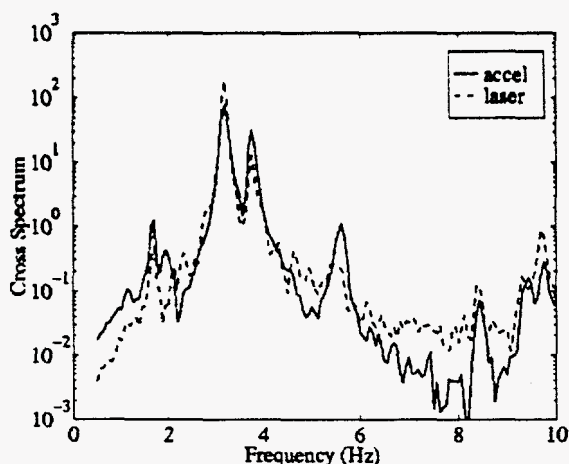
Figure 6. Cross Spectra of Accelerometer Data (200 averages) and Laser Data (10 averages).

If many averages of laser data are gathered, a NExT analysis may be fruitful. Below, in Figure 6, we show the cross spectra of accelerometer and laser data at nodal point 10. The accelerometer cross spectrum is computed from 200 averages of the cross correlation function, while the laser cross spectrum is computed from only 10 averages of the cross correlation function. This figure shows that even though we computed many fewer averages of the laser data, the spectral content of the two plots is very similar.
