ORNL/TM-13265

THE MECHANICAL PROPERTIES OF T-111 AT LOW  
TO INTERMEDIATE TEMPERATURES

Metals and Ceramics Division

H. E. McCoy and J. R. DiStefano

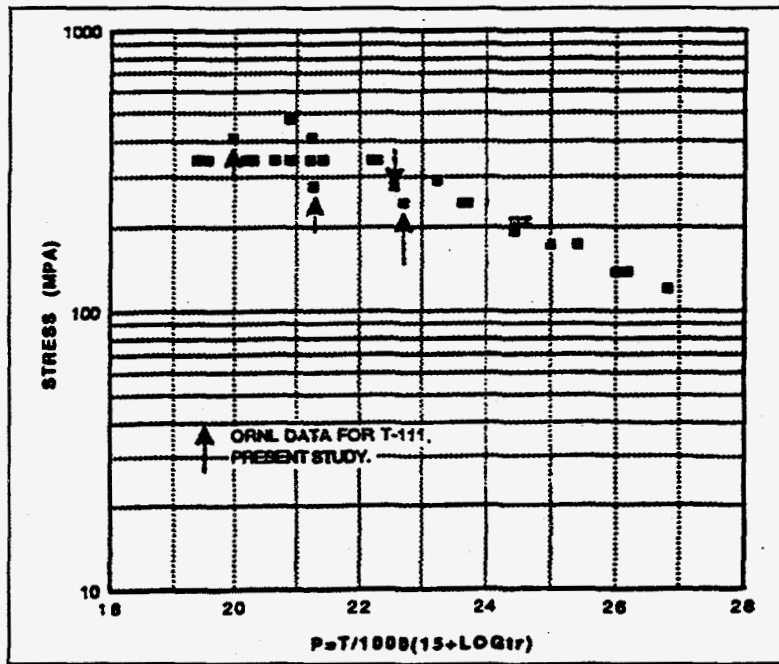
Fig. S.1. Larson-Miller plot of selected rupture data for T-111-type alloys.

The four rupture points from the present study are identified in the figure. Based on the data in Fig. S.1, the results of the present study appear consistent with those from other studies. Figure S.2 is a plot of the time-to-rupture as a function of minimum creep rate (Monkman-Grant correlation) for the same tests shown in Fig. S.1, and once again the present data are consistent with the larger data population, albeit on the lower side.

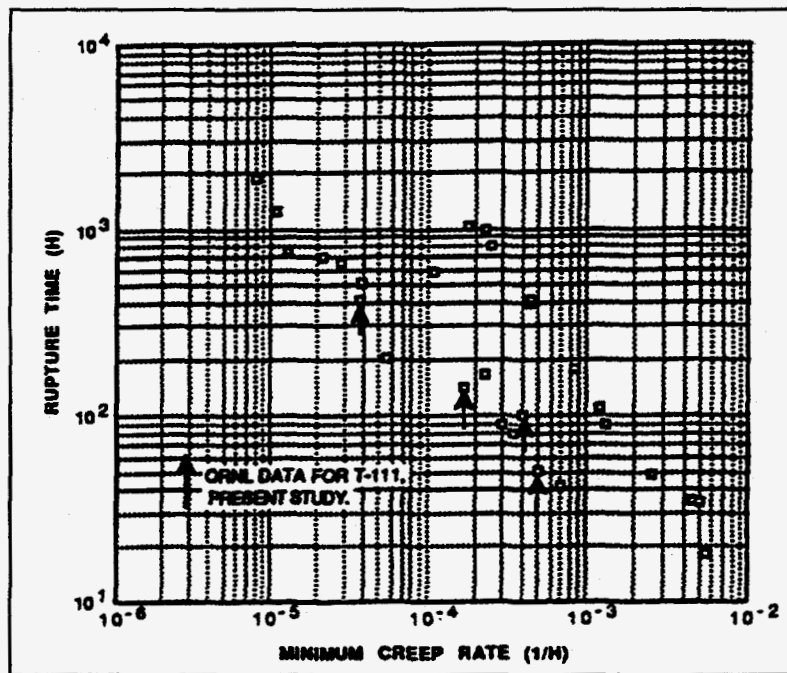
Fig. S.2. Monkman-Grant plot for several T-111-type alloys.

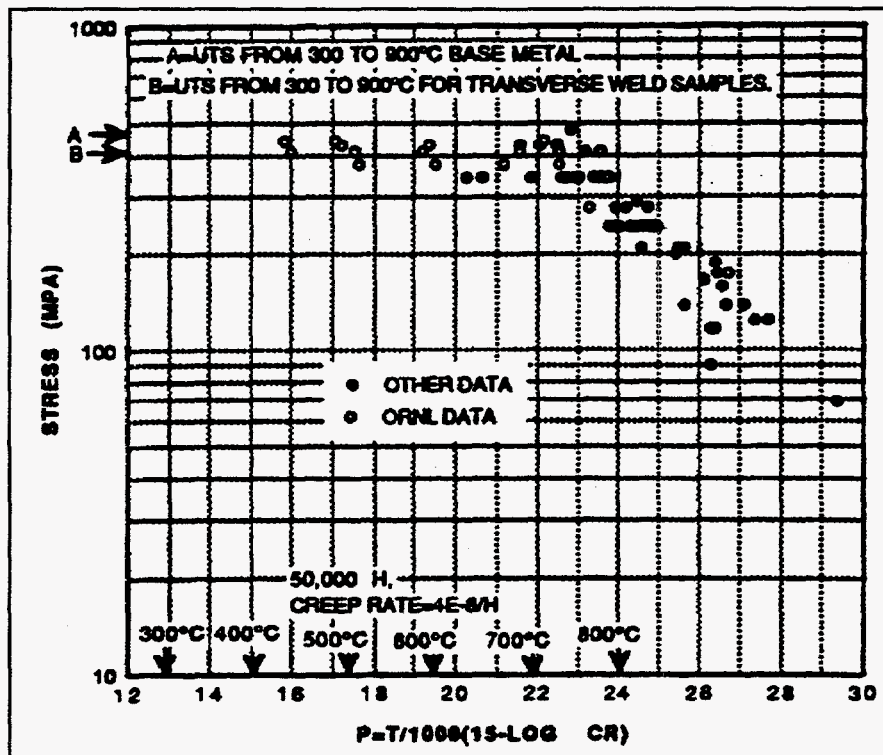
Fig. S.3. Larson-Miller plot based on strain rate including all points.

Another type of correlation is shown in Fig. S.3. The ordinate is the stress and the abscissa is a Larson-Miller parameter that is based upon strain rate (CR in Fig. S.3) instead of time-to-rupture shown previously in Fig. S.1. All of the Oak Ridge National Laboratory data generated in this study together with the previous data are shown in Fig. S.3, and the temperatures shown were calculated based upon the low creep rates and long times of interest to the IHS. This plot suggests a relatively constant stress to cause rupture of T-111 from approximately 300 to 700°C that closely corresponds to the ultimate tensile strength of T-111 at these temperatures.

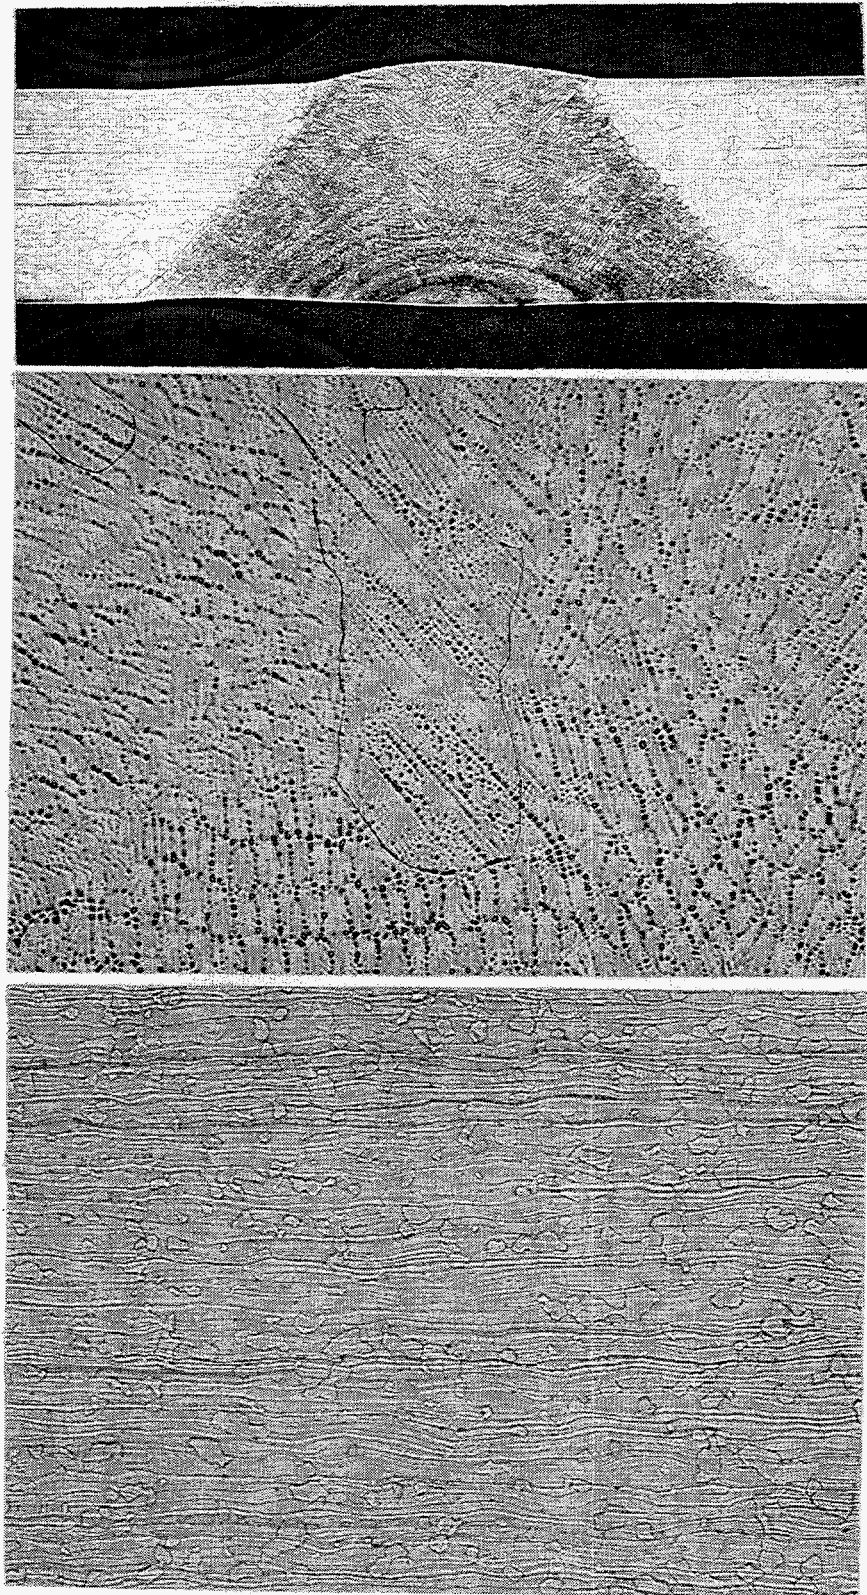
**Fig. 3. Photomicrographs of section of weld:** (a) view of entire weld, 12.8 $\times$ ; (b) base metal, 100 $\times$ ; and (c) weld metal, 100 $\times$ .

A section of the weld was viewed metallographically, and typical photomicrographs are shown in Figs. 3 and 4. A section of the weld is shown in Fig. 3(a) magnified 12.8 times. The initial base metal had the microstructure shown in Fig. 3(b), which has a grain size of American Society for Testing and Materials (ASTM) number 8. The microstructure of the weld metal is dendritic as shown in Fig. 3(c). A portion of the region of large grains adjacent to the weld metal [see Fig. 3(a)] is shown at higher magnification in Fig. 4. Most of the tensile and creep fractures in welded samples occurred in these large grains. Microhardness measurements across the weld and base metal (see Fig. 5) show that the hardness does not vary much across the weldment, but the base metal adjacent to the fusion line is slightly softer than the remainder.

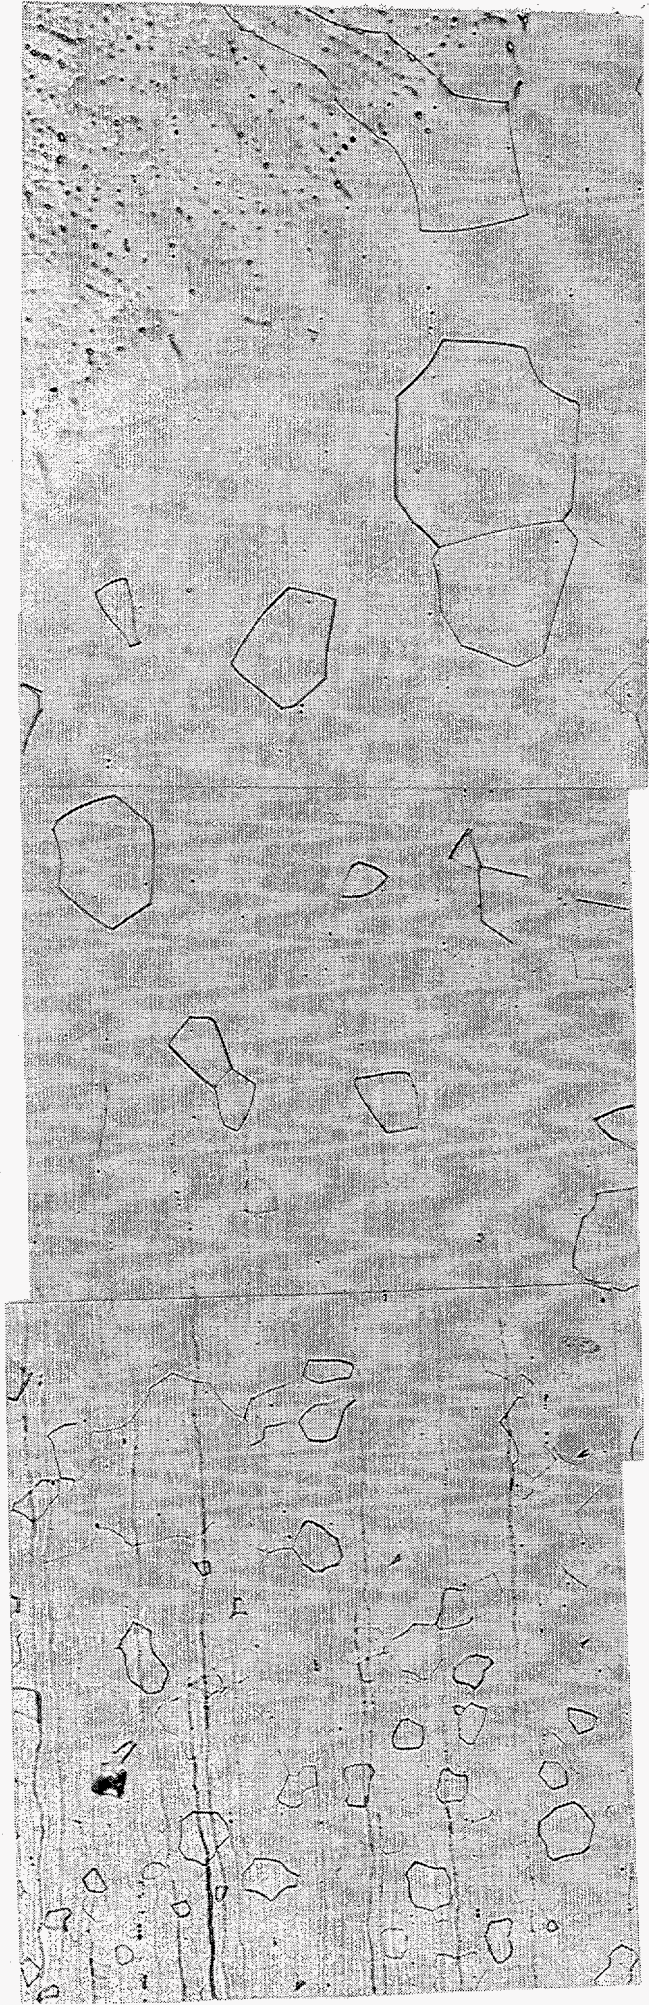
Fig. 4. Photomicrographs at half-thickness made across the weld shown in the previous figure; 100x.

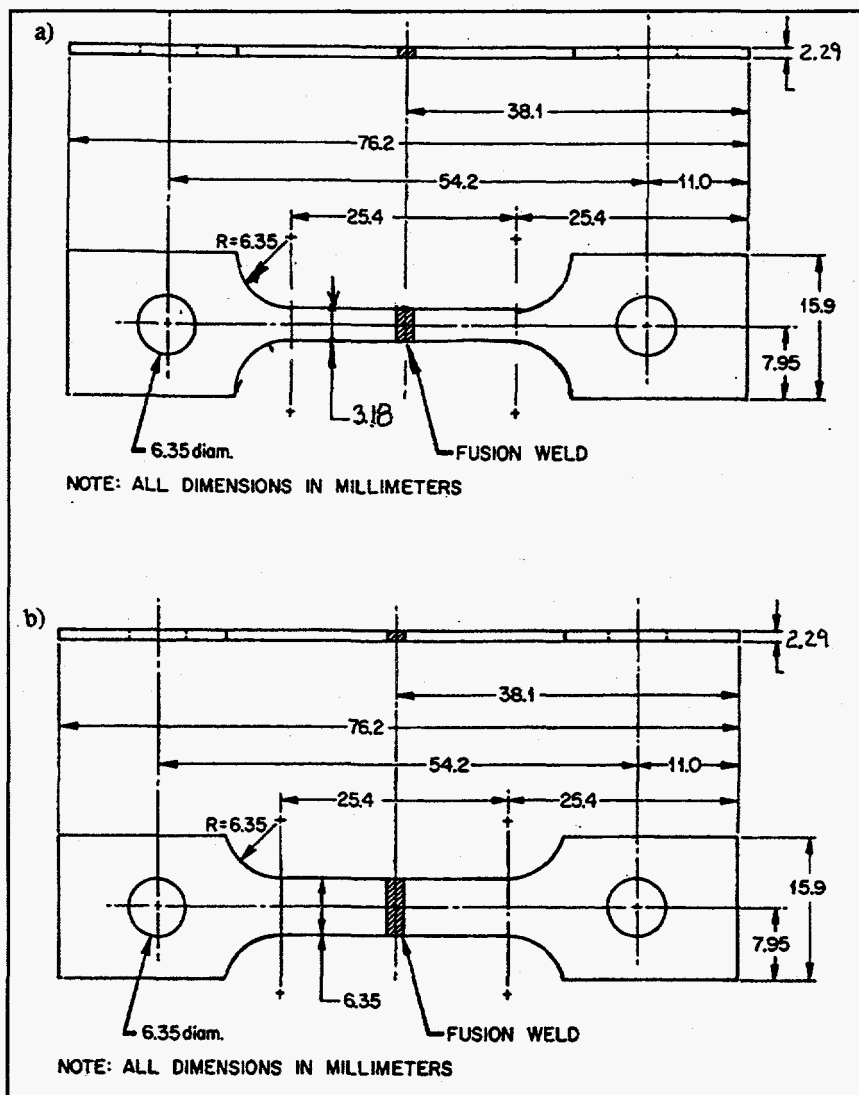
**Fig. 7. Sketches of transverse weld tensile and creep samples:**  
 (a) Sample C which has a gage width of 3.18 mm or 0.125 in. and  
 (b) sample D which has a gage width of 6.35 mm or 0.250 in.

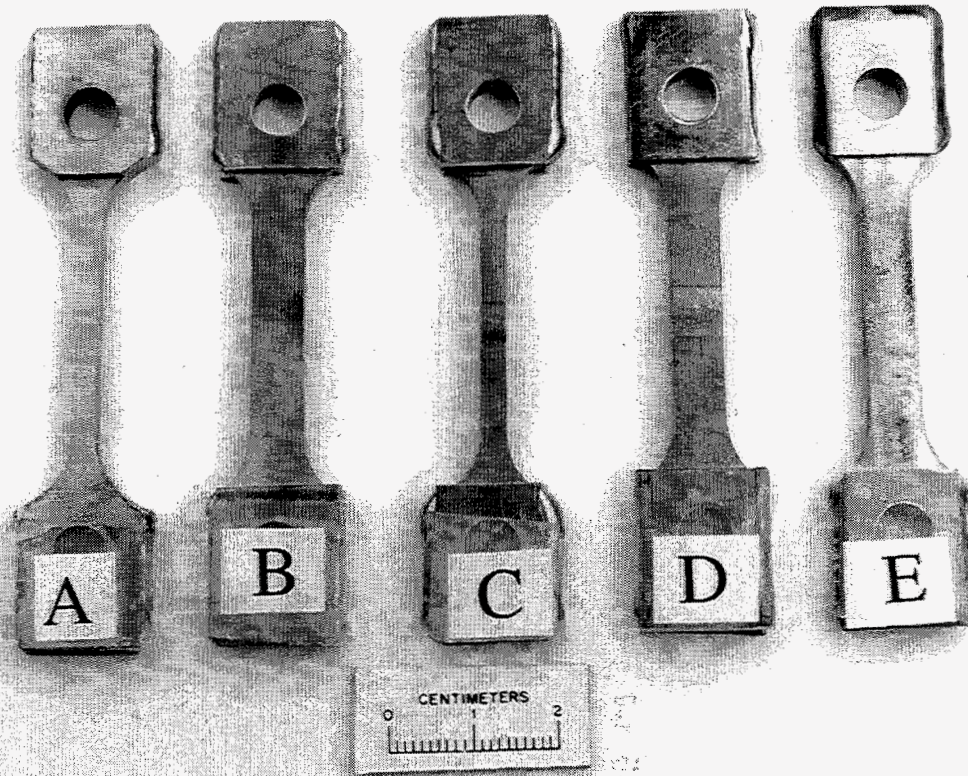
Fig. 9. Photograph of the five types of specimens used in the mechanical testing.

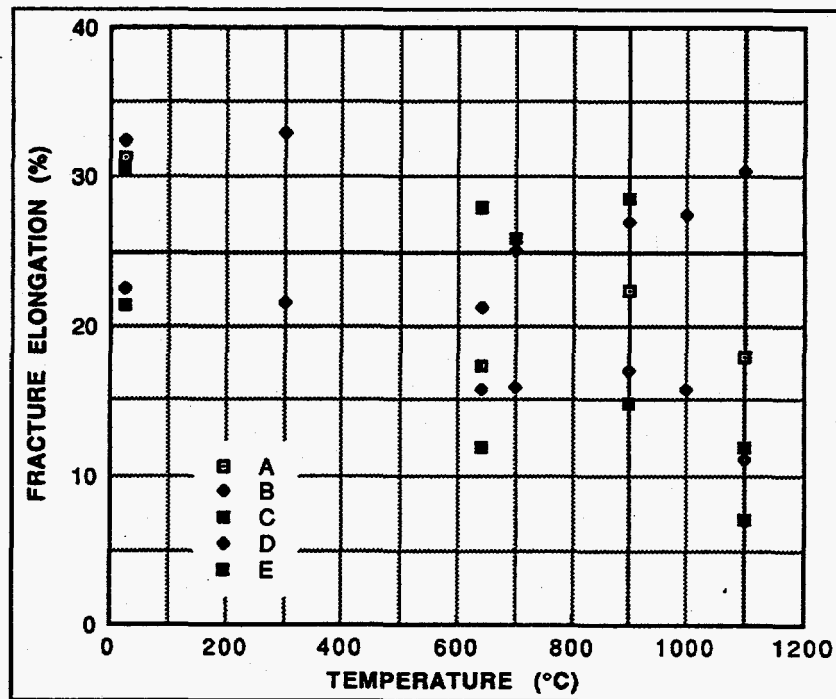
Fig. 13. Comparison of fracture strains of five specimen types as a function of temperature.

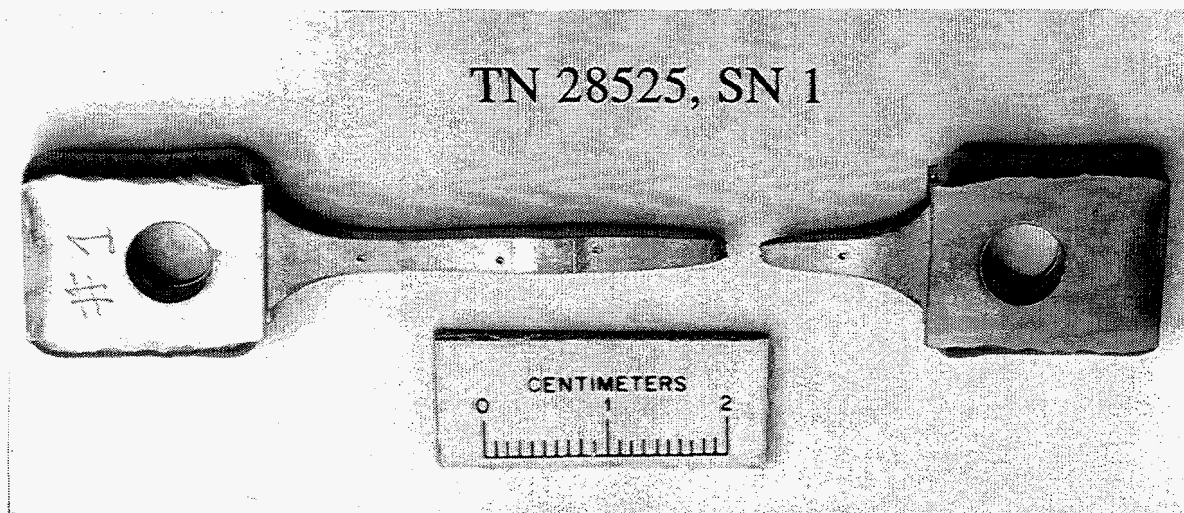
**Fig. 14. Photograph of sample 1 from test 28525.** The sample failed in the base metal. The sample is necked down in the base metal on the end opposite from the fracture, and the weld metal in the center crept very little.

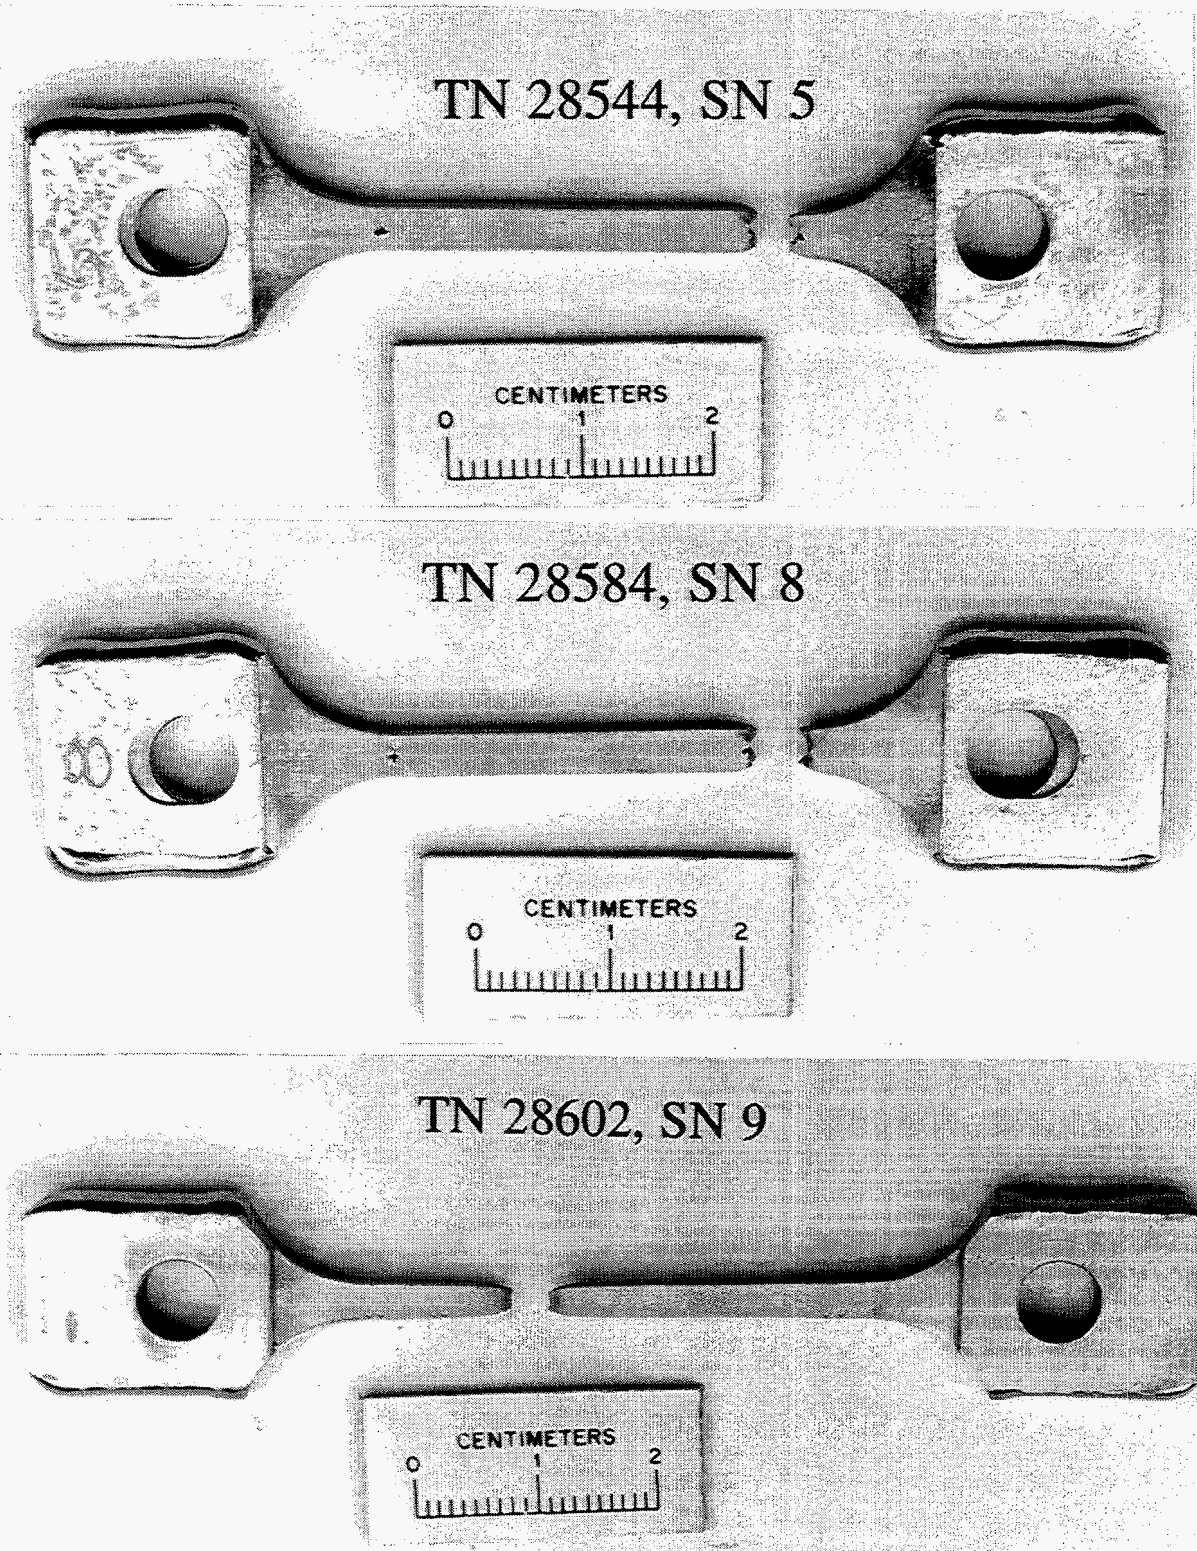
Fig. 15. After-test photographs of the base-metal samples from tests 28544 and 28584 that failed at fiduciary marks, and the sample from test 28602 that did not have fiduciary marks and failed in the gage section.

The problem associated with failure in base metal of creep-rupture samples at laser-machined fiduciary marks was discussed previously when the creep data in Table 4 were presented. One of the fractures was examined in the scanning electron microscope, and typical micrographs are shown in Fig. 39. The laser made a hole 0.0826 mm (0.00325 in.) in diameter as it entered the T-111 and a hole 0.222 mm (0.00875 in.) in diameter as it exited. Using the average of these two diameters, the cross-sectional area was reduced about 5% by the laser hole. Our previous experience has been with a 0.0762 mm (0.003 in.) in diameter hole in a specimen twice as wide as the present specimen, which would reduce the section by 1.2%. Thus failure at the present laser fiduciary marks is likely due to the specimen being narrower and the average diameter of the hole being larger than normal. The hardness impressions that were used successfully in these specimens were very shallow and did not reduce the section appreciably.

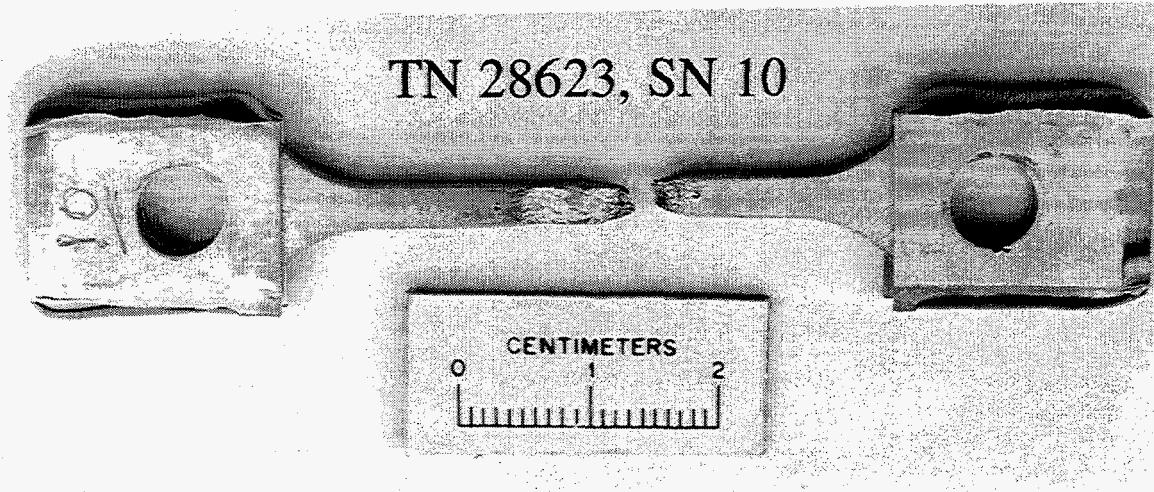
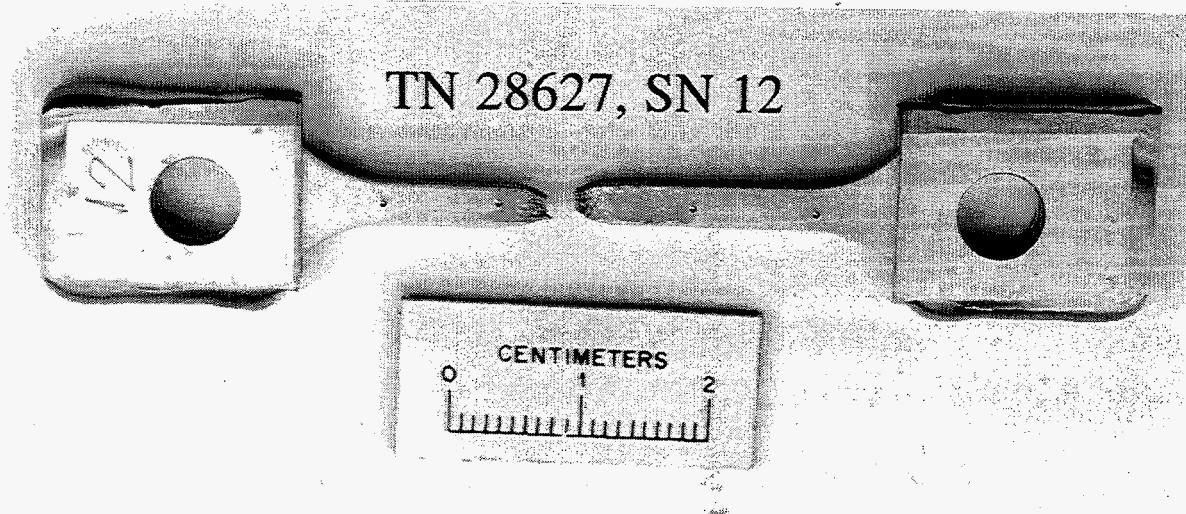
**Fig. 16 After-test photographs of transverse weld samples from tests 28623 and 28627 that failed in the heat-affected zone.**

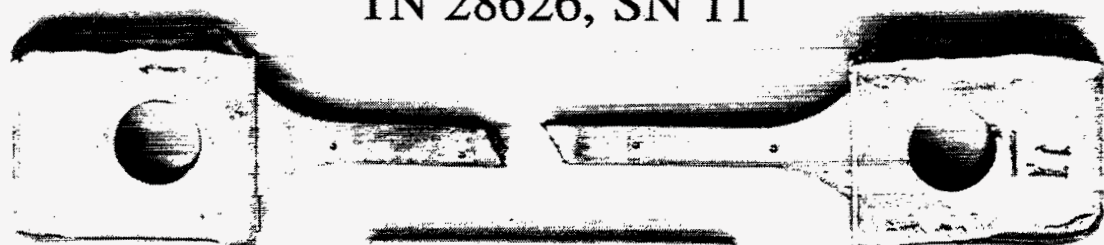
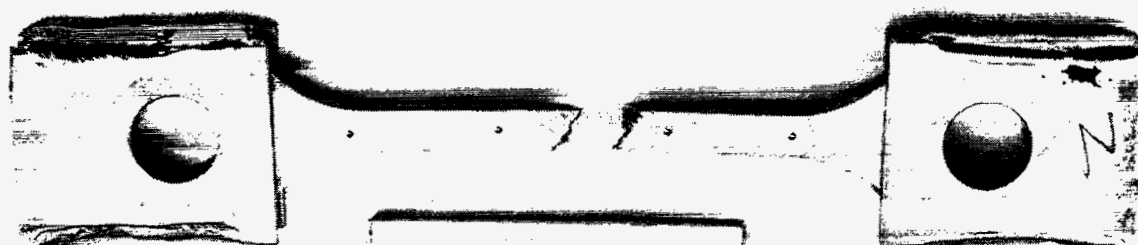
Fig. 17. After-test photographs of transverse welds from several tests that failed in the weld or heat-affected zone.

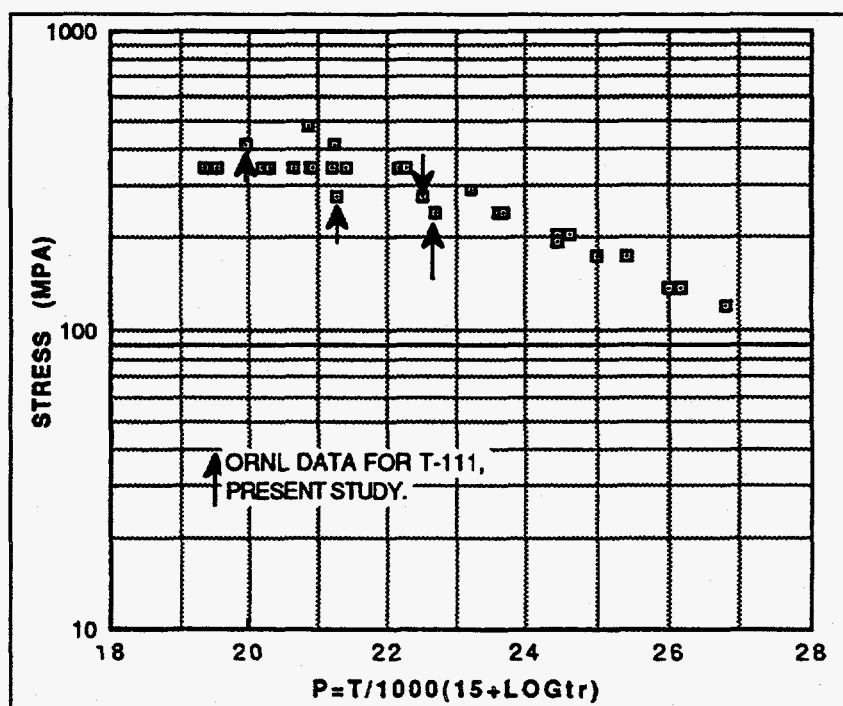
Fig. 18. Larson-Miller plot of selected rupture data for T-111-type alloys.

The various minimum creep rates measured from the tests in Table 4 are summarized in Table 5. Minimum creep rates for the Ta-10%W and T-222 data from ORNL were given but were estimated for the TRW data using the reciprocal of the time to 1% creep strain. Figure 19 shows a plot of the time to rupture as a function of the minimum creep rate (Monkman-Grant Correlation, ref. 4) for the same tests shown in Fig. 18. Although the data appear to split into two lines in Fig. 19, a detailed examination of each point revealed that the scatter is random with respect to the data set. The four points from the present work tend to fall on the lower side (shorter rupture time) of the data.

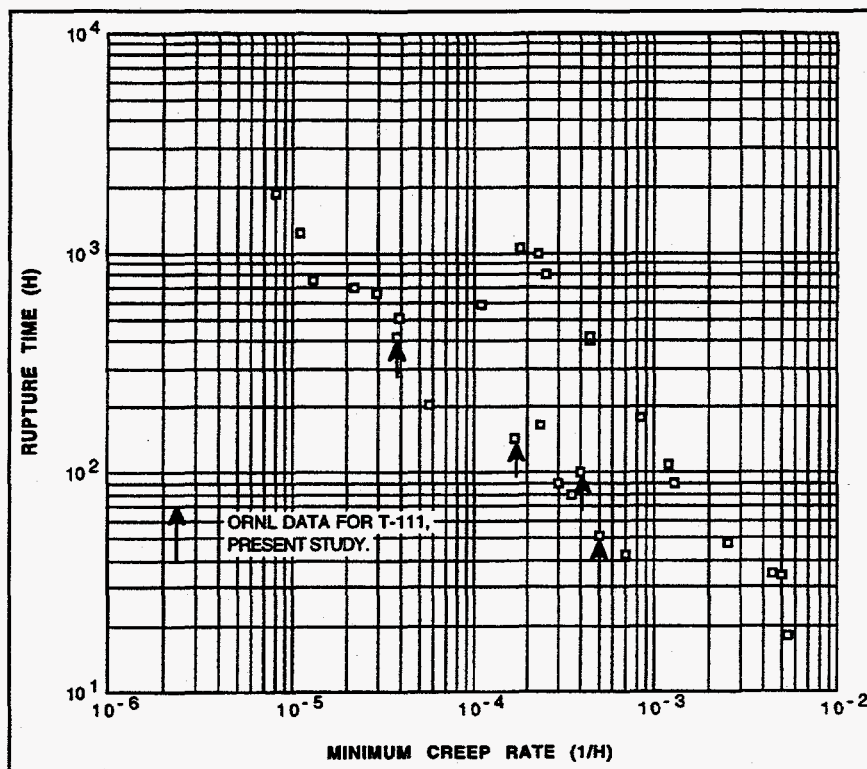
Fig. 19. Monkman-Grant plots for several T-111-type alloys.

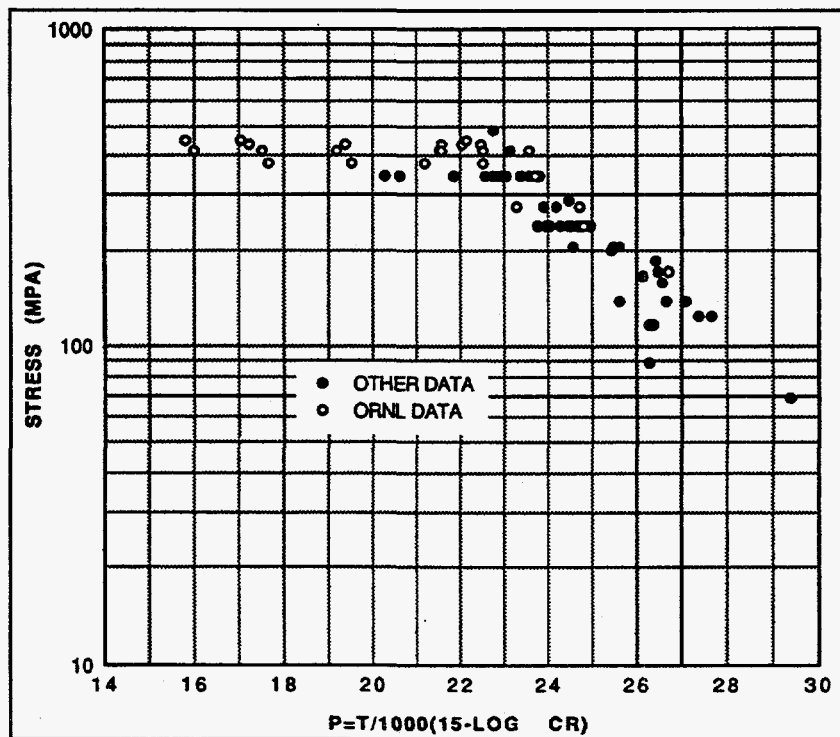
Fig. 20. Larson-Miller plot based on strain rate including all points.

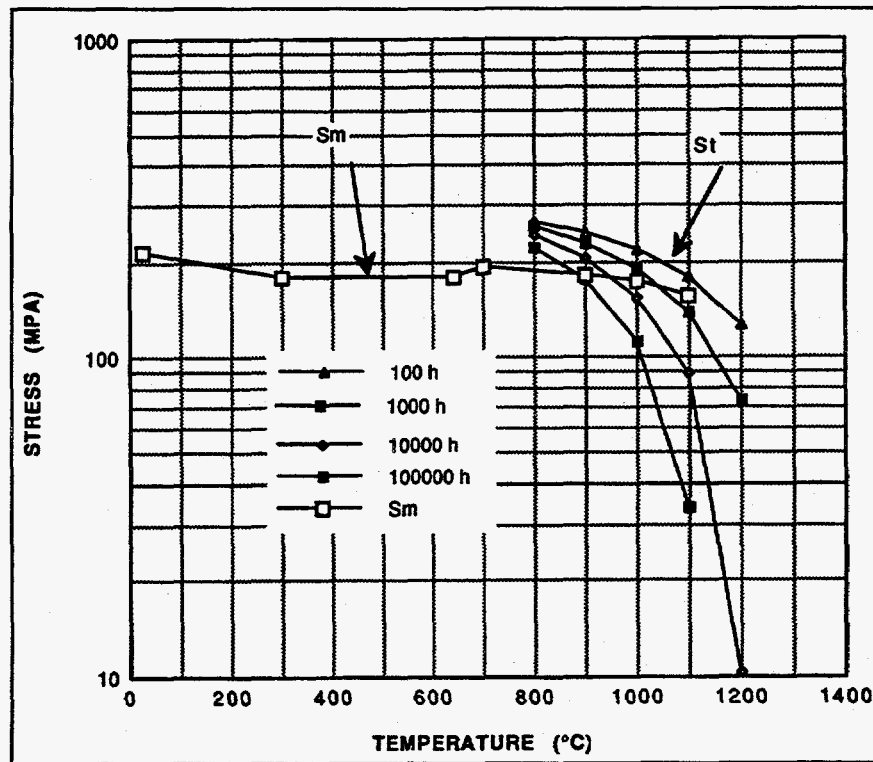
Fig. 22(b). Plot of  $S_m$  and  $S_t$  for T-111 based on American Society of Mechanical Engineers boiler and pressure vessel approach used for Code Case N-47.

An alternate method of determining a design stress was used by the ASME *Boiler and Pressure Vessel Code* in their Code Case N-47. The detailed rules for this method are given in Appendix A of Section III of the ASME *Boiler and Pressure Vessel Code*. Although we do not have sufficient data for T-111 to apply this method rigorously, there are sufficient data to illustrate the methodology. The approach defines a stress intensity,  $S_m$ , as a function of temperature based on time-independent tensile properties. (The Code uses a term called stress intensity or equivalent intensity of combined stresses. It is defined as twice the maximum shear stress on a component and is equal to the largest algebraic difference between any two of the principal stresses obtained by the maximum shear stress theory.) Various creep parameters are used to estimate time-dependent stress intensities,  $S_c$ , as a function of temperature for various service lives. The design stress intensity,  $S_{mb}$ , is the lower of  $S_m$  and  $S_c$ . Some of the data for T-111 was used to develop the design stress intensity plot shown in Fig. 22(b) which is based largely upon the rules of Code Case N-47. The design stress intensity is controlled by the time-independent tensile properties from 25 to 900°C where creep becomes a factor and begins to control the design stress. Below 900°C, the plot in Fig. 22(b) suggests that  $S_m$  values as obtained from tensile test data determine the allowable stress intensity for T-111. The ratio of 900°C to the melting temperature of 2982°C (based on homologous temperatures) is 0.36. This is a very common homologous temperature above which creep has been noted to be significant for numerous other alloys. However, no additional data were used in the Code approach than in the previous analysis, so the results are subject to the same uncertainties, viz., no long-term creep-rupture data, particularly at the temperatures of interest for the IHS.

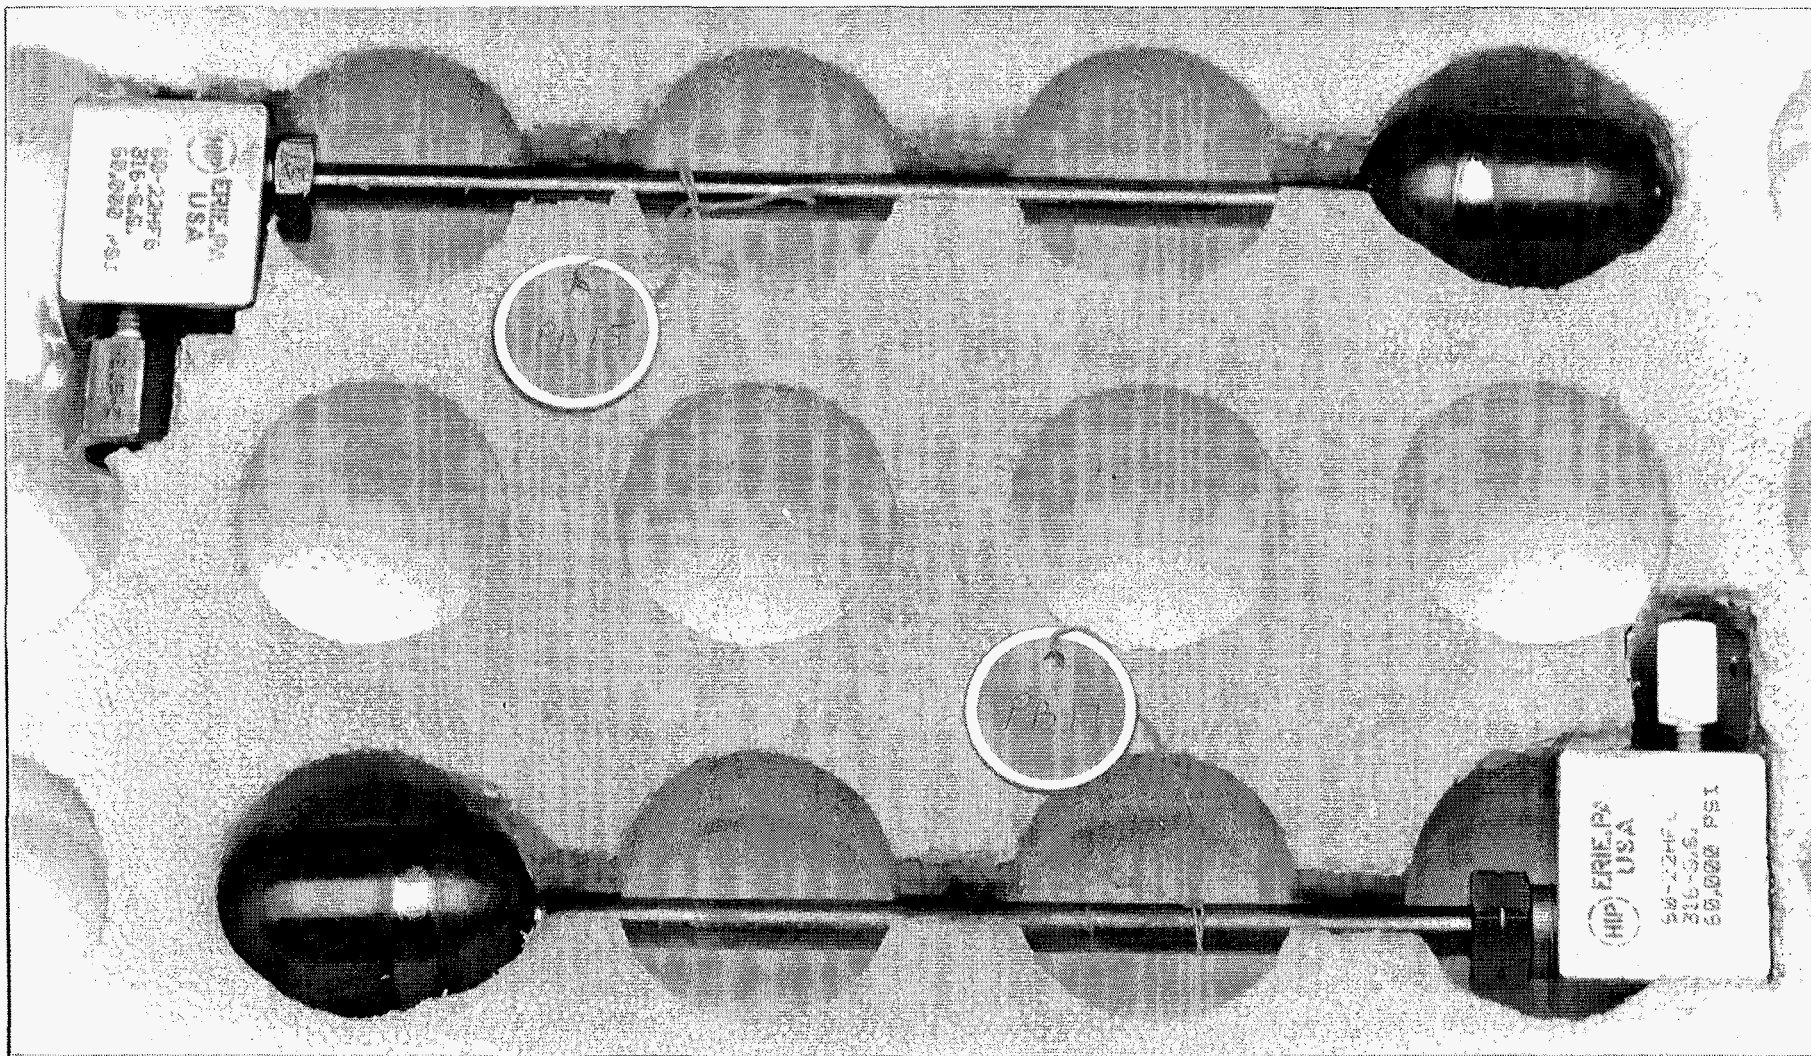
Fig. 23. Photograph of the two capsules received from EG&G Mound Applied Technologies for testing. For scaling purposes, the capsules are approximately 400 mm (1.6 in.) in diameter  $\times$  64 mm (2.5 in.) long. Each capsule has an extension tube of a tantalum-based alloy and a stainless steel compression fitting to make the transition to a stainless steel pressurization tube. The background material is Styrofoam.

One change was made in the as-received condition of the capsules shown in Fig. 23. Originally, the capsules had a short segment of Ta-10%W tubing leading to a stainless steel compression fitting. In similar tests at Mound, stainless steel line was run from the compression fitting to the pressure source. Since the compression fitting would be heated in our system to about 300 to 500°C, the difference in thermal expansion between stainless steel and Ta-10%W would likely cause leakage of the high-pressure gas to the vacuum inside the chamber (giving a false indication that the capsule had failed). Therefore, the Ta-10%W tubing was cut near the stainless steel fitting, and approximately 305 mm (12 in.) of T-111 tubing was welded to the Ta-10%W tubing. The weld was made by the GTA process in a glove box, and tantalum filler

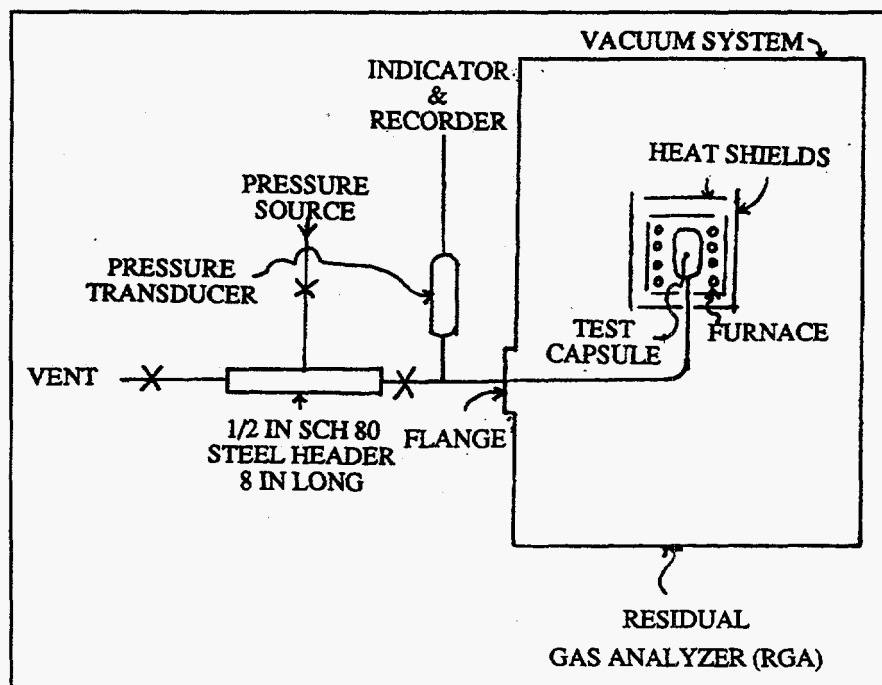
Fig. 24. Sketch of test set-up.

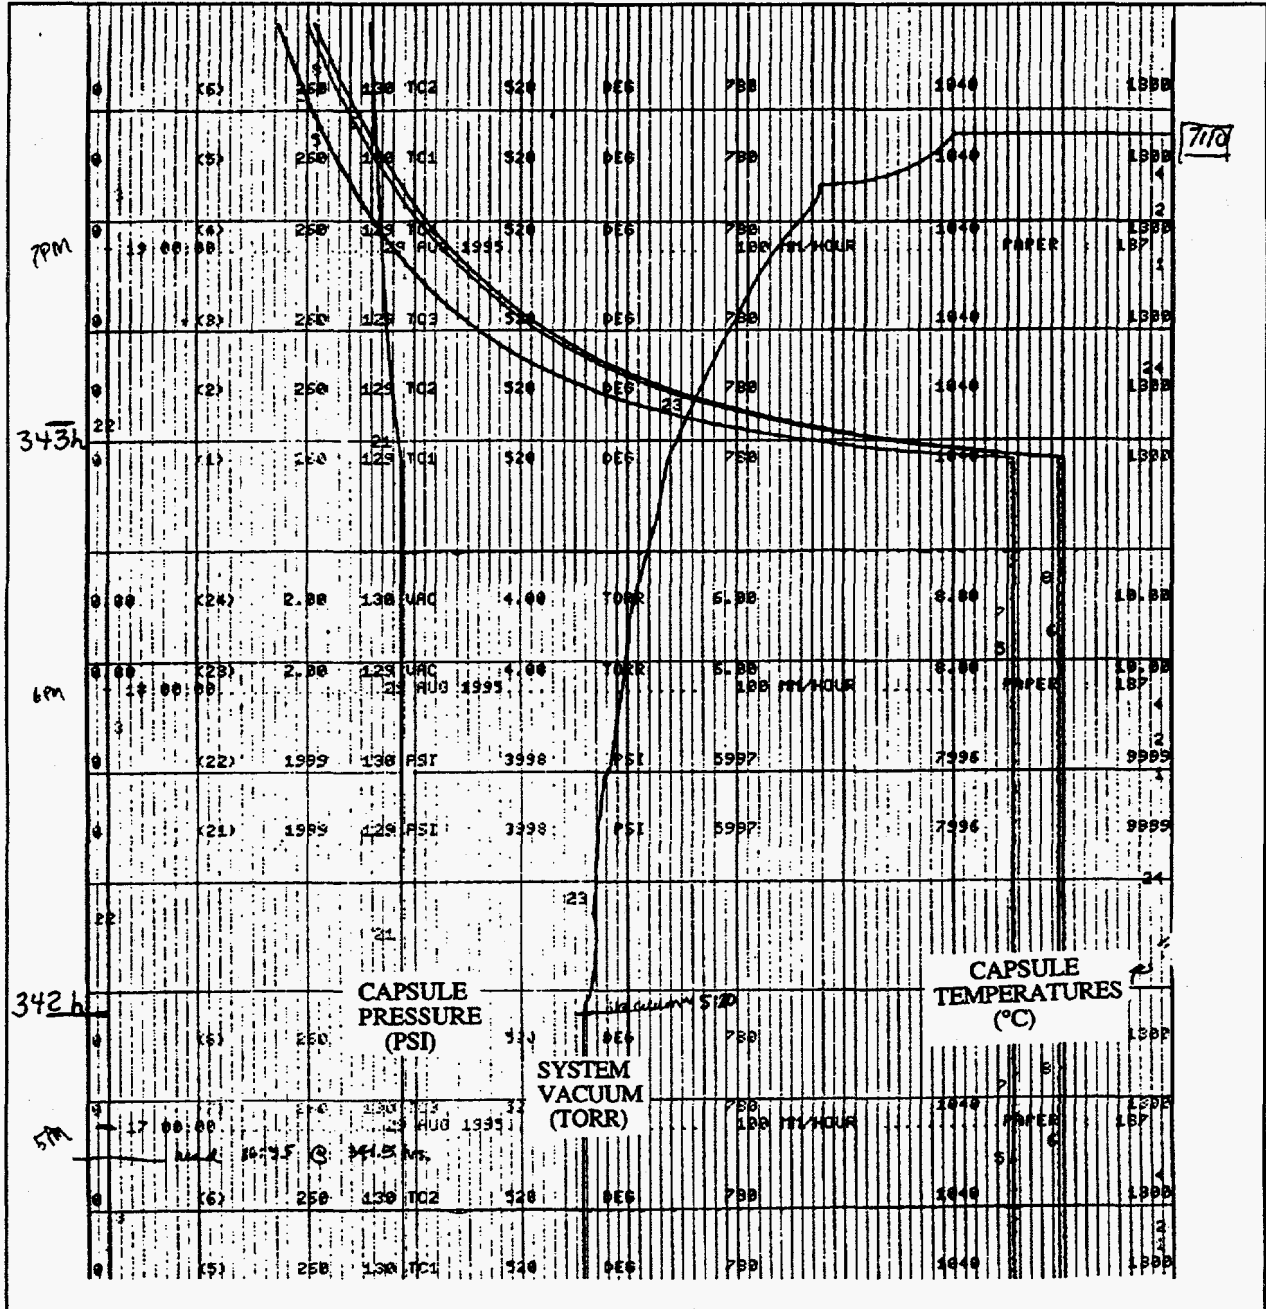
Fig. 25. Section of recorder chart showing failure of capsule 18.

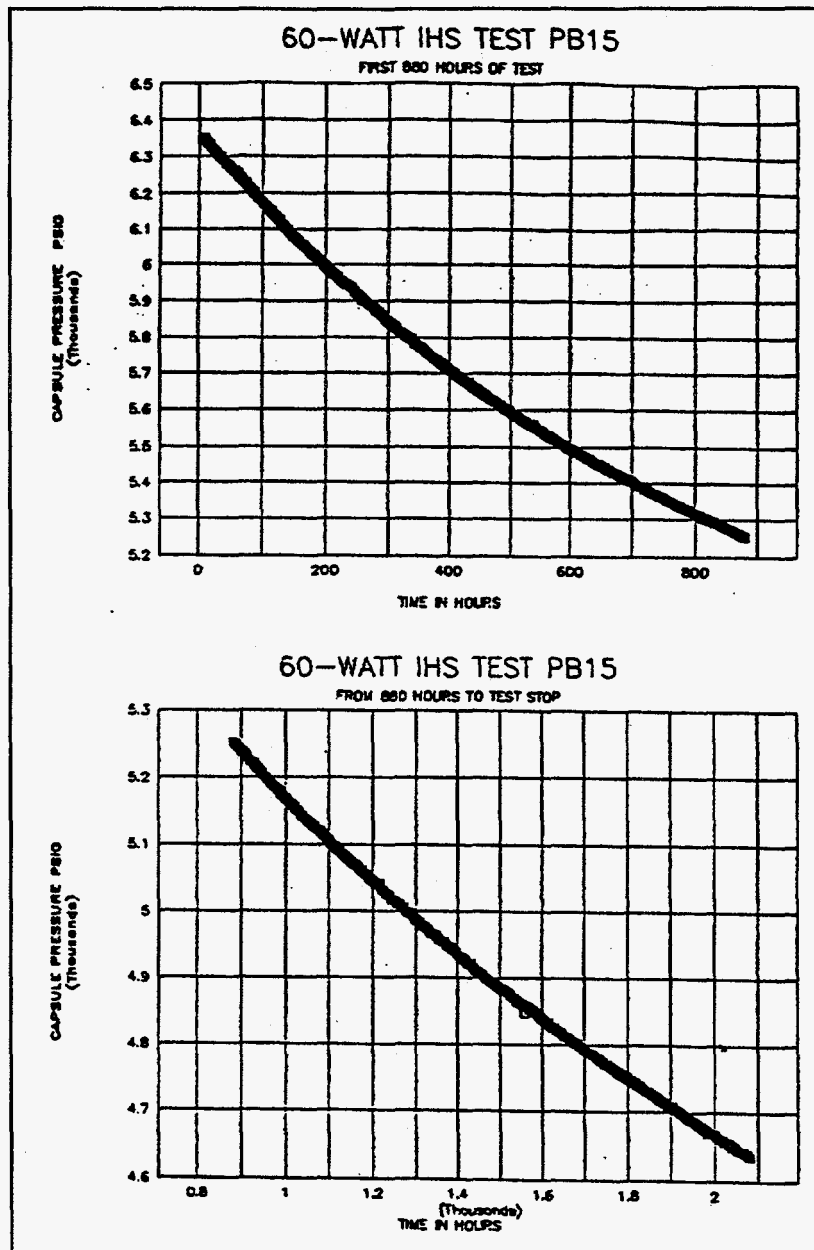
Fig. 26. The pressure history of capsule 15 while in test at Mound. These data were taken in pounds per square inch (psi) units. Multiply psi times 0.006894 to convert to MPa.

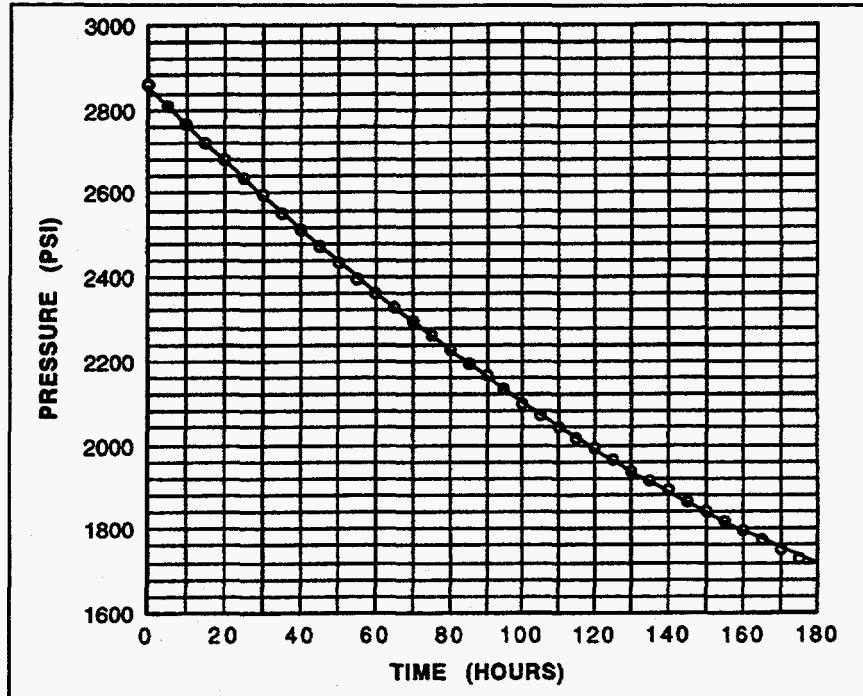
Fig. 27. Pressure reduction in failed capsule 18. Measured at 25°C, using argon in a system with volume of 59 cc.

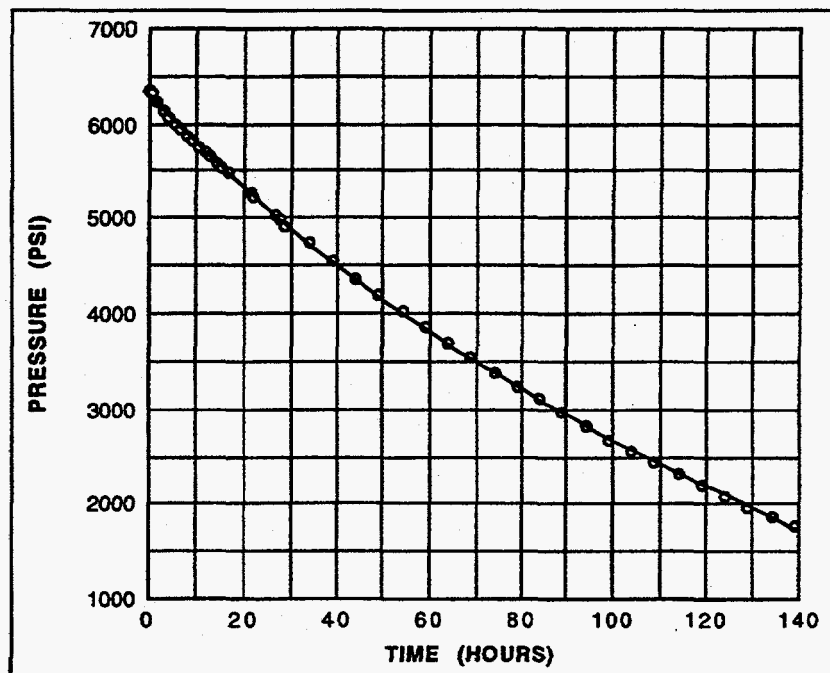
Fig. 28. Pressure reduction in failed capsule 15. Measured at 25°C, using argon in a system with volume of 59 cc.

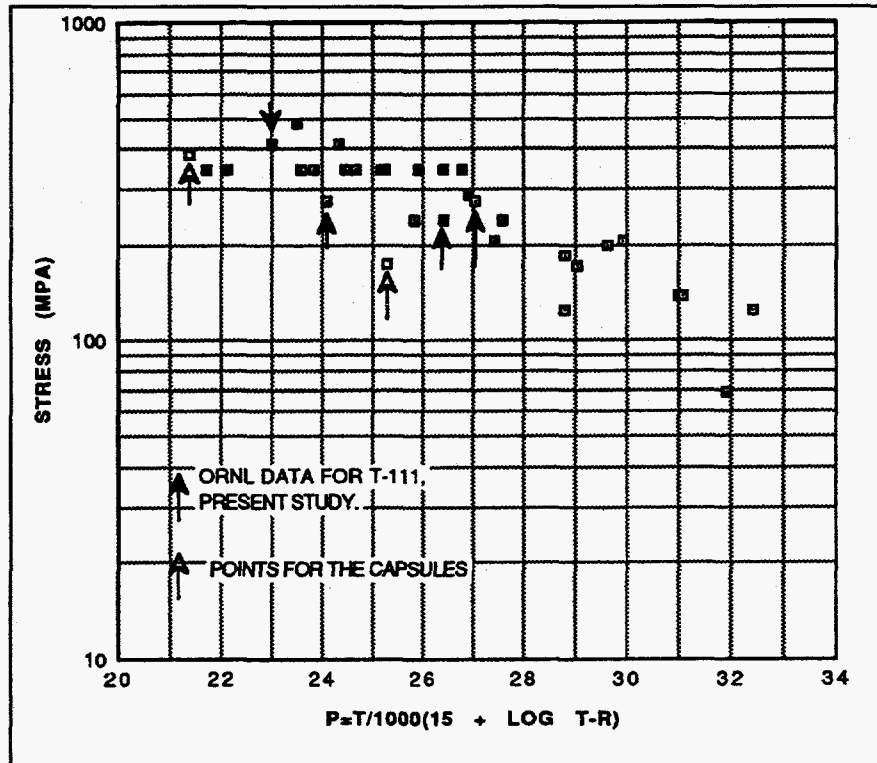
The two rupture points for the capsules agree well with the rest of the data, but the capsules tend to fall on the weak side of the data population. The agreement is good considering the numerous simplifying assumptions made.

Fig. 29. Larson-Miller plot of selected rupture data for T-111-type alloys with points superimposed for capsules.
