ORNL/TM-13265

THE MECHANICAL PROPERTIES OF T-111 AT LOW  
TO INTERMEDIATE TEMPERATURES

Metals and Ceramics Division

H. E. McCoy and J. R. DiStefano

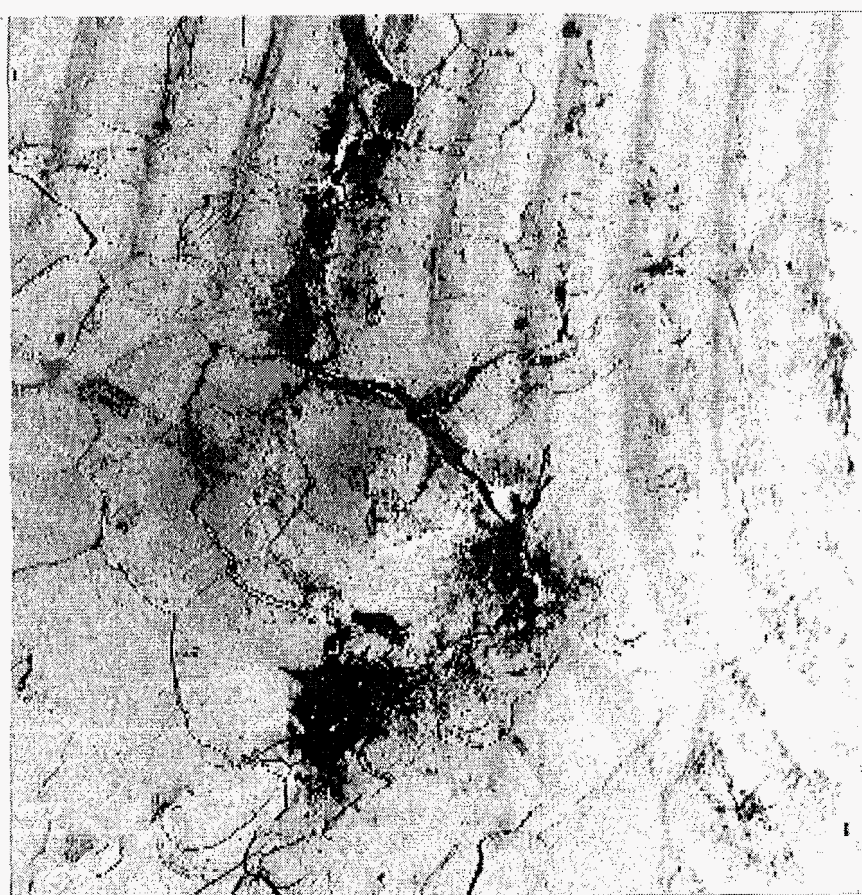
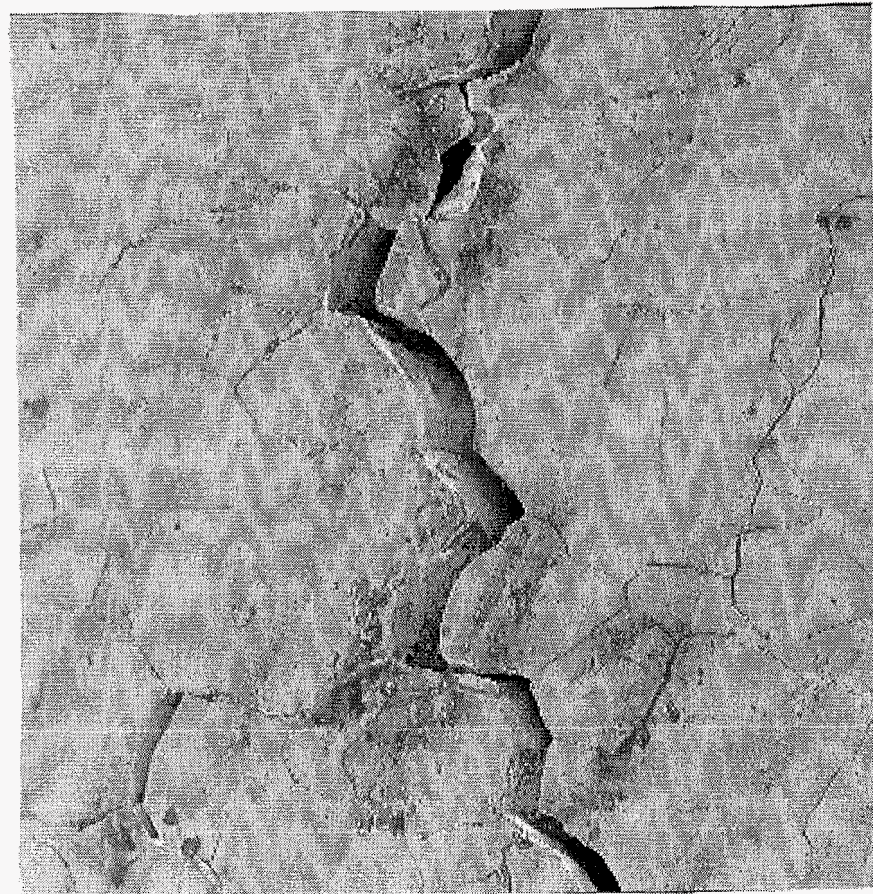
**Fig. 30. Scanning electron micrographs of the failure from the outside surface of capsule 18: (a) 50 $\times$  (ET05405), Outside of weld showing weld arc oscillations and cracks located along the grain boundaries. The dark regions are largely contamination around the cracks. (b) 100 $\times$  (ET05407), View of one of the cracks showing its intergranular path.**

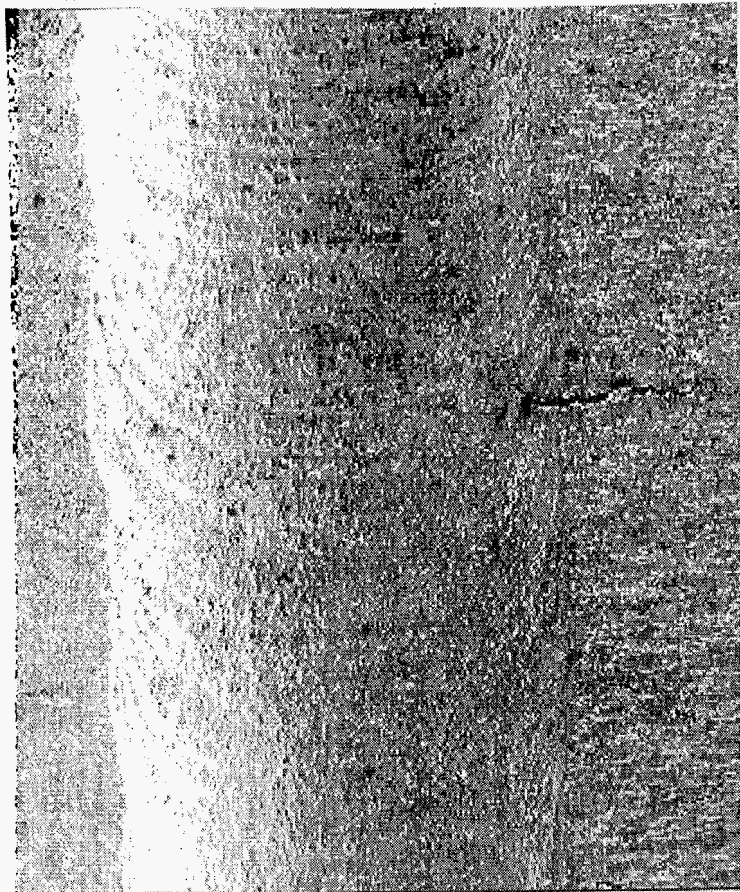
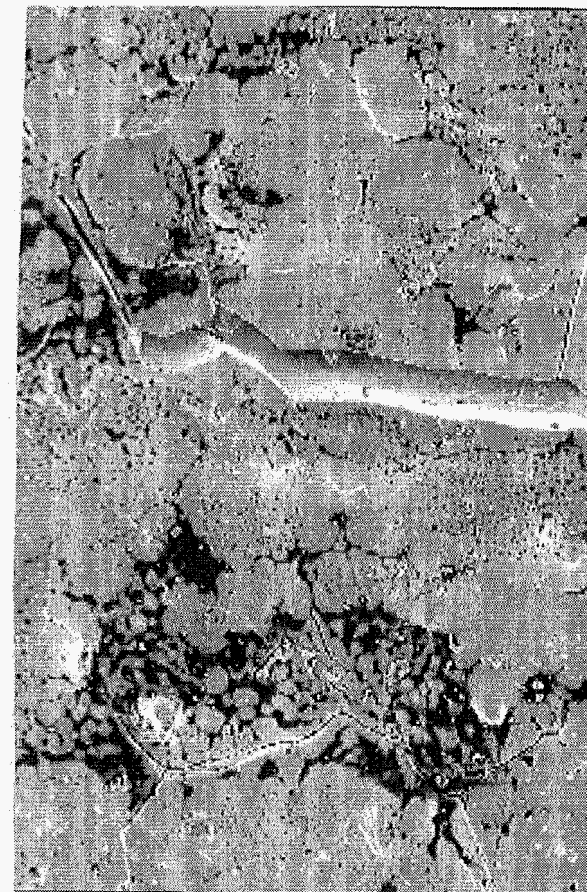
The inside (root) of the girth weld where the failure in PB 18 occurred is shown in Fig. 31. The large crack in Fig. 31(a) passes through both the weld metal and the HAZ. The other electron micrographs in Fig. 31 show considerable debris on the inside surface and some grain boundary grooving associated with the high temperature during welding. Another place on the inside surface of capsule 18 was cracked,

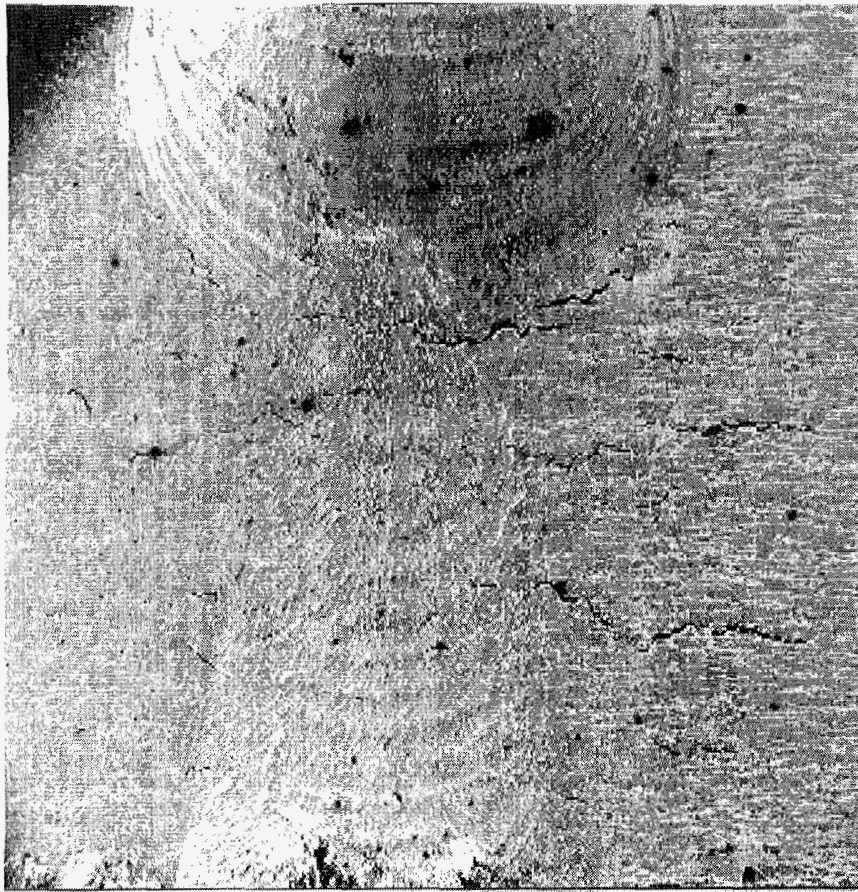
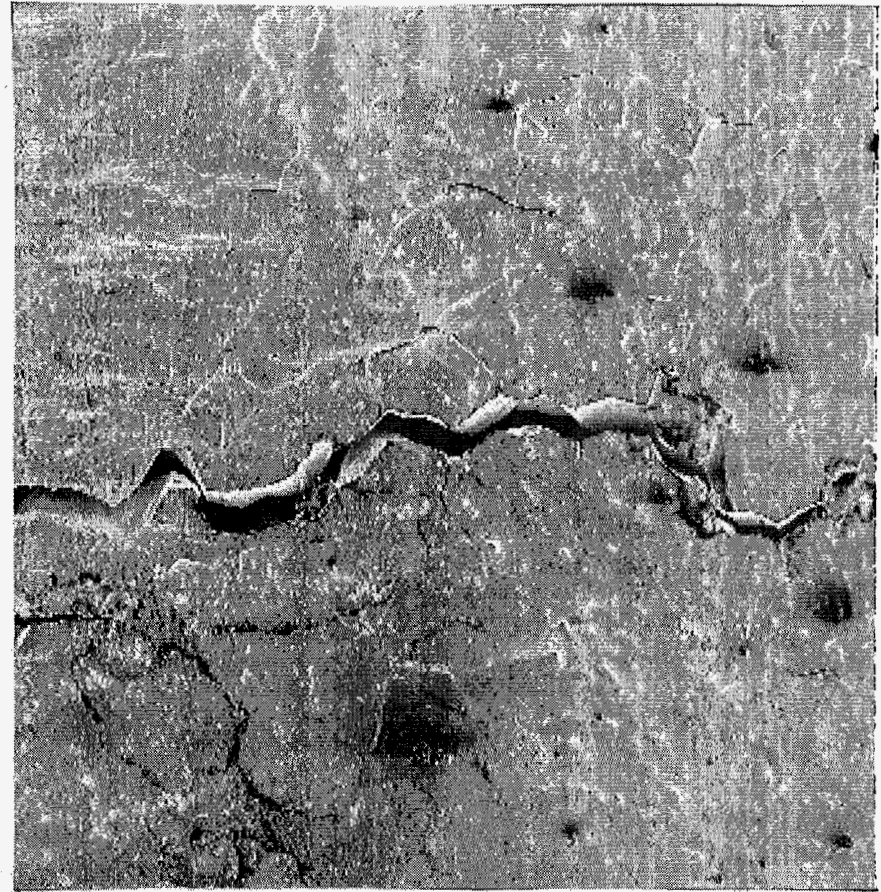
**Fig. 32. Scanning electron micrographs of a cracked region on the inside surface of capsule 18 near the failure location:** (a) 20× (ET05411), Root of weld showing weld arc oscillations, perturbation in weld arc travel, and cracks. (b) 100× (ET05412), View of the intergranular cracks.

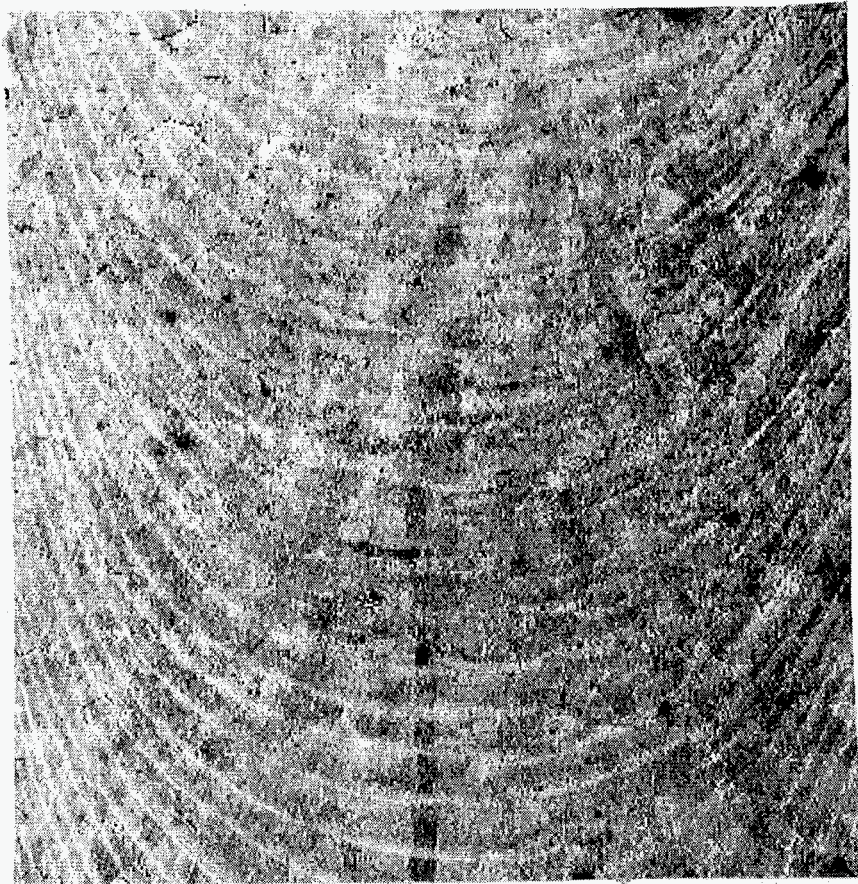
**Fig. 33. Scanning electron micrographs of a sound region in the outside surface of capsule 18: (a) 20× (ET05414), Top of weld showing arc oscillations. (b) 100× (ET05415), View of top of weld showing large grains and some fine surface debris.**

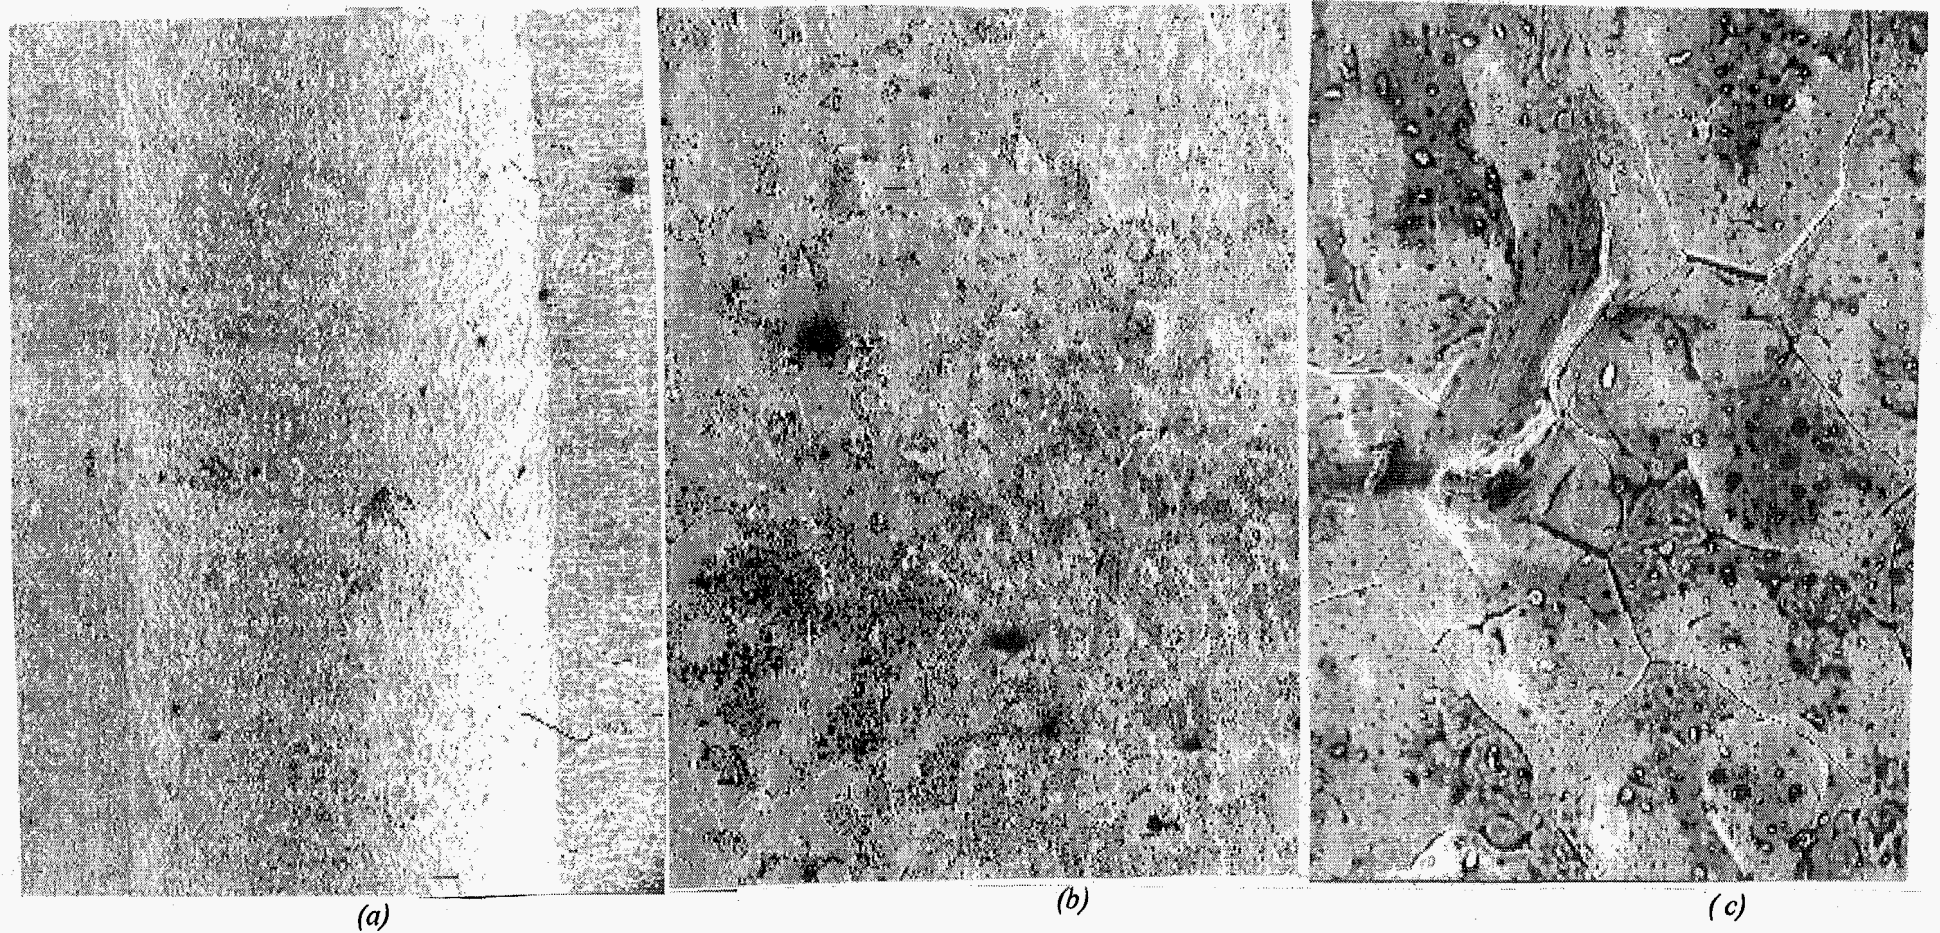
**Fig. 34. Scanning electron micrographs of a sound region on the inside (root) surface of capsule 18: (a) 20 $\times$  (ET05417), Bottom of weld showing arc oscillations. (b) 100 $\times$  (ET05419), View of bottom of weld showing some fine surface debris. (c) 500 $\times$  (ET05417), View of bottom of weld showing grain boundary grooving and debris.**

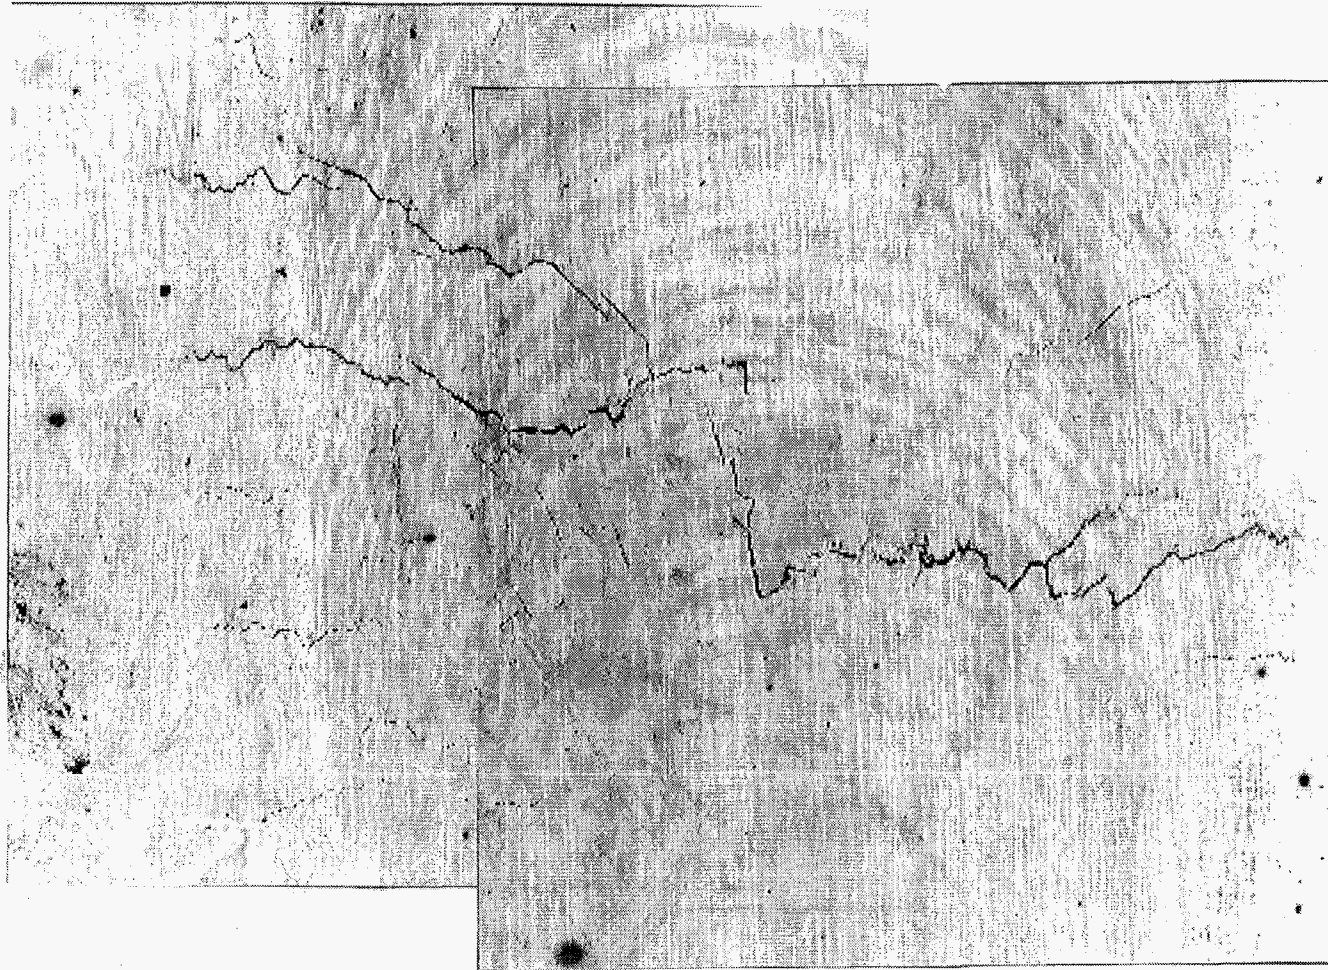
**Fig. 35. Scanning electron micrographs of the top (outside) of capsule 15 showing extensive branching and intergranular nature of cracks. 20× (ET05426, 7).**

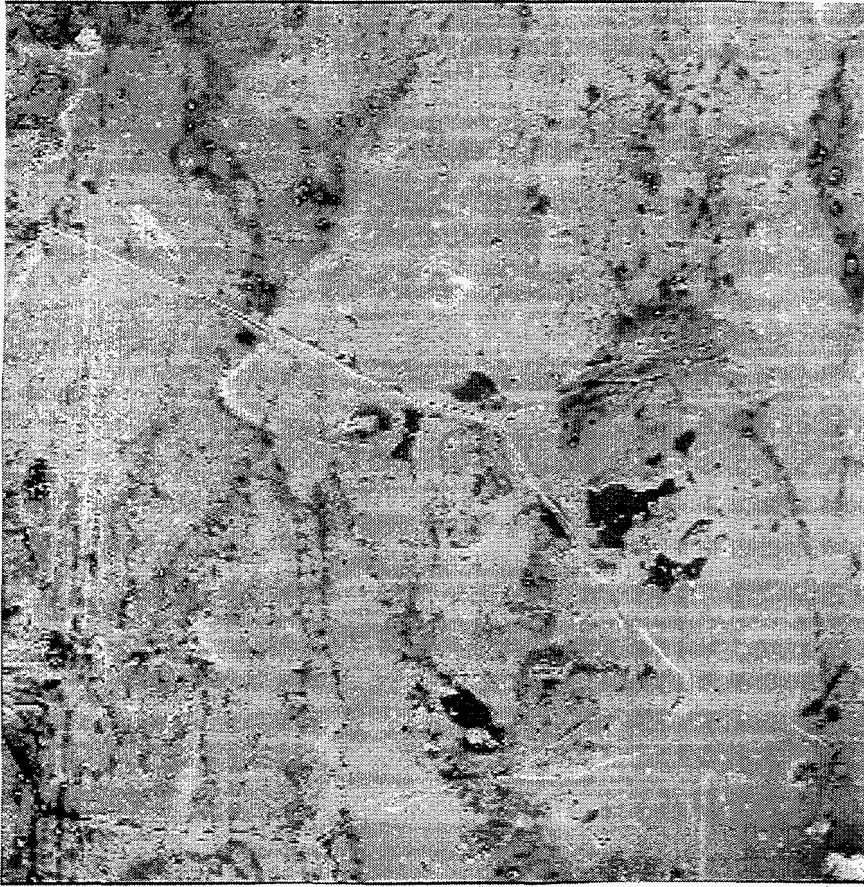
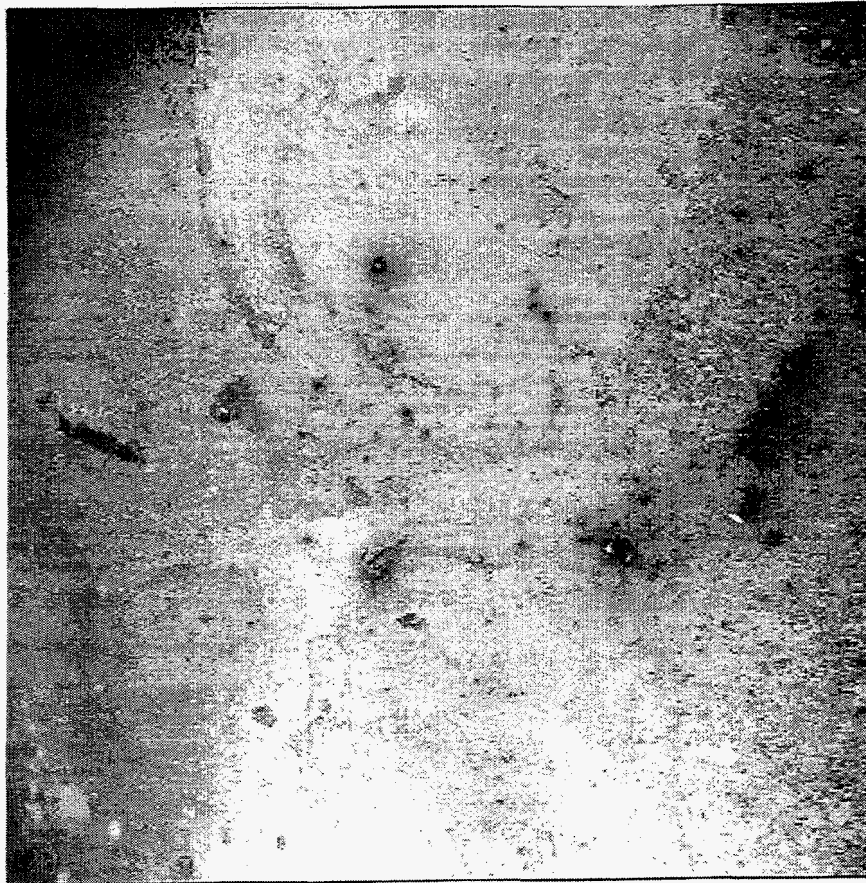
**Fig. 36. Scanning electron micrographs of the root (inside) of capsule 15 under the failure shown in Fig. 35: (a) 20 $\times$  (ET05430) and (b) 500 $\times$  (ET05432) show surface debris.**

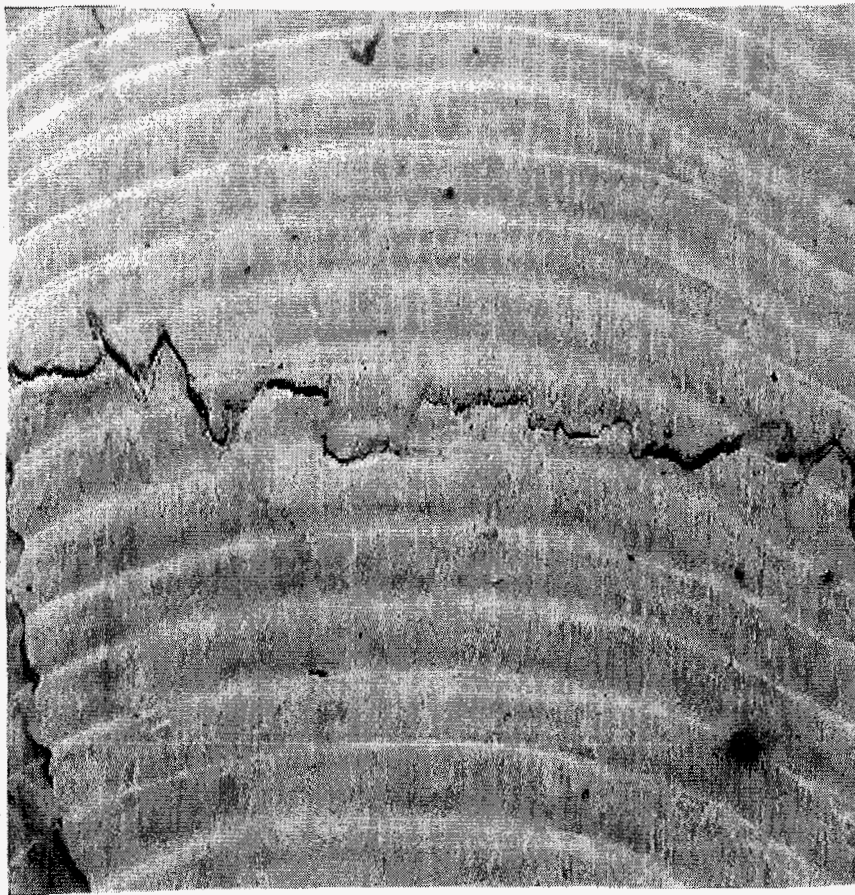
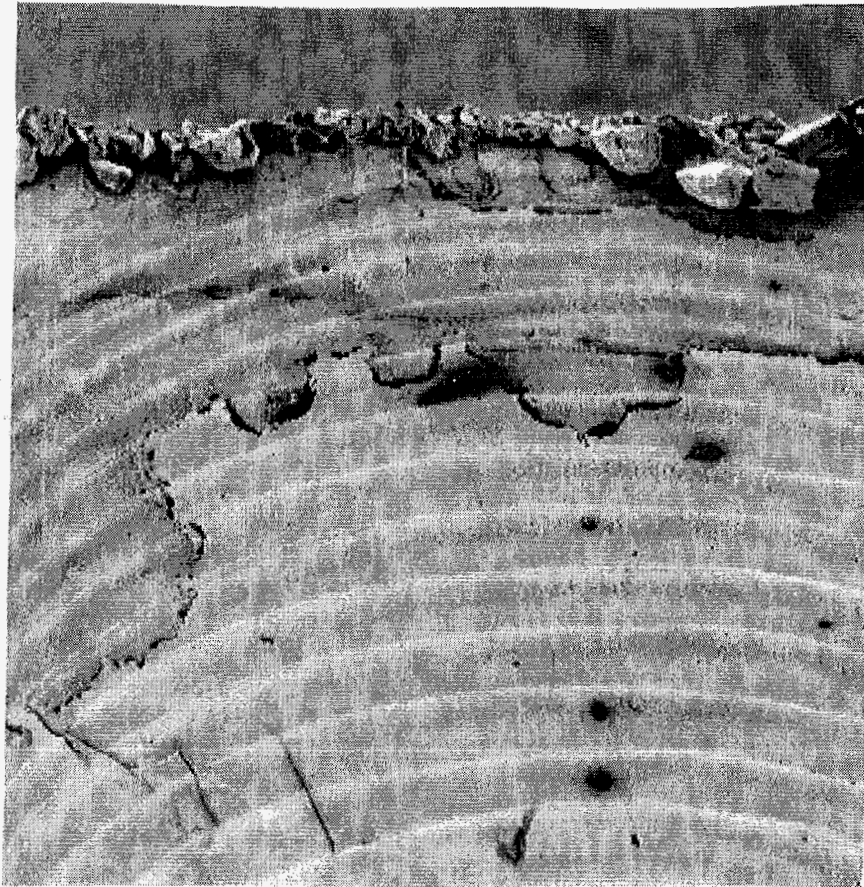
**Fig. 37. Scanning electron micrographs of the top (outside) of capsule 15 approximately 180° from the failure shown in Fig. 35: (a) 40× (ET05435) and (b) 40× (ET05436) show arc oscillation patterns and intergranular cracks.**

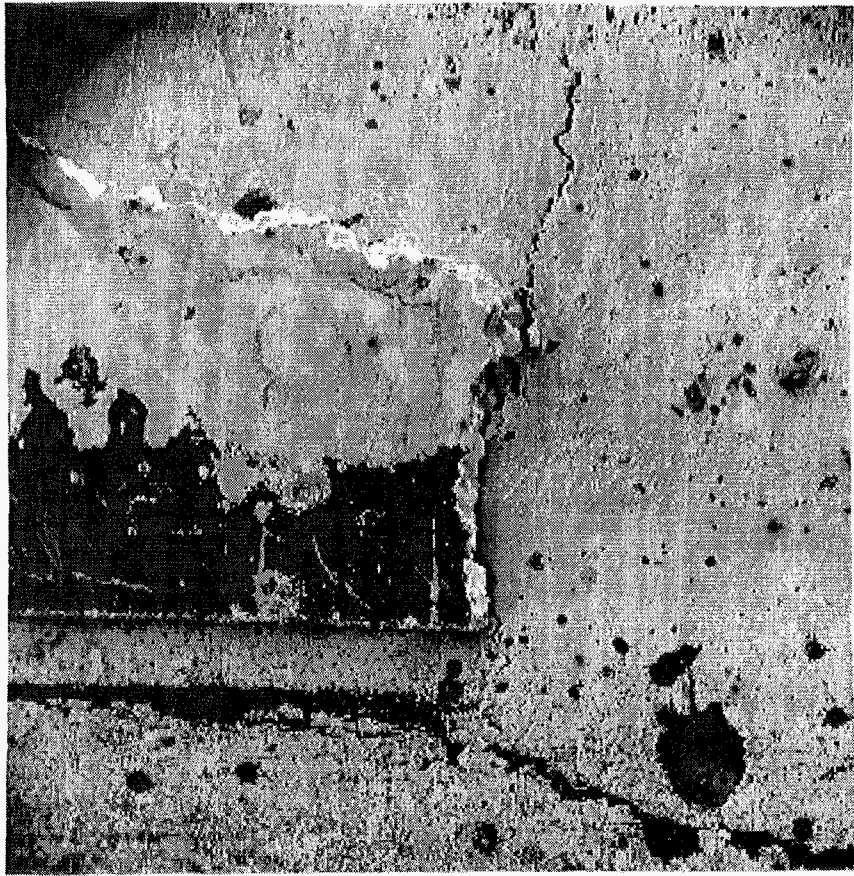
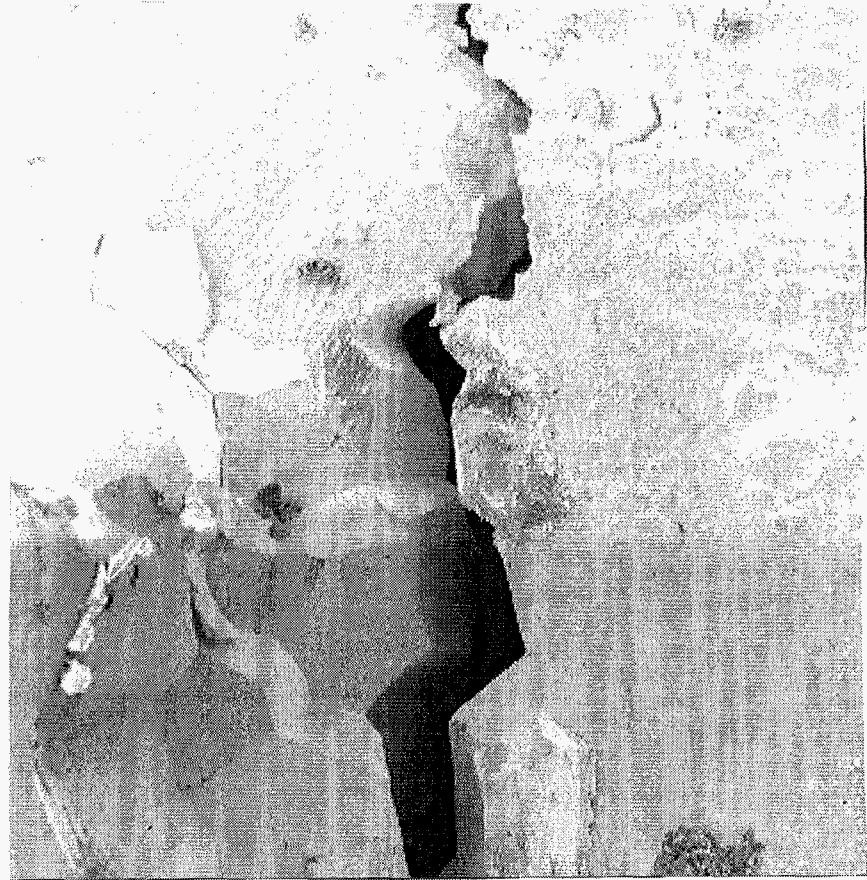
**Fig. 38. Scanning electron micrographs of the root (inside) of capsule 15 under the cracks shown in Fig. 37: (a) 20 $\times$  (ET05433) Shows cracks and a portion of back-up ring. (b) 200 $\times$  (ET05434) Shows intergranular cracks.**

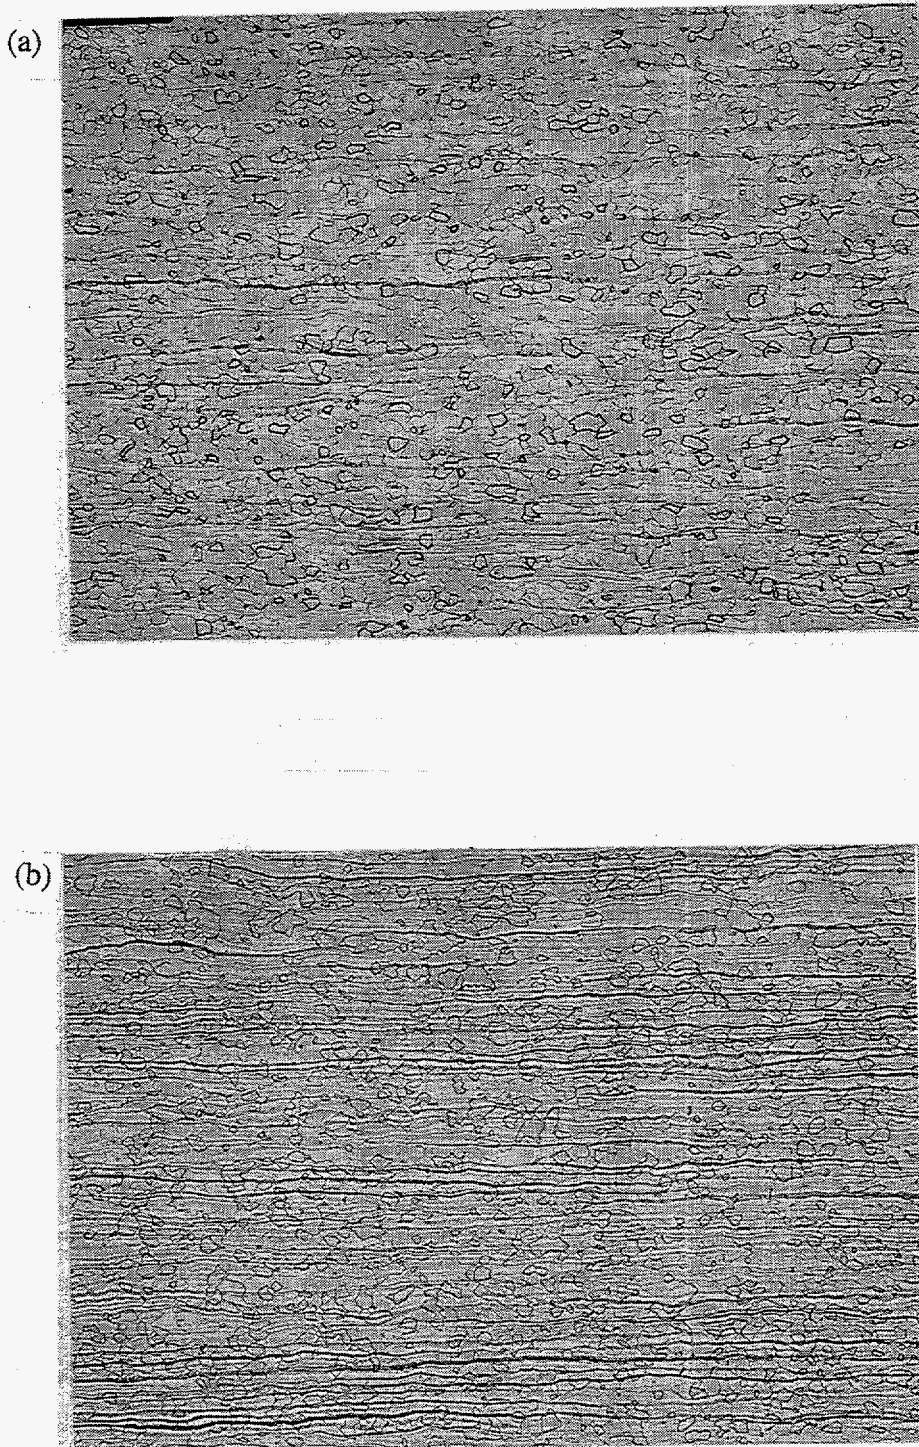
**Fig. 40. Photomicrograph of the T-111 sheet used in this study. Etched. 100 $\times$ . (a) Transverse and (b) longitudinal.**

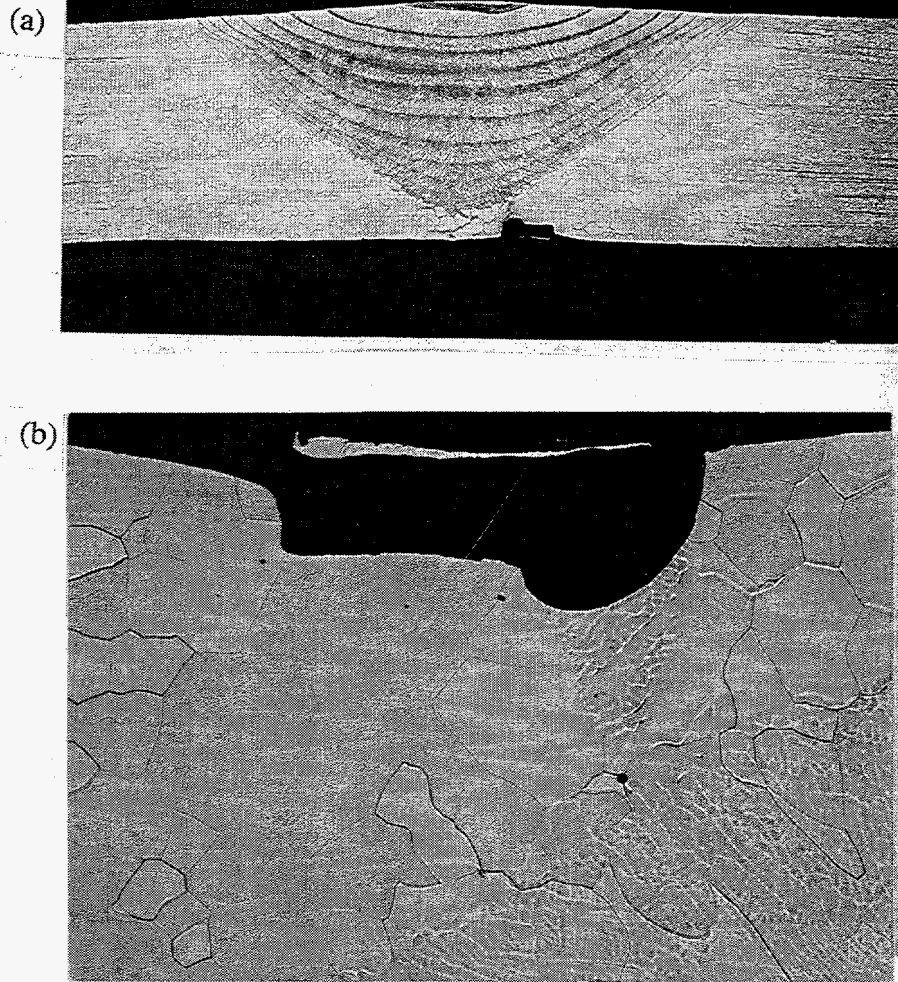
**Fig. 41. Photomicrographs of the T-111 weld made by Mound and designated CB-2. Etched. (a) 12.8 $\times$ , Transverse section of weld and (b) 100 $\times$ , defect present at the root of the weld.**

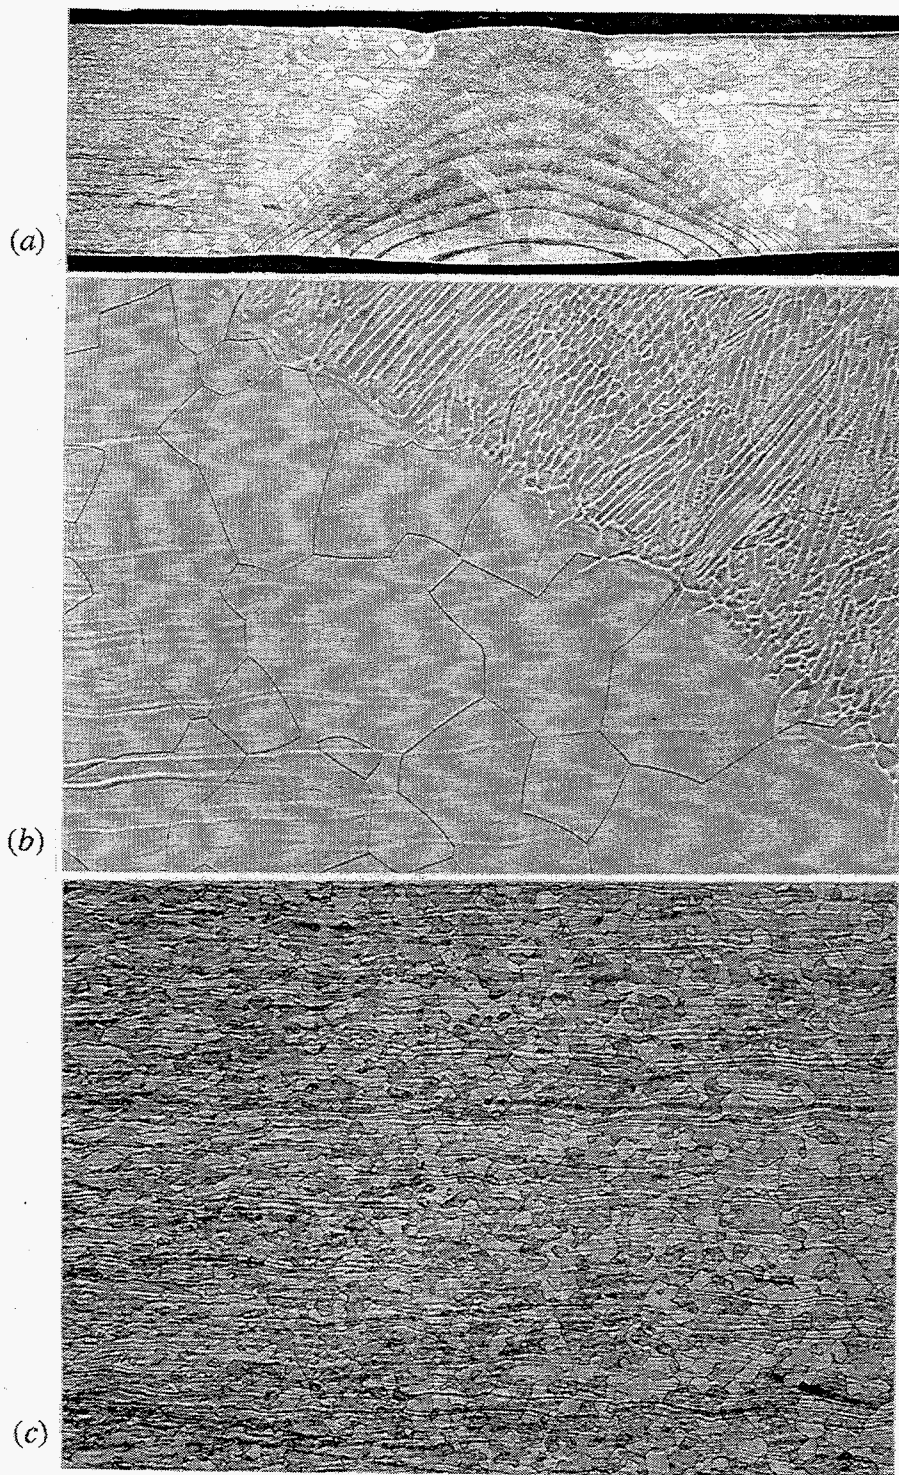
**Fig. 43. Photomicrographs of the T-111 weld made by Mound and designated CB-2, oriented approximately  $180^\circ$  from section shown in Fig. 41. Etched. (a) 12.8 $\times$ , Transverse section of weld; (b) 100 $\times$ , fusion line; and (c) 100 $\times$ , base metal.**

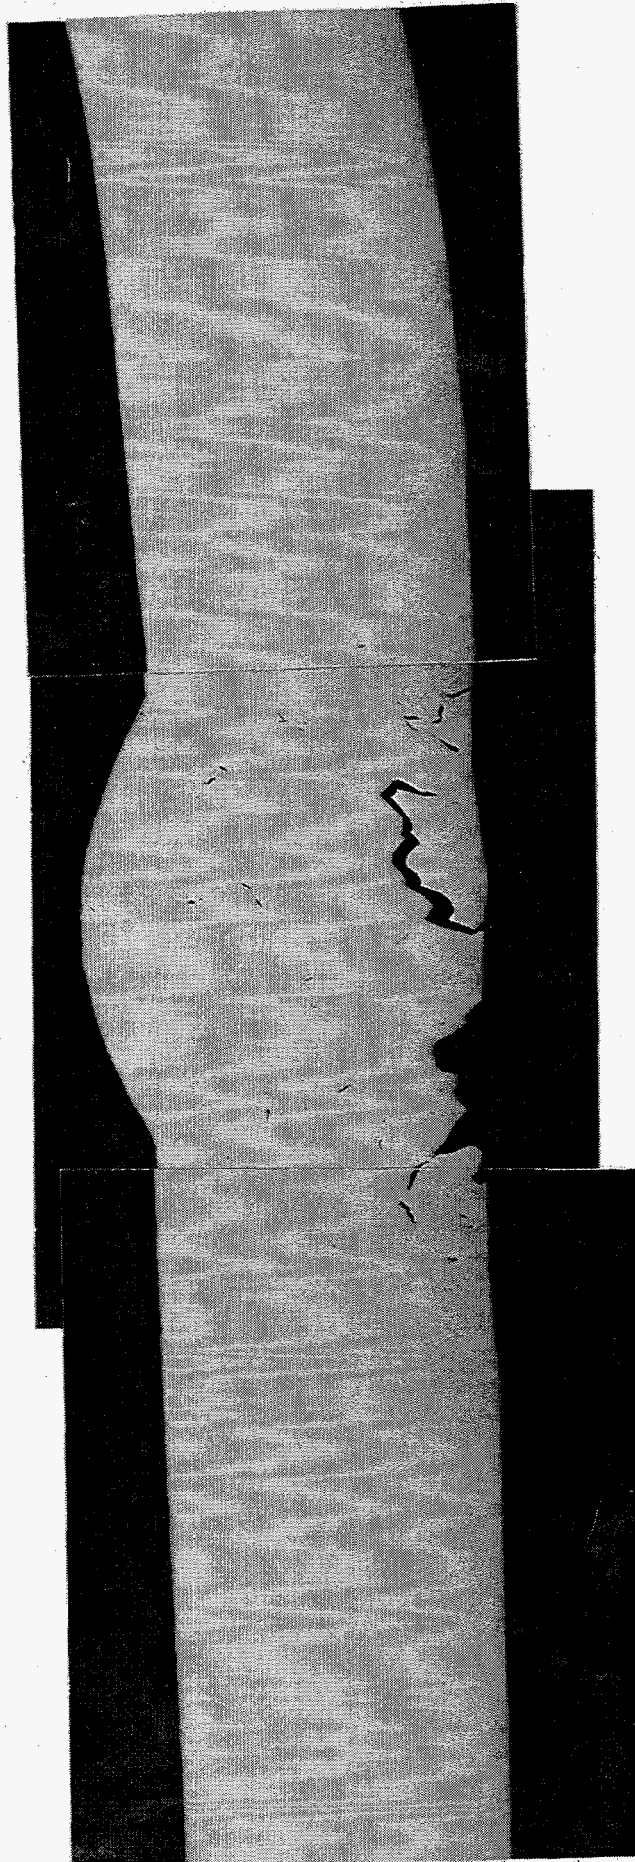
Fig. 47. Photomicrographs of a transverse section through the failure of capsule 18. Etched. 20 $\times$ .

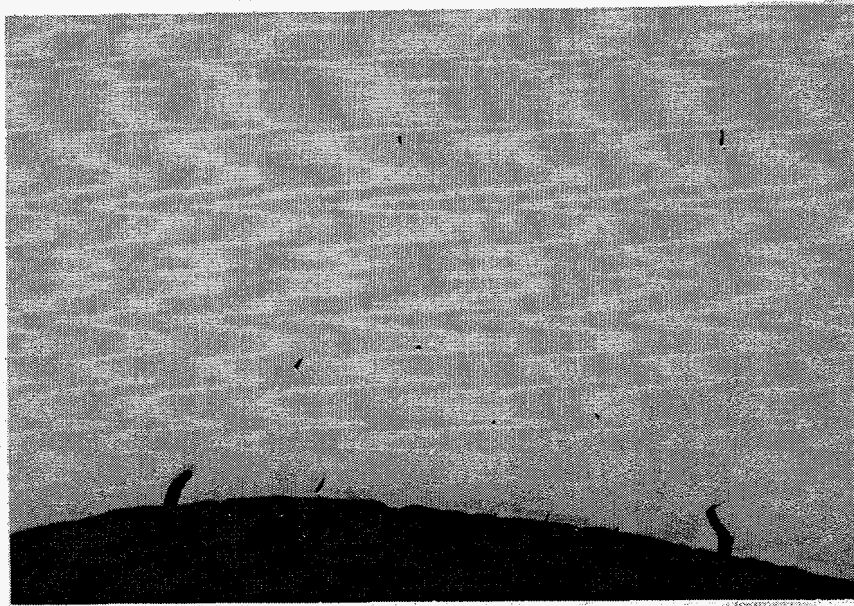
**Fig. 49. Photomicrograph of a longitudinal section through the failure of capsule 18. As-polished. 100 $\times$ .**

A longitudinal section of the failed region in capsule 18 is shown (unetched) in Fig. 49. Some cracks were visible on the root side of the weld. The sample was etched and the photomicrographs in Fig. 50 were made. There are some small cracks on the root side of the weld, but most of the cracks were not made visible in preparation. The oscillation pattern in the weld metal is quite visible.

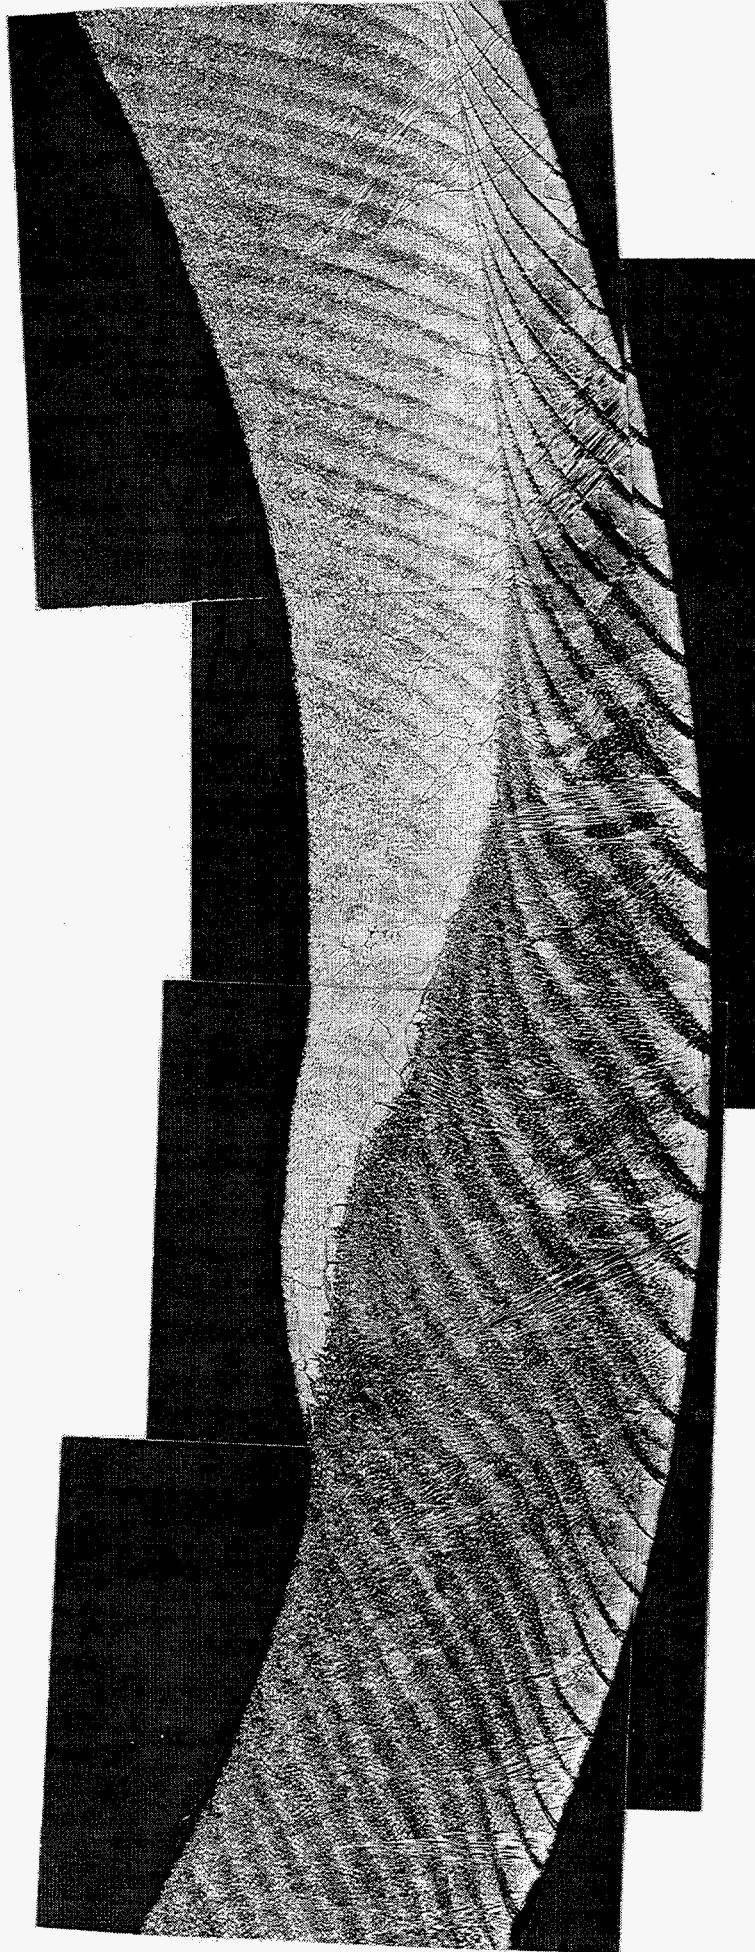
Fig. 50. Photomicrographs of a longitudinal section through the failure of capsule 18. Etched. 20 $\times$ .

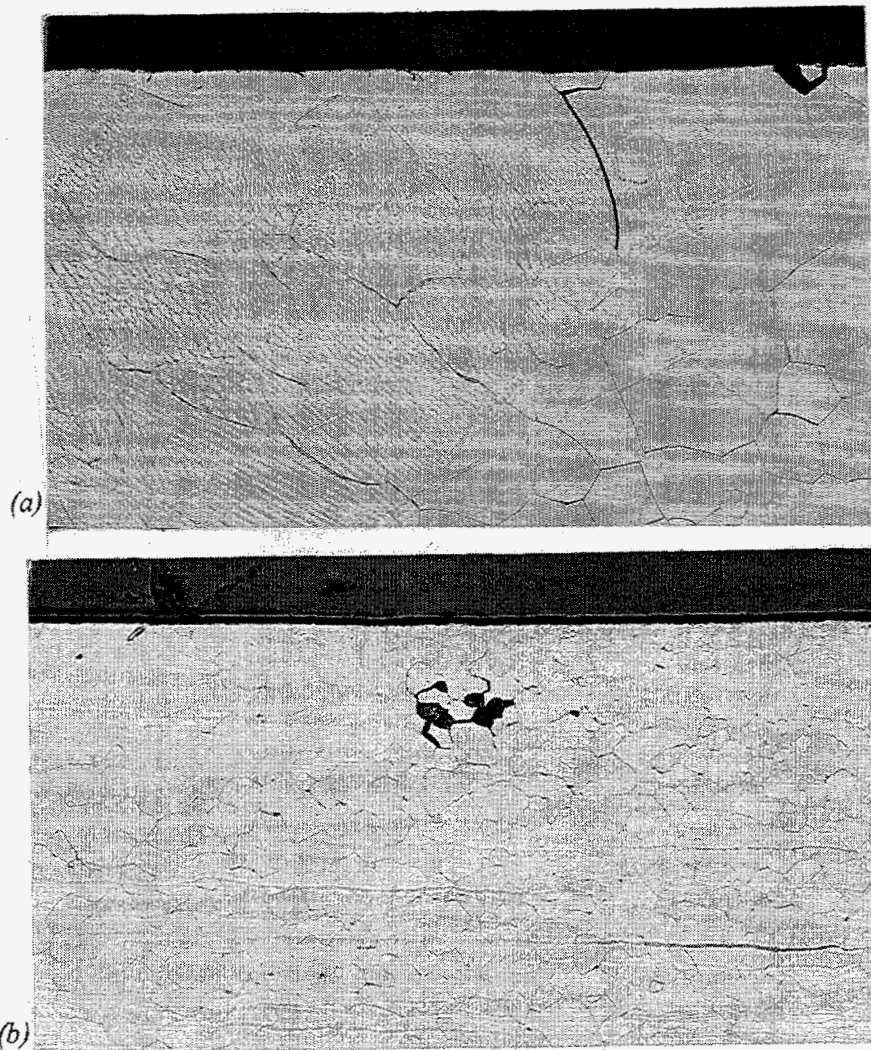
**Fig. 53.** Photomicrograph of a transverse section through the failure of capsule 15 showing cracks. Etched. 100×

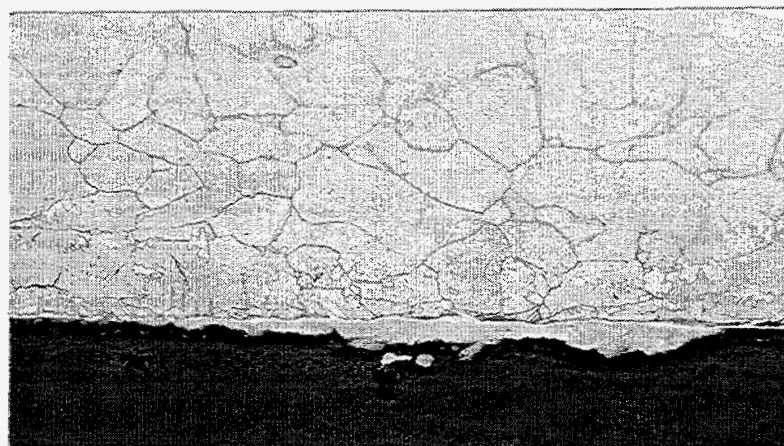
**Fig. 54.** Photomicrograph of the inside surface of a transverse section through the failure of capsule 15 showing surface reaction. Etched. 500×

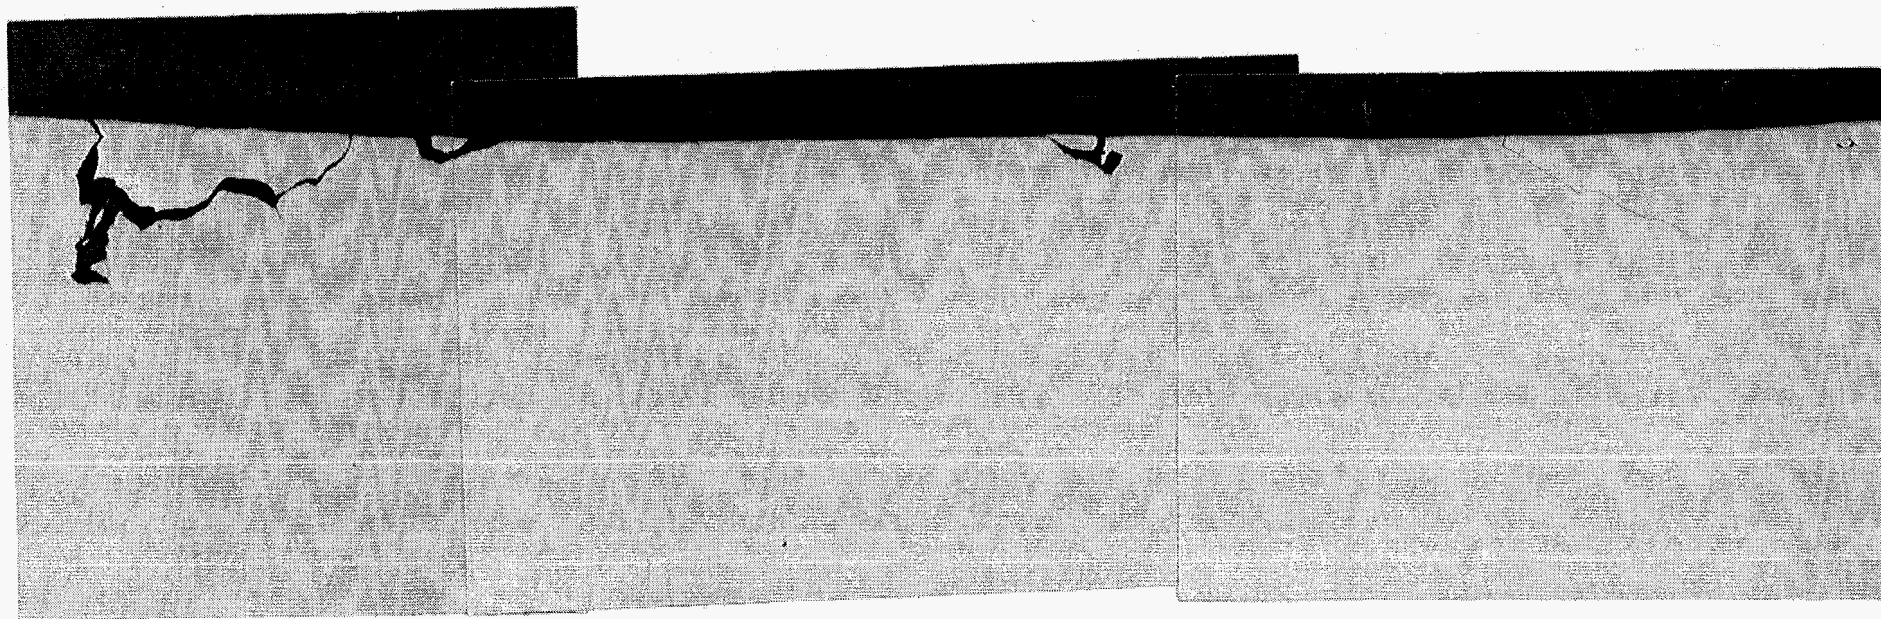
**Fig. 55. Photomicrographs of a transverse section through the failure of capsule 15. Additional material was removed after the photomicrographs shown in Fig. 51 were taken. As-polished. 50 $\times$ . Taken near the outside surface.**
