ORNL/TM-13265

THE MECHANICAL PROPERTIES OF T-111 AT LOW  
TO INTERMEDIATE TEMPERATURES

Metals and Ceramics Division

H. E. McCoy and J. R. DiStefano

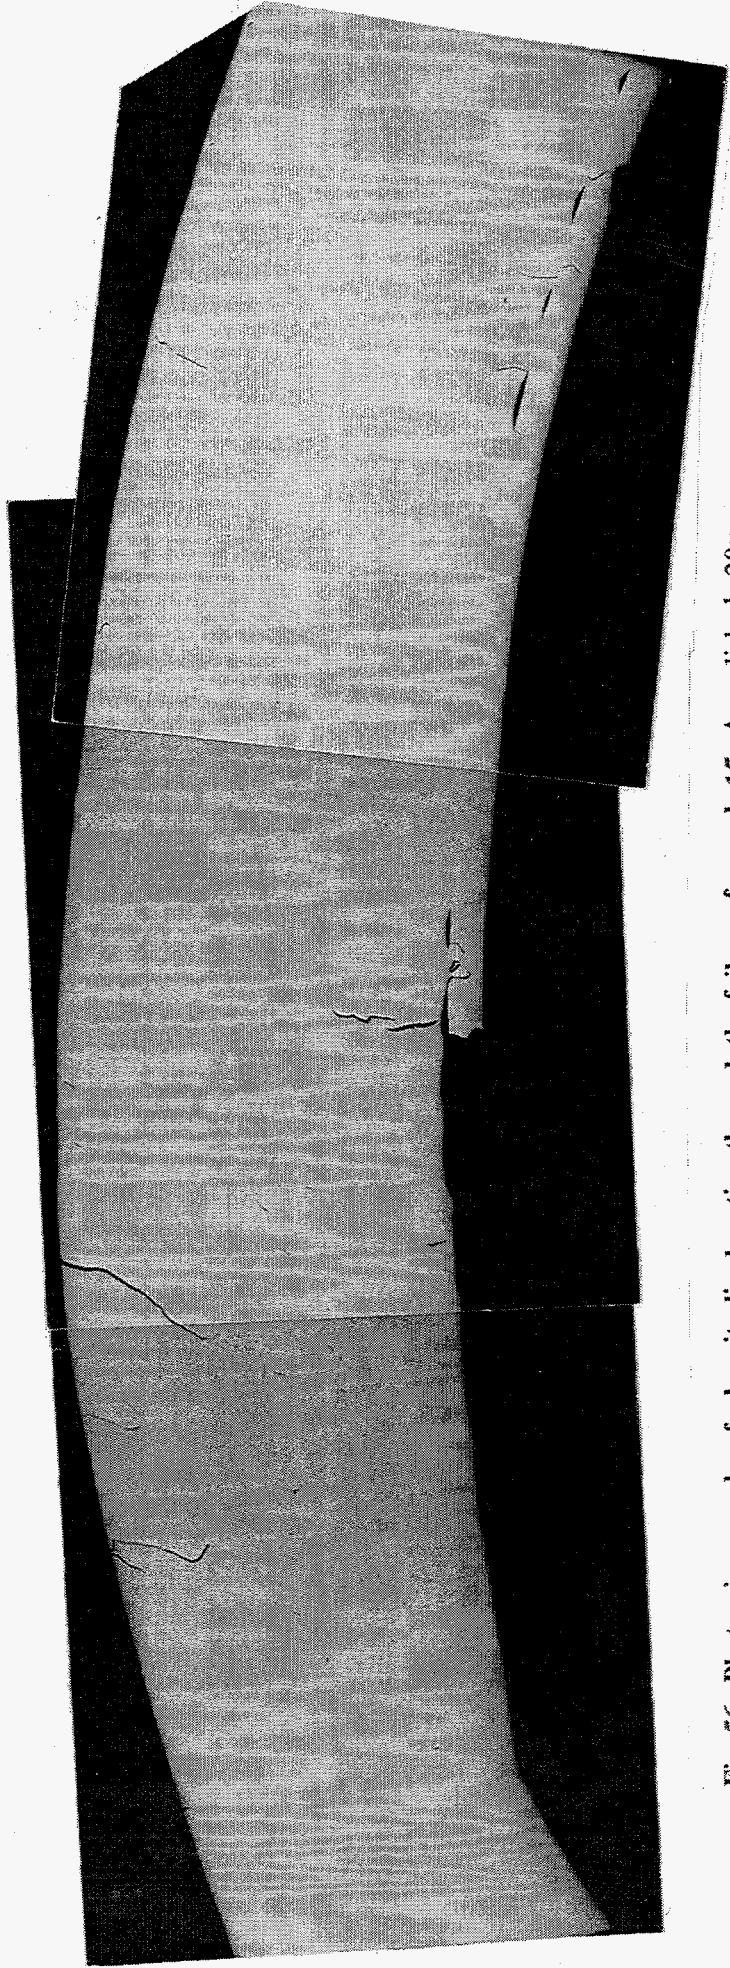
Fig. 56. Photomicrographs of a longitudinal section through the failure of capsule 15. As-polished. 20x.

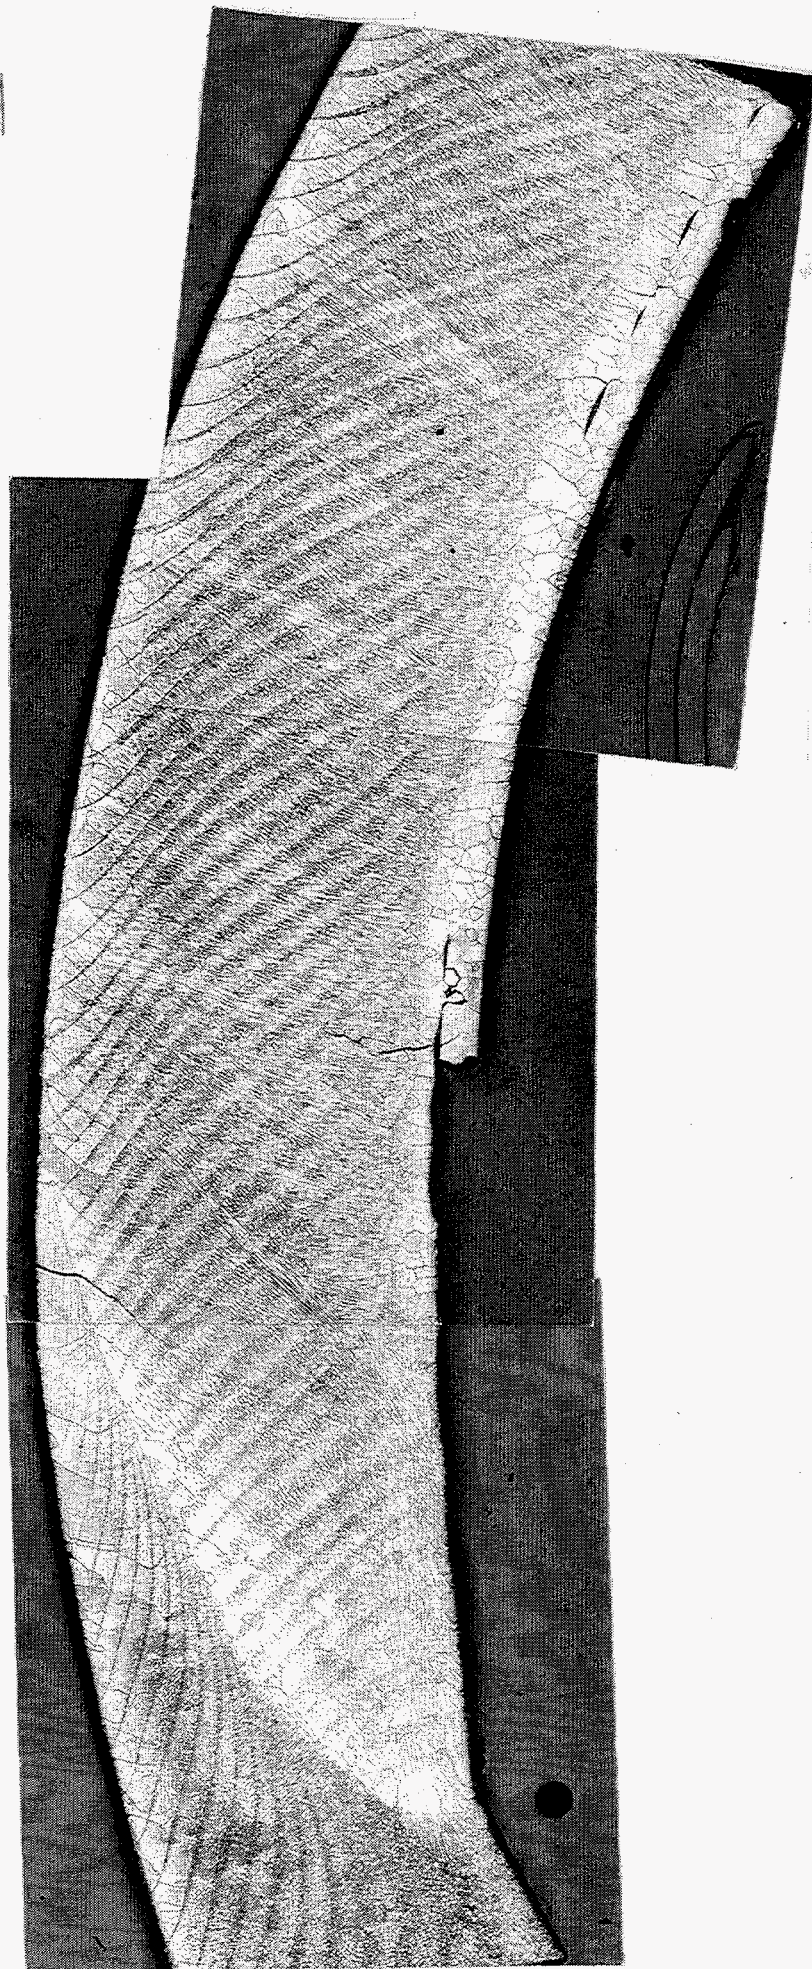
Fig. 57. Photomicrographs of a longitudinal section through the failure of capsule 15. Etched. 20x.

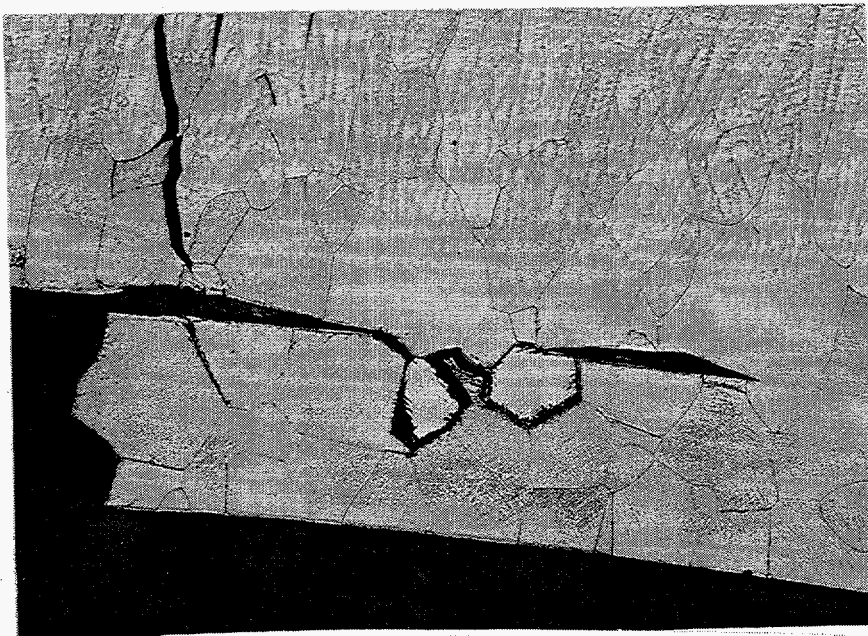
**Fig. 58. Photomicrographs of a longitudinal section through the failure of capsule 15. Etched. 100 $\times$ . (a) Outside edge and (b) inside edge (root).**

A longitudinal section of capsule 15 had numerous cracks on both the inner and outer surfaces. The cracks are visible both in the as-polished (see Fig. 56) and etched (see Fig. 57) conditions. The backup strip is visible in Figs. 56 and 57. Photomicrographs of cracks near the inner and outer surfaces are shown in Fig. 58. Cracking is rather extensive in this view.

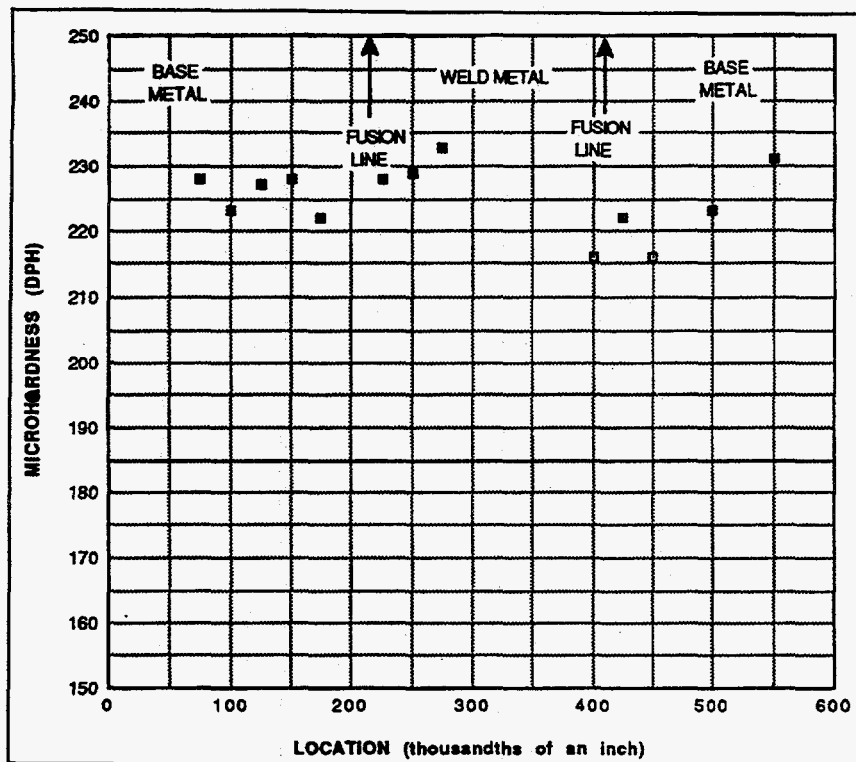
Fig. 59. Microhardness profile across transverse section of weld in capsule 18.
