Comprehensive Testing of Nedwind 12-Meter Wind Turbine Blades at NREL

*Presented at the 19th American Society of Mechanical
Engineers (ASME) Wind Energy Symposium
Reno, Nevada
January 10-13, 2000*

This paper describes the structural testing of two NedWind 25, 12-m blades at the National Renewable Energy Laboratory (NREL). The tests were conducted under the Standards, Measurement and Testing (SMT) Program in conjunction with tests conducted by four European laboratories to develop a common database of blade testing methods. All of the laboratories tested duplicate copies of blades taken from series production. Blade properties, including weight, center of gravity, natural frequencies, and damping were determined. Static load tests were performed at 110% of the extreme design load for strain verification. NREL performed single-axis and two-axis fatigue tests using “business-as-usual” testing practices. The single-axis test combined equivalent life loading for the edge and flap spectra into a single resultant load. The two-axis test applied the edge and flap components independently at a phase angle of 90°. Damage areas were observed at (1) the trailing edge, which cracked near the

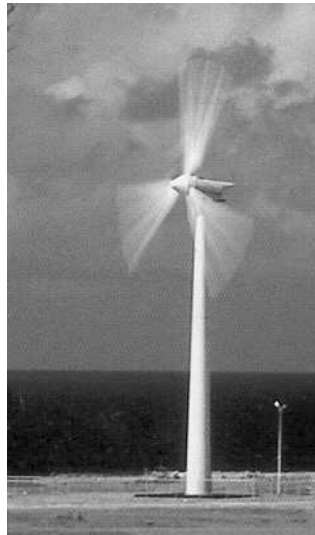
Figure 1. NedWind 25 in Curaçao
(photo courtesy of Paul Gipe)

The NedWind 25 is a 250-kW, upwind, pitch regulated, three-bladed machine. The turbines, manufactured in 1992, are operated in the Netherlands and Curaçao (Figure 1). The blades are 12-meters long and are constructed of glass fiber reinforced polyester. Each blade has a single spar running from 17%–83% of blade span at 40% chord (Figure 2) and is constructed with high strength laminates at the root and at the panels surrounding the blade spar. Lower strength material is used on the leading and trailing edges. The blade hub attachment is a steel flange that clamps with radial bolts around the blade root (Figure 3).

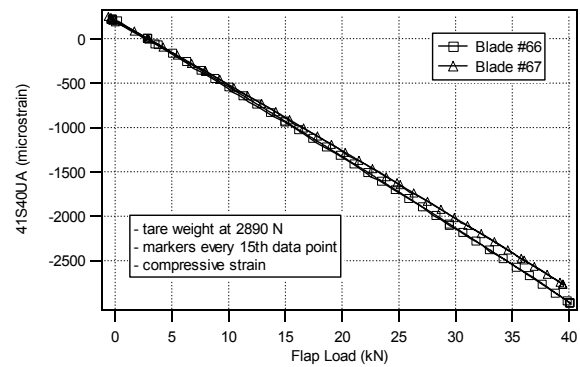
Figure 4. Strain versus load for 41S40UA, static flap loading with gage at 41% span, 40 % chord in longitudinal direction.

Figure 4 shows the strain gage signal 41S40UA, which had the highest strain in the flap loading case. Results from both static blade tests are shown. This gage is positioned at 41% span on the suction surface at the 40% chord spar location. The data shows a 5% difference at the upper end of the loading sequence. This difference could be because of the variability in the gage placement, blade manufacturing, or measurement accuracy.

An indication of imminent buckling is non-linear behavior in the strain gage signals.⁵ The figure shows linear behavior at all loads, which was typical for all the longitudinally aligned gages. We concluded that no structural failure or buckling stability limits were reached during the static tests. This result was also important because the peak fatigue test loads approached the magnitude of these static test loads and it was necessary to verify that the fatigue tests were within the linear range.

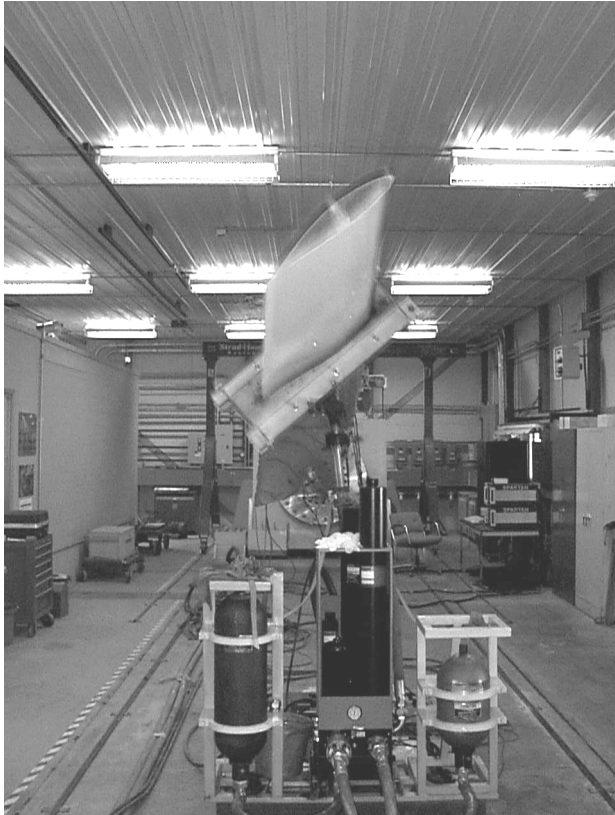
Figure 5. Single-Axis fatigue test in operation

Figure 5 shows a photo of the single-axis fatigue test in operation. The load actuator was aligned such that the resultant load went through the elastic center of the chord, assumed at 40% in order to minimize the introduction of torsional moments.

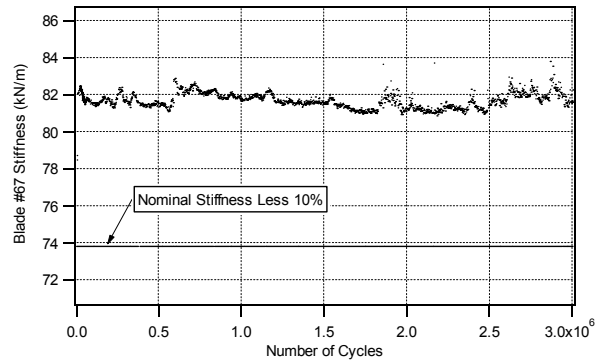
Figure 7. Blade #67 stiffness, single-axis fatigue test

Figure 7 shows the global stiffness of the blade over the test period. The global blade stiffness can be an indication of blade failure. As much as a 10% loss in stiffness has been observed in previous tests prior to failure.⁵ No significant change in test stiffness was noted during the test.

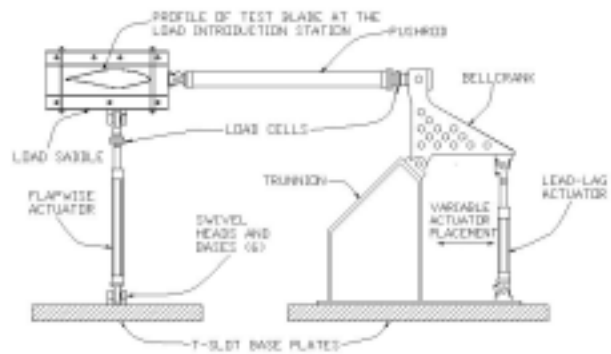
Figure 8. Two-axis fatigue test setup

NREL recently developed a two-axis testing capability. Figure 8 shows a line drawing of the test hardware. Although this is a more complicated test method, it is faster than testing edge and flap separately, and similar

in required time to a single-axis combined load test. The test damage is more realistic to the design load spectrum, because the load ratio (minimum/maximum) can be controlled separately for each axis. Also, the phase angle between flap and edge loads can be prescribed.

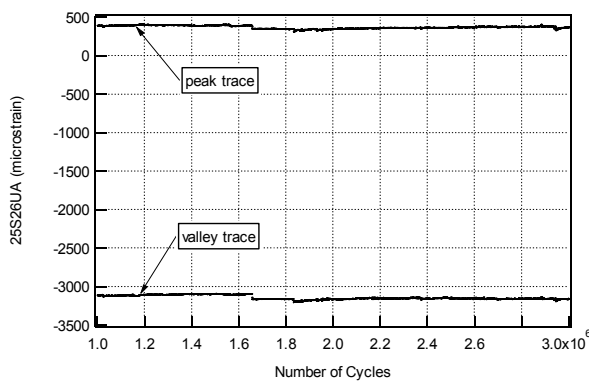
Figure 6. 0-degree strain versus cycle number for gage 25S26UA, blade #67 single-axis fatigue test. 25% span, 26% chord on compressive surface.

Figure 6 shows the longitudinal strain gage signal 25S26UA-peak/valley levels over the duration of the test. This gage was located on the compressive surface at 25% span and 26% chord. This signal is a reduction of 6 million points taken over the test period. Non-peak/valley data was removed around automatic stiffness checks and during startups and shutdowns. The peaks and valleys were separately averaged and decimated every 300 points. The first 100,000 cycles were not plotted because of a gage soldering failure. This figure is representative of most channels where the strain level during the test remained relatively constant.

Figure 9 shows the signal data from the same strain gage location in the two-axis test as Figure 6 did for the single-axis test. Although the signal valleys are approximately the same level, the single-axis data

(Figure 6) had a higher strain amplitude and a reversing component. Some of the two-axis signals showed higher strain amplitude compared to the corresponding single-axis signal. These amplitude differences can be attributed to the different load ratios used between the single-axis test and the two-axis test that were needed to achieve the same damage.

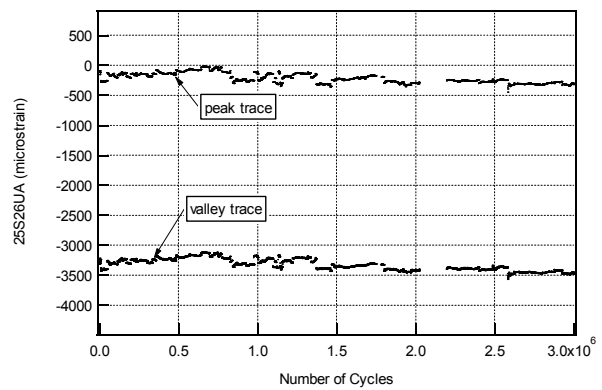
Figure 9. 0-degree strain versus cycle number for gage 25S26UA, blade #66 two-axis fatigue test. 25% span, 26% chord on compressive surface.
