Advanced Hot Gas Filter Development

**Topical Report: Task 3 & Task 4
September 29, 1994 to March 31, 1998**

**AlliedSignal Composites Inc. (formerly DuPont Lanxide Composites Inc.)
1300 Marrows Road
P. O. Box 9559
Newark, DE 19714-9559**

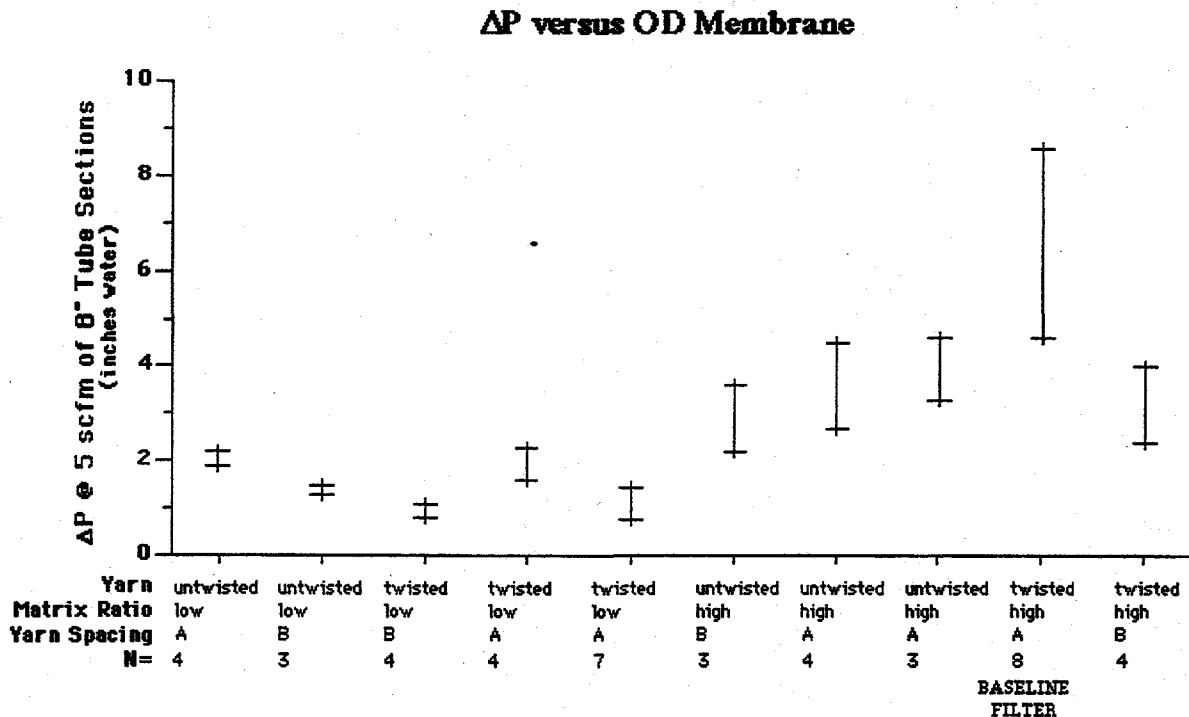
Figure 4 - Impact of three PRD-66 variables on backpressure (ΔP), where "N" is the number of samples.

As seen in Figure 4, every combination of yarn twist, matrix ratio, and yarn spacing examined in these experiments resulted in a reduction in backpressure when compared to the baseline filter. In these experiments, the new combinations were also less variable than the baseline filter. It should be noted that the backpressure measurements were made on 8" long samples taken from full size filters; the backpressure values presented in Figure 4 ARE NOT EQUAL TO values found on full filters, but they are proportional to them, so comparisons are meaningful.

The choice of yarn spacing is less clear. Yarn spacing 'B' generally gave slightly lower backpressure, but resulted in a visual appearance with randomly spaced gaps in the membrane. These gaps are likely to provide dust leak paths, and therefore poor filtration performance and may adversely effect cake release. DLC, therefore, elected to forego the small drop in backpressure and remain with the baseline yarn spacing.

Based on these results, DLC recommended the combination of a twisted yarn, low matrix ratio, and yarn spacing A, because of the low backpressure, retention of a smooth membrane, and ease of manufacture of such filters. DLC manufactured two filters having these parameters for examination by Westinghouse Science and Technology Center; results are discussed in "3.2.5 Filtration and Permeability Testing".

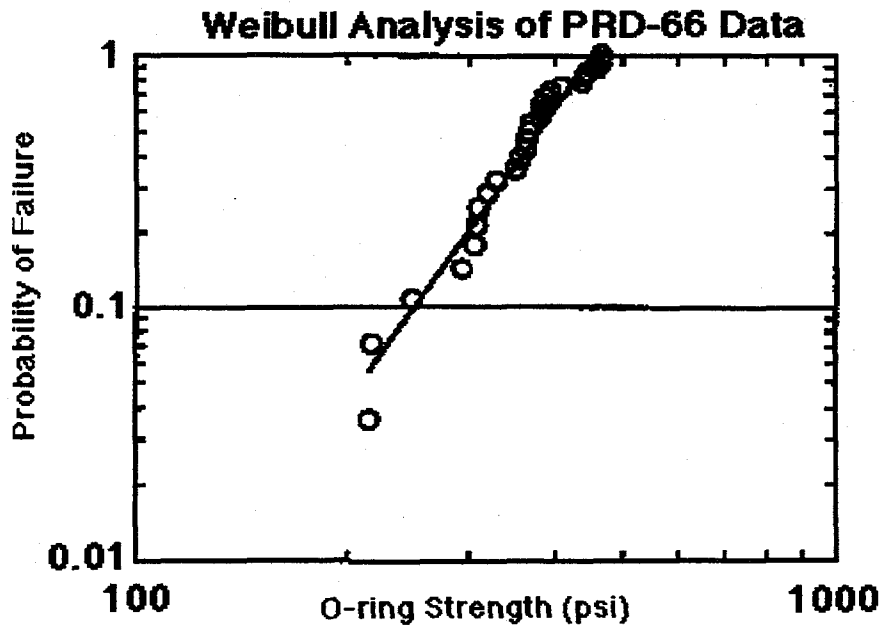
A Weibull analysis, shown in Figure 8, was conducted on the original data after calculating the failure strengths of each of the o-rings at the point of maximum stress on the load/deflection curve (Figure 6). The resulting failure stresses were then used to obtain parameter estimates associated with the underlying population distribution.¹¹ PRD-66 behaved as expected for a porous ceramic material, with a Weibull modulus around "4". Significantly more data would be necessary to correct for statistical bias errors and calculate confidence bounds.

Figure 8 - Weibull Analysis of PRD-66 candle filter segment.

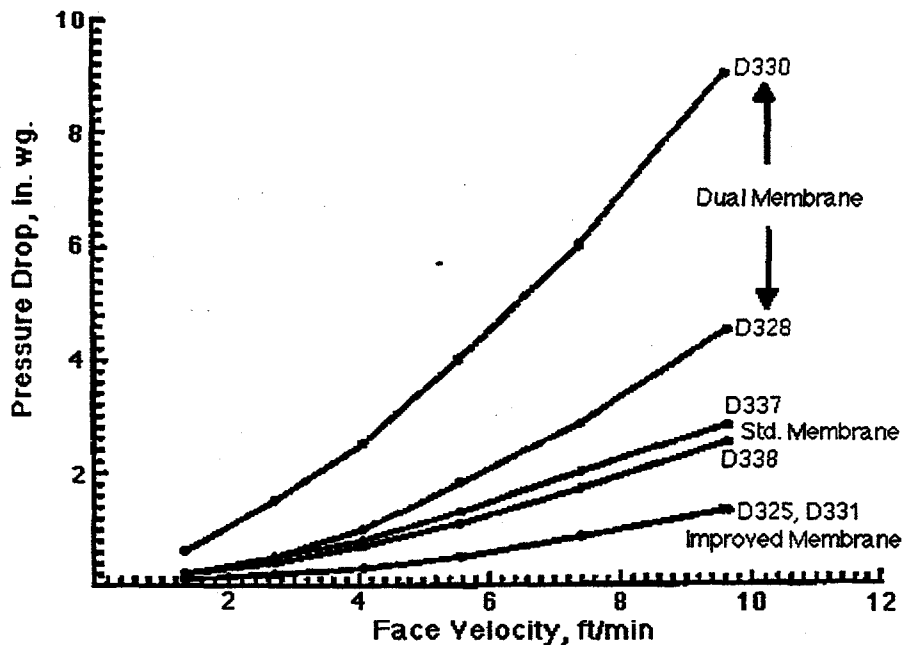
As mentioned earlier, DLC fabricated the following 1.5-meter candles for testing: two with improved (low pressure) outside membrane only, two dual membrane candles, and two "baseline" candles, ALL with strengthened flanges. Westinghouse performed room temperature gas flow resistance measurements on all six candles; results are show in Figure 13. These results parallel measurements conducted at DLC.

Figure 13 - W-STC Room Temperature Gas Flow Resistance measurements of 1.5-meter PRD-66 filter elements with various membranes.¹²

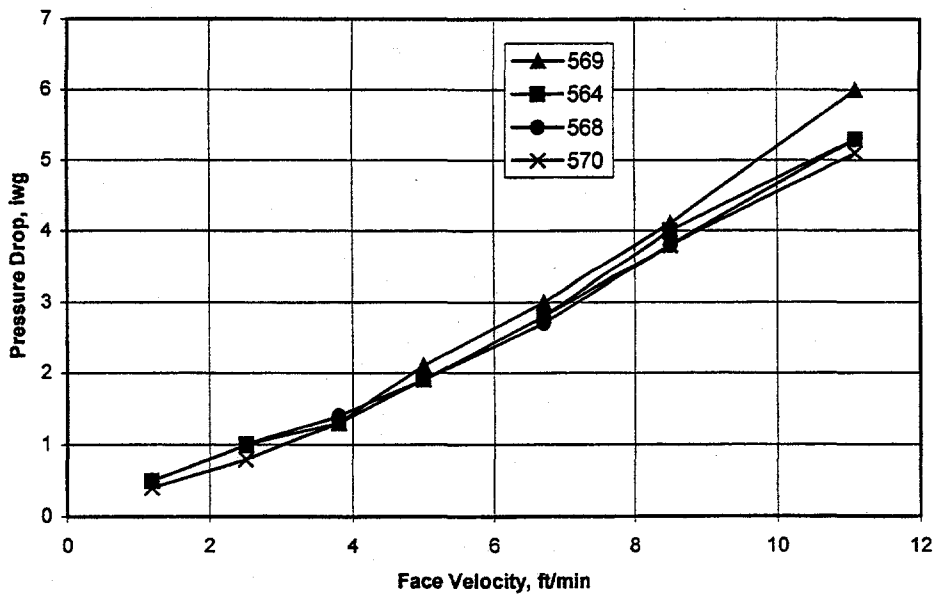
Figure 35 - PRD-66M - Room temperature gas flow resistance¹²

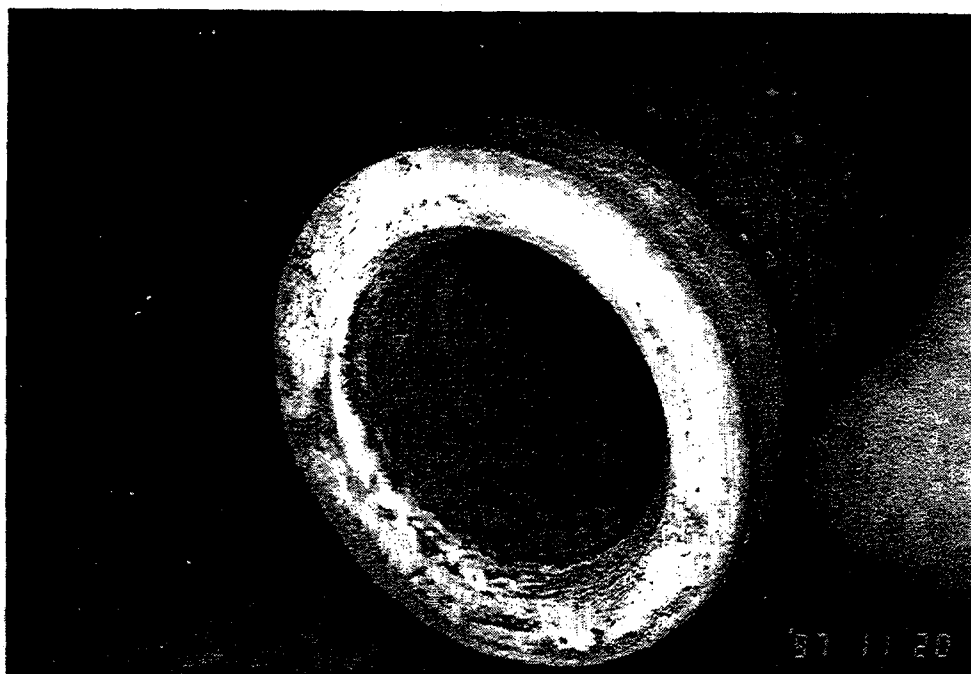
Figure 40 - Inside diameter of Karhula-exposed element before ash removal

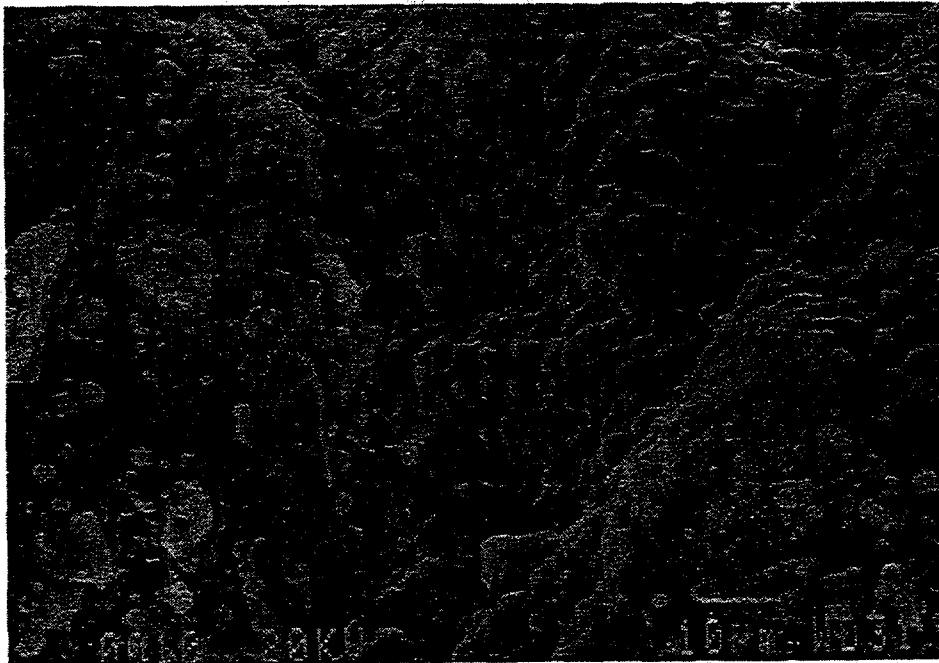
Figure 46 - 1,000X - EXPOSED candle surface

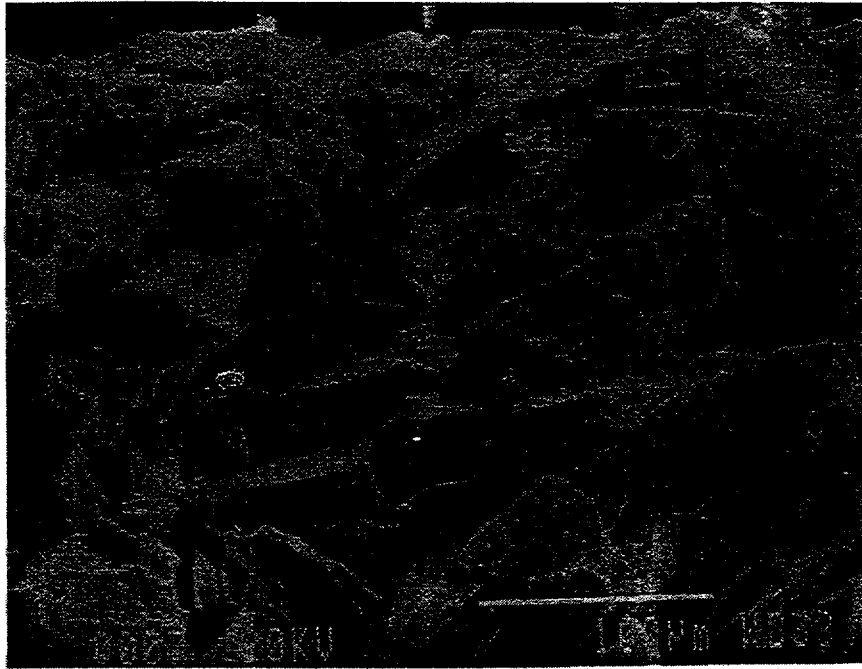
Figure 47 - UNEXPOSED CANDLE, cross-section of membrane filler (300X)

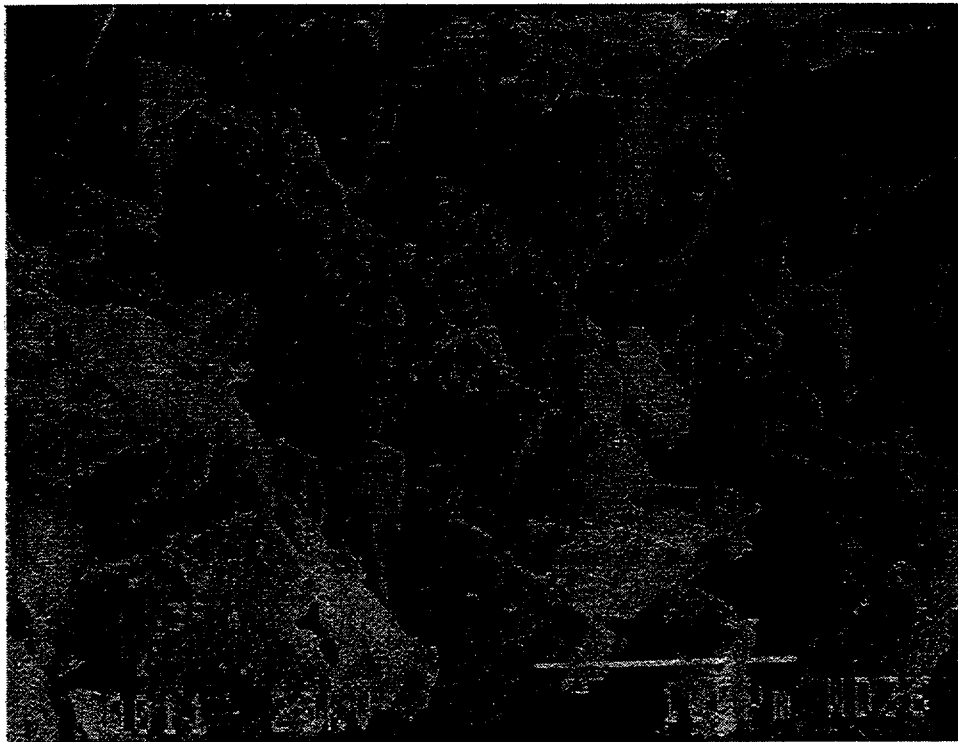
Figure 48 - EXPOSED CANDLE, cross-section of membrane filler (300X)

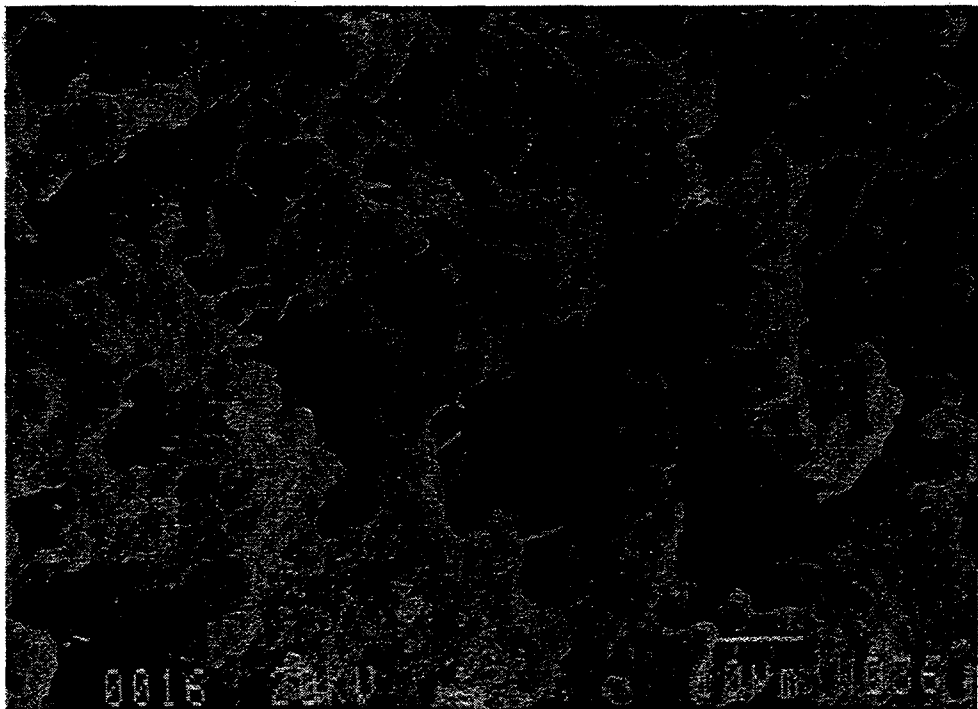
Figure 56 - EXPOSED CANDLE, individual "yarn bundle" (1,000X)

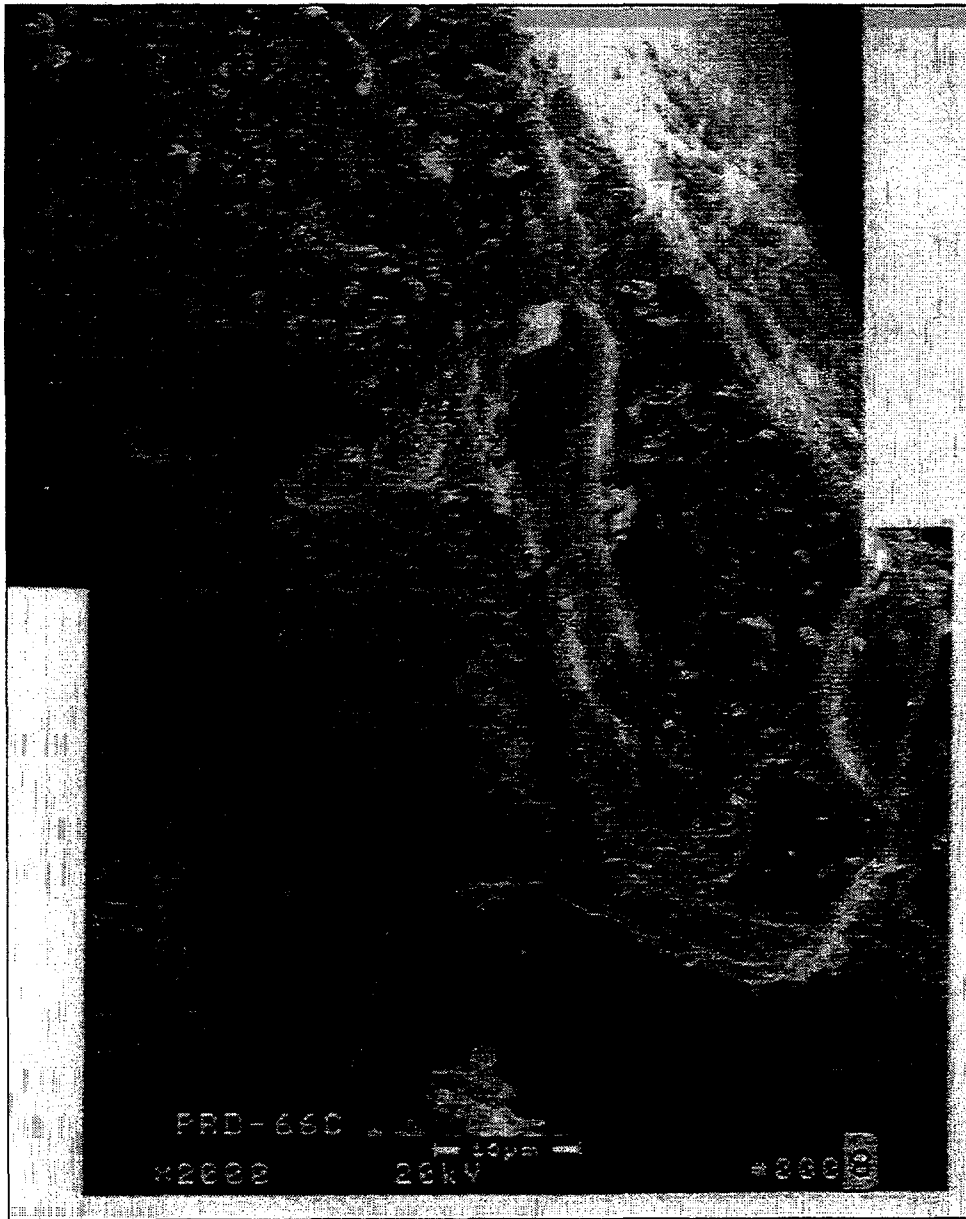
Figure 13 – Adherence of ash fines along the surface of the alumina-rich grains that were present within the outer surface membrane of the qualification-tested PRD-66 filter element.
