GRANDE RONDE BASIN FISH HABITAT ENHANCEMENT PROJECT

Annual Report 1999

DOE/BP-00000628-1

Project No. 1984-025-00

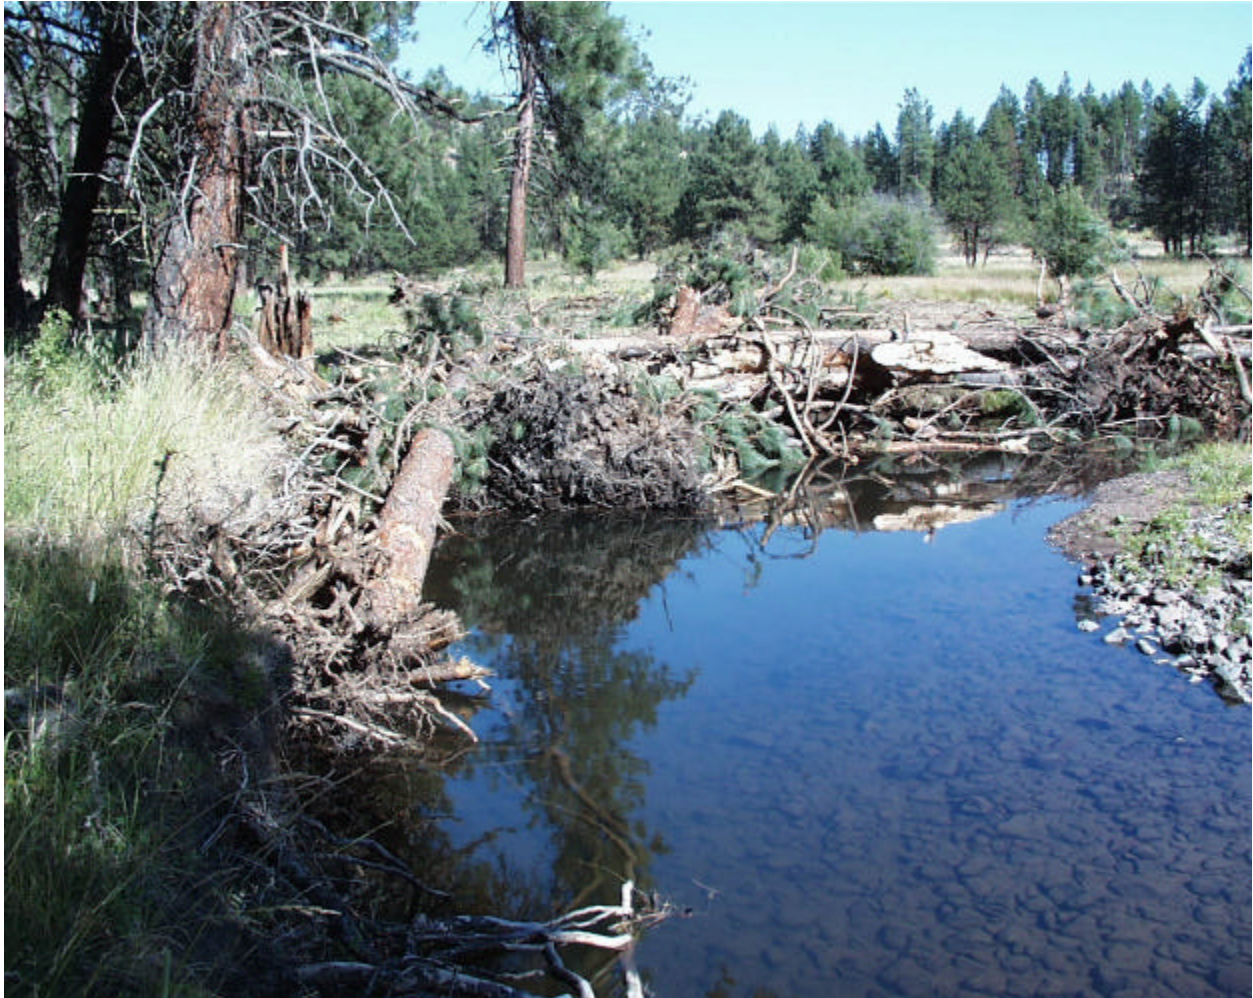
Figure 2. An engineered log jam (ELJ) constructed on Meadow Creek, Site 15, July 1999. Whole trees up to 30 inches in diameter and 80 feet in length were placed revetment style along an outside bend to stabilize the bank and enhance the quality of an existing pool. The largest tree had a 10 ft. diameter root wad that will provide hiding cover for juvenile steelhead. Tree tips were partially buried and placed outside of the bankful area to provide stability during winter flows and ice events.

Medium and large wood was uprooted from nearby hillslopes and transported using trackhoes. This wood was placed in a variety of configurations depending on individual site conditions. Generally, wood was selected to meet the ODF/ODFW minimum size guidelines for key structure members (trees with root wads attached and a minimum length of 1½ times the active channel width). In many cases wood was placed to create scour pools which are lacking in this reach; other structures were designed to aggrade the channel and reactivate the floodplain where the stream had downcut and was disconnected. In most cases, several pieces of wood were used together to mimic natural debris collecting structures. At a few sites it was determined that engineered logjams (ELJ's) were appropriate (Figure 1). A minimal amount of cabling was done, securing key members at a few main joints. It is anticipated that some movement or shifting will occur during high flows.

The majority of boulders used were placed in two rock weir structures. One weir was designed specifically to stabilize a road crossing. Other boulders were used at wood structures sites to provide additional habitat or help secure the wood. One last section of old railroad grade that was not removed last year was obliterated. One backwater pool was constructed, providing fish access to cold water from a floodplain tail seep. Bank shaping was done at two sites on vertical cut banks to reconnect the floodplain and channel, and speed vegetative recovery.

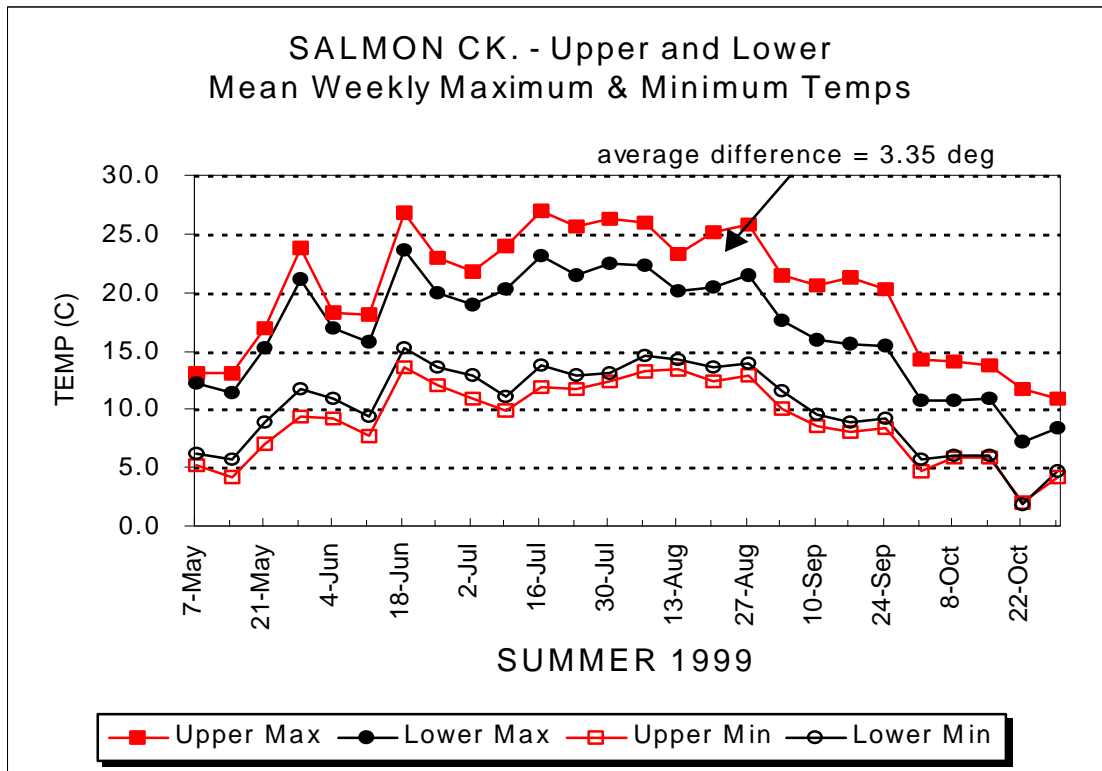
Figure 3. Mean weekly summer temperature data on Salmon Creek in 1999, at RM 2.4 (Upper) and RM 0.1 (Lower).

Salmon Creek has consistently shown cooling of stream temperatures as water travels downstream through the riparian corridor. In 1992, comparison of upper and lower summer mean weekly maximum temperatures showed an average cooling of 1.69°C at the lower (downstream) thermograph. In the summer of 1999 the average was 3.35°C cooler at the lower end (Figure 3). Salmon Creek is a small mid-elevation stream, and despite some recent heavy flooding, the vegetation is now in better condition to prevent damage from high flows, and there has been a considerable increase in the amount of shade along this reach. The stream channel has narrowed and deepened, reducing the stream water surface area and amount of solar radiation reaching the creek. There are also inputs of ground water from some springs that were also fenced off in 1990 which are also becoming more shaded.

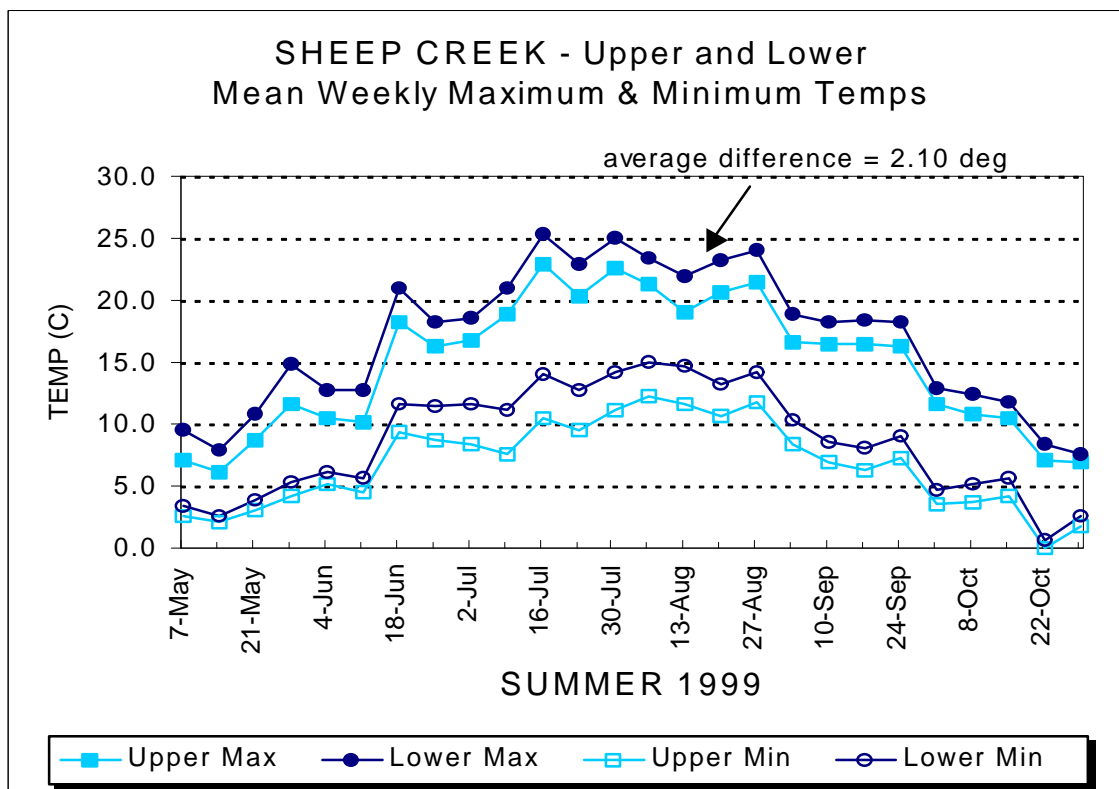
Figure 5. Summer temperatures on Sheep Creek in 1999 at RM 6.7 (Upper) and RM 2.4 (Lower).

Comparison of summer mean weekly maximum temperatures shows that lower Sheep Creek averaged 1.46°C warmer than the upper site in 1988 and 2.10 °C warmer in 1999 (Figure 5). Data collected over the 11 year period continue to show moderate and consistent warming of 1 to 3°C at the lower thermograph, with no apparent trends developing to date. Daily fluctuations at both sights are moderate.

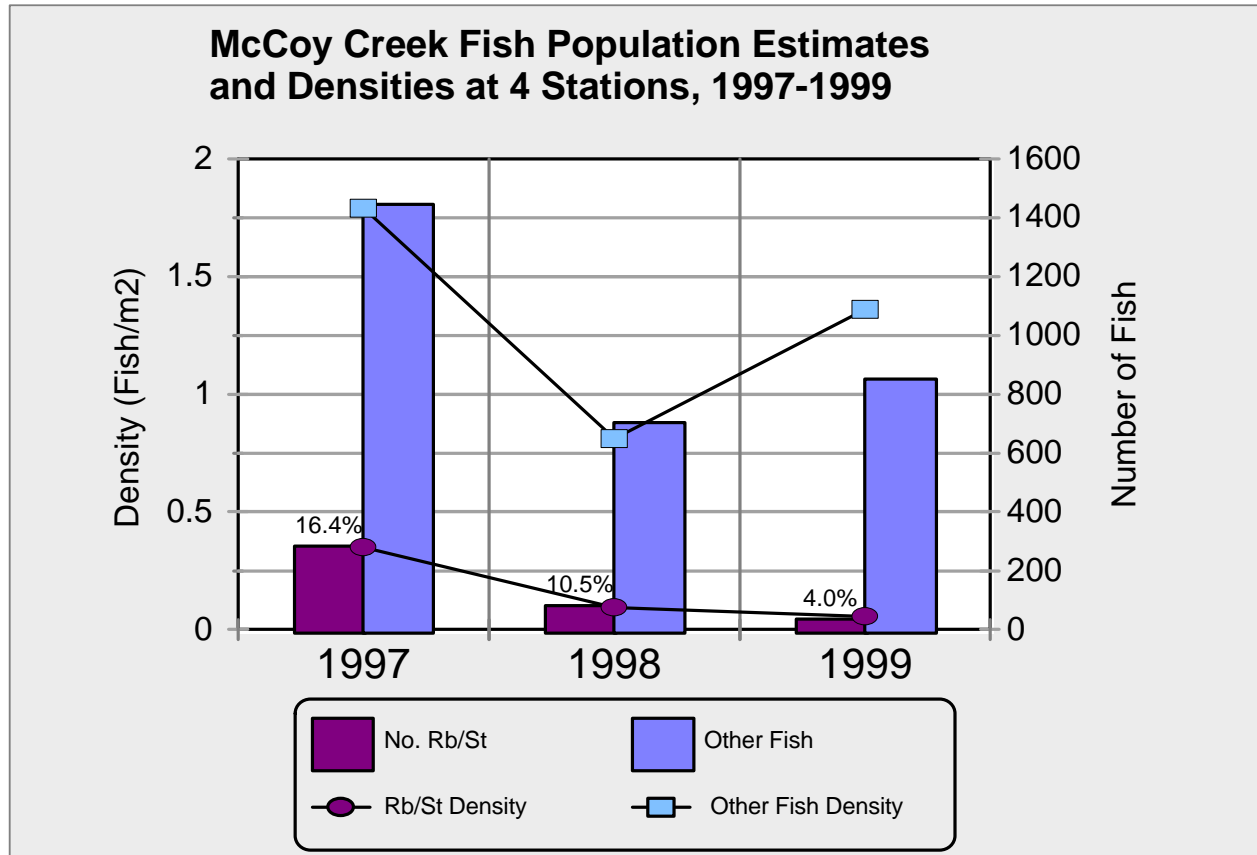
Electroshocking surveys were repeated in McCoy Creek on June 29, 1999. Densities and percent composition of Rb/St have declined over the three year period. Presence/absence of Rb/St may be closely related to stream temperatures which are typically rising quickly this time of year. One of the four stations was not sampled in 1999 due to low water conditions in the former channel. The results are summarized in the chart below:

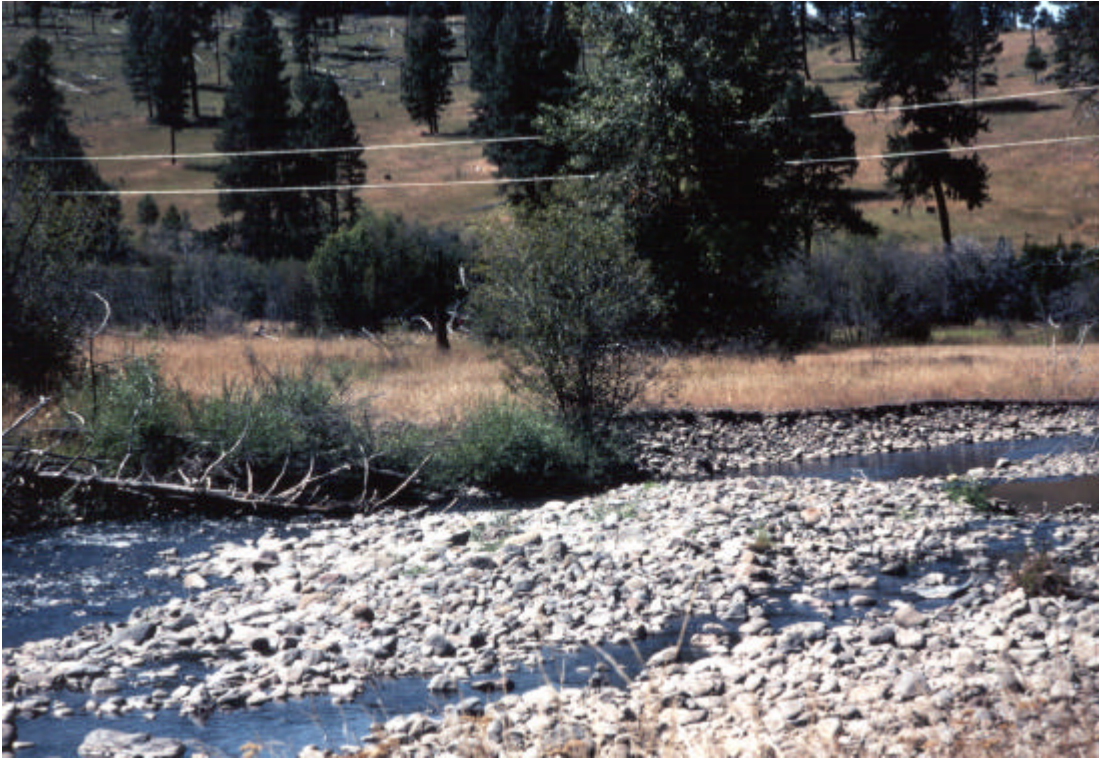
Beaver Creek, Crown Pacific property, Photopoint #8, August 11, 1993. This pre-project photopoint shows an unstable stream channel . Considerable bedload movement is evident, along with a wide, shallow and braided active channel. Very little shade or quality instream habitat is present.

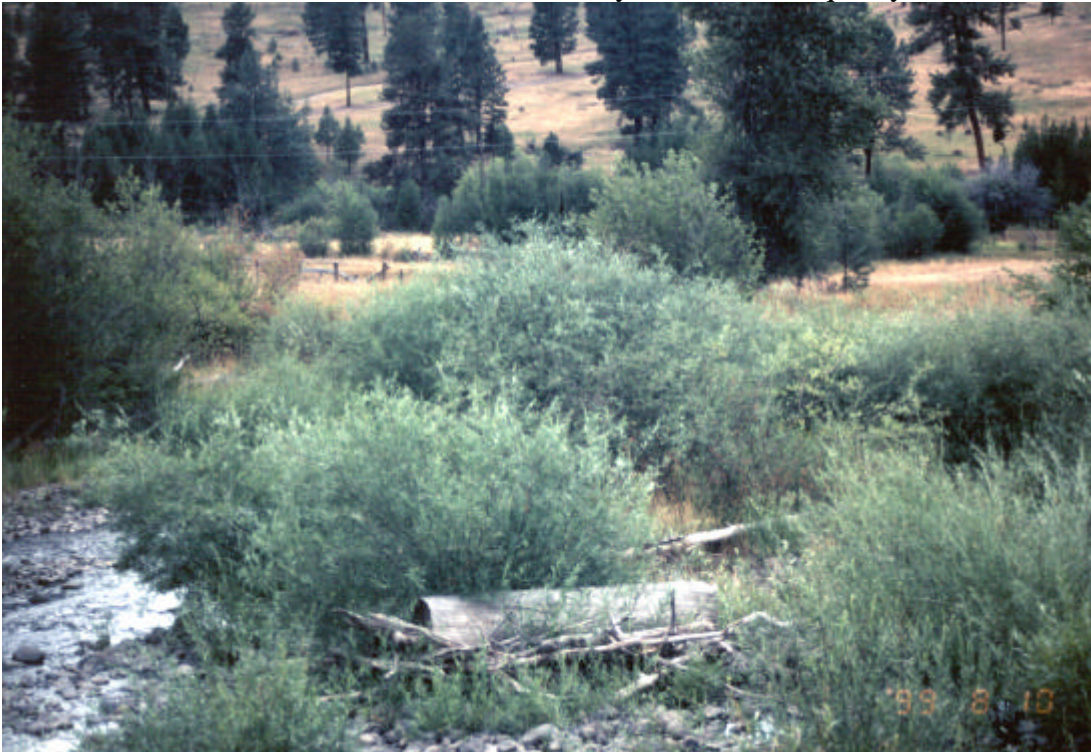
Beaver Creek, Crown Pacific, Photopoint #8, August 10, 1999. After 6 years of rest from grazing willows are well established on the developing point bar. The channel is now a single thread, with the thalweg on the far bank. Recruitment of large wood (in this case old logging slash) is taking place.

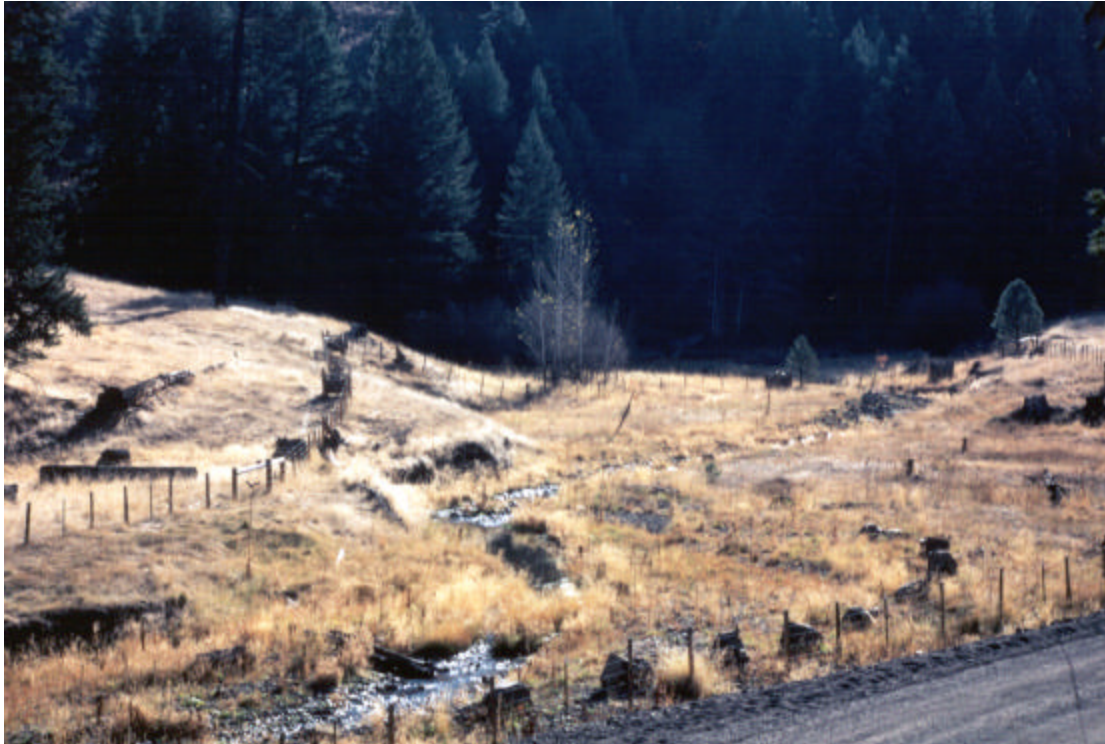
Elk Creek, Birkmaier property, Photopoint #2, October 16, 1987. Riparian fencing and instream structures were completed in 1986. Lack of riparian vegetation from both grazing and timber harvest are evident.

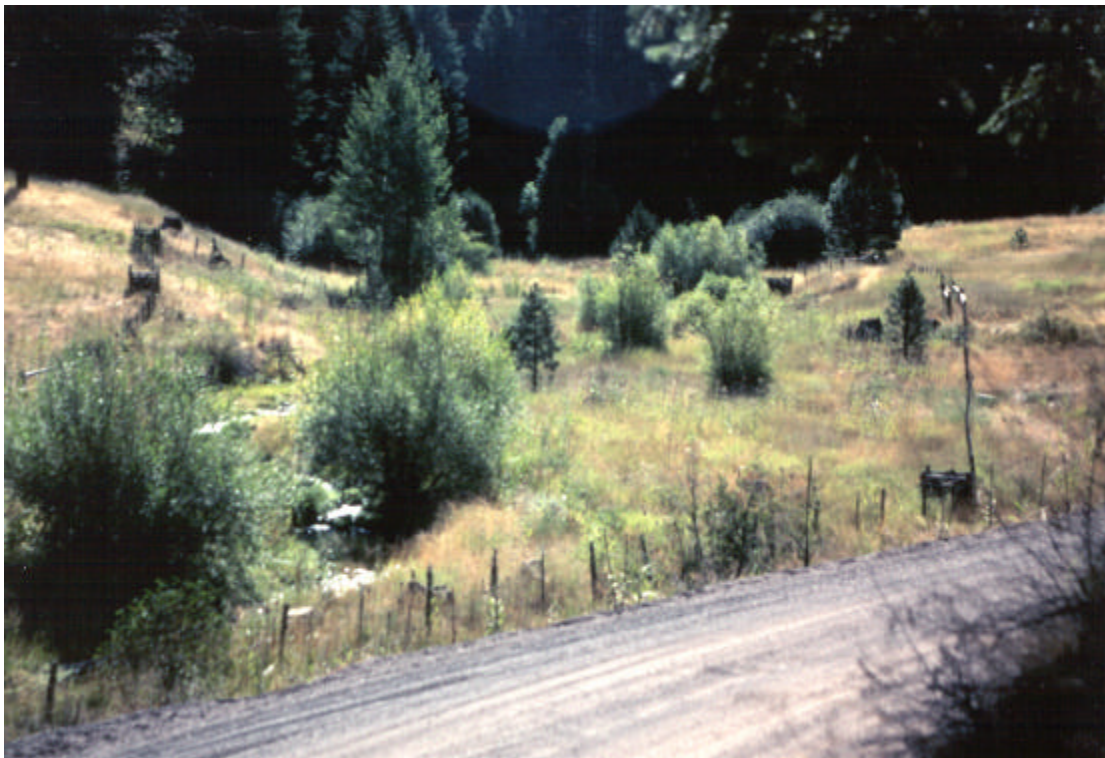
Elk Creek, Birkmaier property, Photopoint #2, August 16, 1999. After 11 years of rest the riparian quantity is dramatically improved. Transect data in this reach shows a narrowing and deepening of the stream channel and significant increases in shade. The lease agreement expired in 1997 but the landowner has kept the area protected since then.

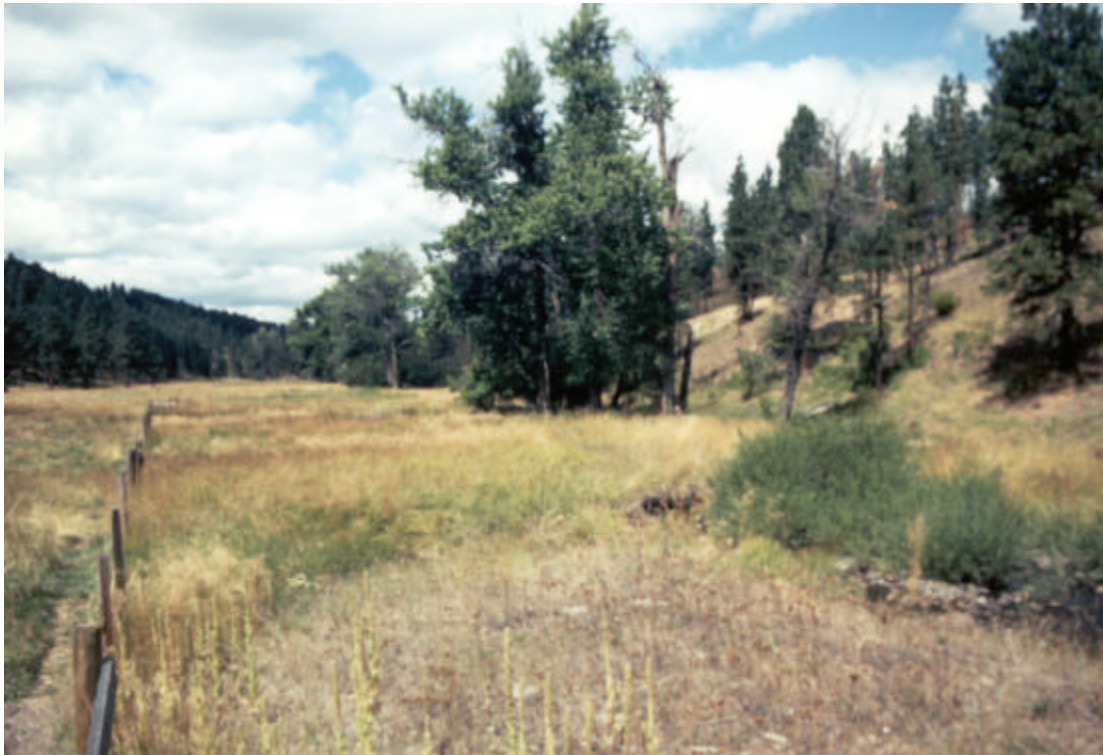
Whiskey Creek, Courtney property, Photopoint #4, August 24, 1993. Fencing was completed in this reach in 1991. After two seasons of rest native shrubs are beginning to recover in this small stream.

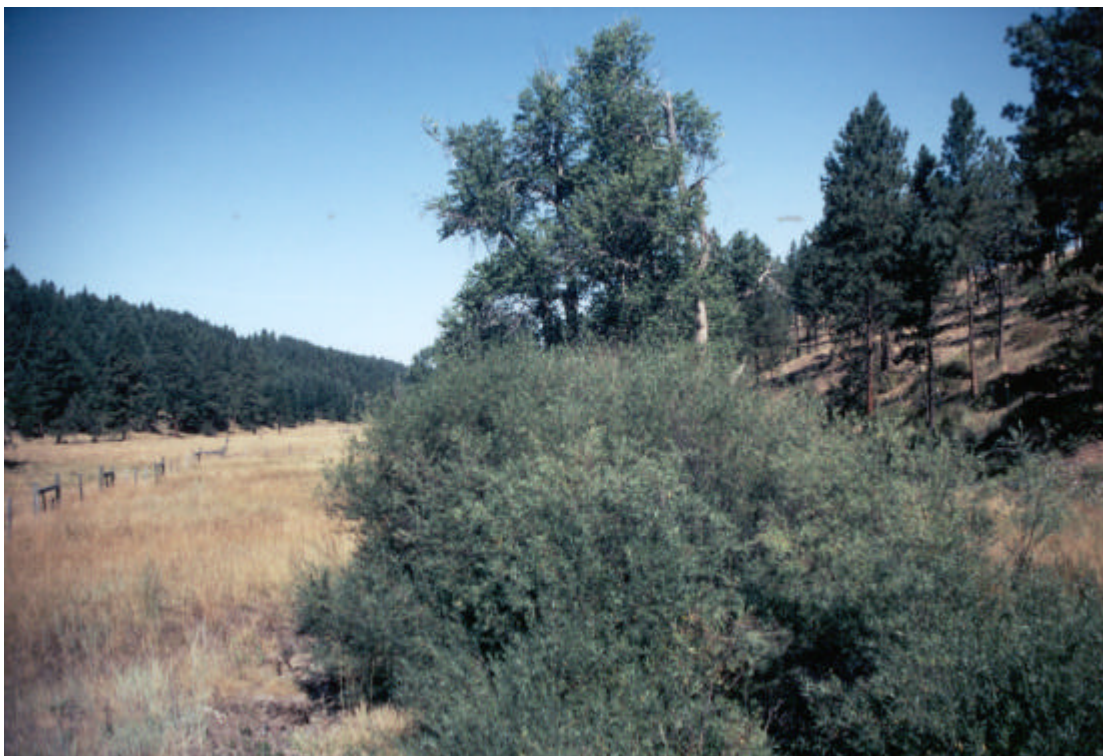
Whiskey Creek, Courtney property, Photopoint #4, August 20, 1999. Willows are now over ten feet high but recovery in this reach is spotty. Replacement groves of cottonwoods (note mature trees in background) and conifers have not yet become well established. This may be due to lack of water and intermittent cattle trespass problems that have occurred. Portions of Whiskey Creek run dry in the summer.
