PROGRAM TITLE
 Fuel Decladding Program DE-AC03-86SF16021

DOCUMENT TITLE
 Annual Report Rockwell International Hot Laboratory Decommissioning - GFY 1993

ANNUAL REPORT ROCKWELL INTERNATIONAL
HOT LABORATORY DECOMMISSIONING GFY 1993

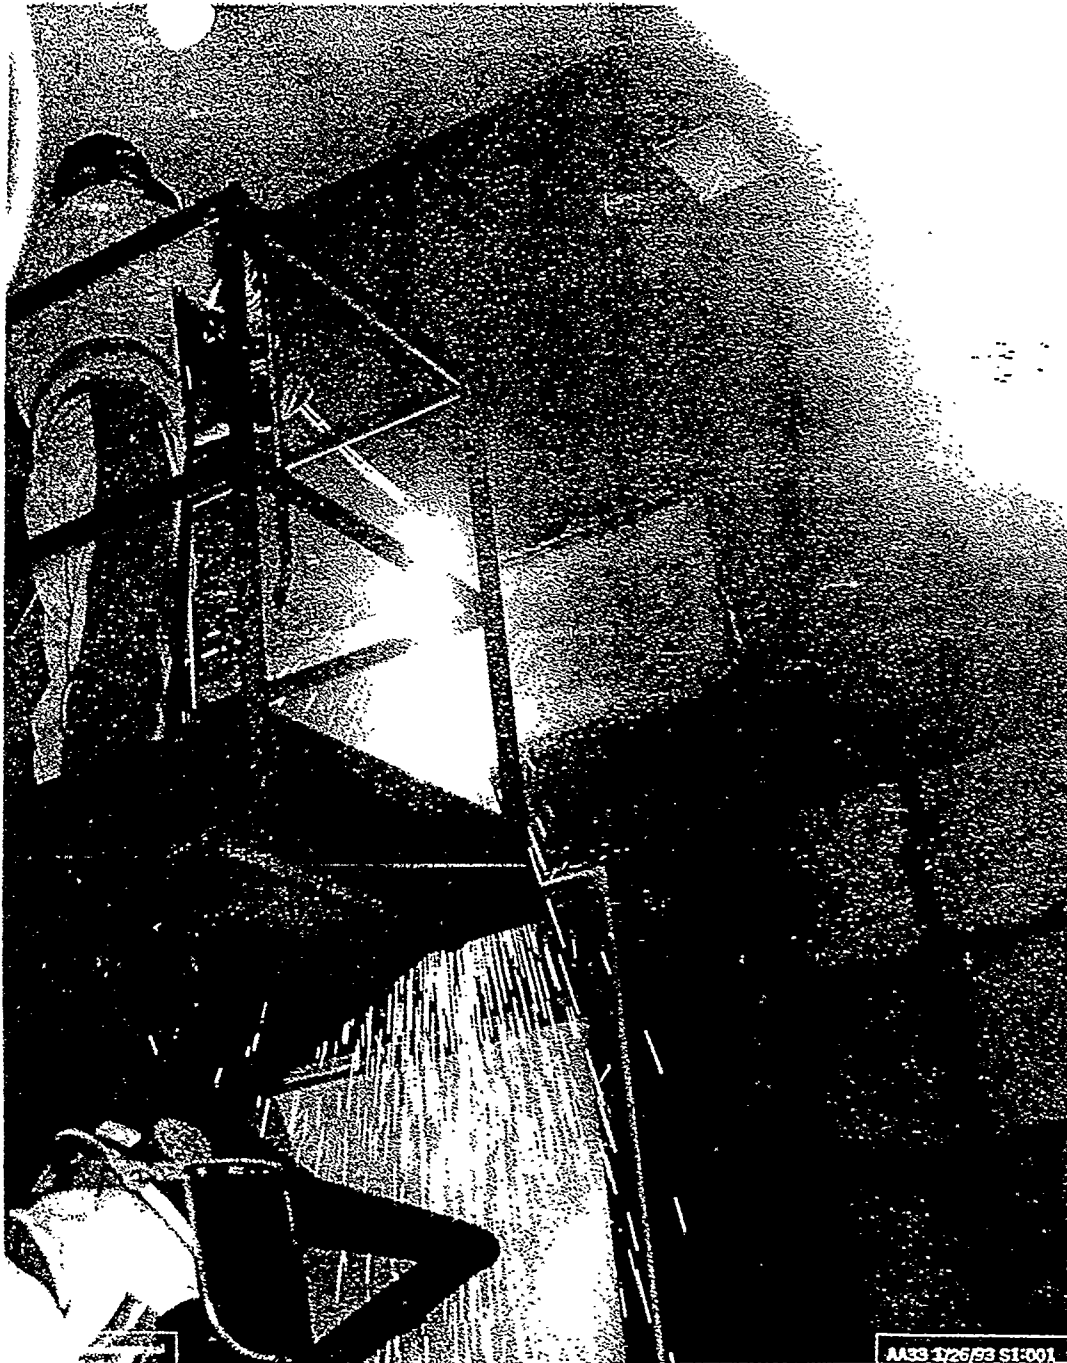
Figure 3-5

East Decon Room Liner Removal

A construction specification was prepared for removal of the cell and decon room floor liners and the decon room east wall liners. A liner removal contract was issued to Lopez Refinery Co. and five subcontractor personnel were trained in Radiation Safety, Respirator Use, Fire Extinguishers, and Facility Familiarization. In preparation for floor liner removal the openings in the R/A drain system in the decon rooms and cells were sealed by welding a cover plate over them and the four storage holes in the cells were also seal welded. The subcontractors removed the steel liners using oxygen/propane torches in January 1993 (see Figures 3-4 and 3-5). This completed the liner removal.

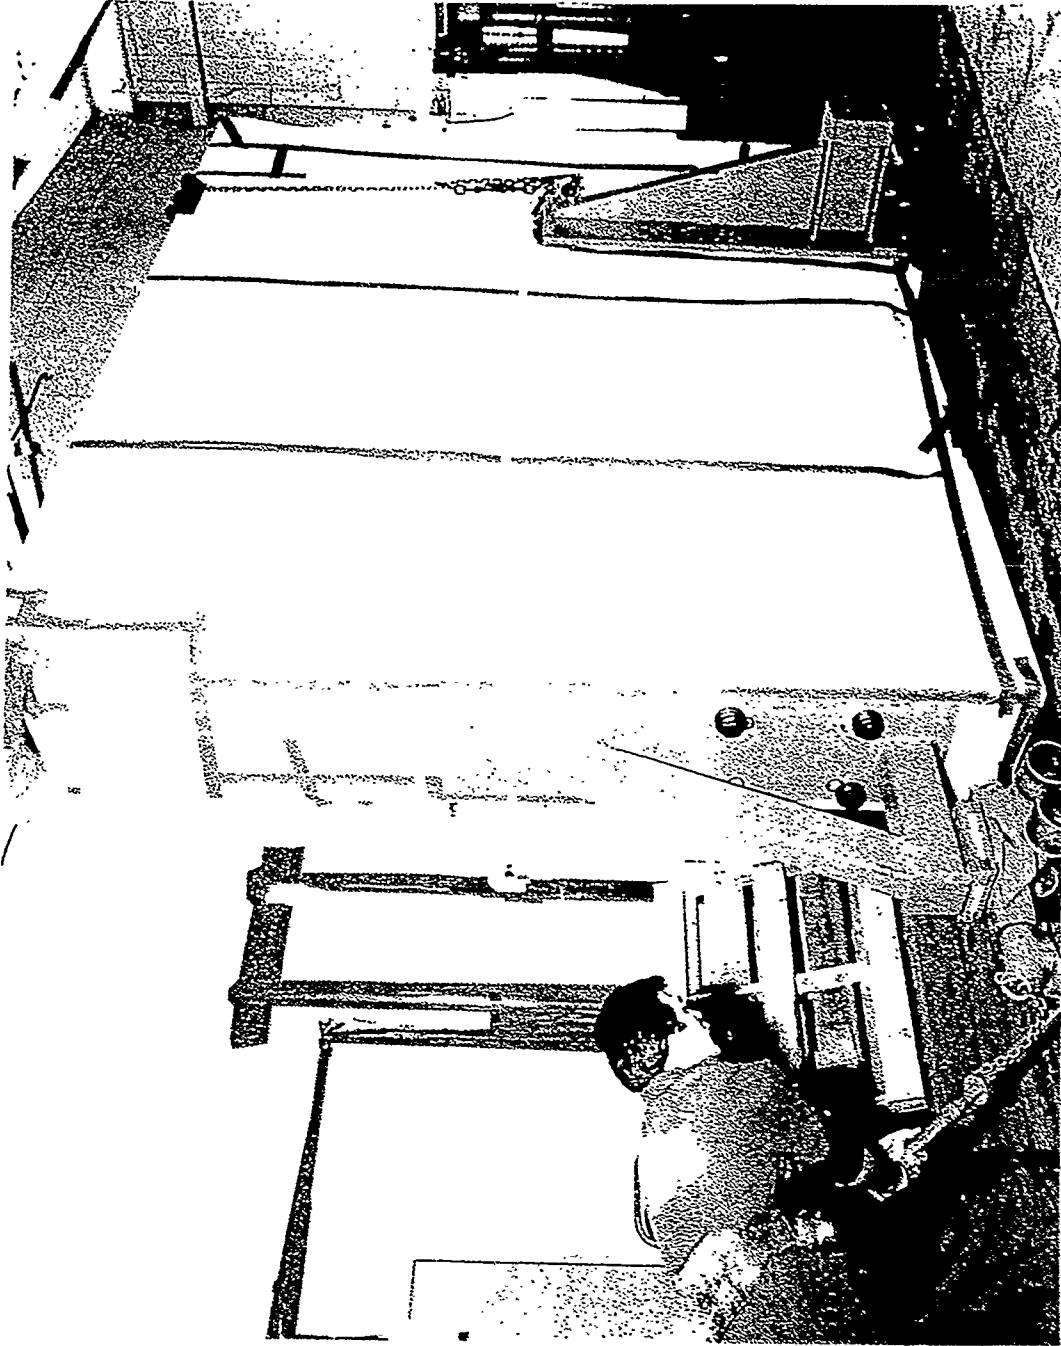
Figure 3-10

Cell 4 North Shield Door

In GFY 1993 the west door of decon room 4 was enlarged by removal of a 48" wide X 41" high section from the wall to provide clearance to remove the cell 4 main shield door. The west wall of the service gallery was also opened up. The north doorway of the mockup area was enlarged to provide clearance to remove the cell 4 north shield door (Figure 3-9). The lead shield plug from the cell 4 north shield door was removed and transported to RMDF for decontamination. Rigging contractors supported by Rockwell personnel removed the cell 4 main shield door (~80,000 lb) and the north shield door (~90,000 lb) and transported them to RMDF for decontamination (See Figures 3-10 to 3-13).

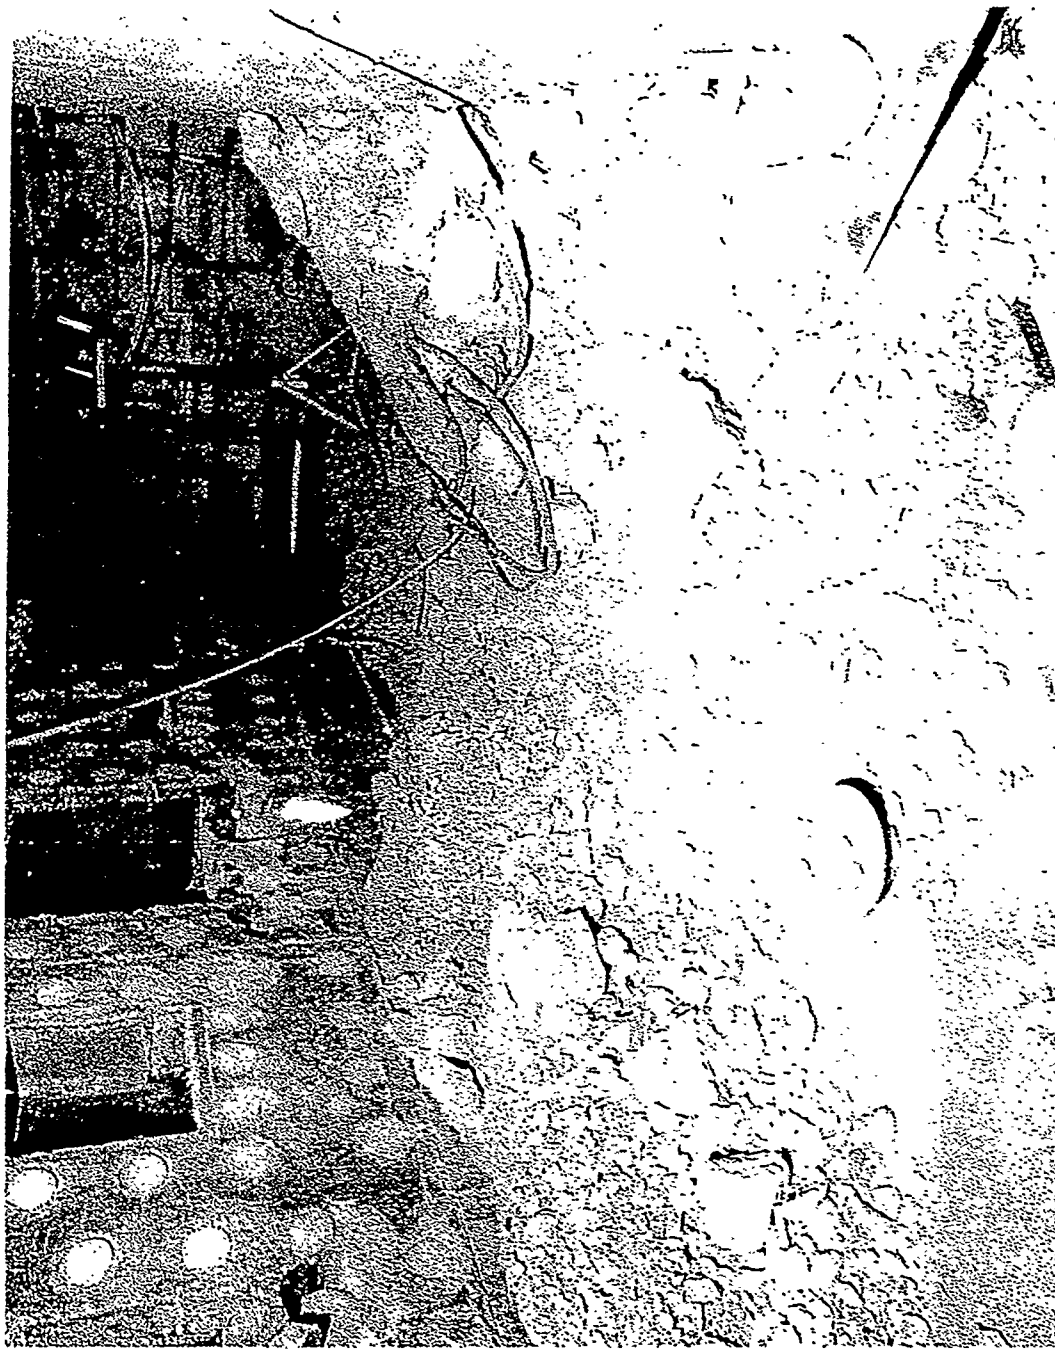
Figure 3-14

Concrete Removal From Cell Floor Under Liner

Concrete under the floor liners in the cells and decon rooms was found to be contaminated. A layer of high density concrete 5"-6" deep was removed from the floors of all 4 cells and all 4 decon rooms with scabblers and jackhammers and was packaged as R/A waste (See Figures 3-14 and 3-15). R/A contamination found in the expansion joint between the cell 4 wall and the mockup area concrete floor around the north shield doorway was removed by "chasing" with jackhammers.

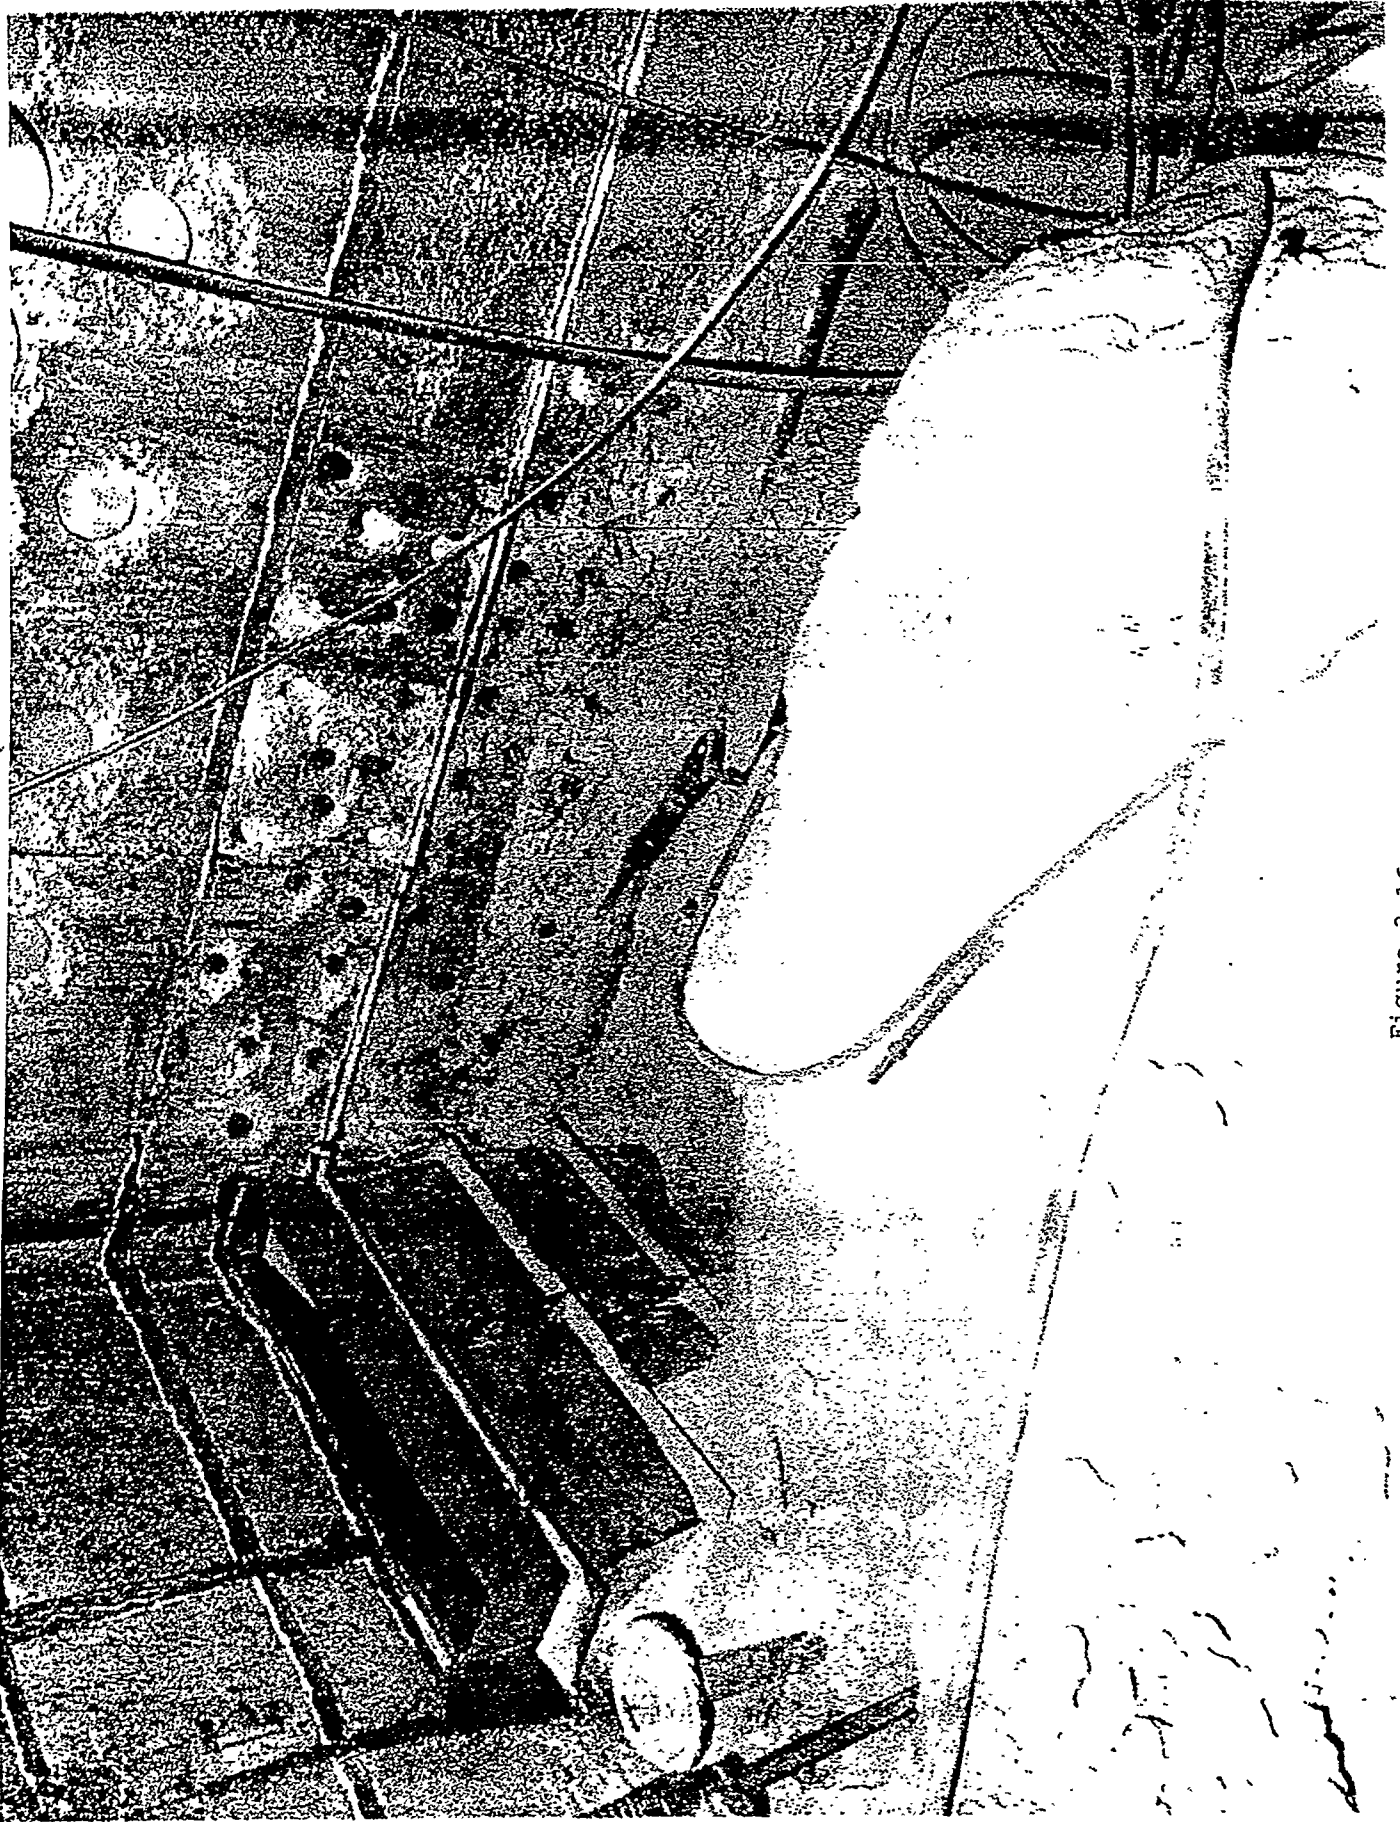
Figure 3-16

Cell Exhaust Duct to be Removed

Work was started early on the R/A exhaust system to gain access to the R/A drain system. Reinforced concrete was removed from around the north cell 1 and the south cell 2 R/A exhaust ducts and the ducting was removed. The exhaust duct elbows were removed from all 4 cells (Figures 3-16 and 3-17). The basement was set up for exhaust duct size reduction. The exhaust duct penetration in cell 2 was removed. The exhaust duct valves and ducting in the basement below all 4 cells was removed, downsized, packaged, and loaded out of the basement to complete the exhaust duct removal for this phase of the work (Figure 3-18). The exhaust ducting and air drop system in the decon rooms remained in service for all 4 cells.

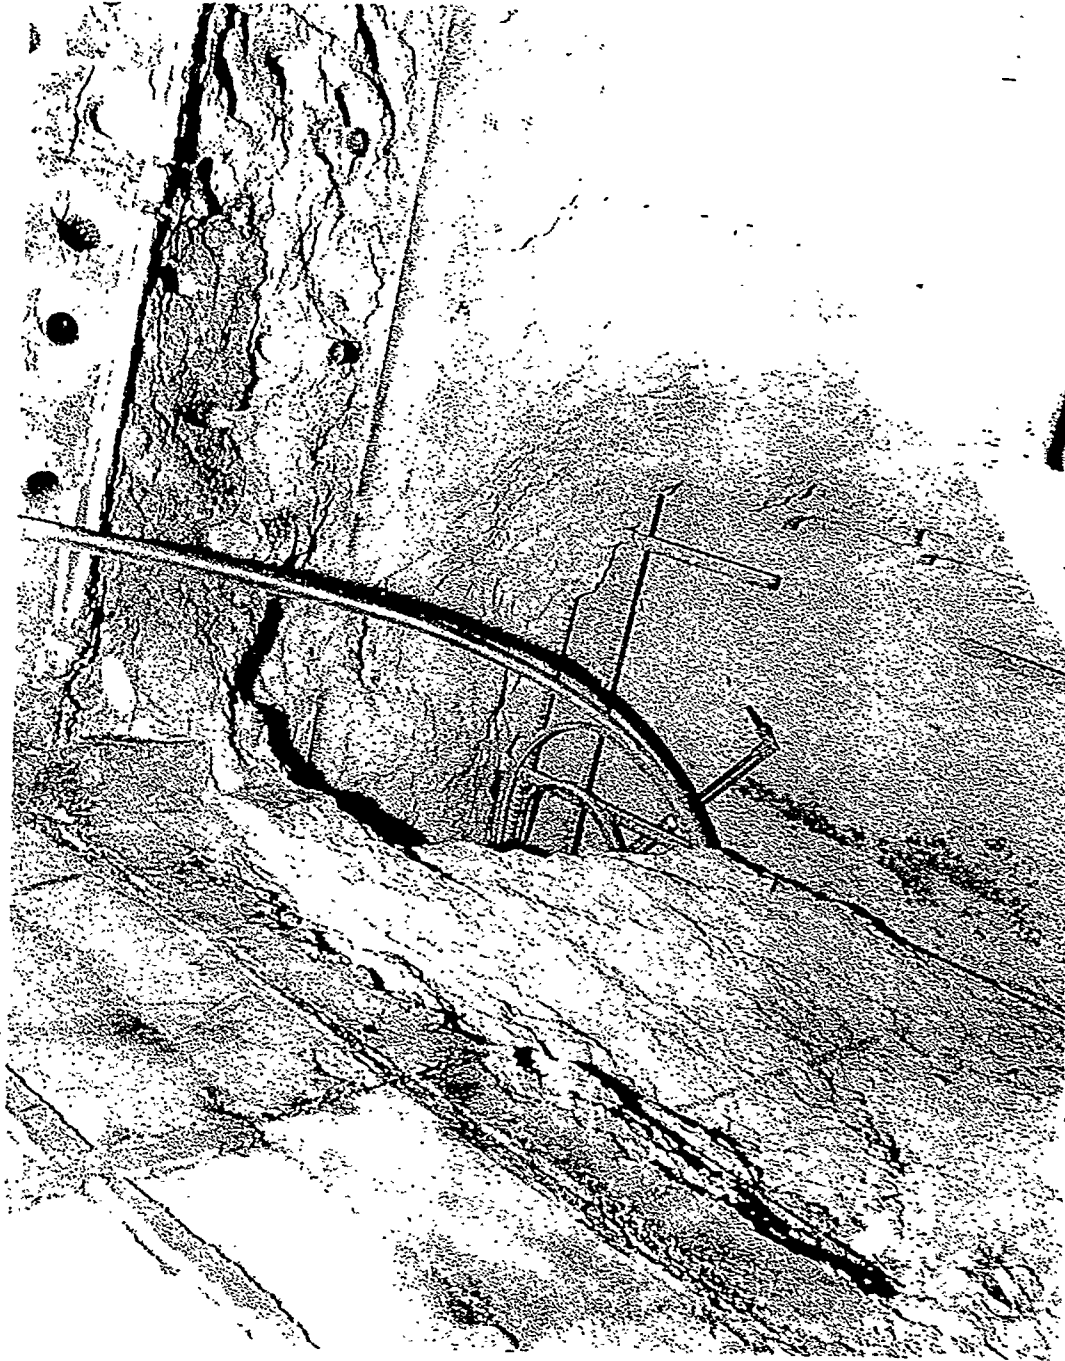
Figure 3-17 .

Cell Exhaust Duct Removed

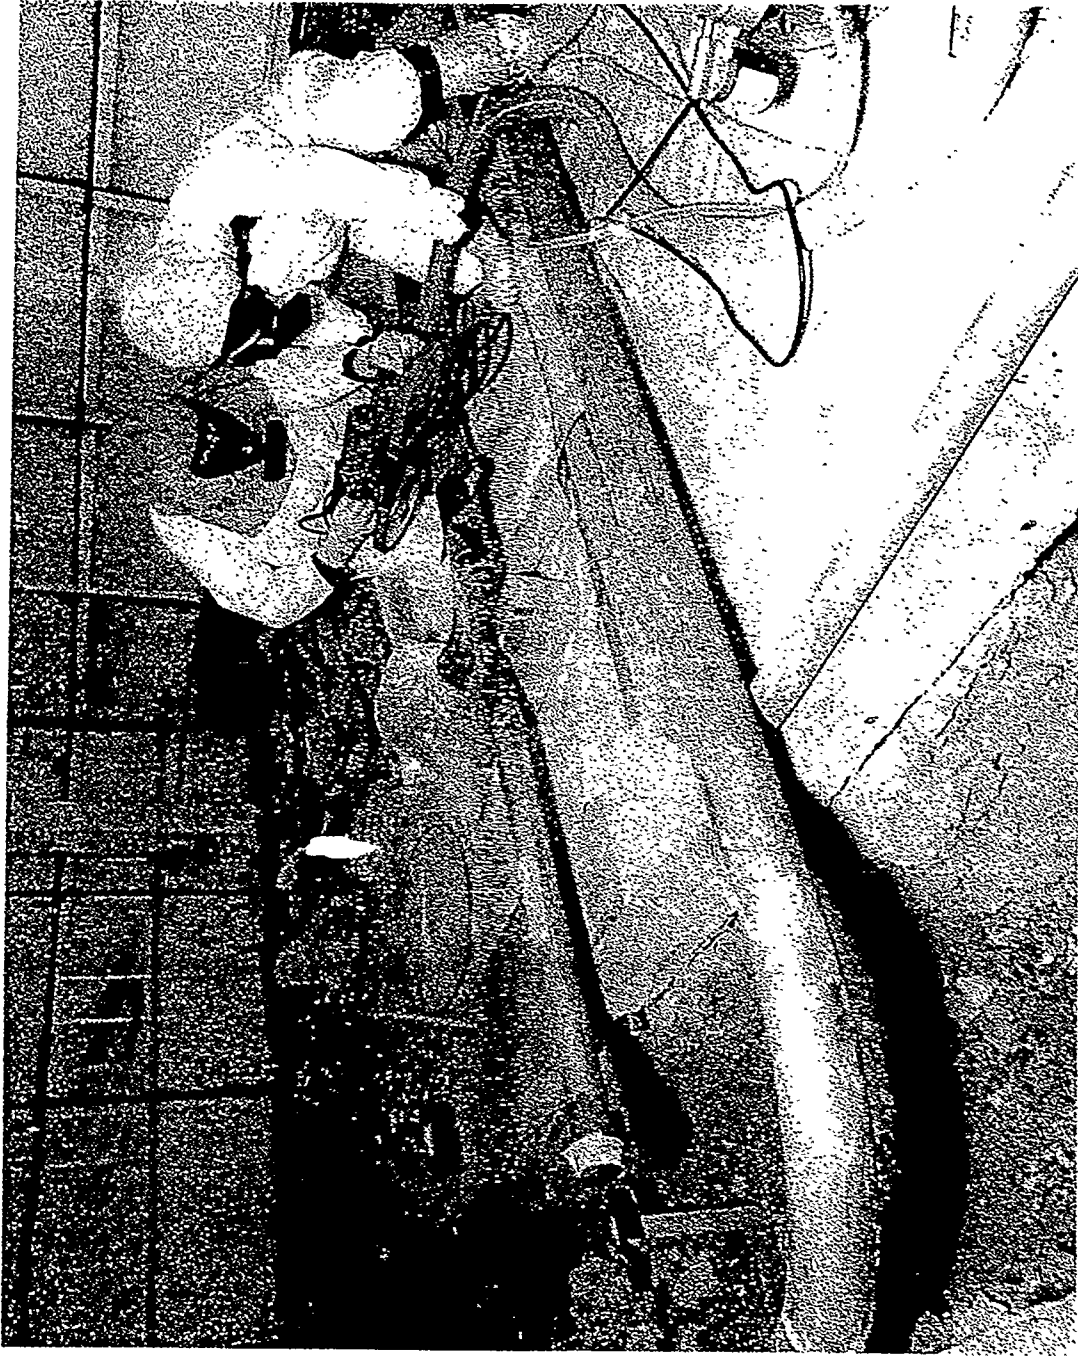
Figure 3-22

Downsizing Drain Lines

The radioactive support drain systems in Room 141, the Lab; Room 128, the Hot Repair Shop; and Room 139, the Glove Box Lab were exposed, removed, and size reduced (see Figure 3-21 & 3-22). The removed sections were packaged and shipped to RMDF for inspection and removal of any hazardous waste.

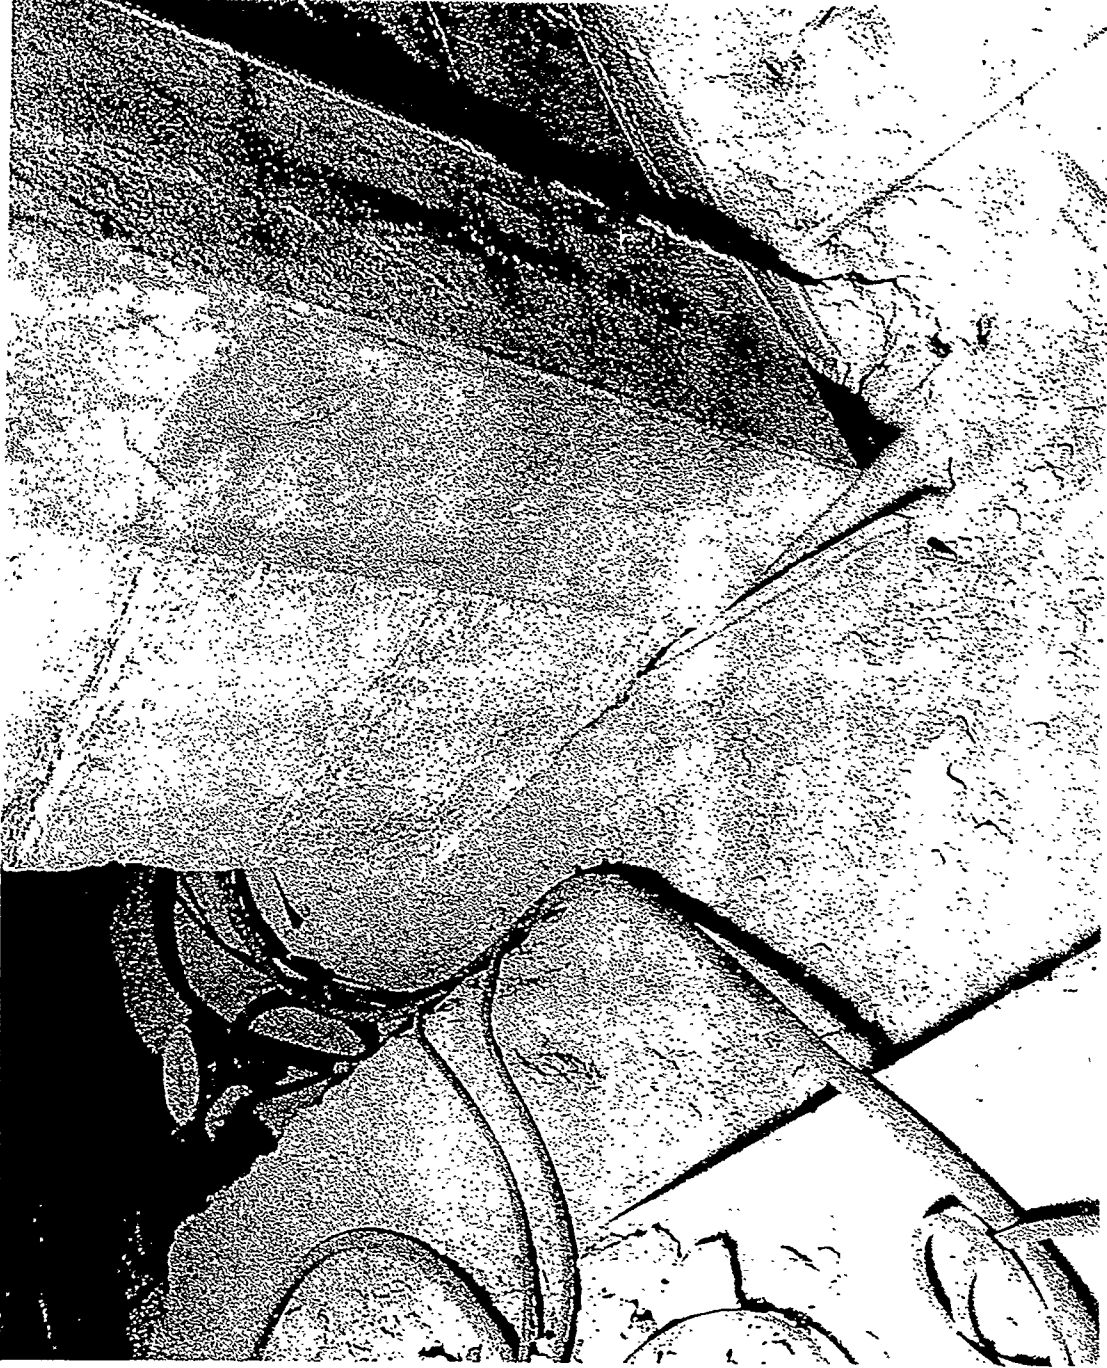
Figure 3-25

R/A Drain Line Under Wall

The concrete was removed from the floors and basement ceilings to expose the drains in the cells and decon rooms (Figures 3-23 to 3-25). Additionally concrete was removed to expose the drain line under the wall between cells 1 and 2 (Figure 3-26). Drain piping removed had radiation contact readings from up to 1R/hr high from cell 2 to 5R/hr high from cell 3. The high readings were caused by debris inside the piping. After removal of the radioactive debris inside, the drain piping had contact readings of 20-25 mR/hr and could be packaged as low level radioactive waste, which was shipped to RMDF (Figures 3-27 and 3-28). The debris, which has gamma radiation readings of up to 20R/hr is being put into vented one gallon cans, which are then placed into shielded drums with HEPA filter vents. Some of the debris is suspected of containing transuranic (TRU) material and is being transferred to RMDF for interim storage.

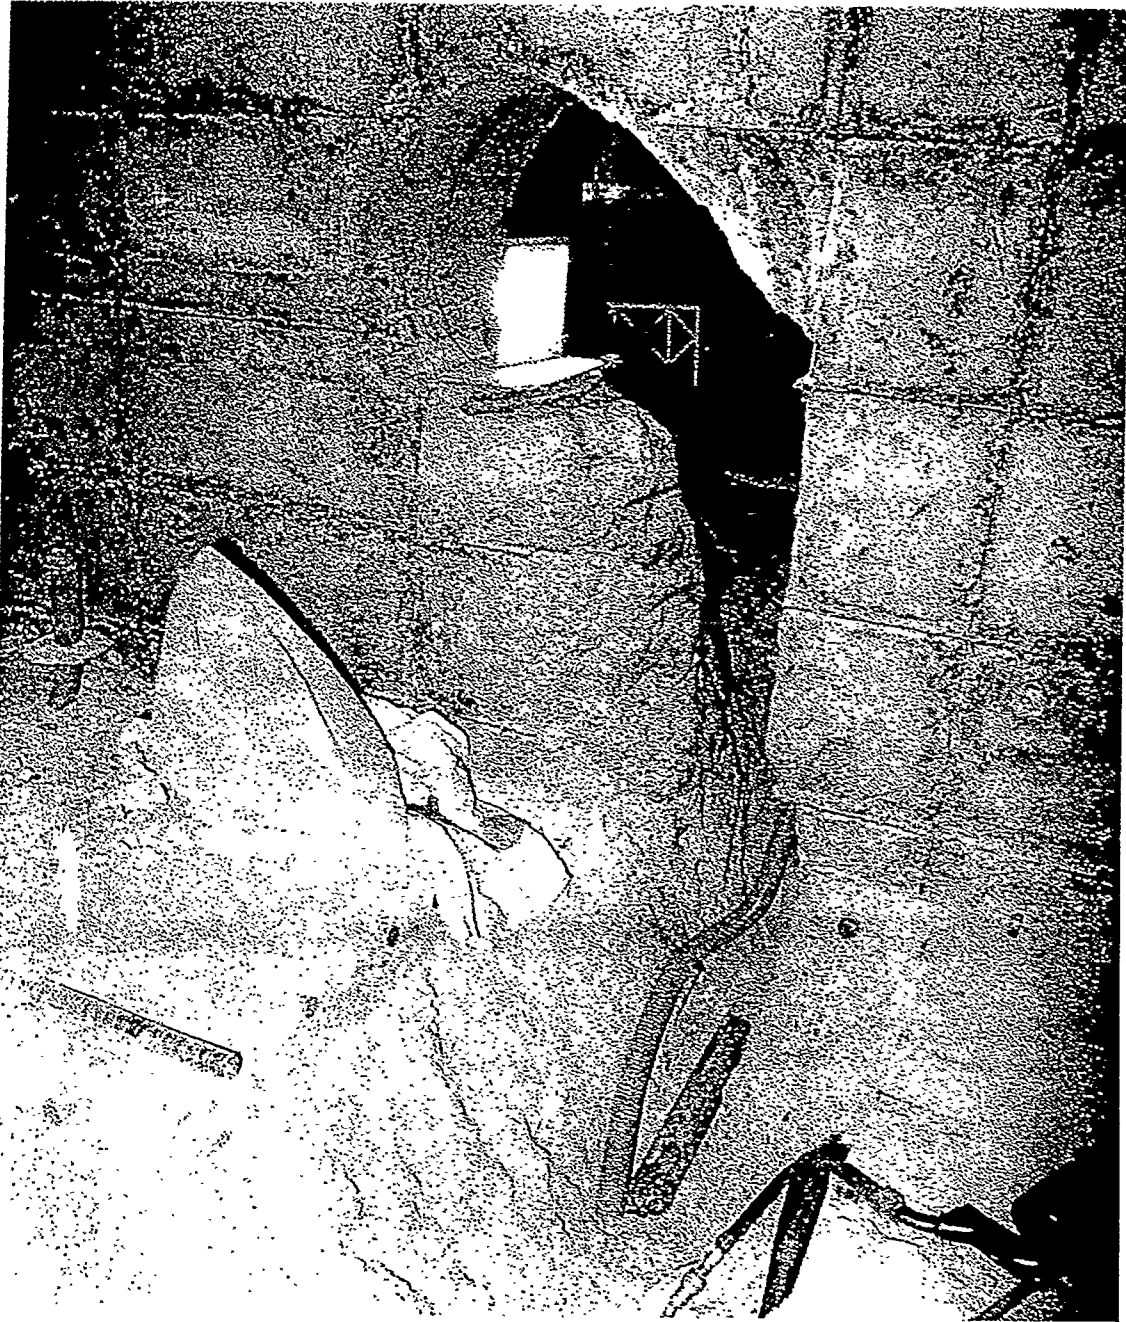
Figure 3-26

R/A Drain Line Through Wall

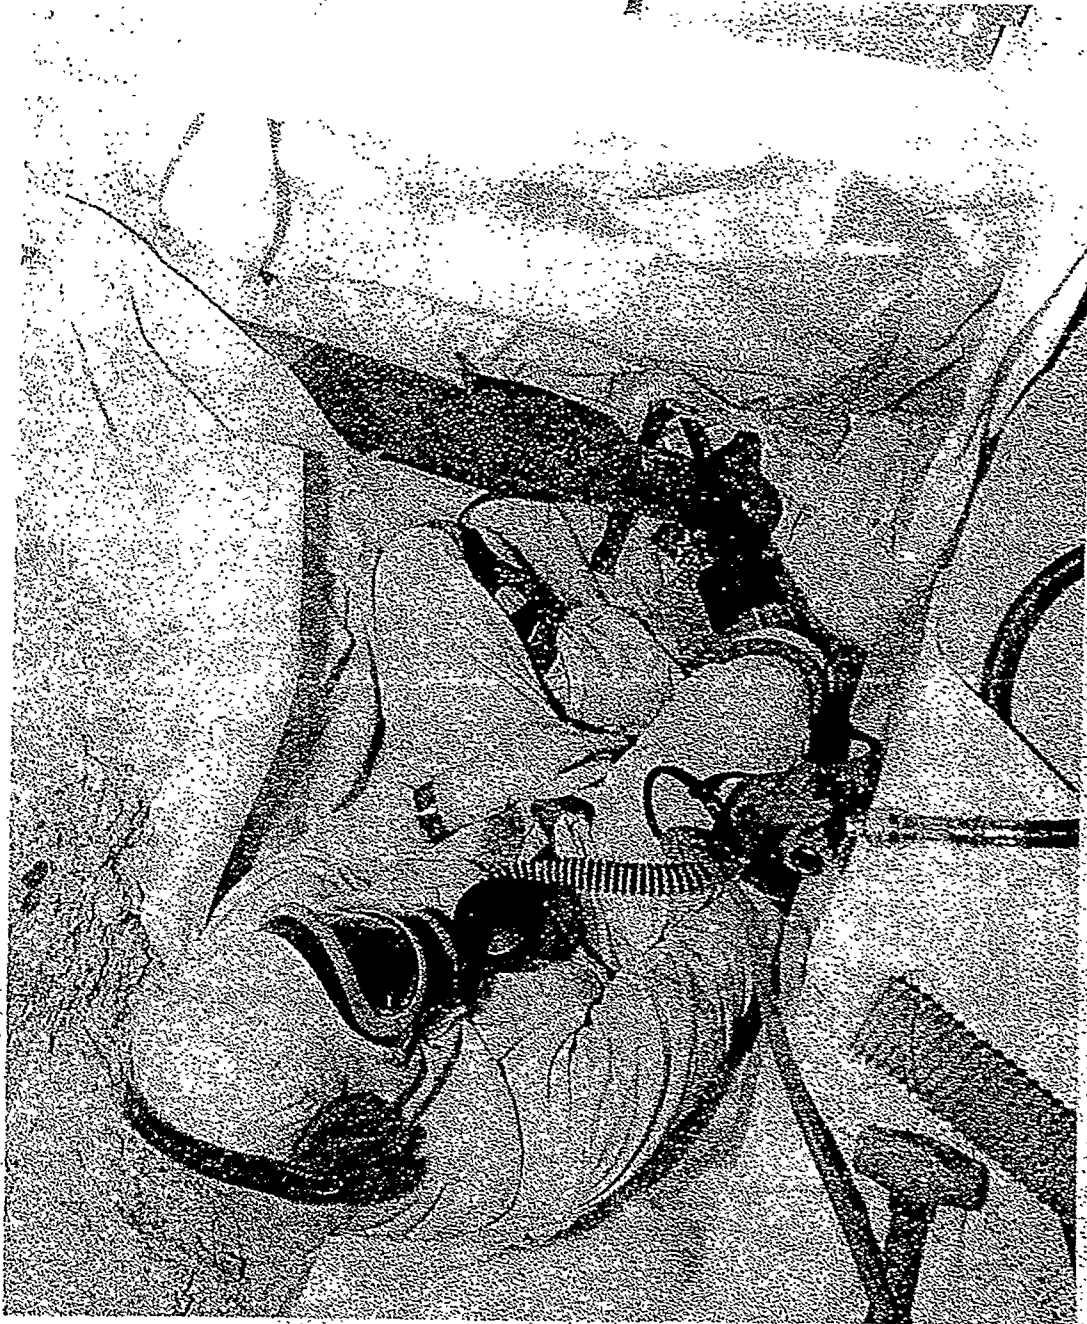
Figure 3-28

Downsize Cutting of Drain Line
