DOE/NV--801

Post-Closure Inspection Report for
Corrective Action Unit 426:
Cactus Spring Waste Trenches
Tonopah Test Range, Nevada
Calendar Year 2001

January 2002

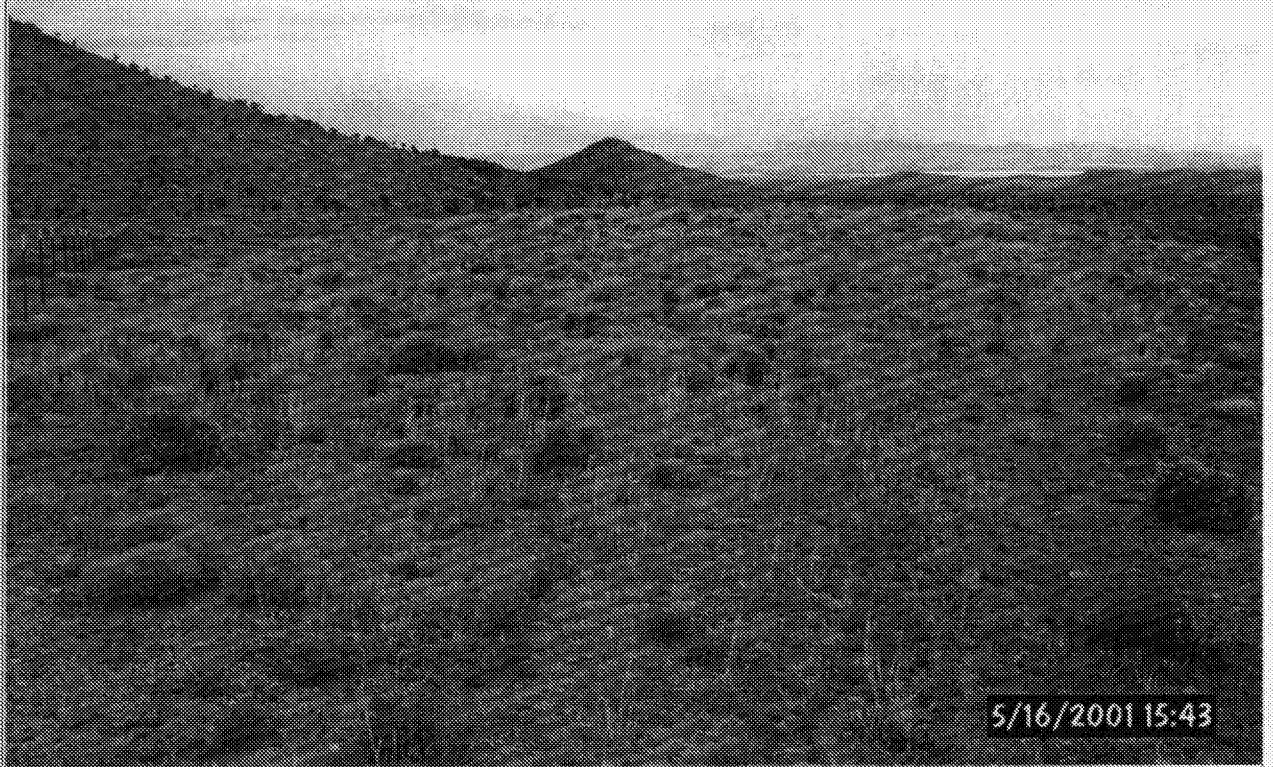
PHOTO NUMBER	DATE	DESCRIPTION
1	05/16/2001	View of the cover and staging area looking east. Vegetation is very healthy inside fenced area.
2	05/16/2001	View of the east end of cover looking west. Vegetation is very healthy at the base of the cover and on the cover.
3	05/16/2001	View to the north of southern side of cover from inside fence.
4	05/16/2001	View to the northeast of the cover of west and south sides of cover.
5	11/06/2001	View to the east of gate and fenced area. Vegetation inside fenced area is well established and healthy; it is as dense as vegetation outside the fence in undisturbed area.
6	11/06/2001	View to the east of staging area and cover from inside the fence.
7	11/06/2001	View to the south of east edge of cover from inside the fence.
8	11/06/2001	View to the west of east edge of cover from inside the fence. Vegetation is well established, healthy and as dense as undisturbed areas outside the fence.
