Title and Subtitle: Cold Work Embrittlement of Interstitial Free Steel

Authors: Pierre Martin and John T. Bowker

Materials Technology Laboratories (MTL)
Canada Centre for Mineral and Energy Technology (CANMET)
568 Booth Street
Ottawa, Ontario K1A 0G1
Canada

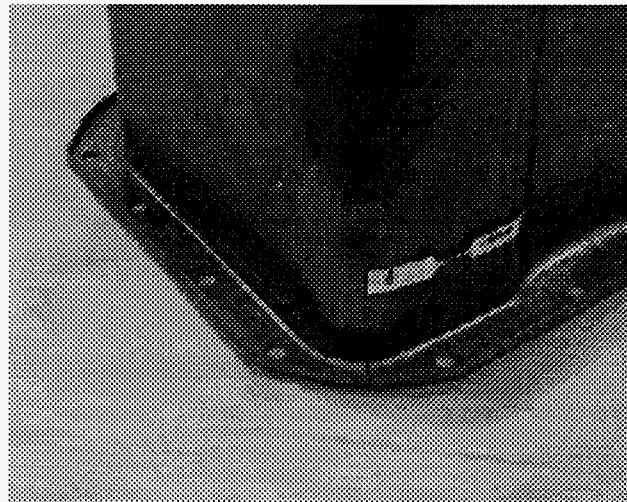
Fig. A-2. View of oil pan showing cracking of flange created during secondary forming operations.

An examination of Fig. A-2 shows the cracking of the flange created during secondary forming operations. Using the 2-in. diameter cup/expansion test, the ductile to brittle transition temperature for this steel S6b was determined to be -20°C (as shown in the main report). Although this result is not as high as that for a highly sensitive rephosphorised IF galvanized grade (0°C), it is still well above other grades that do not exhibit SCWE ($\text{DBTT} \leq -45^{\circ}\text{C}$).

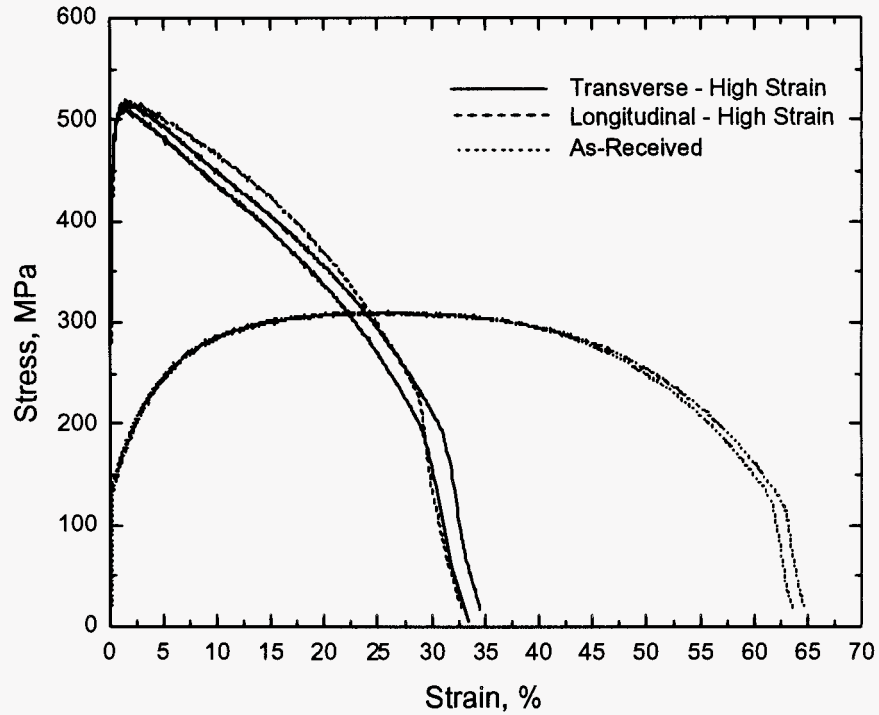
Fig. A-8. Monotonic stress-strain results for as-received sheet and high strain condition (transverse and longitudinal direction).

The monotonic stress strain curves for the as-rolled condition and in the longitudinal and transverse orientation for the high strain condition are shown in Fig. A-8. The yield, tensile, elongation, and strain-hardening exponent are summarized in Table A-3. In the high strain condition there is no real difference between the transverse and longitudinal directions. However, as expected, there is a substantial increase in yield and tensile strength, and decrease in elongation, from the as-received sheet.

The cyclic and monotonic stress strain behaviours from Figs. A-8 and A-11 are compared in Fig. A-26. Cyclic softening for the high-prestrained material and cyclic hardening for the as-rolled condition are evident. However, the cyclic stress-strain behaviour of the high-prestrained material is significantly above that of the as-rolled material. The difference is significantly larger than that apparent in Yan et al. [5] where the maximum applied prestrains investigated were 12% compared to the estimated 89% in this study. The amount of cyclic softening and hardening is affected by dislocation mobility and substructure. It is thought that the amount of prestrain investigated in [5] was sufficient to increase yield strength to similar levels as this study but did not produce as high a level of dislocations and dislocation tangles. It is thought that this resulted in similar cyclically stabilized conditions in [5] for prestrained and as-rolled material. The high prestrain levels in the present study would have produced highly dense dislocation structures that would result in different cyclically stabilized conditions.

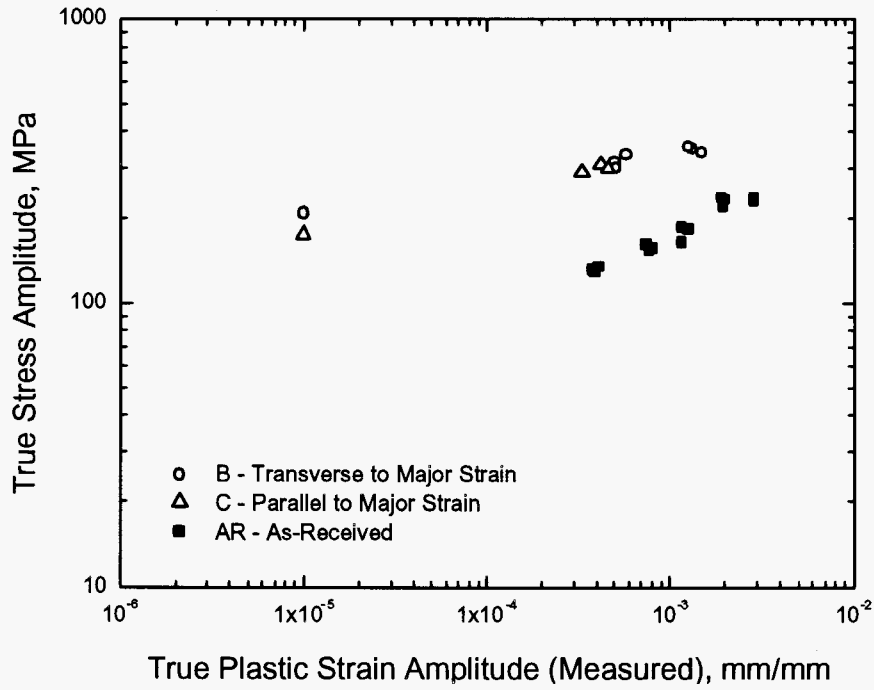
Fig. A-10. Measured true plastic strain amplitude as a function of true stress amplitude at half-life.

Figure A-10 shows the results for the measured true plastic strain amplitude as a function of true stress amplitude at half-life. The specimens for the as-received condition show a significant decrease in stress amplitude for a given plastic strain amplitude. Given the limited data for the high strain condition, there appears to be no significant difference in plastic strain behaviour as a result of specimen orientation in the high strain condition. Applying linear regression analysis to this data for the as-received and deep drawn conditions the cyclic strength coefficient, k' , and strain hardening exponent, n' , were determined. Table A-4 summarizes the results including the cyclic yield strength calculated from Eq 3. The cyclic true stress – true strain curves determined from Eq 2 ($E = 207\,000$ MPa) are shown in Fig. A-11 together with the actual test results at half-life. The results show a significant increase in stress amplitude for the deep drawn condition when compared to the as-received condition.

The analysis of the results in Figs. A-10 and A-11 indicated that there is no real difference in cyclic stress strain behaviour between the transverse and longitudinal orientations for the deep drawn condition. This is also observed for the monotonic tensile results in Fig. A-8. These would tend to indicate that, at very high prestrain levels, one would not expect to observe an effect of orientation.

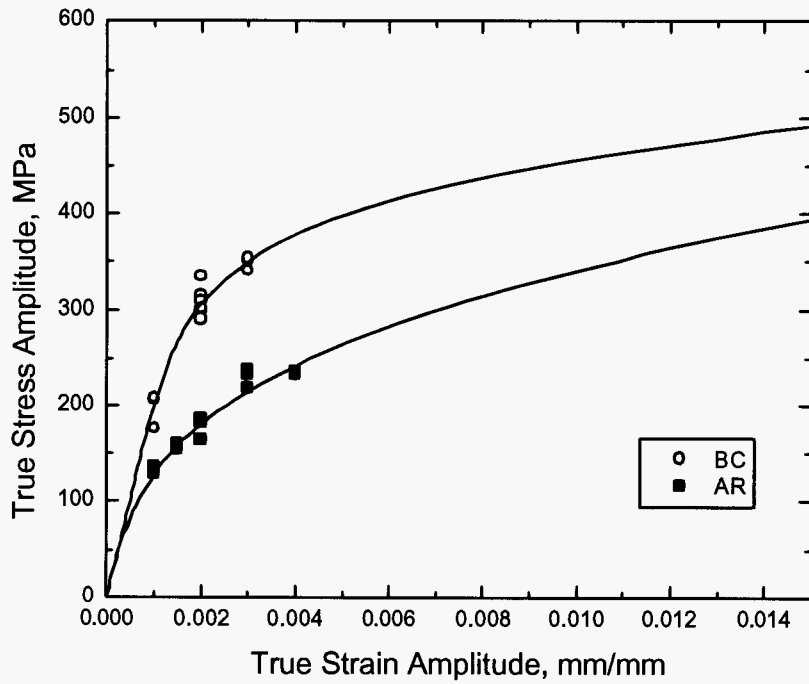
Fig. A-11. Cyclic true stress – true strain behaviour of as-received and deep-drawn conditions.

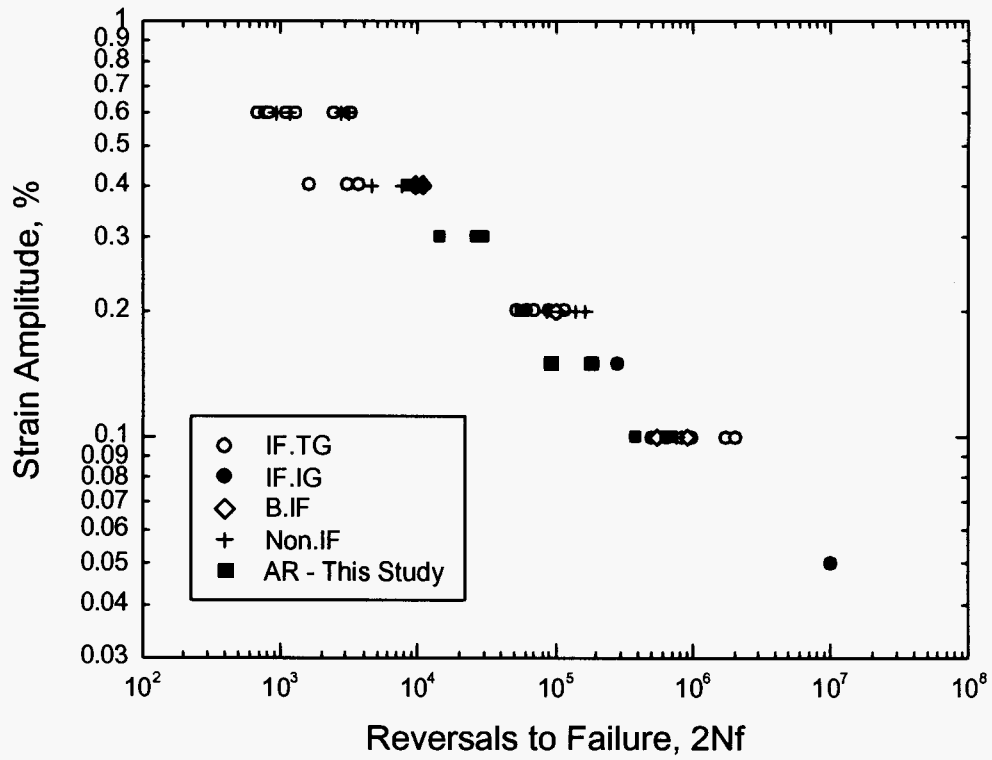
Fig. A-24. Strain amplitude vs. reversals to failure results for IF, Boron IF, and non-IF sheet steels from Yan [1] compared to the as-rolled condition results in this study.

A comparison of fatigue strain – life results for the as-rolled condition with those by Yan [1], Fig. A-24, indicate that the fatigue behaviour of steel S6ba is consistent with other IF and non IF sheet steels. Also, as noted in the previous section, fatigue cracking at applied strain amplitudes of 0.3% and lower occurred by a mixed intergranular/transgranular mode. This too, is consistent with previous observed behaviour that suggests that the appearance of this mode of cracking, and hence SCWE, does not adversely affect fatigue life.

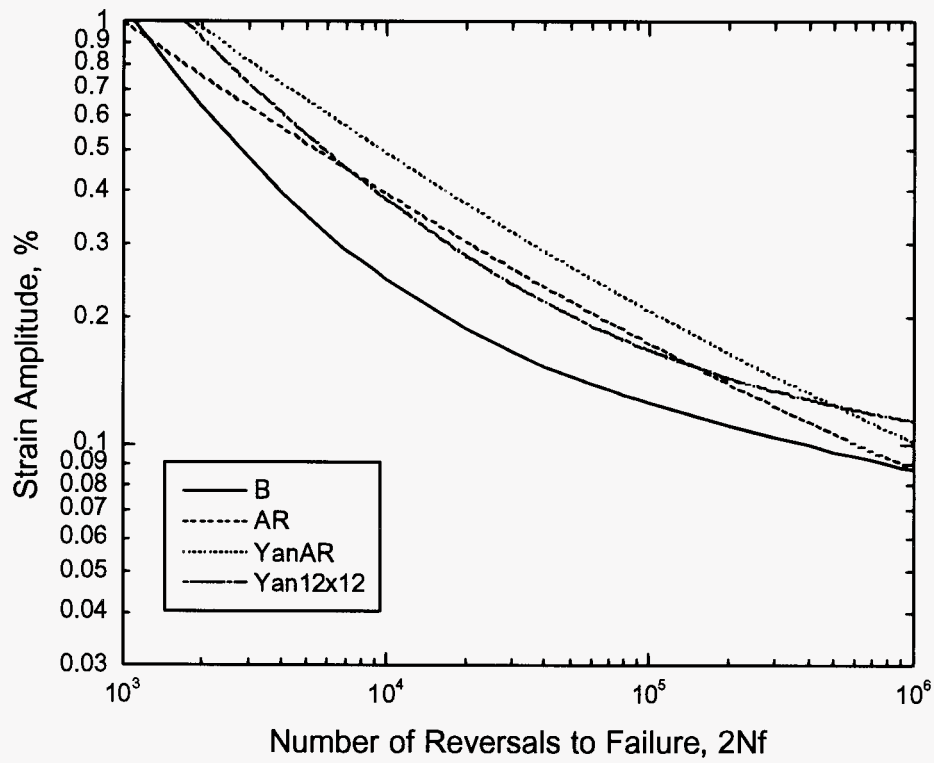
Fig. A-25. Strain – life curves for as-rolled and prestrained conditions for this study and Yan et al. [5].

Recently, Yan et al. [5] have studied the effect of forming strains on the fatigue behaviour of an interstitial-free (IF) grade steel. In the long-life region they found that prestrain improves fatigue resistance while in the short-life region fatigue resistance is reduced. This is consistent with previous work by Morrow, Manson, and others (see Hertzberg [10]) where decreases in the cyclic strain hardening exponent, n' , resulting from forming strains are associated with increases in fatigue life at low strain amplitudes and decreases in fatigue life at high strain amplitudes. Yan et al. [5] also noted an effect of specimen orientation for non-balanced biaxial prestrains where the direction perpendicular to the major strain exhibits a higher monotonic yield strength and slightly better fatigue resistance in the long life region than for the direction parallel to the major strain. The results of this study are somewhat different from those of Yan et al. [5] and indicate that, at very high prestrain levels, there is a significant effect of orientation on fatigue life.
