# MONITORING TECHNOLOGY FOR EARLY DETECTION OF INTERNAL CORROSION FOR PIPELINE INTEGRITY

**Final Report**  
**March 25, 2002 – September 24, 2003**

DOE Award Number DE-FC26-02NT41319  
SwRI® Project 14.05529

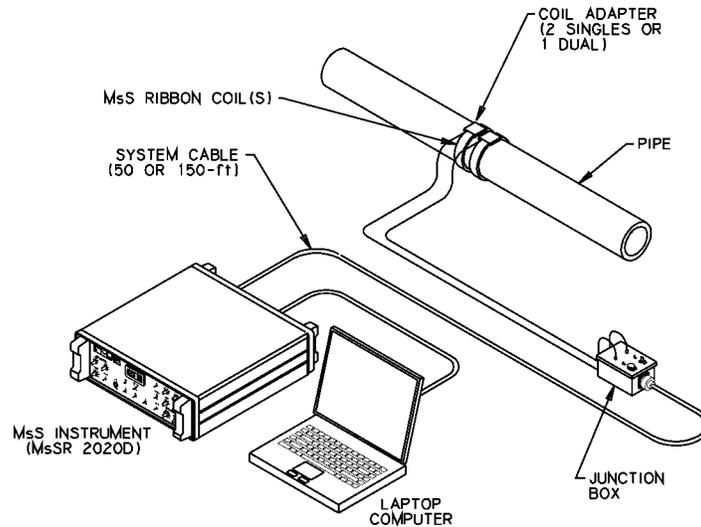
**Figure 1. A schematic diagram of the MsS and associated instruments**

pipe-wall and propagate along the pipe. When guided waves are reflected from welds or defects in the pipe arrive at the sensor location, the waves generate electric voltage signals in the coil. The generation and detection of the guided waves are achieved electromagnetically via a physical phenomenon called “magnetostrictive” and its inverse effects. Figure 1 illustrates the MsS system as applied to pipe.

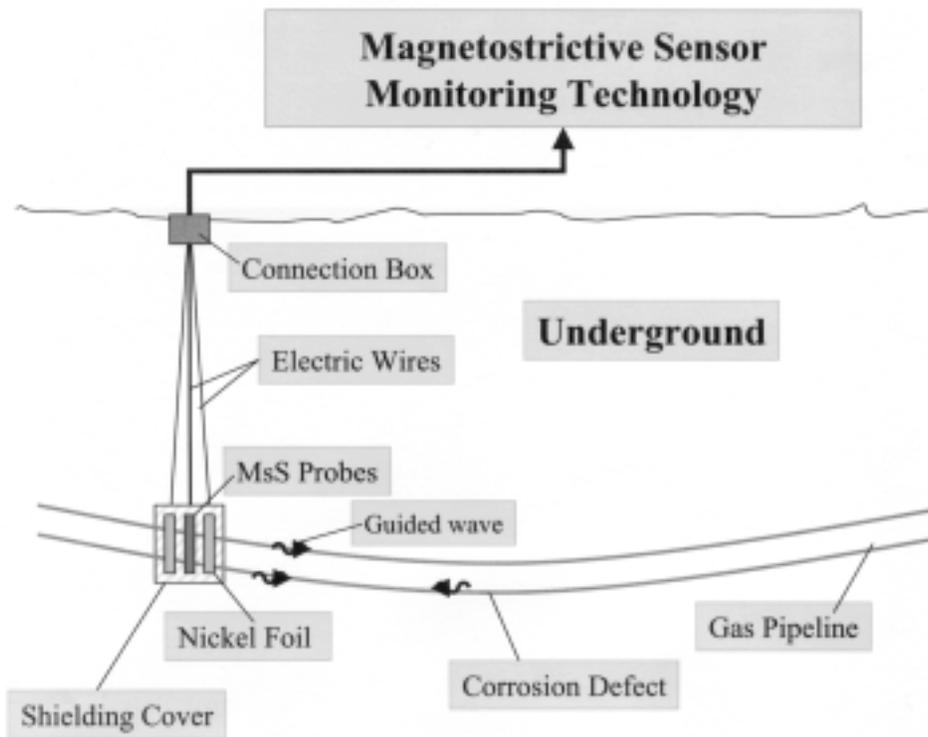
**Figure 2. Illustration of MsS torsional wave technology applied to pipeline in monitoring scenario**

Structural integrity of pipelines in these areas can be cost-effectively achieved by affixing the MsSs to the pipeline within 3.5 to 6 m (10 to 20 feet) of the low point and terminating the electrical leads of the MsSs at a connector box at the surface where an inspector could periodically collect MsS data sets as illustrated in Figure 2. These data sets would be compared to the previous data sets to detect any slight changes caused by initiation or growth of defects in that area.

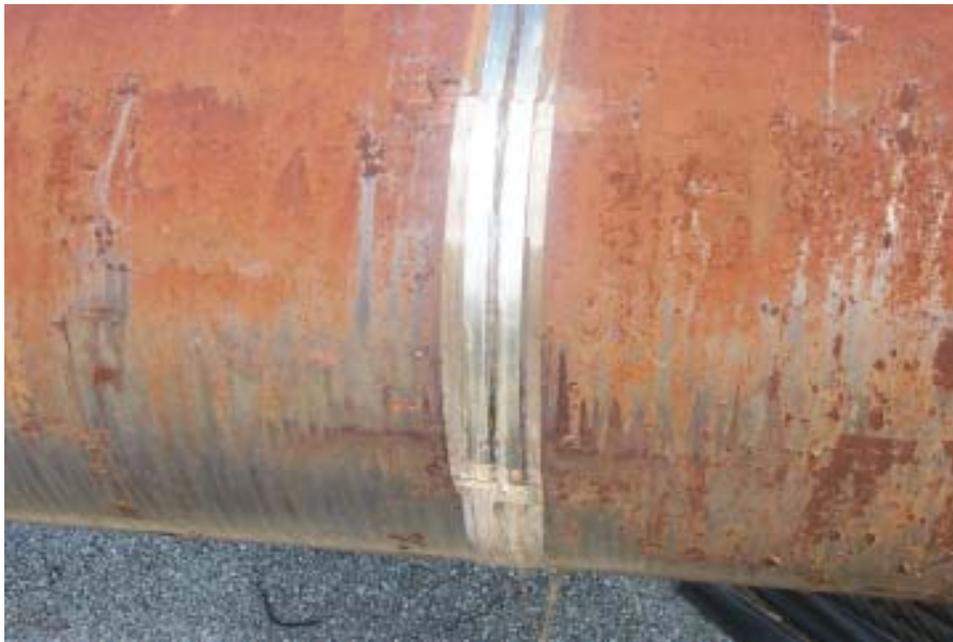
**Figure 3. Photograph showing nickel strip bonded to the 610-mm (24-inch)-diameter pipe. The two strips are used to provide directionality in the transmitted signal.**

A T-wave MsS, consisting of a 0.25-mm (0.01-inch)-thick nickel foil epoxied to the pipe (shown in Figure 3) and a coil consisting of 20 windings wrapped around the nickel foil (shown in Figure 4), was used to collect 32-kHz MsS data from the 610-mm (24-inch)-OD, 9.5-mm (0.375)-inch-thick wall pipe. Data were collected from the pipe prior to and after placing various types of artificial simulated corrosion pits. These simulated corrosion pits ranged in size from approximately 5 mm (0.2 inch) deep by 40.6 mm (1.6 inches) in diameter to 9.5mm (0.375 inch) deep by 57.2 mm (2.25 inches) in diameter (or 0.33% to 1% of the total pipe wall cross section). These defects were placed on the outside and inside surfaces of the test pipe. MsS data were collected from 0.33% defects, 0.66% defects, and 1% defects. Locations of defects along the pipe axis are shown in Figure 5 and schematically represented in Figure 6 (with the depths and diameters of the various percentage defects). A photograph and replica of the 1% defect are shown in Figure 7.

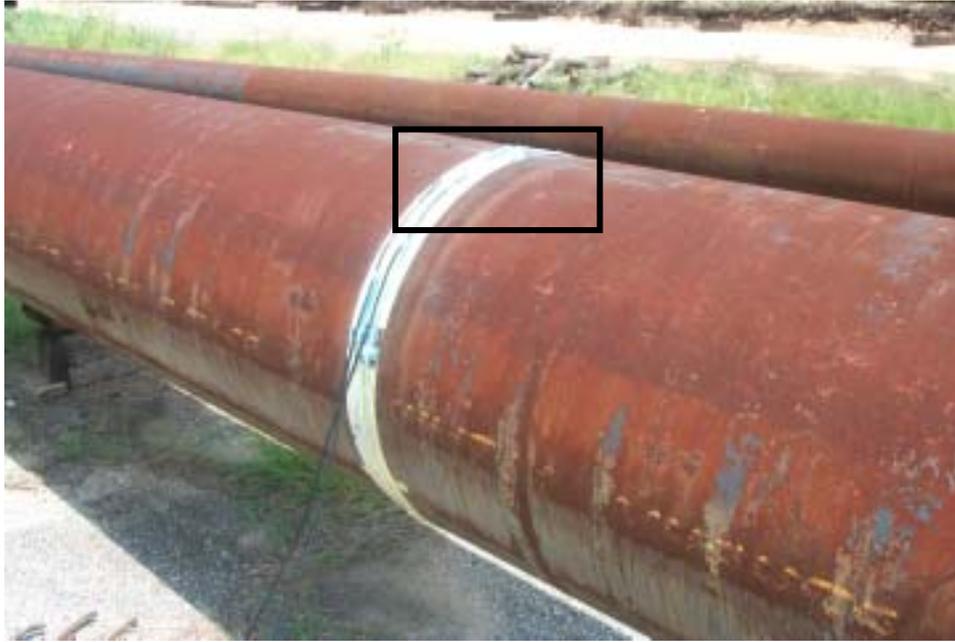
**Figure 4. Photograph of the nickel strip and coil bonded to the test pipe showing the low height profile of the MsS**

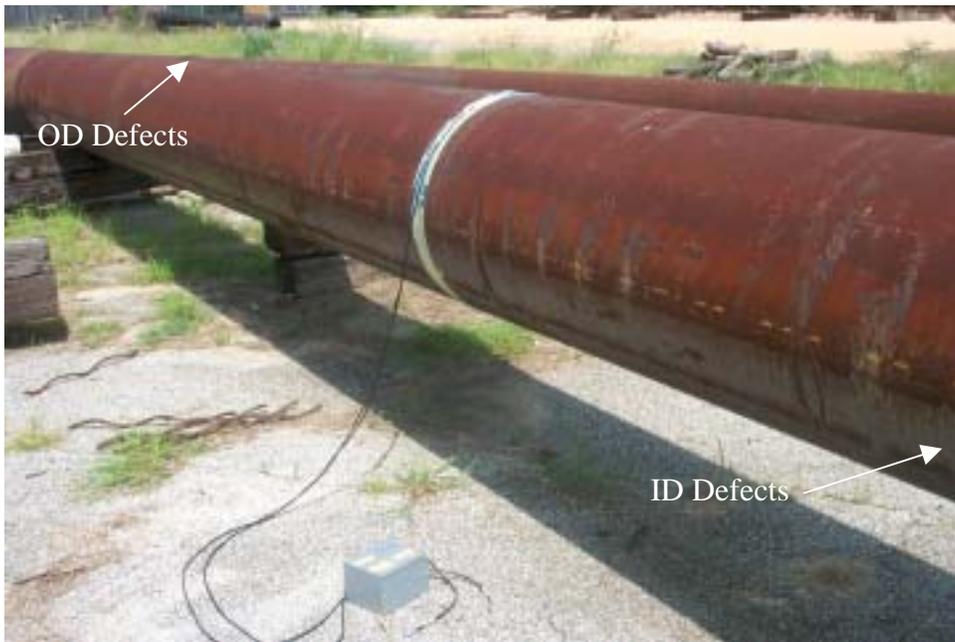
**Figure 5. Photograph of the 610-mm (24-inch)-diameter pipe showing the location of the MsS and the OD and ID defects along the pipe axis**

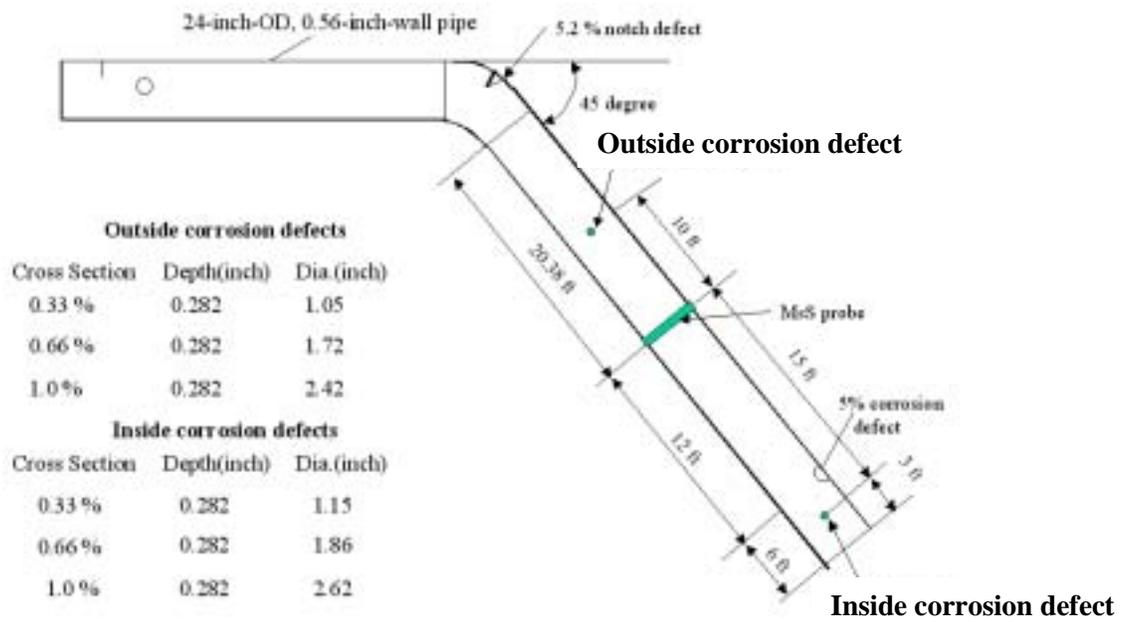
**Figure 6. Schematic drawing of the experimental arrangement used for evaluation of MsS monitoring on above-ground pipe**

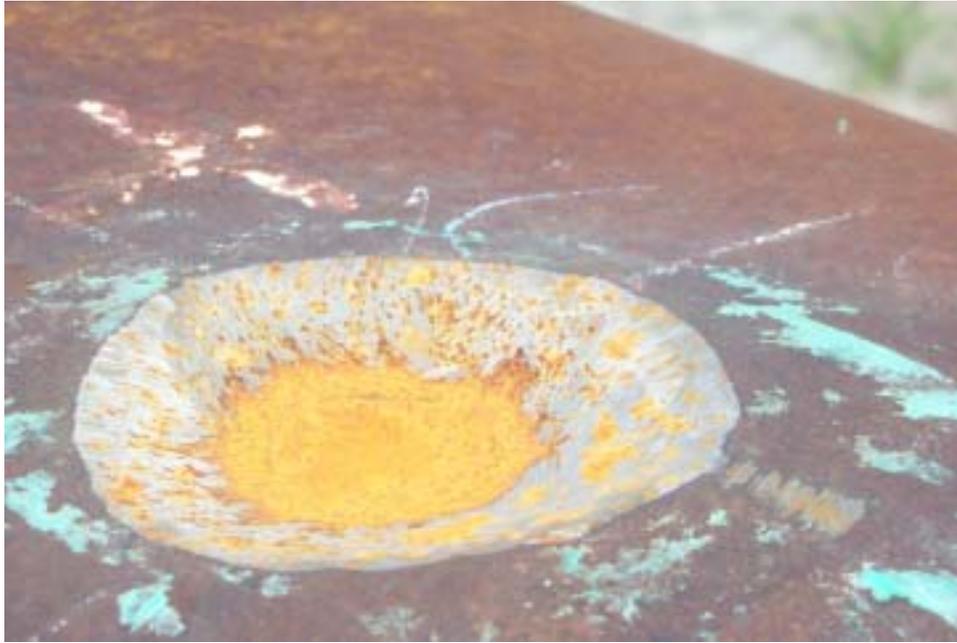
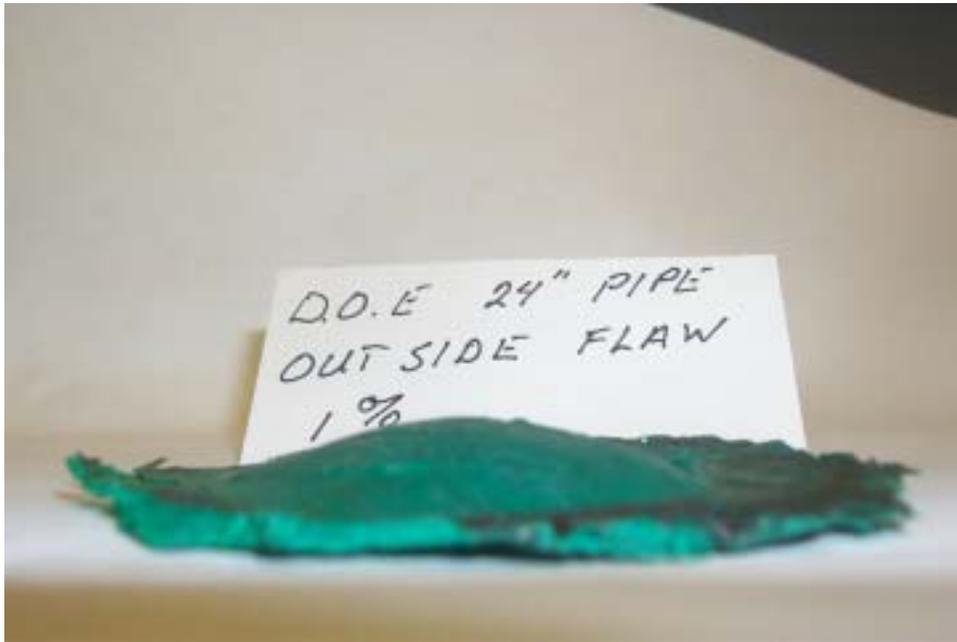
**Figure 7. Photograph showing (a) the topography and (b) replica of the intentionally placed 1% cross-sectional defects**

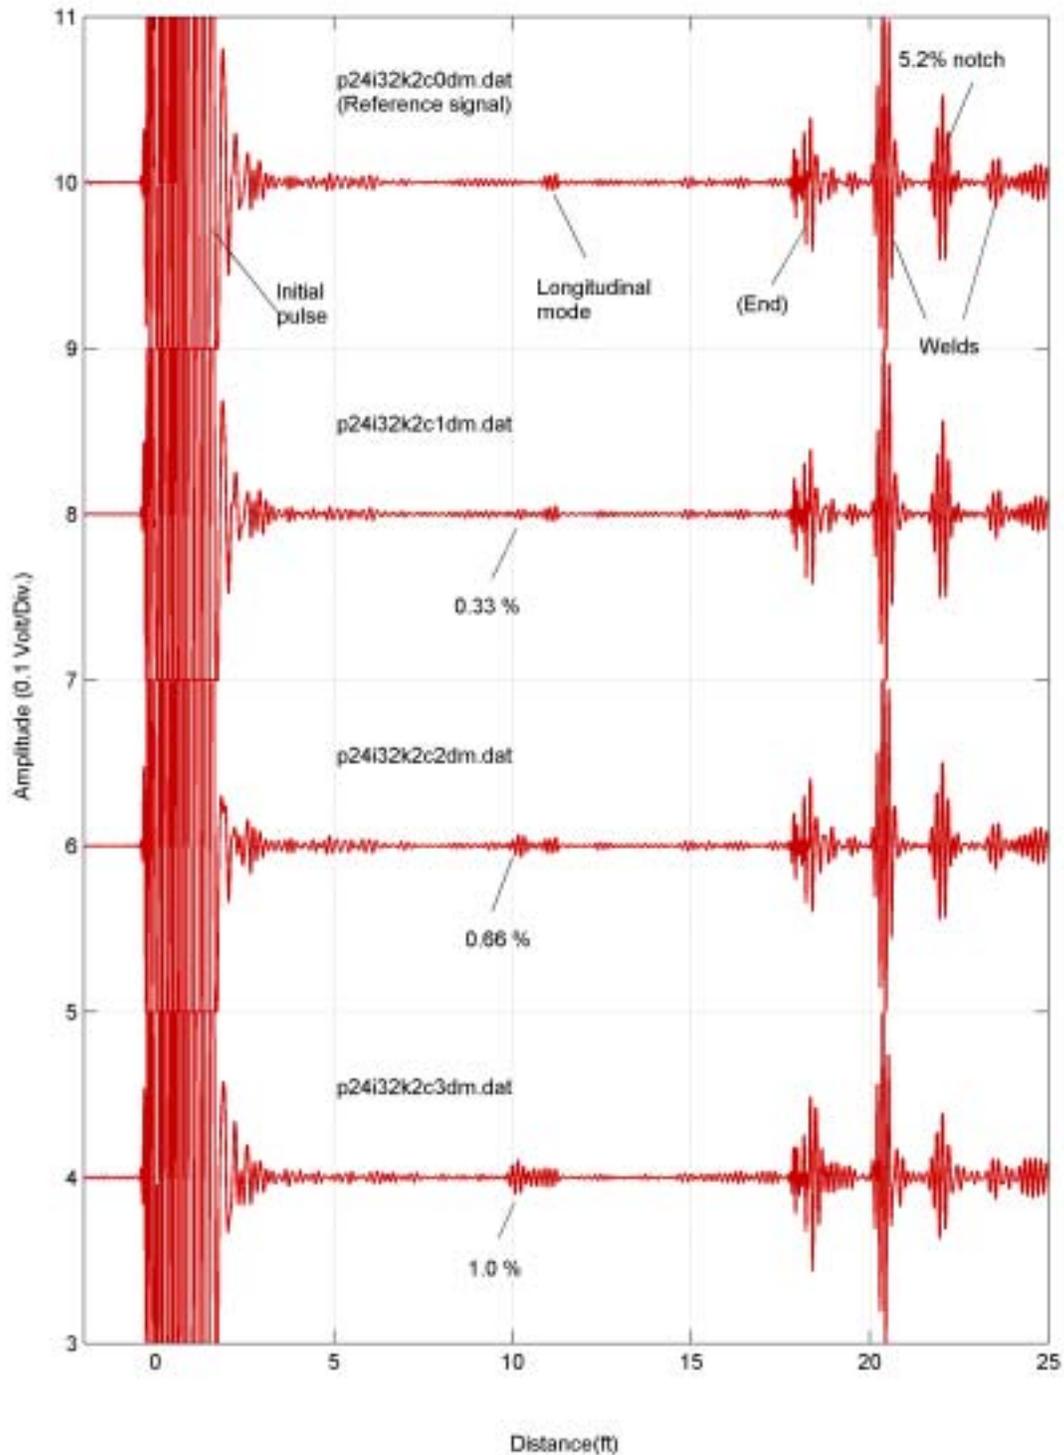
**Figure 8. MsS inspection data obtained from the region of the pipe where the OD flaw is located. The top waveform shows no defect. The remaining waveforms are from a 0.33% defect placed in the pipe, and the defect size is increased to 0.66% and 1% of the pipe wall cross section.**

MsS data were collected from the intentionally placed ID and OD defects. The OD defects were on one side of the MsS sensor and the ID defects were on the other side. Figure 8 shows the actual inspection data collected from the pipe with no OD defect, with an OD defect that is approximately 0.33% of the pipe wall cross section, with the OD defect increased to 0.66% of the pipe wall cross section, and finally with the OD defect increased to 1% of the pipe wall cross section. This defect is approximately 3 m (10 feet) from the MsS. The 0.33% defect is difficult to see in Figure 8, but the 0.66% and 1% defects can clearly be detected. The preliminary monitoring data are shown in Figure 9 where the MsS inspection data collected prior to placing defects in the pipe are used as the reference waveform. These data clearly show that defects as small as 0.33% can be detected in the monitoring mode. The signals on the right side of the last waveform in Figure 9 are caused by slight changes in temperature and the slight offset in subtracting two large signals. In addition, when the amplitude of the signal that would normally travel to the weld and the 5.2% notch is decreased because the signal is scattered by the 0.33%, 0.66%, and 1% defects, then the difference waveform between the reference where there is no defect and the cases where the defect at 3 m (10 feet) increases from 0.33% to 1% would yield a larger and larger difference in the signals observed after the defect at 3 m (10 feet). This behavior is clearly seen in the difference data for the 0.33% and 1% defects. It is unclear why it appears to be minimal in the 0.66% data difference waveform. Similar data are shown in Figure 10 with the video signals.

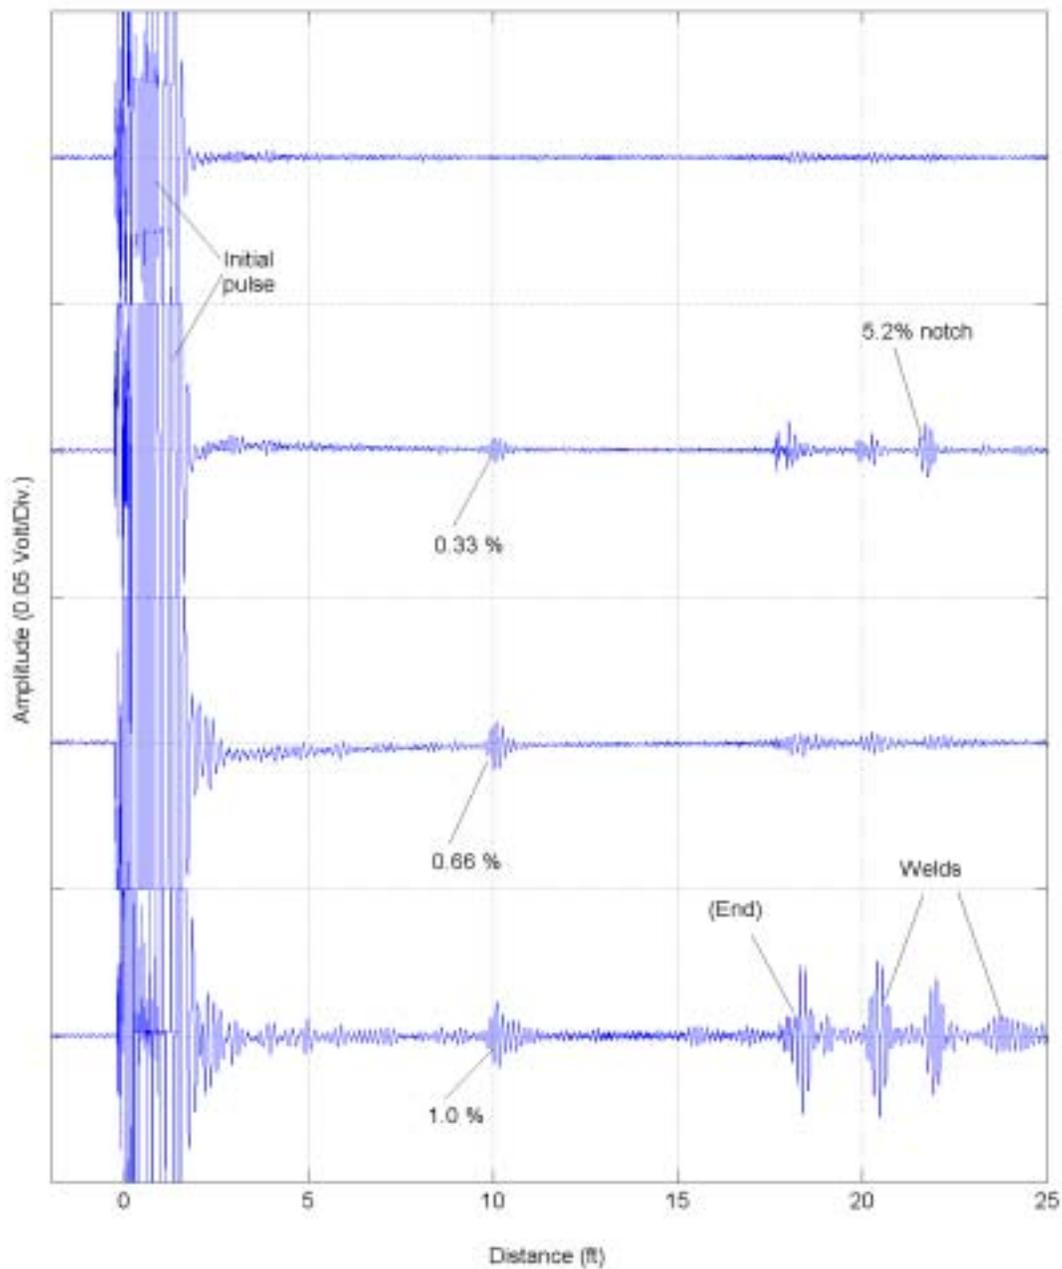
**Figure 9. Monitoring data (subtracted from the reference) obtained from the region of the pipe where the OD flaw is located. The top waveform is the result of subtracting two waveforms from the pipe where there is no defect. The remaining waveforms are the difference waveforms between the reference waveform and the waveform with a 0.33% defect placed in the pipe, and the defect size is increased to 0.66% and 1% of the pipe wall cross section.**

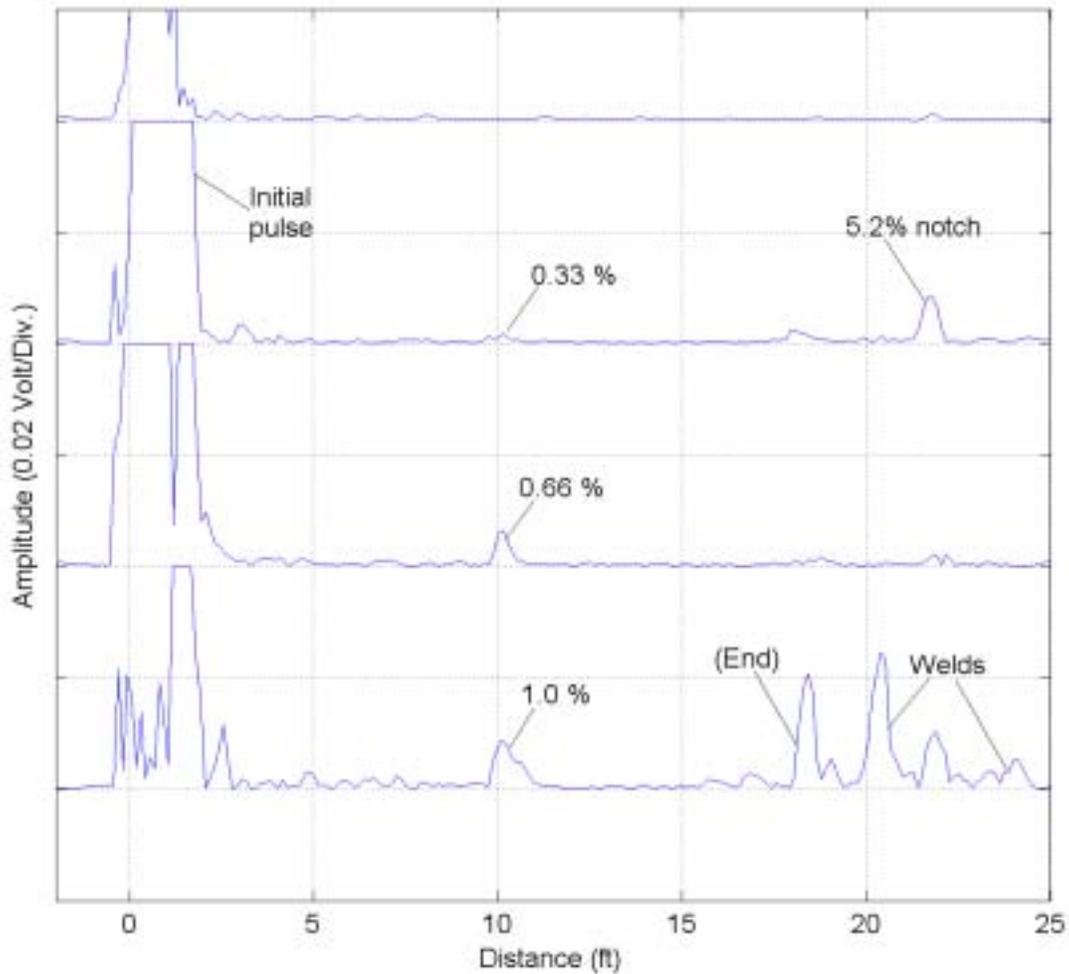
**Figure 10. MsS monitoring data (video) obtained from the region of the pipe where the OD flaw is located. The top waveform is the result of subtracting two waveforms from the pipe where there is no defect. The remaining waveforms are the difference waveforms between the reference waveform and the waveform with a 0.33% defect placed in the pipe, and the defect size is increased to 0.66% and 1% of the pipe wall cross section.**

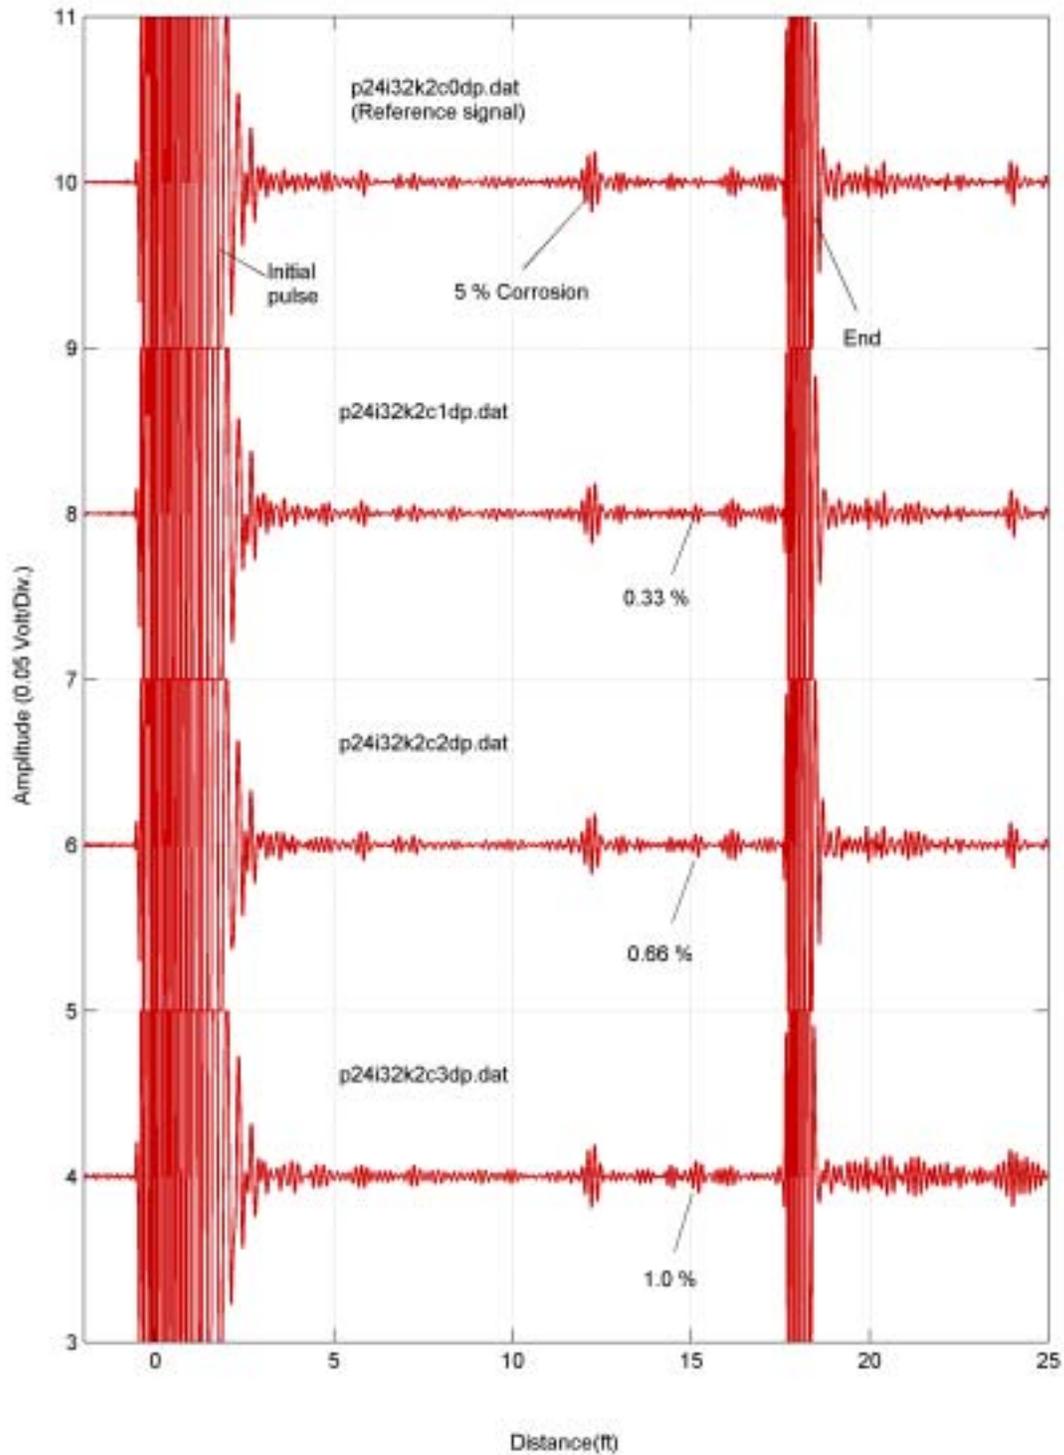
**Figure 11. MsS inspection data obtained from the region of the pipe where the ID flaw is located. The top waveform shows no defect. The remaining waveforms are from a 0.33% defect placed in the pipe, and the defect size is increased to 0.66% and 1% of the pipe wall cross section.**

Similar results were obtained for the ID defects. The inspection data waveforms are shown in Figure 11 and the monitoring (subtracted) waveform data are shown in Figure 12 and Figure 13.

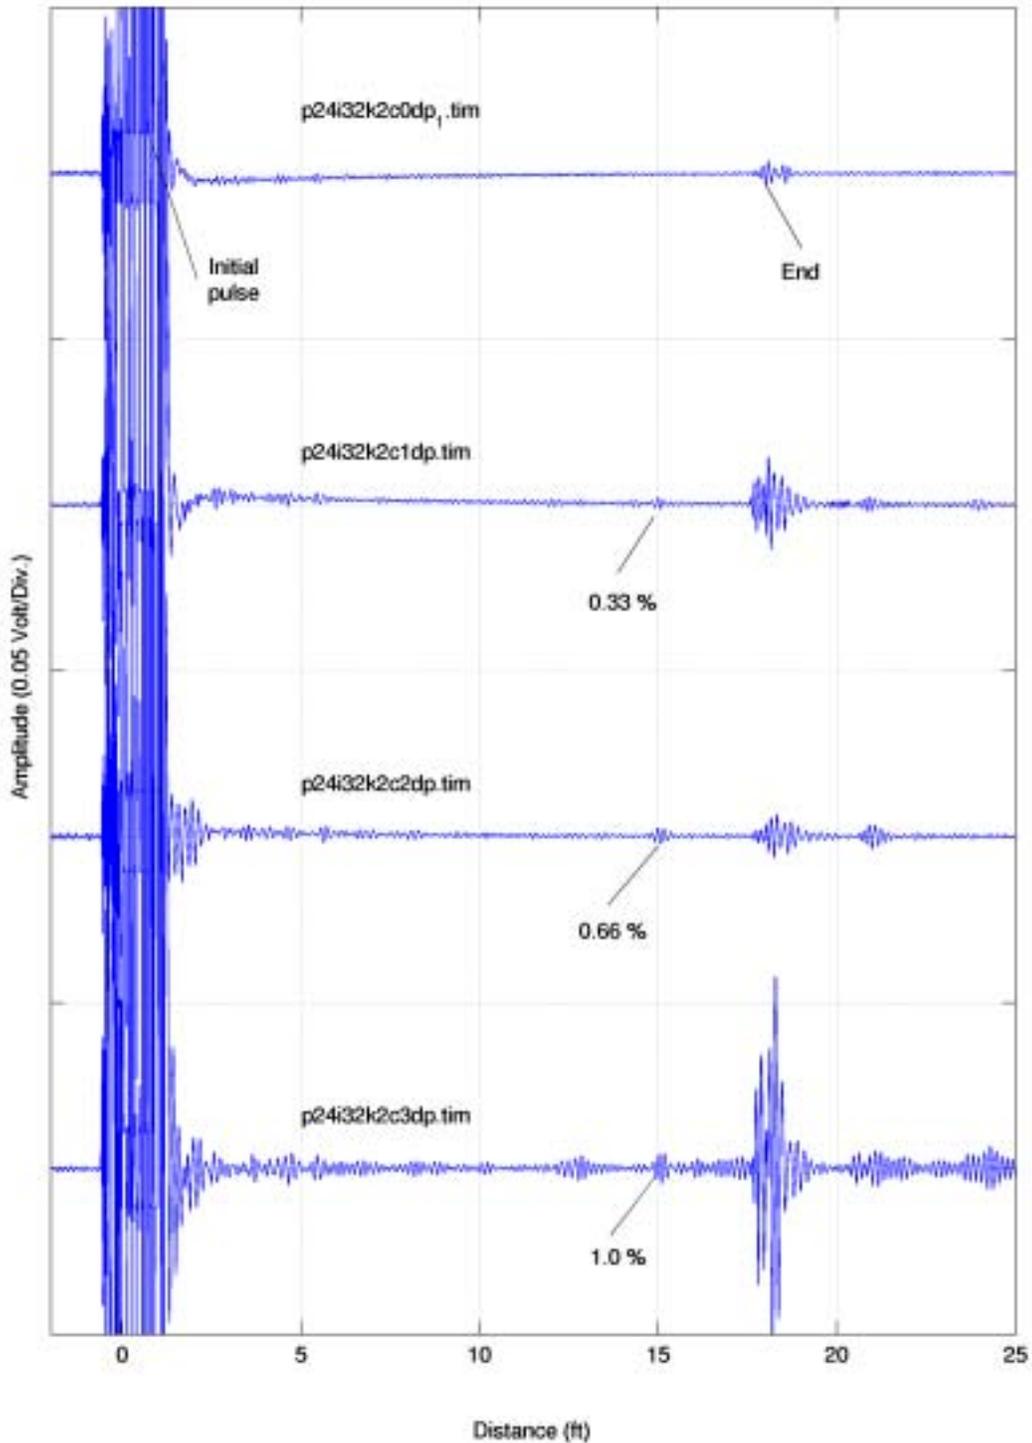
Figure 12. MsS monitoring data (subtracted from the reference) obtained from the region of the pipe where the ID flaw is located. The top waveform is the result of subtracting two waveforms from the pipe where there is no defect. The remaining waveforms are the difference waveforms between the reference waveform and the waveform with a 0.33% defect placed in the pipe, and the defect size is increased to 0.66% and 1% of the pipe wall cross section.

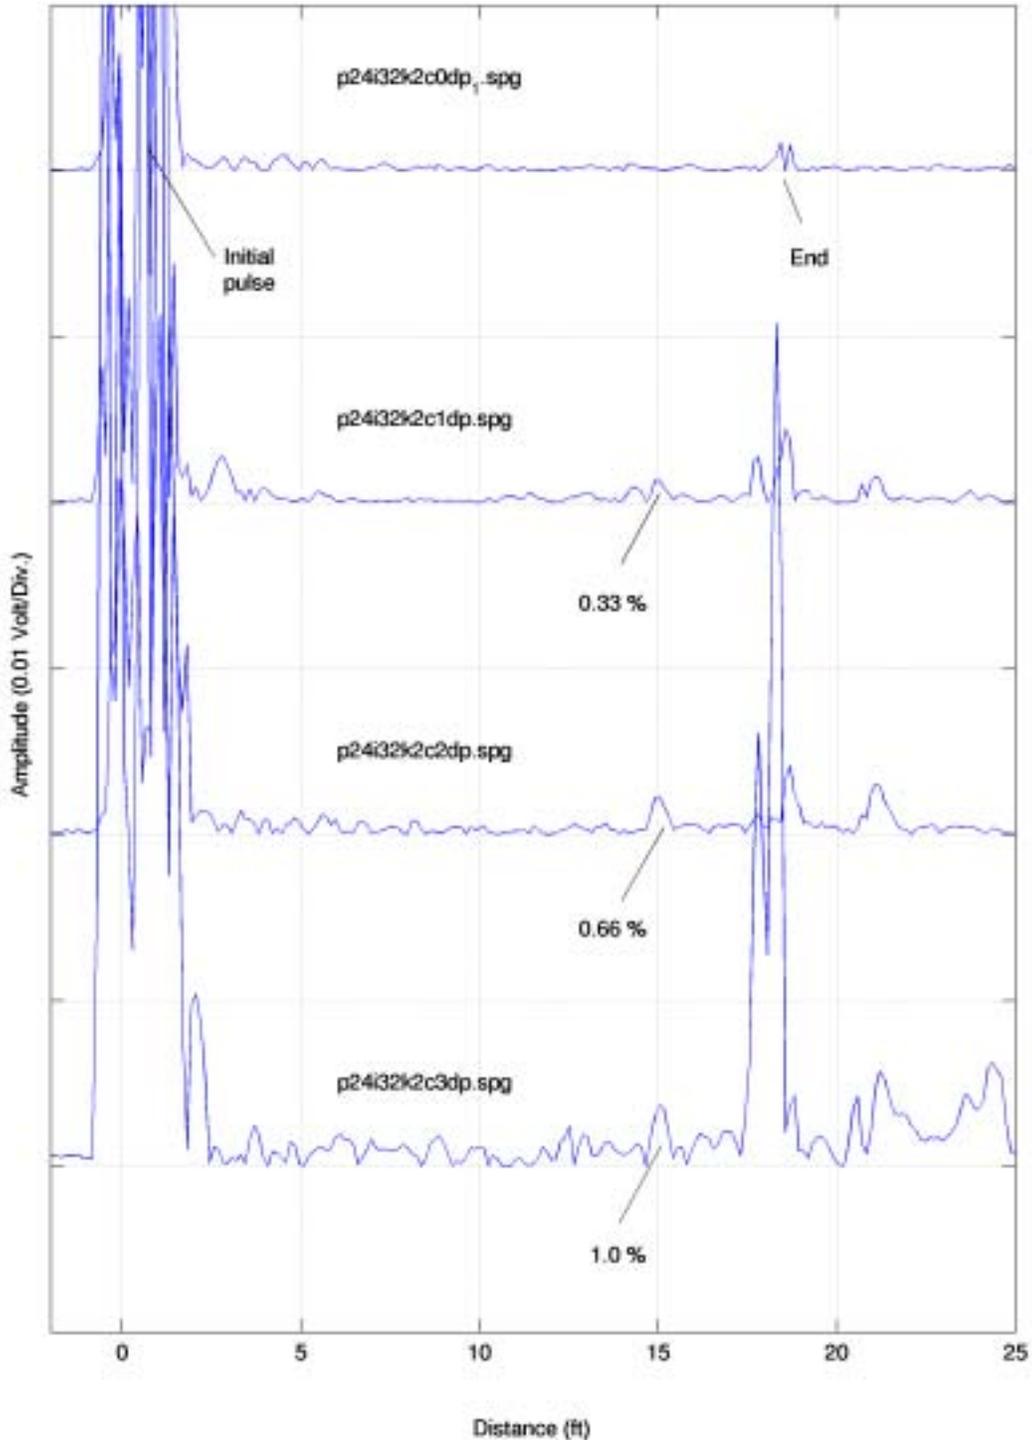
Figure 13. MsS monitoring data (video) obtained from the region of the pipe where the ID flow is located. The top waveform is the result of subtracting two waveforms from the pipe where there is no defect. The remaining waveforms are the difference waveforms between the reference waveform and the waveform with a 0.33% defect placed in the pipe, and the defect size is increased to 0.66% and 1% of the pipe wall cross section.

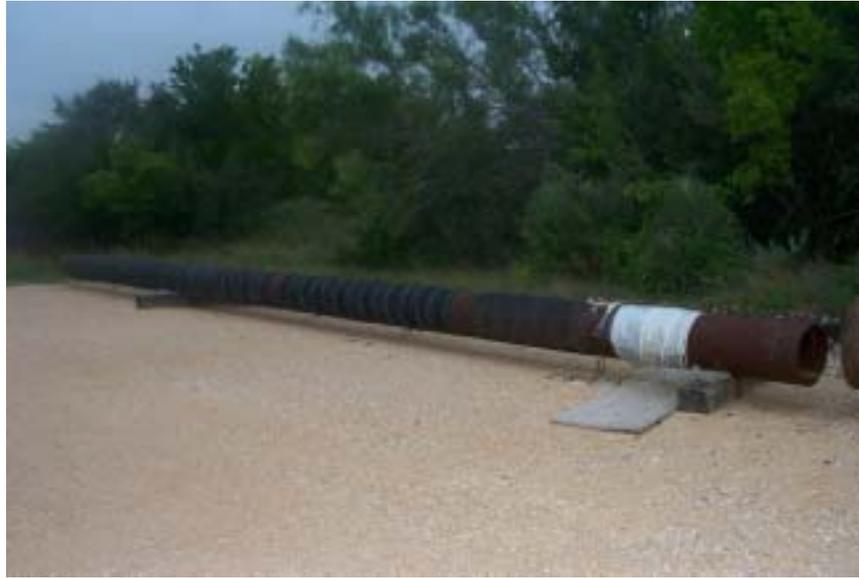
**Figure 14. Photograph of the bitumen coated, 16-inch-diameter pipe**

To address the bitumen effect, a nickel strip was epoxied onto 406-mm (16-inch)-OD, bitumen-coated pipeline as shown in Figure 14 that had a number of 1% defects at various axial locations. Data were collected at 10 and 20 kHz guided wave frequencies. No data were collected at higher frequencies because previous work [1] has shown that bitumen-coated pipe

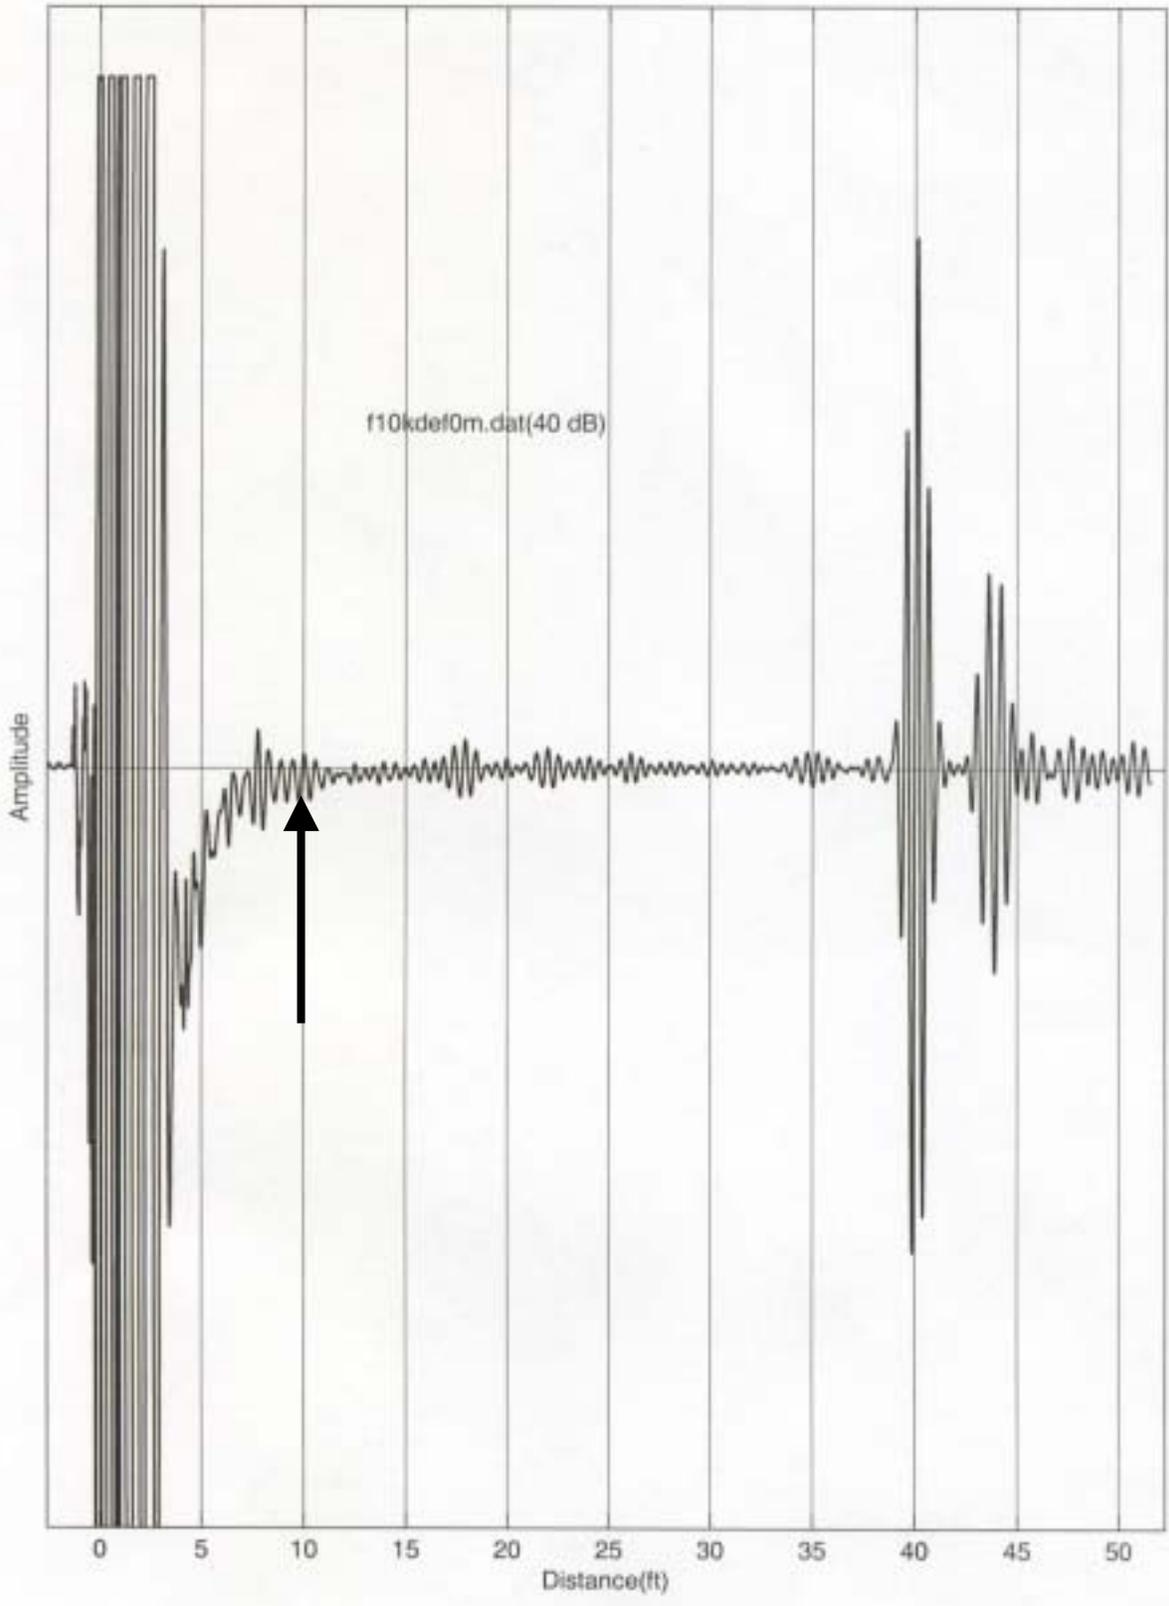
**Figure 15. Data showing that a 1% defect could not be detected using the 10-kHz nickel foil probe at a distance of 10 feet flaw distance**

would not effectively propagate 32-kHz waves. The experiments showed that 20-kHz guided waves were not effectively transmitted. However, 10-kHz guided waves did appear to be effectively propagated. Data were collected on this 406-mm (16-inch)-OD pipe after a 1% defect was placed in the pipe approximately 3 m (10 feet) from the MsS. The data obtained show that a 1% defect could not be detected using the 10-kHz nickel foil probe at a distance of 3 m (10 feet) as shown in Figure 15. This indicates that bitumen-coated pipe is very difficult to inspect and monitor using the present state of the art of the MsS technology.

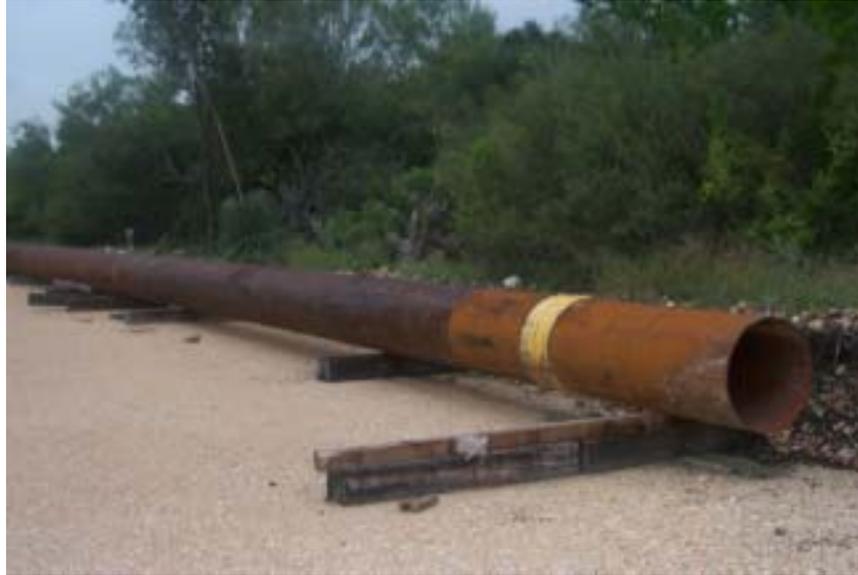
**Figure 16. Photograph of two 40-foot-long sections of 24-inch-diameter pipe welded together**

To address the effects of the MsS signal on buried pipe, a long pipe was constructed from two 12.2-m (40-foot)-long sections of 610-mm (24-inch)-diameter pipe obtained from El Paso Corporation and welded together as shown in Figure 16.

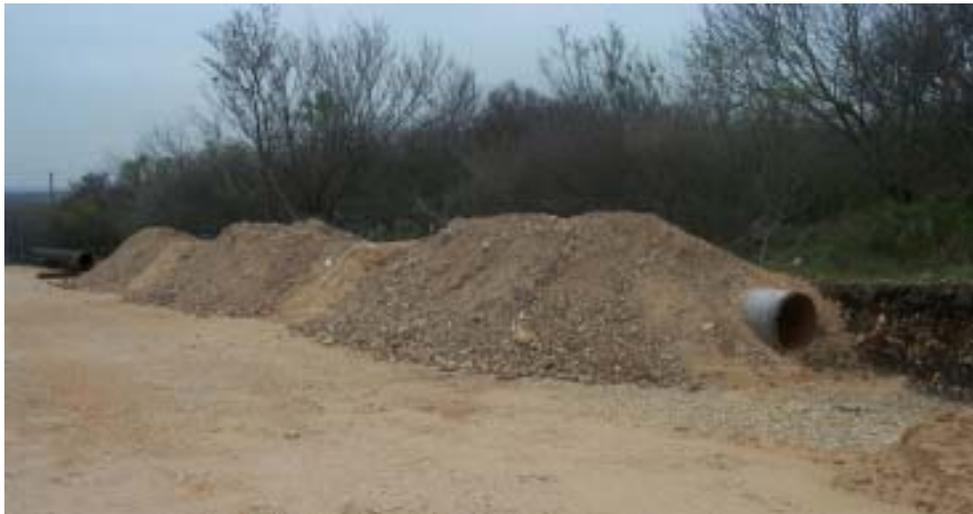
**Figure 17. Photograph of the 24.4 m (80-foot)-long, 610-mm (24-inch)-diameter pipe buried under approximately 0.6 m (2 feet) of soil**

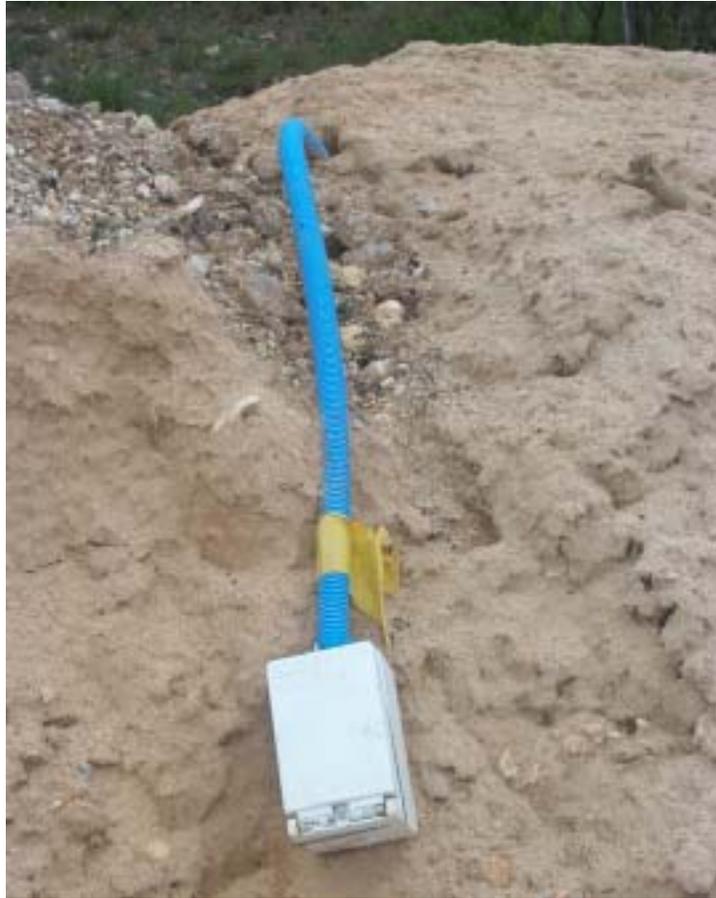
Figure 18. Photograph of one of the locations of an MsS bonded to the buried 610-mm (24-inch)-diameter pipe

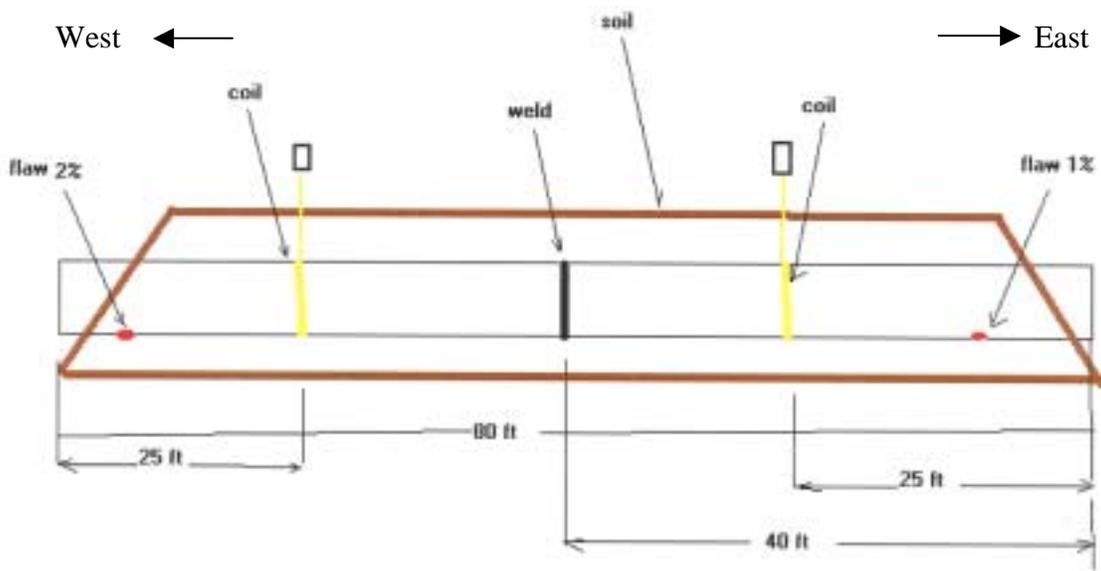
Figure 19. Illustration of the buried 610-mm (24-inch)-diameter pipe showing the locations of the MsS probes, the weld, and the intentionally placed simulated defects

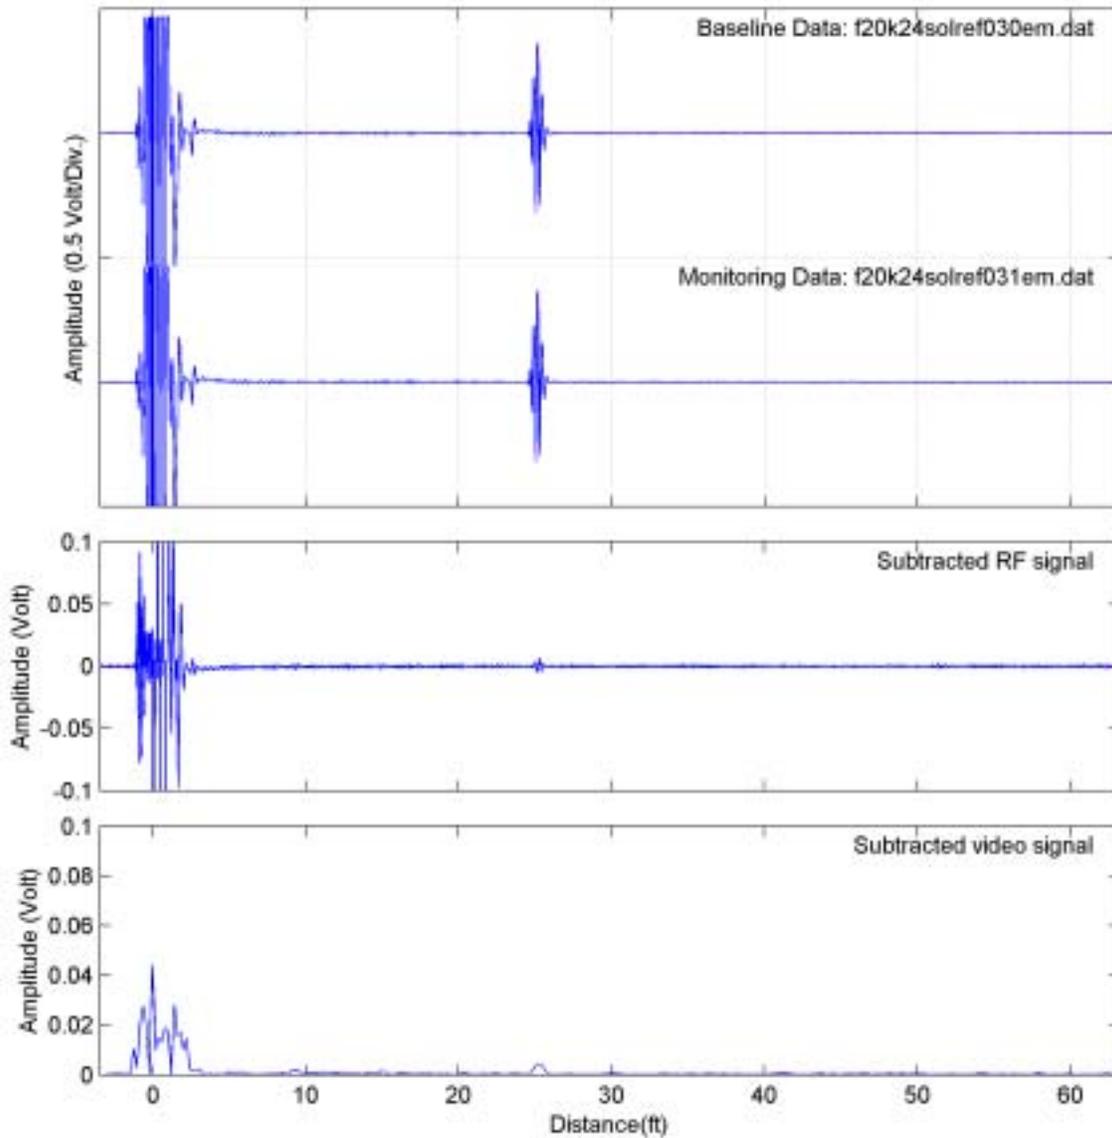
Compensation Method: No Reference  
Reference Signal Location: --  
Velocity Difference: -- %  
Amplitude Difference: -- %  
Origin: -0.80 ft  
Velocity: 10.66 ft

Frequency: 20 kHz  
Filter: 16 kHz  
Total Gain: 34 dB  
Pulse Rate: 16  
Cycles: 2  
Amp: 20 percent

Figure 20. MsS data collected from the east side of the pipe with the guided wave traveling toward the end of the pipe (shown in Figure 18). No intentionally placed defects were present in the pipe.

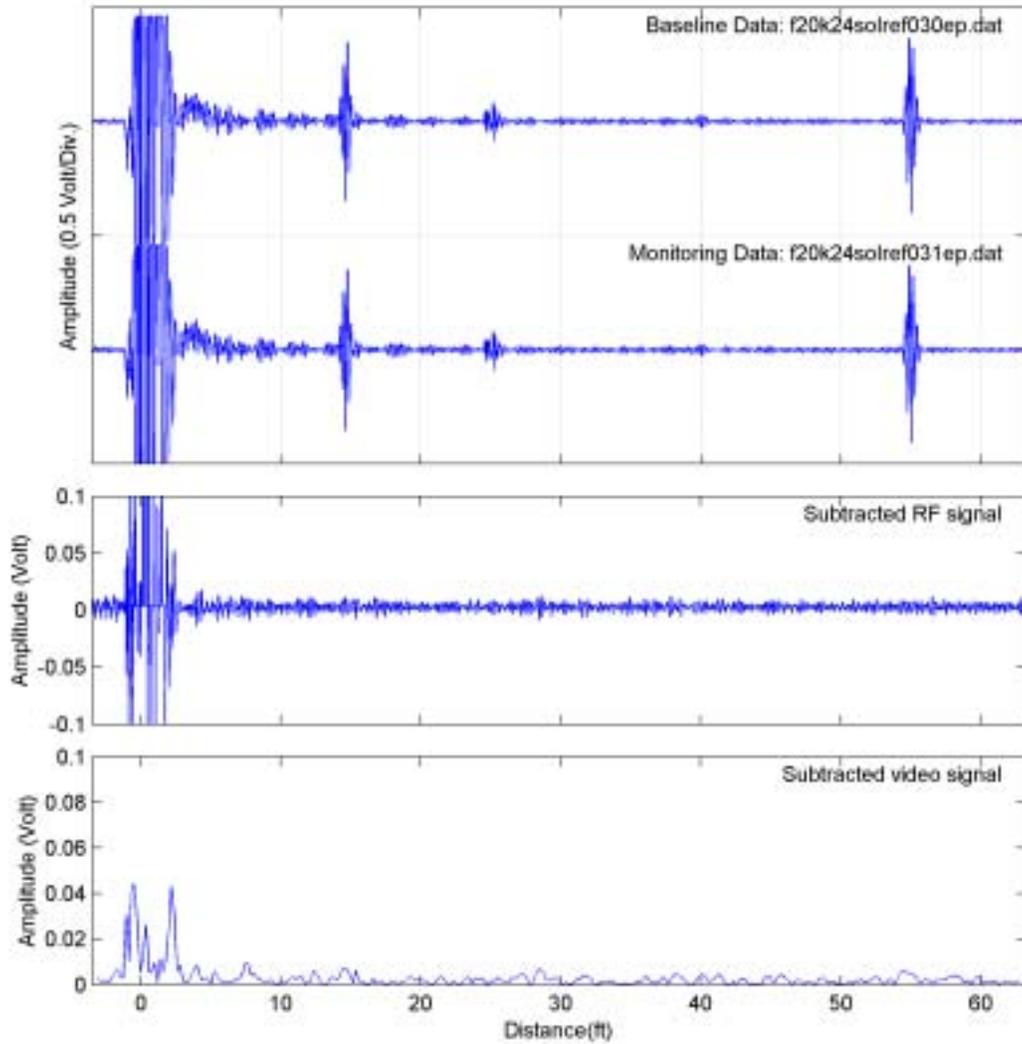
Compensation Method: No Reference  
Reference Signal Location: --  
Velocity Difference: -- %  
Amplitude Difference: -- %  
Origin: -0.80 ft  
Velocity: 10.66 ft

Frequency: 20 kHz  
Filter: 16 kHz  
Total Gain: 52 dB  
Pulse Rate: 16  
Cycles: 2  
Amp: 20 percent

Figure 21. MsS data collected from the east side of the pipe with the guided wave traveling toward the weld in the pipe (shown in Figure 18). No intentionally placed defects were present in the pipe.
