# MONITORING TECHNOLOGY FOR EARLY DETECTION OF INTERNAL CORROSION FOR PIPELINE INTEGRITY

**Final Report**  
**March 25, 2002 – September 24, 2003**

DOE Award Number DE-FC26-02NT41319  
SwRI® Project 14.05529

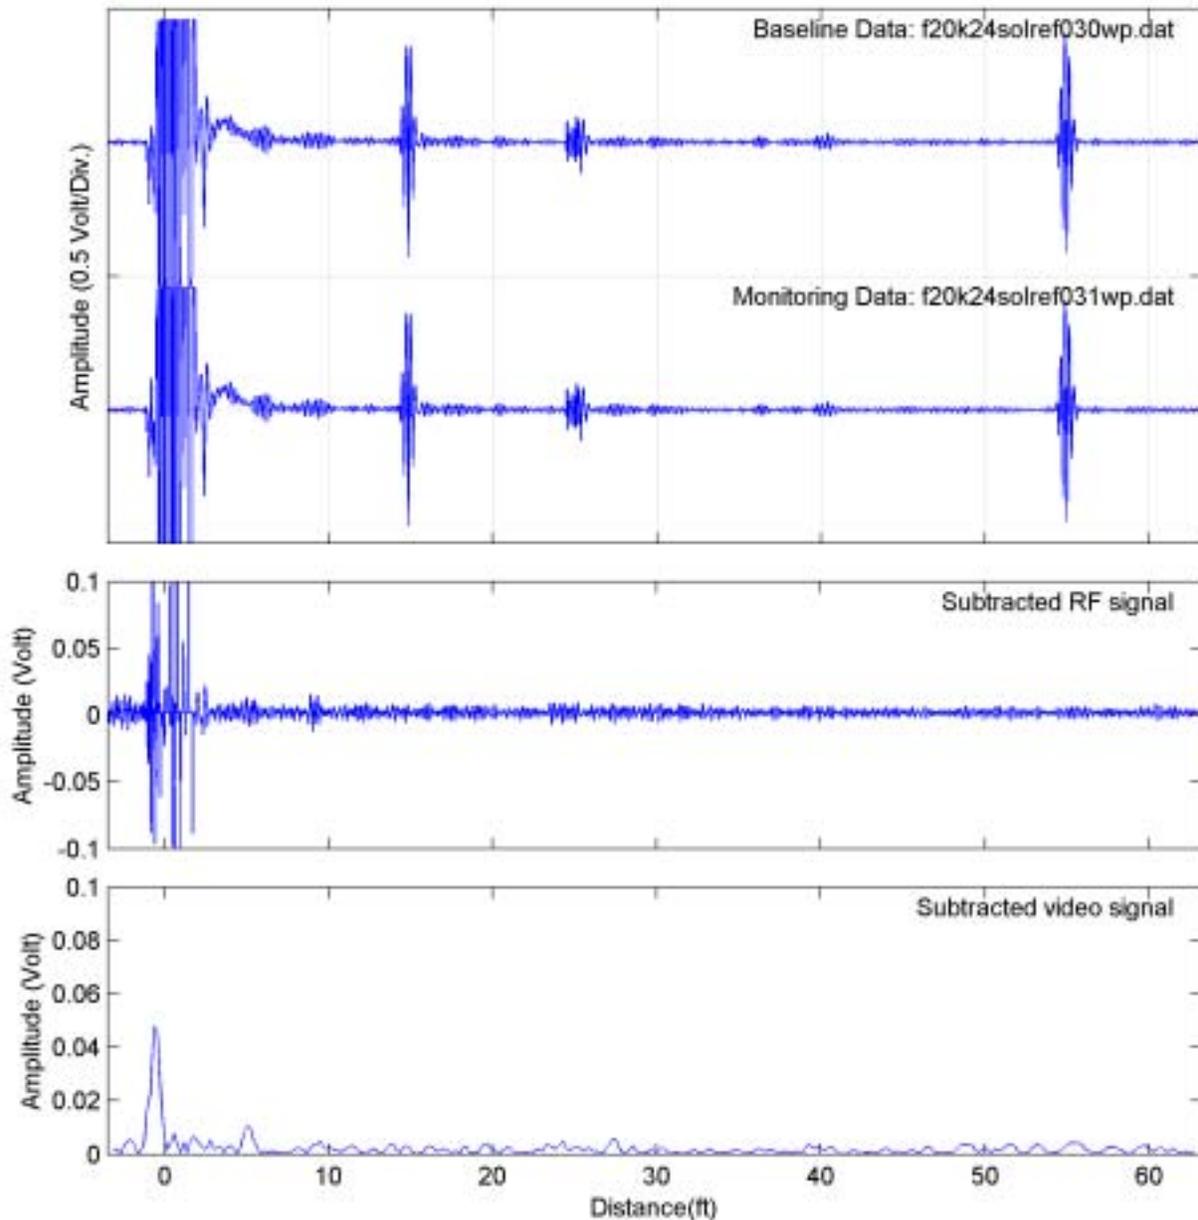
Compensation Method: No Reference  
Reference Signal Location: --  
Velocity Difference: -- %  
Amplitude Difference: -- %  
Origin: -0.80 ft  
Velocity: 10.66 ft

Frequency: 20 kHz  
Filter: 16 kHz  
Total Gain: 50 dB  
Pulse Rate: 16  
Cycles: 2  
Amp: 20 percent

Figure 22. MsS data collected from the west side of the pipe with the guided wave traveling toward the weld in the pipe (shown in Figure 18). No intentionally placed defects were present in the pipe.

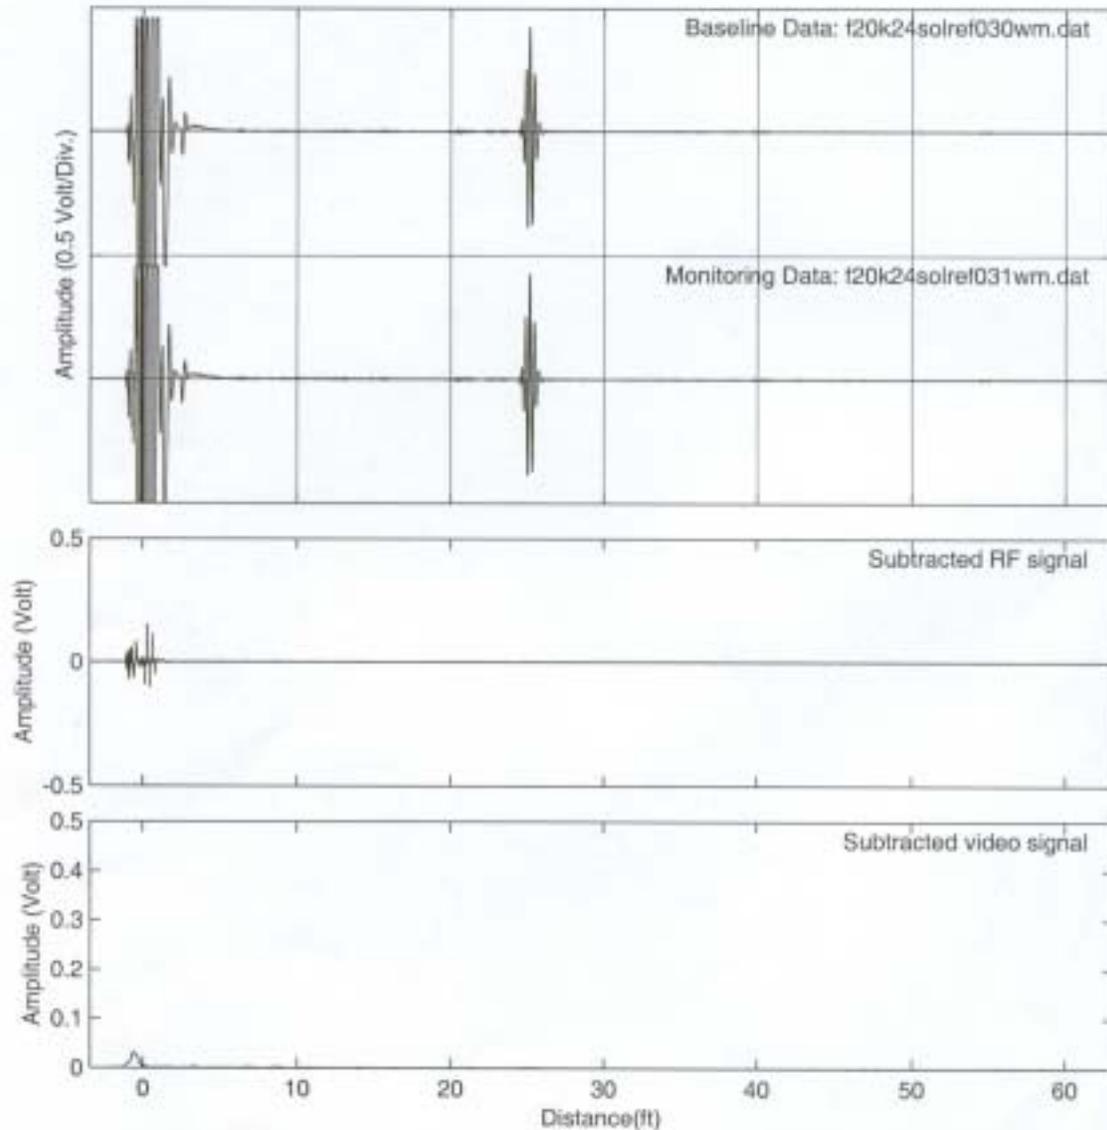
Compensation Method: No Reference  
Reference Signal Location: --  
Velocity Difference: -- %  
Amplitude Difference: -- %  
Origin: -0.80 ft  
Velocity: 10.66 ft

Frequency: 20 kHz  
Filter: 16 kHz  
Total Gain: 34 dB  
Pulse Rate: 16  
Cycles: 2  
Amp: 20 percent

**Figure 23. MsS data collected from the west side of the pipe with the guided wave traveling toward the end of the pipe (shown in Figure 18). No intentionally placed defects were present in the pipe.**

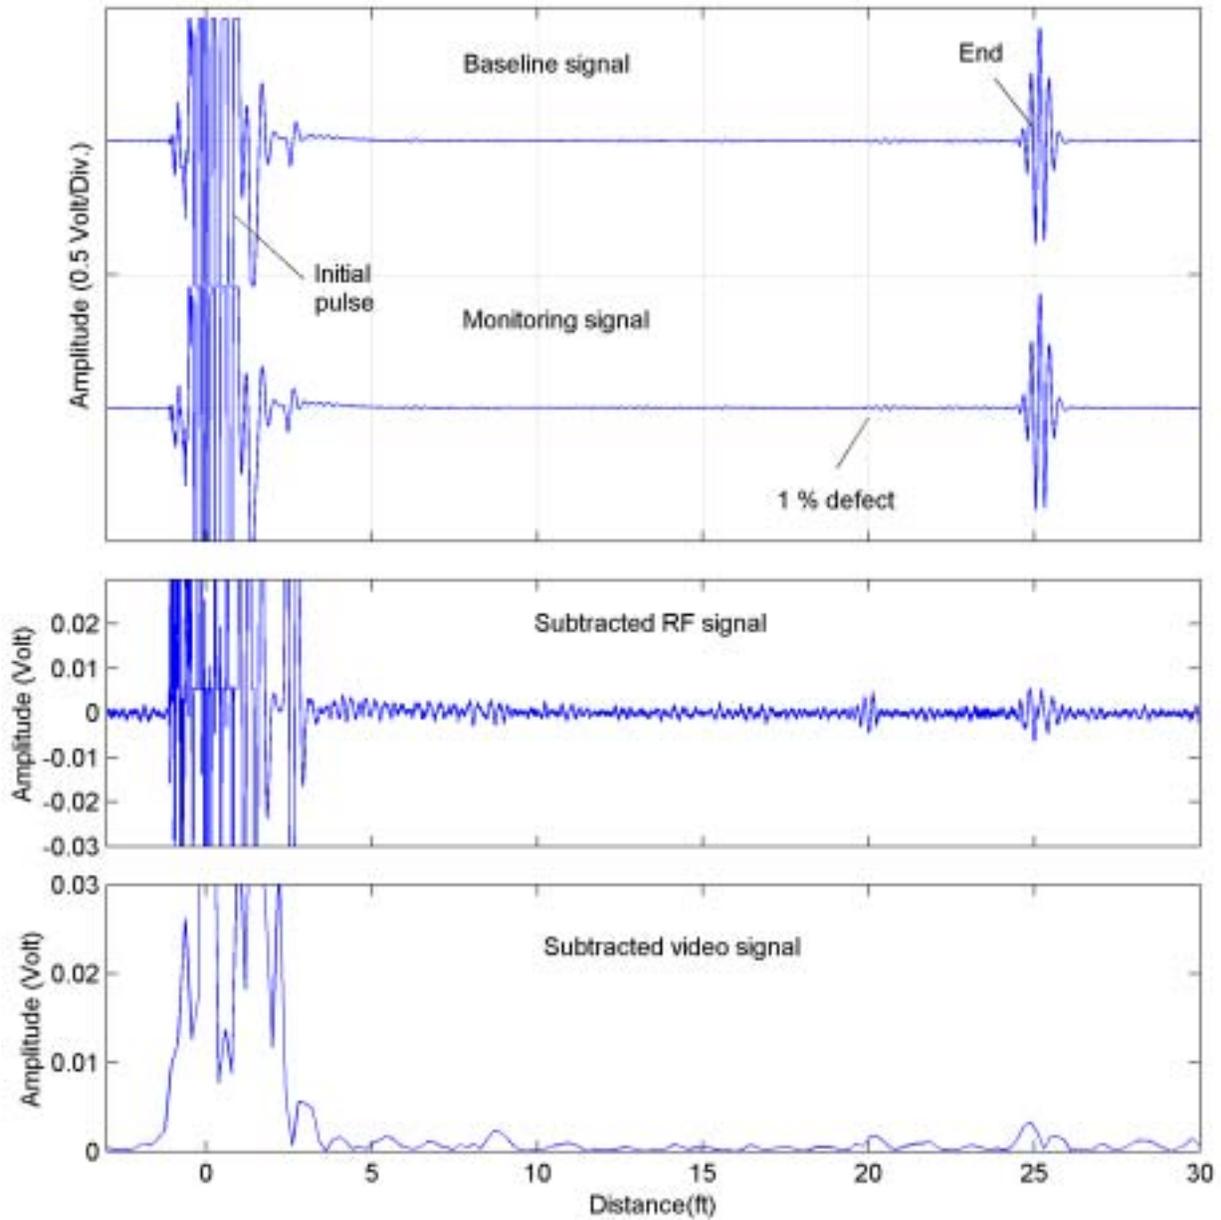
**Figure 24. MsS data collected from the pipe with 1 percent of the total pipewall cross-section defect at 6 m (20 feet). It is difficult to visually detect any difference between the reference inspection data and the inspection data obtained from the pipe with the 1-percent defect. However, the difference (subtracted data) clearly shows a signal at 6 m (20 feet).**

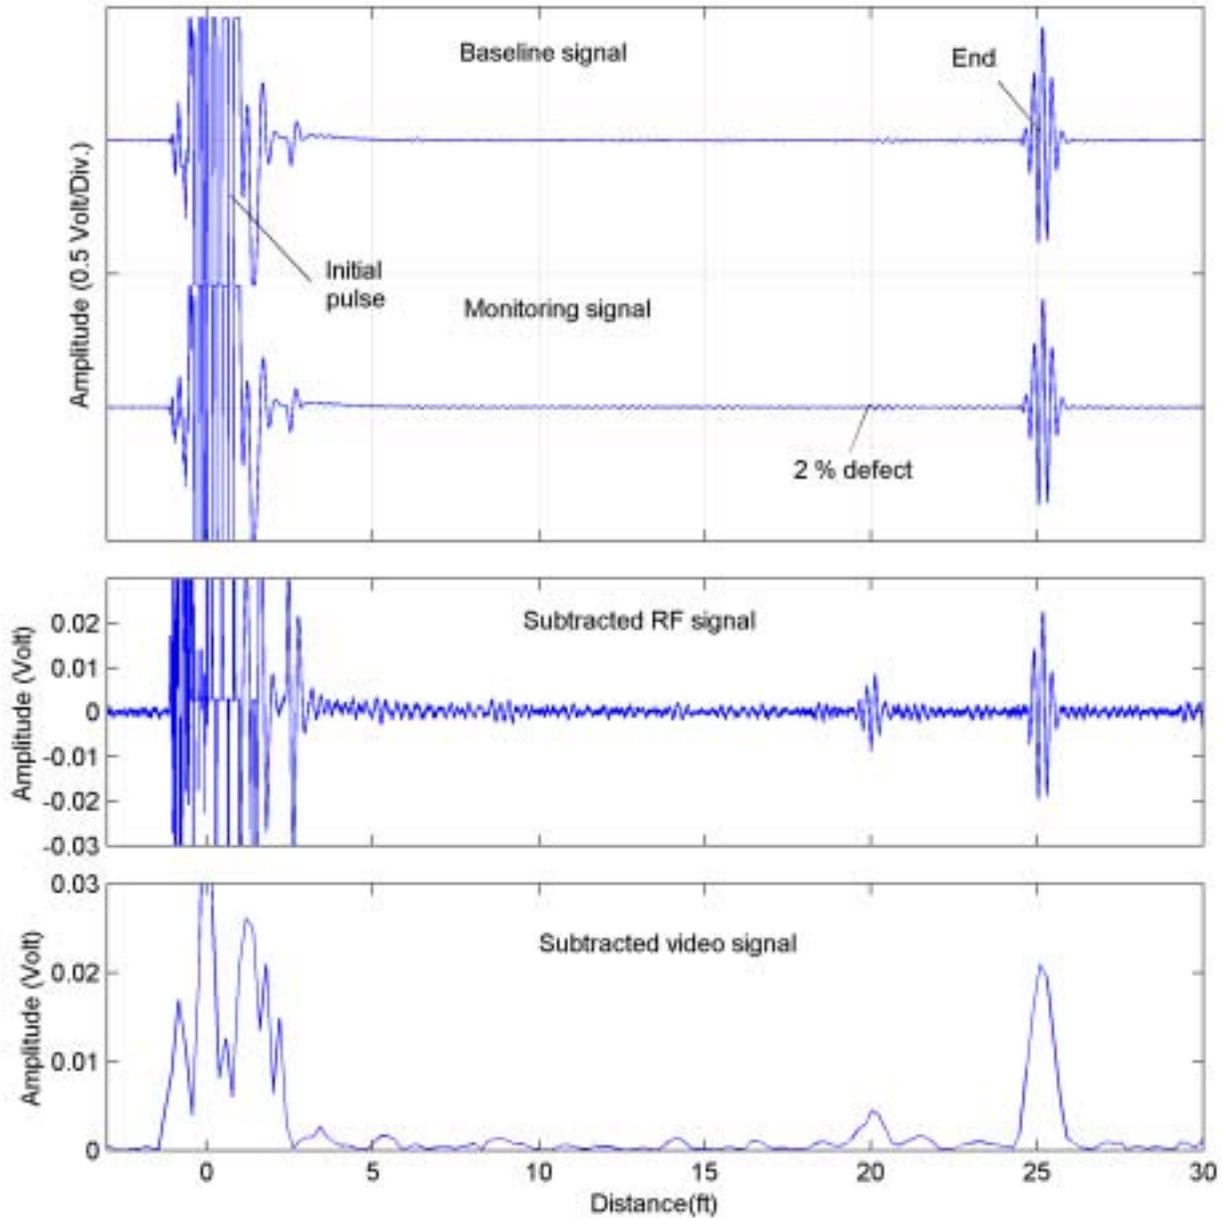
**Figure 25. MsS data collected from the pipe with 2 percent of the total pipewall cross-section defect at 6 m (20 feet). It is difficult to visually detect any difference between the reference inspection data and the inspection data obtained from the pipe with the 2-percent defect. However, the difference (subtracted data) clearly shows a signal at 6 m (20 feet).**

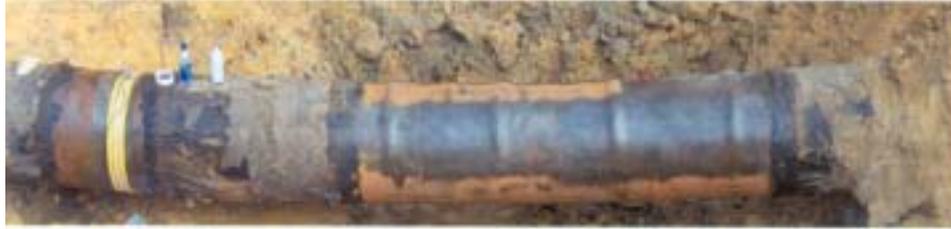
**Figure 26. Photograph of the pipe excavated at the Cleveland site showing the location of the MsS coil and bend rings**

A section of the pipe approximately 7.6 m (25 feet) long was excavated (as shown in Figure 26). The weld was located by the El Paso crew and marked as a landmark. The corrosion defect was approximately 16 feet from the weld. A 2.1-m (7-foot)-long section of wax-based coating was removed for X-ray and UT thickness measurement testing (as illustrated in Figure 27). The topside of the pipe was wrinkled at approximately 0.6 m (2 feet) increments. The wrinkles were the result of the technique used for many years to bend the pipe in the field; however, this practice is no longer used. There was some concern about the effect the wrinkles might have on the MsS results. A 0.3-m (1-foot)-long section of bitumen coating was removed and the pipe was sandblasted so that the MsS probe could be installed.

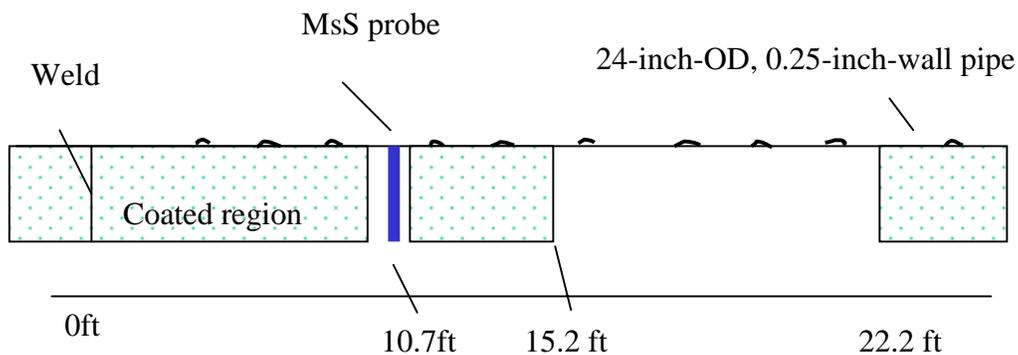
**Figure 27. Photograph and diagram showing the MsS ribbon coil and pipe**

The MsS (as shown as a yellow band in Figure 25) transmitted T-waves into each direction of the pipeline and received T-waves reflected from the defects. The signal amplitudes and arrival times were investigated to measure the defect size and its location, respectively. The MsS, consisting of two bonded 2.5-mm (0.10-inch)-thick nickel strips and an electric coil wrapped on it, were used to inspect and monitor defects that caused the cross-sectional area change.

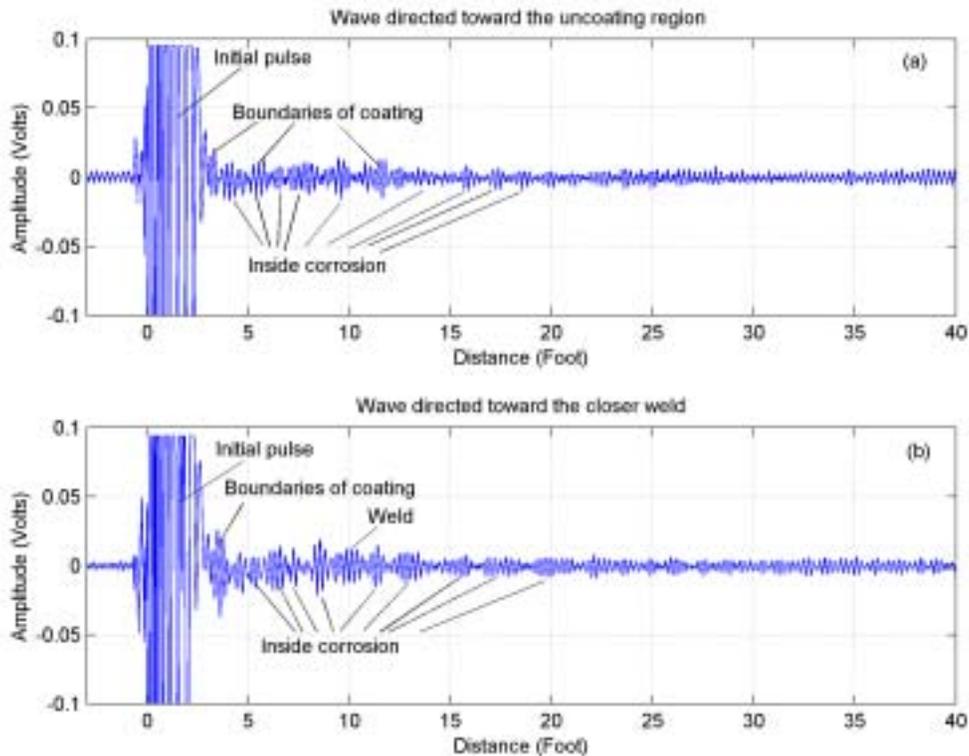
**Figure 28. 20-kHz MsS data acquired from excavated bitumen-coated pipeline: (a) with wave directed toward the uncoated region; (b) with wave directed toward the closer weld**

MsS data were taken the following morning. Figure 28 (a) and (b) show the 20-kHz MsS data taken by directing the T-waves toward the uncoated region (toward the defect) and the weld, respectively, from the MsS probe positioned approximately 3.3 m (10.75 feet) from the weld. Signals from the weld and boundaries of coating in the sample were indicated. A randomly distributed noise-like signal appeared after the initial pulse in both directions, indicating the inside of the pipe had a high level of generalized internal corrosion on both sides of the MsS. Similar MsS data were obtained from a pipe that was heavily corroded on the outside [1]. Figure 29 is a photograph of the heavily surface-corroded section and the location of the MsS probe. The MsS data in Figure 30 clearly show the signal difference between the good surface between W5 and W4 and the heavily corroded section between W4 and W2.

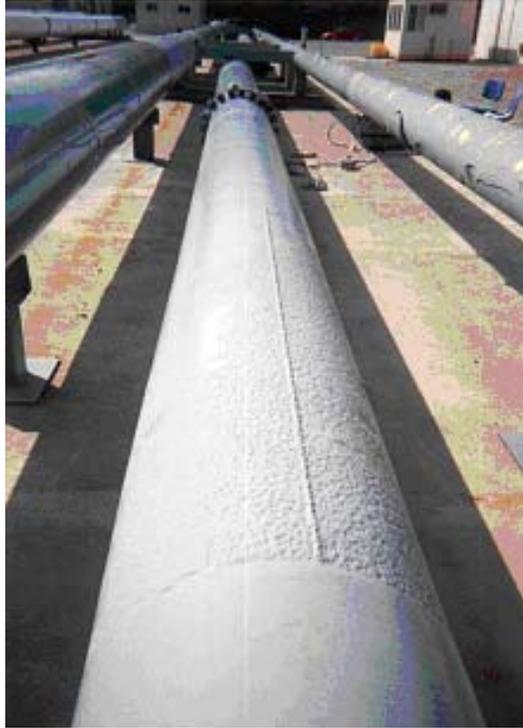
**Figure 29. Photograph showing MsS probe installed on pipe having a heavily corroded section**

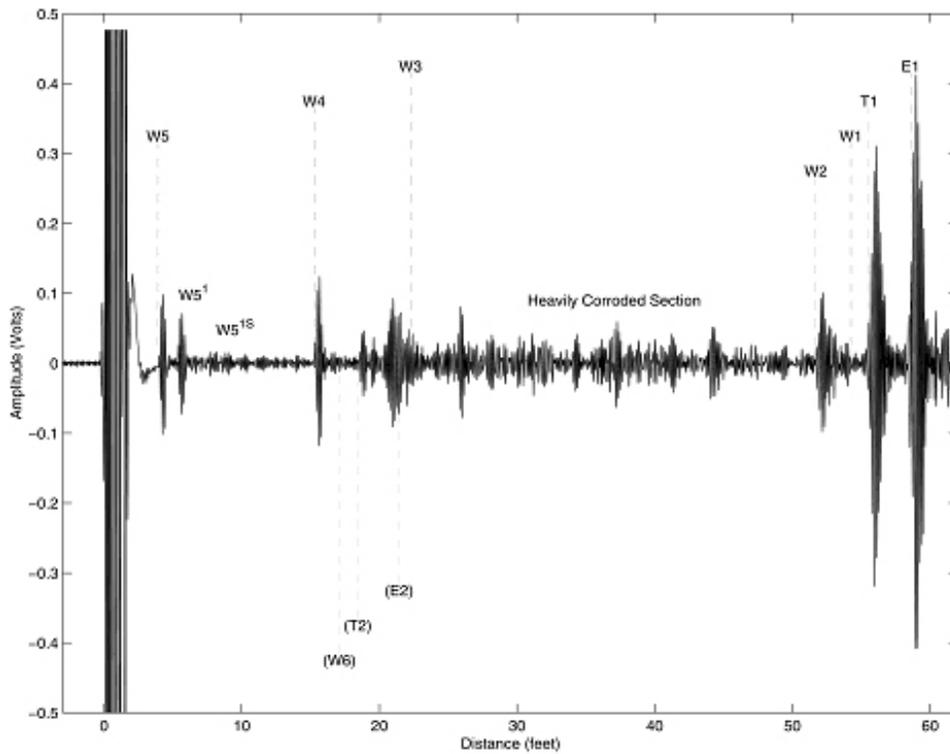
**Figure 30. MsS guided wave data acquired from a natural corrosion pipe sample**

Since the guided wave propagates uniformly with the same wave front through the pipe wall cross-sectional area, generalized corrosion on either the outside or inside surface of the pipe highly attenuates the propagating T-wave by reflecting and scattering randomly distributed noise-like signals. If the MsS had been buried with the pipeline, the initiation and growth of generalized corrosion could have been monitored by observing the appearance and increase of randomly distributed noise-like signals. However, based upon the results of the X-ray and UT thickness measurements and the preliminary results obtained with the MsS, the decision was made to remove this section of pipe. Therefore, this test site was no longer acceptable for evaluating the MsS technique for pipeline monitoring. However, the condition of the pipe did show the need for a monitoring technique such as the MsS. If the MsS could have been put in place and the pipeline had an acceptable corrosion level, then the MsS could be used to monitor the corrosion growth without having to expose the pipe.

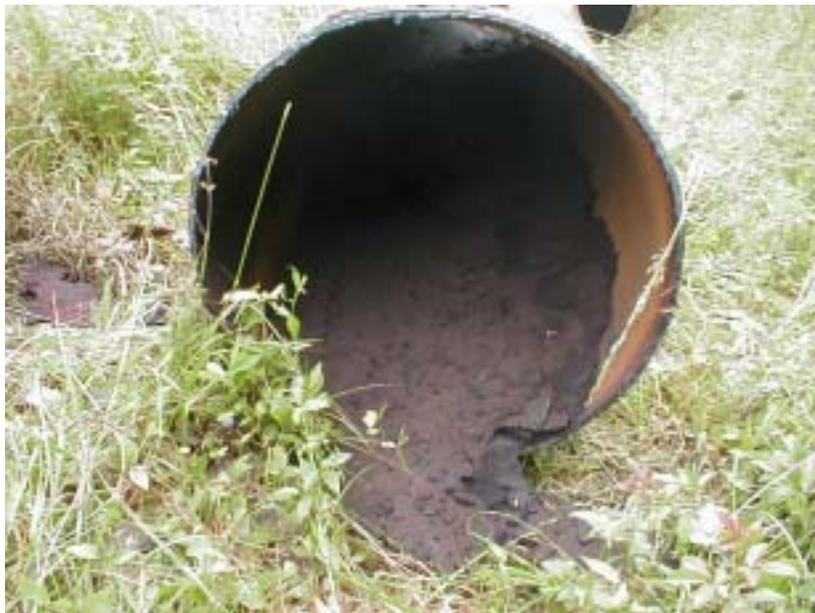
**Figure 31. Inside surface of pipeline showing major internal corrosion**

The corroded pipe section was cut out of the line and photographs were taken of the opening. These photographs are shown in Figures 31 through 34.

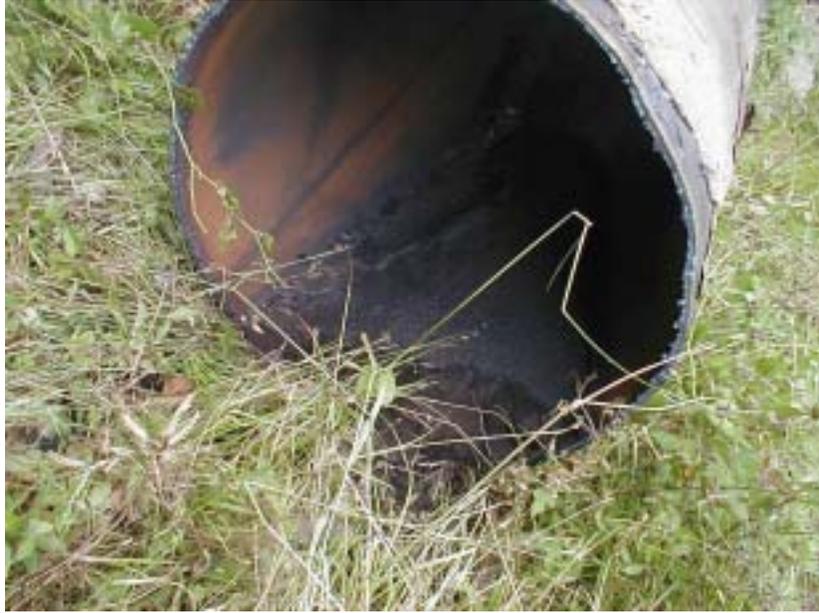
**Figure 32. Another view of the inside surface of the pipeline showing major internal corrosion**

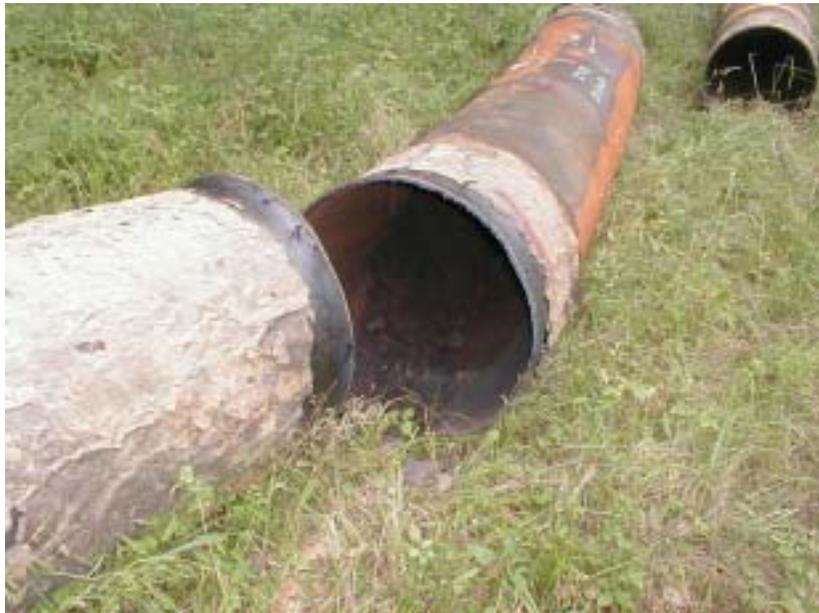
**Figure 33. Photograph of removed pipe**

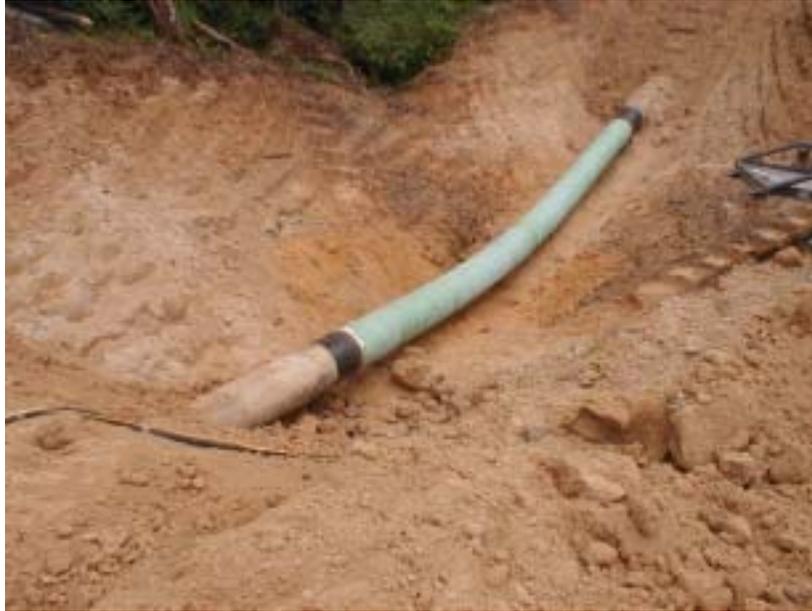
**Figure 34. Photograph of replacement pipe before burying**

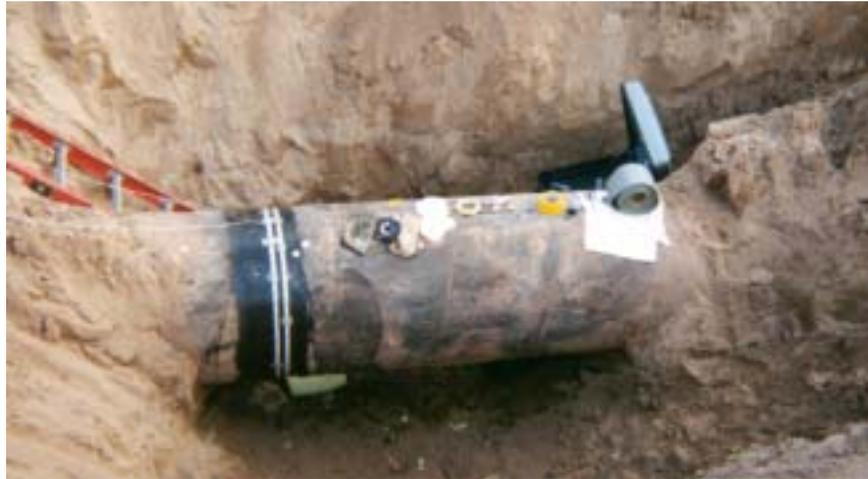
**Figure 35. MsS installed on the 762-mm (30-inch)-OD gas transmission pipeline**

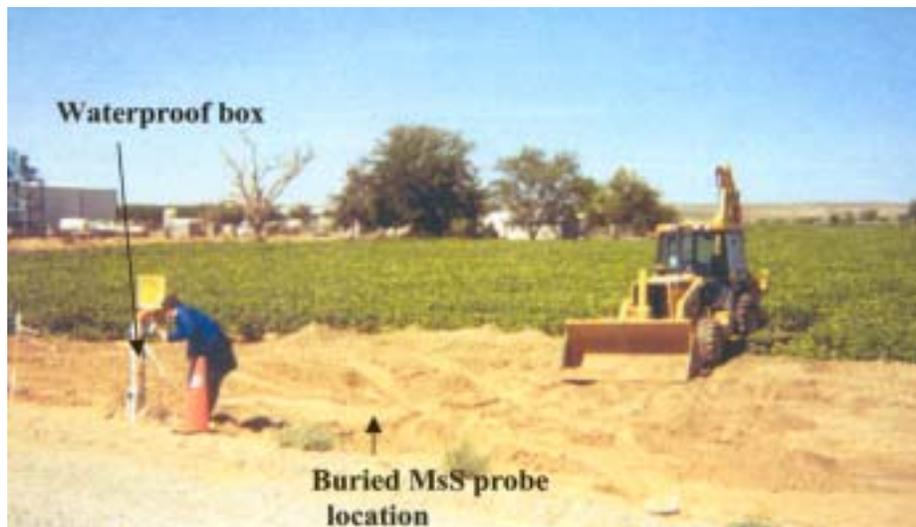
**Figure 36. Photograph showing a waterproof box after the site was restored**

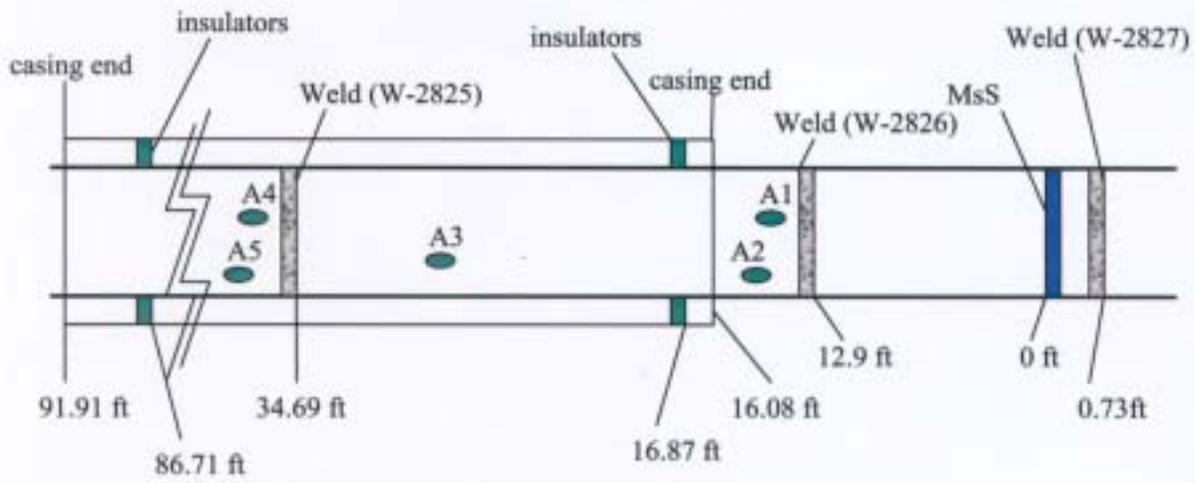
**Figure 37. Configuration of the pipeline at the road crossing. The locations of the MsS and distances to the known geometric features in the line are indicated.**

To identify the locations of the MsSs, the configuration of the pipeline at the road crossing is schematically illustrated in Figure 37, including the locations of known geometric features and known defects found from the ILI results. The distance between the center of two MsSs and the nearest weld (No. 2827) was 0.22 m (0.73 feet). The corrosion defects found from the ILI results are indicated as A1 through A5 and their characteristics are summarized in Table 3. It should be noted that the detection sensitivity determined during laboratory tests on buried pipe was on the order of 1.5 to 2% of the pipe wall cross section. The defects listed in Table 3 were much smaller. These small defects can be detected by pigs, but monitoring could detect defects that are larger but still acceptable for continued pipeline operation, then the monitoring technology would provide an inexpensive alternative to pigging (if it is possible at all).

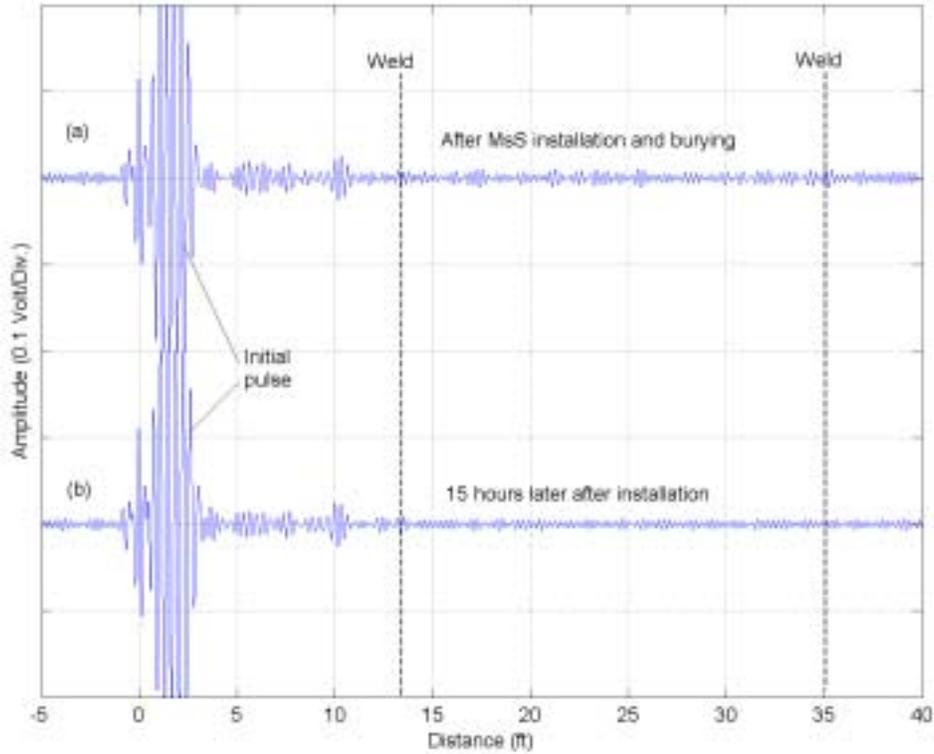
**Figure 38. 20-kHz MsS data acquired from the 762-mm (30-inch)-OD gas transmission line: (a) after restoration of the line and (b) 15 hours after restoration of the line**

Figure 38 (a) and (b) shows the data acquired on August 18 and 19, respectively. The locations of welds (Nos. 2825 and 2826) are indicated in the figure as the vertical dotted lines. As shown, the two sets of data were approximately identical, indicating that the installed MsSs were stable and repeatable.

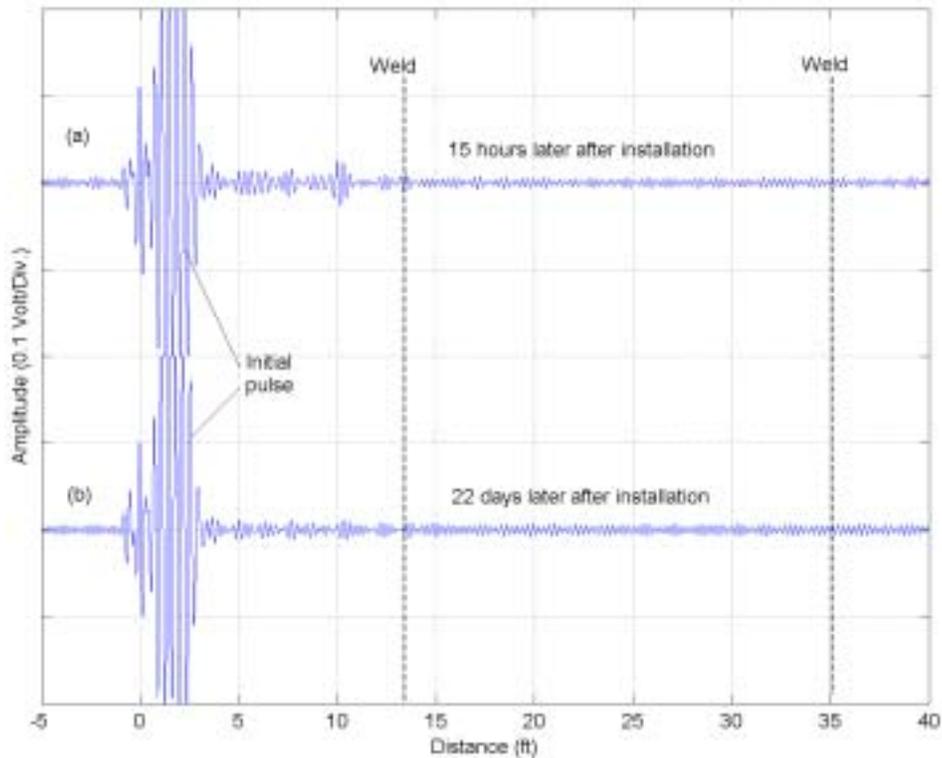
**Figure 39. 20-kHz MsS data acquired from the 762-mm (30-inch)-OD gas transmission line: (a) 15 hours later after restoration of the line and (b) 22 days later after restoration of the line**

At high amplifications such as those used in this test, detectable signals are produced from the MsS system after the excitation of the initial pulse. The signals over 3-m (10-foot) distance in Figure 37 are, therefore, most likely to be those produced from the MsS system and not from any actual anomalies in the pipeline itself. This interpretation would indicate that the signals seen past 3 m (10 feet) were from electronic noise, not defects. This interpretation is consistent with Tuboscope's test results that showed no defect indications in the pipe section between welds 2826 and 2827 on which the MsS was installed. A second data collection was conducted on September 9, 2003. The comparison of the initial data and the most recent data is shown in Figure 39. As expected, no significant difference in signal was detected. It is believed that perhaps changes will occur within a year, and the setup was left in place so that data could be collected again in approximately 1 year.

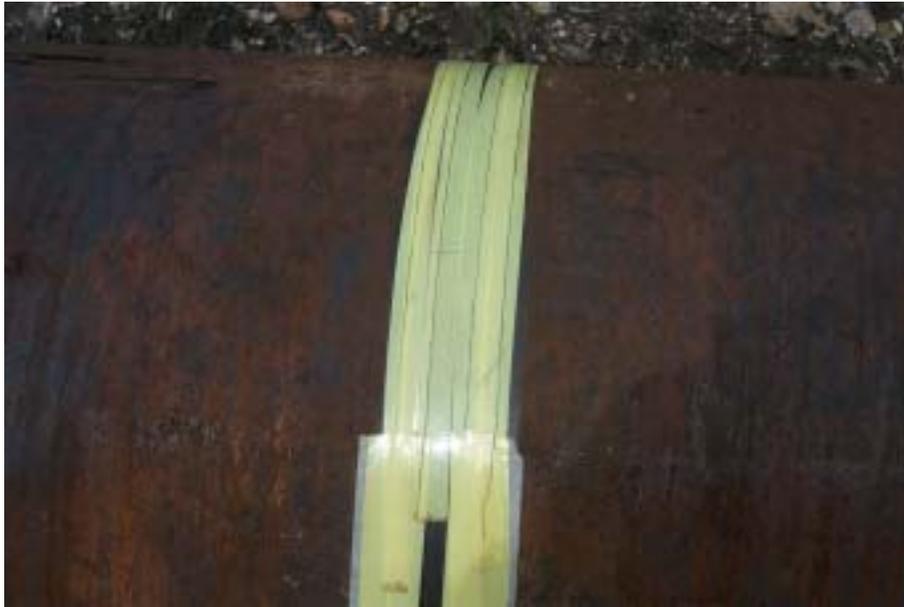
**Figure 1. Photograph showing tape wrapped around the two-nickel strips with their outline marked with a pen**

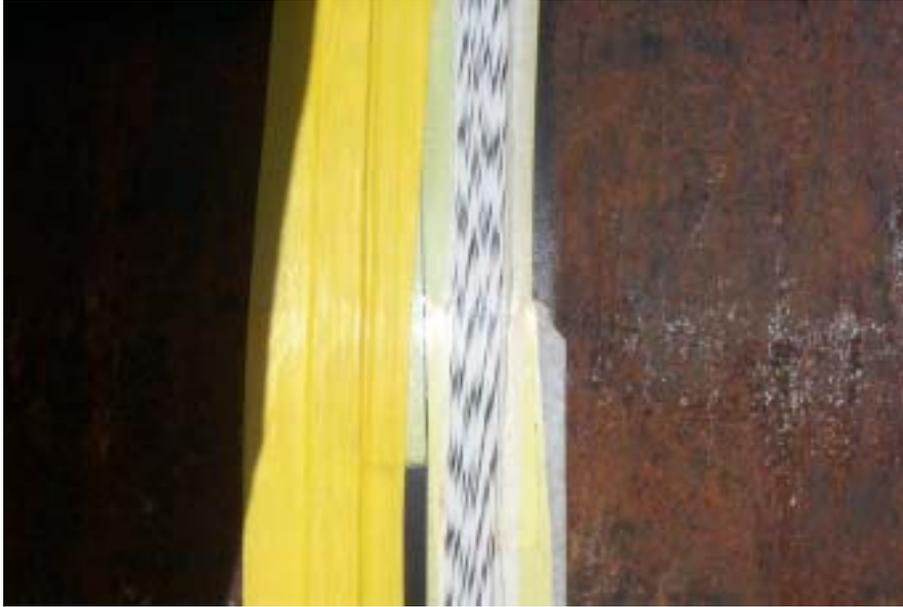
**Figure 2. Photograph of the coils wound on the pipe showing yellow vinyl duct tape used to cover the windings of one coil while the second coil is held down with double-sided tape**

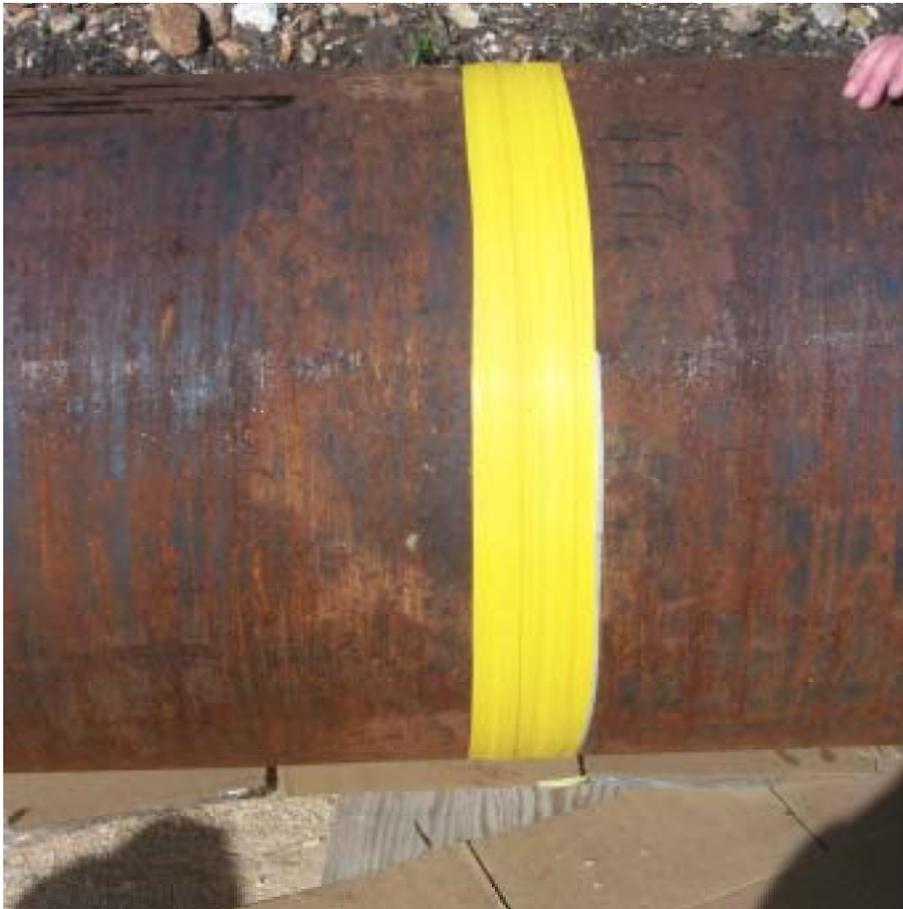
**Figure 3. Protective tape coating over nickel strip and electrical coil**

9. *Remove* the temporary coils and place double-sided tape over the nickel foil once good guided wave results have been observed and recorded. The reason for marking the edge of the nickel with a pen is to aid in the placement of the tape directly over the nickel foil. Using #22 awg insulated wire, carefully wrap a coil of 16 turns around the pipe. Double-sided tape placed over the nickel foil is used to hold the wire in place while the 16 turns are being made. Mark one end of the wire with tape prior to beginning the wire wrapping process. Leave enough wire free at both the beginning and the end of the coil to extend out of the excavation to the eventual test box. It is good practice to use different colored wires for the two coils so that the two coils can be properly identified when connected into the test box. **(NOTE: Always wind the coils in the same direction. A mix-up here could mean you are looking in the wrong direction later.)** Once the two coils have been wound around the pipe, twist the ends of the coil wires together so that coming out of the excavation are two twisted pairs of wires of different colors with a tape tag indicating the first turn wire. Figure 2 is a photograph of the coils wound on the pipe showing a yellow vinyl duct tape used to cover the windings of one coil while the second coil is held down with double-sided tape. Then, the layer of protective tape is placed over the nickel strip and electrical coil (Figure 3).

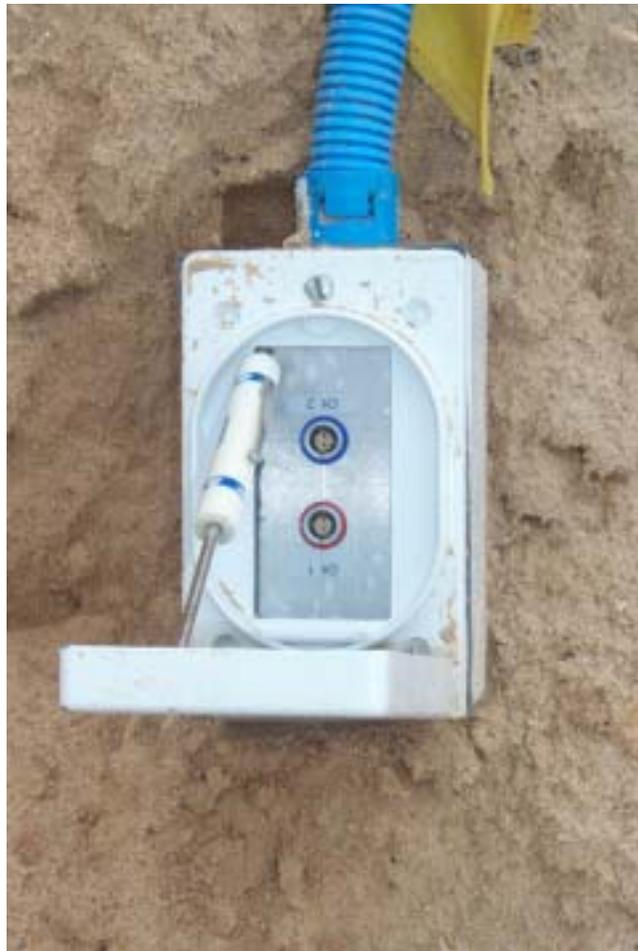
**Figure 4. Photograph of the junction box showing the connectors that are connected to the MsS instrument for collecting MsS data**
