Development of Permanent Mechanical Repair Sleeve for Plastic Pipe

Semi-Annual Report

D.O.E. Contract No. 03-NT41880

GTI Project No. 15446

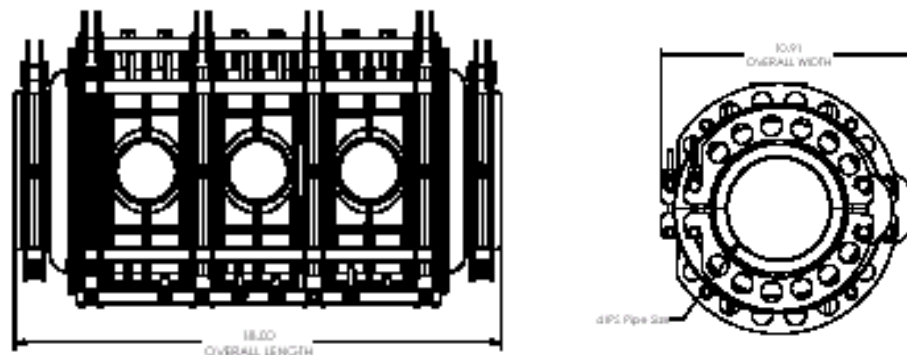
Based on the aforementioned product definition, GTI and its manufacturing partners undertook an iterative design process. A finite element model was created to ascertain the overall system stress between the pipe and installed fitting. The model was created in SolidWorks and the static analysis was performed with CosmosWorks utilizing a solid mesh and the FEEPLUS solver. A best-case design concept for the mechanical repair fitting was finalized. In essence, the mechanical repair fitting design consists of two half circular cylindrical parts that are hinged together. After they have encircled a pipe segment that has been damaged, these two parts can be mechanically fastened to each other to contain the damage. The repair fitting is not chemically bonded to the pipe. It is expected to stay in place by friction that is induced by tightening the bolts sufficiently that pressure is transmitted through compressed elastomeric rings at the ends of the sleeve. As these rings are the only portion of the sleeve that actually contact the pipe, there is an annular cavity between the inner wall of the fitting sleeve and the outer wall of the damaged portion of the pipe that is contained within the fitting body, as shown in Figure 1 below.

Figure 1: Illustration of the proposed design for Mechanical Repair Fitting

Because the mechanical repair fitting is intended to cope with the entire range of damage that can occur in service, the principal design challenge was the repair of a “blowing” failure; i.e., a through wall opening in the pipe wall through which pressurized gas escapes. Thus, the unique feature of the mechanical repair fitting is three axially-aligned holes that will allow gas to escape during the repair procedure.

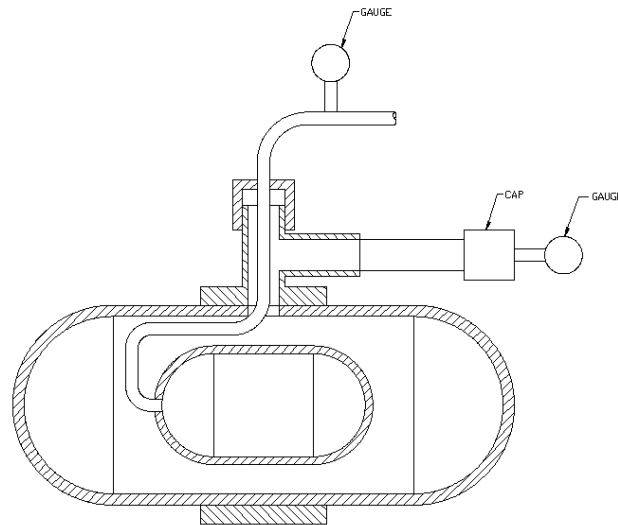
In order to validate the analytical model, a modified experimental set-up was fabricated. Controlled sharp notches (95% of the pipe wall thickness) were placed on three pipe specimens from both 2-inch medium density and high density PE materials. The 2-inch pipes were then inserted into 4-inch PE pipes and pressurized, as shown in Figure 1. The 2-inch pipes were allowed to fail on their own accord at room temperatures. The pipe specimen assemblies have been on test to date with only one failure. The failed pipe specimen was removed and the crack length was recorded. The assembly was then re-pressurized and monitored. The results of the testing showed that the modern PE materials have excellent SCG resistance characteristics and did not fail under pressure. The test specimens were removed and the damage lengths were measured. The results indicate that equalization of pressure does remove the necessary strain energy and effectively mitigates that propensity for the damage length to grow in the axial directions.

Figure 1: Schematic Illustration of the modified SCG test set-up

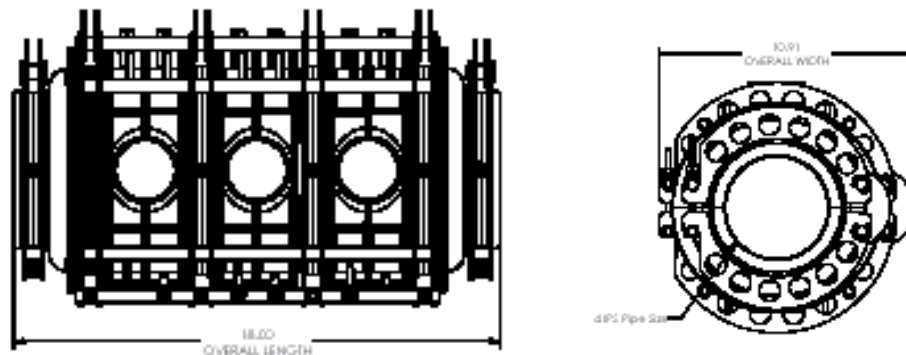
In the previous semi-annual report, it was noted that multiple design alternatives were investigated. Based on a series of Finite Element Analysis (FEA), it was observed that a small scale separation occurred after the fitting had been pressurized to 60 psig for a prolonged duration. To resolve this concern, the fitting design was modified with additional reinforcement members to ensure that the fitting was leak tight and was capable of withstanding the internal pressure over its intended design life. The final design concept, as shown in Figure 2 and 3, was accepted by the project team, and a decision was made to proceed to the prototype development.

Figure 2: Schematic Illustration of the 2nd Generation Mechanical Repair Fitting – Top View and Side View

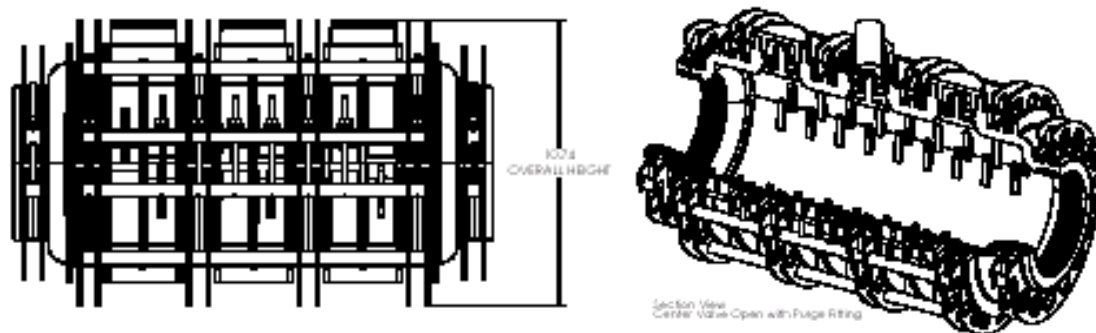
Figure 3: Schematic Illustration of the 2nd Generation Mechanical Repair Fitting – Front View and Cut-out

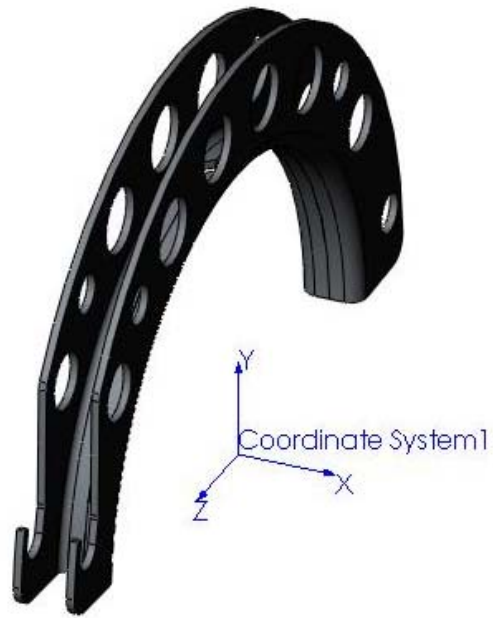
The entire clamp structure was made of 316 CRES (Stainless Steel). Each collar clamp half was made in two pieces by piercing and blanking the outline of the collar channel and then forming the perpendicular surface. For the prototype, the blanks were laser cut in their flat form to represent a part that would be produced on a pierce and blank die. Two simple tools, one (1) for the small collar clamp and one (1) for the large collar clamp, were built that could be loaded in a hydraulic press brake for forming the perpendicular radial surface. Two (2) blanks were loaded in the forming tool where one (1) cycle of the tool would produce a left and a right version of the part. Laser cutting the blank allowed for easily changing and optimizing the shape of the blank to produce a formed part needing only minimal cleanup before the welding process. The formed left and right parts were then placed into a welding fixture where a stitched seam weld was placed on the inside of the channel making the two pieces into one half ($\frac{1}{2}$) of the collar clamp as shown in Figure 4.

Figure 4: Small clamping structure

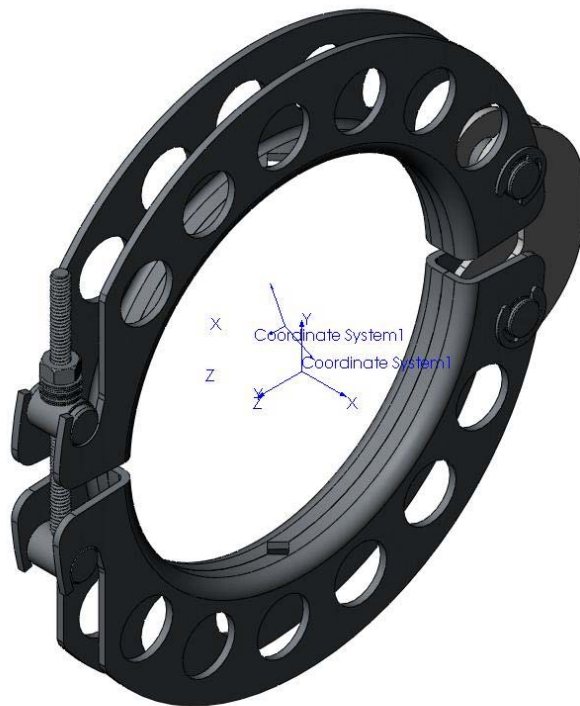
Link plates for the clamp hinge were also laser cut for the prototypes where they will be pierced and blanked from a die in production. The threaded Swing Pin and Threaded Stud were welded together to form the tee bolt for the Small Collar Clamp. Two Small Collar Clamps halves were assembled together with the Link Plates, Link Pins and E-Rings. The tee bolt was crimped in to the saddle on one of the collar halves to capture the bolt and allow it to pivot. This with the Nylock nut completed the Small Collar Clamp assembly as shown in Figure 5.

Figure 5: Assembled small clamping structure

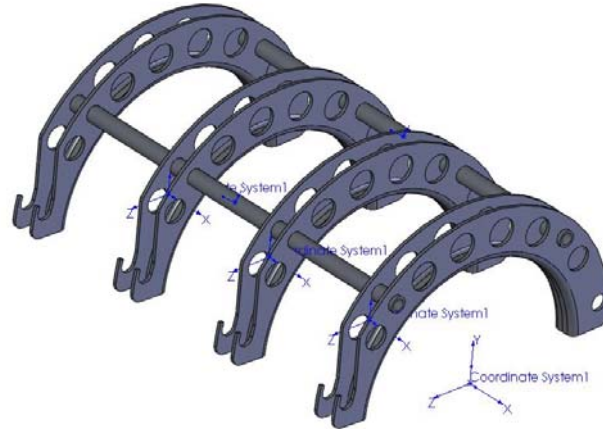
Four (4) Large Collar Clamp Halves were welded to two (2) Structural Clamp Rods in a welding fixture to form the Large Collar Clamp Sub-Assembly as shown in Figure 6.

Figure 6: Assembly

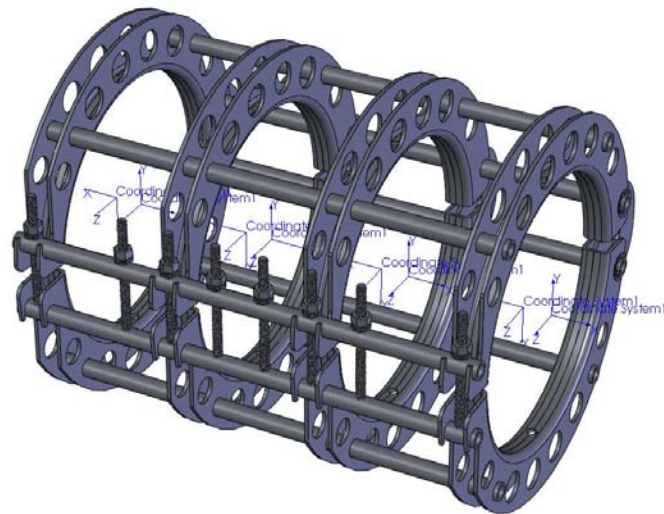
Two Large Collar Clamp Sub-Assemblies were assembled together with the Link Plates, Structural Clamp Rods and Roto-Clips. The threaded Clamp Rod and Threaded Stud were welded together to form the ganged tee bolt for the Large Collar Clamp Assembly. The ganged tee bolt was crimped into the saddle on one of the Large Collar Clamp Sub-Assemblies to capture the bolt and allow it to pivot. This with the Nylock nuts completed the Large Collar Clamp Assembly as shown in Figure 7.

Figure 7: Assembly superstructure

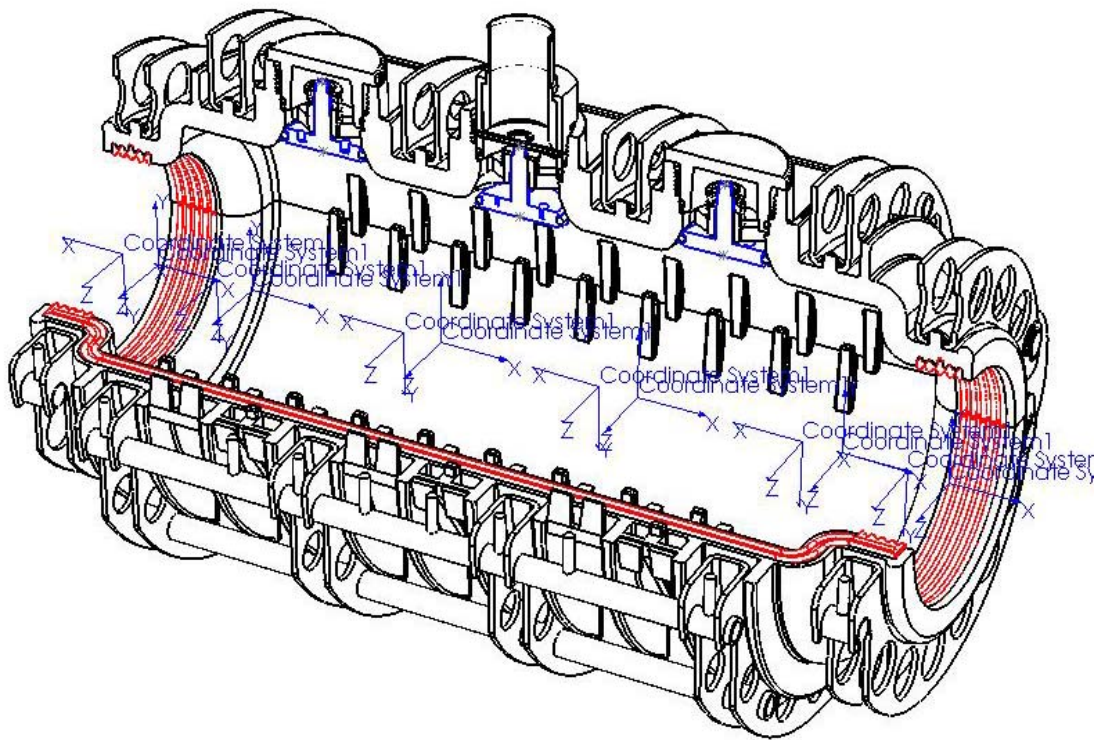
In addition to the clamping structure, the body of the prototype mechanical repair fitting was machined from solid blocks of plastic. The design material (PA 11) was not available in sufficient size to hog-out each half of the fitting. Polypropylene was available in blocks large enough to machine each half of the fitting so it was procured for the prototype fittings. As mentioned earlier the major changes to the fitting design were in the area of additional ribs and increased rib height. To expedite the prototype process the electronic model was transferred directly to the machine shop for tool path generation without the need for time-consuming detail drawing creation. Special care was taken in cutting the seal glands into the fitting halves so as closely as possible the as machined geometry would reflect that of the molded part. The Purge Valves and Purge Caps were also machined from Polypropylene. Figure 8 shows a cut-away view of the Generation III assembly with a purge fitting in the center port showing the valve in the open position.

Figure 8: Molded Cut out of the plastic body

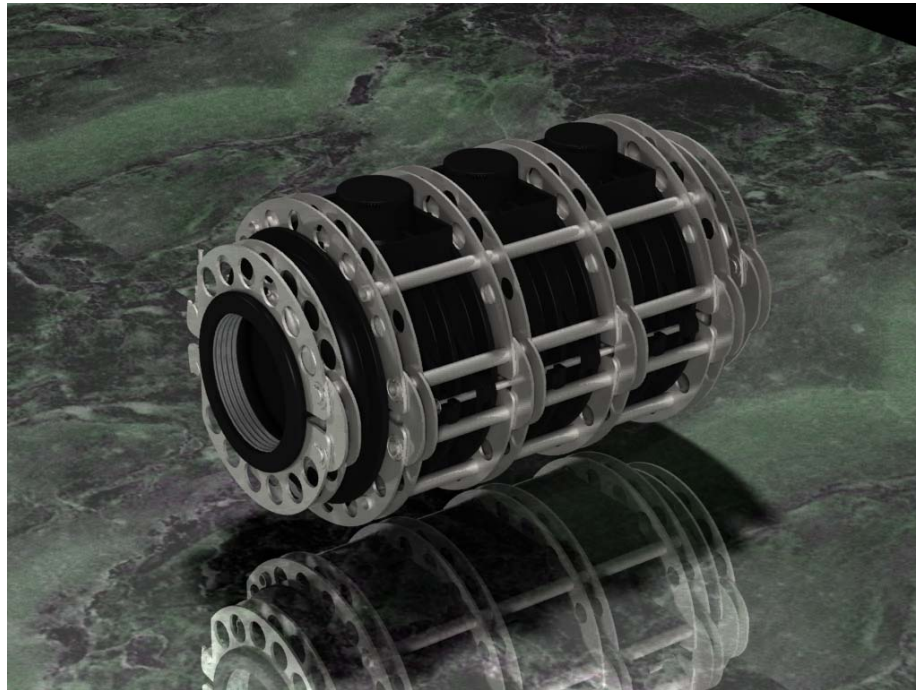
Because the mechanical repair fitting is intended to cope with the entire range of damage that can occur in service under typical line pressure of up to 60 psig, the principal design challenge is not only ensuring the repair of a “blowing” failure; i.e., a through wall opening in the pipe wall through which pressurized gas escapes, but also ensuring a leak tight seal and ability to withstand the internal pressures. To that end, based on a series of FEA analysis and the prototype build, as shown in Figure 9, it has been shown that the objectives of this program can be successfully achieved.

Figure 9: Final prototype
