IMPROVEMENT OF WEAR COMPONENT'S PERFORMANCE BY UTILIZING ADVANCED MATERIALS AND NEW MANUFACTURING TECHNOLOGIES: CASTCON PROCESS FOR MINING APPLICATIONS

Quarterly Technical Progress Report

For the period starting October 1, 2003, ending December 31, 2003

DE-FC26-01NT41055

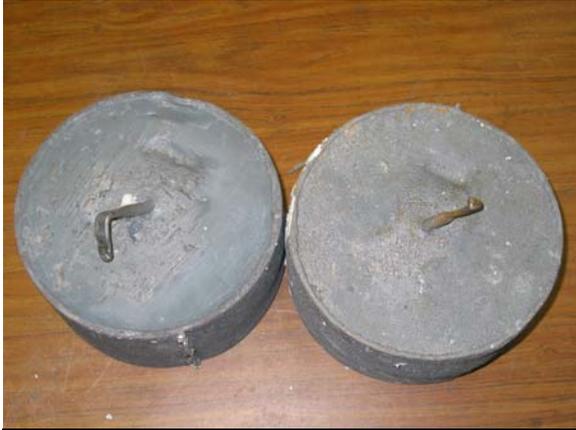
Figure 1. Cans after HIPping

The cans did not leak during HIPping. This showed that our measures to solve the can vacuum leakage were effective. Figure 1 shows the cans after HIPping.

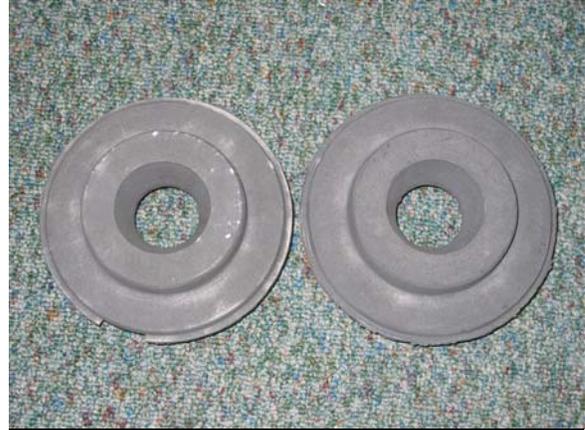
Figure 2. 6.5" discs produced, left H13 only and right with WC inserts.

The discs produced using the modified pattern achieved fairly good near net shapes as seen in Figure 2 and were large enough for machining to final specifications.

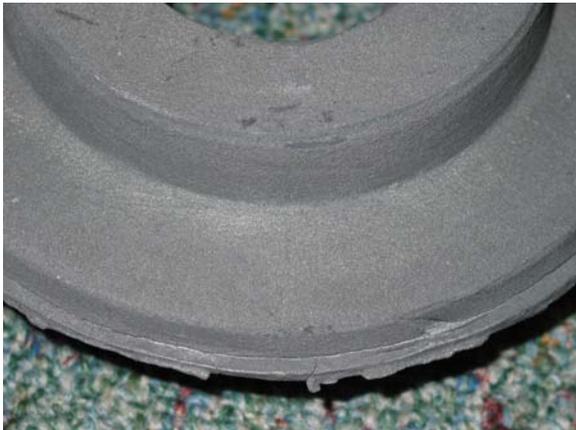
Figure 3. A radical crack in the middle of picture

Although the off-gassing temperature was increased from 500°C to 1050°C, cracking still can be seen on the disc radial directions (Figures 3 and 4) and contact regions of H13 steel and WC inserts. We assume there are several issues contributing to the problem: 1) powder oxidation, 2) low ductility of H13 material, 3) residual stress caused by the shrinkage restriction of the disc center hole, 4) improper vacuum during off-gassing, 5) too slow cooling after off-gassing to cause re-oxidation, and 6) too little oxidation prevention agent added into the sand mold. A piece of sample was taken out of a disc (Figure 5). The examination under a microscope revealed oxidation films on H13 powder surfaces (Figure 6). Oxidation of H13 powder during off-gassing could be the major reason of cracking.

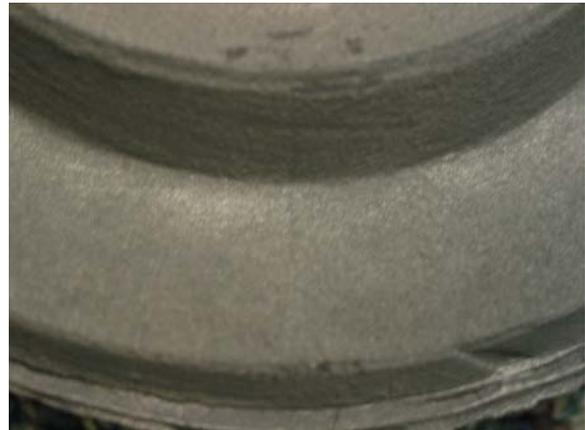
Figure 4. A closer look at the radical crack

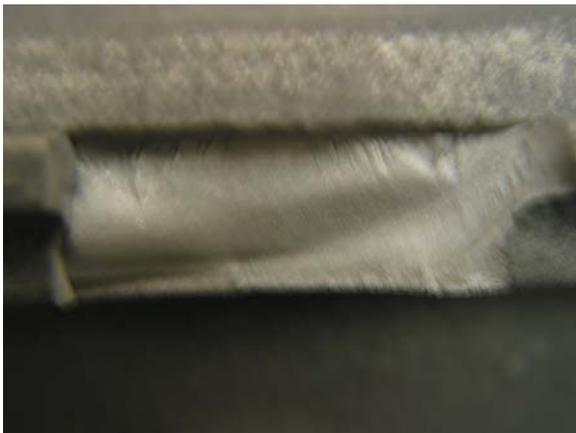
Figure 5. A piece knocked off for microstructure examination

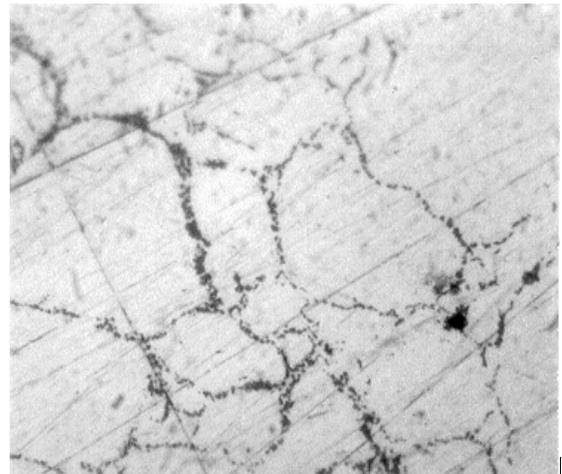
Figure 6. Microstructure examination revealed oxidation films on H13 powder surfaces
