**ANALYSIS OF CLADDING RESIDUES FROM THE DISSOLUTION OF
IRRADIATED DRESDEN-1 REACTOR FUEL**

G. F. Kessinger

March 31, 2004

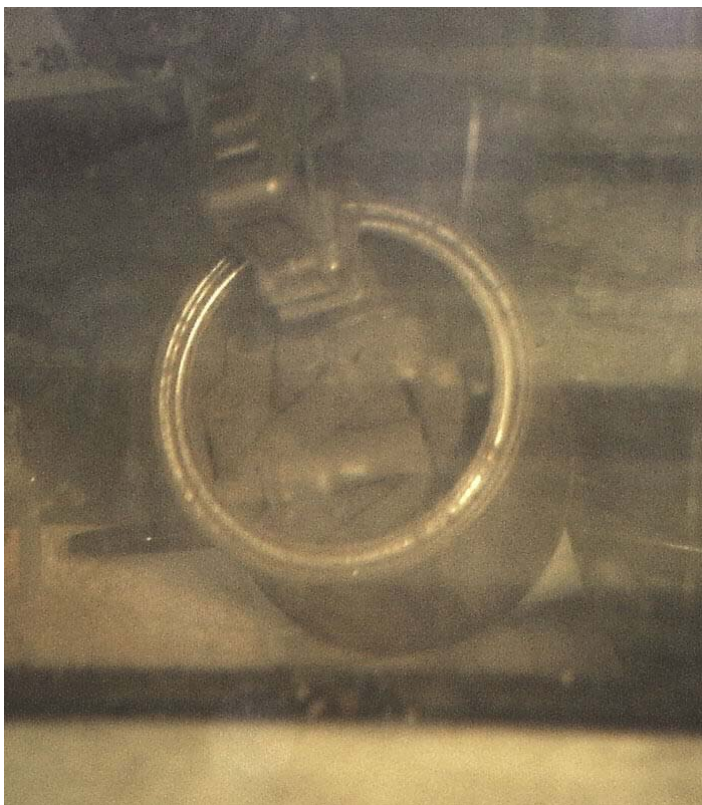
Figure 1. Photograph (taken through remote cell window) of as-received Dresden reactor fuel in can.

The sample of Dresden spent fuel used in this study, with a burn-up 23,480 MWday/t, was discharged from the Dresden-1 Reactor, Morris, IL, on September 1, 1975. It was transferred to Savannah River Site from Oak Ridge National Laboratory in the late 1970's in support of the Consolidated Fuel Reprocessing Program. The fuel rods were sheared to expose the UO₂ before arriving at the Savannah River Technology Center. The physical appearance of the fuel before dissolution is shown in Figure 1.

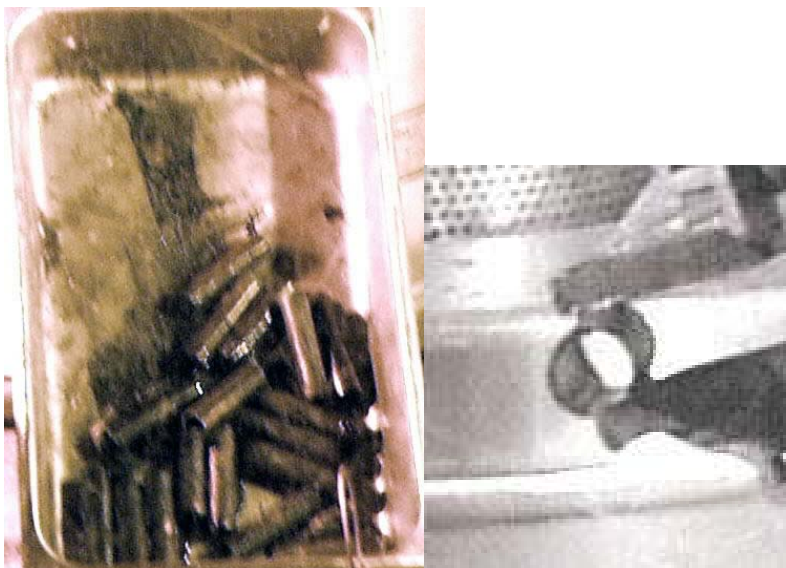
Figure 2. Photographs of cladding (after fuel meat dissolution) taken through cell window.

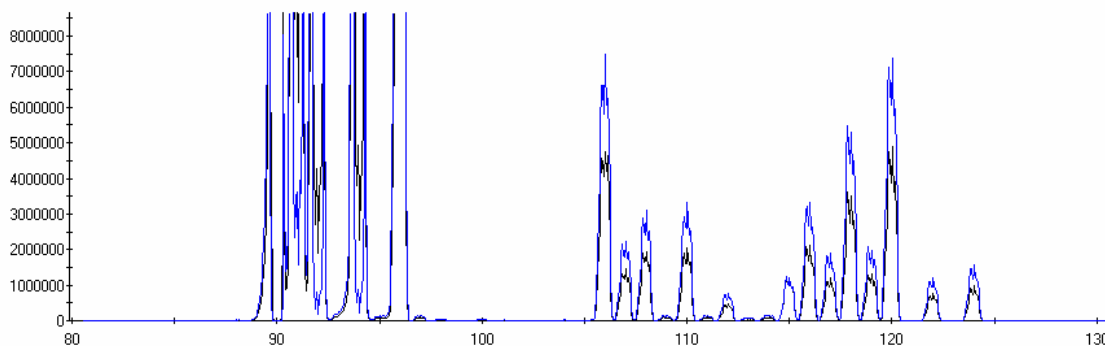
Figure 3. ICP-MS fission product spectrum, m/z = 80 to 130.

The fission product spectrum is quite complex. There is signal at essentially every integral m/z value across the spectrum (Figures 3 and 4), especially in the range 115 to 160, and most every integral m/z has associated with it more than a single isotope, rendering the spectrum of little assistance when attempting to determine the chemical composition of the cladding. The fission product spectrum is further complicated by the calibration of the instrument. Because of the broad range of signals, a few thousand counts up to 10^6 counts, it was not possible to calibrate the instrument over the entire range of signals. Instead, the calibration of the instrument was performed at the lower end of the range of signals. While this calibration renders the signal that is attributable to Zr, $m/z = 90$ to 96, useless when interpreting the results of these measurements, it does not impact other elements such as Sn. For this reason, the fission product spectrum has been used primarily as an "internal standard" for the actinide results as described below.

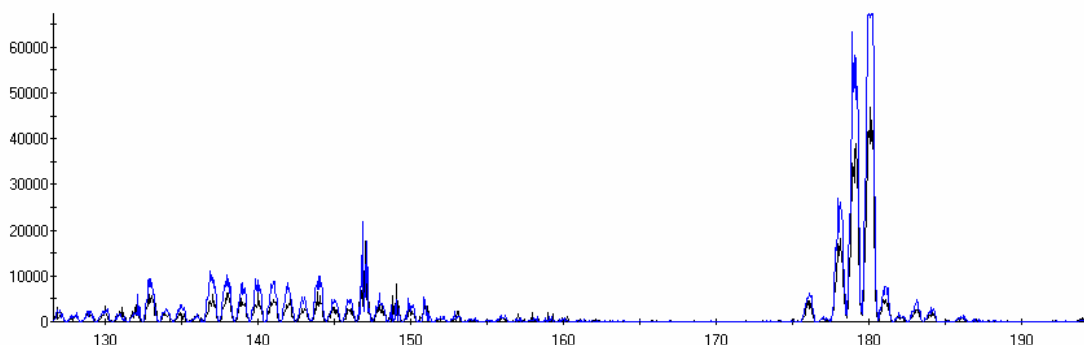
Figure 4. ICP-MS fission product spectrum, m/z = 125 to 195.

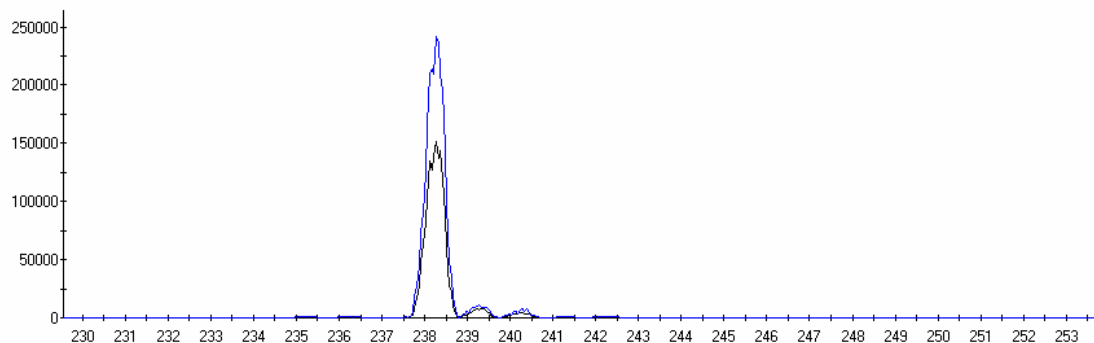
Figure 5. ICP-MS actinide spectrum, $m/z = 229.5$ to 255, low sensitivity. The dual traces are due to different dilutions of the sample (the more intense signal is due to a 2X more concentrated sample).

The signal at m/z = 237 was present in the spectra in Figures 5 and 6, but not others, so it was not included in the data analysis. Discussion and justification of this choice are presented later in the Discussion section.

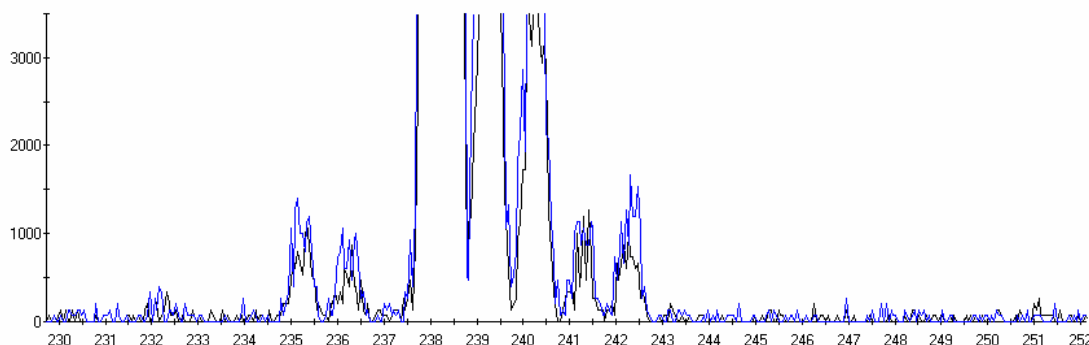
Figure 6. ICP-MS actinide spectrum, $m/z = 229.5$ to 252, high sensitivity.

ICP-MS analyses were performed on the sample solutions and blank to aid in the determination of the chemical composition of the cladding. Two types of scans were performed. The first was a fission product scan, which enveloped the m/z range 80 to 195. The second was an actinide scan, which includes the portion of the mass spectrum with m/z values ≥ 230 . These scans are shown in Figures 3, 4, and 5, with an additional high sensitivity plot of the actinide spectrum shown in Figure 6.

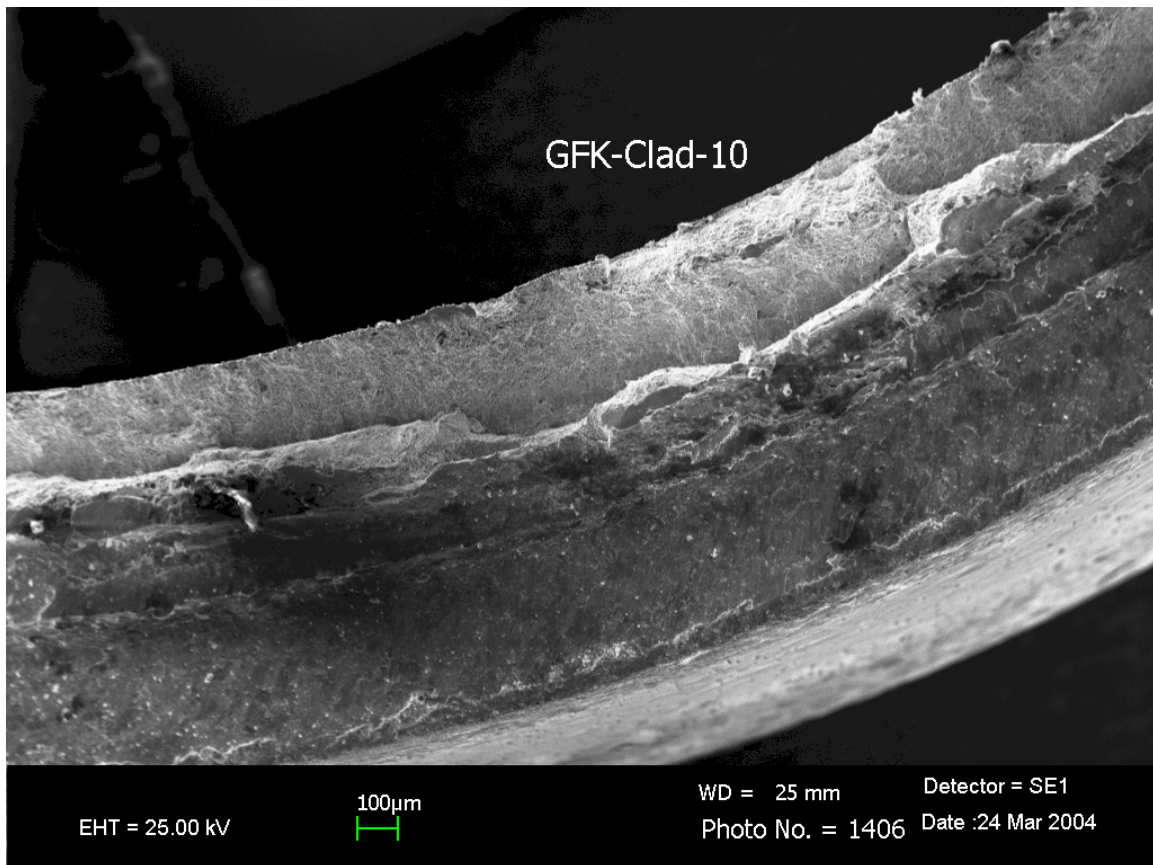
Figure 7. Emitted electron image of as-received cladding slice, 40x magnification.

The surface texture of the as-received sample (Figure 7) shows that the cutter used to cut the samples actually fractured the surface (as opposed to cutting it). The portion of the sample near the outer diameter of the cladding appears to have been cut (note the smoothness and surface striations), while most of the interior of the sample surface is rough. (The bright ring around the lower right-hand side of the cladding picture is a reflection from the side of the sample). Upon higher magnification of the surface, three spots were analyzed. One spot (Spot 1 on Figure 8.) appeared to be representative of the bulk of the surface, while two other spots (Spot 2 on Figure 8.) identified from the backscattered electron image appeared to be different than the rest of the surface. Analysis of Spot 1 identified it as Zr-rich (Figure 9.). Analysis of the Spot 2 locations identified them as nearly pure uranium (Figure 10). Other such spots were also identified at other locations on the surface of the sample and they too were identified as nearly pure U. Both the backscattered and emission images suggested that the U-bearing spots were particles on the surface of the sample. It should be noted that the signals near 7.5 and 8 keV in the spectra shown in Figures 9,10, and 12 are believed to be a commonly-encountered artifact that is caused by the radiation field associated with highly-contaminated samples.

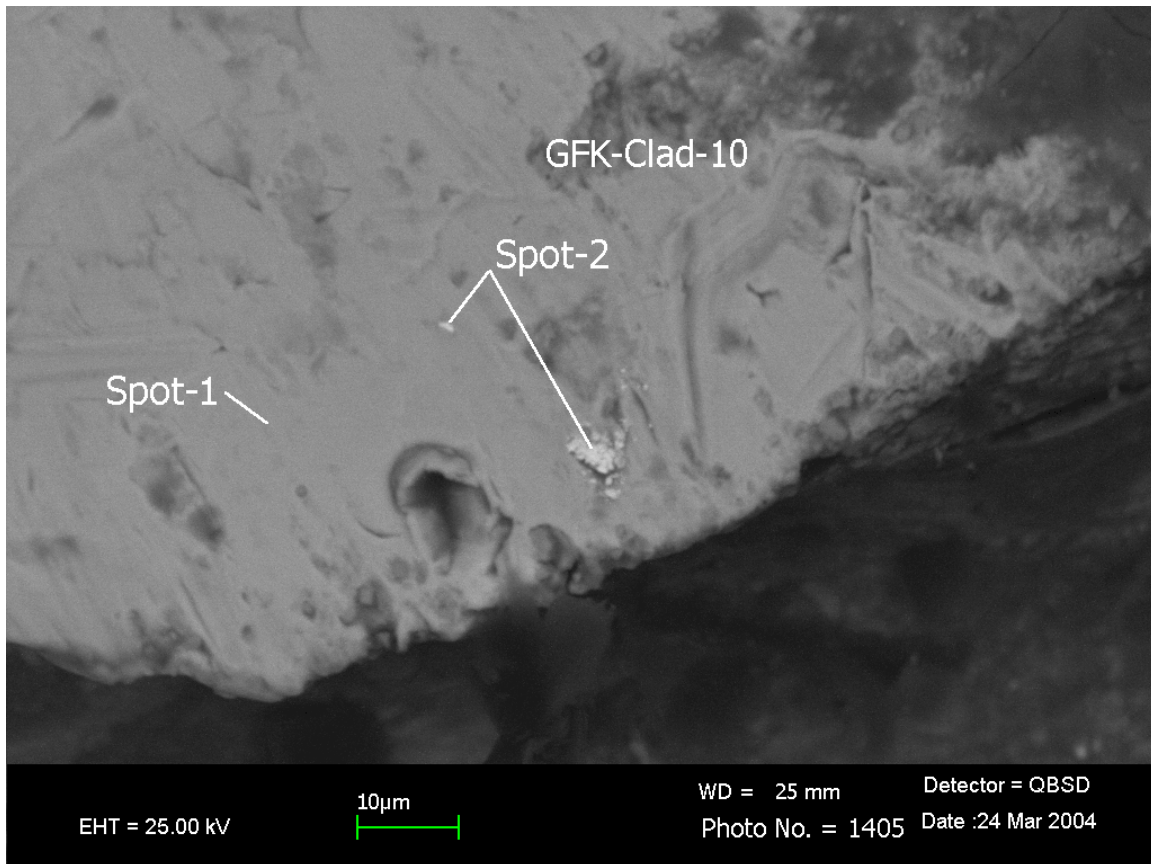
Figure 8. Back scattered electron image of the surface of the as-received slice of cladding, 1000x magnification.

Other surface discontinuities, especially when viewed in the back-scattered electron mode, showed regions of the cross-sectional surface that were visually and compositionally unique as compared to the bulk of the material. One type of region, which was very large in area (with dimensions in the tens of μm range), was rich in Fe. Other regions, with dimensions in the 1-10 micron range, were essentially pure U. While it was not possible to determine the depth of the Fe-rich regions, which also showed the presence of considerable Zr, the U-rich regions looked like particles of nearly pure U (or UO₂) resting on the surface of the sample. No U was detected except in these regions.

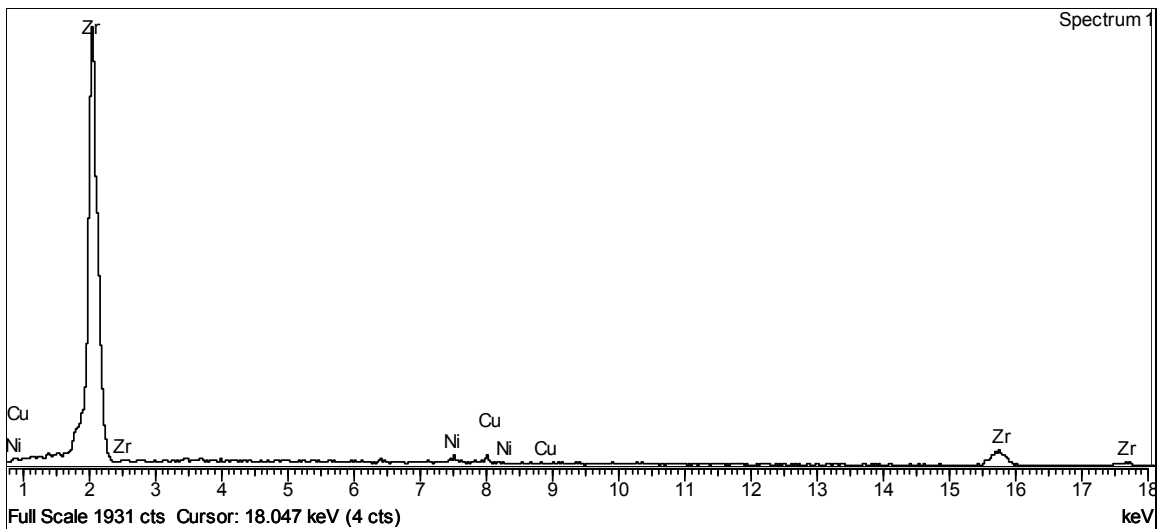
Figure 9. SEM-EDS spectrum of Spot 1.

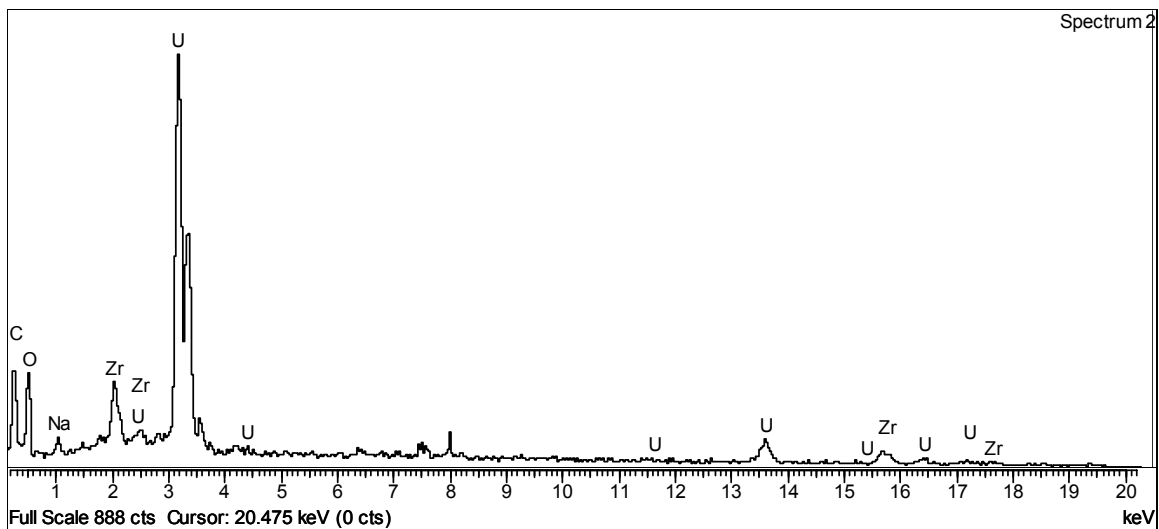
Figure 10. The EDS spectrum of Spot 2.

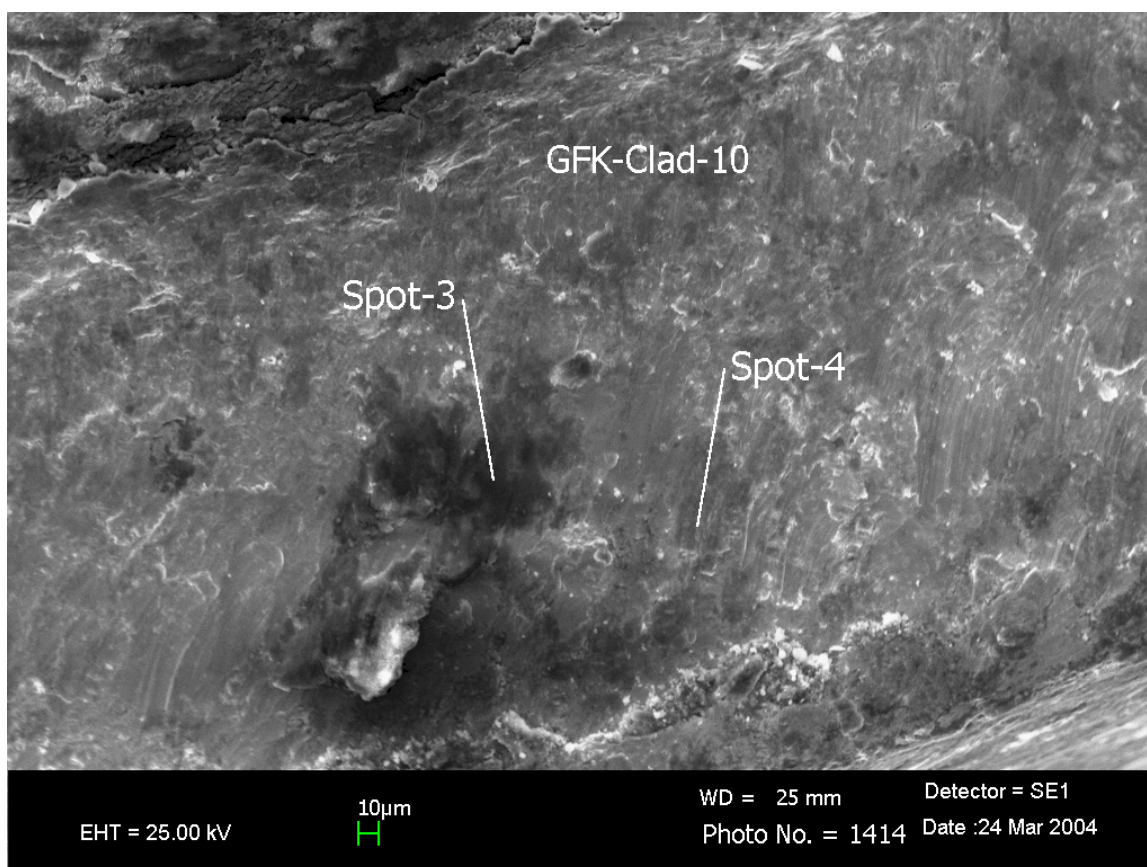
Figure 11. Electron emission image of surface of as-received sample at Spots 3 and 4, 200x magnification. The bright spots in this image indicate the topography (high spots) on the sample surface.

Elemental analyses were also performed on two other regions of the surface that appeared to be unique (Spot 3 and Spot 4 in Figure 11.). Analysis of Spot 3 (Figure 12.) identified that area as being high in Fe, while analysis of Spot 4 identified that spot as being high in both Fe and Zr.

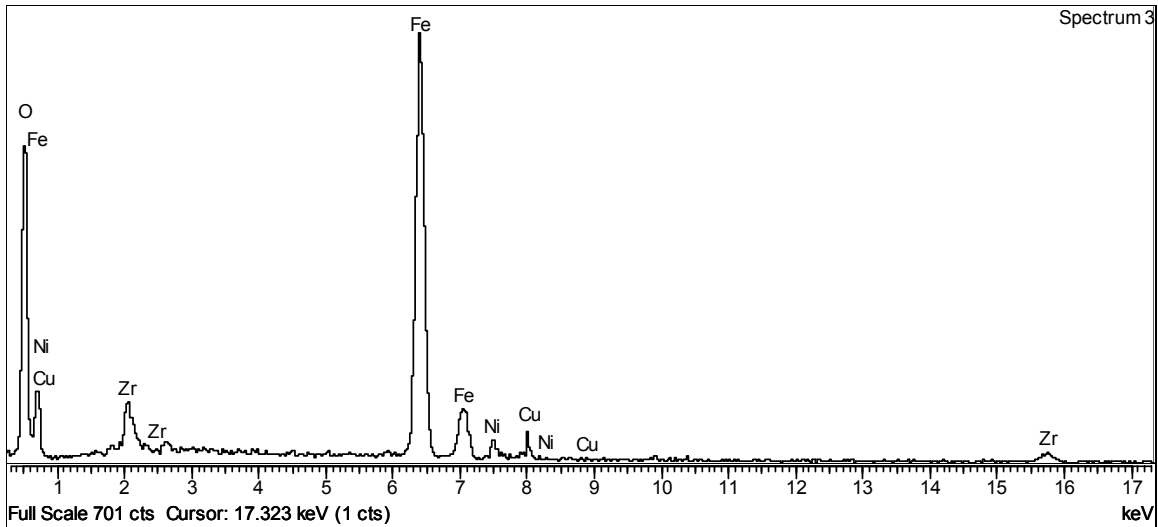
Figure 12. SEM-EDS spectrum of Spot 3.

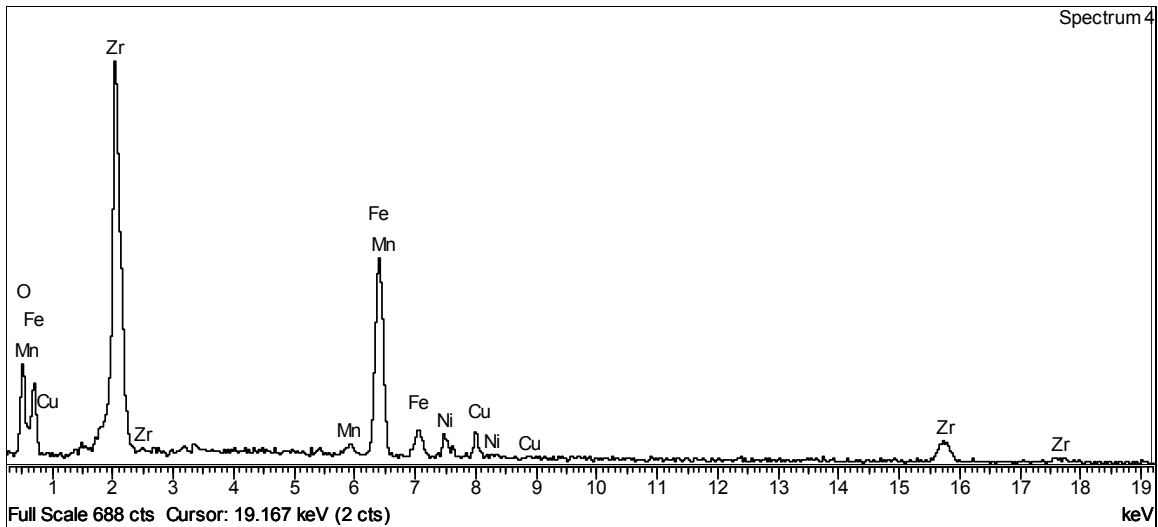
Figure 13. SEM-EDS spectrum of Spot 4.
