DYNAMIC BEHAVIORS OF HISTORICAL WROUGHT IRON TRUSS BRIDGES – A FIELD TESTING CASE STUDY

UNIVERSITY OF NORTH TEXAS

CASE STUDY OF OLD ALTON BRIDGE

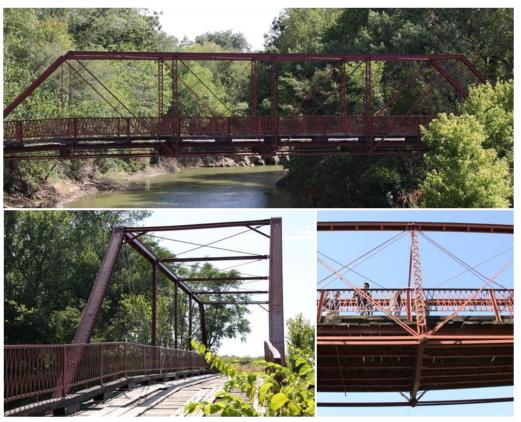
Figure 3: The Old Alton Bridge main span

Old Alton Bridge is a simple three span, wrought iron Pratt Truss. It consists of three spans, two approach spans of wrought iron beams and a single main wrought iron truss span. The main truss structure spans a total 109 ft, with the total bridge length as 145 feet, and is simply supported at both ends on concrete columns. The main truss is 16'1" wide and 18' high vertically. The top chord of the main truss is comprised of two iron channels joined by an iron plate 12"x3/8", riveted to the top flanges. The top chord is continuous for the entire length and forms a trapezoidal shape with the bottom chord. The bottom chords are made of two iron bars, 3"x3/4", that span from intermediate vertical posts and are connected with pin connections. Three main vertical posts are suspended from the top chord at the three center panel points and smaller rods are used on the two panel points closest to the support columns. Non prismatic floor beams span from one truss to the other, starting as 11" deep wide flange beams to 24" deep in the center. These support w-shaped stringers and the road decking. For more detailed section information please see the following Table 1 which contains on site measurements for each member cross sections.

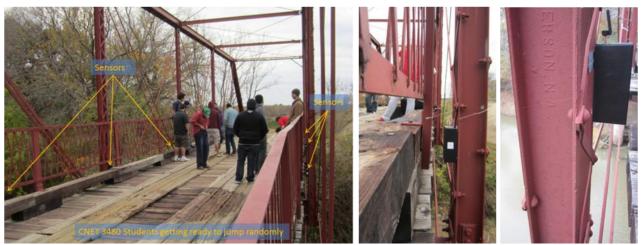
In order to ensure the network is laid out in an efficient and reliable geometry the predicted mode shapes, size of the network and communication range of the package must be considered. The tested truss length of the Old Alton Bridge is 109 feet (33.22 m) long, 16 feet 1 inch (4.90 m) wide, and 18 feet (5.49 m) high. The current range of the iMote2 WSSN with an external 2.4 GHz antenna is around 650 feet (200 m). The relatively small size of the bridge allows for just one base station to be used for the testing. The base station and corresponding computer are located near the center of the span to allow for the best transmission to and from the sensor nodes.

Previous FEA has predicted the first three modes shapes to involve the bridge deck vibrating in a vertical, horizontal and torsional motion. Since the bridge deck is where pedestrian traffic or loading would typically occur, the SHM-A sensor nodes for acceleration measurement were placed on the six center vertical members near their pin connection to the bottom chord. Because the pin joints are below the bridge deck and hard to access, the sensors were placed approximately 2 feet above the pin joints on the vertical members. The sensor nodes were placed in plastic sealed boxes and attached to the wrought iron members with magnets and, as a precaution, two-sided tape. The following Figure 5 shows the sensor node locations.

Figure 5: Sensor Node Attachment Locations

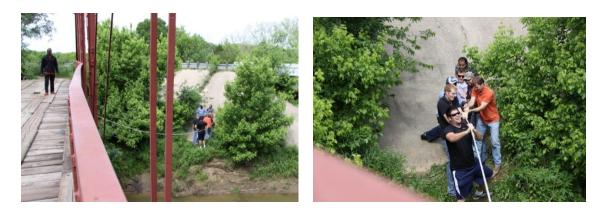
Test 7 was a test in which a group secured a rope to the midpoint of the span and pulled in the transverse direction, North-South, Figure 23. The data was collected at a sampling rate of 100 Hz and for duration of 130 seconds. Figure 24 is the graphical representation of the vertical response tests results. The unprocessed acceleration data shows what look like several pulls on the bridge. For Test 7 the sensors provided very consistent results for both the vertical responses and the transverse responses. The first identified vertical frequency was exactly 5.689 Hz across all the sensor locations, with the second identified frequency be seeing seen at an average of 8.447 Hz. Figure 25 shows the structural responses for vibrations in the transverse (side to side) direction. The transverse vibration does show a clear peak across of the sensors at an average of 2.441 Hz and shows a single peak ranging from 13.76 Hz to 18.19 Hz. For this test the horizontal pulling motion provided clear very tall peaks in the vertical Fourier Spectra and a very clear and high magnitude peaks for the first transverse mode. From these results the first and fundamental mode of the Old Alton Truss Bridge was determined to be a transverse sway in the bridge deck at a frequency of 2.441 Hz with the second and third corresponding to the identified maxima seen in the vertical response spectra as 5.689 Hz and 8.447 Hz respectively.

Figure 23: Test 7 Group Pulling Rope
