PNNL- 21476

Demonstration of LED Retrofit Lamps at the Smithsonian American Art Museum, Washington, DC

Final Report prepared in support of the U.S. DOE Solid-State Lighting
Technology Demonstration GATEWAY Program

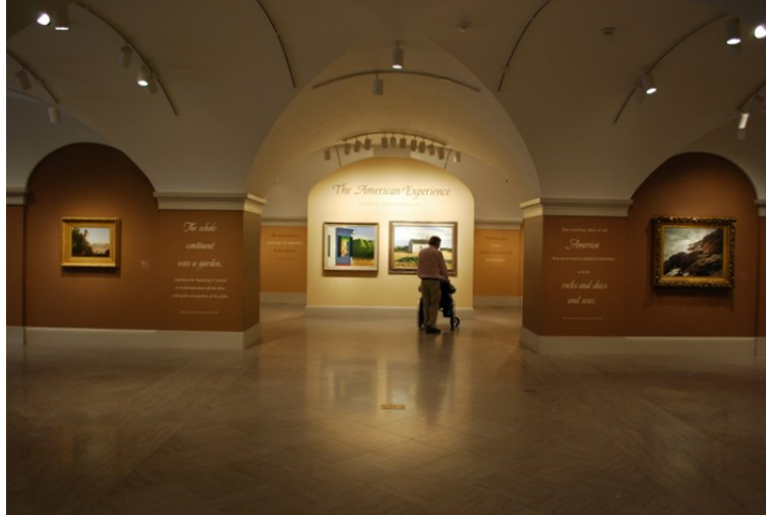
The gallery lighting system at the Smithsonian Art Museum has more than 7000 late 20th-century track luminaires, with four different kinds of track heads. These heads were originally designed to accommodate halogen PAR38 lamps, halogen PAR30 lamps, MR16 halogen lamps (the track head incorporates an electronic 12V transformer), and PAR36 incandescent and halogen lamps (the track head incorporates a dual-tap 5.5V and 12V magnetic transformer). All of the track heads were designed for maximum flexibility, accommodating lenses, theatrical filters, louvers, baffles, snoots, screens, and wallwasher reflectors that allow the PAR lamp light beam to be sculpted to create the ideal light distribution for the area or artwork. These accessories can also control glare and reduce illuminance to the maximum levels recommended for each individual work. Figure 1 shows a typical track head installation using halogen PAR30 lamps in one of the museum galleries.

Figure 1. The American Experience gallery at the Smithsonian American Art Museum, lighted with typical cylinder-shaped track heads.

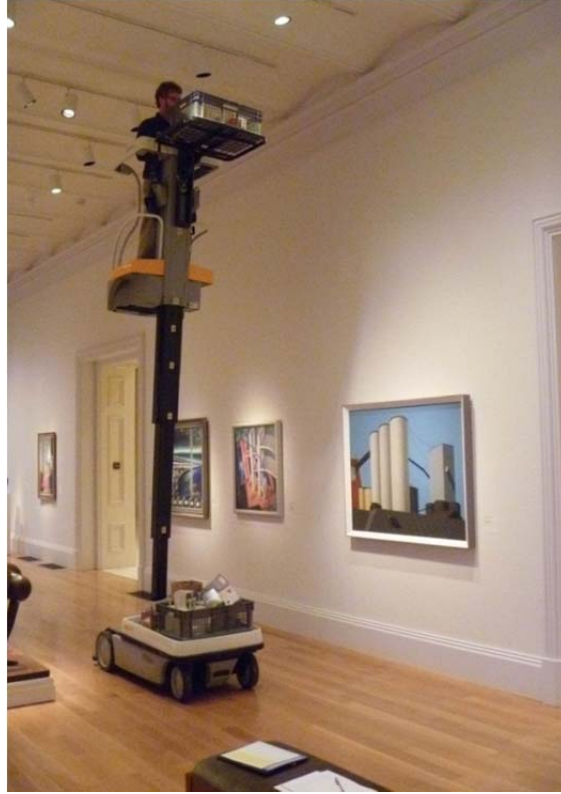
Figure 2. Early test of LED replacement lamp in Rose Gallery. Photo courtesy of PNNL.

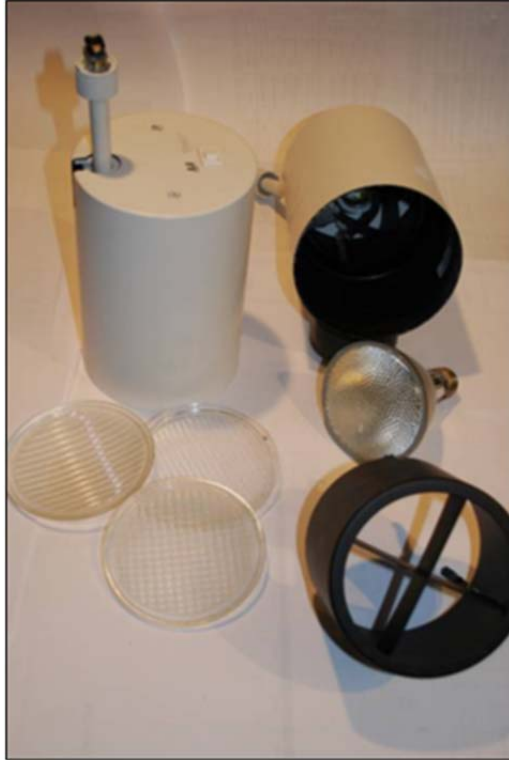
Figure 3. PAR30 display track head with three types of lenses (70, 55, and 55 x 75°), and a cross-baffle

The Smithsonian American Art Museum's display lighting system was installed in 2006. The track heads, custom made by Zumtobel Lighting, were designed to accommodate a wide range of lamps and media. Between the flexibility of different halogen lamp beam angles and intensities, and the interchangeability of accessories, the lighting designer can create a specific appearance for each unique work of art. The track light used for focal lighting is illustrated in Figure 3, and the wallwasher in Figure 4.

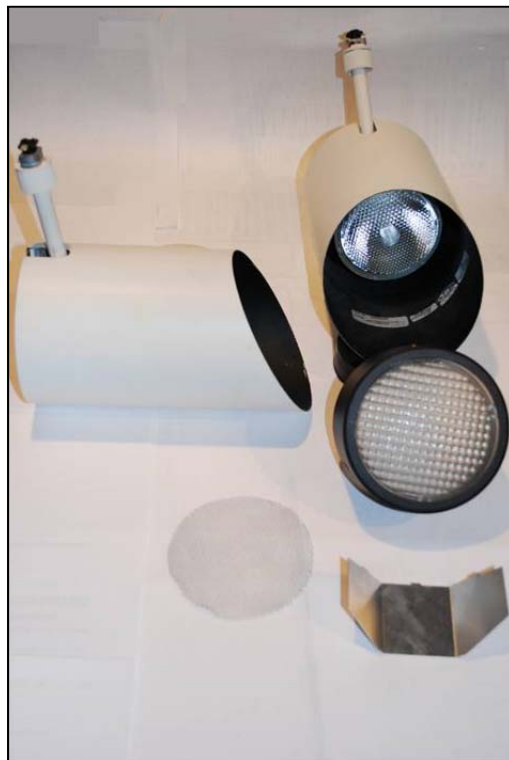
Figure 4. PAR30 wallwasher track head, shown with lens, light reduction screen, and optional kicker reflector

The wallwasher track head (shown in Figure 4) worked extremely well with the LED replacement lamp because the LED product's light distribution is very similar to that of the halogen PAR lamp it replaced when combined with spread and asymmetrical spread lenses. Asymmetrical spread lenses can be rotated in the fixture, spreading the light linearly and pushing it down the wall to where the art objects (and people) are. The cross baffle was especially important in the track heads used for focal lighting because of the increased direct glare potential for the light sources with exposed LEDs on the face of the lamp.

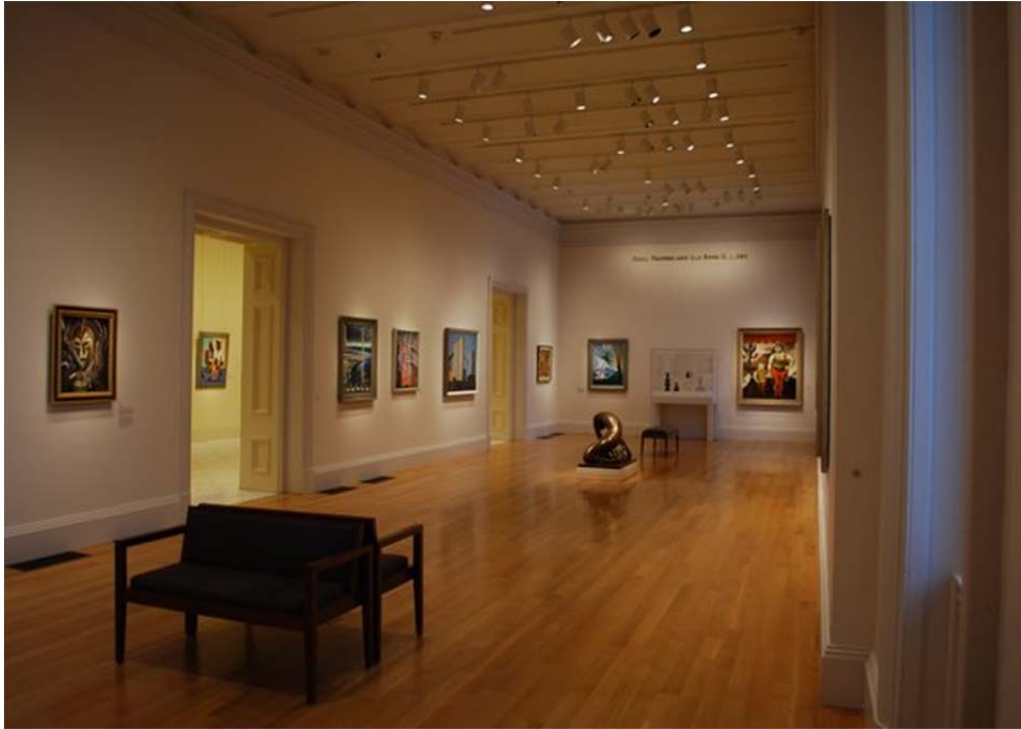
Figure 5. Early Modernism Gallery lighted with incandescent and halogen lighting (“before” condition). Photo by Scott Rosenfeld.

The Early Modernism Gallery is 1200 ft² in area, with a 16 ft 4 in. ceiling. (See Figures 5 and 6.) Illuminance on the paintings is a compromise between low levels for conservation purposes and high

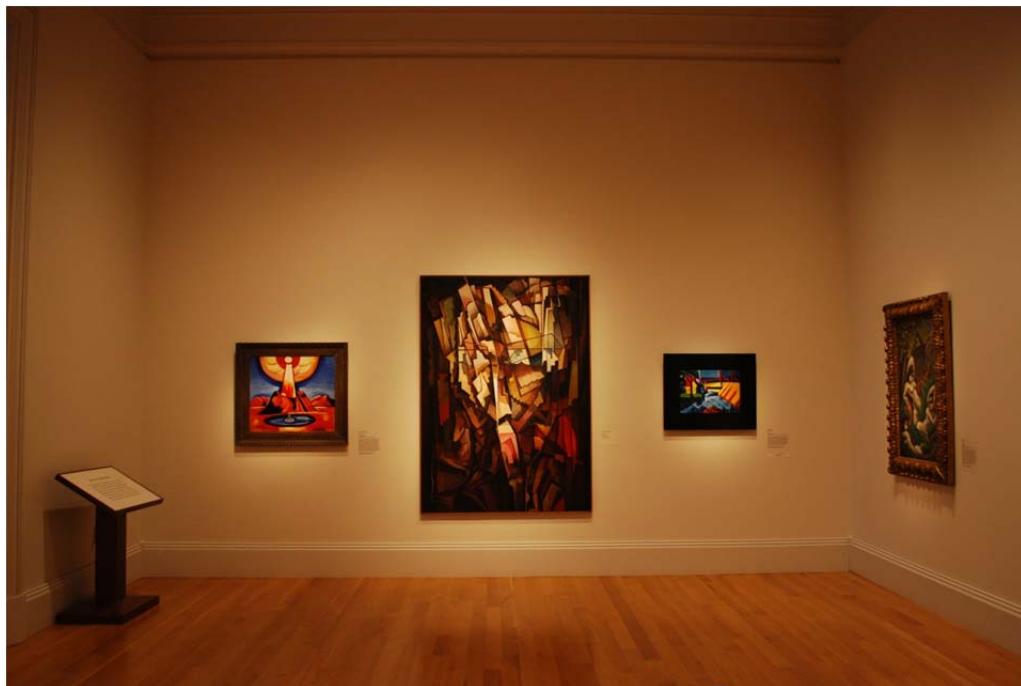
Figure 6. One wall of the Early Modernism Gallery lighted with incandescent and halogen lamps before the LED replacement lamp trials. Photo by Scott Rosenfeld.

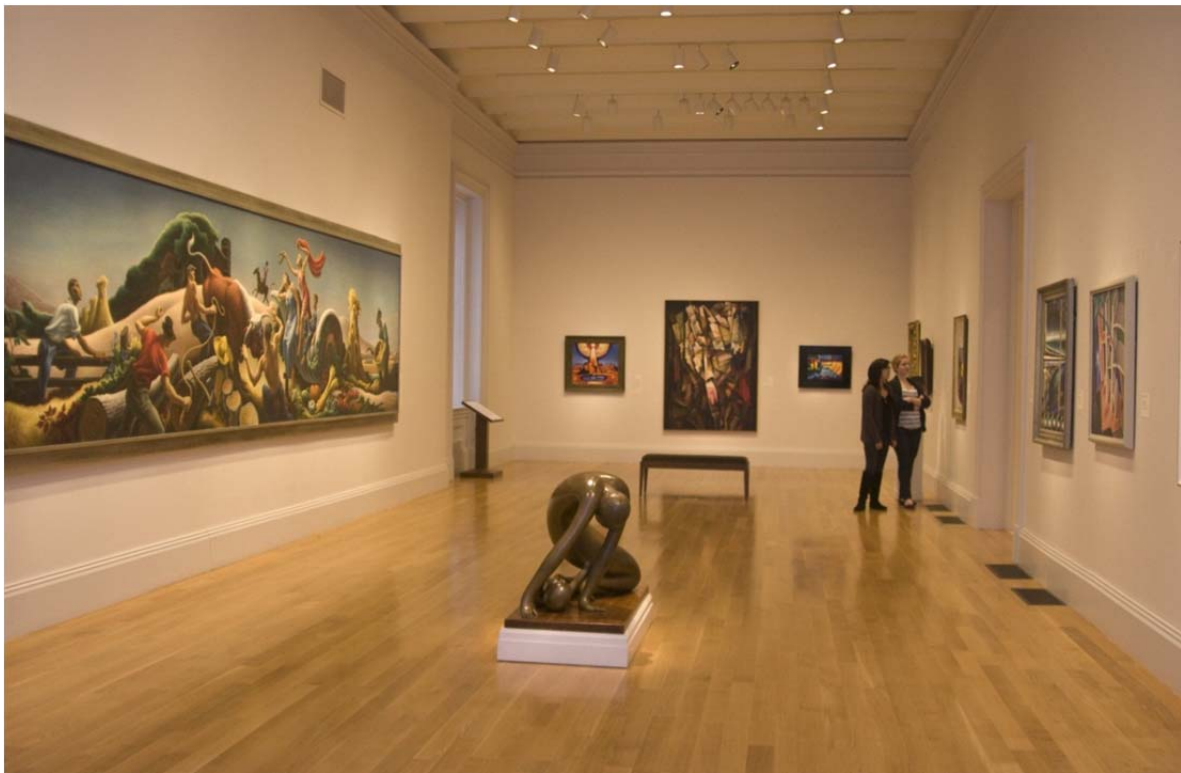
Figure 7. Early Modernism Gallery relighted entirely with LED replacement lamps. Photo courtesy of the Smithsonian American Art Museum.

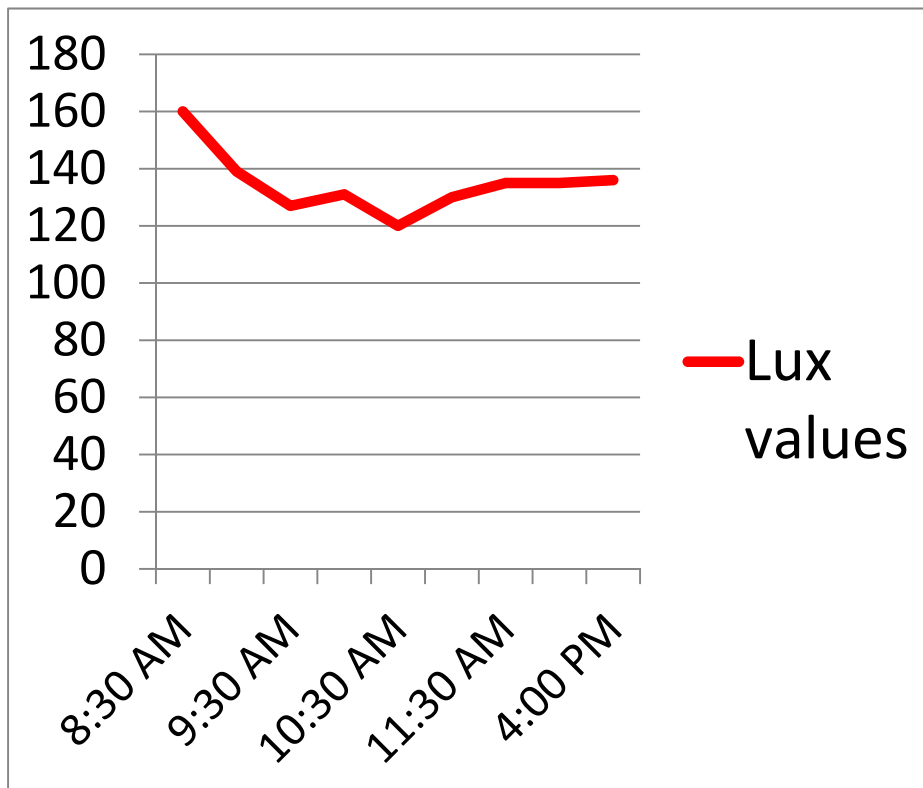
Figure 8. Plot of lux values measured on one painting in the Early Modernism Gallery. The variation over time is due to the thermistor built into the Solais PAR38 lamp. There is a 25% decrease from the highest to lowest measured illuminances. (Note that the values on the horizontal axis are not equally spaced. There was little measured change in output between 11:30 a.m. and 4 p.m.)

The Solais PAR30LN (longneck) LED lamps produced the best 10°, 25°, and 40° beams for the collection in terms of beam size, beam uniformity, beam edge, and color quality. However, the light output had to be modified with metal screens in order to limit the total display lighting on the paintings in the gallery to no more than 250 lux vertical. In the case of the track heads, which were used to produce a soft, low level of uniform background lighting (“wallwash”), one of two kinds of asymmetric glass lenses was clipped in front of the lamp. The glass or plastic media blocked normal air flow to the LED replacement lamps, which may have contributed to the lamp’s rise in temperature. The lamp design contains a thermistor, which reduces the lamp wattage and light output by approximately 25% when it senses overheating, and the thermistor is not reset until the next time the lamp is switched on. Consequently, the designer found that the output from these lamps could be expected to decrease over a period of 1 hour, and learned to apply final aiming and lens adjustments after the lamp had dropped in its output. Even at the lower output, the color and beam characteristics still made this a desirable lamp, and the thermistor behavior was acceptable in this gallery. Figure 8 plots the measured illuminance on one painting against time for this Solais LED PAR30 lamp.

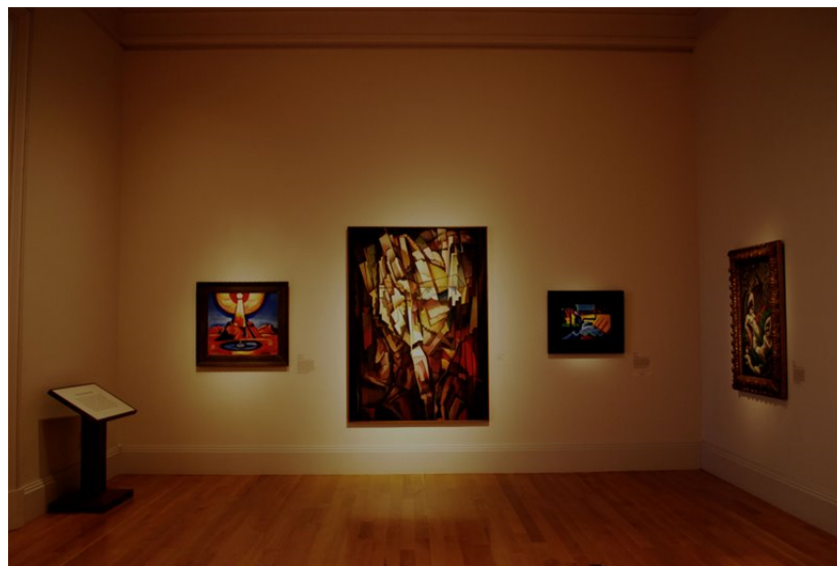
Figure 9. Early Modernism Gallery photographed with LED display lighting layer only. Photo by Scott Rosenfeld.

Figure 9, Figure 10, and Figure 11 show one wall of the gallery using the display lighting layer only, the wallwashing layer only, and the final composite of the two.

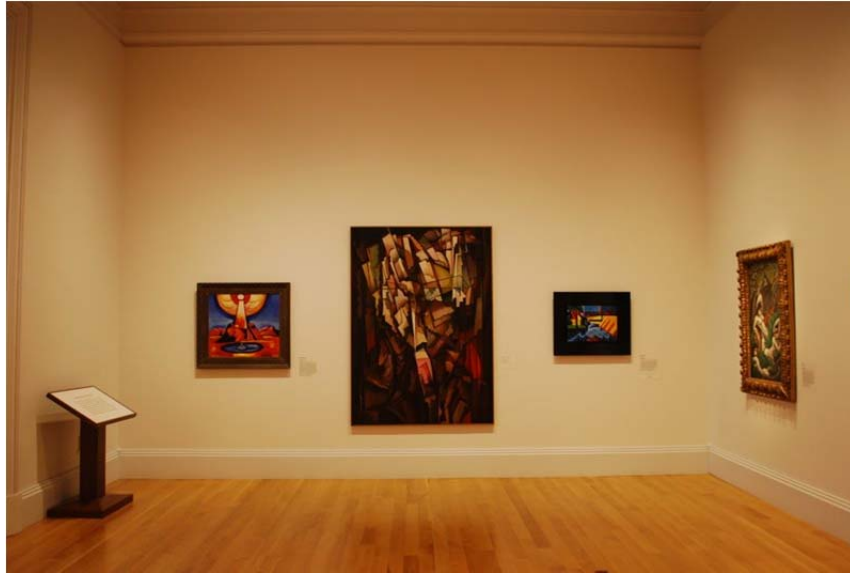
Figure 10. Early Modernism Gallery with LED wallwash lighting layer only. Photo by Scott Rosenfeld.

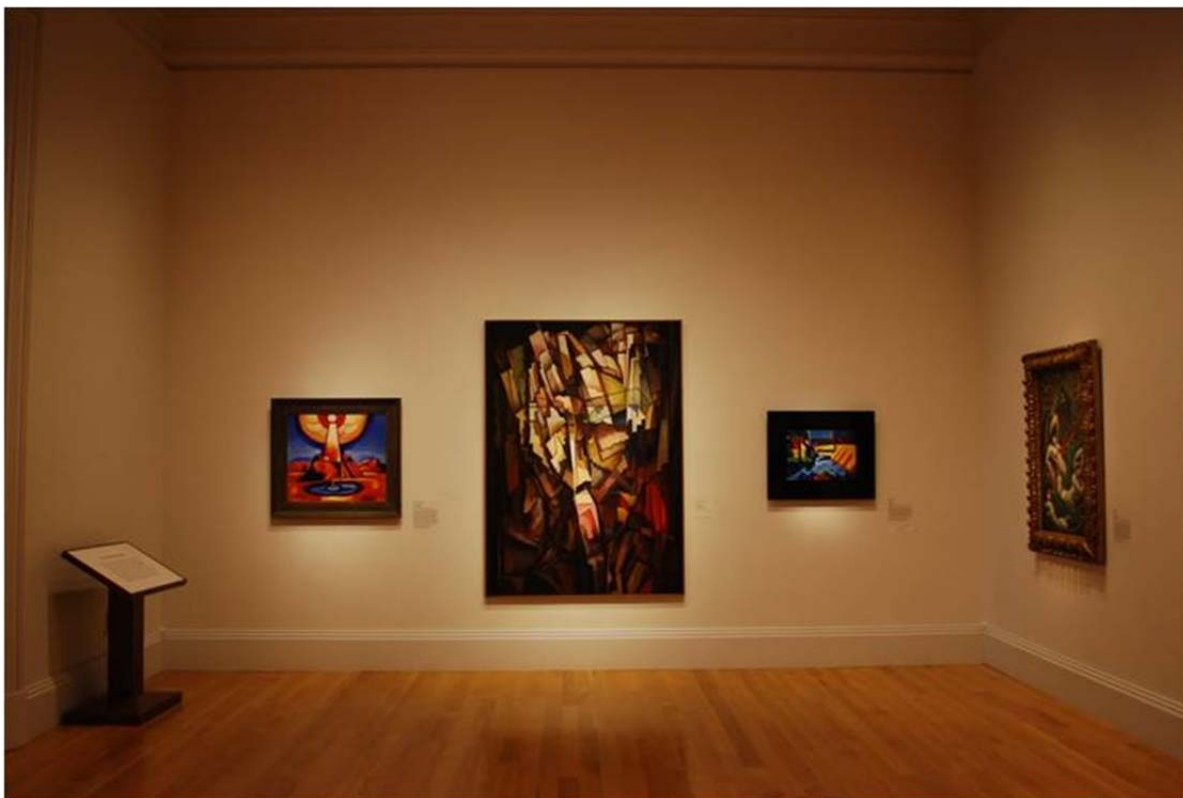
Figure 11. The Early Modernism Gallery with LED replacement lamps. Composite of display lighting and wallwashing. Photo by Scott Rosenfeld.

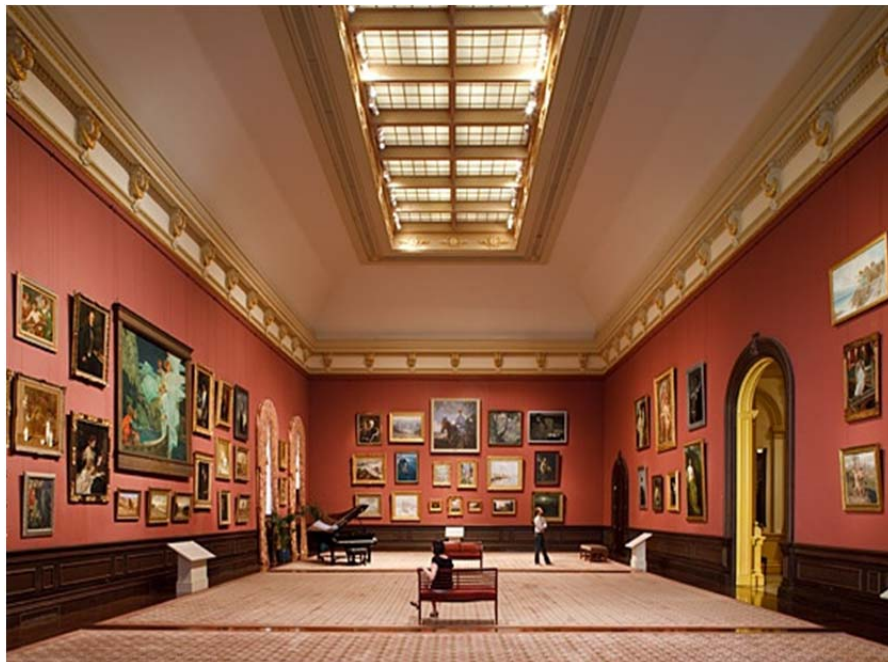
Modeled after the Louvre's Tuileries galleries, the Grand Salon currently exhibits a collection of 19th and 20th century paintings from the Smithsonian American Art Museum. The Grand Salon exhibits paintings in multiple heights on the wall, as shown in Figure 12. The display track lighting is located next to the simulated skylight in the ceiling, and the throw distances to the objects can be 20 ft or more. Consequently, the gallery generally uses high-wattage, narrow-distribution, high-intensity incandescent and halogen lamps, including 25W 6V PAR46 VNSP lamps with a center beam candlepower (CBCP) of 55,000 candelas (cd), 120W PAR38 9° NSP lamps with a CBCP of 18,000 cd, and 250W PAR38 30° FL lamps (9000 CBCP, 3600 lumens) for wallwashing. Because LED replacement lamps are still evolving, they cannot yet deliver high-intensity spots or high-lumen packages for this kind of application. However, the designer was still able to substitute one-third of the lamps in the room with LEDs.

Figure 12. Renwick Gallery Grand Salon with 35 ft 0 in. ceiling, lighted with halogen and incandescent track lighting. Photo courtesy of the Smithsonian American Art Museum.

Long throw distances called for narrow, intense beams of light for the specific art objects. The PAR38 LED replacement lamps from MSI delivered a 10° beam that worked very well as an accent light for some works, allowing the designer to eliminate all 120W PAR38 SP10° halogen lamps, most 50W PAR36 VNSP6° halogen lamps, and several 250W PAR38 SP10° and 25W 5.5V PAR46 pinspot lamps. The MSI lamps, shown in Figure 13, have an adjustable ring that changes the wattage and light output from 10W (13,250 cd, 550 lumens) to 12W (15,250 cd, 650 lumens) to 16W (18,000 cd, 800 lumen) according to the manufacturer. This feature allowed the illuminance on the objects to be reduced to conservation levels and saved energy because the designer could reduce light output to the lowest level needed. The visual result of the partial change to LED lamps can be seen in Figure 14, and it resulted in an estimated reduction of 2054W in the Grand Salon, with a corresponding annual lighting energy savings of \$1,294, assuming 4500 annual operating hours at \$0.14/kWh. There has been no effort to publicize this partial lamp change in the Grand Salon, but it is significant that the changes seem to have gone unnoticed by the public so far. That may mean that the LED lamps blend well with the existing halogen sources still in use.

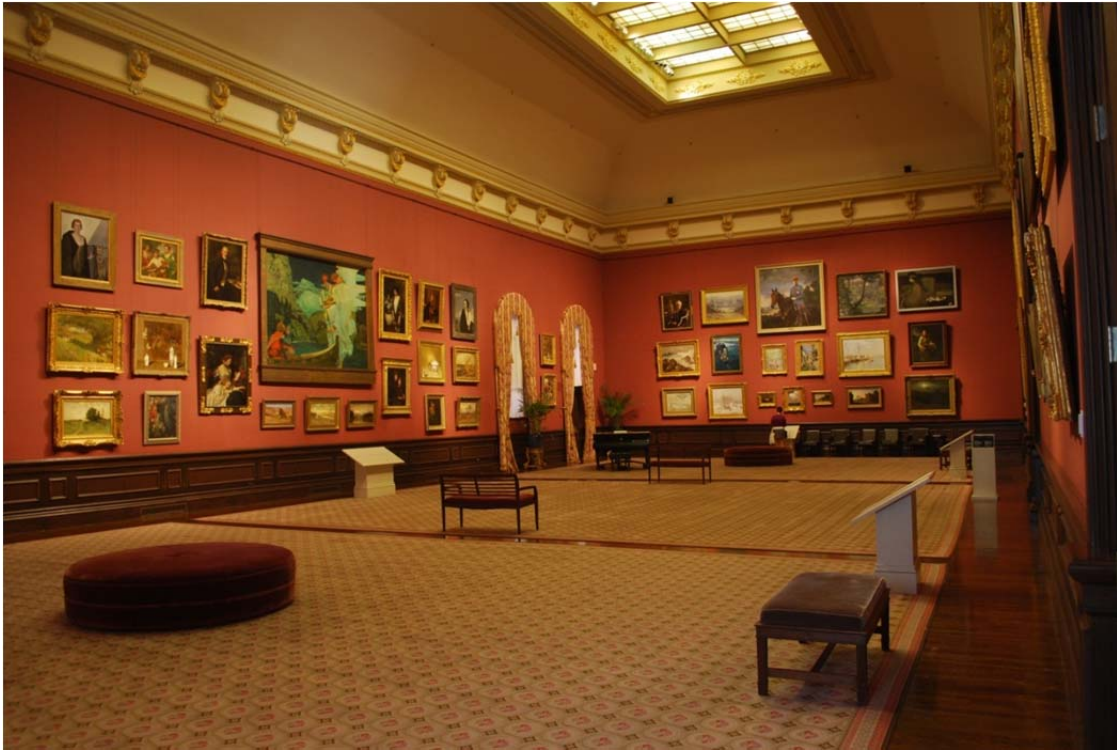
Figure 14. The Renwick Gallery Grand Salon with LED replacement lamps in approximately one-third of the display track lighting located near the simulated skylight. There are approximately six MSI 16W LED PAR38 10° NSP lamps among the lamps used to light the wall on the left, but only incandescent lamps are used on the end wall. Photo by Scott Rosenfeld.

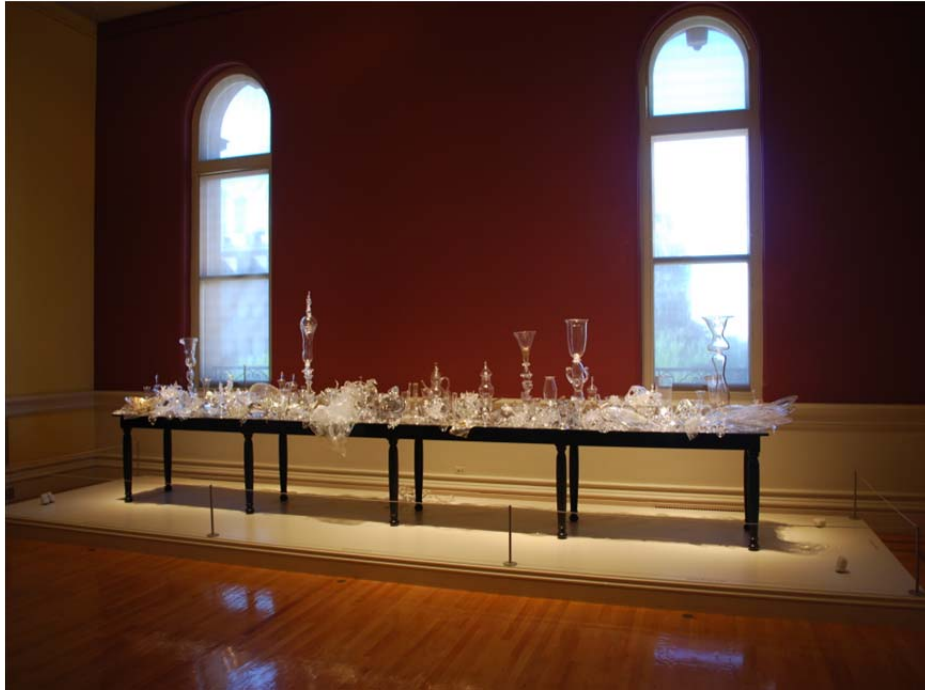
Figure 16. Gallery 202 of the Renwick Gallery, lighted with MSI PAR38 10° NSP LED replacement lamps. 22 ft 0 in. ceiling. Photo and lighting design by Scott Rosenfeld.

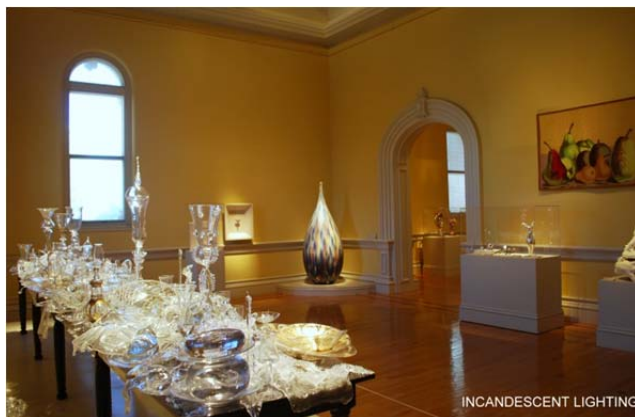
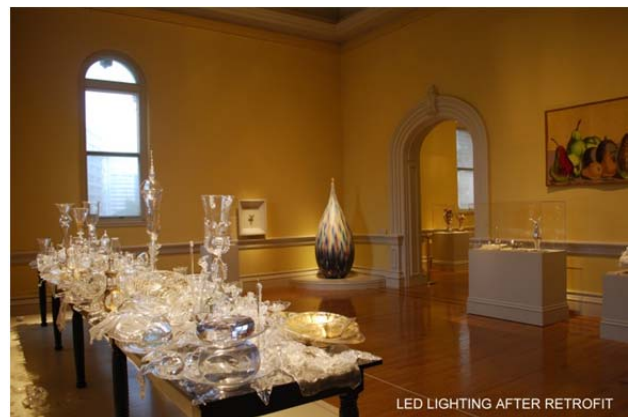
Figure 17. Gallery 202 with original incandescent lamping (left) and LED lamping (right). Photos and lighting design by Scott Rosenfeld.

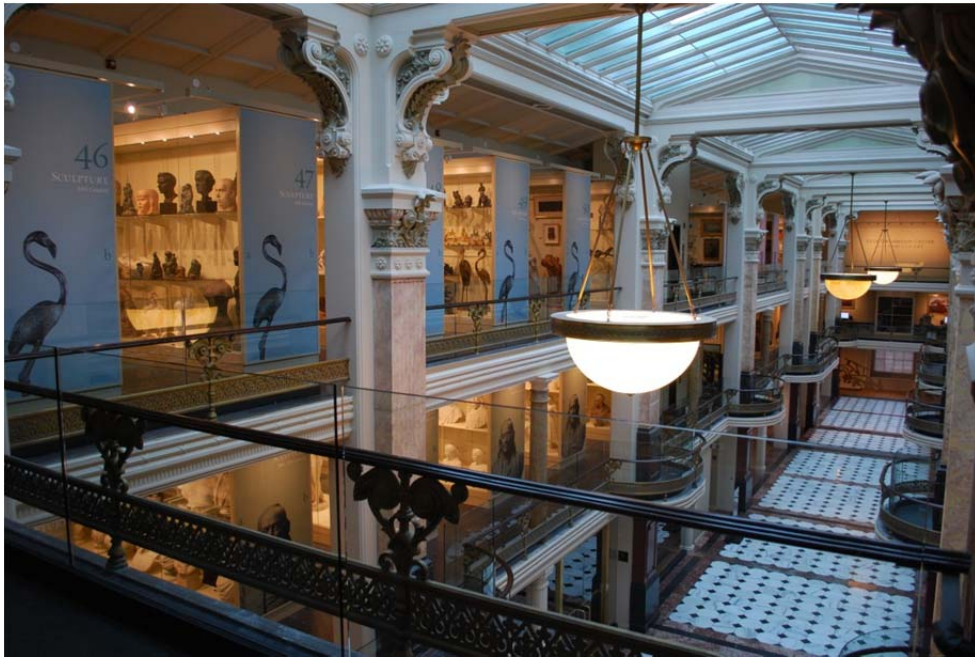
The Luce Foundation Center for American Art (Figure 18) is high-density visible art storage featuring 3500 paintings, sculptures, miniatures, and folk art pieces from the collection of the Smithsonian Art Museum. The collection is stored in 64 cases where the art is fully accessible to the public and scholars. The Luce Center is housed in one of the grand rooms of the Old U.S. Patent Office, which was built to store scale models for patent applications. Ceilings are only 8 ft high (Figure 19).

Figure 18. The Luce Center Gallery of the Smithsonian American Art Museum with storage galleries flanking the three-story center atrium. Photo courtesy of Smithsonian American Art Museum.

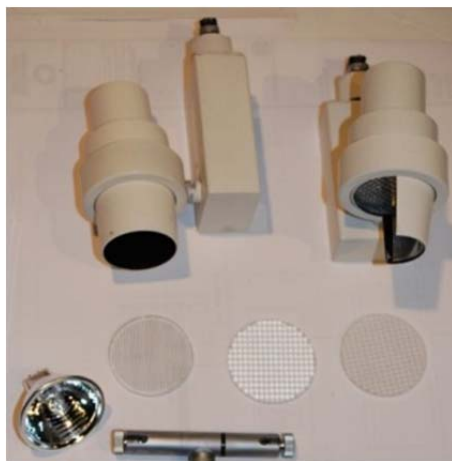
Figure 20. MR16 track heads with electronic transformers used in Luce Center. Photo by Scott Rosenfeld.

An electronic-transformer track luminaire is used for display lighting, equipped with a GE “Constant Color” 50W MR16 40° FL halogen lamp. The lighting system in the Luce Center Gallery is controlled by a Lutron dimming system, with a reverse phase (“ELV” or “trailing edge”) dimmer for this type of load.

Knowing that electronic transformers and dimmers can introduce incompatibilities into the lighting system, the lighting designer was willing to reprogram the dimming system so that it delivered “full output” or was “off,” but was never a significant phase-cut waveform to the replacement lamps. However, little could be done about the electronic transformer, since magnetic transformers are usually larger than the housings designed for electronic transformers. (Size was critical because the existing MR16 fixtures, seen in Figure 20, were specially built to allow the glass case doors to open without hitting the lighting fixtures.) The lighting designer was determined to find 12V LED replacement lamps compatible with electronic transformers.

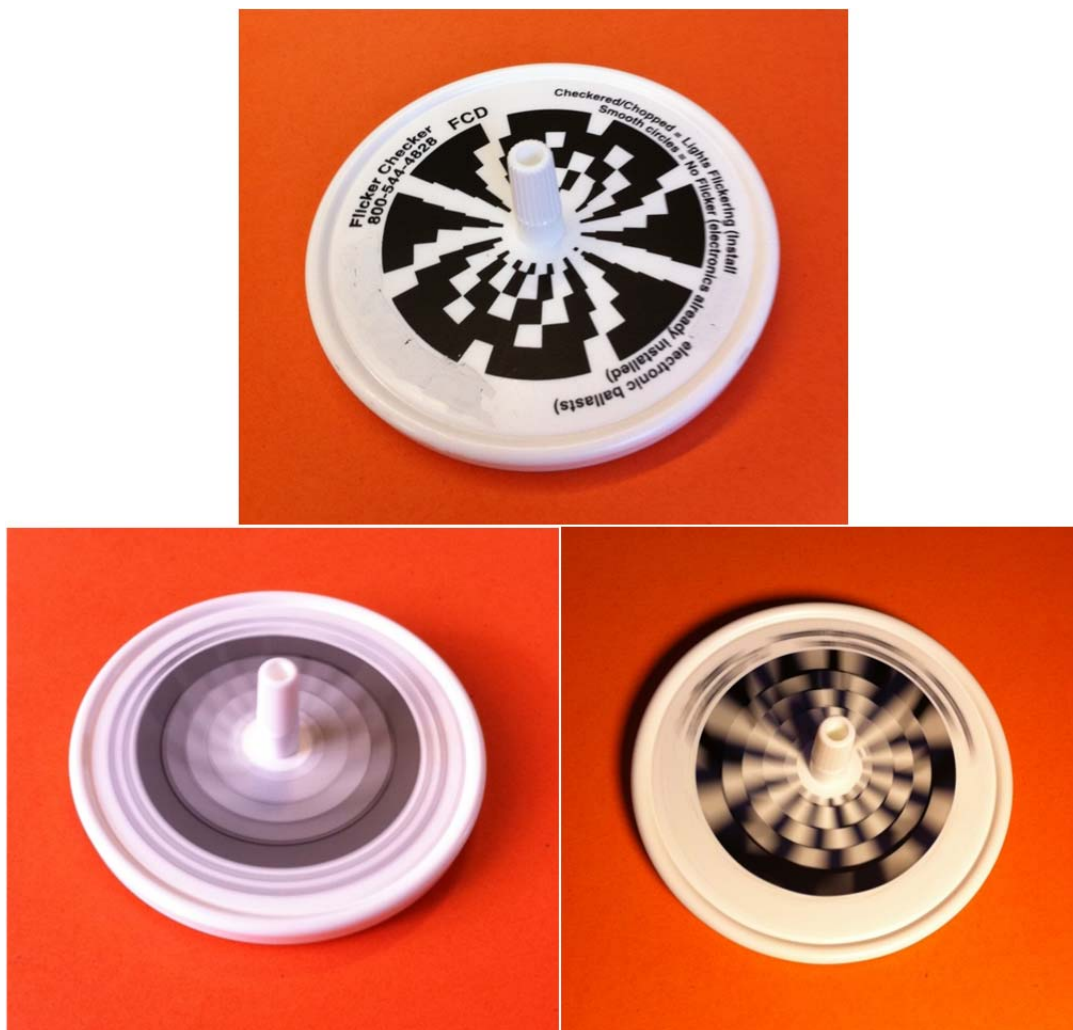
Figure 21. Flicker checker top. The top image shows it at rest, the bottom left image shows the top spinning under LED sources with very low modulation (i.e., minimal flicker); the bottom right image shows the top spinning under a source with very high modulation (i.e., pronounced flicker). Photos by PNNL.
