Final Report Testing of Iron Phosphate LAW Glass (VSL-11R2340-1) April 25, 2011

Prepared for the U.S. Department of Energy
Assistant Secretary for Environmental Management

H. Gan
A. C. Buechele
Z. Feng
C. Wang
C. Viragh
I. L. Pegg
Vitreous State Laboratory
The Catholic University of America

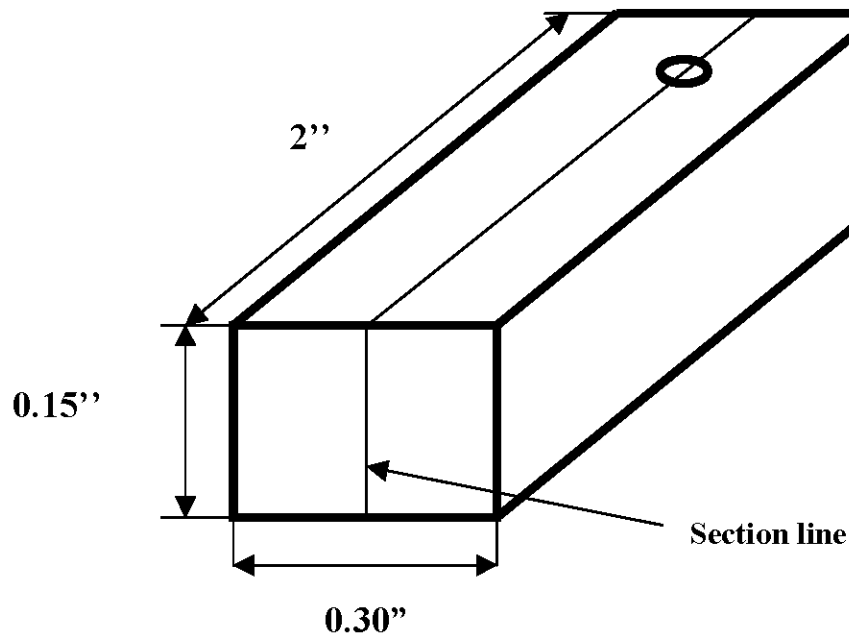
Figure 2.1. Schematic diagram of a metal coupon showing typical dimensions and line indicating where the coupon is sectioned after testing.

After the test coupon was removed from the corrosion setup, it was sectioned at 1 mm, 5 mm, and 9 mm from the bottom tip and the cross-sections were prepared for subsequent microscopic analysis.

After each corrosion test, the reacted coupons were embedded in resin and then sectioned at the mid-point and polished. Both halves of the sectioned coupons were examined for corrosion characteristics (e.g., morphology of new, modified, and original phases, the texture of the reacted alloys, etc.) using a microscope. The thickness of the reacted coupon was measured using a measuring microscope, which has a precision of better than 0.05 mil (1.27 μm). Typically, 10 transverse lines were measured perpendicular to the length of the coupon. The overall uncertainty associated with these measurements is about 0.5 mil. The dimensional loss is calculated as half of the difference of the measured widths between the original and reacted coupons near the glass line (or sometimes referred as the *neck* if such a feature develops) and at the location corresponding to half of the immersed length of the coupon (referred to as the *half-down* position). The measurements are illustrated in Figure 2.5. The sectioned coupons were further characterized using Scanning Electron Microscopy - Energy Dispersive X-ray Spectroscopy (SEM-EDS).

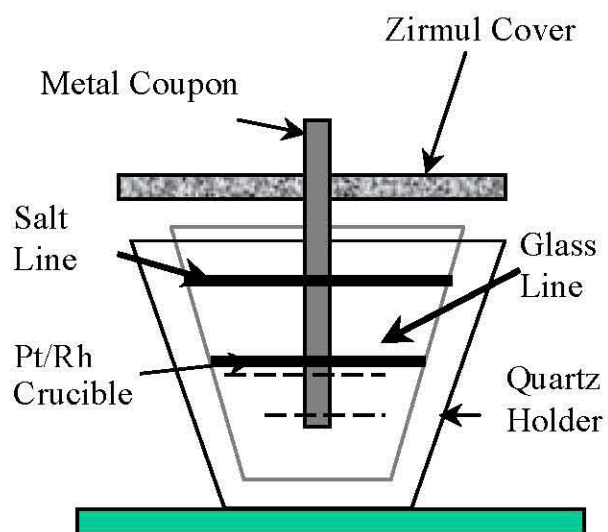
Figure 2.2. Experimental setup for metal coupon corrosion tests. Note: No salt phase was present in the present tests so the salt line is not relevant.

Corrosion tests with molten glass were conducted using the experimental arrangement shown schematically in Figure 2.2. The experimental setup consisted of a 50 ml platinum crucible placed into a quartz holder. On the top of the crucible there is a cover with a 5 mm slot. The coupon is placed through the slot and suspended by a rod that is placed through a hole drilled through one end of the coupon. For each corrosion test, 70 grams of glass is melted at 1150°C (nominal) for 30 minutes; this quantity gives an ratio of the coupon surface area to the volume of glass (S/V) for these tests of 0.15 cm⁻¹ and the crucible is filled to ³/₄ of its height (29 mm) with glass. The coupon with the lid is preheated to 800°C, allowing an oxide layer to form on the coupon, which is then placed into the crucible with the molten glass. The experimental setup is then placed into a furnace that is preheated to the desired test temperature (1050°C, 1100°C, or 1150°C). After the designated period of time, the setup is removed from the furnace, the coupon is extracted from the glass, and the glass melt is poured into a graphite mold for further analyses. The coupon with the glass coating is allowed to cool and then embedded in epoxy. For the extended tests, the coupon and lid are removed from the initial crucible after 7 days, excess glass is allowed to drip off the coupon, and the coupon with lid are placed in a crucible containing fresh glass. The glass from the first crucible is poured into a graphite mold

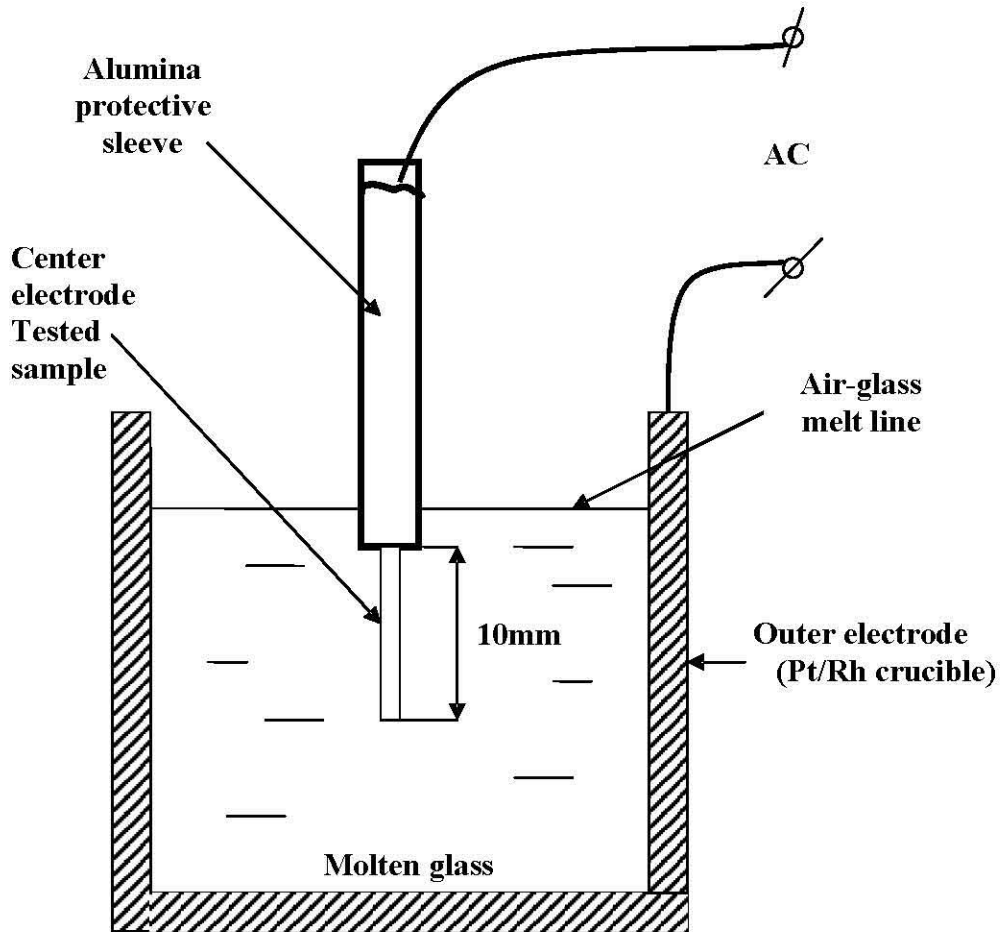
Figure 2.3. Test setup for the electrical corrosion experiments.

Corrosion tests in the presence of an electric field were conducted in molten glass at 1050°C. The test employs concentric cylinder geometry. The outer cylinder is normally fabricated from Inconel 690 and forms both the container for the molten glass and one of the electrodes. The inner cylinder, which is of much smaller diameter, is fabricated from the test material and forms the second electrode. In this way, a high current density is achieved at the test coupon while maintaining a low current density at the container and a relatively low total current, which avoids excessive joule heating. The entire assembly is installed in a vertical tube furnace set at the desired test temperature. The center electrode with attached wire is introduced inside the tube furnace after being inserted into an alumina protective sleeve and made to protrude from the sleeve by 10 mm. In the normal VSL procedure for this test, another Inconel wire is welded to the top edge of the Inconel 690 crucible for electrical connection. However, for the present electrical corrosion test with the FeP glass, due to excessive foaming in experiments using Inconel 690 crucible, a Pt/Rh crucible with a Pt/Rh wire was used. During the test, the center electrode is positioned at the center of the crucible and introduced into the glass melt to a depth of 12 mm, which allowed the alumina sleeve surrounding the center electrode to extend 2 mm into the melt. This 2-mm immersion helps to prevent enhanced corrosion of the center electrode at the air-glass melt line during the test (Figure 2.3).

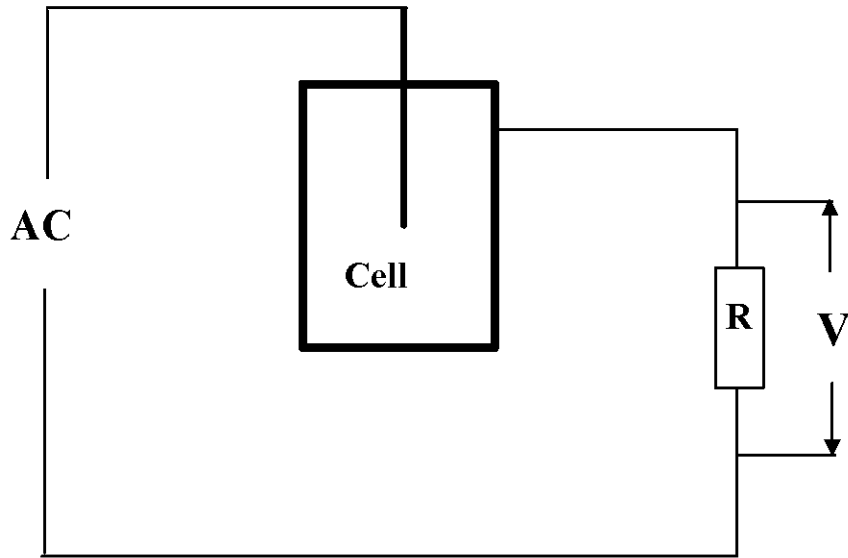
Figure 2.4. Electrical circuit for the corrosion tests.

The electric circuit for the tests is shown in Figure 2.4. A 60 Hz AC source was used to maintain a current density of 10 A/inch² at the center electrode pin. Over the entire duration of the electrical corrosion experiments (three days at 1050°C under ambient conditions), the actual current passing through the corrosion cell was controlled by monitoring the voltage across a precision resistor that was in series with the corrosion cell. The actual current passing through

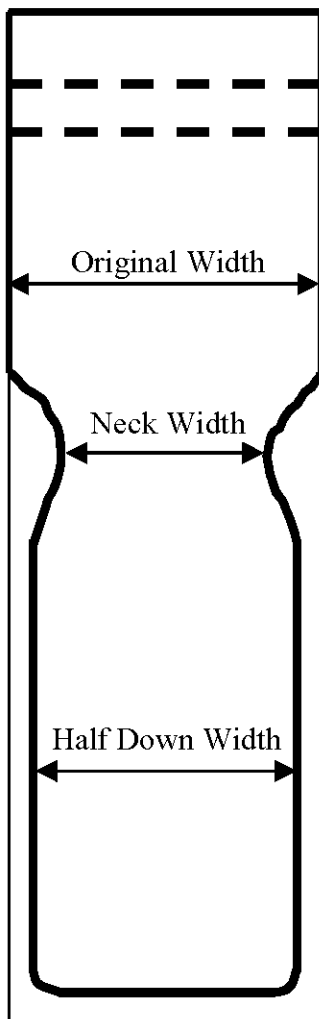
Figure 2.5. Schematic diagram of the cross section of a reacted metal coupon after a typical glass contact corrosion test. Measured widths do not include any scale.

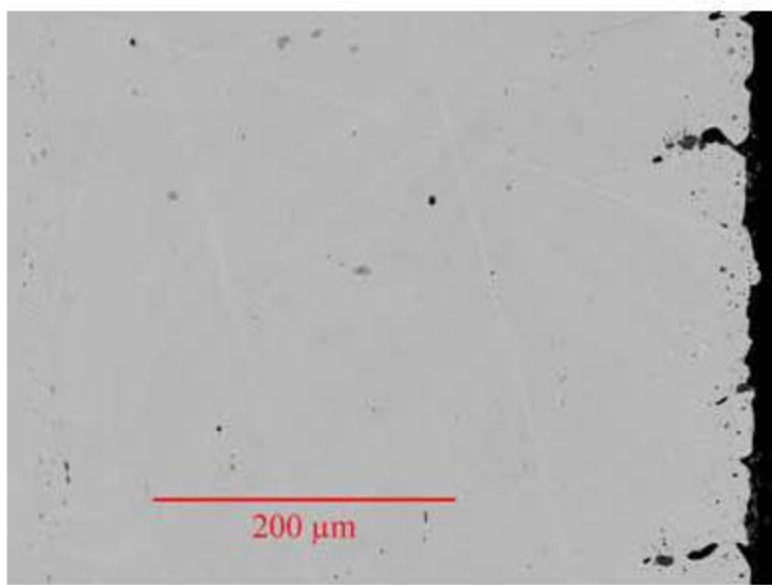
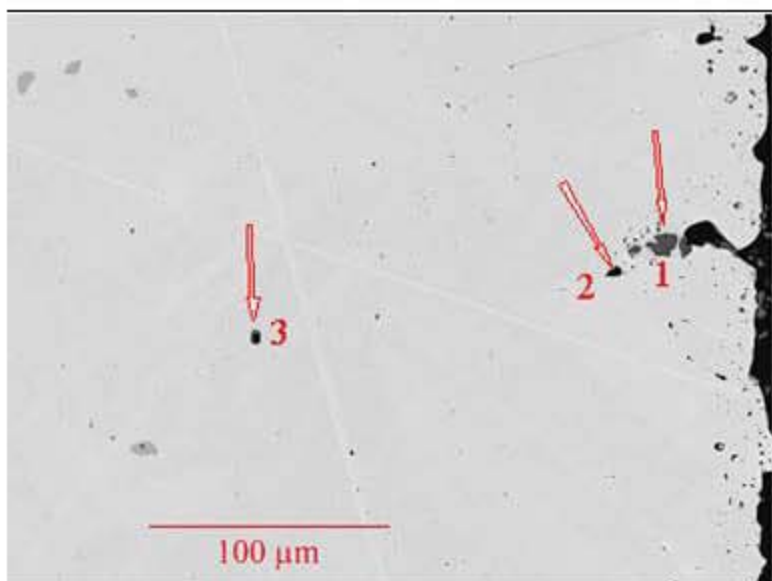
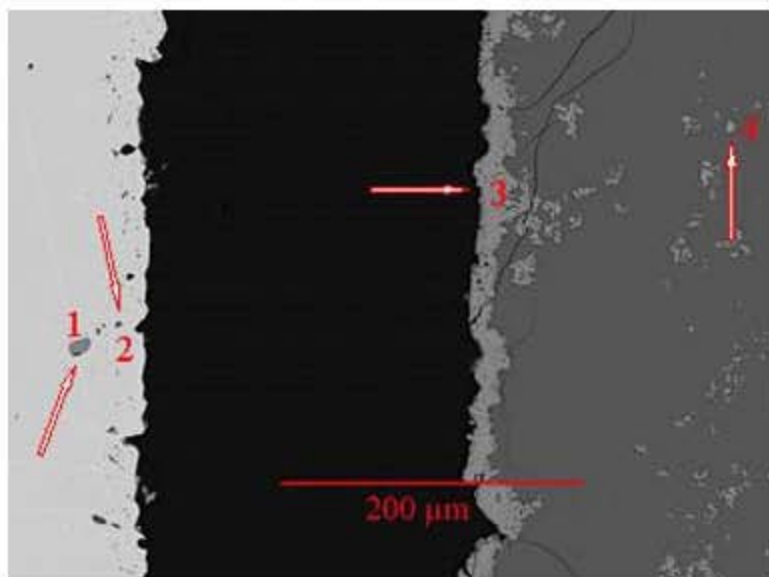
a) Cross section near coupon surface

b) Metal near surface

1: Cr_2O_3 , 2: Al_2O_3 , 3: MgO containing a trace of Ti (probably an impurity in the original Inconel 690).

Figure 3.1. Micrographs of INC690-FeP1050 (Inconel 690, 7 days at 1050°C).

c) Metal near surface

- 1: Cr_2O_3 containing traces of Ti and Al, 2: Al_2O_3 , 3: Cr_2O_3 containing a trace of Fe,
4: Chromite spinel

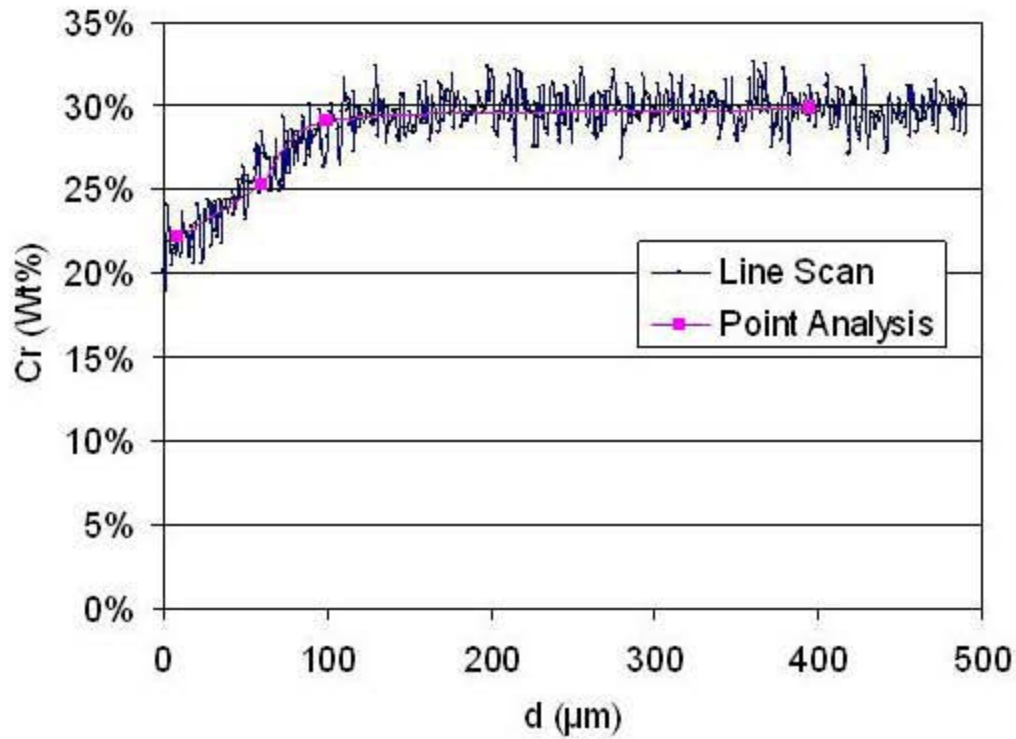
Figure 3.2. Cr concentration profile in coupon INC690-FeP1050 (Inconel 690 in FeP glass at 1050°C for 7 days). Cr depletion is based on the SEM X-ray line scan into the coupon near the half-down area. Point analyses were done and are overlaid on the curve to calibrate concentration. The Cr depletion depth is about 100 μm .

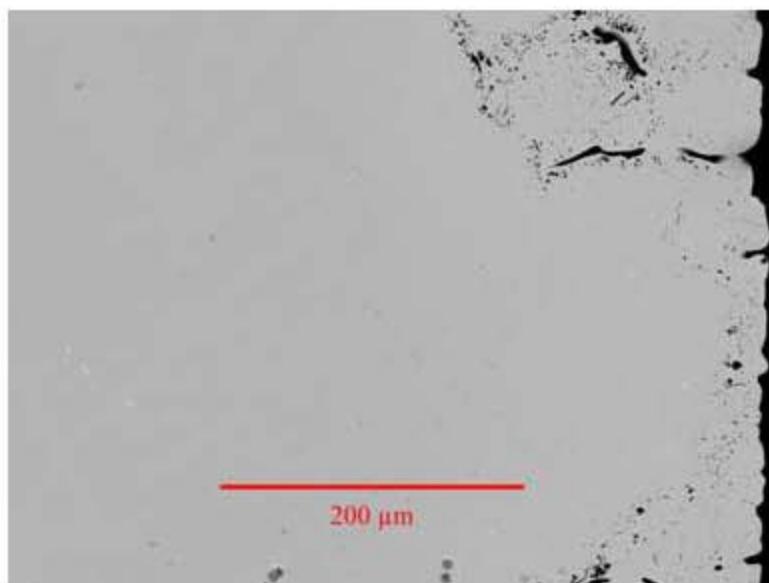
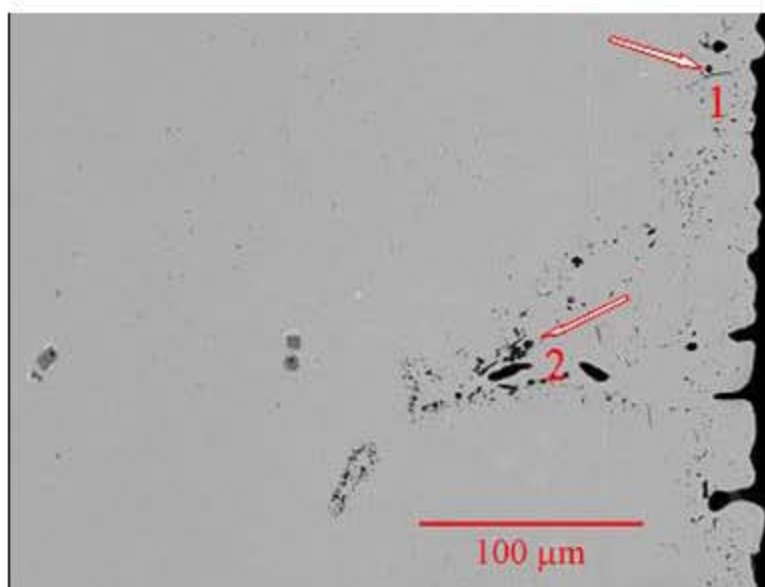
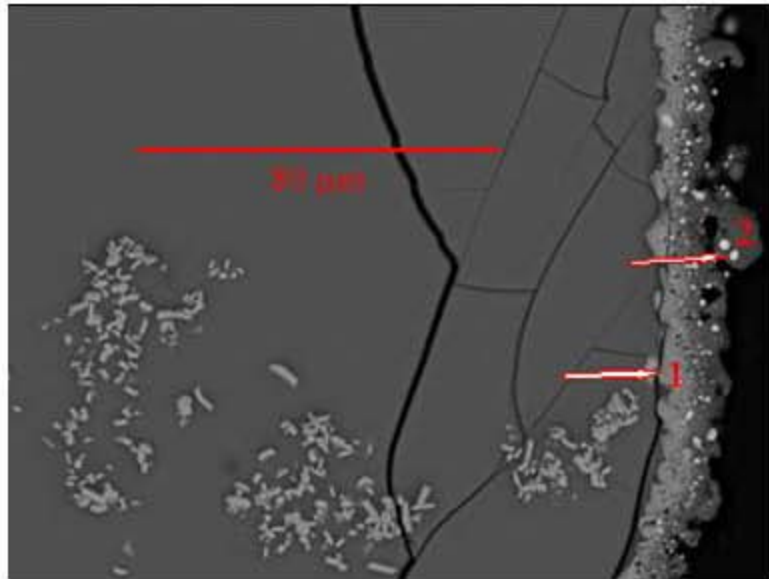
a) Coupon cross section near surface

b) Metal near surface

1, 2: Al_2O_3 . Several inclusions present in the original Inconel 693 and not corrosion products are also evident in the micrograph. The three dark grey spots to the left of arrow 2 are Ti containing traces of Zr and occasionally Nb. The small bright spot in the center of the micrograph is mostly Zr with some Ti.

Figure 3.3. Micrographs of INC693-FeP1050 (Inconel 693, 7 days at 1050°C).

c) Detached scale with adherent glass

Scale (to right) detached from coupon and adherent glass (to left). 1: Cr_2O_3 containing Fe and Al, 2: Complex Ni, Fe, Cr, P, Al, O-containing region; probably metallic, mostly reduced material. Inner (to right) dark layer on scale surrounding the bright spot appears to be high alumina $\text{Cr}_2\text{O}_3\text{-Al}_2\text{O}_3$ solid solution.

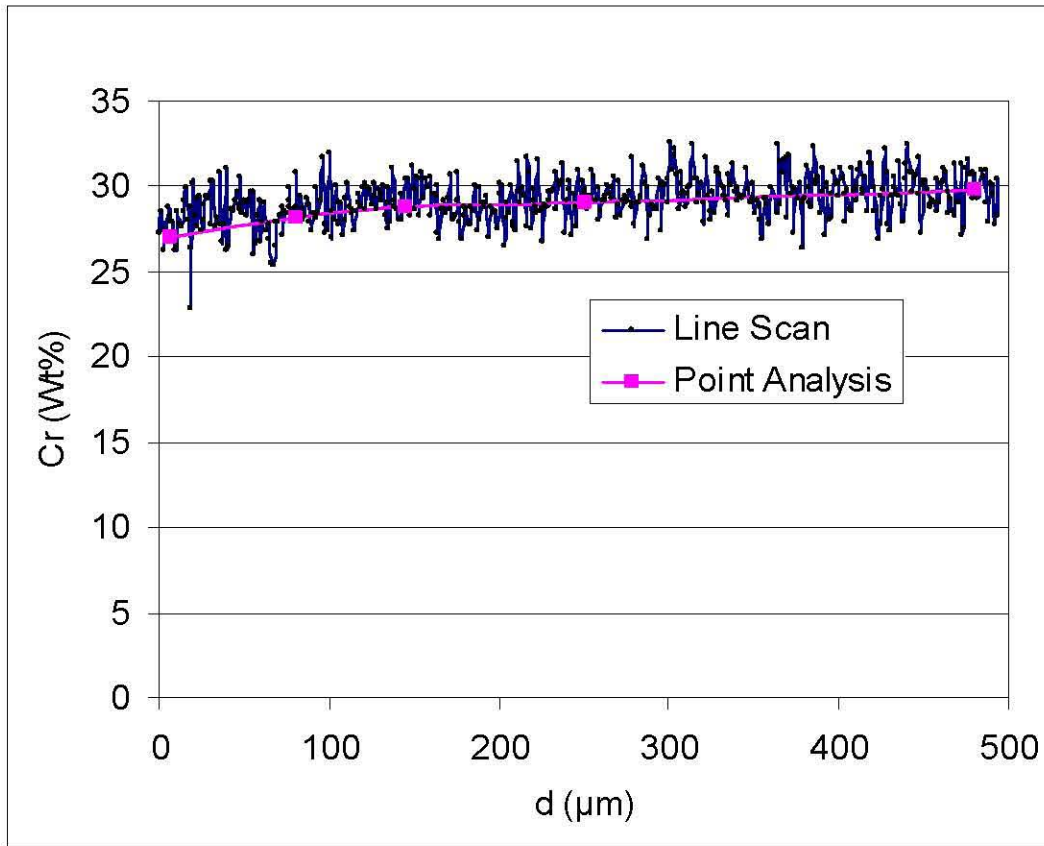
Figure 3.4. Cr concentration profile in coupon INC693-FeP1050 (Inconel 693 in FeP glass at 1050°C for 7 days). Cr depletion is based on the SEM X-ray line scan into the coupon near the half-down area. Point analyses were done and are overlaid on the curve to calibrate concentration. The slope of the curve is small, but point analyses indicate a Cr depletion depth of about 100 μm.

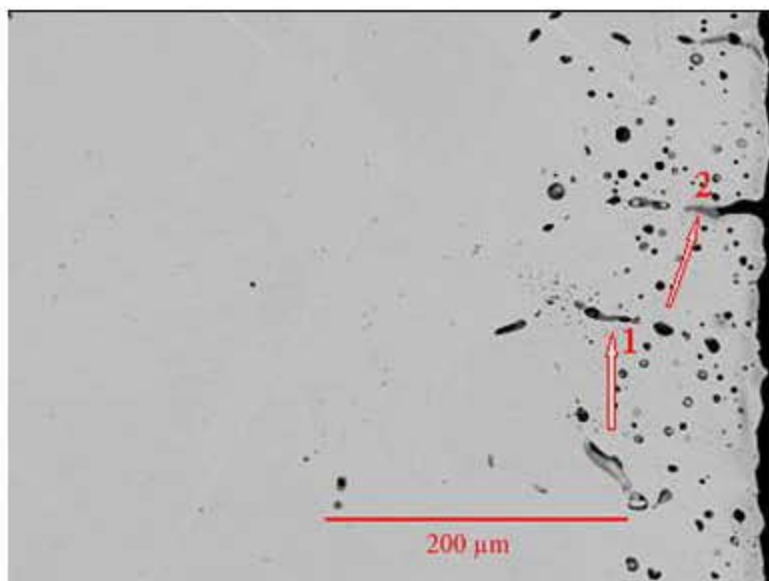
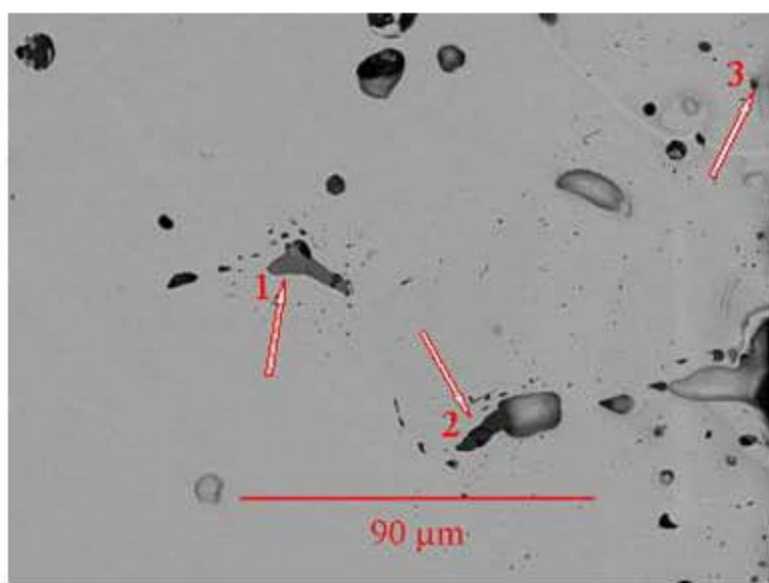
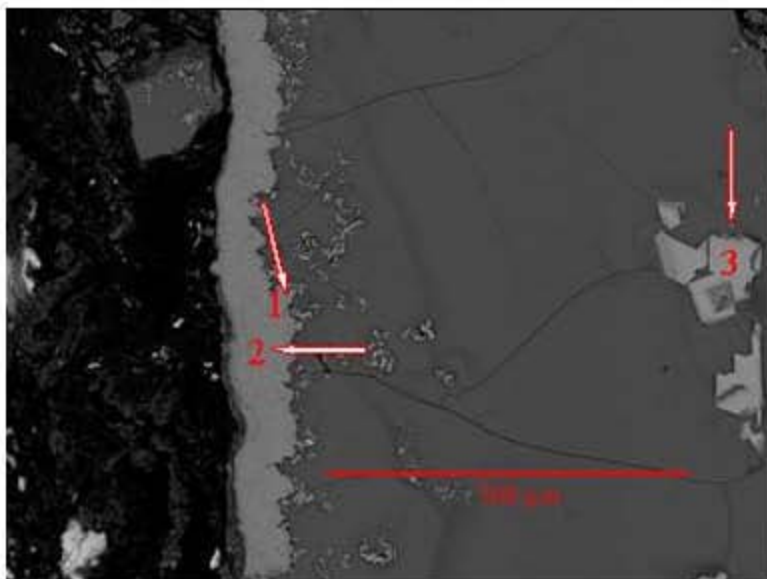
a) Coupon near the half-down region
 1: TiO_2 , 2: Cr_2O_3 incorporating some Ti

b) Coupon near the half-down region
 1: TiO_2 , 2: Al_2O_3 with some Zr and Si, 3: Al_2O_3 with trace of silica.

Figure 3.5. Micrographs of INC690-FeP1100 (Inconel 690, 7 days at 1100°C).

c) Cross section of the detached scale
 1: Fe-Cr spinel (high Cr), 2: Cr₂O₃, 3: Fe, Zn-Cr spinel (zincchromite with some Fe substituting for Cr).

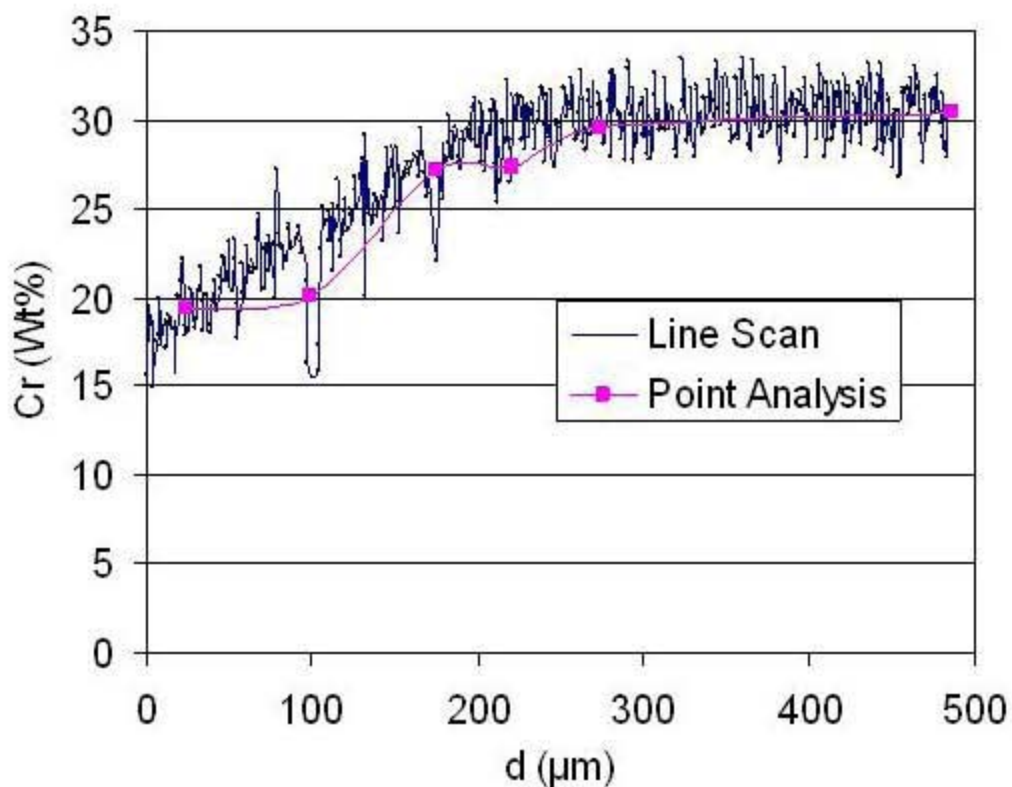
Figure 3.6. Cr concentration profile in coupon INC690-FeP1100 (Inconel 690 in FeP glass at 1100°C for 7 days). Cr depletion is based on the SEM X-ray line scan into the coupon near the half-down area. Point analyses were done and are overlaid on the curve to calibrate concentration. The Cr depletion depth is about 250 μm .

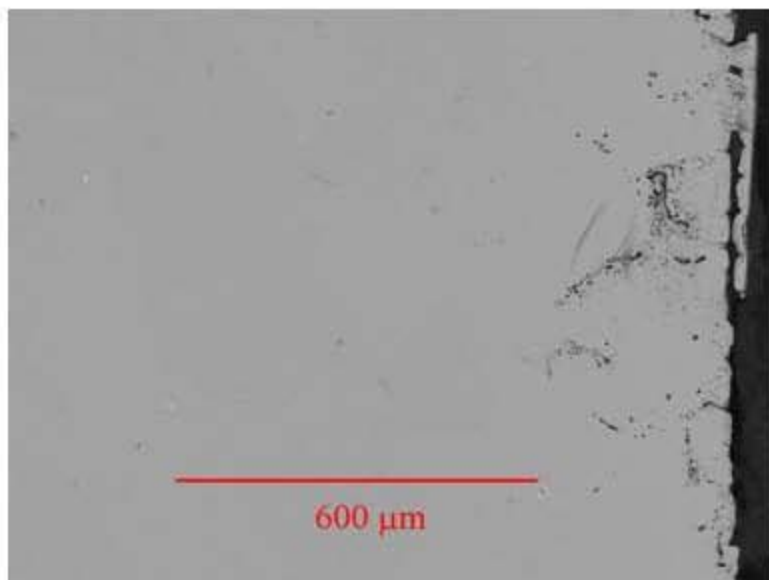
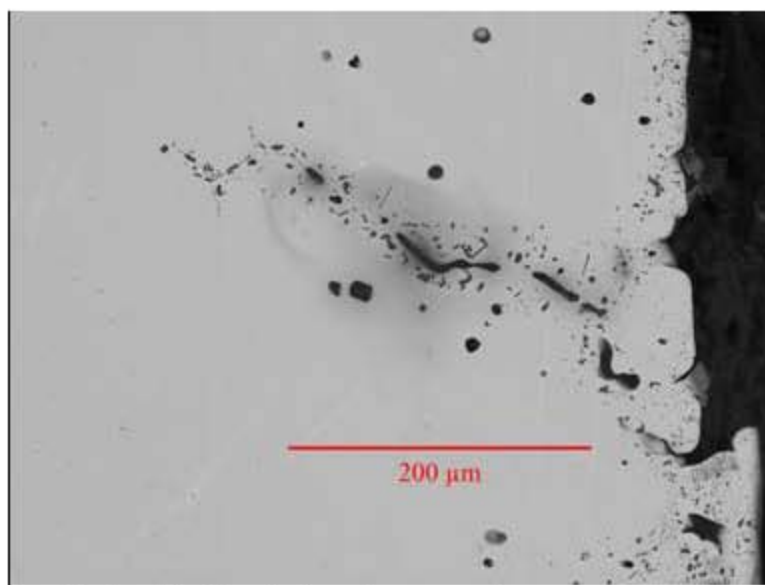
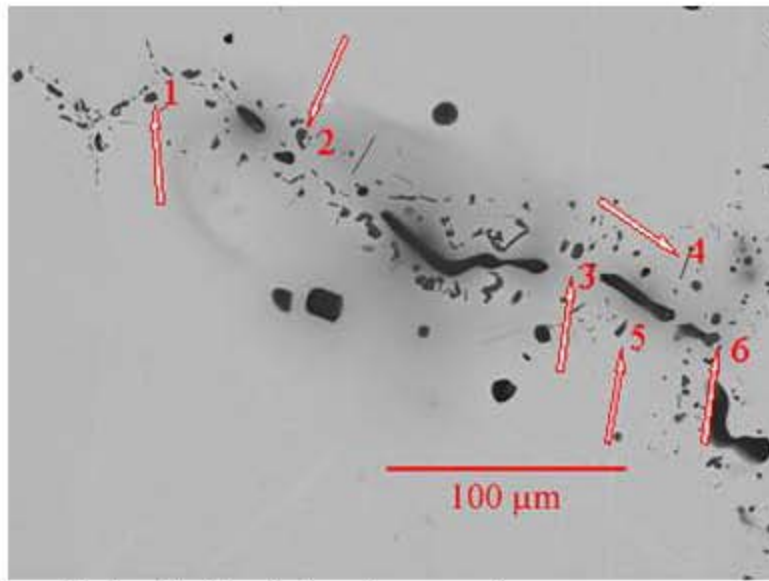
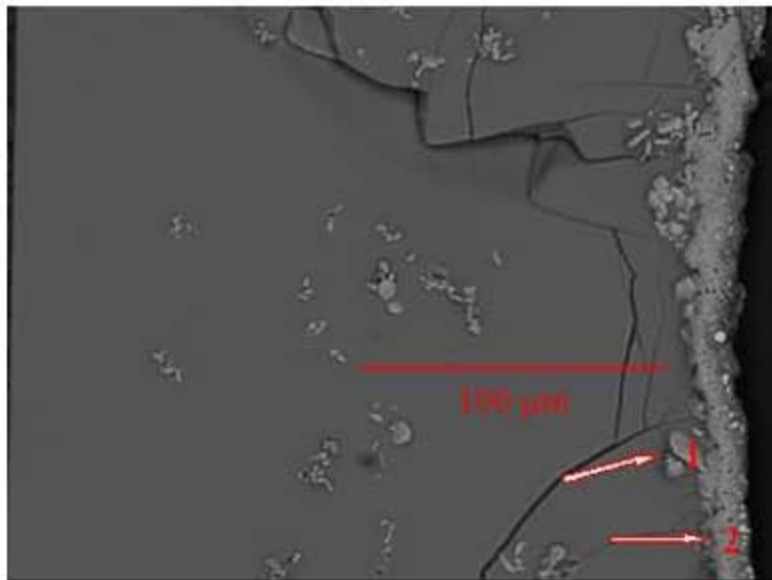
a) Coupon cross section near half down region.

b) Detail of grain boundary attack.

Figure 3.7. Micrographs of INC693-FeP1100 (Inconel 693, 7 days at 1100°C).

c) Detail of grain boundary attack

Detail of b) above. 1, 2, 3, 4 5 and 6 are all Al_2O_3 phases containing small amounts of silica. Pockets of pure silica are sometimes found in the linear grain boundary regions.

d) Detached scale with adherent glass

1, 2 are Fe-Cr-Al spinel. Bright spots in the metal contact scale at the right are metallic residue of corroded Inconel containing varying amounts of phosphorus, probably as phosphide.

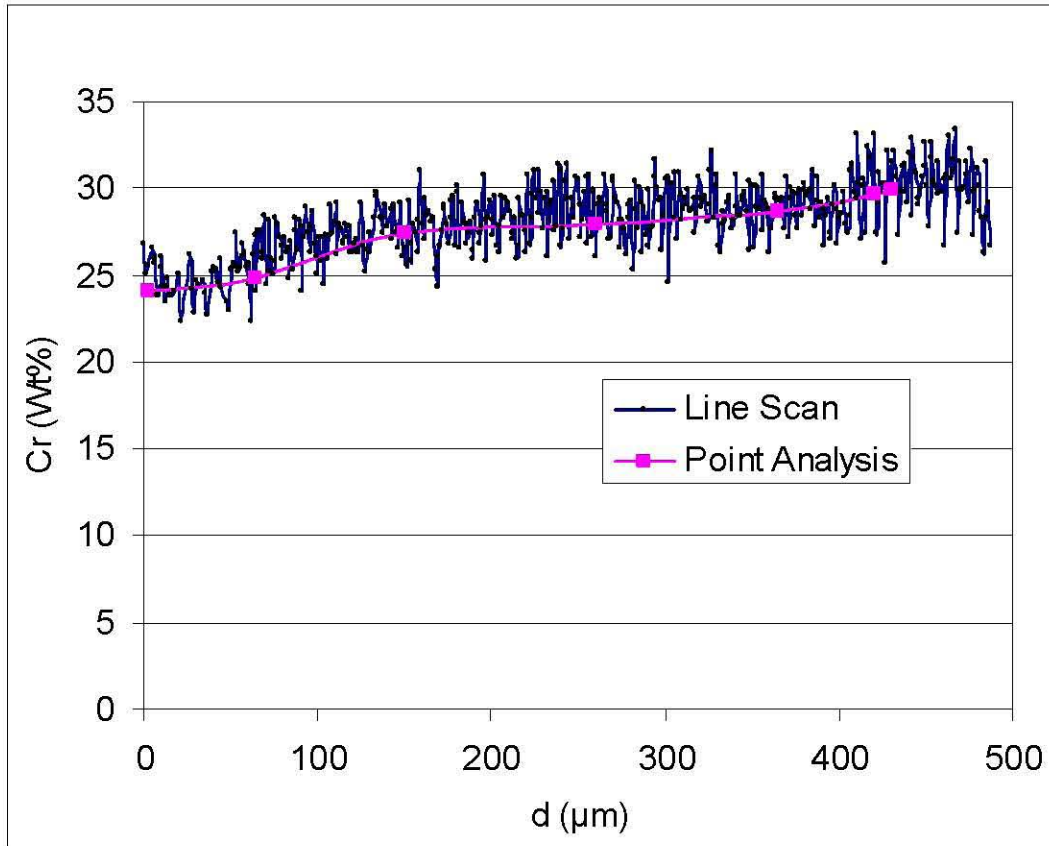
Figure 3.8. Cr concentration profile in coupon INC693-FeP1100 (Inconel 693 in FeP glass at 1100°C for 7 days). Cr depletion is based on the SEM Cr line scan done near the half-down area. The Cr depletion profile actually seems to have two segments. The first segment starts at about 400 μm and proceeds with a small slope to about 200 μm from the surface where its slope increases. The Cr depletion depth is reported in the results as 200 μm .

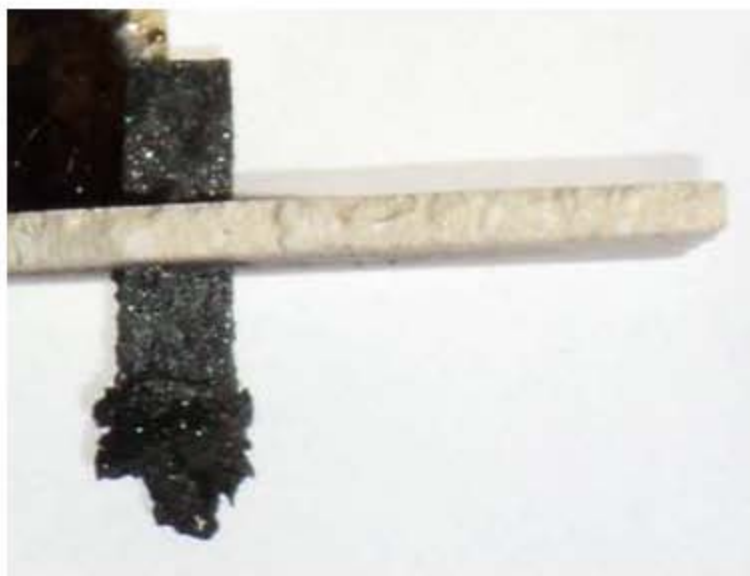
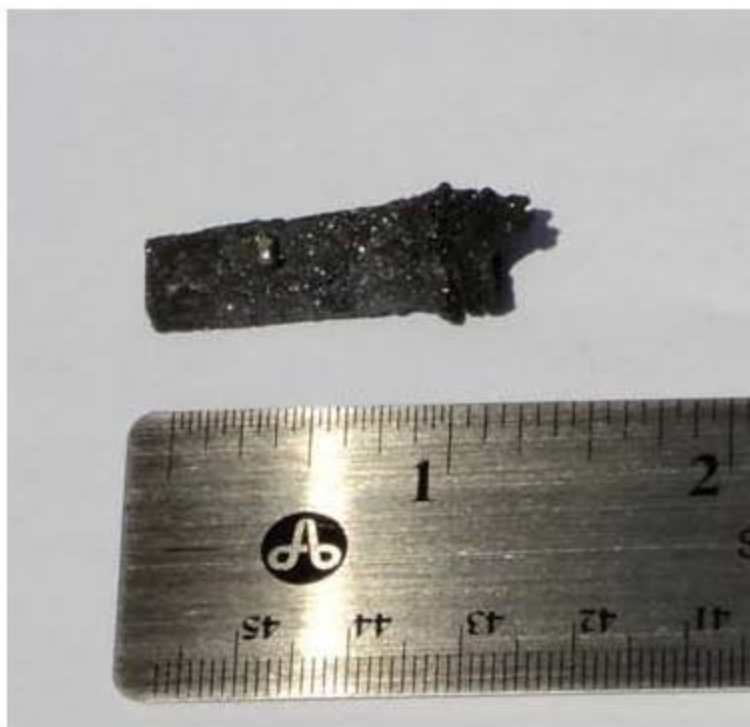
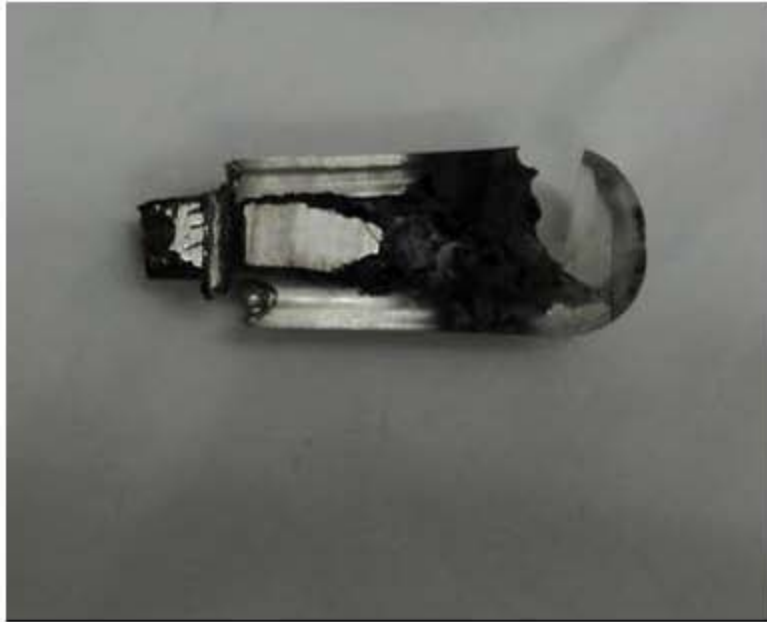
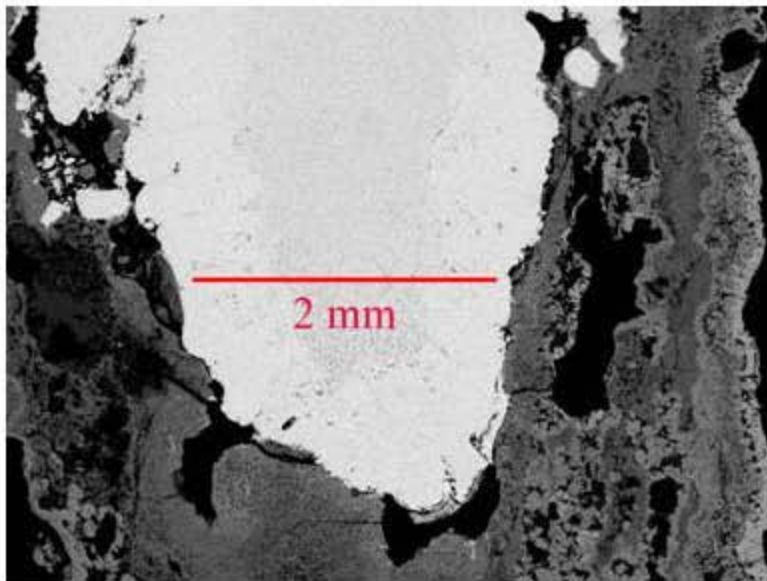
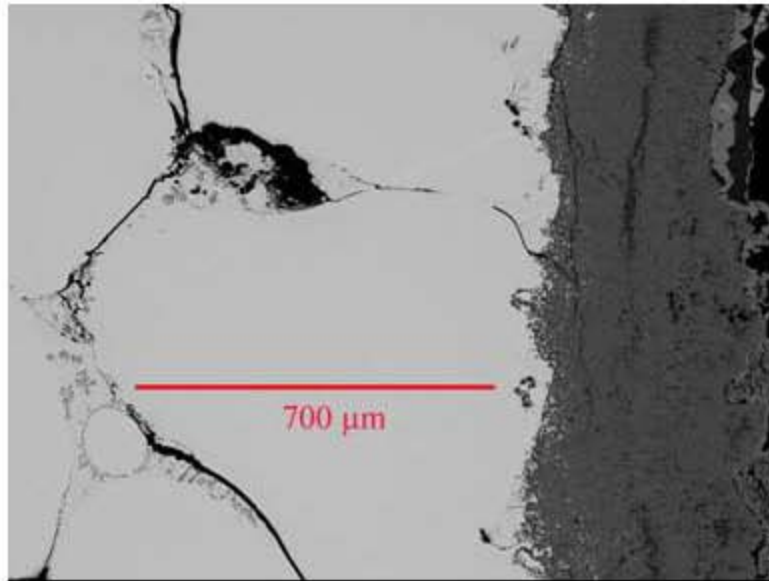
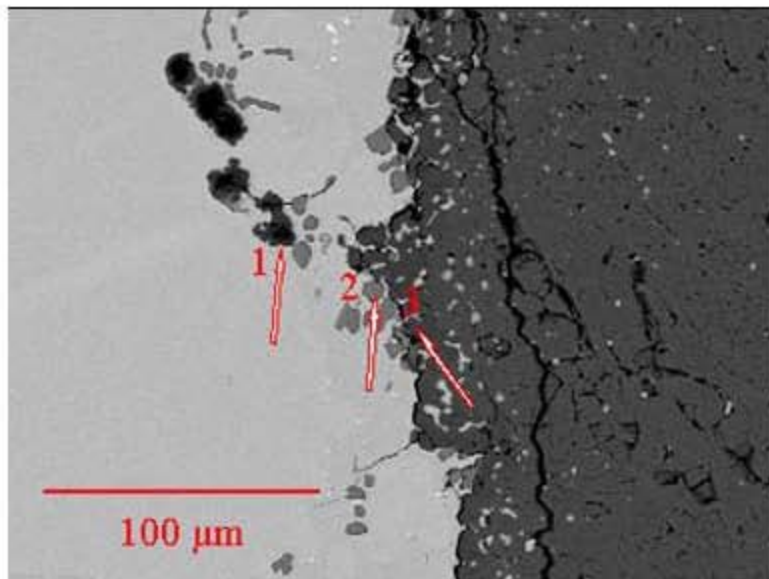
a) The damaged Inconel 690 coupon still mounted to Zirconium ceramic cover.

b) Damaged Inconel 690 coupon next to ruler for size reference.

Figure 3.9. Images of damaged INC690-FeP1150 (Inconel 690, 1150°C for 7 days).

c) The damaged Inconel 690 coupon cross sectioned after mounting in epoxy.

d) SEM micrograph of the cross section through the lower tip area of the remaining upper portion of coupon INC690-FeP1150 and its adherent scale. This region constituted the upper neck area at the time of coupon failure. The brighter area about 800 μm wide around the perimeter of the tip is the region of greatest Cr depletion.

- e) SEM micrograph of the cross section of the scale-coupon interface in the tip area of coupon INC690-FeP1150 showing the cracking caused by grain boundary attack and metal loss. The round nodule at the junction of the three cracks in the lower left of the micrograph is surrounded by extensive dendritic CrS crystallization.

- f) SEM micrograph detailing an attacked area at the metal-scale interface of coupon INC690-FeP1150. Bright spots in remaining metal at top-center of micrograph are bismuth. Arrows 1, 3 locate $\text{Cr}_2\text{O}_3\text{-Al}_2\text{O}_3$ solid solution (Cr-rich); arrow 2 locates CrS.

The first 7-day test for both alloys was run at 1050°C, and the second at 1150°C. The Inconel 690 coupon failed dramatically during the 1150°C test, splitting at the glass-air interface area with the result that the lower portion of the coupon settled to the bottom of the platinum crucible and destroyed the crucible. As a result, the remaining standard corrosion tests for Inconel 690 were performed in alumina crucibles, as is standard practice in tests performed at MS&T [14]. However, the substitution of alumina crucibles resulted in a significant increase in the concentration of alumina in the FeP glass during the course of the test.

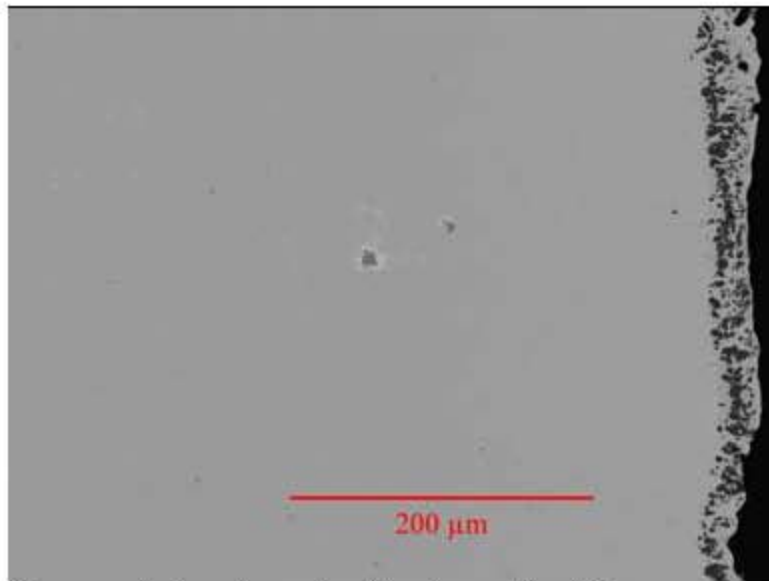
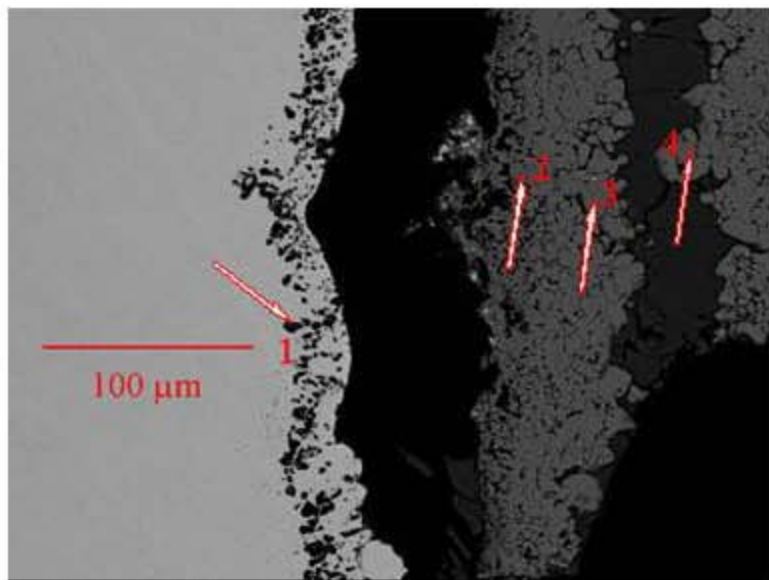
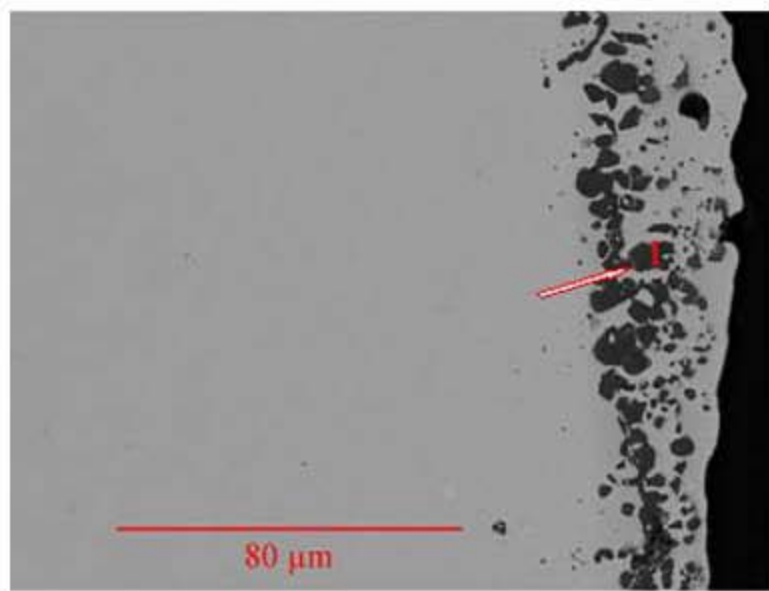
- a) Micrograph showing subsurface layer of nodules
The grey spots with a lighter rim in the center of the micrograph are an occasionally seen non-uniformity in the original Inconel, Ti surrounded by Nb-Zr.

- b) Details of nodules from a)
1: Al_2O_3 . 2, 3, and 4: Cr_2O_3 containing a small amount of Fe-Cr-Al spinel.

Figure 3.10. Micrographs of INC693-FeP1150 (Inconel 693, 7 days at 1150°C).

c) SEM micrograph detailing the surface attack
1: Al₂O₃

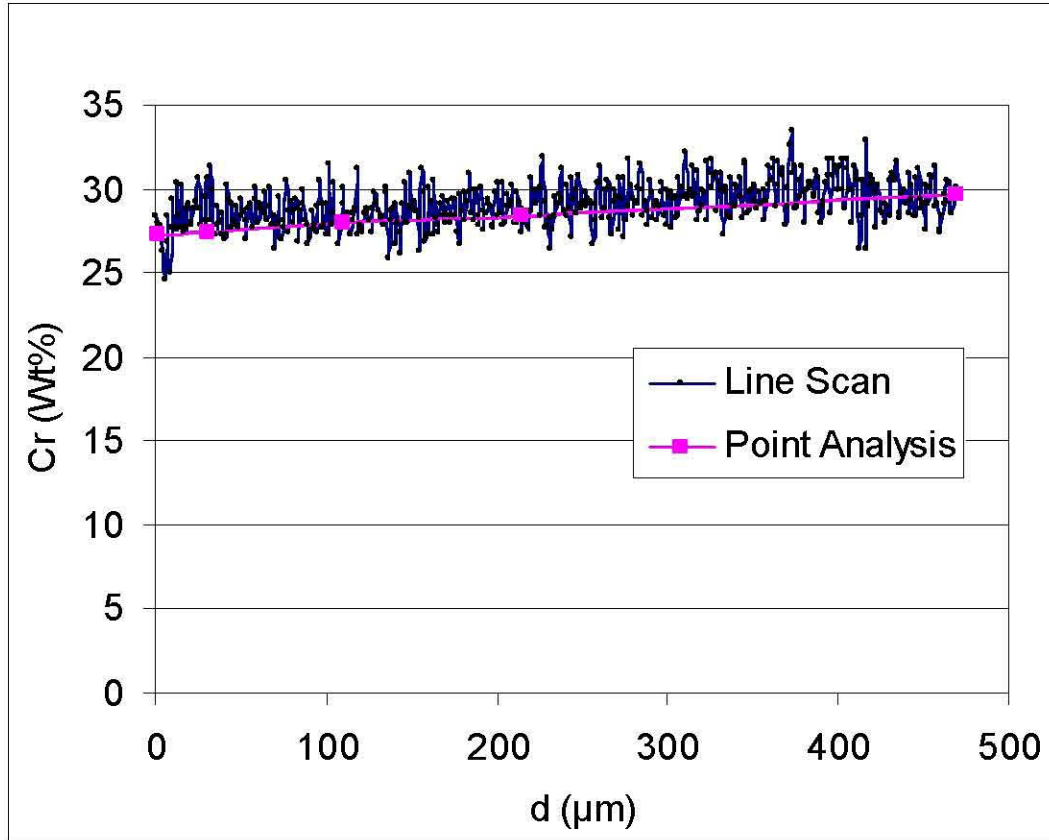
Figure 3.11. Cr concentration profile in coupon INC693-FeP1150 (Inconel 693 in FeP glass at 1150°C for 7 days). Cr depletion is based on the SEM X-ray line scan into the coupon near the half-down area. Point analyses were done and are overlaid on the curve to calibrate concentration. The Cr depletion depth is about 300 μm.

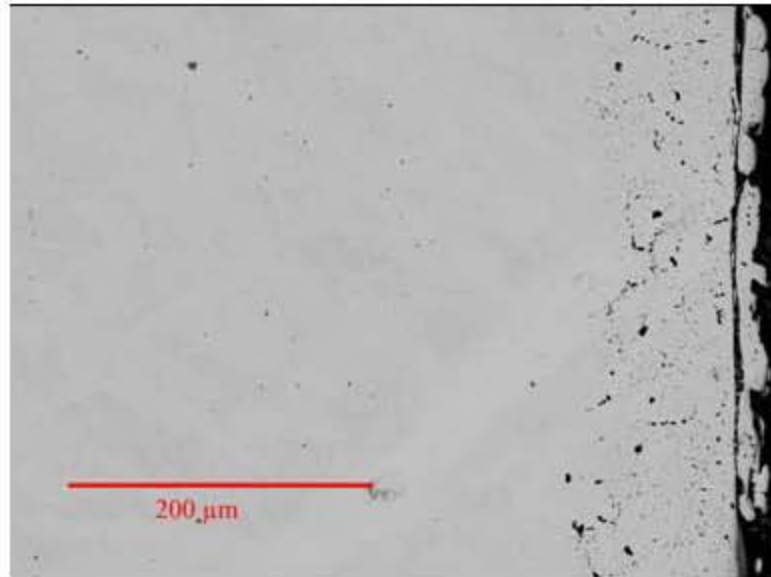
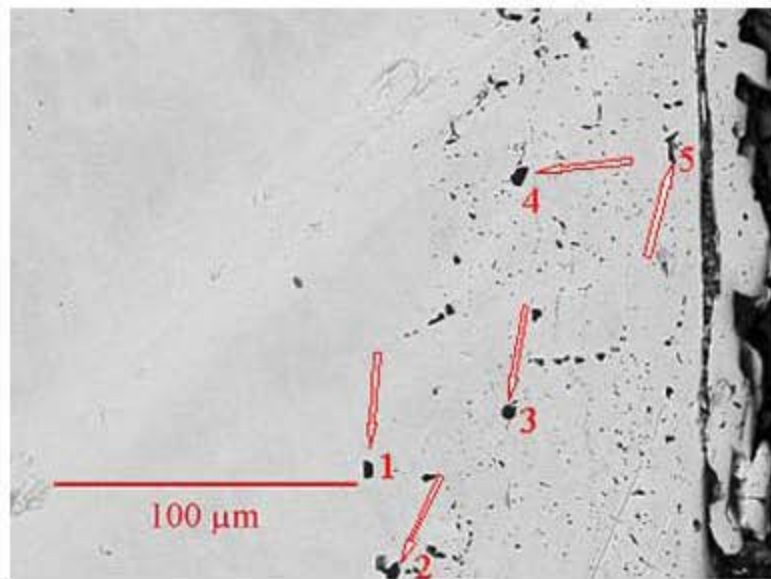
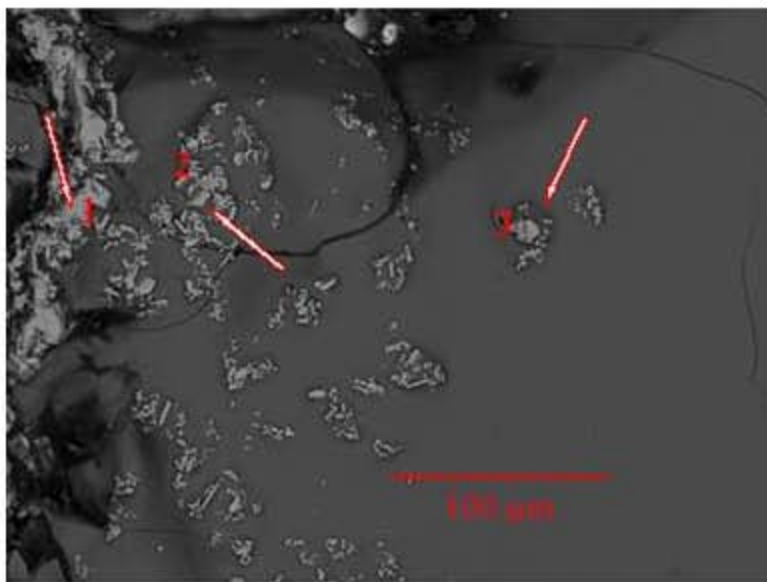
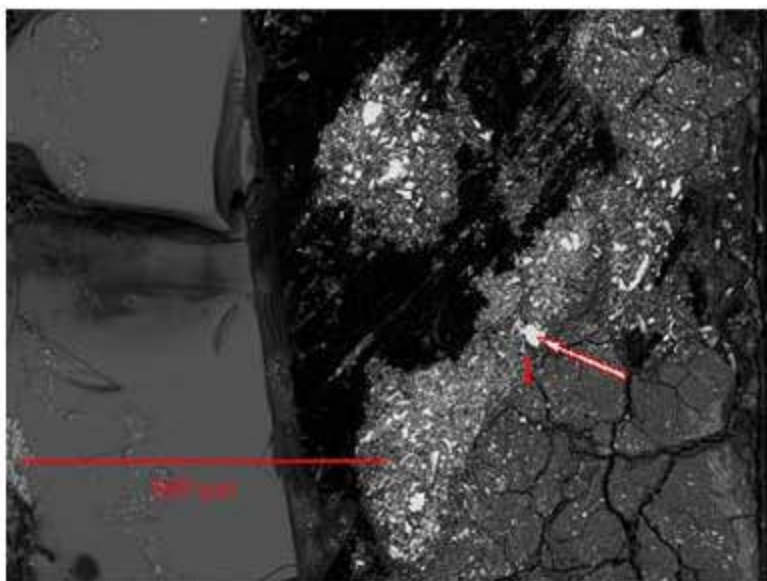
a) Coupon cross section.

b) Detail of grain boundary attack region.
1, 2, 3, 4, 5 are all Al_2O_3

Figure 3.12. Micrographs of INC690-FeP1050-2 (Inconel 690, 14 days at 1050°C).

c) Corrosion products in scale
 1: Cr₂O₃ containing a little Fe, Al, and a trace of Si, 2, 3: Fe-Cr-Al spinel

d) Inconel in scale
 1: Inconel 690 metal particle

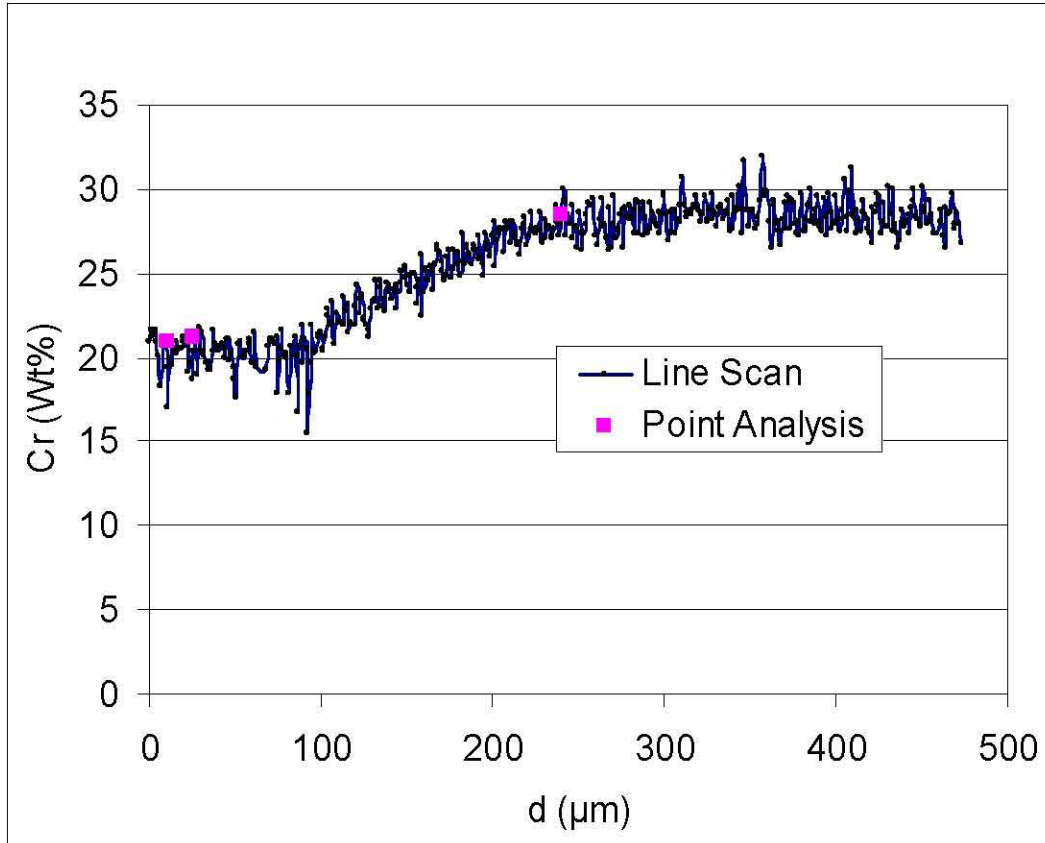
Figure 3.13. Cr concentration profile in coupon INC690-FeP1050-2 (Inconel 690 in FeP glass at 1050°C for 14 days). Cr depletion is based on the SEM X-ray line scan into the coupon near the half-down area. Point analyses were done and are overlaid on the curve to calibrate concentration. The Cr depletion depth is about 250 μm.
