Final Report Testing of Iron Phosphate LAW Glass (VSL-11R2340-1) April 25, 2011

Prepared for the U.S. Department of Energy
Assistant Secretary for Environmental Management

H. Gan
A. C. Buechele
Z. Feng
C. Wang
C. Viragh
I. L. Pegg
Vitreous State Laboratory
The Catholic University of America

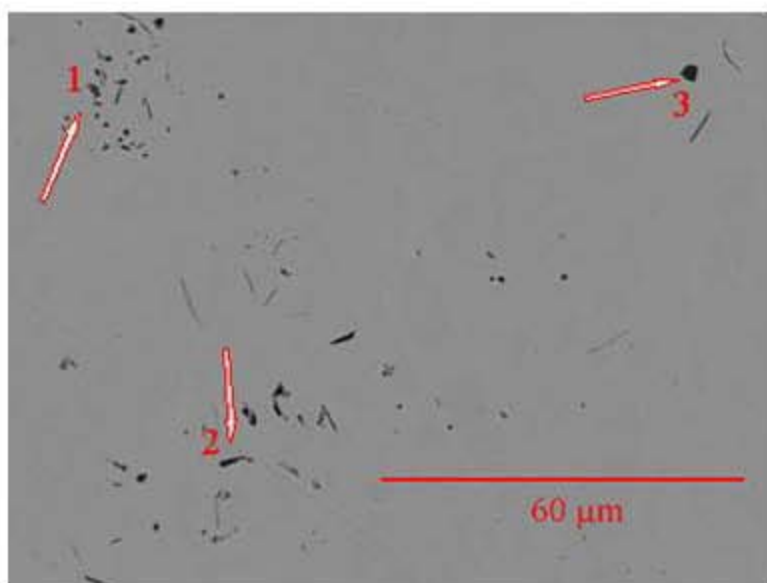
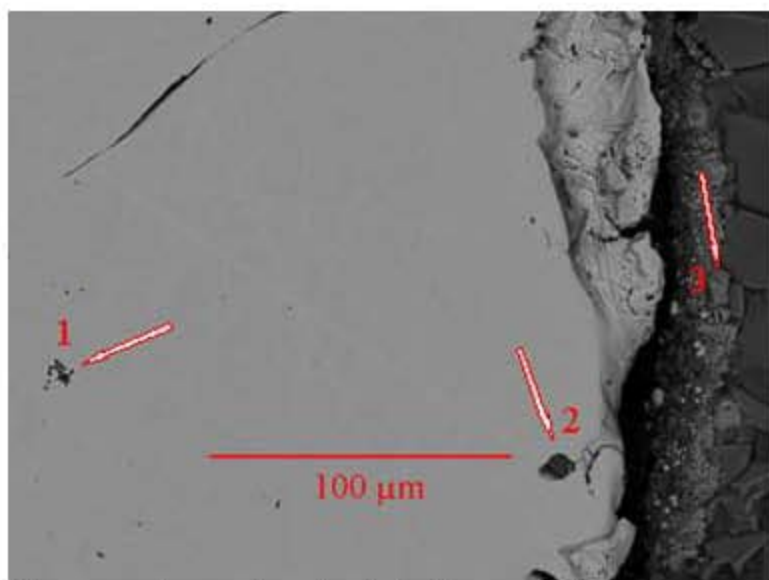
a) Coupon surface near half-down area

b) Detail of grain boundary attack
Phases 1, 2 and 3 are all Al_2O_3

Figure 3.14. Micrographs of INC693-FeP1050-2 (Inconel 693, 14 days at 1050°C).

c) Coupon surface and scale originally attached to coupon.
1: Al_2O_3 and MgO , probably MgAl_2O_4 spinel, 2: Al_2O_3 , 3: Fe-Cr-Al spinel. The Mg in phase 1 probably came from a contaminant in the original Inconel.

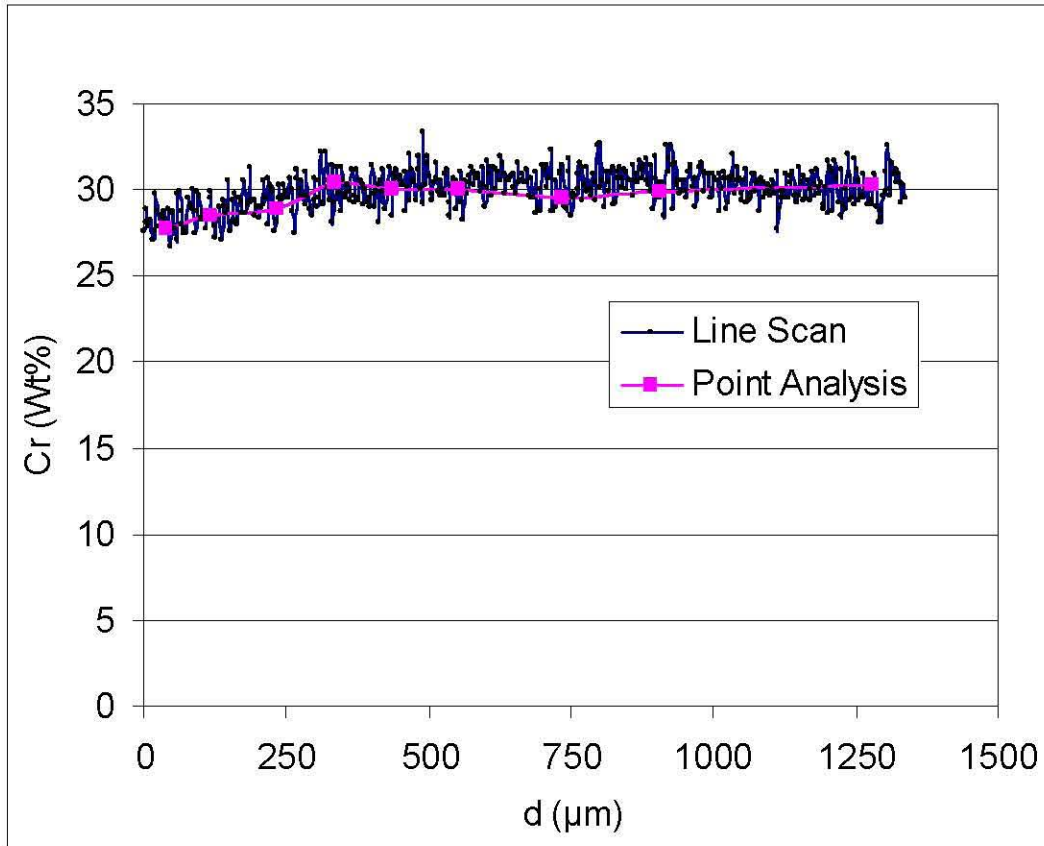
Figure 3.15. Cr concentration profile in coupon INC693-FeP1050-2 (Inconel 693 in FeP glass at 1050°C for 14 days). Cr depletion is based on the SEM X-ray line scan into the coupon near the half-down area. Point analyses were done and are overlaid on the curve to calibrate concentration. Depletion depth for Cr is about 325 μm.

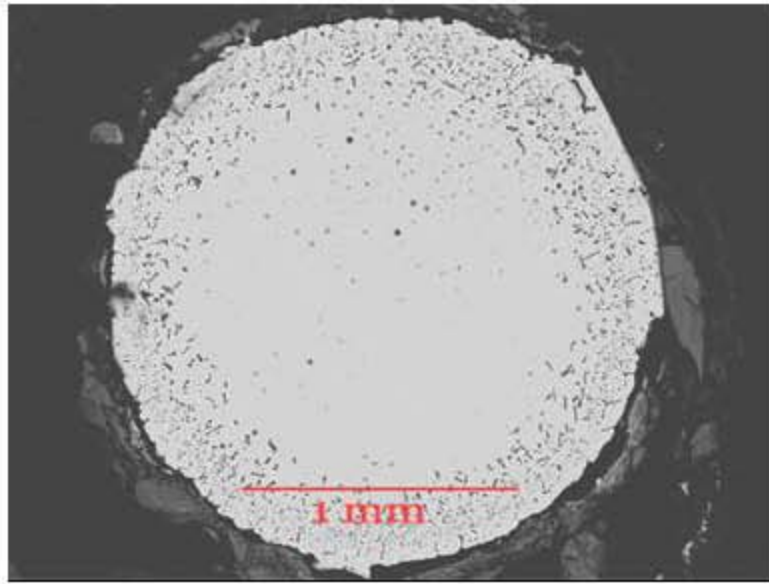
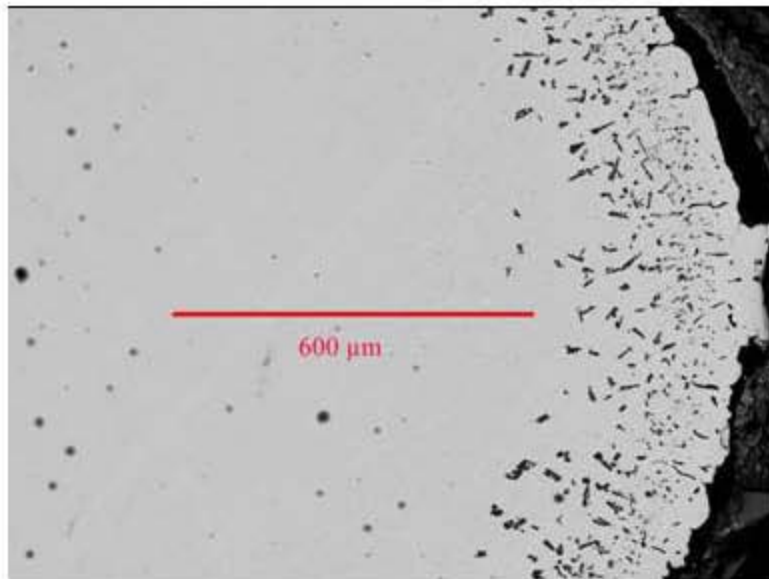
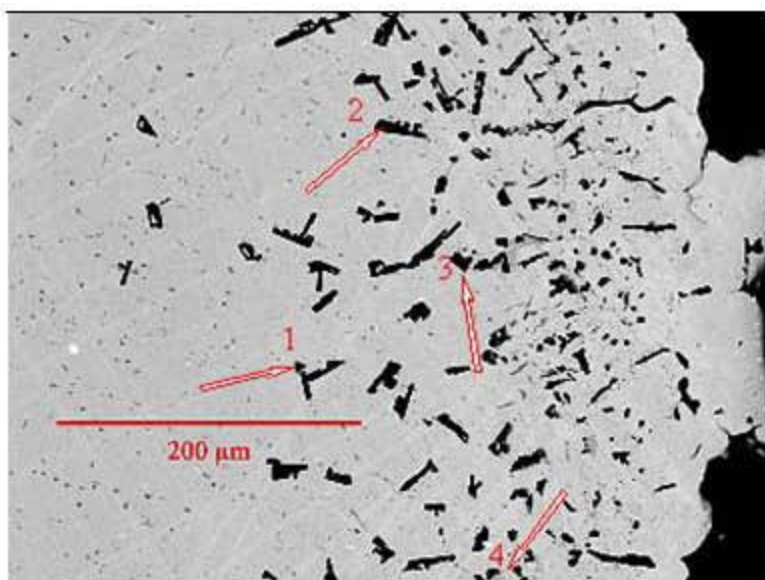
- a) SEM micrograph of full cross section at 1.5 mm from the pin tip
The surrounding glass and scale are present.

- b) Detailed SEM micrograph of center to edge of coupon.
The somewhat fuzzy, small (5-20 μm) black spots toward the center are not corrosion features, but carbon contamination. X-ray line scan to determine composition profiles was done in this area.

Figure 3.16. Micrographs of INC693EC-1050-A (Inconel 693 pin in FeP glass at 1050°C for 3 days at a current density of 10 A/inch²; Section 1.5 mm from tip).

c) Edge region of the 1.5 mm section of the coupon

1: Ti-Zr-Nb nitride phase, 2, 3: Aluminum nitride phase, 4: Cr-Ni phosphide phase (very light grey and difficult to see in the micrograph; present only in band from 50 to 100 μm beneath the coupon surface.)

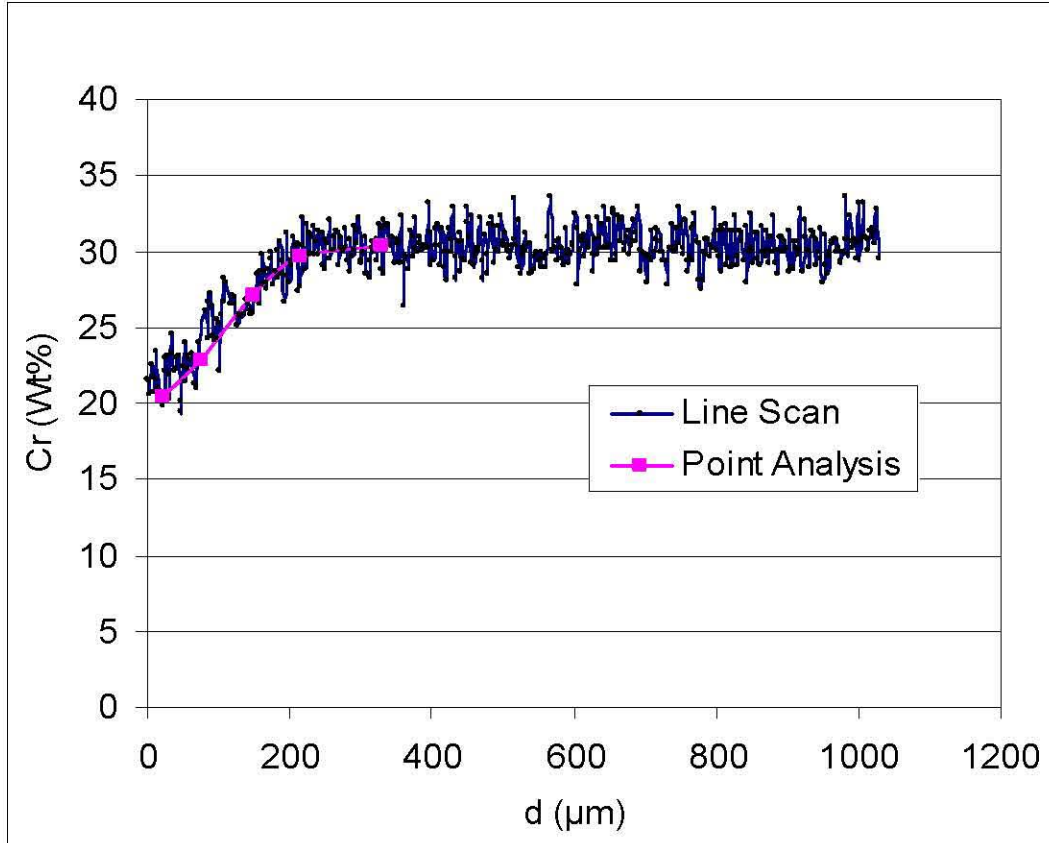
Figure 3.17. Cr concentration profile in coupon INC693EC-1050-A (Inconel 693 pin, immersed in FeP glass at 1050°C for 3 days at a current density of 10 A/ in²; sectioned 1.5 mm from tip). Cr depletion is based on the SEM X-ray line scan into the sectioned coupon. Point analyses were done and are overlaid on the curve to calibrate concentration. The Cr depletion depth is about 200 μm.

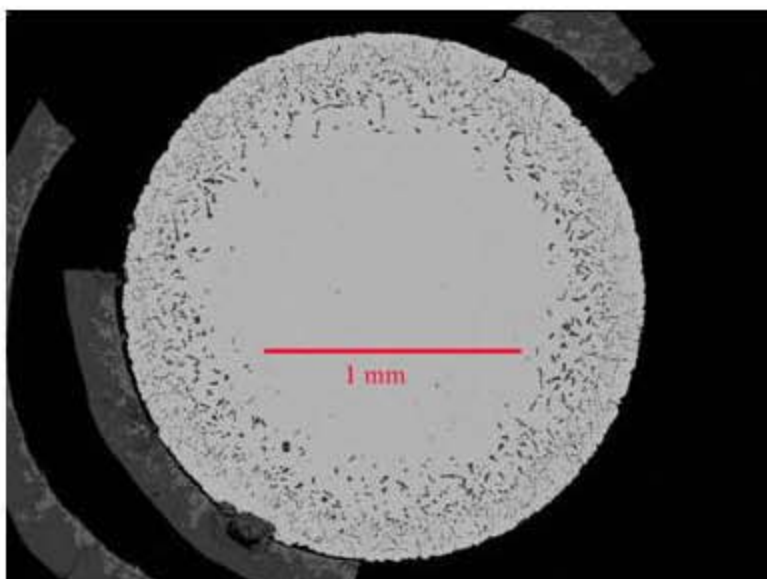
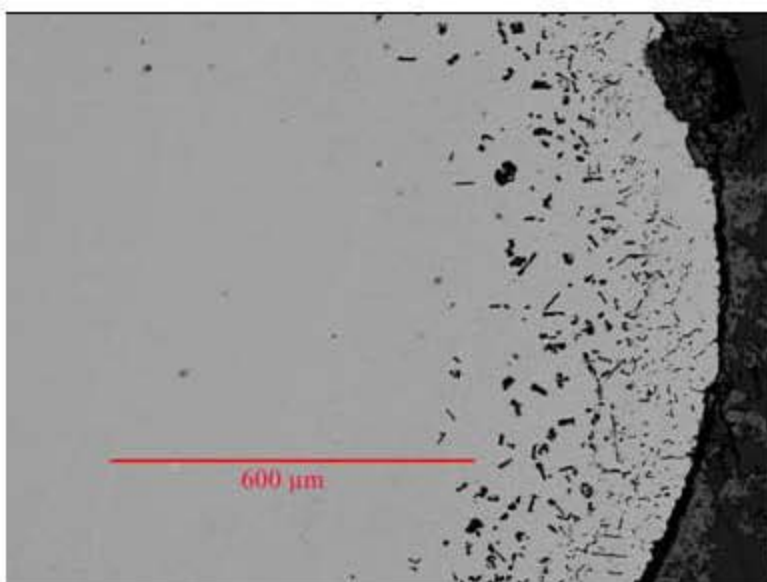
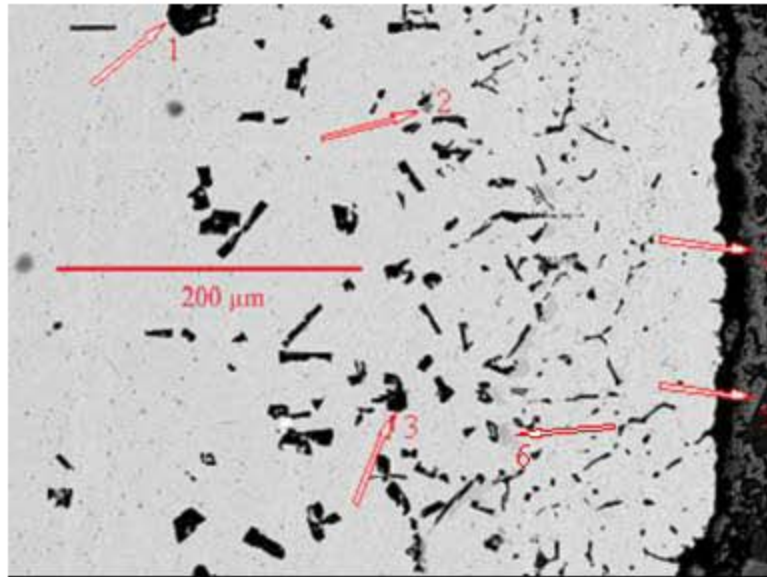
a) SEM micrograph of full cross section at 5.0 mm from the pin tip
The surrounding glass and scale are present, but mostly detached.

b) More detailed SEM micrograph of center to edge of coupon
X-ray line scan to determine composition profiles was done in this area.

Figure 3.18. Micrographs of INC693EC-1050-B (Inconel 693 pin in FeP glass at 1050°C for 3 days at a current density of 10 A/inch²; Section 5.0 mm from tip).

c) Edge region of the 5.0 mm section of the coupon
 1 and 3 are aluminum nitride phase, 4 and 5 are Cr₂O₃ containing 5 to 8 at% Fe, 6 is Cr-Ni phosphide phase (very light grey).

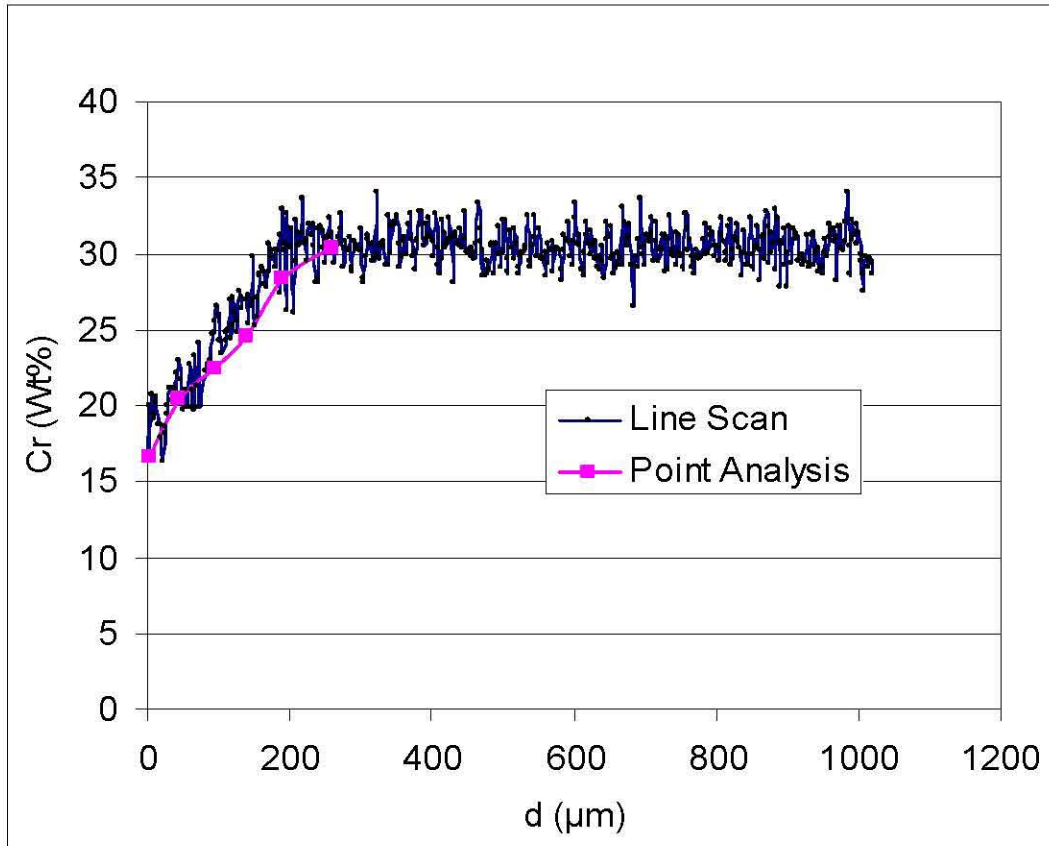
Figure 3.19. Cr concentration profile in coupon INC693EC-1050-B (Inconel 693 pin, immersed in FeP glass at 1050°C for 3 days at a current density of 10 A/ in²; sectioned 5.0 mm from pin tip). Cr depletion is based on the SEM X-ray line scan into the sectioned coupon. Point analyses were done and are overlaid on the curve to calibrate concentration. The Cr depletion depth is about 220 μm.

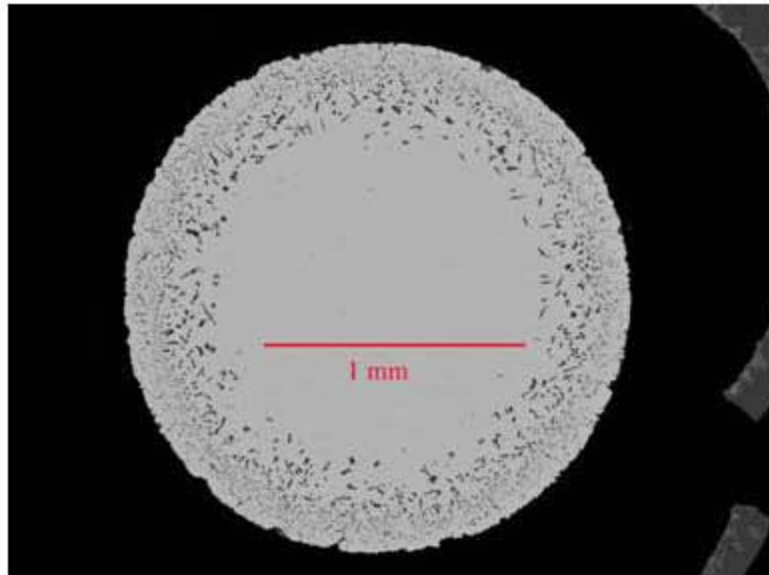
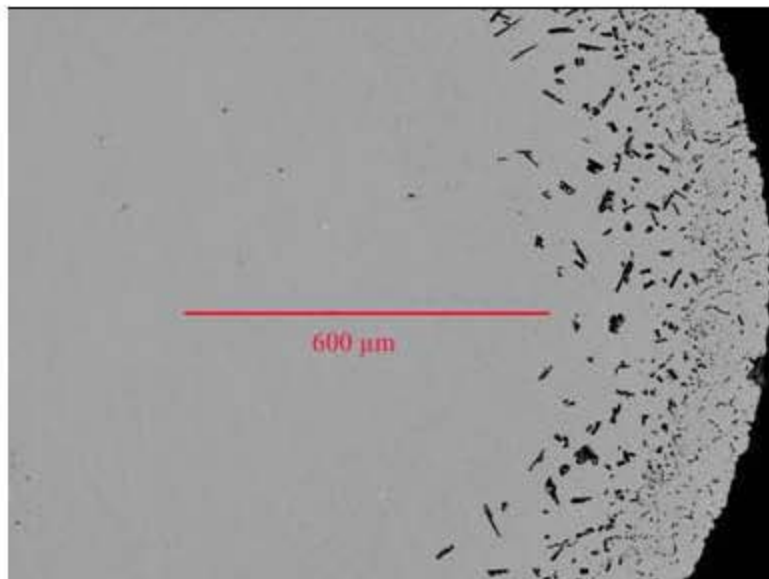
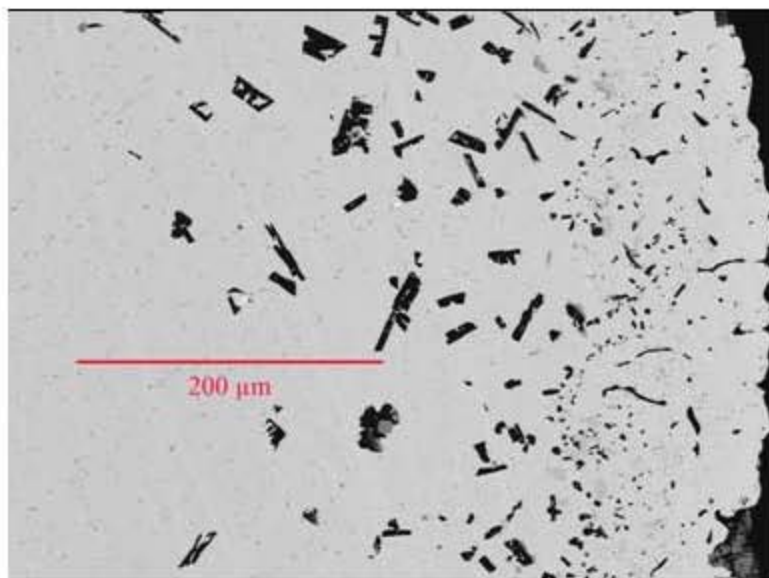
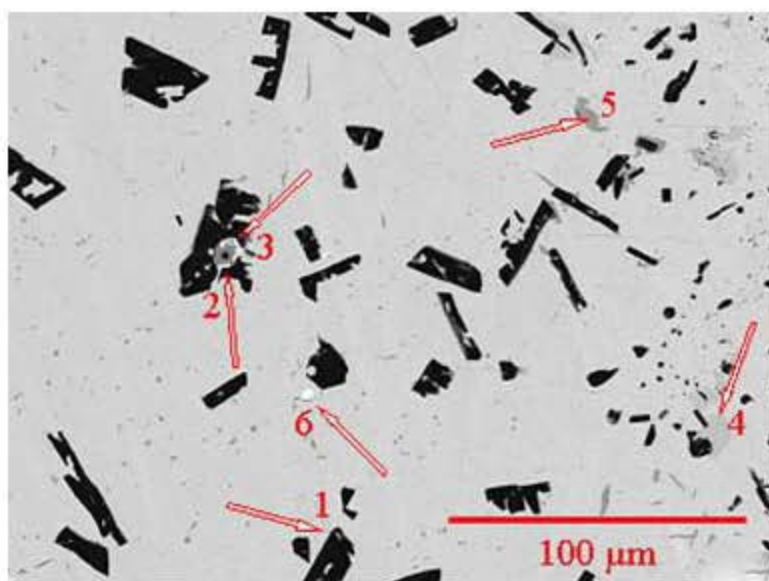
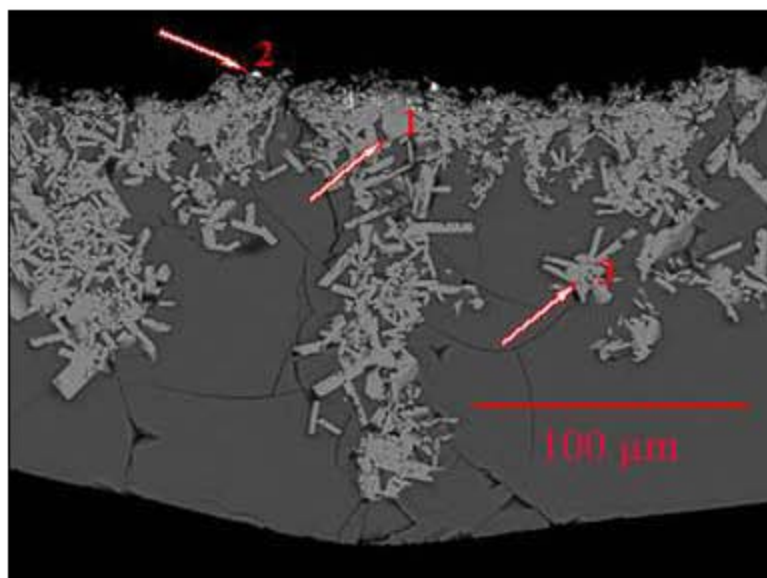
a) SEM micrograph showing 9 mm cross section.
Some detached surrounding glass and scale are visible at the right.

b) More detailed SEM micrograph of center to edge of coupon.
X-ray line scan to determine composition profiles was done in this area.

Figure 3.20. Micrographs of INC693EC-1050-C (Inconel 693 pin in FeP glass at 1050°C for 3 days at a current density of 10 A/inch²; Section 9.0 mm from tip).

c) Edge region of the 9.0 mm section of the coupon

d) Edge region showing locations that were analyzed

e) Detached section of coupon scale

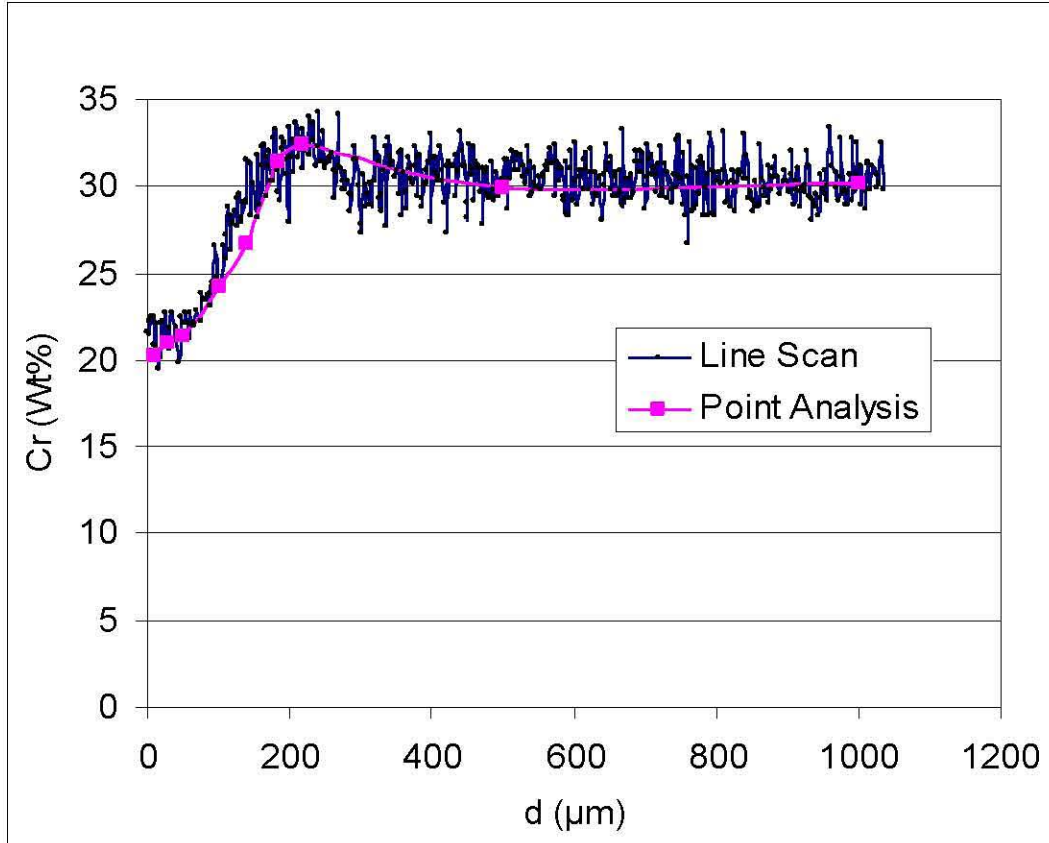
Figure 3.21. Cr concentration profile in coupon INC693EC-1050-C (Inconel 693 pin immersed in FeP glass at 1050°C for 3 days at a current density of 10 A/ in²; sectioned 9.0 mm from pin tip). Cr depletion is based on the SEM X-ray line scan into the sectioned coupon. Point analyses were done and are overlaid on the curve to calibrate concentration. The Cr depletion depth is about 180 μm.

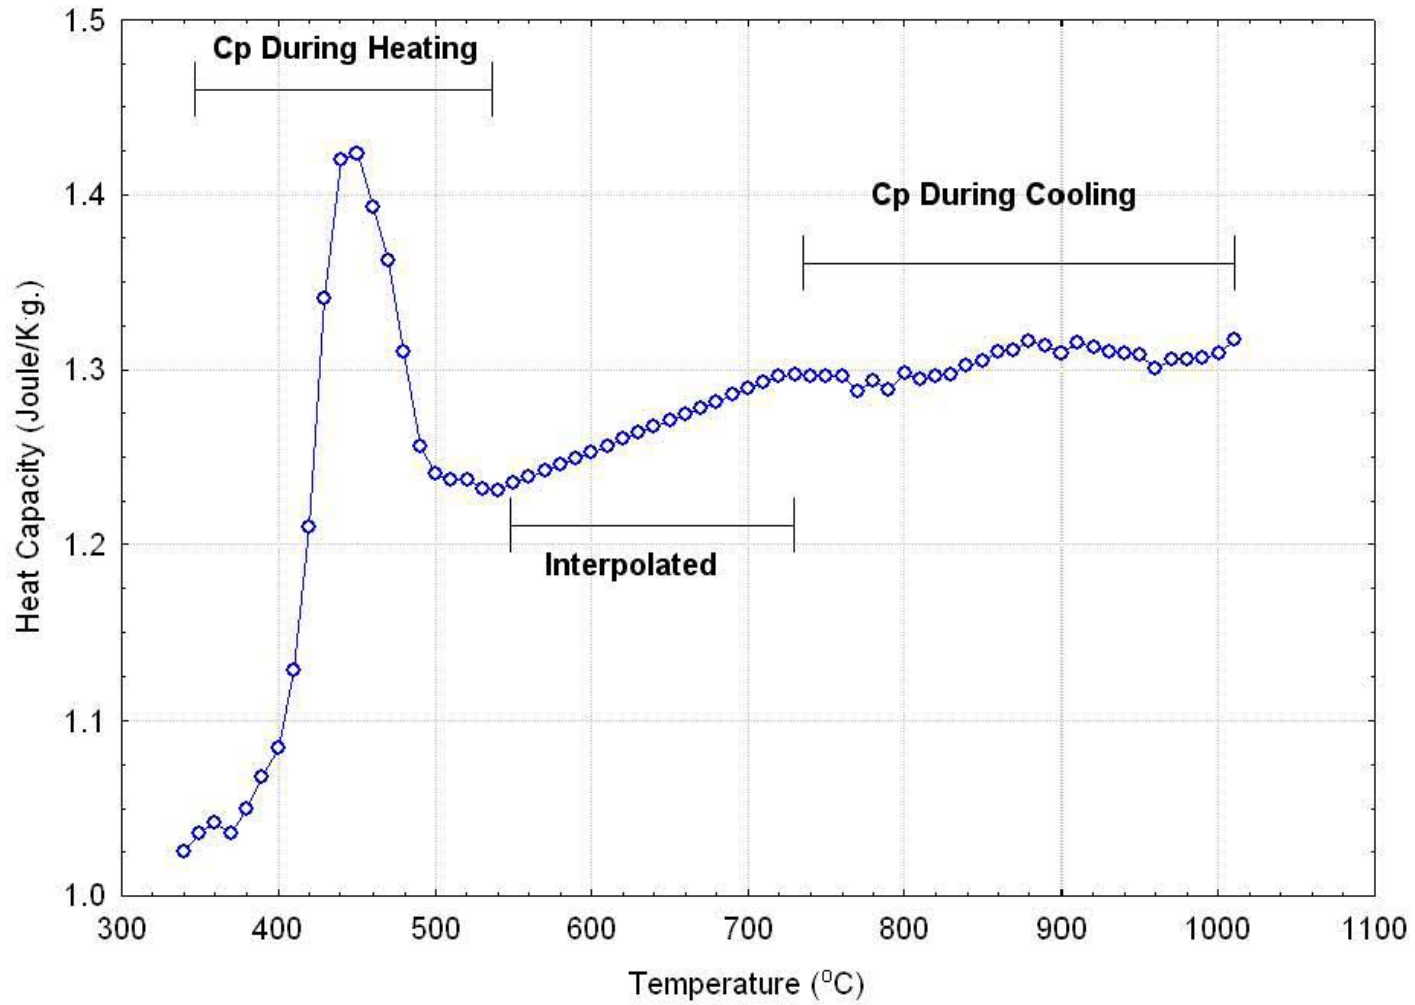
Figure 4.1. Heat capacity of FeP glass.

The specific heat of glass melts and solid glass samples was measured by Differential Scanning Calorimetry (DSC). Under a controlled environment and constant heating rate, the heat flux between the reference and the sample were continuously measured by two highly sensitive thermocouples. After proper baseline correction, the specific heat as a function of temperature can be calculated from the observed heat flux.

A SetaramTM MHTC96 with TG-DSC module was used for measurement of specific heat of glass and glass melt samples. The system was calibrated using National Institute of Standards and Technology (NIST)-traceable standards under identical conditions as used for the samples and over the same temperature range for the measurement of specific heat of melt and glass samples. All measurements of the blank, NIST standard, and glass samples, were made at a heating (or cooling) rate of 5°C/minute in an ambient environment controlled by regulated air flow through the sample chamber. For each measurement, about 500 mg of sample was loaded into a Pt sample cup and melted in a box furnace at 1150°C before the DSC measurements. Data from three consecutive heating and cooling cycles were collected, calculated, and averaged for the final presented data; any obvious outlying points in the raw data were removed prior to averaging. The low temperature end (above 300°C) was limited by the temperature control of the calorimeter and the high temperature end was set to be below 1050°C to minimize corrosion problems of the Pt-ware in the DSC module.

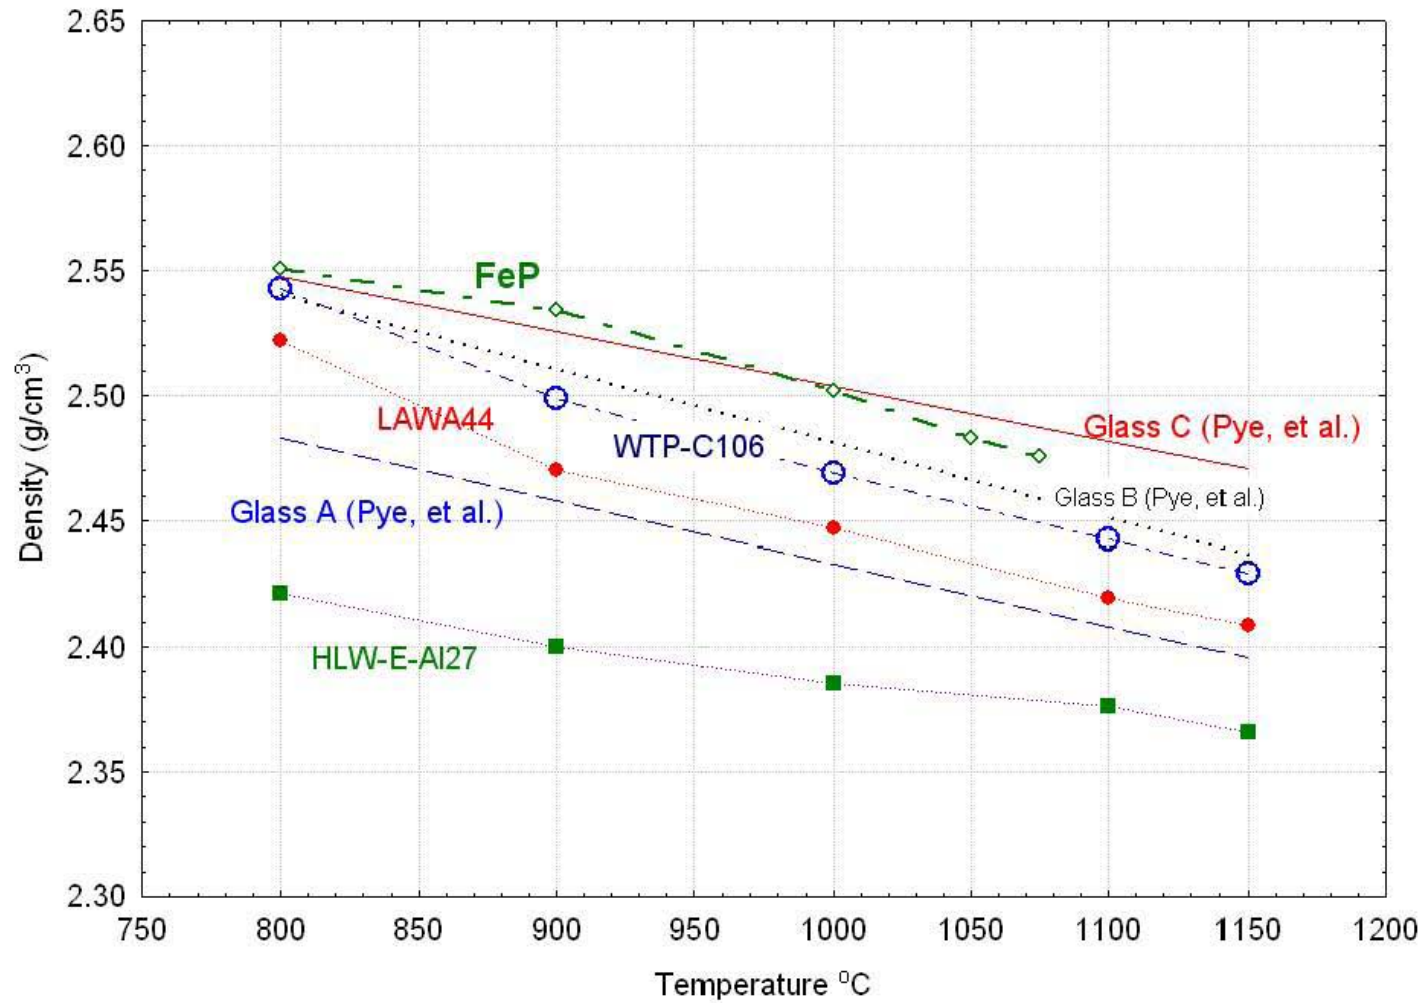
Figure 4.2. Density of FeP glass along with density data for four simulated WTP waste glass melts and three simulated waste glass melts from regression equations provided by Pye et al. [17].

different volume and mass was also used in the measurement. The difference of the observed buoyancy and volume of the two bobs at a given temperature was used in the calculation of the density of the FeP melt in order to eliminate the effect of surface tension. The experimental temperature range over which the density was measured was largely determined by the condition of the glass melt. For the FeP glass studied in the present work, the low temperature end was limited to 800°C by the viscosity and the tendency for crystallization of the glass sample.

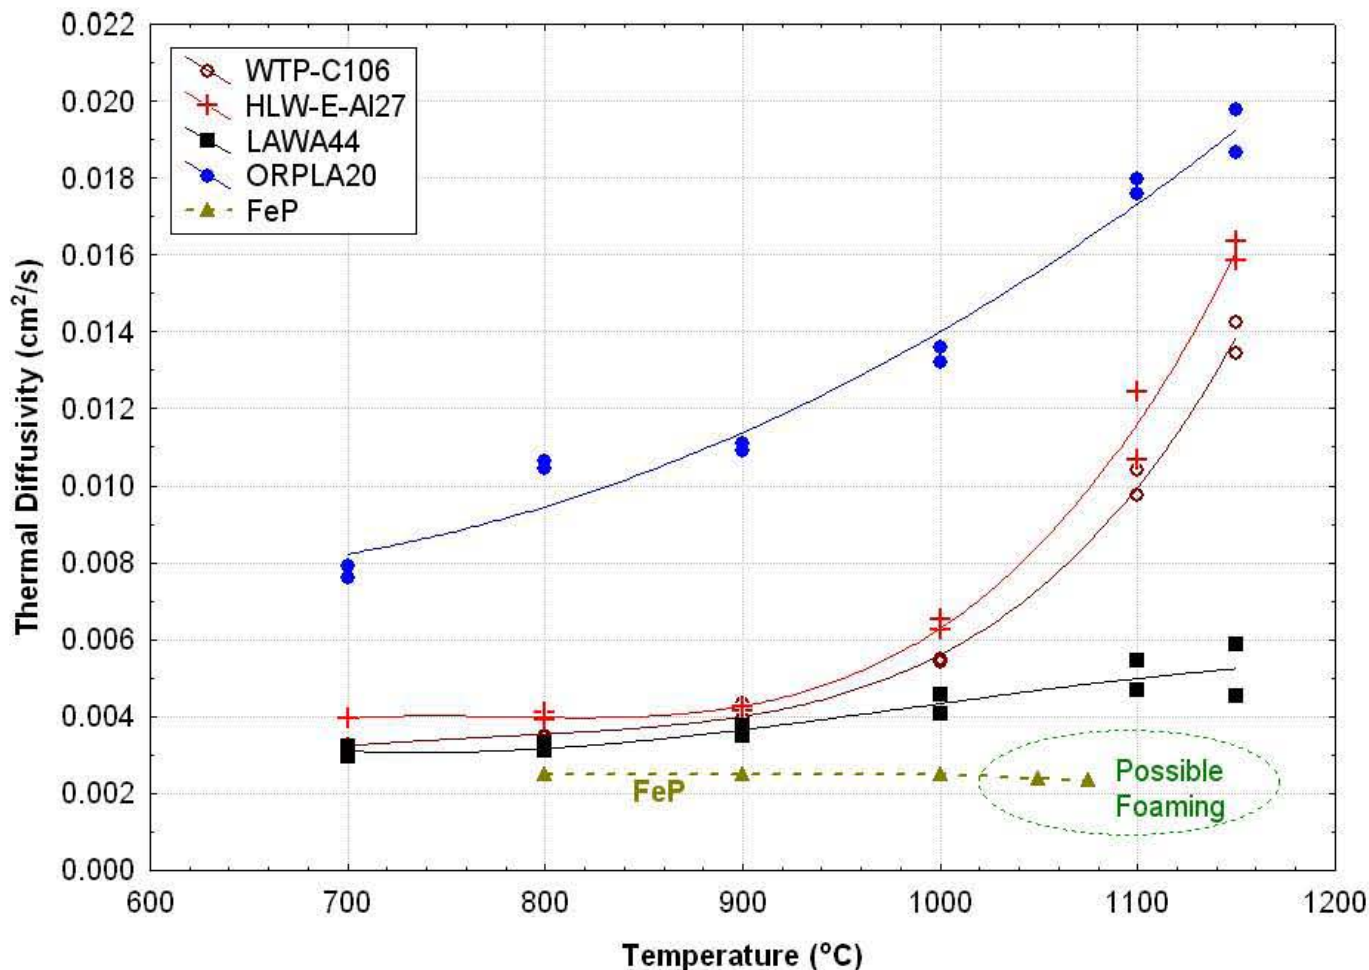
Figure 4.3. Thermal Diffusivity of FeP glass and four simulated WTP waste glass melts. Multiple points for a melt sample at a given temperature are from separate experiments using heat waves of different periods. Curves are polynomial fits.

A modified Ångström method was used for measurement of the thermal diffusivity of glass melts at high temperature. The method can be applied to a material in cylindrical geometry, the surface of which is subjected to periodic temperature variations around a given mean temperature, at a given amplitude and period, created by a concentrically aligned cylindrical heat source. The propagation of heat waves is monitored radially at two locations. The thermal diffusivity of the substance at the given mean temperature can be calculated from the observed phase lags of the temperature waves.

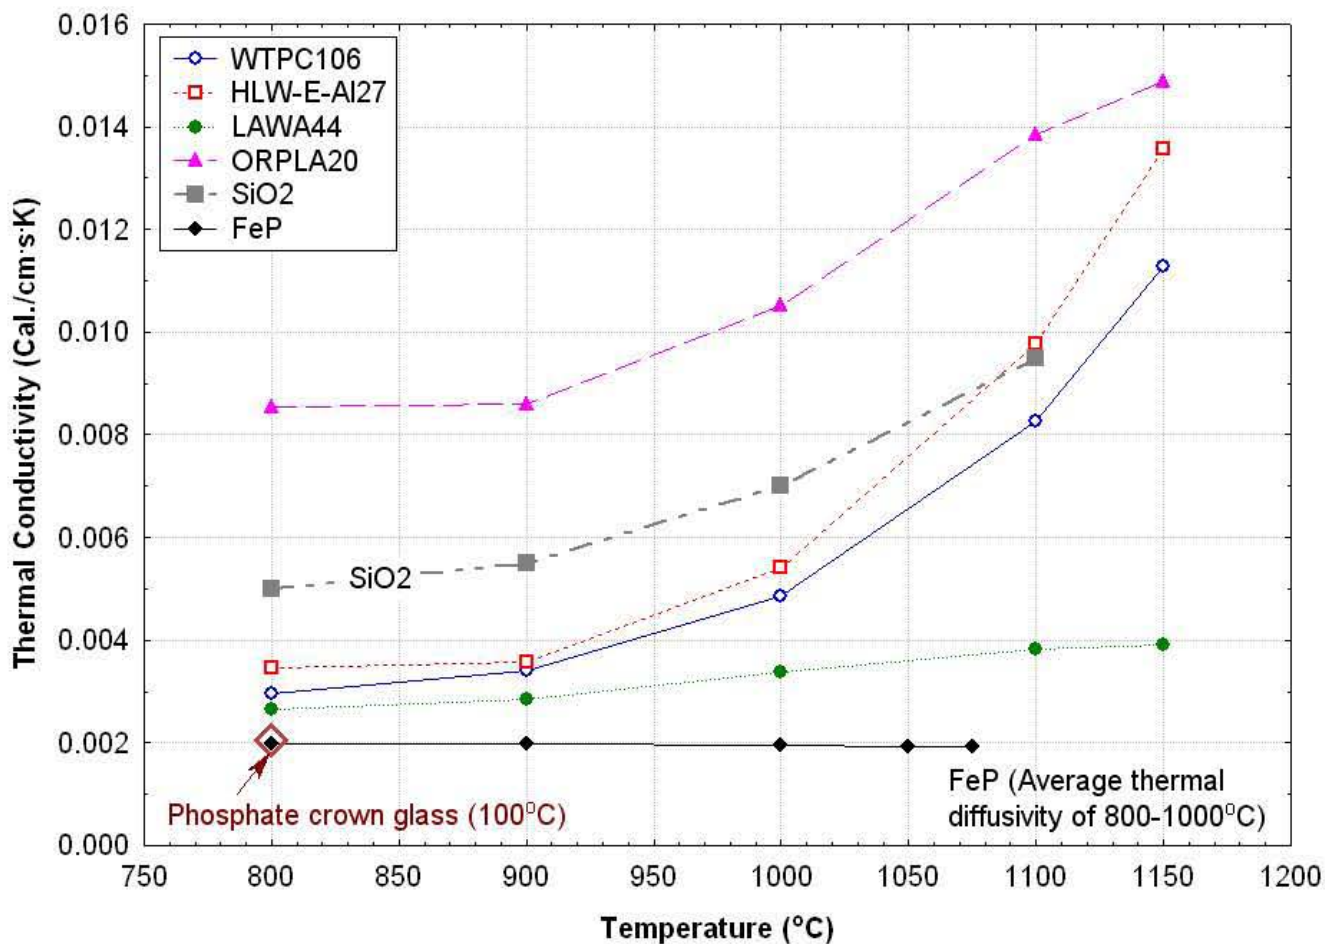
Figure 4.4. Thermal conductivity of FeP glass calculated from data for specific heat, density, and thermal diffusivity. Thermal conductivity values for four simulated WTP waste glasses and SiO₂ glass are included for comparison.
