River Corridor Closure Contract

100 Area D4 Project Building Completion Report – December 2008 to December 2009

WCH-410
Rev. 0

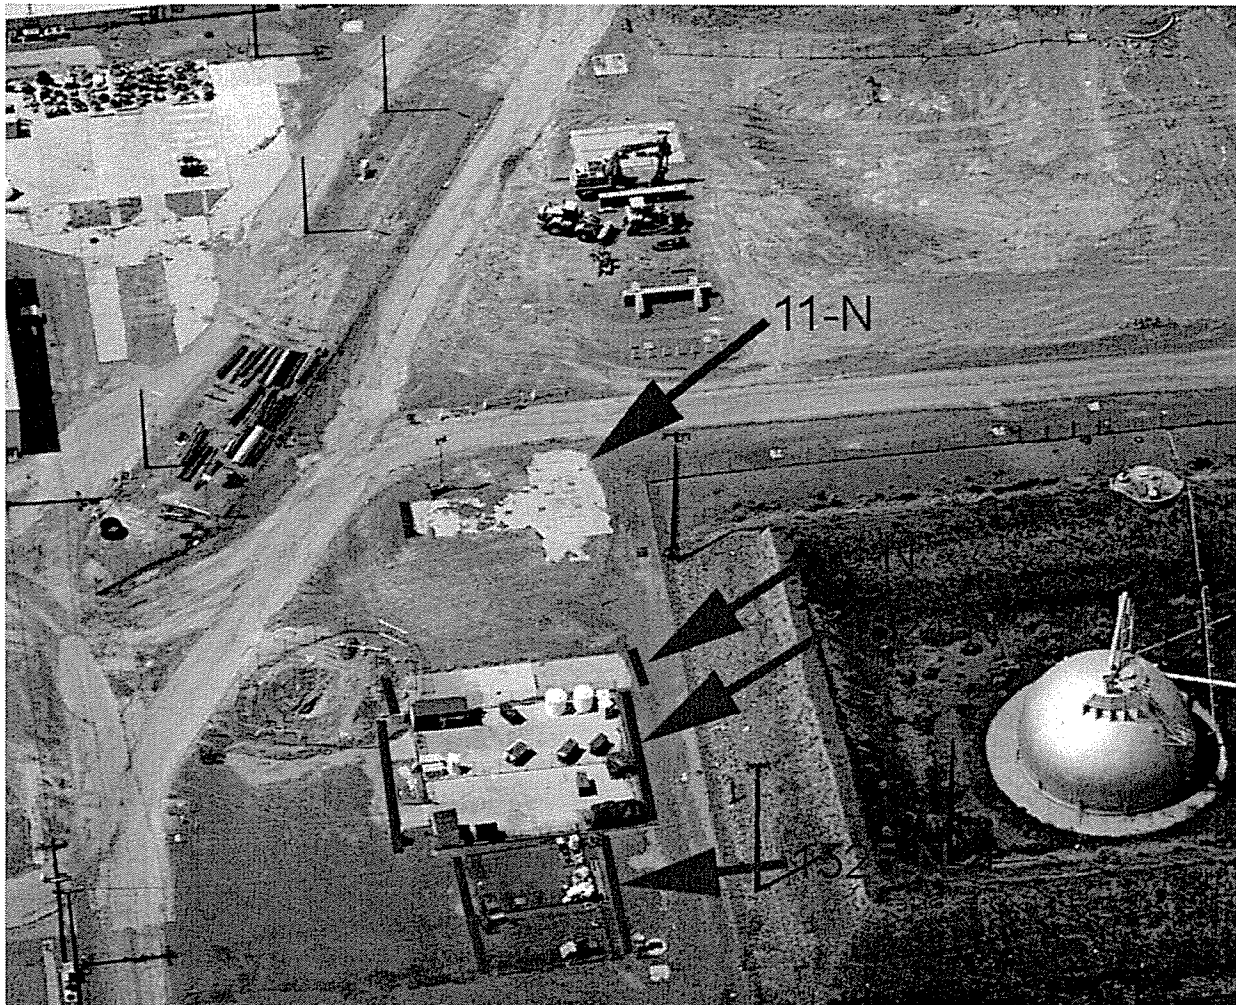
Figure 1. 11-N and 13-N Concrete Pads.

The remaining concrete pad (Figure 1) was demolished in December 2008 and debris associated with the demolition was disposed of at EDRF. Soil material from 100-N Borrow Pit was used to backfill the excavation, which was downposted and released. Final D4 documentation includes the GPERS and GPS surveys and sample data, all of which are included in the PDSR (WCH 2009b).

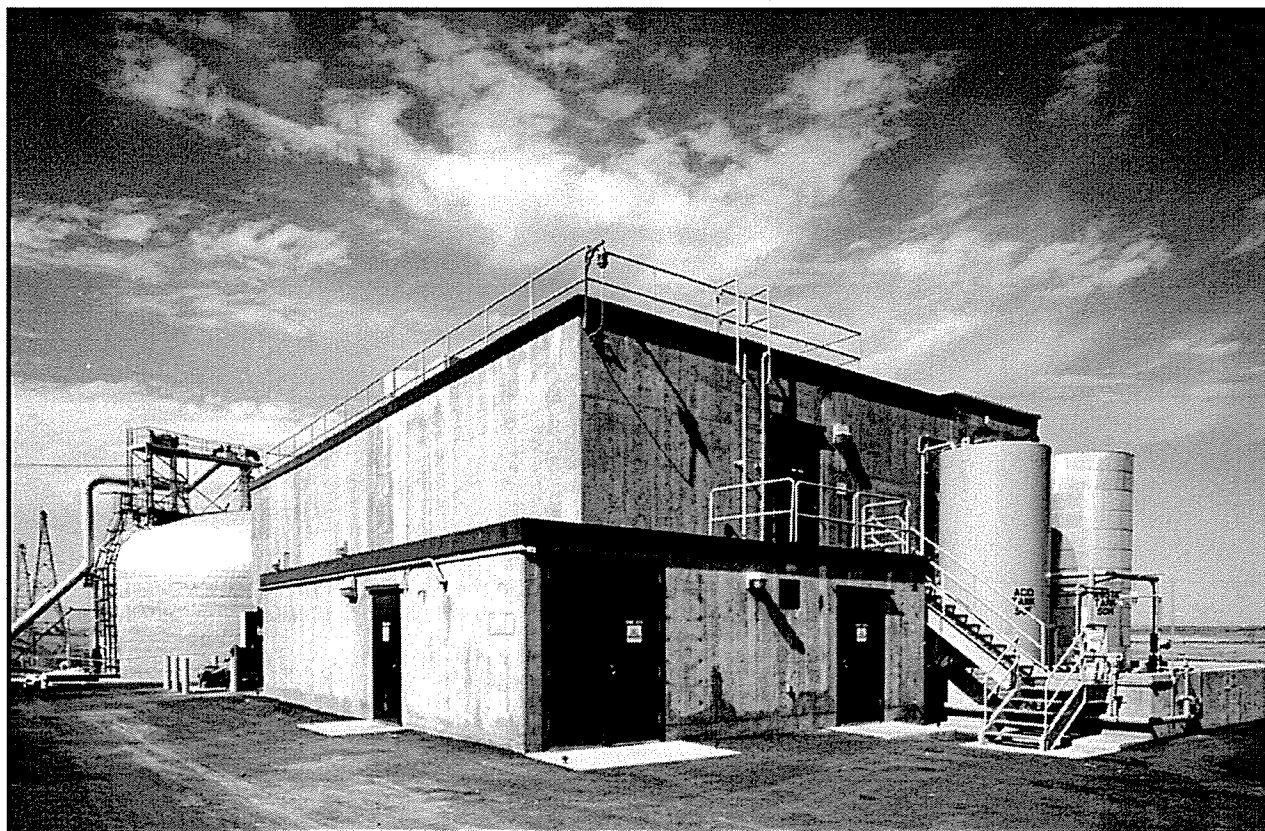
Figure 2. 107-N Facility During Operations.

The 107-N Basin Recirculation Facility was a two-story reinforced-concrete structure approximately 47-ft wide by 69-ft long by 48-ft high. The 107-N building was located 328 ft west of the 105-N Reactor and 131 ft from the Columbia River (Figure 2). 107-N was operational between 1984 and 1989 and primarily housed the equipment to cool, filter, and demineralize 105-N fuel storage basin water. The 105-N basin water and suspended solids were collected in overflow weirs at the surface of the 105-N basin pool, and then piped by gravity to the 107-N Building pump well, which was further pumped through process equipment before returning to the basin (DOE/RL 2004).

The 107-N Facility consisted of a ground floor, basement, and a partial second floor. The floors of the facility consisted of reinforced concrete or metal grating. The roof was pre-cast concrete. A control room was located on the second floor and had its own access separate from the main building entrances. A concrete-bermed annex with a metal weather enclosure that housed caustic and acid tanks was located on the north side of the 107-N building.

Facility components included: a pump well and two recirculation pumps, two heat exchangers, two sand filters, a sand filter backwash tank (T-1 tank), three ion exchange vessels (2-cation, 1-anion), one caustic tank, one acid tank, one regeneration waste collection tank (T-4 tank removed under Environmental Restoration Contractor), one resin loadout tank (T-5 tank), three building sumps, and one hydrogen peroxide tank and pump.

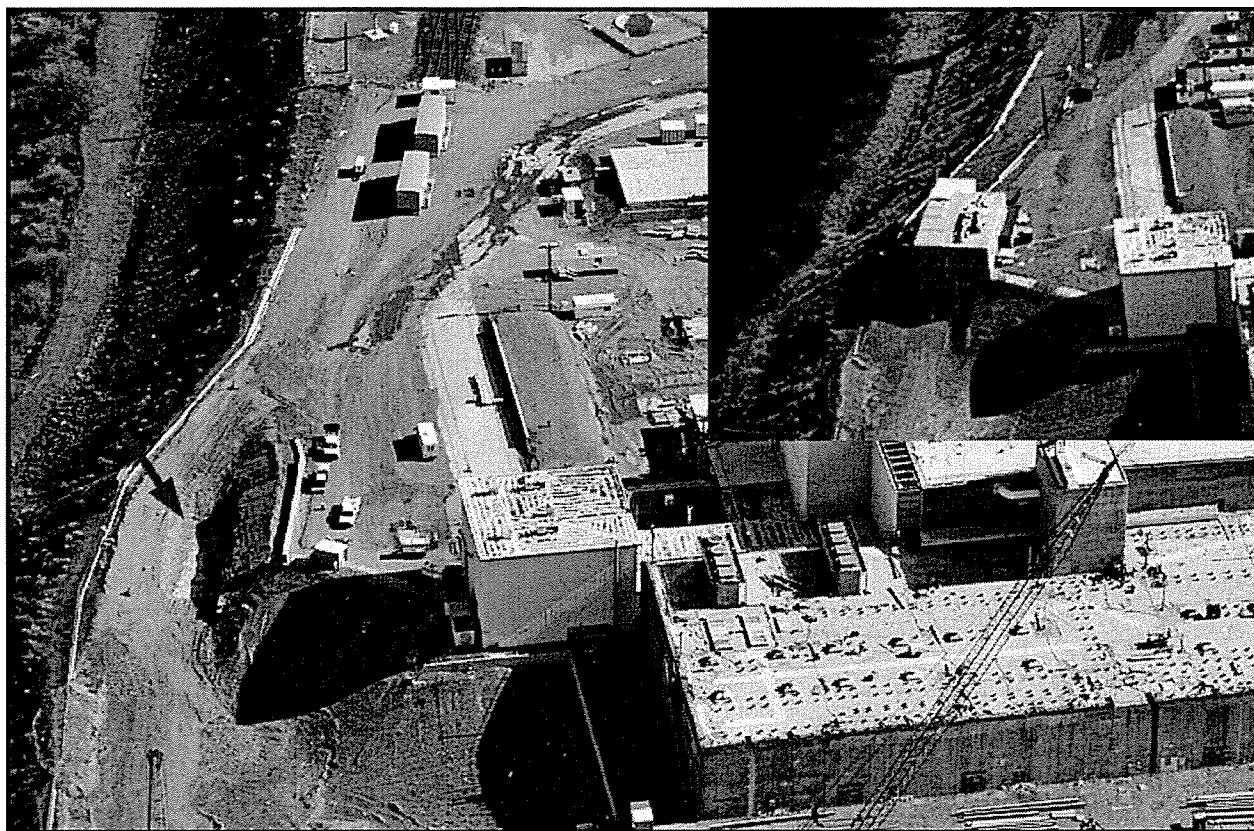
Figure 3. Post-Demolition Condition of 107-N; Inset Shows Original Structure.

The majority of the 107-N Facility was demolished in 2009. The basement floor and the below-grade portion of the east wall were left in place pending demolition of the 105-N fuel storage basin (Figure 3). Tanks and filters were removed during demolition and disposed of at ERDF. Their contents had been previously stabilized, or removed, treated, and disposed at ERDF. Demolition debris also was disposed at ERDF. The site was partially backfilled using material from the 100-N Borrow Pit. Typical final D4 information such as the post-demolition GPERS radiological survey and the GPS survey reports have not been fully compiled because the building demolition is not complete.

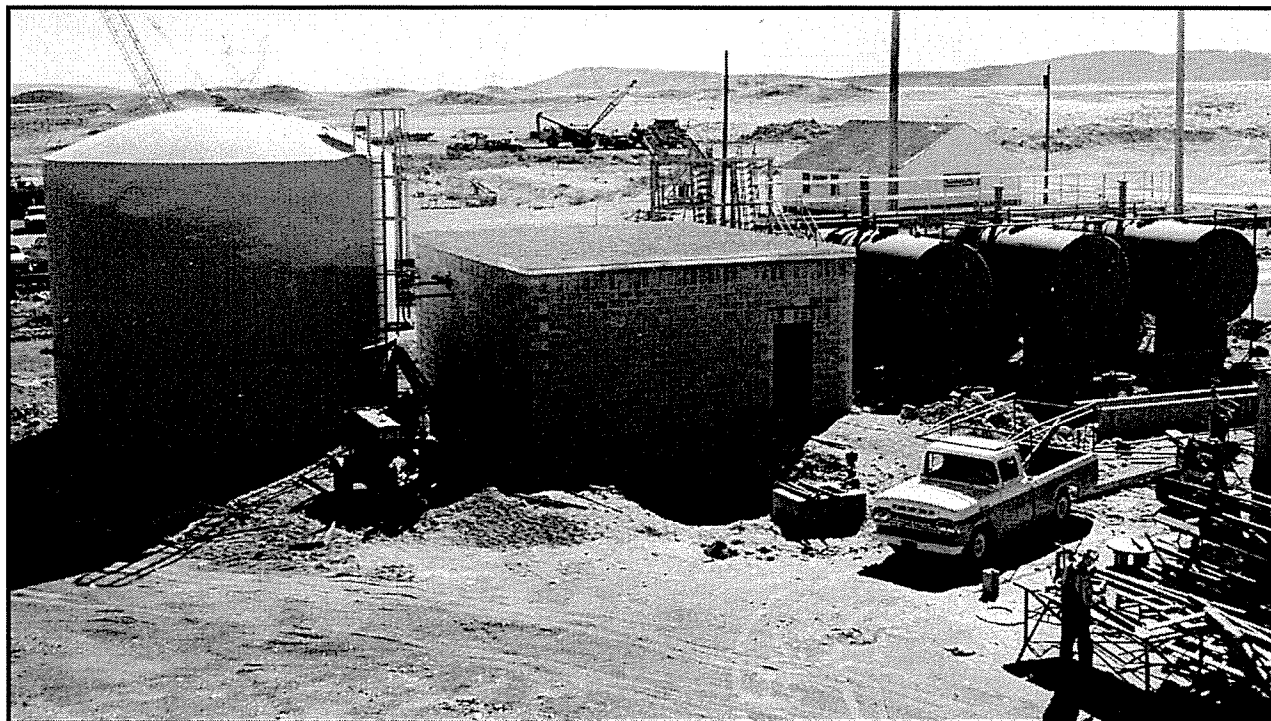
Figure 4. The 108-N Chemical Unloading Facility During Construction in 1961.

The 108-N Chemical Unloading Facility consisted of several parts, a single story 27 ft by 30 ft pump house, three acid storage tanks, one caustic storage tank and a pneumatic transfer tank (Figure 4). A covered underground neutralization pit was located adjacent to the pump house. A tank car unloading station was located east of the pump house and adjacent to the railroad (BHI 1995).

The 108-N Chemical Unloading Facility and 120-N-5 Transfer Pipes and Neutralization Pit were demolished in 2006-2008. After demolition was completed the concrete debris was stockpiled, sized reduced, loaded out, and disposed of at ERDF. Soil material from 100-N Borrow Pit was used to backfill the site, which has since been downposted and released. Final D4 documentation includes the GPERS and GPS surveys and sample data, all of which are included in the PDSR (WCH 2005b).

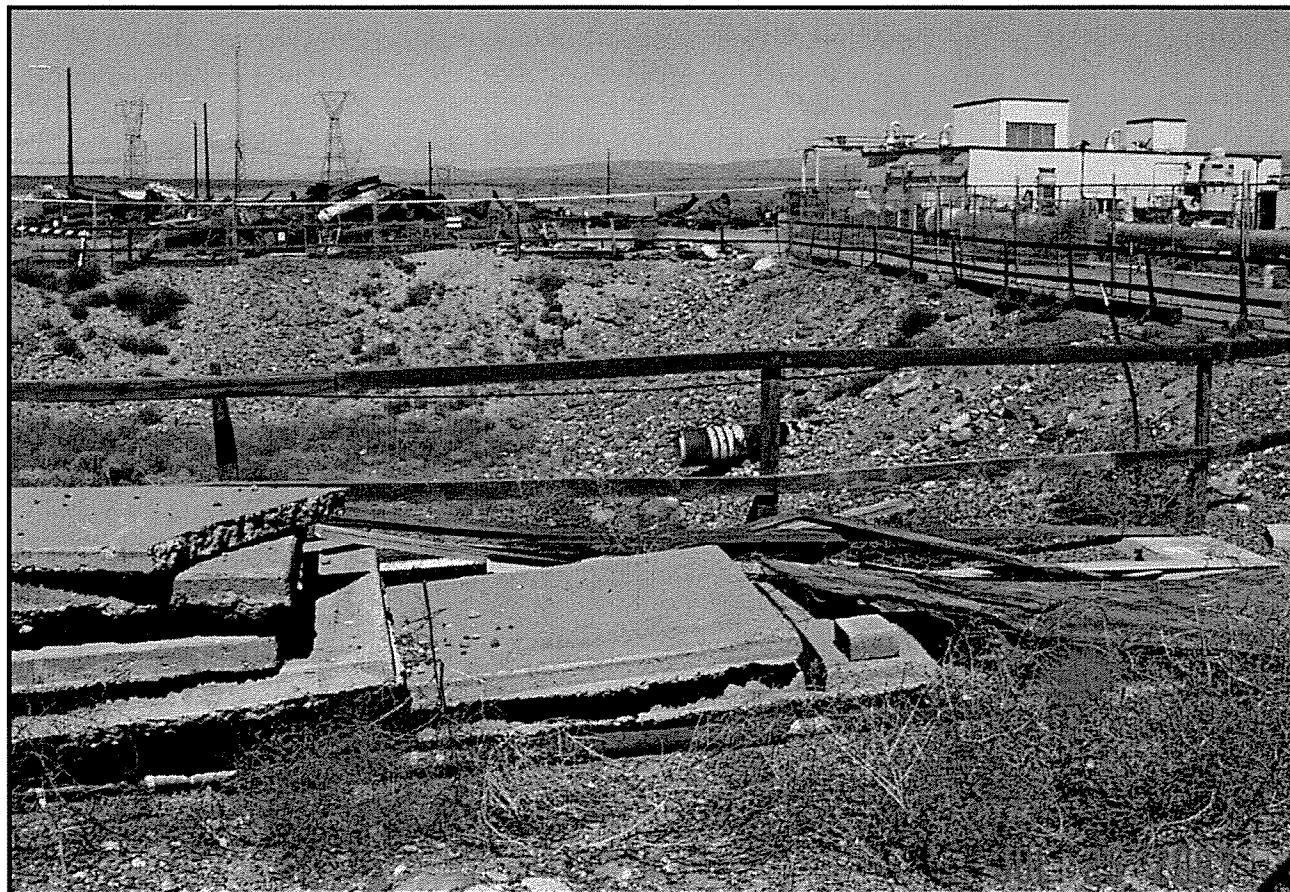
Figure 5. 183-ND Resin Disposal Pit.

The 183-ND Resin Disposal Pit (Waste Information Data System [WIDS] site 100-N-23) was an open rectangular pit approximately 80-ft long by 35-ft wide and 15-ft deep with a 24-in. drain pipe protruding horizontally from the north side into the pit (Figure 5). The pit was used to dispose spent resin from the 163-N Demineralization Plant. The pit later served as the 183-NB Clearwell overflow. Although the pit was not used for either of the intended purposes after 1990, it remained in place for use on an emergency basis. Between 1990 and 1992, the resin was excavated from the pit (WCH 2009e).

The physical pit still exists and is surrounded by a temporary metal cyclone fence for safety. All above-grade demolition was performed per D4 removal action requirements; the completion date was June 30, 2008. Removal of the remaining inlet pipe, any below-grade work and backfill will be performed by Washington Closure Hanford (WCH) Field Remediation (FR) project.

A pre-existing wood fence around the pit was demolished and removed along with miscellaneous wood and concrete debris. Demolition material was loaded into roll-off containers and shipped to ERDF for disposal under Waste Profile No. HGP001 (WCH 2010a). Final D4 documentation includes the GPERS and GPS surveys and sample data, all of which are included in the post-demolition summary report (WCH 2009e).

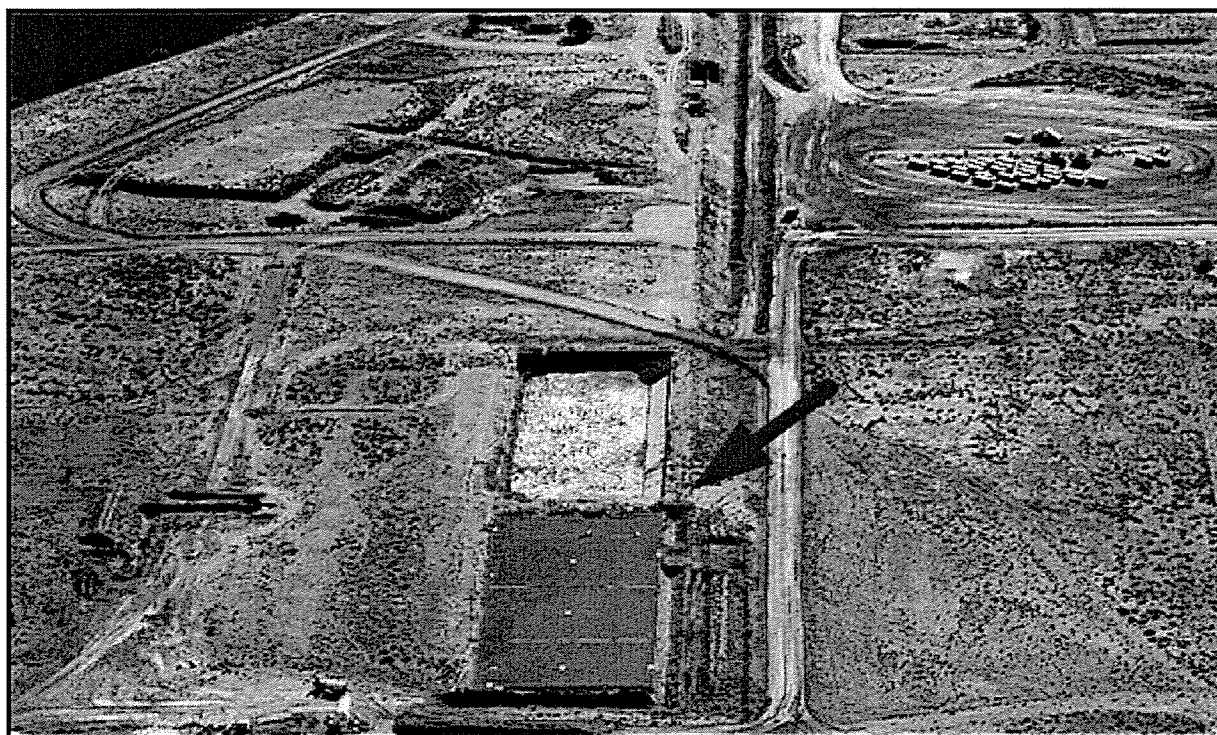
Figure 6. 183-F Clearwells in 2007.

Each of the two reinforced concrete clearwells stored 4.5 million-gal of treated water from the filter building, which was pumped as needed to the reactor cooling system. Beginning in the 1970s, the eastern clearwell received demolition wastes from the 183-F, 185-F, 189-F, 1717-F, and 190-F Buildings, as well as uncontaminated portions of the 115-F Building (BHI 1994).

In 2006 a maternity bat colony, estimated to be approximately 2,000 bats and the largest known colony in eastern Washington, was discovered at the 183-F west Clearwell facility (126-F-2 waste site) that was planned for demolition. Between June 2007 and September of 2008, an ecological study recognized the ecological significance of the 183-F west Clearwell and identified a preferred alternative that included leaving the clearwell and flumes in-place and installing fencing and signage to protect the bat colony.

Site remediation was performed from July to September 2005 and included the removal of debris within the eastern clearwell structure down to the concrete floor. Excavated material was staged onsite before ERDF disposal. Radiological surveys and visual inspection of the

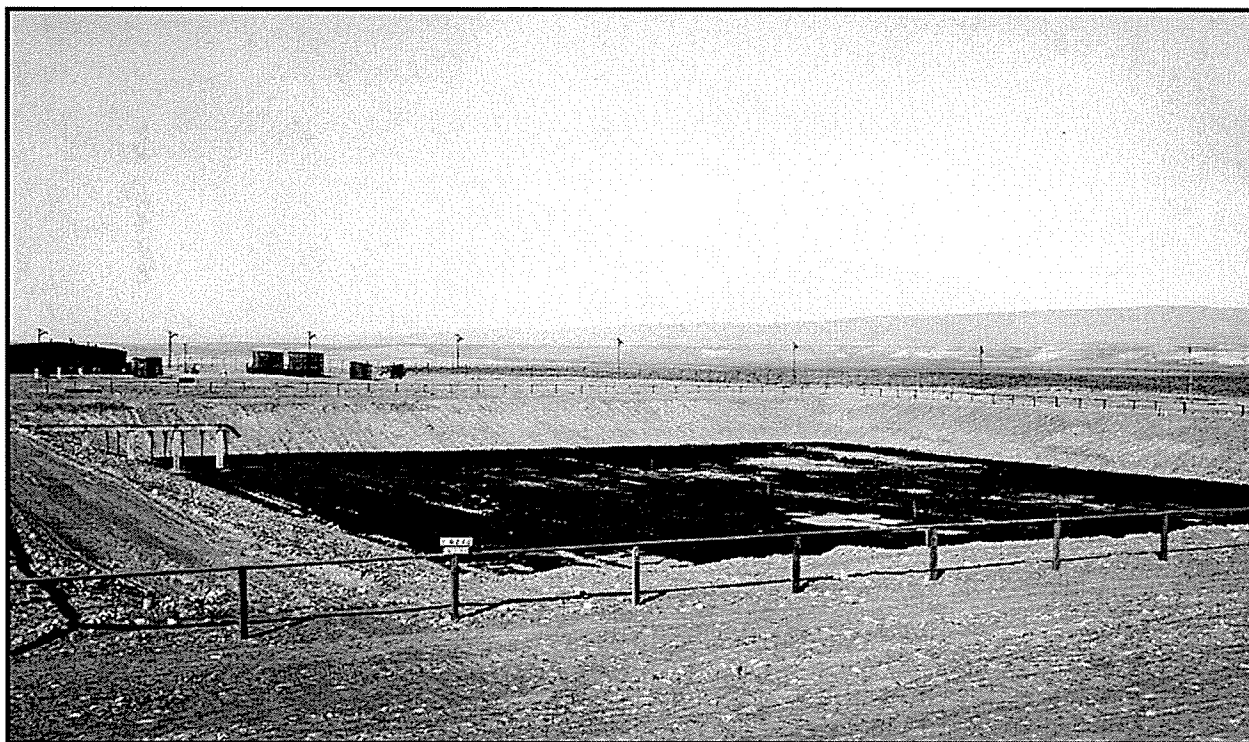
Figure 7. 188-D Ash Disposal Basin in 1944.

The 188-D Ash Disposal Pit was a rectangular basin that 260 ft by 290 ft by 13.5 ft (Figure 7). It was originally constructed as a pit to hold ash from the 184-D-31 Power House. Ash was pumped directly from the power house to the pit by means of an 8-in. cast-iron underground pipeline. From 1944, until the pit was retired in 1966, it received ash/water effluent from the power house. Between 1966 and 1977, the pit received no discharges. Between 1977 and 1979, two ponds were constructed in the 188-D Ash Disposal Pit. These ponds (the 100-D Ponds; WIDS site code 120-D-1) were used as a land surface impoundment for the disposal of primarily non-radioactive, non-dangerous liquid effluents from the 183-D Water Treatment Facility.

The 100-D ponds were remediated in 1996 and received closure certification in 1999. In June 1998, the 126-D-1 waste site (188-D Ash Disposal Pit) was reclassified as rejected based on information indicating that ash from Hanford Site power plants is not radioactive and not a dangerous waste (BHI 1998b). The 188-D Ash Disposal Pit was left in place. There were no down-posting or GPERS surveys associated with the 188-D Ash Disposal Pit because it was never posted for radiological contamination (WCH 2010a).

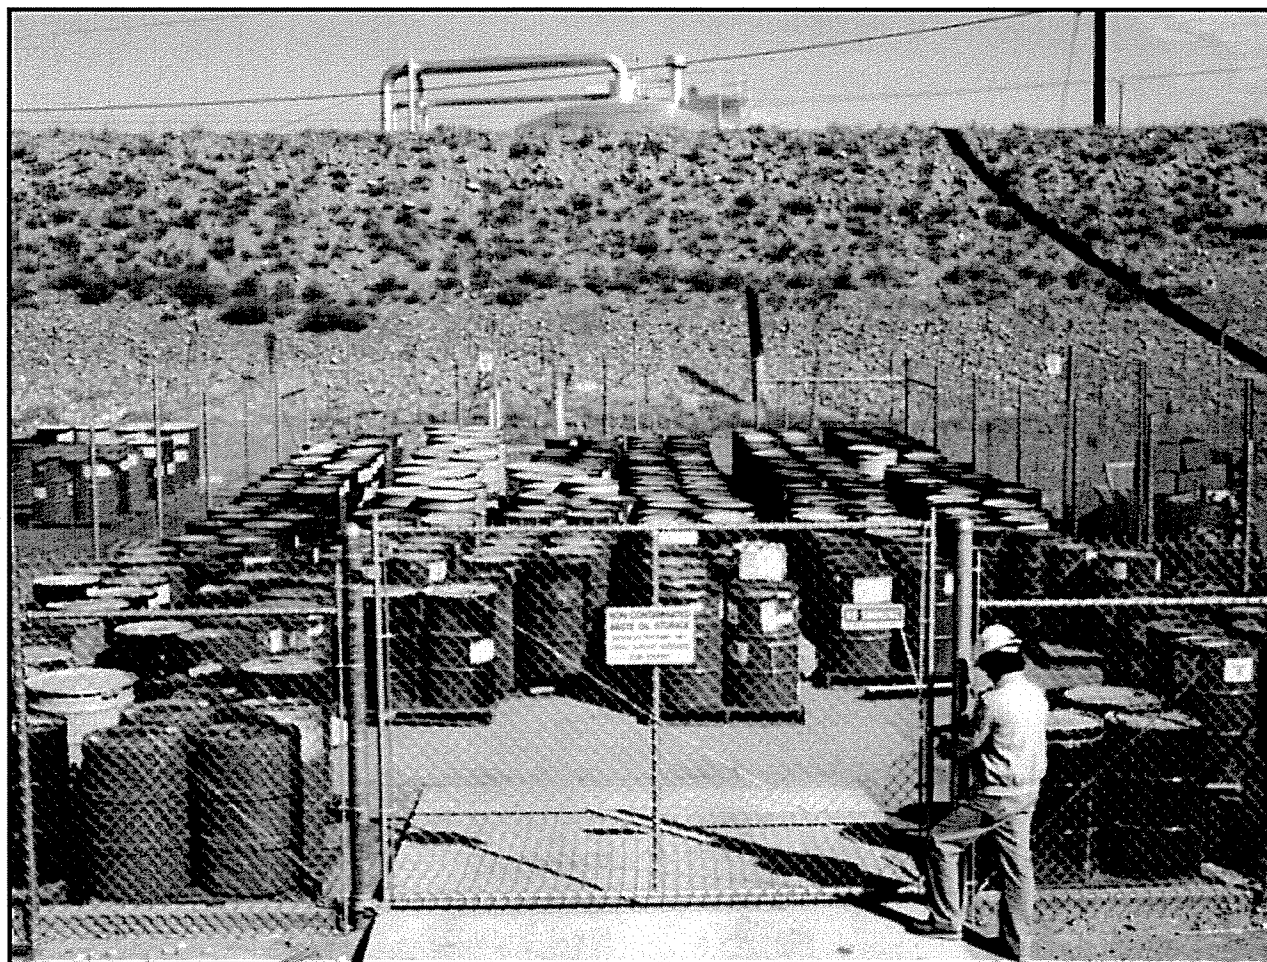
Figure 8. 1524-N Hazardous Waste Storage Pad During Operations.

The 1524-N Hazardous Waste Storage Pad consisted of a curbed concrete pad approximately 80 ft by 80 ft, enclosed with a chain link fence (Figure 8). Two small wood sheds (8 ft by 20 ft and 8 ft by 10 ft), each with one side open, were located on the south end of the pad. 1524-N was located south of the 1310-N "Golf Ball" and between the 13-N and 1525-N facilities.

1524-N began operation in 1985 and was used to store drums and other containers of waste materials until 1989. During N-Area deactivation it was used for the storage of radioactive materials including shipping casks and shielded containers.

The 1524-N Storage Pad was demolished and excavated in December 2008. The demolition material was loaded into roll-off containers and sent to ERDF for disposal. Soil material from 100-N Borrow Pit was used to backfill the site, which has since been downposted and released. Final D4 documentation includes the GPERS and GPS surveys and sample data, all of which are included in the PDSR (WCH 2009b).

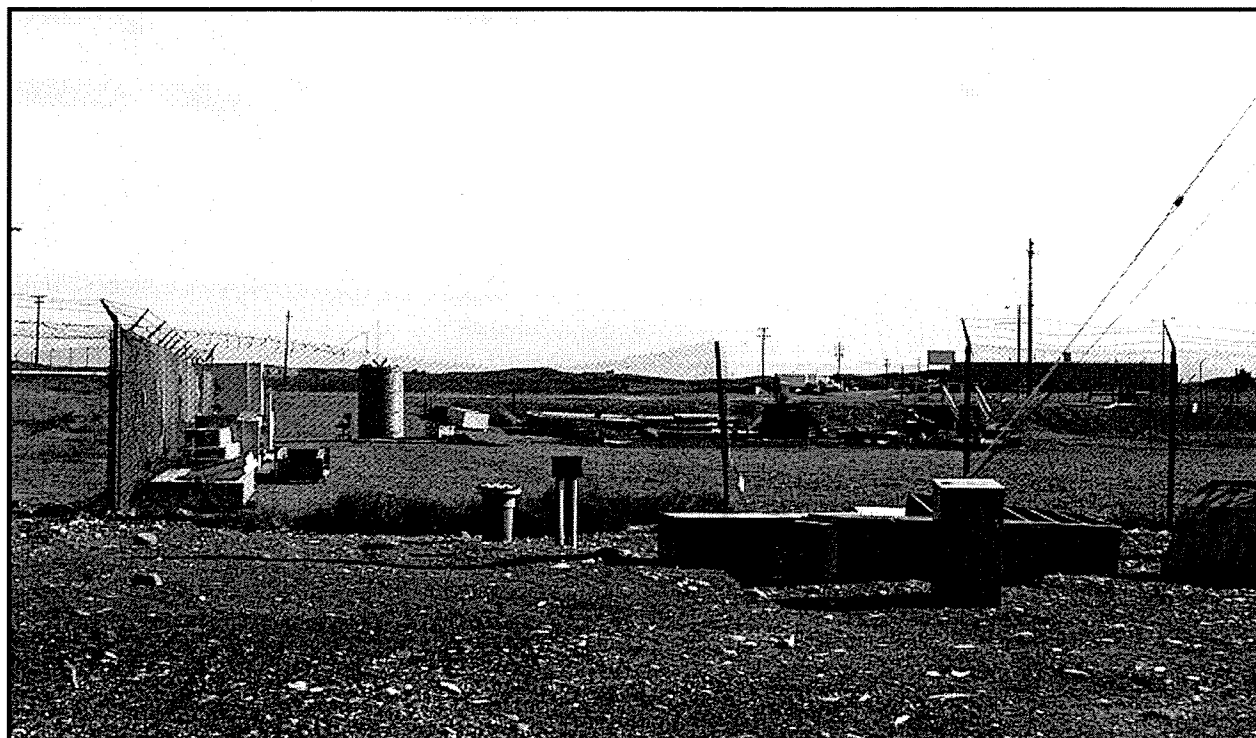
Figure 9. 1525-N Laydown Yard in 2006.

The 1525-N facility was a 40-ft by 60-ft graveled laydown storage yard enclosed with a chain link fence (Figure 9). It was located south of the 1310-N "Golf Ball" and was on the east side of 1524-N. 1525-N was a fenced laydown yard to prevent unauthorized removal of materials stored in the area. The facility was used for storing construction materials, and no contamination events are known to have occurred.

The 1525-N Storage Area was demolished in December 2008. The demolition material was loaded into roll-off containers and disposed at ERDF. The excavation was backfilled with material from the 100-N Borrow Pit, and the site has been downposted and released. Final D4 documentation includes the GPERS and GPS surveys and sample data, all of which are included in the PDSR (WCH 2009b).

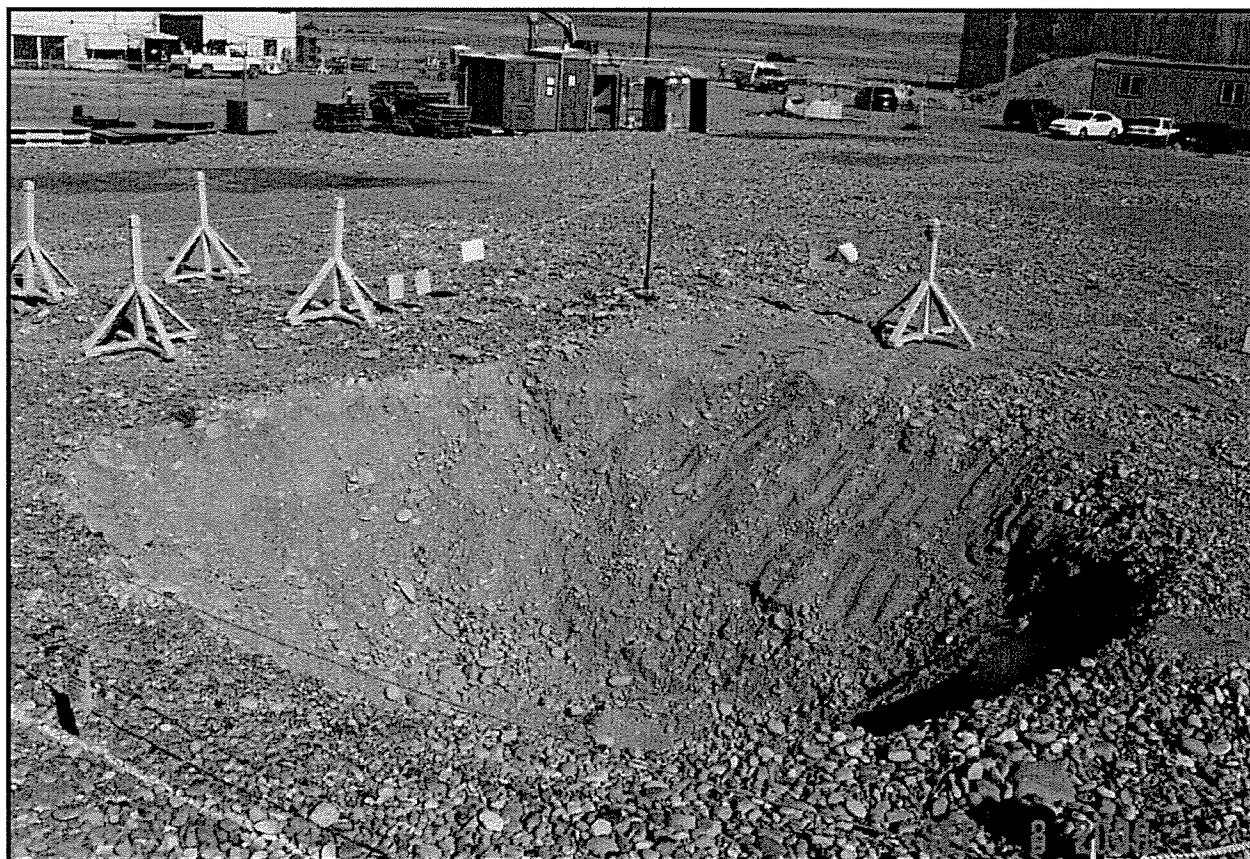
Figure 10. 1607-N1 Tank Excavation.

The tank was demolished and excavated in September 2009 (Figure 10). Debris was disposed of at ERDF. The cesspool was not removed and is to be remediated by FR. The excavation was backfilled with material from the 100-N Borrow Pit, and the site has been downposted and released. Final D4 documentation includes the GPERS and GPS surveys and sample data, all of which are included in the PDSR (WCH 2009c).

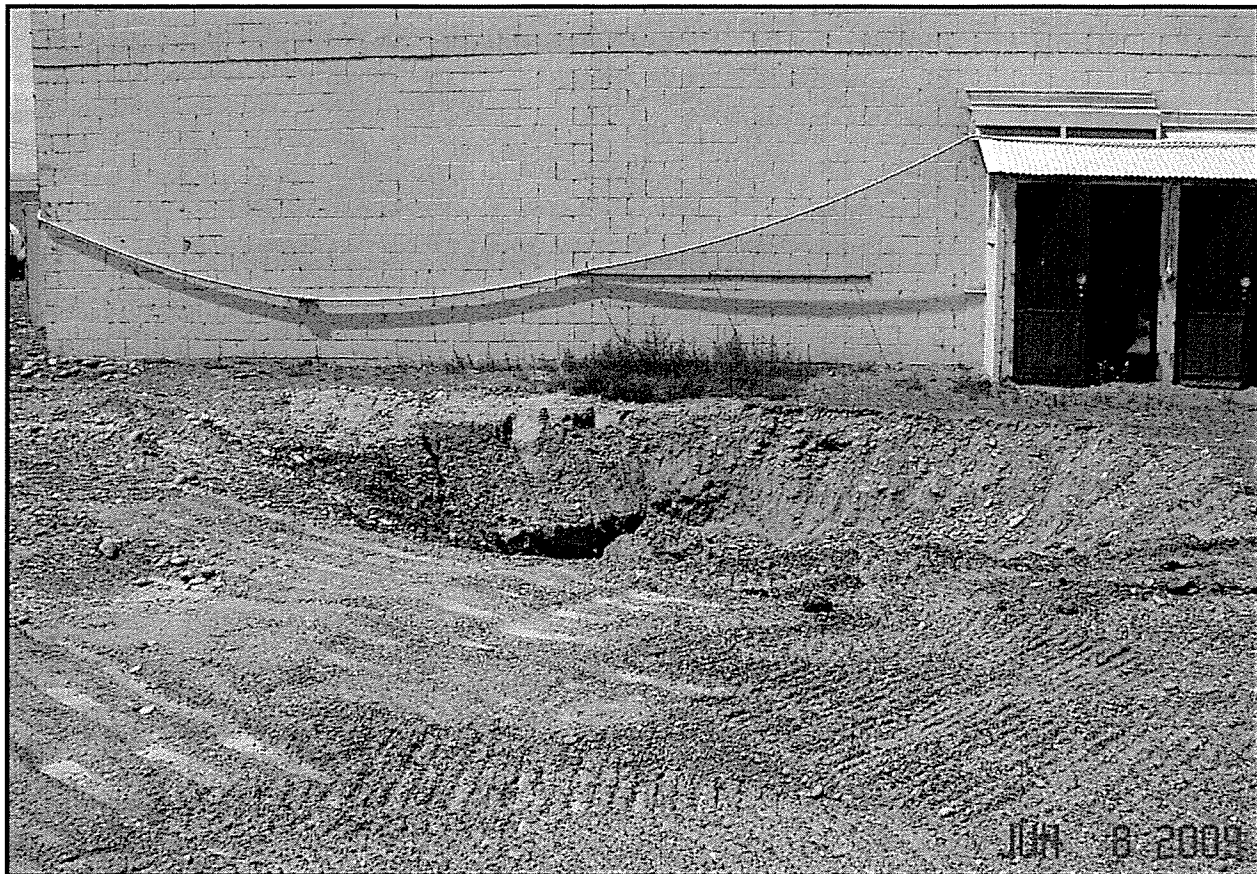
Figure 11. 1607-N2 Tank Excavation.

Tank 1607-N2 was demolished and excavated (Figure 11). Following disposal of debris and soil to ERDF, the site was backfilled to facilitate safe removal of the 182-N Building. The excavation was backfilled with material from the 100-N Borrow Pit, and the site was downposted and released. Final D4 documentation includes the GPERS and GPS surveys and sample data, all of which are included in the PDSR (WCH 2009d).

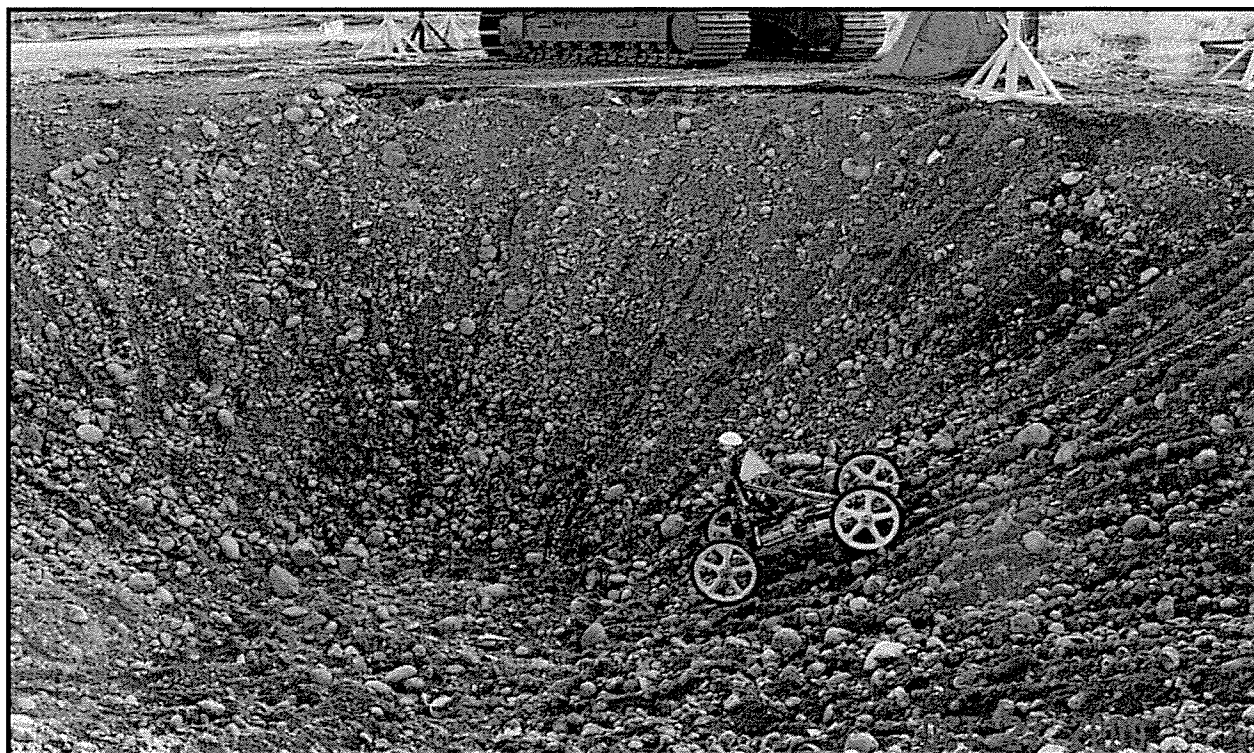
Figure 12. 1706-NA Sewage Lift Station Excavation.

The 1706-NA Sewage Lift Station was used to pump water and sewage from the 1705-N Instrumentation and Electrical Facility. The lift station was a below-grade concrete structure consisting of two pumps with associated electrical conduit, junction box, and framework connected to a common 4-in. diameter galvanized steel piping located in a 6-ft diameter precast manhole with 6-inch thick cylindrical walls. The lift station was approximately 15-ft deep with an 8-in. thick concrete base. The 1706-NA Sewage Lift Station was used to collect sewer wastes for pumping to a discharge basin. It replaced an earlier septic tank and cesspool, which was located near the same location. The 1706-NA Lift Station was isolated in 2002, and it was demolished and excavated in 2009 (Figure 12).

Debris was disposed at ERDF and the excavation was backfilled with material from the 100-N Borrow Pit. The associated cesspool, 100-N-22, was not removed and is to be remediated by FR. The excavation was backfilled with material from the 100-N Borrow Pit, and the site has been downposted and released. Final D4 documentation includes the GPERs and GPS surveys and sample data, all of which are included in the PDSR (WCH 2010b).

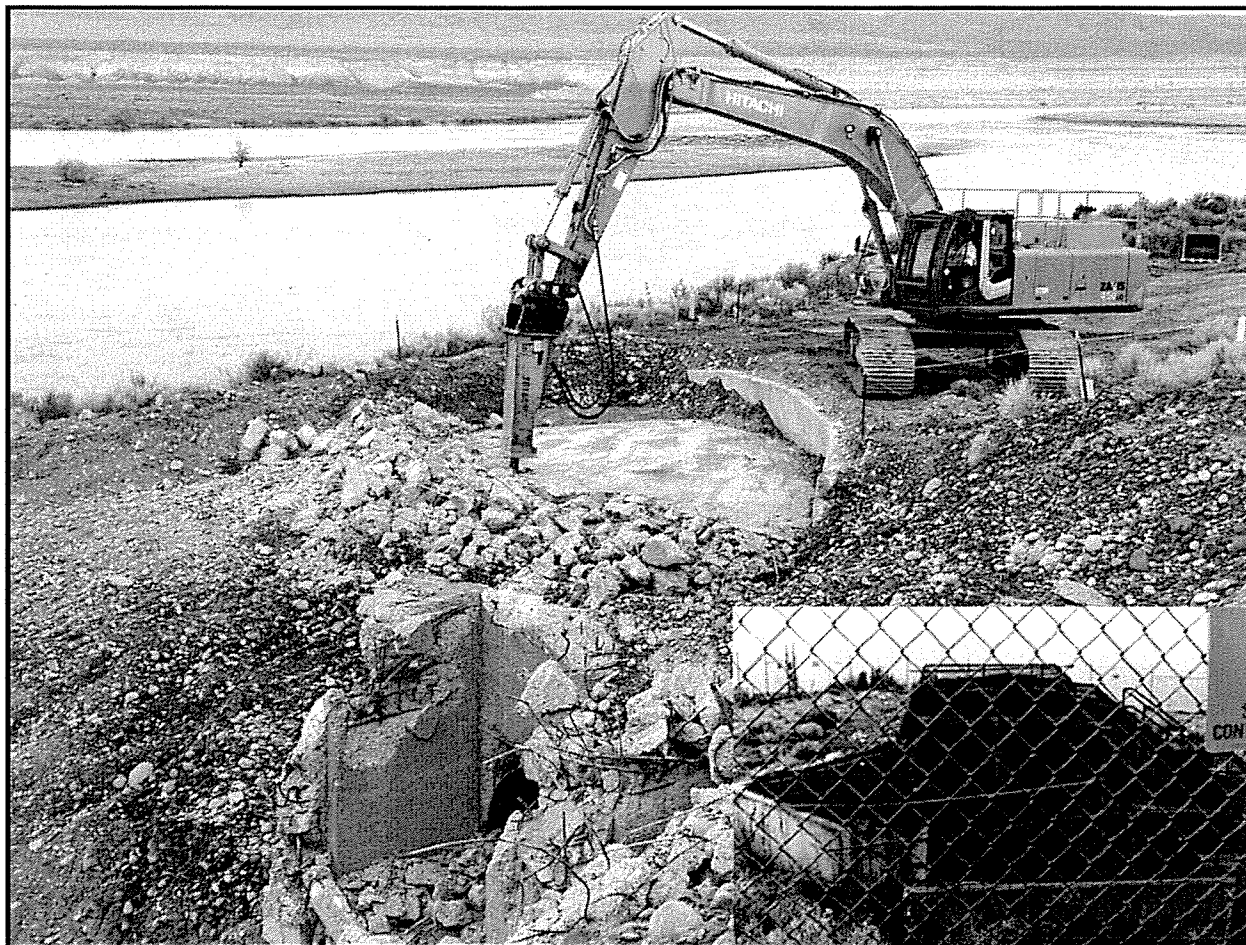
Figure 13. Demolition of the 1904-D Outfall Structure; Inset Shows Original Structure.

The 1904-D Outfall was a concrete feature that received reactor effluent water from the 107-D Retention Basin and discharged into the river (Figure 13). Effluent water exited the structure by two paths. Under normal operations, water discharged through two pipes that extended to the center of the river. The second exit path was via a flume/spillway that exited into the river. The outfall structure was partially demolished in 1998 and backfilled with clean soil.

A geophysical survey conducted in May 2004 identified anomalous subsurface features believed to be remains of the demolished concrete. From February to April 2009, the remnants of the 1904-D Outfall Structure were demolished and excavated for ERDF disposal. The southern edge of the 1904-D excavation was collocated with a section of concrete pipeline associated with the 100-D-31:7 waste subsite that currently is undergoing post-remediation close-out verification sampling and analysis (WCH 2009h).

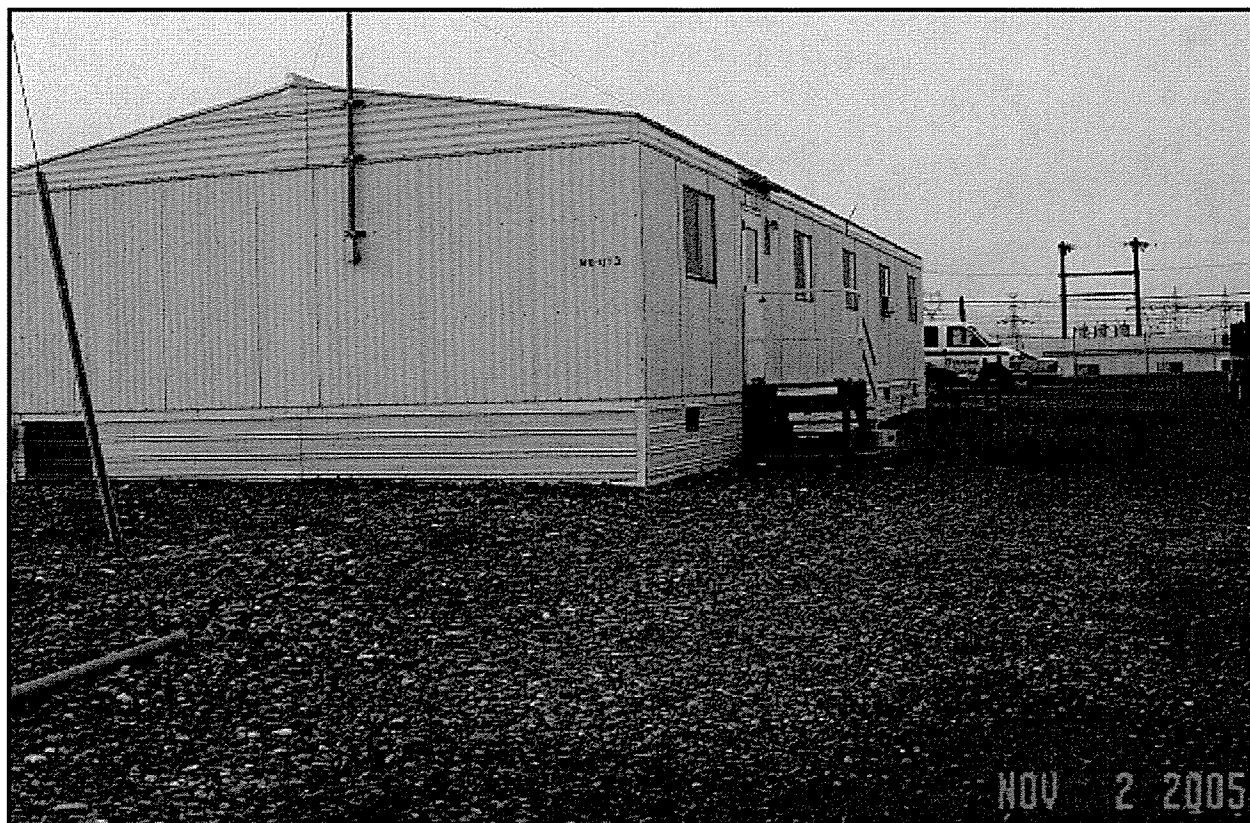
Figure 14. Mobile Office Trailer MO-013 in 2005.

MO-013, also known as 1158-N, was one of several mobile offices that were installed in the 100-N Area in the 1980s. It was a double-wide sheet metal and plywood trailer facility and contained ten offices (Figure 14). It was a 1977 Mico trailer, serial number 7219A-B, and was installed near the 1120-N Building between August 1985 and April 1986.

The MO-013 Mobile Office was demolished in late 2008. After demolition was completed the building debris was stockpiled, size-reduced, loaded out and disposed at ERDF in February 2009. A minimal amount of soil was removed along with the building debris. The MO-013 site has been downposted and released. Final D4 documentation includes a pre-demolition GPS survey and sample data, which are included in the PDSR (WCH 2009f).

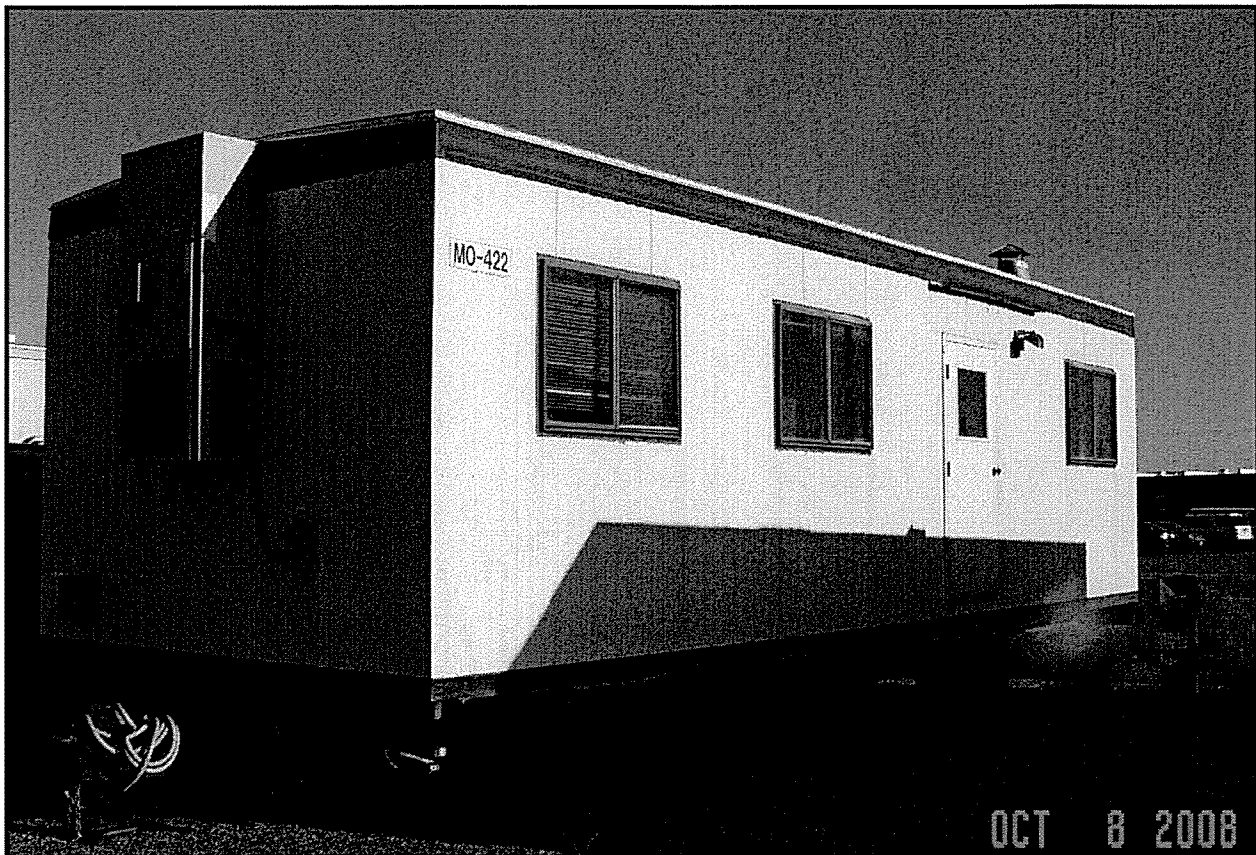
Figure 15. MO-422 Before Disposal.

The MO-422 Building (Figure 15) was a single-wide modular office trailer that measured 12 ft by 32 ft. It was first located in the 200-W Area, and then was transported to a site northwest of the 105-DR Reactor Building where it served as the Field Support Trailer (BHI 1997b).

In 2008, the MO-422 trailer was relocated to 100-N area. In 2009 it was towed intact to ERDF for disposal (WCH 2009g).

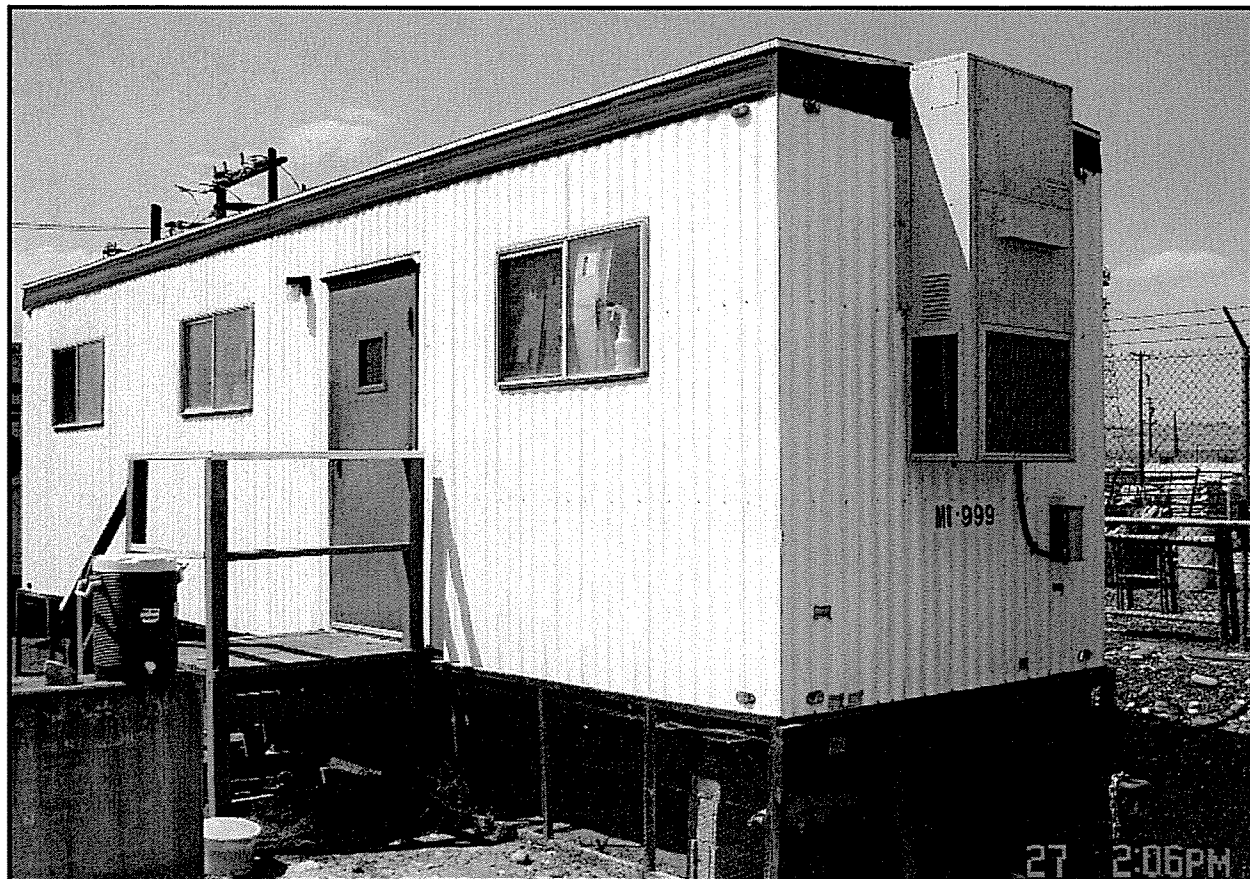
Figure 16. MO-999 Before Disposal (2006).

The MO-999 building was a single-wide office trailer, manufactured in March 1991, and last located in the 100-N Area (Figure 16). It had previously been located in the 100-D Area, where it functioned as the supervisor's office during work for the 105-DR reactor ISS project. The MO-999 facility was relocated to the 100-N Area in 2003. At 100-N, MO-999 was located just south of the 151-N Switchyard, between MO-864 and MO-866. The MO-999 facility provided office space in the 100-N Area. One section of the facility was used as a count room and as a radiological control technician office (WCH 2008a).

The MO-999 trailer was towed intact to ERDF for disposal in 2009 (WCH 2009g).
