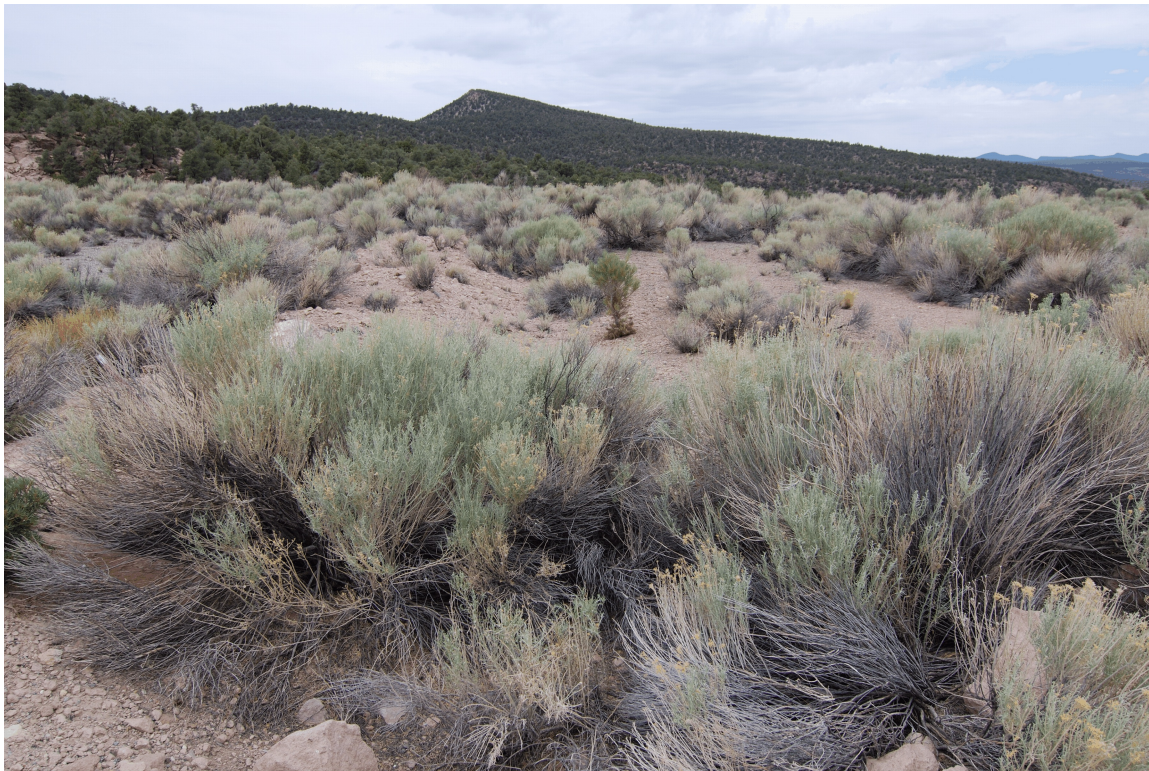
Figure 126. Plan map of Features 67 and 68 (UN = Unnumbered) and photograph of Feature 67, U12t Tunnel, view northwest (2007).

Feature 67 is an open dirt trench (Figure 126). It is 48 ft 9 inches (14.8 m) in length and 6 ft 7 inches (2 m) in width and 2 ft deep. The trench is at the southwest corner of Feature 68. Use of the trench is undetermined at this time.

Feature 68 is a series of core holes (Figures 126 and 127). Four of the nine holes are marked with wooden stakes with identifying numbers. Near the stakes are rock core samples that are 2 1/2 inches in diameter and vary in length.

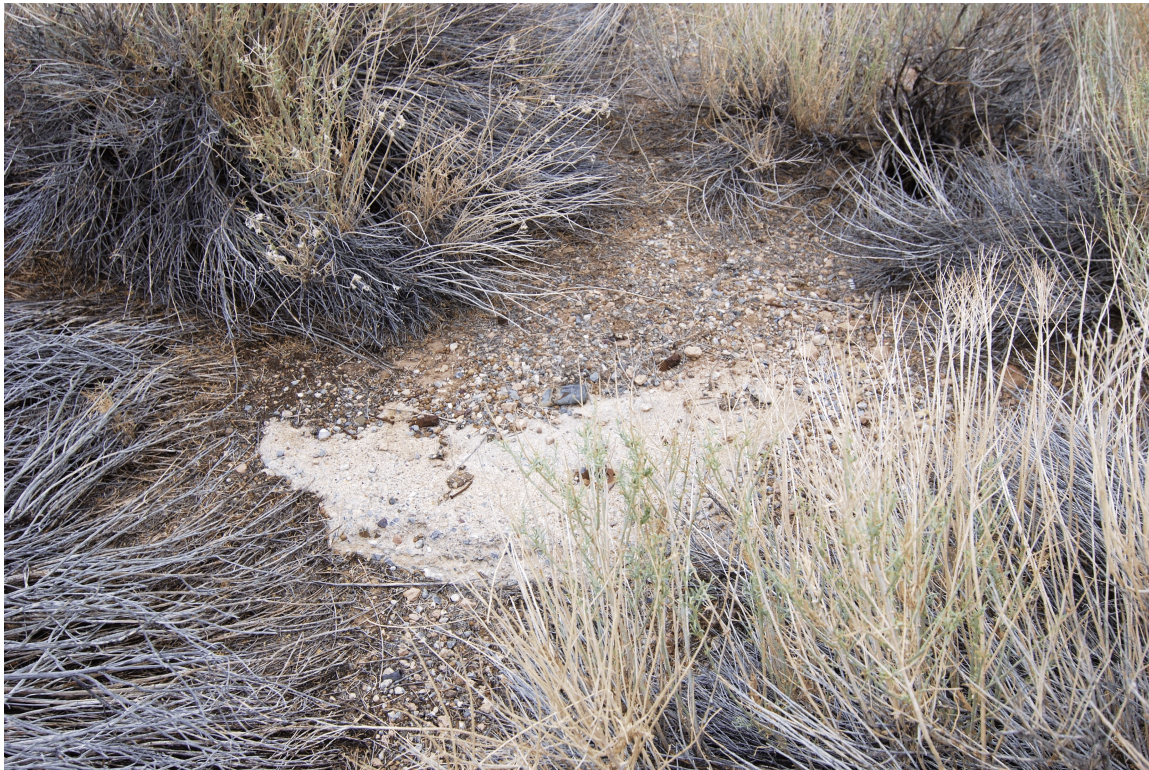
Figure 128. Plan map and photograph of Feature 69, U12t Tunnel, view east (2007).

Feature 69 is a rough poured concrete block (Figure 128). It is approximately 36 x 36 inches with electrical conduit and insulated wire extending through the surface of the block. It is similar to Feature 64 and is probably the base support of a light pole. The concrete was poured without the use of forms, was not leveled, the surface was left unfinished, and the edges are now covered with soil and vegetation.

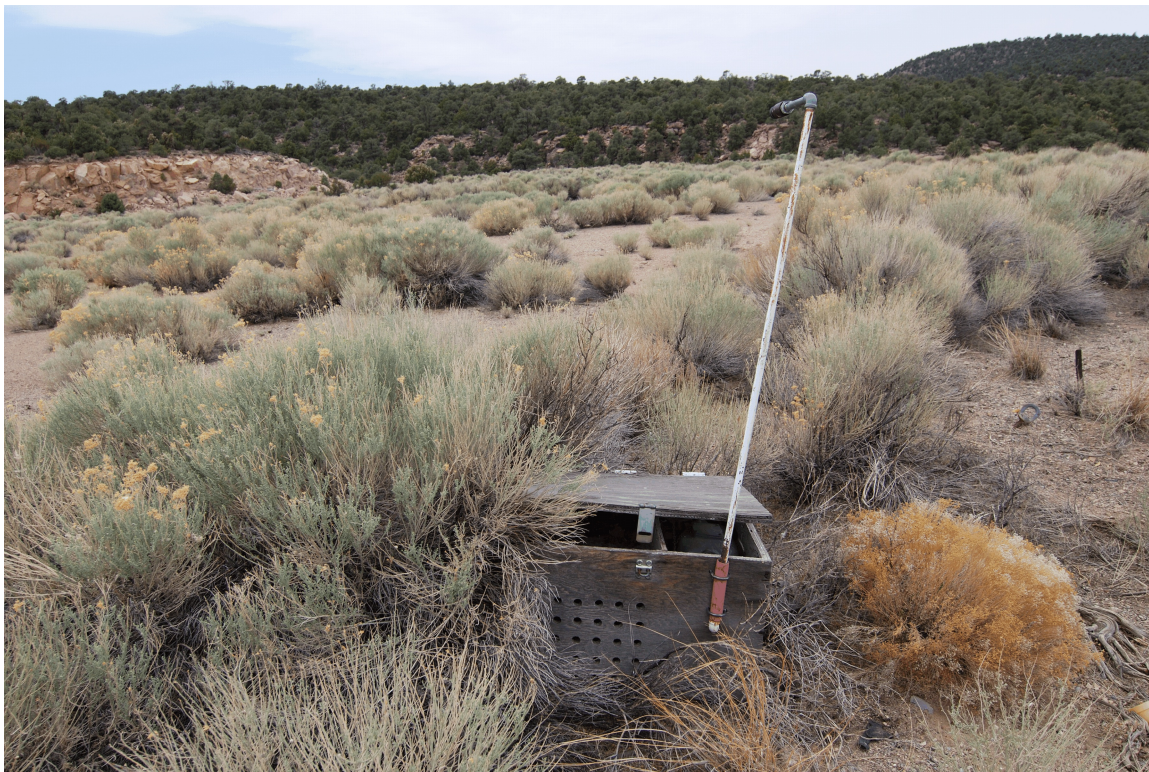
Figure 129. Plan map and photograph of Feature 70, U12t Tunnel, view south (2007).

Feature 70 is a wood box (Figure 129). The box is constructed of 1/2 inch plywood and measures 24 x 22 x 12 inches. Inside the box is a battery and insulated wire and on the outside of the box is a 1/2 inch pipe assembly for air monitoring. A yellow plastic cup typical of air monitoring devices is near the box.

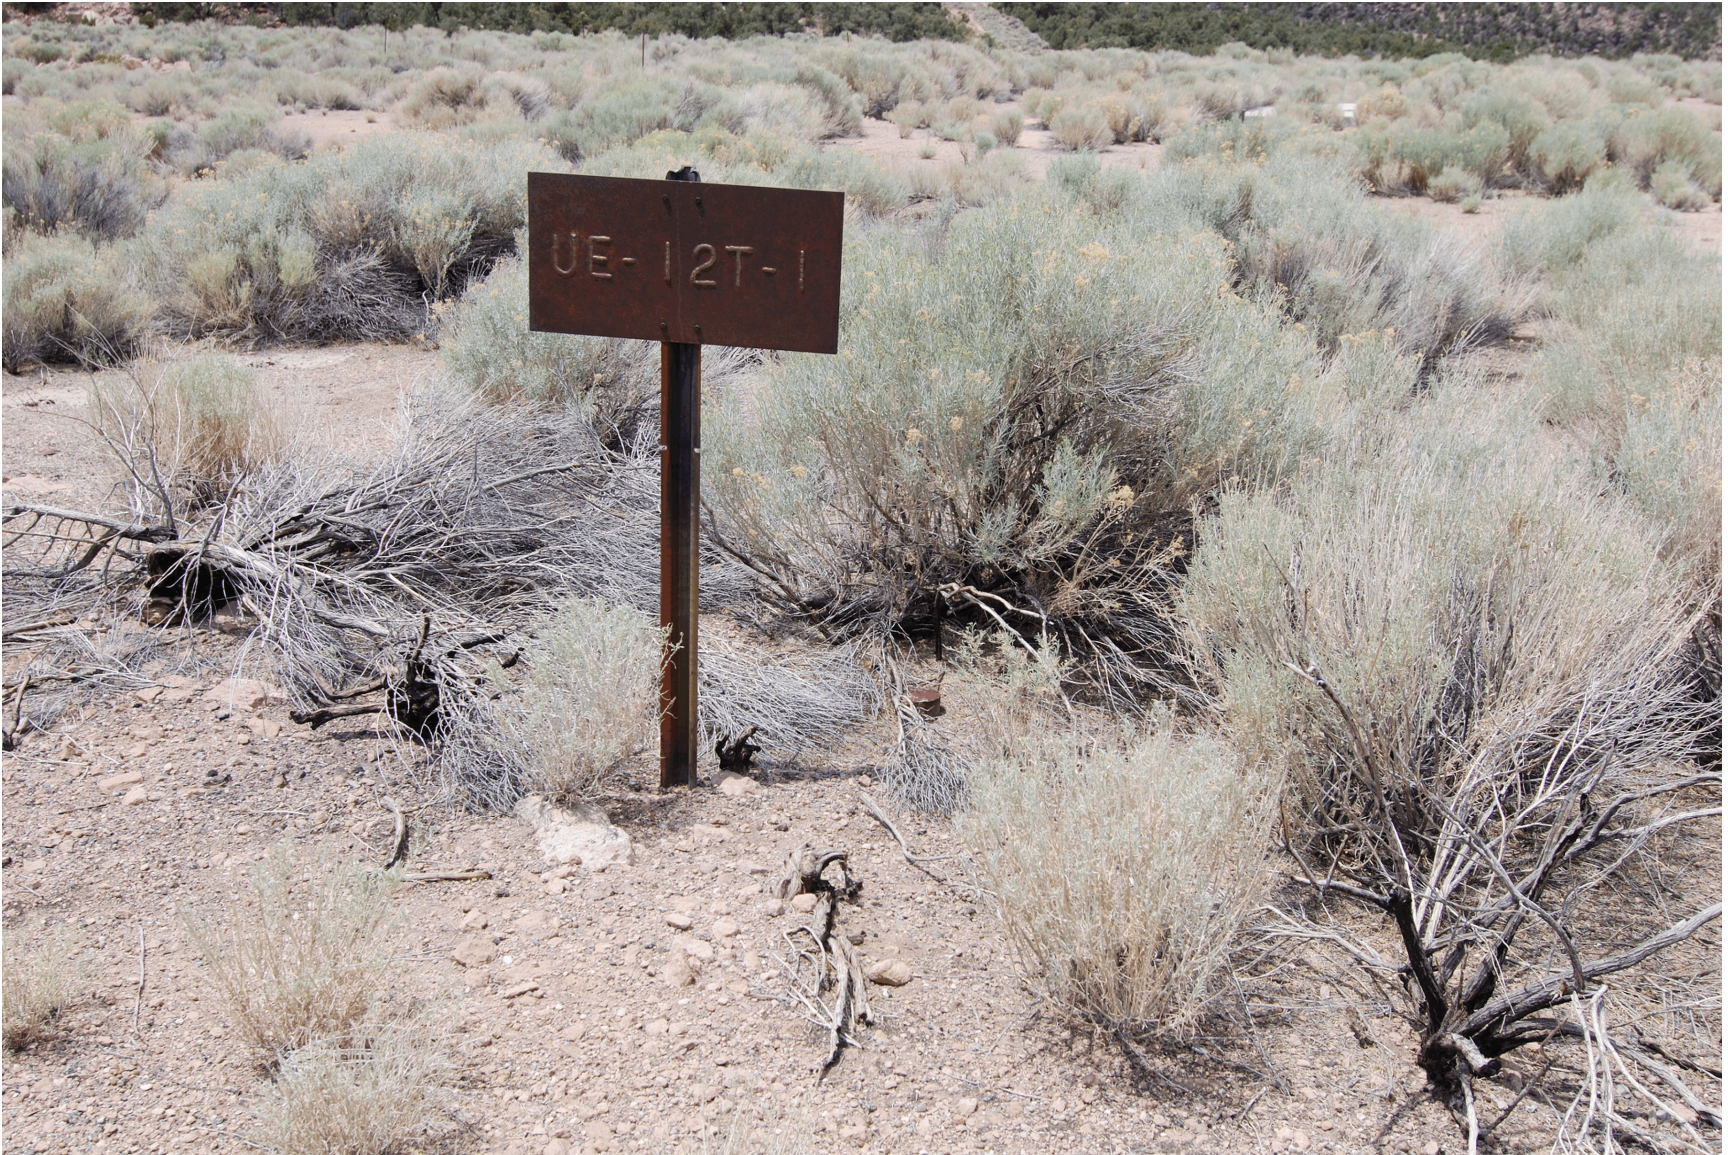
Figure 131. Photograph of Feature 72, UE12t#1, view northwest (2007).

Feature 72 is exploratory drill hole UE12t #1 (Figure 131). The feature is near the center of the trailer park and consists of a metal pipe with the signage UE-12T-1.

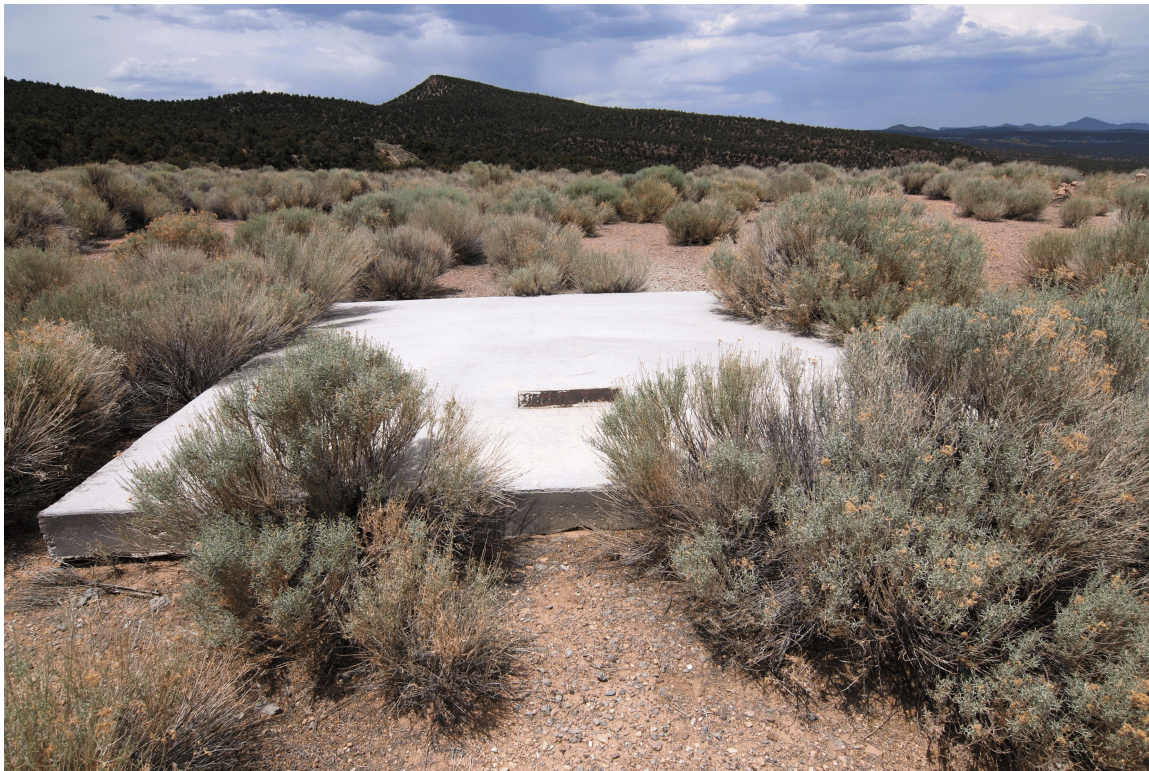
Figure 132. Plan map and photograph of Feature 73, concrete pad covering post-shot drill holes U12t.04PS#1A and U12t.04PS#1AA, U12t Tunnel, view northwest (2007).

Feature 73 is a concrete pad and post-shot drill holes U12t.09PS#1A and U12t.09PS#1AA (Figure 132). The pad covers the drill holes and measures 13 x 13 ft and is 8 inches thick around the perimeter and 16 inches thick at the center (domed). Near the east edge is a metal plaque labeled 12t.09PS1APS1AA. The drill holes are not visible through the concrete pad.

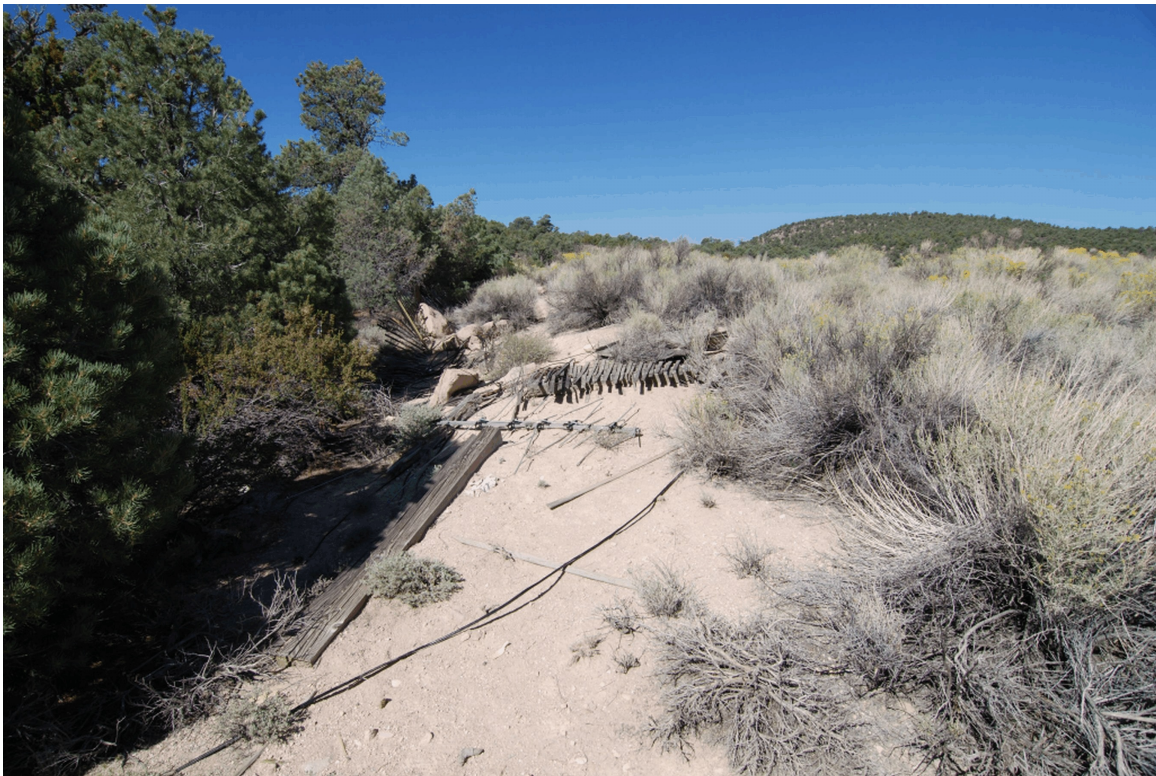
Figure 133. Plan map and photograph of Feature 74, U12t Tunnel, view west (2007).

Feature 74 is stored equipment in a 21 x 8 ft area (Figure 133). Equipment is two rolls of 4 ft wood picket fencing, an aluminum antenna, a galvanized trash can, four pieces of 18 x 36 x 1/4 inch plywood (possible box), and four pieces of 6 x 6 inch milled lumber (two 96 inch and two 48 inch lengths). Most of the equipment was used for drilling and construction activities at this location.

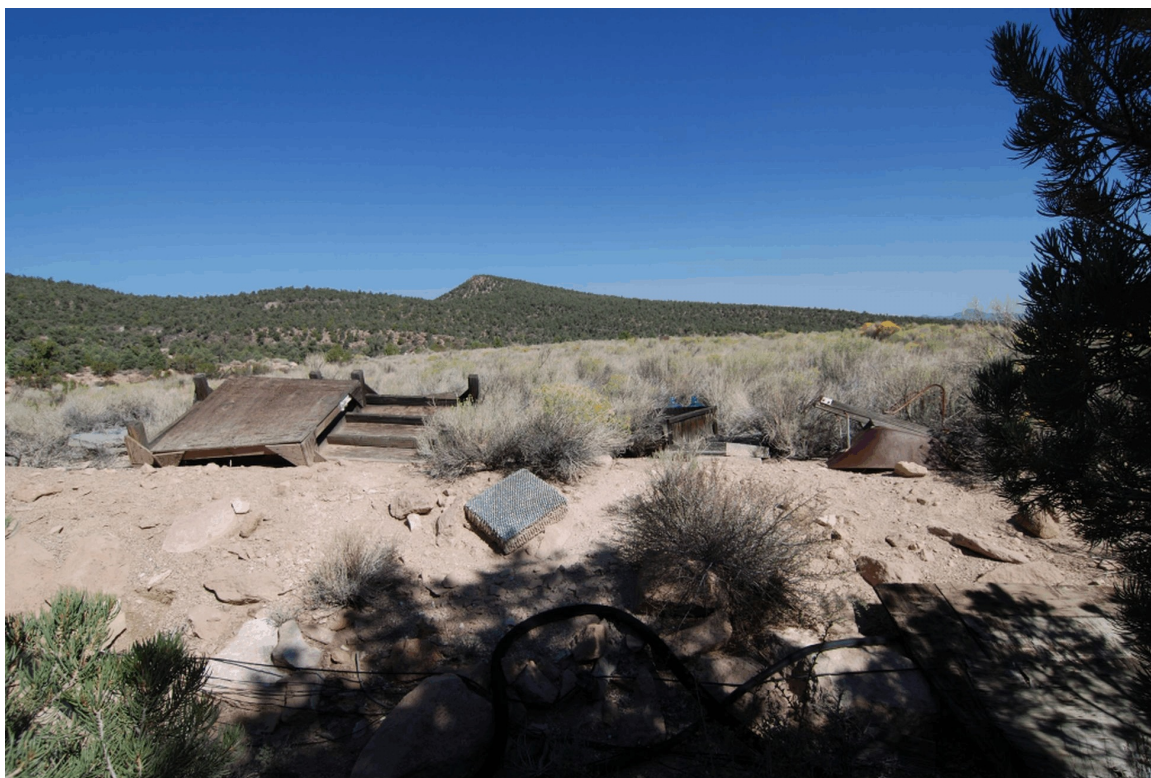
Figure 134. Plan map and photograph of Feature 75, U12t Tunnel, view north (2007).

Feature 75 is stored equipment in a 26 x 13 ft area (Figure 134). Equipment is 1 wheel barrow, 2 glass five gallon water bottles, 11 hex-cell aluminum pads (seven 24 x 24 inch and four 20 x 20 inch), 3 wood stands, 5 wood panels, and one 36 x 40 x 16 inch plywood box. Also found are two 5 x 5 ft pieces of 3/4 inch plywood and insulated cable. The hex-cell pads were used as shock absorbing devices that supported various types of equipment (e.g., trailers). The wood stands are constructed of a 4 ft x 4 ft x 3/4 inch plywood (platform) attached to a 2 x 4 frame. A 2 x 4 x 14 inch leg is attached at each corner of the frame. The wood panels are 2 ft x 4 ft x 3/4 inch plywood with a 2 x 4 frame. Most of the equipment was used for drilling and construction activities at this location.

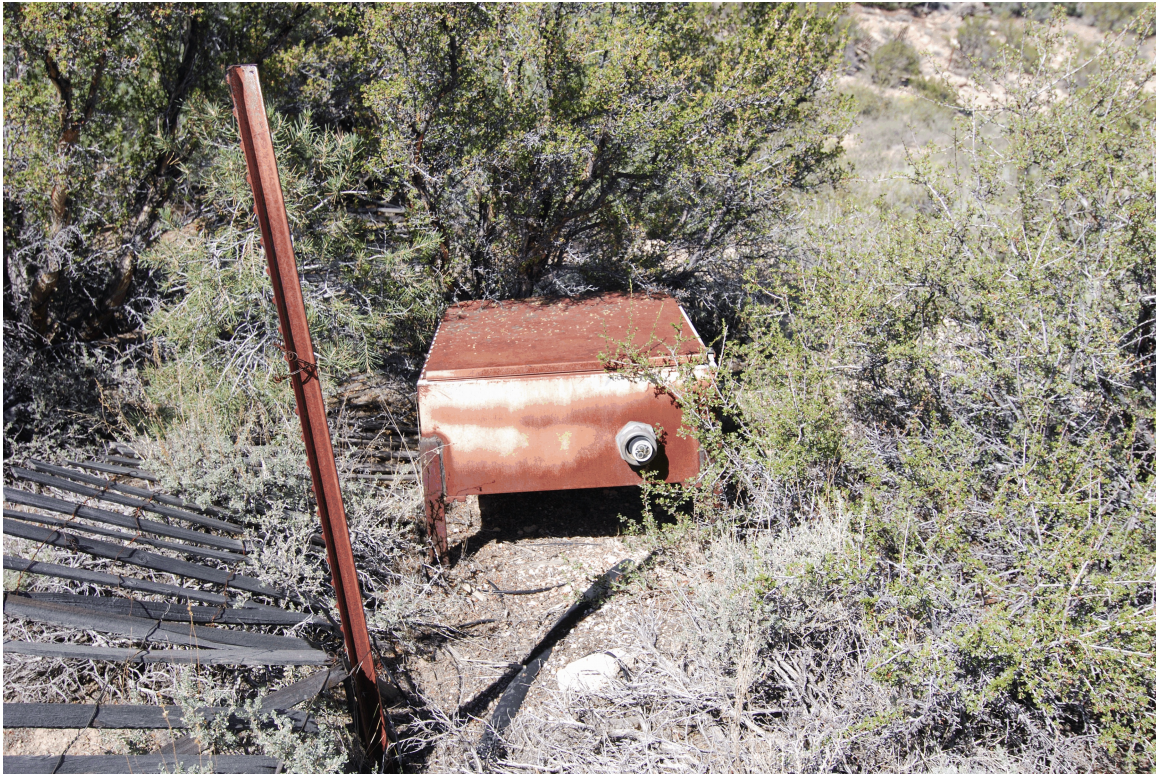
Figure 135. Plan map and photograph of Feature 76, U12t Tunnel, view west (2007).

Feature 76 is an electrical junction box (Figure 135). The box measures 36 x 30 x 13 inches, is horizontal to the surface, and is supported by 2 inch angle iron welded to each corner of the box and driven into the surface. A 1 1/4 inch insulated cable (near the box) was attached to the box. A portion of a wood picket fence supported by metal T posts is near the feature.

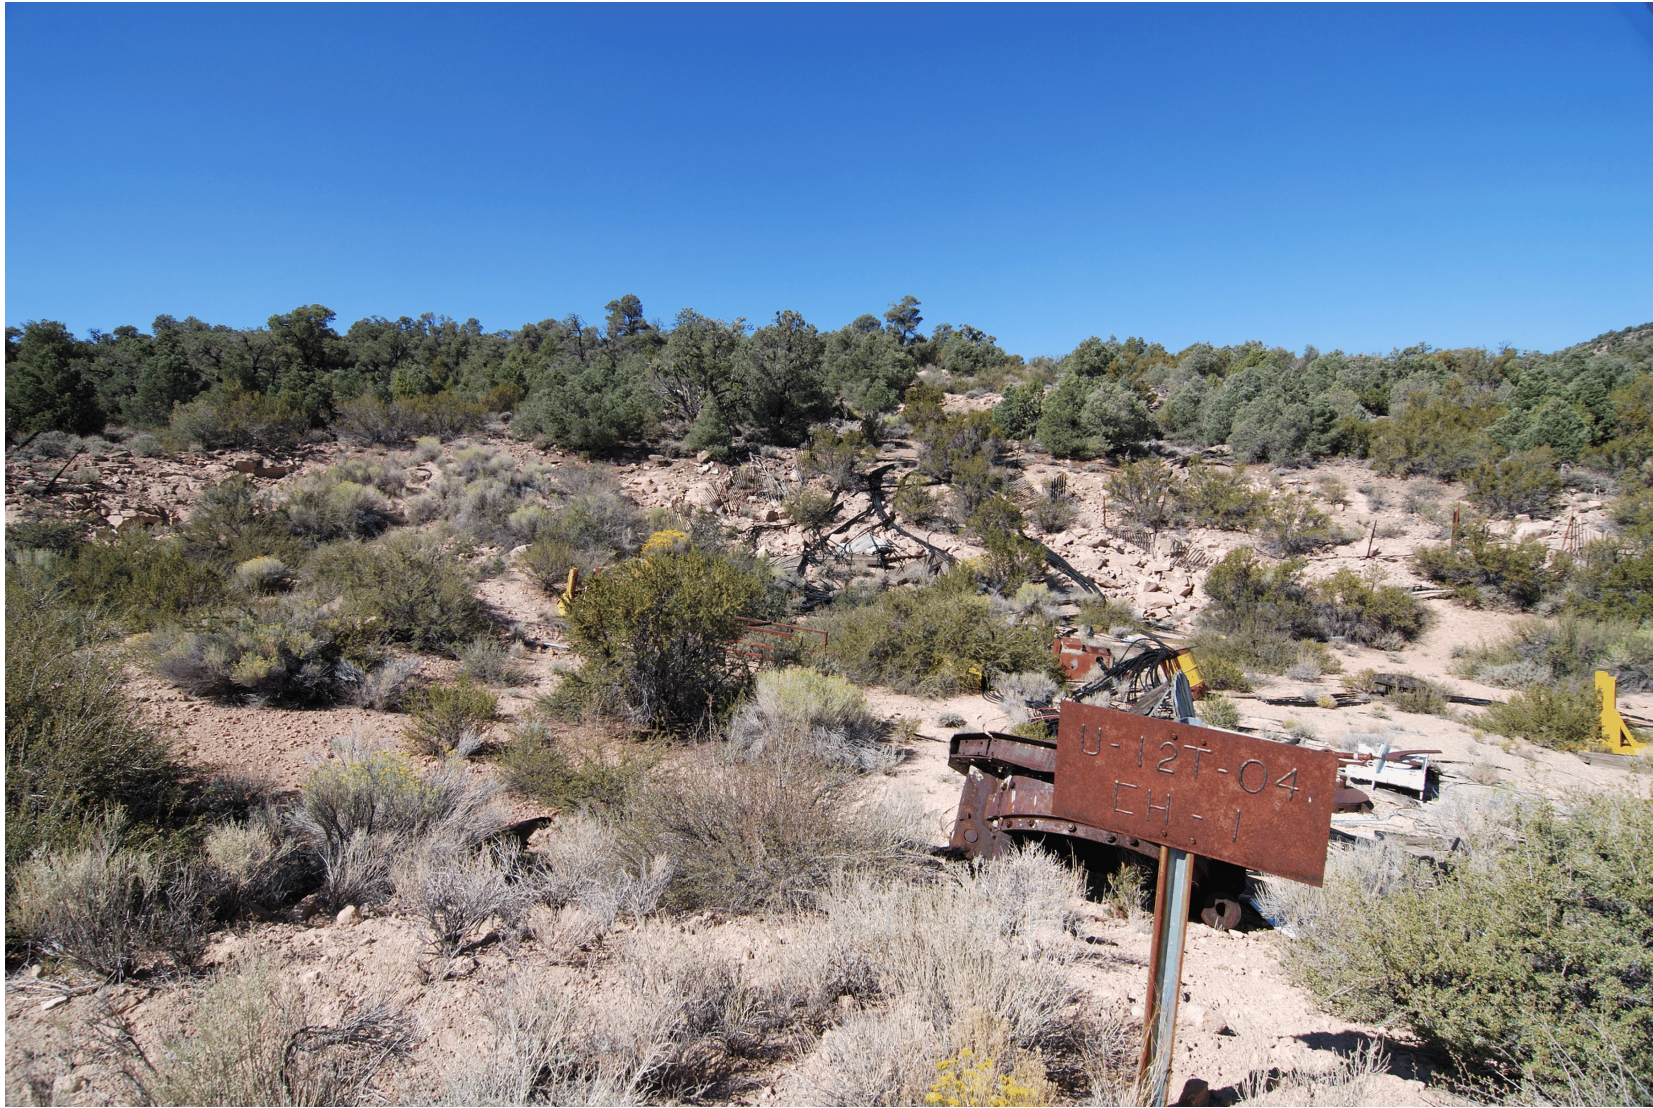
Figure 136. Photograph of Feature 77, cratered area around U12t.04CH#1, U12t Tunnel, view southwest (2007)

Feature 77 is a crater area containing equipment and Cable Hole U12t.04CH#1 (Figure 136). The area is 165 ft (50.3 m) east-west and 215 ft (65 m) north-south, has subsided and has signage (lying

on the surface) SECURITY AREA DO NOT ENTER. Because this area had cratered, no entry into the area for in-depth recording of the artifacts was attempted. Equipment visible in the crater area includes metal stands, metal racks, insulated cable, hex-cell pads, wood panels, five metal barrels, two galvanized trash cans, two plywood platforms, insulated cable, and channel iron. The platforms consist of a plywood deck, three stairs, and 2 x 4 railing. The panels are similar to those at Feature 75 and the metal stands are similar to those at Feature 79. Cable hole U12t.04CH #1 consists of a concrete pad and metal cover with a metal post and plate with signage U12T-04-1.

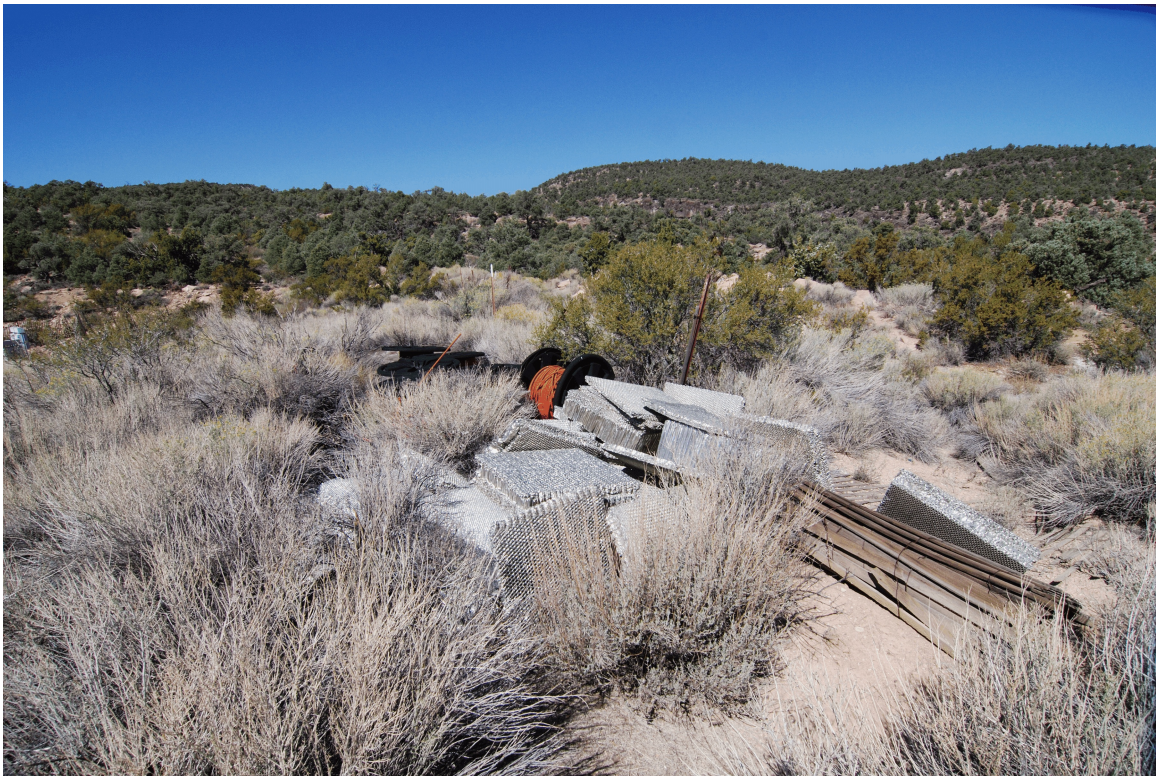
Figure 137. Plan map and photograph of Feature 78, U12t Tunnel, view southwest (2007).

Feature 78 is stored equipment within a 25 x 13 ft area (Figure 137). Equipment is 11 sheets of 5 ft x 4 ft x 3/4 inch plywood, 6 black cable spools (32 inch diameter) with orange insulated cable, random lengths of black insulated cable, and more than 30 hex-cell aluminum pads (partially covered with soil and vegetation). The equipment was used for drilling and construction activities at this location.

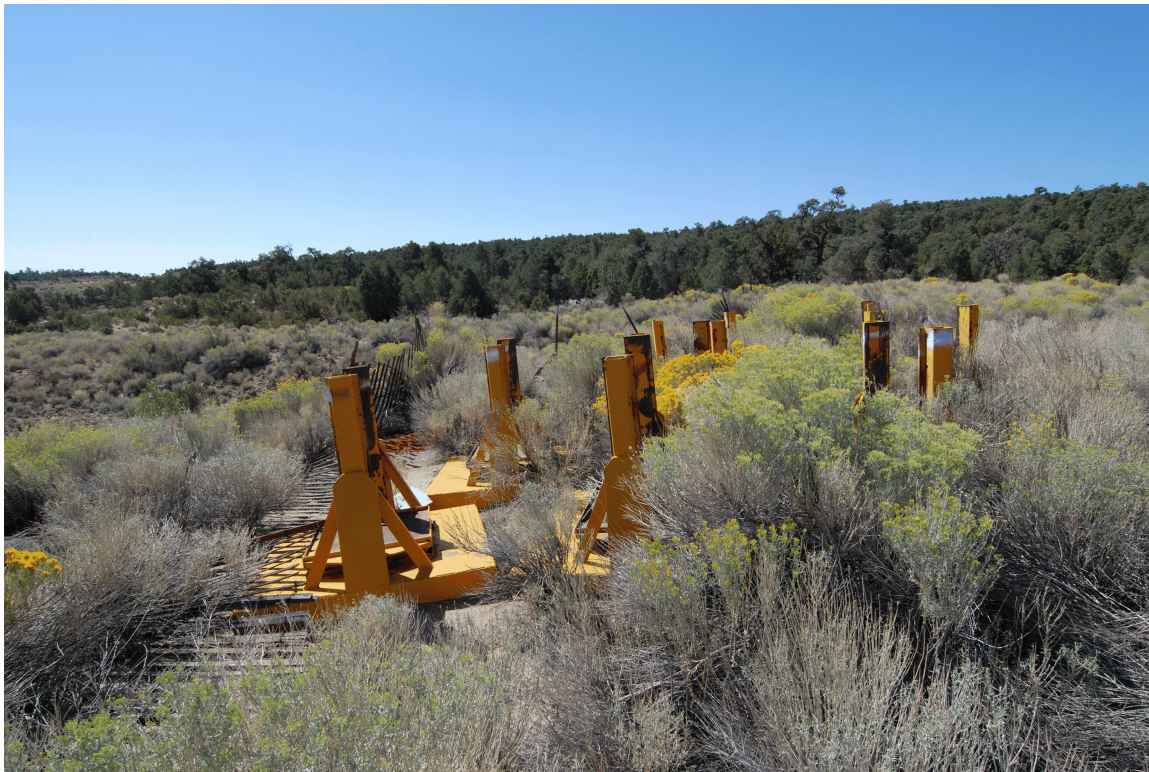
Figure 138. Plan map and photograph of Feature 79, U12t Tunnel, view south (2007).

Feature 79 is stored equipment consisting of one circular metal plate, eight yellow painted metal stands, and a light stand within a 20 x 20 ft area (Figure 138). The metal plate is a probably a drill hole cover that is 96 inches in diameter and may not be associated with the U12t Tunnel. It is similar to other vertical test hole covers and was placed at this location for storage. Welded to the center of the cover (concentric) are one 16 inch and one 10 inch diameter metal rings 4 inches in height. Two pieces of 6 inch metal I beam are welded along the sides of the plate. The metal stands consist of a 48 x 48 x 5 inch metal base to which two 4 x 4 x 40 inch posts (one on each side) have been welded. The posts are braced with diagonal bracing. A 26 x 26 inch metal plate is centered between the posts. It appears that an object was placed and secured between the base and plate. The light stand is constructed of a 2 inch channel iron base (x shaped) and a 2 inch galvanized pole 8 ft in height. Two rectangular lights are attached to a brace on top of the pole. Black insulated cable was found near the feature.

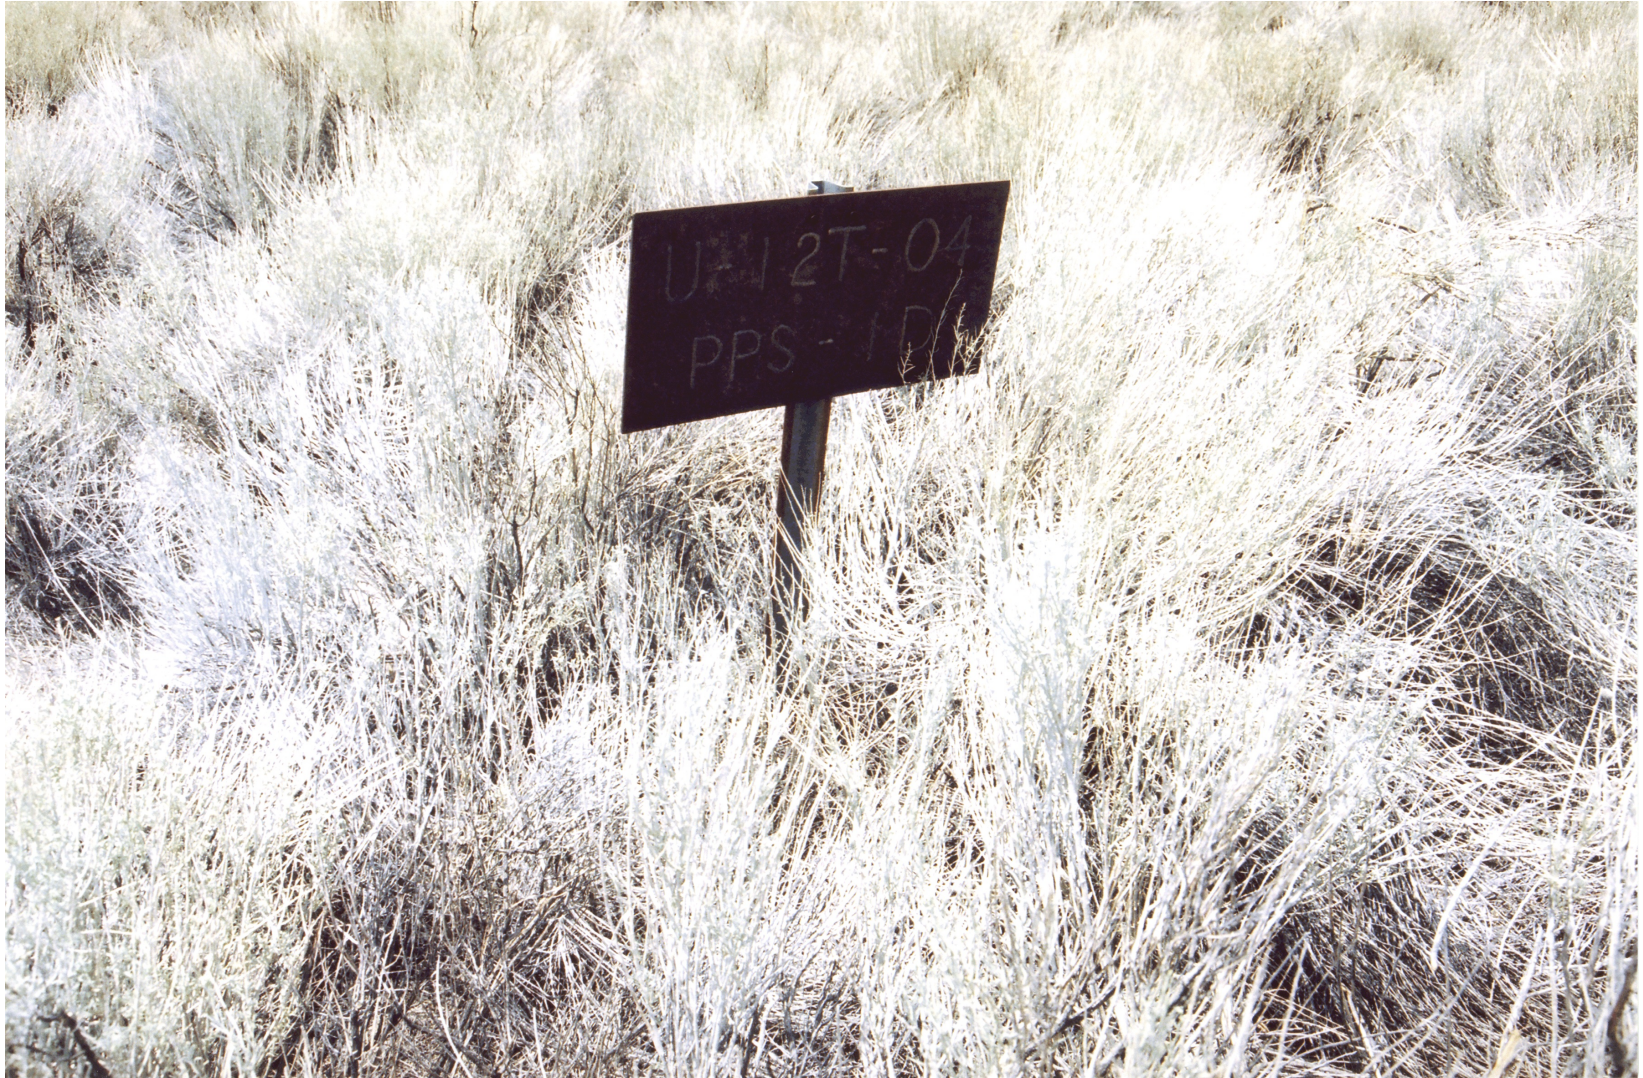
Figure 139. Photograph of Feature 80, U12t.04PS#1D, view northwest (2007).

Feature 80 is the U12t.04PS#1D postshot drill hole (Figure 139). The feature is near the center of the trailer park and consists of a metal post with the signage U-12T-04-PSS-1D.

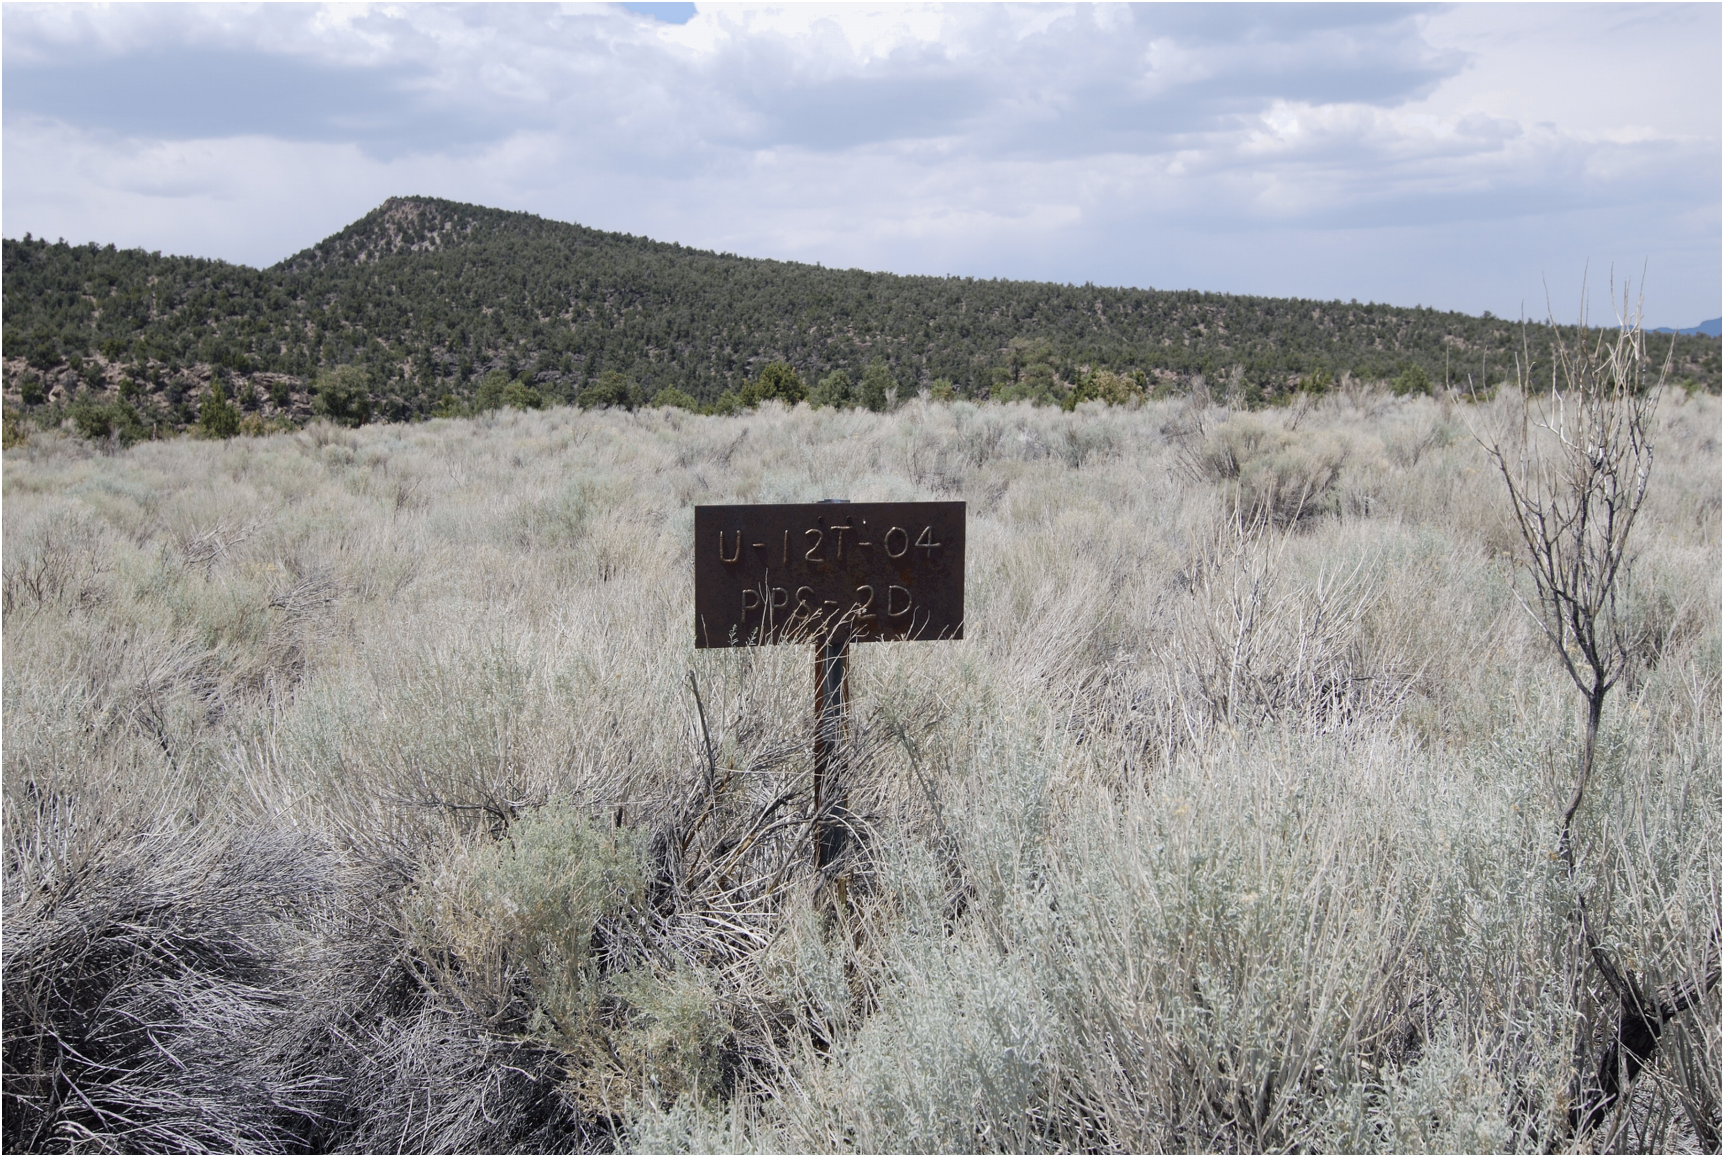
Figure 140. Photograph of Feature 81, U12t.04PS#2D, view northwest (2007).

Feature 81 is the U12t.04PS#2D postshot drill hole (Figure 140). The feature is near the center of the trailer park and northeast of Feature 80. It consists of a metal post with the signage U-12T-04-PSS-2D.

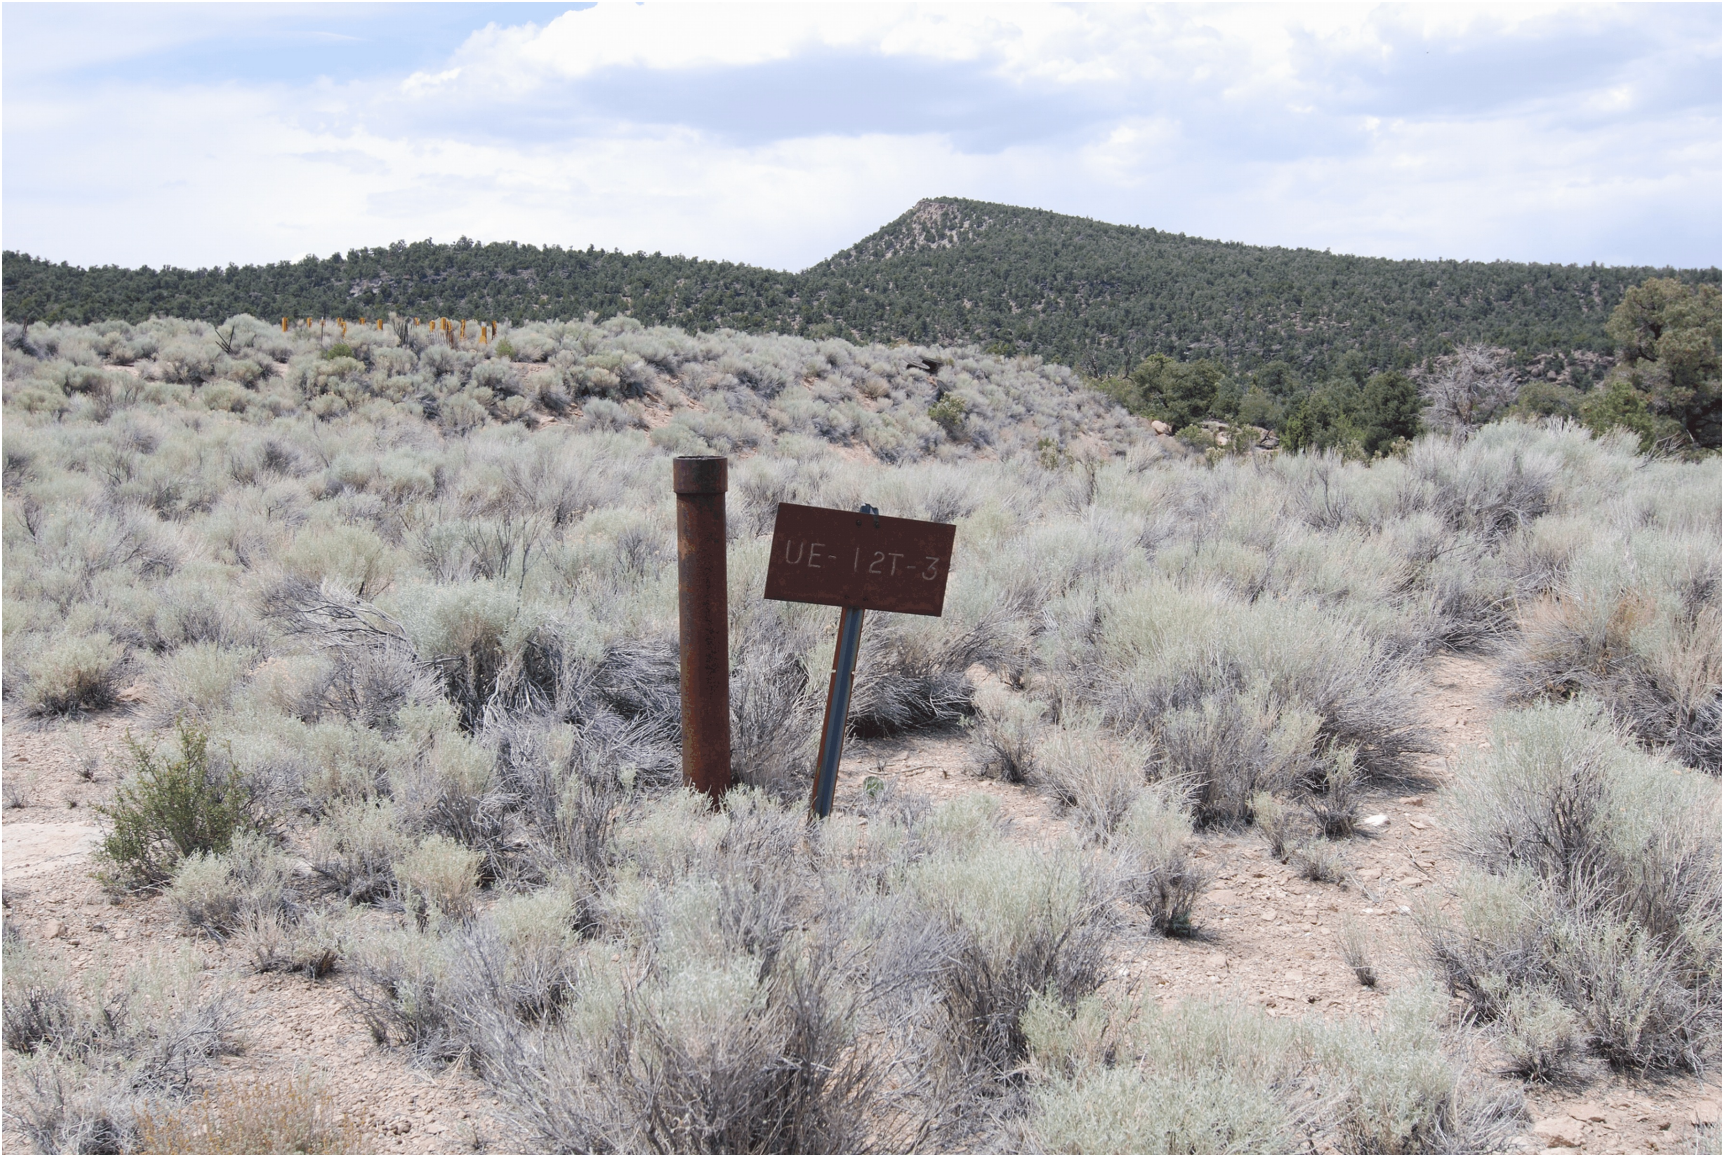
Figure 141. Photograph of Feature 82, UE12t#3, view northwest (2007).

Feature 82 is the UE12t #3 exploratory drill hole (Figure 141). The feature is near the east end of the trailer park and consist of a metal pipe extending approximately 40 inches above the surface and a metal post and plate with the signage UE-12T-3.

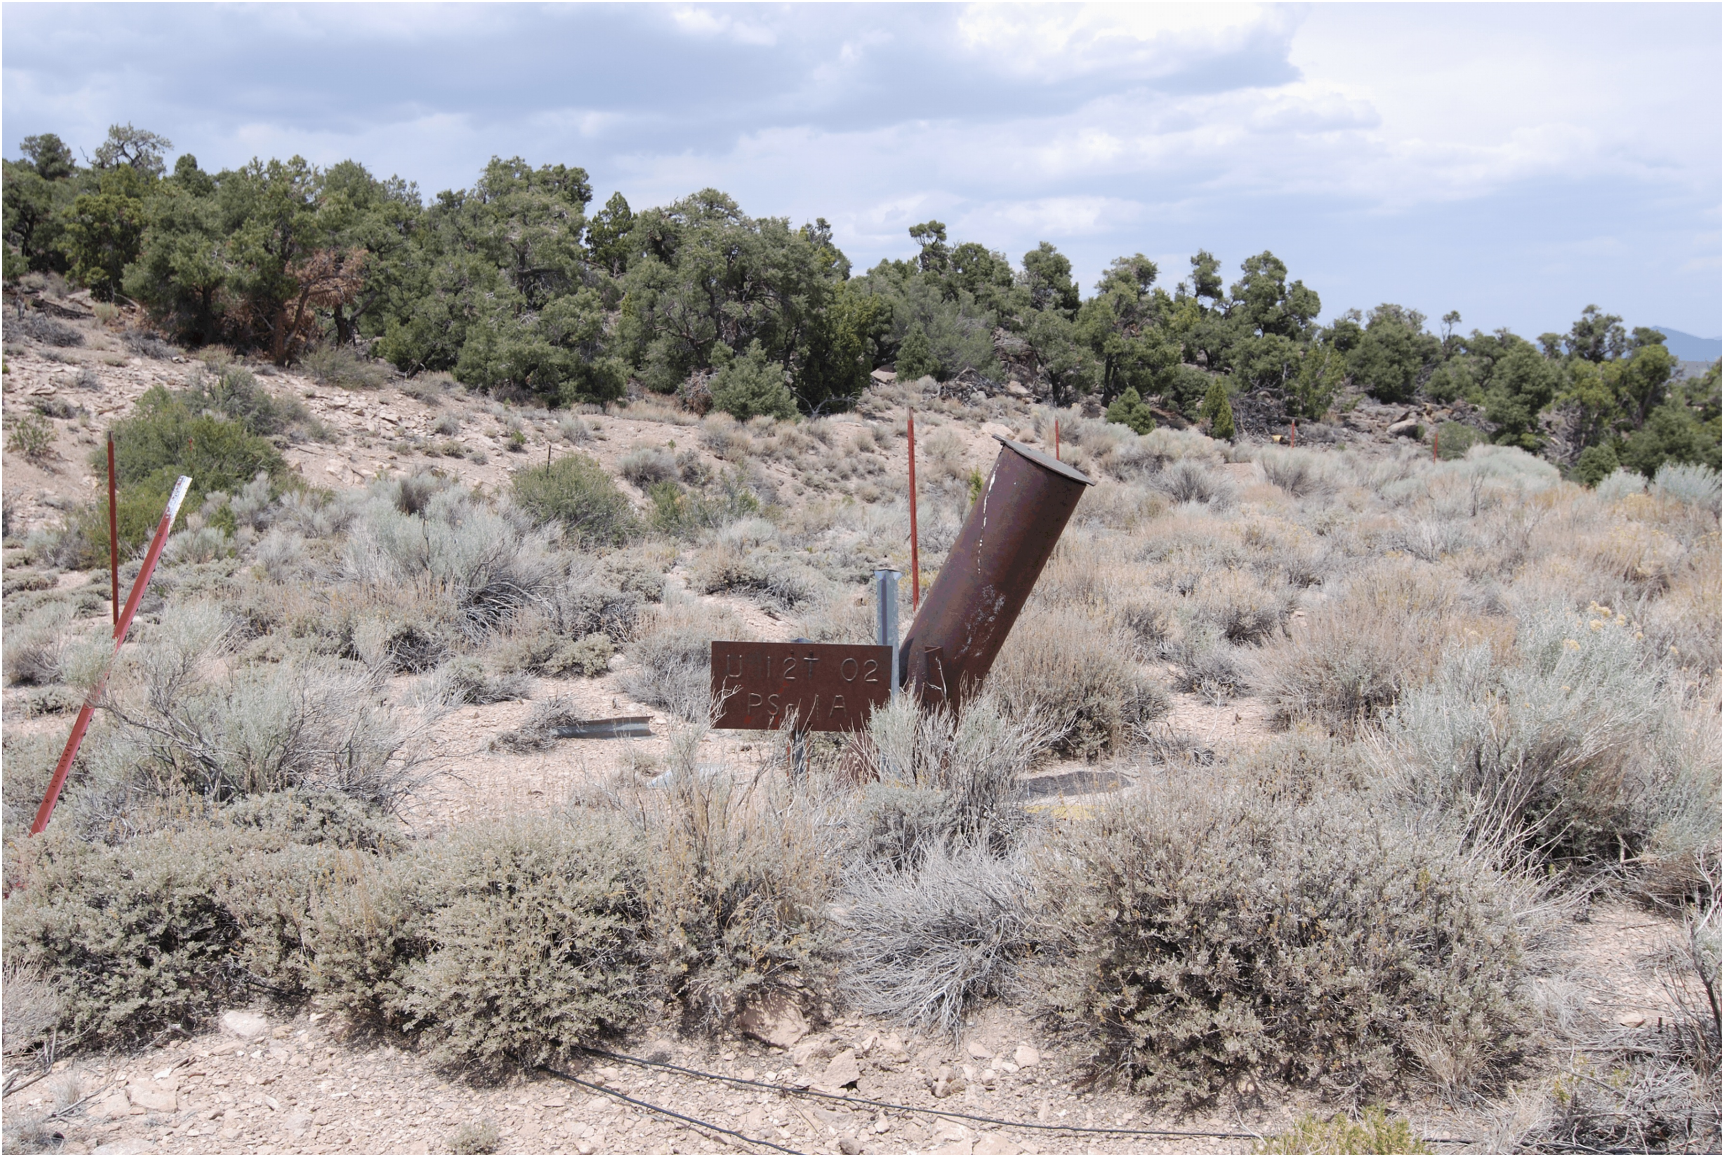
Figure 142. Photograph of Feature 83, U12t.02PS#1A, view northwest, (2007).

Feature 83 is the U12t.02PS#1A postshot drill hole (Figure 142). The feature is on a dirt pad along the north edge of North Mesa Road. It consists of a metal pipe extending above the surface, metal T posts, and a metal post and plate with the signage U-12T-02-PS-1.
