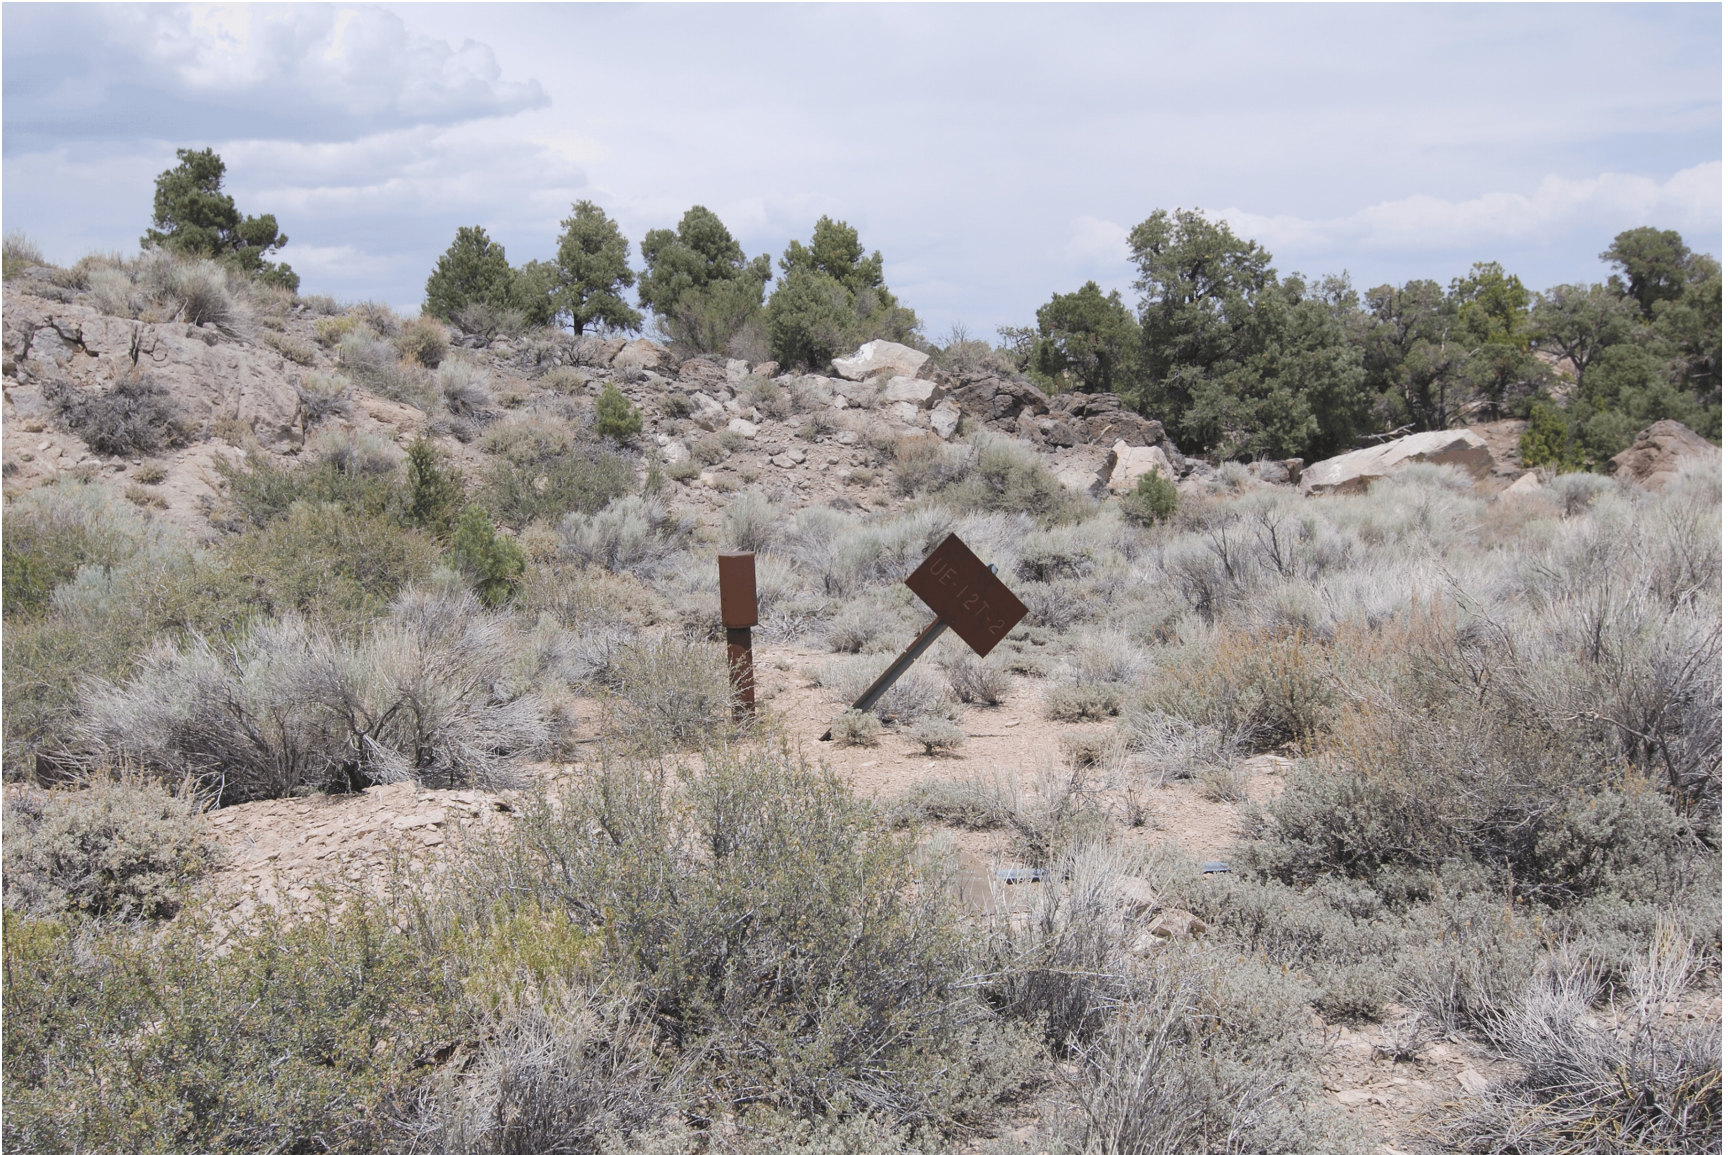
Figure 143. Photograph of Feature 84, UE12t#2, view northwest (2007).

Feature 84 is the UE12t #2 exploratory drill hole (Figure 143). The feature is on a dirt pad along the north edge of North Mesa Road. It consists of a metal pipe extending above the surface and a metal post and plate with the signage UE-12T-2.

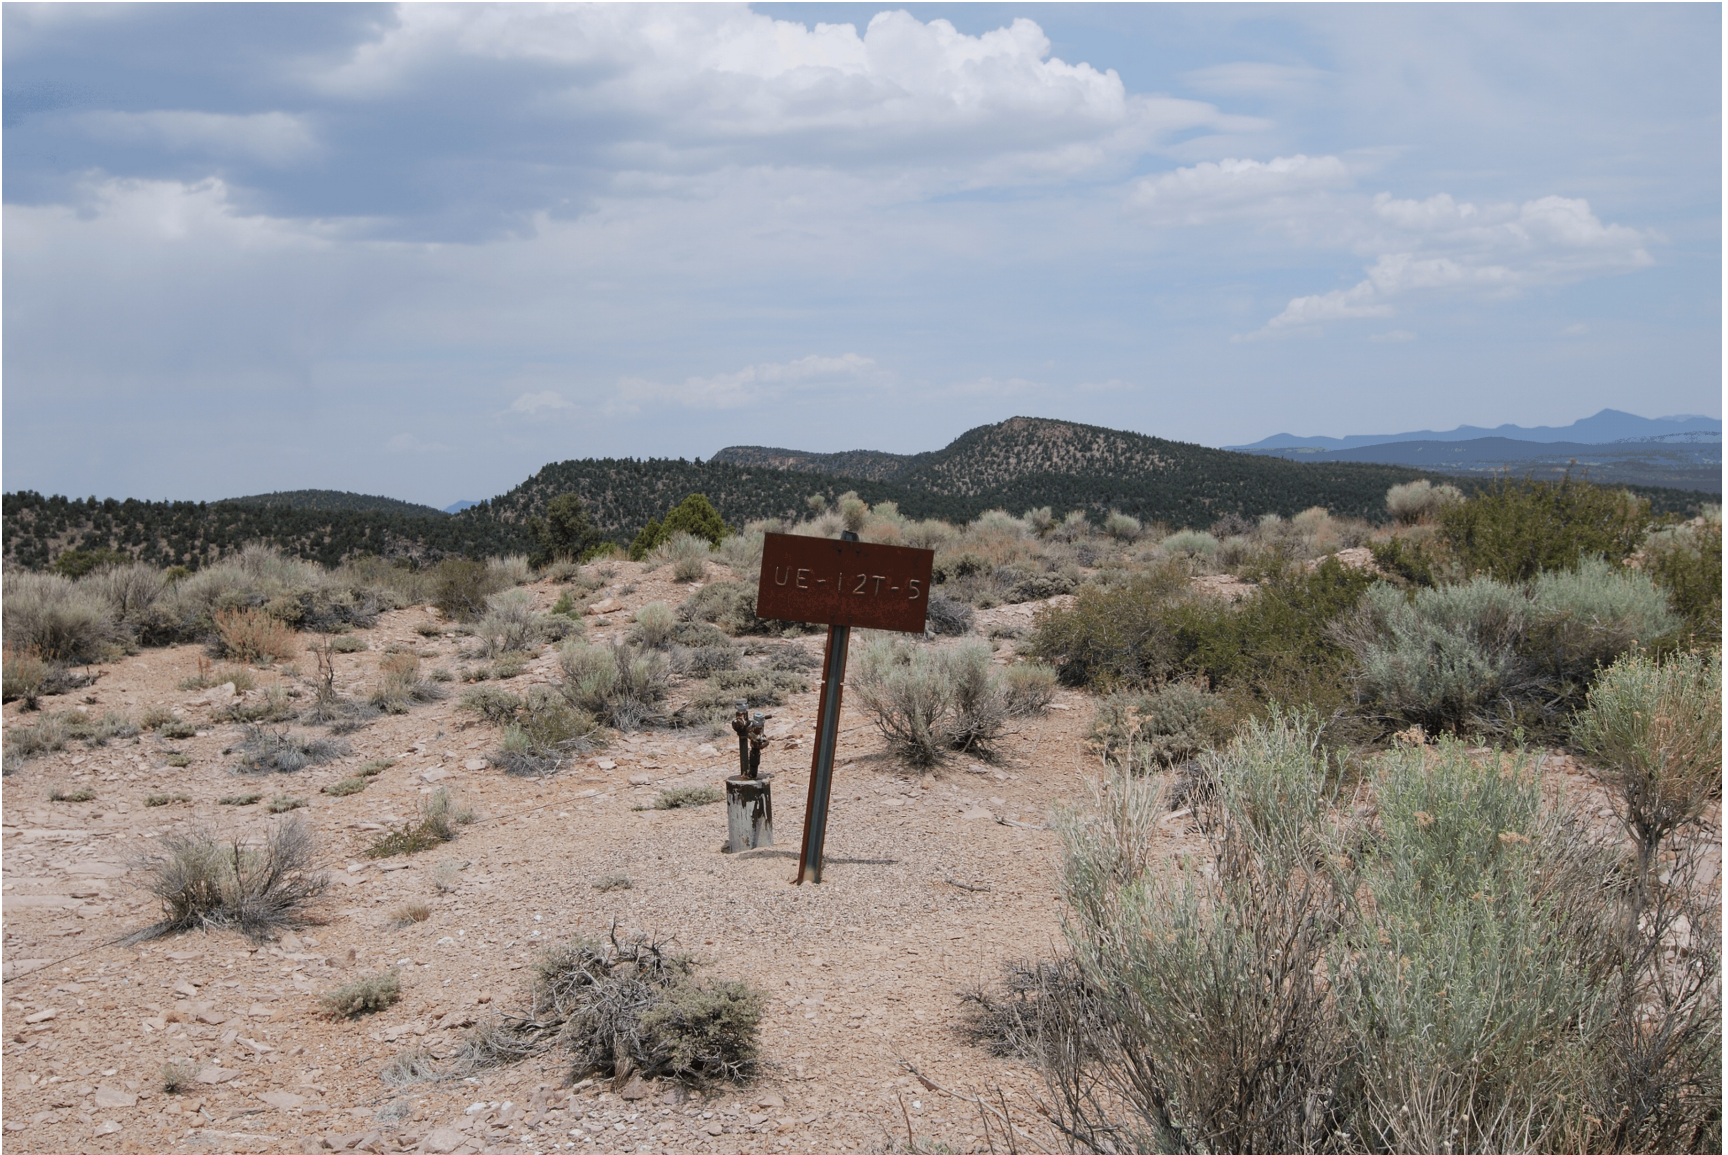
Figure 144. Photograph of Feature 85, UE12t#5, view northwest (2007).

Feature 85 is the UE12t #5 exploratory drill hole (Figure 144). The feature is along the west side of an access road near its intersection with the North Mesa Road. It consists of a metal pipe extending above the surface and a metal post and plate with the signage UE-12T-5.

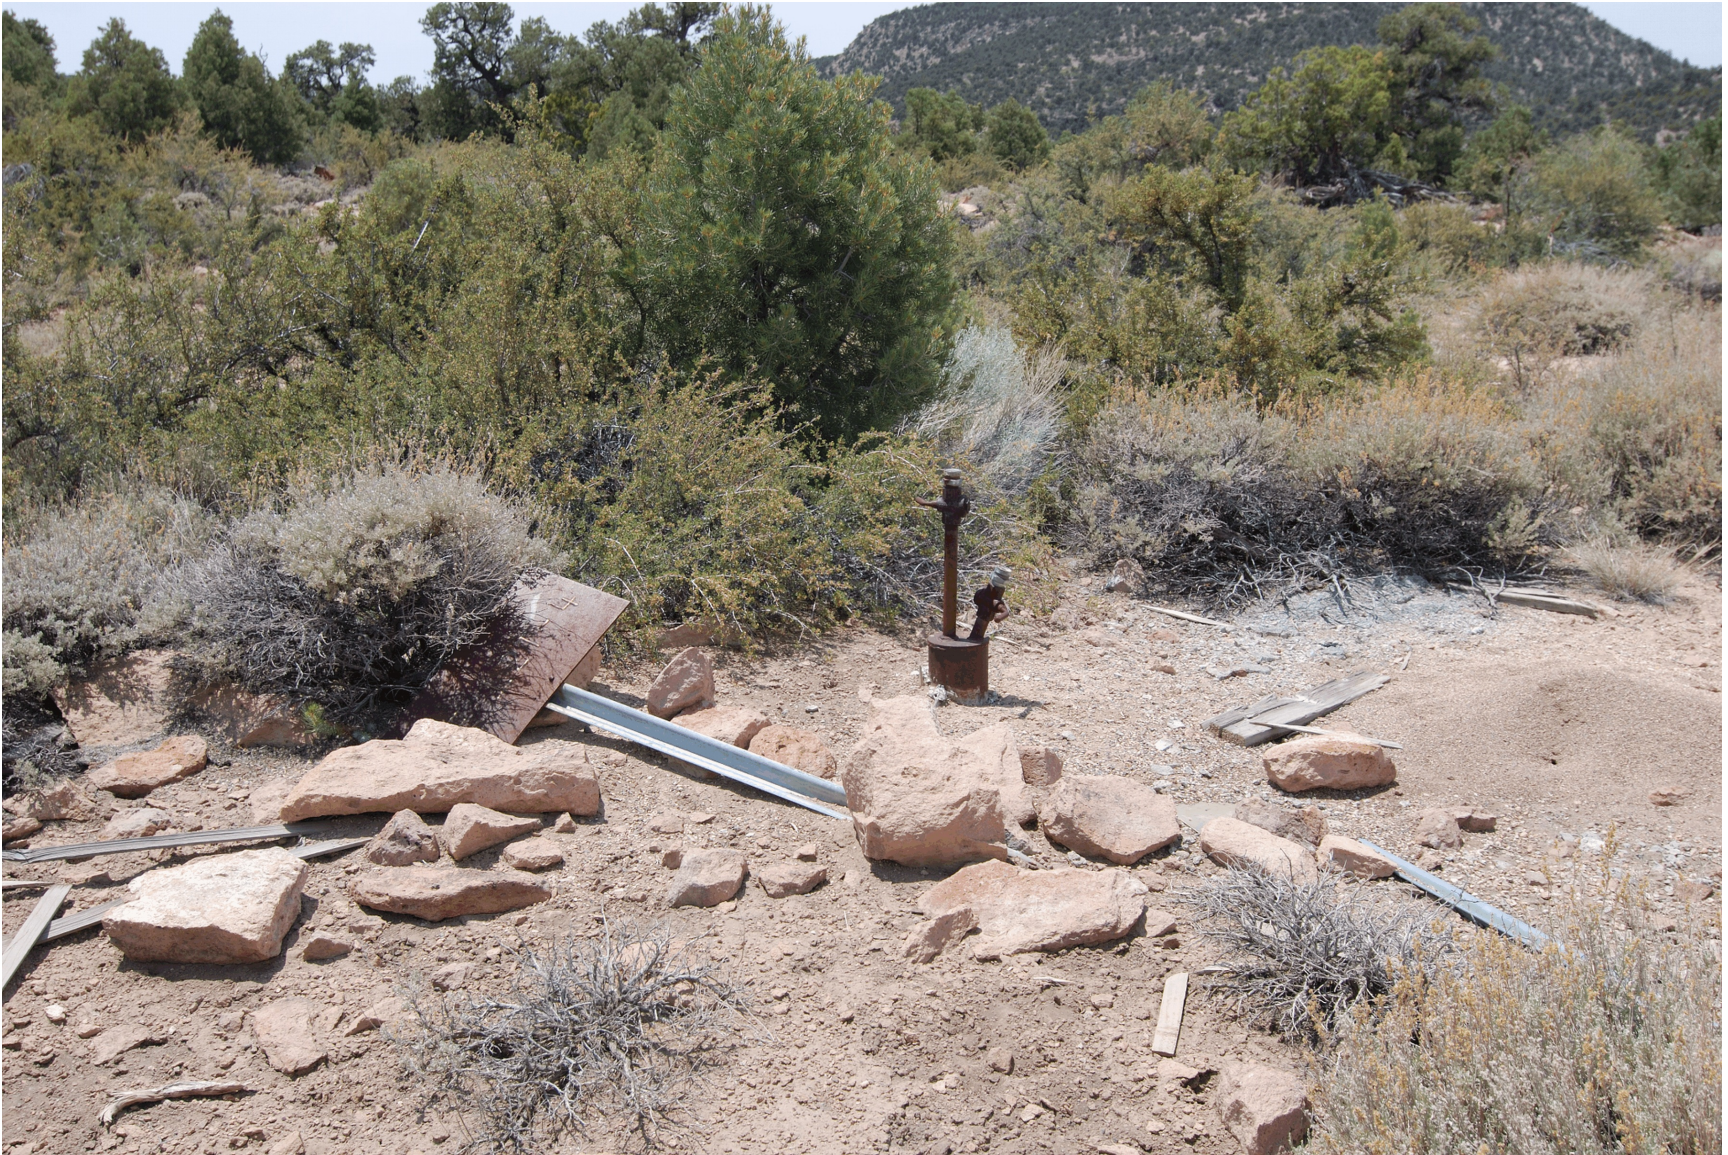
Figure 145. Photograph of Feature 86, UE12t#4, view west (2007).

Feature 86 is the UE12t #4 exploratory drill hole (Figure 145). The feature is near the center of a dirt pad along an unnamed dirt road. It consists of a metal pipe extending above the surface and a metal post and plate with the signage UE-12T-5. The post and sign are lying on the surface.

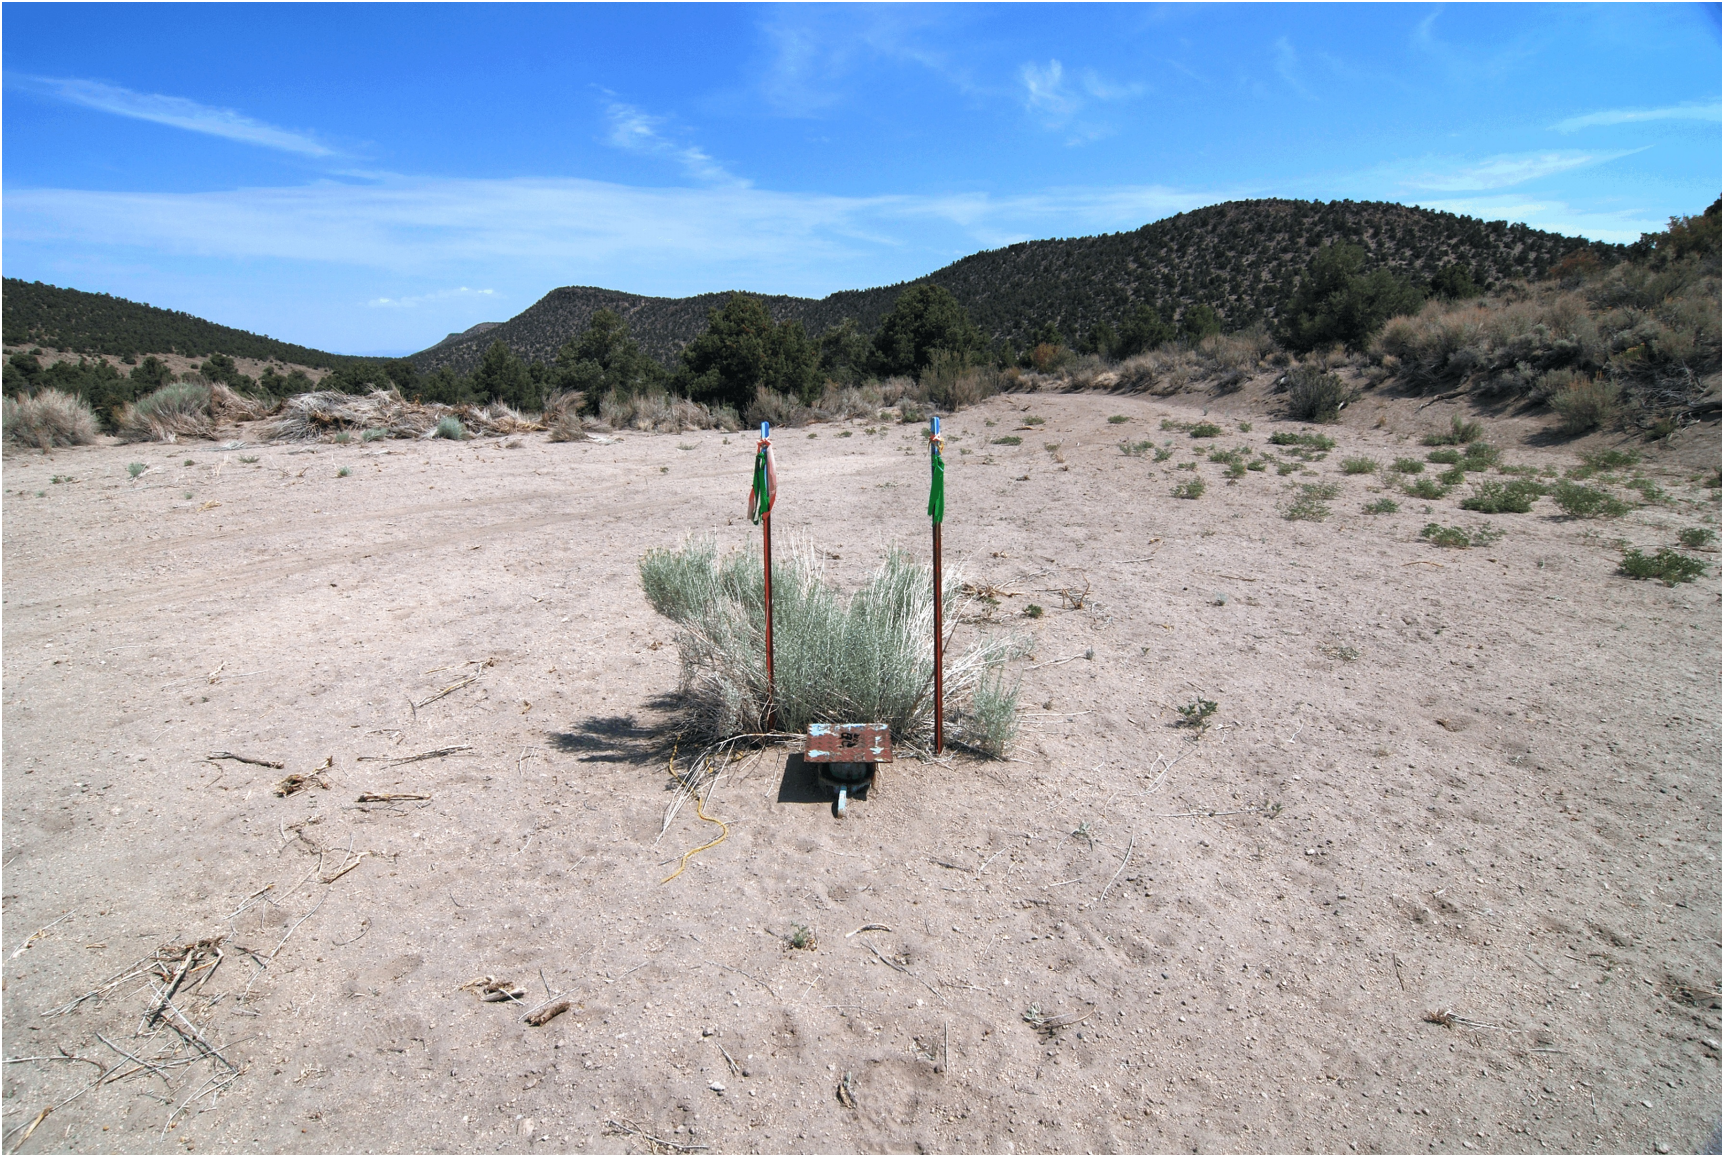
Figure 146. Photograph of Feature 87, UE12t#6, view northeast (2007).

Feature 87 is the UE12t #6 exploratory drill hole (Figure 146). The feature is near the center of a dirt pad that is south of the road that accesses Aqueduct Mesa through Gold Meadows. It consists of a metal pipe extending a few inches above the surface that is capped with a metal plate with the signage UE-12T-5. Two metal T posts are near the pipe.

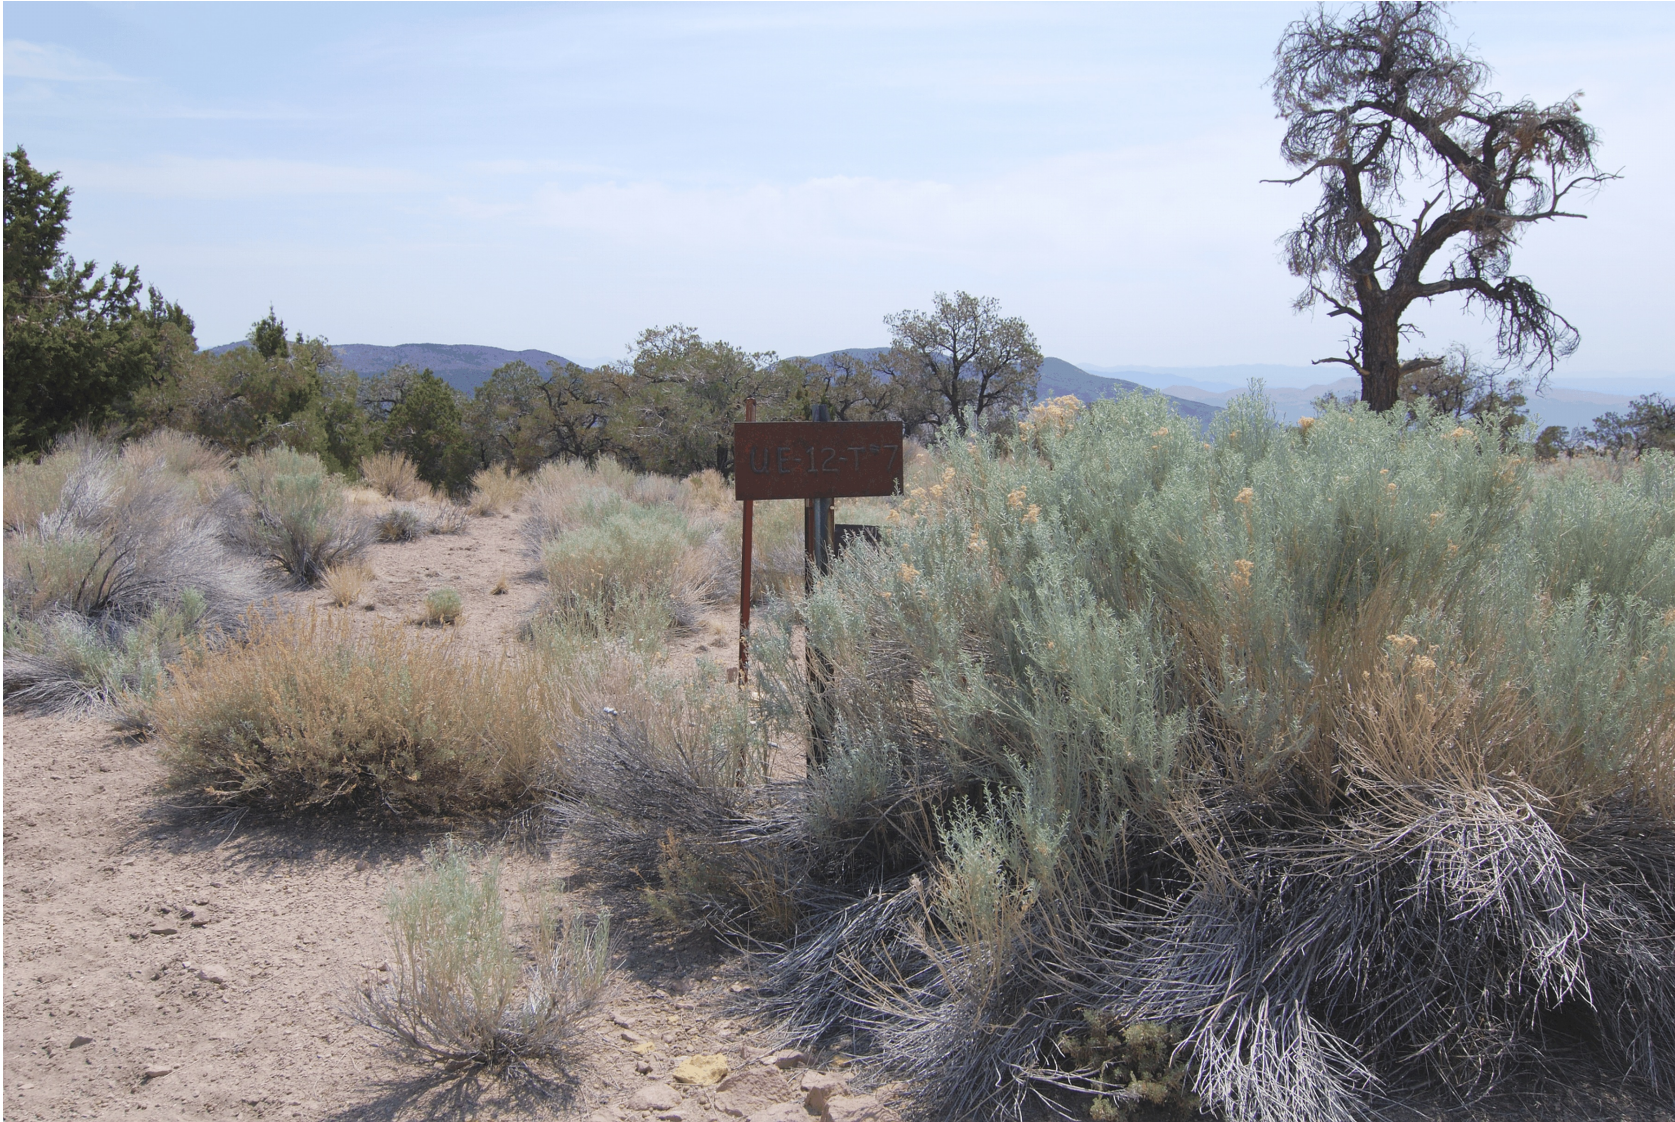
Figure 147. Photograph of Feature 88, UE12t #7, view east (2007).

Feature 88 is the UE12t #7 exploratory drill hole (Figure 147). The feature is near the center of a dirt pad along the north side of the road that accesses Aqueduct Mesa through Gold Meadows. It consists of a metal pipe extending above the surface and a metal post and plate with the signage UE-12T-7.

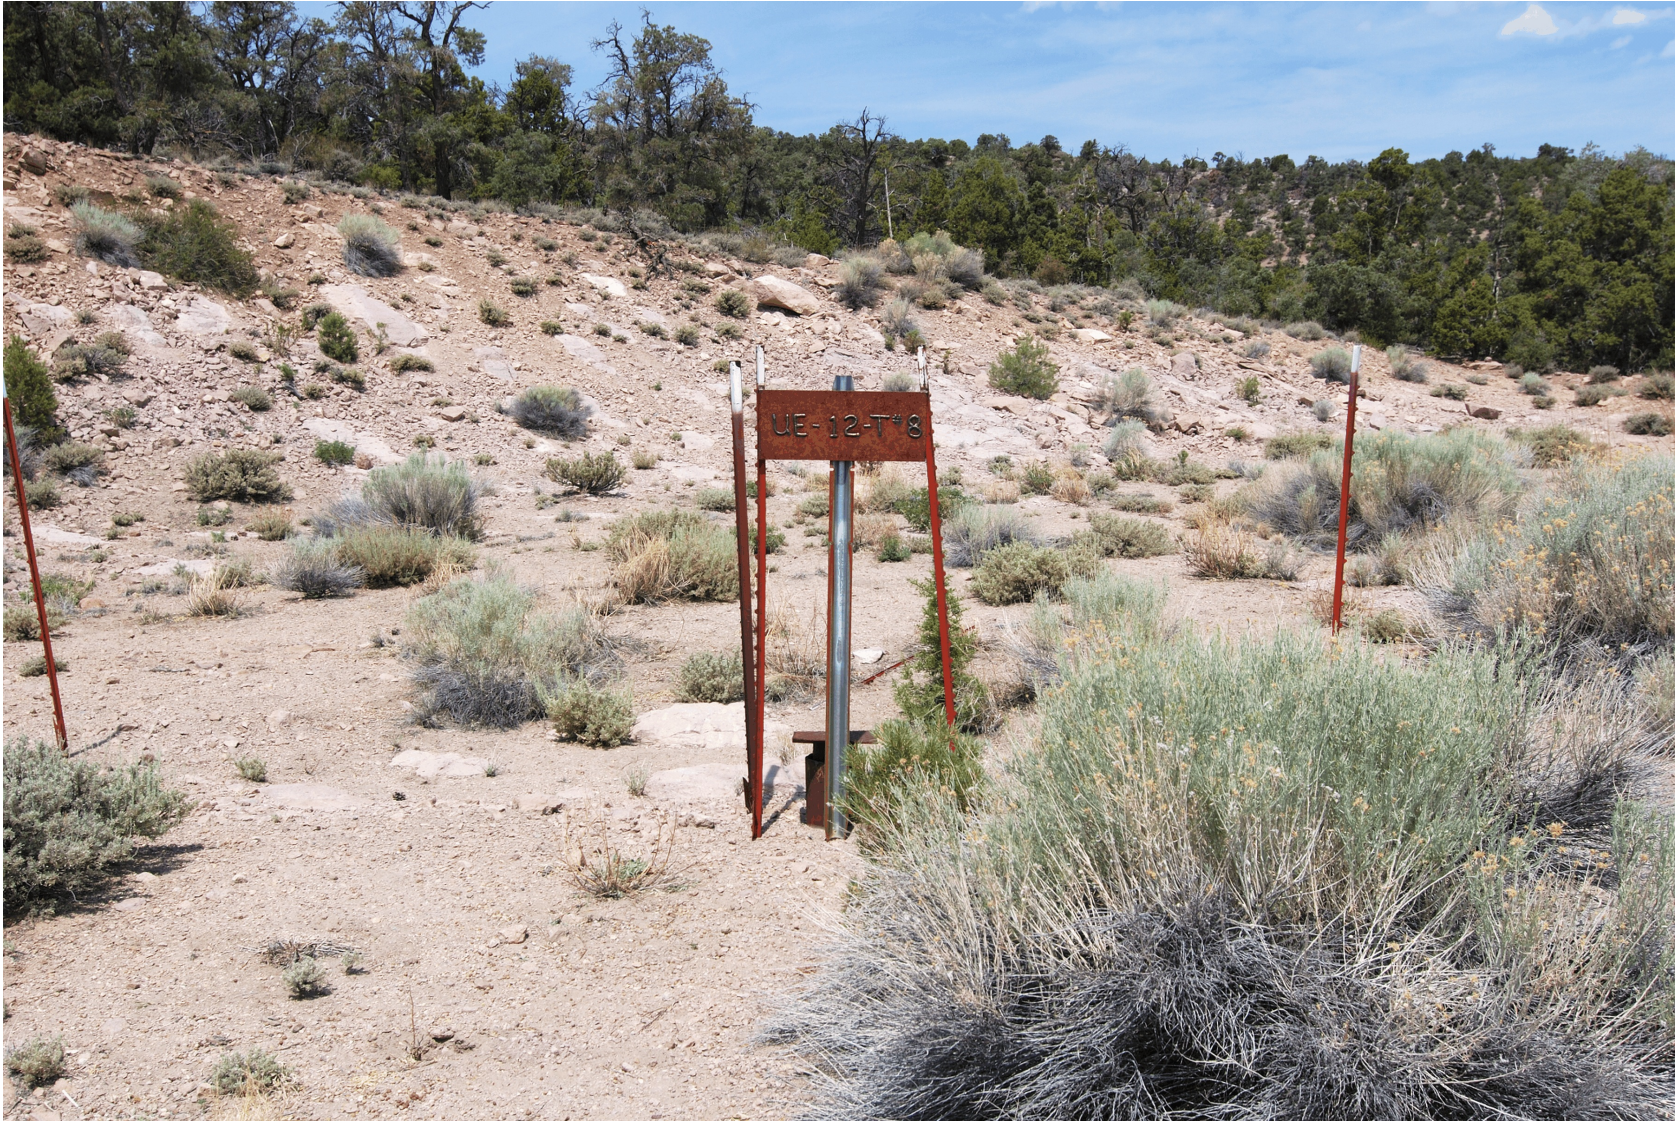
Figure 148. Photograph of Feature 89, UE12t#8, view northwest (2007).

Feature 89 is the UE12t #8 exploratory drill hole (Figure 148). The feature is near the center of a dirt pad along the north side of the road that accesses Aqueduct Mesa through Gold Meadows. It consists of a metal pipe extending above the surface and a metal post and plate with the signage UE-12T-8. Three T posts are near the pipe.

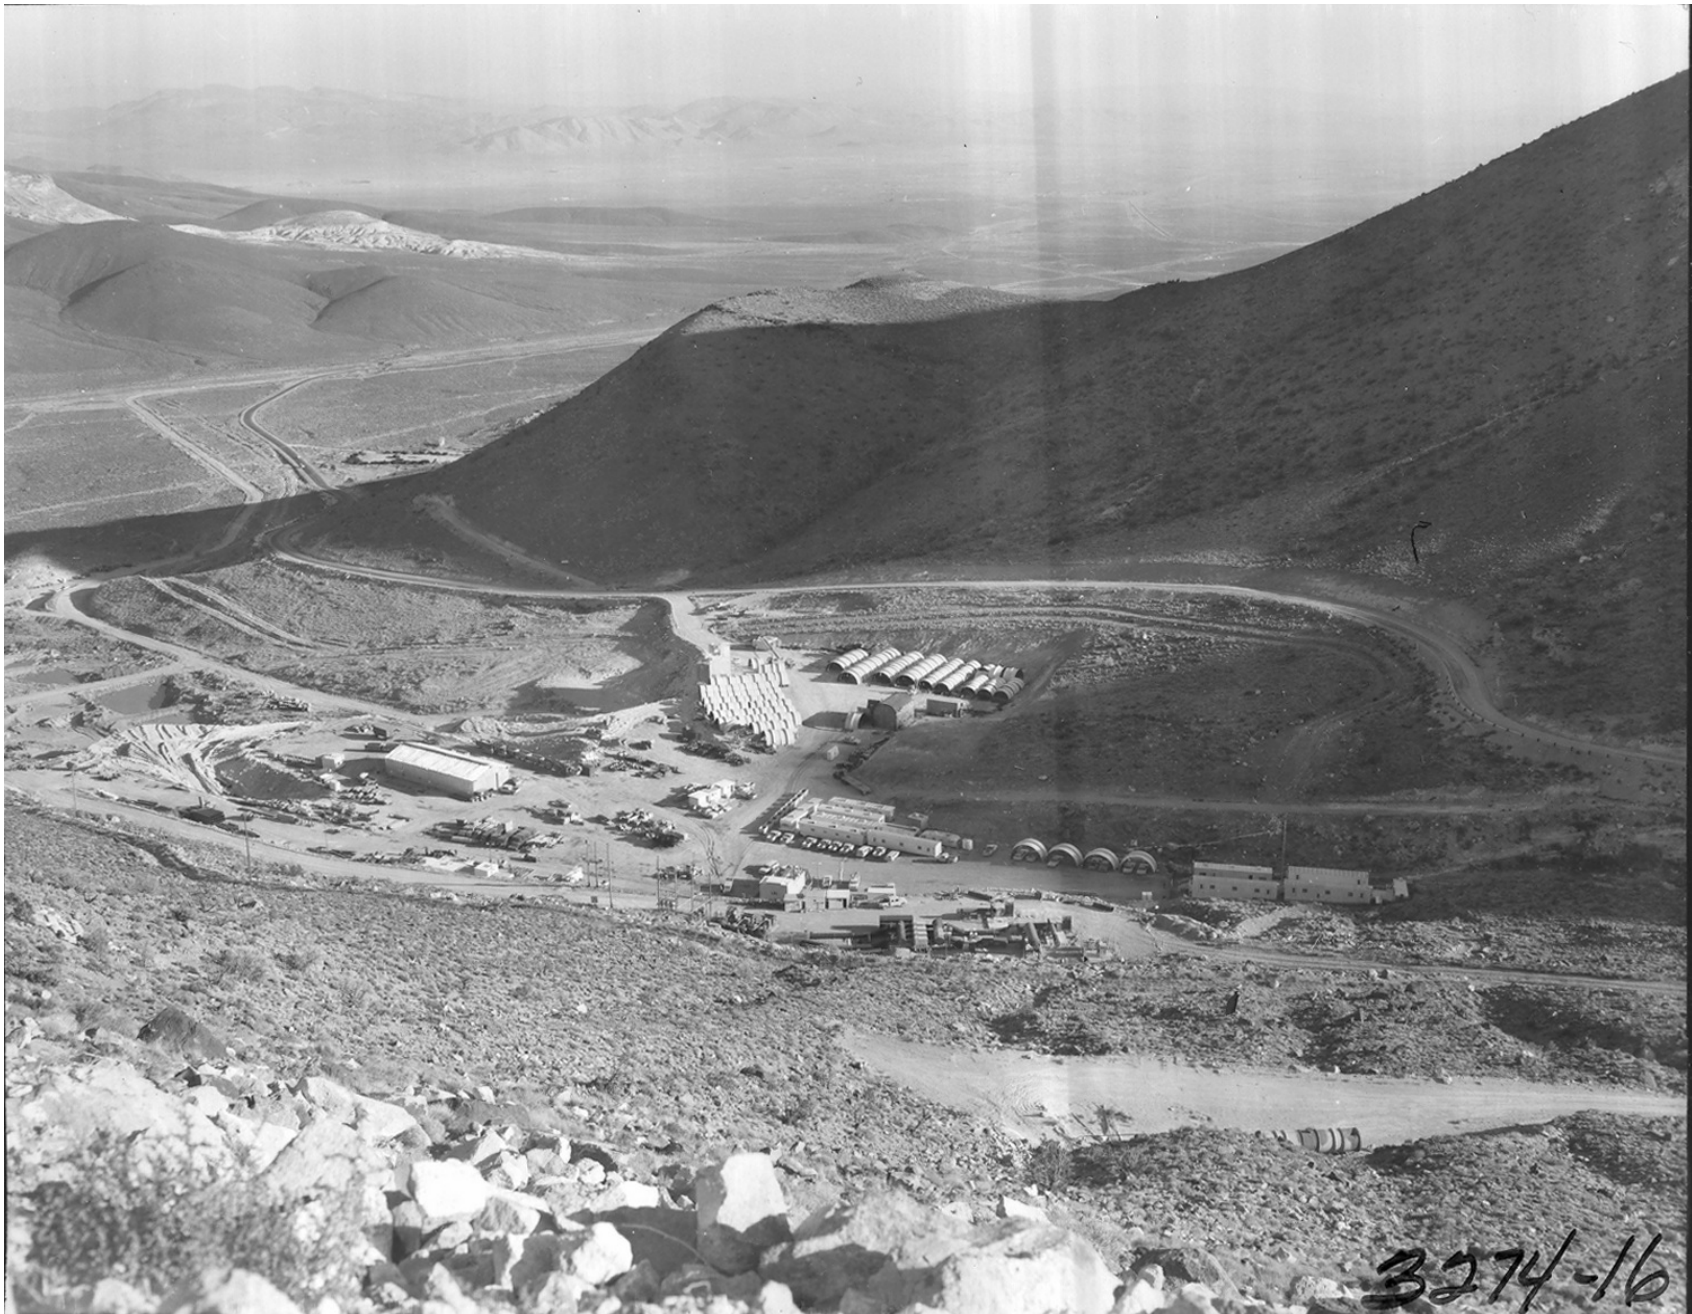
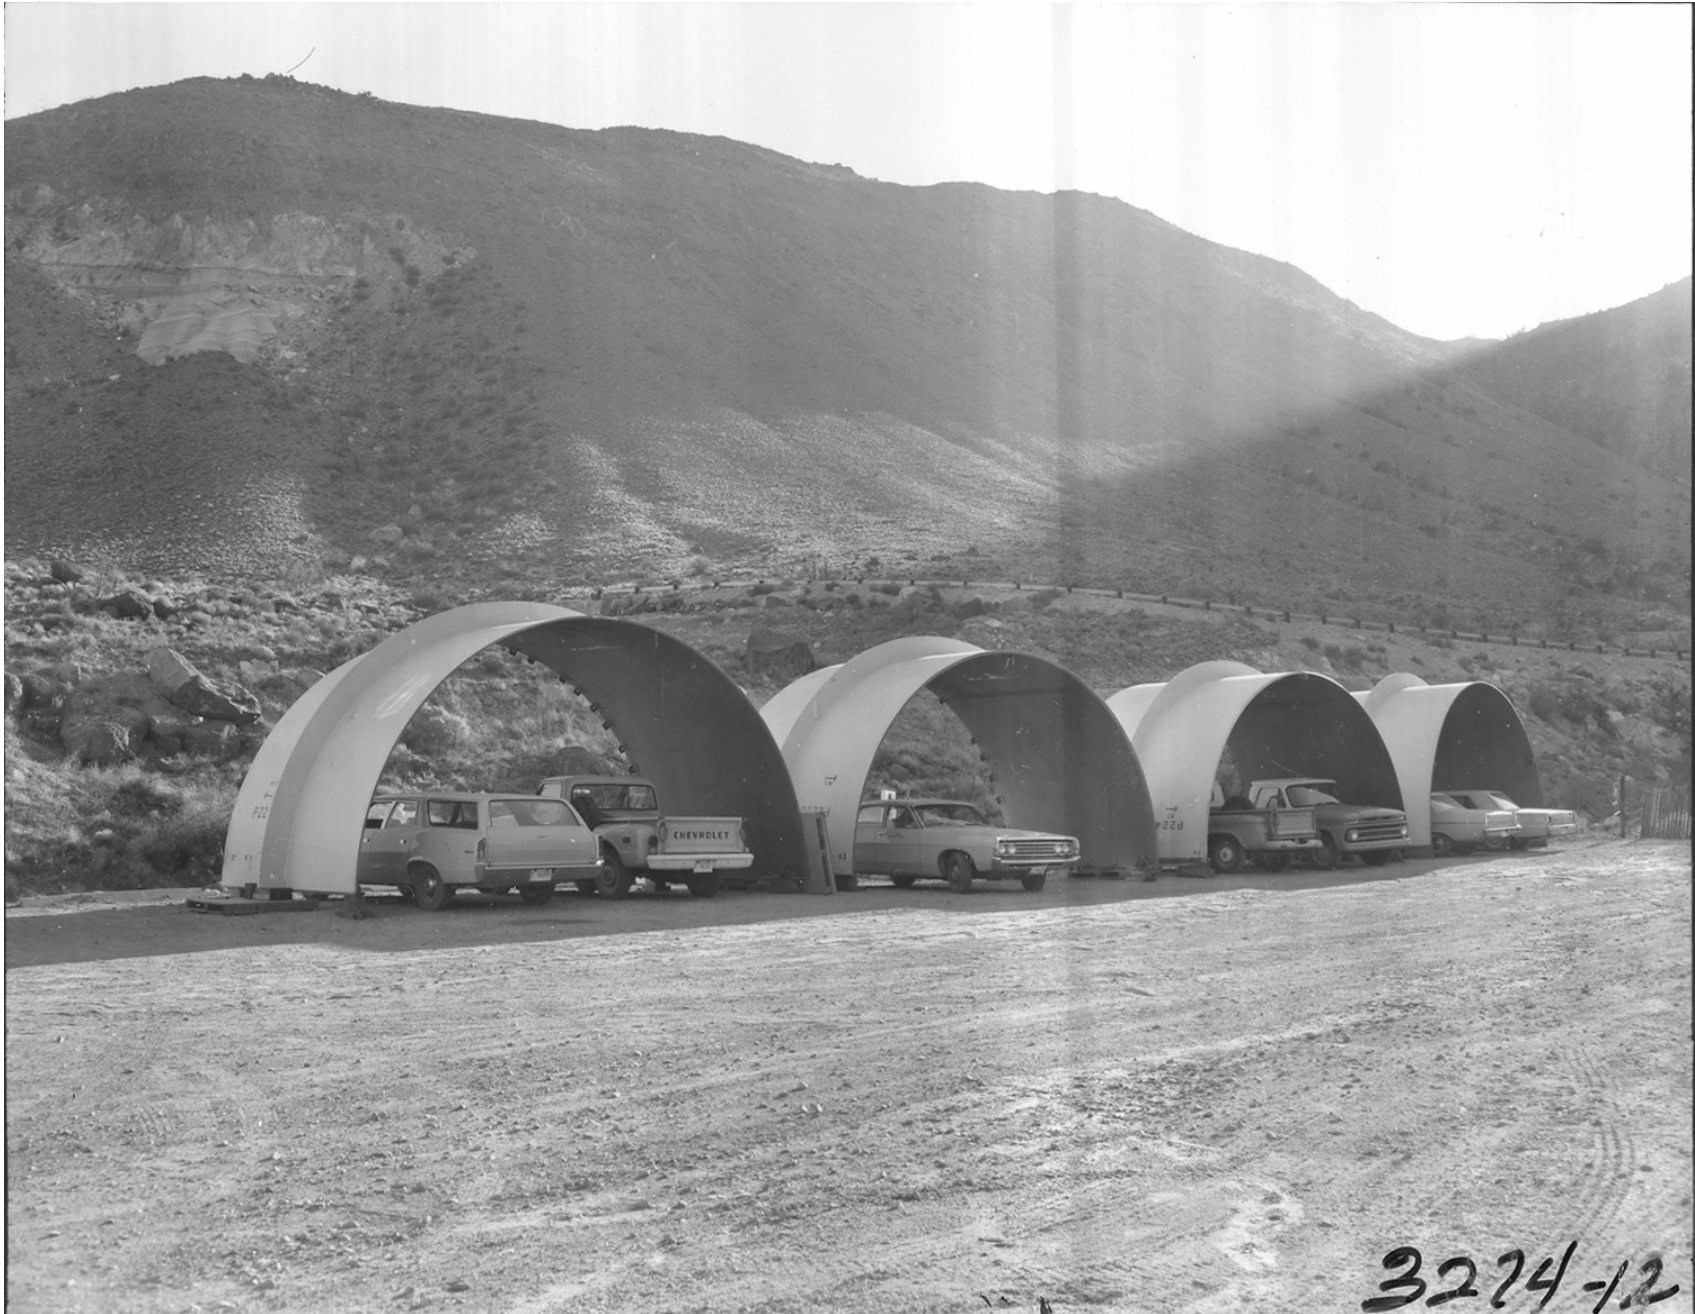
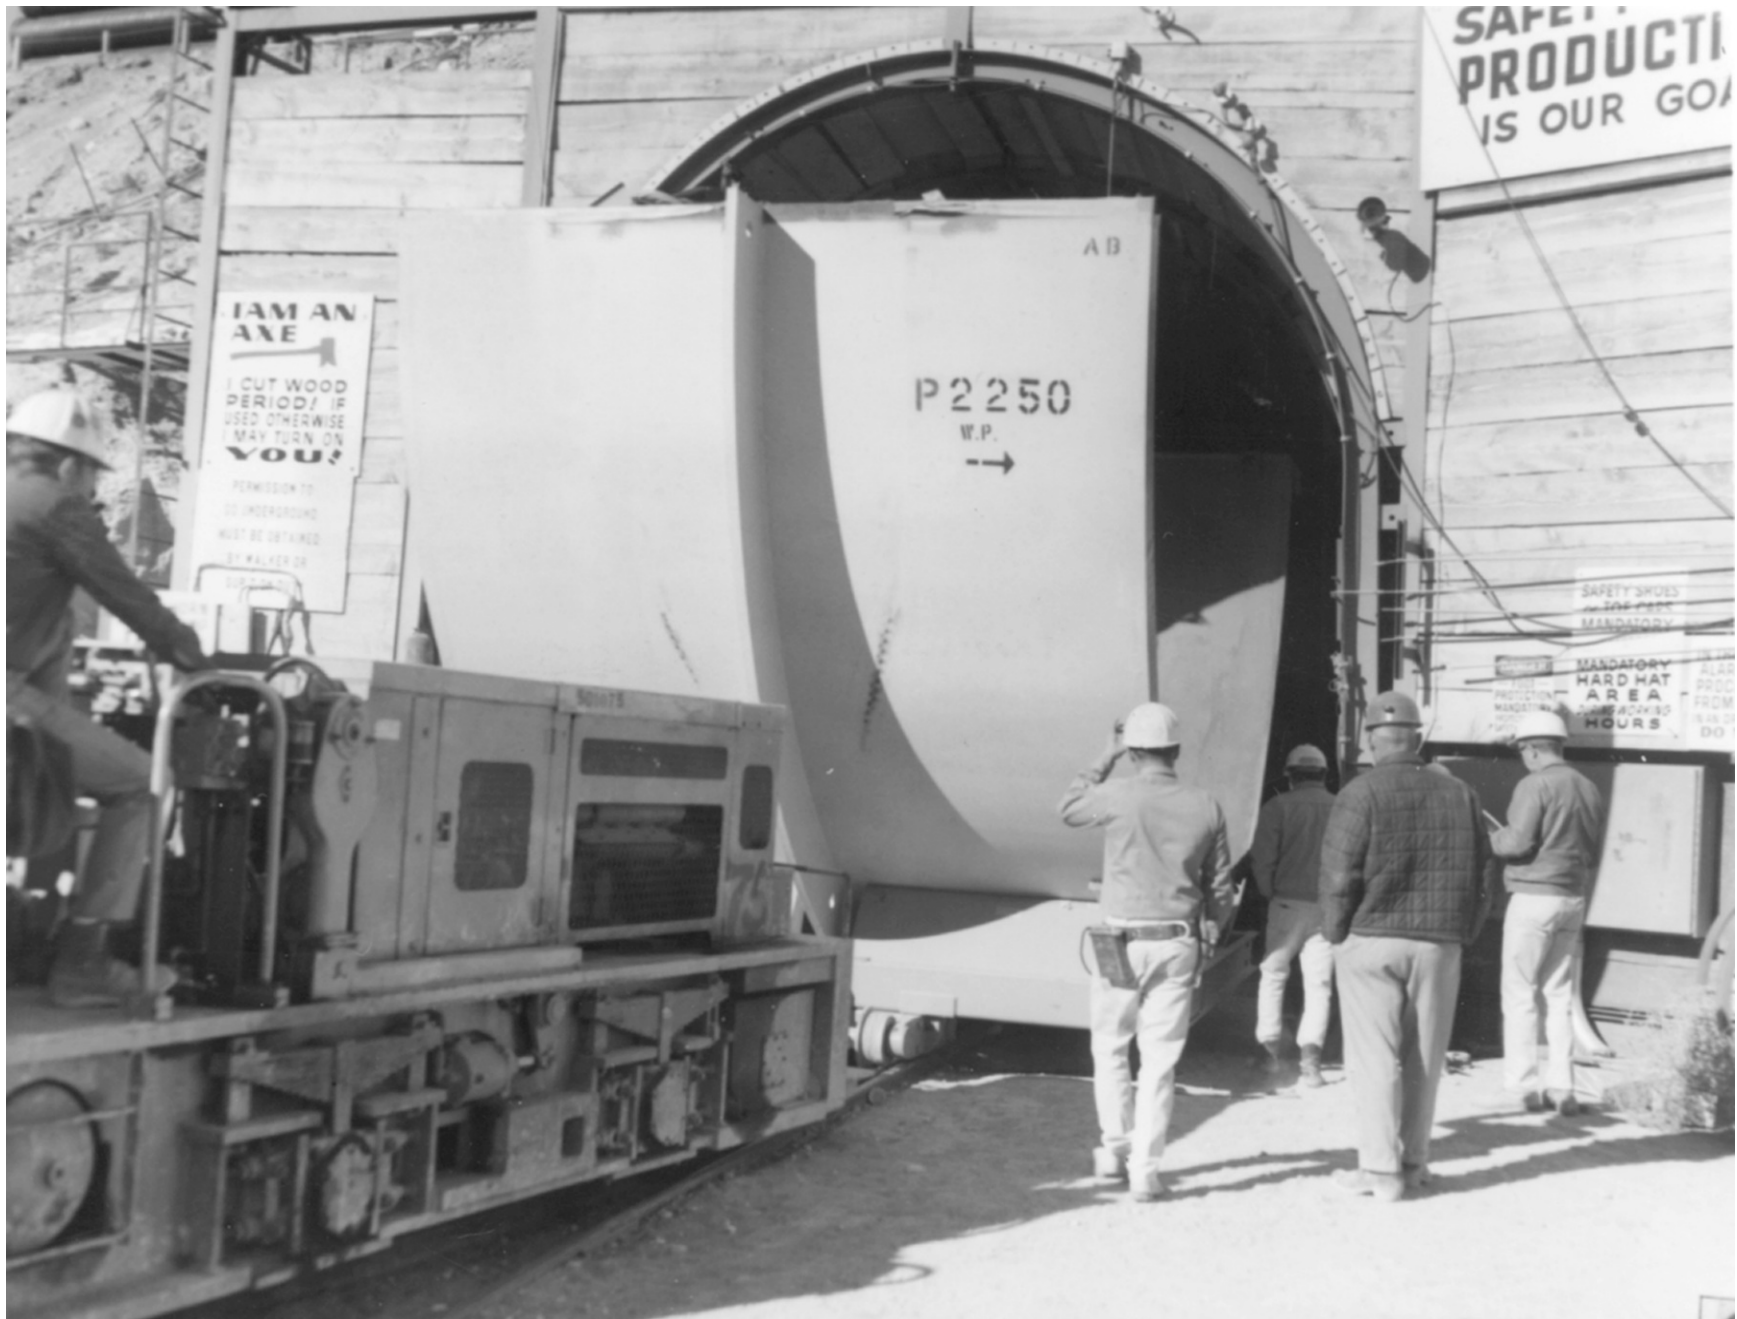
Diamond Sculls has the distinction of being the largest diameter and longest line-of-sight pipe ever used at the NTS (DTRA 2002:382; McDowell et al. 1987:91). The pipe was 1,940 ft (591 m) long and tapered from a 1 ft (30 cm) diameter at the A-box in the zero room to a 26.67 ft (8.1 m) diameter at the last test chamber, Test Chamber No. 1. This test chamber also has the distinction of being the largest. The total length of the line-of-sight pipe, including the stub pipes mounted to the end of Test Chamber No. 1 was 2,540 ft (774 m) long. Volume of the pipe was 300,000 cubic feet (Flangas and Harvey 2007). To accommodate the size of the pipe, an Assembly Area was constructed underground in the line-of-sight drift. This area was 176 ft (54 m) long, 38 ft (11.6 m) high, and 33 ft (10 m) wide (Figures 152, 157). It had four bays where different tasks were performed to complete the assembly of the larger pipe segments (Carpenter 1971). A bridge crane was installed in the Assembly Area to lift and move the pipe sections. Half-round sections of pipe, each 12 ft (3.7 m) long, were moved into the tunnel on specially designed rail transporters (Figure 156). When the pipe sections reached the Assembly Area, they were lifted, rotated, fitted, welded together, moved forward, precisely aligned, and welded in place (Figure 158). The smaller segments of pipe not requiring assembly underground were moved into position by way of the bypass drift and crosscuts (Carpenter 1971).

Figure 153. U12t Tunnel Portal Area, with storage of the half sections of the line-of-sight pipe for the Diamond Sculls test, view southeast, 1970 (photograph on file, Nuclear Testing Archive, Las Vegas).

Figure 154. Half sections of the line-of-sight pipe for the Diamond Sculls test, U12t Tunnel Portal Area, view south, 1970 (photograph on file, Nuclear Testing Archive, Las Vegas).

Figure 156. Half section of the line-of-sight pipe being moved into the portal entrance, U12t Tunnel, 1970 (photograph on file, Defense Threat Reduction Information Analysis Center, Albuquerque).

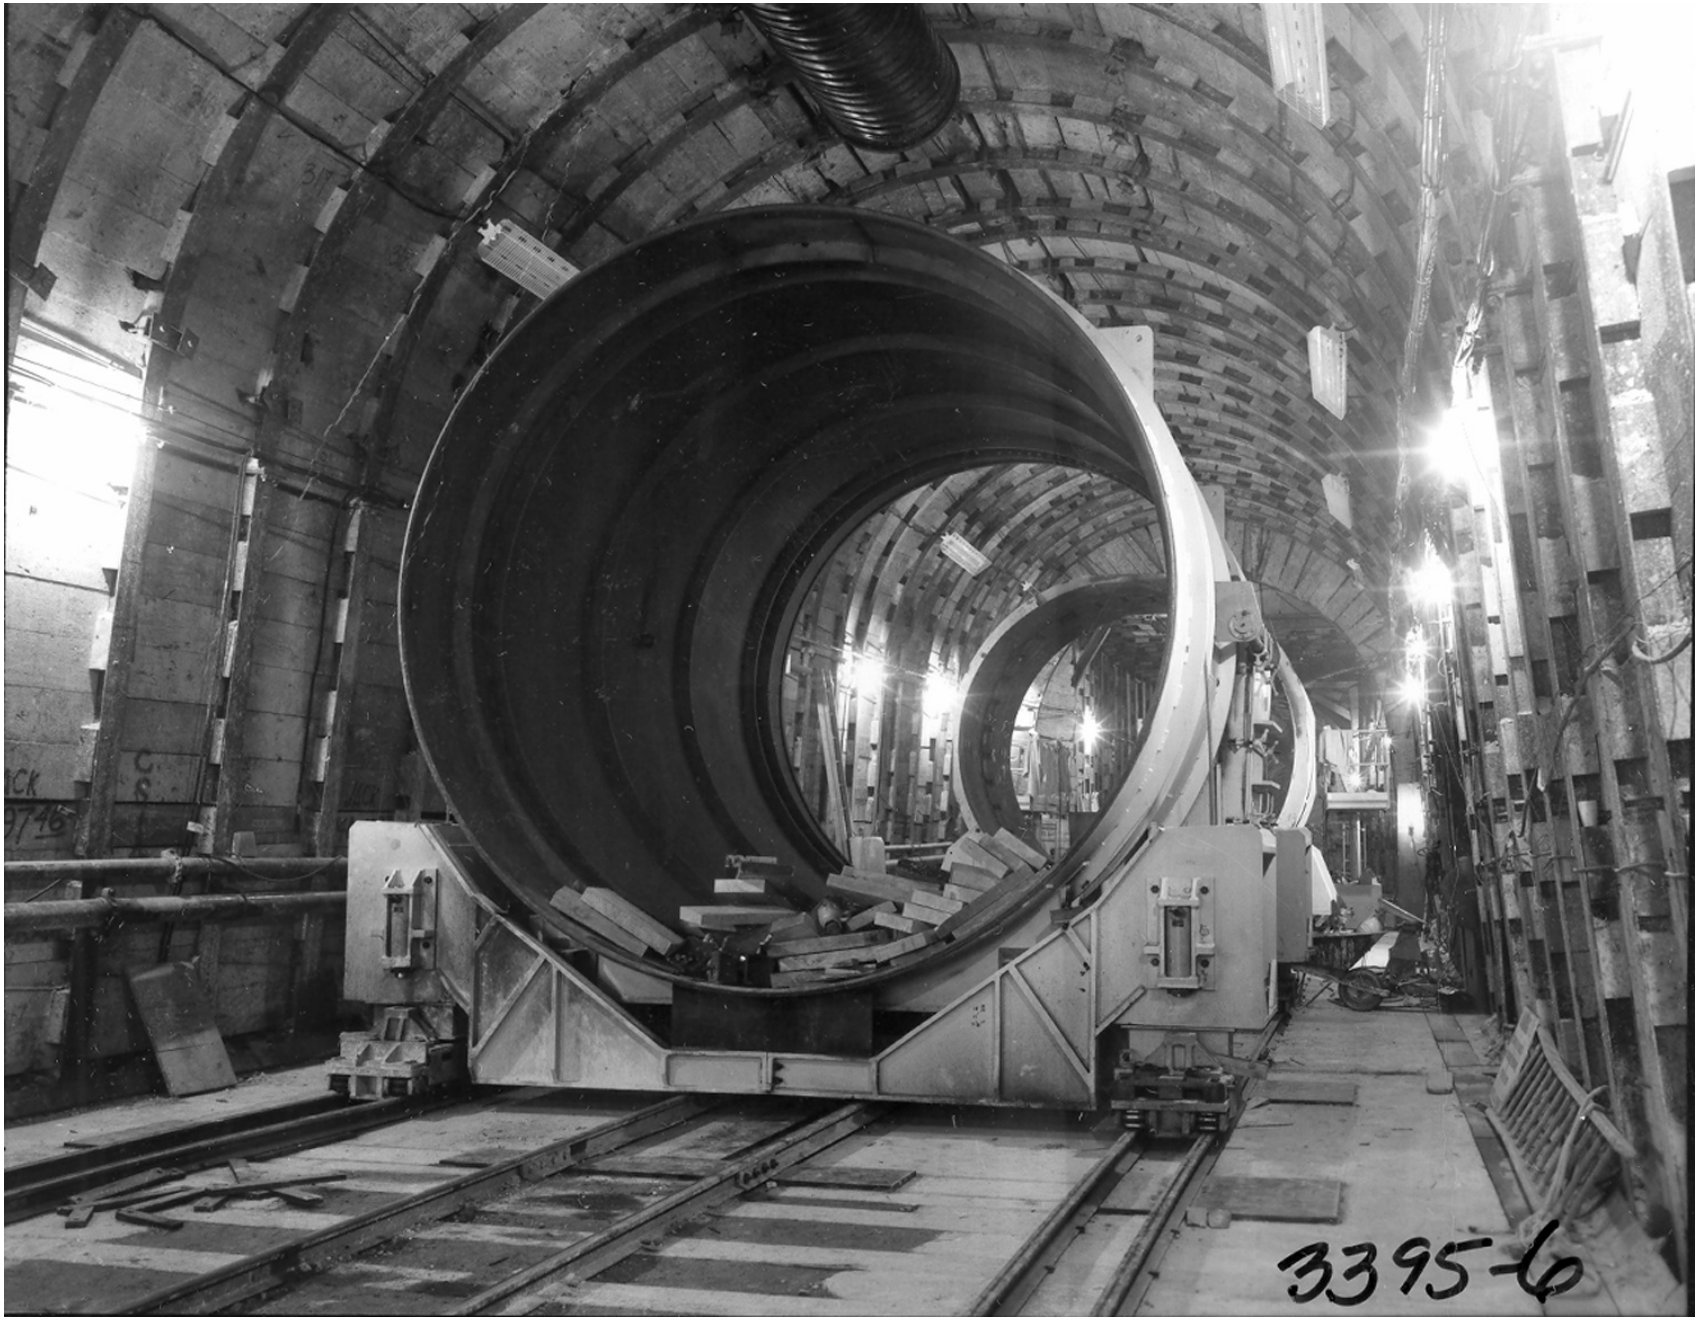
Figure 158. Construction of the line-of-sight pipe, U12t.02 drift, 1971 (photograph on file, Nuclear Testing Archive, Las Vegas).

An assembled large pipe segment consisted of six sections, with three on the bottom and three on the top, and measured 36 ft (11 m) long (Flangas and Harvey 2007). The largest segment assembled

weighed 84 tons. To produce a uniform weld, and with no tolerances, the welding tool was held stationary and the pipe rotated during the welding process. Situated above the pipe was a hopper that provided a continuous flow of flux to the weld. Two passes of welding were conducted for each pipe segment and the process was continuous until the welding operation was completed. Test Chamber No. 1 was the last segment assembled and was attached to the line-of-sight pipe in Bay No. 3 of the Assembly Area (Carpenter 1971). The equipment used to assemble the pipe was unique to all the tunnel operations, created just for this test, and is still there today inside the tunnel (Flangas and Harvey 2007).
