Fuel Performance Improvement Program

Power-Ramp Testing and Postirradiation Examination of PCI-Resistant LWR Fuel Rod Designs

**Power-Ramp Testing and
Postirradiation Examination of
PCI-Resistant LWR Fuel Rod
Designs**

**J. O. Barner
R. J. Guenther**

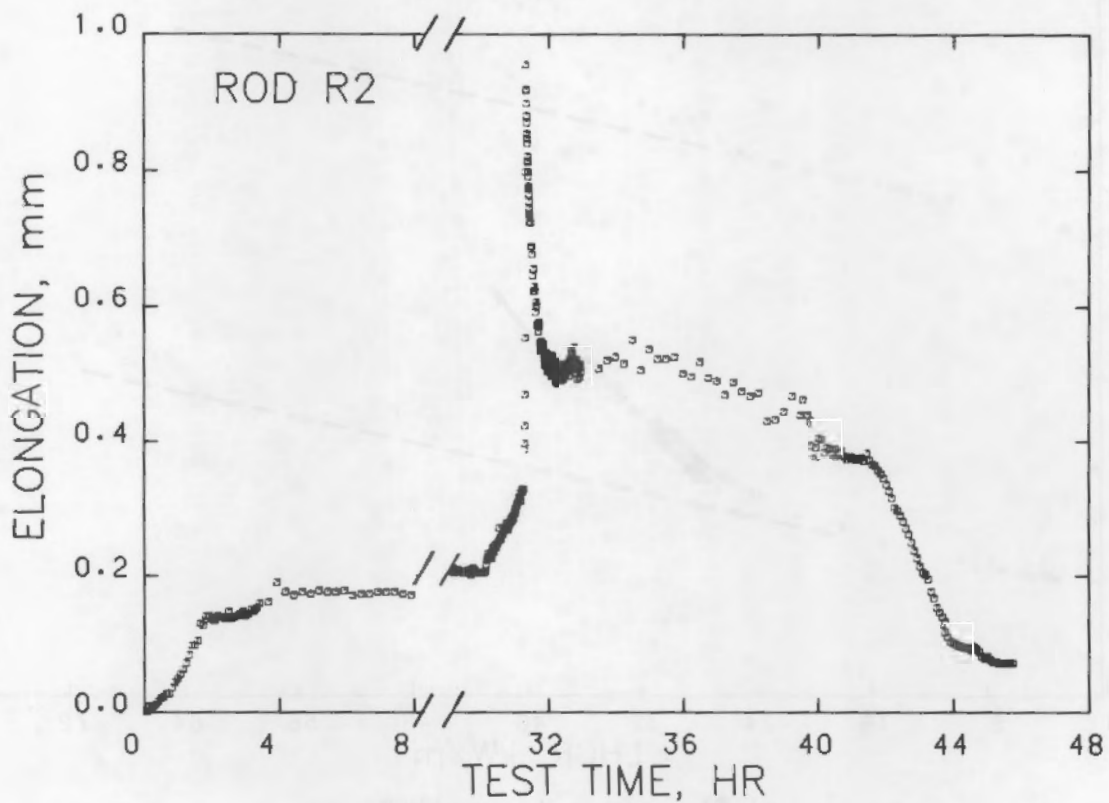
FIGURE 4. Elongation Signal During Power-Ramping of Rod R2 (see Table 4)

FIGURE 4. (contd)

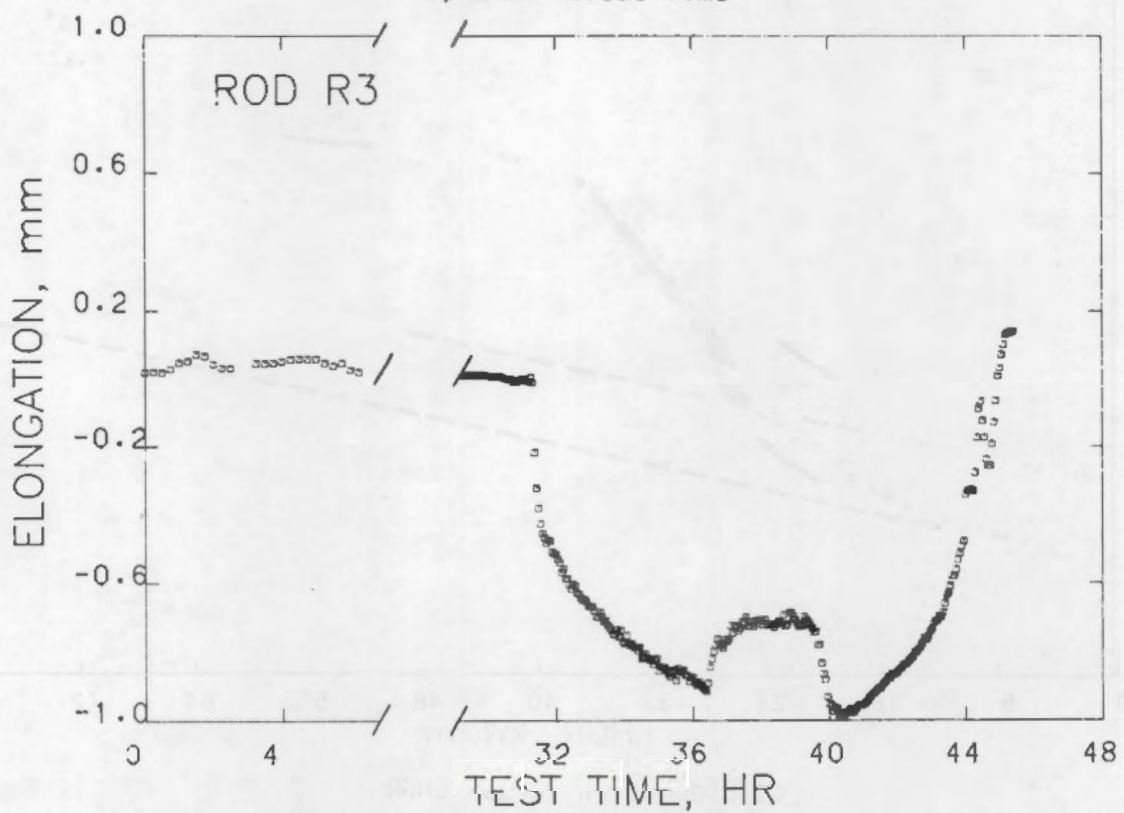
FIGURE 5. Elongation Signal During Power-Ramping of Rod R3 (see Table 4)

FIGURE 5. (contd)

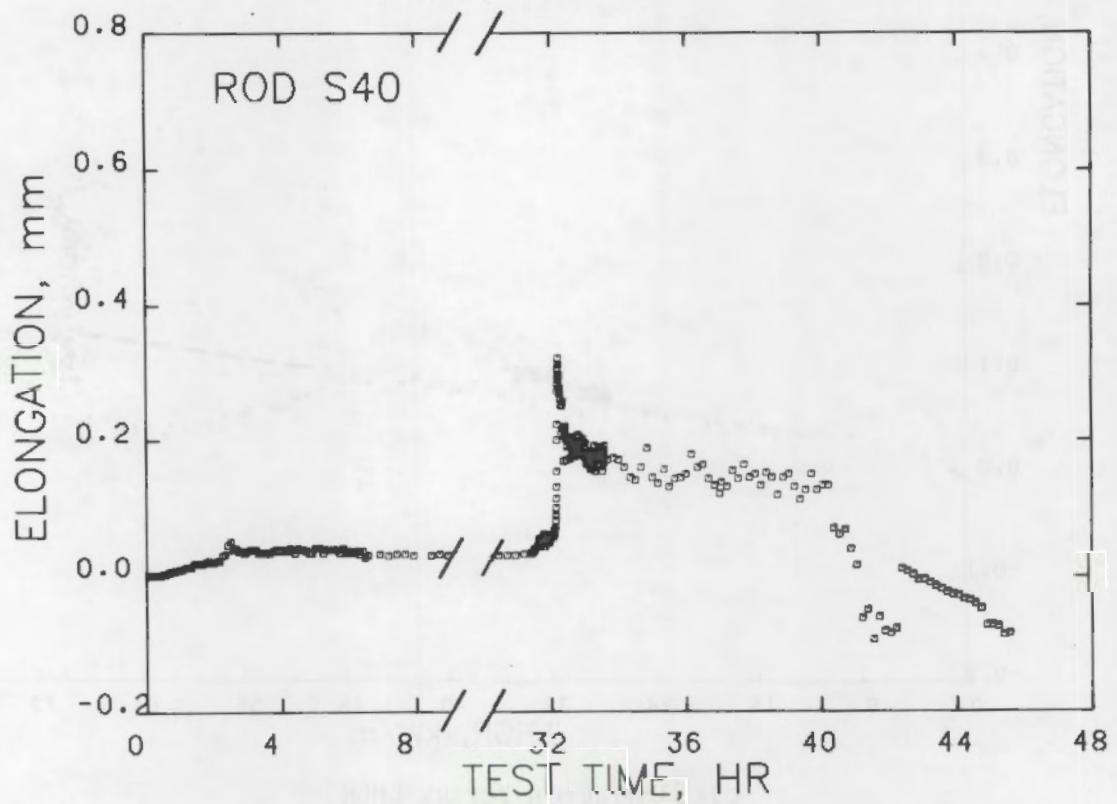
FIGURE 10. Elongation Signal During Power-Ramping of Rod S40 (see Table 4)

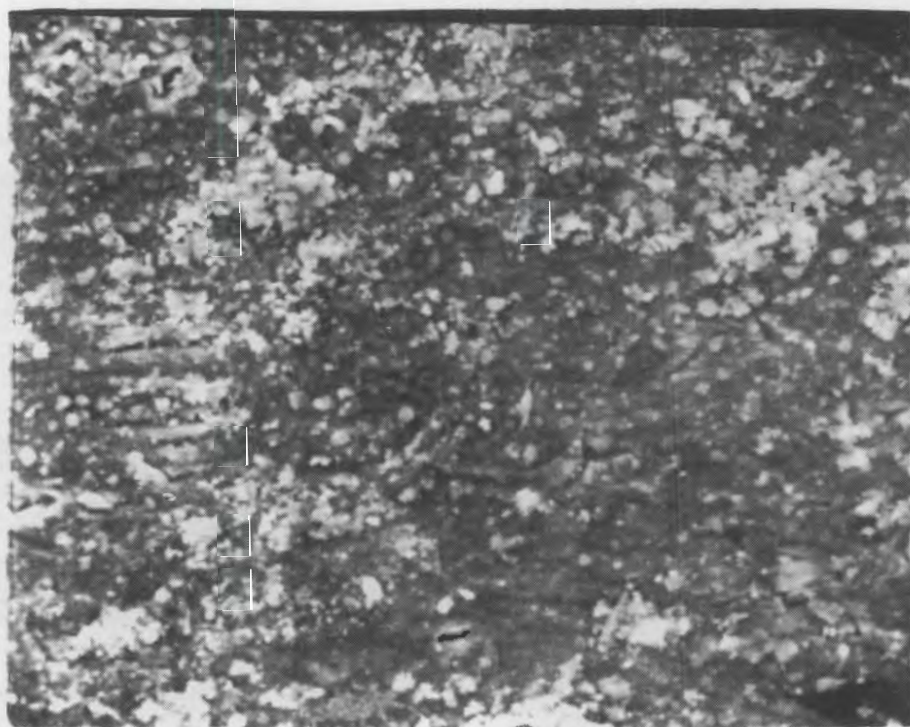
FIGURE 103. SEM View of Fission Products on Inner Cladding Surface from Rod R1 (1250X)
