Tank 241-AY-102 Leak Assessment Supporting Documentation: Miscellaneous Reports, Letters, Memoranda, and Data

Key Words: DST, 241-AY-102, leak assessment, leak, tank construction

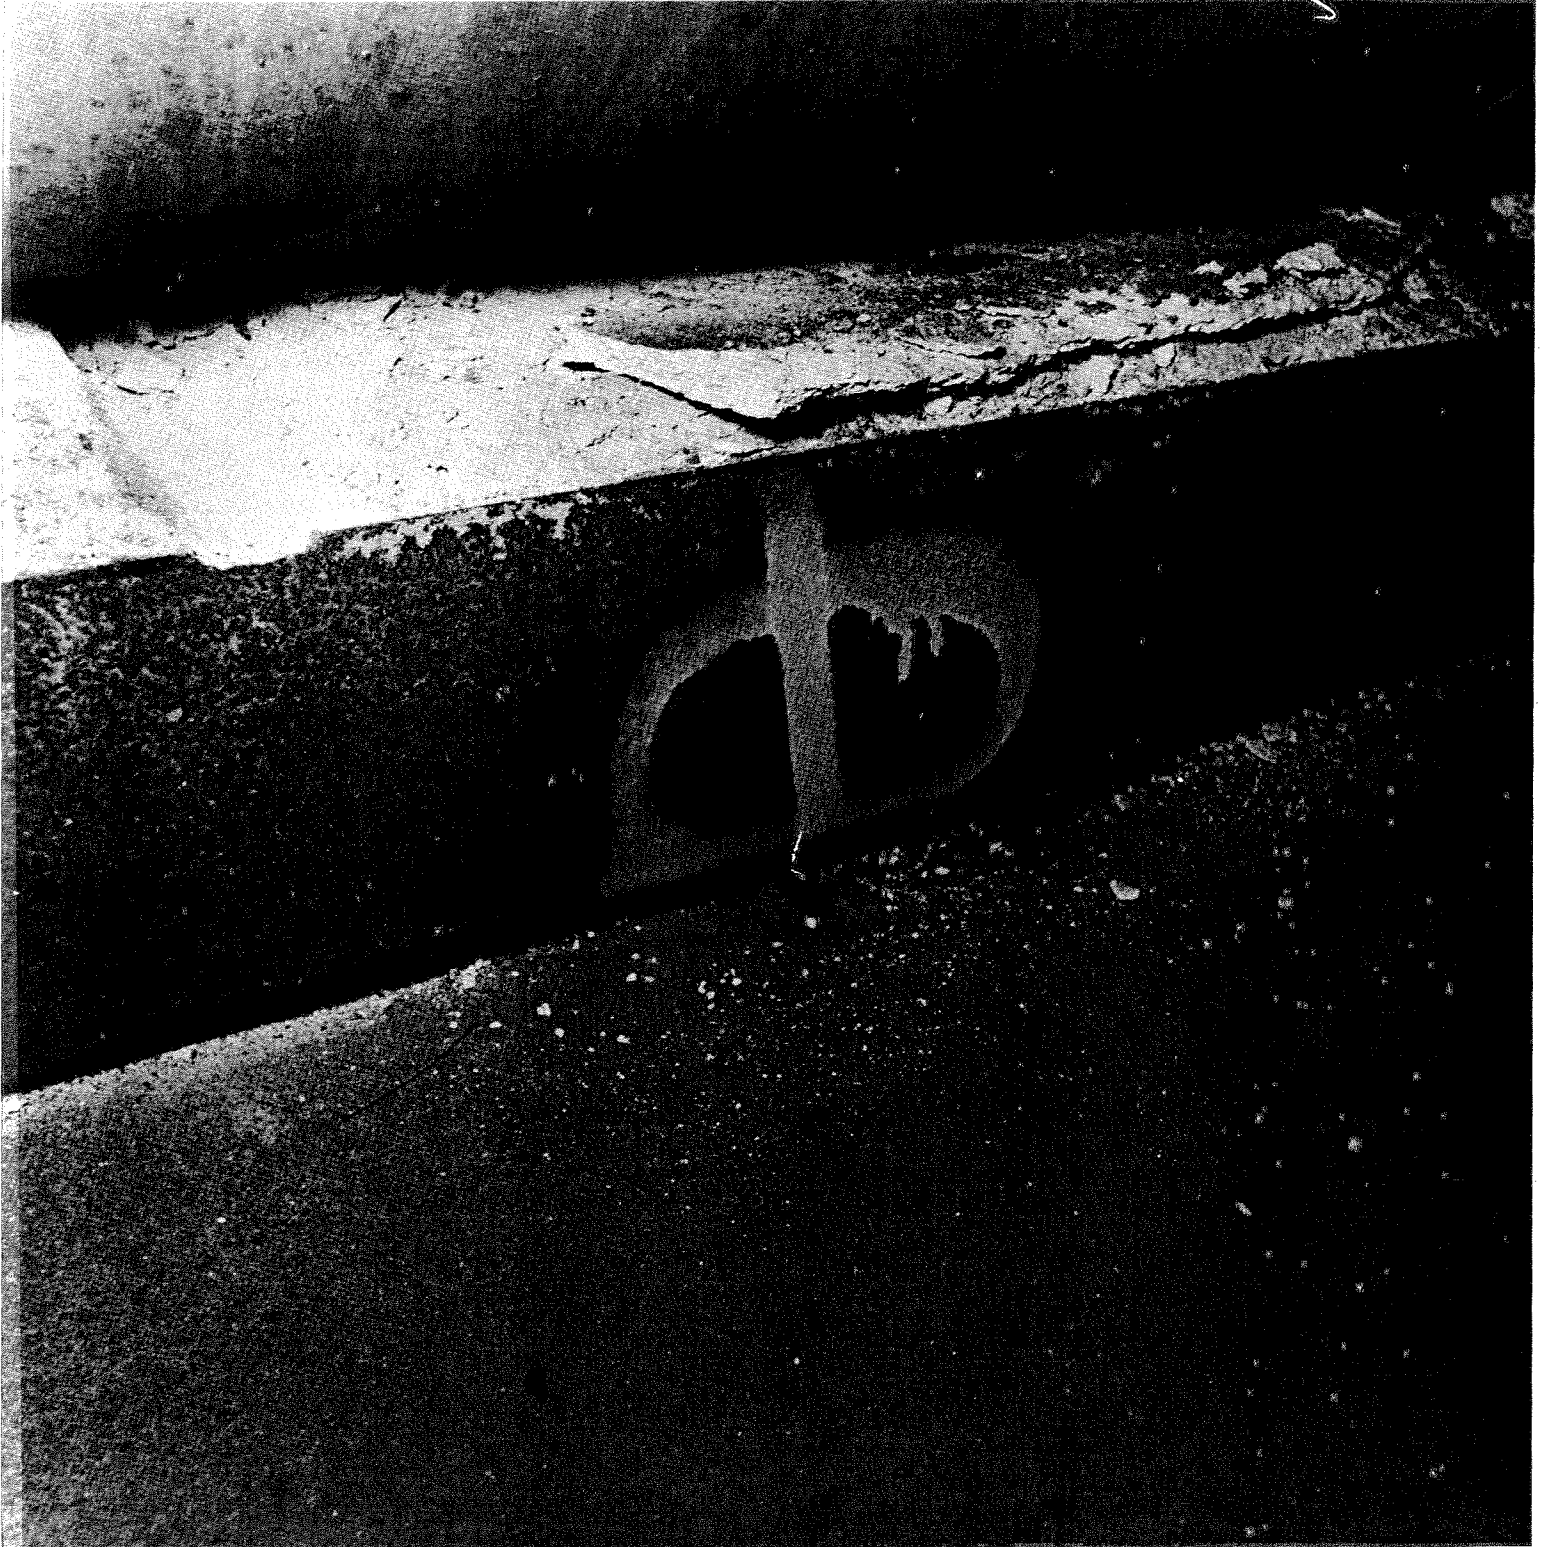
FIGURE 1

Tank 102 - The condition of the refractory in TK-102, as observed on the outer periphery, was described as follows: The surface of the slab was generally deteriorated to an average thickness of 3/4 to 1 inch. (Localized surface deterioration much greater than 1 inch thick were noted.) The deteriorated surface readily broke off in friable flakes, i.e., the surface was nearly cohesionless. Competent refractory existed below. Also, a few cracks through the slab's 8 inch thickness were visible on the periphery. The only marked differences from this condition were: Two areas, identified as individual 10° pours, were soft and friable for the entire thickness. One area, also an individual 10° pour, was in very good condition with minimal surface deterioration (less than 1/4 inches) relative to the rest of the 102 slab. Figure 1 is a photograph showing the typical condition of the 102 refractory. Figure 2 shows one of the extremely poor areas, while Figure 3 is a photograph of a crack in the 102 refractory. Figure 4, AY Tank 102 Condition Plot, shows the location of these general refractory conditions.

TYPICAL 3/4 IN. REFRACTORY SURFACE
DETERIORATION, TANK 102

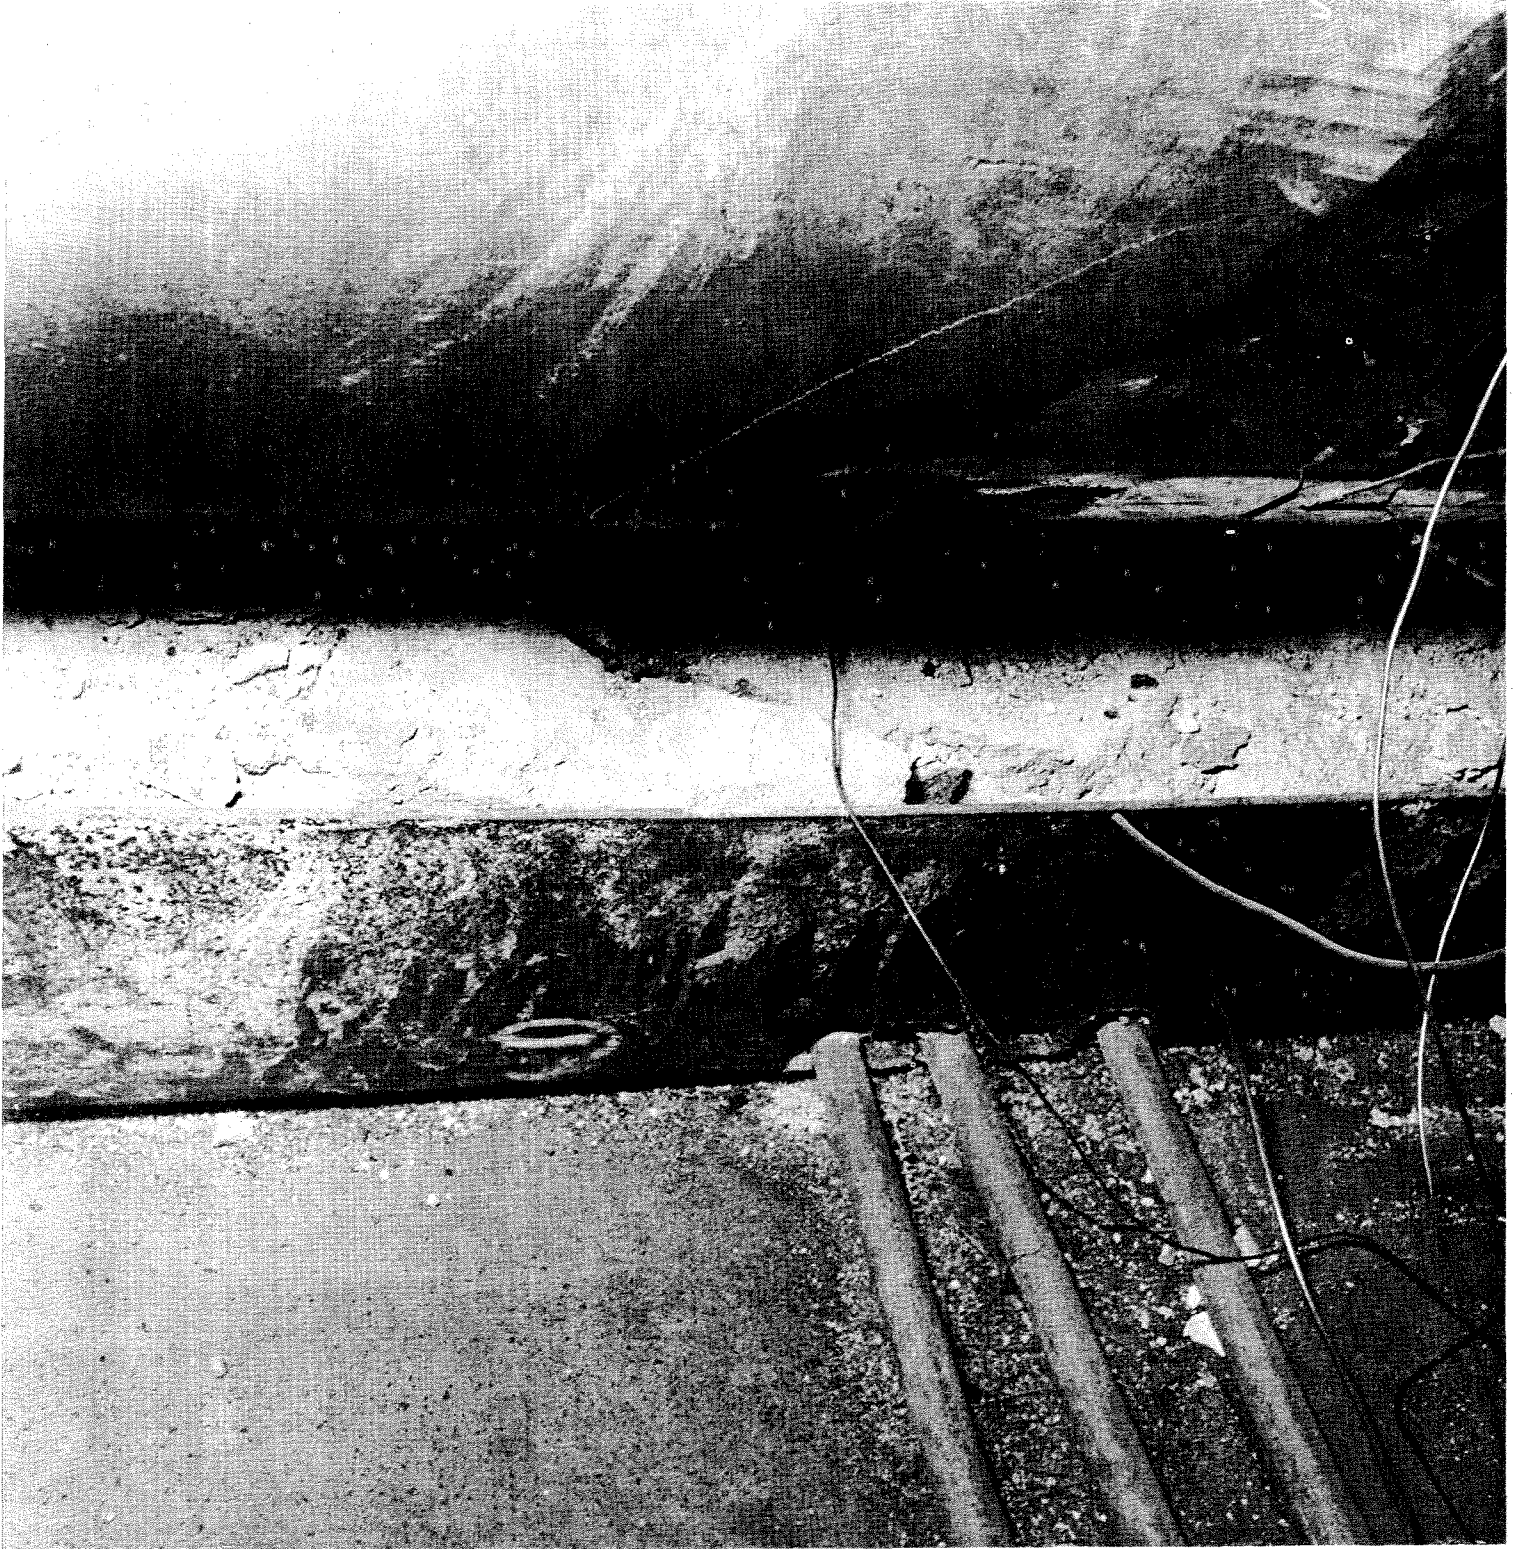
FIGURE 2
EXTREMELY POOR SECTION OF REFRACTORY
TANK 102

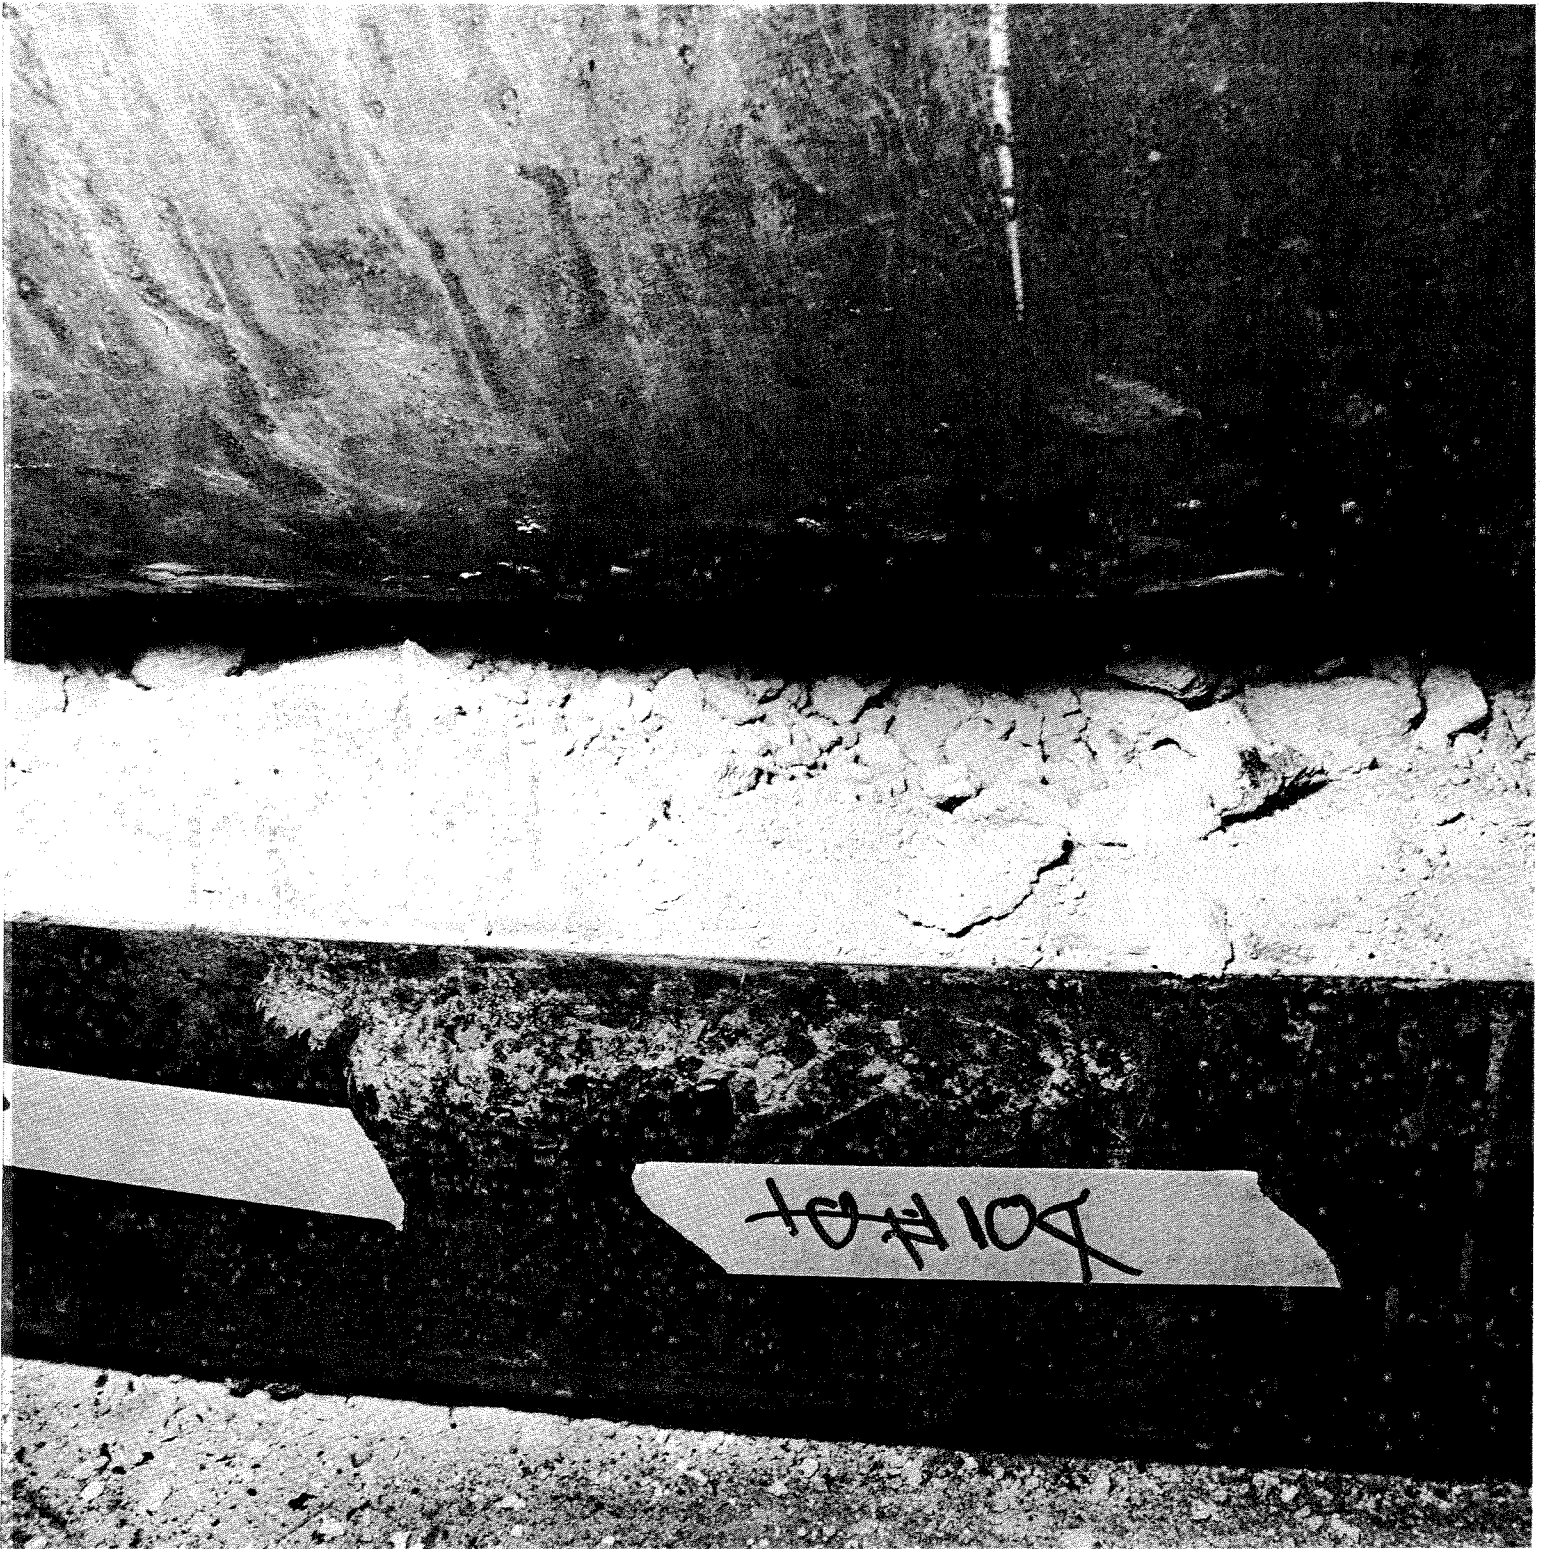
Tank 101 - The general condition of the refractory in TK-101, as observed on the periphery, varied from good (less than 1/4 inches deterioration) to a condition of 3/4 inches surface deterioration. (Localized surface deterioration much greater than 1 inch thick were noted.) One localized badly fractured area was noted on the periphery. Also, a few cracks through the 8 inch thickness occurred around the slab. The deteriorated surface broke off in friable flakes, i.e, the surface was nearly cohesionless. Competent refractory existed below. Figure 5 is a photograph of the badly fractured

BADLY FRACTURED REFRACTORY, TANK 101

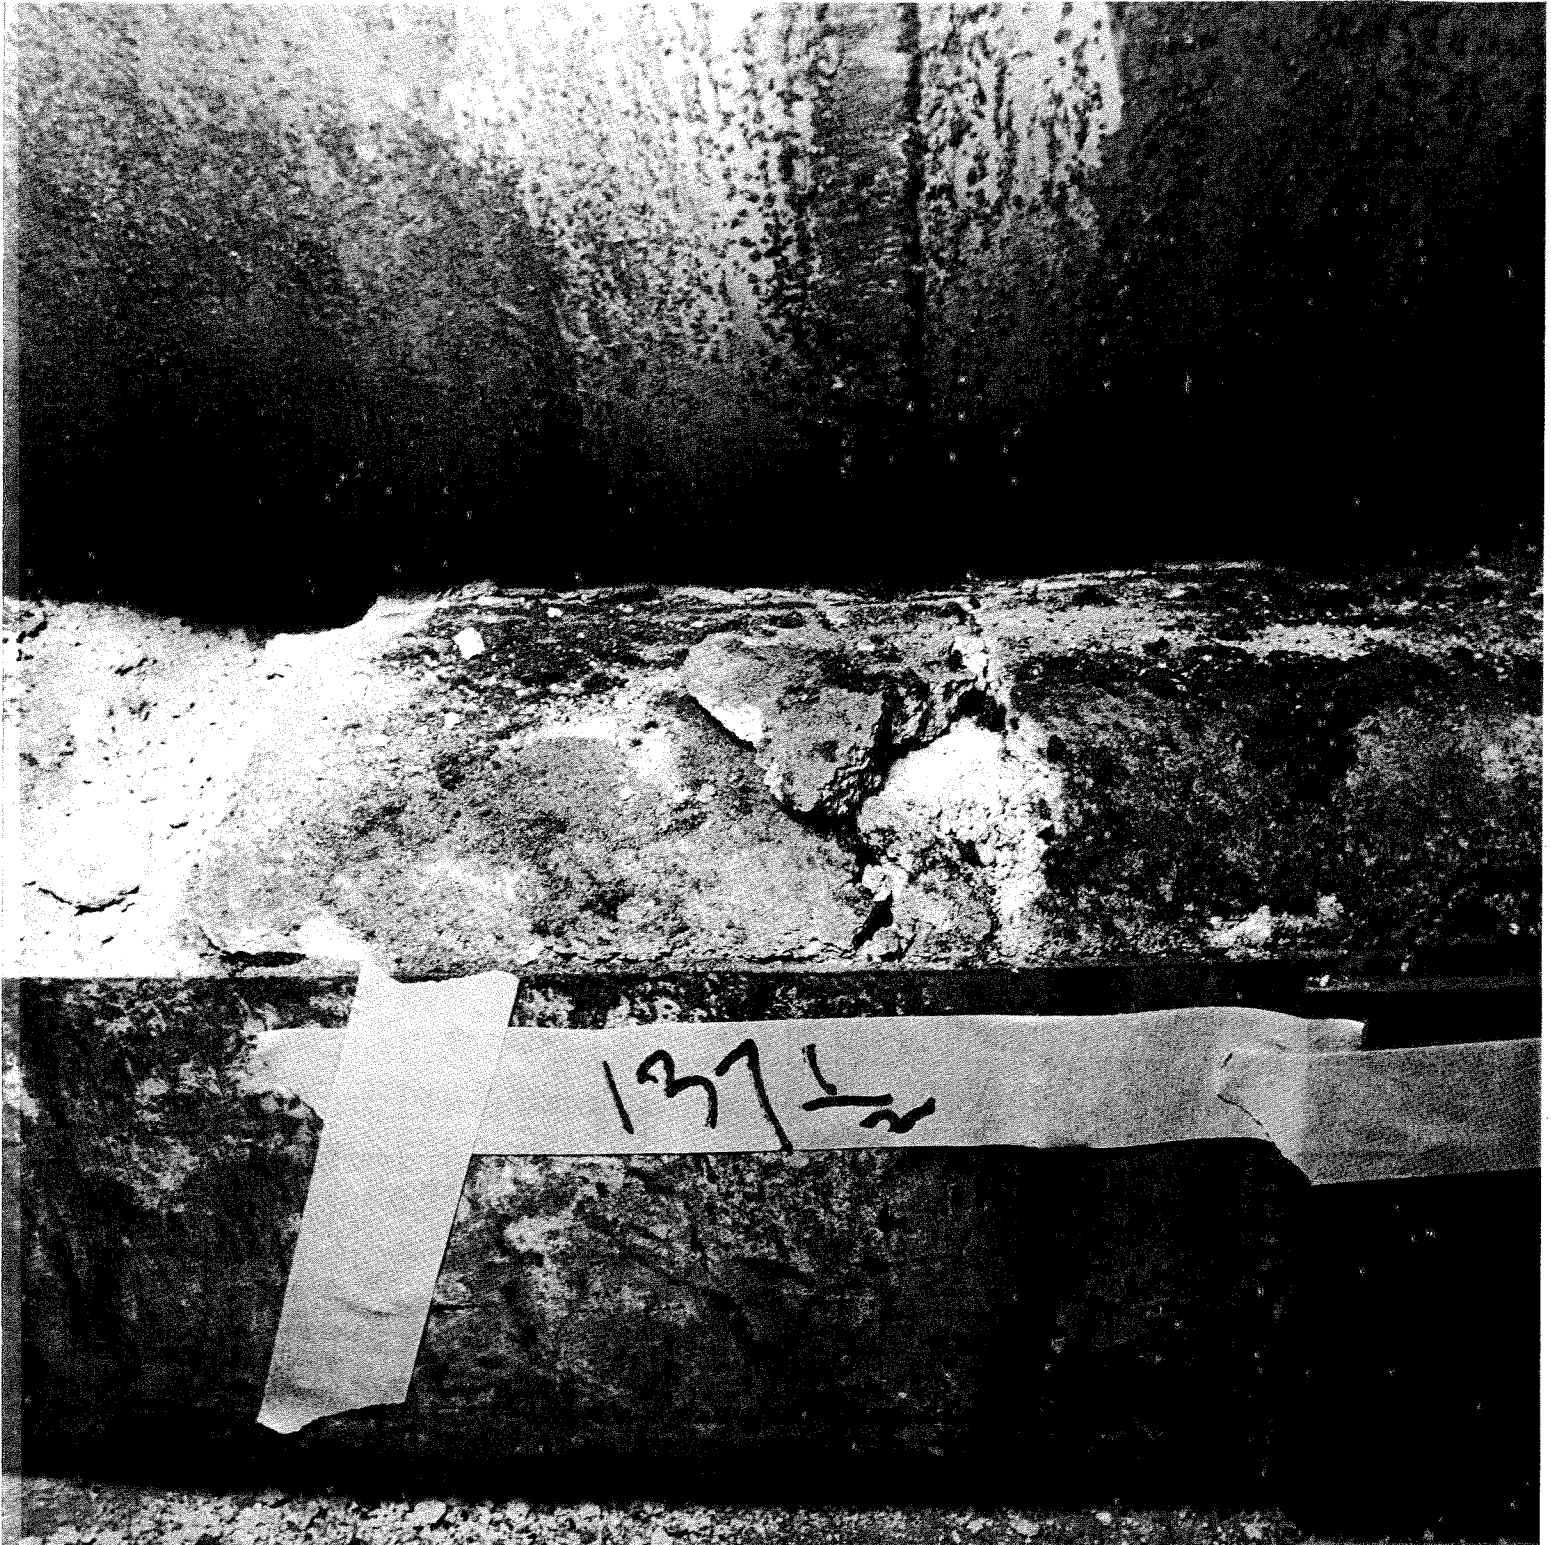
FIGURE 6

area. Figure 6 is a photograph of the 3/4 inch surface deterioration. Figure 7 is a picture of surface deterioration less than 1/2 inches. Figure 8 is the picture of a typical crack and Figure 9 is a photograph of a good area in 101. Figure 10, AY Tank 101 Condition Plot, locates these general refractory conditions.

3/4 IN. REFRACTORARY SURFACE DETERIORATION
TANK 101

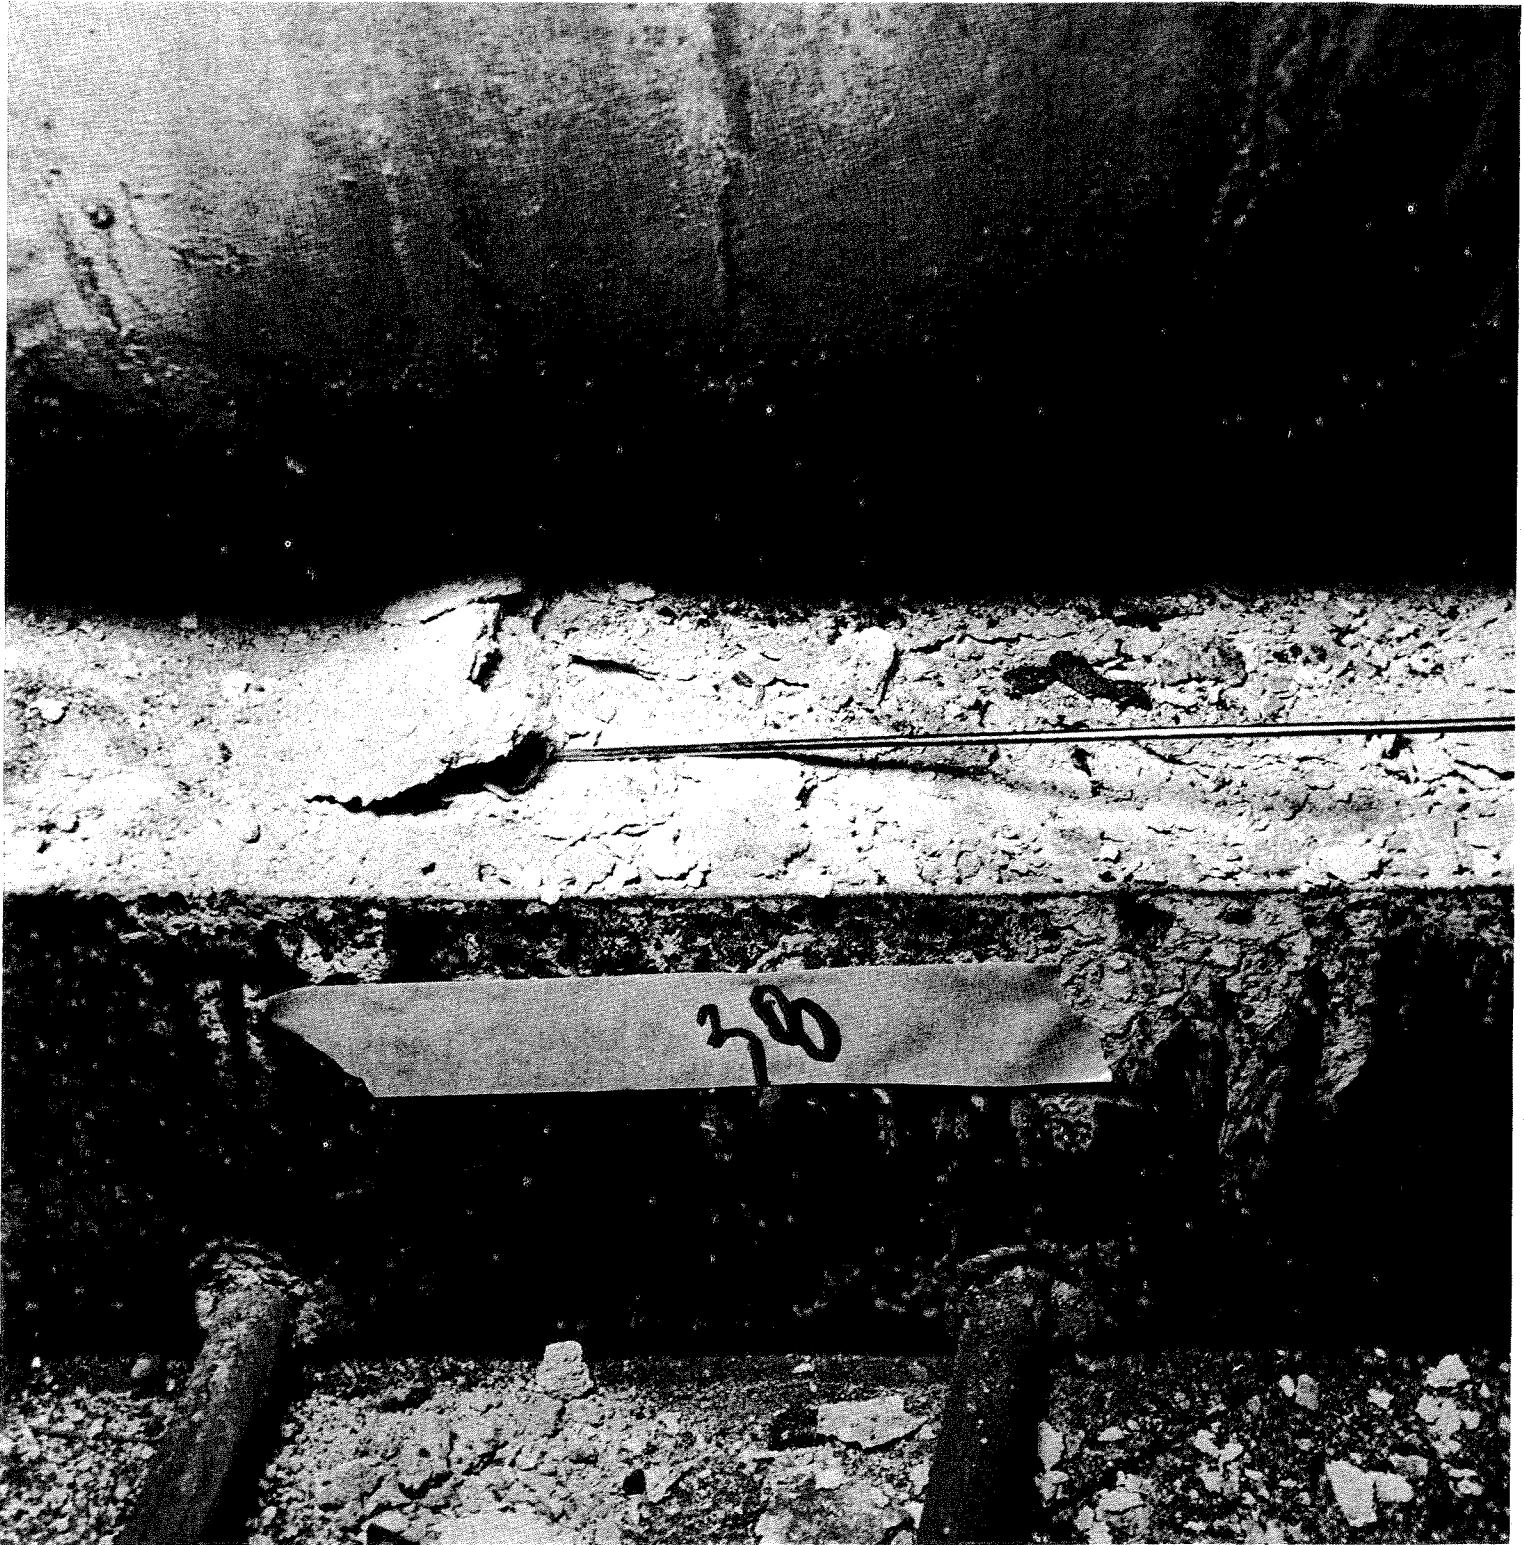
FIGURE 7

REFRACTORY SURFACE DETERIORATION
LESS THAN 1/2 IN., TANK 101

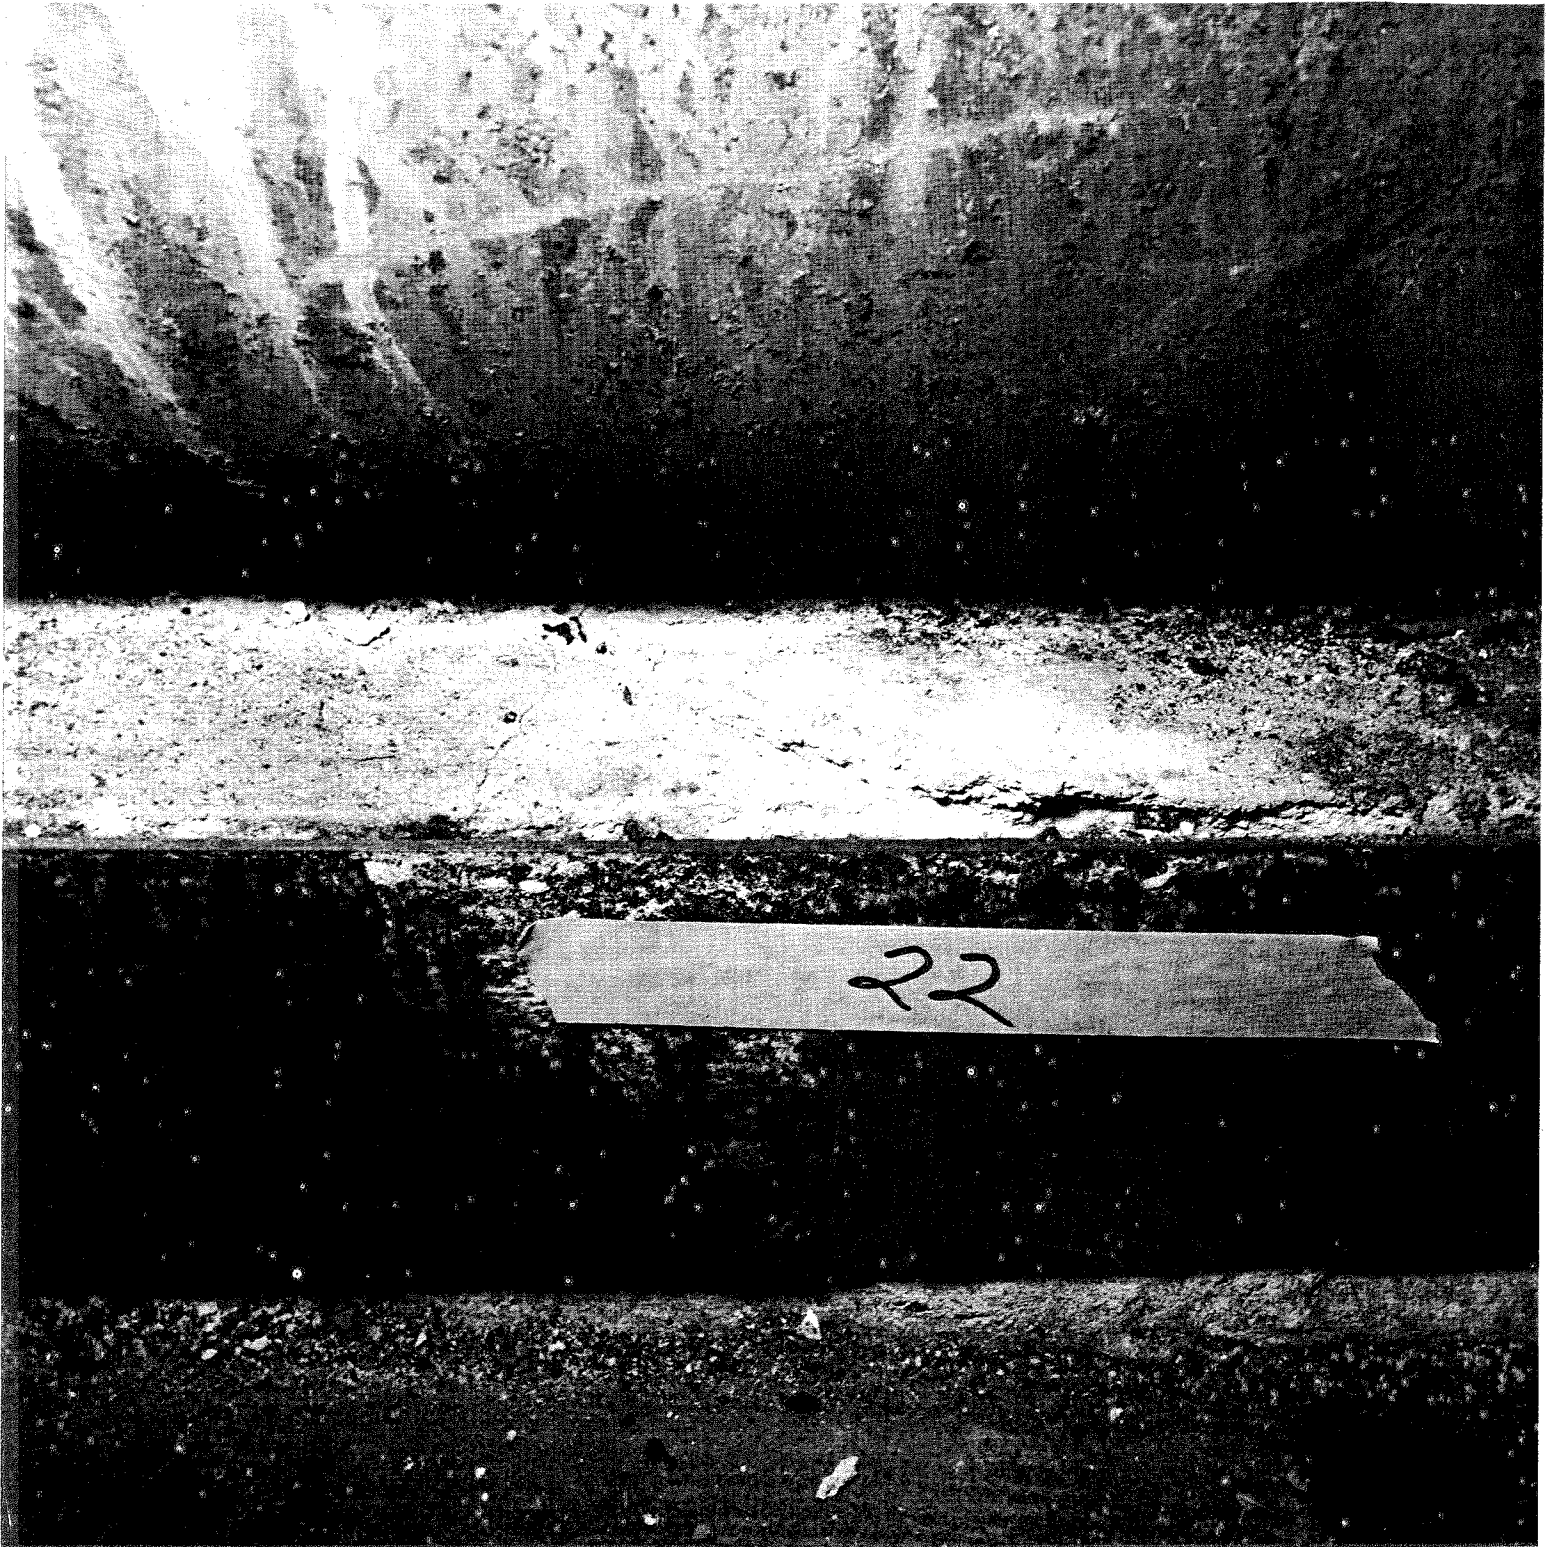
FIGURE 8

TYPICAL CRACK IN REFRACTORY, TANK 101

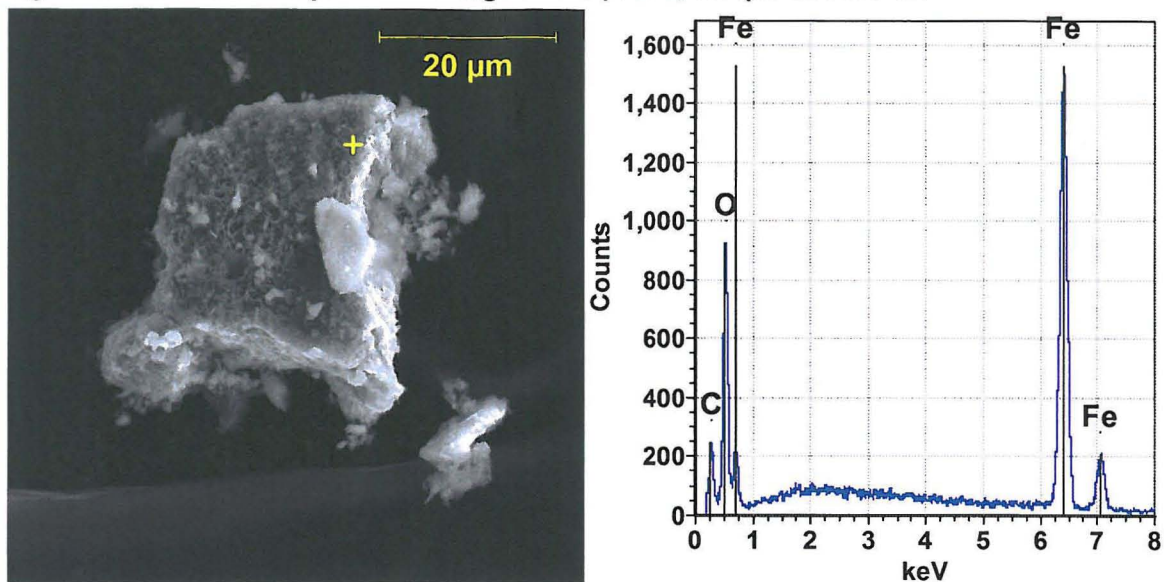
Figure 11. SEM Secondary Electron Image of Rust/Scale, Sample 12-ANU-5A

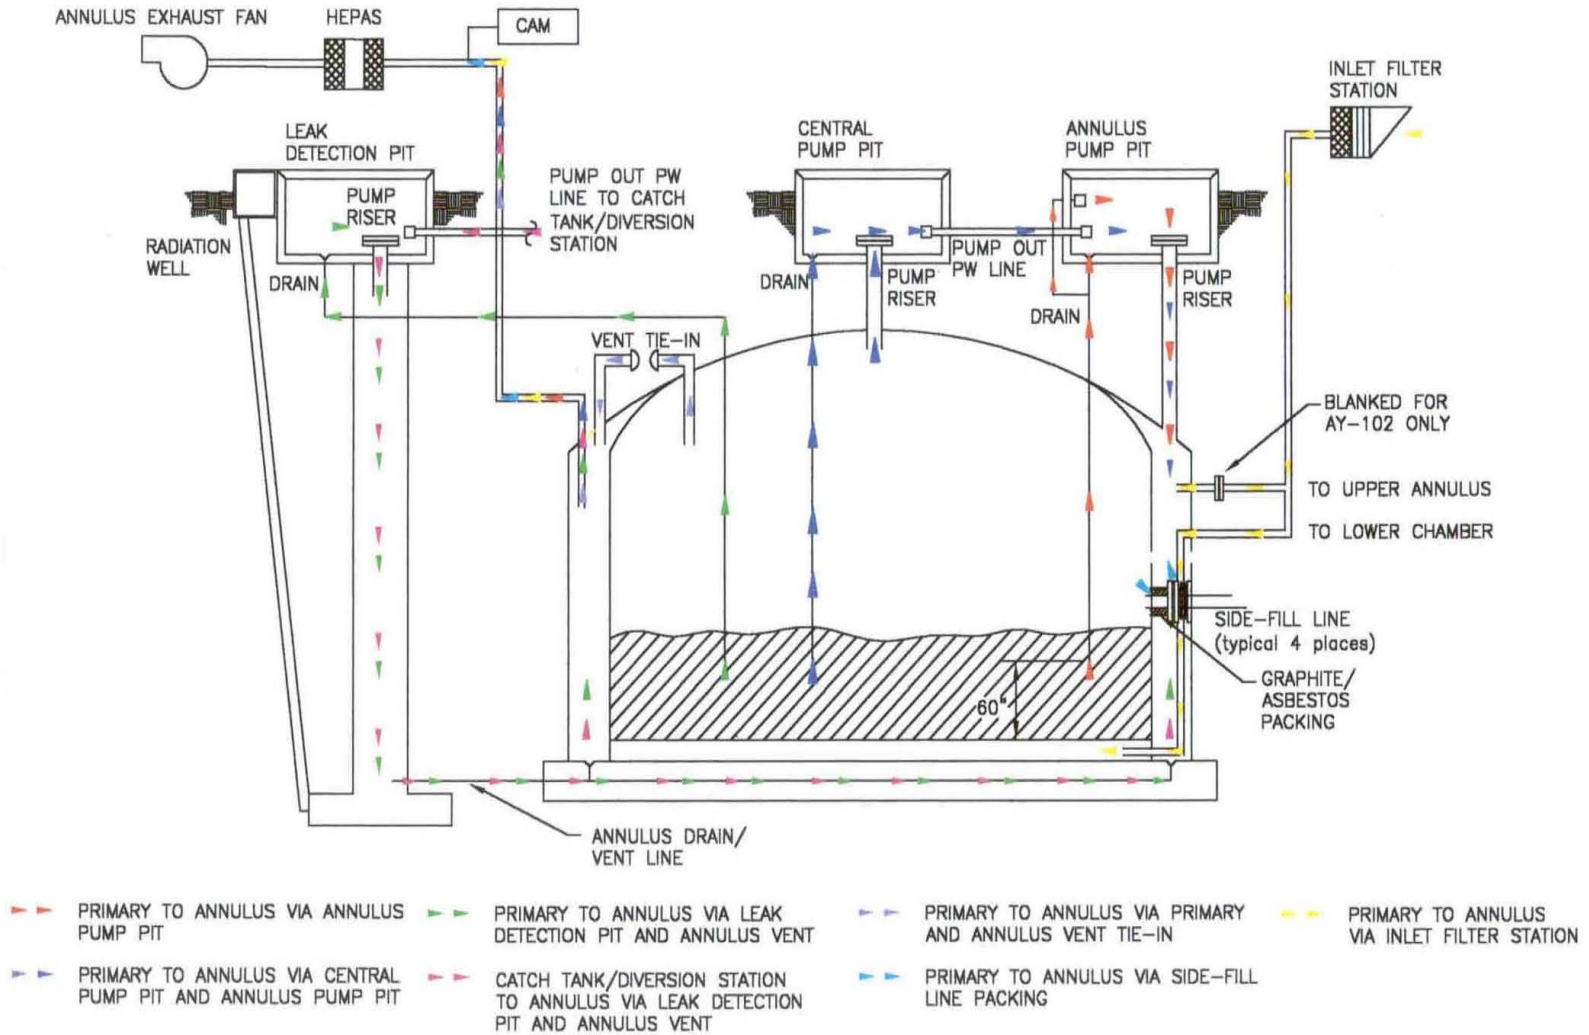
IV. AWF LEAK PATH DIAGRAM

POTENTIAL CROSS CONNECTIONS BETWEEN PRIMARY AND ANNULUS HEADSPACE
AGING WASTE FACILITY TANKS (TYPICAL)
