RESEARCH REPORT

RE-ENTRY FLIGHT DEMONSTRATION NUMBER ONE (RFD-1);
DESIGN, DEVELOPMENT, AND PERFORMANCE OF
THE RE-ENTRY VEHICLE

SC-RR-64-511
TID-4500 (27th Edition)
AEROSPACE SAFETY

RE-ENTRY FLIGHT DEMONSTRATION NUMBER ONE (RFD-1):
DESIGN, DEVELOPMENT, AND PERFORMANCE OF THE RE-ENTRY VEHICLE

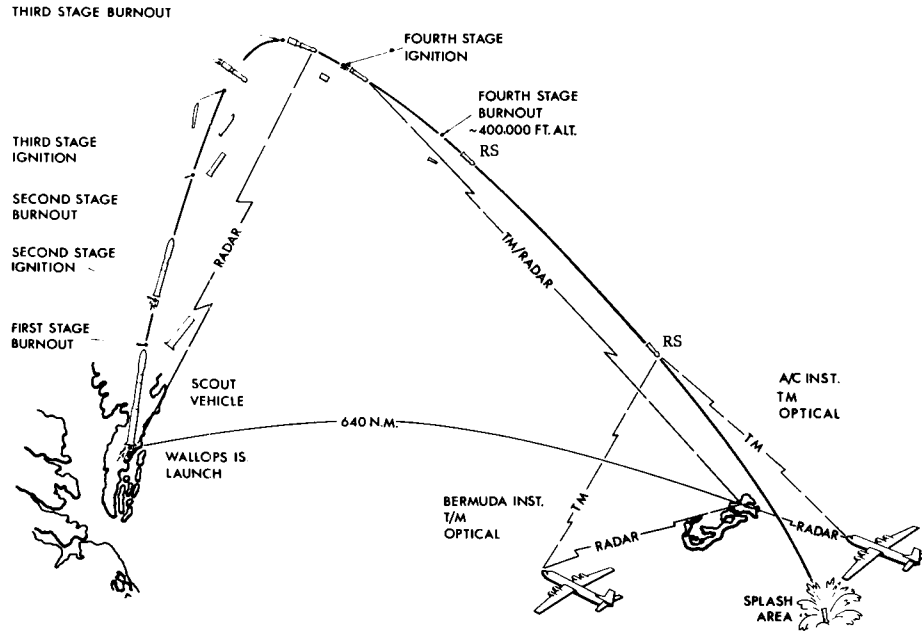
Figure 5. SNAP-10A safety flight-test trajectory

In an attempt to approximate the aerodynamic heating of the reactor which occurs during orbital decay, the RFD-1 was flown on a re-entry trajectory from Wallops Island, Virginia, to an impact area approximately 200 miles southeast of Bermuda. The NASA Scout booster (Figure 3) was used to place the re-entry system (Figure 4) into the required trajectory. As Figure 5, the flight trajectory, shows, the Scout fourth-stage motor burned out at an altitude of approximately 400,000 feet. This altitude was considered to be the start of re-entry for RFD-1.

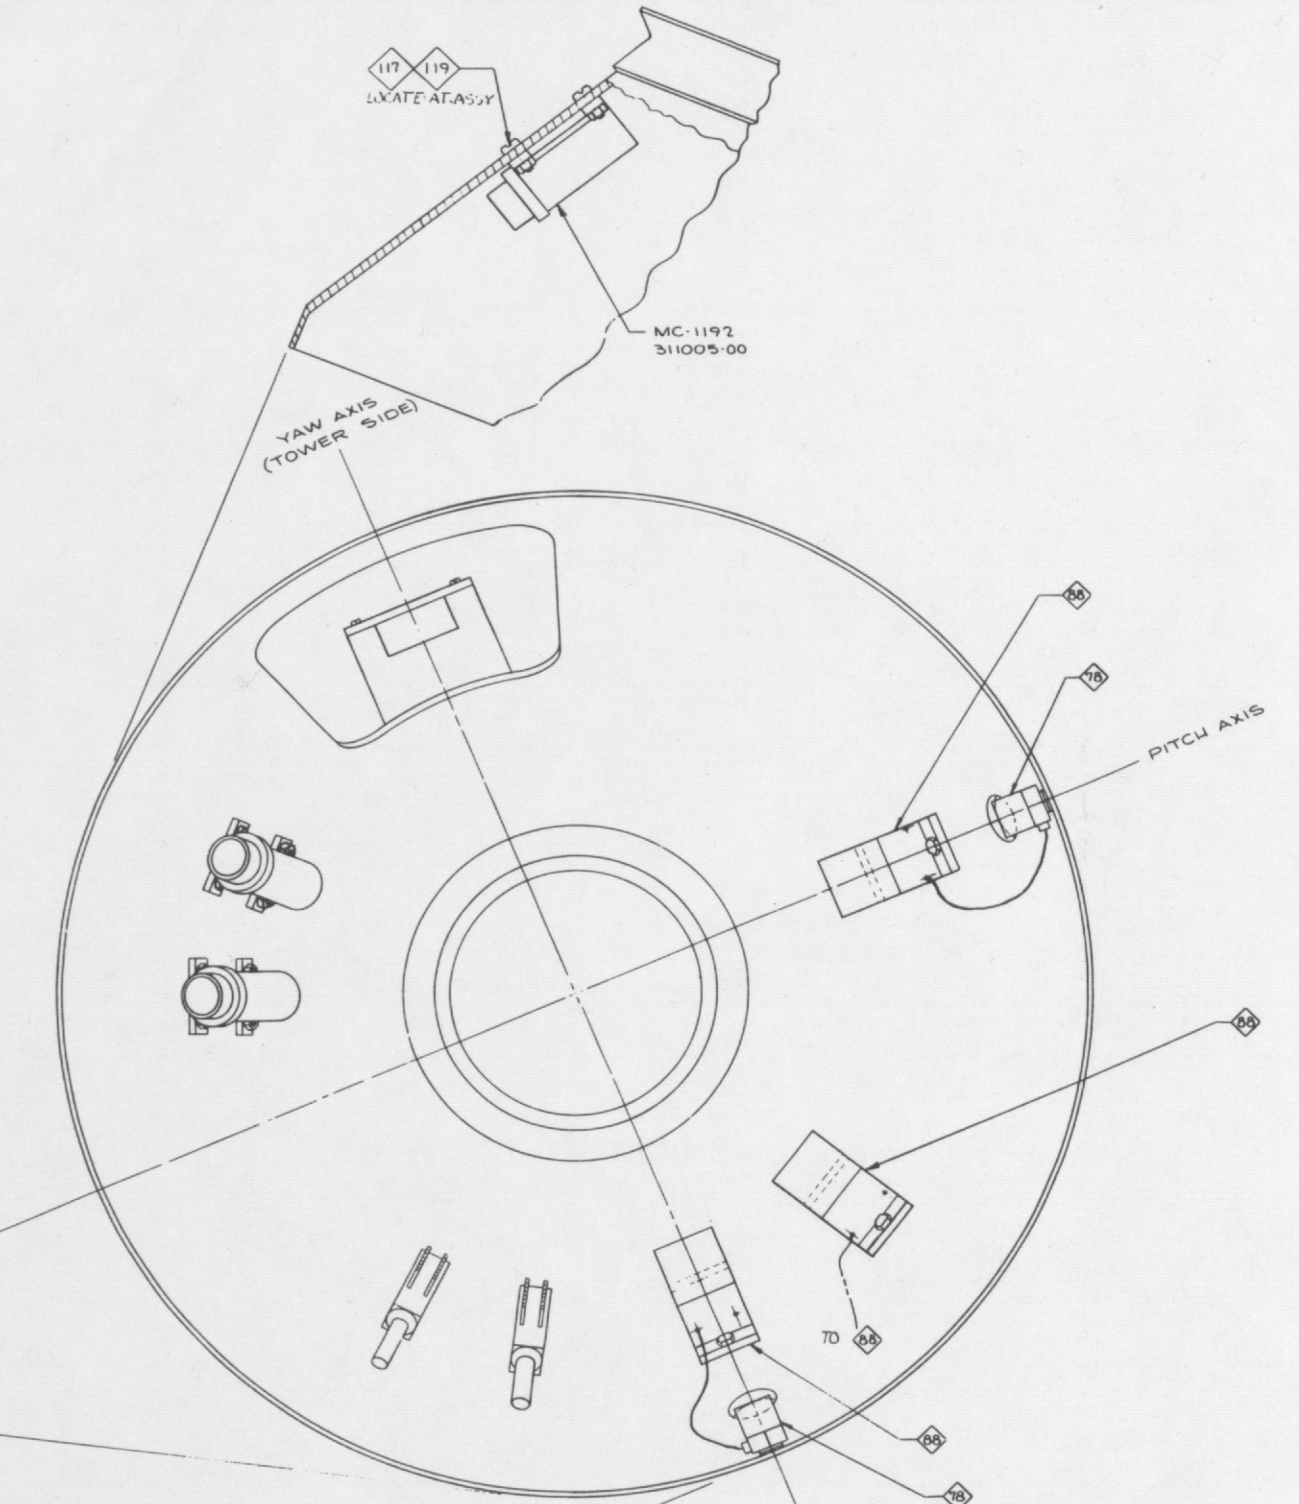
Figure 6. Re-entry vehicle assembly

The body of the re-entry vehicle was simply supported by the fourth-stage motor at Scout Station 84.65 by means of the four centerings supports attached to the motor (these supports were designed to wedge against the re-entry vehicle).

CVC754-124-E12
 WASHERS TO SEPARATE STEEL AND MAGNESIUM COMPONENTS

CVC754-124-E12
 1 WASHER UNDER EACH NUT

In the interests of establishing a center of gravity to render the re-entry vehicle aerodynamically stable, the Scout fourth stage had to be separated as soon as possible after motor burnout. The separation system was designed to accomplish this separation reliably and also to serve as the structural link between the fourth-stage motor and the re-entry system. The components making up the separation system are individually described below and are shown in Figure 6, p. 19.

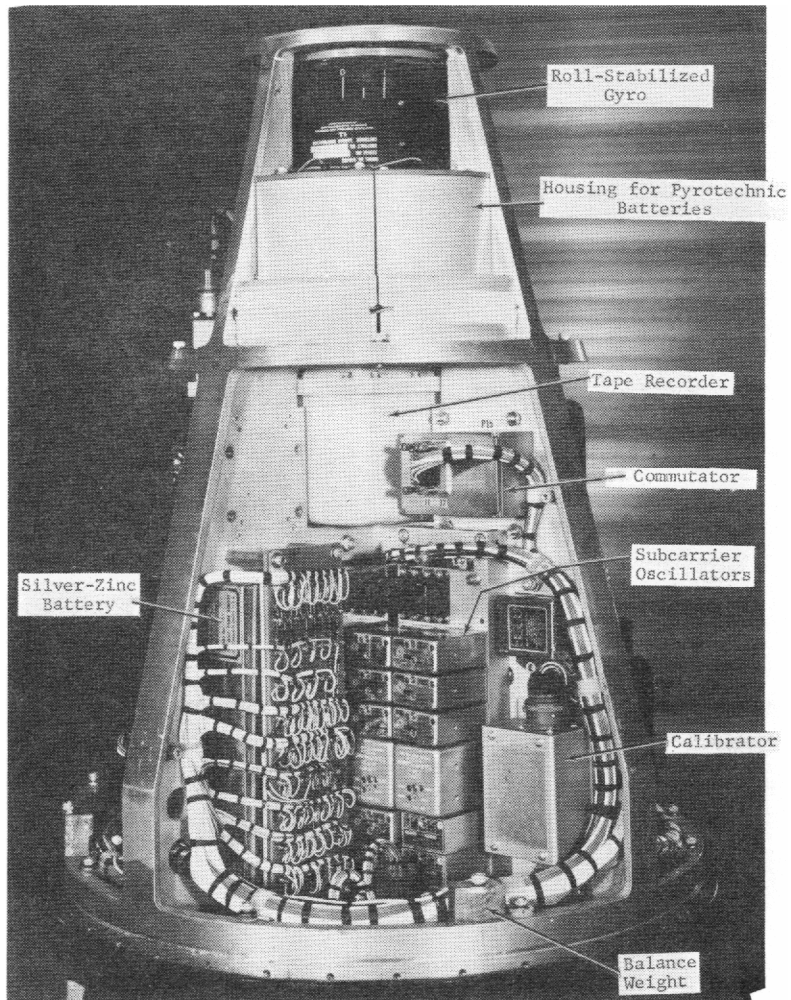
Figure 10. TM package

The RF amplifier provided an output of 10 watts when driven by the 2 watts from the RF transmitter. Both amplifier and transmitter were standard models used and proved by Sandia Corporation in previous missile flight tests. Figures 10 through 13 show the telemetry package.

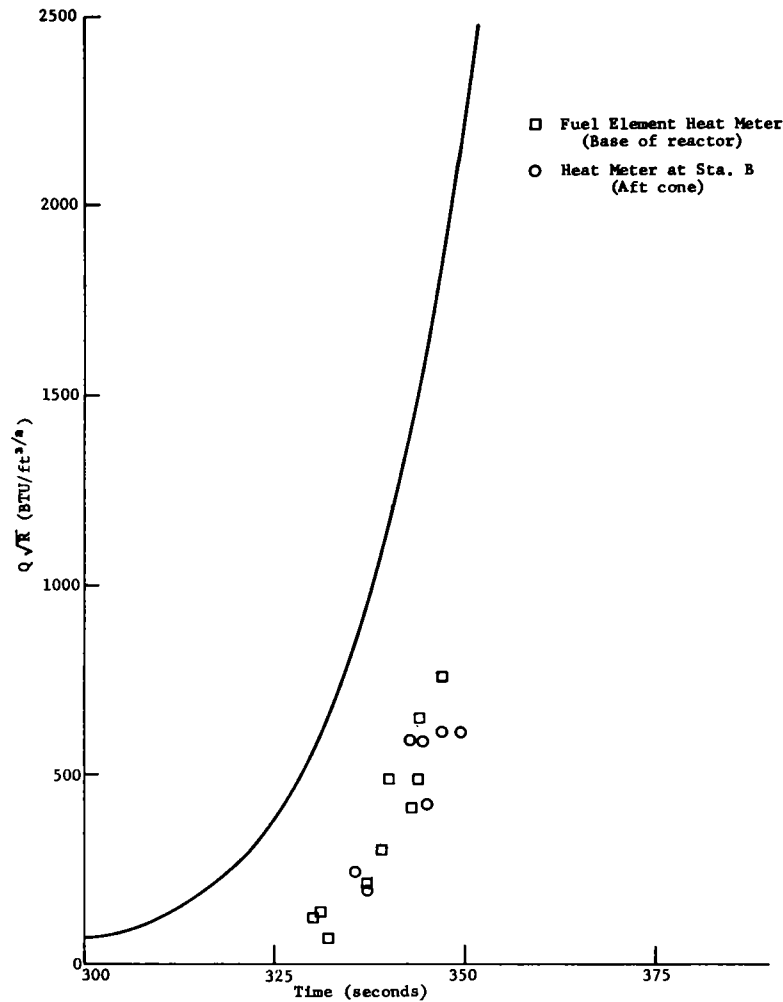
Figure 16. Heat meter results on RFD-1 integrated heating

The re-entry vehicle heat meters consisted of two copper slugs mounted in the skin of the nose. The copper slugs were instrumented with chromel/alumel thermocouples and were designed to operate in the same manner as the fuel rod meter described above.

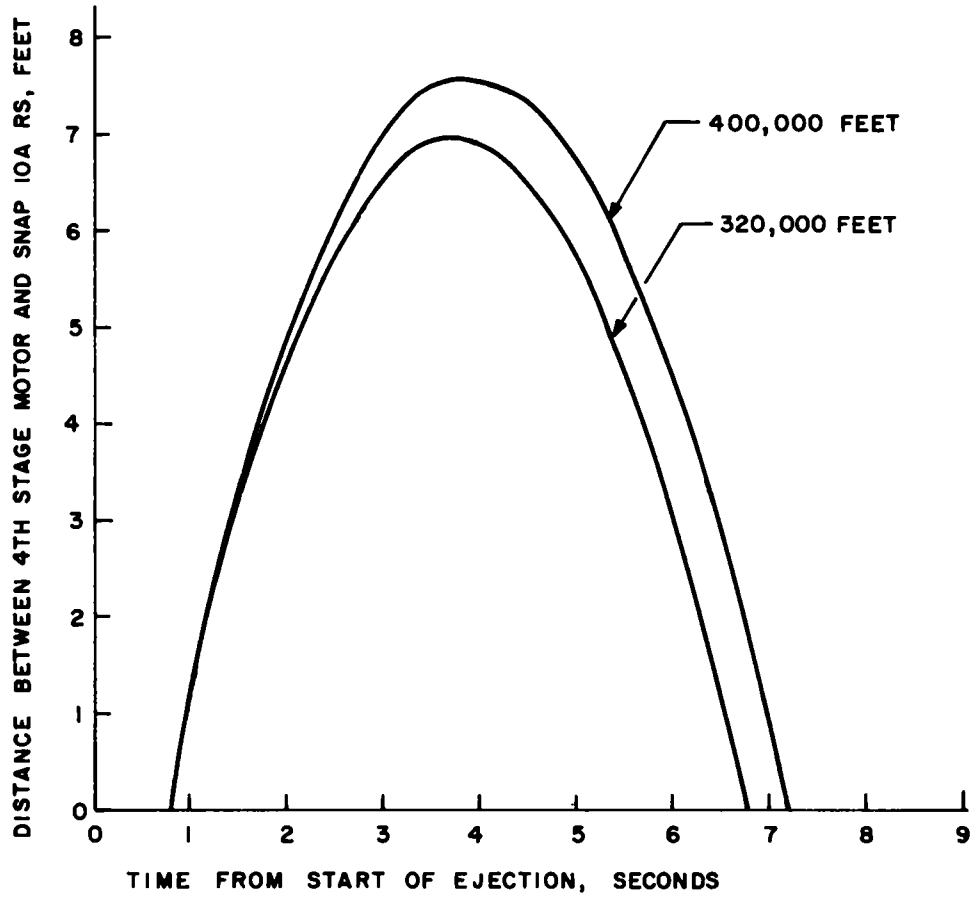
Figure 20. Fourth-stage-motor separation distance versus time

To decrease the possibility that the exhaust from the retro-rockets would interfere with the stability of the re-entry vehicle, it was necessary to provide for the maximum possible separation distance between the fourth-stage motor and the re-entry vehicle before igniting the retro-rockets. Ignition was therefore delayed (Figure 8, p. 26) for about 3 seconds after the separation of the marmon clamp. As Figure 20 shows, 3 seconds corresponds to a separation distance of about 6 feet.

THREE POUNDS RESIDUAL THRUST IN 4TH STAGE MOTOR
NO RETRO-ROCKETS FIRED

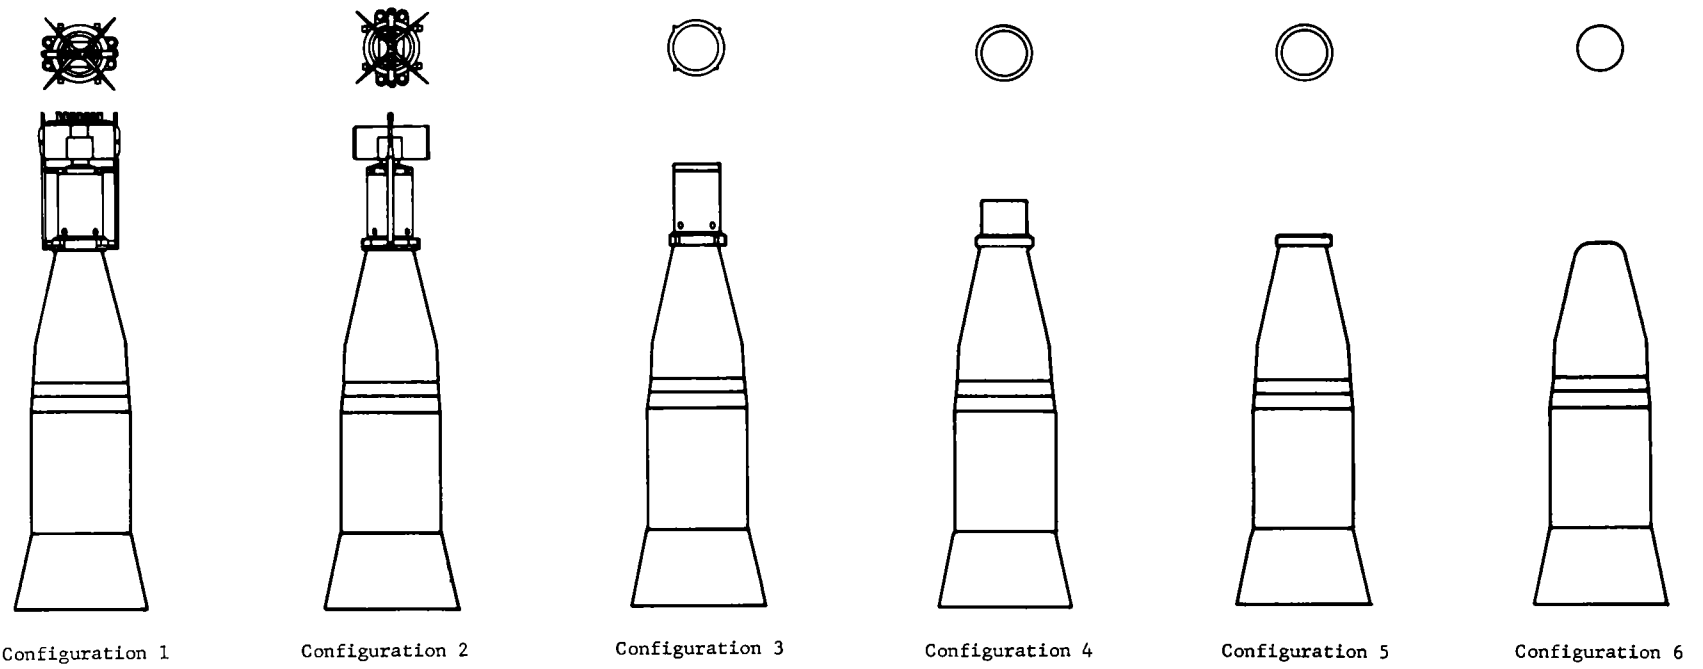
Figure 30. Wind tunnel tested re-entry system configurations

Conditions for the first three of these tests were based on the re-entry phase of a preliminary Scout launch vehicle trajectory arrived at by the use of theoretically calculated aerodynamic coefficients. The coefficients obtained from these three tests were in turn used in a trajectory to obtain test conditions for the fourth test. (See next section.) In the third test, the viscous interaction parameter was simulated within the limitations of the facility. In the other three tests, the Reynolds number was simulated as closely as the limitations of the facilities permitted. Figure 31 presents typical photographs of the flow field around scale models of two of the re-entry system configurations during wind-tunnel tests.

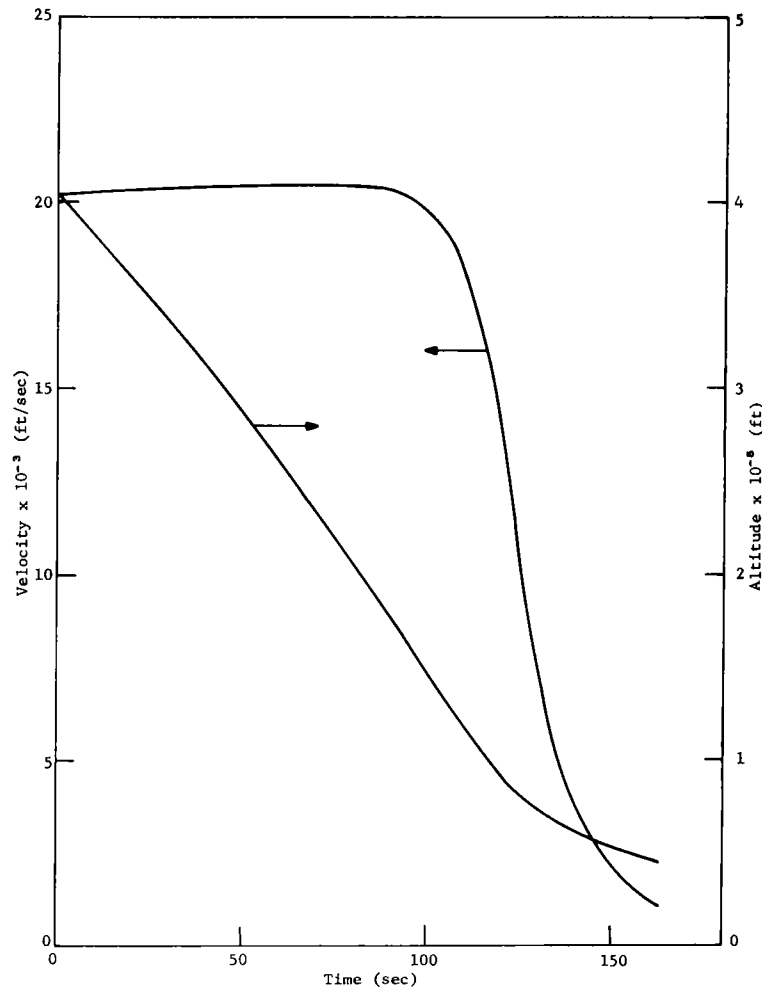
Figure 43. RFD-1 trajectory (altitude and velocity versus time)

The ballistic coefficient ($W/C_D A$) varied from 134 to 329 lb/ft² due to Mach number effects and to the changes in drag coefficient (C_D) and weight with disassembly of the reactor and ablation of the RV. The method of calculating the trajectory is described in Sandia Corporation report SC-RR-64-510. Altitude and velocity as functions of time from 404,066 feet are shown in Figure 43.

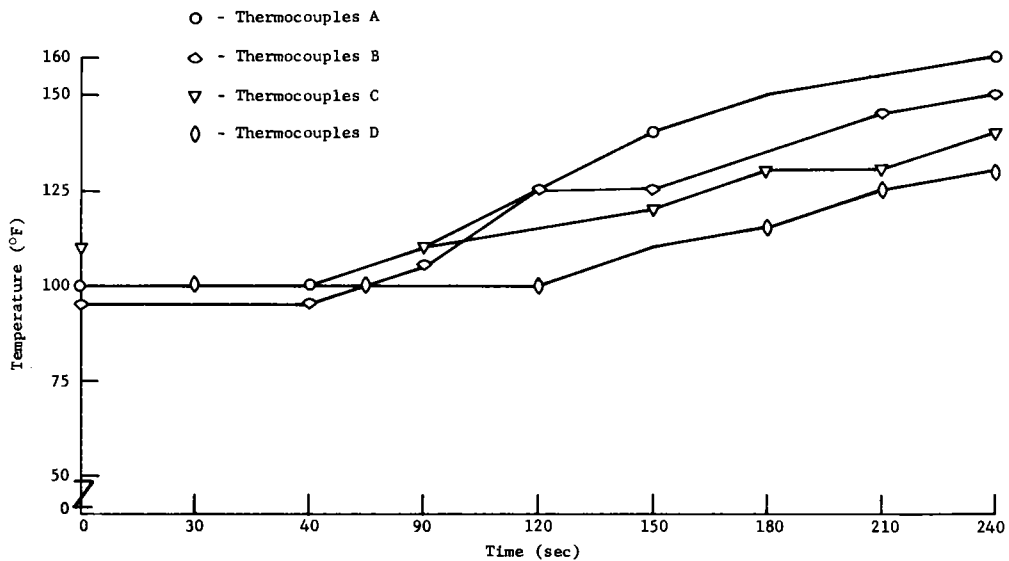
Figure 61. Results of radiant-heat test of baroswitches

Baroswitches -- The thermal protection system used on the baroswitches was identical to that used on the CO₂ bottles. The baroswitches were subjected to a peak heating pulse of 18 BTU/ft² sec (twice the expected value) in the Radiant Heat Facility. Temperatures and switch function were monitored during the test. The switch operated satisfactorily, and the temperature recorded on the switch, as shown in Figure 61, was within acceptable limits.

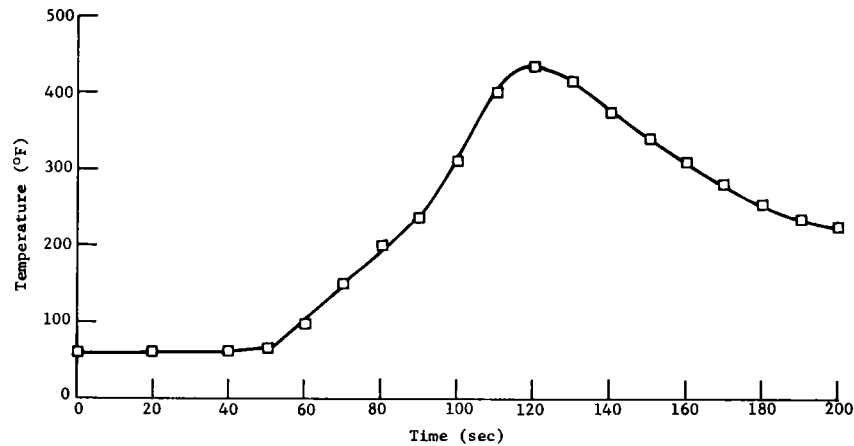
Figure 62. Radiant-heat test of the parachute cord

Parachute Cord -- The parachute cord which connected the recovery chute to the re-entry vehicle consisted of a flat, woven, 1-inch wide fiberglass cord coated with a 0.040-inch layer of D-65 intumescent coating. When this cord was subjected to an expected peak heating pulse of 9 BTU/ft² sec in the Radiant Heat Facility, the maximum temperature experienced by the fiberglass under the layer of D-65 coating was 435°F (see Figure 62). The cord was subsequently tensile-tested in a 425°F oven. It failed at 700 pounds in the oven test, as against its strength of 980 pounds at ambient temperature. However, the 700-pound strength was adequate for service with the recovery parachute.

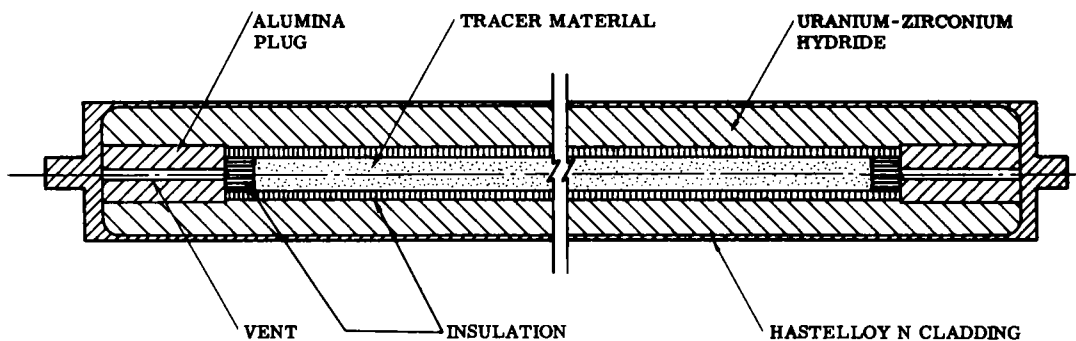
Figure 72. Sectional view of fuel element with tracer

<u>Wall Thickness (inches)</u>	<u>Tracer</u>
Group 1	0.106	Strontium
Group 2	0.184	Barium
Group 3	0.306	Silver
Group 4	0.406	Gold

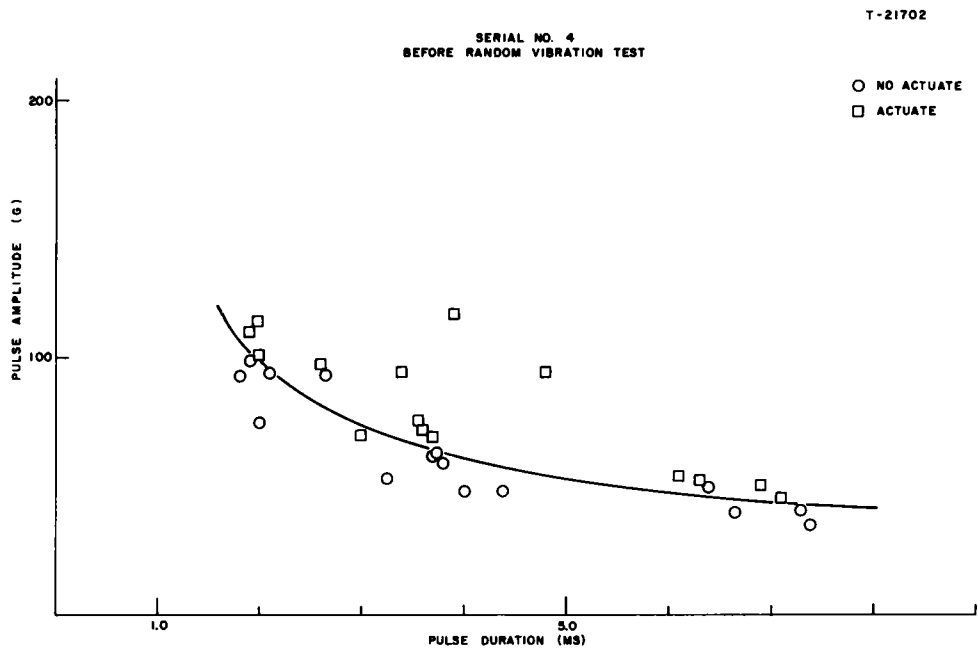
Figure 75. MC1441 functional shock test

In order to determine the effect of angle impact, some other units were tested with the actuation axis of the switch 30 degrees off from the vertical axis. No significant increase in level of actuation was observed to be associated with angle impact as compared with vertical impact.

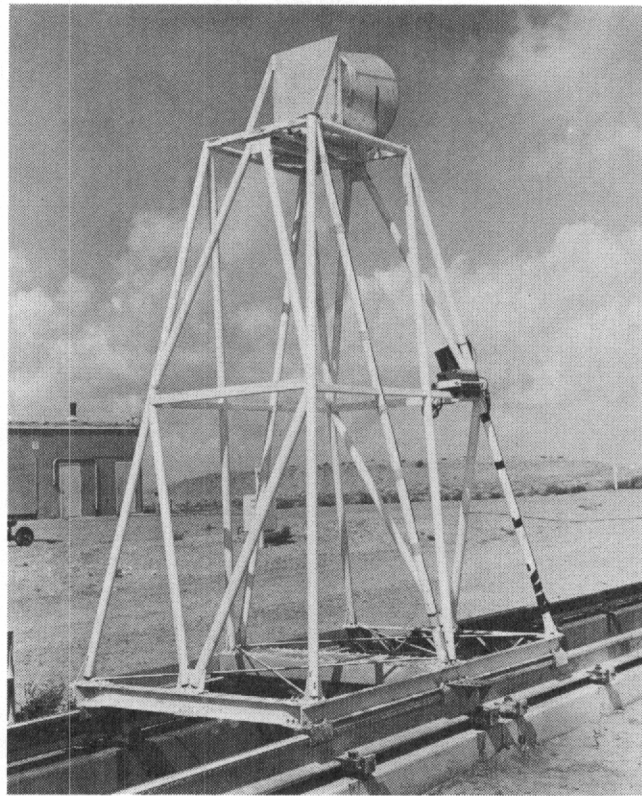
Preliminary sled tests were performed on an aluminum simulated version of the structure of the parachute compartment of the re-entry vehicle. This test setup is shown on Figure 78. These tests demonstrated that the parachute compartment was structurally adequate. They also showed that, with a pressure cartridge able to eject a 1-pound projectile at 250 fps, the drogue gun would deploy the parachute

after releasing the bonded-in-place parachute cover. Four tests were conducted in velocities ranging from 398 to 453 fps (corresponding to dynamic pressures of from 158 to 206 lb/ft²).

Figure 78. Test setup for sled tests of an aluminum simulated version of the parachute compartment

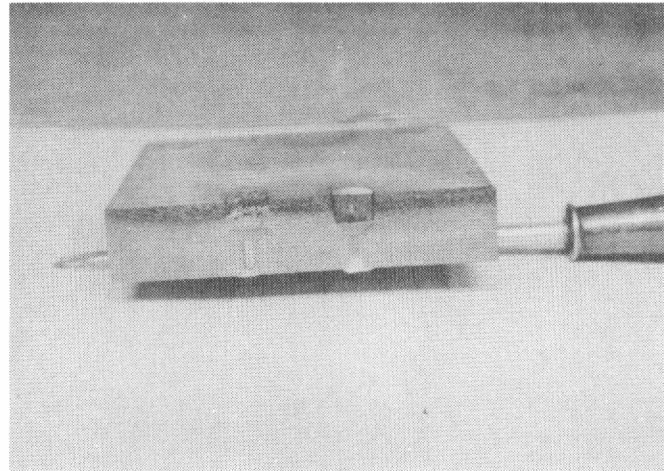
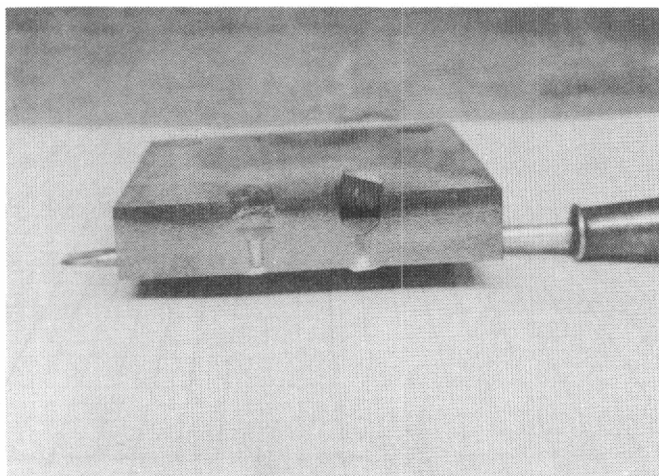
Figure 83. Results of plasma jet test of fiberglass plugs for countersunk bolt holes

b. Cross section of sample

c. Loosened fiberglass pin

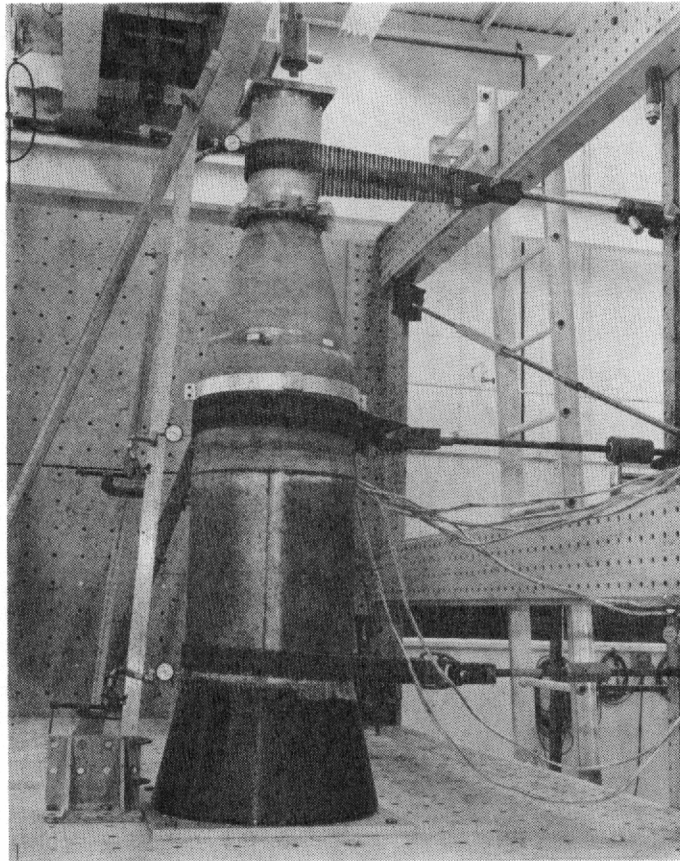
Figure 86. Test setup for mechanical load tests of the flight vehicle

<u>Test No.</u>	<u>P₁ Lateral Load at Center of Gravity of Re-entry Vehicle (pounds)</u>	<u>P₂ Lateral Load at Center of Gravity of Simulated Reactor (pounds)</u>	<u>P₃ Axial Load (pounds)</u>
1	1440	140	1060
2	530	580	1380
3	530	580	3940

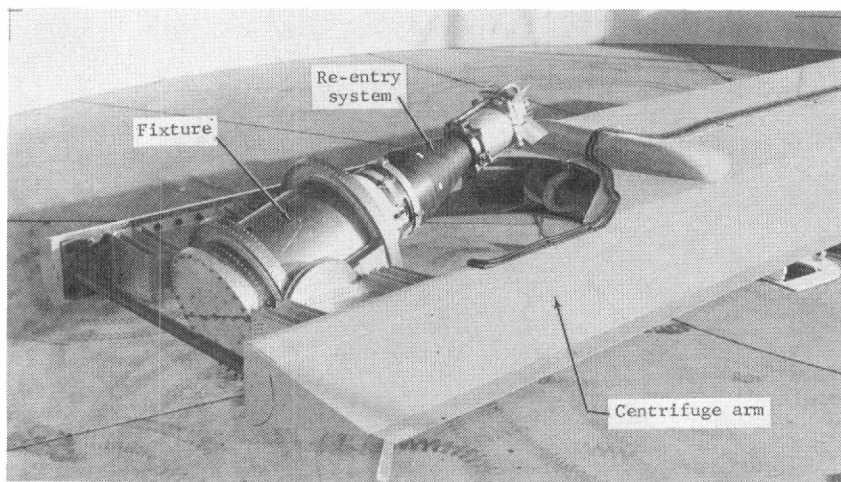
Figure 87. Test setup for linear acceleration test of the re-entry vehicle

Performed as follow ups to the static tests, these further checked the structural integrity of the re-entry vehicle and its response when subjected to linear acceleration simulating the loading condition during launch and flight of the Scout vehicle. The test setup is shown on Figure 87.

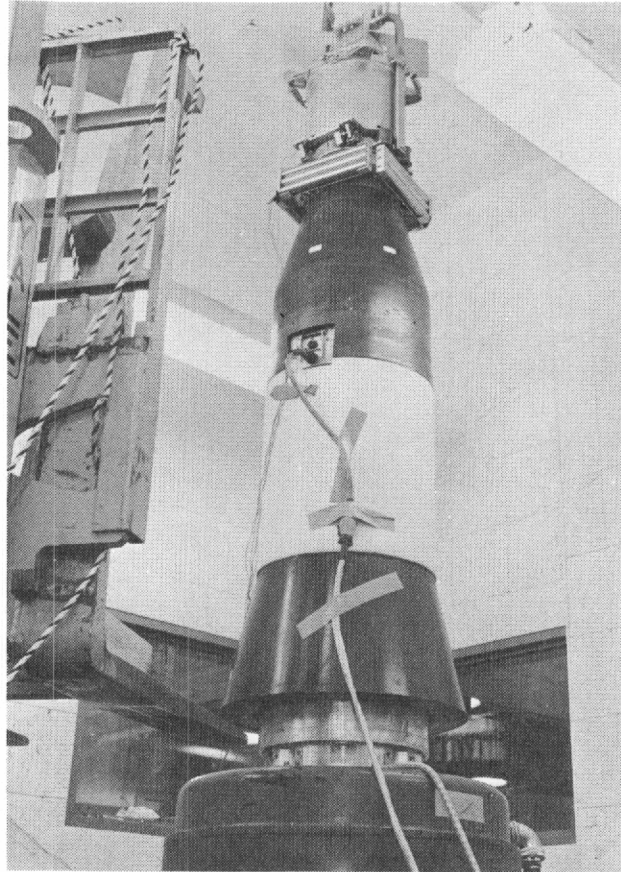
Figure 89. Test setup for sinusoidal and random vibration tests of the re-entry system

These tests checked the structural integrity of the re-entry system under a vibration environment approaching a constant force of 1/10 the nominal rocket thrust. Since the X-258 motor was being considered for use on RFD-1, 5000 pounds was chosen as the figure for nominal thrust. The test setup is shown in Figure 89. Three vehicles were tested to this type of vibration: one development unit and two qualification units. The telemetry package of the development unit contained simulated components only, but operating telemetry systems were contained in the two qualification units.

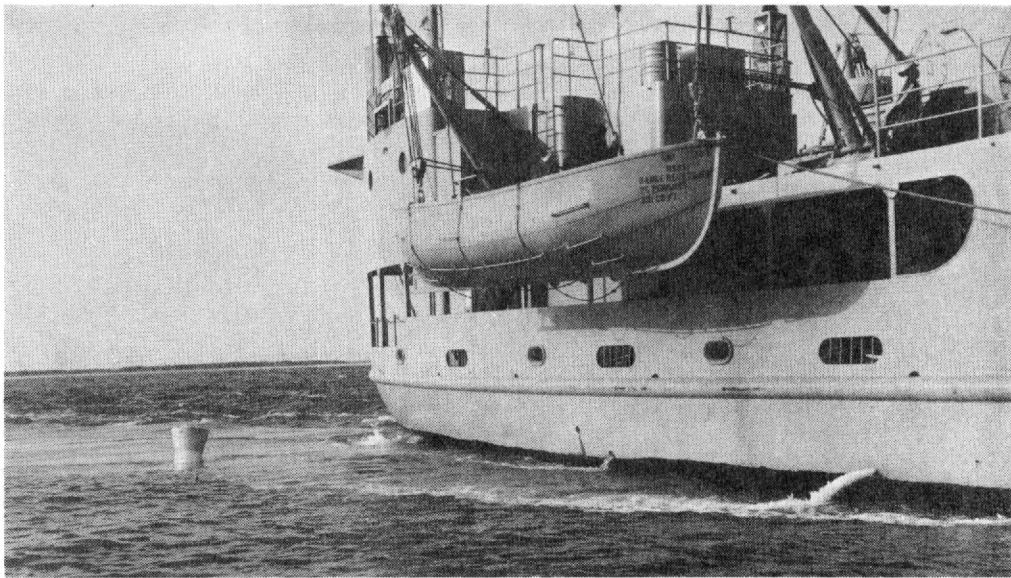
Figure 97. Floating of the re-entry vehicle after Airdrop Test S10-6 (Wallops Island Test Range)

S10-6 -- This test was conducted at Wallops Island on February 4, 1963. Except for minor modifications, instrumentation was identical to that used in S10-4. The vehicle spun up to the required velocity, the fourth stage separated, and the parachute deployed properly. The flotation bag was deployed and the vehicle floated (see Figure 97). However, the impact switches designed to turn on the SARAH beacon system upon water impact failed to actuate. This failure was attributed to an adverse impact angle (more than 30 degrees from vertical) caused by coning of the vehicle after parachute deployment.

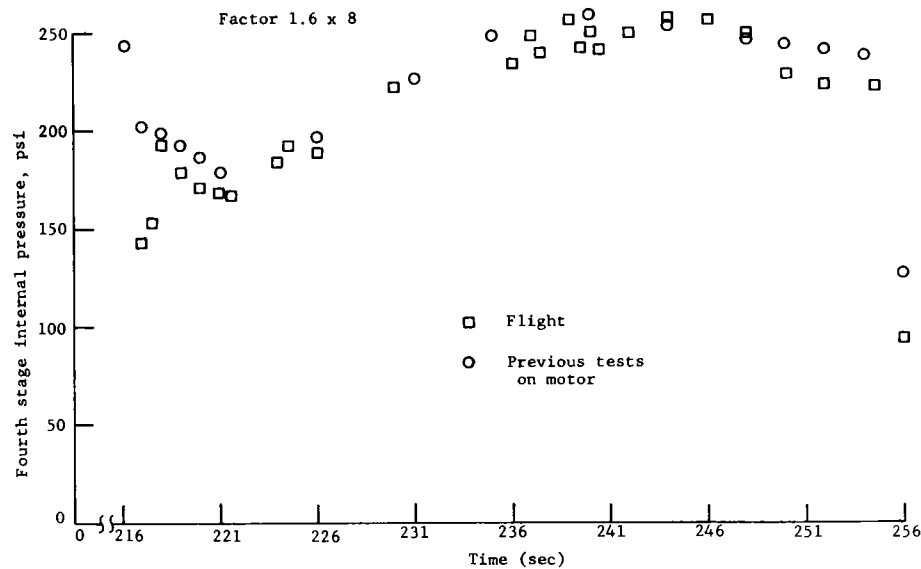
Figure 109. Data reduced from NASA pressure transducer included in RFD-1

In order that the motor thrust chamber pressure of the X-248 motor (Scout fourth stage) might be measured, a pressure transducer supplied by NASA was included in the flight. A curve of the data reduced from the transducer is shown in Figure 109. In addition, this figure shows a comparison between flight-test data and data taken from a previous static firing (ground test) of an X-248 motor. As seen in the figure, the flight data compare well with the ground test data. Unfortunately, even though data were recorded after burnout of the fourth stage, it was not possible to determine residual thrust because the data were of the same order of magnitude as the reading accuracy.
