RESEARCH REPORT

RE-ENTRY FLIGHT DEMONSTRATION NUMBER ONE (RFD-1);
DESIGN, DEVELOPMENT, AND PERFORMANCE OF
THE RE-ENTRY VEHICLE

SC-RR-64-511
TID-4500 (27th Edition)
AEROSPACE SAFETY

RE-ENTRY FLIGHT DEMONSTRATION NUMBER ONE (RFD-1):
DESIGN, DEVELOPMENT, AND PERFORMANCE OF THE RE-ENTRY VEHICLE

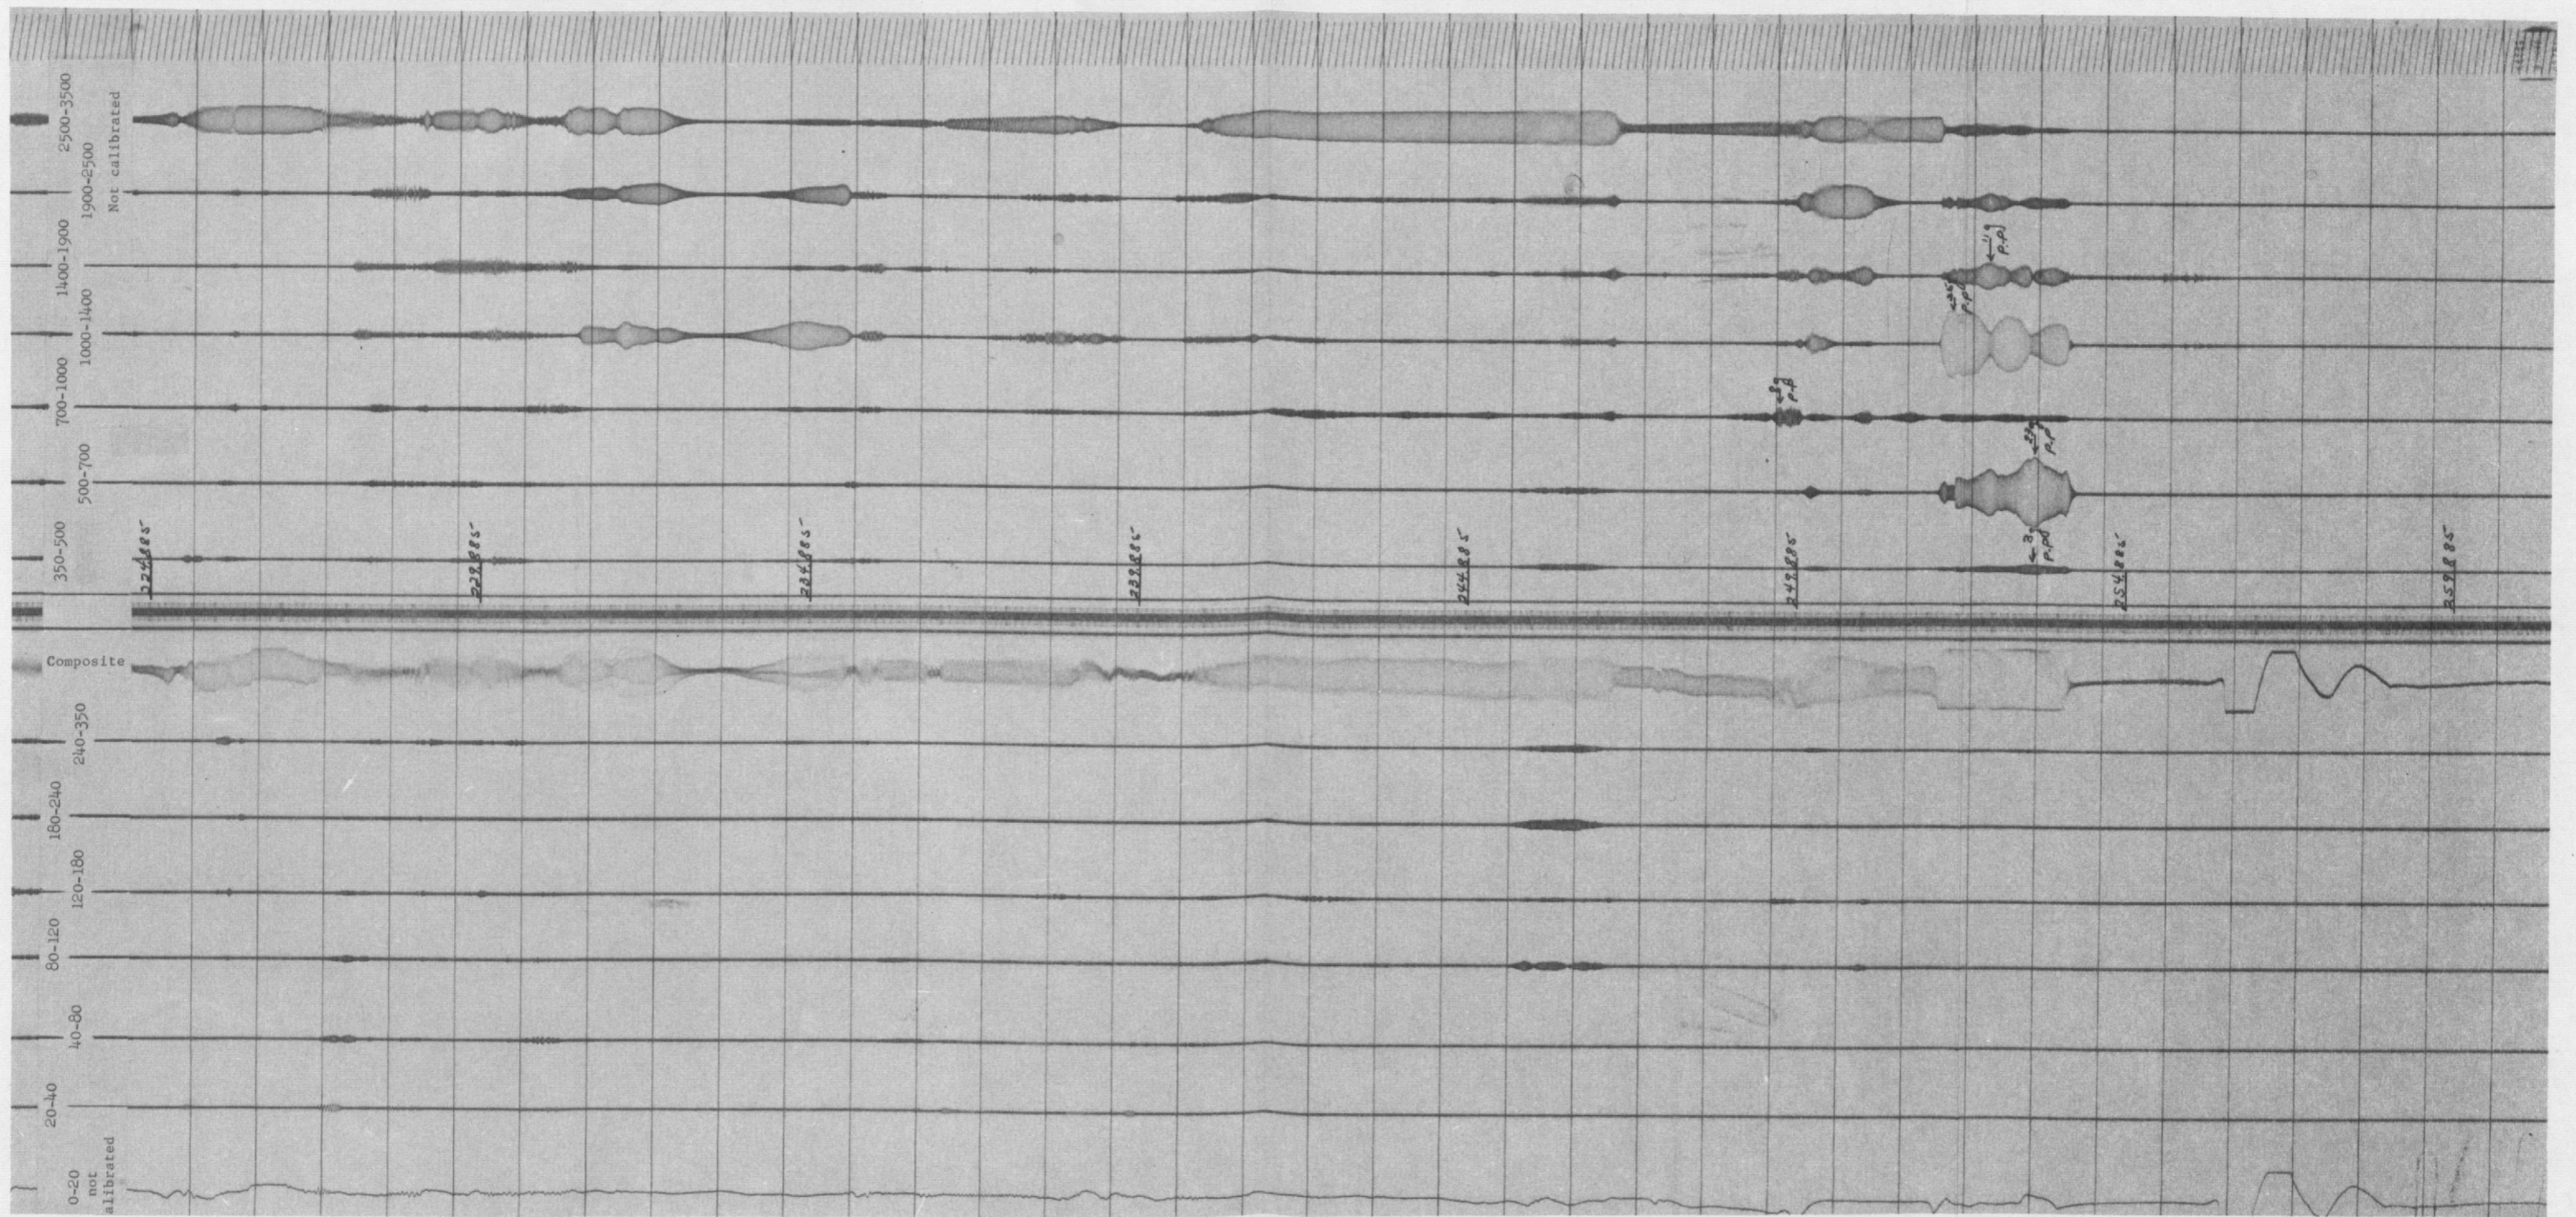
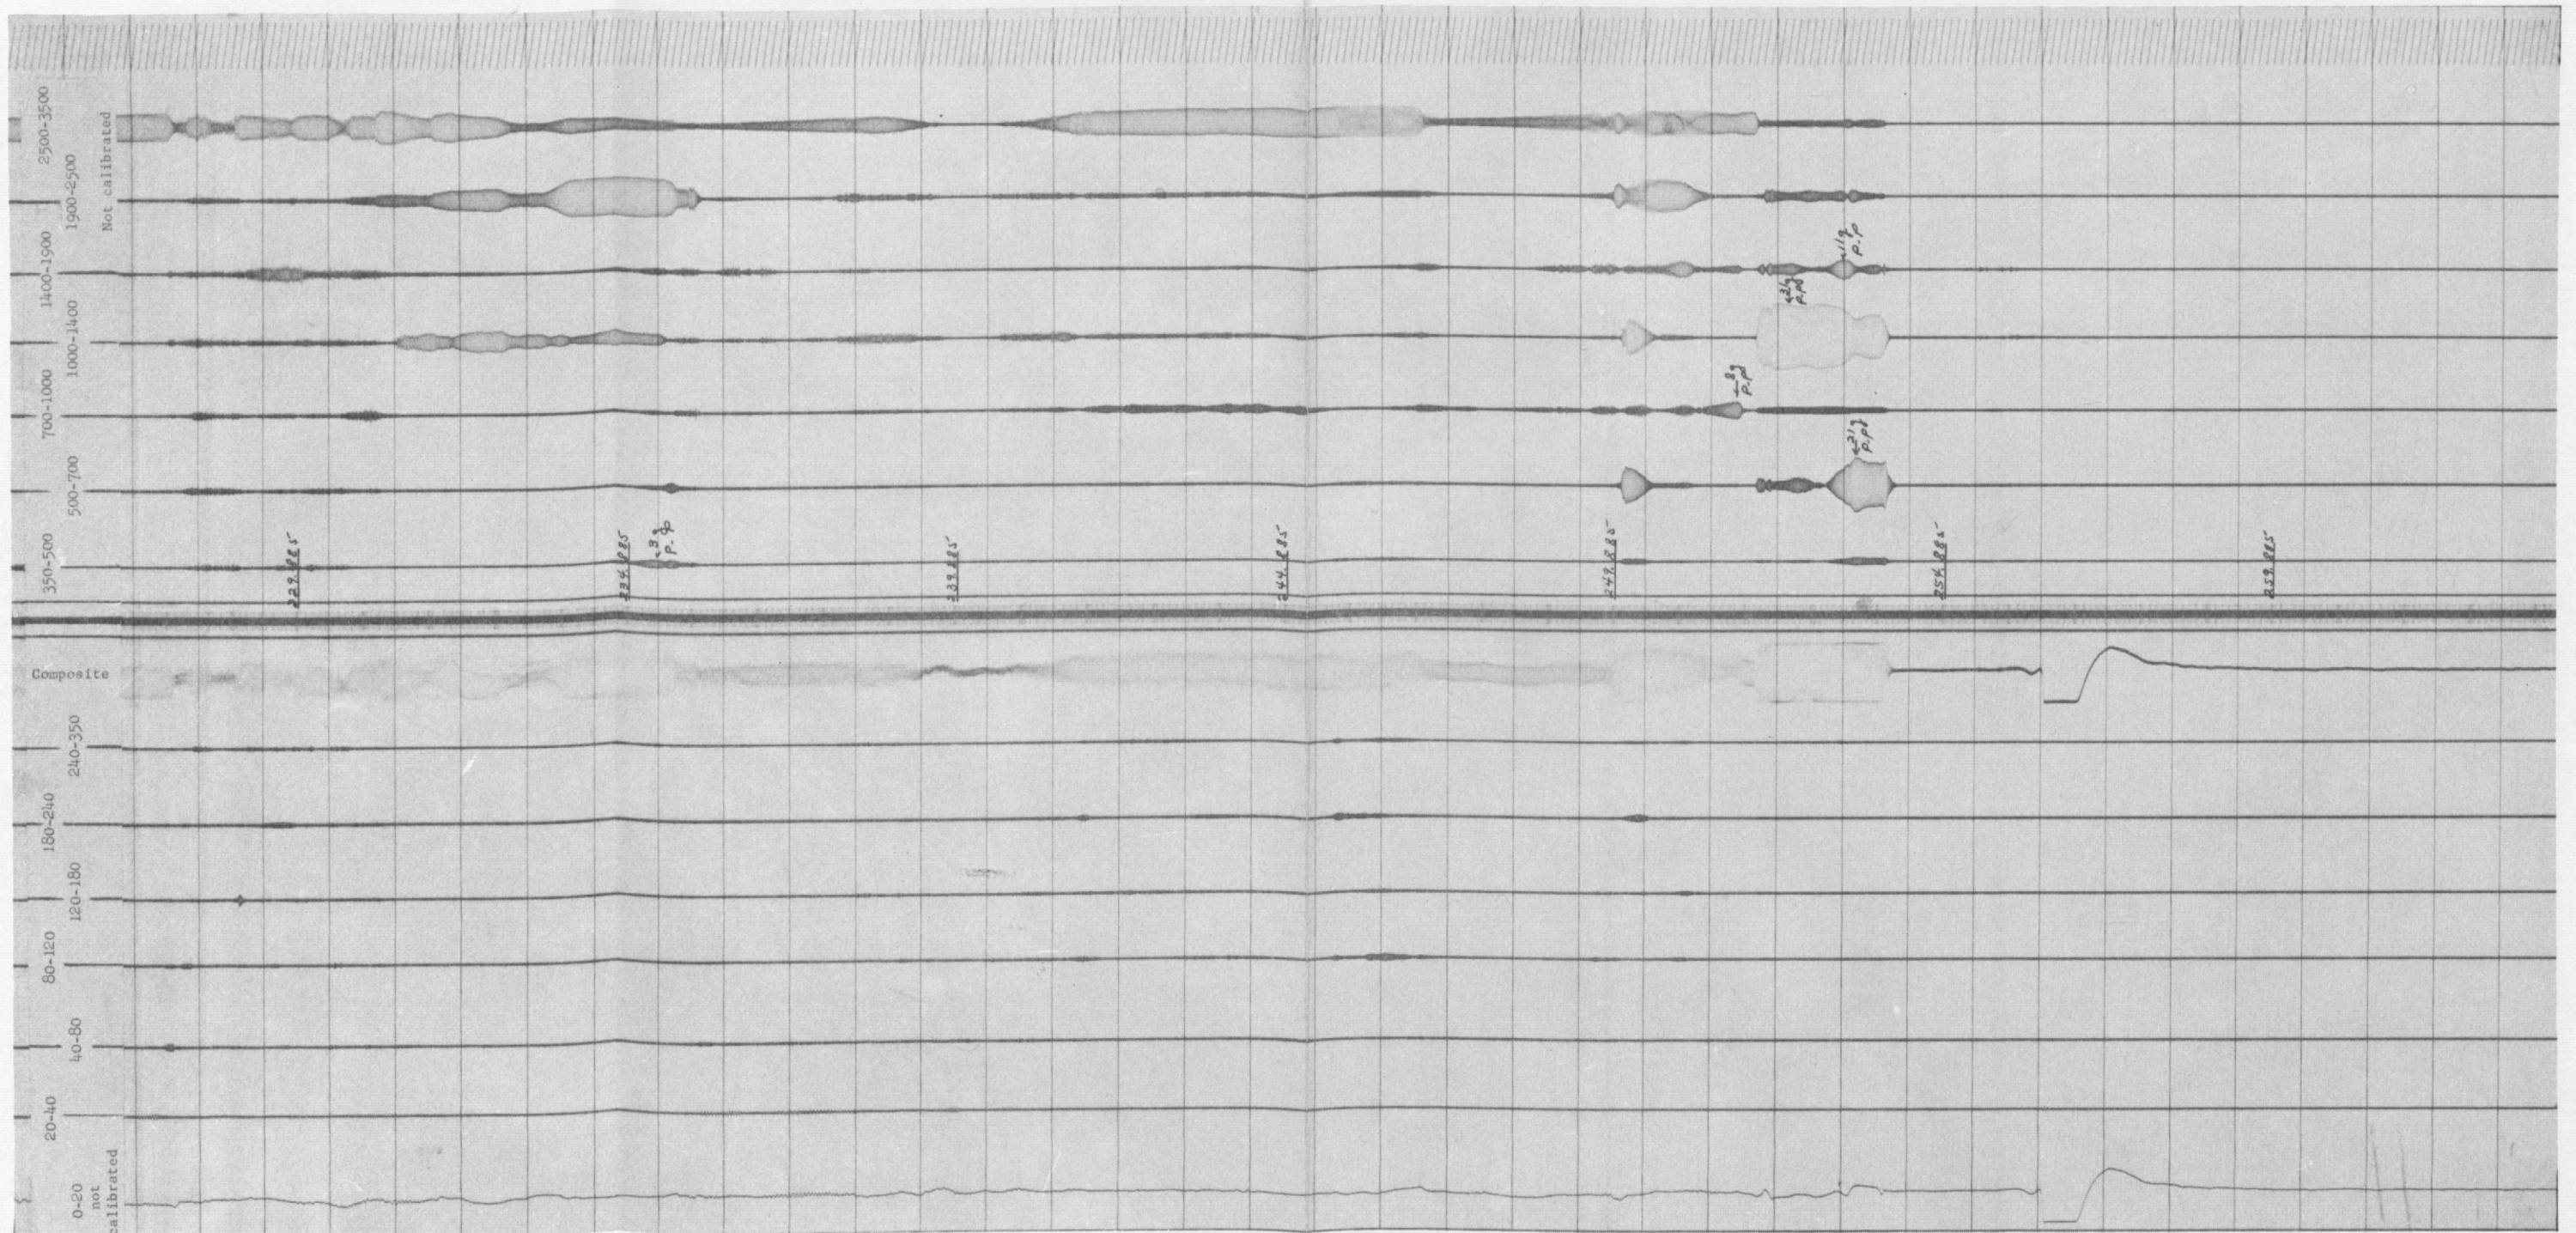
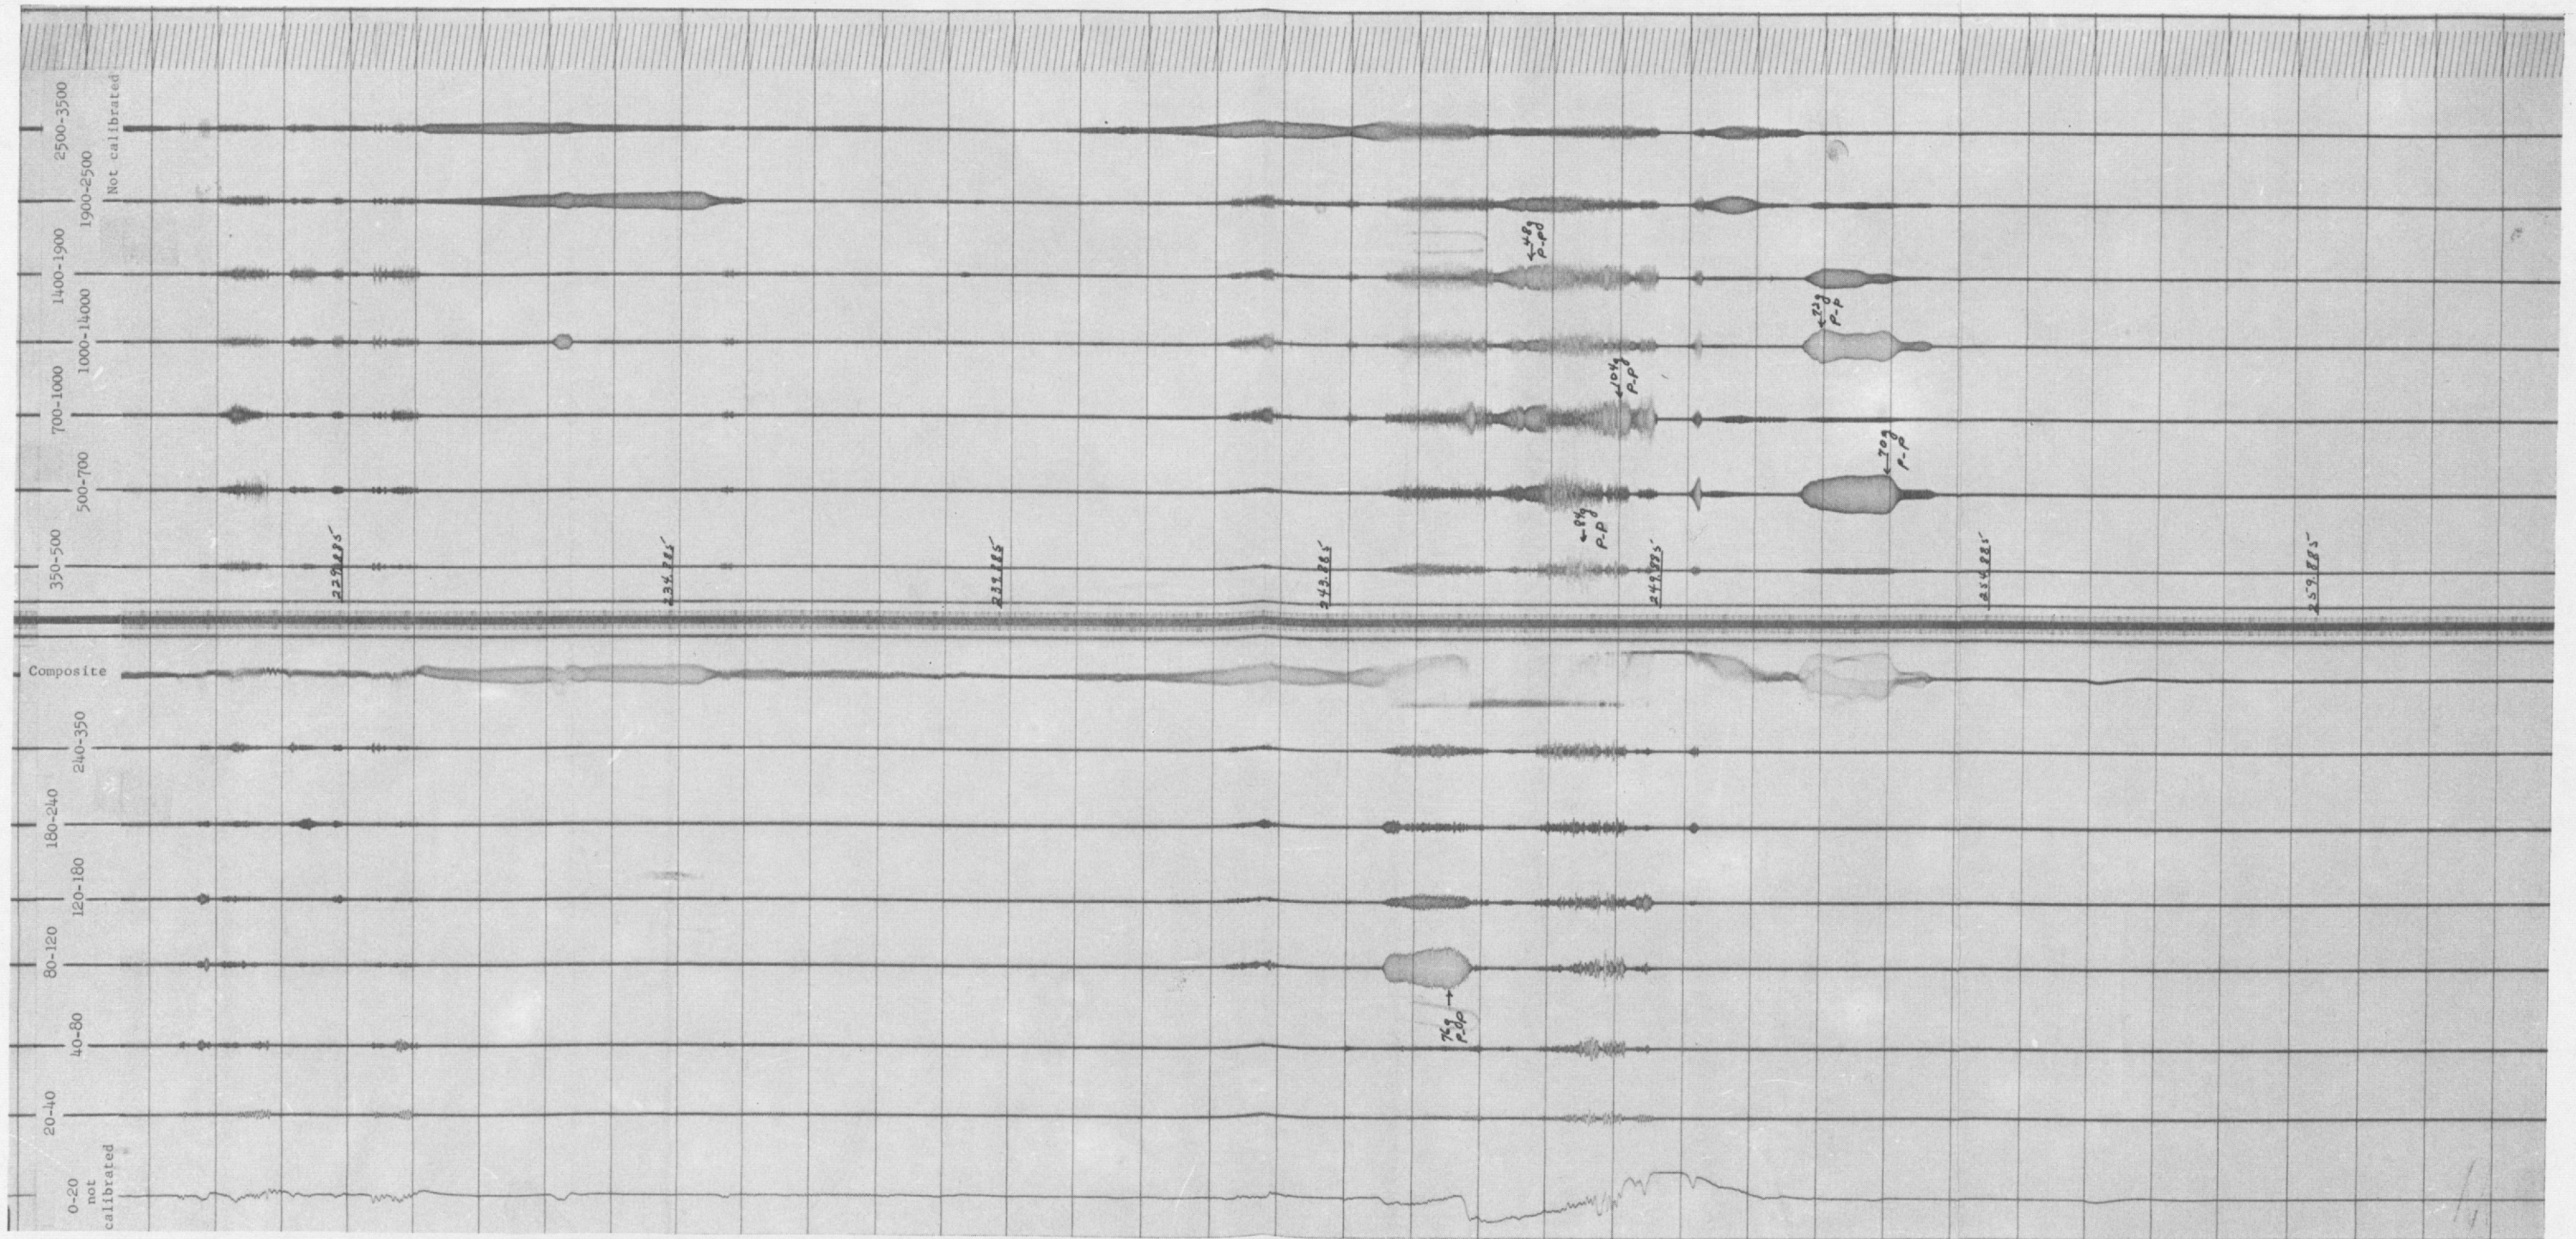
Figure 110. RFD-1 vibration data

a. Pitch vibration

b. Yaw vibration

c. Longitudinal vibration
